Bull Trout Investigations in Tributaries to Little Kachess

To Inform Design of Restoration Projects

Scott Kline Washington Department of Fish and Wildlife

Mitch Long Kittitas Conservation Trust

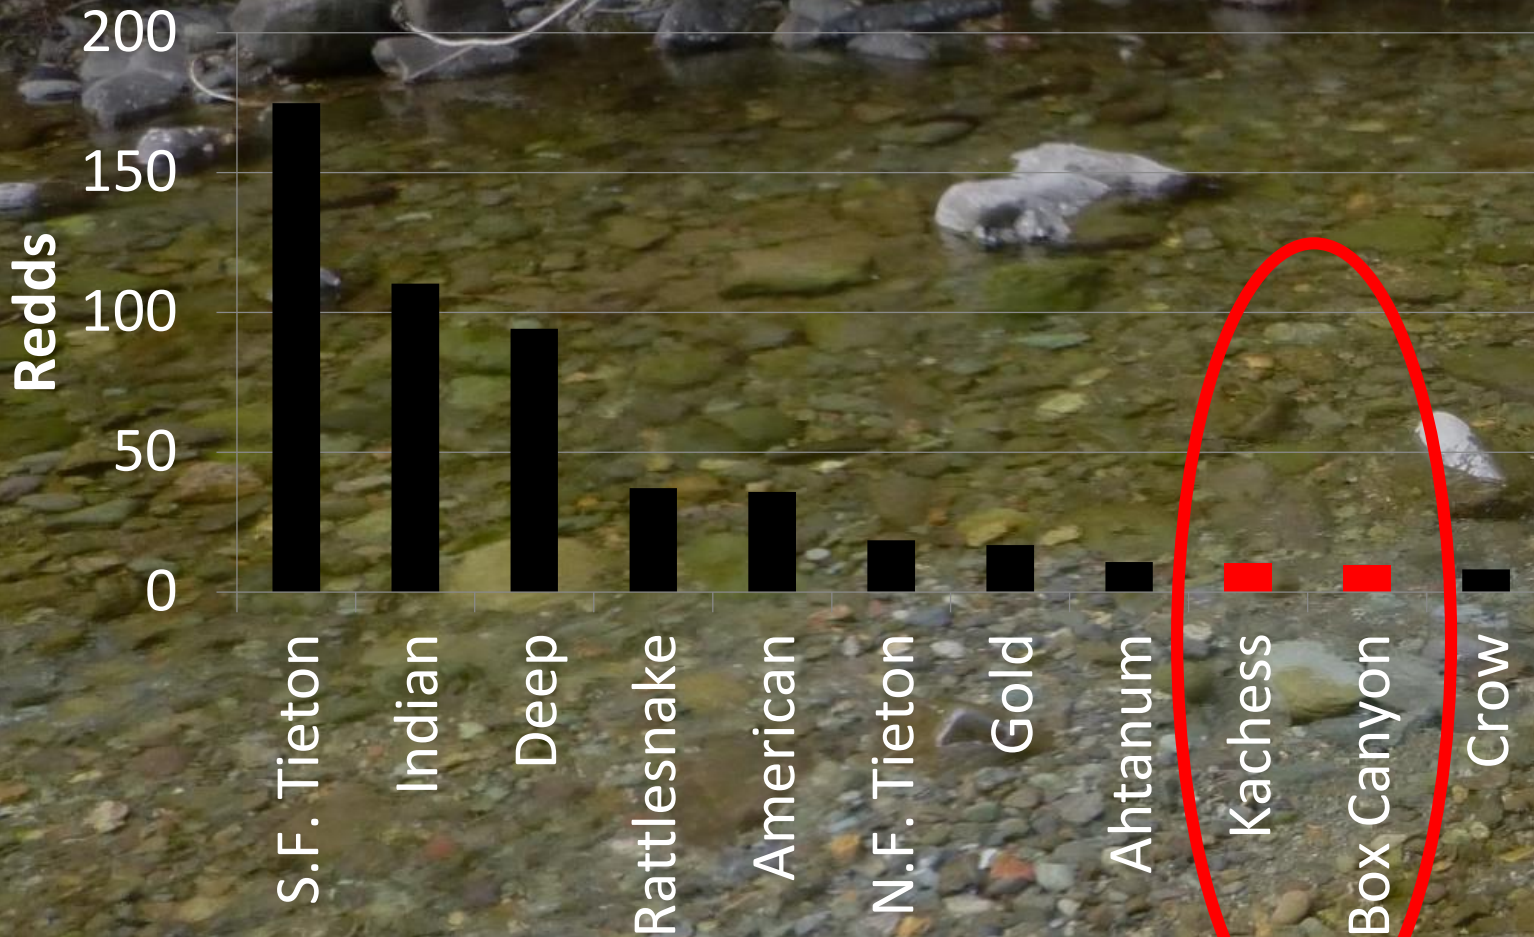
Bull Trout Redd Counts

10 – 34 year record through 2017

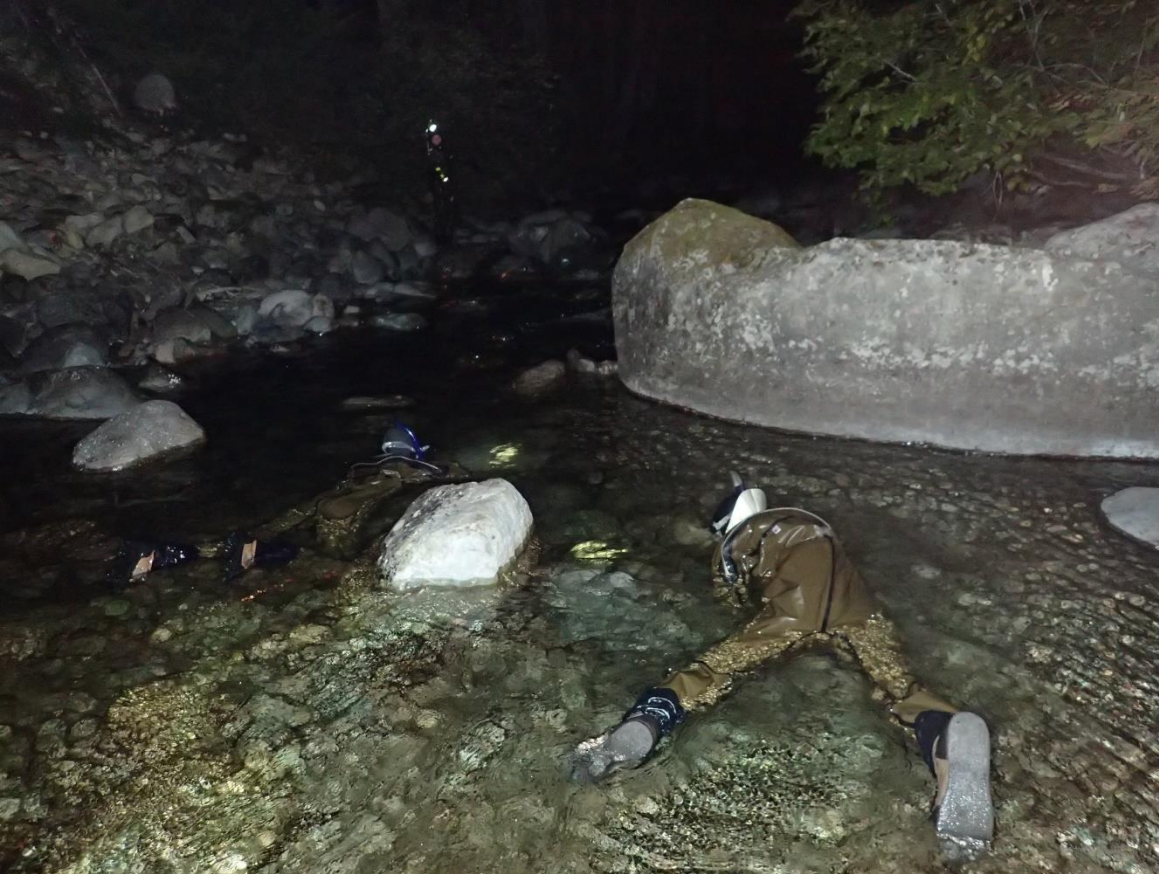
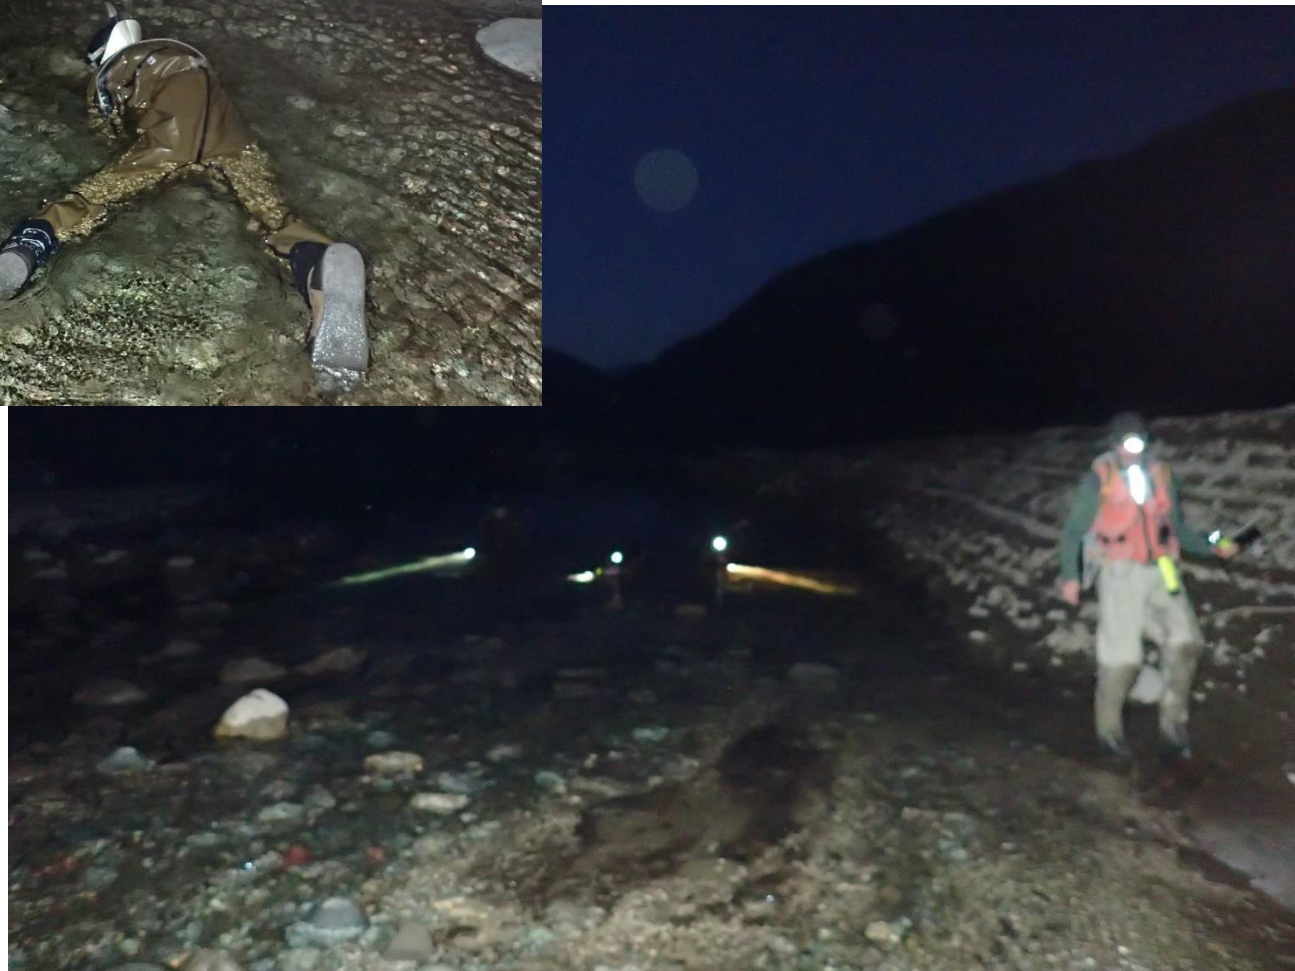
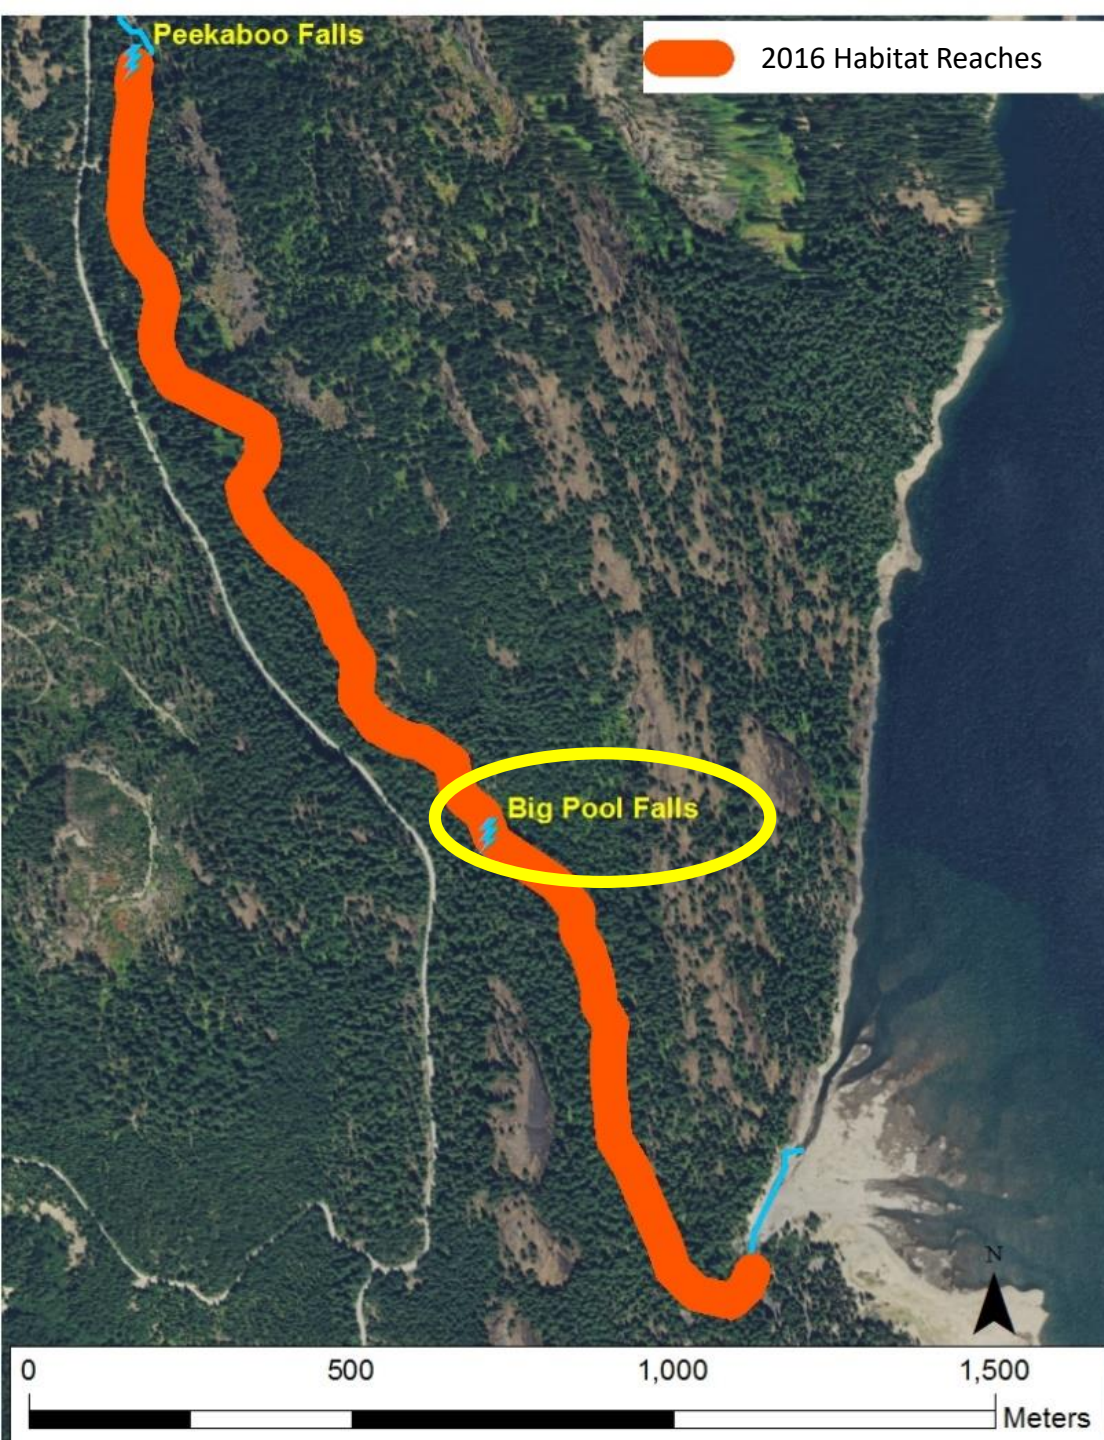
- Besides traditional snorkeling, also included observers on both banks to observe YOY in the stream margins
- 5 people typically, 4 people minimum

Box Canyon Night Snorkel Surveys

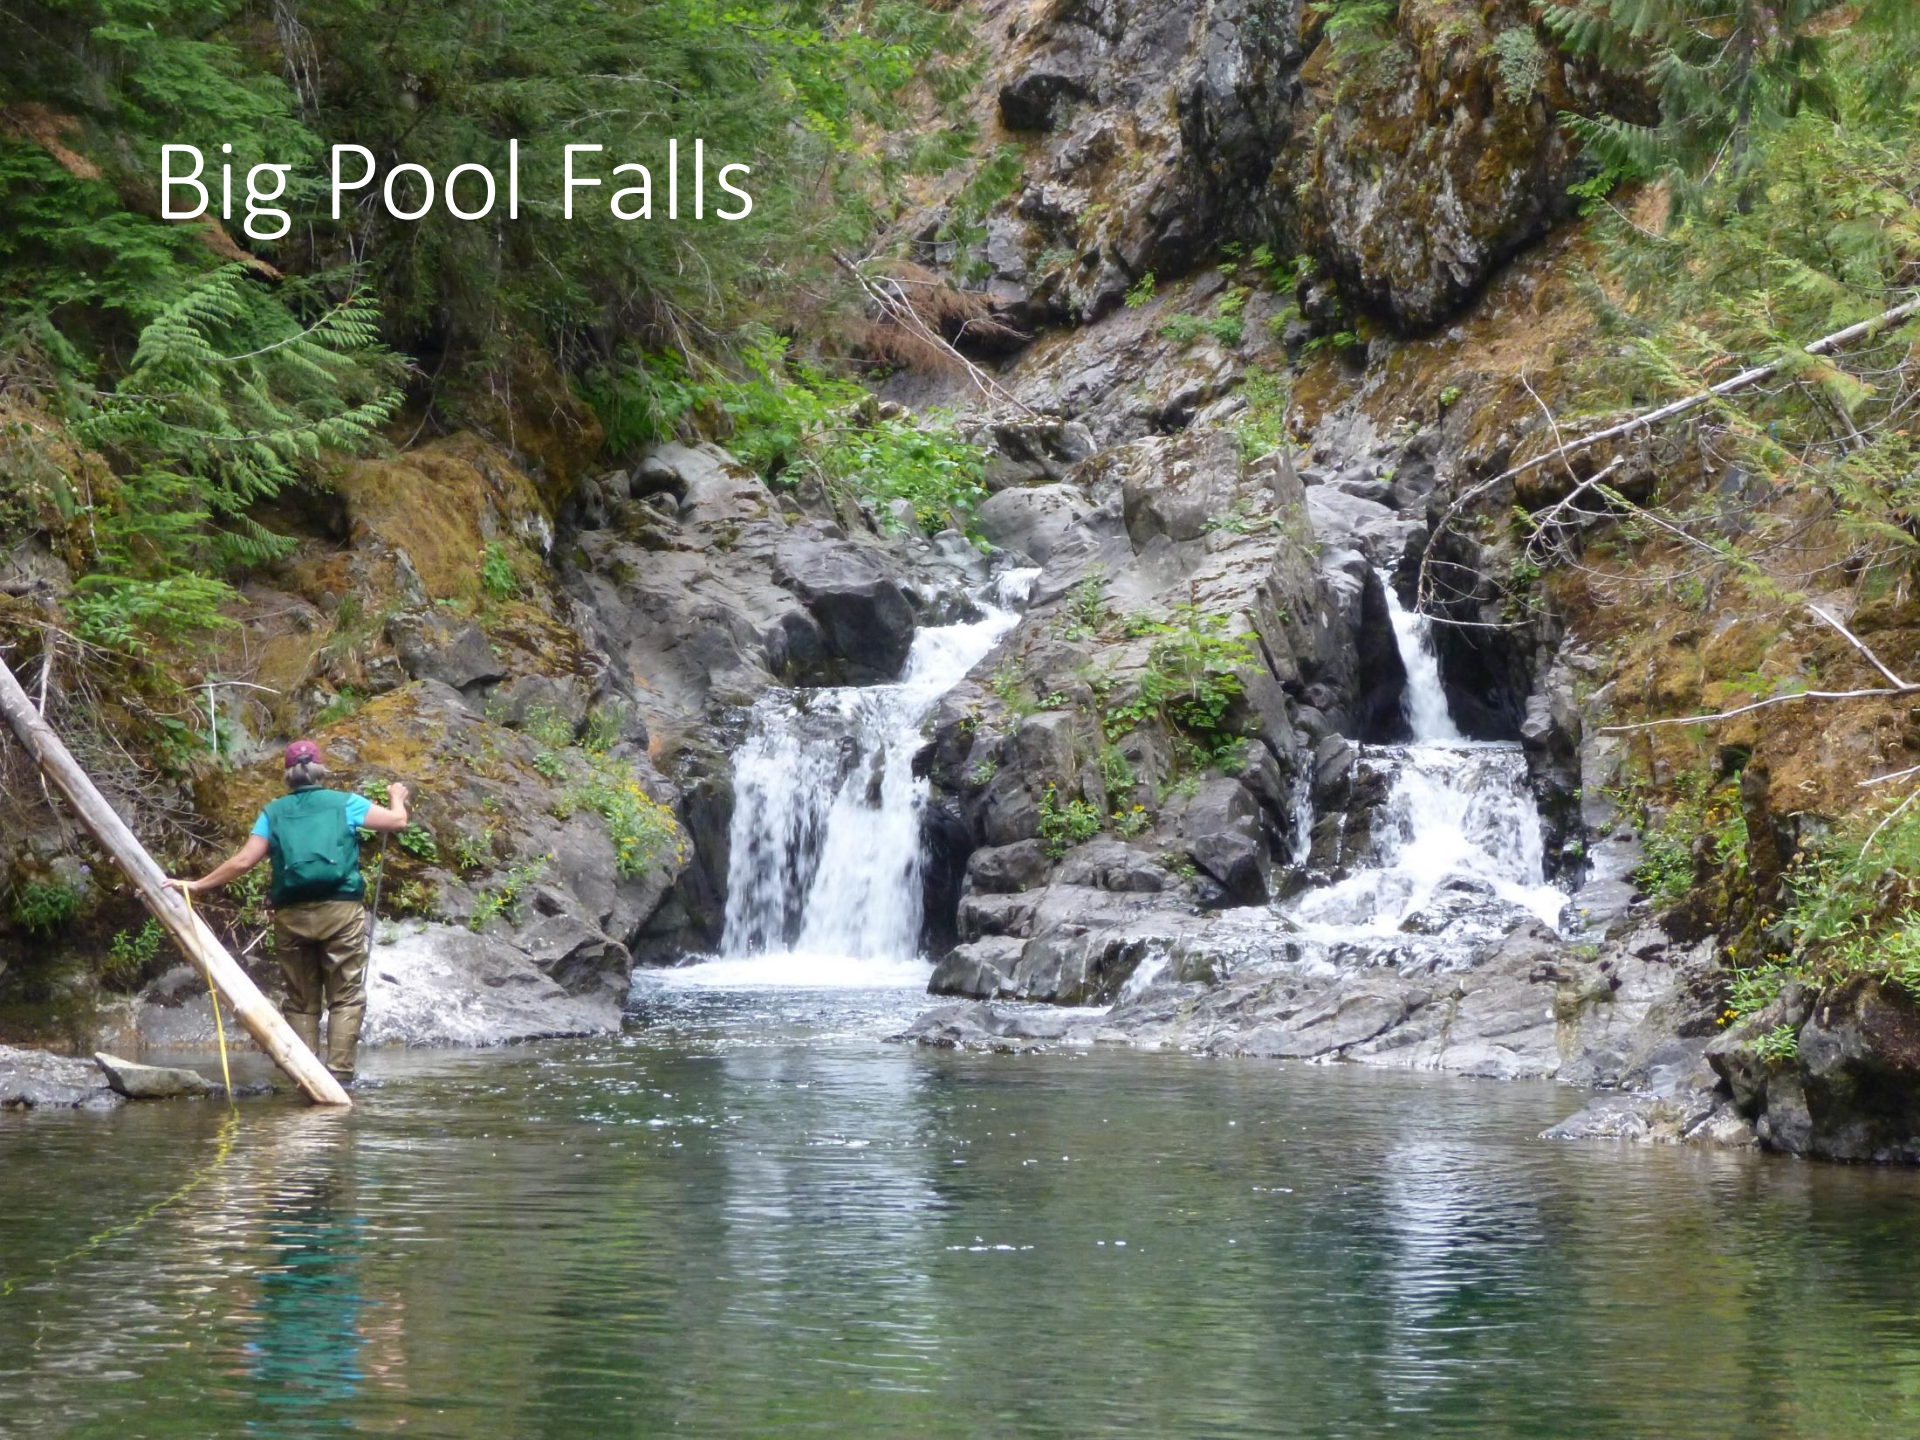
Box Canyon Habitat Survey 2016

- Slow/Fast Channel Units
- BankFull Width
- Wetted Width
- Substrate
- Pools
- Instream Large Woody Habitat

Despite very different redd distributions, many YOY found below Big Pool Falls

Big pool falls keeps them from utilizing upstream habitat

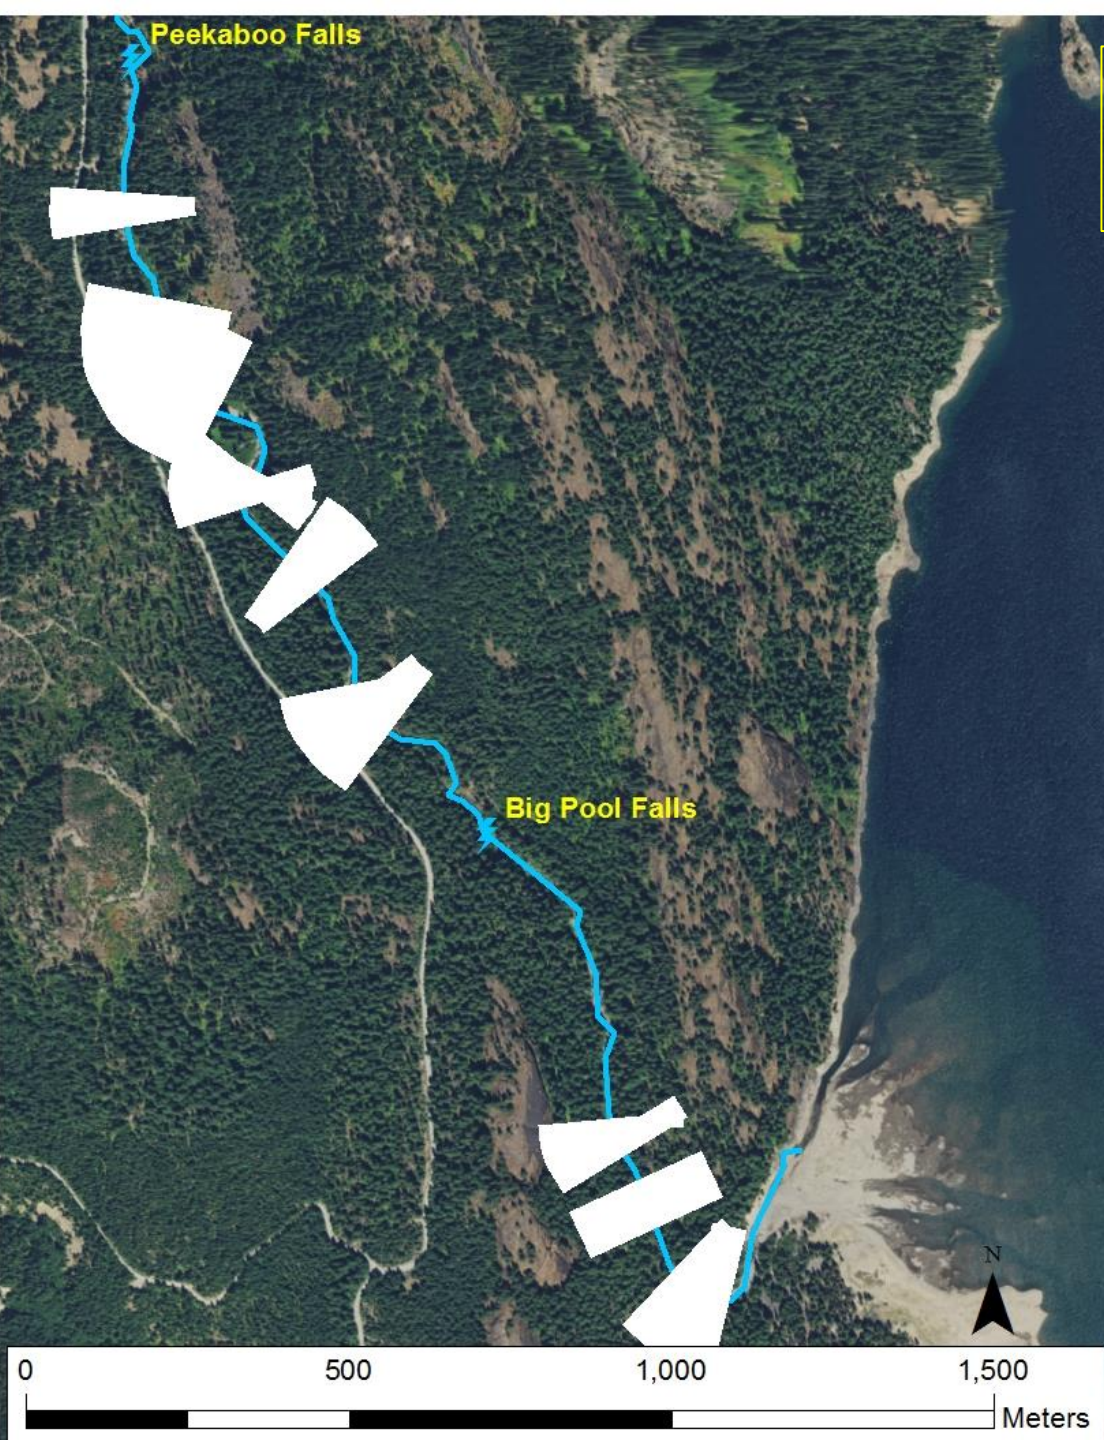
Action: Add Wood

Placement Areas Based on
Many Factors

- Slow water
- Lower gradient
- Low wood load
- YOY distribution
- Redd distribution
- Avoid creating upstream passage barriers
- Presence of natural anchors to maintain wood position
- Equipment access

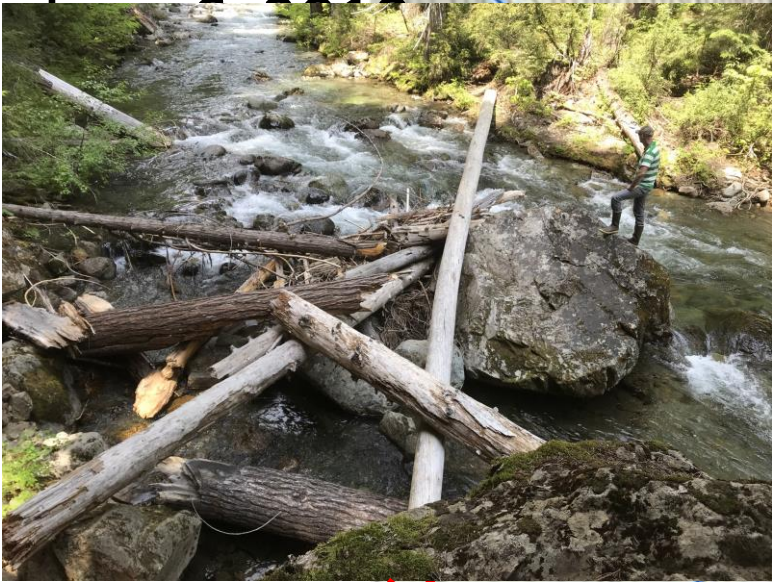
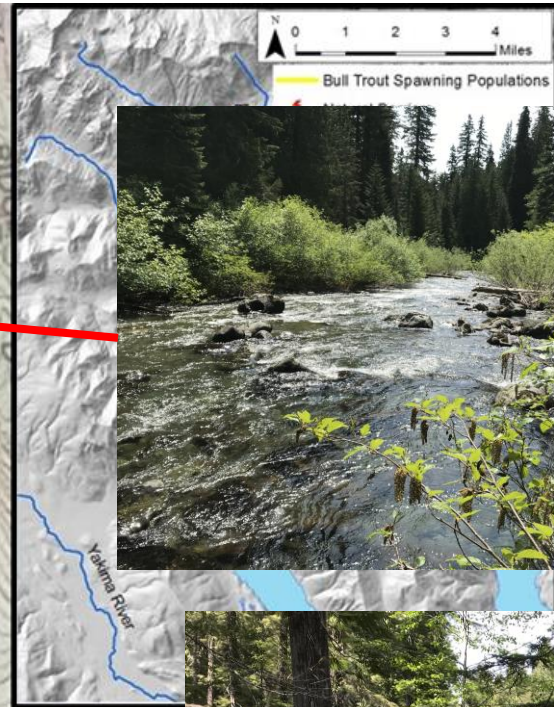
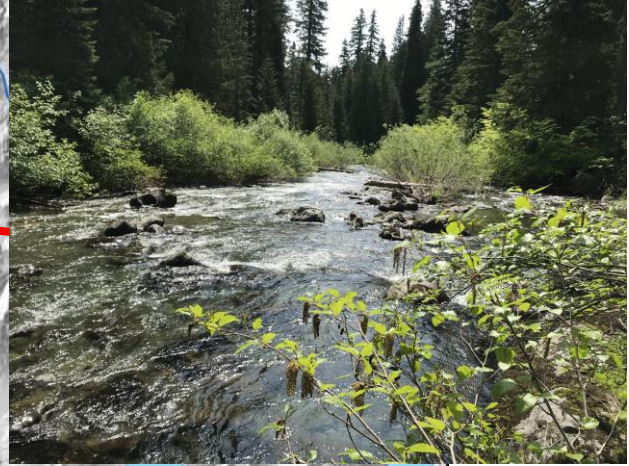
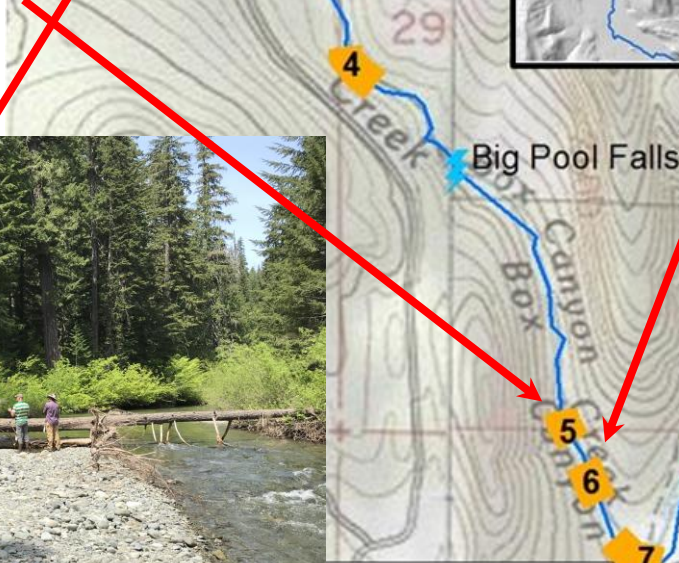
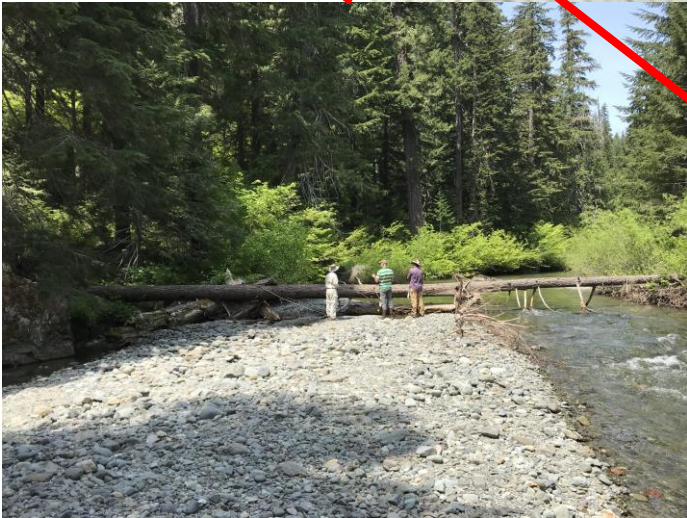
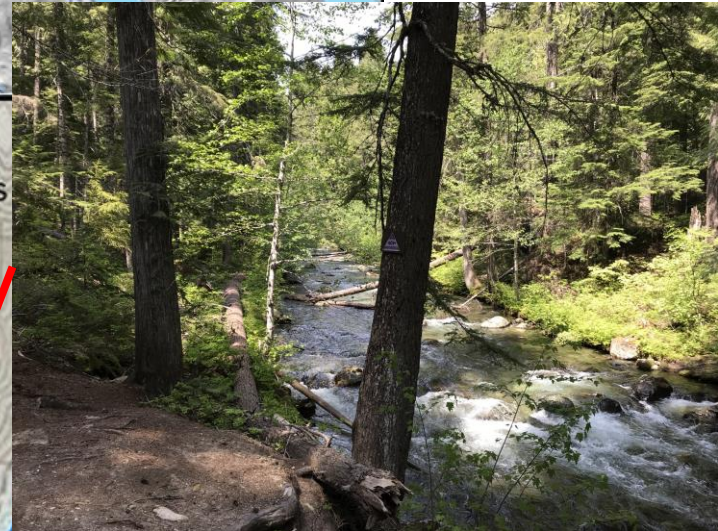
Box Canyon Large Wood Replenishment Project #18-1425

- Deliverables
 - Planning, Design & Permitting
 - Partners – KCT, USFWS, USFS, WDFW, YN
 - Procurement & Staging of ~ 360 Large Wood Pieces
 - Potential Sources – TNC, USFS, Suncadia
 - Helicopter Placement in Box Canyon
- Estimated Construction – August 2019
- Available Funding = \$411,349
 - \$331,349 – YBIP/BTEP
 - \$80,000 – USFWS

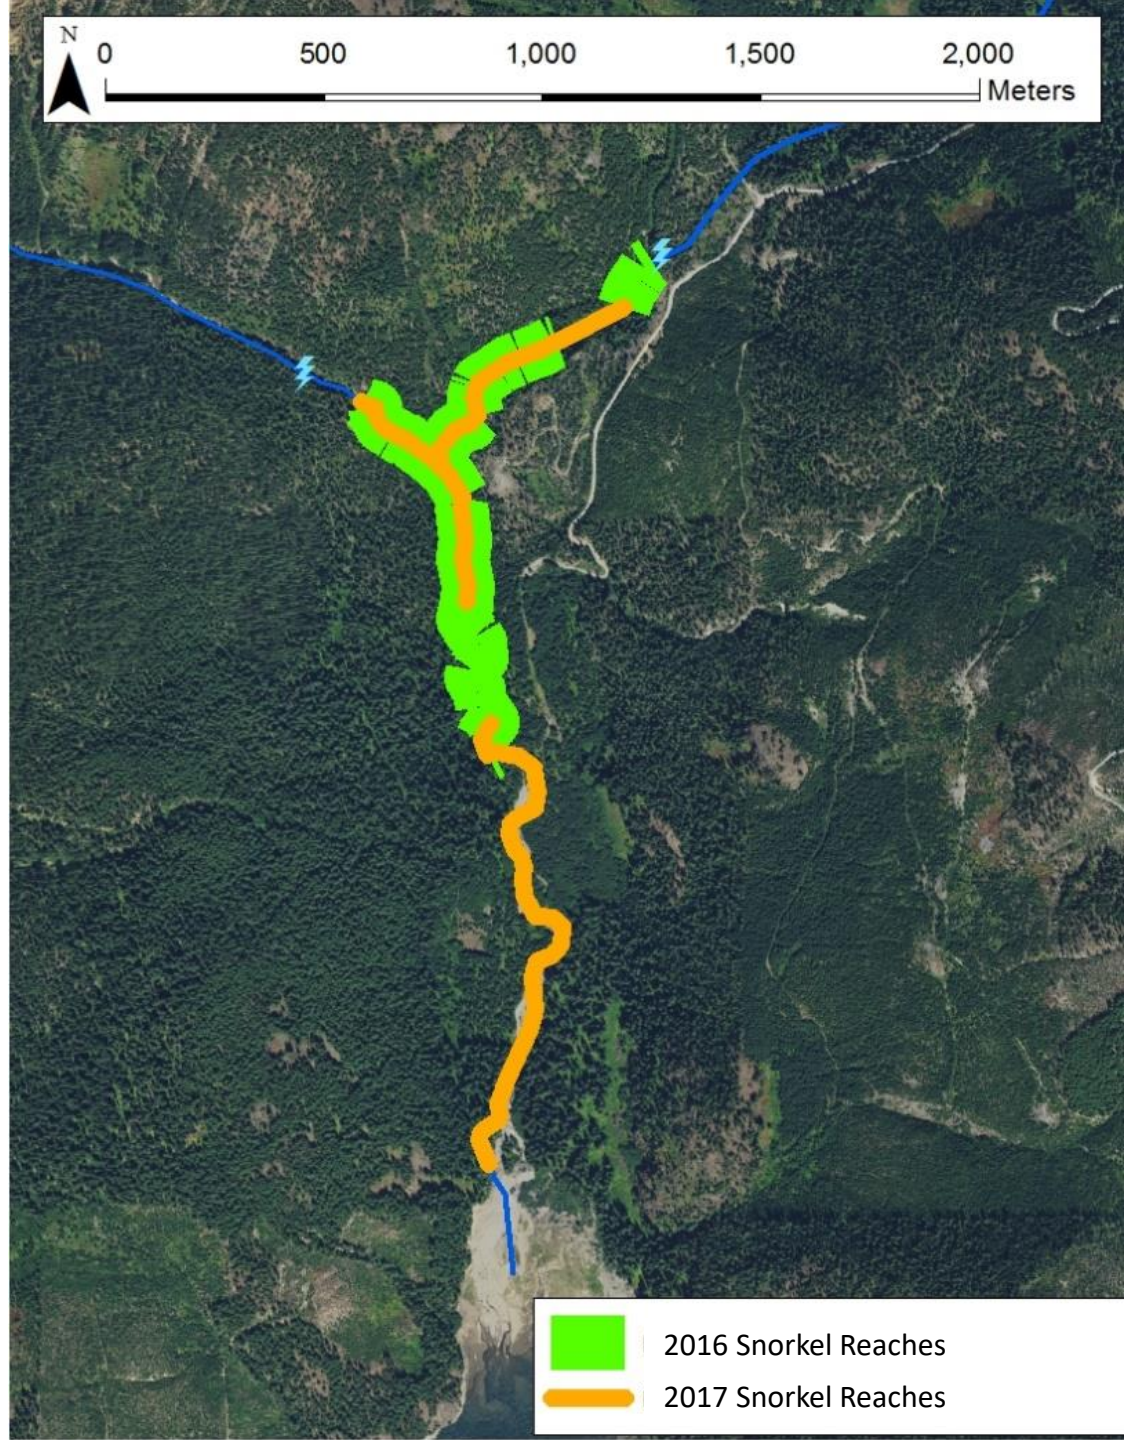
Kachess Habitat Survey 2017

- Slow/Fast Channel Units
- BankFull Width
- Wetted Width
- Substrate
- Pools
- Instream Large Woody Habitat (**USFS**)
- Mouth to confluence with Mineral Cr. does not meet wood targets
- Data will be used to inform the design of habitat restoration

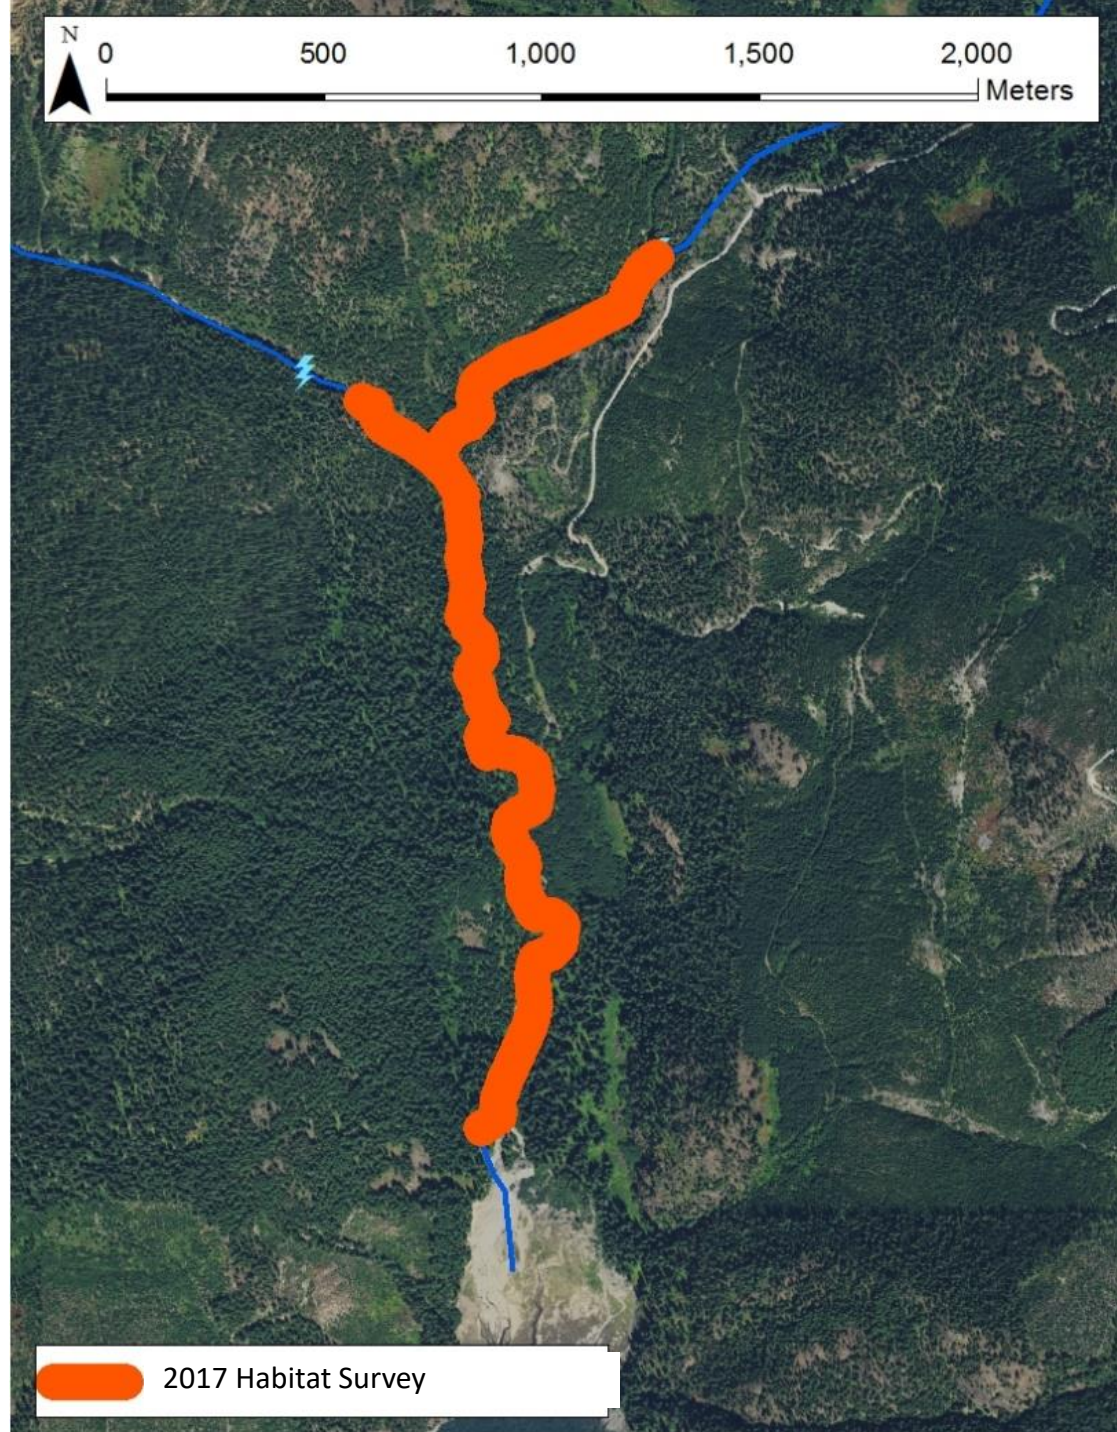
Kachess Dewatering

- All fish blocked from going to reservoir
- YOY not moving upstream to perennially-flowing 1.1 miles
- No macroinvertebrate production for 0.8 miles
