Nile Valley Landslide

Joel Freudenthal
Fish and Wildlife Biologist

**Science and
Management Review
June 16, 2010**

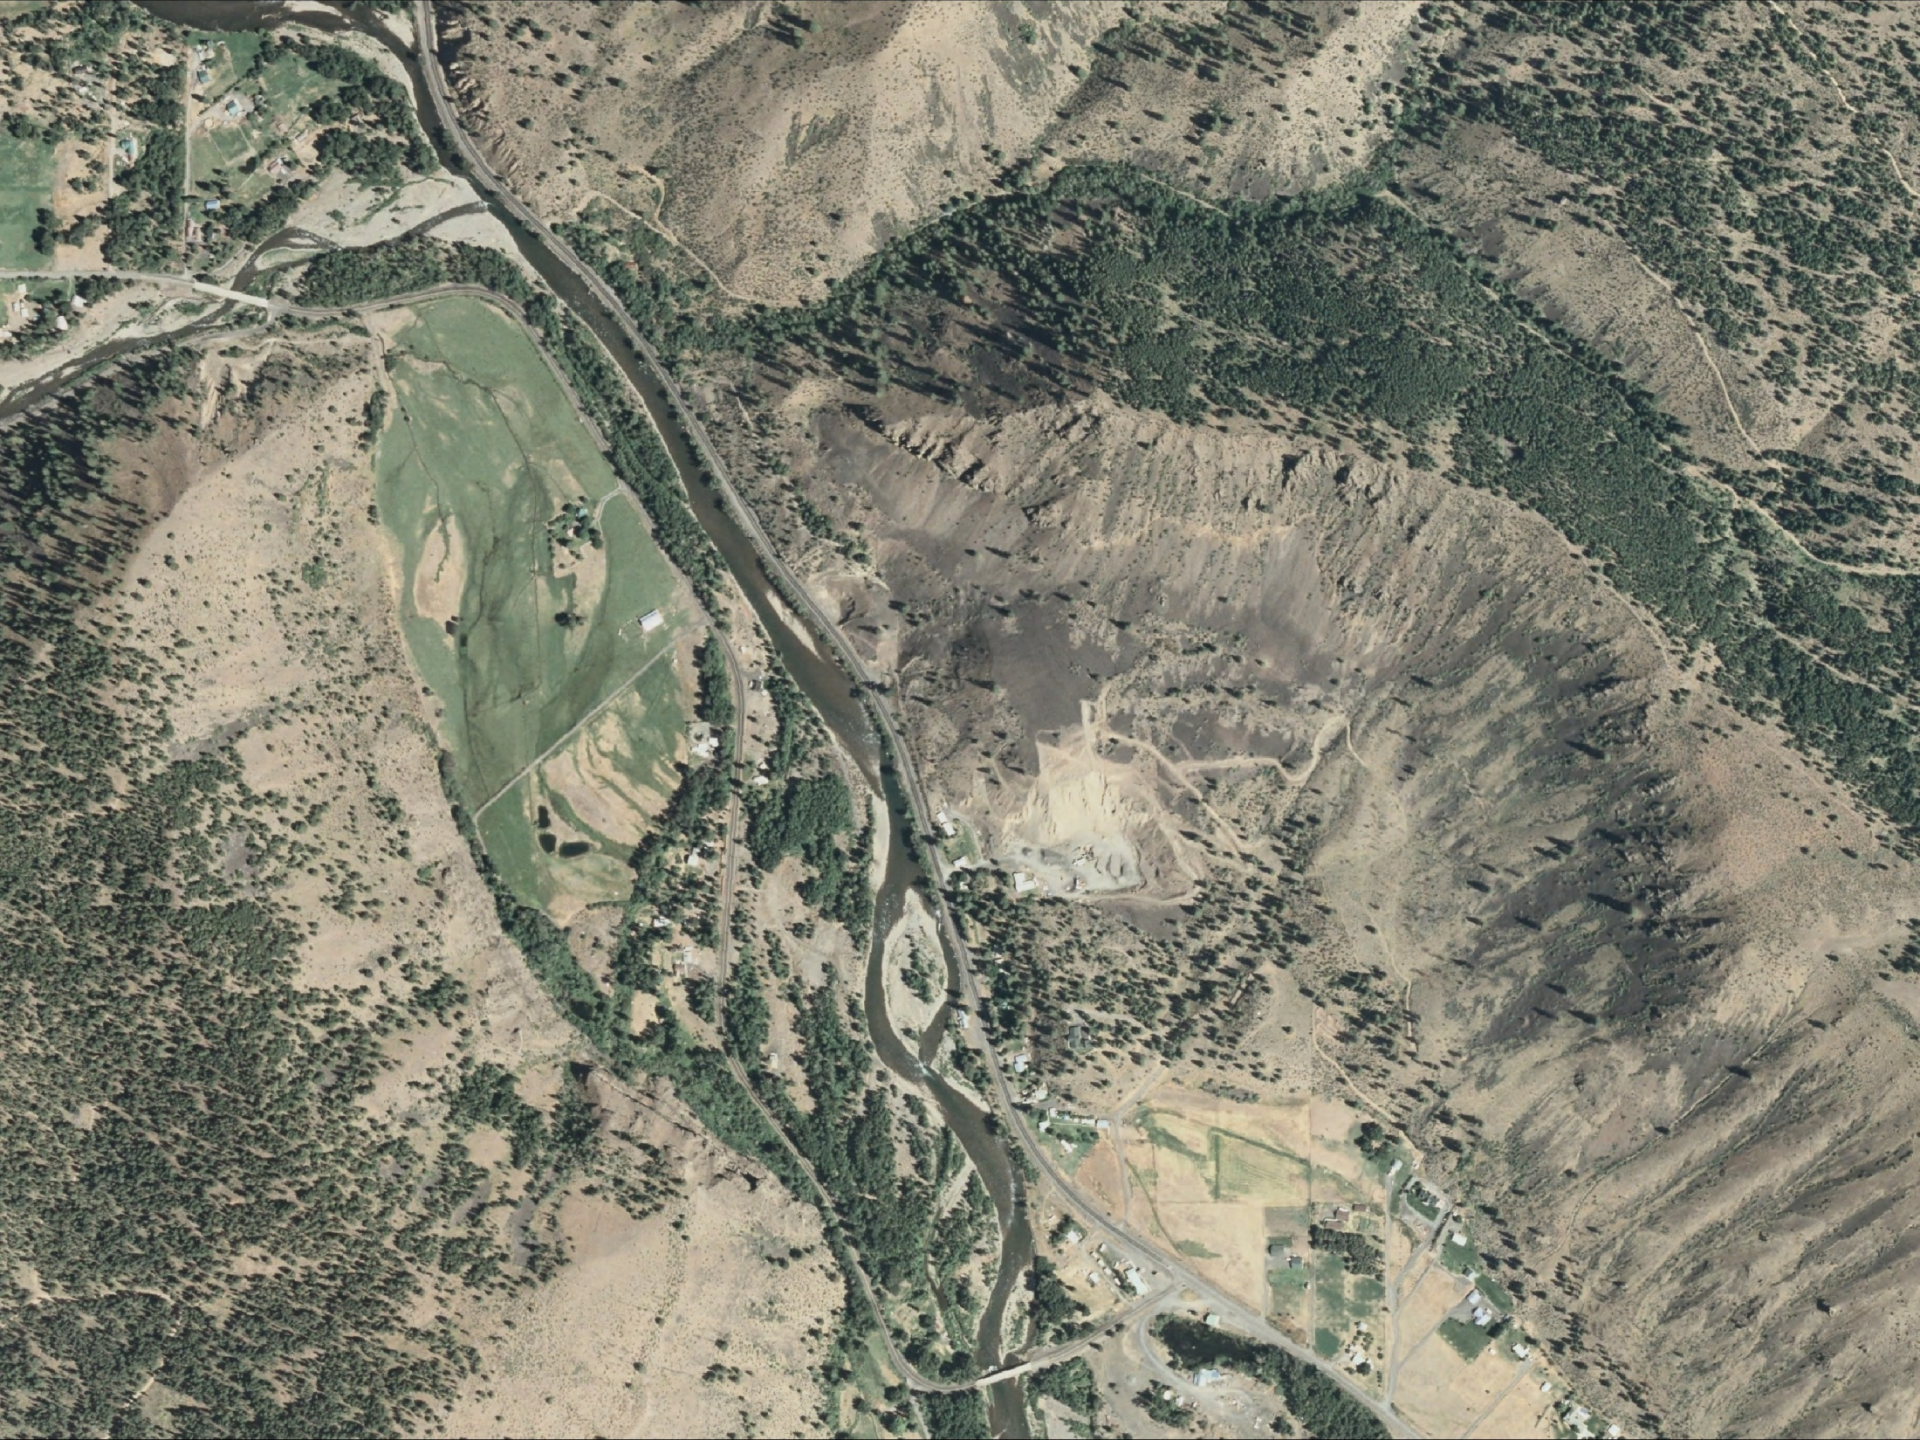
Rattlesnake Creek

Naches River

Nile Road

LANDSLIDE

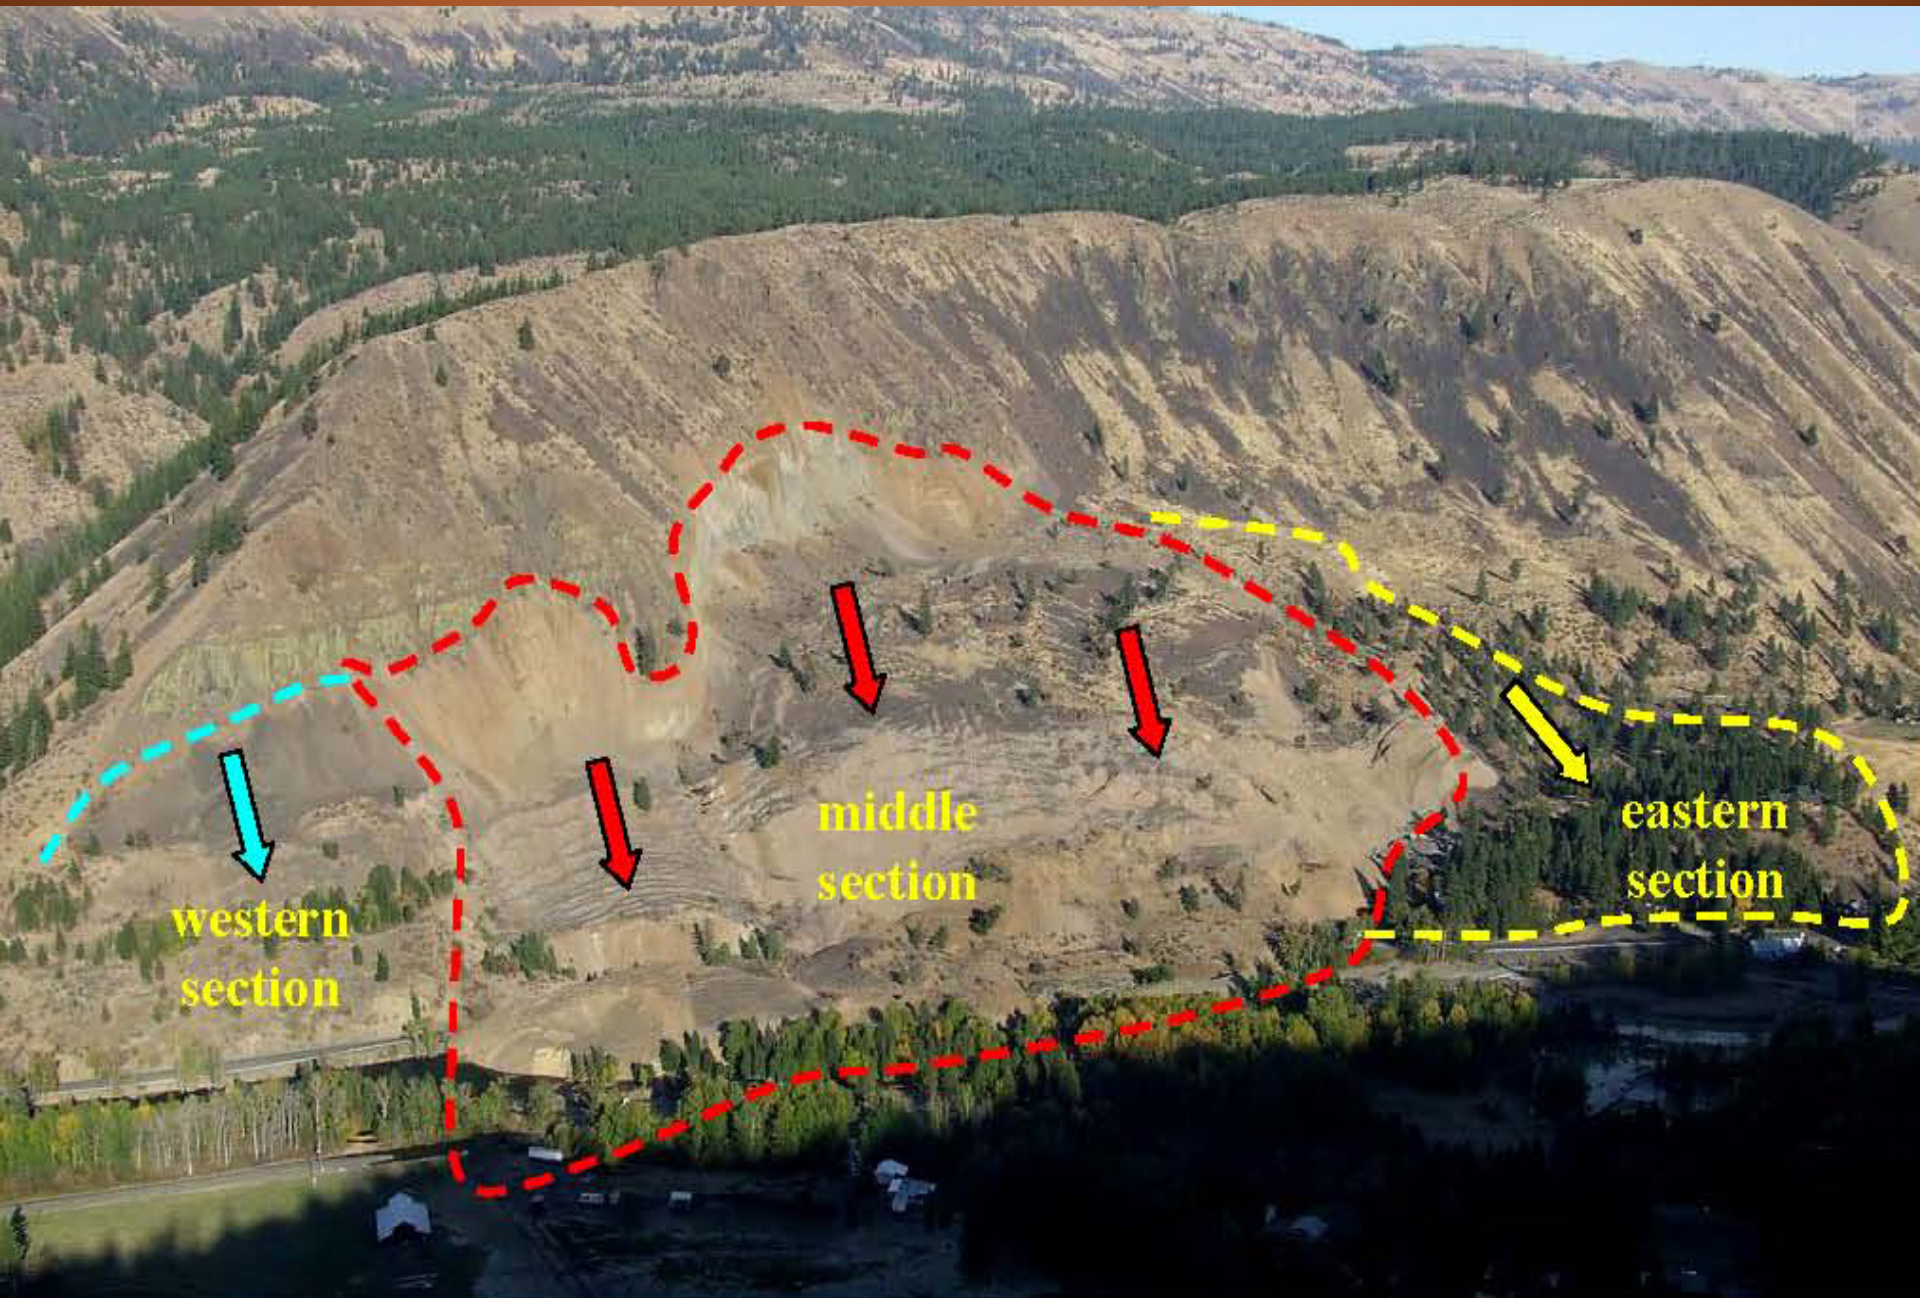
western
section

middle
section

eastern
section

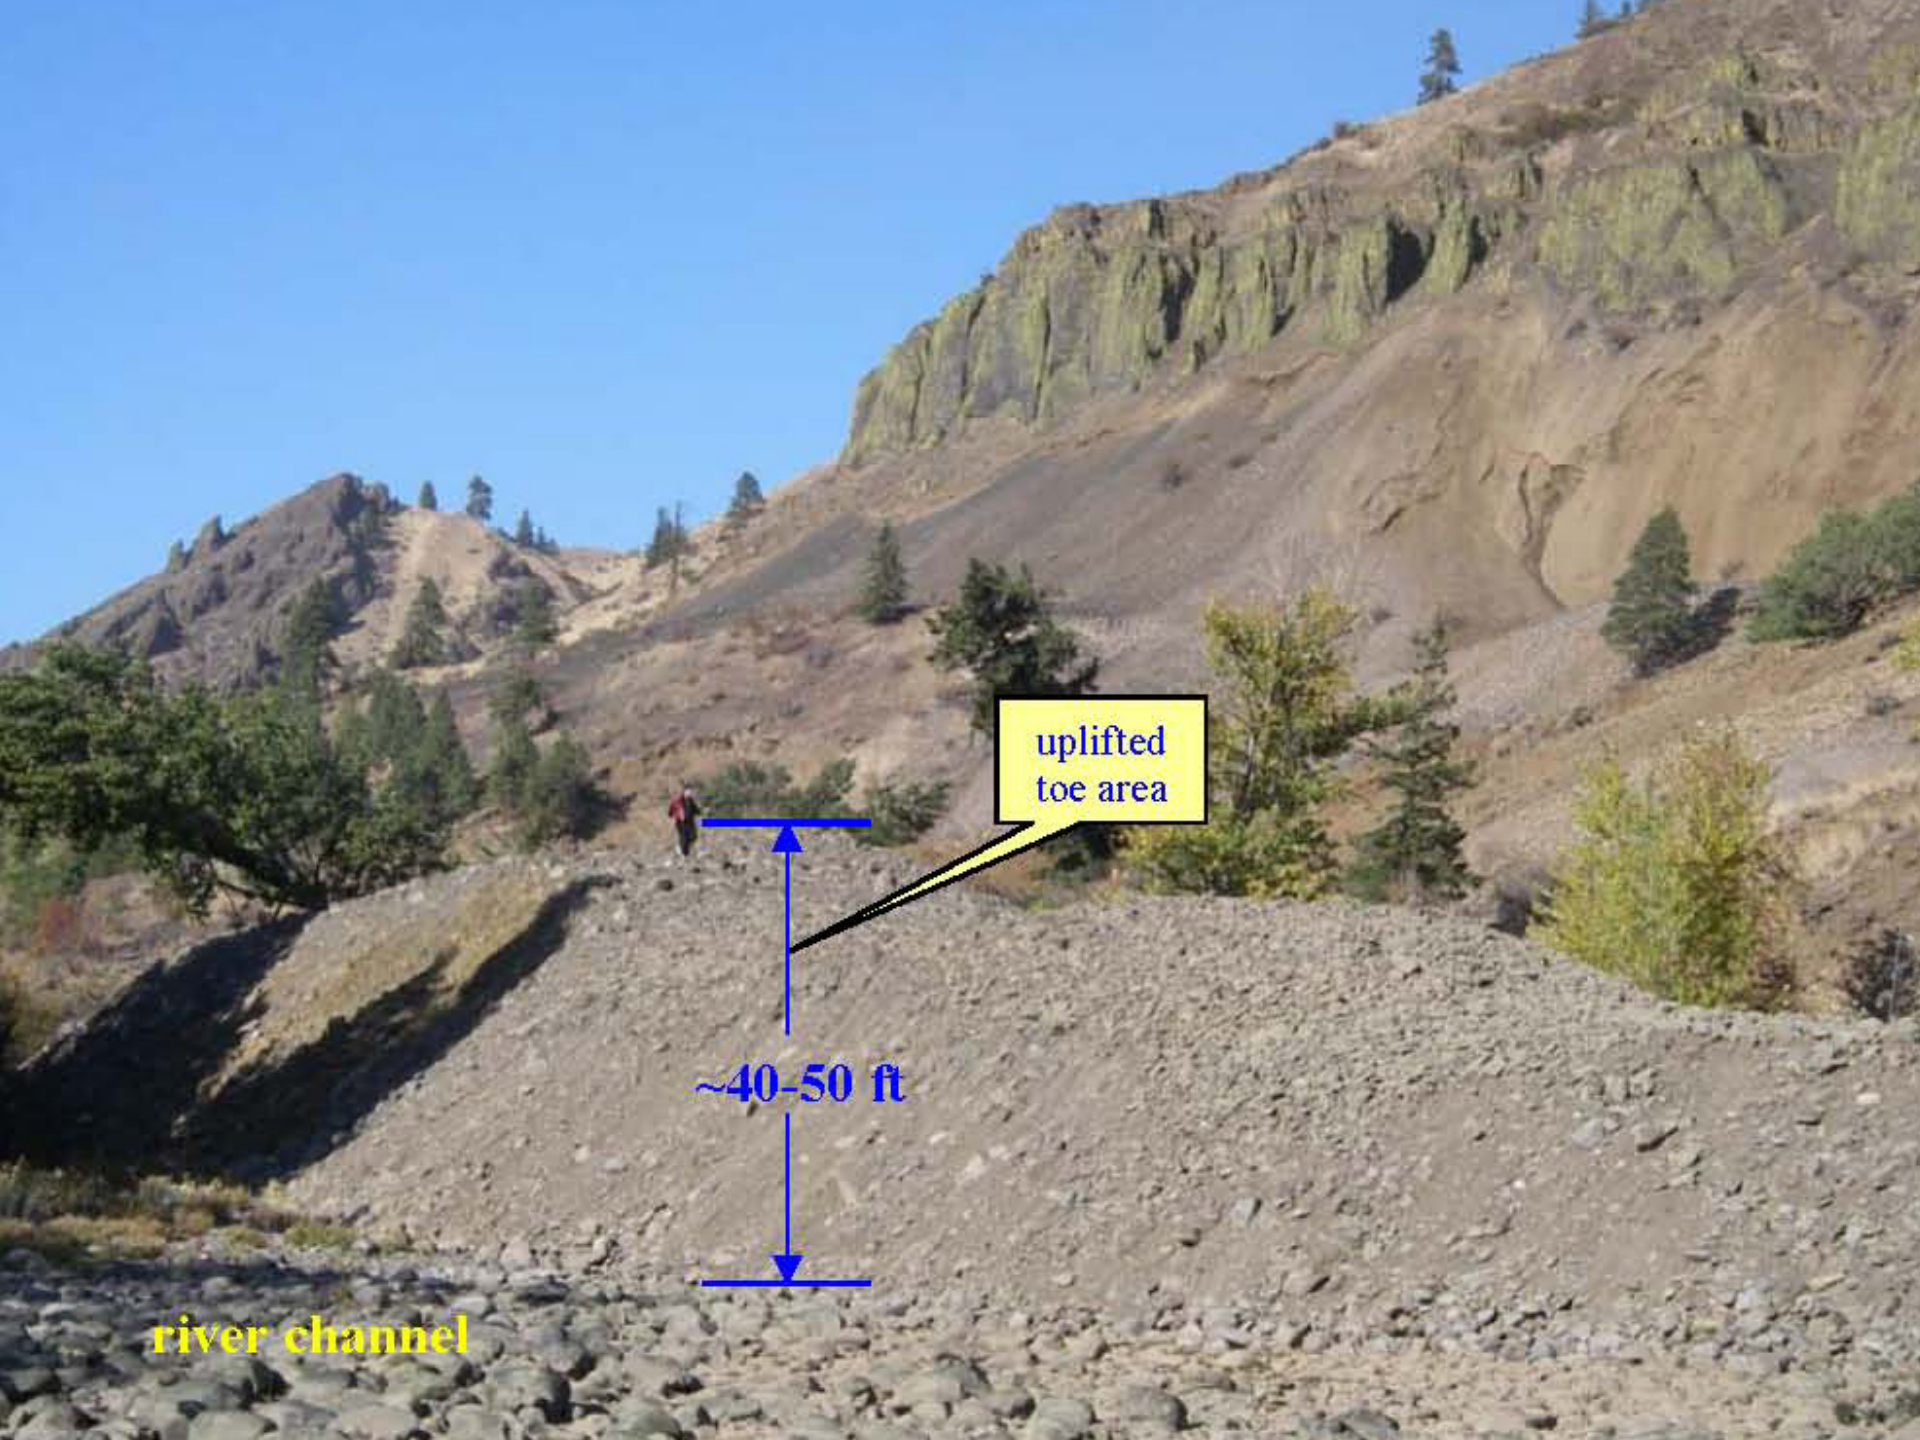
uplifted
toe area

~40-50 ft

river channel

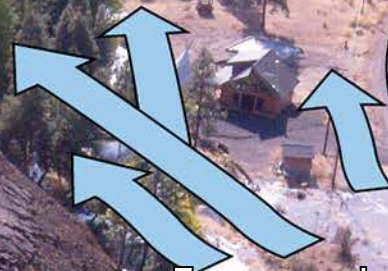
Landslide

Temporary river channel

Raised road

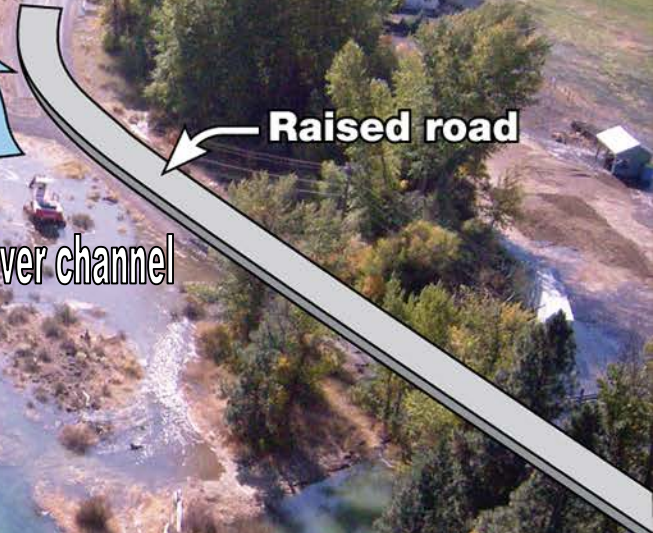
**Danger pool
of back water**

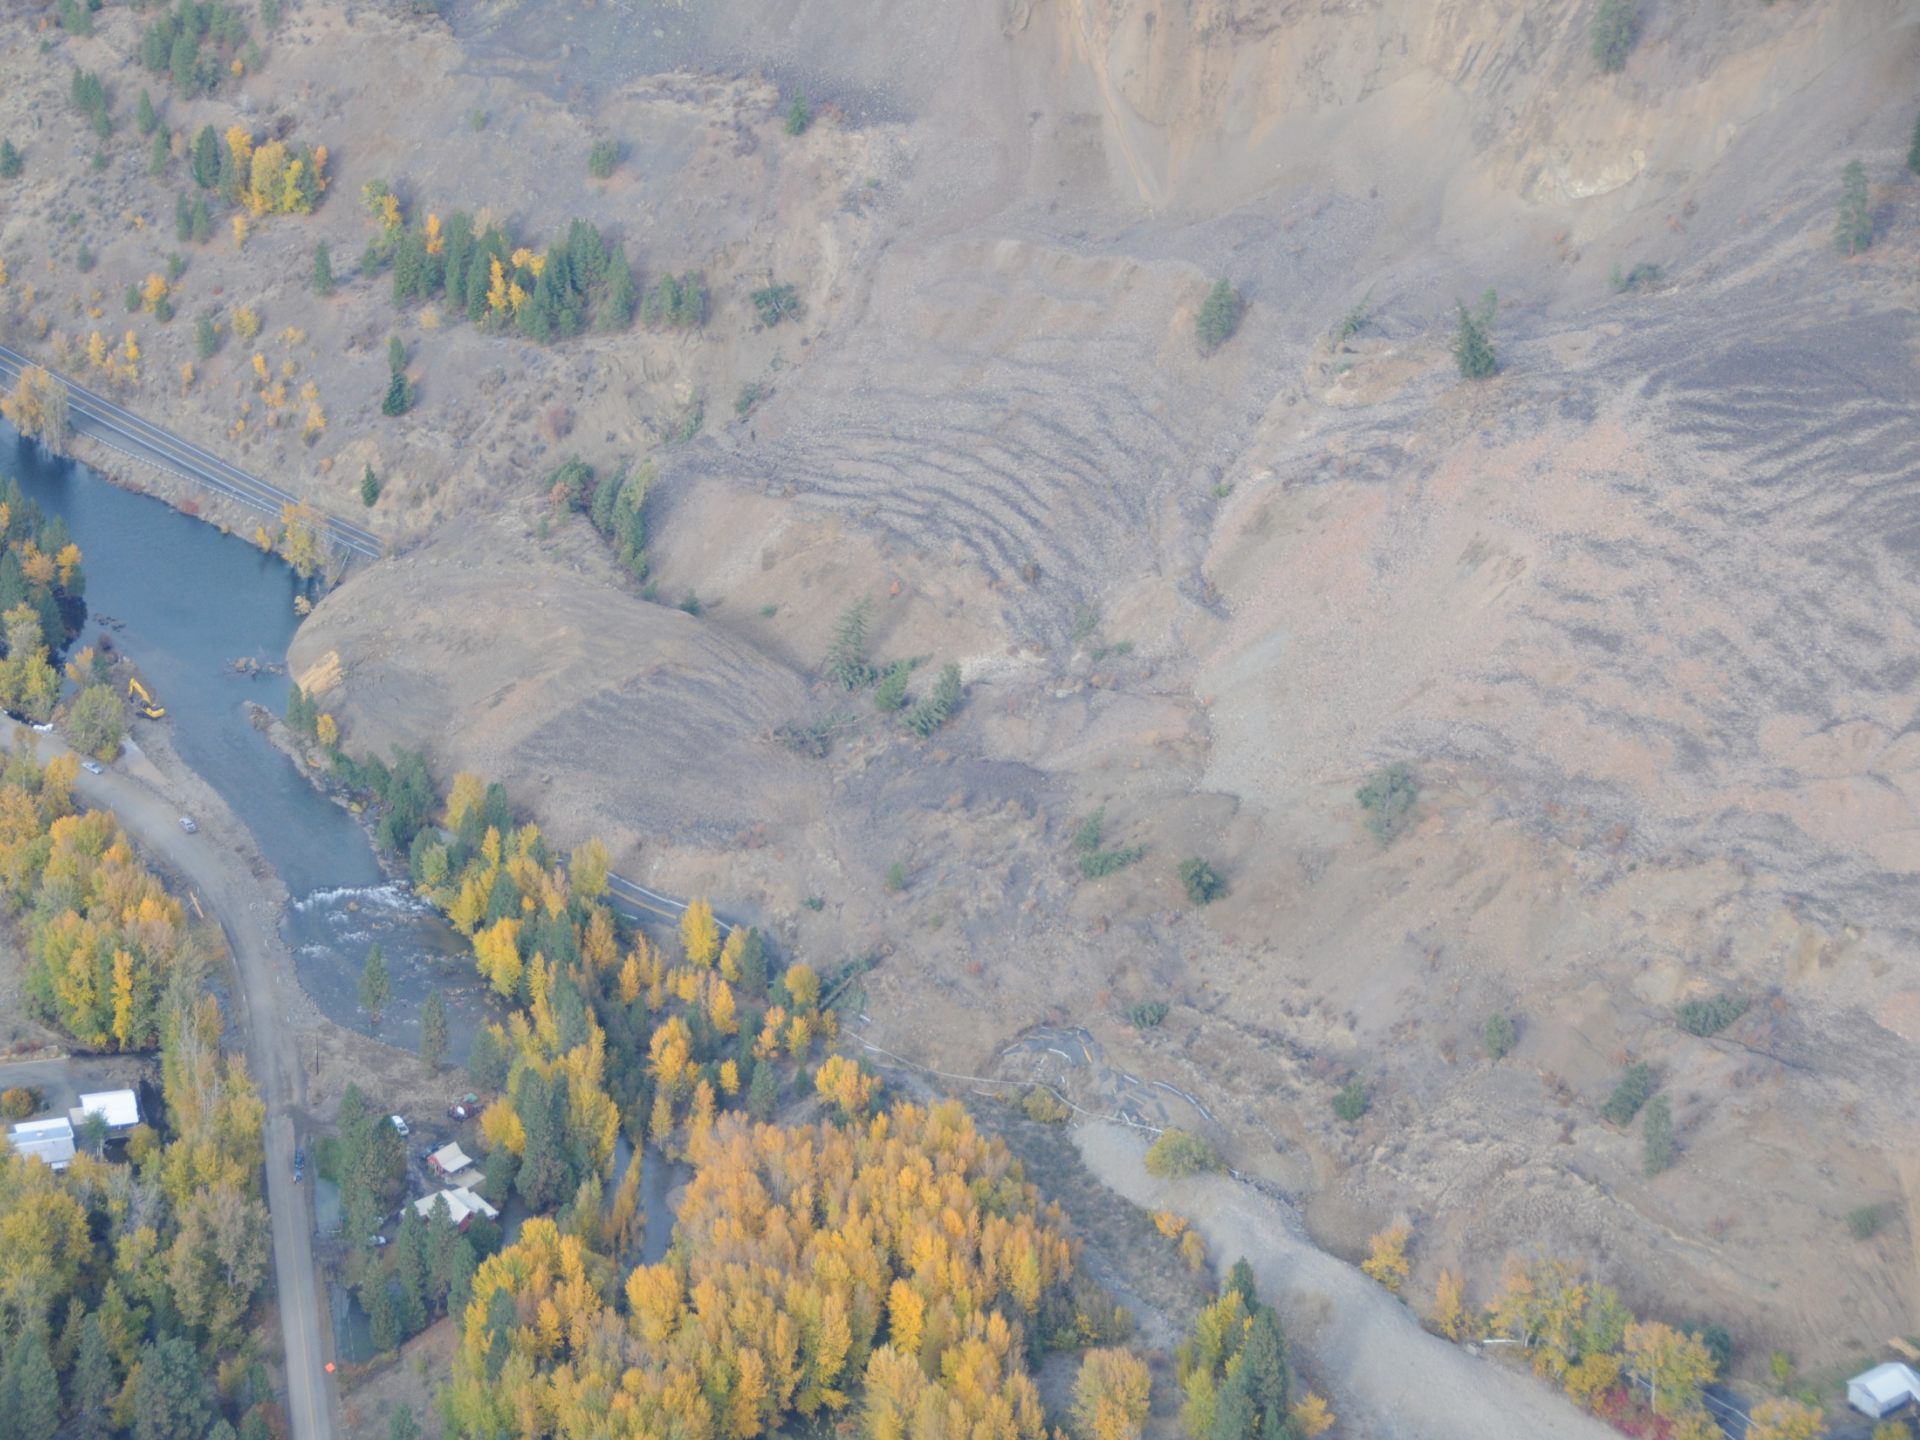
Channel configuration and Capacity

– A significant element of randomness should be incorporated into the channel configuration, particularly along the channel margins. The initial channel excavation should be very rough and without any final grading or smoothing of banks. A smooth, even shoreline and trapezoidal configuration should be avoided. Random alcoves, point bars, and anchored log jams, buried trees and root-wads, and boulder groupings, should be incorporated along the channel margins to provide additional shear resistance to scour, prevent erosion, and provide a variety of water depths, substrate, and velocity, as well as providing instream habitat.

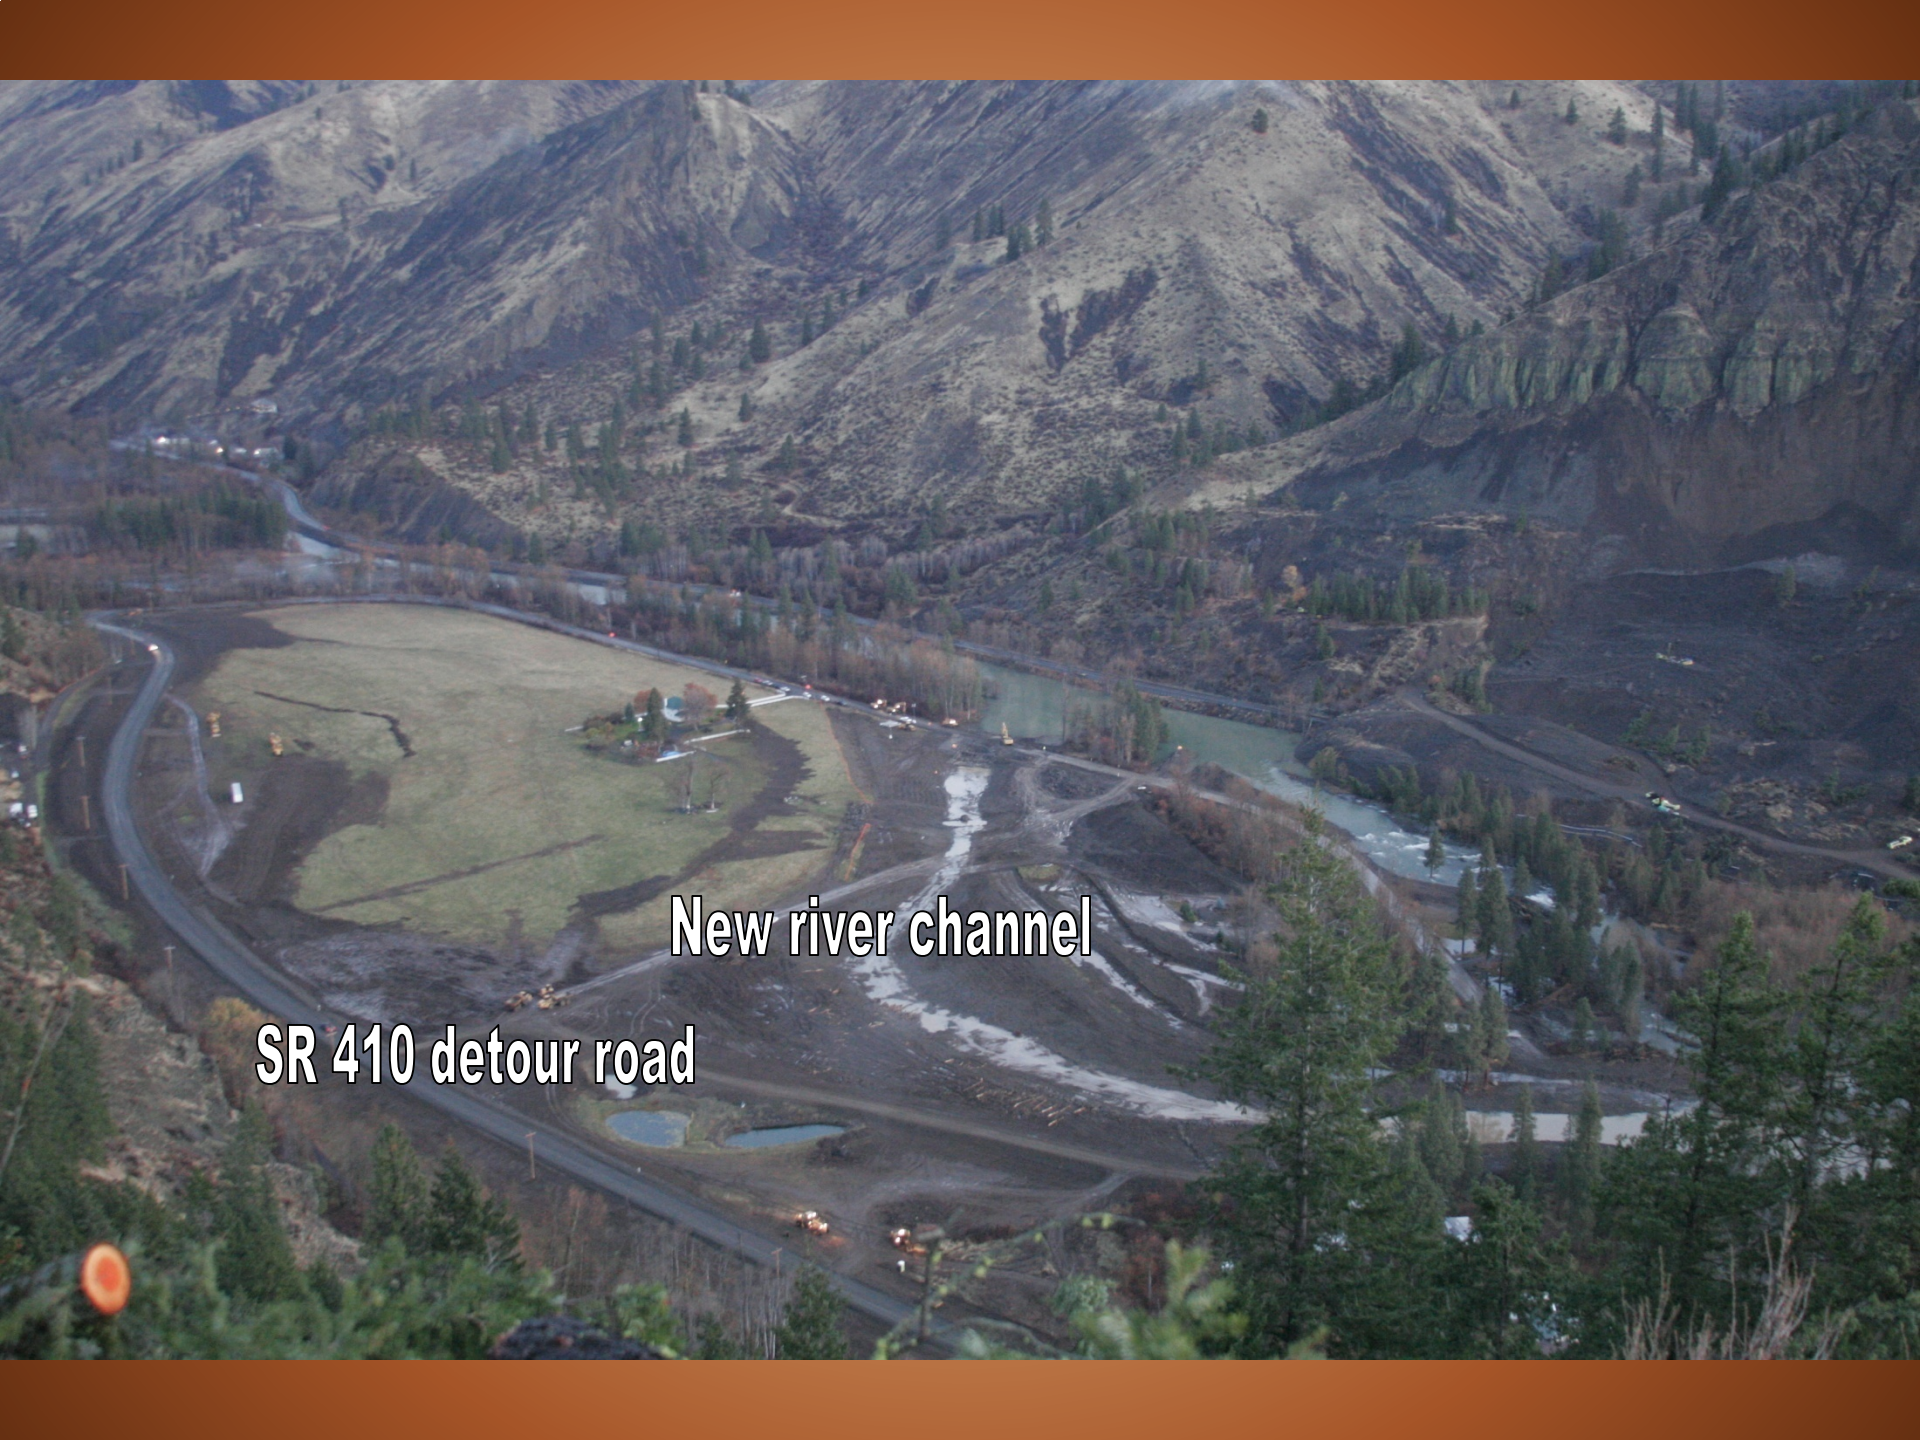
New river channel

SR 410 detour road

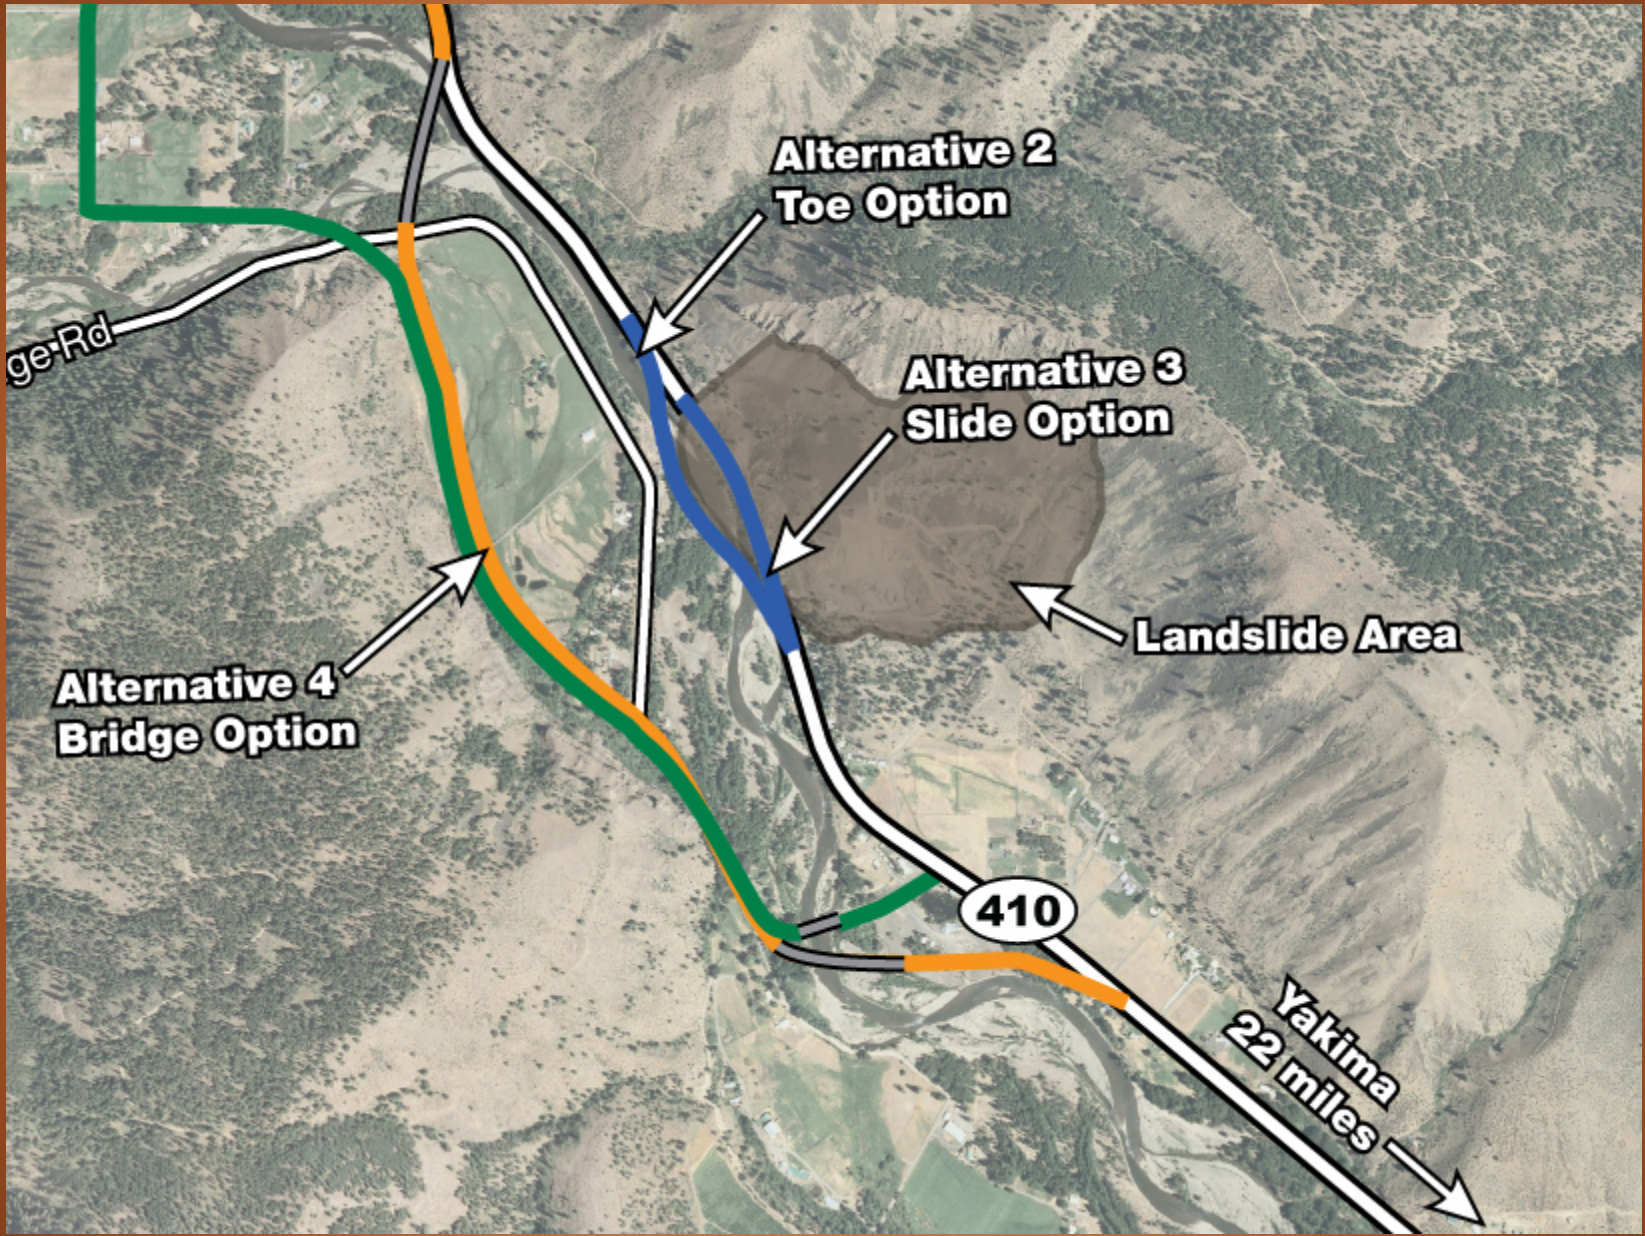
**SR 410
Nile Valley Landslide
Alternatives for
Permanent Solution**

**Alternative 2
Toe Option**

**Alternative 3
Slide Option**

Landslide Area

**Alternative 4
Bridge Option**
