## Storage Dam Fish Passage Feasibility Study

U.S. Department of the Interior  
Bureau of Reclamation

# Cle Elum Dam Interim Downstream Fish Passage

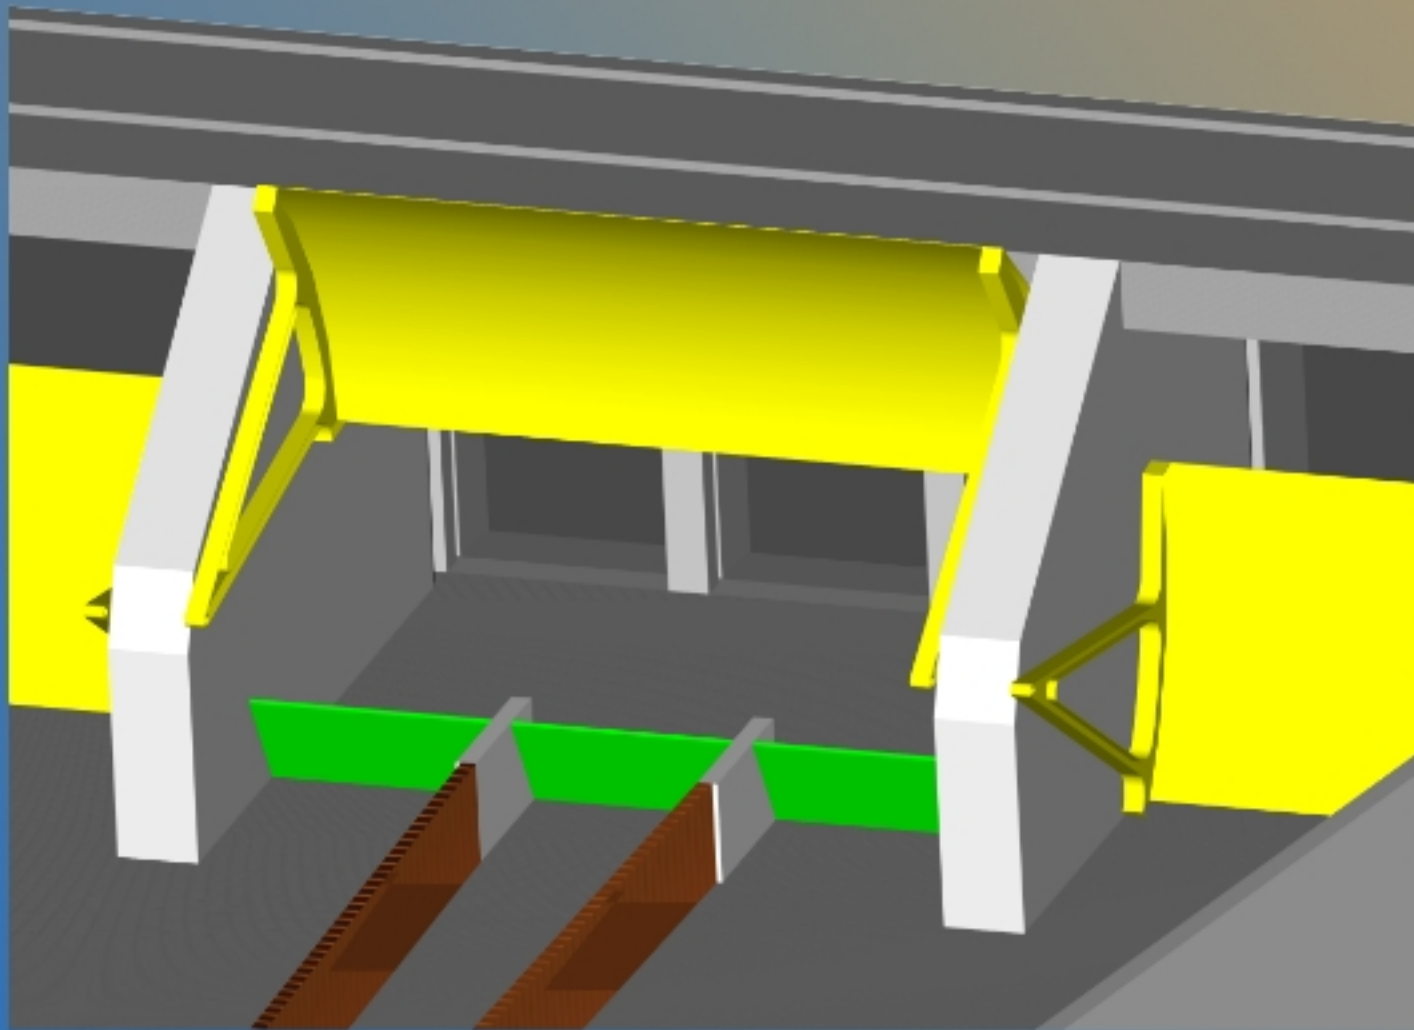
# The Concept

- **Develop temporary conditions that will allow juvenile fish to volitionally pass downstream at critical migration times**
  - Provide surface releases at the spillway of sufficient quantity to attract fish
  - Provide physical features to safely pass fish down the spillway
- **Reclamation**
  - Construct temporary passage features
  - Modify operations on temporary basis as needed
- **YN & WDFW**
  - Develop goals and objectives for reintroduction of fish
  - Develop monitoring and evaluation plans
  - Supply and handle fish

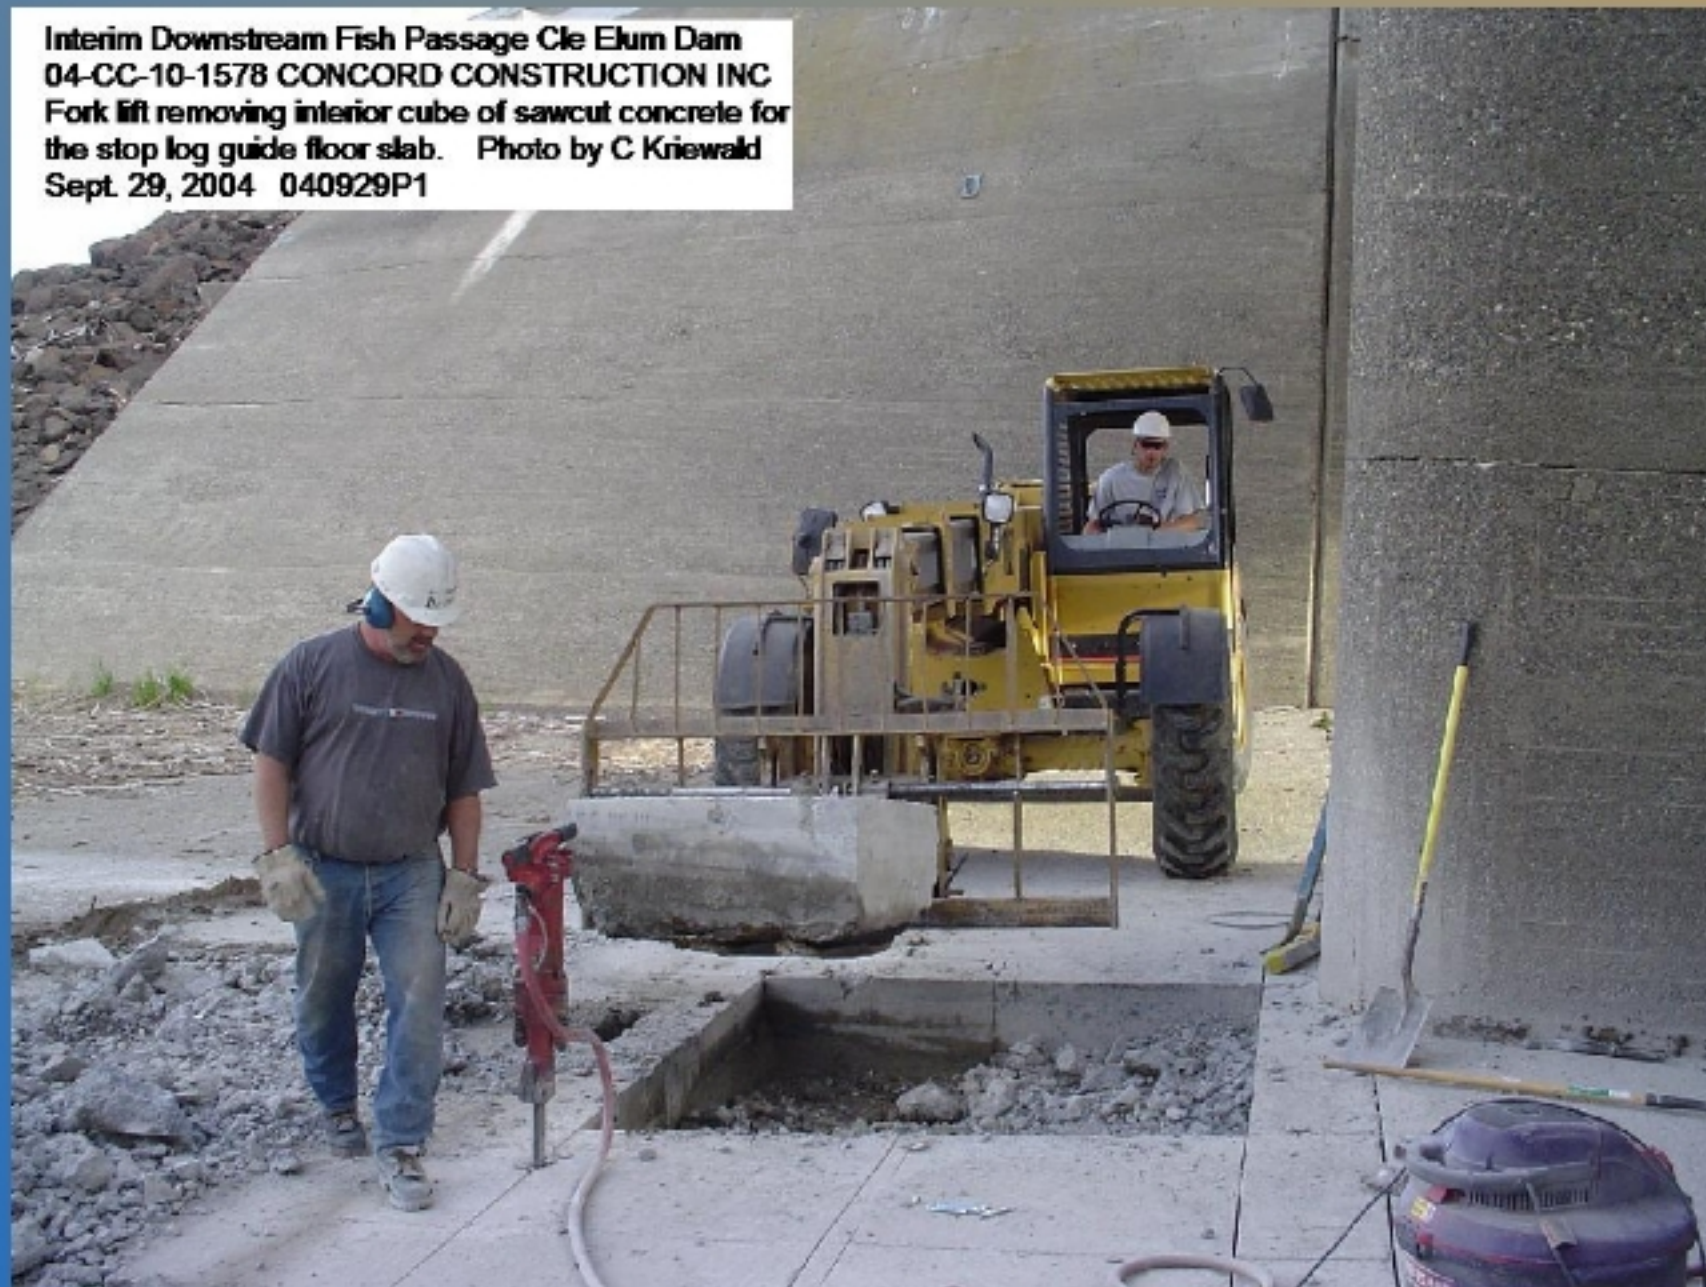
Interim Downstream Fish Passage Cle Elum Dam  
04-CC-10-1578 CONCORD CONSTRUCTION INC  
Fork lift removing interior cube of sawcut concrete for  
the stop log guide floor slab. Photo by C Kriewald  
Sept. 29, 2004 040929P1

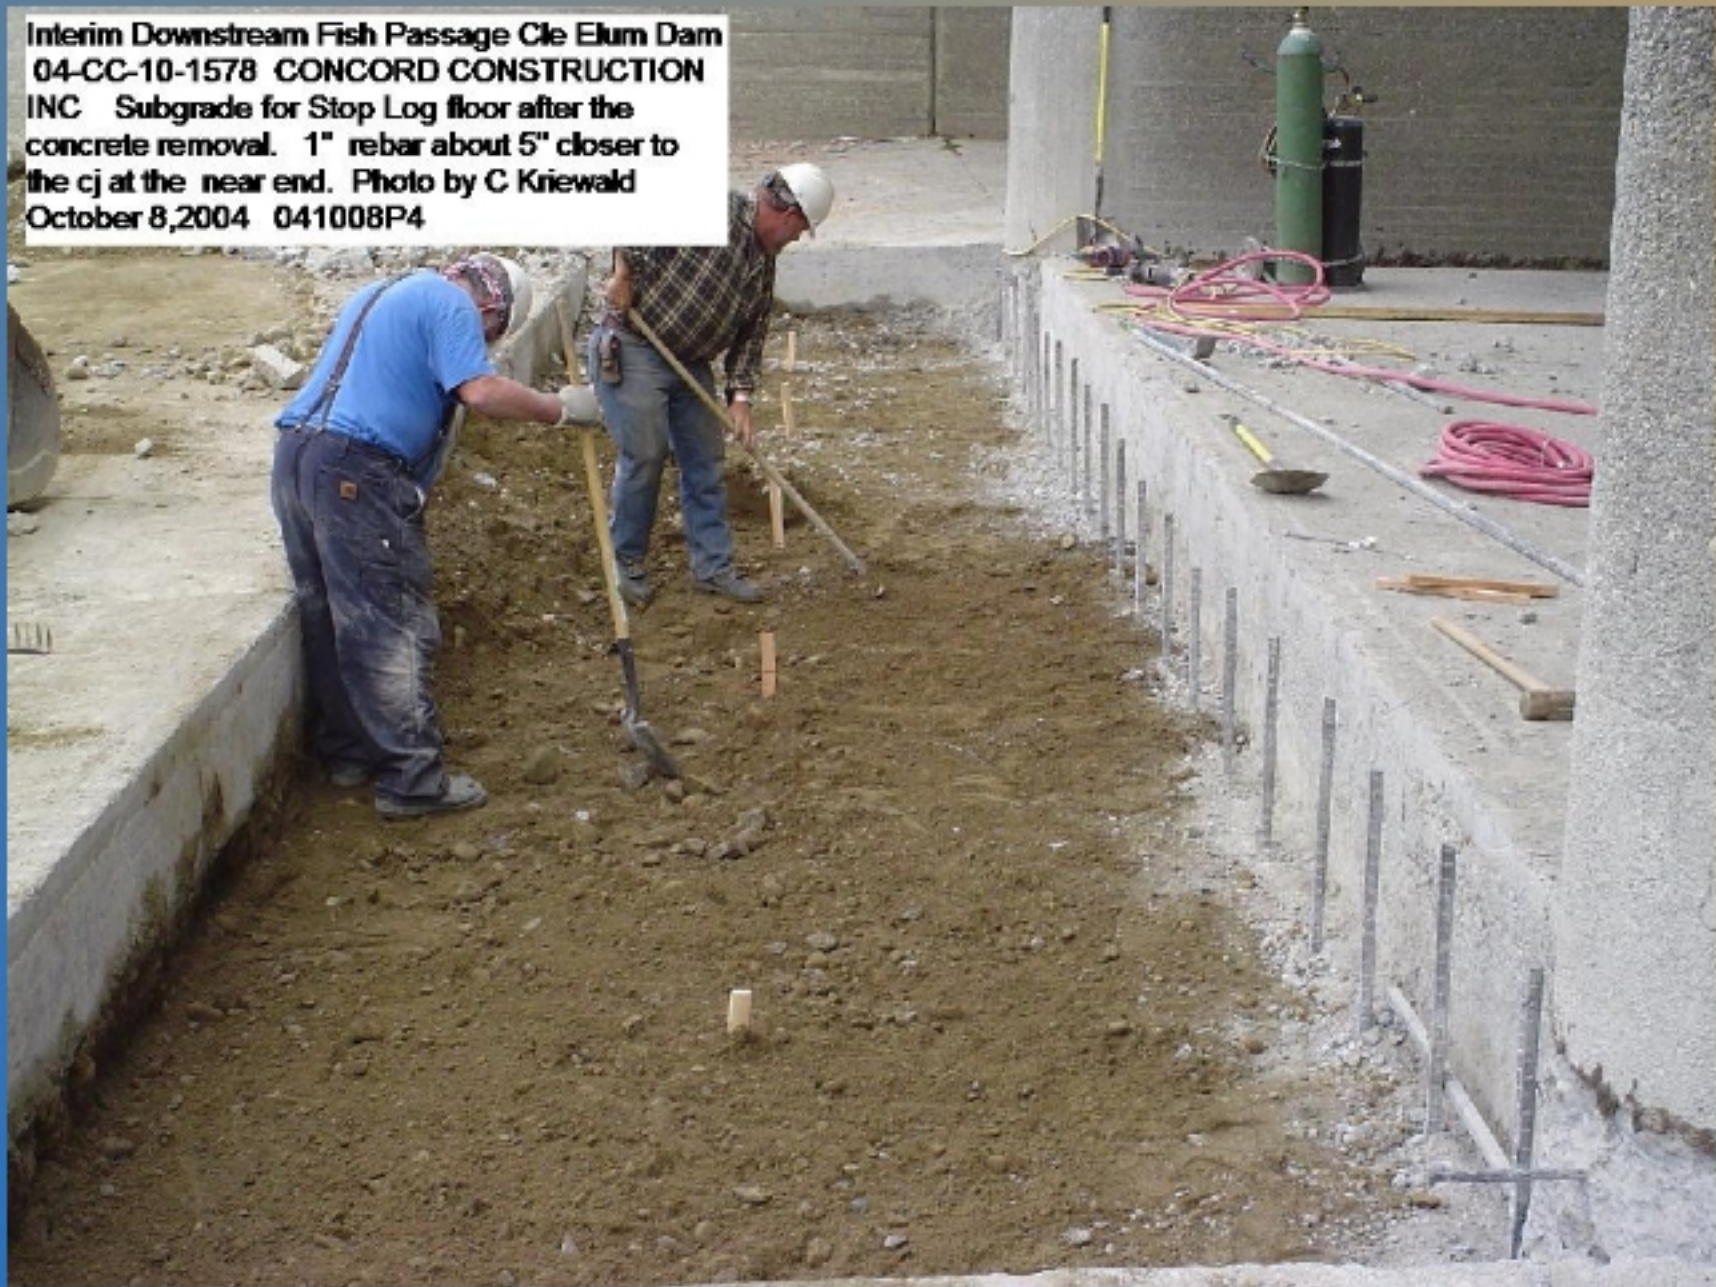
Interim Downstream Fish Passage Cle Elum Dam  
04-CC-10-1578 CONCORD CONSTRUCTION  
INC Subgrade for Stop Log floor after the  
concrete removal. 1" rebar about 5" closer to  
the cj at the near end. Photo by C Kriewald  
October 8, 2004 041008P4

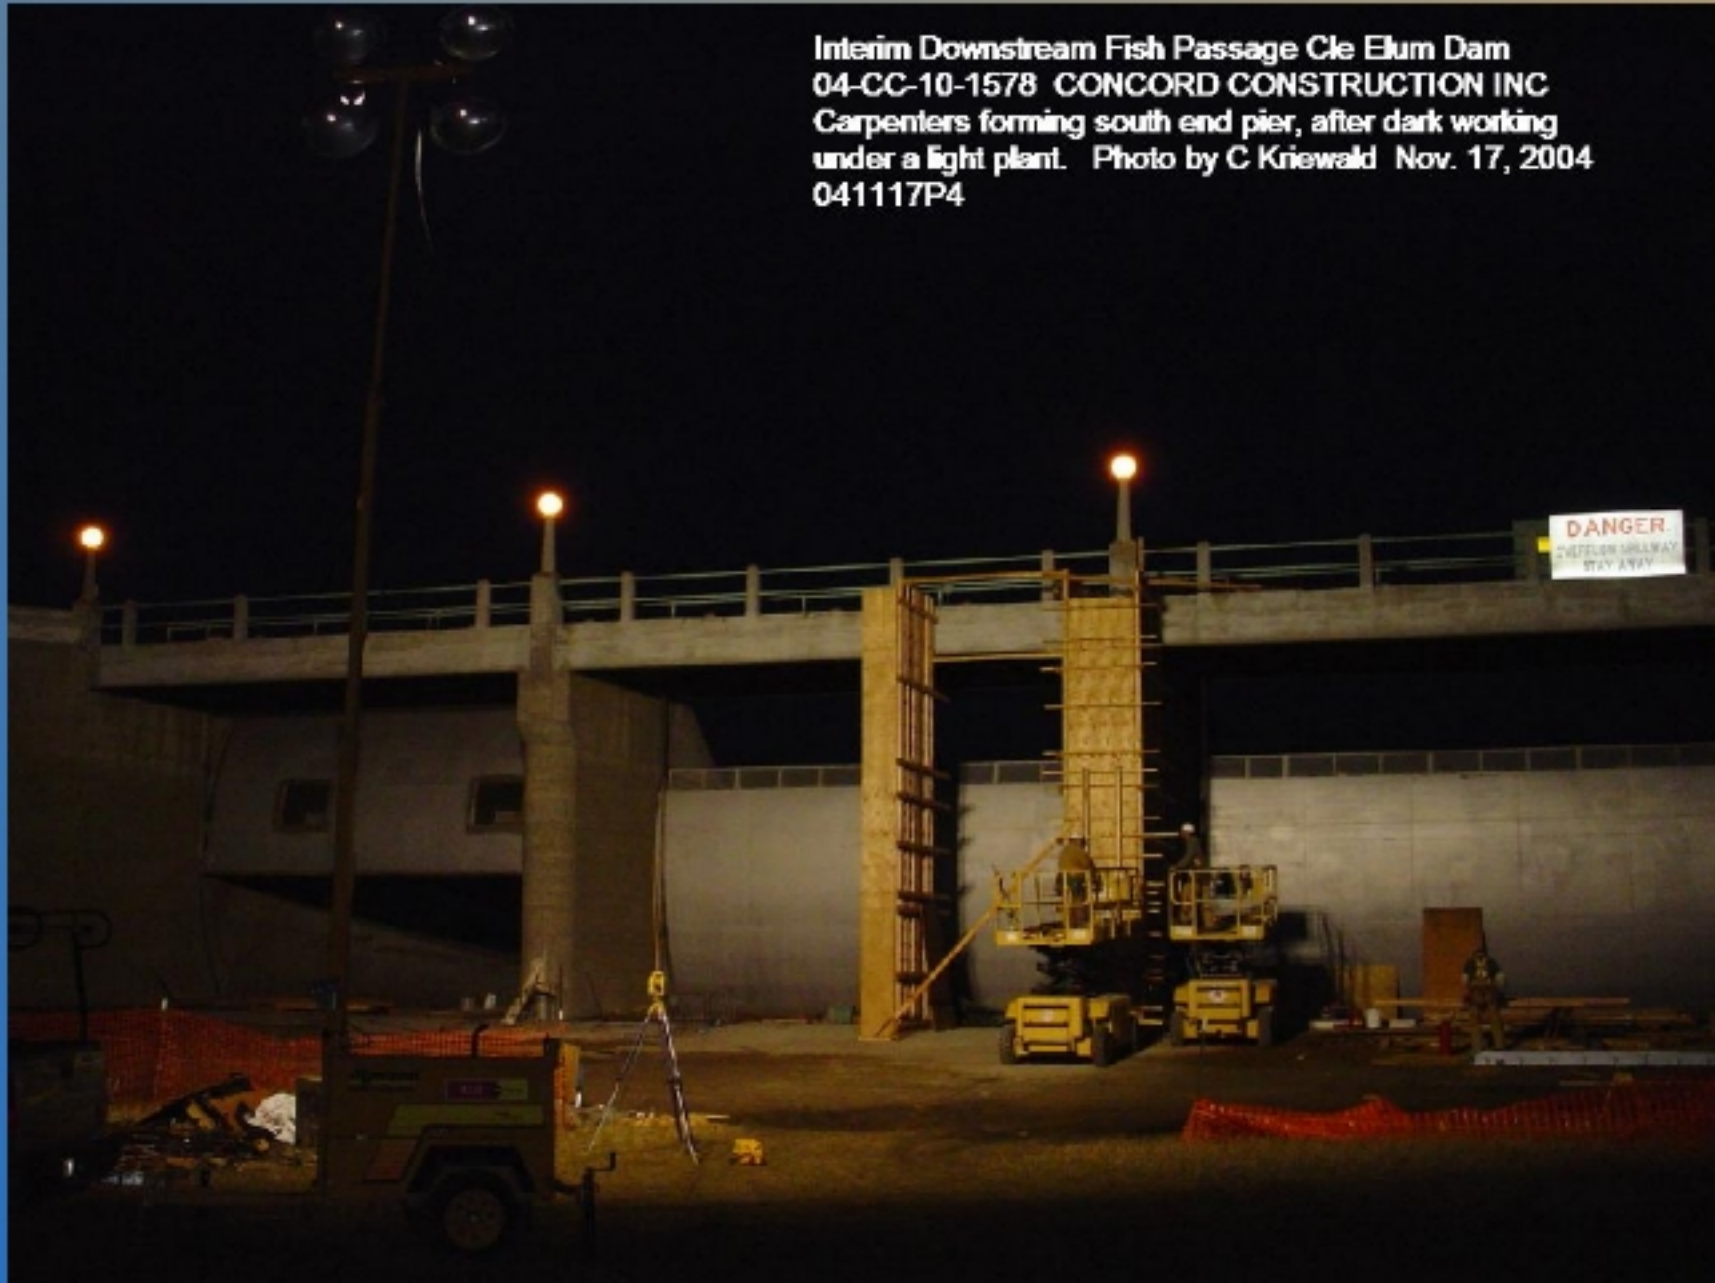
Interim Downstream Fish Passage Cle Elum Dam  
04-CC-10-1578 CONCORD CONSTRUCTION INC  
Carpenters forming south end pier, after dark working  
under a light plant. Photo by C Kriewald Nov. 17, 2004  
041117P4

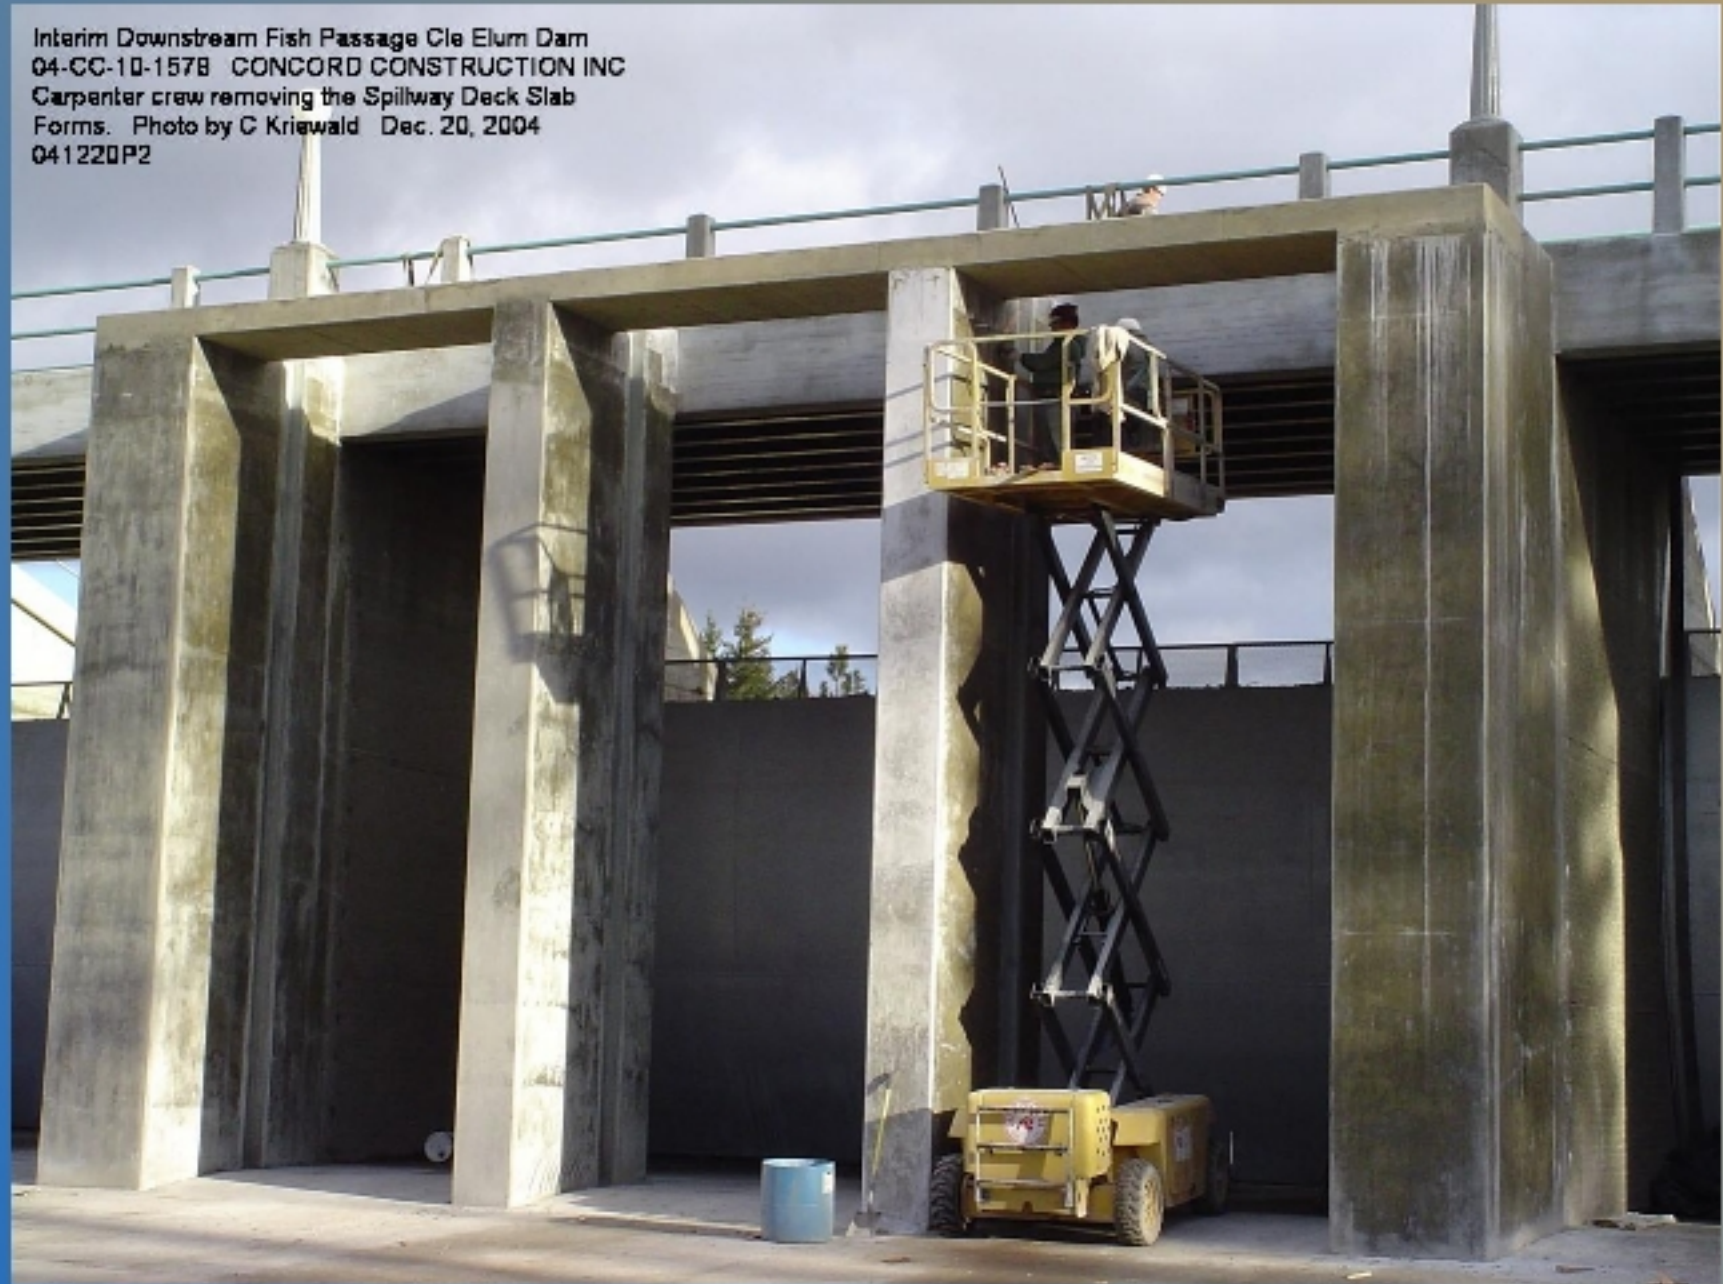
Interim Downstream Fish Passage Cle Elum Dam  
04-CC-10-157B CONCORD CONSTRUCTION INC  
Carpenter crew removing the Spillway Deck Slab  
Forms. Photo by C Kriewald Dec. 20, 2004  
041220P2

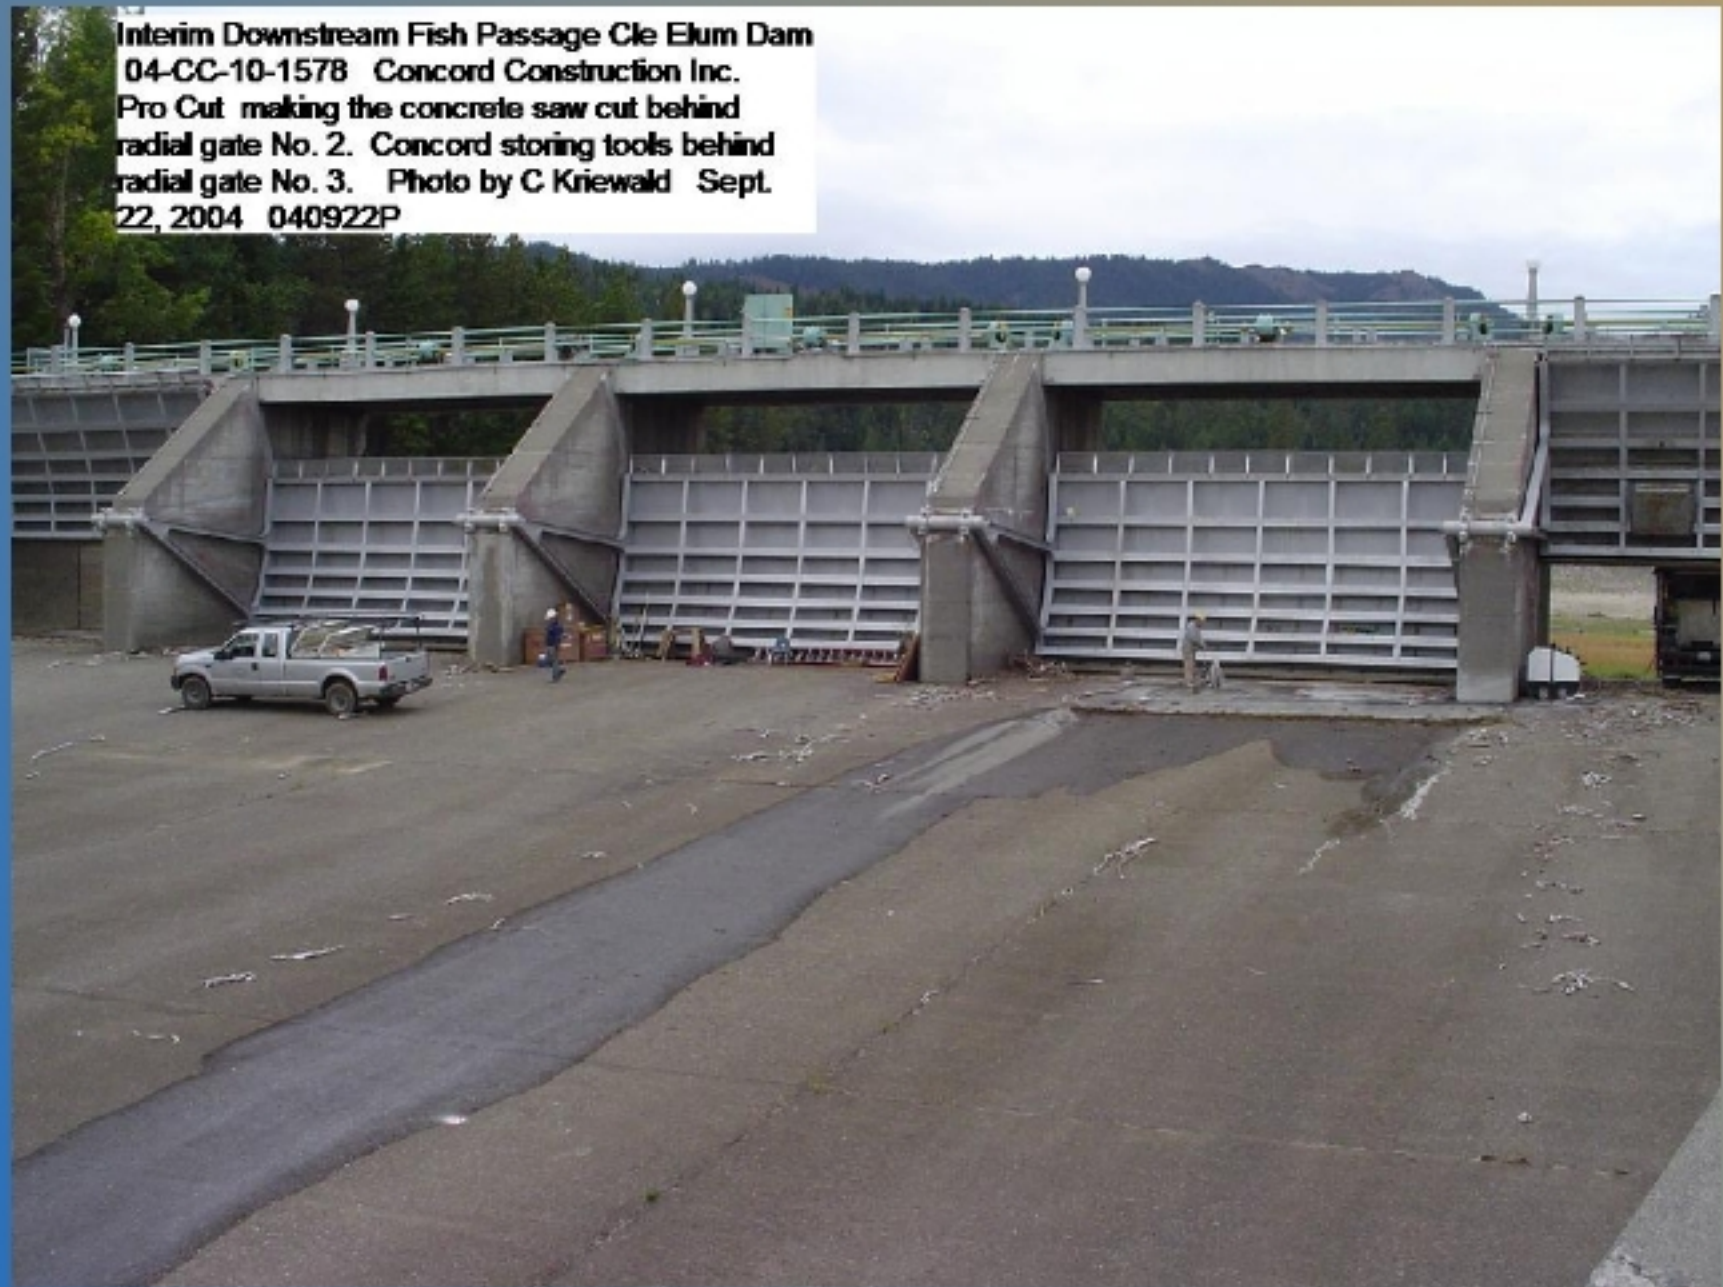
Interim Downstream Fish Passage Cle Elum Dam  
04-CC-10-1578 Concord Construction Inc.  
Pro Cut making the concrete saw cut behind  
radial gate No. 2. Concord storing tools behind  
radial gate No. 3. Photo by C Kriewald Sept.  
22, 2004 040922P

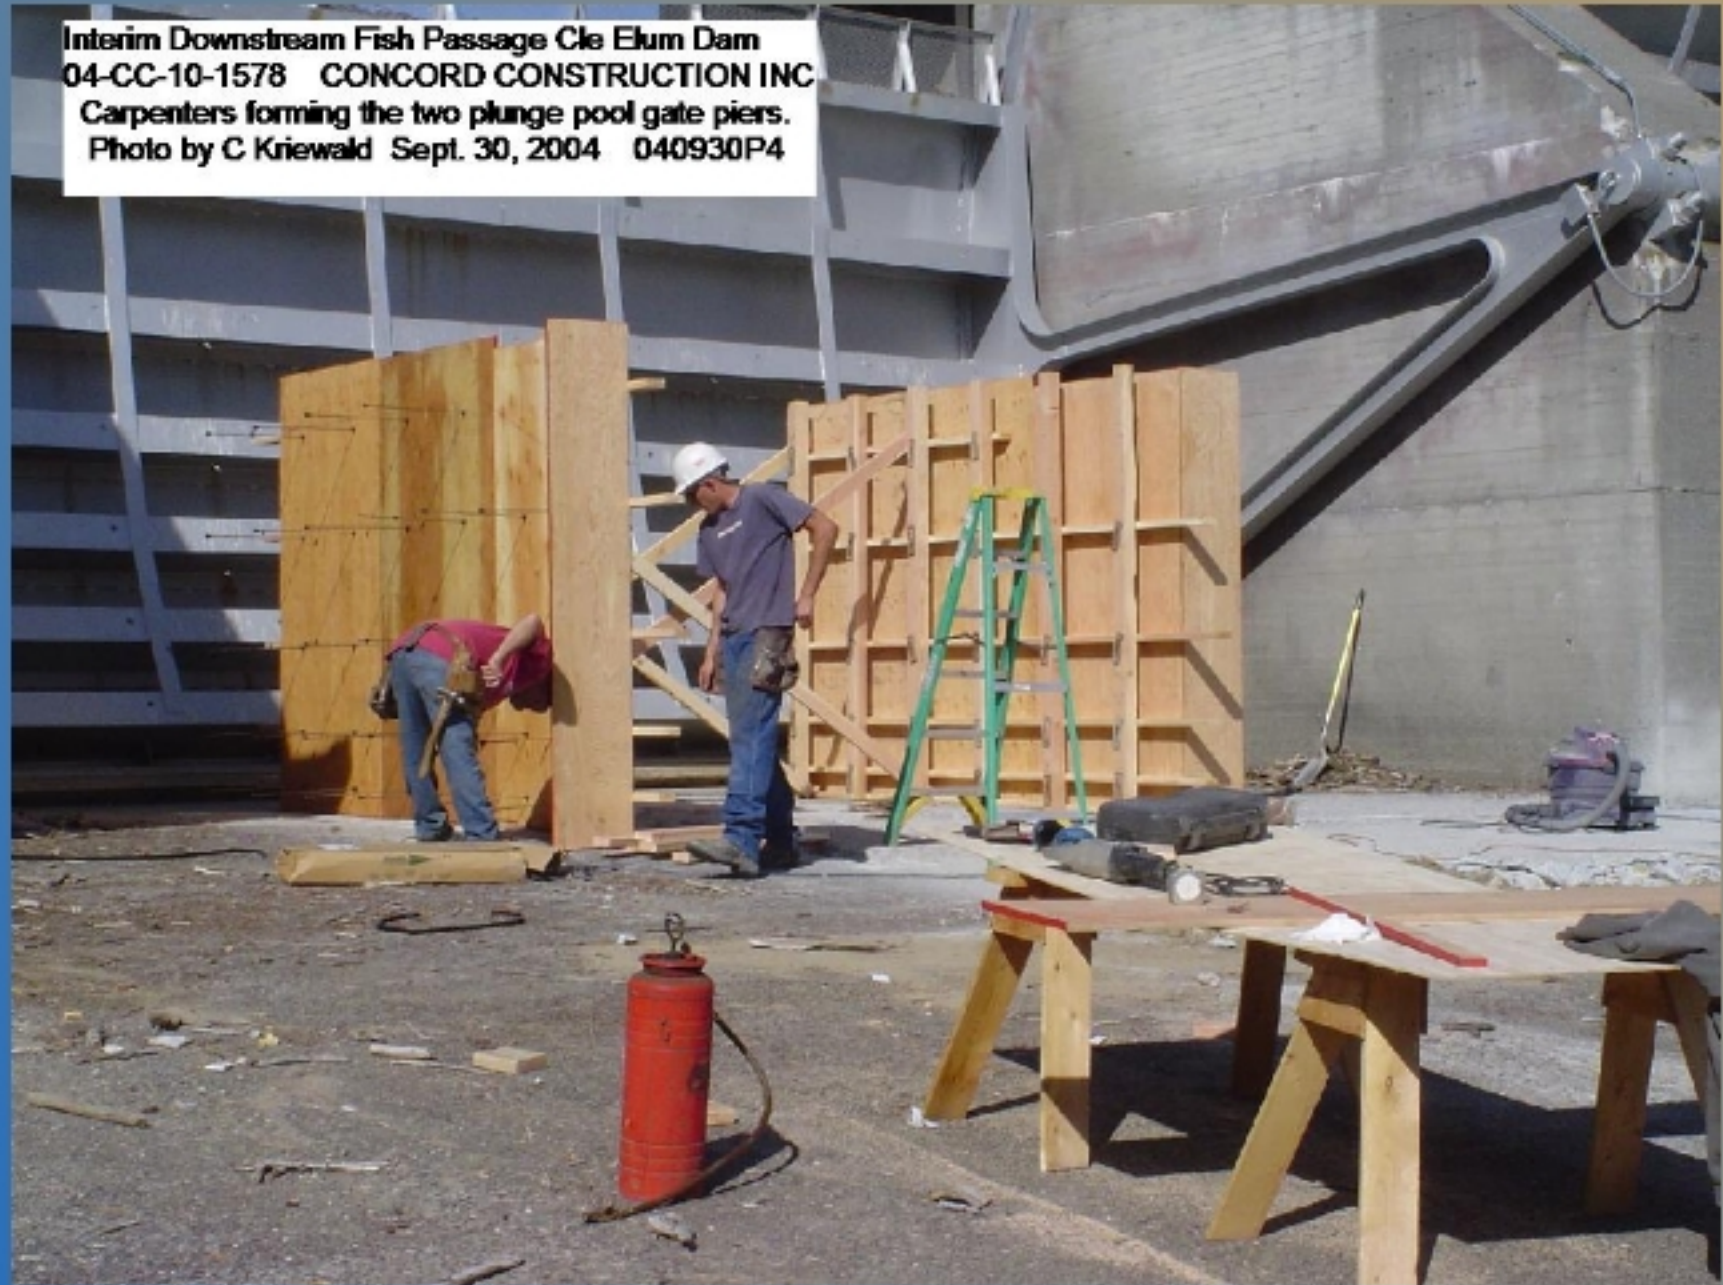
Interim Downstream Fish Passage Cle Elum Dam  
04-CC-10-1578 CONCORD CONSTRUCTION INC  
Carpenters forming the two plunge pool gate piers.  
Photo by C Kriewald Sept. 30, 2004 040930P4

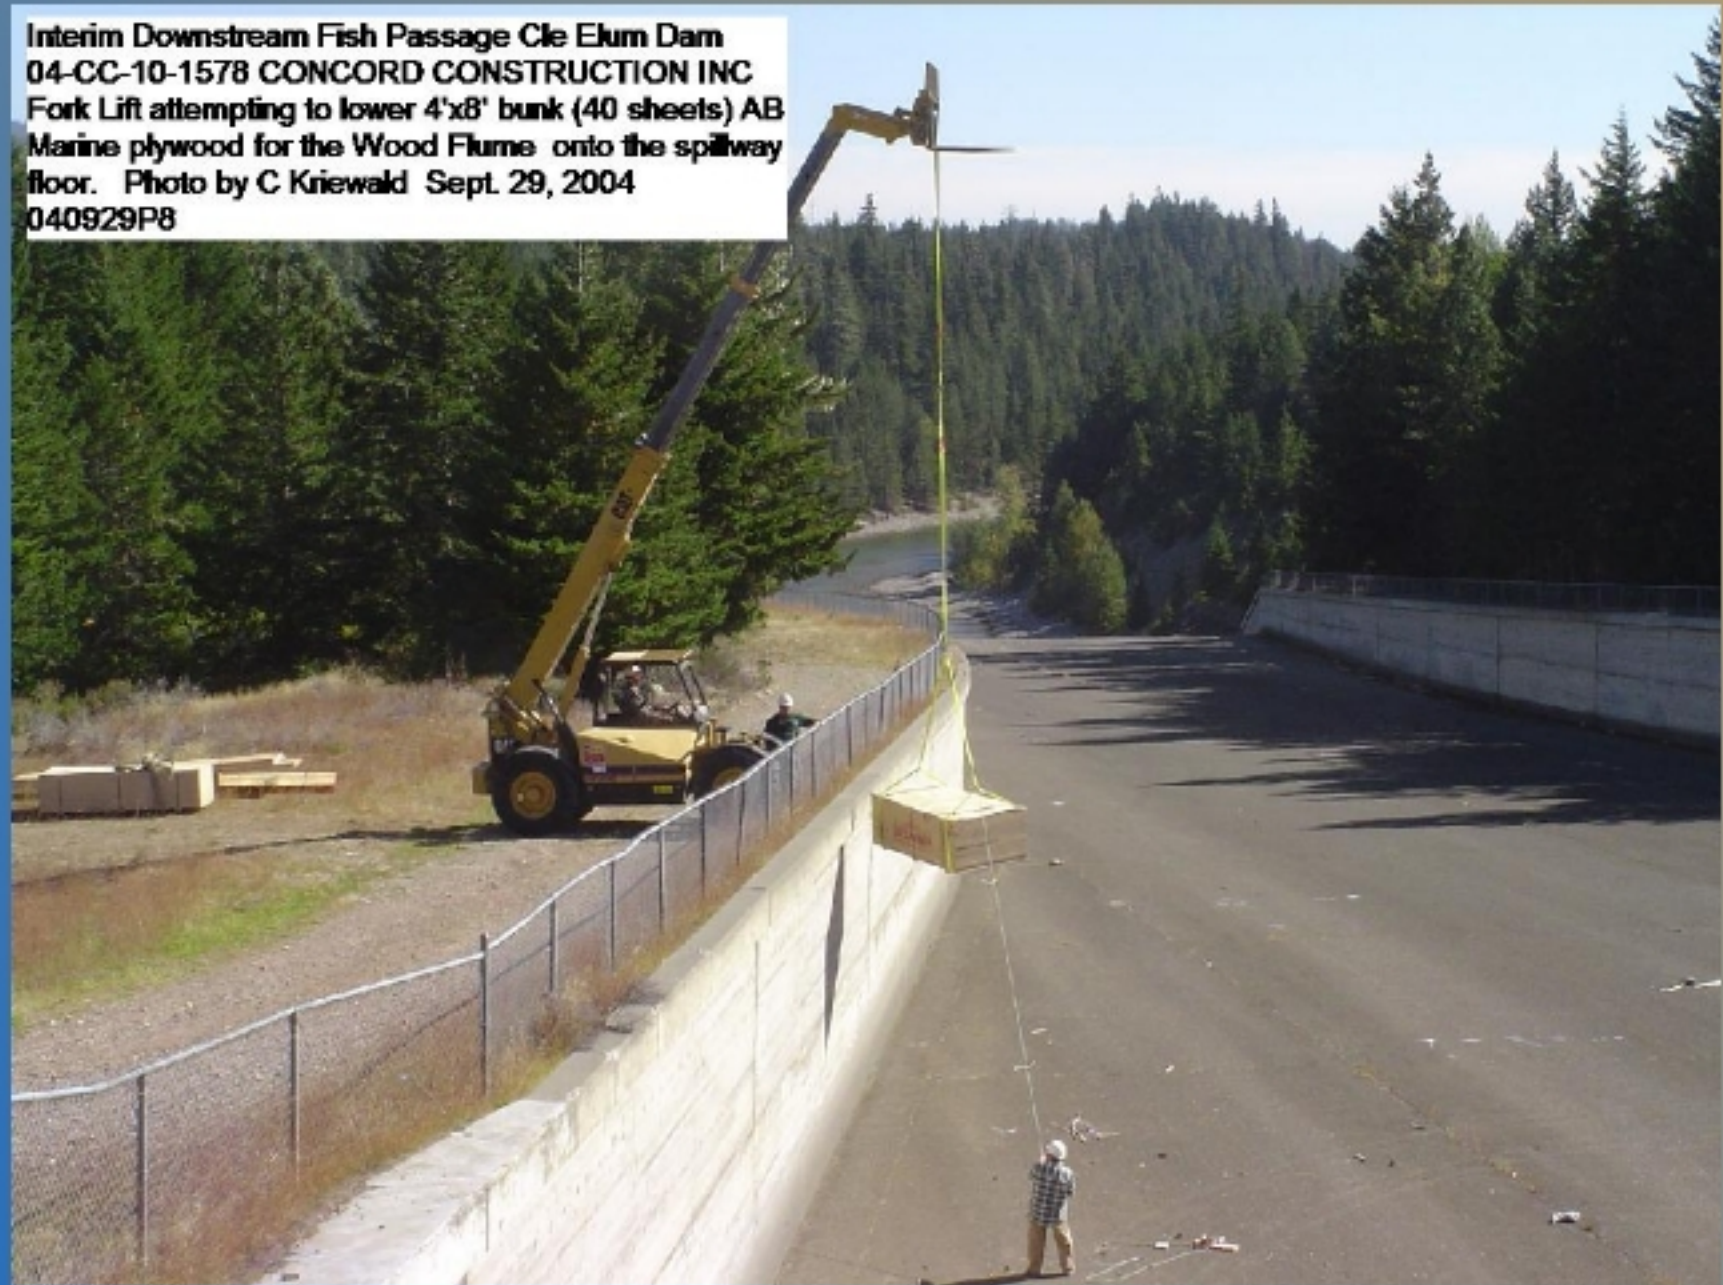
Interim Downstream Fish Passage Cle Elum Dam  
04-CC-10-1578 CONCORD CONSTRUCTION INC  
Fork Lift attempting to lower 4'x8' bunk (40 sheets) AB  
Marine plywood for the Wood Flume onto the spillway  
floor. Photo by C Kriewald Sept. 29, 2004  
040929P8

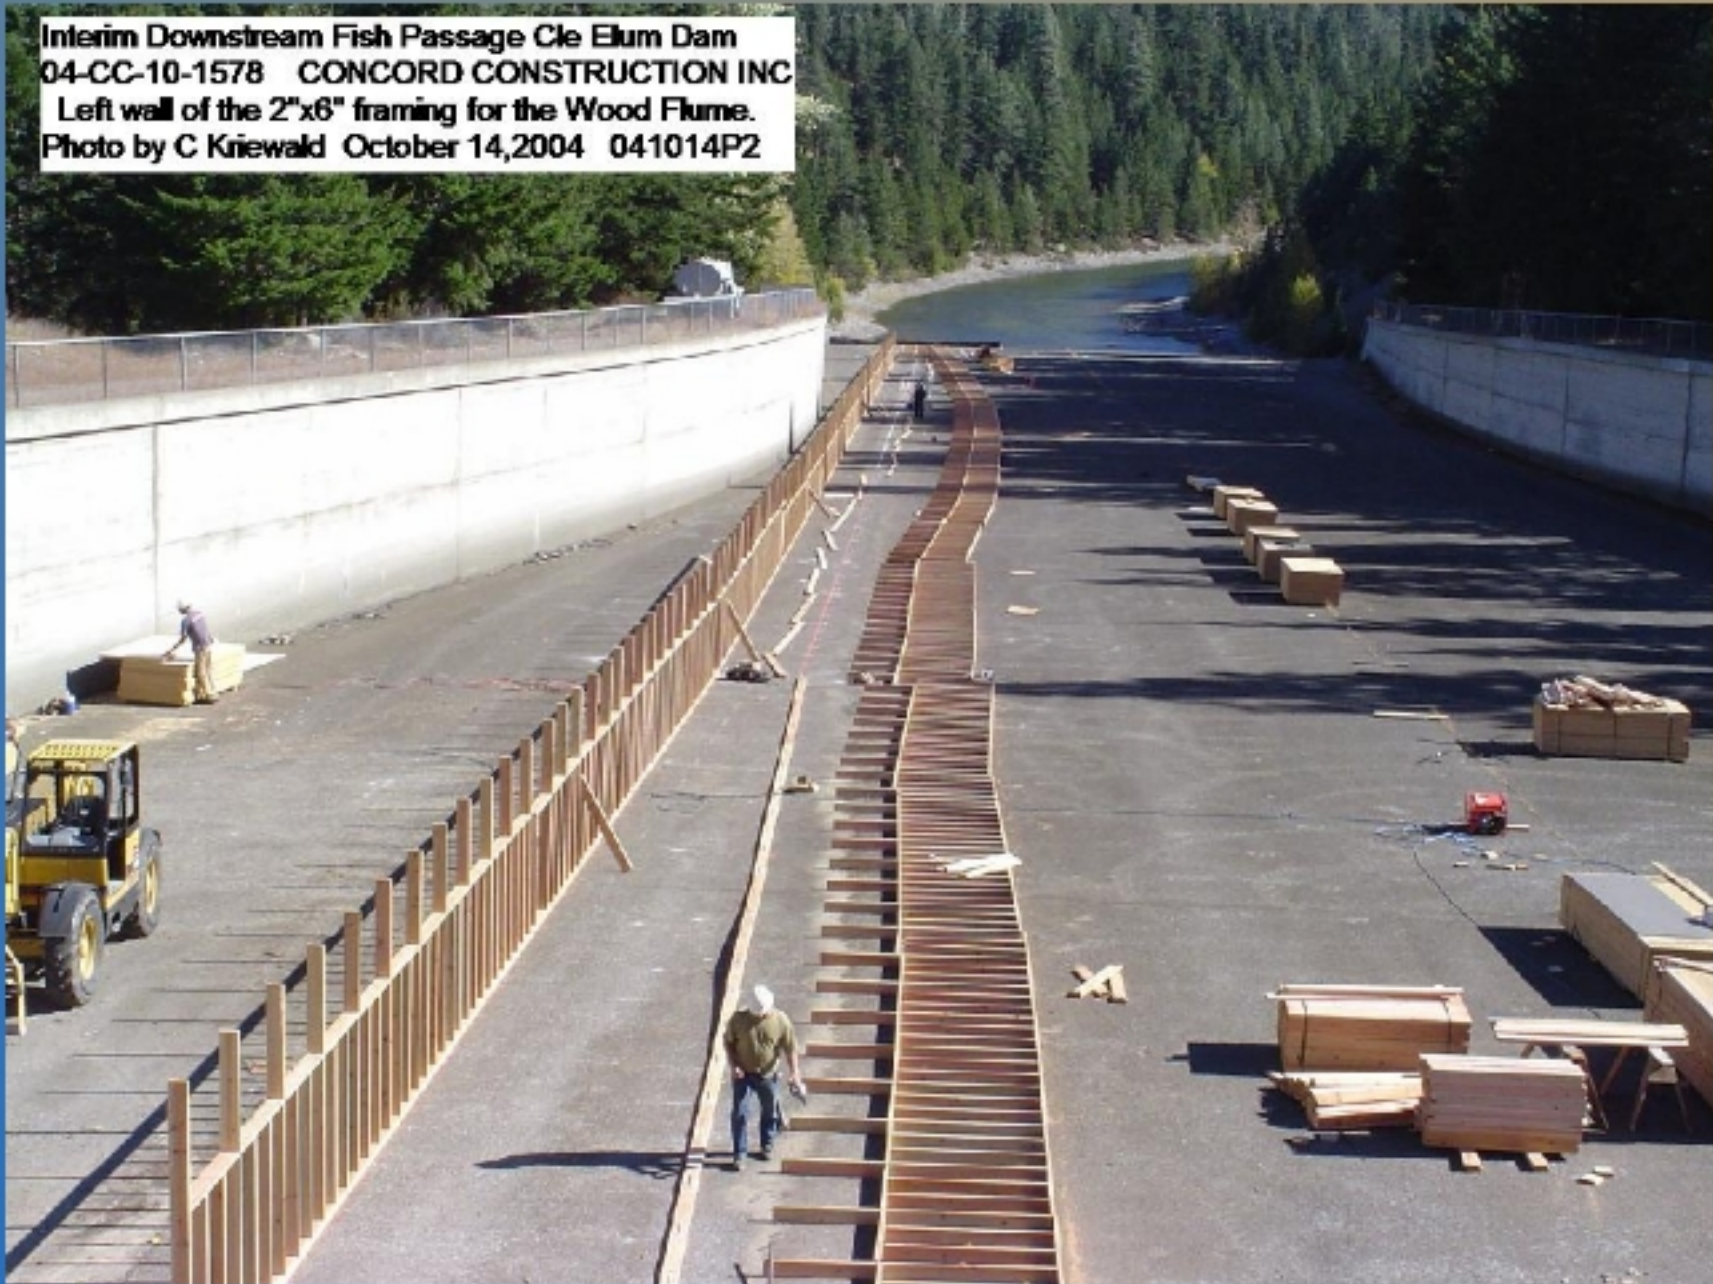
Interim Downstream Fish Passage Cle Elum Dam  
04-CC-10-1578 CONCORD CONSTRUCTION INC  
Left wall of the 2"x6" framing for the Wood Flume.  
Photo by C Kriewald October 14,2004 041014P2

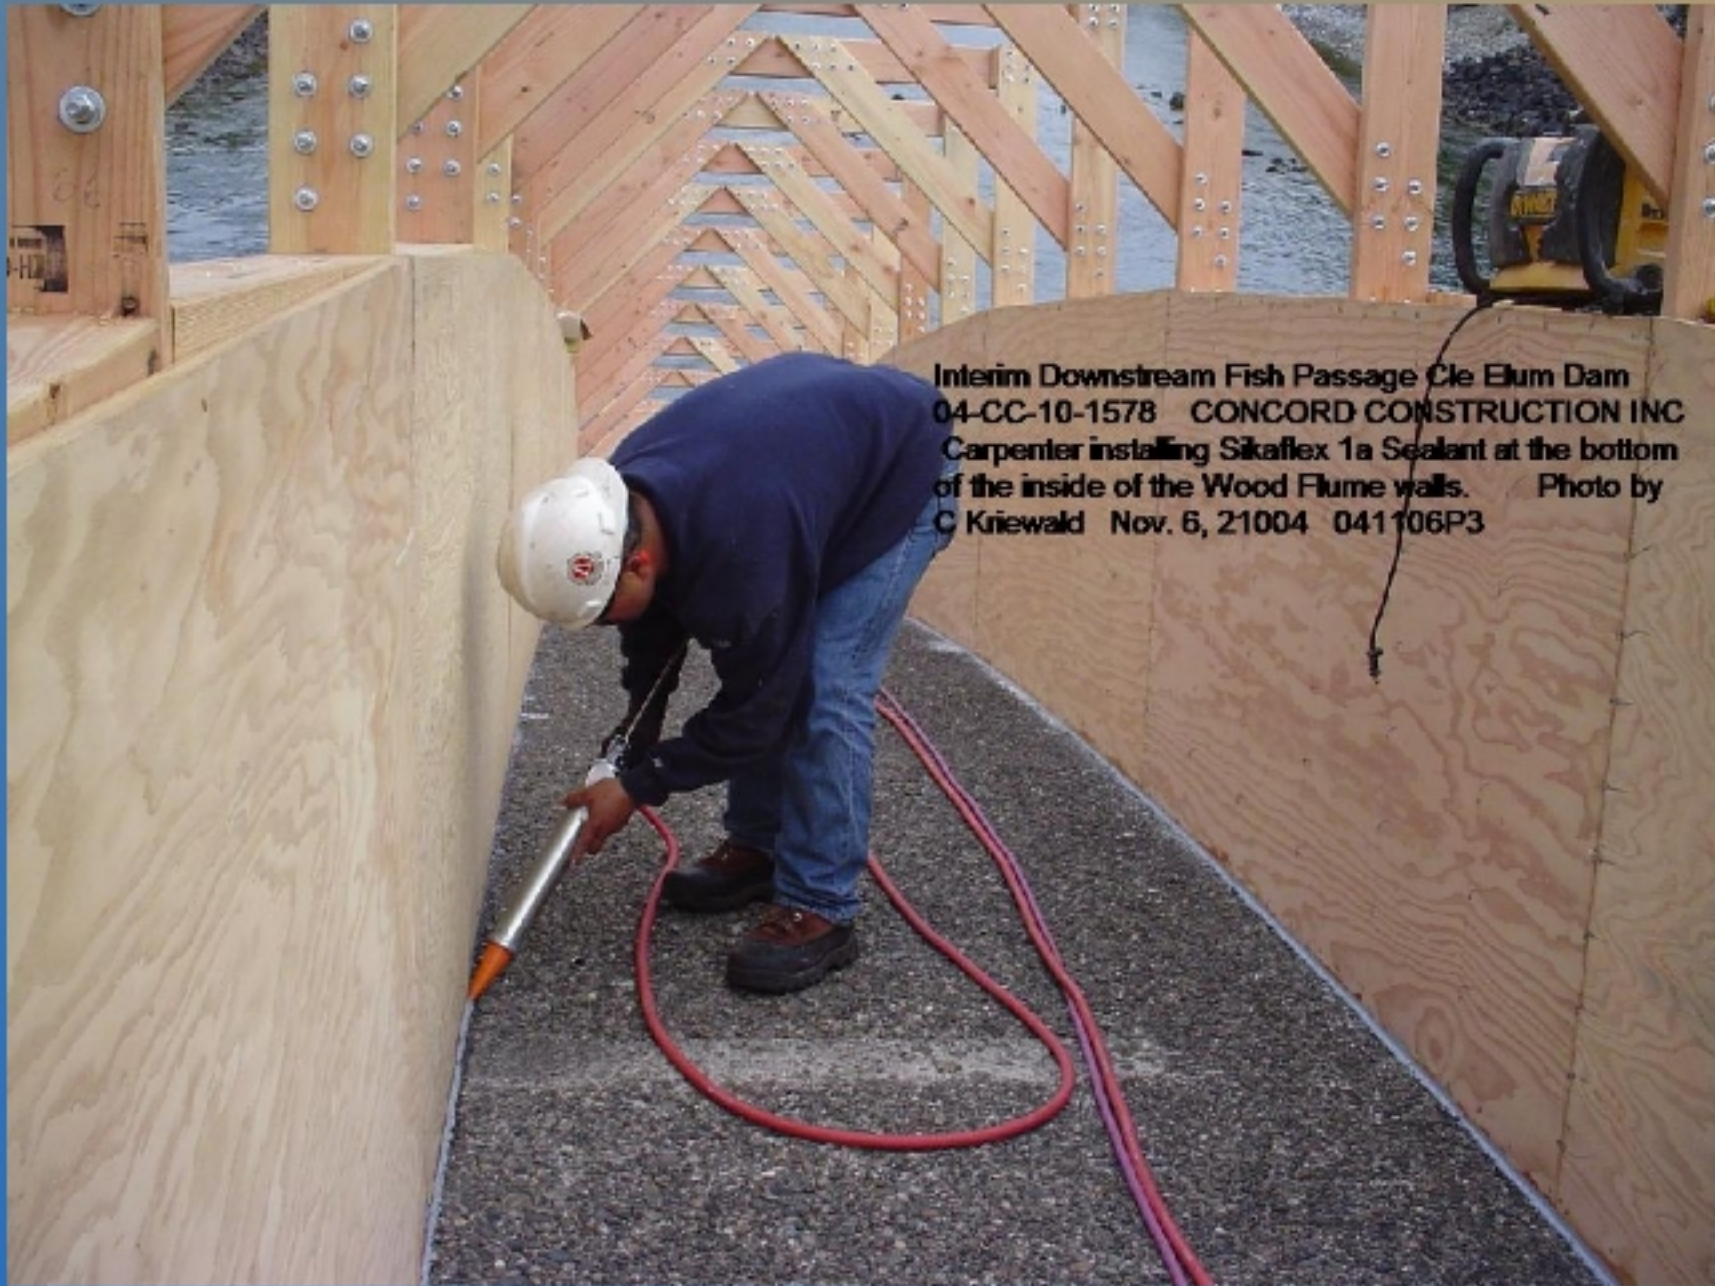
Interim Downstream Fish Passage Cle Elum Dam  
04-CC-10-1578 CONCORD CONSTRUCTION INC  
Carpenter installing Sikaflex 1a Sealant at the bottom  
of the inside of the Wood Flume walls. Photo by  
C Kriewald Nov. 6, 21004 041106P3
