## Storage Dam Fish Passage Feasibility Study

U.S. Department of the Interior  
Bureau of Reclamation

# Cle Elum Dam Interim Downstream Fish Passage

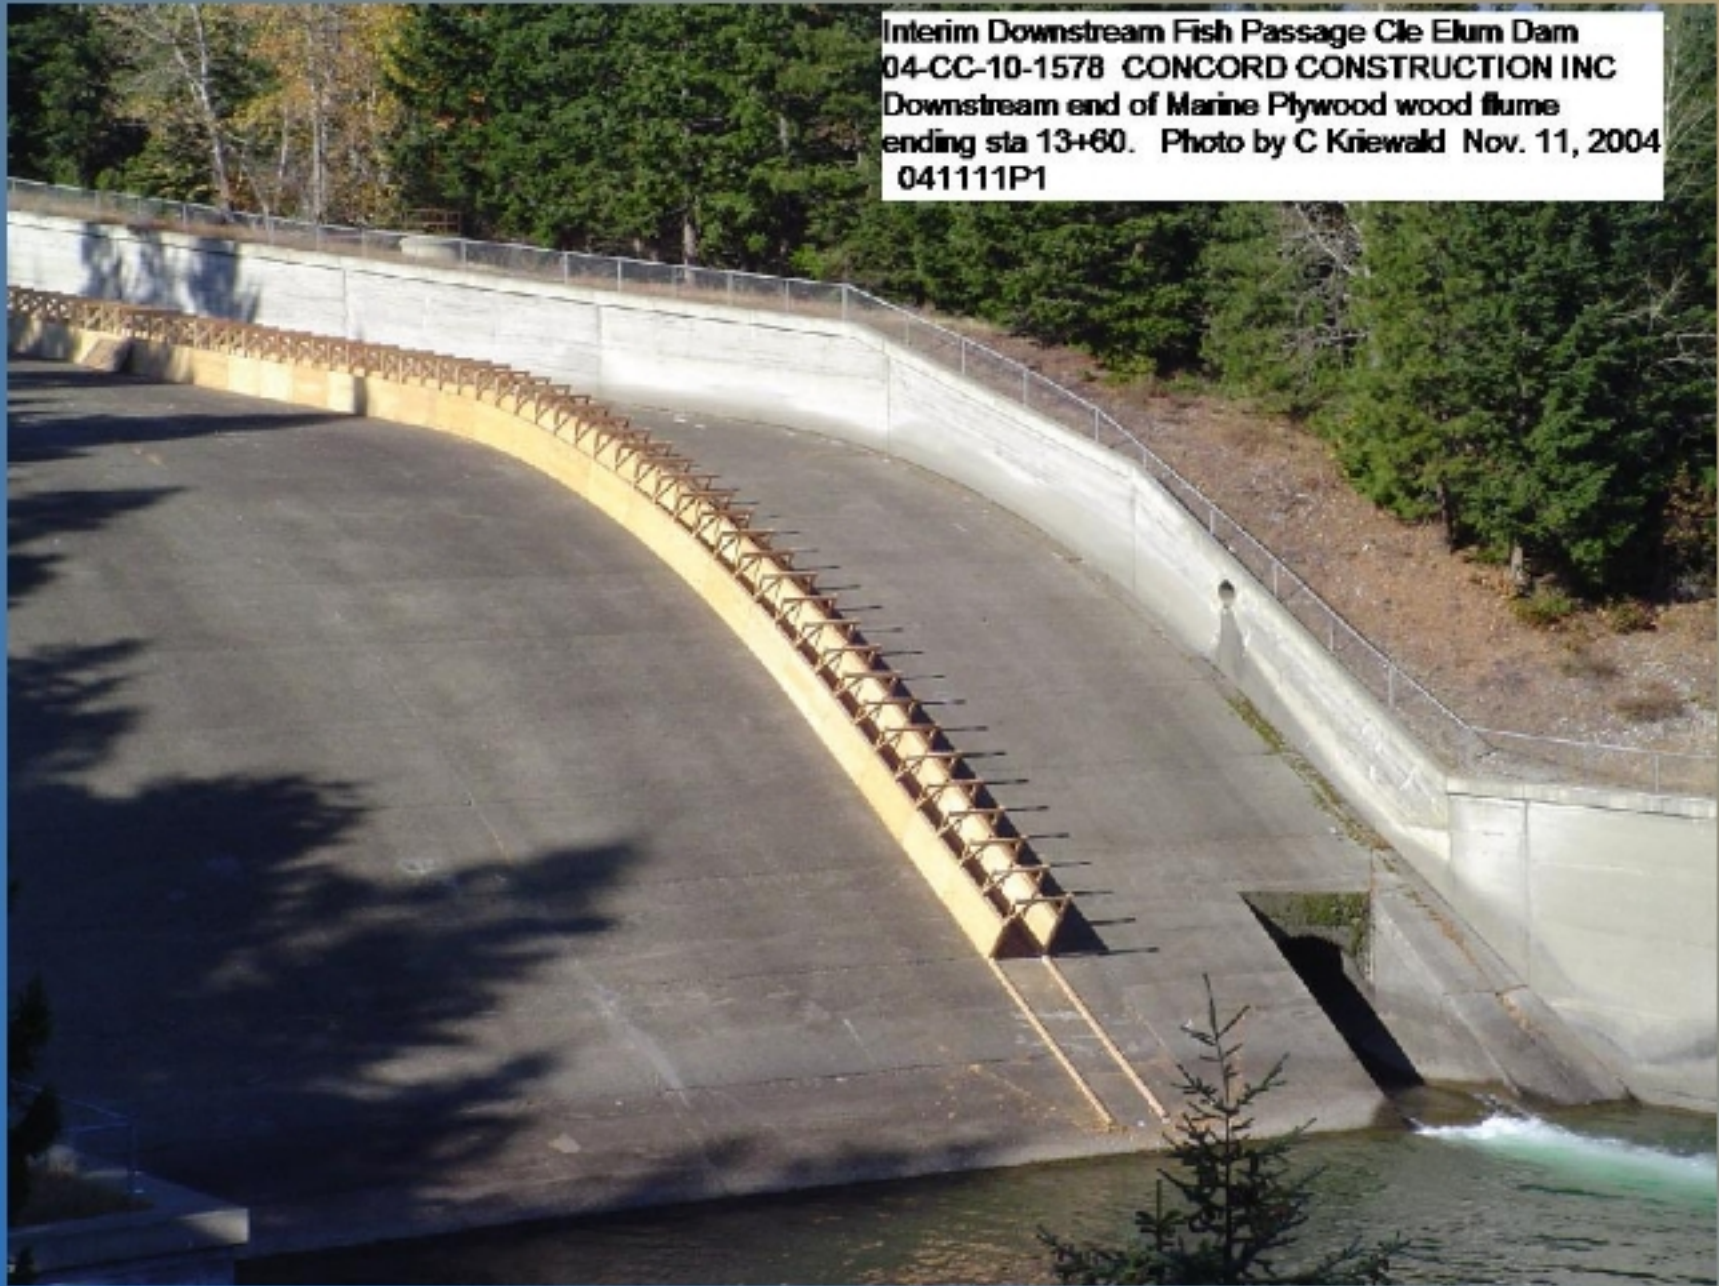
Interim Downstream Fish Passage Cle Elum Dam  
04-CC-10-1578 CONCORD CONSTRUCTION INC  
Downstream end of Marine Plywood wood flume  
ending sta 13+60. Photo by C Kriewald Nov. 11, 2004  
041111P1
