- Two Year Assessment Results
- Conceptual Designs
- Moving Forward

Gold Creek Habitat Assessment & Conceptual Design

**Gold Creek
 Project Site Area**

**Northeast of Snoqualmie Pass
 Kittitas County, Washington**

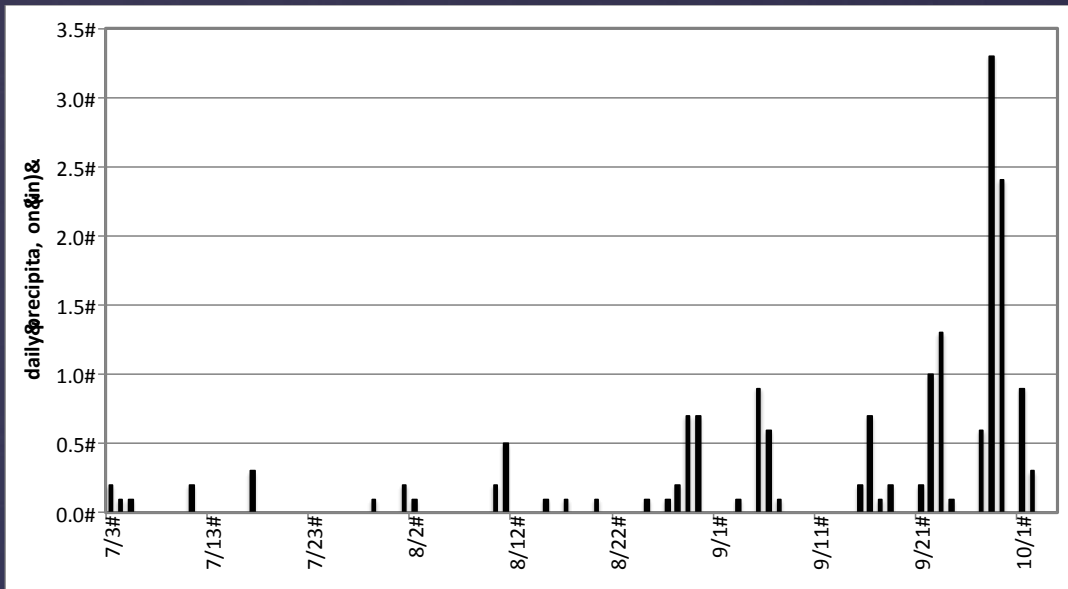
2013

- Extended period of little to no rainfall from July to Mid-September
- Extended period of seasonal dewatering

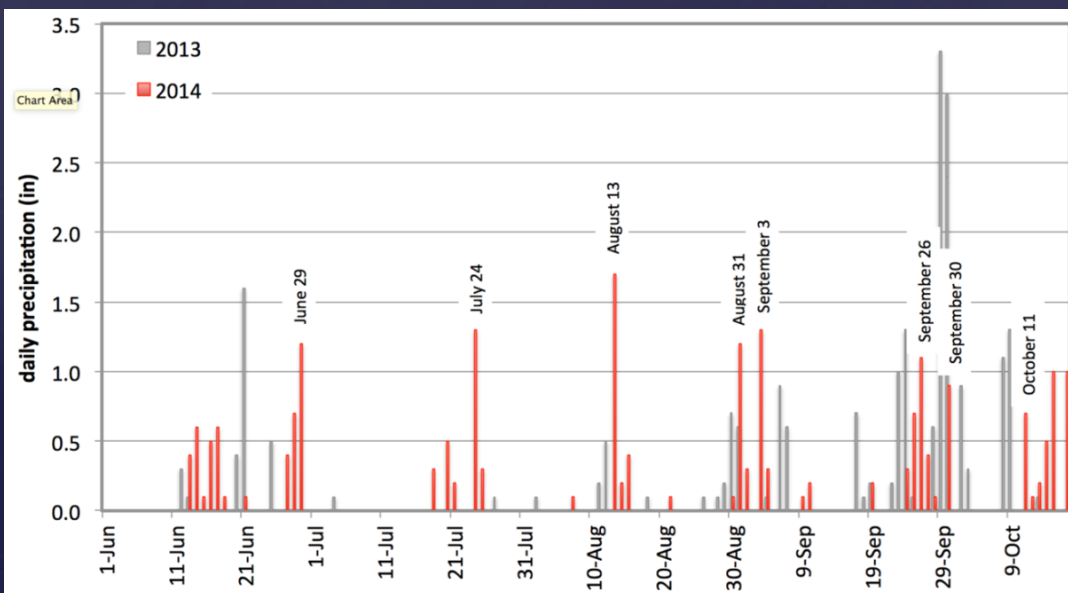
2014

- Four rainfall events throughout the summer over 1"
- Four distinct dewatering events through this same period

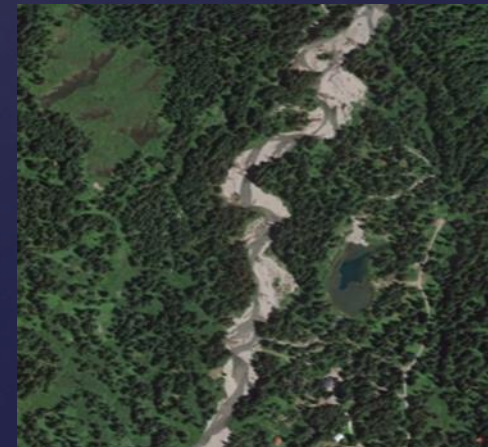
2015

- Accelerated widening following logging in the 1950's
- Average peak width in the 1990's
- Expansion greatest downstream of RM 1 and between RM 1.4 and 1.75
- Current trends suggest the riparian trees are starting to achieve key size (60 years after logging)

YEAR	AVERAGE ACTIVE CHANNEL WIDTH (FT)	AVERAGE INCREASE IN ACTIVE CHANNEL WIDTH SINCE 1944 (%)	MAXIMUM ACTIVE CHANNEL WIDTH MEASURED
1944	96	0	233
1954	104	7.8	253
1957	123	27	446
1970	179	86	403
1985	179	85	373
1991	183	90	339
1998	183	90	315
2003	169	75	282
2006	158	64	318
2011	181	88	332
2014	168	74	290

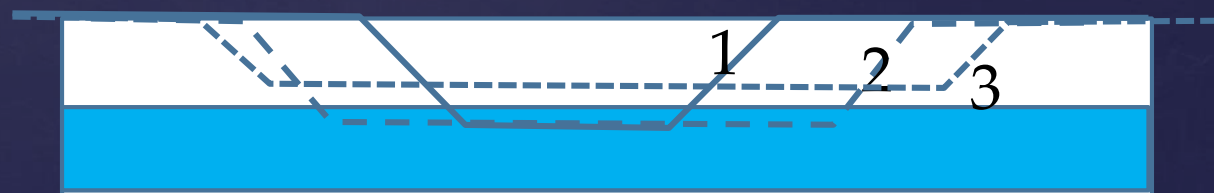
Stream discharge into creek bed (Q)

α

Surface area of creek bed (A)

↑ stream bed surface area

= ↑ infiltration into groundwater

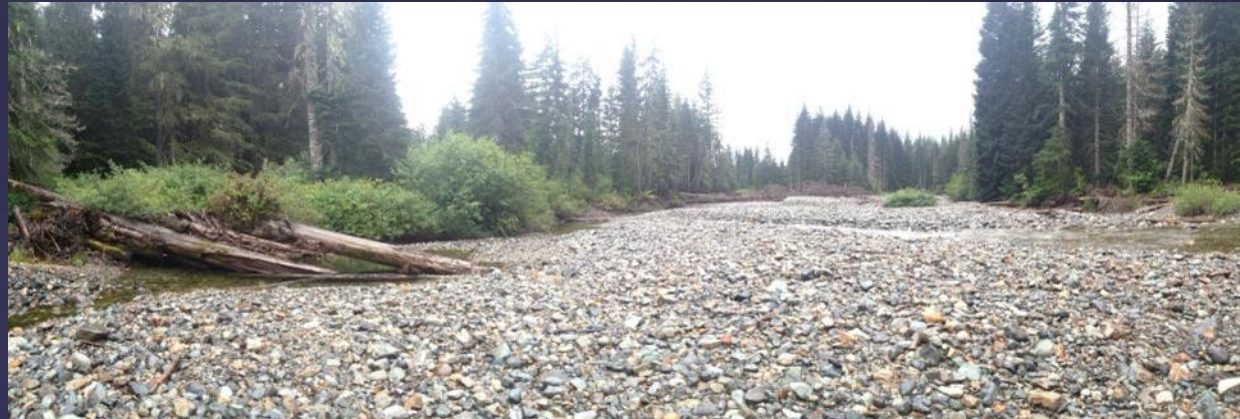
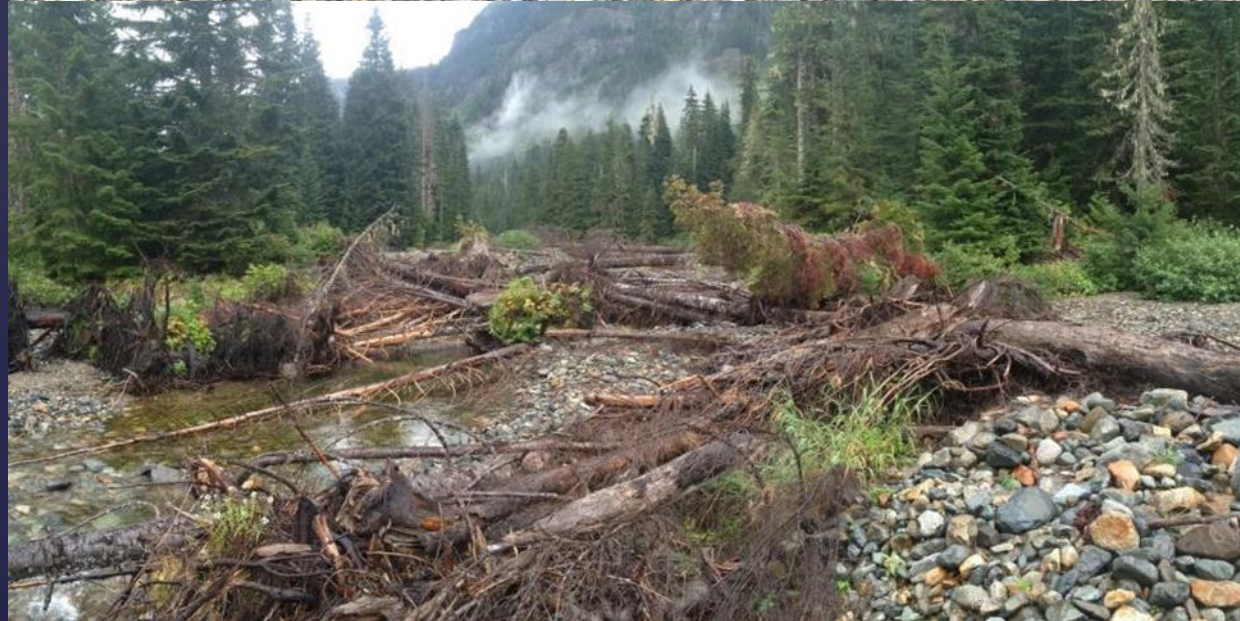
INSTREAM RESTORATION

Restoration of forested floodplain

- Restoration of historic channel widths
- Roughened floodplain to confine flows and reduce infiltration area
- Target sub-reaches with most significant widening
- Use of large timber to provide bank strength

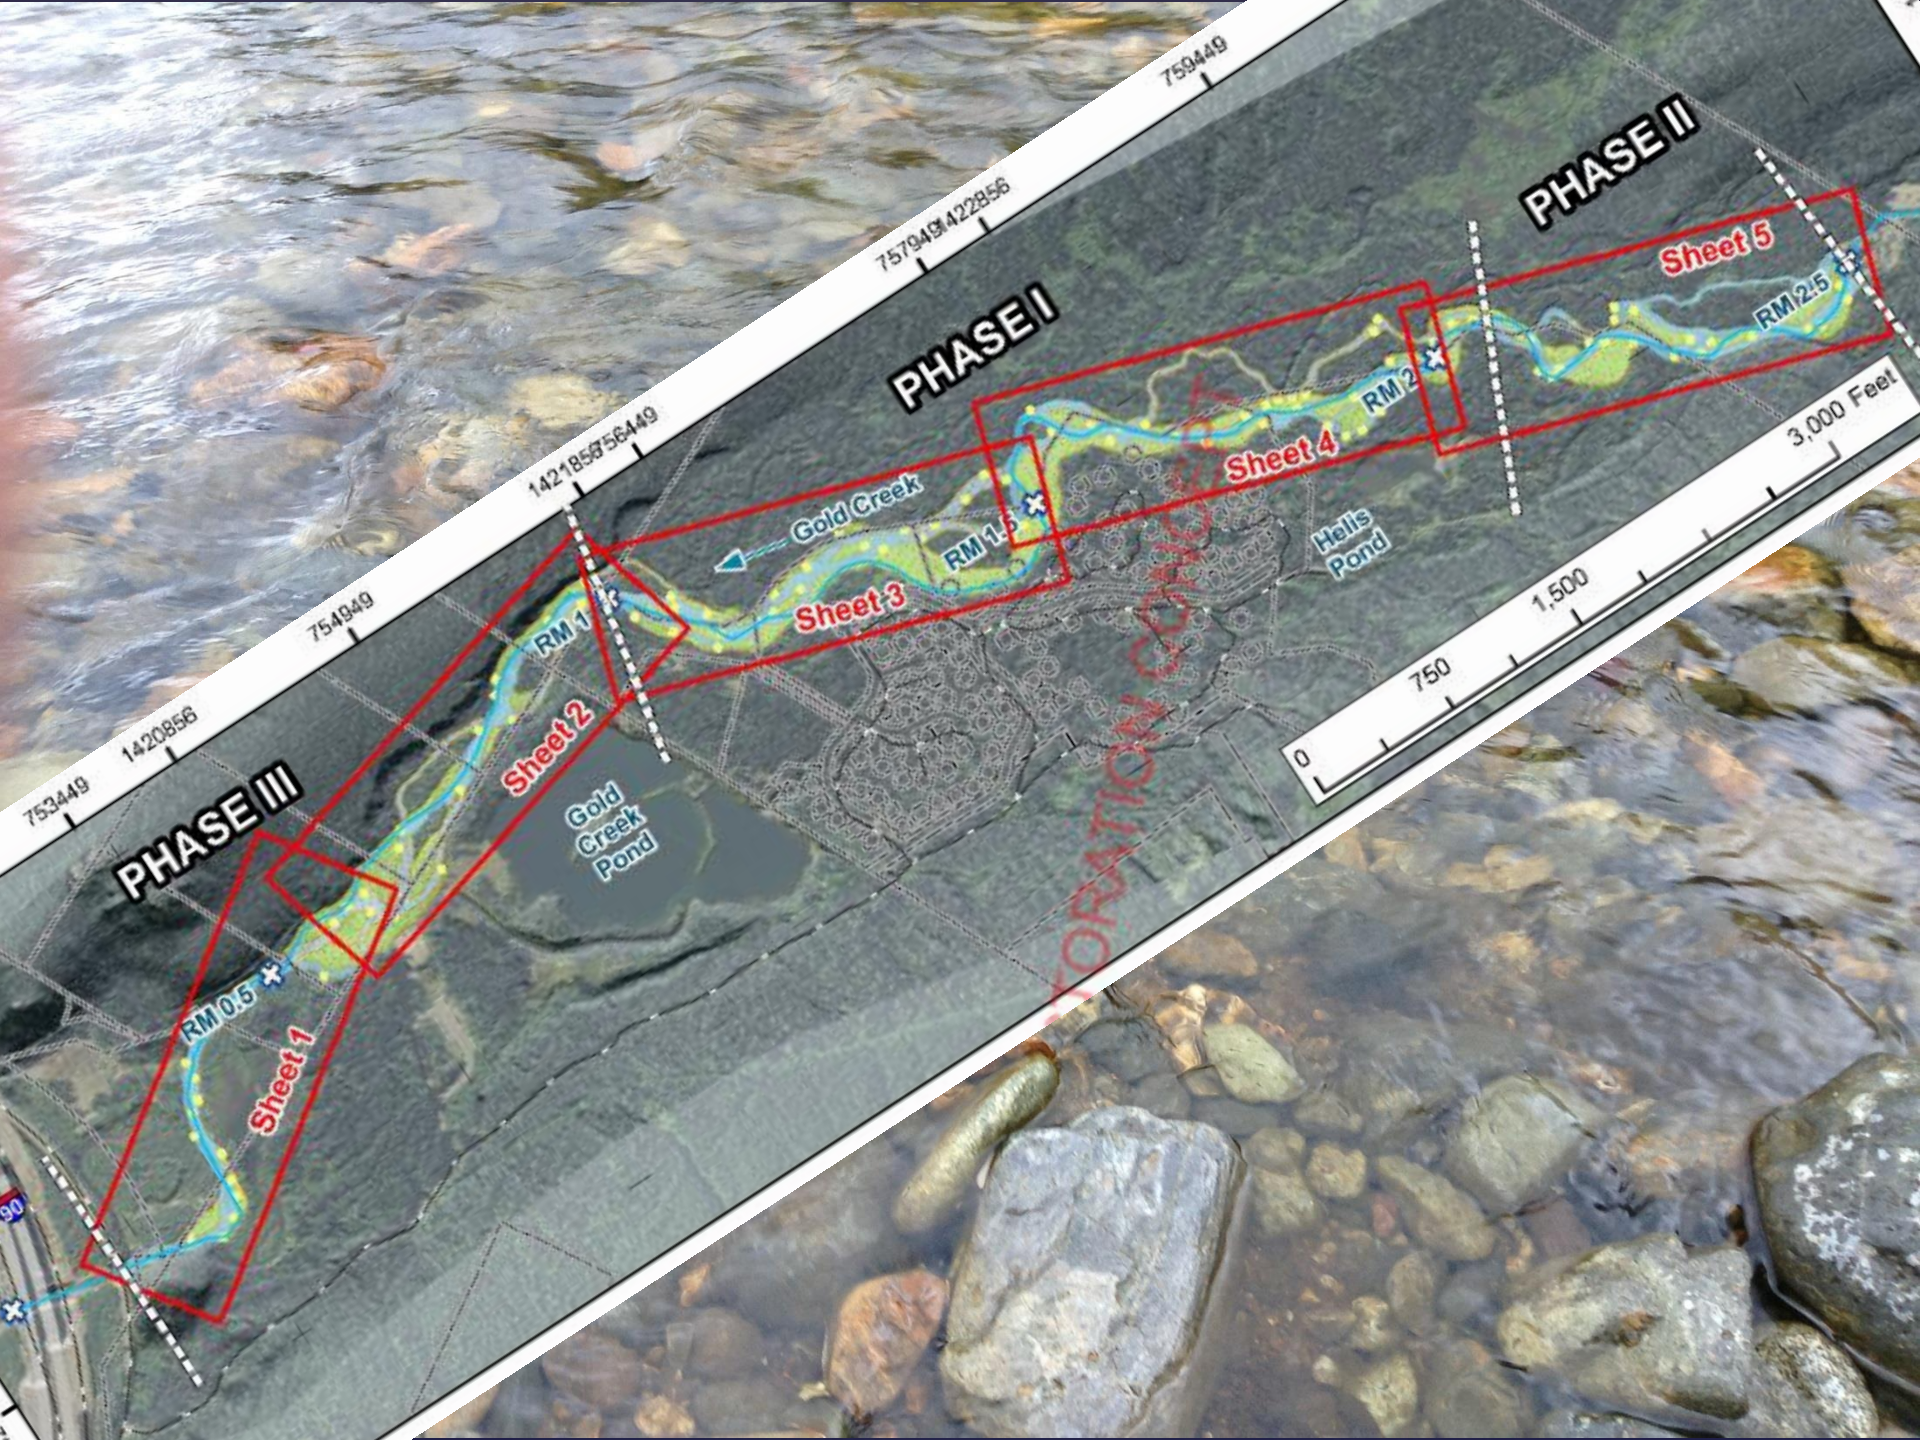
PHASE III

PHASE I

PHASE II

Sheet 1
RM 0.5

Sheet 2
RM 1
Gold Creek Pond

Sheet 3
RM 1.5
Gold Creek

Sheet 4
RM 2
Hells Pond

Sheet 5
RM 2.5

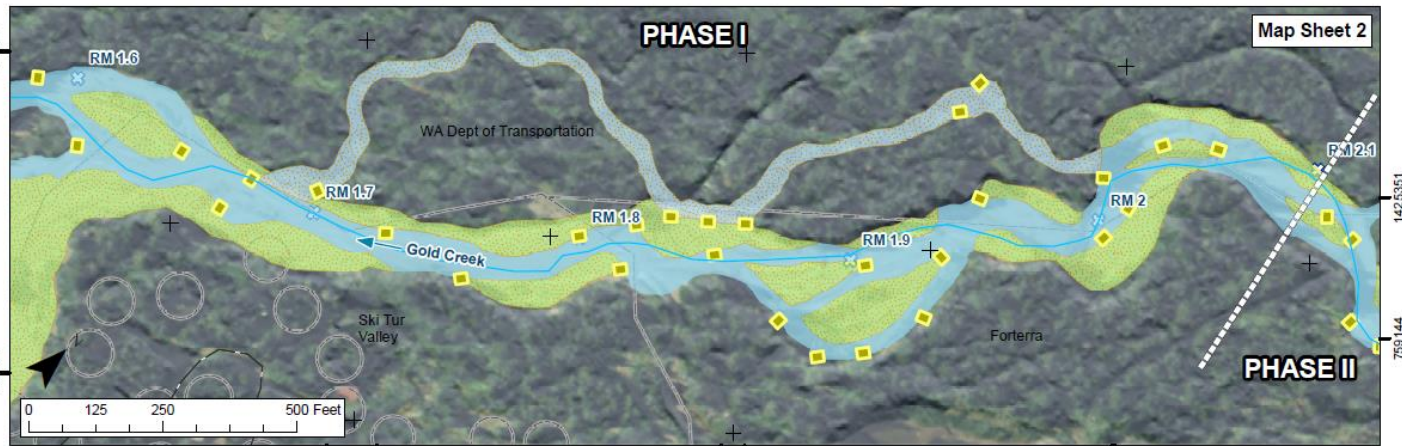
**Gold Creek
 Instream Restoration
 Concept Design**

2015 SRFB
 Project Proposal
 PRISM #15-1153
 RM 1 – 2.1

Main Dewatered
 Reach

This generalized concept is to portray basic plan for restoring this portion of Gold Creek valley within Gold Creek to pre-disturbance condition circa 1944. The project will restore critical instream habitat by emulating natural processes that once sustained habitat and stabilized the channel. The concept area will complement larger scale restoration within Gold Creek valley that include restoration of Gold Creek Pond. The concept presents major project elements to be addressed in restoration planning and the specific boundaries of project elements are anticipated to change based on stakeholder input.

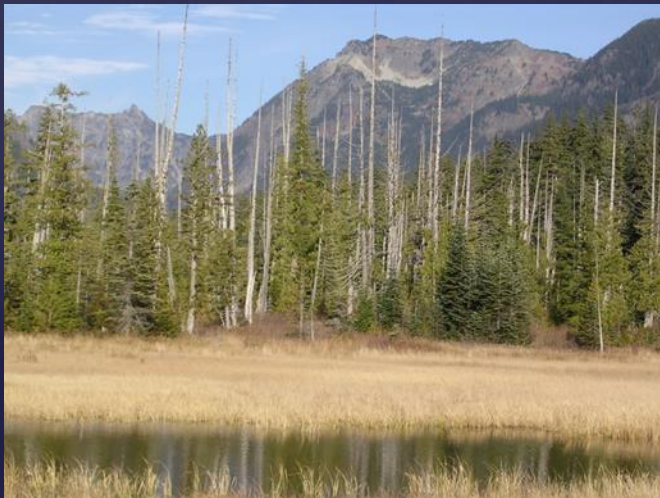
CONCEPT DESIGNS GOLD CREEK PIT RESTORATION

Restore Pre-Disturbance Condition

- Wetland mosaic
 - Forested wetlands
 - Emergent wetlands
 - Open water
- Upland Forests
- Tributary Re-Alignment
