# Gold Creek

## Habitat Assessment & Conceptual Design

# PROJECT GOALS

- Identify the causal mechanisms of seasonal dewatering & habitat loss
- Produce detailed conceptual design plans

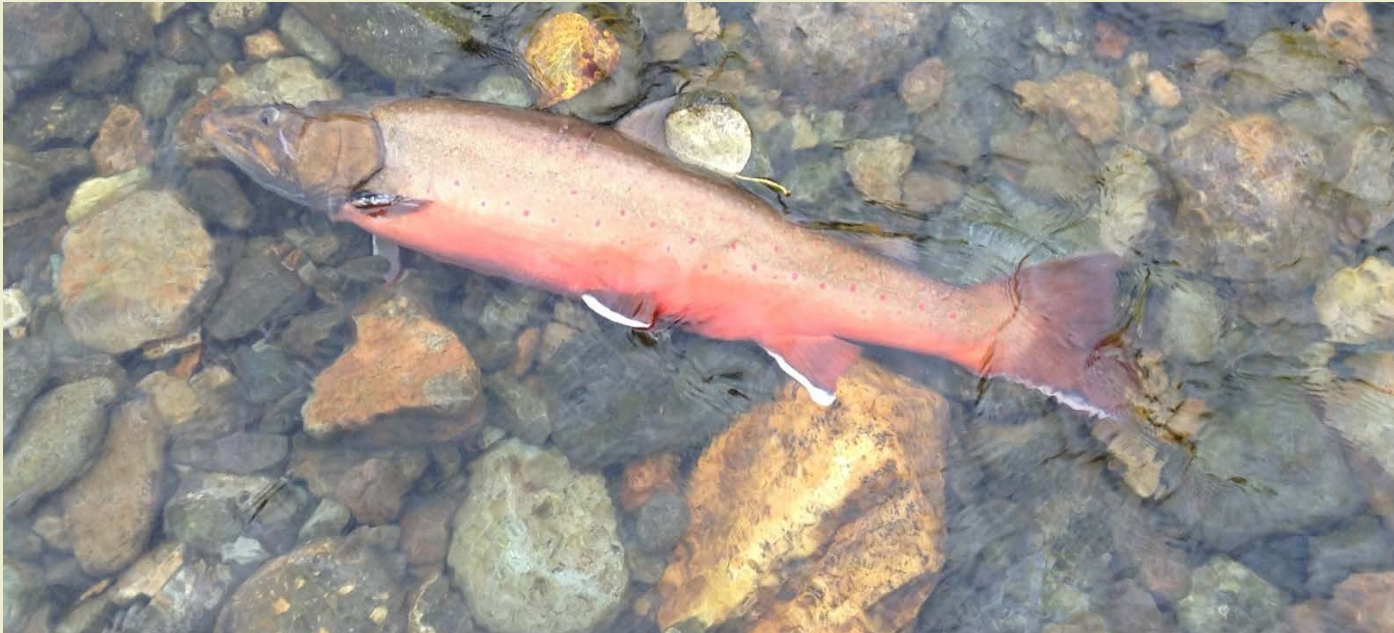
## **Bull Trout - *Salvelinus confluentus***

*Photo of stranded Bull Trout taken on 9/26/2013 in shallow riffle below Gold Creek Pond*

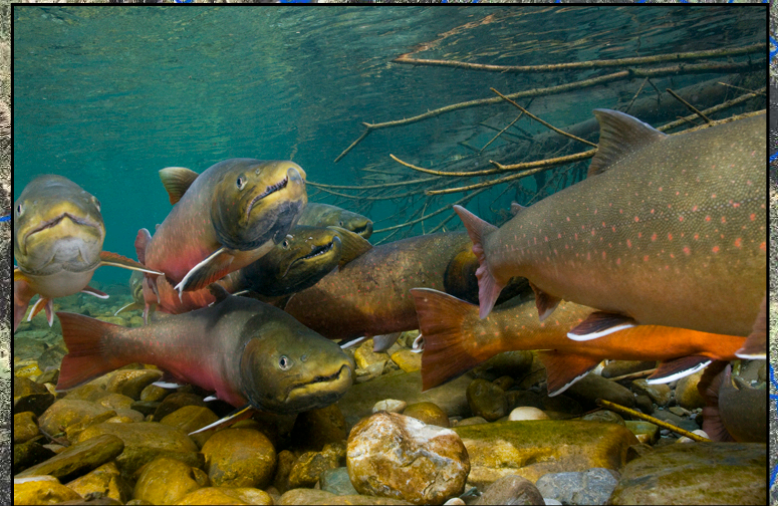
# Gold Creek bull trout redds 2008

● = redd location

Final Count = 40

Gold Creek Falls

Problem Reach

I-90 Bridge

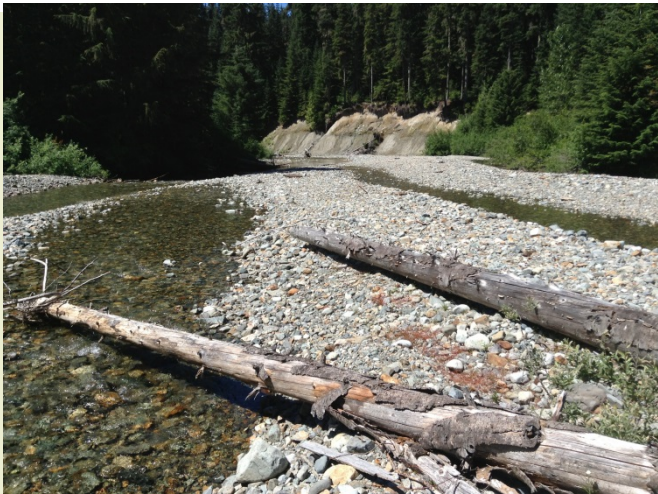
7/26/2013

- Seasonal Dewatering
- Degradation of Bull Trout Habitat

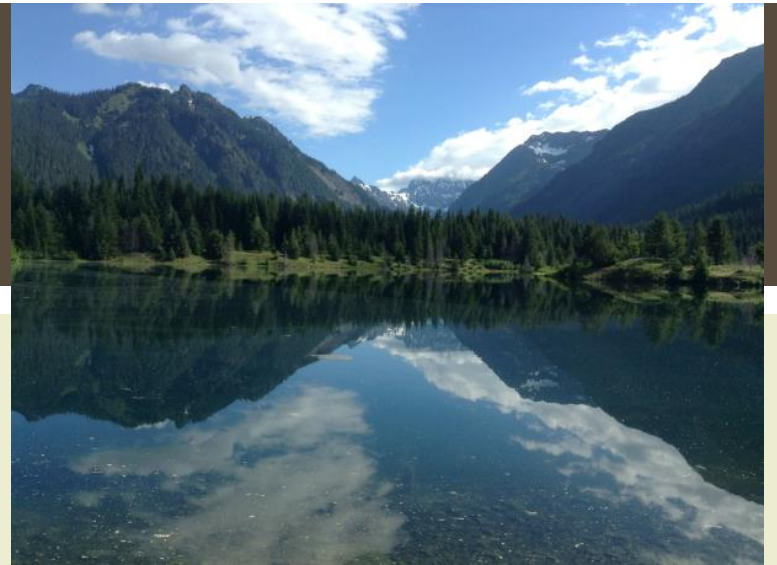
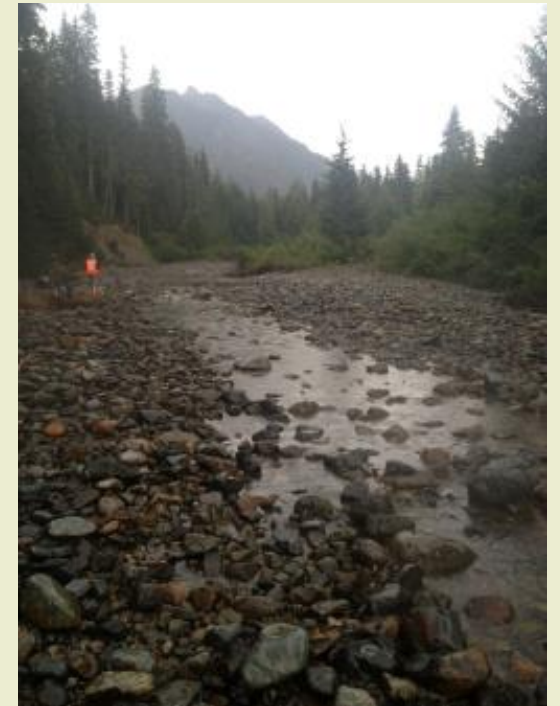
- Gold Creek Pond remains relatively constant
- Heli's Pond fluctuates with groundwater
- Field observations of dewatering correspond to surface water station and groundwater well data
- Dewatering initiates near RM 1.5
- Second dewatered reach upstream of RM 0.5

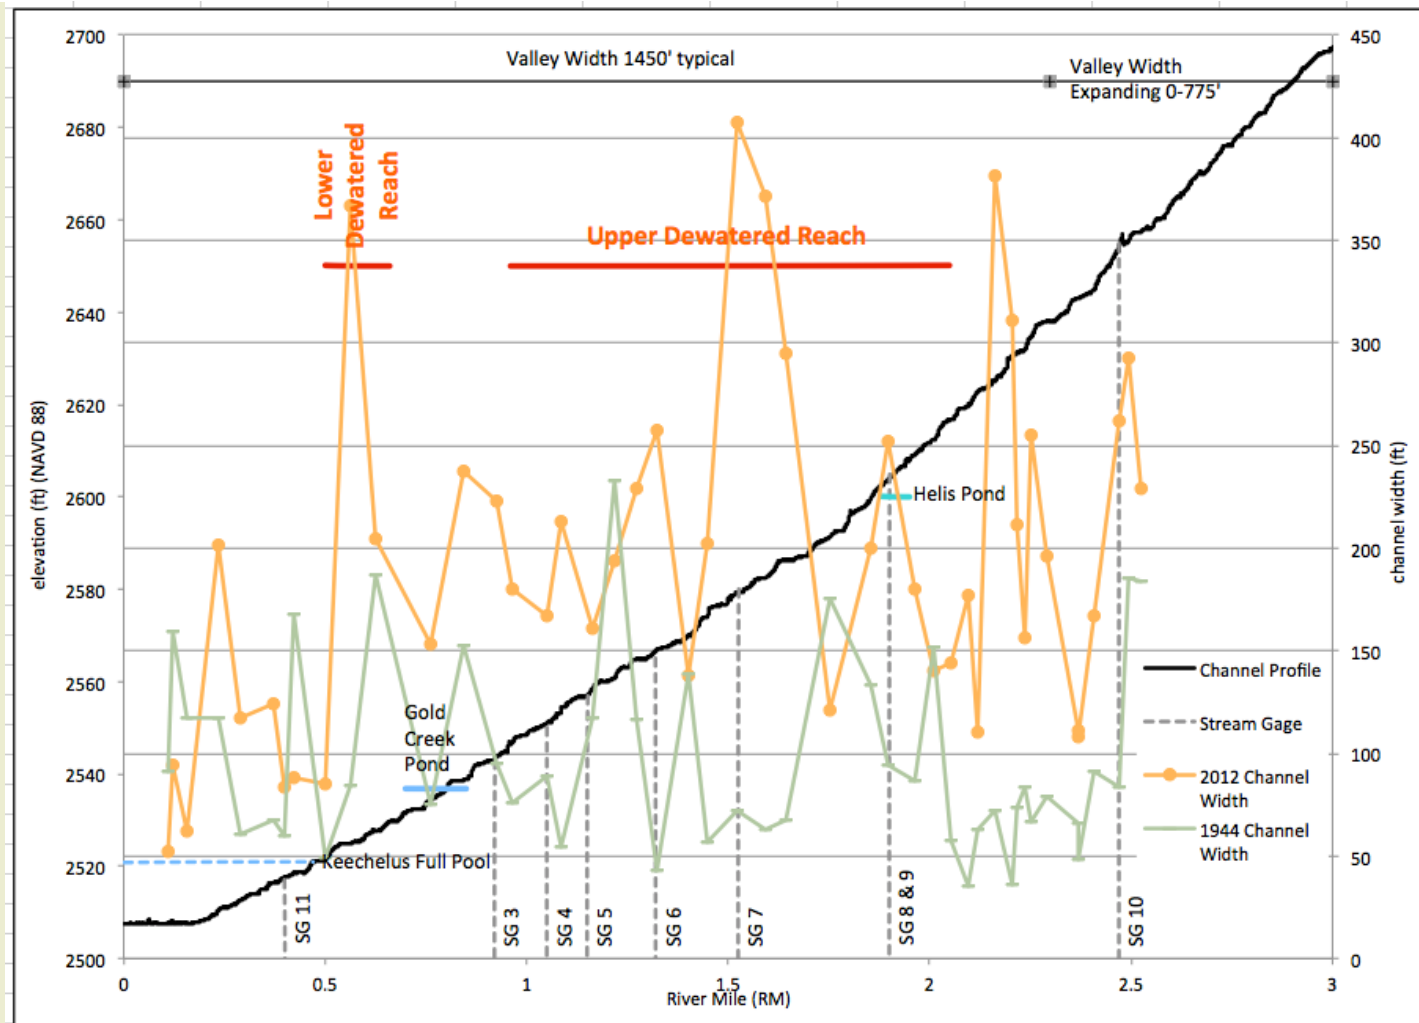
## Dewatered Reach linkages to unvegetated channel width

- Current Width (orange) & Historic (1944) Channel Widths
- 4.6 fold increase in channel width from 1944 - present at RM 1.5

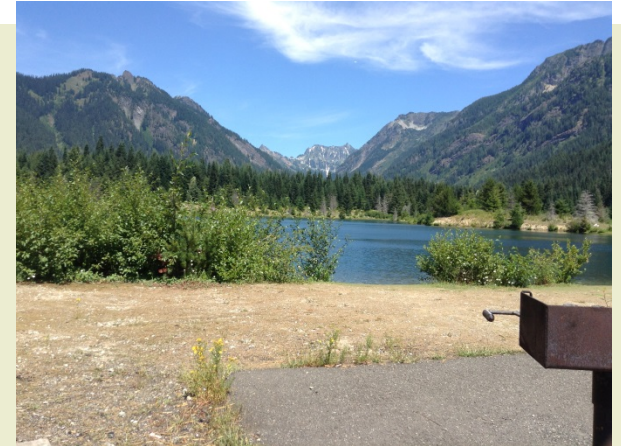
## *Gold Creek Pond*

### 1. Restore Natural Wetland Mosaic

- Fill estimate 0.75 – 1.5 million CY

### 2. Focused Restoration

- Emphasis on northeastern corner of Pond to restore down valley groundwater gradients

### 3. Raising Pond WSE

- Installation of gates to outlet channel

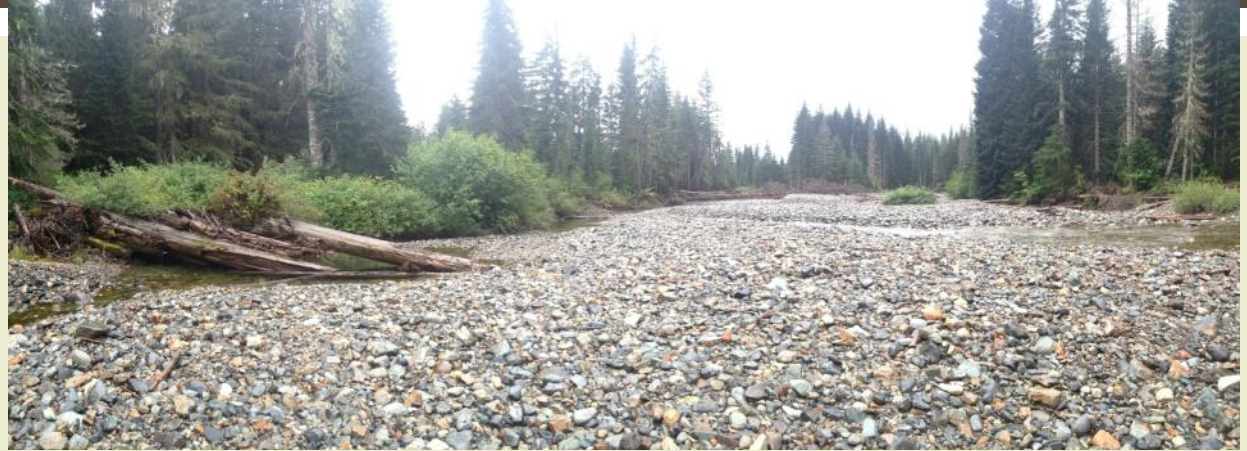
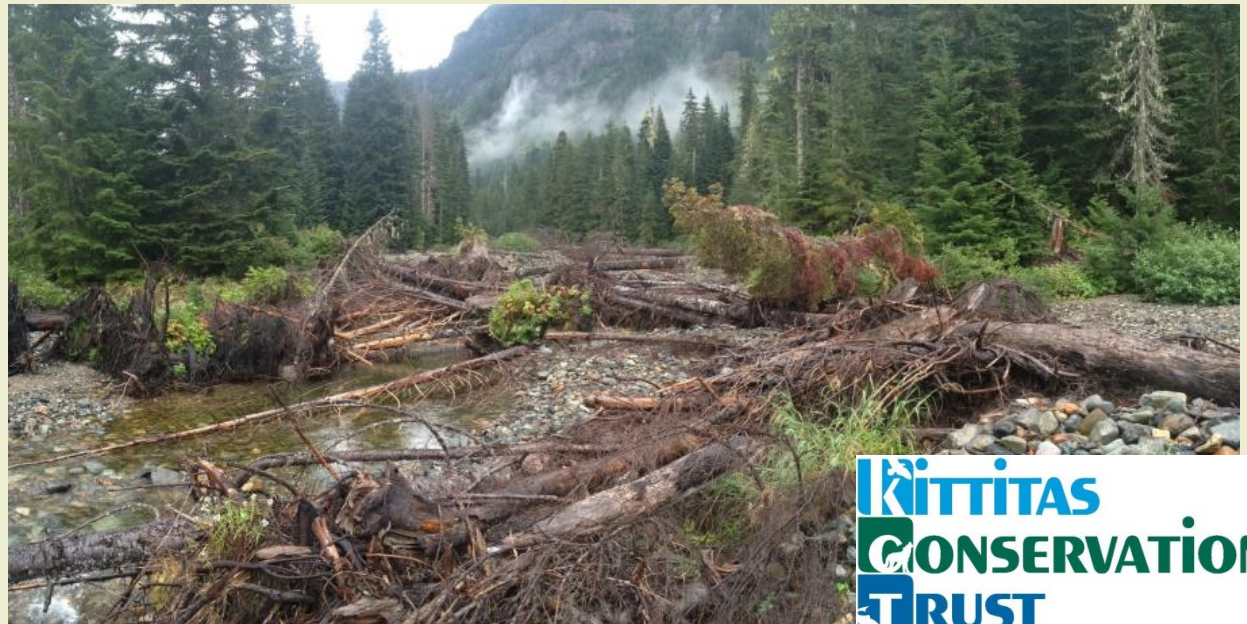
# RESTORATION OF FORESTED FLOODPLAIN

- Restore historic channel widths
- Create a roughened floodplain
- Targeted to sub-reaches with the most significant widening
- Use of large timber to provide bank strength and prevent re-widening
