Project Scale Stream Restoration Monitoring: A Regional Review of Habitat Data in the Mid-Columbia

Jennifer O'Neal

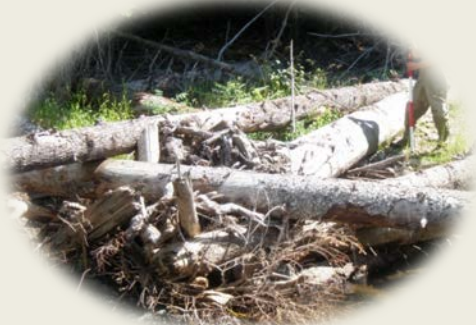
In-stream habitat

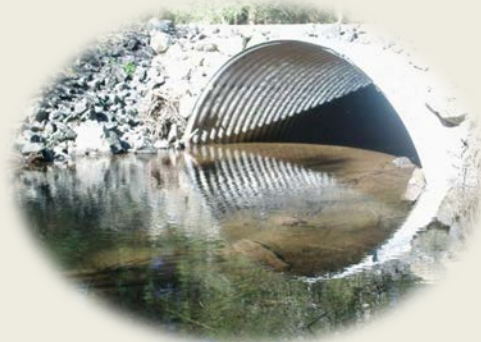
Barrier removal & passage improvements

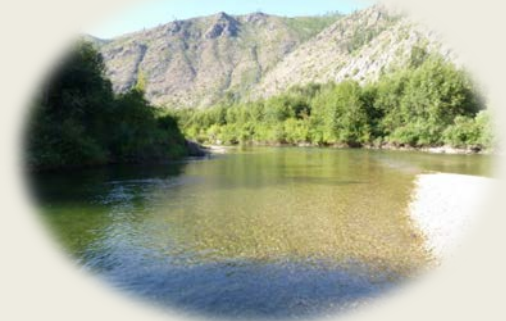
Habitat protection & acquisition

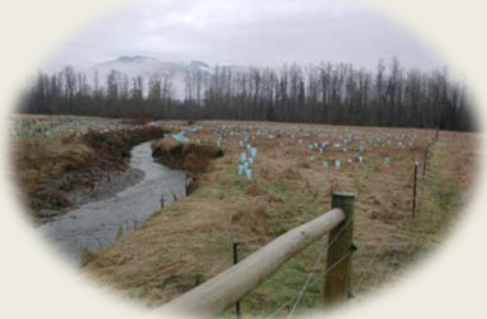
Riparian planting

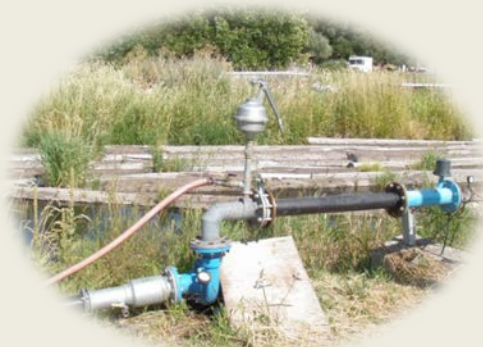
Diversion screening

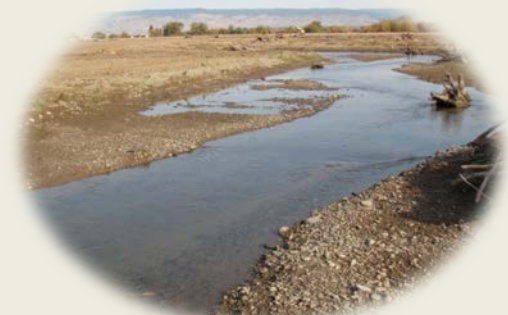
Floodplain Enhancement

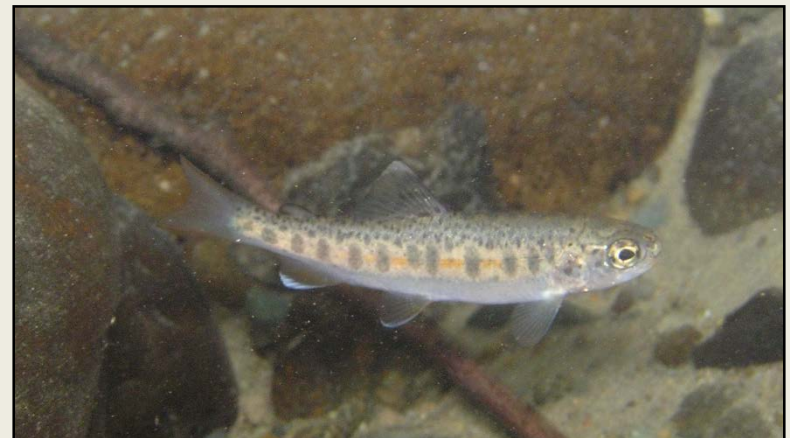
Instream Habitat

Cle Elum River Instream Habitat Project-Klickitat Conservation Trust

- Successful at diverting flow into side channel
- Decreased temperatures in the side channel (esp. lower reaches)
- Increase in the number of habitat units
- Increase in LWD in the side channel
- Decreases in percent fines and embeddedness

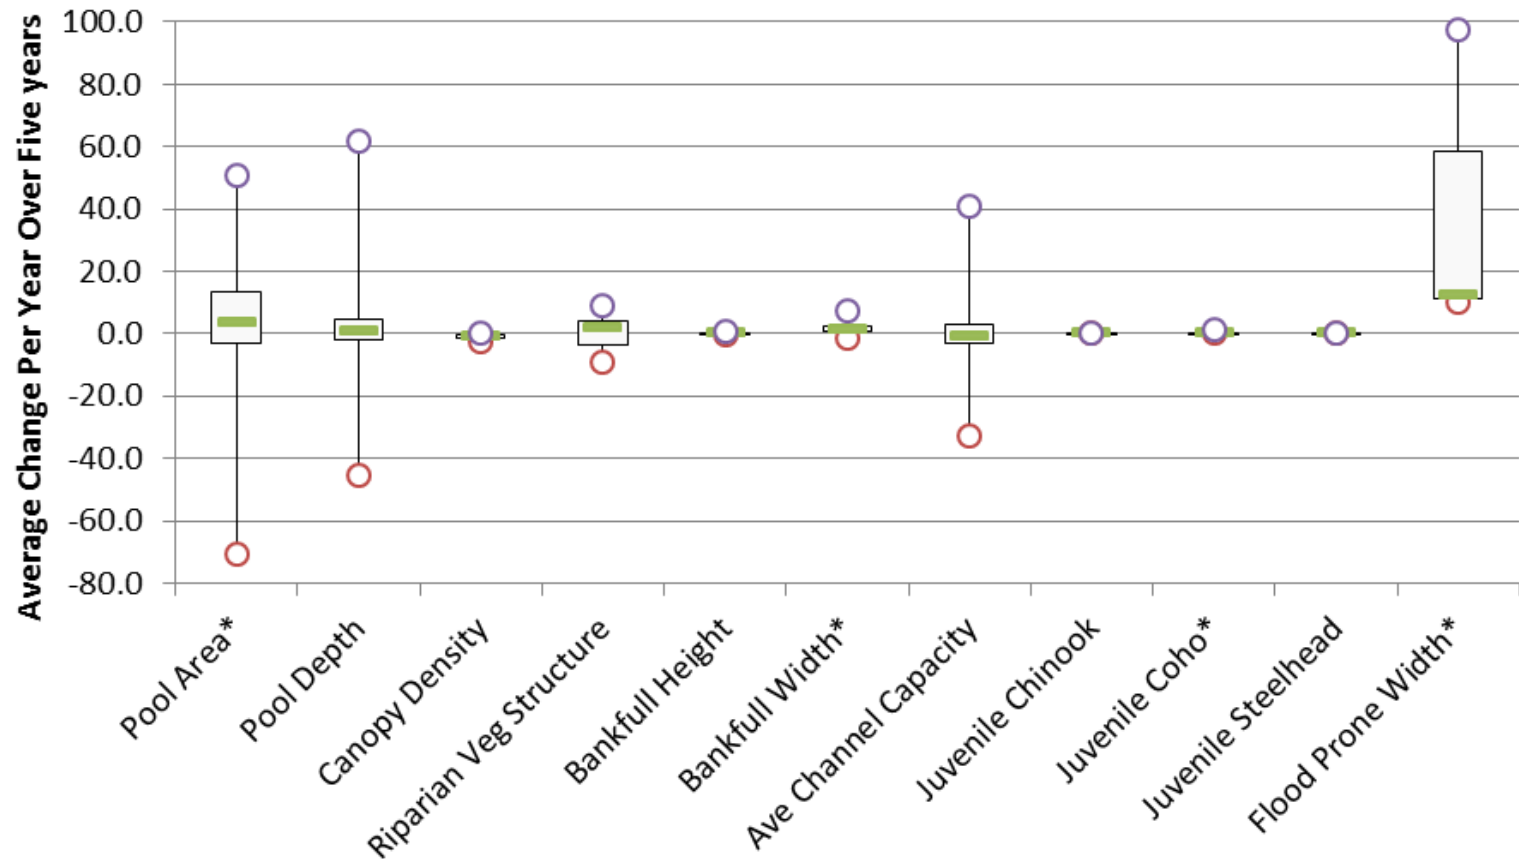
Slope Distribution of Trendlines for Floodplain Enhancement Projects

*Statistically significant result detected
