Ecosystem response during the removal of the Elwha River Dams

June 2016

Today's talk

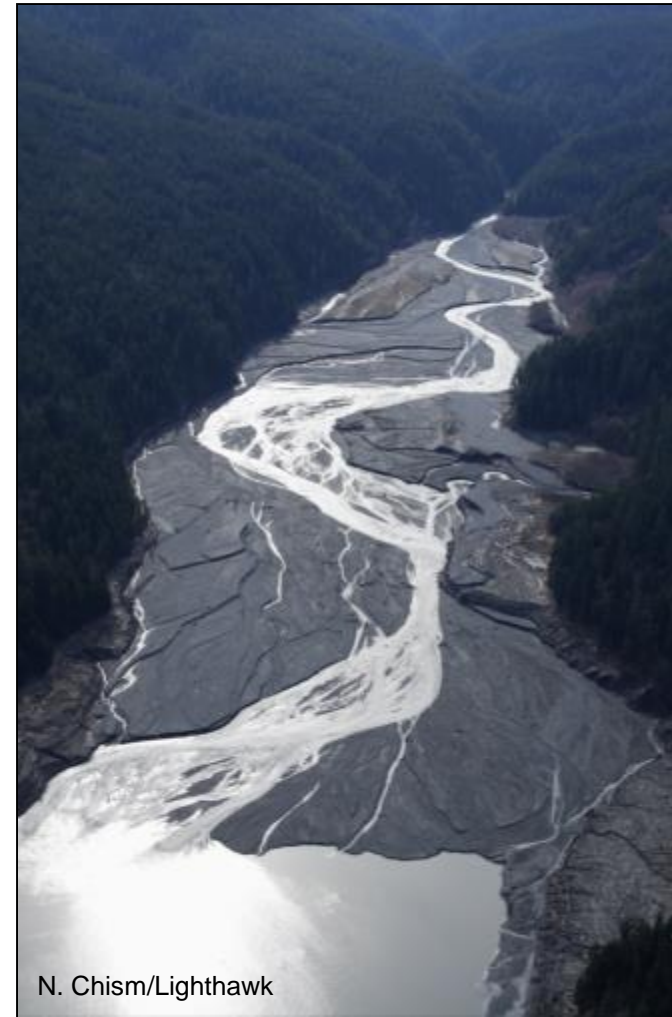
What's going to happen to all the sediment?

~ 21 million m³ of sediment accumulated in reservoirs

- ~ 54% fine, ~46% coarse
- ~40%-60% predicted to erode downstream

Predictions

- suspended-sediment > 10,000 ppm
- temporary deposition of fines in pools
- more dynamic floodplain
- bed aggradation in lower river
- beach formation in estuary

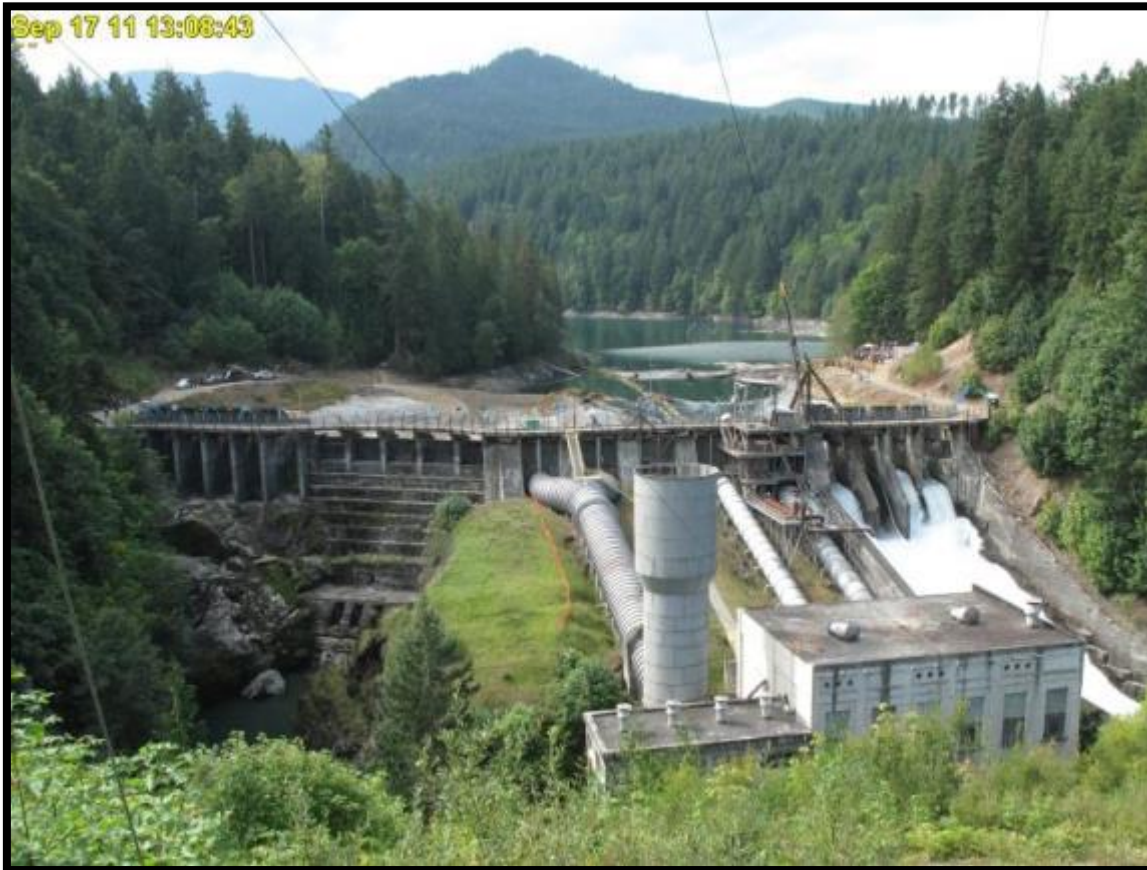
Elwha Dam removal

Before Dam Removal: September, 2011

- Completed in 1912
- 33m concrete gravity dam

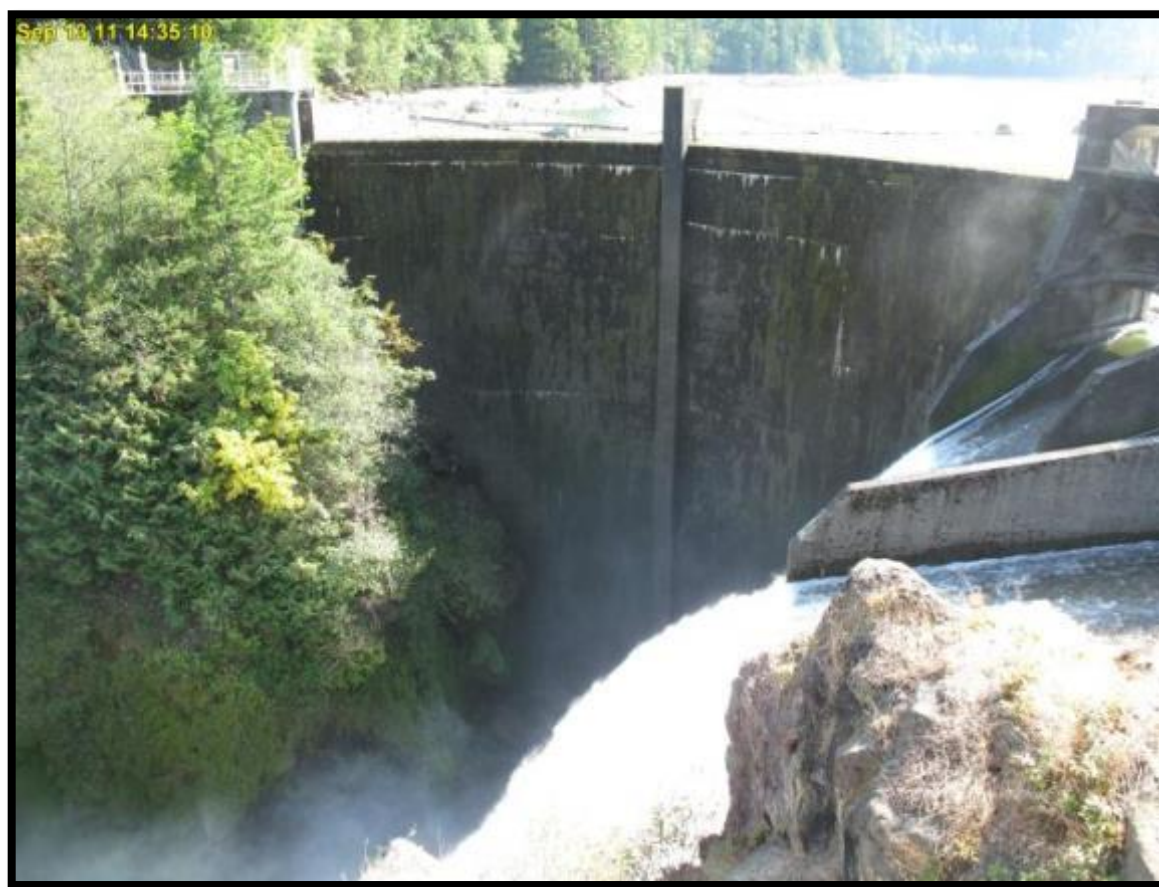
Glines Canyon Dam removal

Before Dam Removal: September, 2011

- Completed in 1927
- 64m concrete arch dam

Lake Mills
(15.6 million m³)

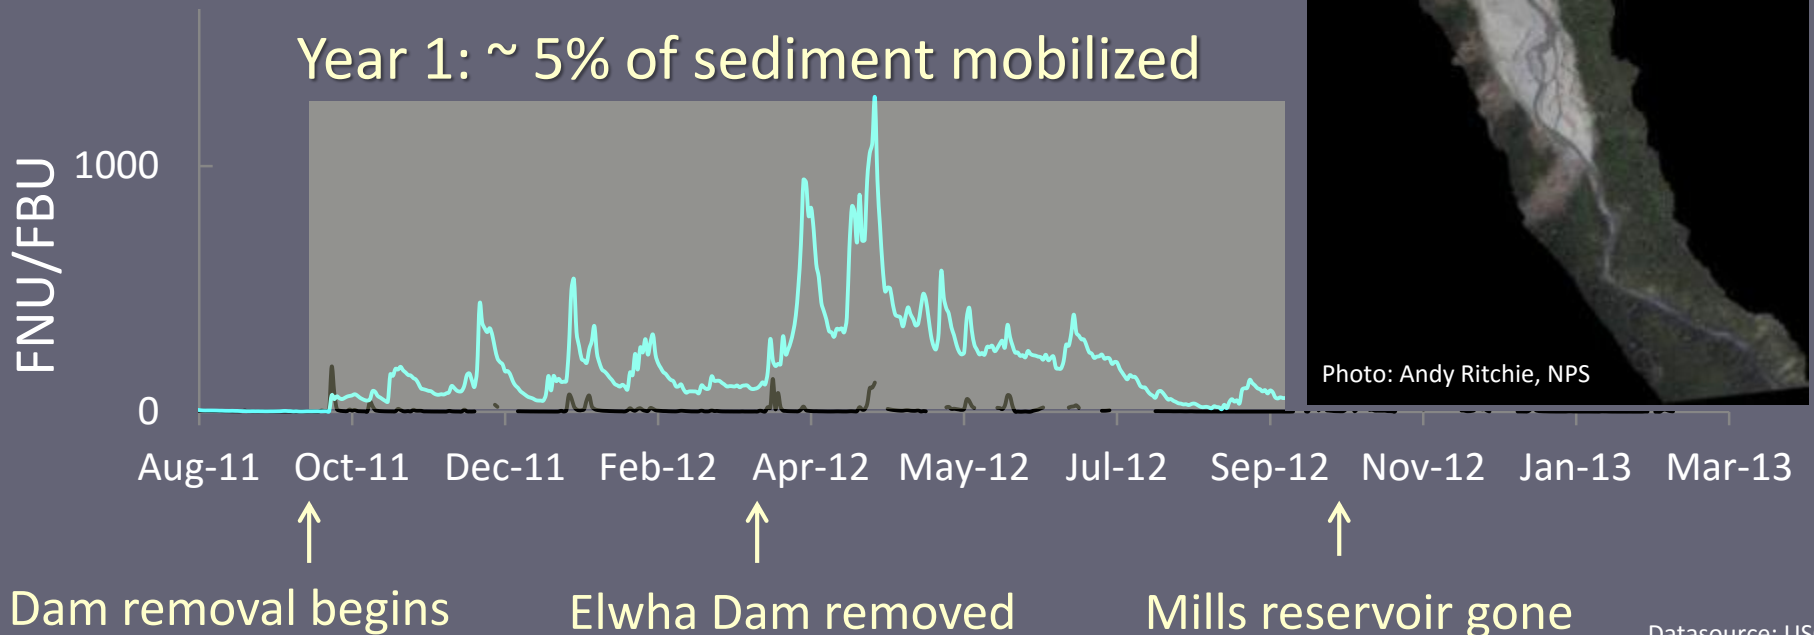
How has sediment supply changed?

Above Dams
Below Dams

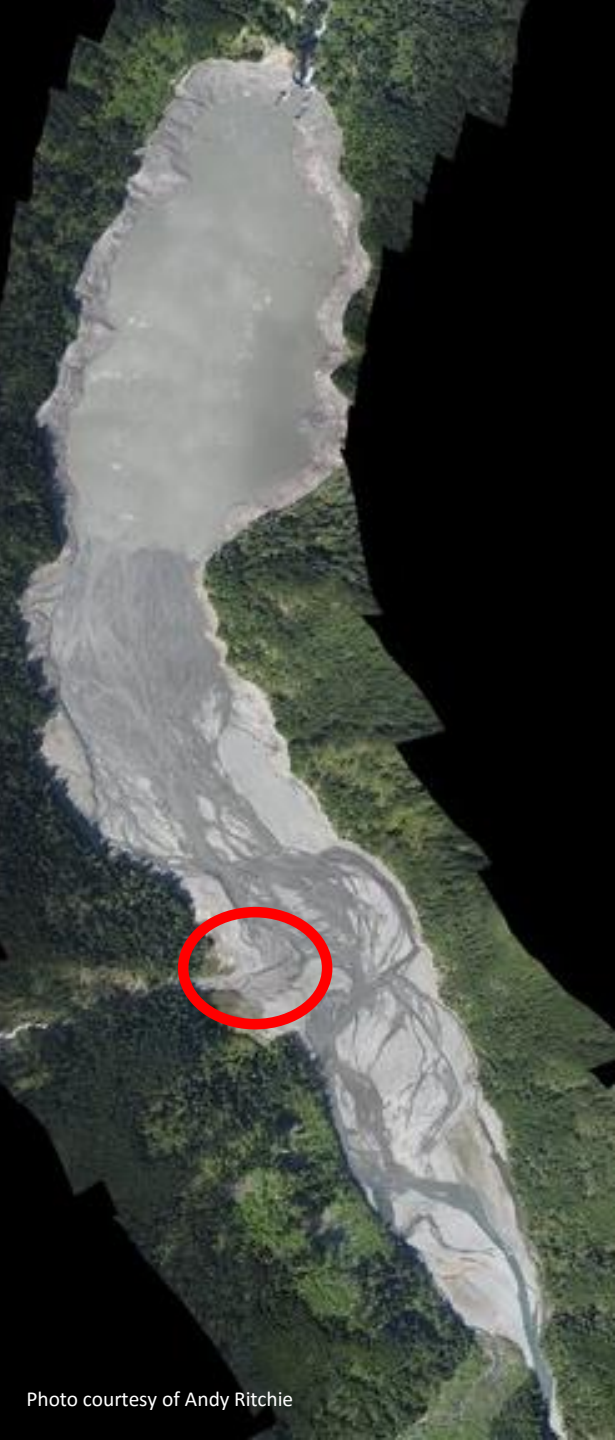
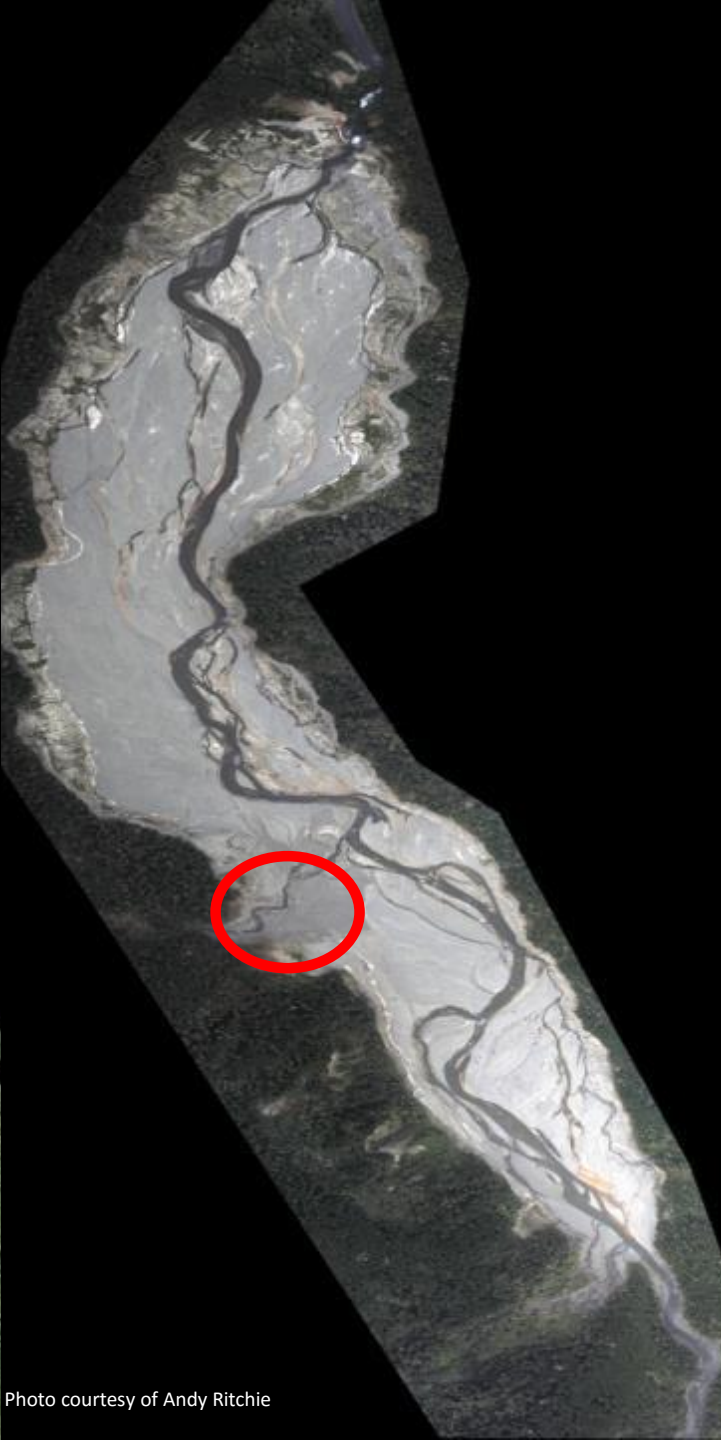
Mills reservoir

~ 58% of the total stored released as of October 2015

Pre dam removal

2015

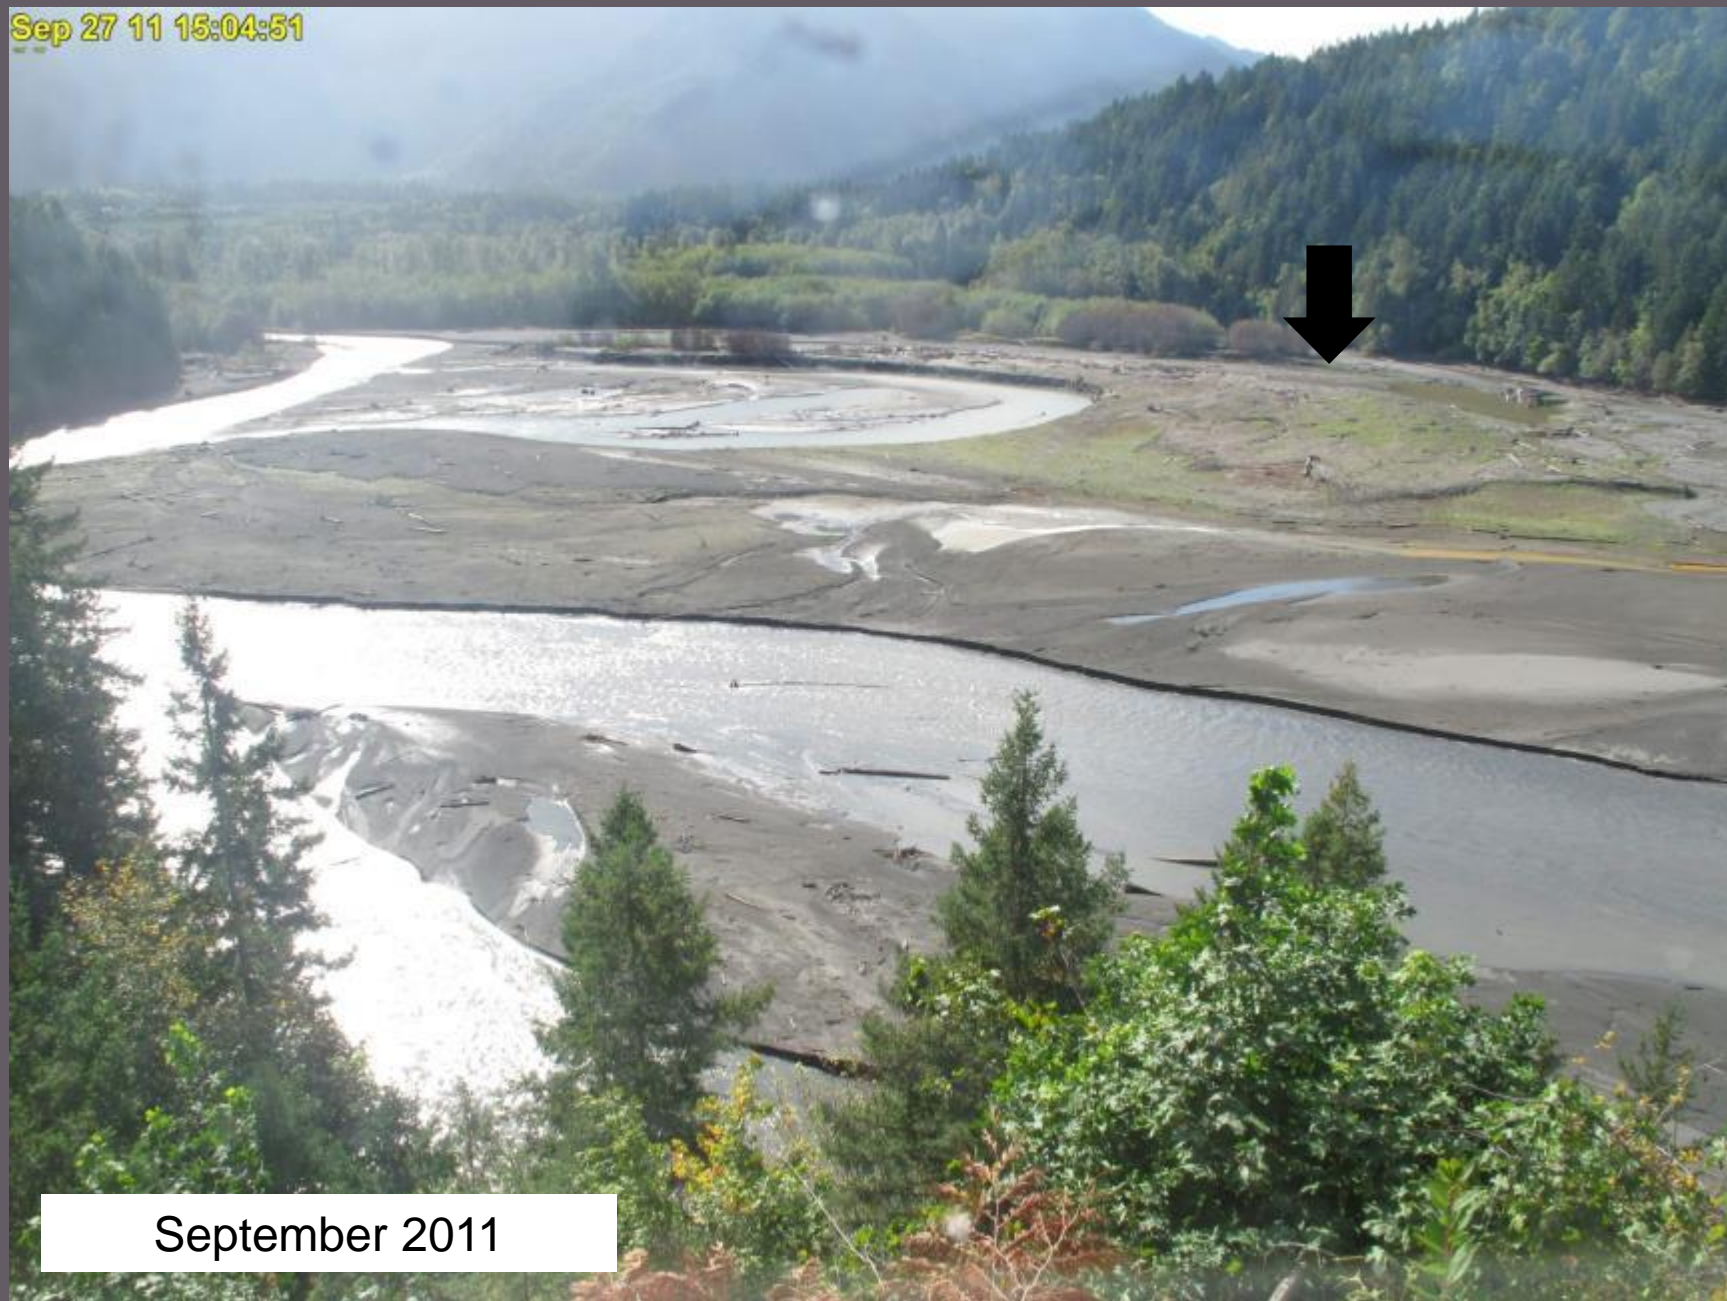
Former Aldwell reservoir

September 2011

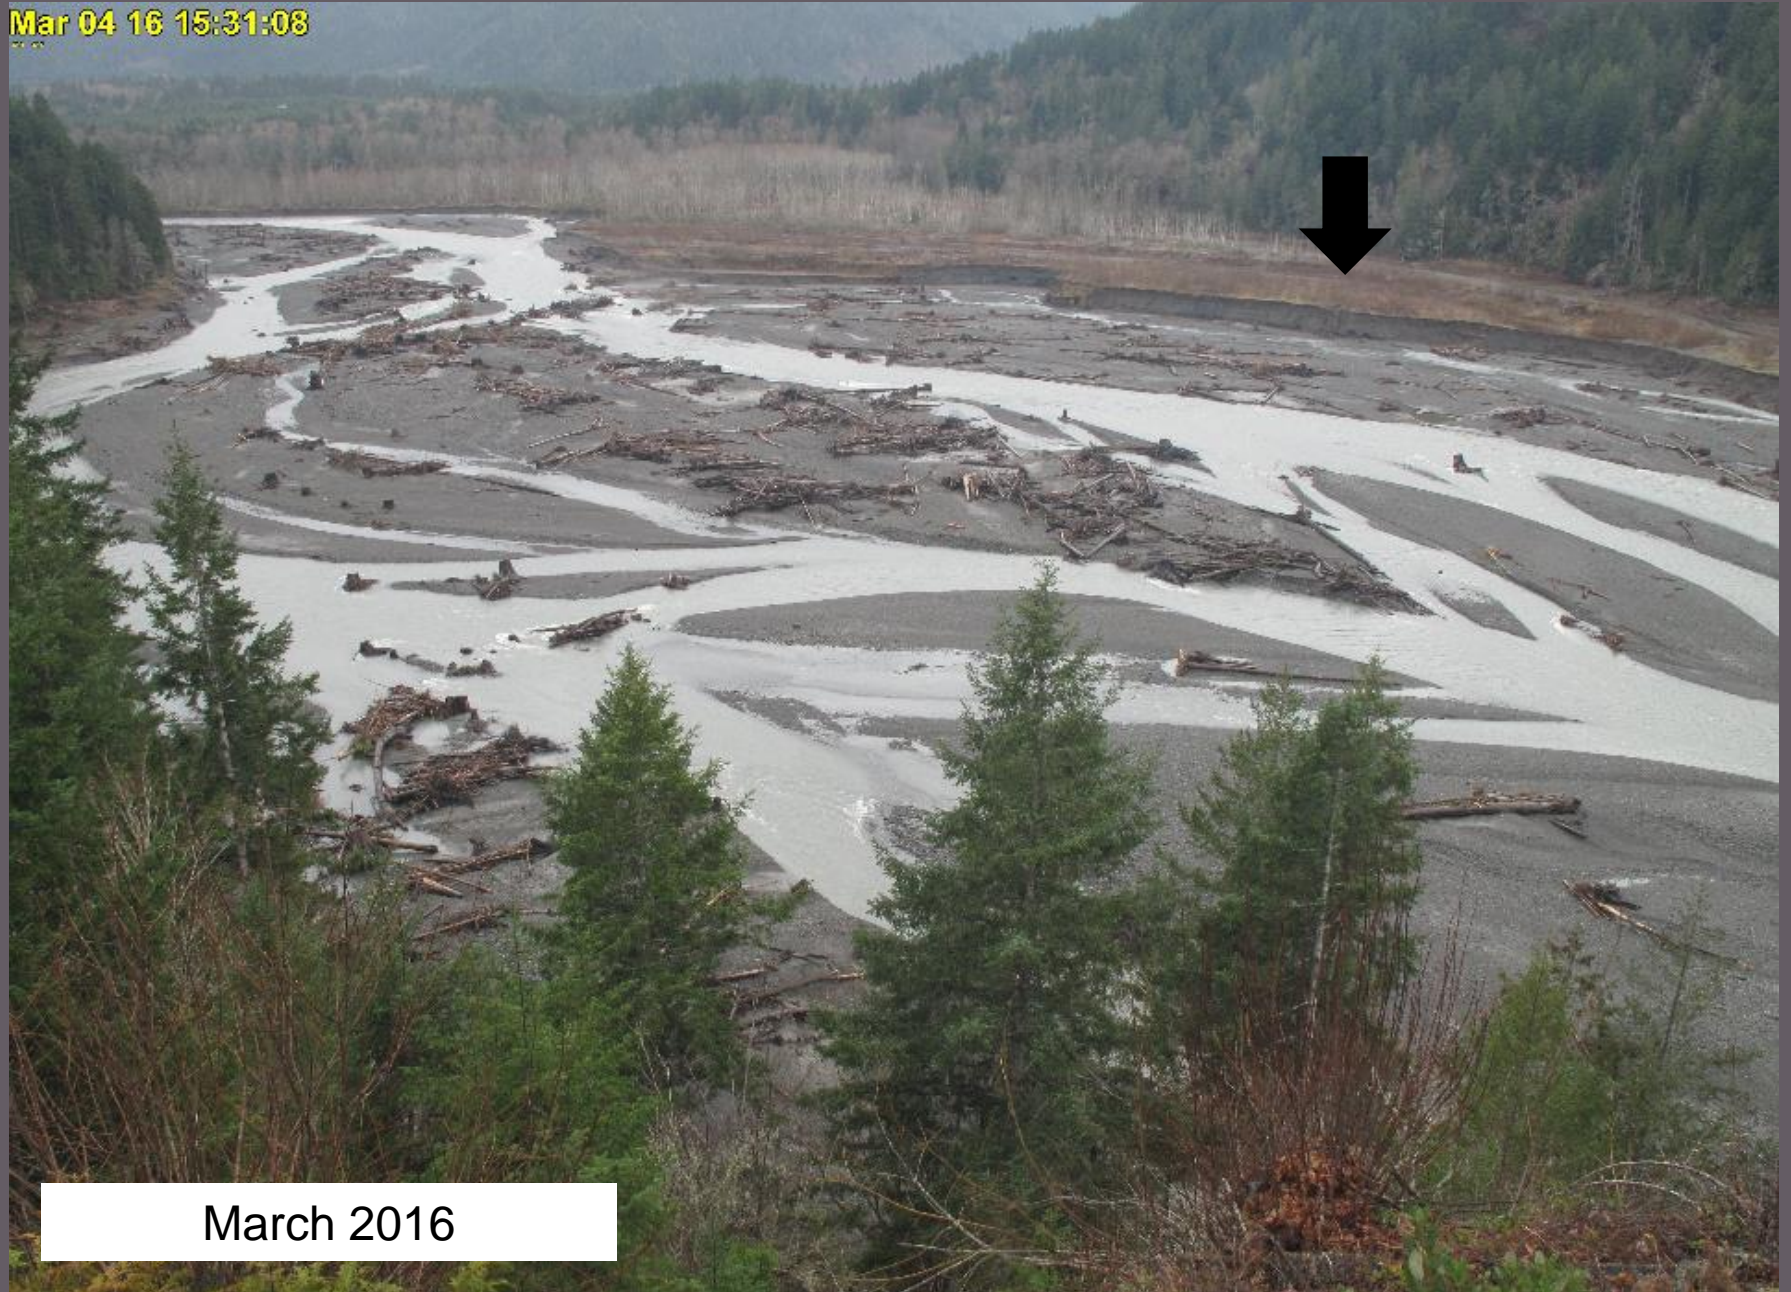
Former Aldwell reservoir

March 2016

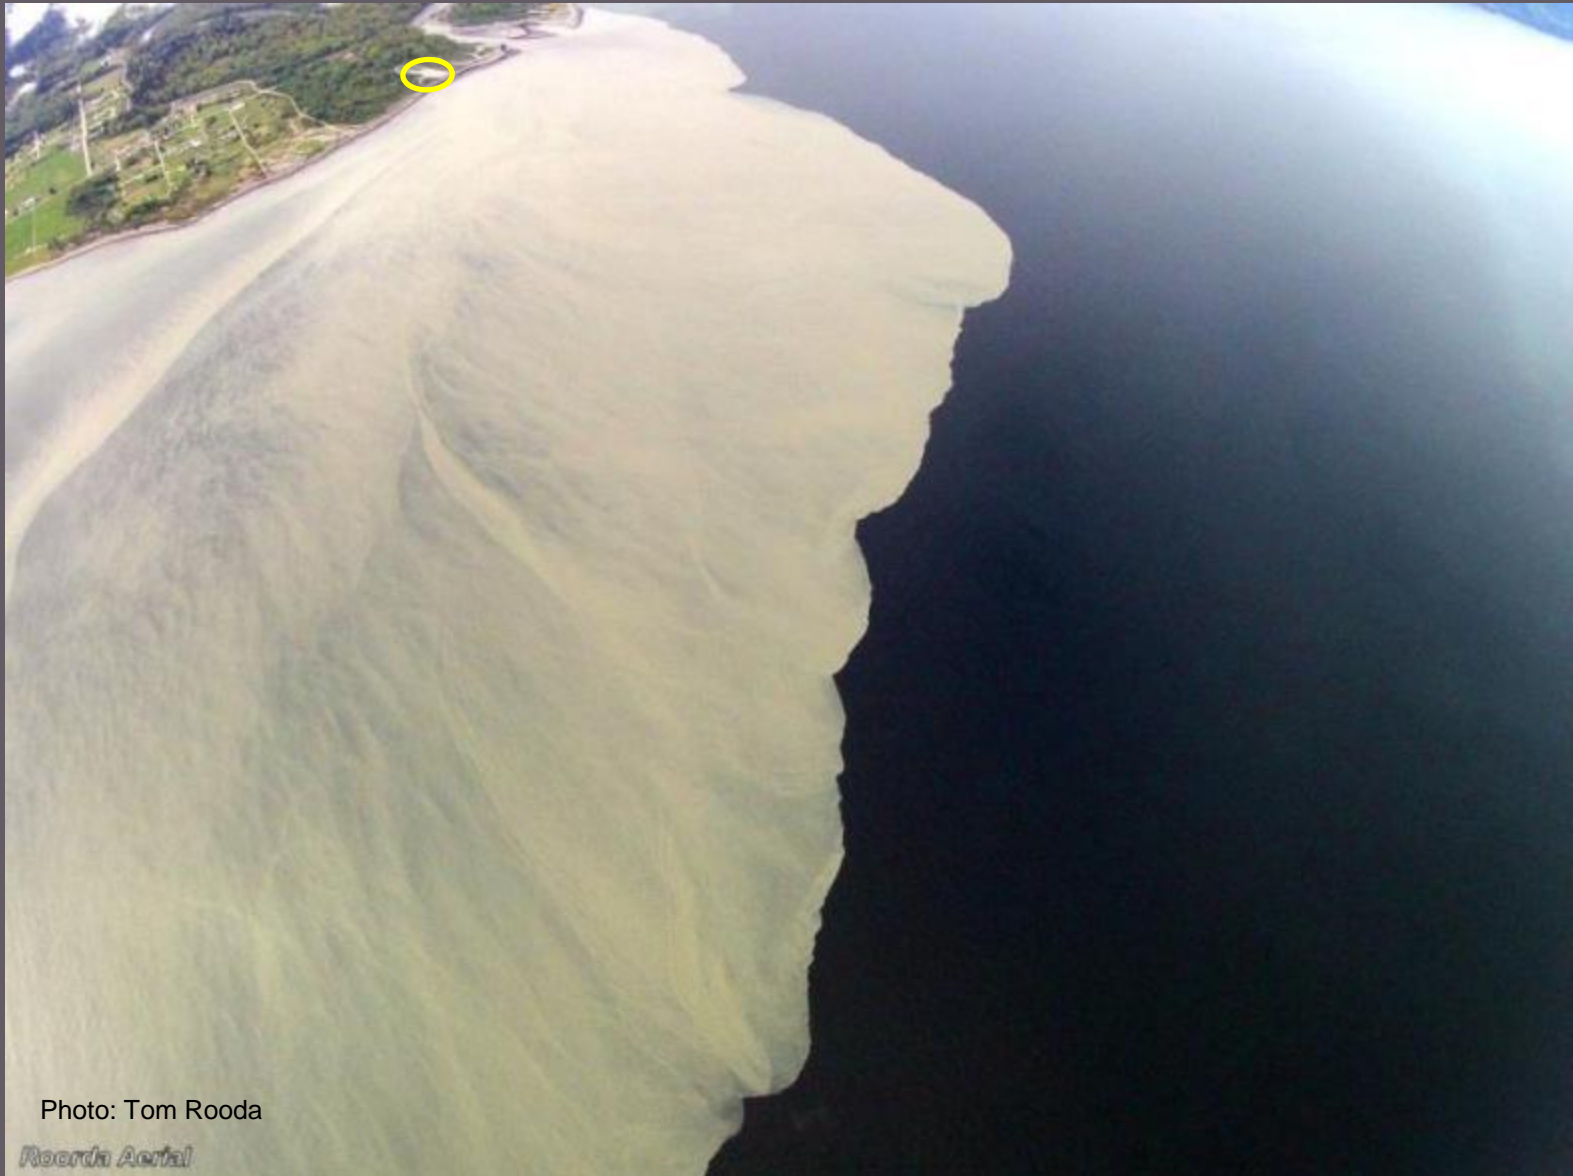
Mouth of the Elwha River - April 2012

Much suspended sediment transported to the Strait of Juan De Fuca

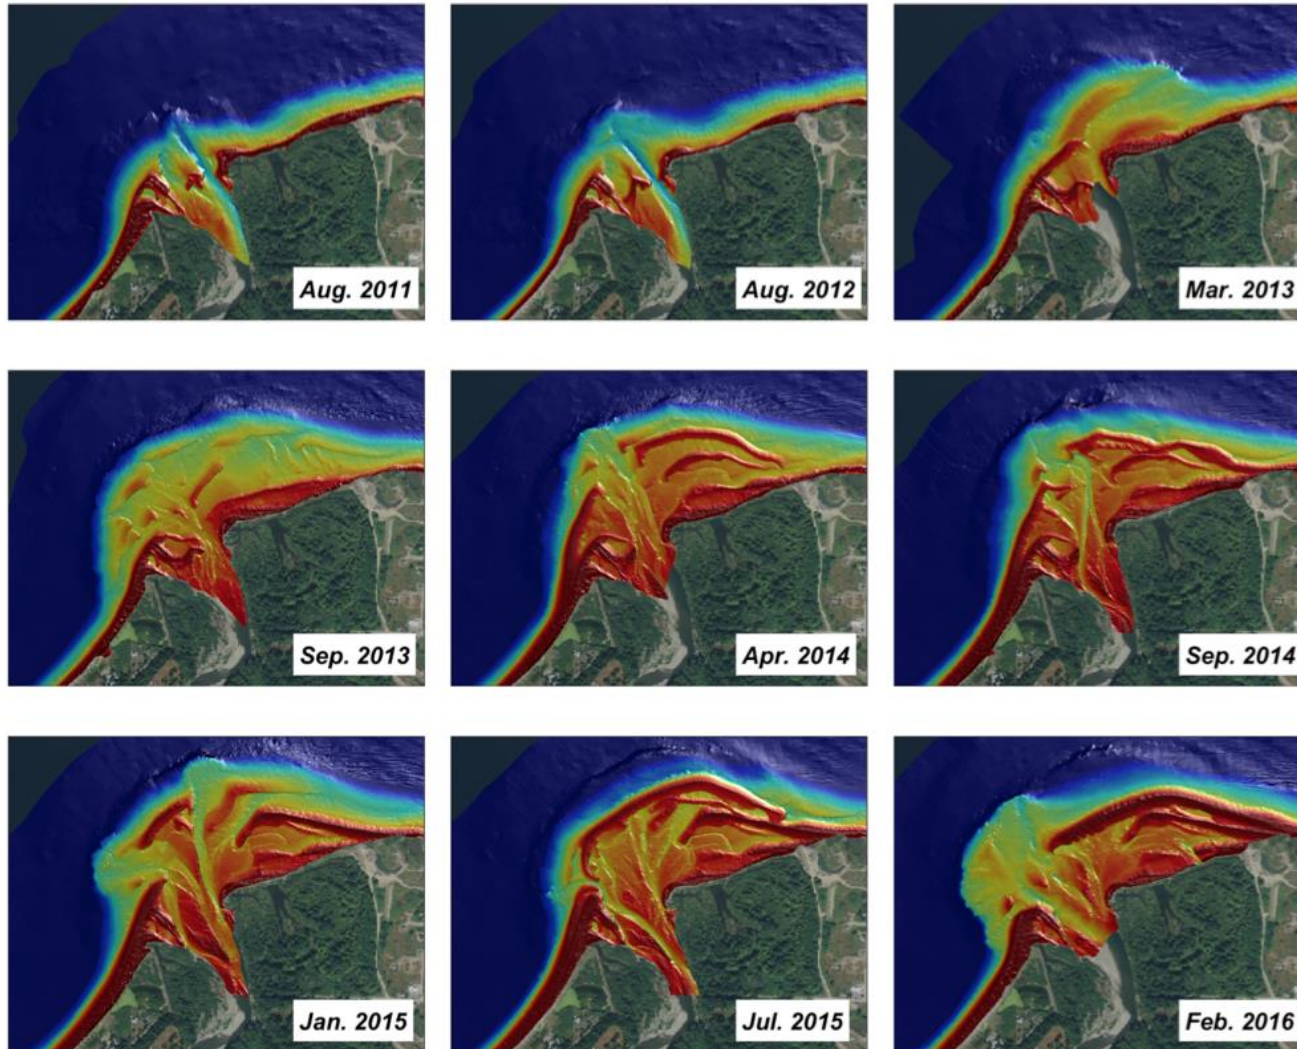
Elwha River mouth, estuary, & nearshore 2011 to 2016

Pre
2012
2013
2014

The majority of sediment deposited in the nearshore would be eastward or radial and not westward

The majority of Elwha River delta is eastward and radial

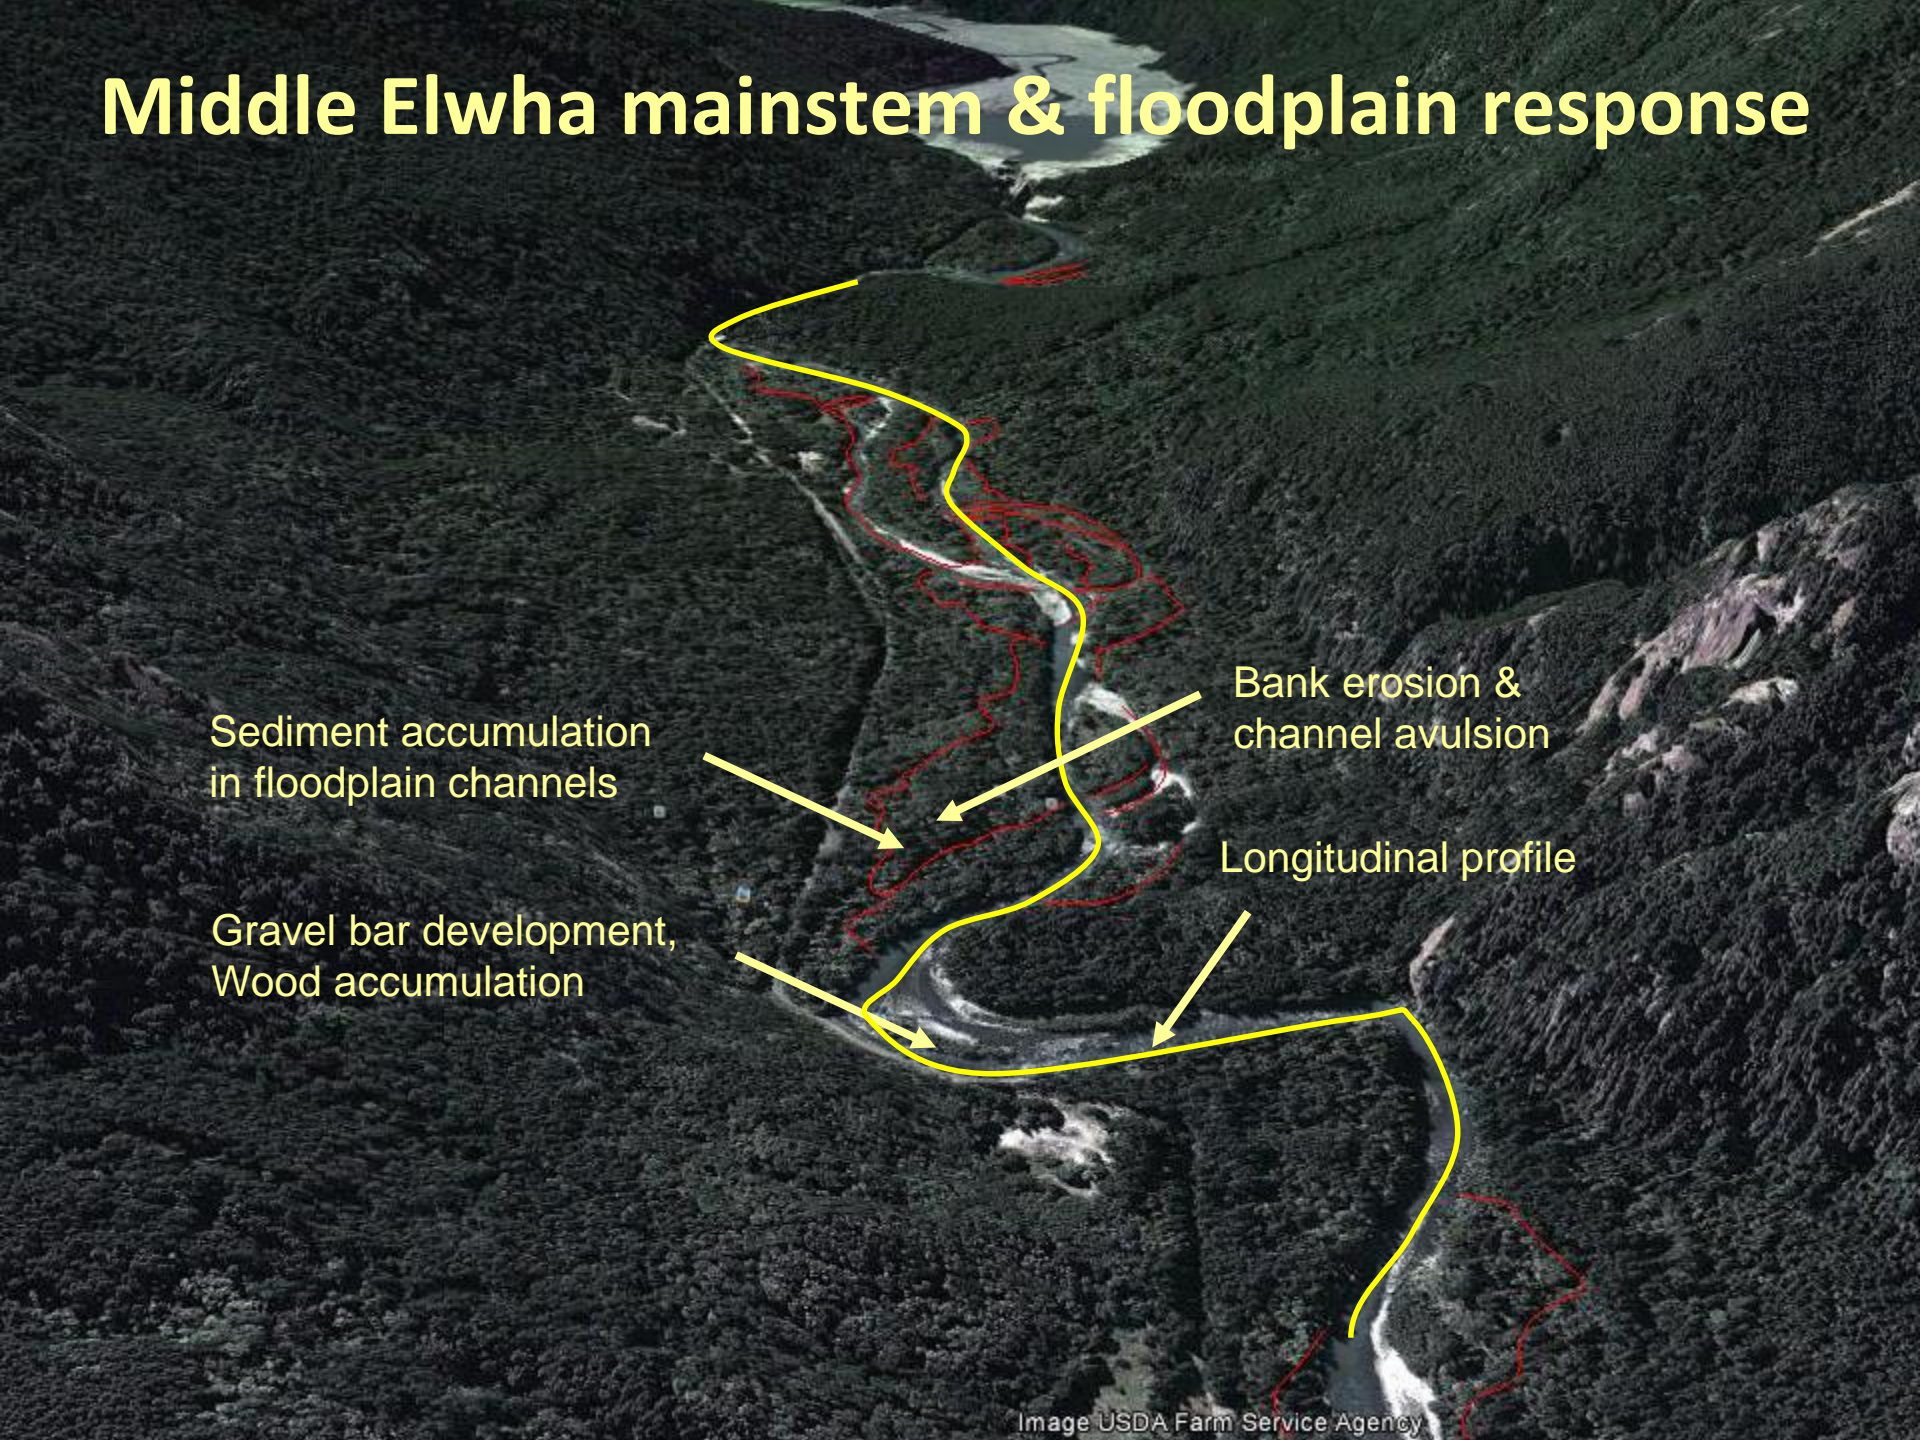
Gravel bar development & wood accumulation in the Middle Elwha River

Aug 2011

Feb 2013

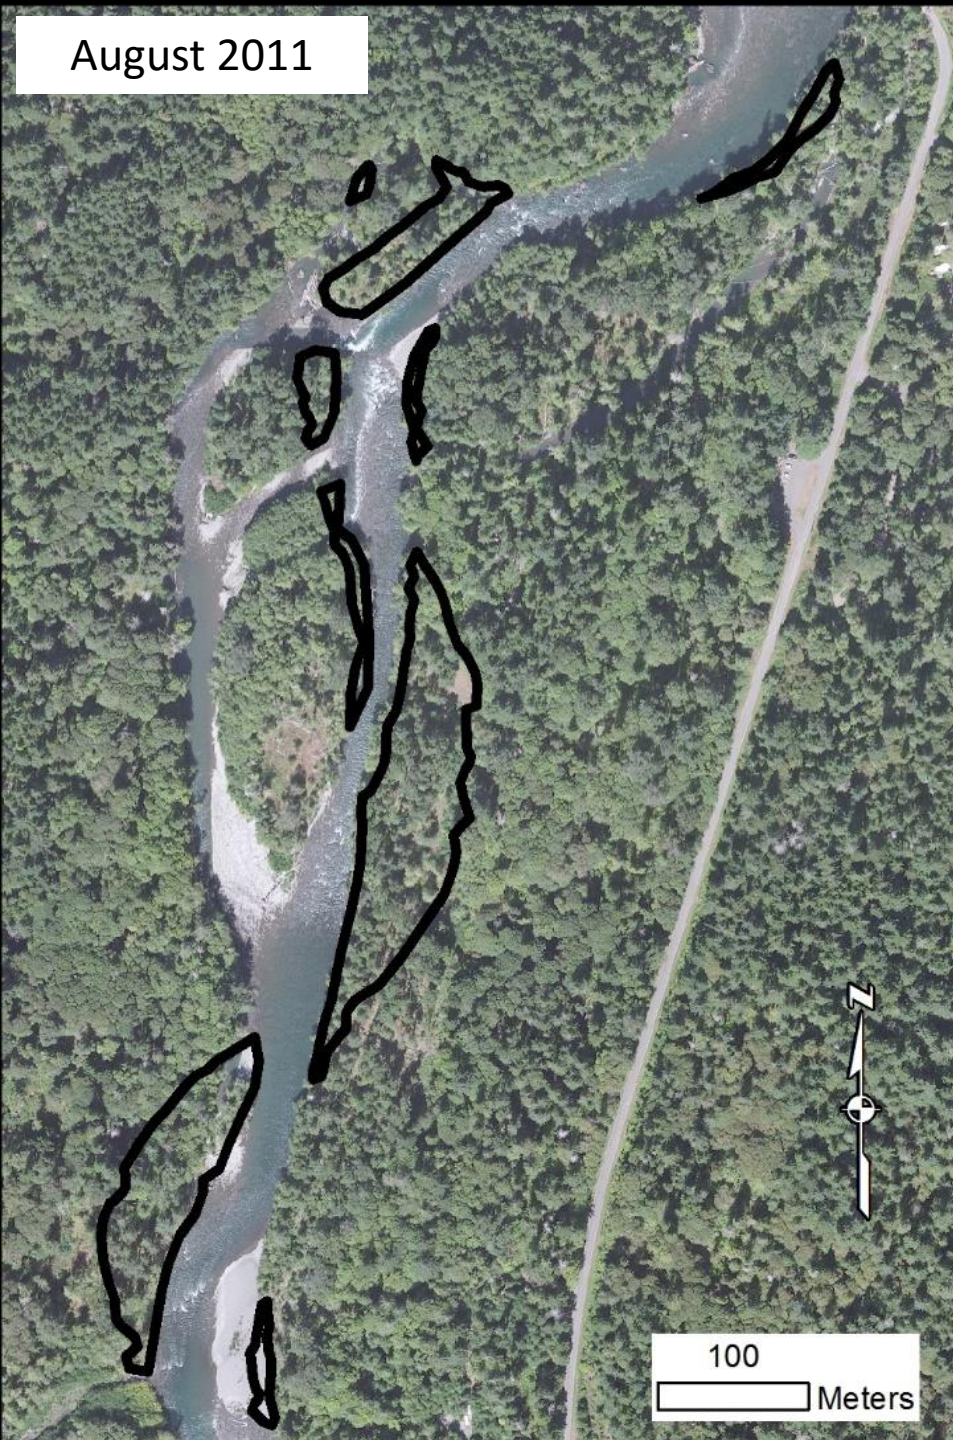
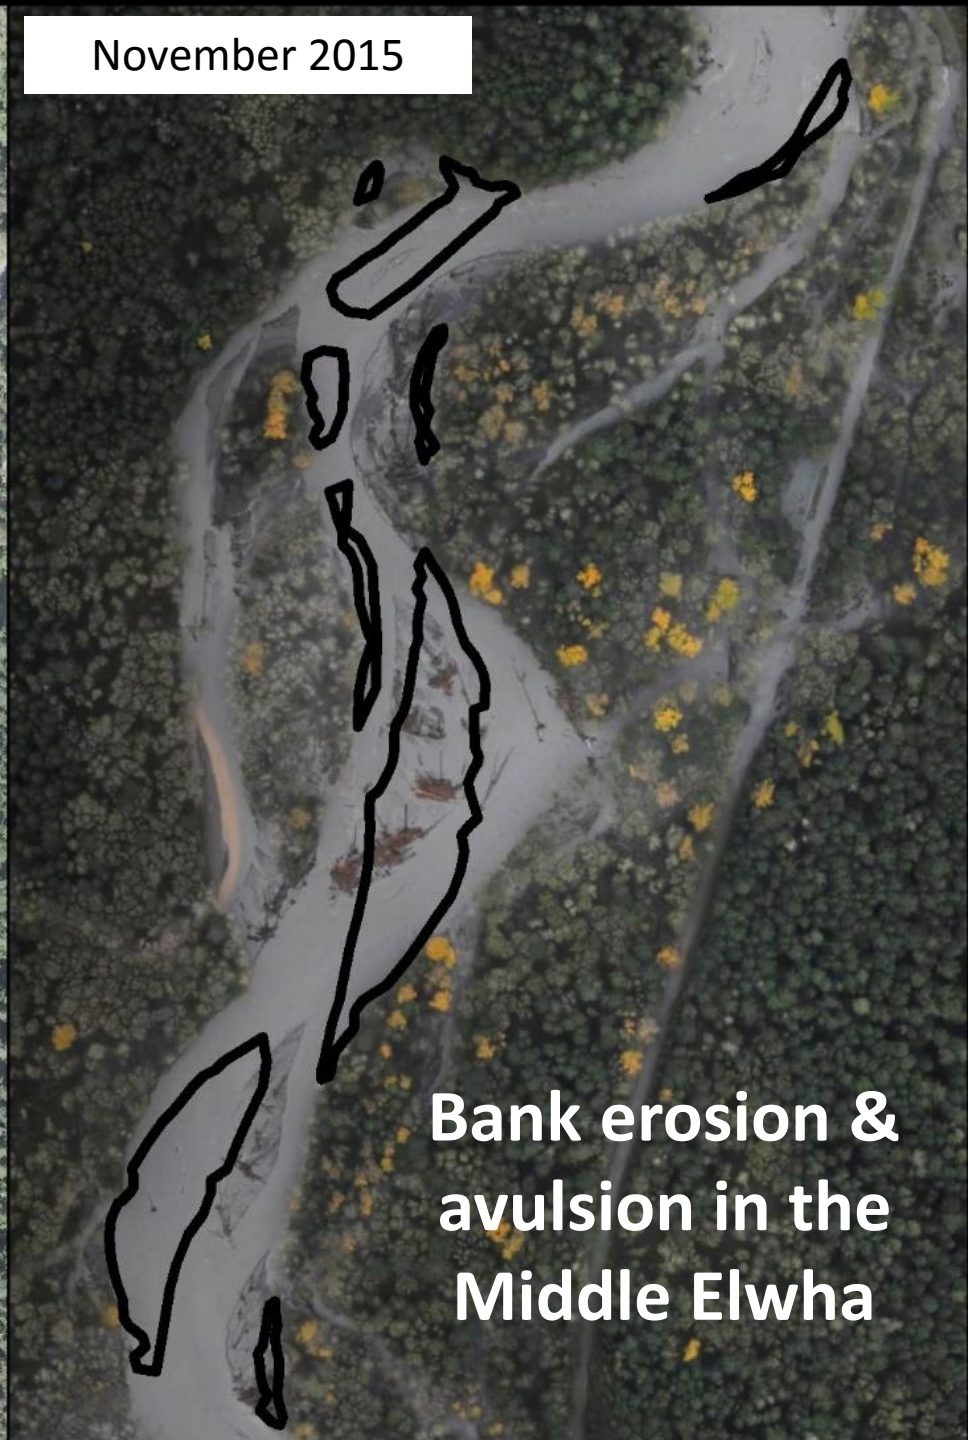
August 2011

November 2015

**Bank erosion &
avulsion in the
Middle Elwha**

- All pools have filled, now starting to “unfill”
- Mid channel gravel bar development & wood accumulation evident
- Filled floodplain channels stabilizing, more sediment accumulation on floodplain
- Bank erosion becoming more prevalent with larger flows combined with mainstem aggradation

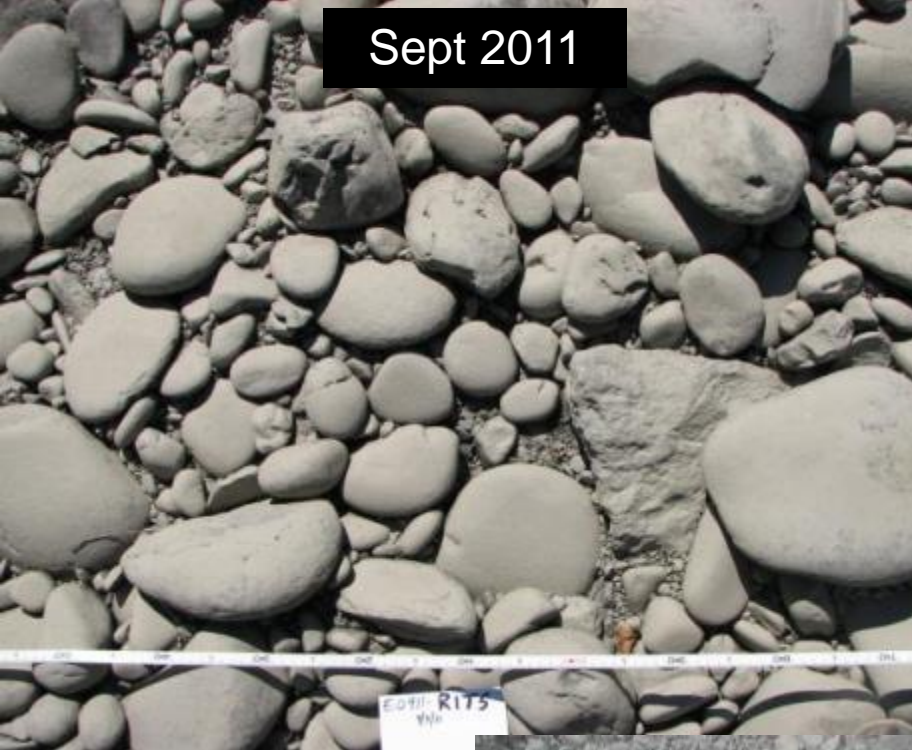
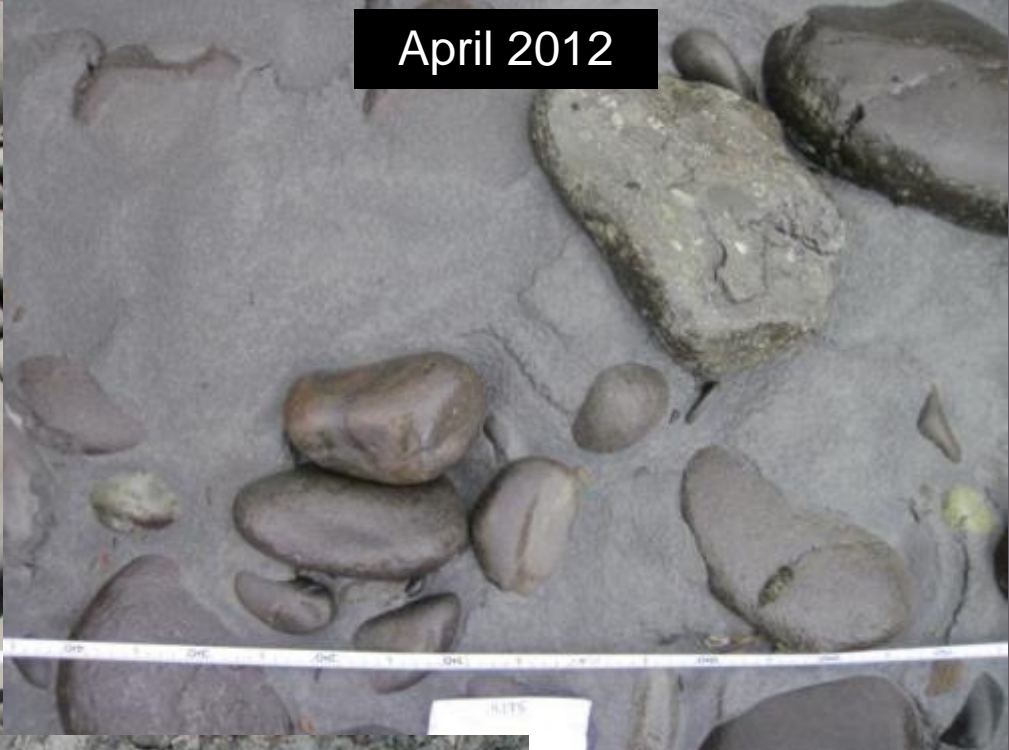
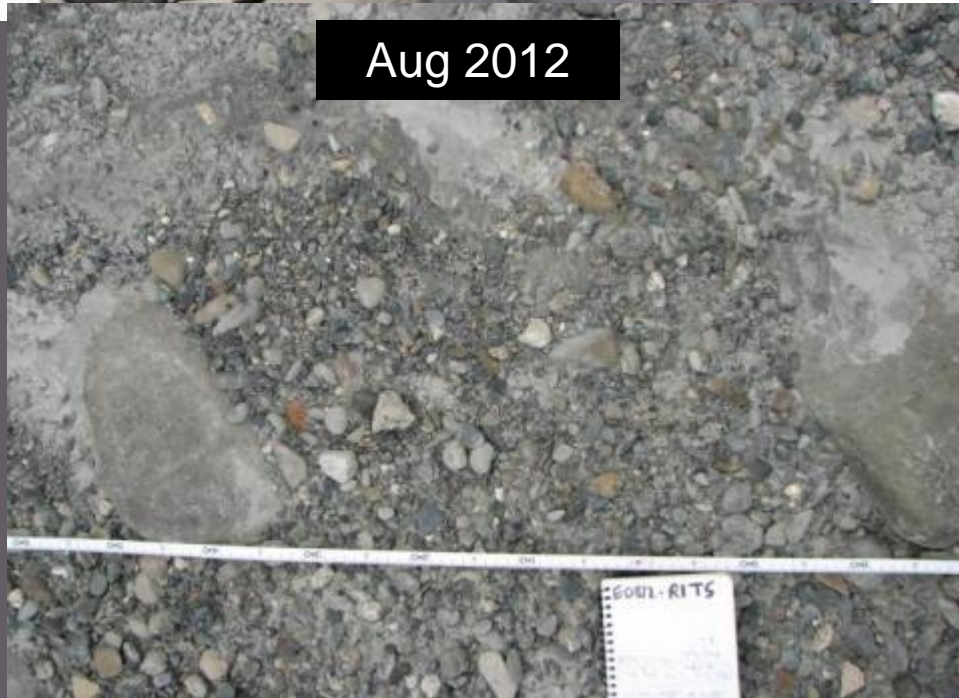
Change in streambed particle size

Sept 2011

April 2012

Aug 2012

- Pools have filled, not really “unfilling” yet
- Riffle crests largely exposed
- Less evidence of mid-channel bars relative to the middle Elwha
- Floodplain channels filled, more sediment accumulation on floodplain
