Ecosystem response during the removal of the Elwha River Dams

June 2016

Today's talk

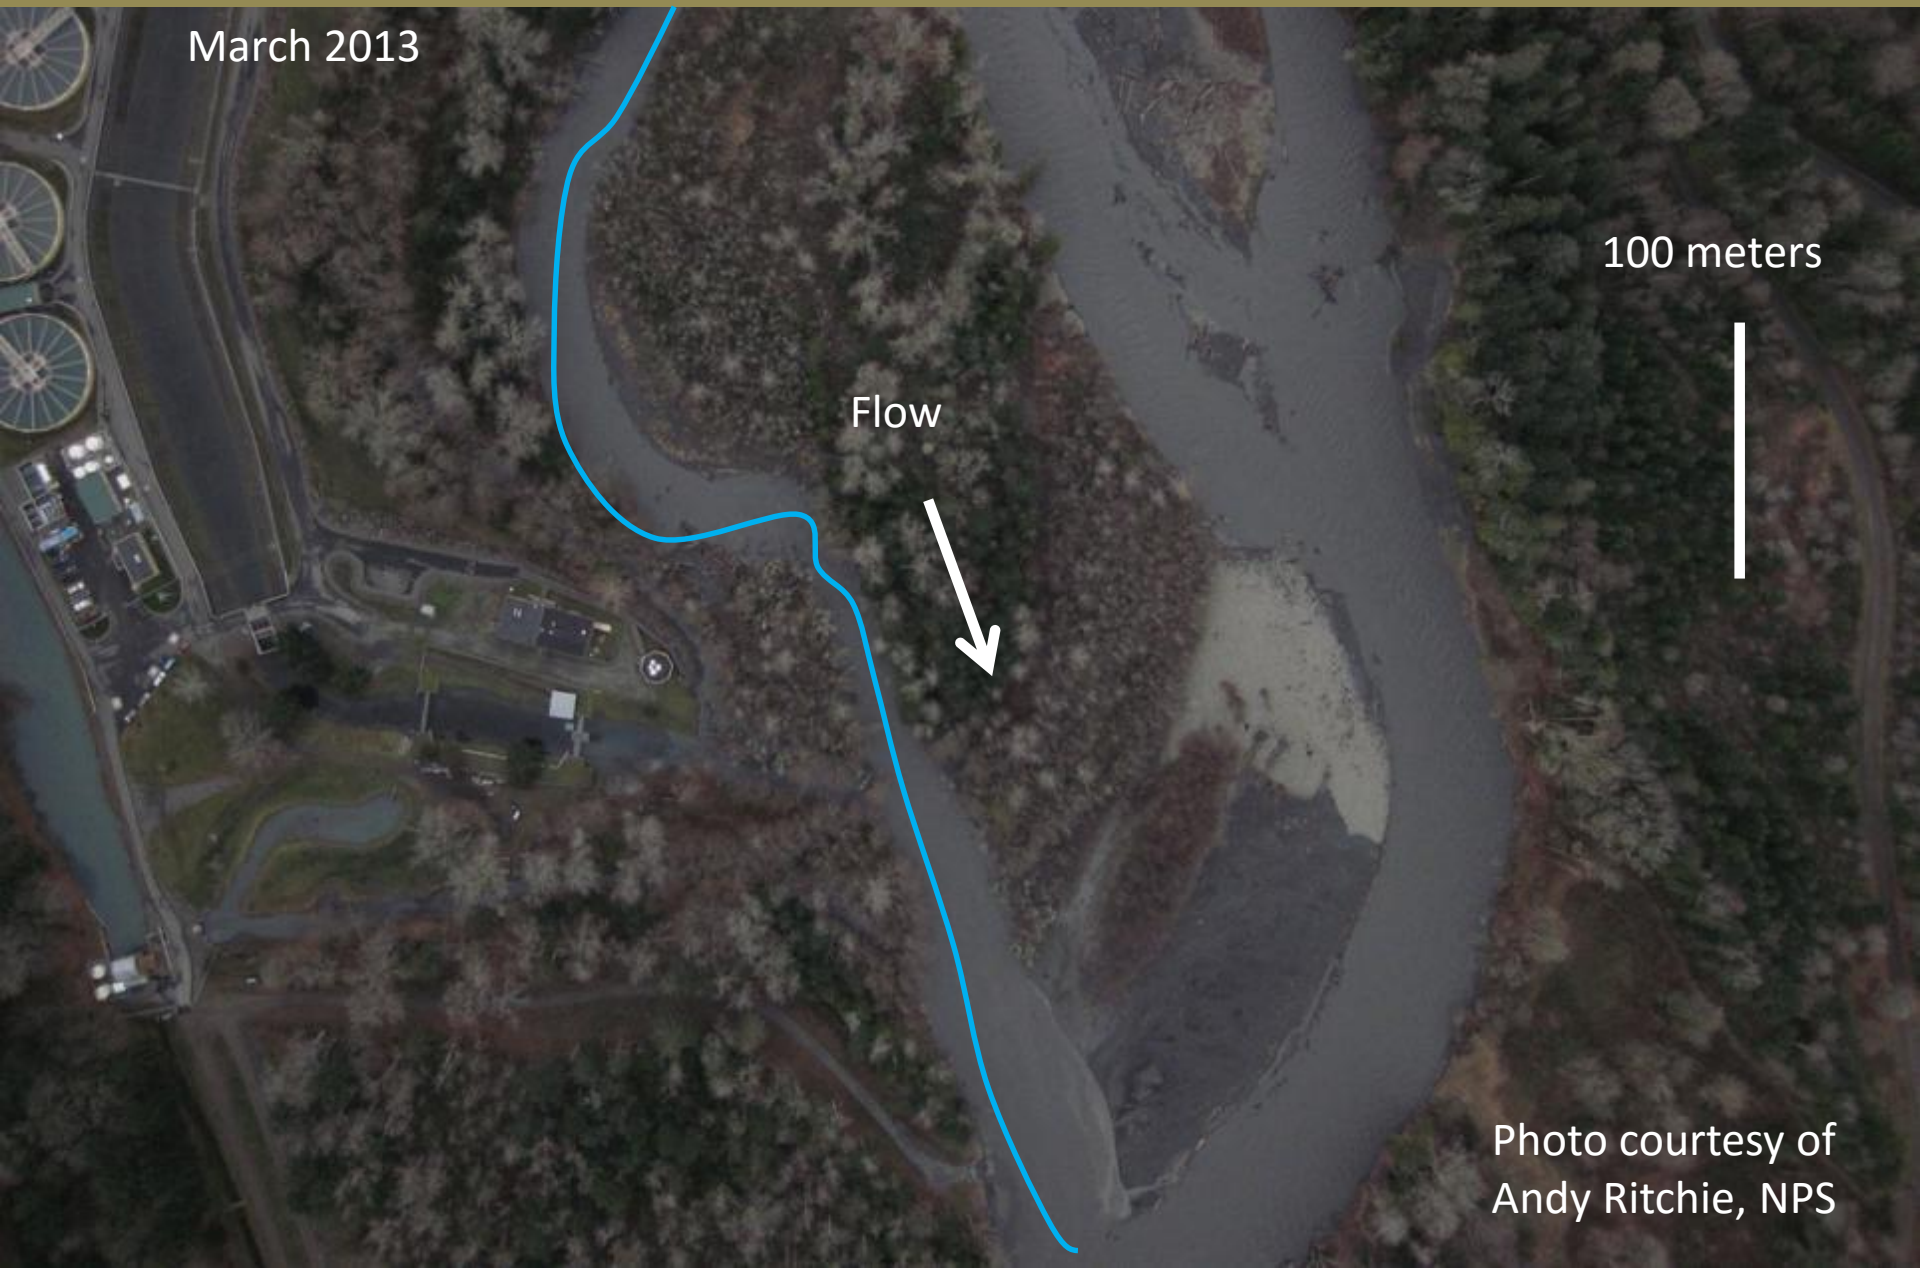
Sediment accumulation in Lower Elwha floodplain channels

March 2013

Flow

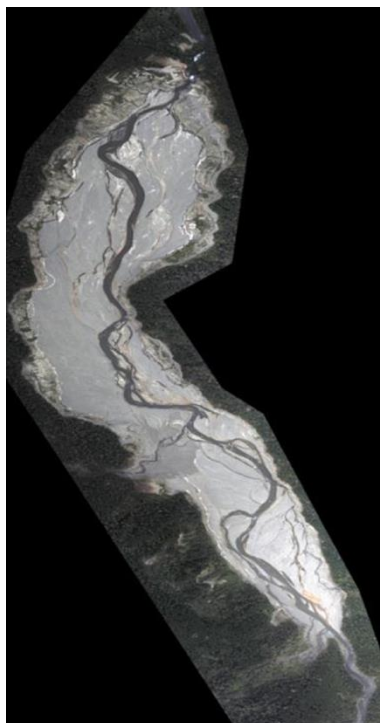
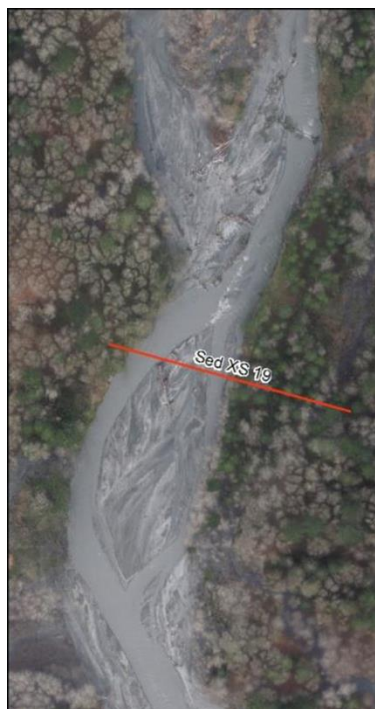
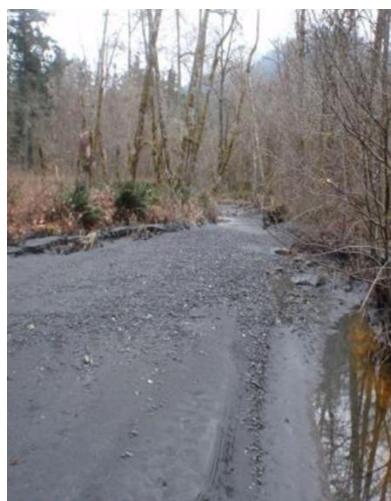
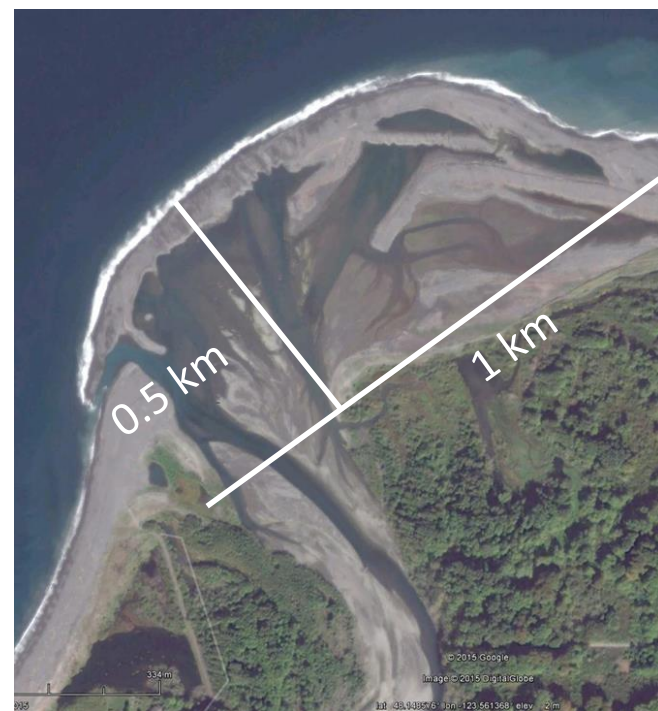
Where has the sediment gone during dam removal?

~10million m³ released

12% stored in main stem (7%)
& floodplain channels (5%)

39% of sediment transported to
Strait of Juan de Fuca

34% deposited in nearshore

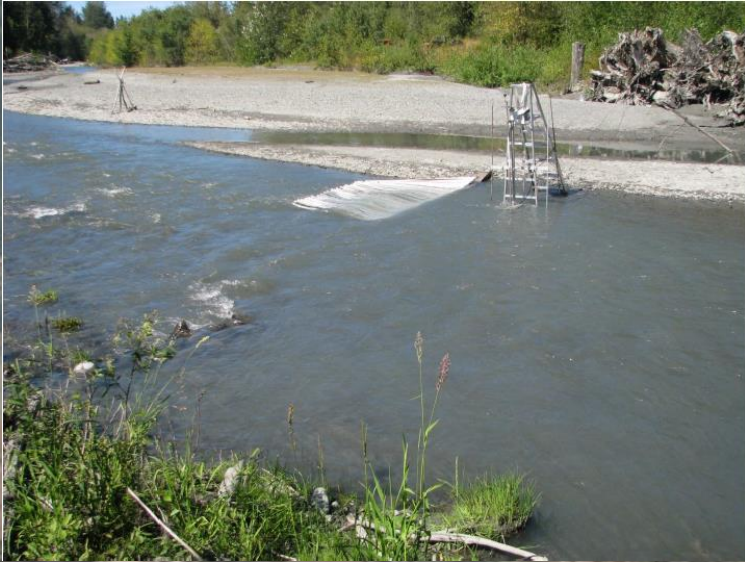
Elwha River SONAR location to enumerate adult Chinook salmon & Steelhead

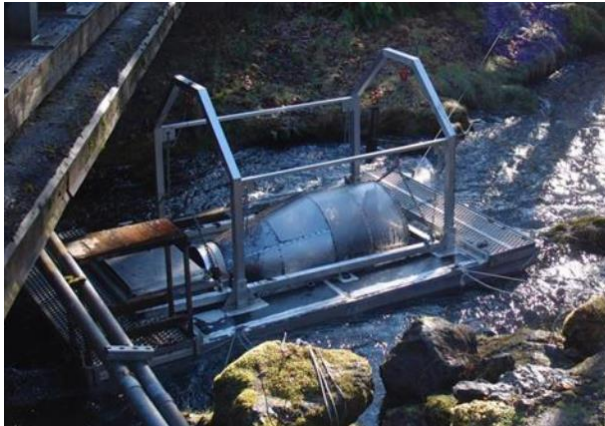
Screw traps

How are the methods used to determine juvenile populations & their spatial distribution?

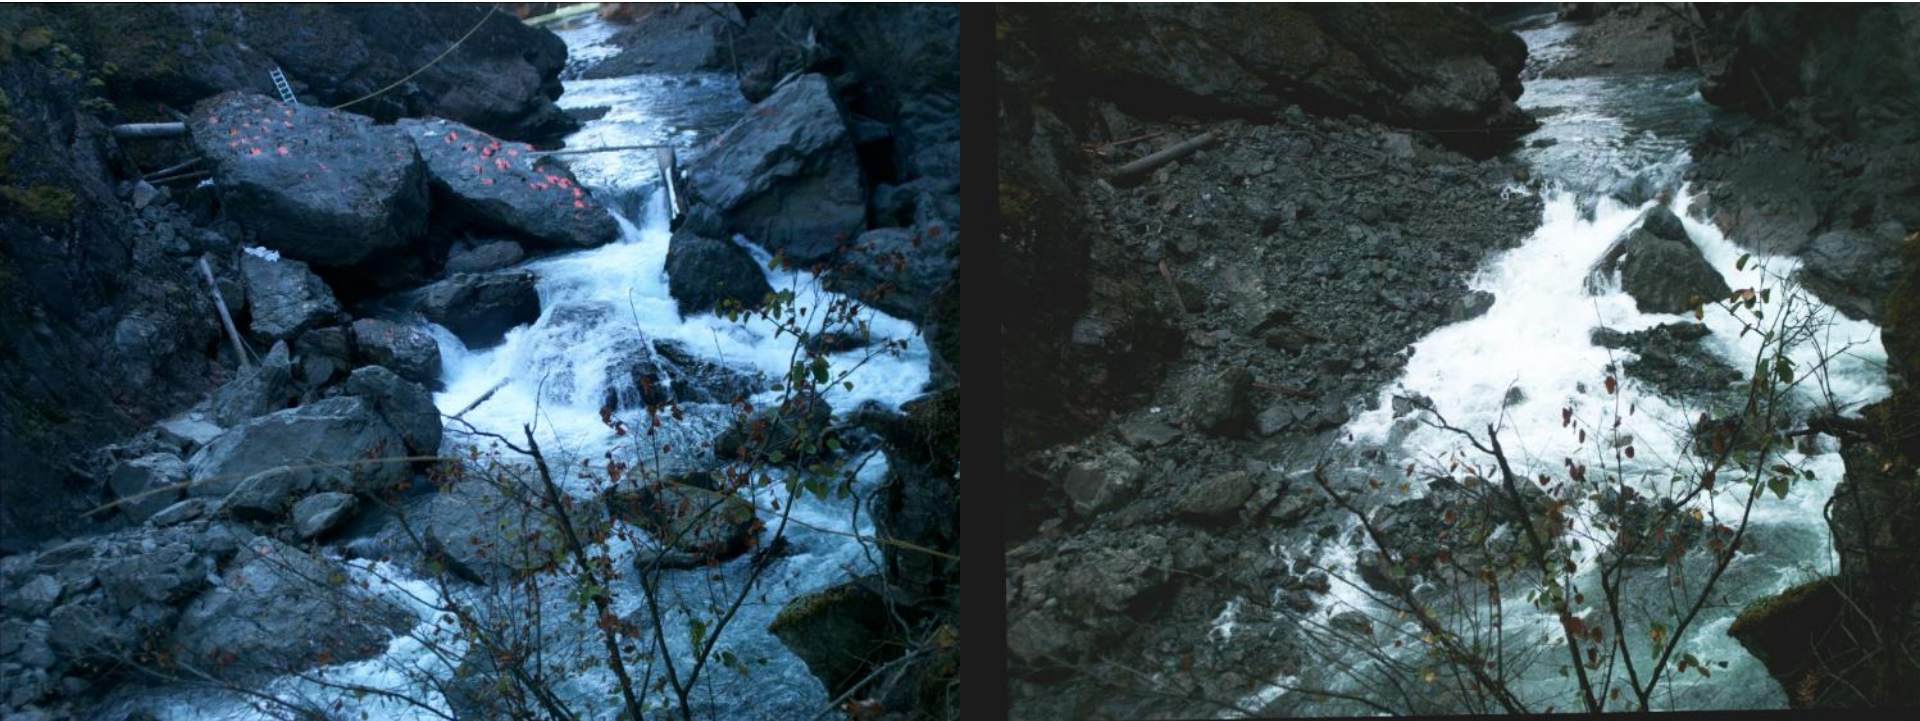
Former Glines Canyon Dam rockfall blast September/October 2015

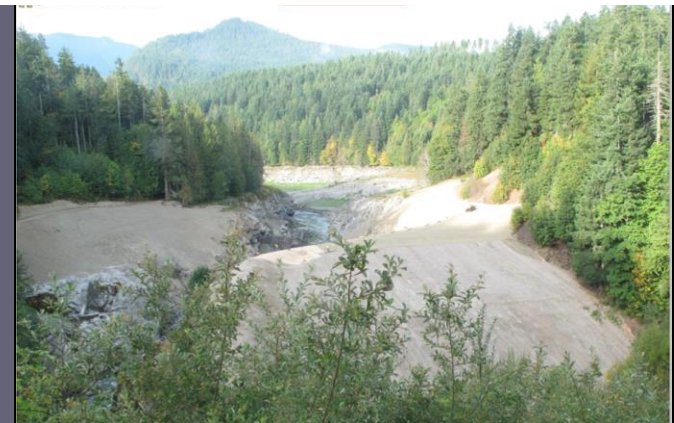
Return of Marine-derived Nutrients to Elwha Foodweb

Modified from: Tonra, C. M., et al. 2015. The rapid return of marine-derived nutrients to a freshwater food web following dam removal. *Biological Conservation*

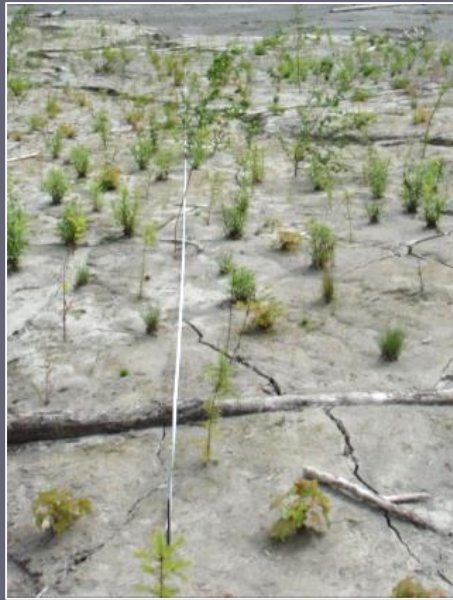
2012

Fine
sediments

- Reservoirs being re-vegetated both naturally and with restoration efforts.
- Natural regeneration and plantings readily establish and thrive on fine sediments
- Coarse sediments proving to be a difficult substrate for most plants

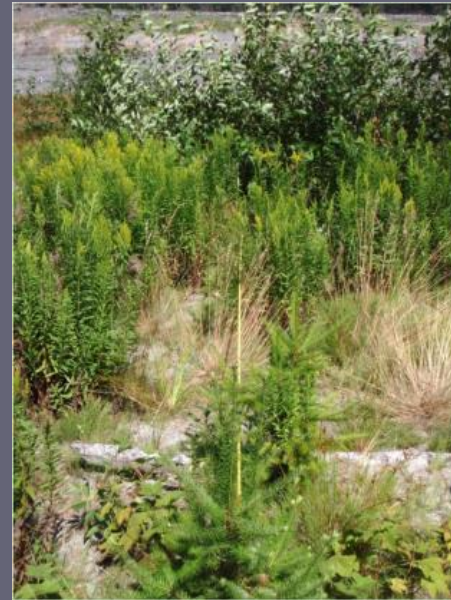
2014

Coarse
sediments

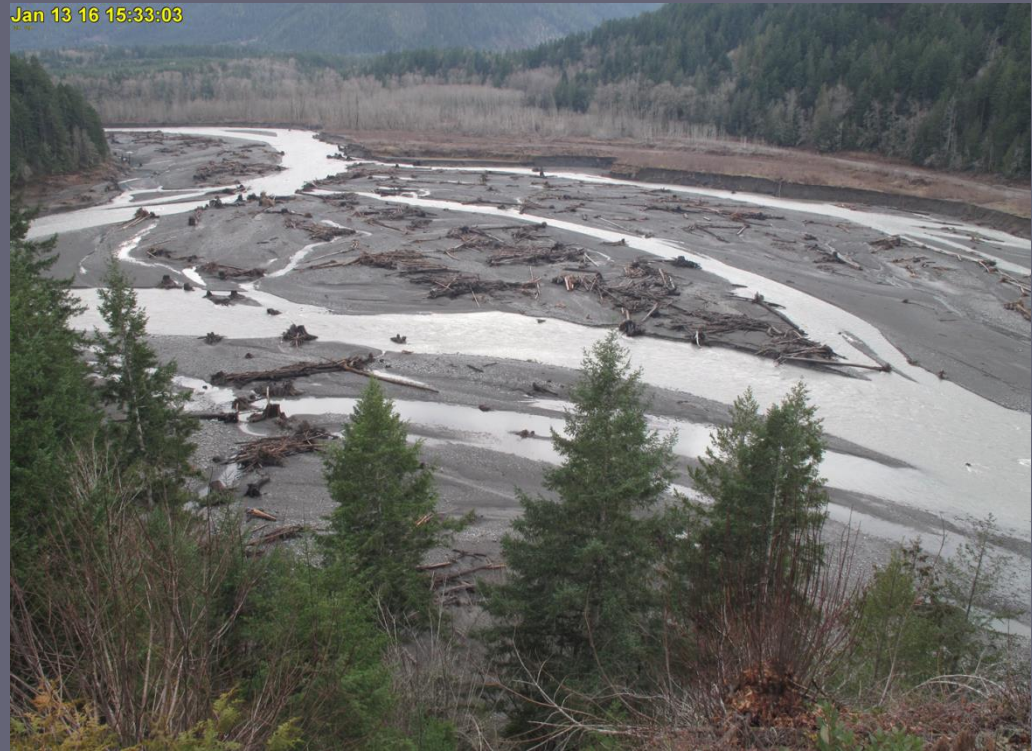
Elwha River dams and former reservoirs

- Elwha and Glines canyon dam removal complete.
- ~58% of total stored sediment has been released as of October of 2015.
- Reservoirs being re-vegetated both naturally and with restoration efforts.

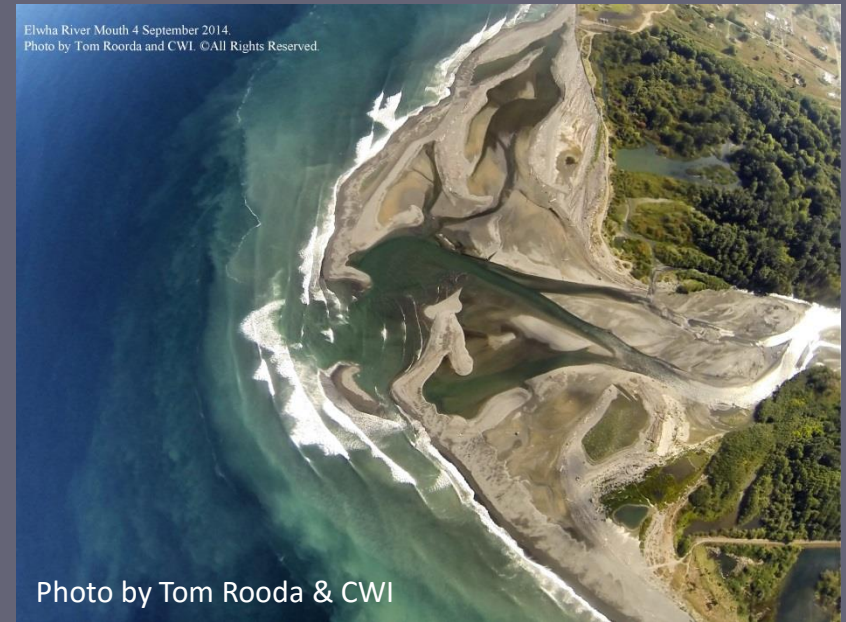
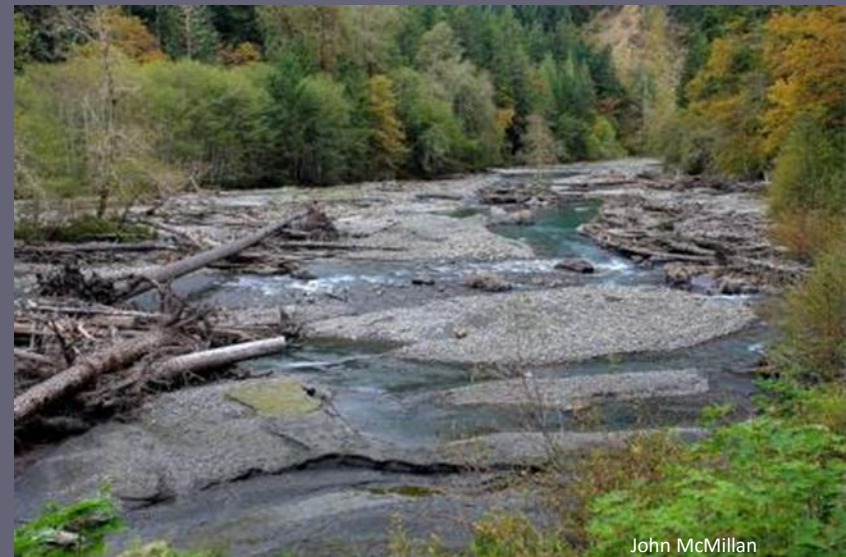
Elwha River nearshore, main stem, & floodplains

- Majority of sediment transported to Strait of Juan de Fuca
- Delta at river mouth has prograded into the Strait of Juan De Fuca.
- ~12% of sediment stored in-river.
- Main stem & floodplain channels downstream of dams aggraded (~1-2m)
- Gravels bars developed, large increase in wood accumulation
- Floodplain channels filled with sediment
- Floodplain surface now accumulating sediment
