Bateman Island Causeway Conceptual Design

Mid-Columbia Fisheries Enhancement Group • Benton Conservation District
Gray and Osborne • Northwest Hydraulic Consultants

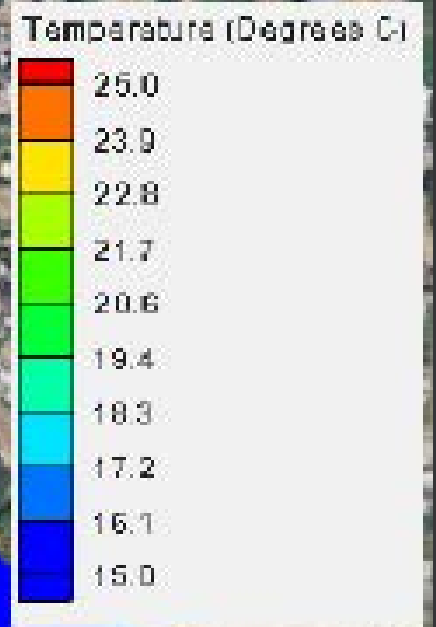
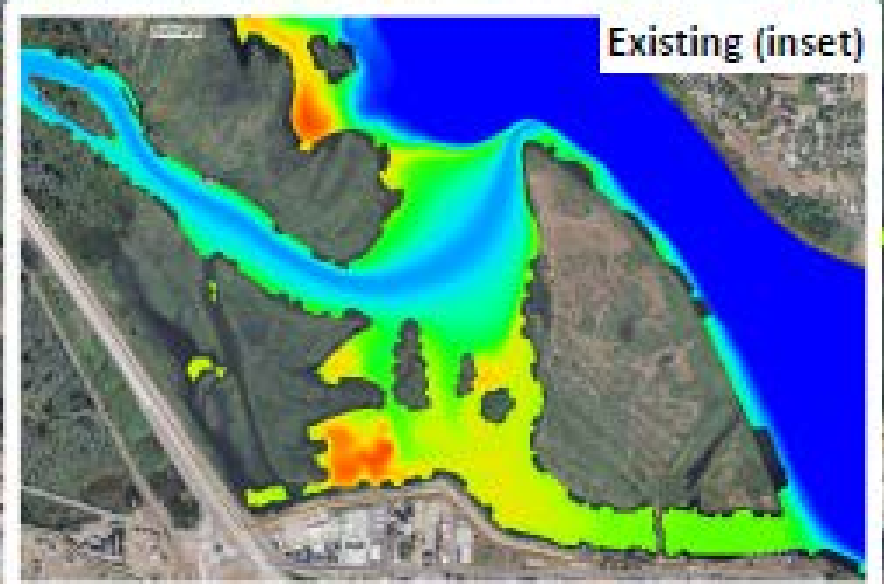
Alternative 8, June 1, 2012

Existing (inset)

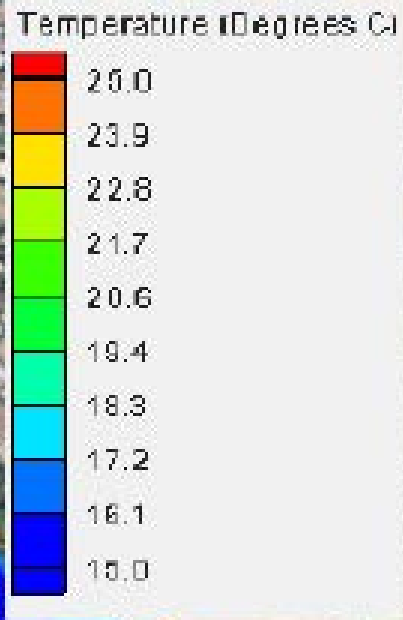
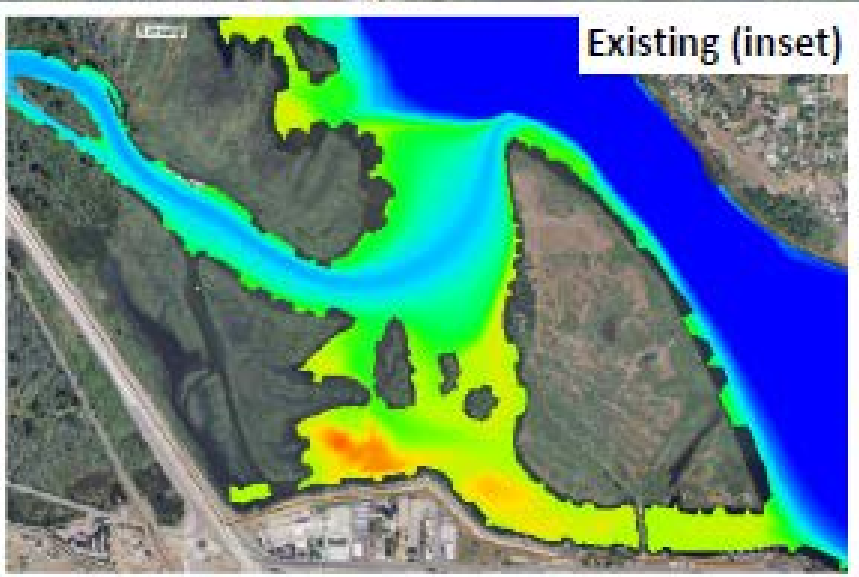
Alternative 8, June 3, 2012

Existing (inset)

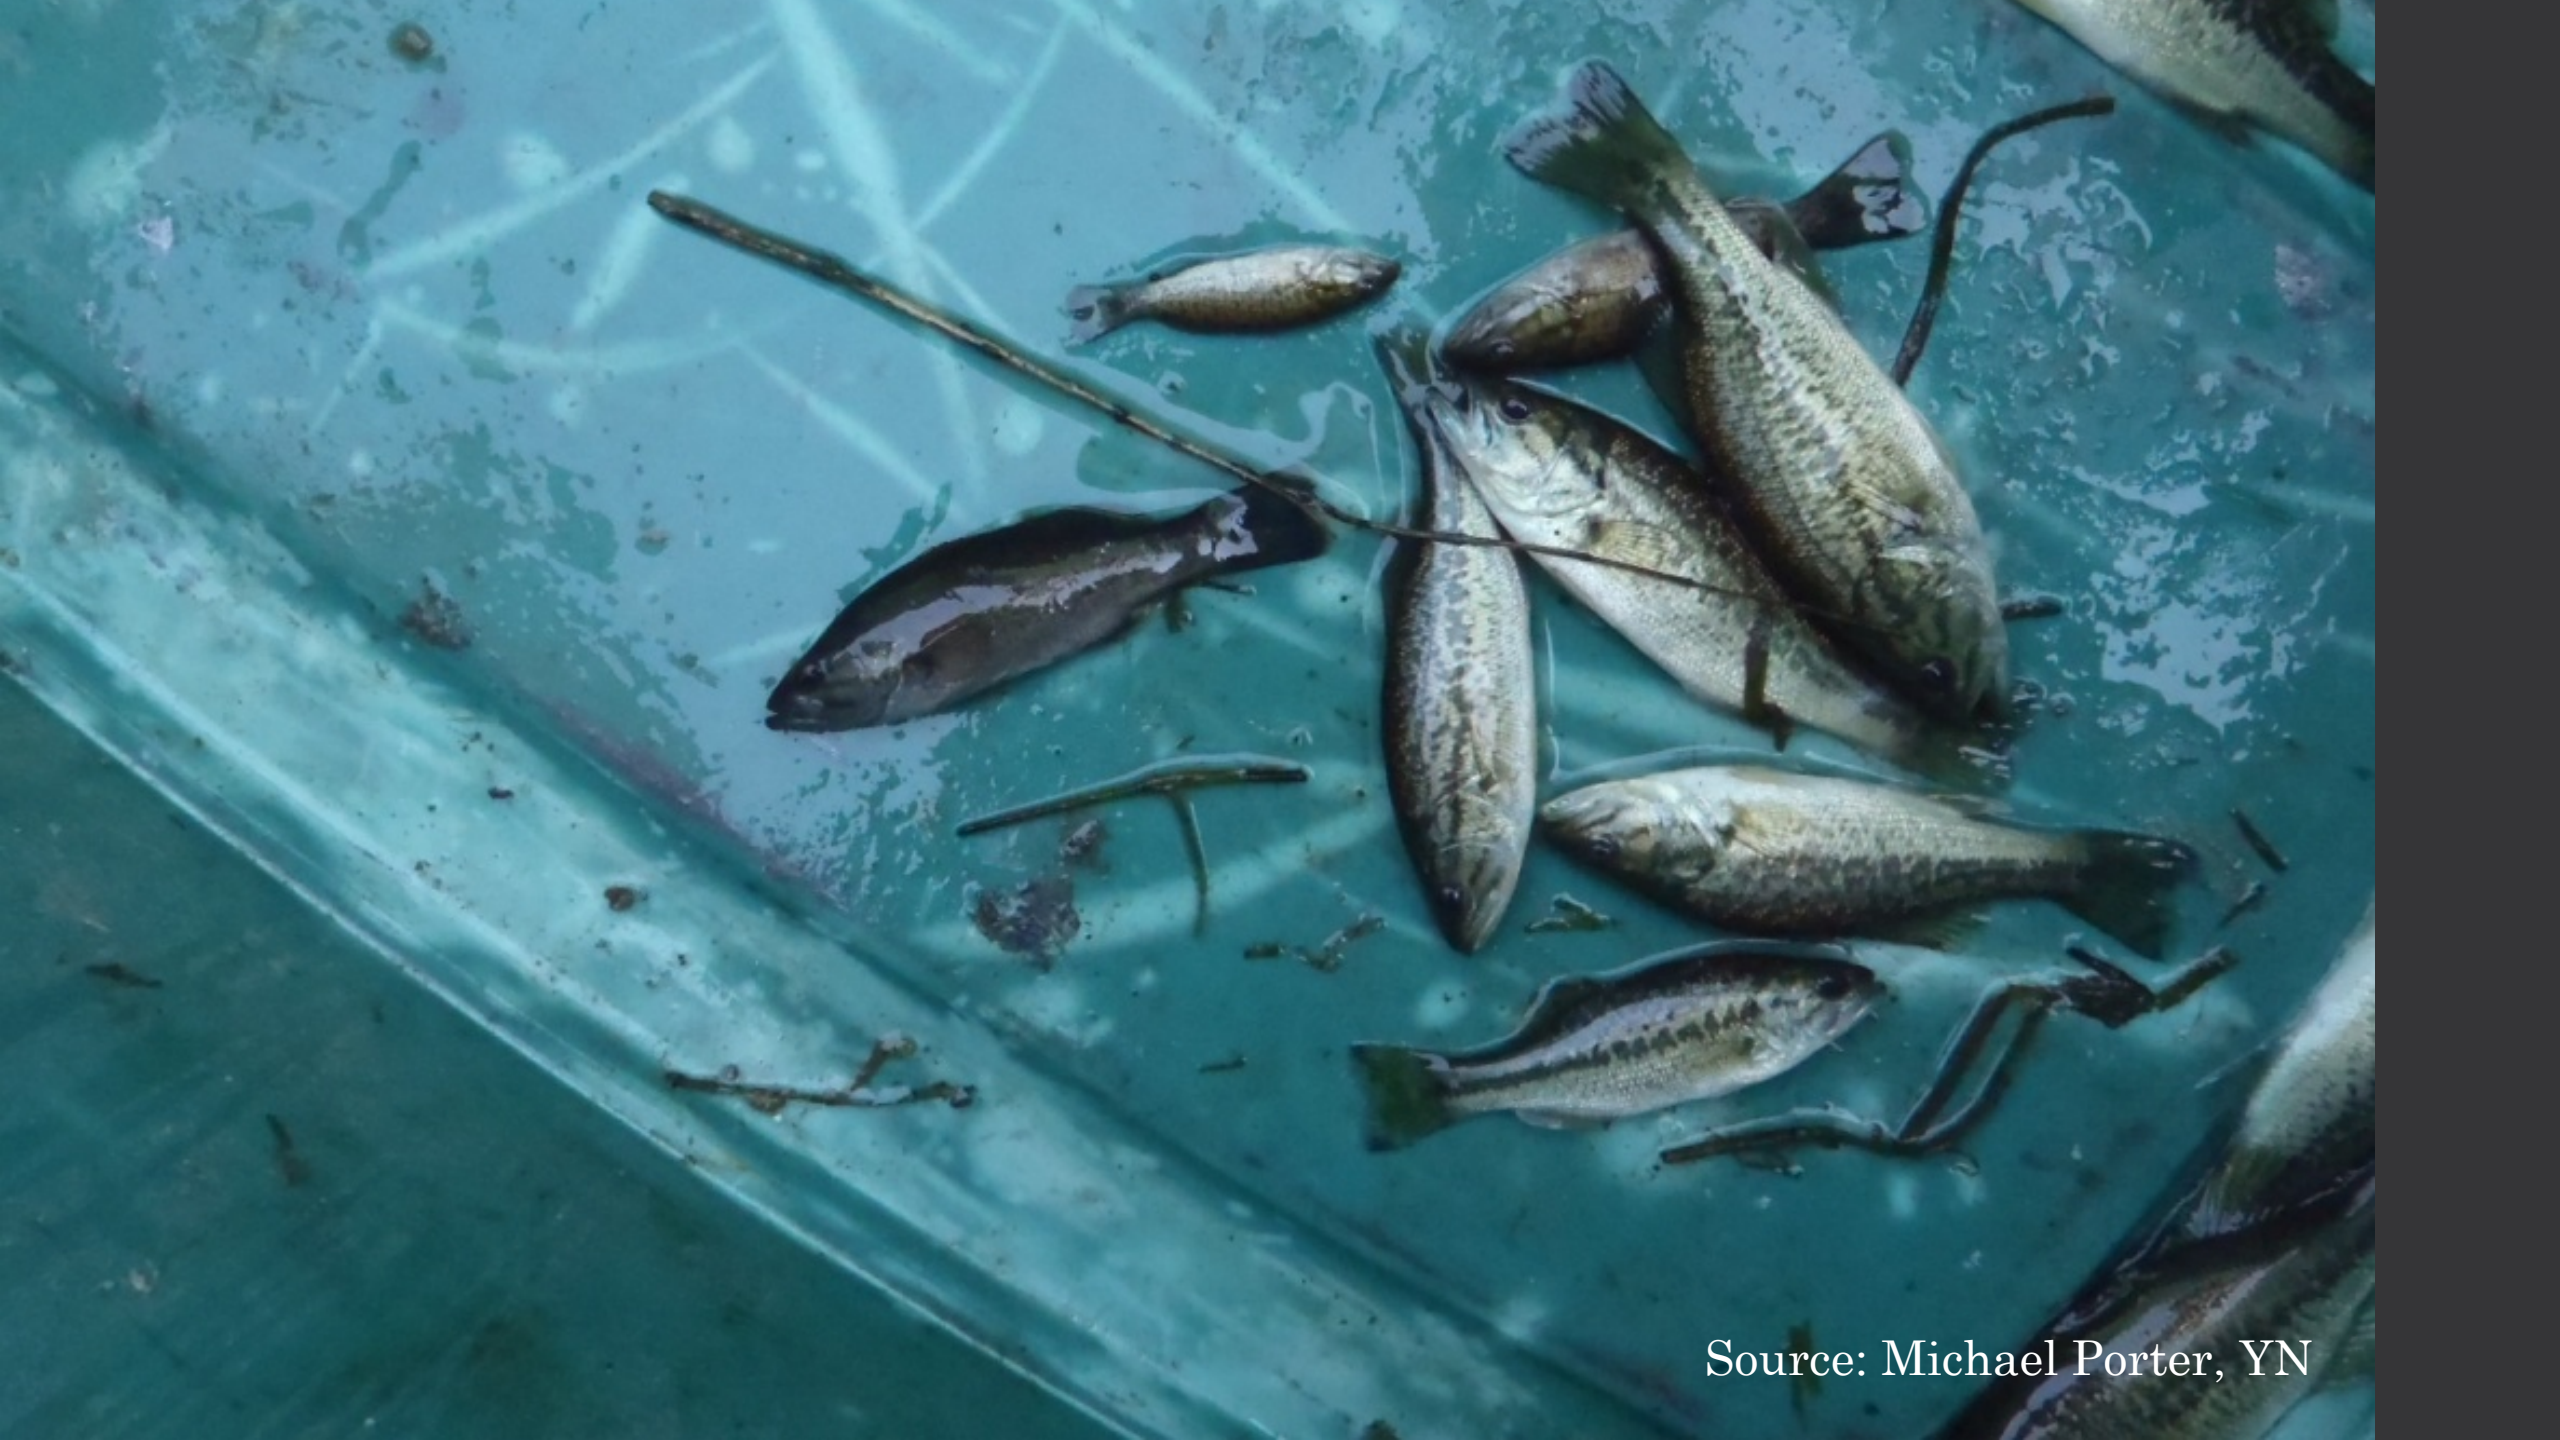
Maximum Spring (March 15 – May 31) 7-DADMax Temperature

Alternative	Measured in channel west of island	
	2012	2014
Alt. 1 - Existing Conditions	19.6 °C	21.1 °C
Alt. 6 - 130 foot Breach	17.7 °C	18.7 °C
Alt. 7 - 200 foot Breach	17.6 °C	18.6 °C
Alt. 5 - 260 foot Breach	17.6 °C	18.5 °C
Alt. 3 - 560 foot Full Breach	17.6 °C	18.5 °C
Alt. 8 – 560 foot Breach + Breakwater	17.6 °C	18.5 °C

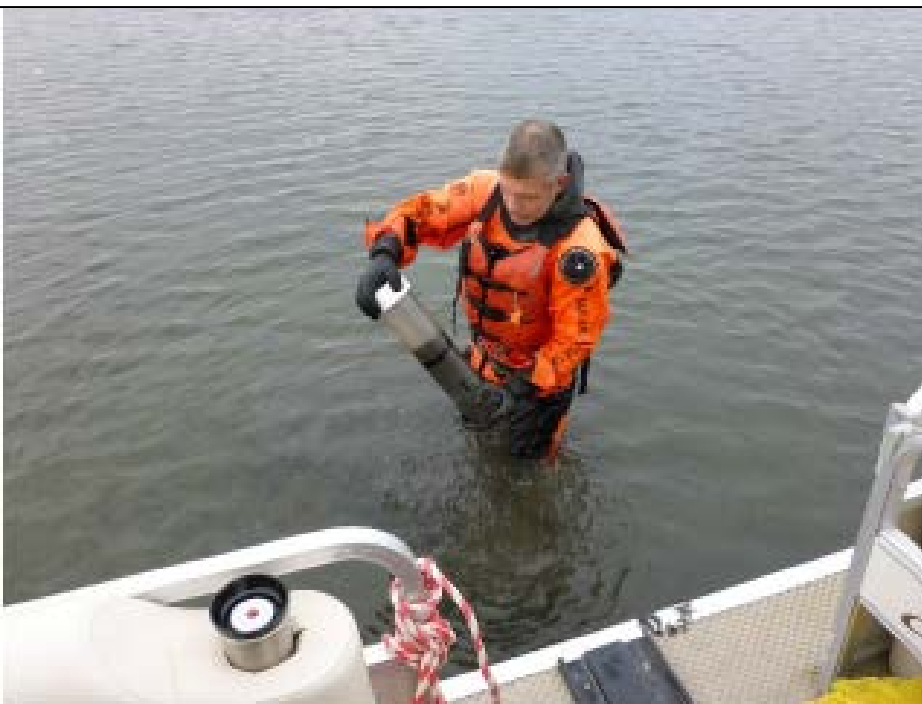
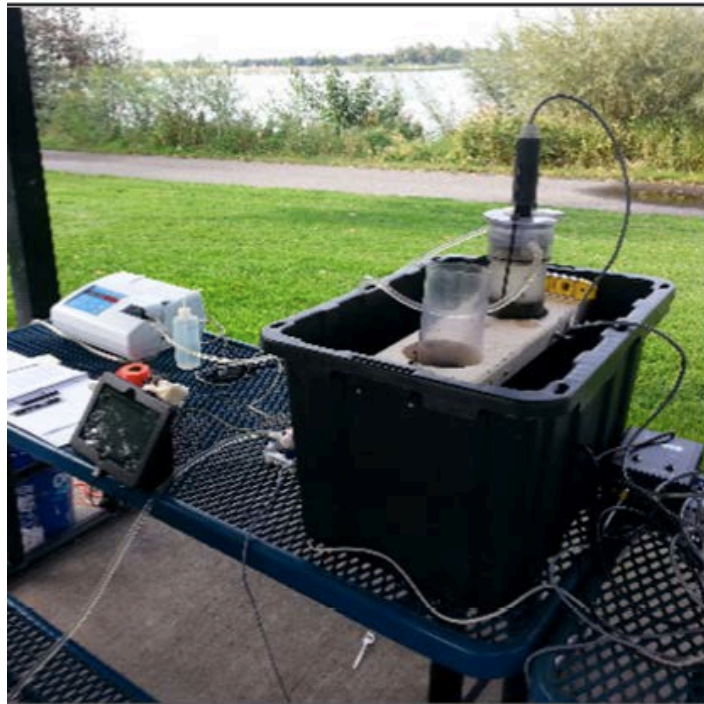
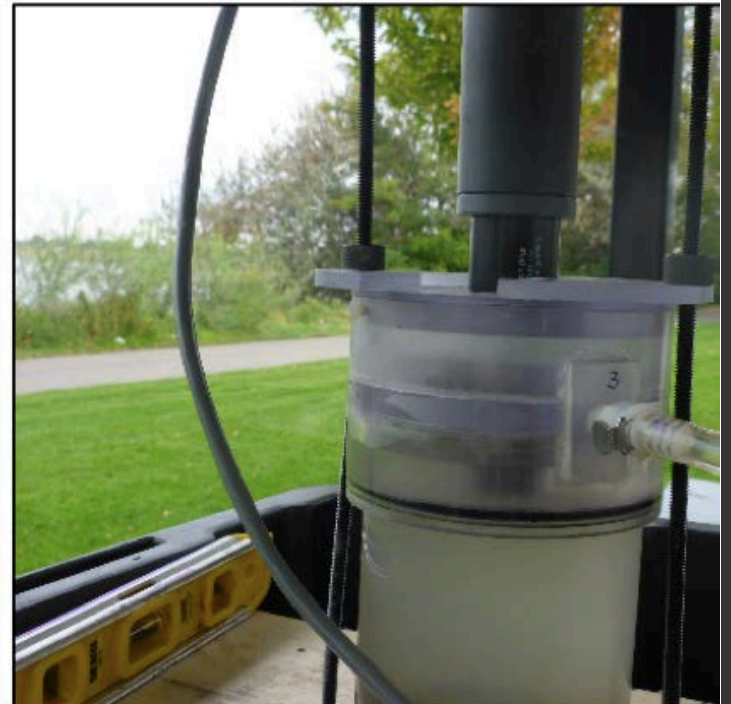
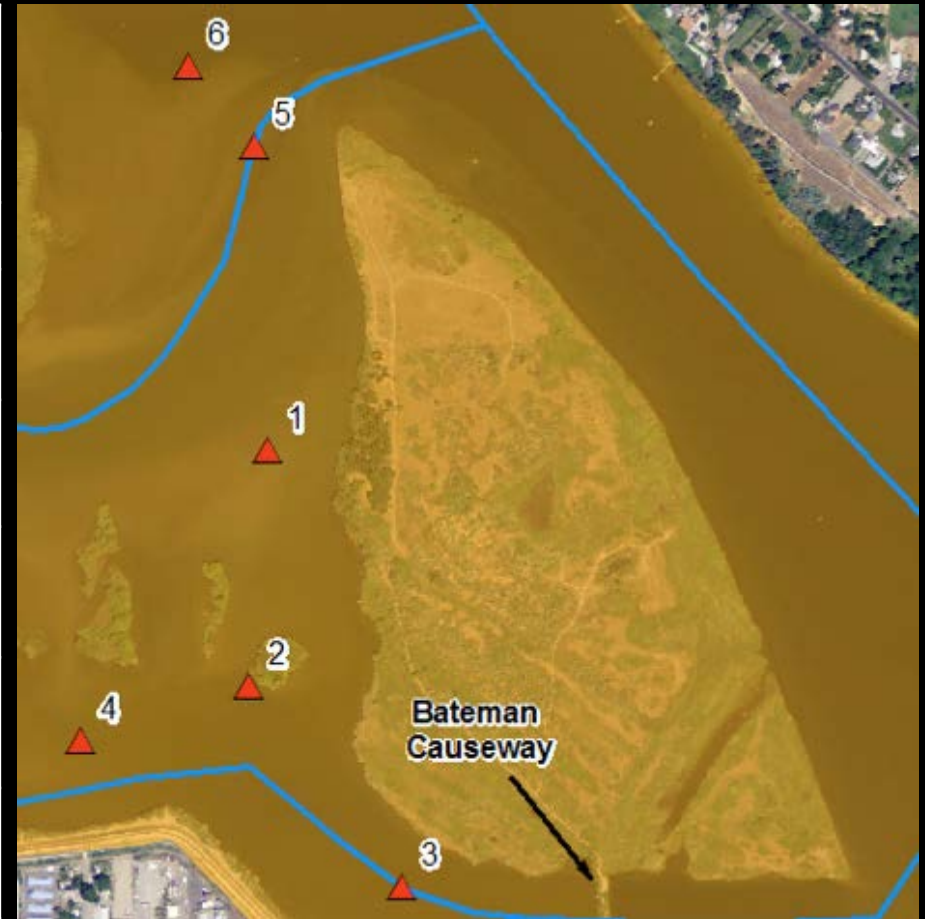
Sediment

Time required for full erosion at each area after full breach

Area	Low Flow	Mid Flow	High Flow
	weeks	weeks	weeks
Area 6: North of Yakima Inflow	11.9	0.7	0.2
Area 5: Yakima River	no movement	1.1	0.3
Area 1: West Side of Island	112	6.2	1.8
Area 4: Small Channel South	no movement	184.7	10.2
Area 3: West of Causeway	57.9	3.5	1.0
