Mass Wasting in the Swauk Watershed, Washington: Spatial Extent, Timing, and Implications

Karl Lillquist

Geography Department & REM Program
Central Washington University

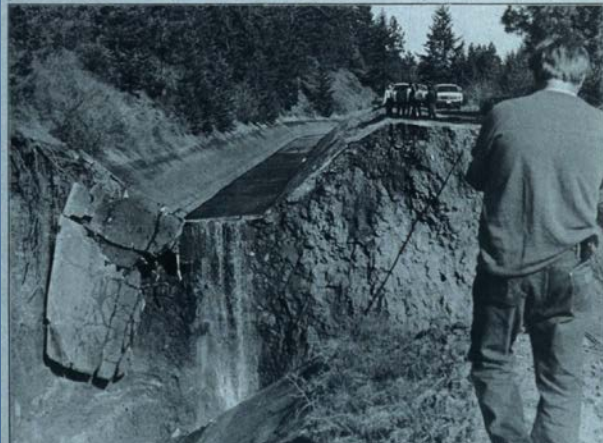
Officials surveyed the scene of the wrecked KRD Highline Canal this morning. The ruptured canal released a wall of water that wiped out power and telephone lines. Irrigation water deliveries will be delayed until the canal is repaired, officials report.

What the lack of water did last summer in shutting down early the Kittitas Reclamation District, the abundance of water did again late Monday night by washing out a 25-foot section of the KRD's main branch canal and canceling plans to start water deliveries May 1.

Devenport speculated that the washout, hole or void in the concrete lining and dug out underneath the concrete and eroded away the earthworks and hillside. The water erupted into the Yakima River area west of.

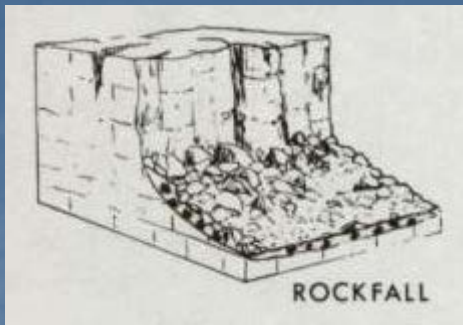
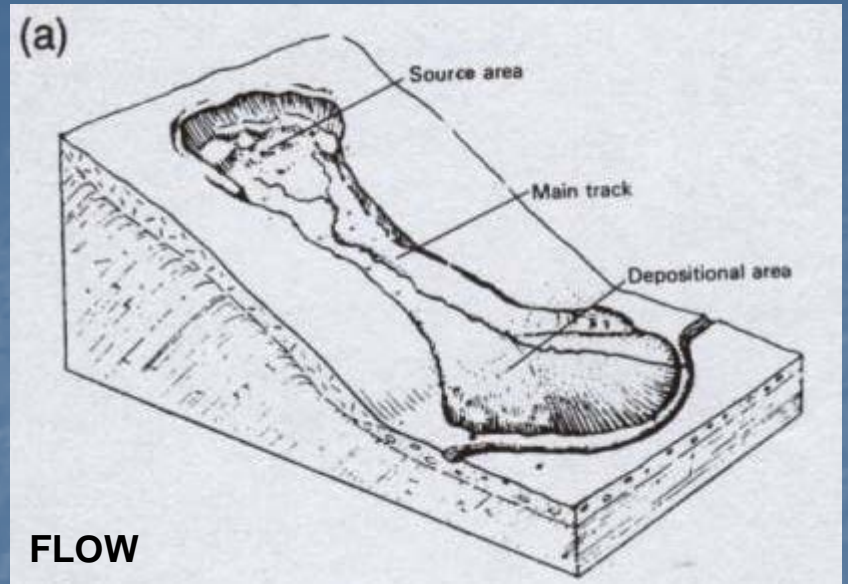
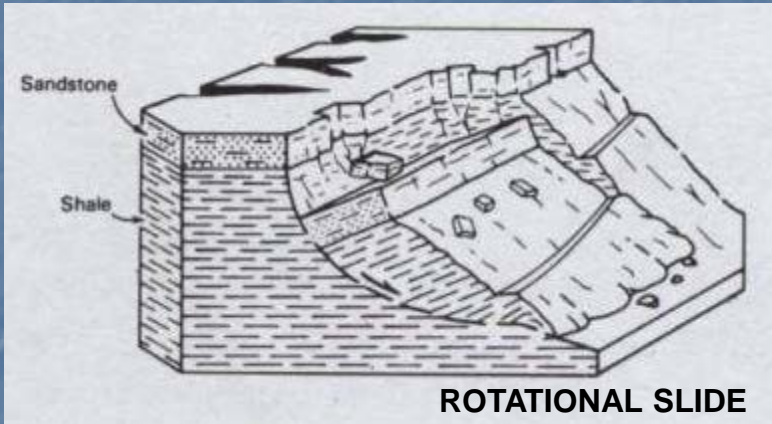
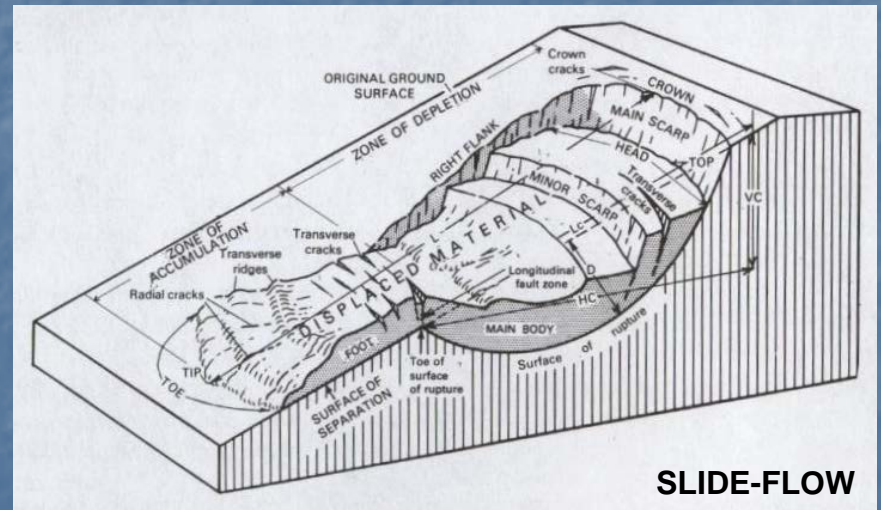
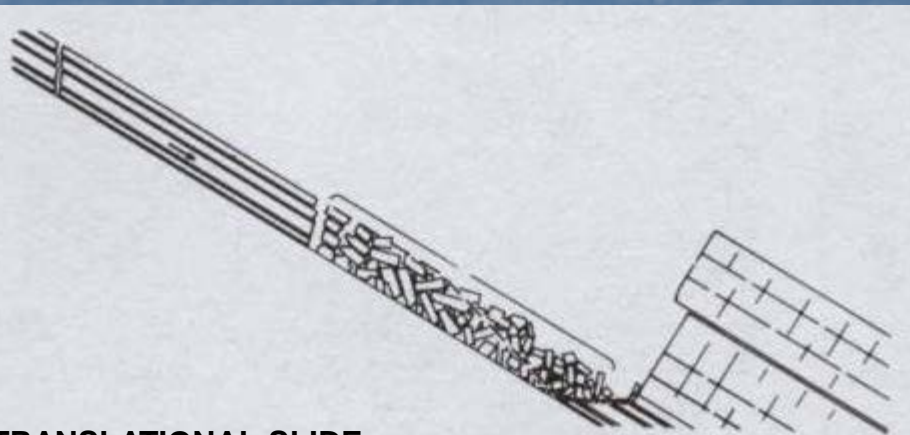
Spatial Extent

- 38% of watershed!
- Mostly in headwaters
- >156 discrete events
 - rockfall
 - flows
 - translational slides
 - rotational slides
 - slide-flows

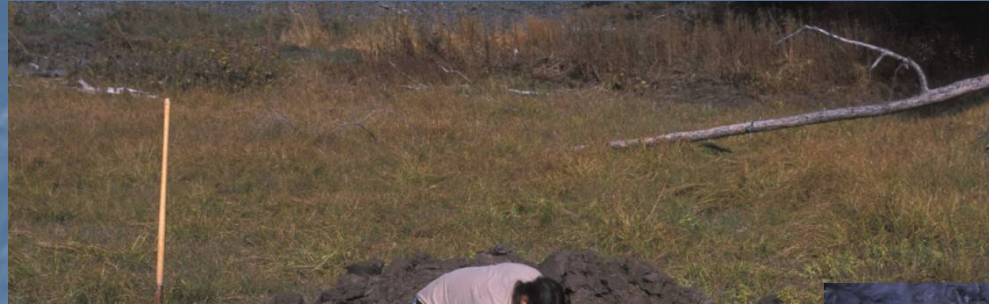
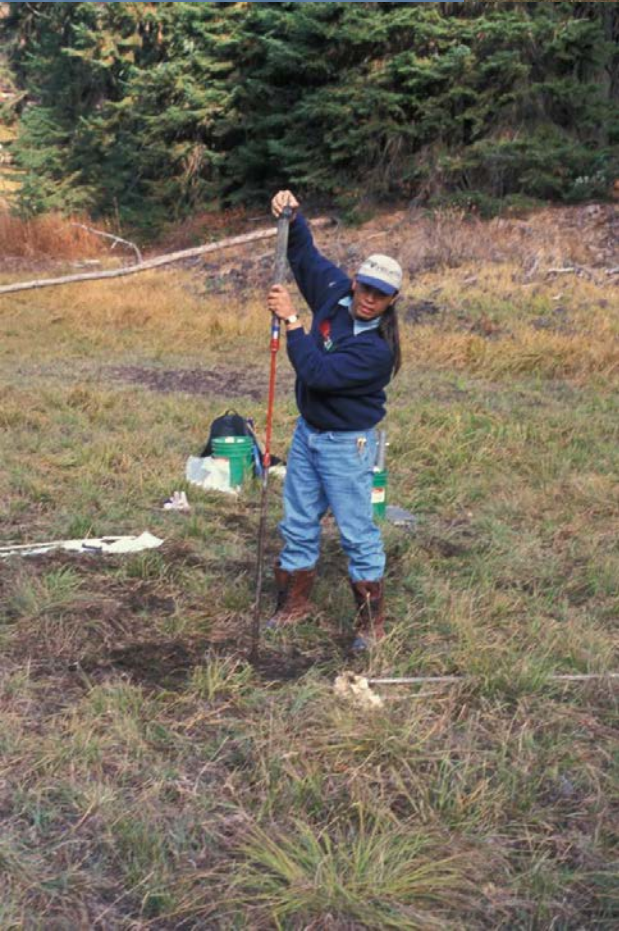
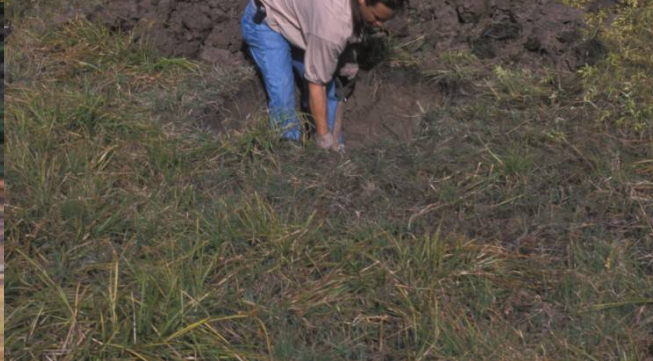
Absolute Timing Methods

- ^{14}C dating
- Tephrochronology

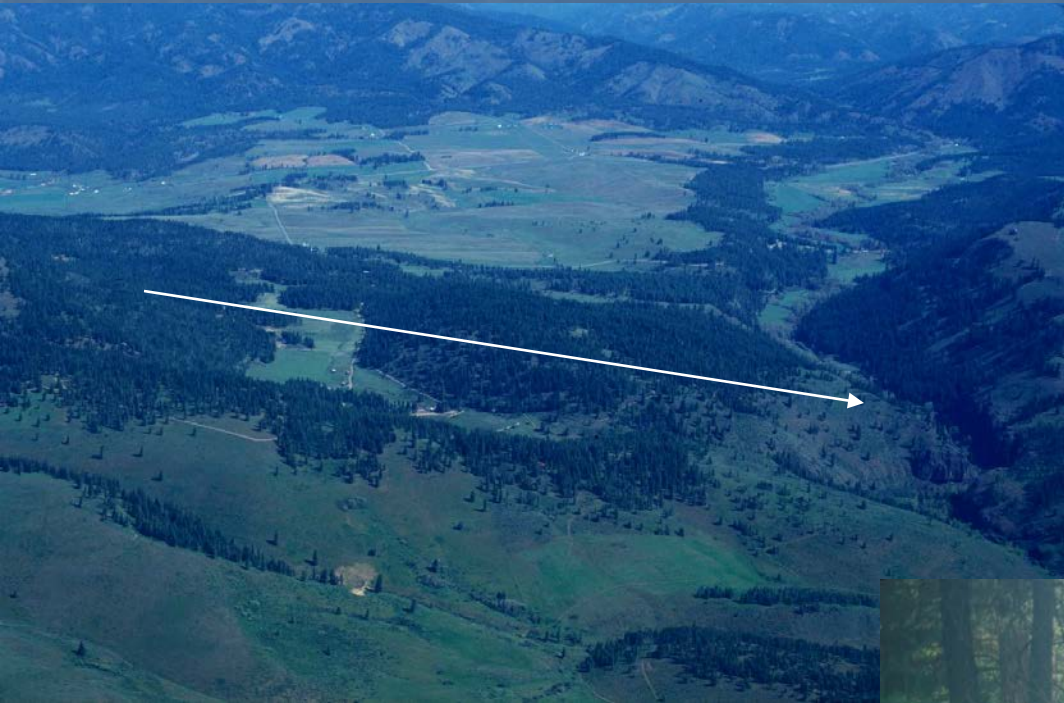
Implications II

Impacts on Stream Channels:

- temporary dams
- increased sinuosity
- increased sediment load
- increased large woody debris
- increased habitat diversity

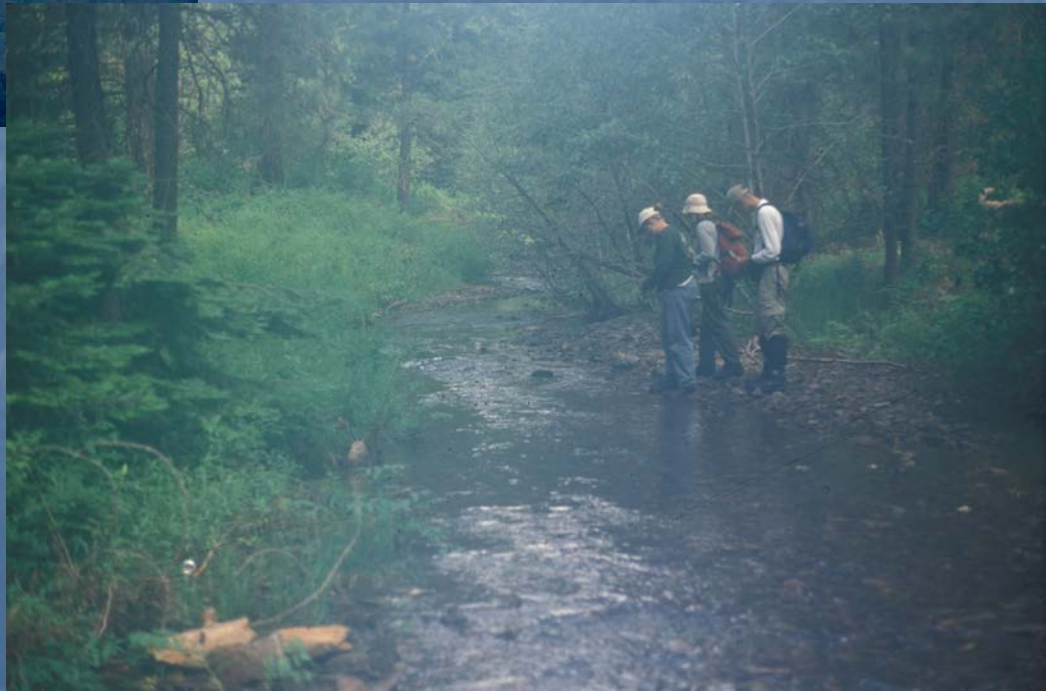
Mass Wasting-Induced Capture of "Green Canyon Creek" by First Creek >10,560 ¹⁴C yr BP
