## **Intensive Monitoring of Larval/Juvenile Lamprey Entrapment within Dryden Diversion, Wenatchee River, 2017**

**Project No. 2008-470-00**

**Report was completed under BPA Contract No. 56662 REL 123**

**Ralph Lampman**

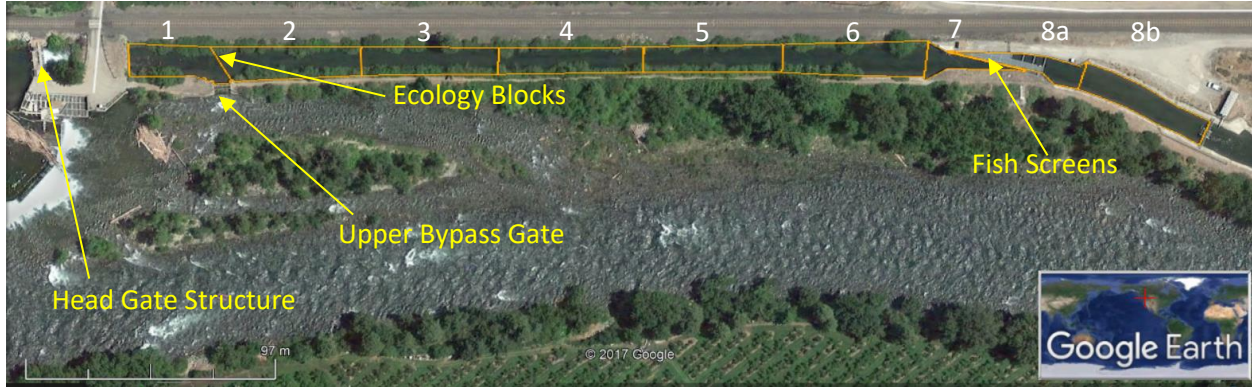
**Figure 1. Aerial map of Dryden Diversion (Dryden, WA) from headgate structure to just downstream of the fish screens. Sections are delineated by orange lines and section ID numbers are shown in white font at the top of the map.**

Dryden Diversion was separated into eight sections (each 35-55 m long; Fig. 1) to be able to assess the density and abundance levels in various parts of the diversion. Ribbon flagging were used to clearly identify the section boundaries. Each team recorded the salvage data separately by these sections. Type I / II larval lamprey habitat (preferred and acceptable habitat, respectively) was surveyed, with Type I habitat given priority. Specific sections (and areas within the sections) to primarily focus each day were determined based on a combination of water level conditions and larval lamprey densities (past and current). Total area of the sections were determined based on Google Earth polygons using Earth Point 2018 (<http://www.earthpoint.us/Shapes.aspx>).

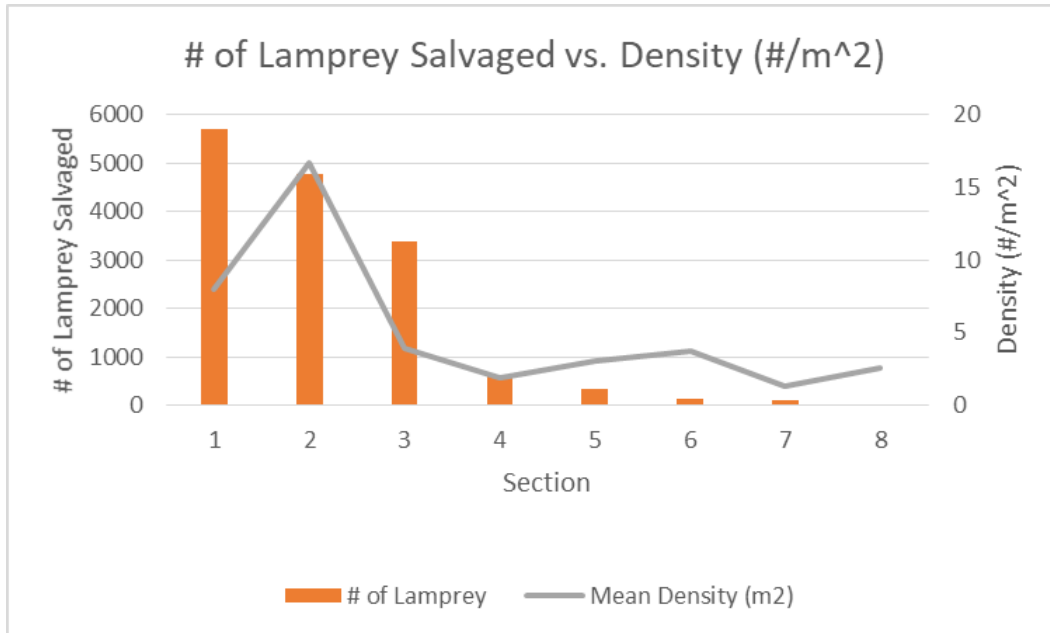
**Figure 2. Total number of lamprey salvaged and mean survey density by sections at Dryden Diversion (Dryden, WA).**

During the salvage efforts between October 16 and 20, 2017, a total of 15,035 lampreys were captured and salvaged from Dryden Diversion (Table 1). This consisted of 13,797 larval lampreys (i.e. ammocoete) and 1,238 juvenile lamprey (i.e. macrophthalmia), which comprised 8.2% of the total number of lampreys. A total of 14,952 lampreys (13,724 larvae and 1,228 juvenile) were released in Jolanda Lake upstream of Tumwater Dam between October 16 and 18, 2017 at river km 50.4. Those captured on October 20, 2017, were released in Wenatchee River just downstream of Dryden Diversion (river km 27.8). Number of mortality recorded was limited this year (<10), but not all lamprey were examined thoroughly after being released at Jolanda Lake. The largest number of lamprey was captured from Section 1 (n=5,698) followed by Section 2 (n=4,780), and Section 3 (n=3,392) (Fig. 2). The smallest number of lamprey was captured from Section 8 (n=13); however, density levels in Section 8 were similar to Section 4 through 7, indicating some lamprey are getting entrained through the 1.75 mm mesh-size vertical-bar fish screens.

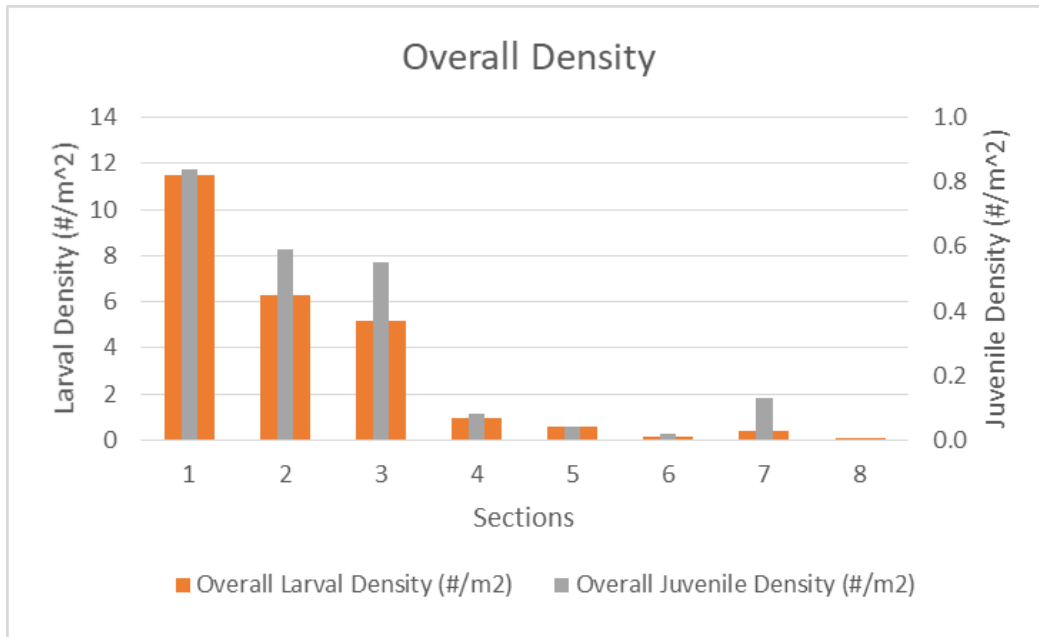
**Figure 3. Density of larval and juvenile lamprey from Dryden Diversion (overall number of lamprey salvaged divided by overall section area at full water level) by sections at Dryden Diversion (Dryden, WA).**

Mean density (mean density value from all surveys within the section) was highest in Section 2 (16.6 #/m<sup>2</sup>), followed by Section 1 (8.0 #/m<sup>2</sup>), and Section 3 (4.0 #/m<sup>2</sup>) (Table 1, Fig. 3). Mean density was lowest in Section 7 (1.3 #/m<sup>2</sup>) followed by Section 4 (1.9 #/m<sup>2</sup>). Mean pace of electrofishing ranged from 1.2 m<sup>2</sup>/min (Section 2 and 8) to 2.3 m<sup>2</sup>/min (Section 1 and 3). Overall salvage density (total number of salvaged lamprey divided by total area of the section) was highest in Section 1, 2, and 3 for both larvae (11.5, 6.3, and 5.2 #/m<sup>2</sup>, respectively) and juvenile (0.8, 0.6, and 0.6 #/m<sup>2</sup>, respectively). Although the overall number of juvenile (macrophthalmia) collected from the lower sections were lower, the percent of juvenile within the overall catch were considerably higher for the lower sections compared to the upper sections (Fig. 4).

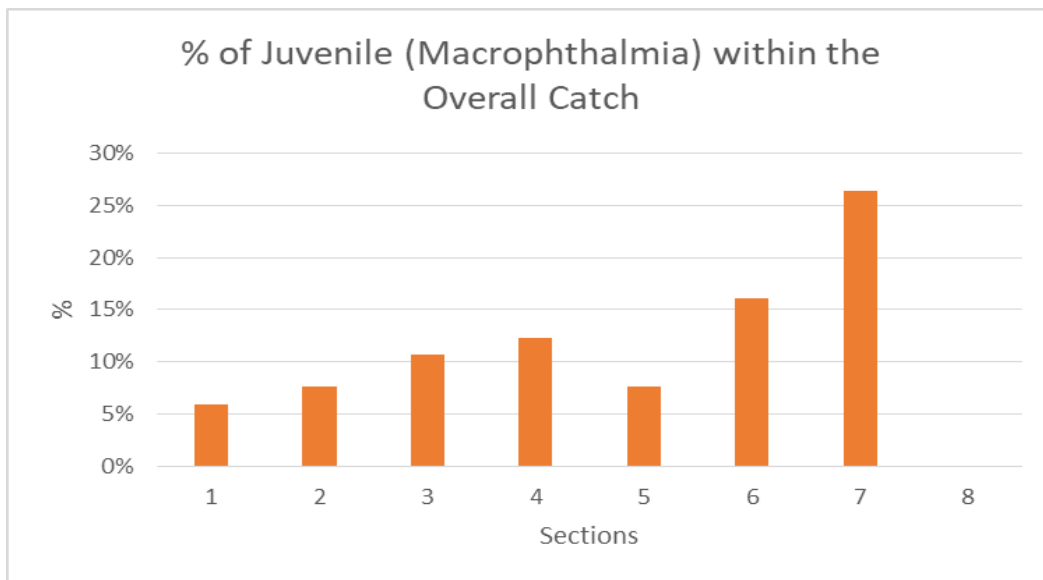
**Figure 4. Percent of juvenile lamprey within the overall capture numbers by sections at Dryden Diversion (Dryden, WA).**

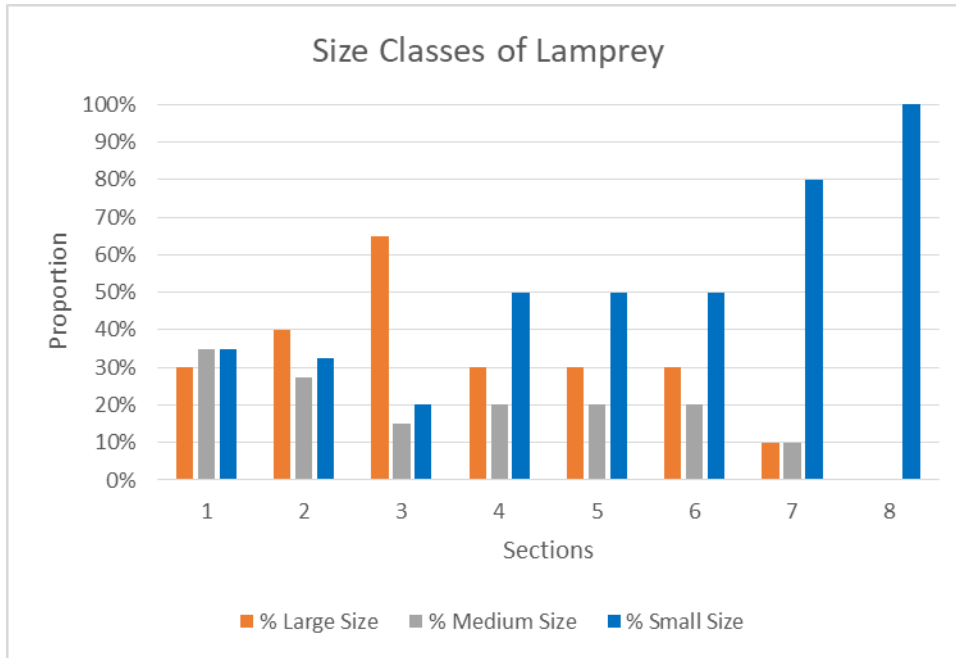
Figure 5. Size classes of lamprey on October 18, 2017, by sections at Dryden Diversion (Dryden, WA).

The size classes of lamprey from each section were recorded on October 17, 2017. In general, the number of small lamprey (<50 mm) proportion increased in the downstream direction (Fig. 5). The large lamprey (>90 mm) peaked in Section 3. Although efforts were made to capture all lamprey we observed at each section, a large number of the lamprey, especially smaller ones, escaped our nets due to high density and limited water clarity. As a result, the size distribution of captured lamprey may be slightly different from the truly representative section samples.

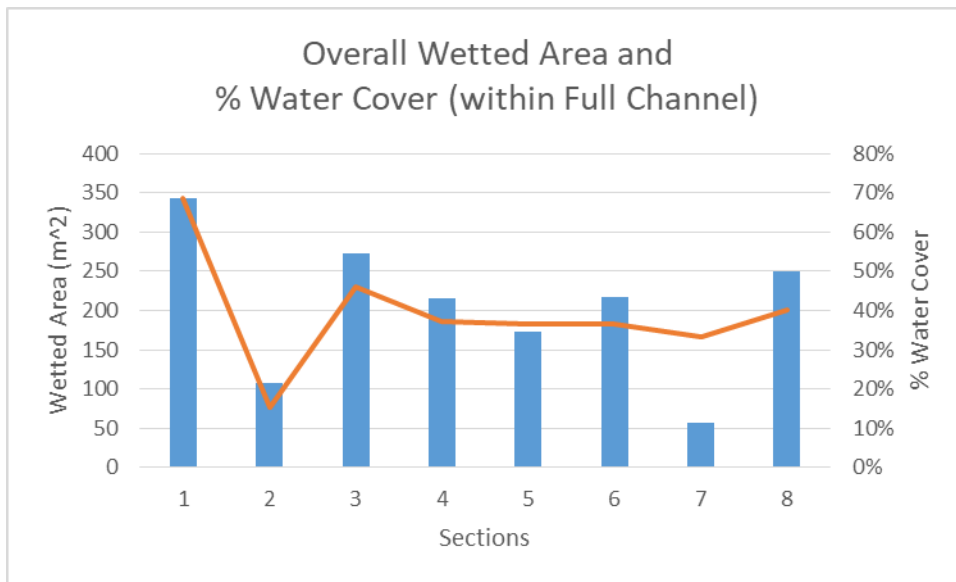
Figure 6. Overall wetted area in comparison with percent water cover within the full channel by sections at Dryden Diversion (Dryden, WA).

The overall wetted area was highest at Section 1 (343 m<sup>2</sup>), followed by Section 3 (273 m<sup>2</sup>) and Section 8 (249 m<sup>2</sup>) (Table 2, Fig. 6). This was influenced heavily by the mean percent water cover (within the full channel water line) during salvage operations; Section 2 contained significantly less water compared to Section 1 as well as other sections (although the high density area of Section 1 at the lower end experienced pronounced dewatering due to deep fine sediment deposits that are in front of the ecology blocks).

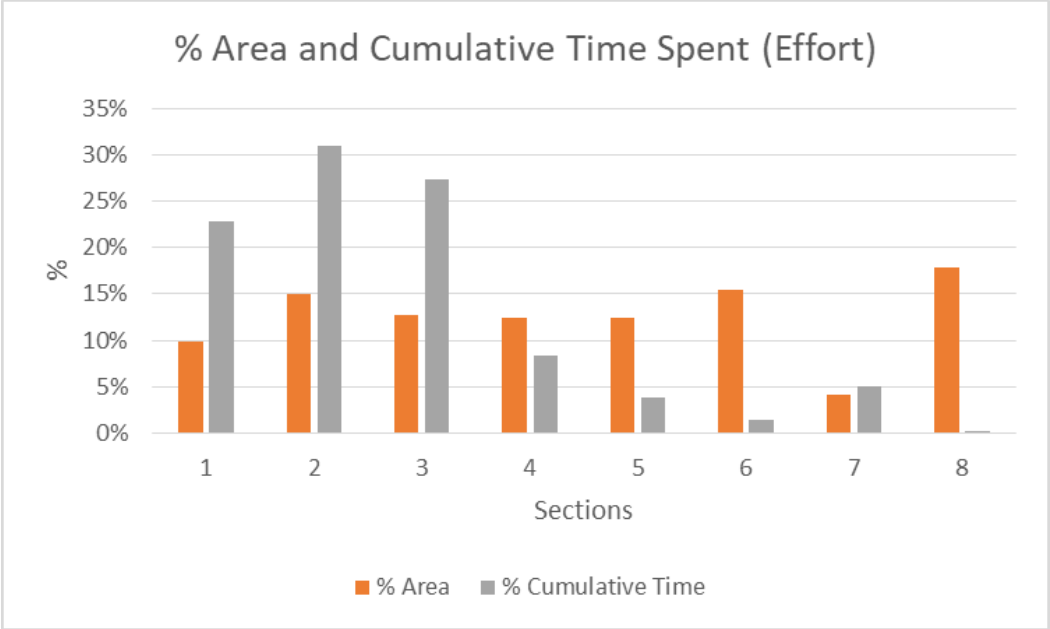
**Figure 7. Percent area and cumulative time spent within each section compared to the overall total area and time, respectively, at Dryden Diversion (Dryden, WA).**

The cumulative time spent in each section by survey teams was highest in Section 2 (18.8 hr; 30.9% of overall effort) followed by Section 3 (16.7 hr; 27.3%) and Section 1 (13.9 hr; 22.9%) (Table 2, Fig 7). This was primarily due to the high number of lamprey observed in these three

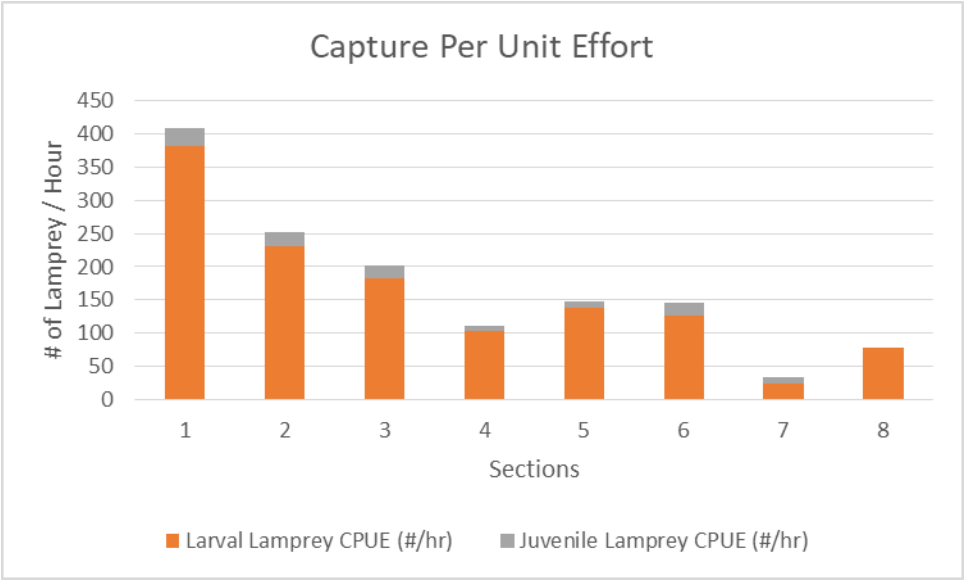
**Figure 8. Capture per unit effort for lamprey salvage by sections at Dryden Diversion (Dryden, WA).**

sections. Very little effort was spent in Section 8 downstream of the fish screens (0.2 hr; 0.3% of overall effort). Percent of electrofishing time in each section was similar to the trend observed for total time spent in each section. The section that had the highest capture per unit effort (CPUE) value was Section 1 (408.9 #/hr), followed by Section 2 (254.3 #/hr) and Section 3 (203.7 #/hr) (Table 1). The lowest CPUE value was observed at Section 7 (32.8 #/hr) (Fig. 8).

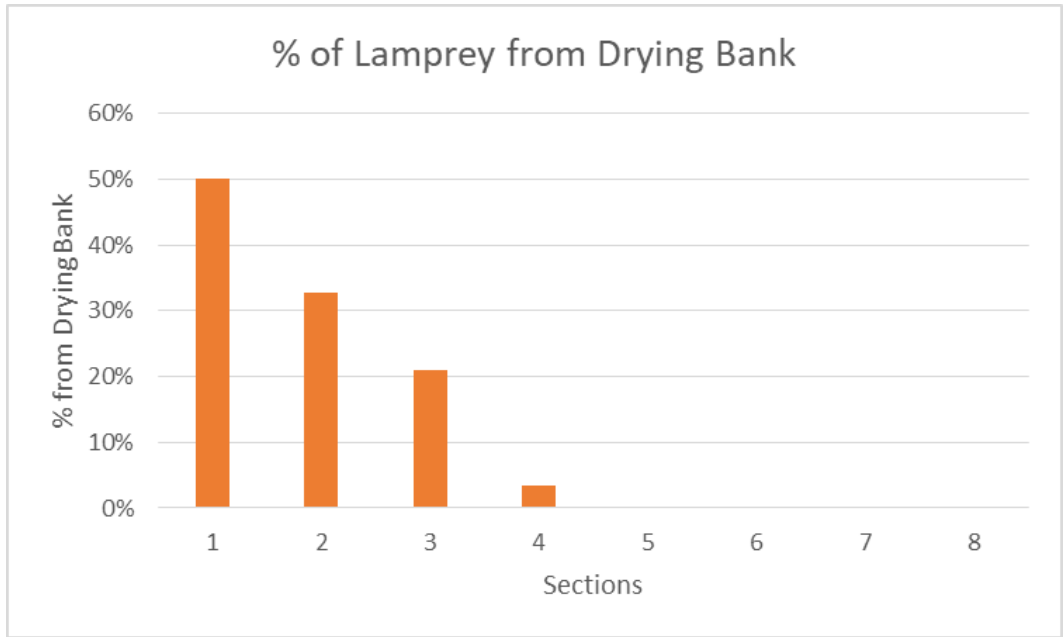
**Figure 9. Percent of lamprey that were captured from the drying banks or fine sediment heaps by sections at Dryden Diversion (Dryden, WA).**

Number of lamprey from drying banks and heaps were difficult to track separately and estimate, but were calculated to be at least 1,690 (11.2%), which is a very conservative estimate based on limited data (Table 3). Percent of lamprey salvaged from drying banks was highest in Section 1 (50.0%) followed by Section 2 (32.9%) and Section 3 (21.0%) (Fig. 9). Although lamprey from drying sediment in the lower sections were present especially as the water level dropped down further, we were not able to tally and record them consistently as they emerged.

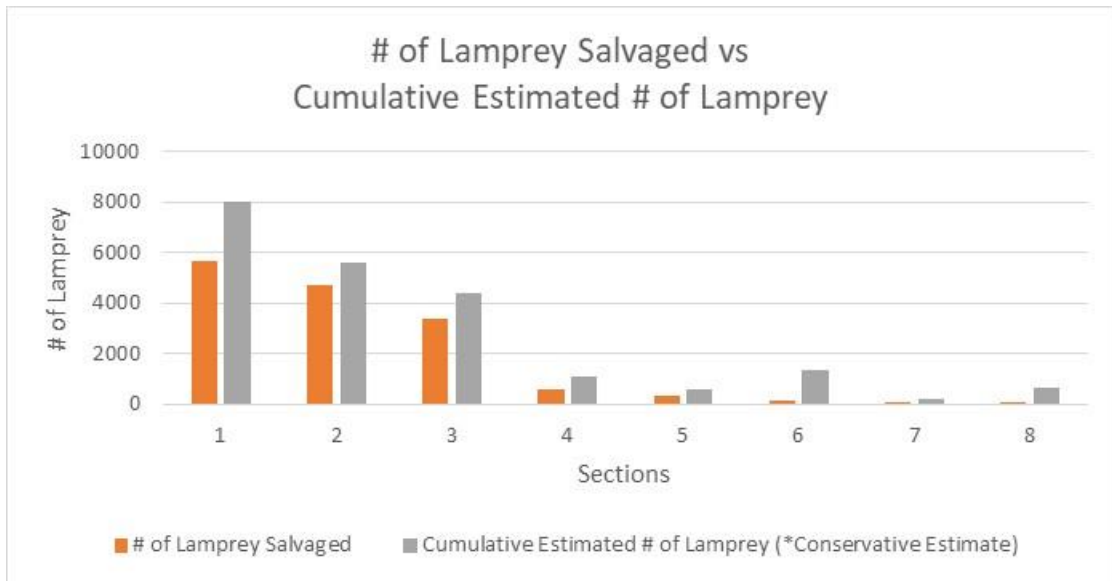
**Figure 10. Number of lamprey salvaged compared to cumulative estimated number of lamprey by sections at Dryden Diversion (Dryden, WA).**

Finally, number of lamprey present in each of the section was estimated by using the density and wetted area (Table 3). The simple estimate (“Section Estimate #” in Table 3) was 15,111 lamprey. When the removed lamprey numbers from salvage (from prior multipass sampling that were conducted within the same day within the same area of the same section) were combined to this estimate, the total number was 15,897 (“Section Estimate # + Daily Salvage #” in Table 3, “Cumulative Estimated # of Lamprey” in Fig. 10). When all removed lamprey numbers from prior salvage days were added to the new estimate, the total number was 21,936 (“Section Estimate # + All Salvage #” in Table 3). However, this estimate is likely a conservative estimate because it assumes that the electrofishing efficiency is 100%. In reality, the effectiveness of the electrofishing method can vary considerably, especially in high density conditions, and have been described as ~50% for larval density (Harvey and Cowx 2003; Steeves et al. 2003; Lasne et al. 2010; Beals and Lampman 2015). As a result, these estimates, though comprehensive, are still most likely a conservative estimate.

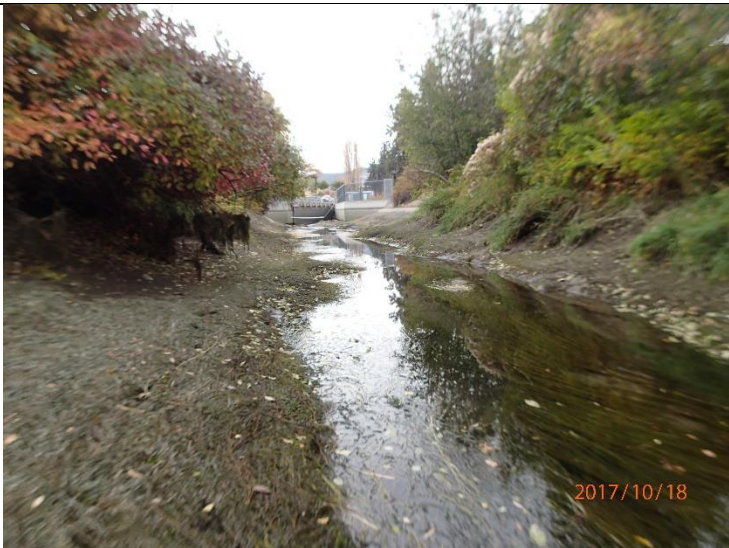
**Section 6, looking  
downstream  
(October 18, 2017)**

**Aquatic vegetation  
forming a thick mat,  
making the spotting  
of lamprey difficult  
both in water and on  
bank.**

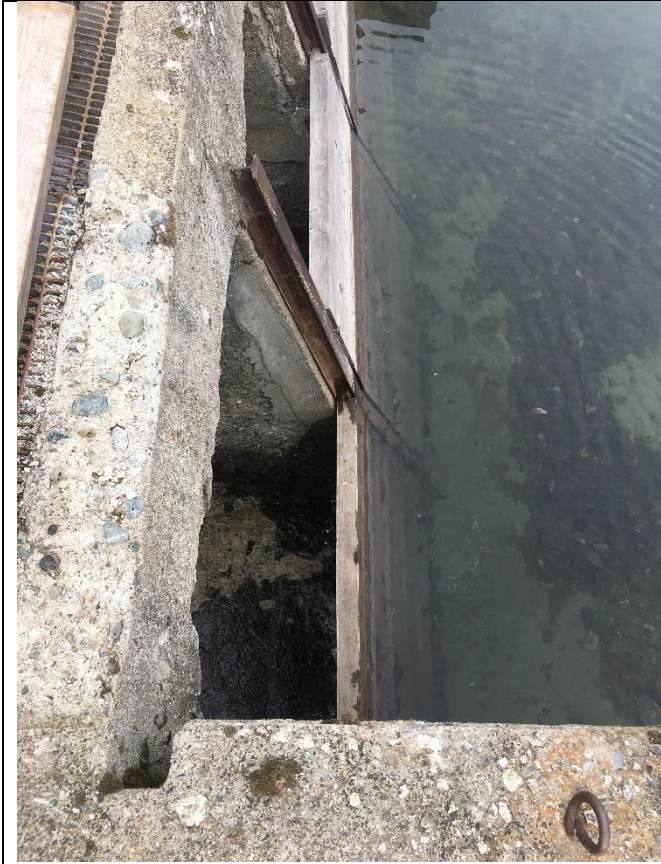
**Section 1, near the downstream end where the bypass gate is located (large amount of fine sediment building in front of the gate). (March 2, 2017)**

as they are helpful and compatible with canal operations, should continue in future years. Other potential measures to consider include 1) placement of a sprinkler system to allow drying banks to stay moist and allow desiccated lamprey to move back to wetted areas, 2) open the upper bypass gate prior to or during dewatering to allow more fine sediment deposits, and hence lamprey, to return to the river.

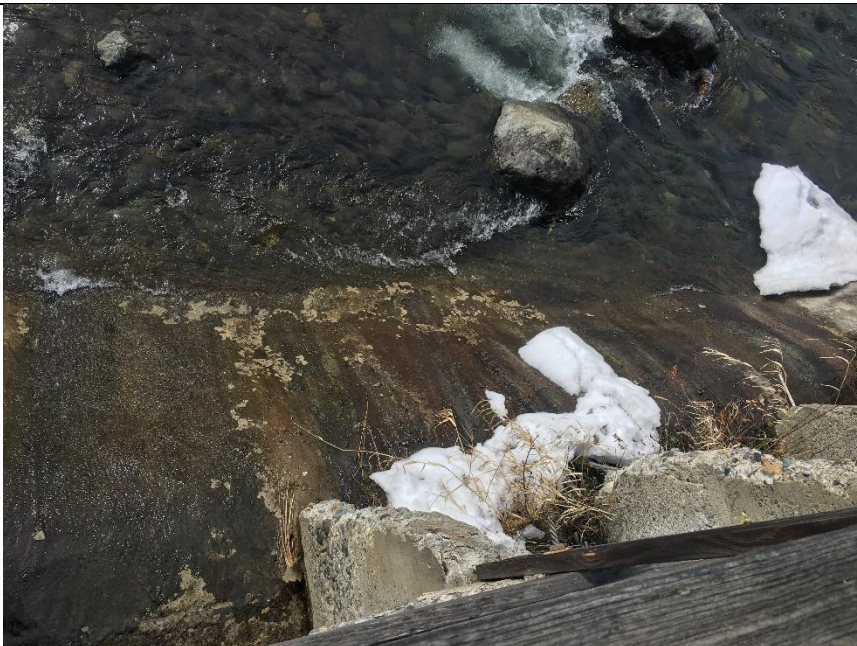
**Section 1, upper bypass gate outlet on the Wenatchee River. (March 2, 2017)**

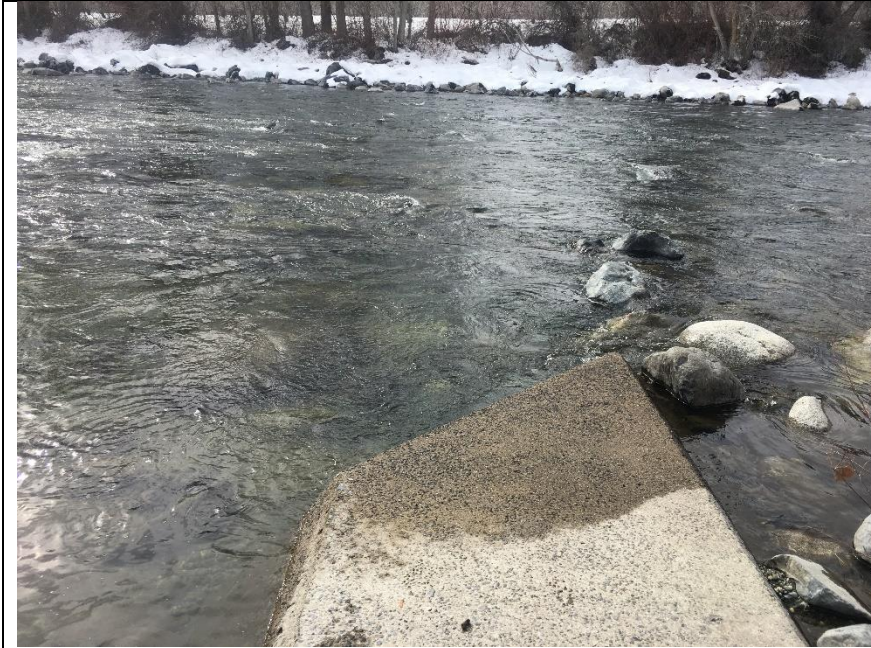
**Section 7, lower  
bypass channel outlet  
into Wenatchee River  
(some questions  
remain as to whether  
adult lamprey may be  
attracted to this outlet  
flow)  
(March 2, 2017)**
