UPPER YAKIMA BULL TROUT HABITAT RESTORATION PROJECTS

Gold Creek | Kachess River | Box Canyon

Mitch Long and Melissa Speeg
Kittitas Conservation Trust

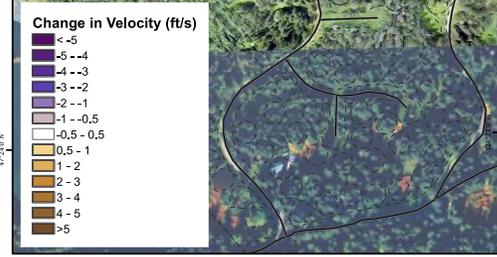
Gold Creek Instream Restoration
Change in Velocity (EC vs PC) - Q100 (3000cfs)
 Hydraulic results calculated using RiverFlow 2D
 Aerial Imagery: 2016 Aerial Photography (Kittitas Conservation Trust) and 2015 NAIIP imagery (USDA)

Updated Proposed Conditions hydraulic model results

- Incorporating design changes
- Minimizing flood risk to private property

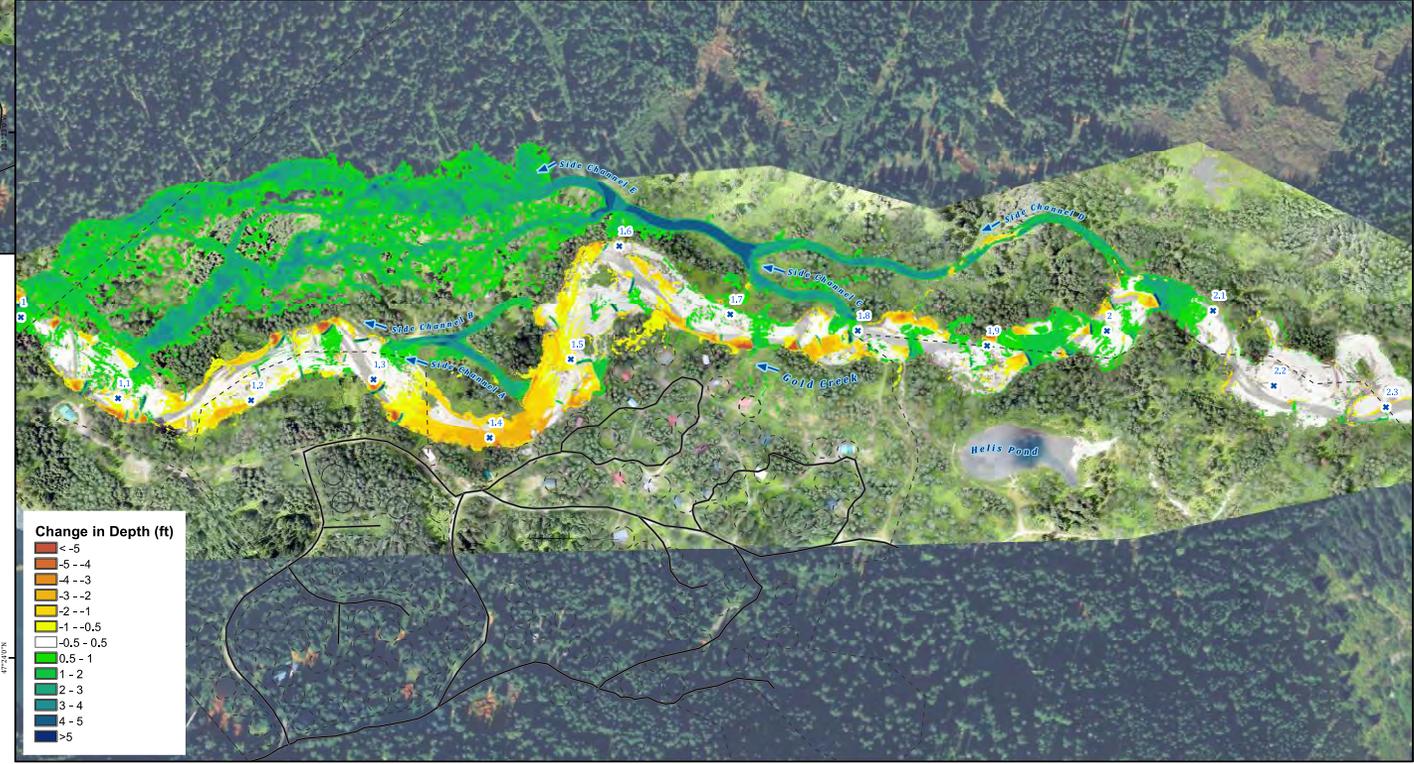
Gold Creek Instream Restoration
Change in Depth (EC vs PC) - Q100 (3000cfs)
 Hydraulic results calculated using RiverFlow 2D
 Aerial Imagery: 2016 Aerial Photography (Kittitas Conservation Trust) and 2015 NAIIP imagery (USDA)

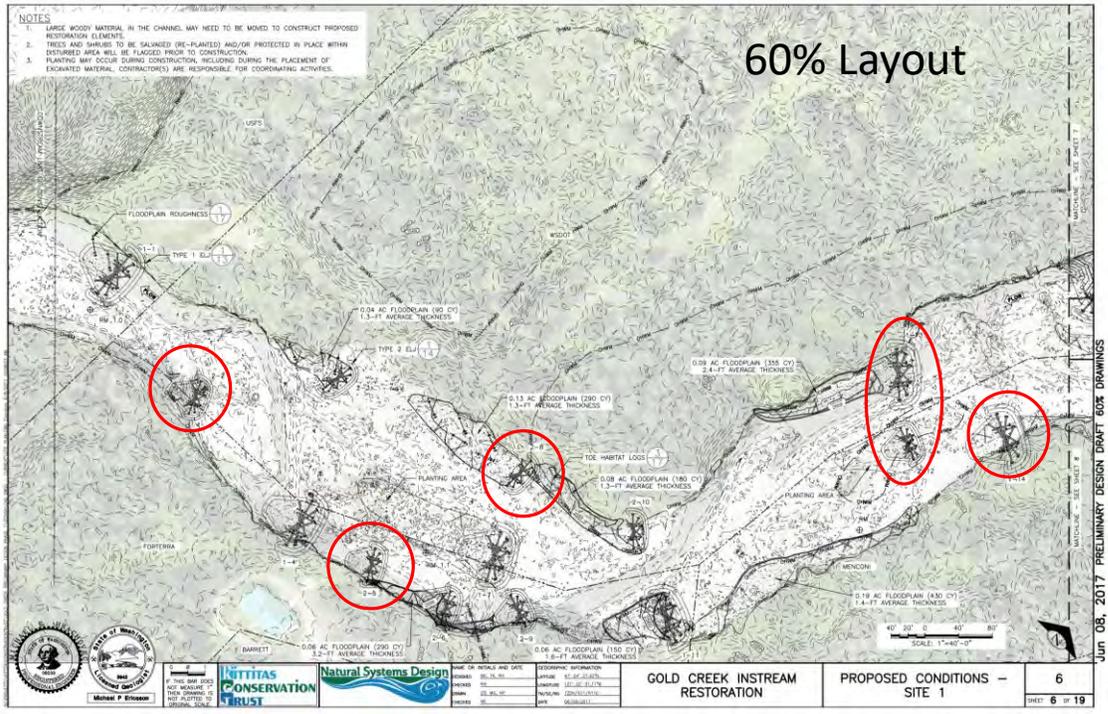
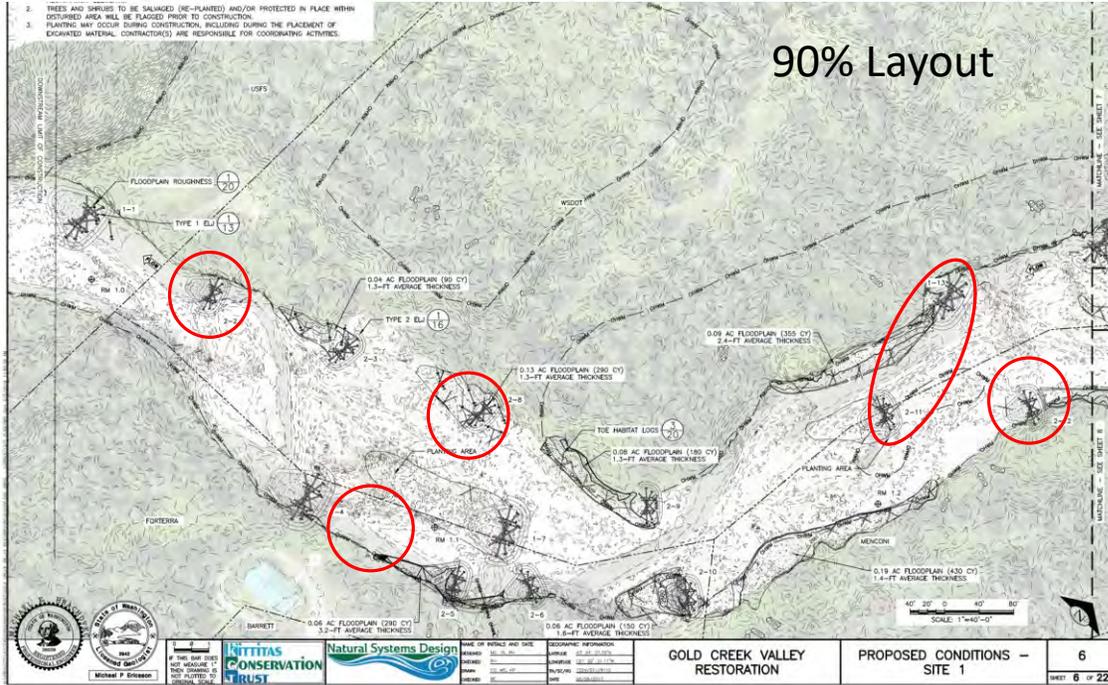
Updated locations and types of proposed instream structures

- to reflect the current condition of the channel
- Limit constricting the channel below 60-ft to reduce likelihood of channel spanning logjams from forming
- Minor adjustments at side channel inlet locations, including additional upstream structure to limit widening potential

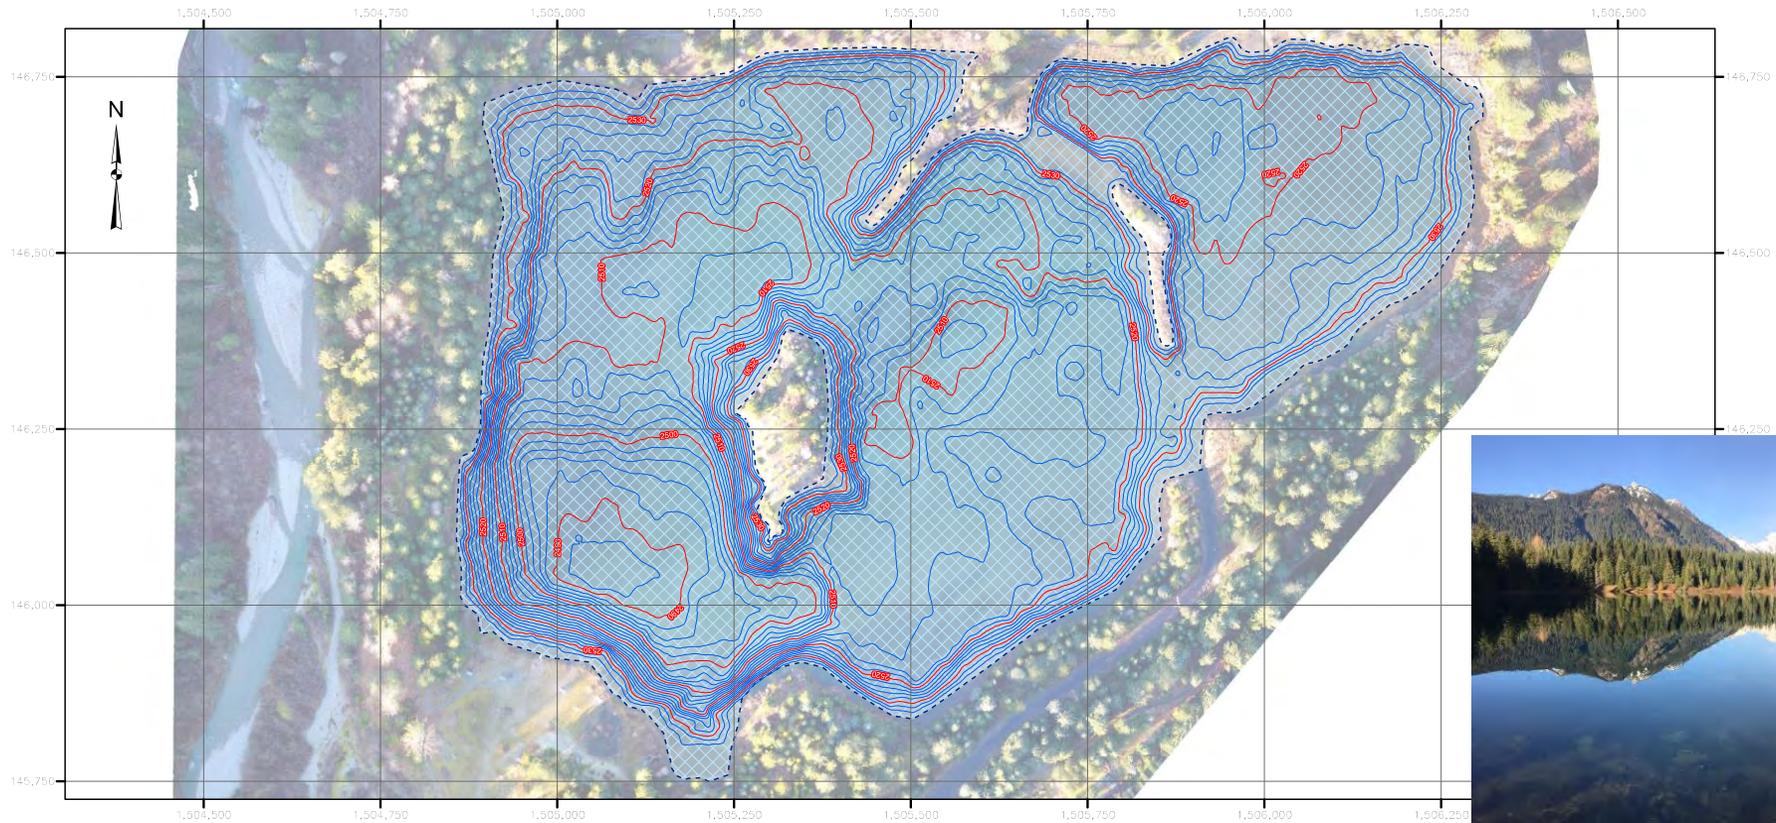
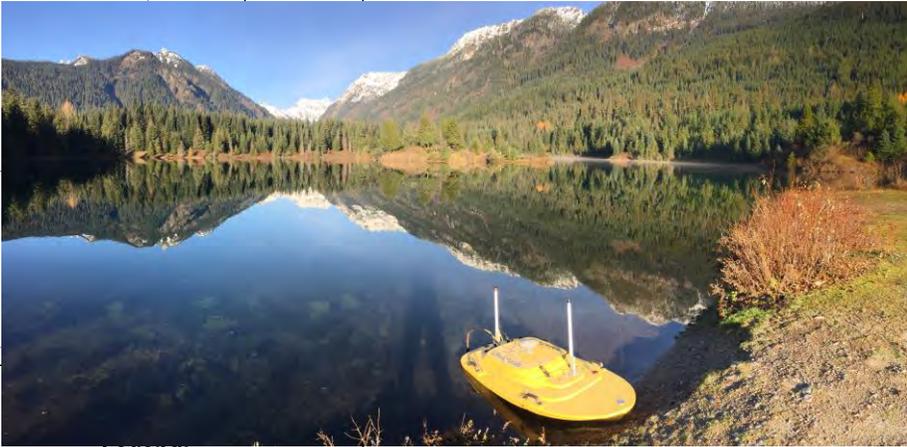
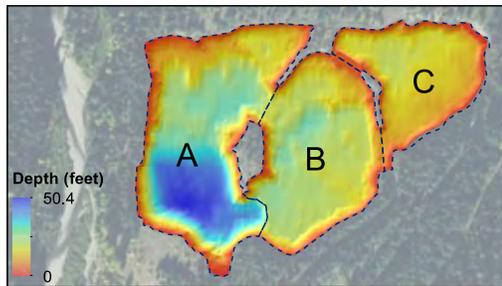
Project		Gold Creek Valley Design	
		Gold Creek Pond Bathymetry	
Location	Kittitas County, WA	Figure No.	01A - DRAFT
Acquisition Date	Nov. 08, 2018

Bathymetric Surface Model:

Pond Level (ft)	Area (Acres)	Storage Volume (yd ³)	Max Depth (ft)
Total Pond Area	2,536.76	22.5	700,144	50.4
Basin A		10.1	383,535 (55%)	50.4
Basin B		7.4	218,272 (31%)	30.3
Basin C		5	99,337 (14%)	21.2

This Digital Surface Model (DSM) was created from interpolated single-beam echosounder data. See accompanying report for additional detail.
Storage Volume was calculated as the displacement between the model surface below and the pond level using ArcGIS 3D Analyst.

Bathymetry data collection at Gold Creek Pond

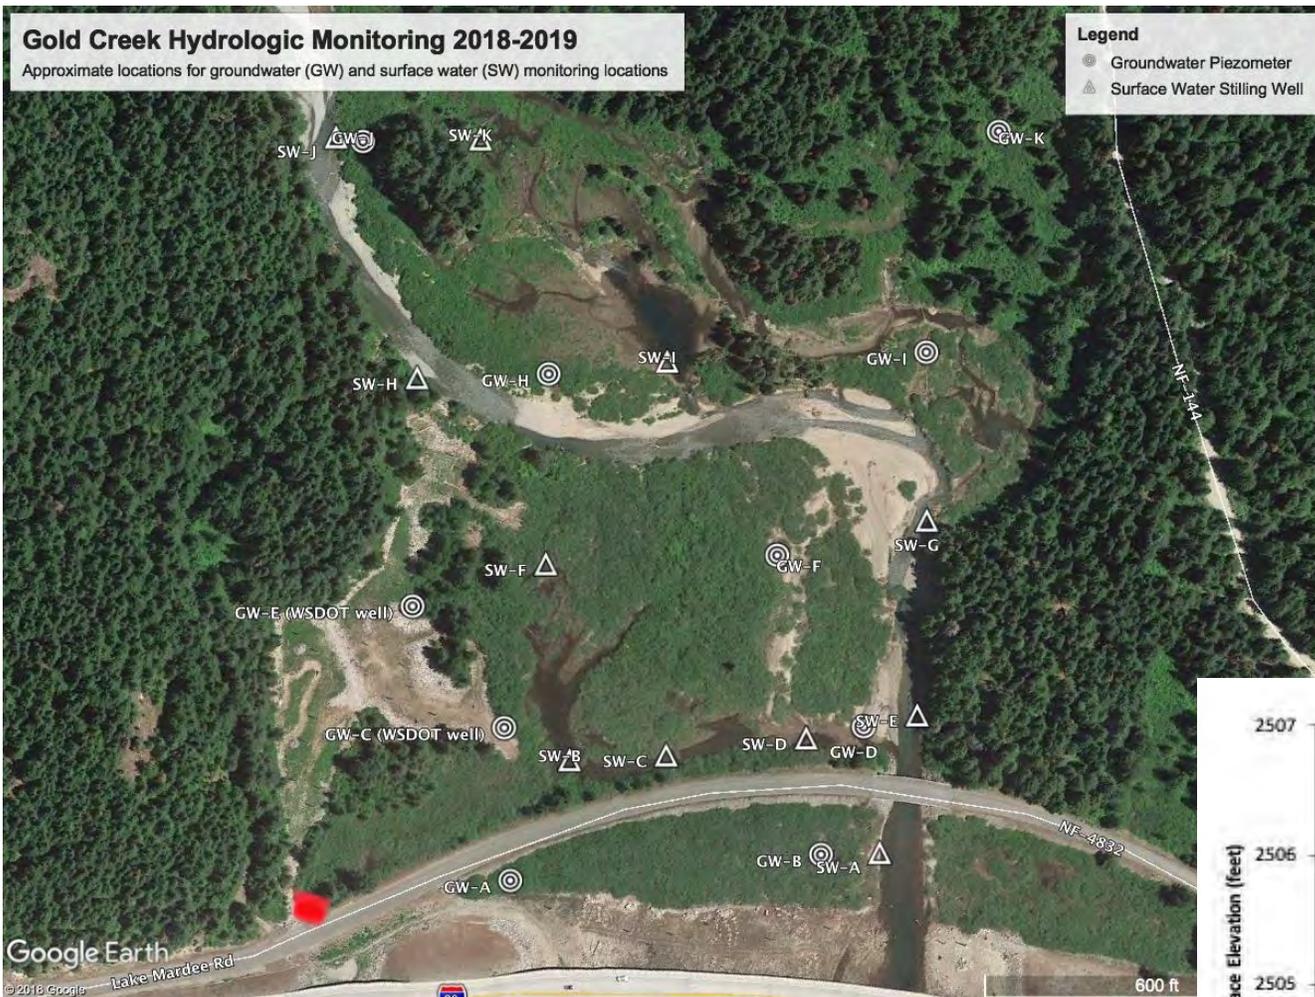
Gold Creek Frontage Road Hydrologic Monitoring

- Installed groundwater and surface water monitoring network
 - 7 groundwater wells (10-ft deep)
 - 2 additional WSDOT wells
 - 11 surface water gages
 - Collecting data from Fall 2018 - Fall 2019

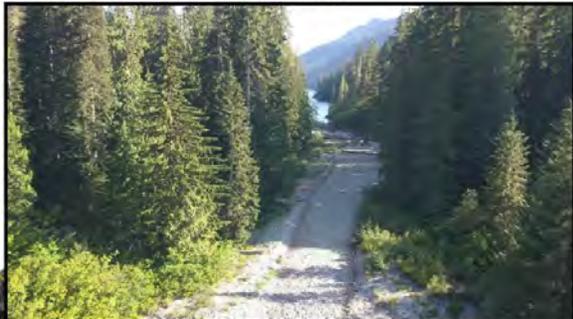
REACH 2
THIS IS AN AGGRADING REACH WITH A BROAD, OVER-WIDENED, PLANE-BED CHANNEL IN WHICH FLOW RUNS SUB-SURFACE IN THE SUMMER.

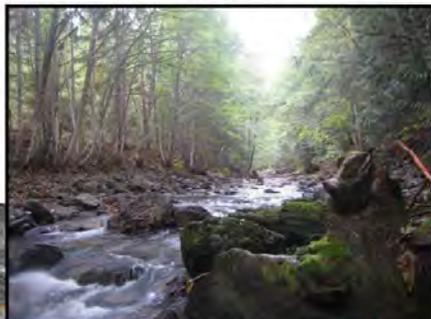
REACH 4
THIS REACH IS STEEPER AND PARTIALLY CONFINED TO CONFINED. THE UPSTREAM END IS CONFINED BY DISCONTINUOUS LEVES. FLOW IN THIS REACH IS PERENNIAL.

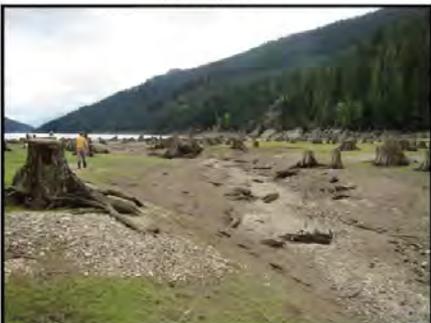
REACH 1
THE KACHESS RIVER DELTA IS EFFECTED BY SEASONAL LAKE LEVELS. VEGETATION IS LIMITED TO LARGE STUMPS LEFT BEHIND WHEN THE AREA WAS LOGGED. SECTIONS OF THE LOW FLOW CHANNEL SEASONALLY RUN DRY.

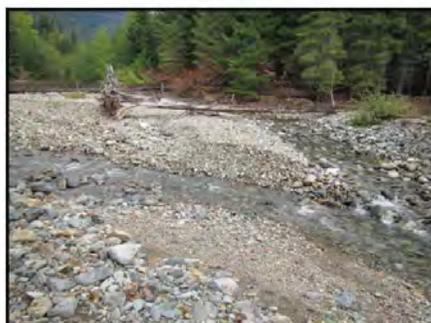
REACH 3
THIS REACH CONTAINS DISCONNECTED SCOUR POOLS FORMED BY KEY PIECES OF LARGE WOOD. THIS REACH IS OVER-WIDENED AND LACKS HABITAT DIVERSITY. MID-CHANNEL BARS ARE PRESENT, BUT VEGETATED ISLANDS HAVE FAILED TO ESTABLISH.

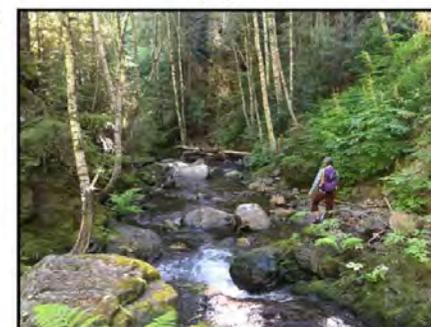
REACH 5
THIS IS A CONFINED REACH WITH INCREASED GRADIENT AND INCREASED HABITAT COMPLEXITY. FLOWS ARE PERENNIAL AND THE UPSTREAM END IS DEFINED BY A BARRIER FALLS.

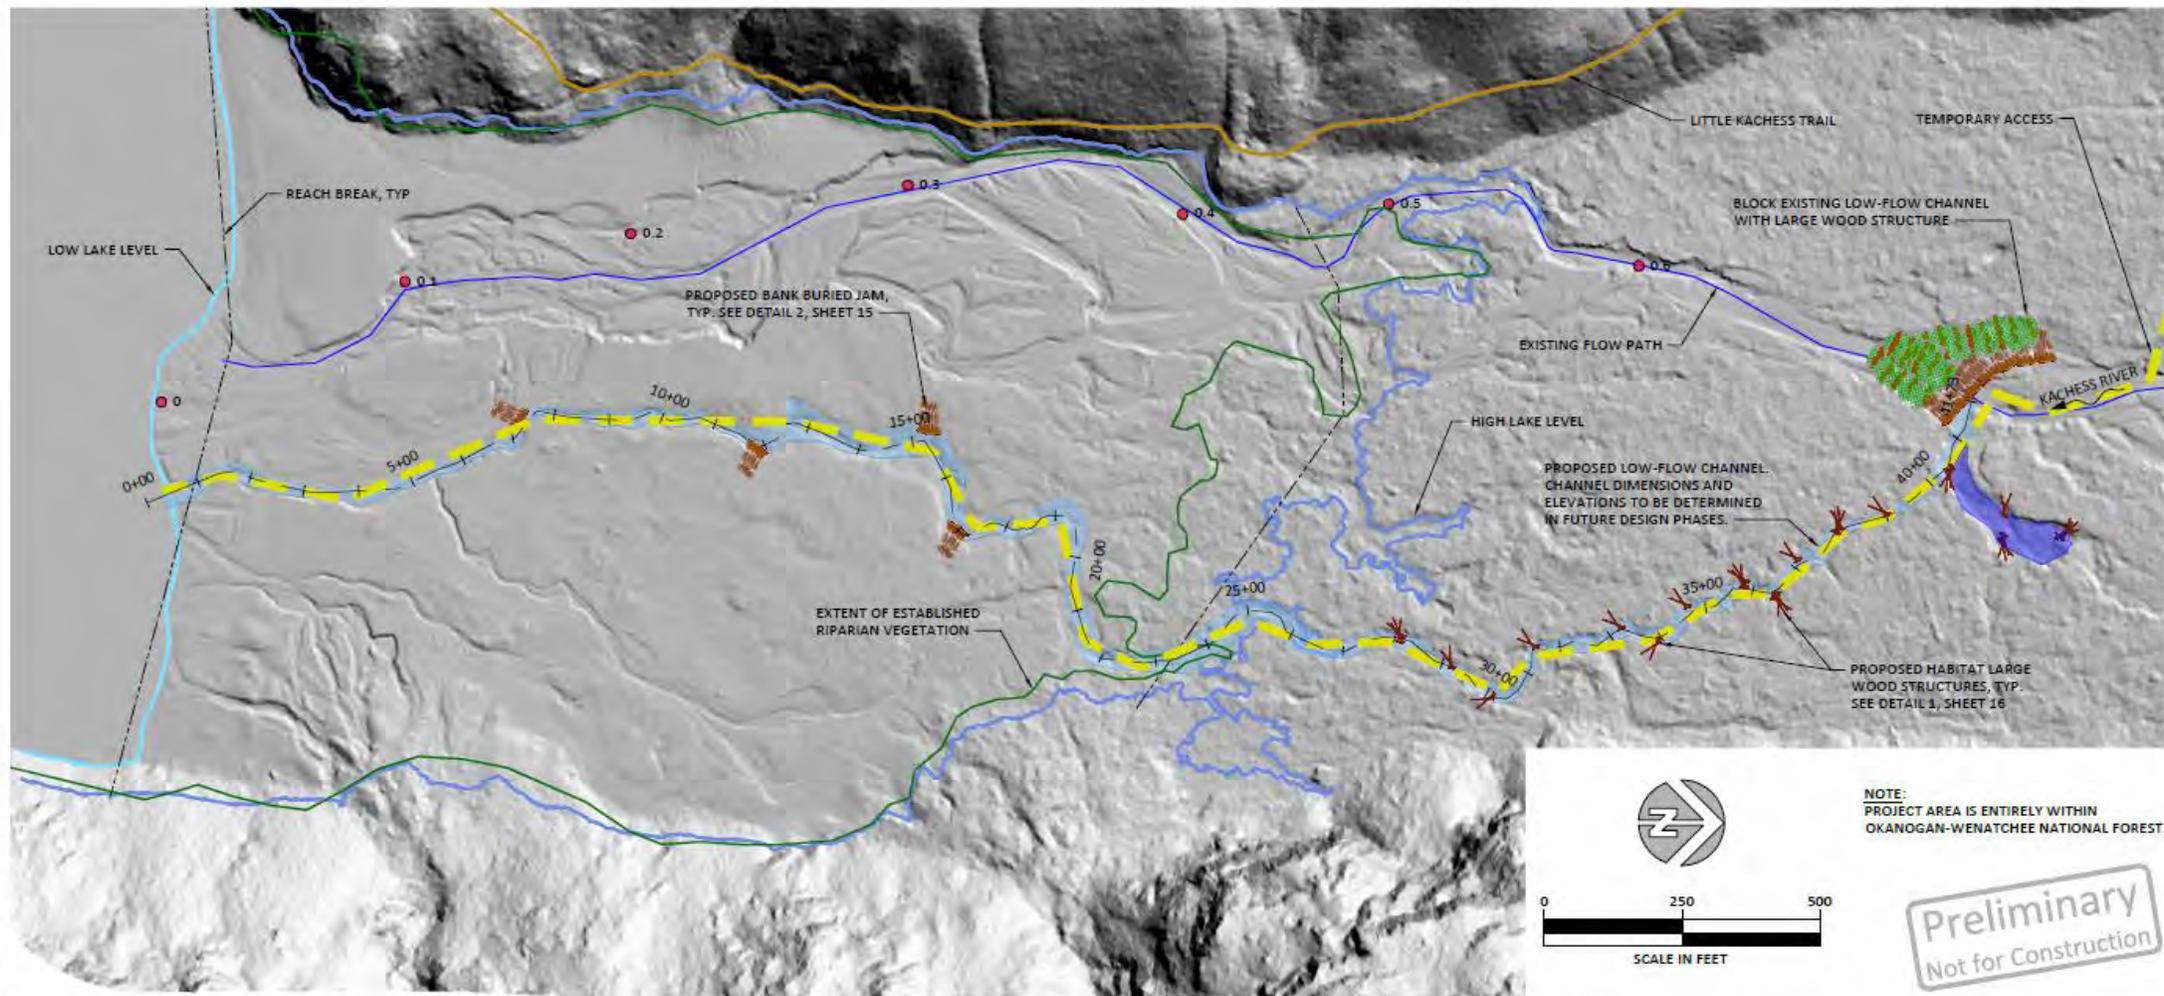
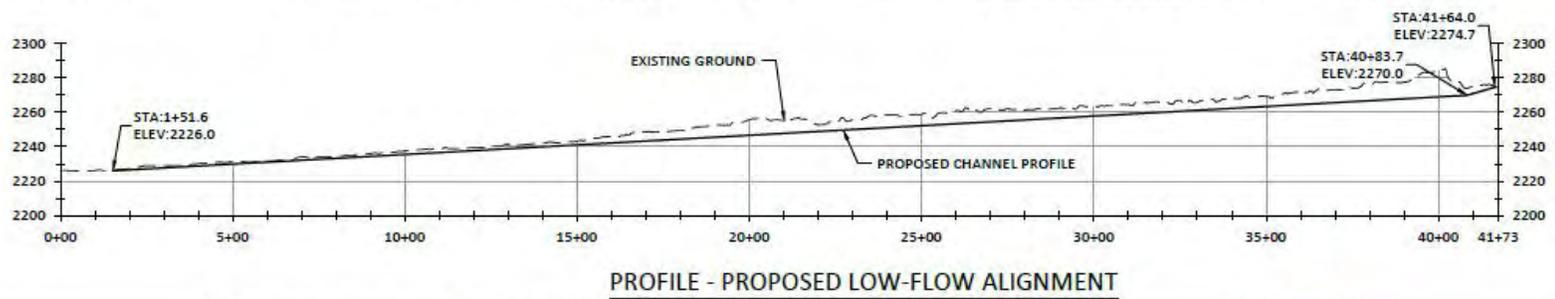
PROPOSED CONDITIONS -
REACH 1 & 2, ALTERNATIVE 2

PROFILE - PROPOSED LOW-FLOW ALIGNMENT

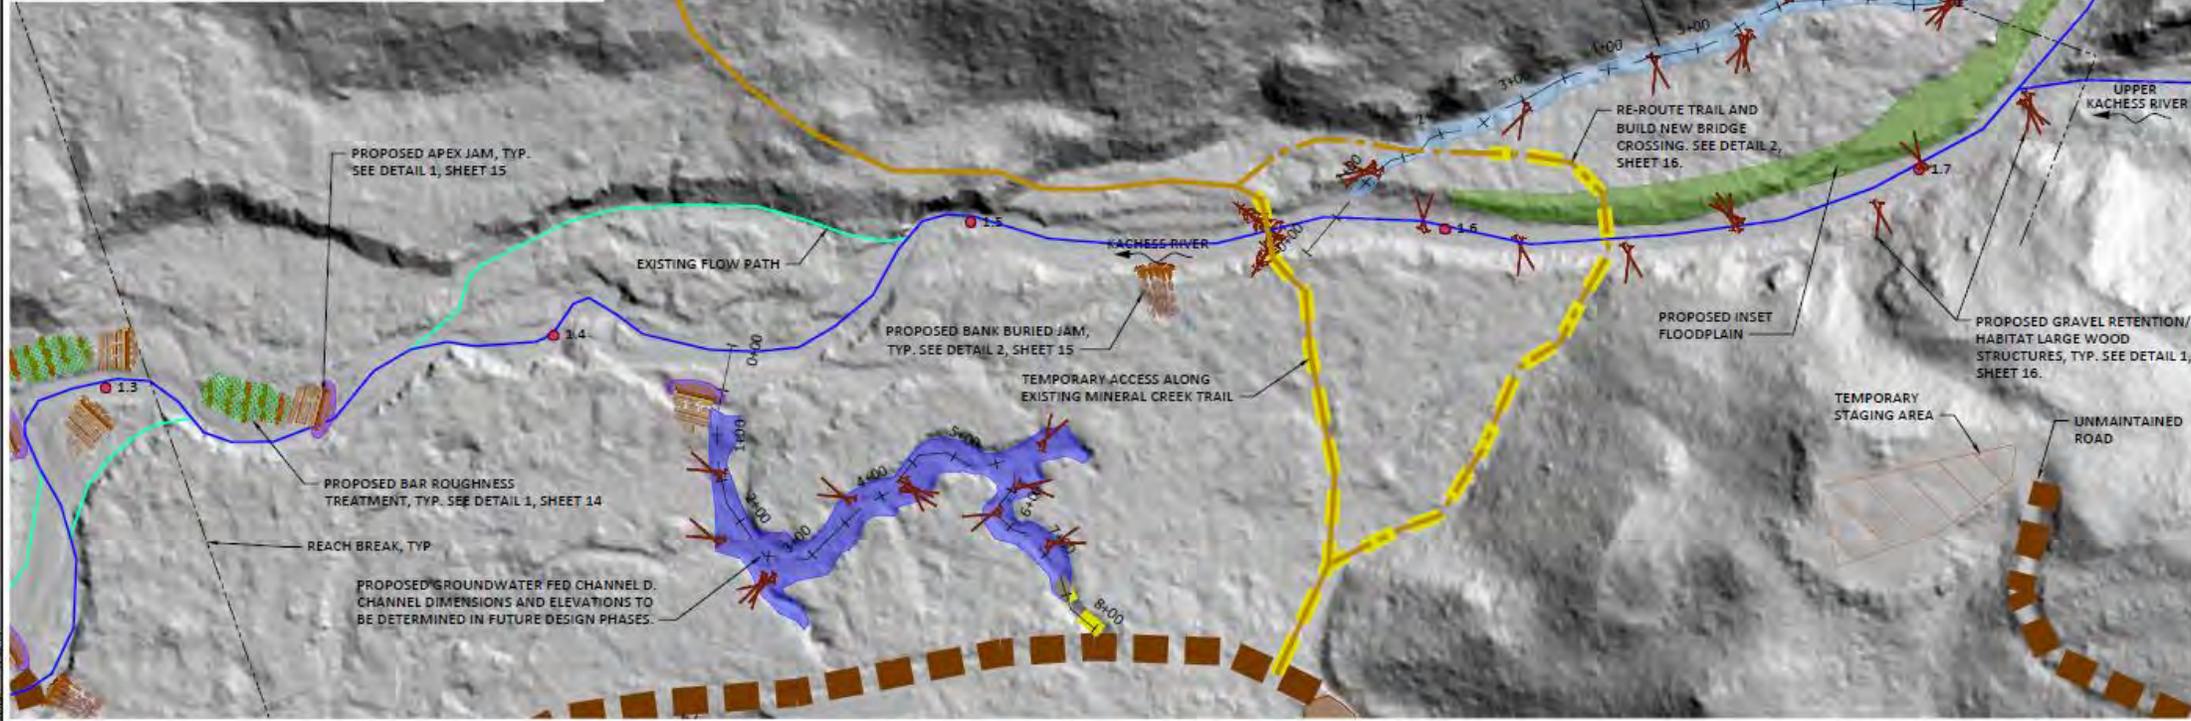
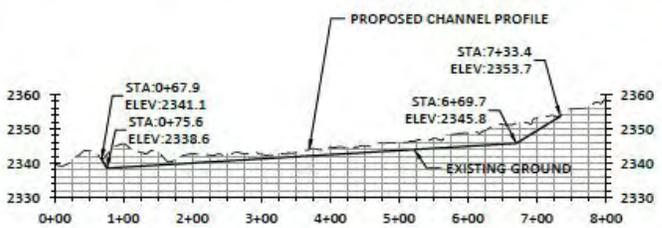
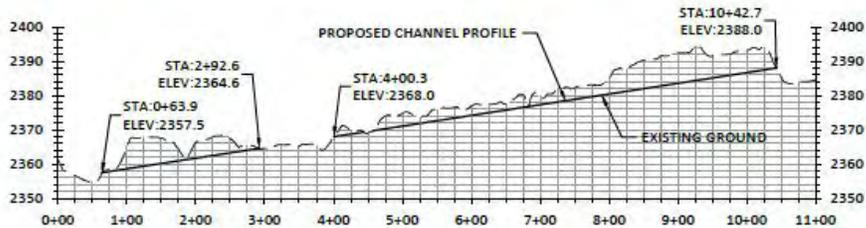
PROPOSED CONDITIONS -
REACH 4

PROFILE - GROUNDWATER CHANNEL D

PROFILE - HIGH-FLOW CHANNEL

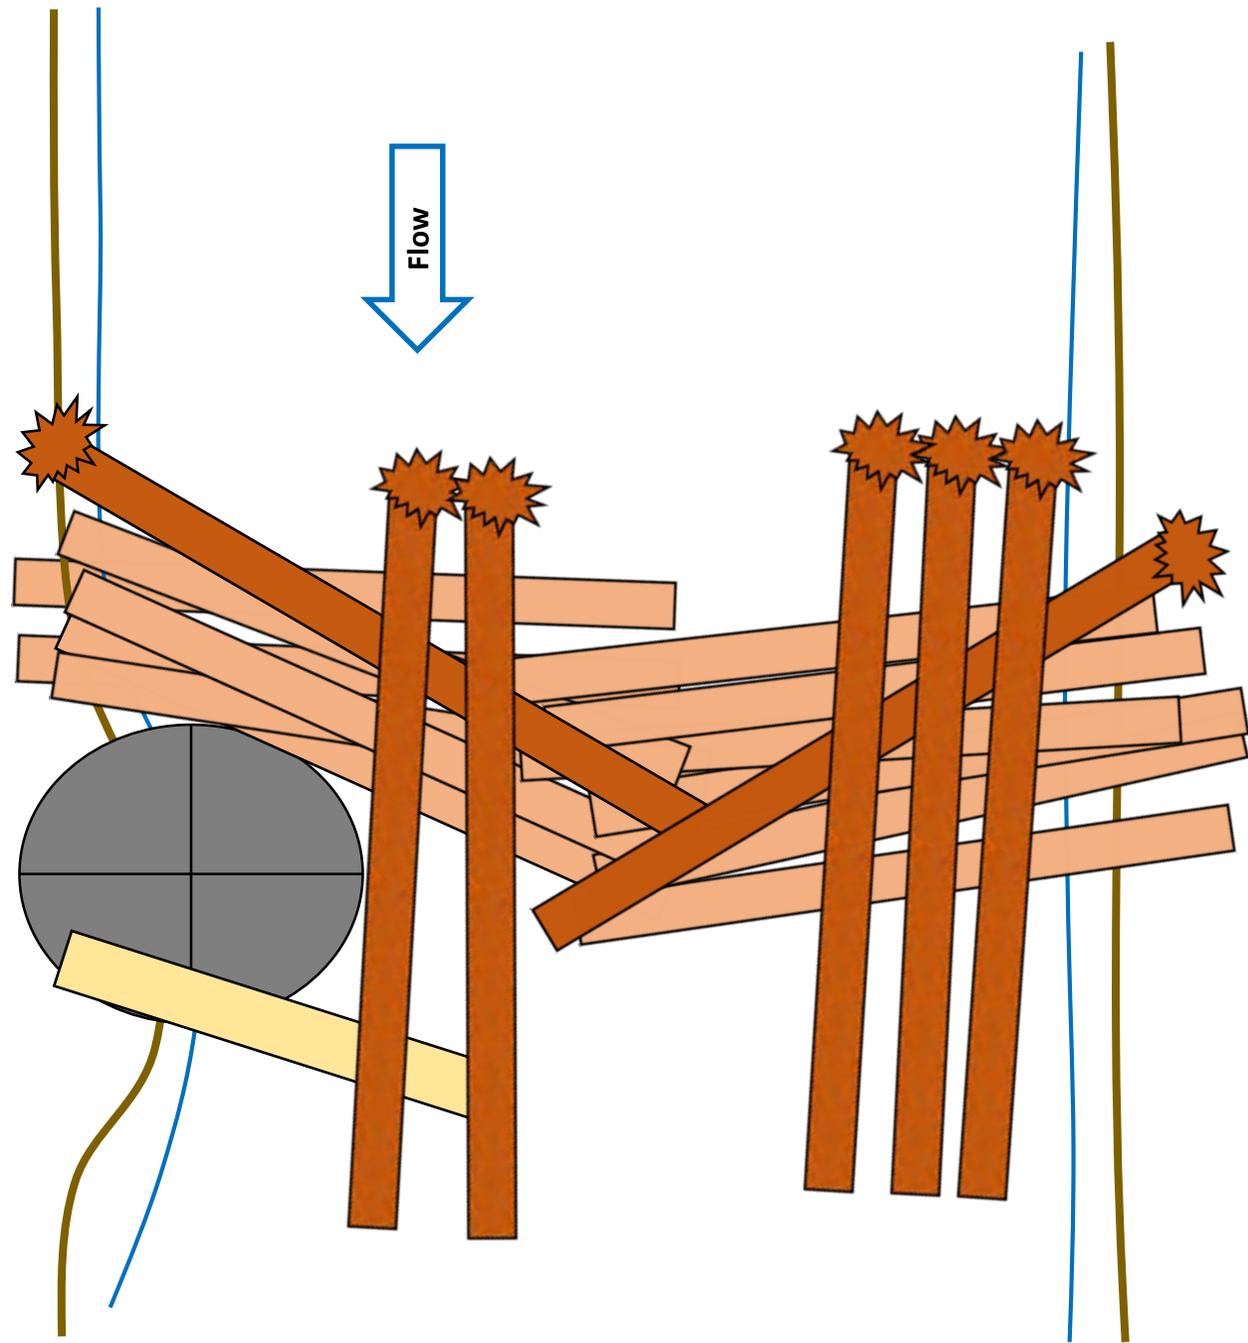
LWH Installation

Location 19

Cut logs = 12

Logs with rootwads = 7
