Ground Water Effects of Toppenish Creek Restoration

Tom Elliott

Yakama Nation Wildlife

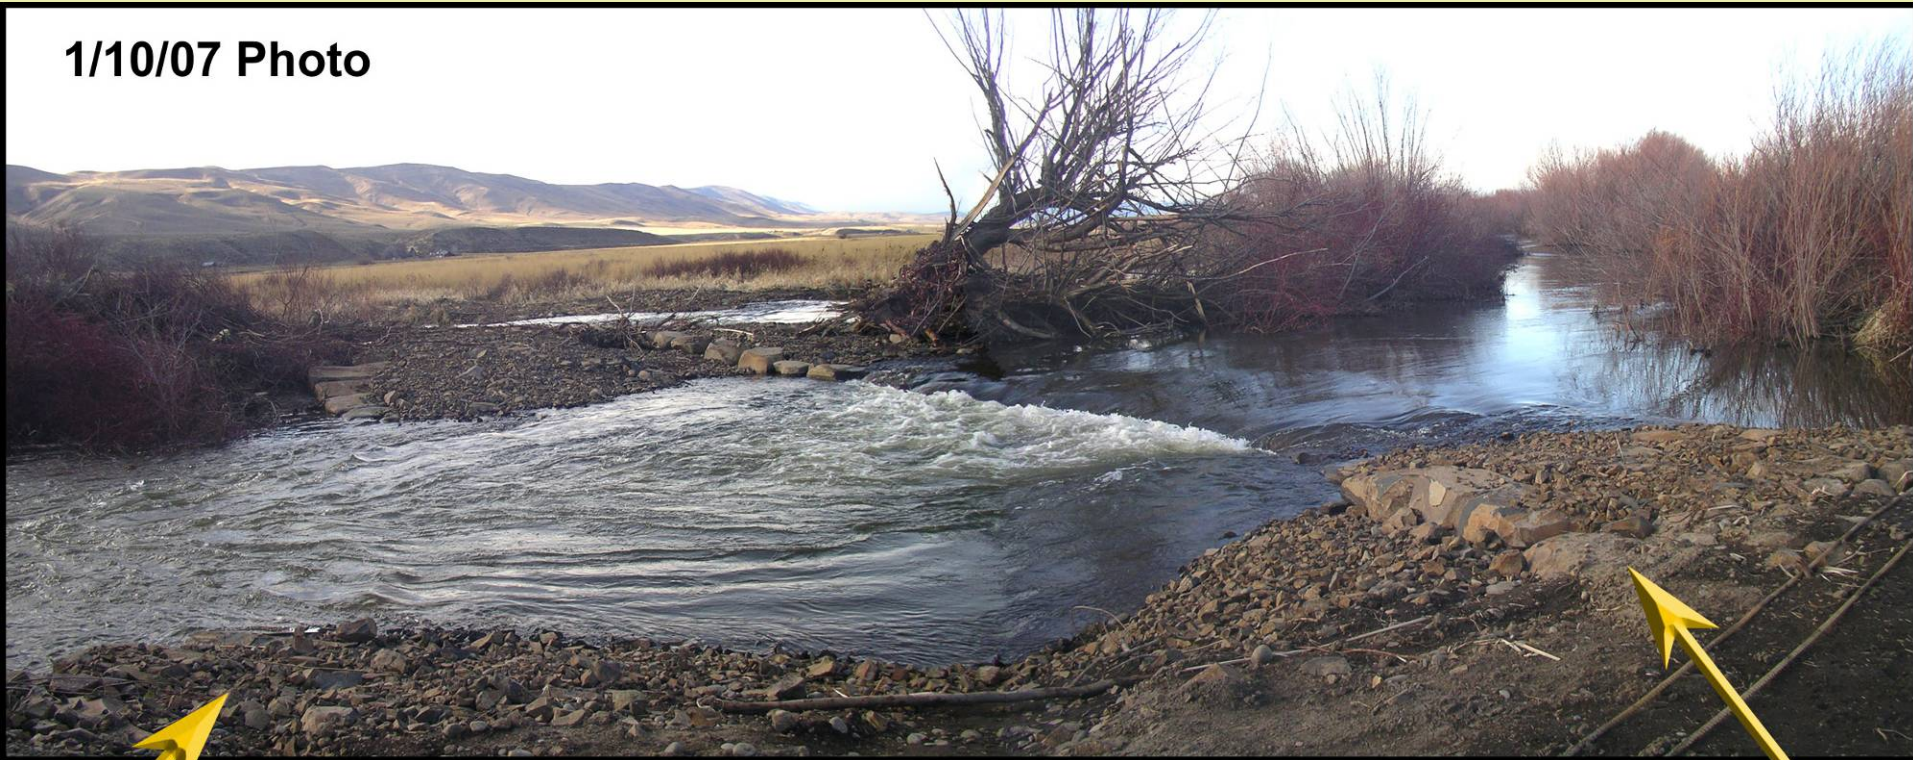
1/10/07 Photo

Floodplain Restoration Using Grade Control

- Reconnect previously active channels and floodplain
- Spread flood waters
- Raise water table for riparian habitat improvement

Lower Rock Drop

Upper Rock Drop

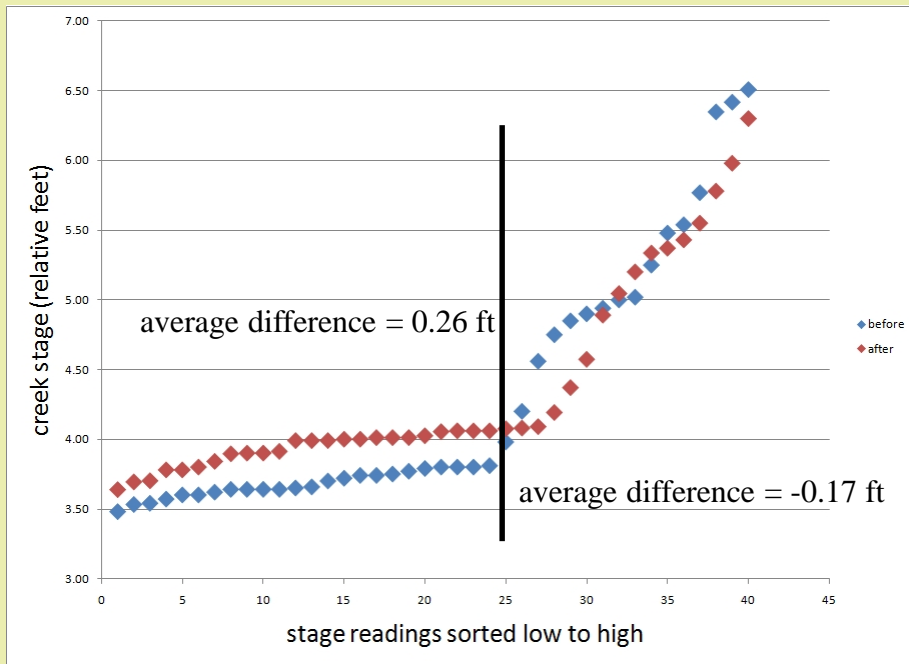
Toppenish Creek at Unit 2

Water levels before and after

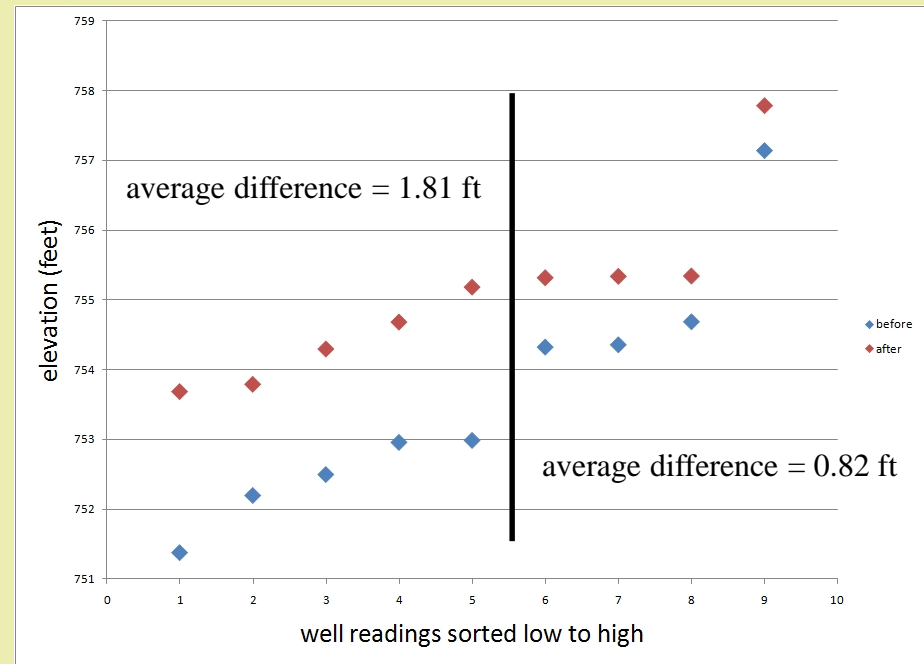
Average water levels in selected wells

$$1.81 \text{ ft} - 0.26 \text{ ft} = 1.5 \text{ ft}$$

- Grade control structures appear to have raised water table relative to upstream flow by at least 1 foot at low flow
- Project effects vary by well location
- The biological significance is likely to be positive
- Better data collection is necessary for future monitoring efforts
