# Middle Twisp River Reach Assessment & Restoration Strategy

SUBMITTED TO  
Yakama Nation Fisheries Program

FEBRUARY 2015

PREPARED BY  
Inter-Fluve, Inc.  
501 Portway Ave, Suite 101  
Hood River, OR 97031  
(541) 386-9003

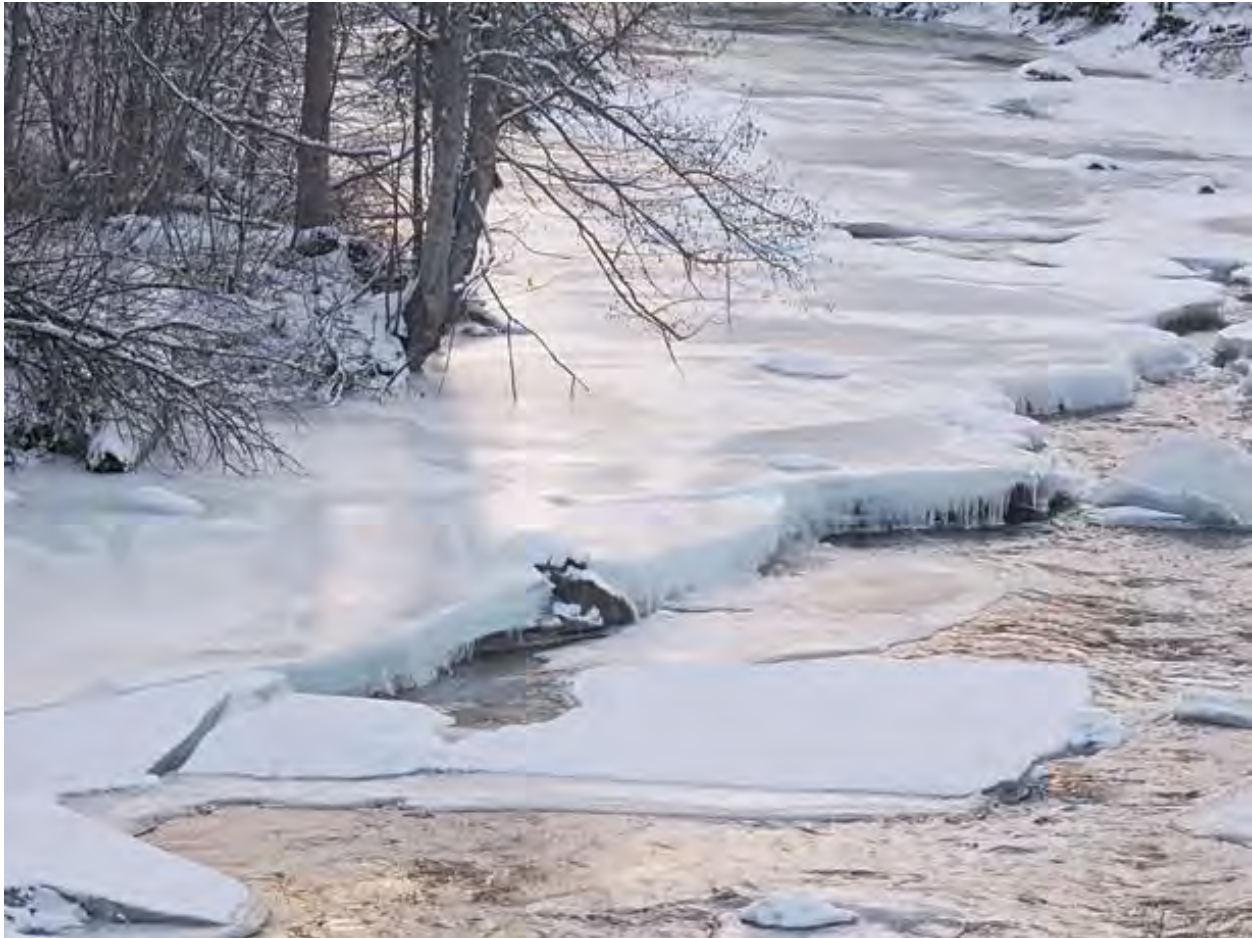
*Figure 12. Photo of surface ice on lower Twisp River (Stamper 2013).*

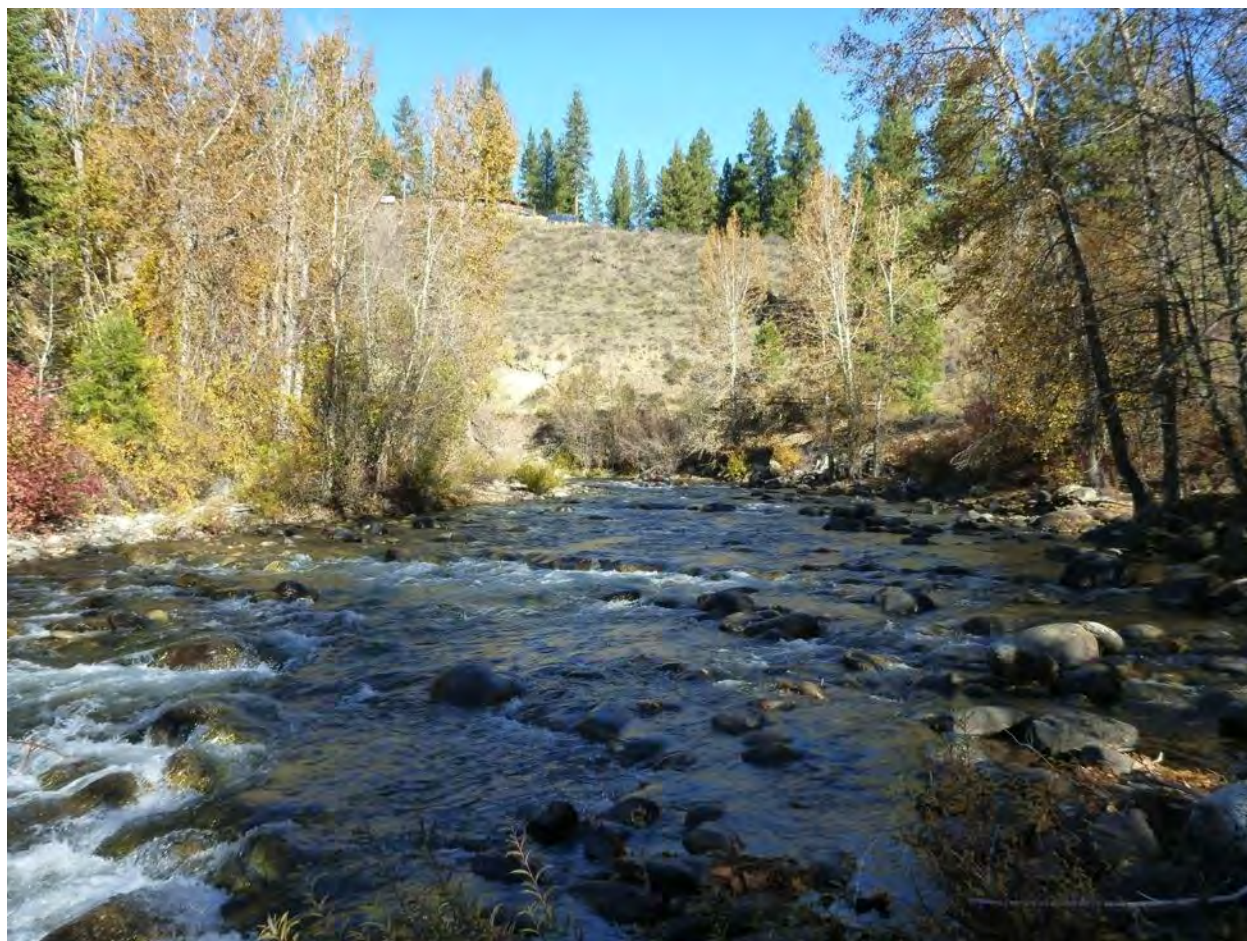
**Figure 14.** A representative section of Reach 1 at RM 8.

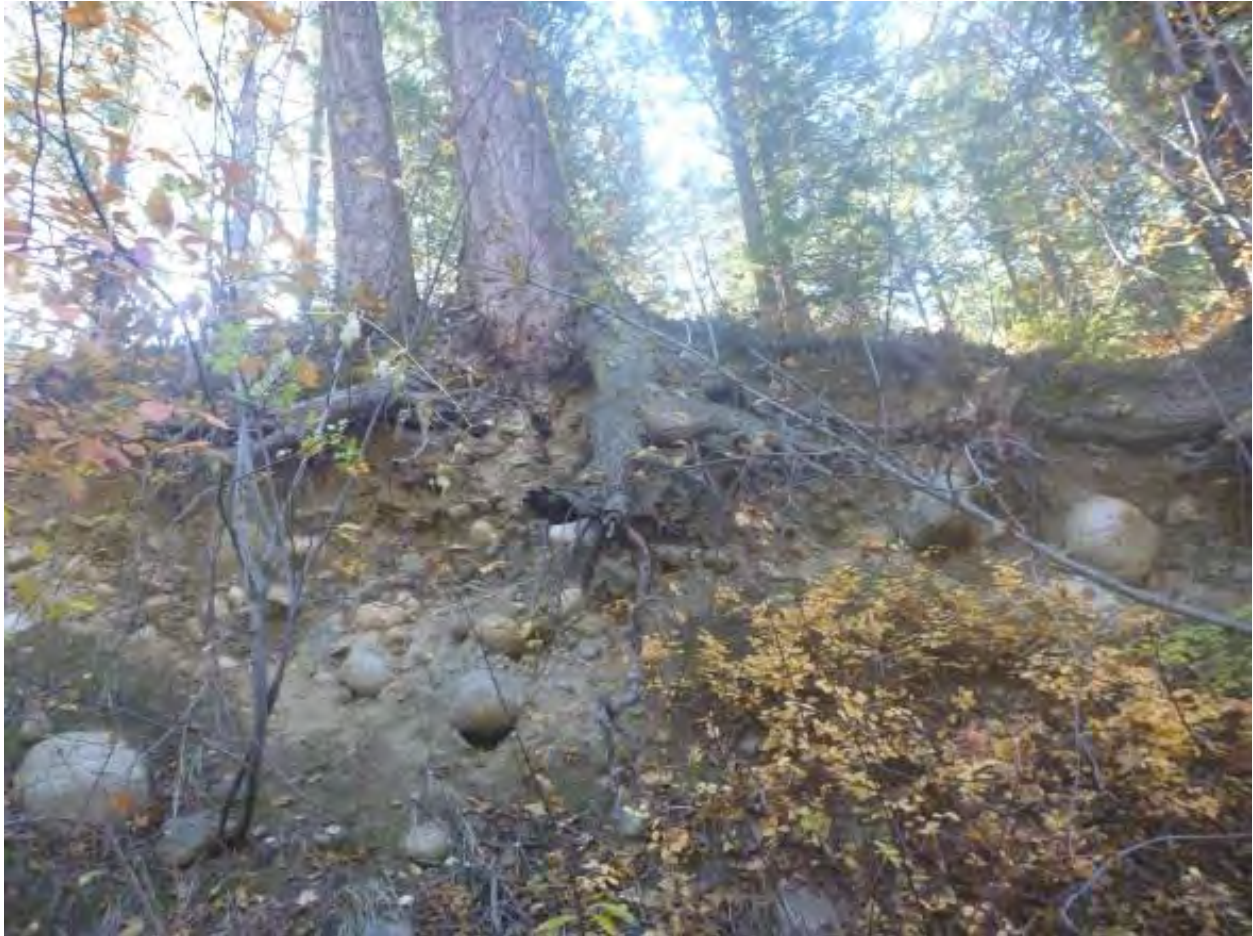
*Figure 20 Potential for large wood recruitment along river-right terrace at RM 8.5. There are several mature conifers with exposed root masses on the edge of the terrace.*

The upstream portion of Reach 1 has a high density of riparian vegetation along the south side of the channel with significant reduction of vegetation along the north side of the channel and the downstream portion of the south side of the channel. The majority of the riparian clearing was prevalent on the south side of the river for the first half of the reach, and on the north side of the river for the second half of the reach. Based on the habitat survey, Reach 1 had a variable riparian corridor with a majority of the reach composed of grassland/ forbes (75%) and small trees (25%). Species composition was variable with most of the understory identified as hawthorne, dogwood, and willow; the overstory was largely composed of cottonwood, Douglas fir, and ponderosa pine. The first return LiDAR image indicates that in areas where clearing did not take place, a majority of the overstory was between 25 and 100 feet tall. The channel banks were primarily composed of old growth conifers on the terraces that provide shade to the channel as well as act as a potential source for large wood recruitment to the channel (Figure 20).

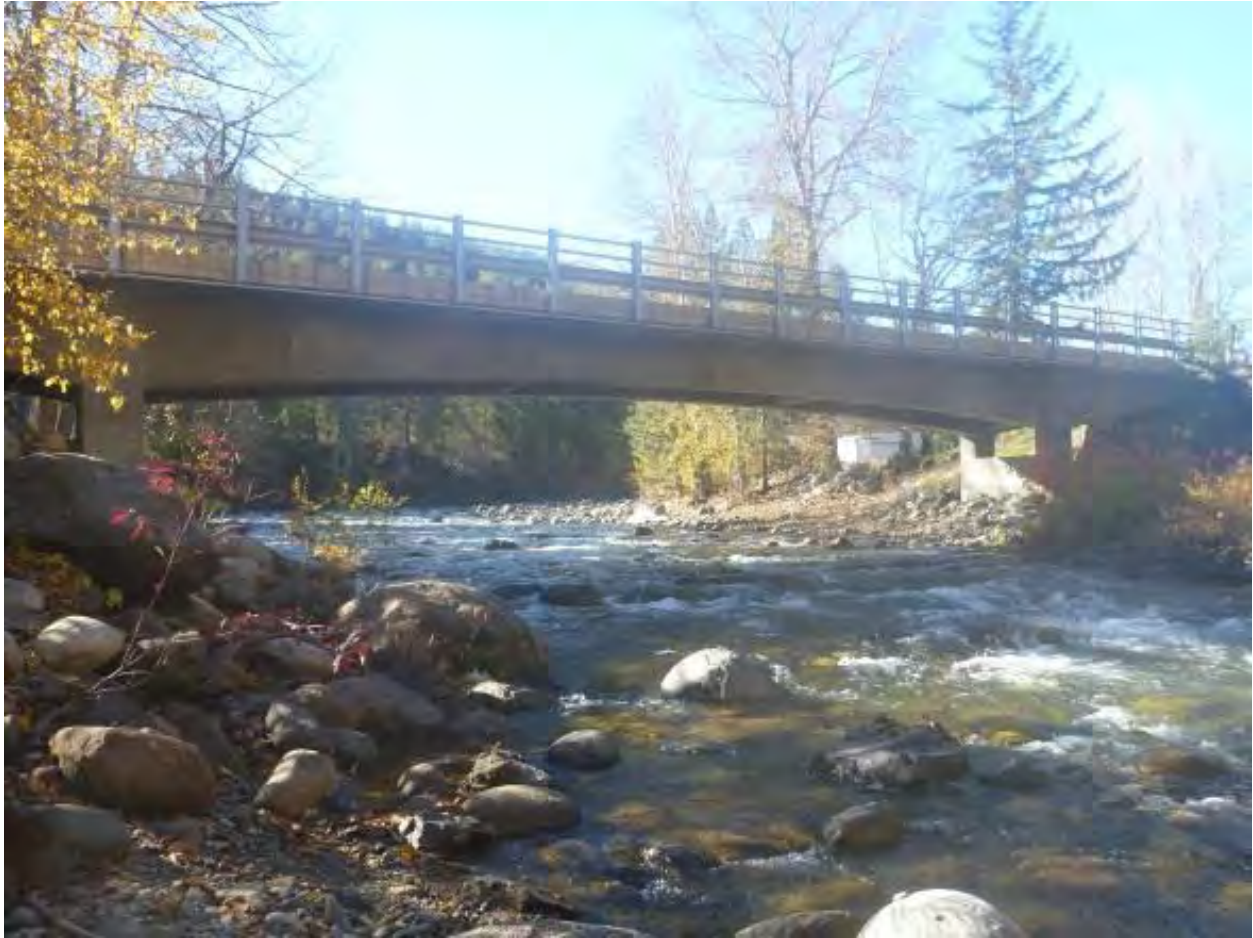
**Figure 23** Looking upstream at the bridge at RM 8.4.

The roadway construction, embankment creation, and riprap installation that has occurred in Reach 1 impedes stream bank complexity but does not seem to greatly impact natural channel migration, as the channel is naturally confined. Lateral channel dynamics have been impacted by the bridge and its associated abutments at RM 8.4 (Figure 23). The bridge does not have piers in the channel and appears to be appropriately sized, but the riprap along both sides of the channel, up and downstream of the structure, is acting as a lateral constriction to the channel upstream of the bridge. Riprap was also installed to protect the property banks in locations where residential clearing and grading occurred (Figure 22). The use of riprap along those banks, as well as the pushup levee along river-right (RM 8.8), disconnects the river from the floodplain by reducing the frequency and extent of floodplain inundation.

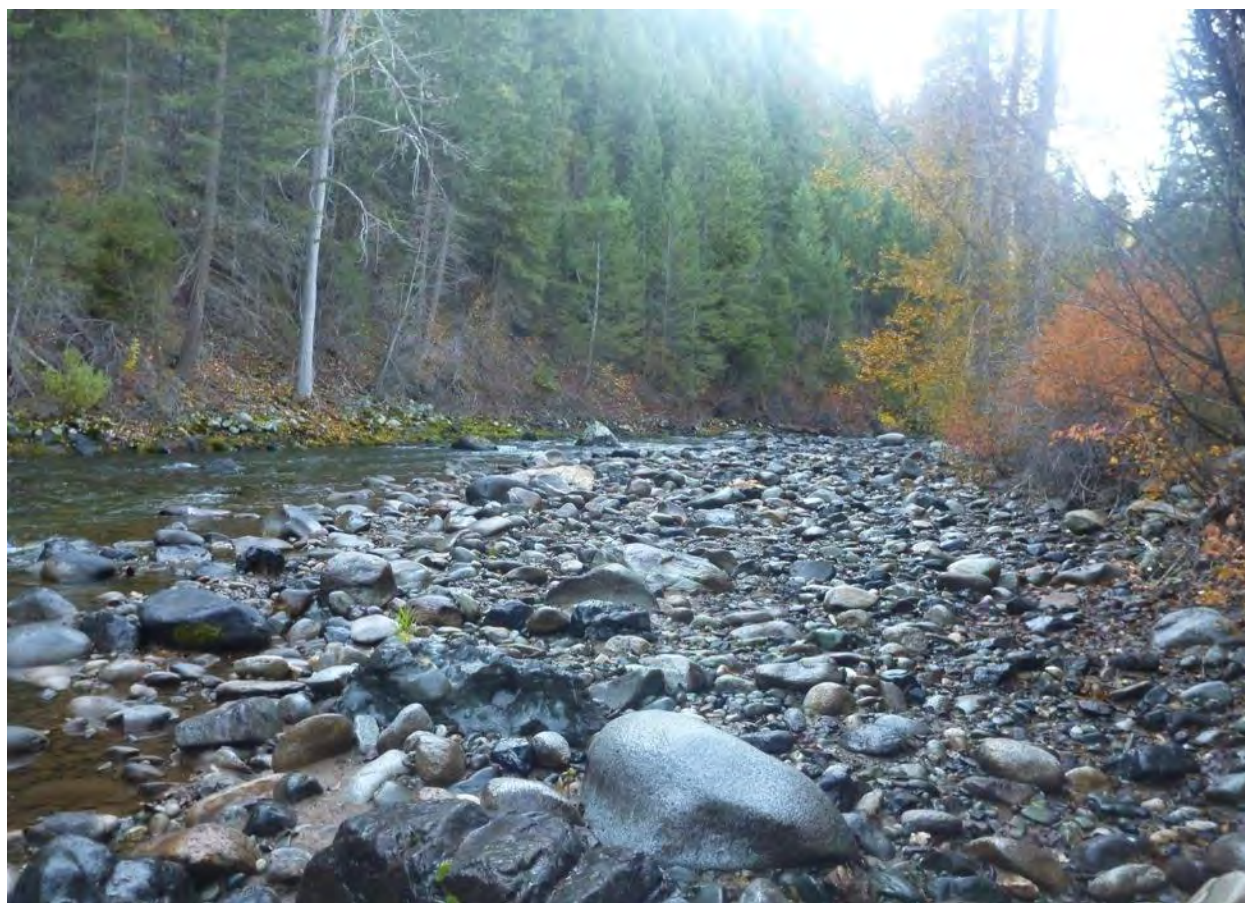
*Figure 24. A representative photo of Reach 2 taken at RM 9.4.*

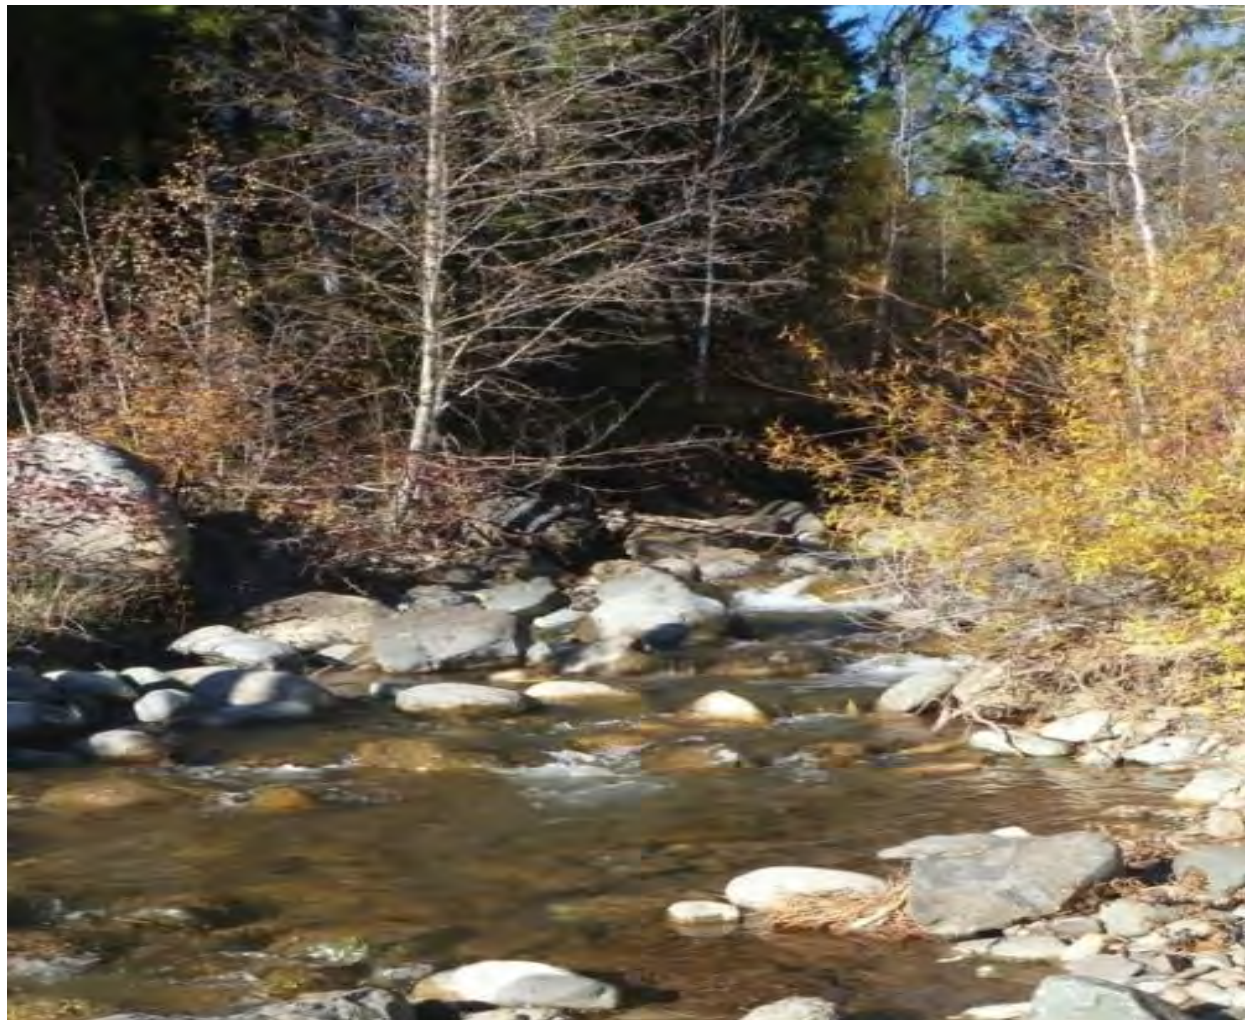
**Figure 28** Looking upstream at Little Bridge Creek

Little Bridge Creek enters the main channel along the north side of the channel, in the upstream portion of this reach. It is connected to the mainstem of the Twisp River through a large bottomless arch culvert that runs under Twisp River Road. This tributary contributes about 10% of the flow to the Twisp River at this location. Little Bridge Creek is a naturally laterally and vertically confined boulder-step-pool system with a boulder-cobble bed. The aggradation observed within the culvert at the mouth of the tributary provides evidence that Little Bridge Creek is contributing sediment to the main channel (Figure 28).

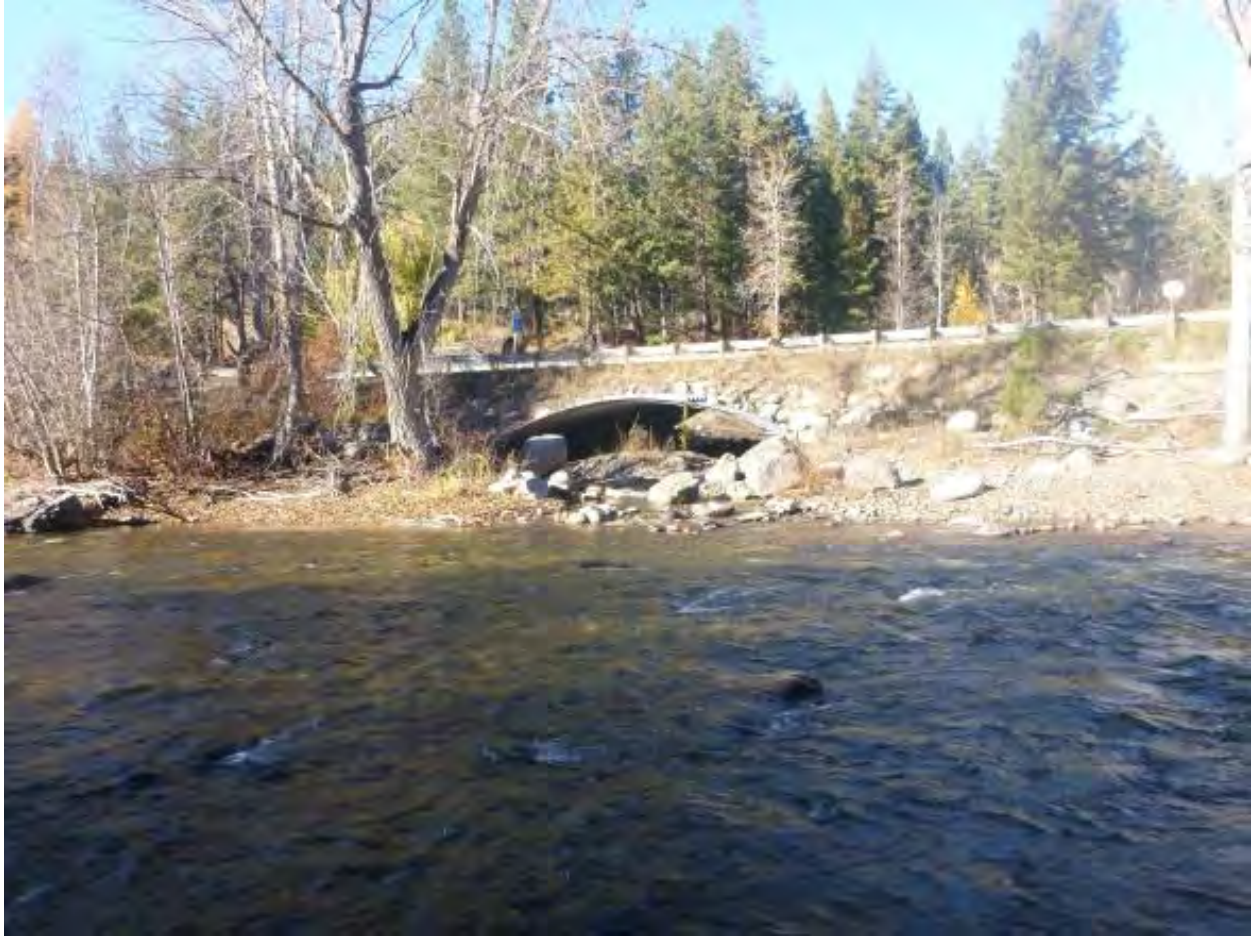
***Figure 31 Sediment accumulation in the bottomless culvert at the confluence of the Little Bridge Creek tributary and the Twisp River.***

There are several sediment sources to this reach including contributions from Little Bridge Creek, bank erosion from the road embankment, and older alluvial fan deposits that the river has eroded into. At the upstream end of the reach, Little Bridge Creek contributes sediment during floods as evidenced by the sediment accumulation at the mouth of the tributary (Figure 31). The Twisp River Road embankment along the north side of the channel is unvegetated and provides fine sediment and limited amounts of gravel to the channel throughout this reach (Figure 32).

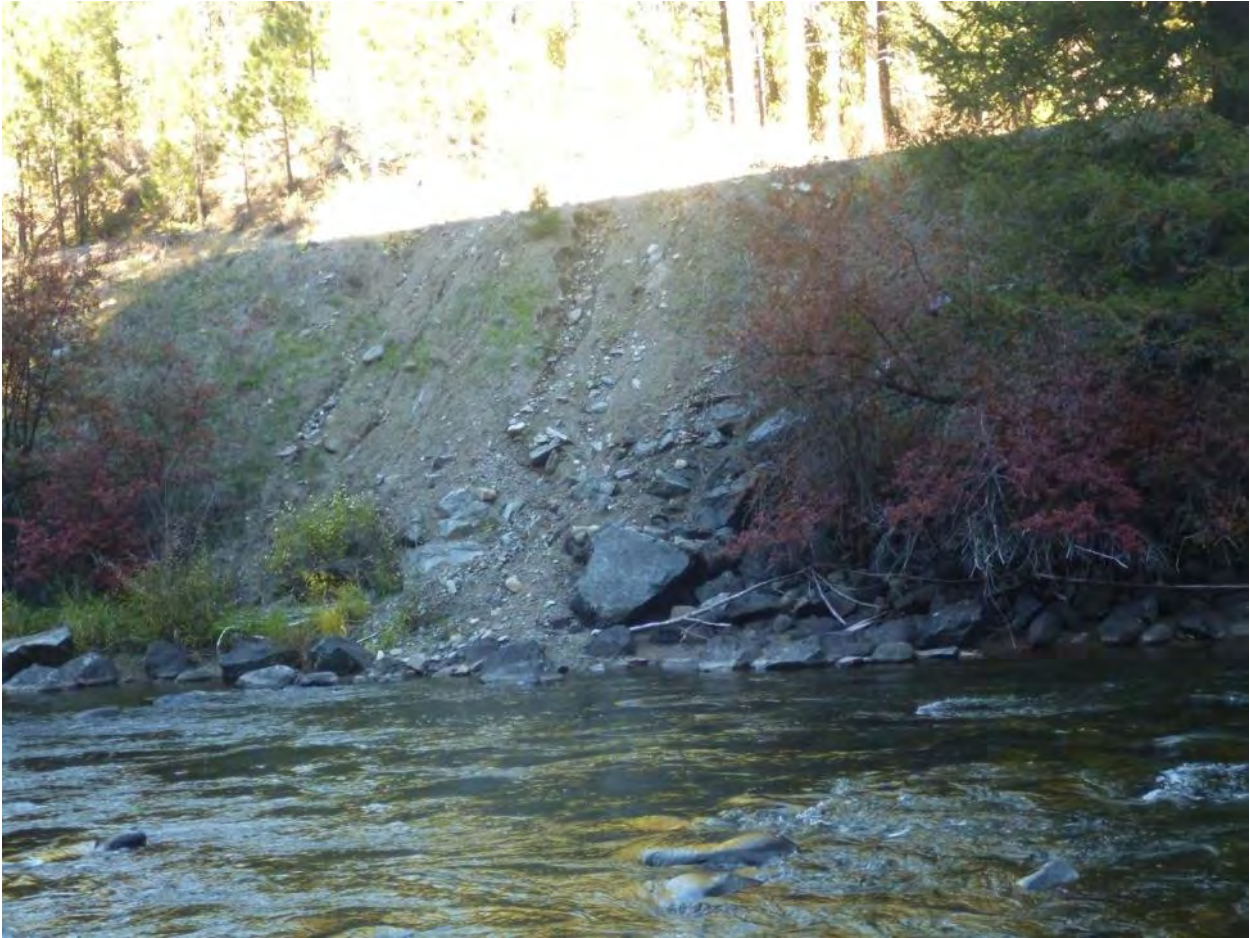
**Figure 32** *The roadway on river-left acts as a source for fine sediment, sand, and gravel entering the channel.*

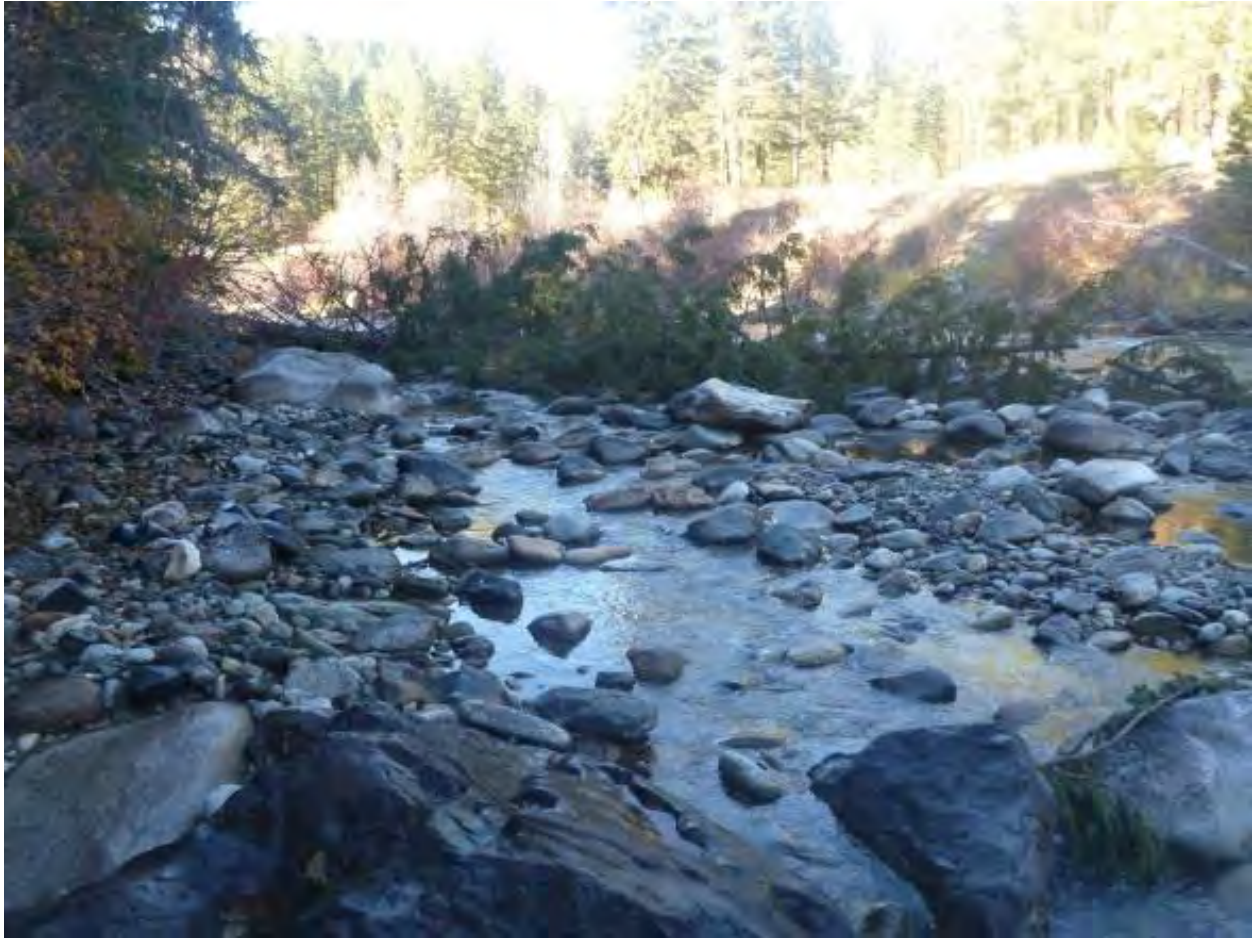
**Figure 33 large wood recruitment at RM 9.7.**

Reach 2 had the lowest wood counts of the entire study area (18 total pieces total) and did not have any log jams. A fallen conifer was noted in this reach at RM 9.7 (Figure 33) and resulted in an area of localized cobble accumulation, but the overall lack of wood in the reach, swift current, and large substrate are indicative of a transport reach that lacks instream habitat. The steep, heavily vegetated banks, primarily along the south side of the river, are potential sources of additional large wood recruitment to the system.

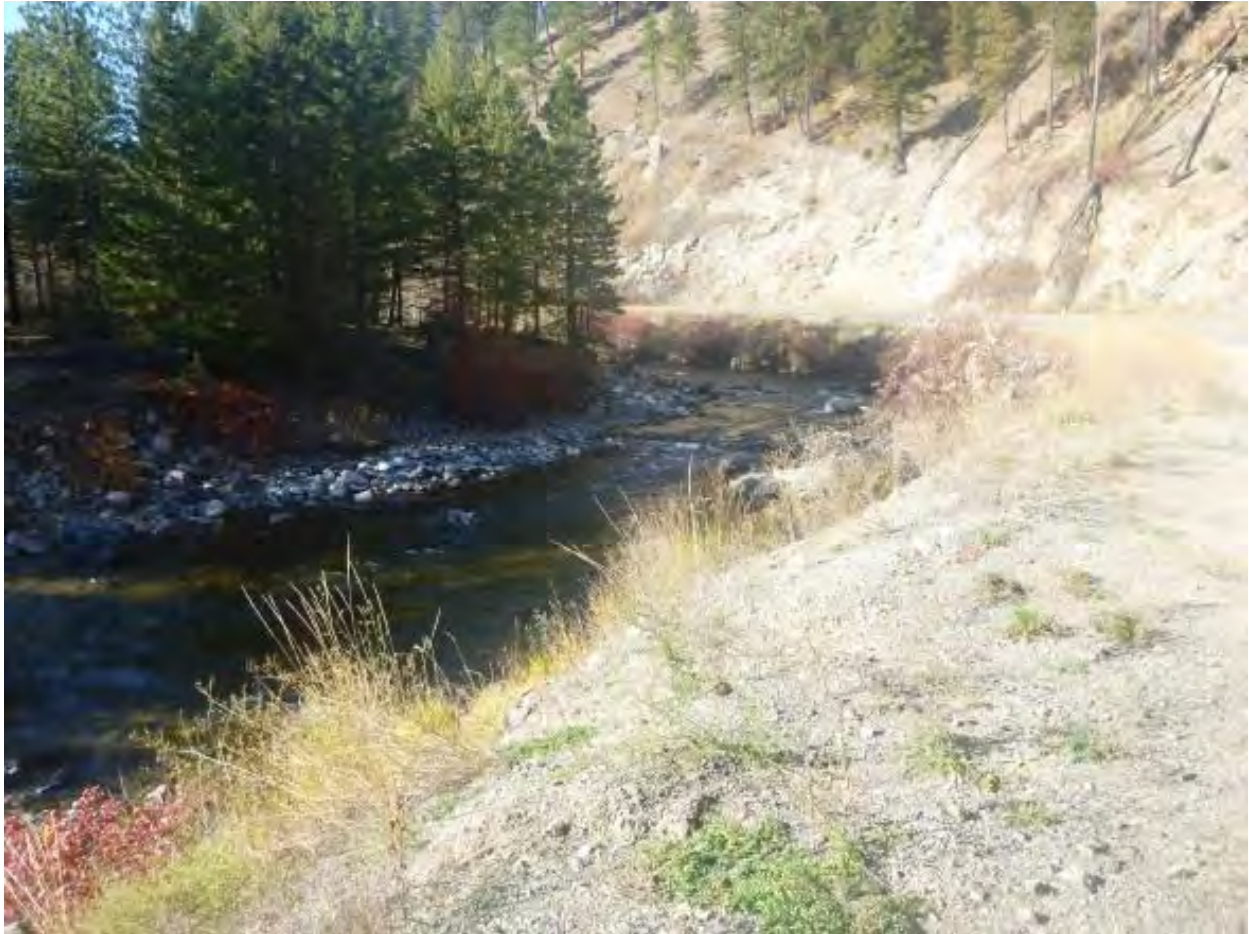
**Figure 36** The road embankment at RM 9.15 looking upstream.

Large angular riprap has been installed along the base of the road embankment along river-left (Figure 36). The riprap likely does not have a significant impact on channel migration due to the confined nature of the reach, but it does have some effect on gravel and large wood recruitment processes along the channel margins. There is a large bottomless culvert at the confluence of Little Bridge Creek and the Twisp River (approximately RM 9.75) along river-left (Figure 31). Sediment deposition within the culvert has occurred, which is a result of the change in profile of Little Bridge Creek as it meets the Twisp.

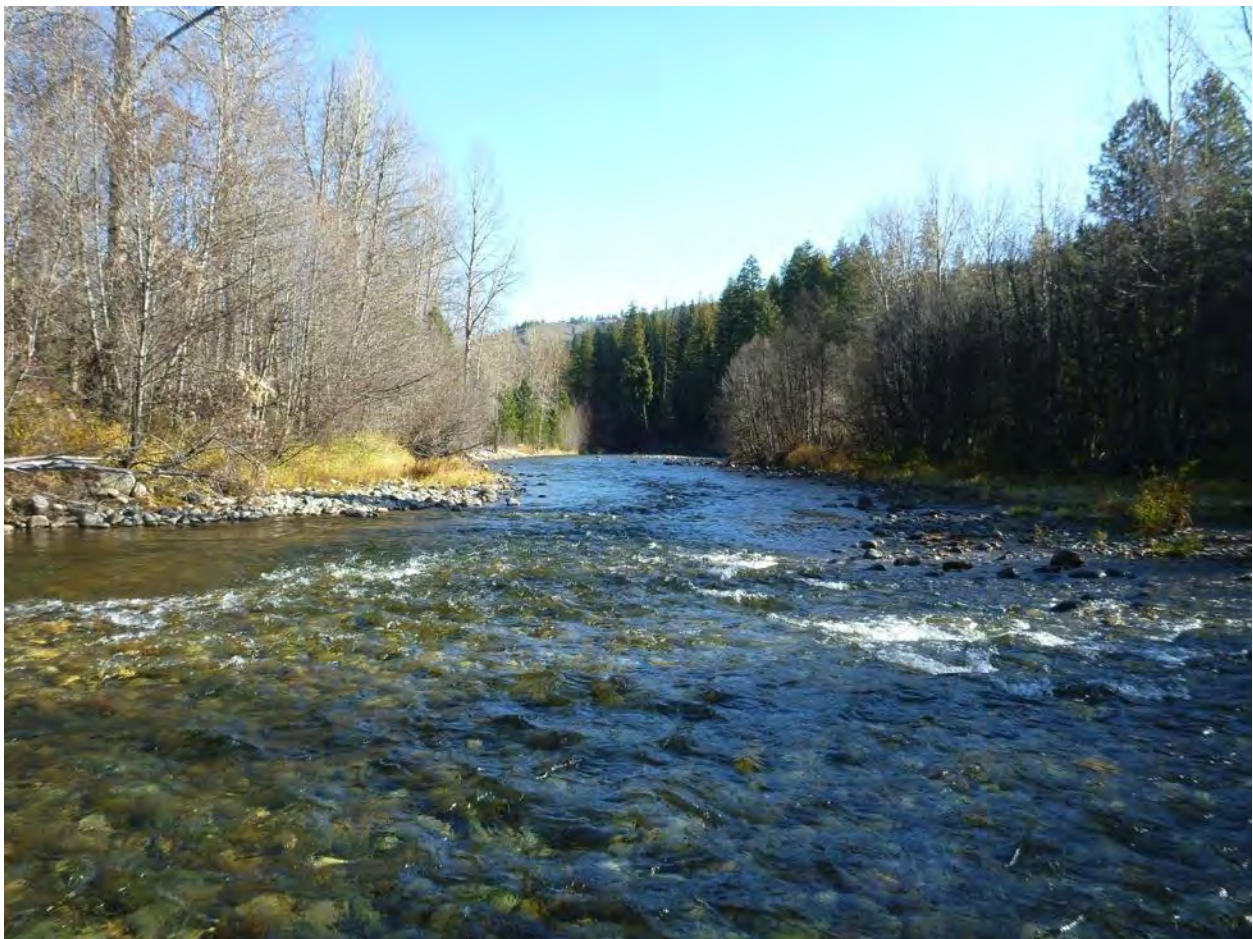
*Figure 37. A representative photo of Reach 3 at RM 11.8.*

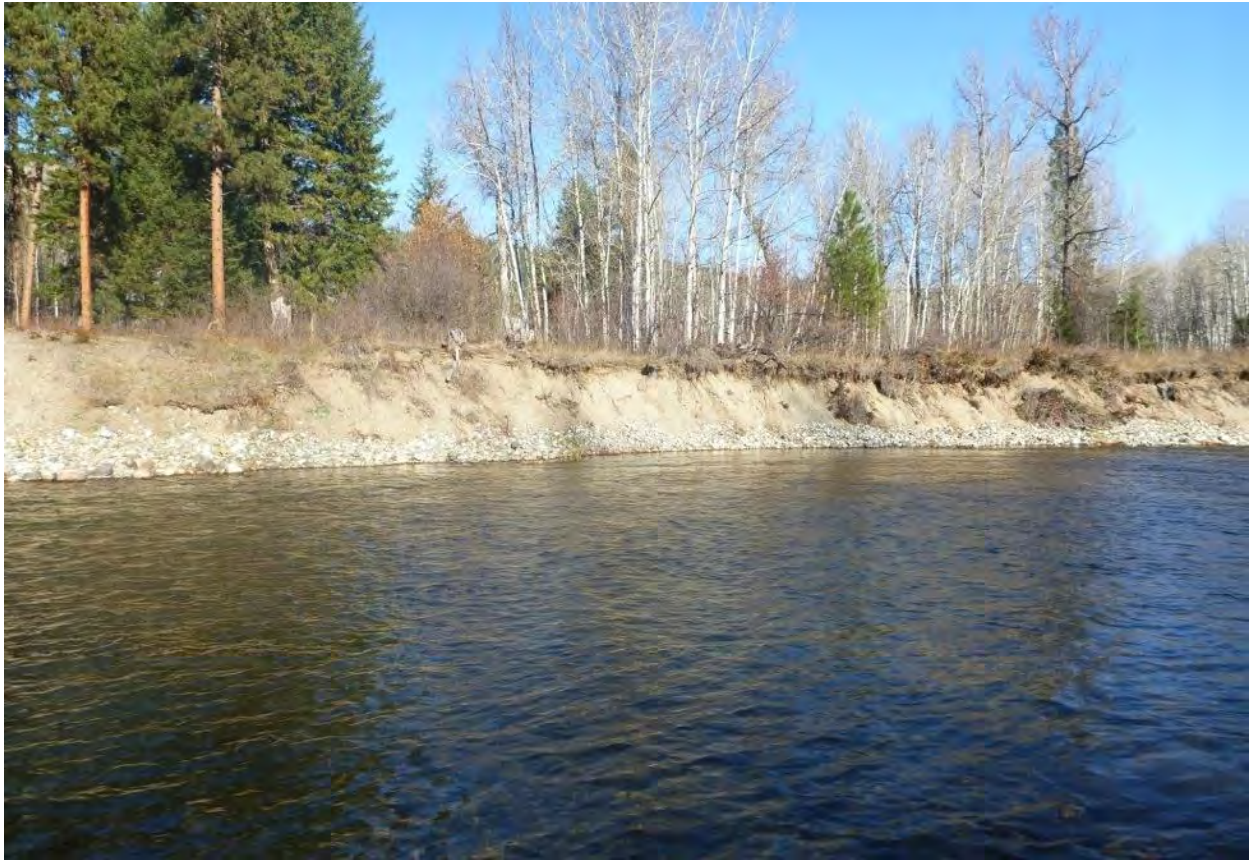
***Figure 43. The high eroding banks with natural alluvium protecting the toe of the bank at RM 11.77 are acting as a source of fine sediment to the system.***

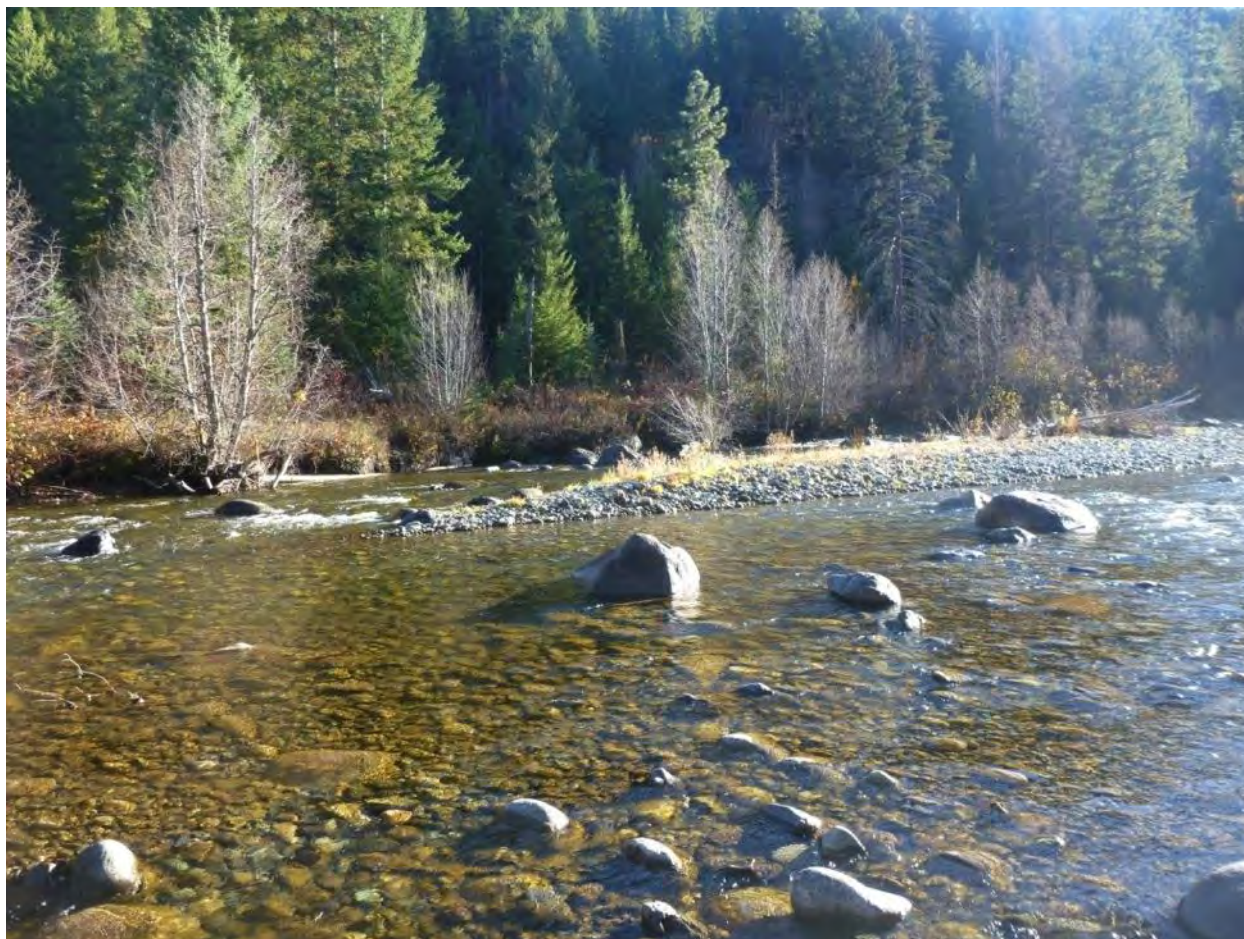
**Figure 44.** Gravel/cobble bar at RM 9.96 looking upstream, just out of the photo is a large boulder at the upstream side of the bar.

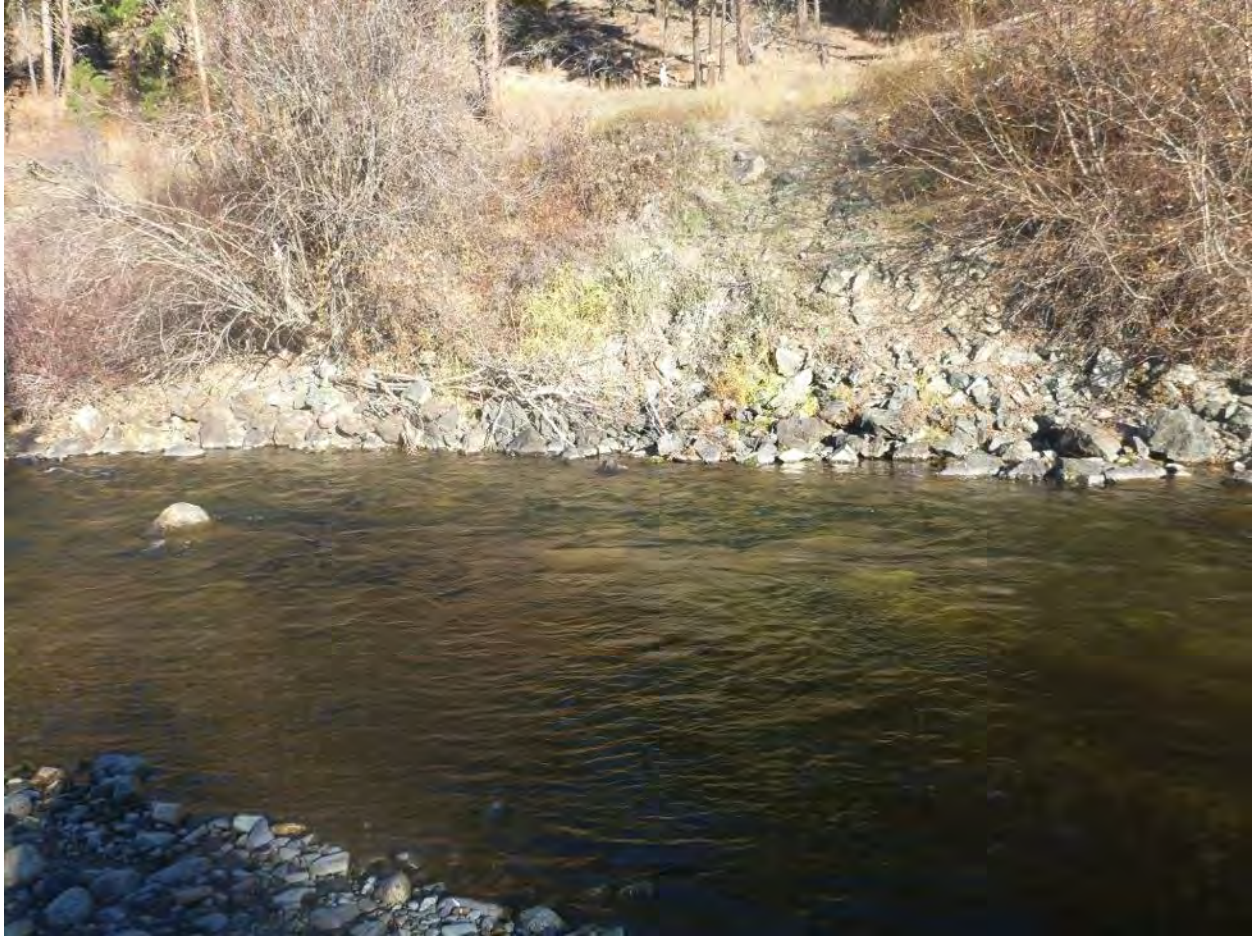
*Figure 46. RM 10.27 river left, the road embankment and large angular riprap installed at the bank toe.*

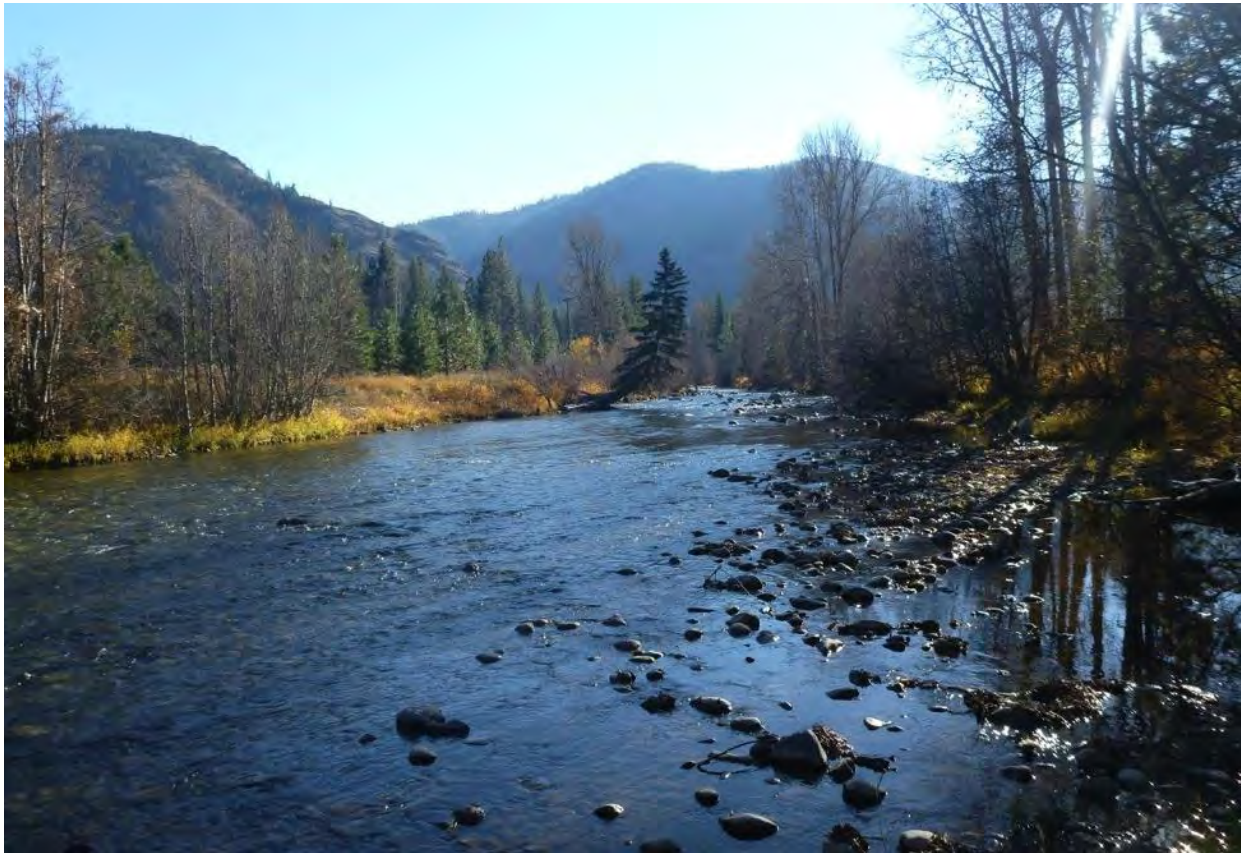
*Figure 48. A representative section of Reach 4 at RM 12.8.*

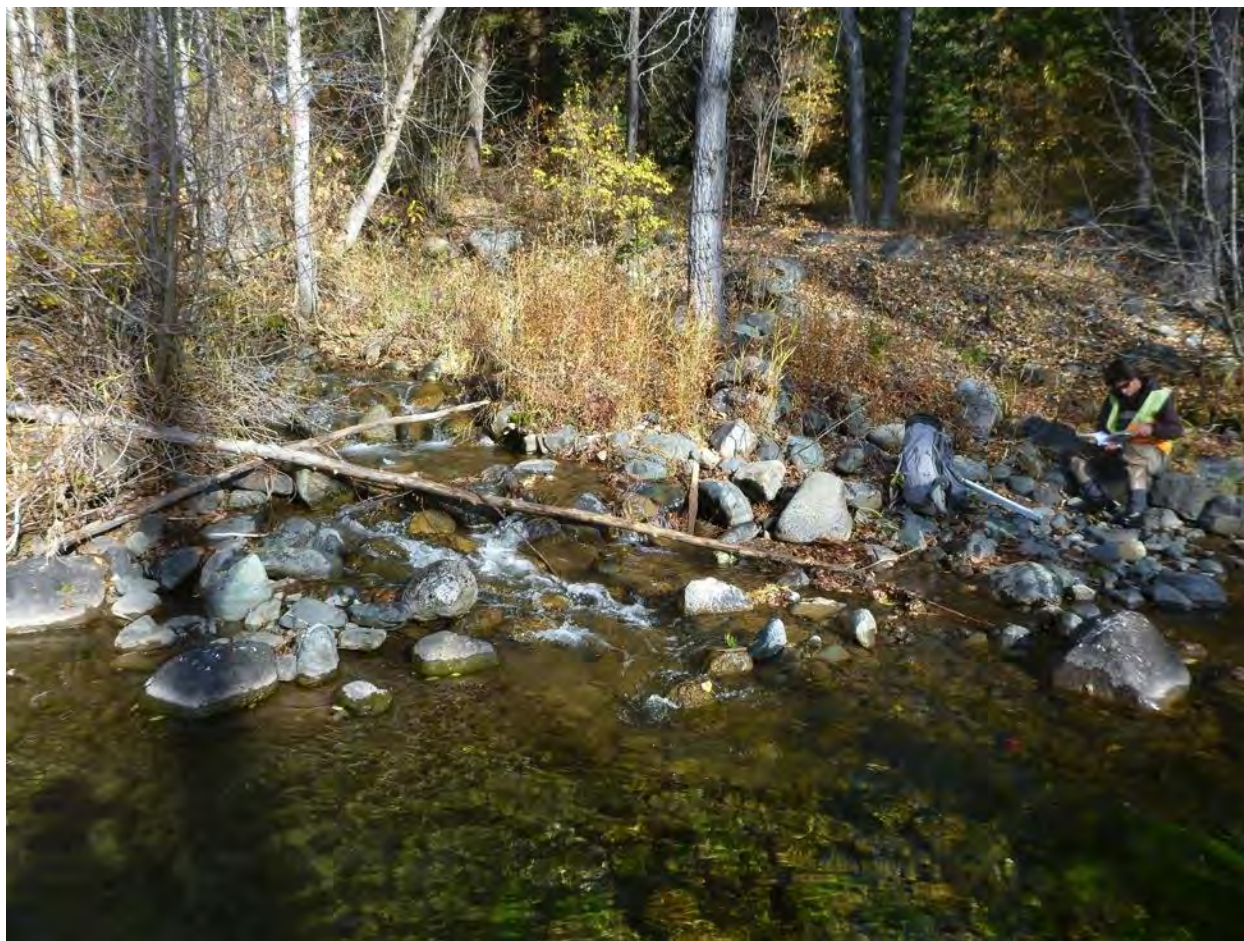
**Figure 53. Mouth of Canyon Creek showing large cobble and boulder material contributed to the mainstem Twisp.**

There are two tributaries that enter the reach at the upstream end: Buttermilk Creek and Canyon Creek. Buttermilk Creek, which enters from the south, is a significant contributor of flow. Buttermilk Creek adds approximately 20% of the flow to the Twisp River at this location. The contemporary Buttermilk Creek channel is located along the upstream edge of the fan. It has been in this location at least since the period of the earliest aerial photo records (1953). Canyon Creek is smaller, but is steep and contributes large material to the Twisp River channel (Figure 53).

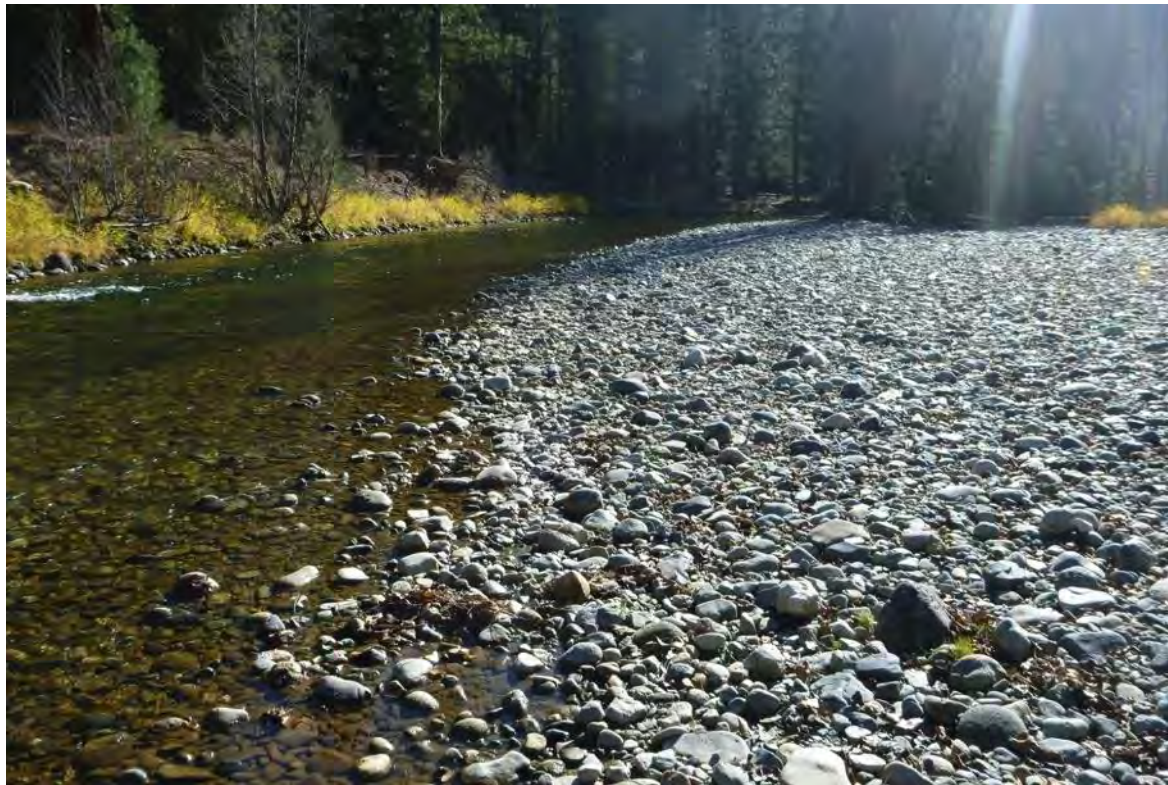
Figure 56. One of the few cobble bars in Reach 4. This one is located on river-right near RM 12.3.

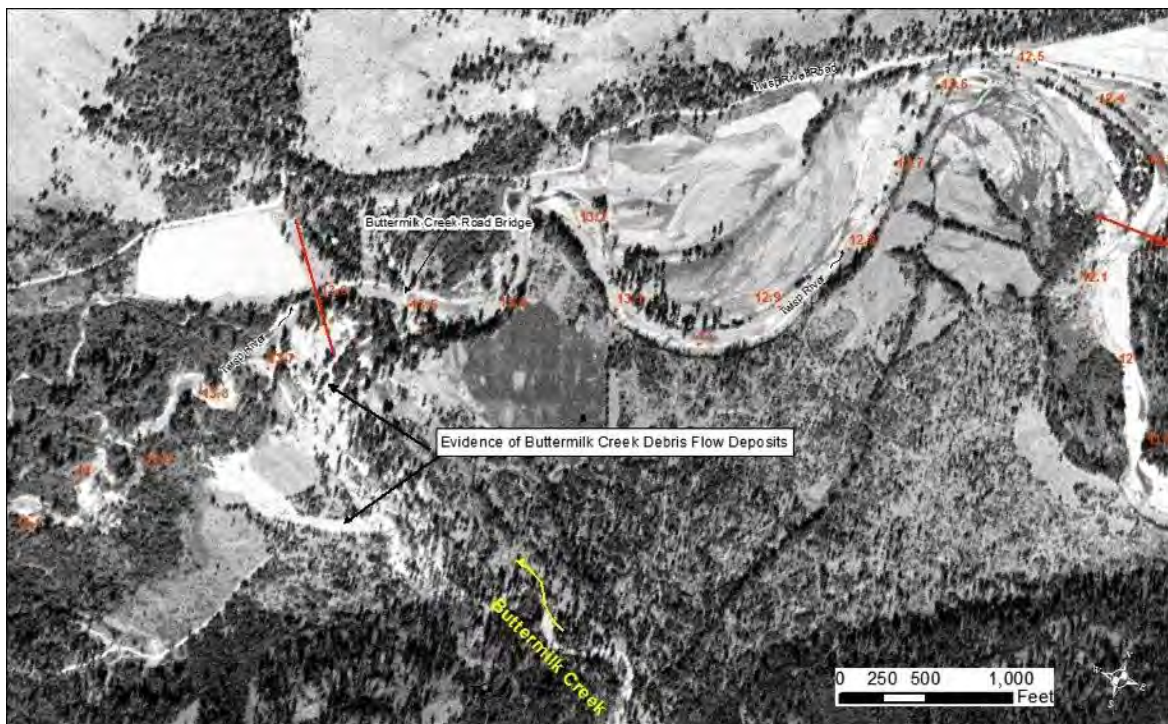
**Figure 57. 1953 aerial photo of Reach 4 and downstream portion of Reach 5 showing evidence of Buttermilk Creek debris flow deposits. The red lines are the reach breaks.**

Buttermilk Creek and Canyon Creek enter the reach at the upstream end and contribute sediment during floods. The 1953 aerial photo shows evidence of a recent debris flow in Buttermilk Creek, which likely contributed a significant amount of sediment, including bedload, to the Twisp River (Figure 57). It is possible the debris flow occurred during the 1948 regional flood event.
