# Middle Twisp River Reach Assessment & Restoration Strategy

SUBMITTED TO  
Yakama Nation Fisheries Program

FEBRUARY 2015

PREPARED BY  
Inter-Fluve, Inc.  
501 Portway Ave, Suite 101  
Hood River, OR 97031  
(541) 386-9003

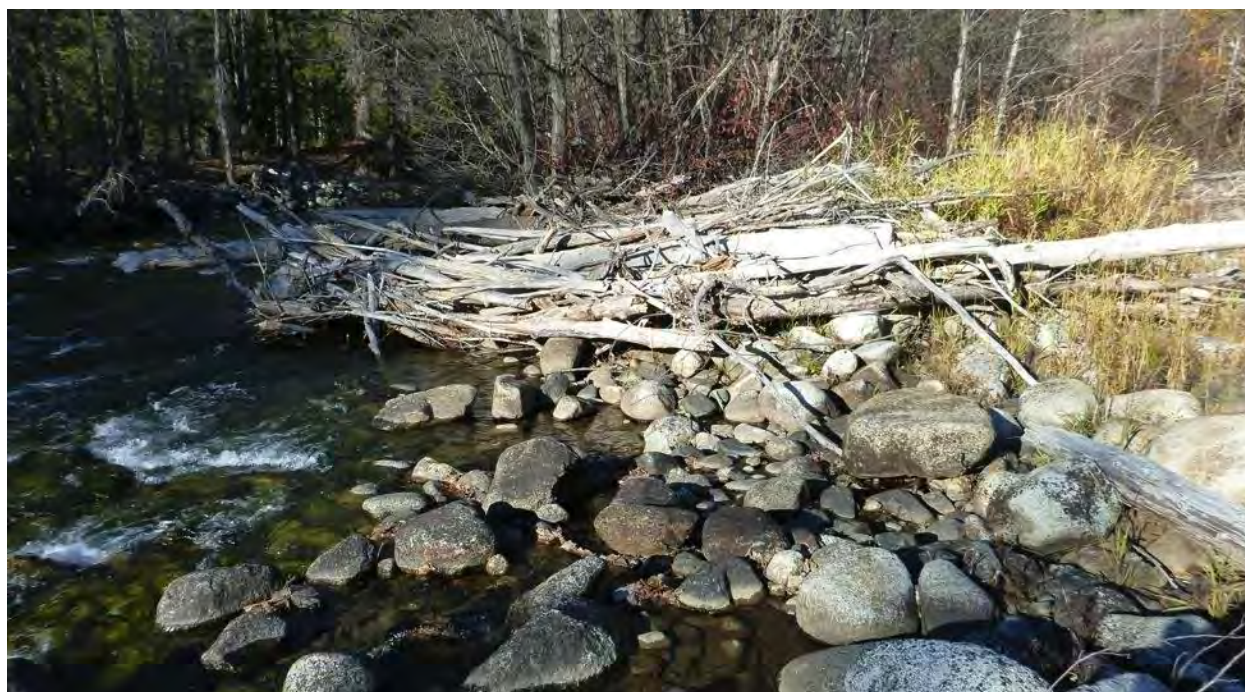
**Figure 58. Bar apex log jam near RM 12.8 in Reach 4. This is one of only two log jams in the reach. Both jams were comprised primarily of the 'small' size class of large wood.**

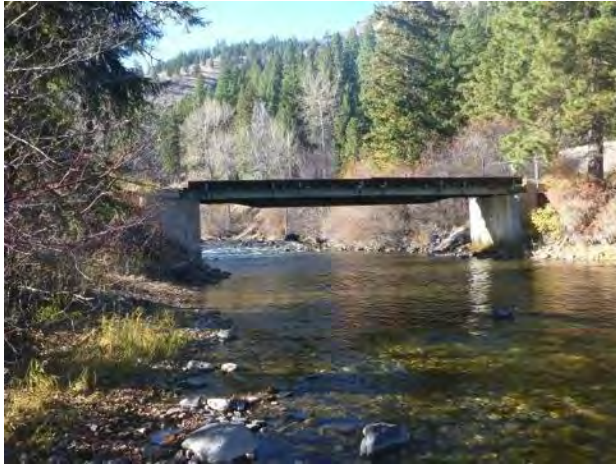
***Figure 60. A small single lane bridge with abutments on the channel margin at RM 12.46.***

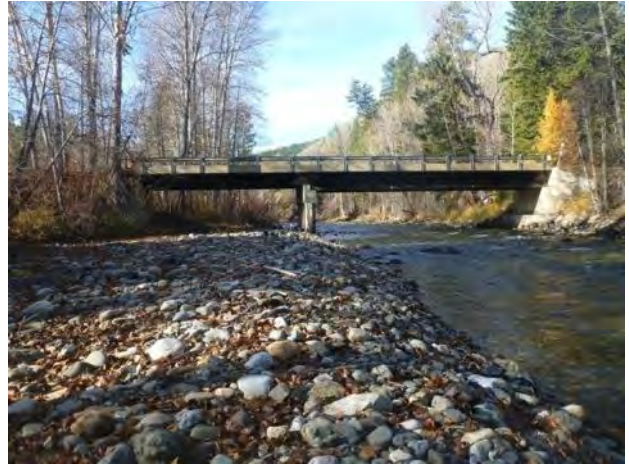
***Figure 61. Bridge at RM 13.5 looking upstream.***

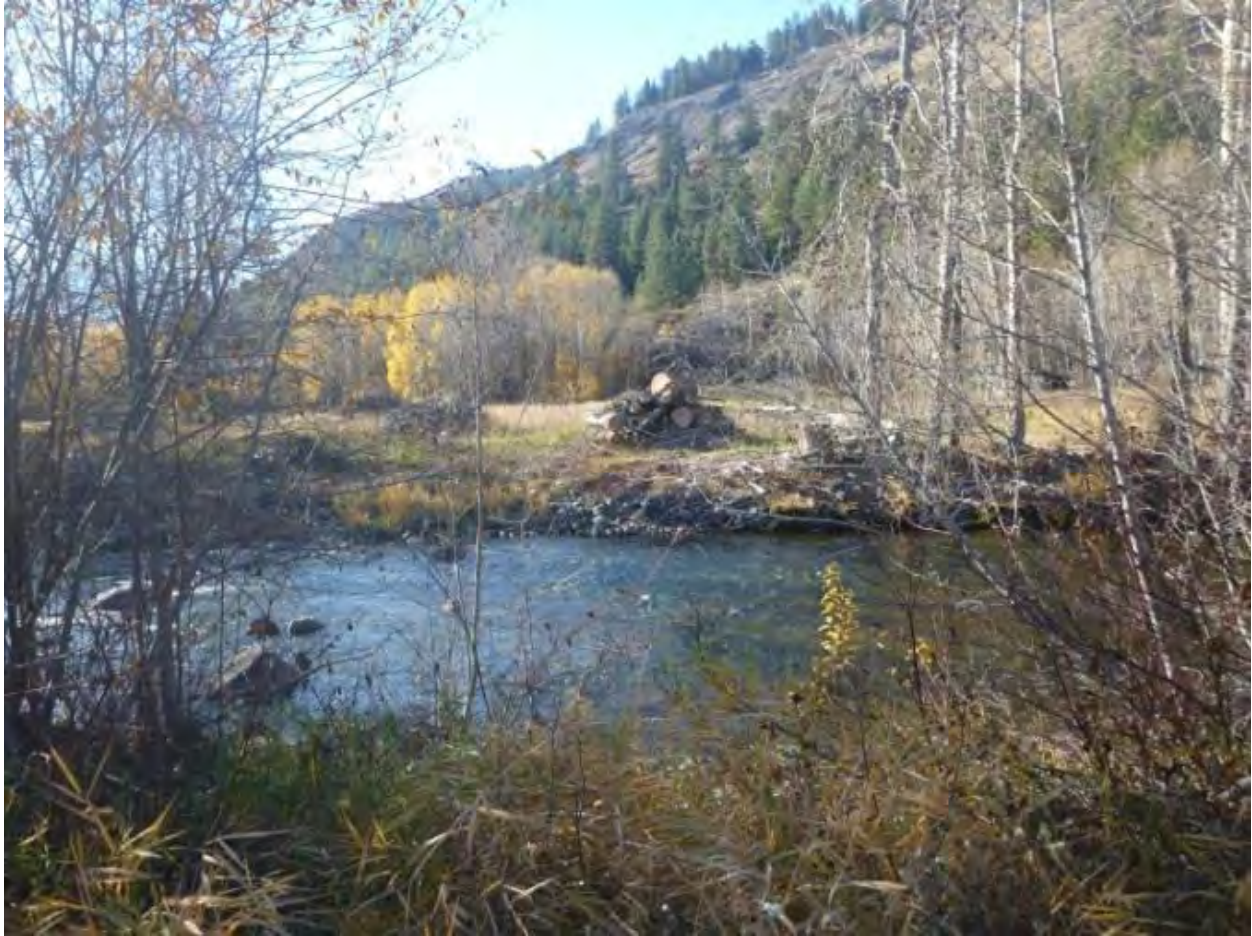
*Figure 63. View of river-left bank near RM 12.65 showing evidence of active clearing of riparian and floodplain vegetation.*

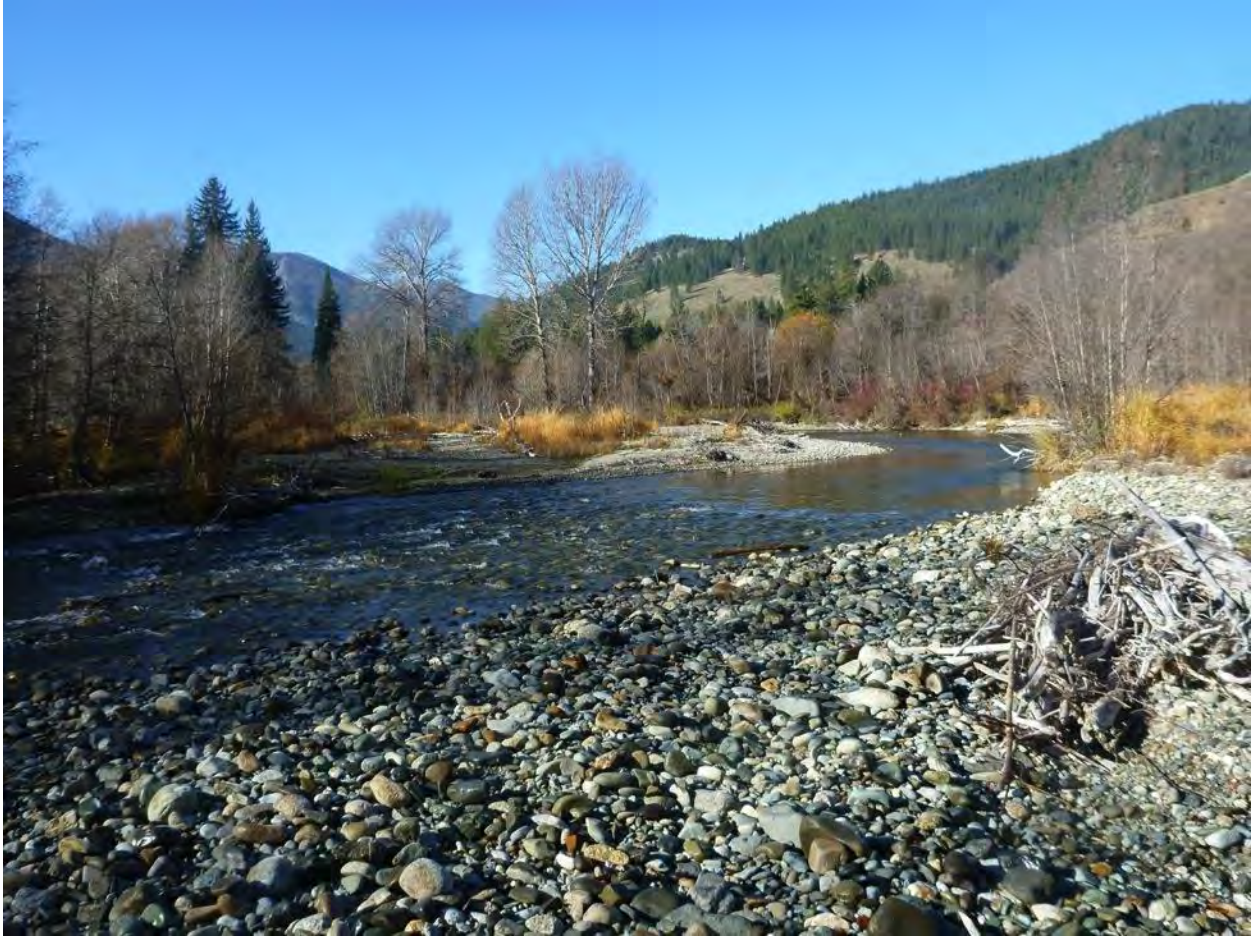
*Figure 64. A representative section of Reach 5 at RM 14.1.*

Reach 5 corresponds to the downstream portion of T6a from the USBR Methow Subbasin Geomorphic Assessment and extends 2.59 miles from RM 13.6 (confluence of Buttermilk Creek) to RM 16.19. Reach 5 is a dynamic, lower gradient braided reach (Figure 64). This portion of the study area provides analog conditions as much of the reach has a dynamic, multi-thread channel, with active lateral channel dynamics, abundant off-channel habitats, and high large wood and log jam numbers. There is a large levee/pond complex in the upstream portion of the reach along river-left, reducing available habitat and limiting lateral migration to the north in this area. This reach exhibits rapid channel repositioning via bank erosion and avulsions. Significant channel changes occur on the order of every 10 to 15 years. This degree of change, although good for creation of new habitats, may be greater than under historical conditions when larger riparian trees, larger downed trees in the channel and floodplain, and large stable log jams would have created a greater degree of stability. The more active contemporary channel could potentially be a redd scour and sedimentation issue.

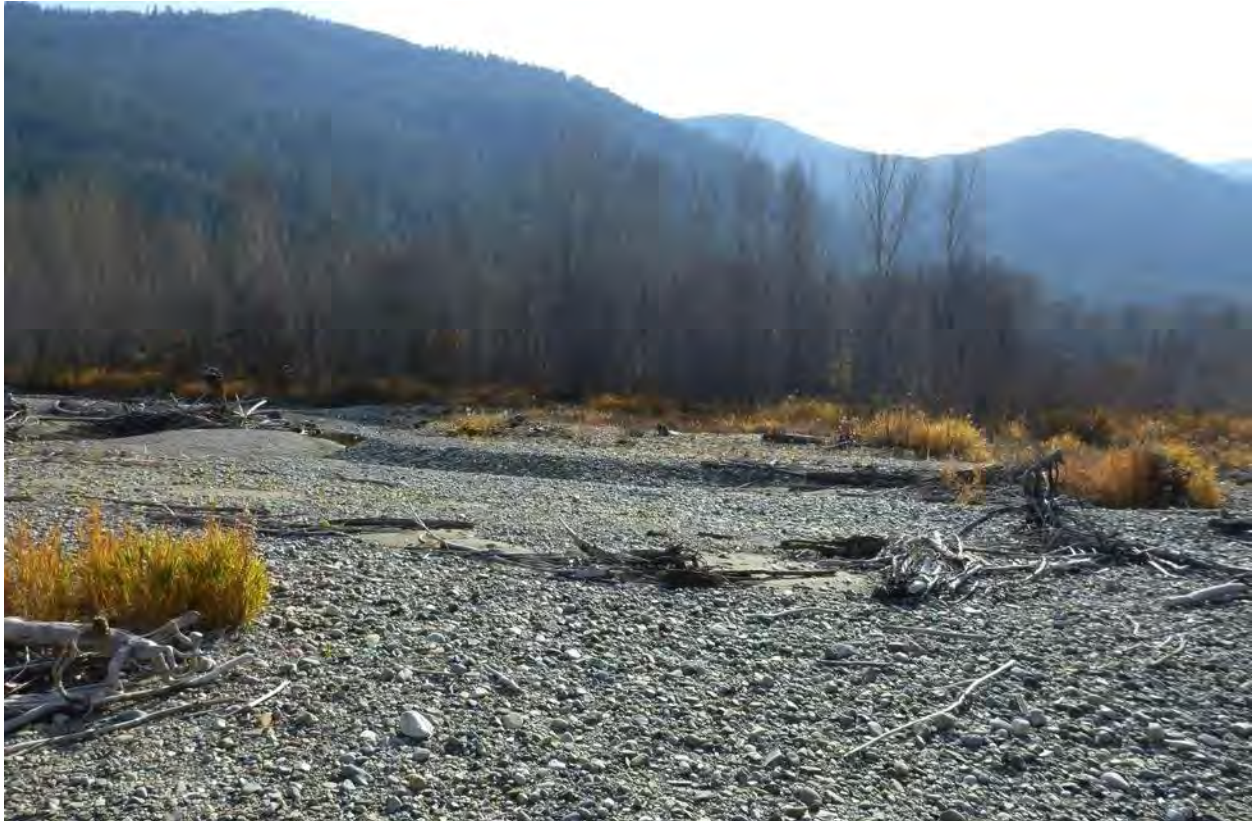
**Figure 68.** Channel avulsion occurred at RM 14.5 and a large gravel deposit remains on river-left in the previous main channel with evidence of high flow scour

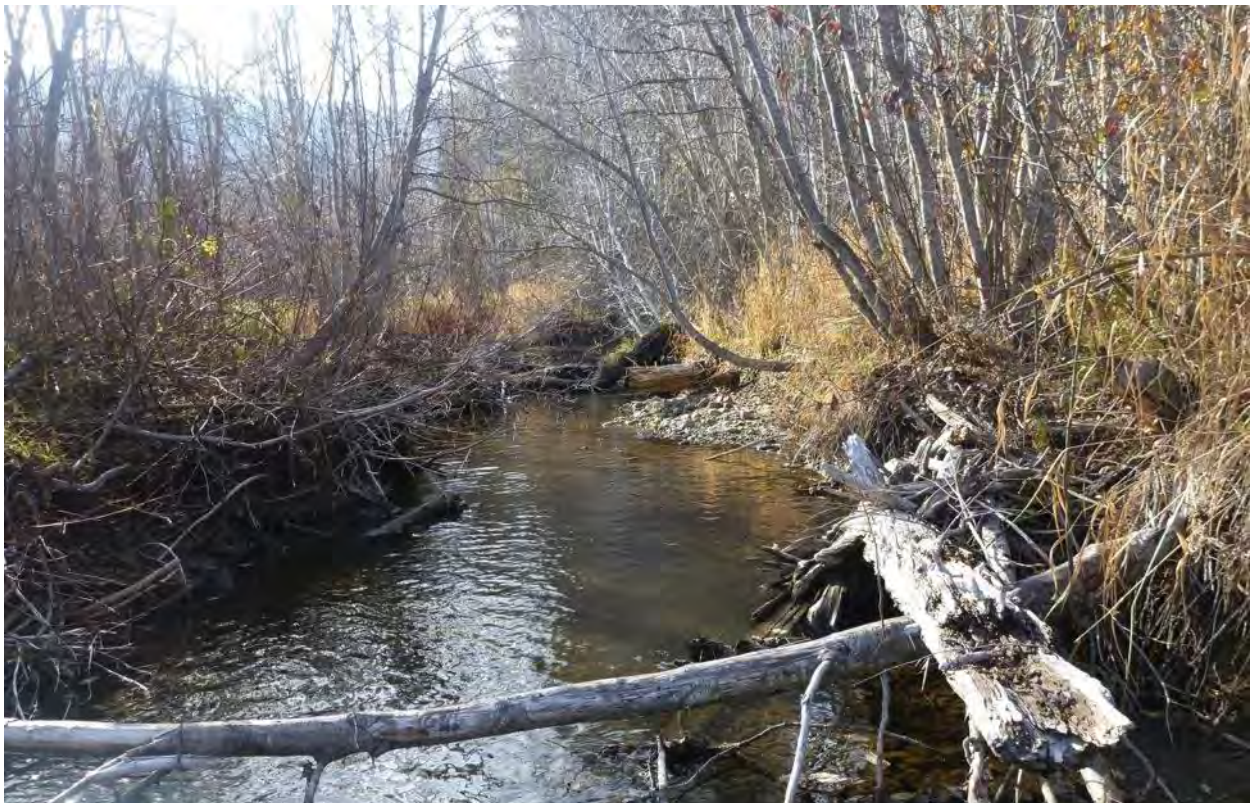
*Figure 69. A representative photo from the 4,956 foot long side channel.*

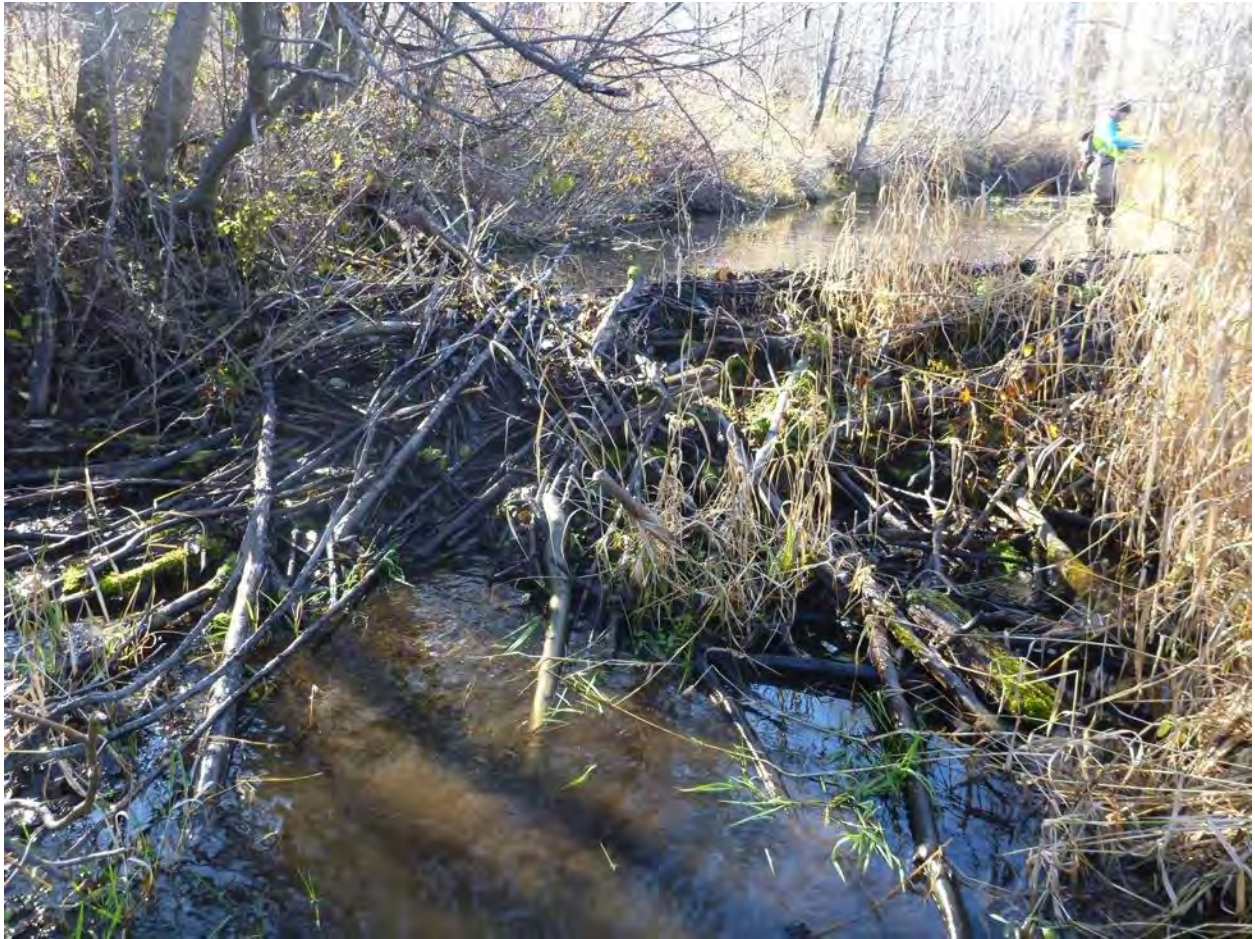
*Figure 70. River right at RM 14.4 there is a beaver dam creating a backwater alcove.*

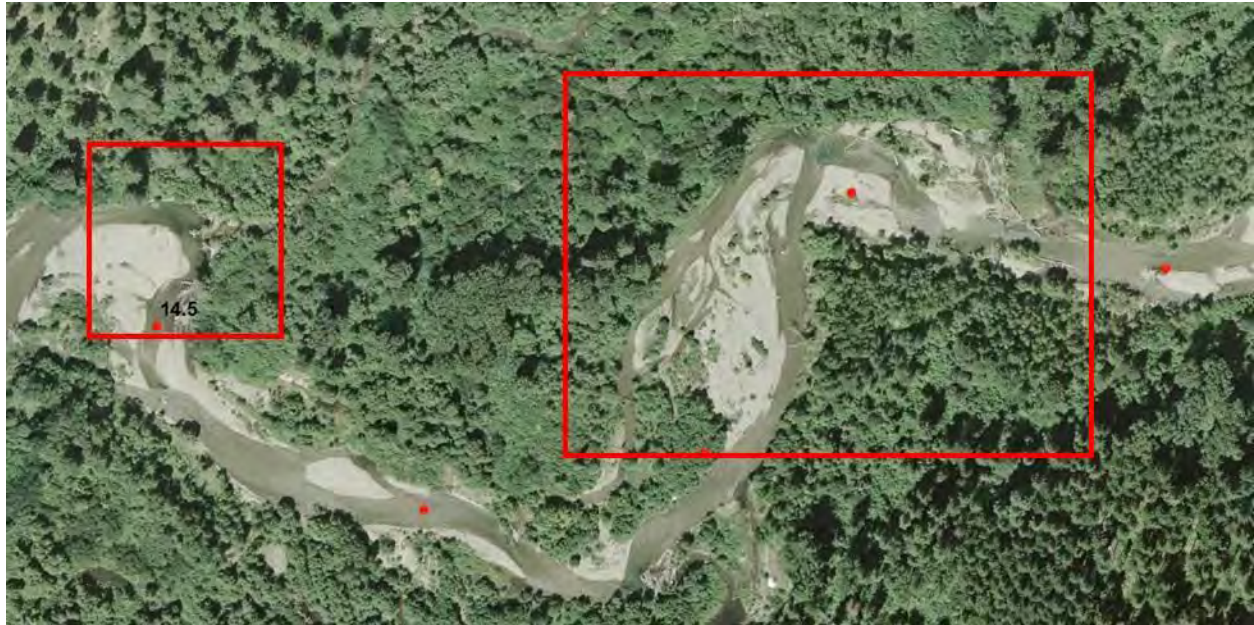
**Figure 73.** Large amounts of LWD have accumulated throughout this reach especially in the areas highlighted in red boxes.

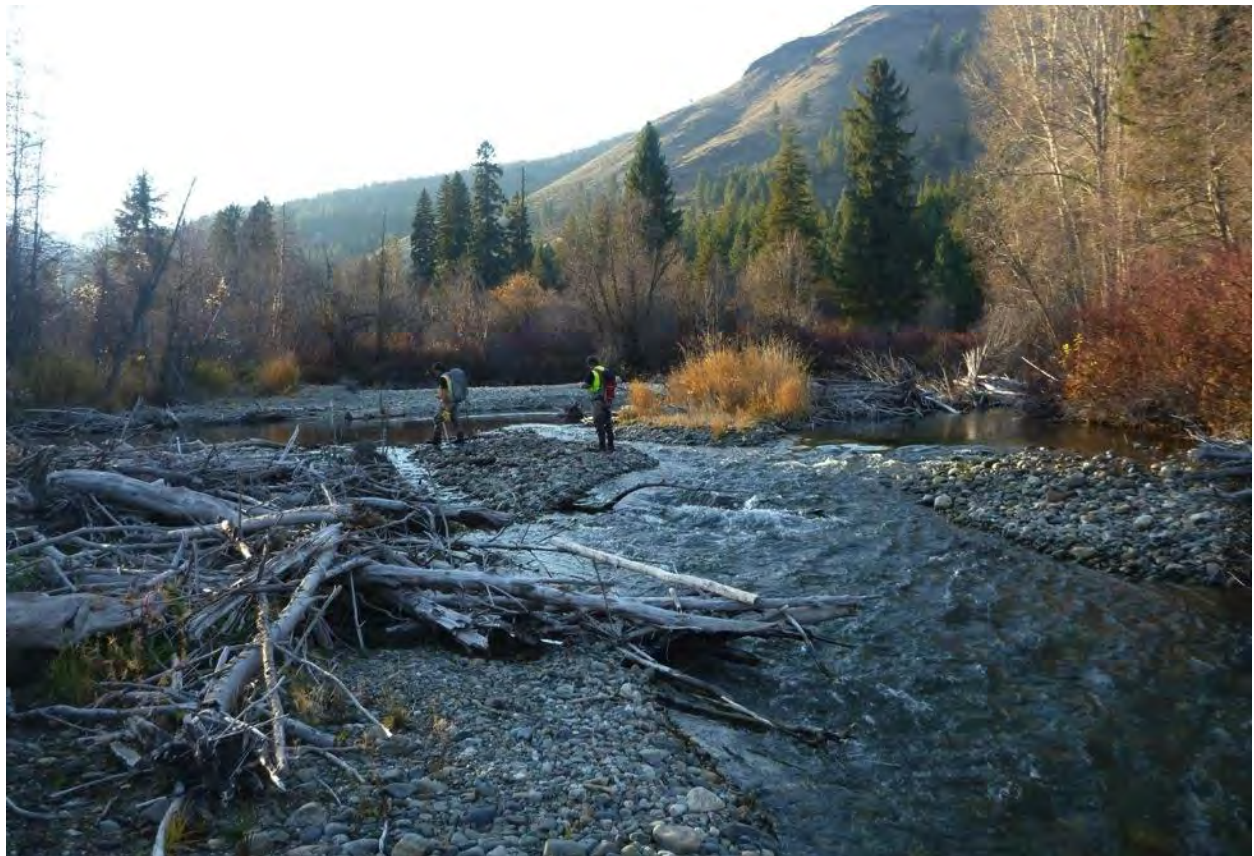
**Figure 74.** Rm 13.85 wood deposition on the gravel bars throughout the channel.

Reach 5 had high quantities of large wood and log jams when compared to the remainder of the study area. This reach had 537 pieces of wood, for 207 pieces per mile. A significant portion of the wood (27%, or 145 pieces) were found in the over 15,000 feet of side channel habitat (Appendix A). Although this reach had a significant amount of total wood, only a fraction of the pieces (34 pieces) were considered “large” pieces (>20 inches diameter; >35 feet long). There was also a lot of smaller wood that was smaller than the minimum length required for a qualifying piece, and therefore was not counted. A total of ten log jams were observed in Reach 5, comprising 155 pieces of wood (Appendix A). Significant quantities of cut wood were found near RM 15.4 that appeared to have been cut just upstream. Large wood was observed to typically accumulate at bar apexes and along low-angle gravel bars (Figure 73 and Figure 74). Wood is an important catalyst for rapid channel repositioning via bank erosion and avulsions. The frequency of channel adjustment may actually be greater now compared to historical conditions due to the relatively small size of the wood that is in the channel and that is available to be recruited. Historically, large wood would serve as key pieces that would form large jams that would persist for many years or even decades. In the current condition, there are smaller jams that are more transient and allow for more frequent channel adjustment. This poses a potential risk to salmonids via increased potential for redd scour or burial.

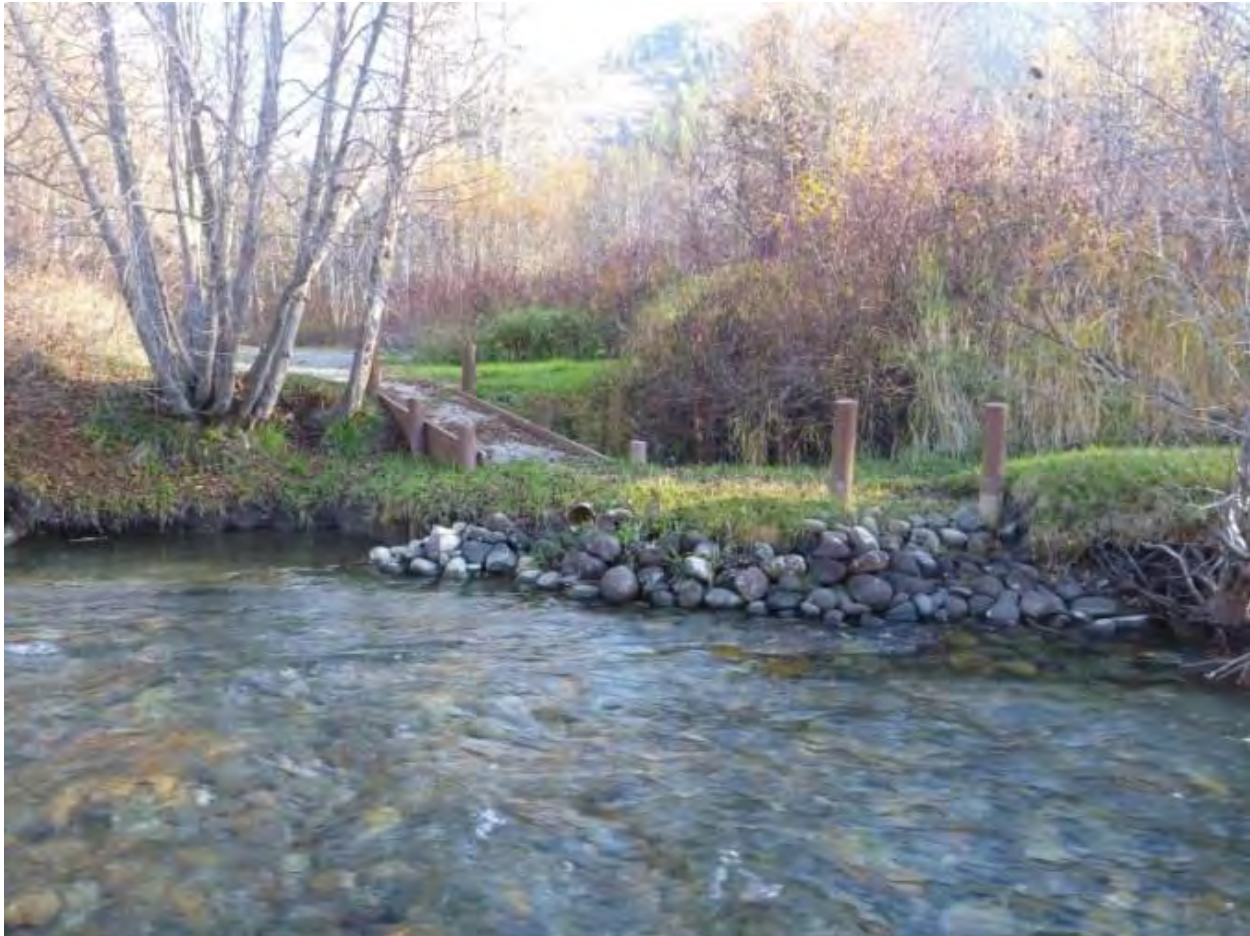
*Figure 76. RM 13.8 riprap with large posts and a constructed footbridge constructed along river right opening to a gravel clearing.*

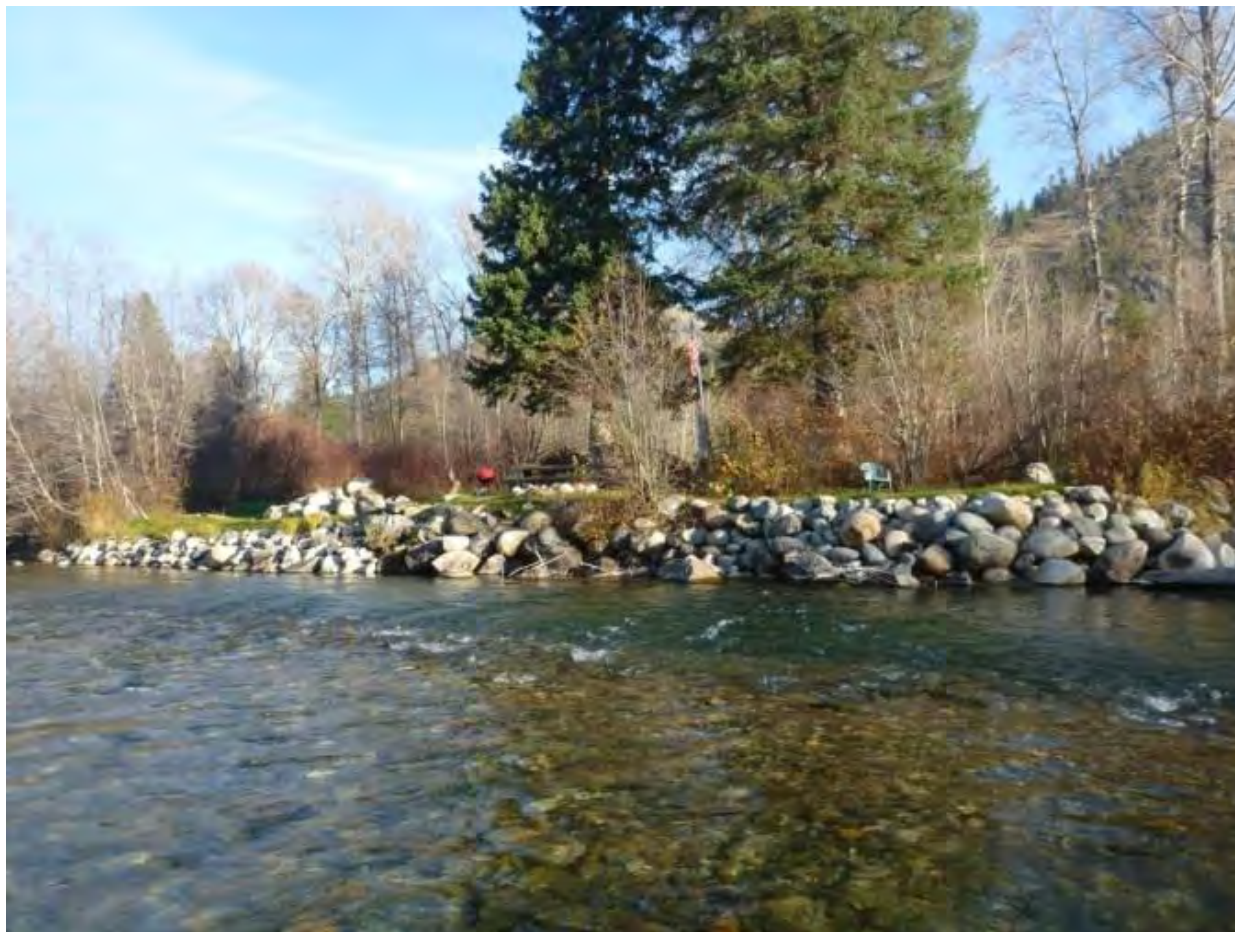
**Figure 77. RM 13.85 Significant riprap has been placed along river right of this residential clearing with recreational elements up to the bank's edge.**

At the downstream end, clearing and grading have occurred within the 100-year floodplain related to recreational and residential uses (Figure 76 and Figure 77). There are also several areas of riprap along the channel banks and the construction of a small footbridge (RM 13.8). There is also a gabion wall that lines the lower end of Buttermilk Creek, near the confluence.

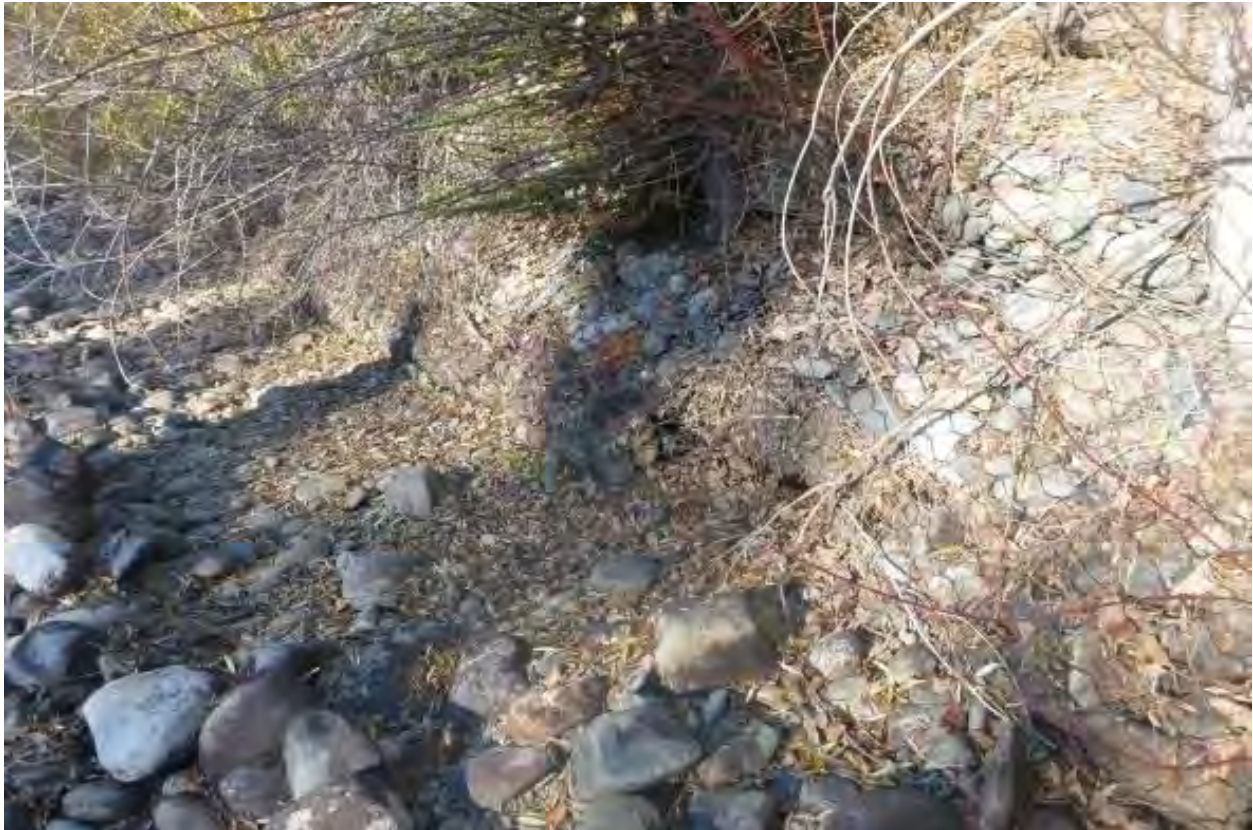
**Figure 78.** Gabion wall and culvert located at the upstream end of the large pond complex along river left at RM 16.1.

At the upstream end, there is a levee and excavated pond complex that impairs floodplain function, channel migration, and off-channel connectivity in this area. The levee complex limits lateral channel migration, reduces floodplain inundation, and disconnects the open water ponds and floodplain features from the mainstem Twisp River (Figure 79 and Figure 80). There is a gabion wall at the inlet to this levee complex (RM 16.1; Figure 78). A culvert provides an inflow to the pond complex under annual high flows with an outflow location at the levee breach at RM 15.91. The gabion walls prevent lateral channel migration. The culvert allows high flows to enter the pond complex, but does

not allow for fish to access the area, except for at very high flows. The near channel pond at RM 15.8 has no low flow connectivity to the main channel, but is connected under high flows. The pond is approximately 4 feet deep and has fine sediment accumulation and submerged vegetation; there was no evidence of fish present in the pond complex. Just downstream of the primary levee and pond complex, there are a few areas where bank armoring (primarily riprap) is protecting houses within the floodplain and channel migration zone.

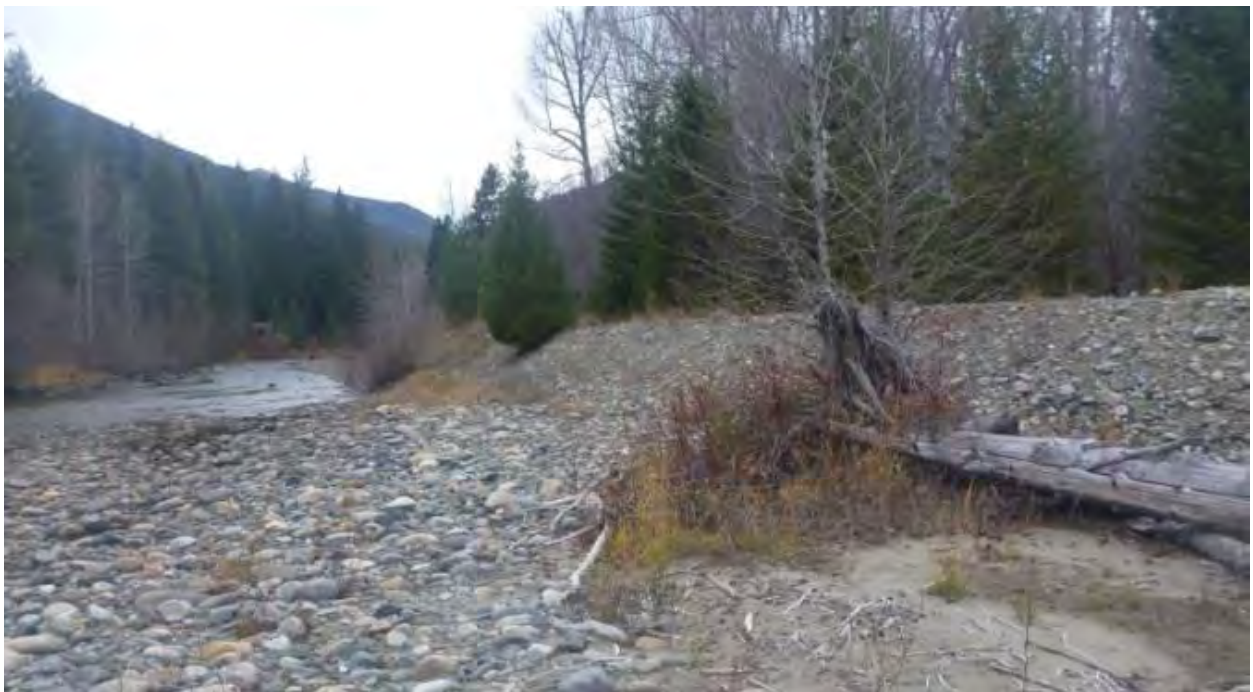
**Figure 79.** Pushup levee at RM 15.9 along river-left with established conifers

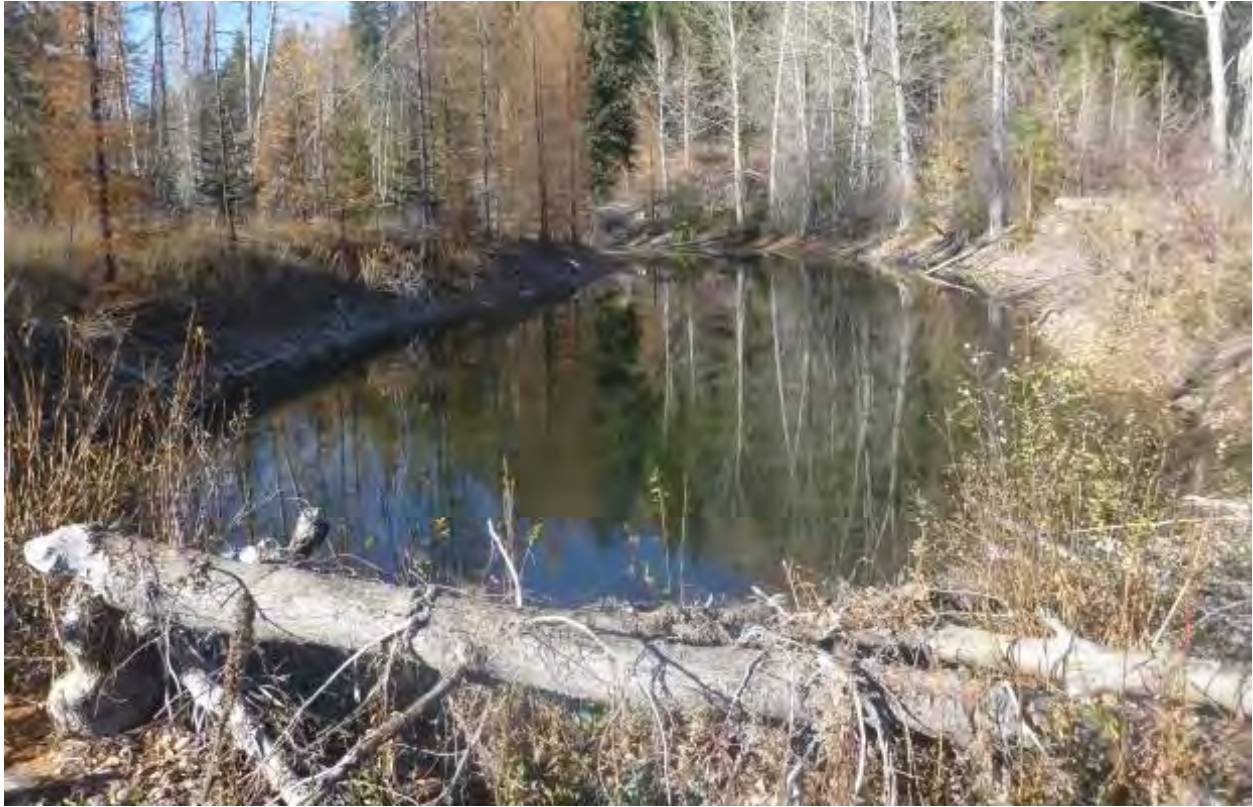
*Figure 80. The near channel pond at RM 15.75 has no low flow connectivity to the main channel*

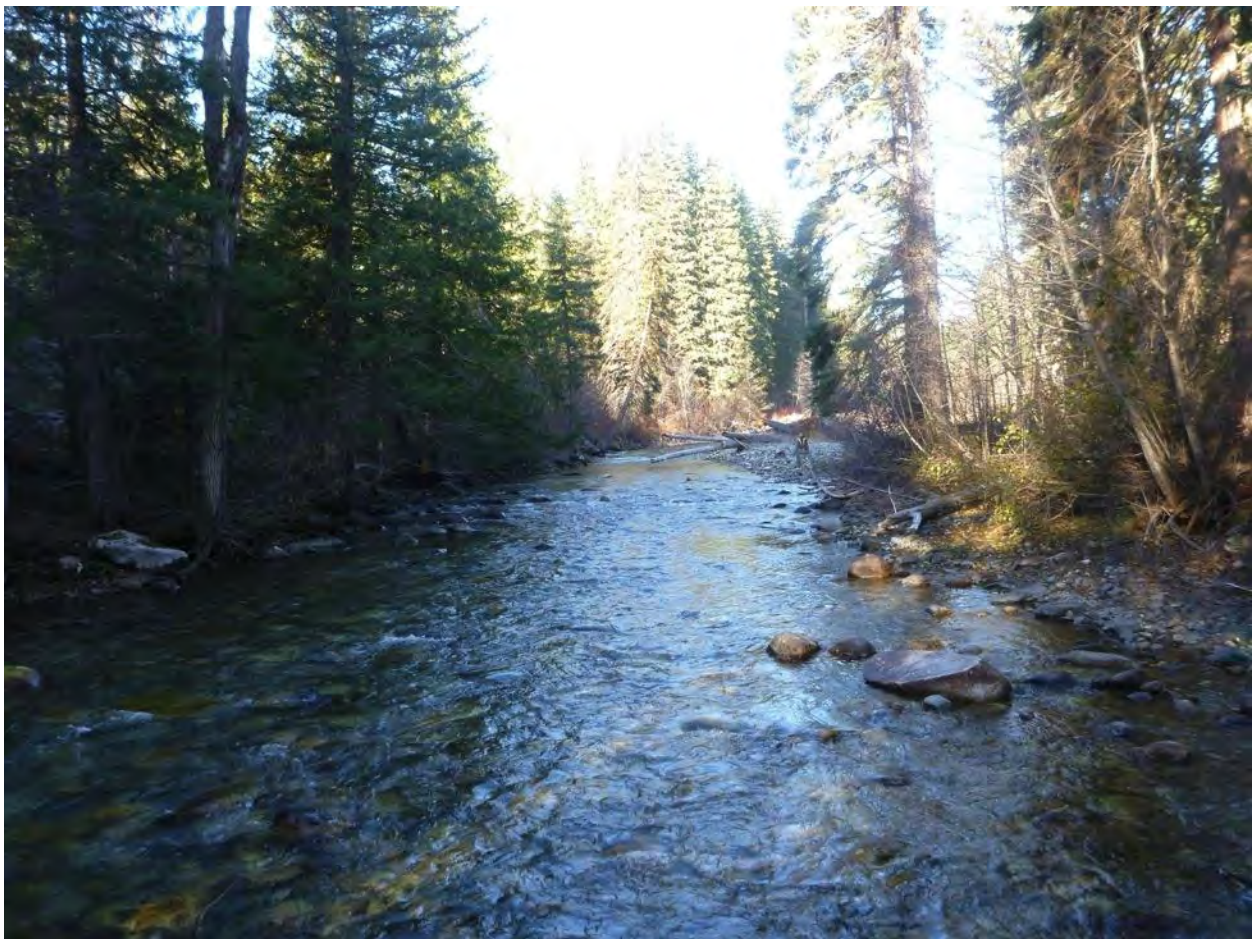
*Figure 82. A representative section of Reach 6 at RM 17.6.*

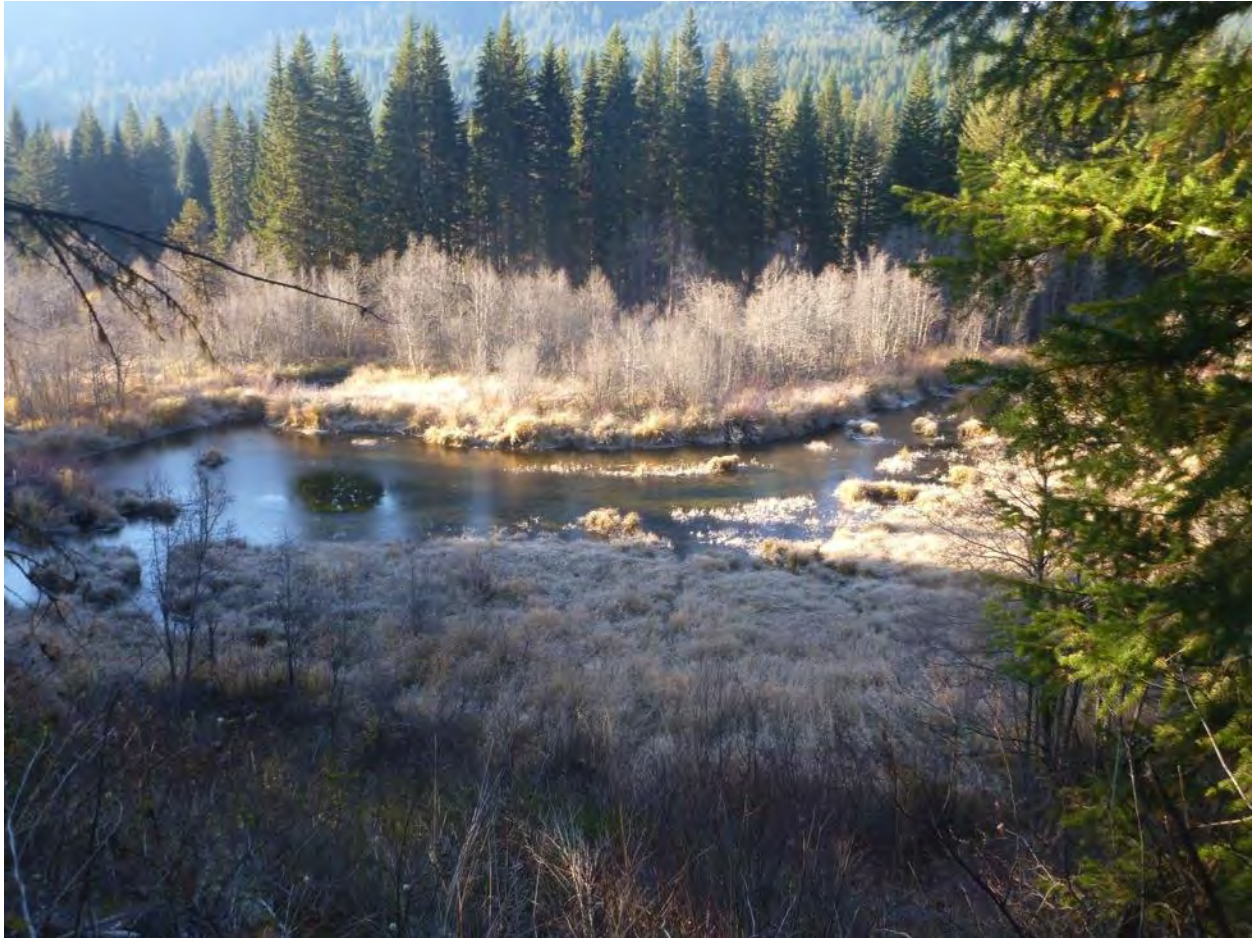
*Figure 86. Wetland complex along river-left at RM 16.6.*

There is a wetland complex along valley-left at RM 16.6, which are old channel scars and were 3 to 4 feet deep at the time of the survey (Figure 86). The water surface elevation is controlled by beaver dams and natural earth berms. The outflow location does not appear to have low flow surface

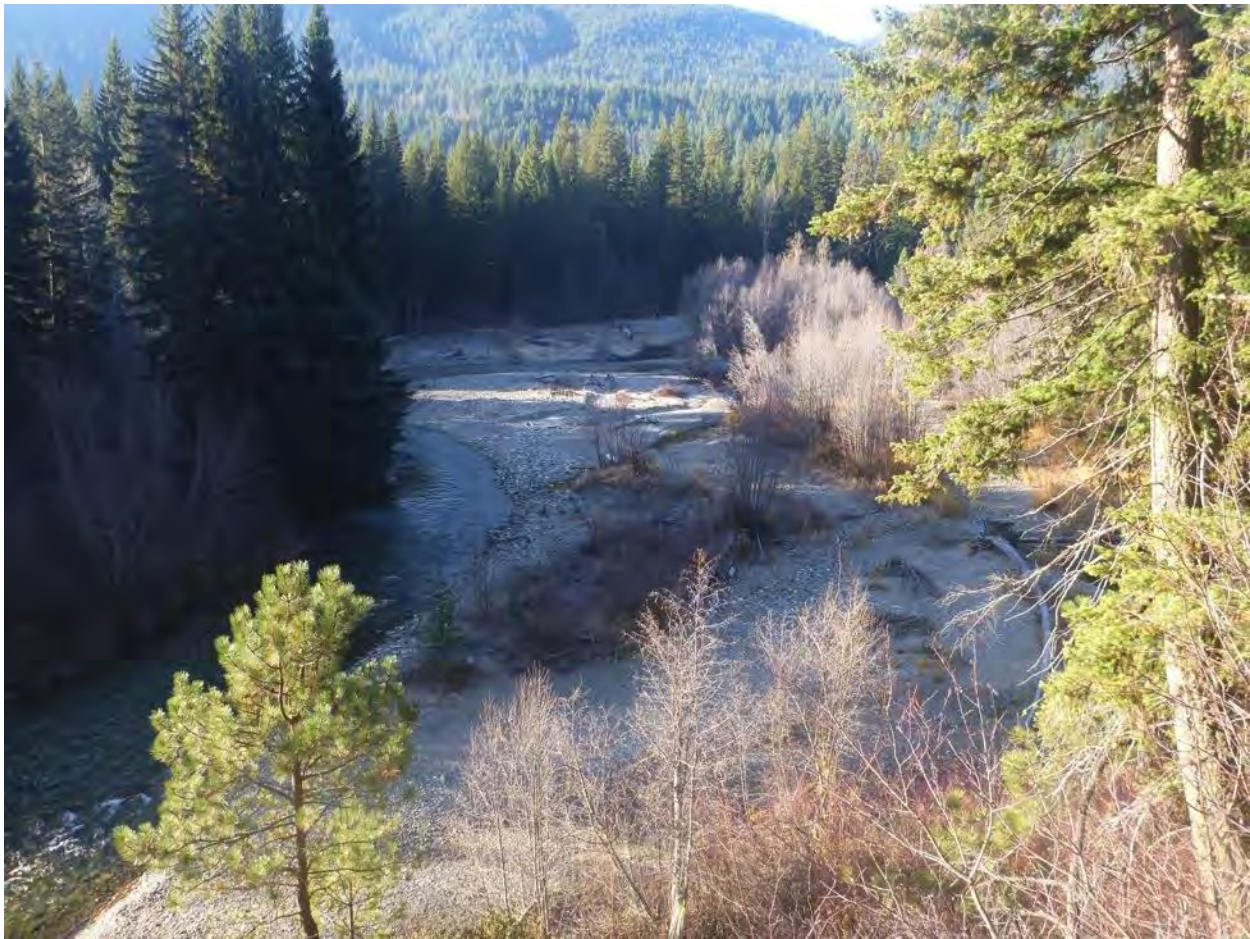
**Figure 89.** Looking upstream at RM 16.6, the highly dynamic nature of this portion of the reach is evidenced by the exposed gravels and high flow channels.

Bed substrate is dominated by cobble (55%), with gravel subdominant at 38%. Sources of sediment include War Creek and Eagle Creek, which periodically contribute debris flow deposits. Much of the material is derived from the modern floodplain surfaces along river-left, which are regularly eroded into through natural channel adjustment processes. During debris flows from river-right, these surfaces are rapidly eroded due to the influx of larger debris flow deposits from valley-right. Another source of sediment is the erosion into glacial deposits along river-left near RM 16.5. This erosion recruits large boulders that add complexity to in-stream habitat. The mid-channel bars are primarily composed of gravel and sand with little established vegetation on the exposed surfaces, indicating frequent scour (Figure 89).

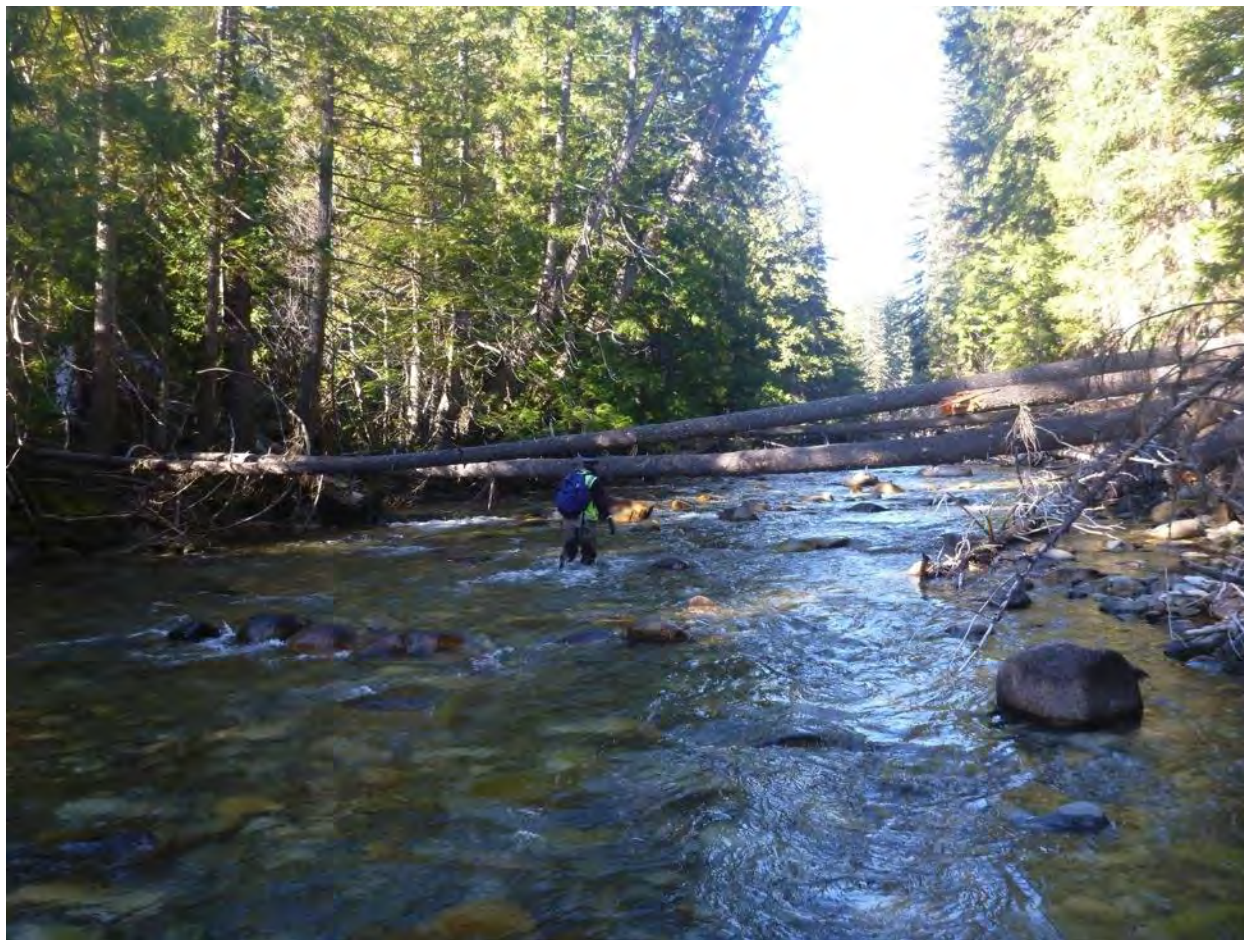
**Figure 90. RM 17.25 looking upstream. Channel spanning woody debris and highly vegetated banks that have the potential for future recruitment.**

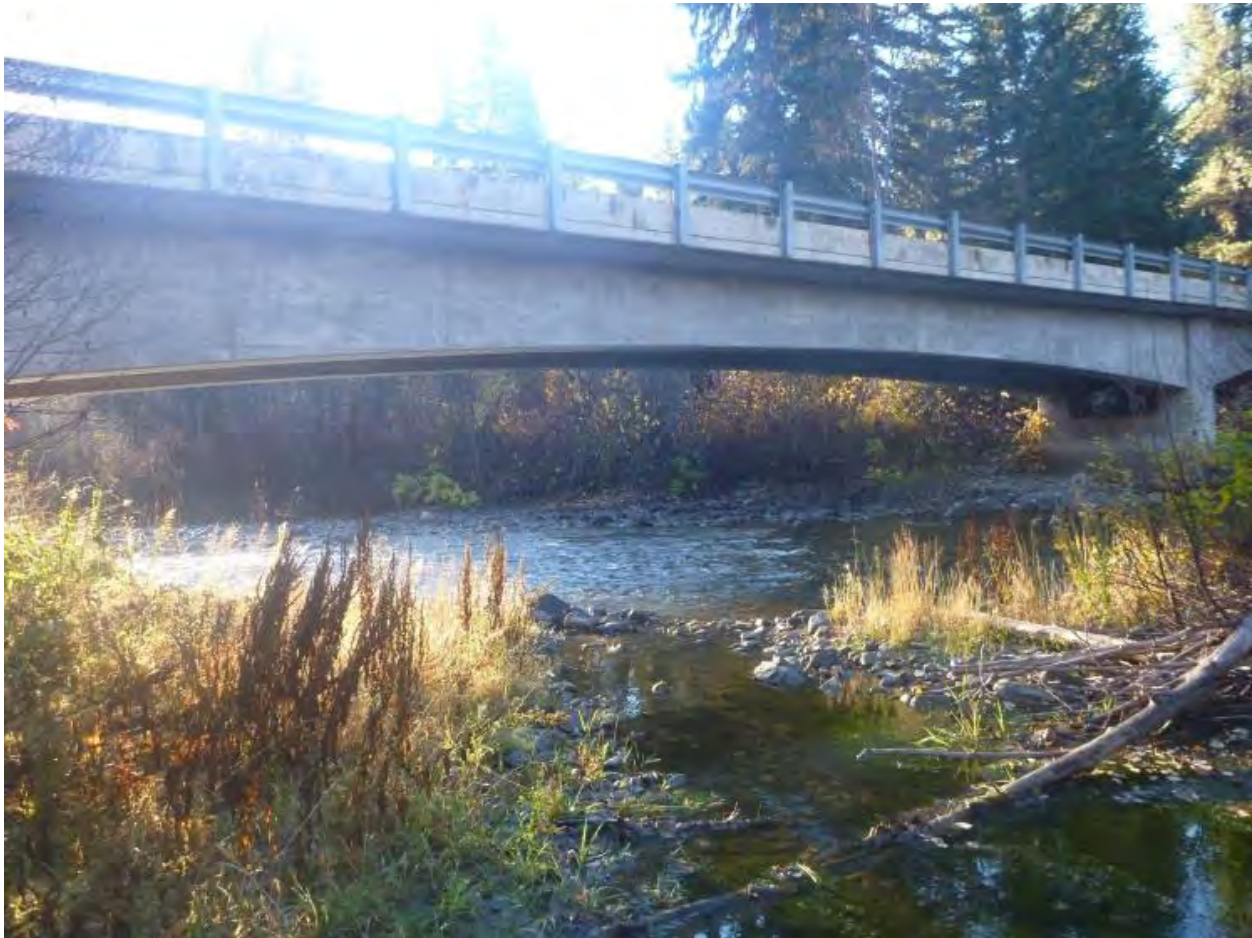
***Figure 92. Channel spanning bridge at RM 18.12, the upstream extent of this geomorphic study.***

The bridge at the upstream end of the reach affects floodplain function and channel migration (Figure 92). The primary impact on floodplain function is the fill associated with the north approach, which bisects the floodplain. There is a single undersized culvert under the road fill, but the upstream intake was unidentifiable and did not appear to be conveying flows effectively. High flows are currently routed along the upstream edge of the fill back into the channel at the bridge. The bridge also restricts channel migration and prevents natural planform adjustment. In addition to altering flow and channel migration patterns, the bridge and associated roadway is acting as a fine sediment input along river-right, with evidence of scouring flows in this location.
