# Middle Twisp River Reach Assessment & Restoration Strategy

SUBMITTED TO  
Yakama Nation Fisheries Program

FEBRUARY 2015

PREPARED BY  
Inter-Fluve, Inc.  
501 Portway Ave, Suite 101  
Hood River, OR 97031  
(541) 386-9003

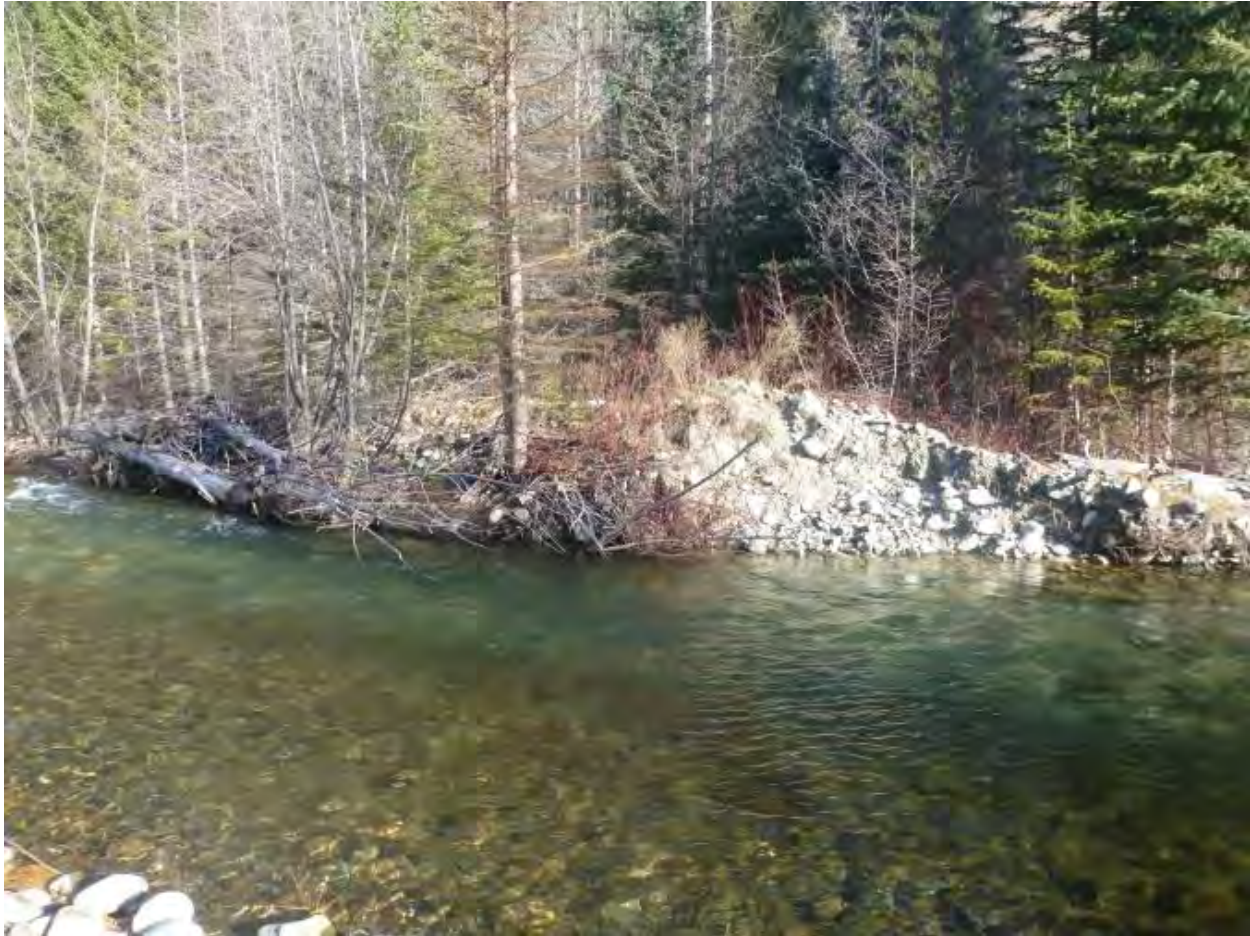
*Figure 93. The push-up levee on river left at RM 16.8 is composed of cobbles and sands.*

In the upstream portion of the reach in the river-left floodplain (from approximately RM 17.8 to 18), there has been clearing and grading for a gravel roadway (Figure 94). There is riprap along the toe to prevent erosion. This does not have a significant impact on channel or floodplain processes as it is located at the outside edge of the 100-year floodplain. Near RM 16.8, there is the remnant of a push-up levee. The push-up levee was breached during the channel avulsion at this location.

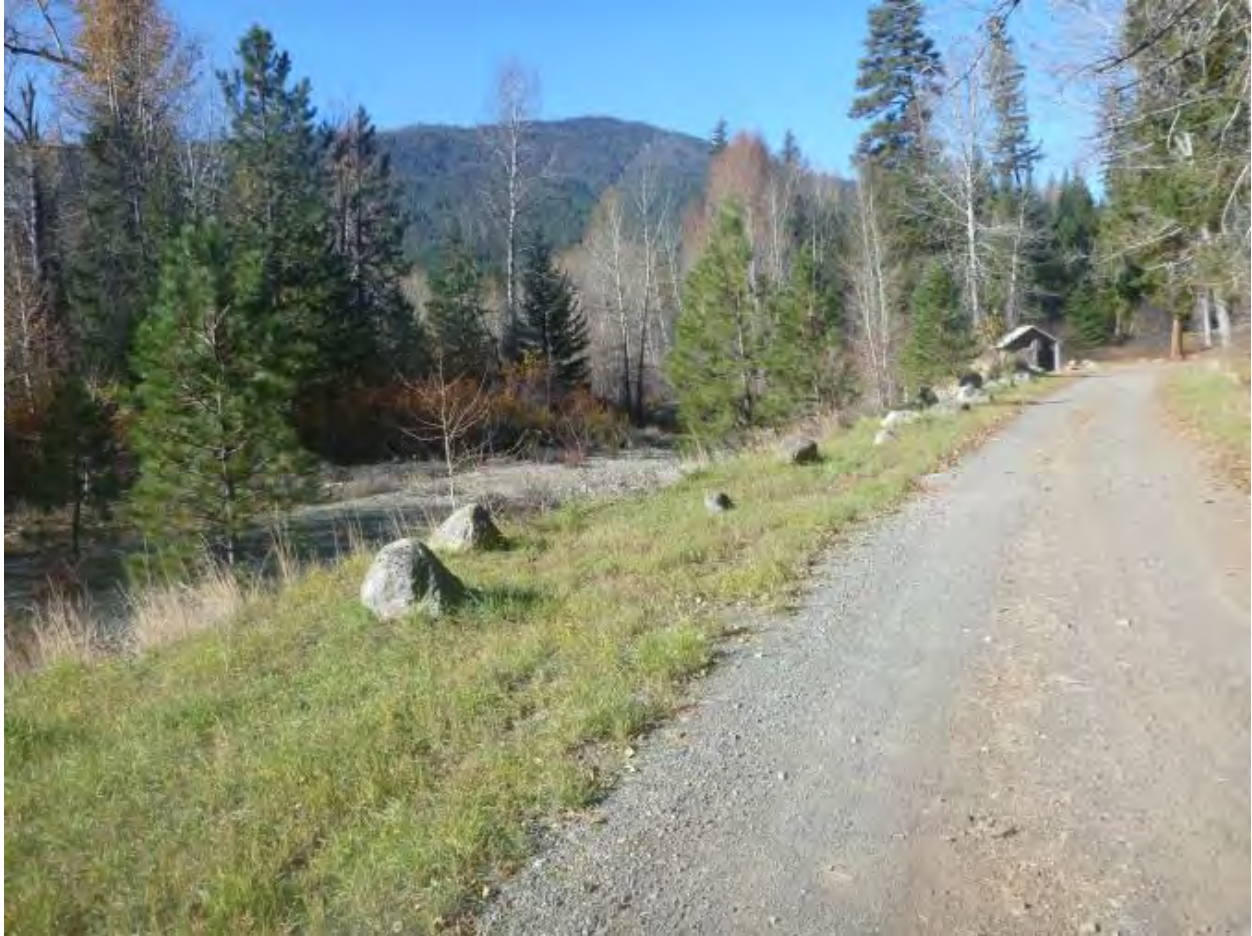
***Figure 94. Gravel road and clearing and grading along river left corresponding to RM 17.8 to 18.0***

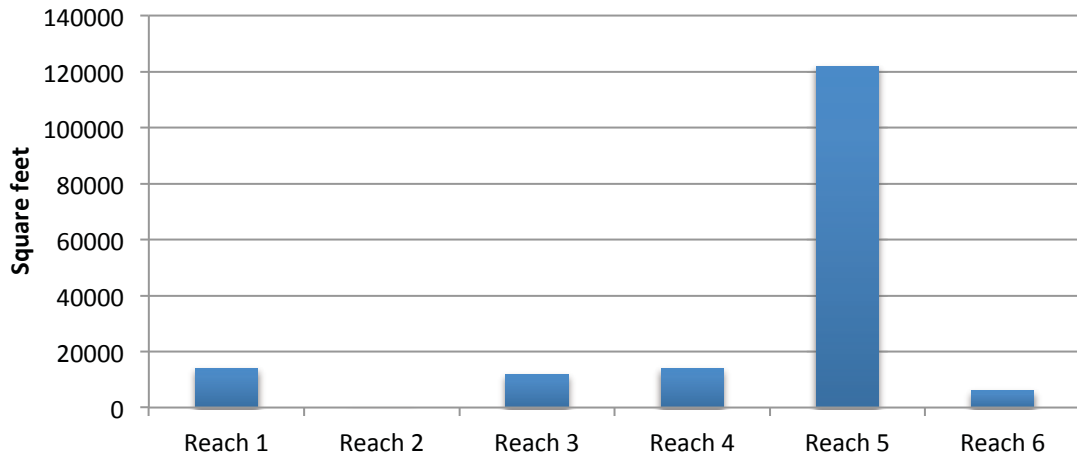
Figure 5. Side channel habitat area by reach. Reach 5 accounted for 73% of the side channel habitat area.

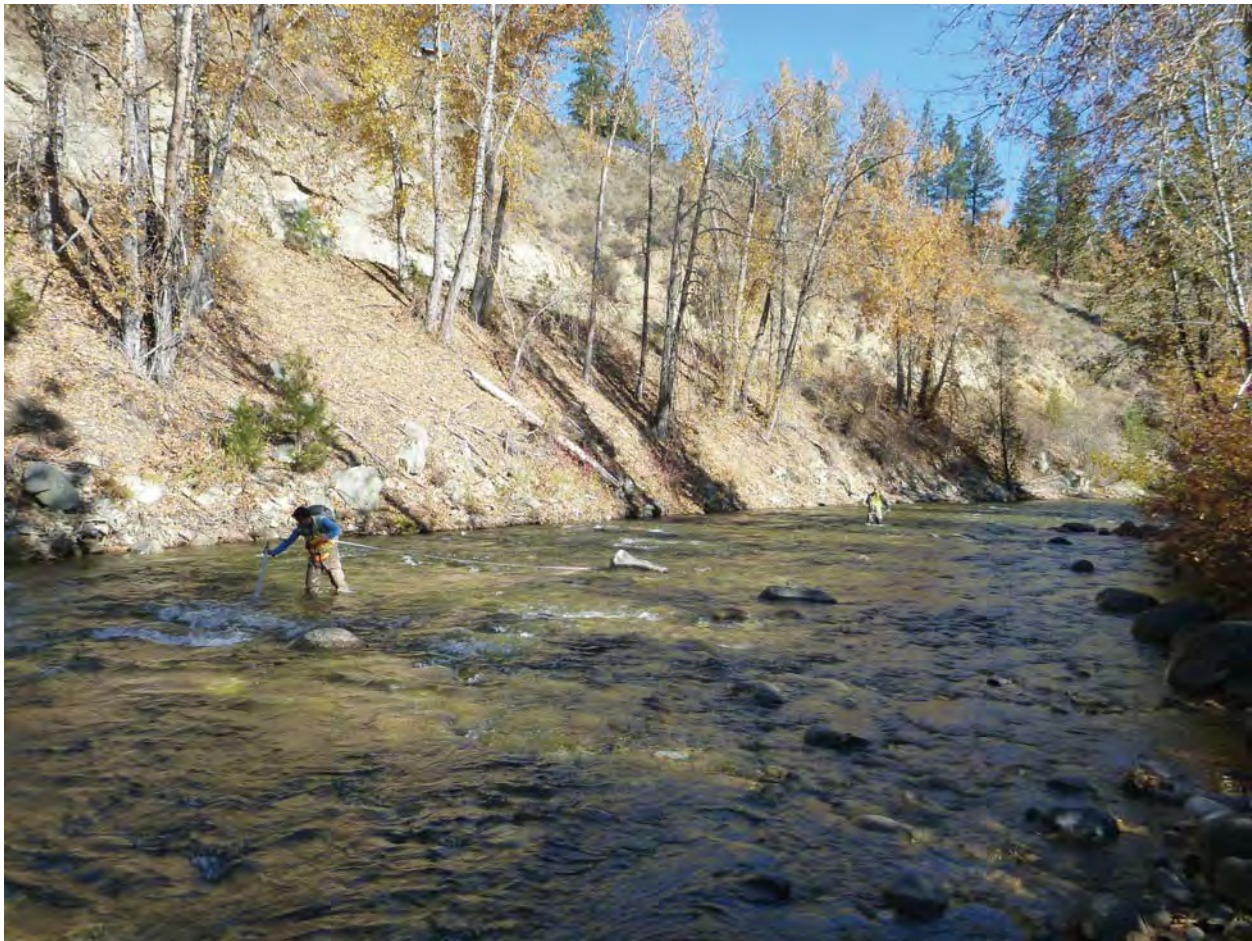
**Figure 12. Representative view of a Reach 1 riffle. Riffles composed 74% of the reach.**

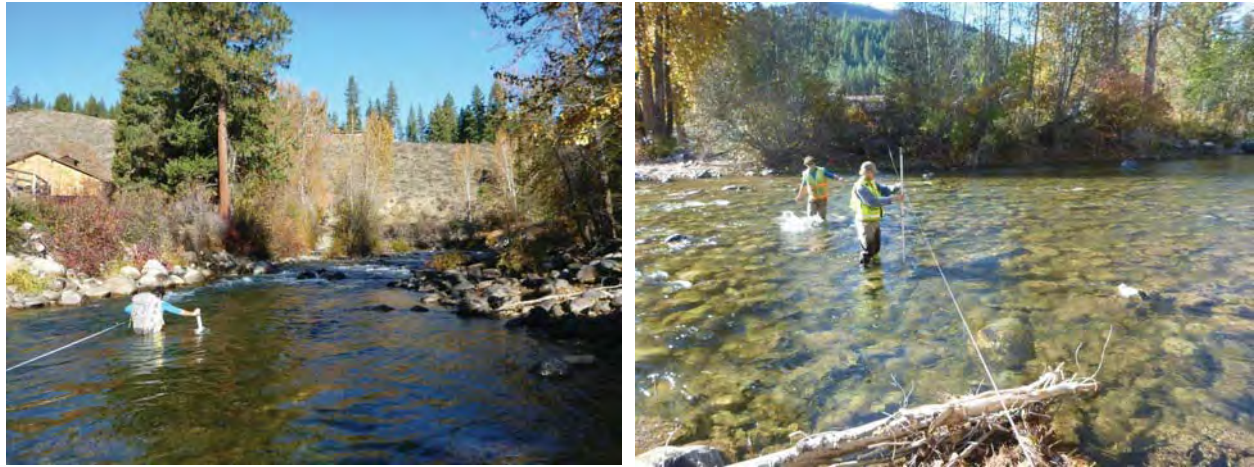
Figure 16. One of five pools in Reach 1 at RM 7.95 (left). Measuring bankful width (right).

Five pools were observed in Reach 1, composing 12% of the habitat area (Figure 14) and averaging 3.7 pools/mile (the entire study area averages 7 pools/mile). None had high-quality habitat. All had substrate that is relatively large and 80% had residual depths of under 3 feet (Figure 16). Eighty percent of the pools do have large woody material in the channel to provide complexity and cover. Pools occur at a mean spacing of 15.8 bankfull channel widths/pool in Reach 1 – nearly the same as the study area average of 15.4 bankfull channel widths/pool. Average residual pool depth was 2.4 feet with a maximum residual depth of 3.2 ft.

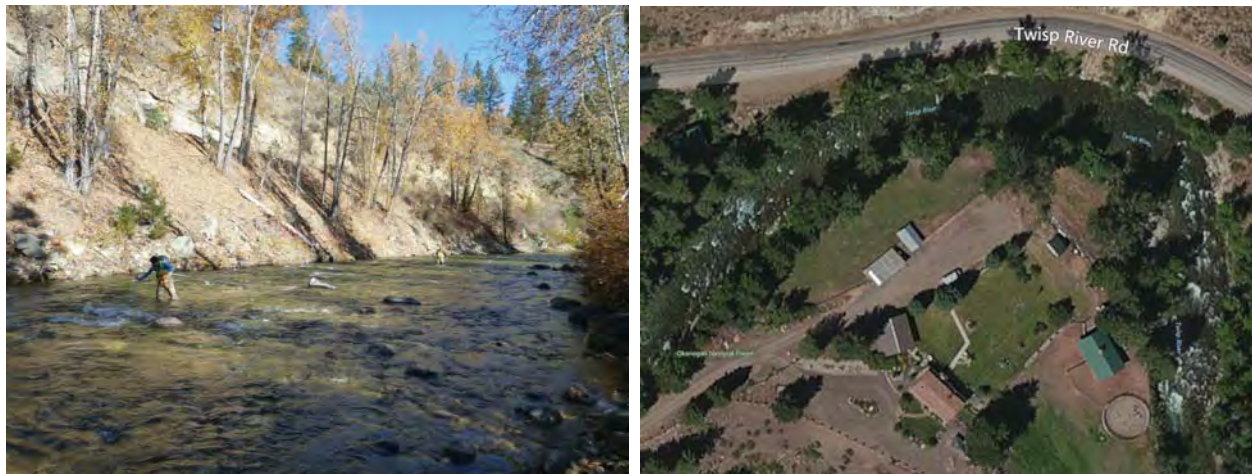
**Figure 20. Reach 1 is bordered on the north by the Twisp River Rd and on the south by several residences. The reach is relatively fast moving with little wood retention. Both images taken at RM 8.1.**

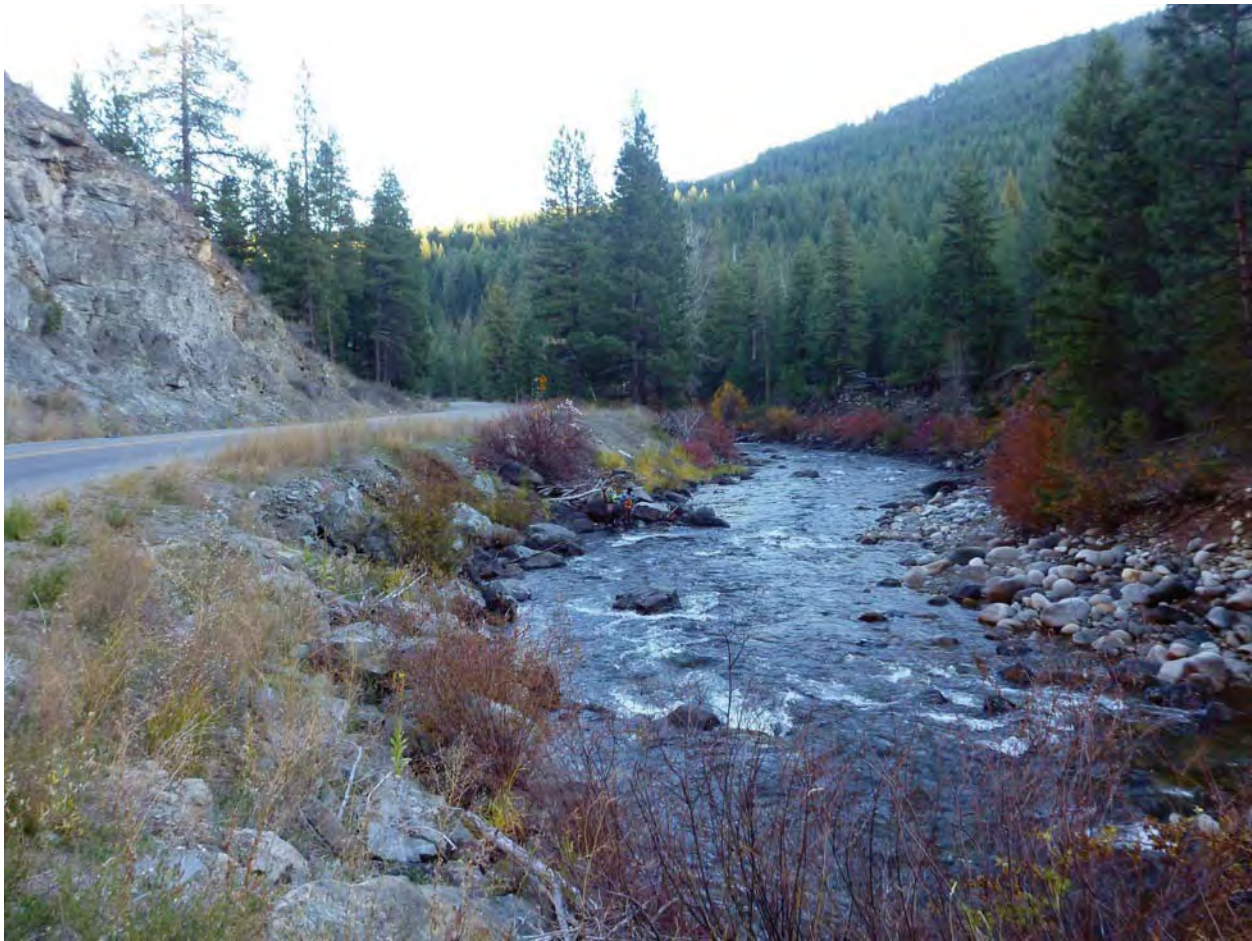
**Figure 22.** Downstream view of a riffle in Reach 2 with high percentages of boulders.

Reach 2 was the shortest reach in the study area. It is a high gradient reach, largely constrained by road on the north (left side of photo in Figure 22) and residential housing with push-up levees and rip-rap on the south side of the river. Fast water units (glides and riffles) comprised 99% of the reach area habitat (Figure 24). Only one pool was identified in the Reach, accounting for 1% of the reach area. No side channels were present in this reach.

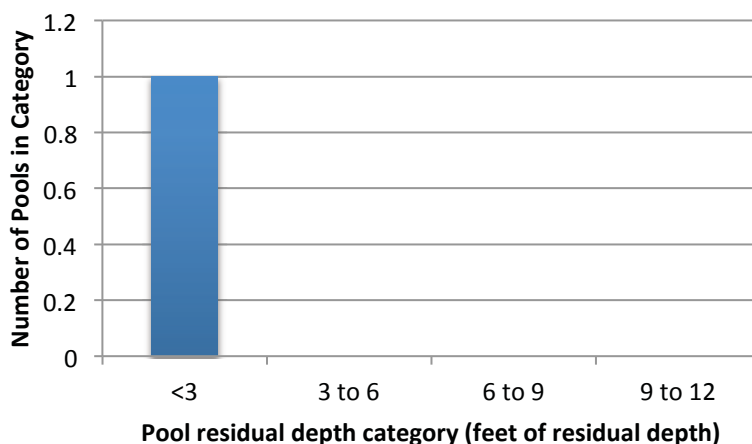
Figure 25. Residual pool depth and total count of pools in reach 2.

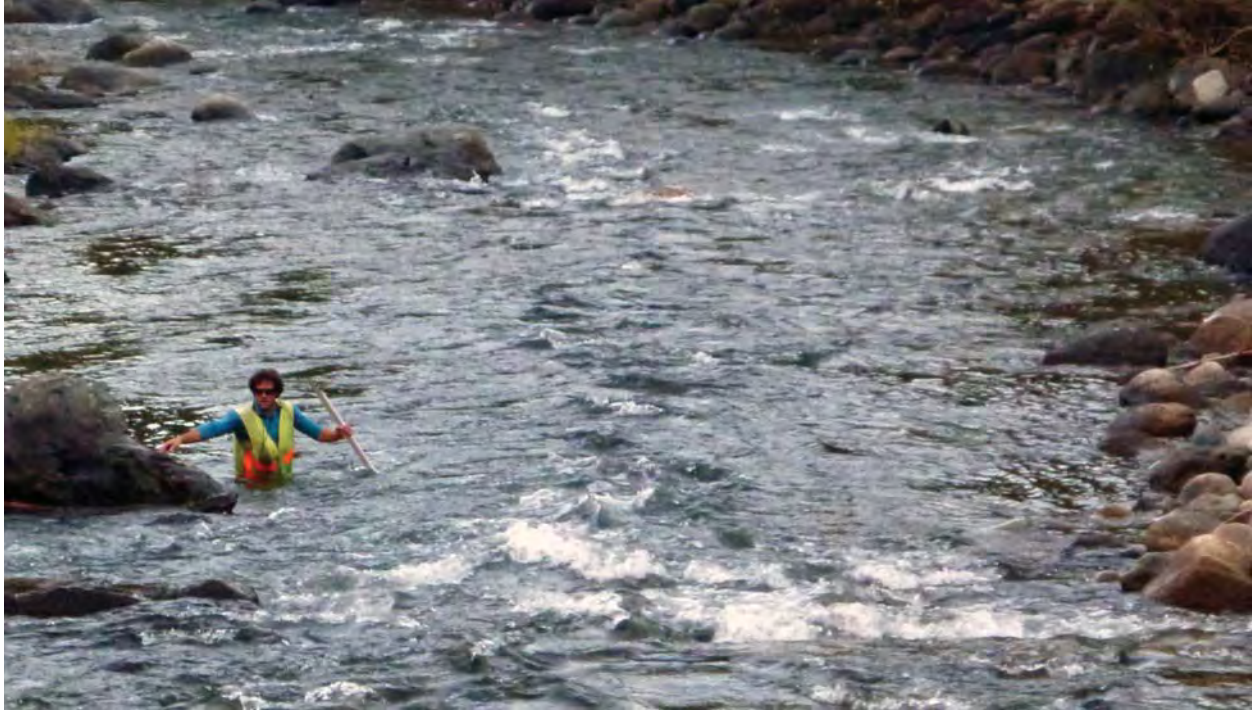
**Figure 26.** A relatively high-gradient reach, only one pool was identified in Reach 2. While the residual depth qualified this unit as a pool, due to fast current, large substrate, and no wood or cover, this pool is not representative of good habitat.

One pool was identified in Reach 2, equating to a pool frequency of 1.54 pools per mile (compared to a study area average of 7 pools/mile). While the pool did have a residual depth of 2.7, it was not exemplary of good salmon habitat (Figure 26) due to fast current, large substrate, and no wood or significant cover. Reach 2 had a frequency of 36.8 channel widths/pool (verses the average of 15.4 channel width/pool observed within the study area).

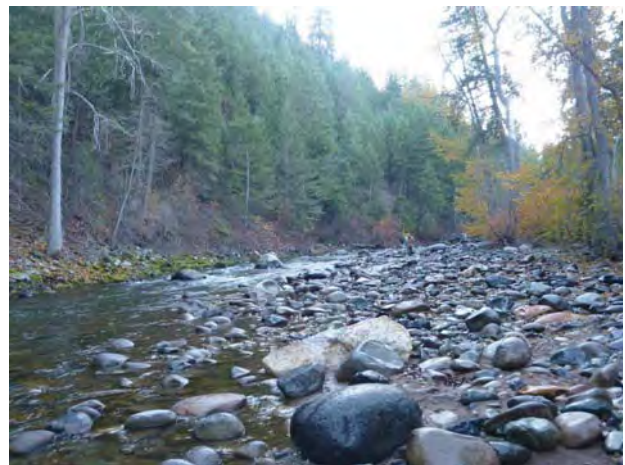
Figure 30. Upstream and downstream photos at RM 9.33 show large cobbles and boulders.

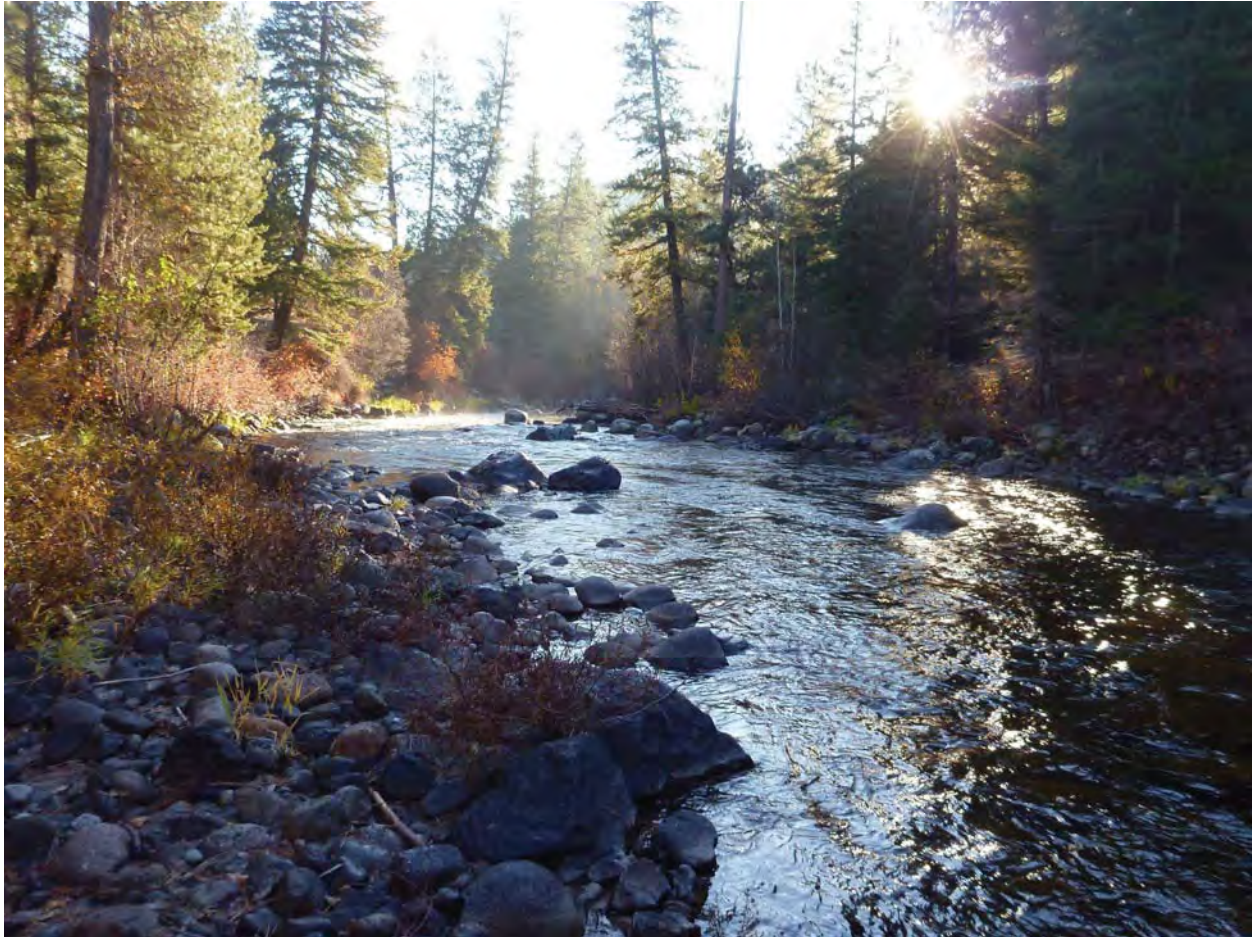
**Figure 32. Representative view of a Reach 3 glide.**

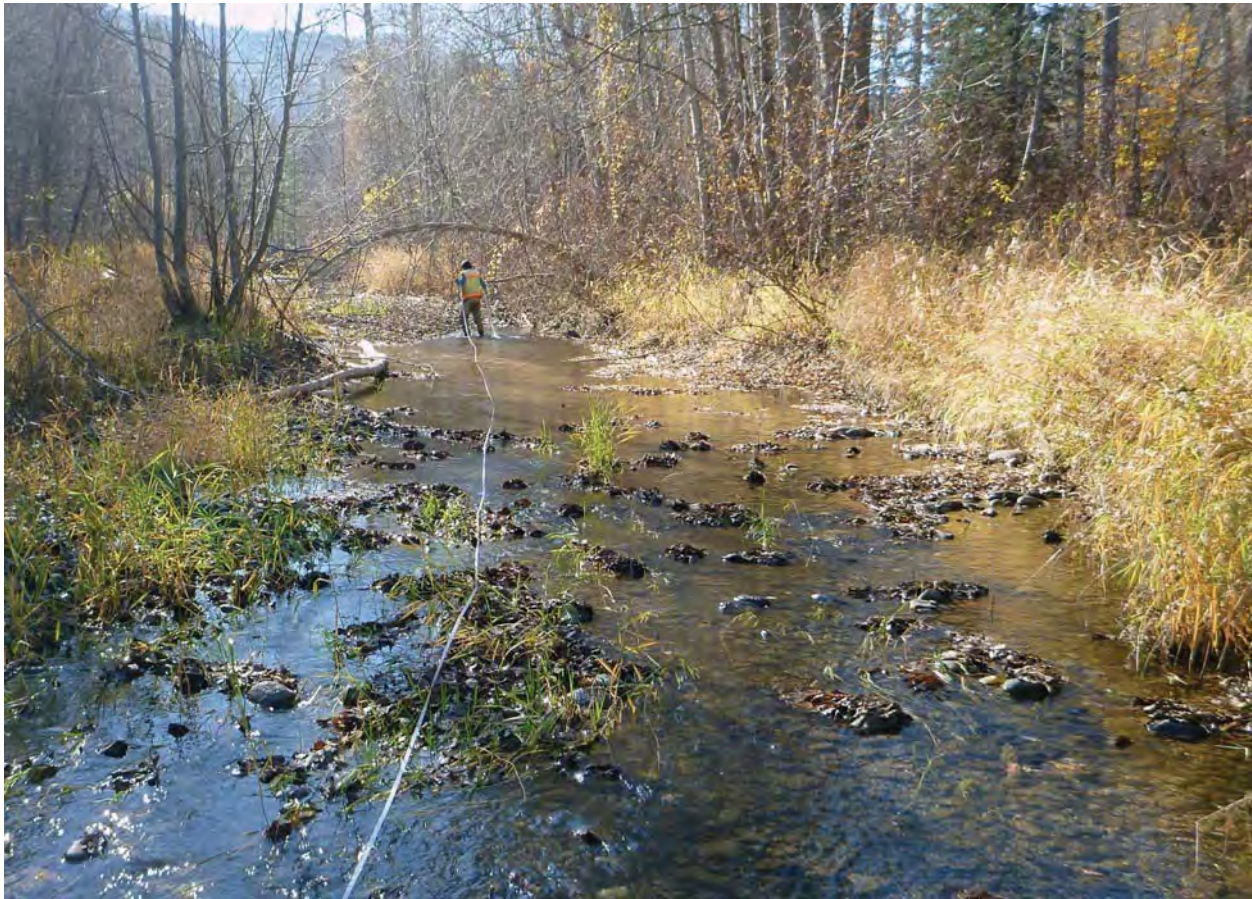
*Figure 37. Reach 3 had 765 feet of side channel. Above is an image a 505-ft-long side channel that enters the Twisp River at RM 10.35*

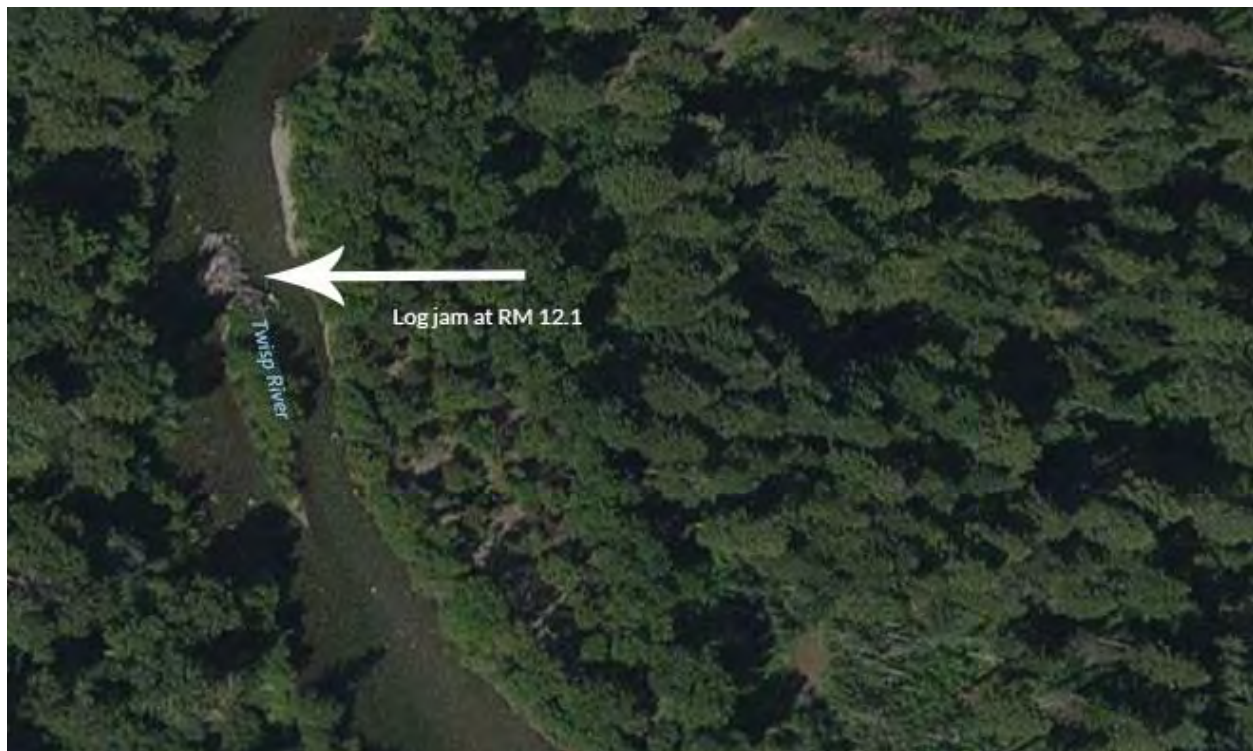
**Figure 38. Two log jams were present in Reach 3. This apex log jam at RM 12.1 had 10 medium and 25 small pieces of wood.**

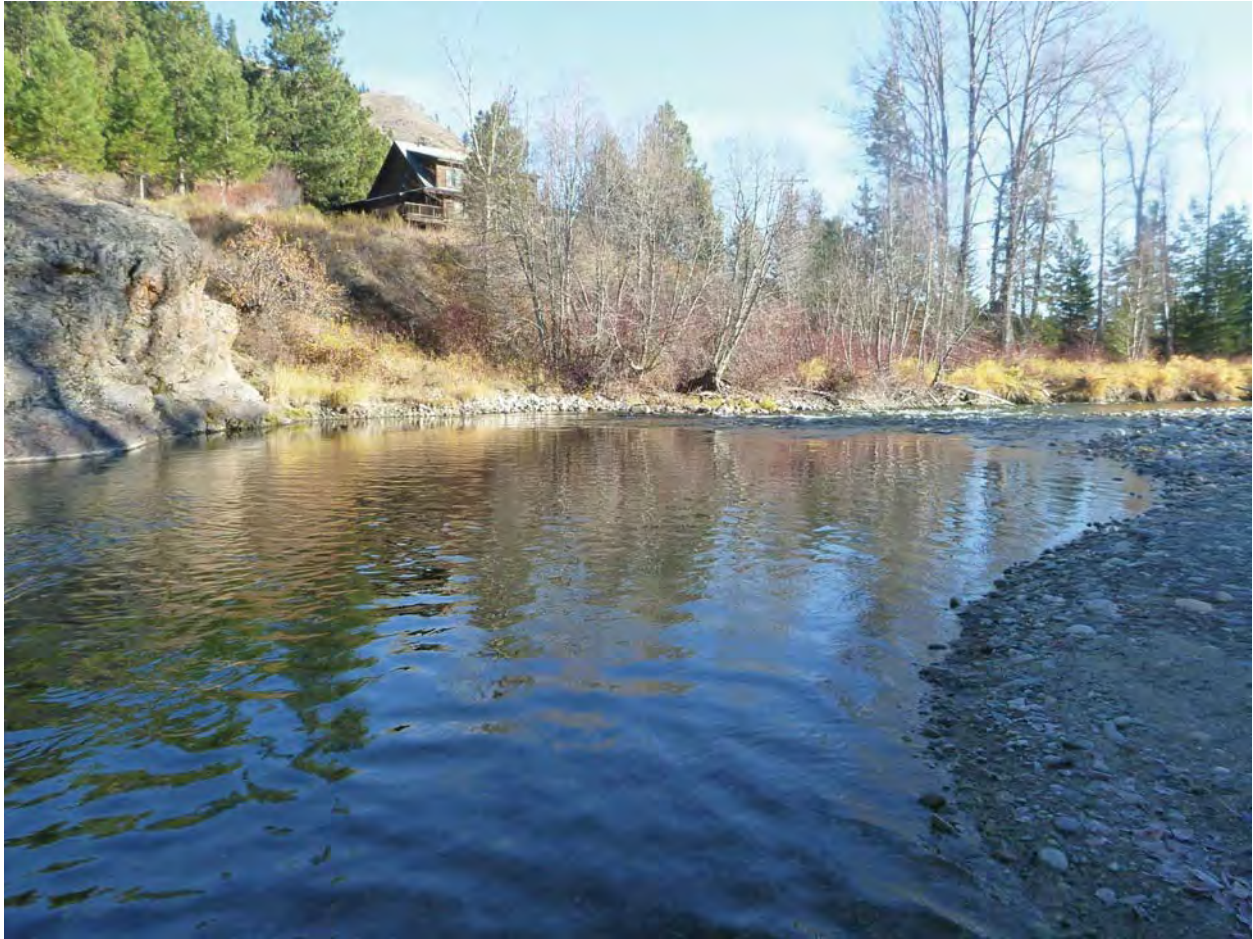
*Figure 43. Looking upstream at a 9-foot-deep pool at RM 12.55 in Reach 4.*

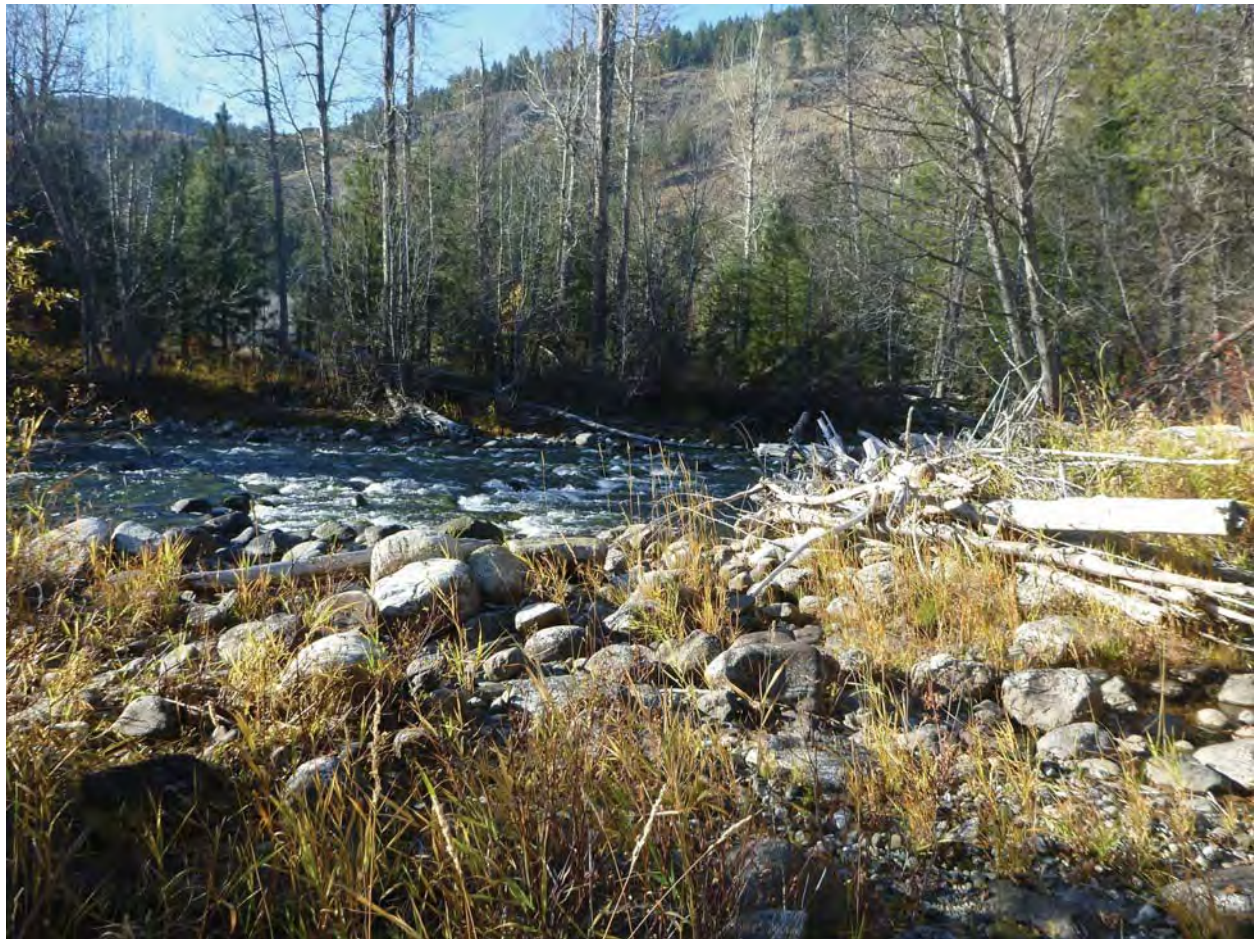
*Figure 48. Slow-moving side channel at RM 12.77 with apex log jam at the upstream end.*

Side channels in Reach 4 accounted for 2% of the habitat area of the reach. A total of four side channels were identified with 5 pieces of wood total. An apex log jam was identified at the upstream end of the RM 12.77 side channel (Figure 48). The RM 13.4 side channel also had a log jam at its upstream end,

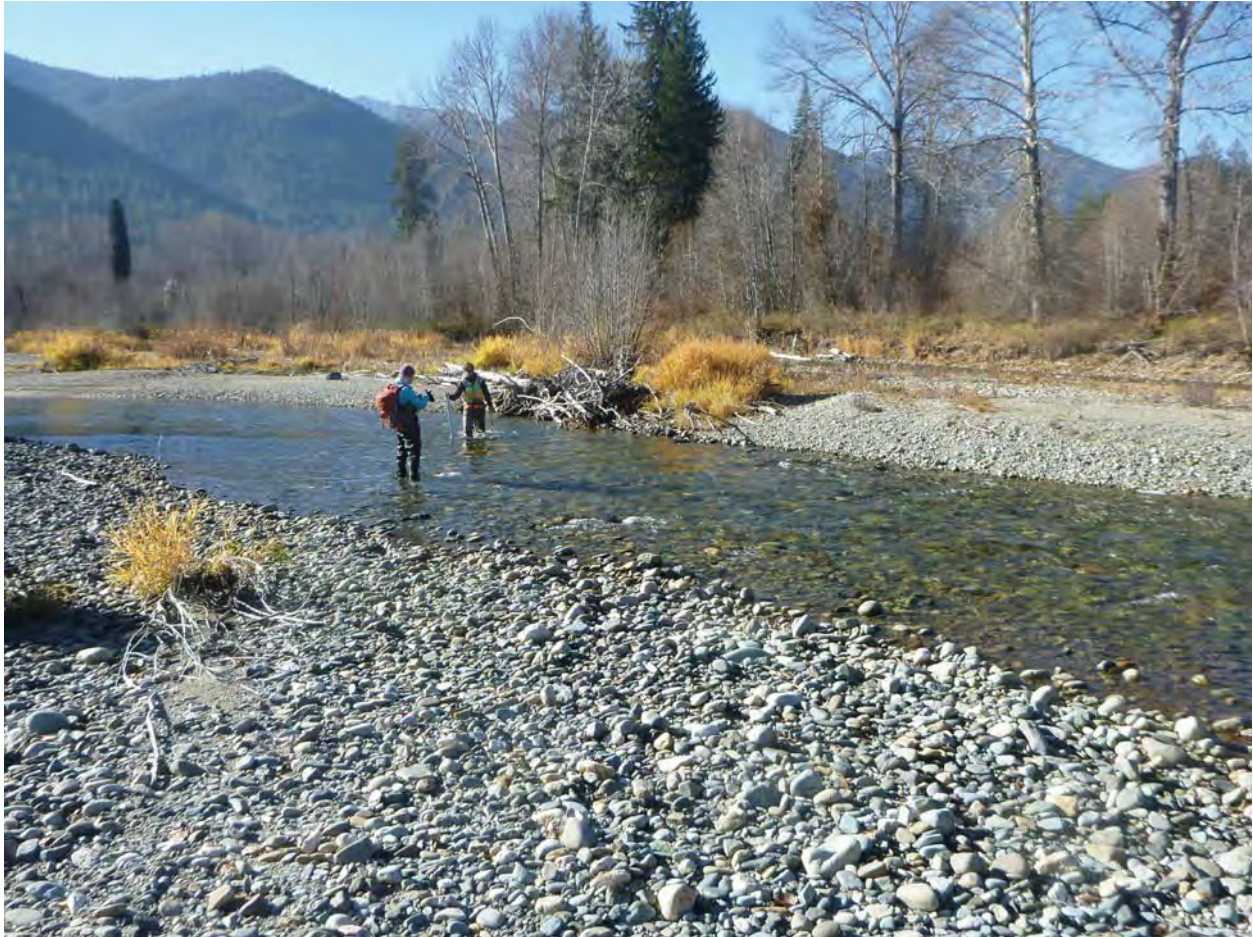
***Figure 53. Reach 5 is a lower gradient, highly braided reach with vastly improved habitat characteristics compared to lower reaches in this study area.***

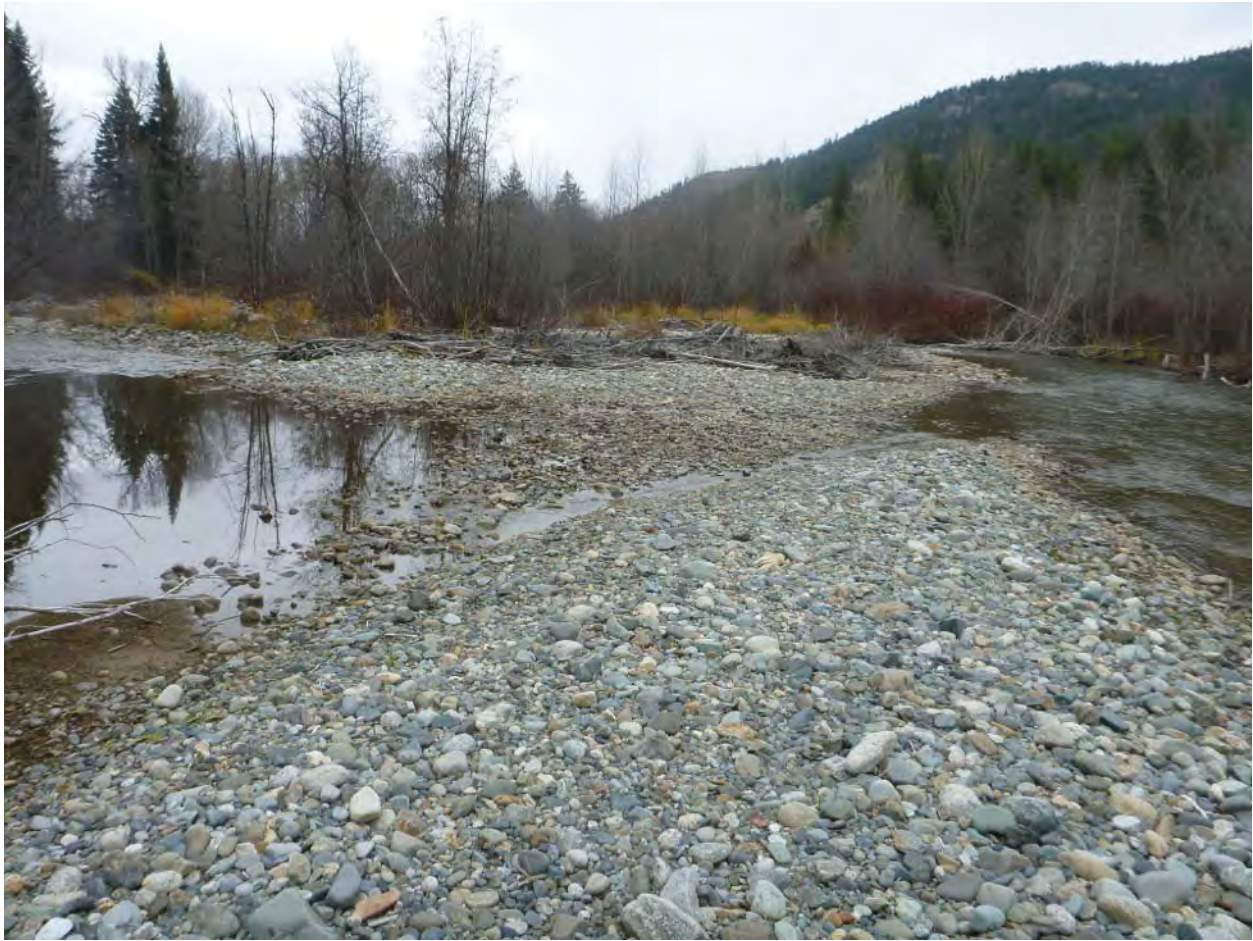
*Figure 56. Bankfull widths varied from 48 – 200 feet in Reach 5. The above photo is taken near RM 15.4 where the bankfull width was recorded at 200 feet.*

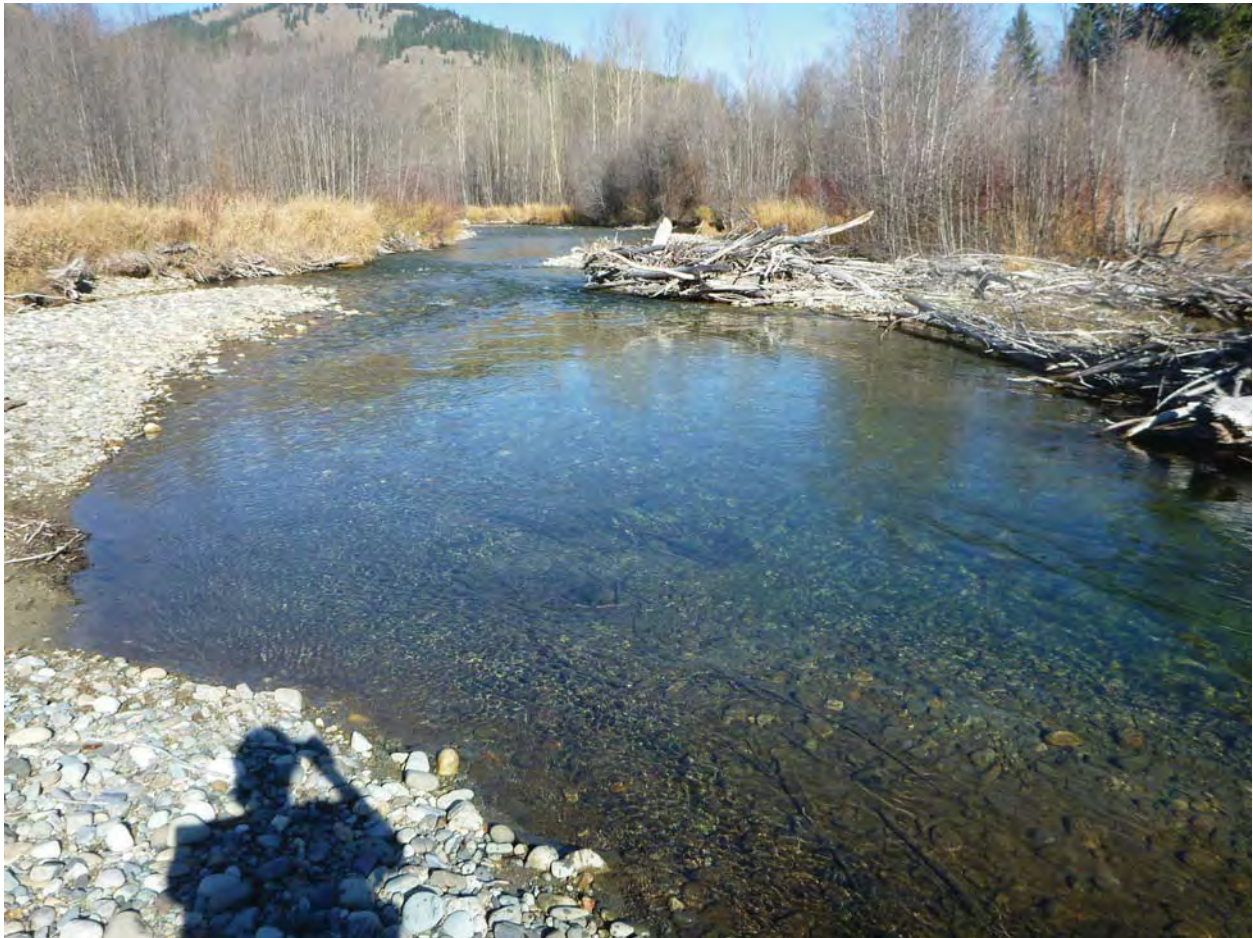
**Figure 58.** Looking downstream at a six-foot deep pool at RM 14.35. Note side channel entering on river right.

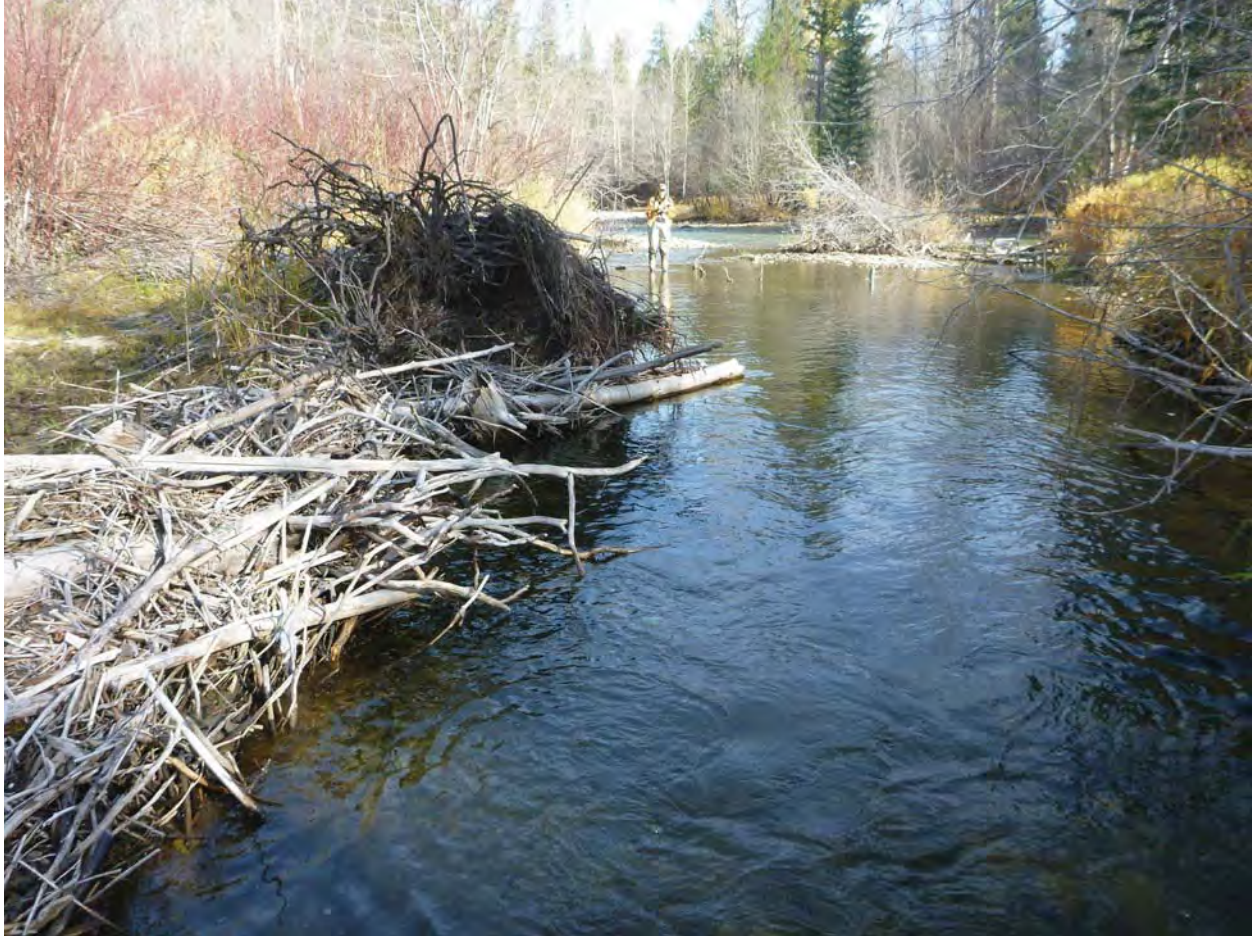
*Figure 60. Downstream end of 4956-foot side channel that exits at RM 13.65. While there was significant wood throughout the channel (see left of photo), most of the wood was not long enough to quantify as small wood. As a result, only 34 pieces of wood quantified as LWD.*

Reach 5 had the most side channel habitat area within the study area. Nineteen side channels were identified, accounting for 18% of the habitat area (Figure 55) within the reach. In total, side channels measured 3 linear miles. Of the 19 side channels, 18 were slow-water side channels and 1 was a fast-water side channel. Reach 5 had the longest side channel, measuring nearly a mile (4956 feet). While this channel had significant wood accumulation throughout the channel, only a fraction of the wood (34 pieces) quantified as LWD. Much of the wood was slightly shorter than the minimum length for a small piece of LWD and thus was not counted.

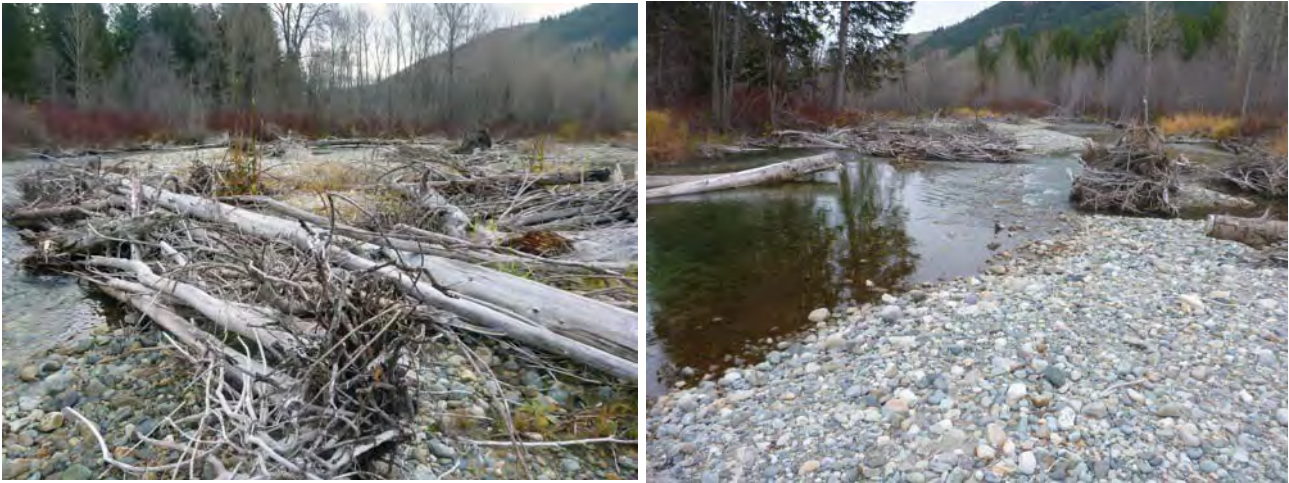
***Figure 61. Significant portions of wood were observed in SO 181 that appeared to have been cut instream just upstream of where this photo was captured.***

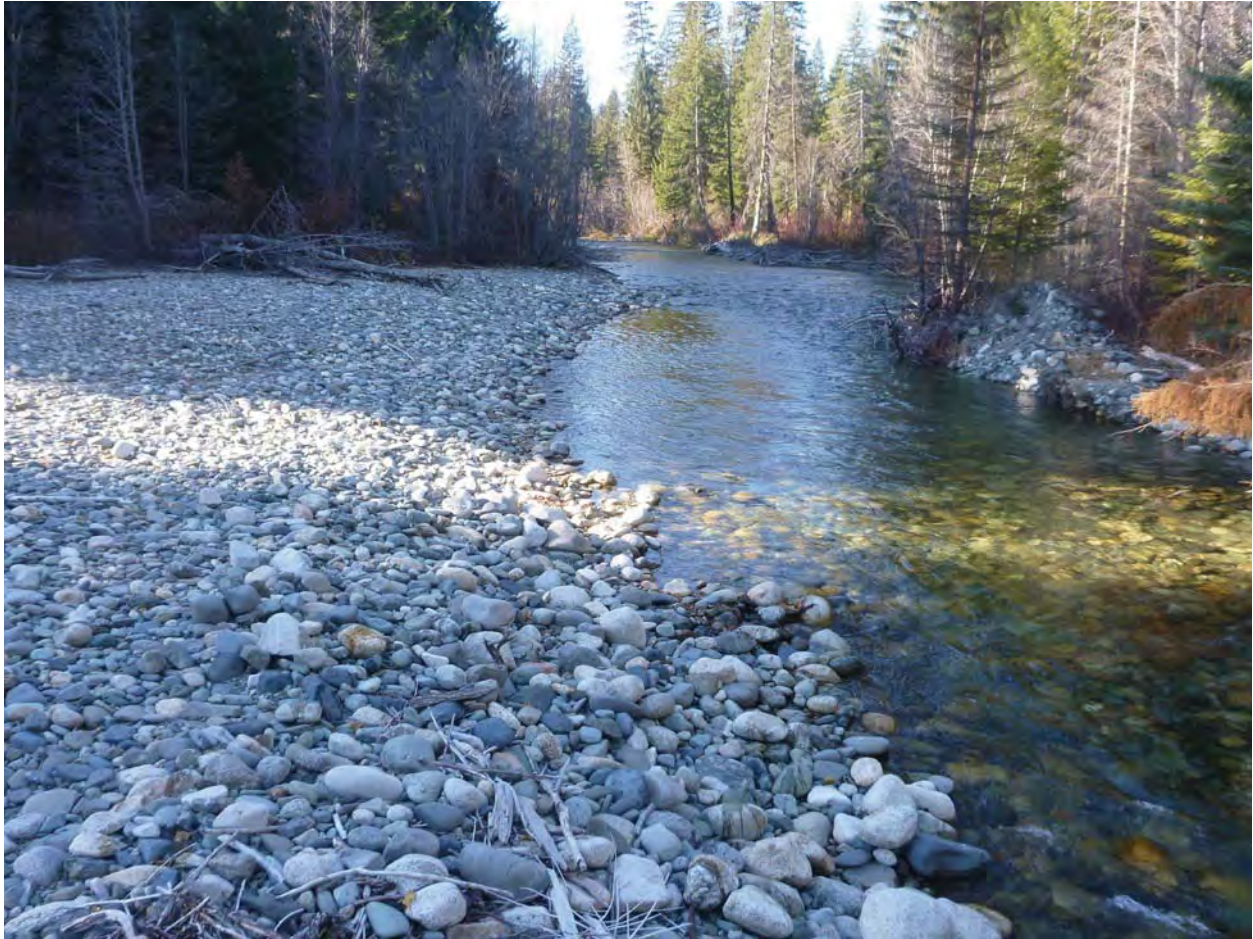
**Figure 66.** Reach 6 had 15 pools translating into 7.7 pools per mile. While pools were prevalent, they were relatively short in length, many only slightly longer than the channel width. Note the pool/glide/pool sequence at RM 16.9.
