# Middle Twisp River Reach Assessment & Restoration Strategy

SUBMITTED TO  
Yakama Nation Fisheries Program

FEBRUARY 2015

PREPARED BY  
Inter-Fluve, Inc.  
501 Portway Ave, Suite 101  
Hood River, OR 97031  
(541) 386-9003

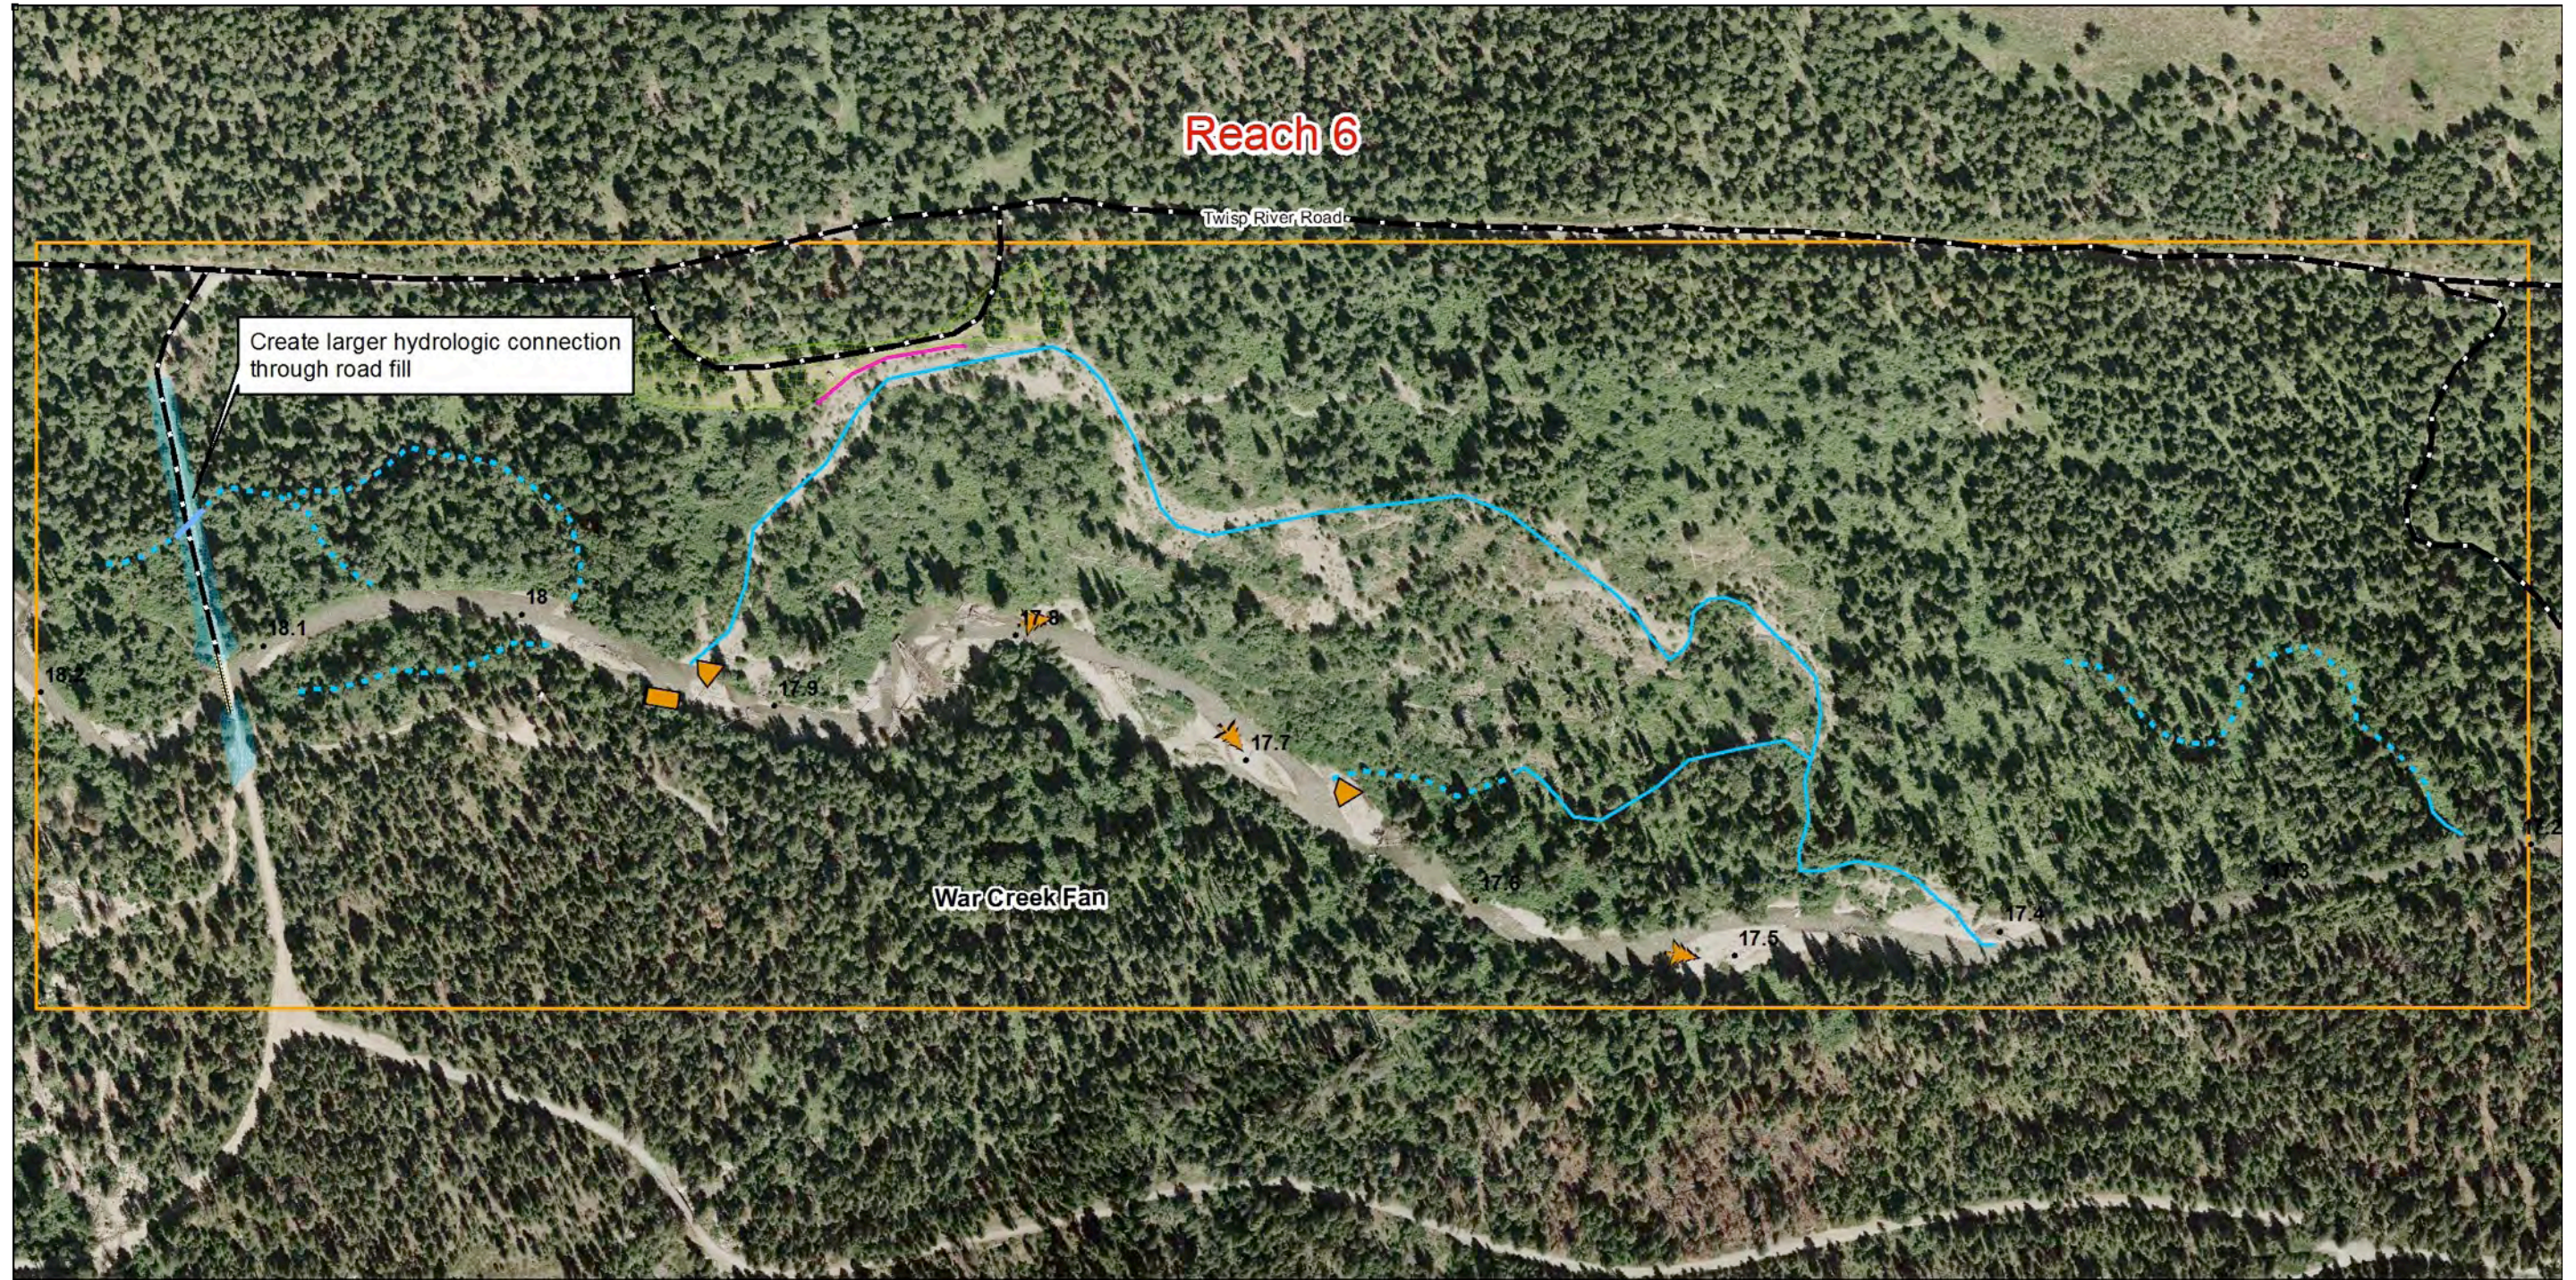
**Middle Twisp Reach Assessment**  
*Project Opportunities*  
**War Project**

These drawings should be viewed only as very preliminary concepts intended to describe the types of potential restoration work that could be performed. Additional site investigations and analysis will be necessary to determine specific treatment types and locations.
