Translocation of Adult Pacific Lamprey within the Yakima Subbasin, 2017-2018 Broodstock

Project No. 2008-470-00

Ralph Lampman

**Confederated Tribes and Bands of the Yakama Nation
Yakama Nation Fisheries Resource Management Program, Pacific Lamprey Project
P. O. Box 151, Toppenish, Washington 98948, USA**

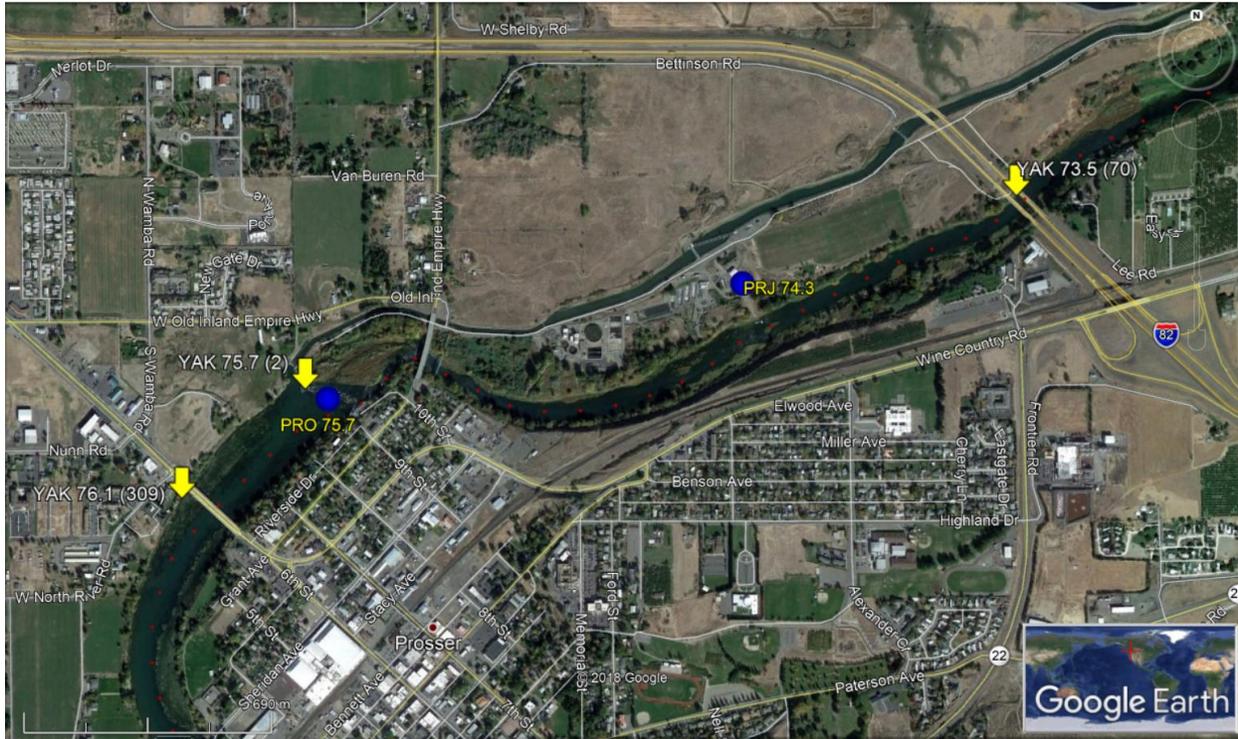
Figure 2. Aerial map of Pacific Lamprey translocation release sites (yellow arrows) in the Lower Yakima River. “YAK” stands for Yakima, the number next to the stream abbreviation is the river km, and the number in parenthesis is the total number of lamprey released. Also shown with the blue circles are the PIT tag array locations, including the location of Chandler Juvenile Monitoring Facility (PIT arrays are located on each of the three fish ladders at the dam). The red dots indicate 0.1 km segments of the Yakima River.

In the Lower Yakima River, there were three release sites: 1) 70 lamprey were released at river km 73.5 downstream of Prosser Dam (left bank looking downstream) on April 12 and May 3, 2018 (35 lamprey each); 2) 2 lamprey were accidentally dropped within Prosser Dam Left Fish Ladder at river km 75.7 on May 16, 2018; and 3) 309 lamprey were released at river km 76.1 upstream of Prosser Dam on March 22, April 21, May 7, May 8, May 11, May 15, and May 21, 2018) (Fig. 5).

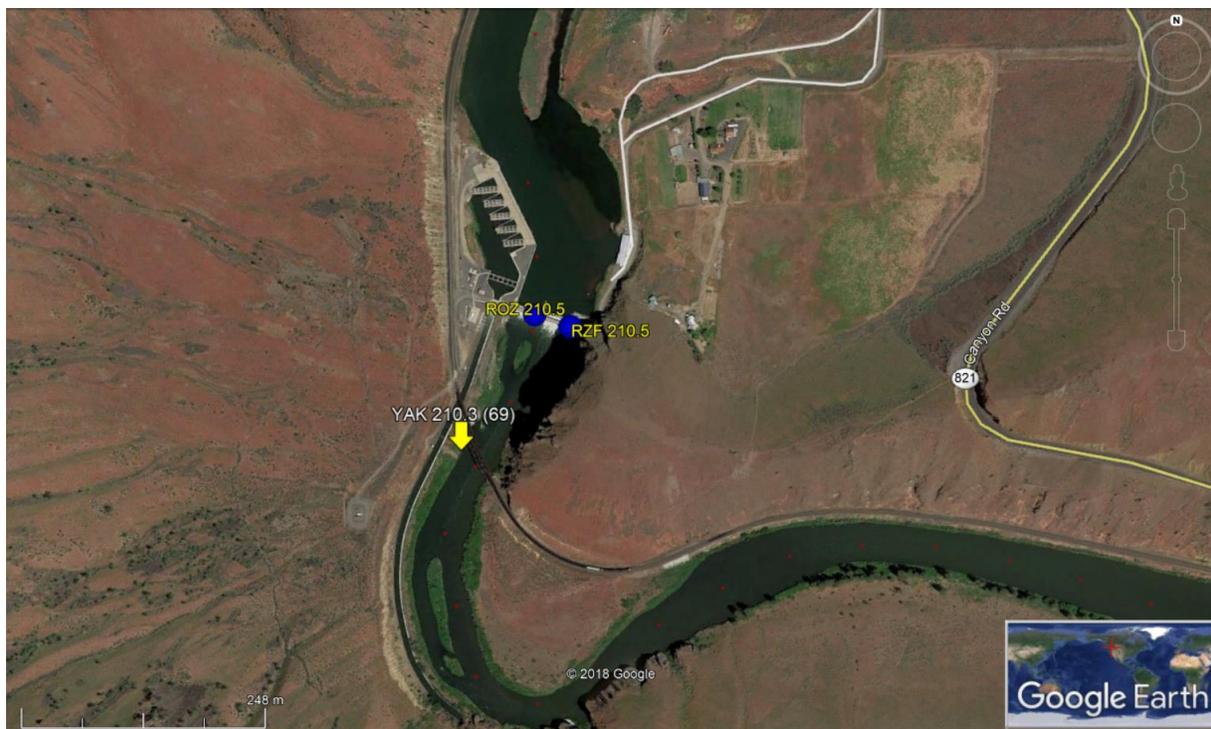
Figure 3. Aerial map of Pacific Lamprey translocation release sites (yellow arrows) in the Upper Yakima River. “YAK” stands for Yakima, the number next to the stream abbreviation is the river km, and the number in parenthesis is the total number of lamprey released. Shown with the blue circles are the PIT tag array locations. The red dots indicate 0.1 km segments of the Yakima River.

There was one release site in the Upper Yakima River: 1) 35 and 34 lamprey were released at river km 210.3 on April 26, 2018, and May 15, 2018 (Fig. 6).

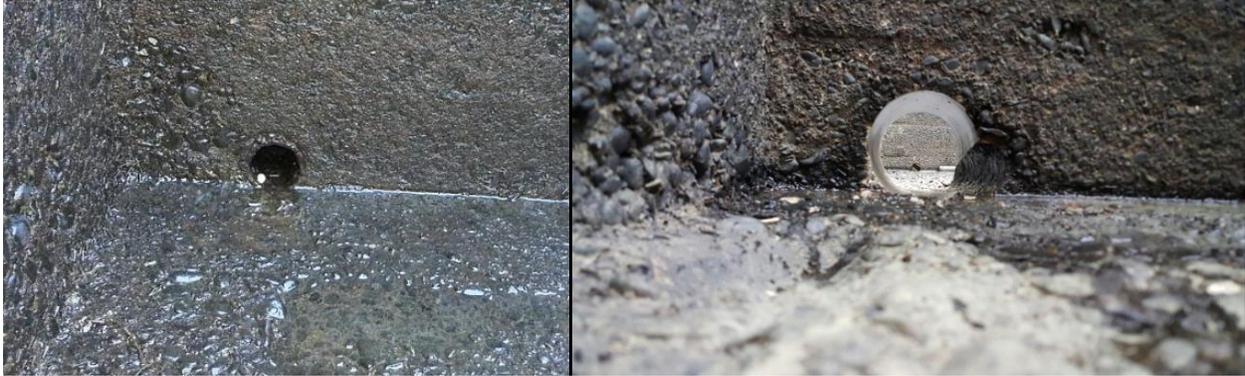
Figure 7. Photos of the drainage holes at Roza Dam. Left photo is the original 2 inch hole, and the right photo is the new 4 inch holes.

The primary goal for the releases downstream of Roza Dam was to evaluate their passage at the dam and migration further upstream in the Upper Yakima Subbasin. Drainage holes within the Roza Fish Ladder weirs were widened (from 2” to 4”) in the lower section of the ladder during the winter of 2017, completing the widened drainage holes for the entire fish ladder (the upper section drainage holes were widened in winter of 2015). Whereas the holes are flush to the bottom of the floor in the upper section of the ladder, holes in the lower section were unfortunately offset from the floor bottom (~1 ft); Bureau of Reclamation staff were unable to drill the holes flush to the bottom due to the specific configuration of the weir structures in the lower section. Due to the potential of lamprey holding downstream of the ladder weir PIT arrays at Roza Dam, all lamprey for these releases were tagged with 8 mm full duplex tags.

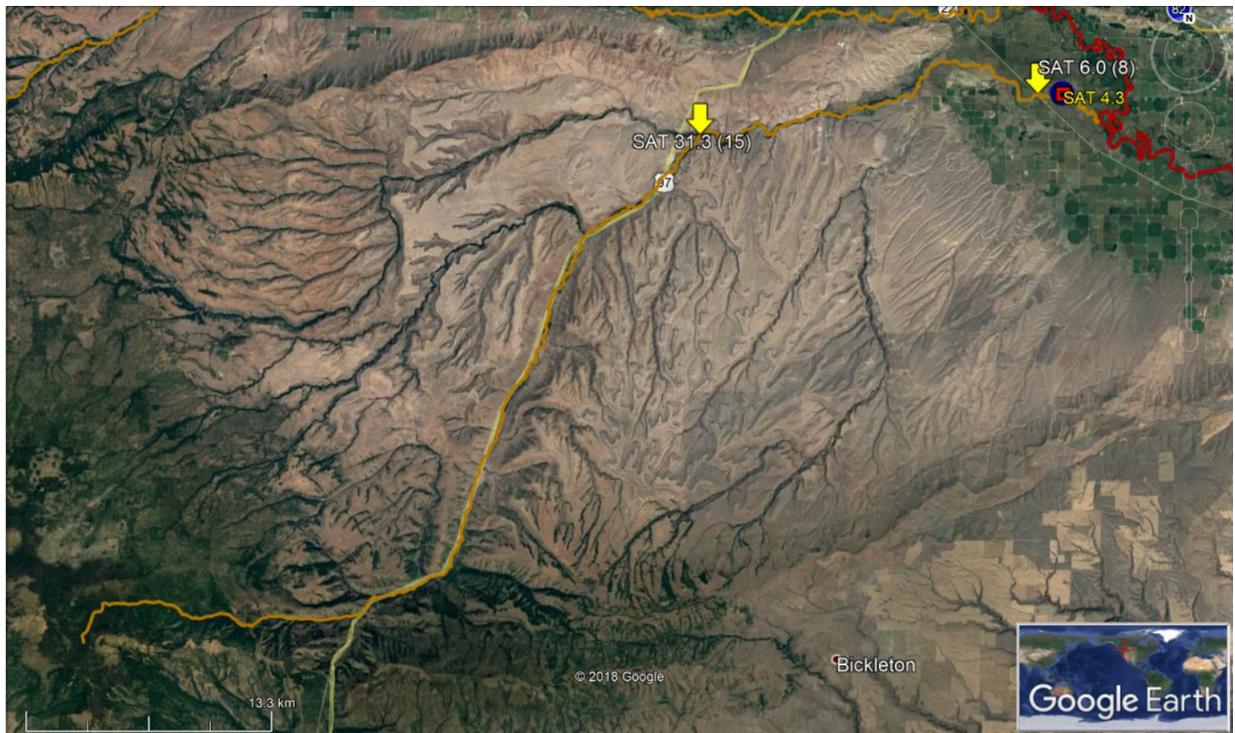
Figure 4. Aerial map of Pacific Lamprey translocation release site (yellow arrow) in Satus Creek (bottom orange line). “SAT” stands for Satus, the number next to the stream abbreviation is the river km, and the number in parenthesis is the total number of lamprey released. Also shown with the large blue circle is the PIT tag array location (river km 4.3), and the red square is the location of a screw trap for juvenile monitoring. Yakima River is the red line.

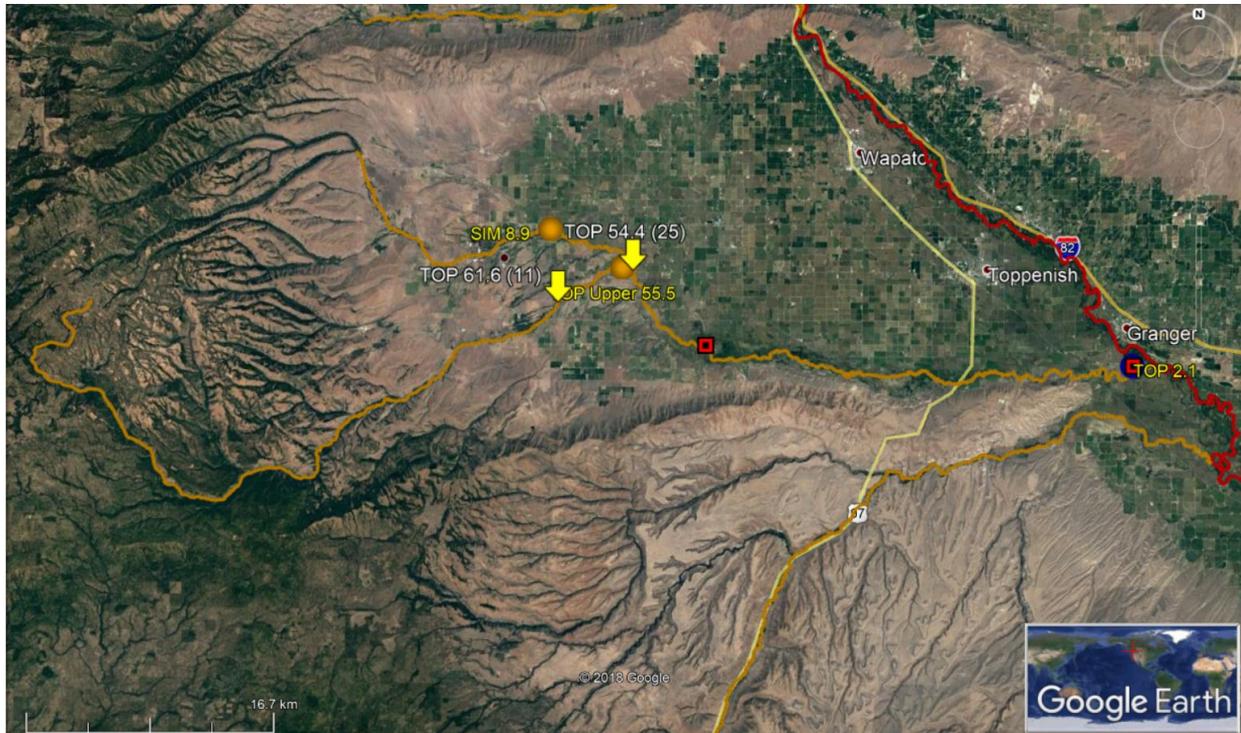
Figure 5. Aerial map of Pacific Lamprey translocation release sites (yellow arrows) in Toppenish Creek (upper orange line). “TOP” stands for Toppenish, the number next to the stream abbreviation is the river km, and the number in parenthesis is the total number of lamprey released. Also shown with the large blue and orange circles are the PIT tag array locations [one in lower Toppenish (river km 2.1), one in upper Toppenish (river km 55.5), and one in Simcoe Creek (river km 8.9)], and the red squares are the locations of screw traps for juvenile monitoring. Yakima River is the red line.

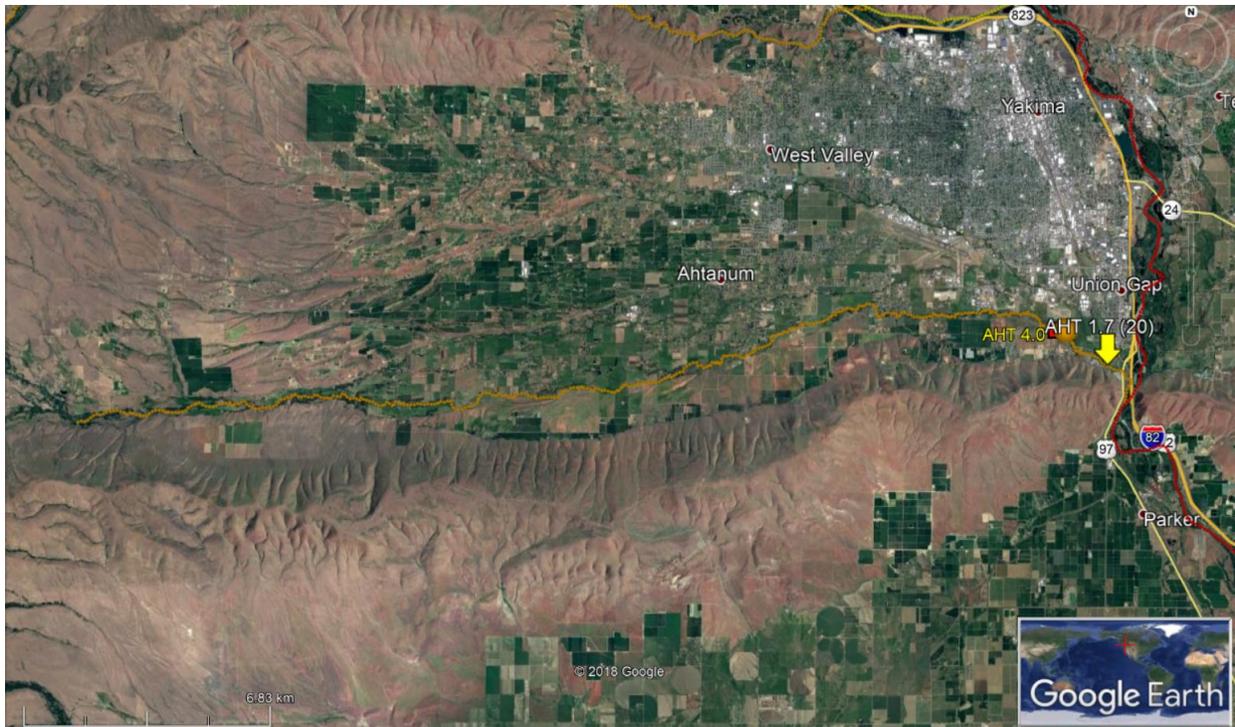
Figure 6. Aerial map of Pacific Lamprey translocation release site (yellow arrow) in Ahtanum Creek (orange dots / line). “AHT” stands for Ahtanum, the number next to the stream abbreviation is the river km, and the number in parenthesis is the total number of lamprey released. Also shown with the large orange circle is the PIT tag array location [one in lower Ahtanum (river km 4.0)], and the red square is the location of a screw trap for juvenile monitoring. Yakima River is the red line.

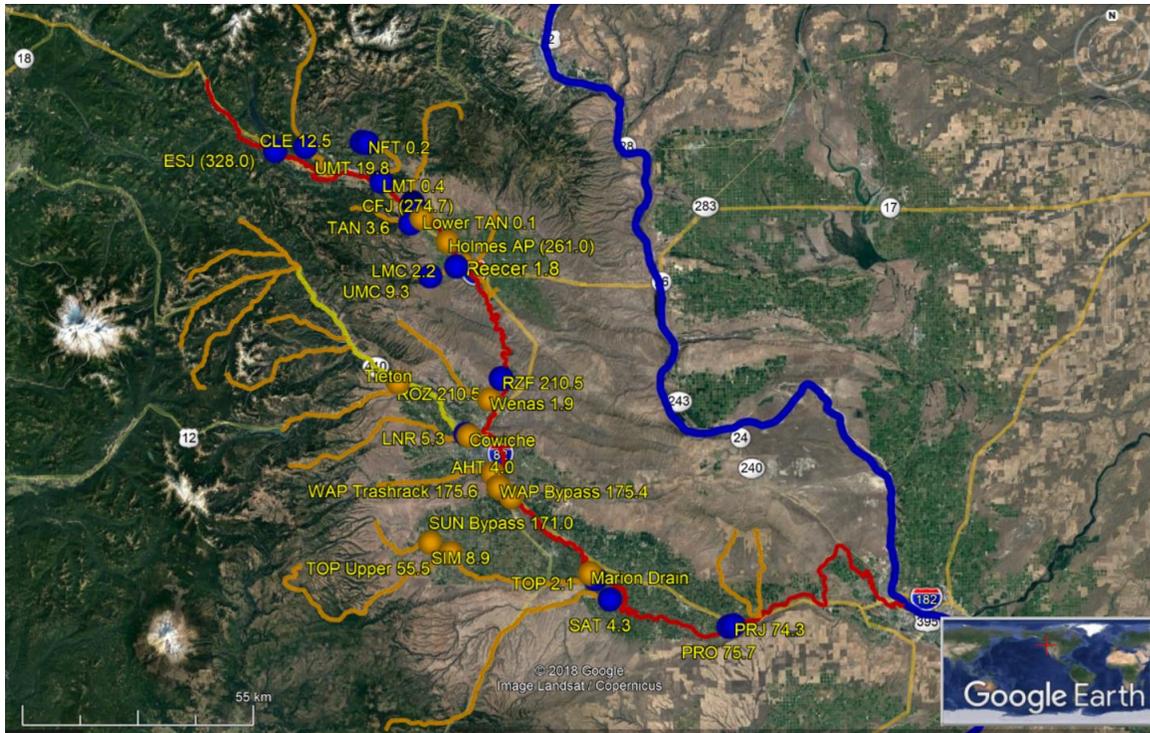
Figure 8. Overall aerial map of PIT tag arrays within the Yakima Subbasin. The two- to three-letter abbreviation or name and its associated river km is labeled in yellow font. The red line represents mainstem Yakima River, the orange lines represent its tributaries, and the blue line represents the Columbia River.

There are a total of three instream PIT array sites on the mainstem Yakima River (river km 75.7, 171.2, and 210.5) and many more within the tributaries (Fig. 8). Within the Lower Yakima, there are two sites in Toppenish Creek (river km 2.1 and 55.5), and one site each in Simcoe (river km 8.9), Satus (river km 4.3), and Ahtanum (river km 4.0) creeks. Within the Upper Yakima, there are three sites within Teanaway River (river km 0.4, 19.8, and North Fork Teanaway river km 0.2), two sites within Menastash (river km 2.2 and 9.3) and Taneum (river km 0.1 and 3.6), and one site each within Swaulk (river km 0.3). Additional sites are being established in other tributaries (e.g. Naches, Cowiche, Tieton, Wenas, Reecer, and Cle Elum) and side channels / canals (Marion Drain, Holmes Acclimation channel) as well. Some of these arrays are temporary and are not running year around. Most sites have a pair of arrays, consisting of lower (downstream) and an upper (upstream) array.

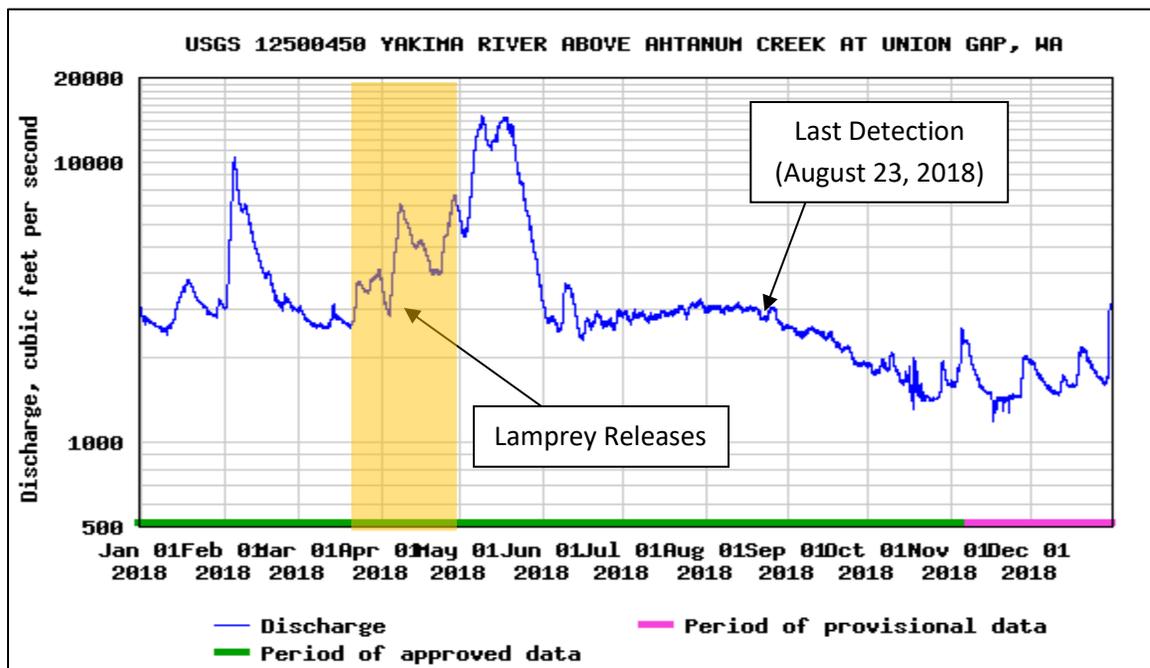
Figure 97. Discharge (cubic feet per second) data of the Yakima River at Union Gap, WA (river km 177.7) between January 1, 2018, and December 31, 2018 (US Geological Survey National Water Information System: Web Interface), and associated lamprey release and detection information.

Based on data provided by the flow monitoring station within Yakima River (river km 177.7), the release events occurred primarily during the beginning of the snow melt peak flow (Fig. 9). Discharge ranged approximately between 2,750-7,750 cfs within the Yakima River during the adult release period. The last detection was on August 23, 2018, which corresponds to the start of a decline in summer discharge in the subbasin (second decline after the large decline in May and June).

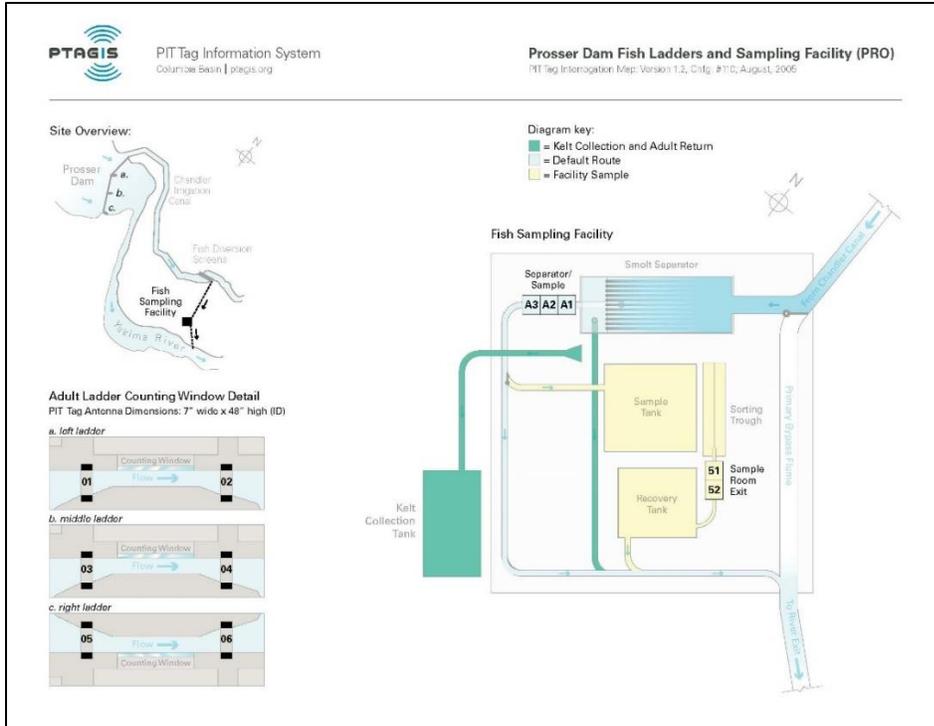
Figure 10. PIT array configuration at Prosser Diversion Dam.

- Three lamprey that were not recorded to be released were detected at PRO (Prosser Diversion Dam Combined; river km 75.7; Fig. 10); these were adults that likely escaped the vertical wetted wall structures while they were being held inside the traps to attract wild adults. The release dates are unknown, but are estimated based on last detection from our scanners.
- Their PIT tag codes are the following: 3DA.1A19B397E8, 3DA.1A19B38FE6, 3D6.1D593D9509.
- One of these three lamprey were last detected at the upper array, indicating it likely passed the dam.

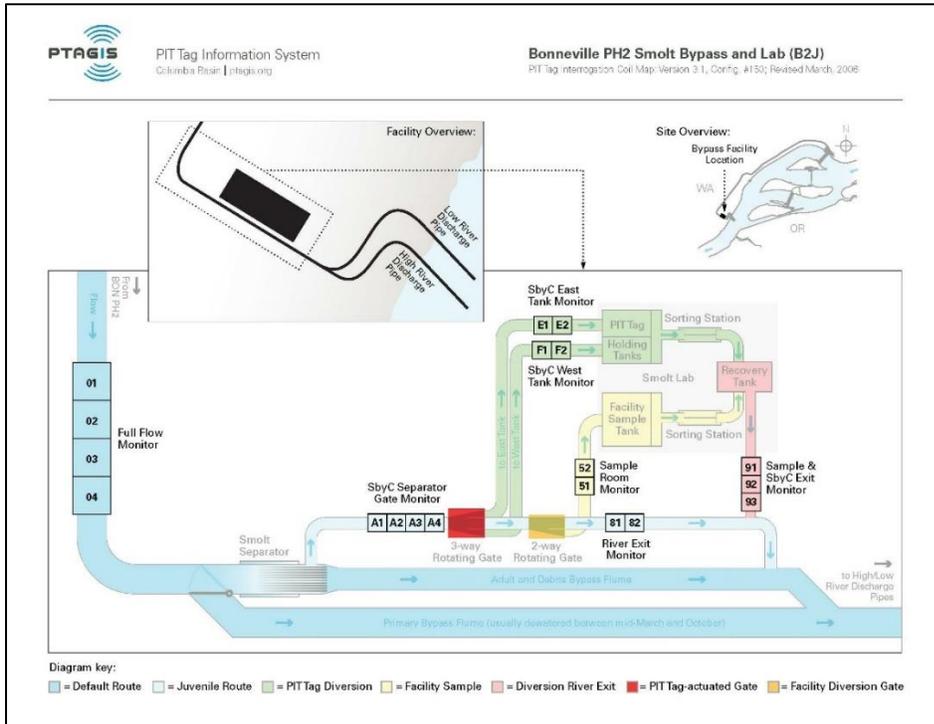
Figure 11. PIT array configuration at Bonneville Dam PH2 Smolt Bypass and Lab (B2J).

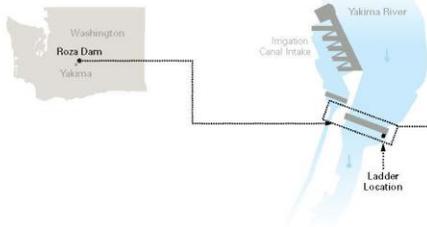
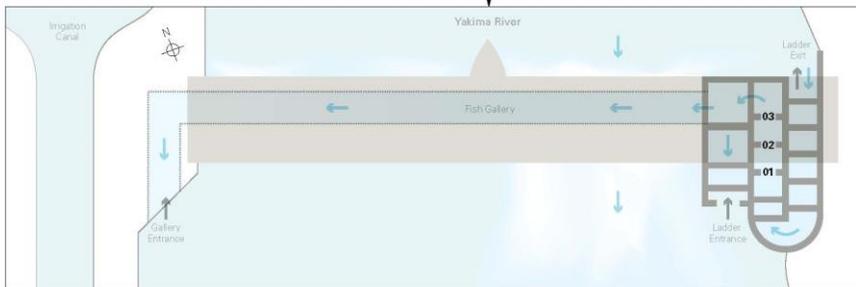
Figure 12. PIT array configuration at Roza Diversion Dam.

- One of the 21 lamprey (50%) first detected at PRO, was also detected later at ROZ (Roza Diversion Dam Combined; river km 210.5; Fig. 12). This adult was detected at Roza Dam for 40.9 days and was last detected at the upper weir array (however, it is uncertain if it passed the upper most section of the fish ladder). The total number of detection hits were 35,675, indicating that it spent a lot of time in front of the PIT tag arrays within the lower fish ladder weirs at Roza Dam.

- One of the 16 lamprey (6%) first detected at PRO was also detected later at ROZ (Roza Diversion Dam Combined; river km 210.5; Fig. 12). This adult was detected at Roza Dam for 40.9 days and was last detected at the upper weir array (however, it is uncertain if it passed the upper most section of the fish ladder). The total number of detections were 35,675, indicating that it spent a lot of time in front of the fish ladder weir PIT tag arrays.

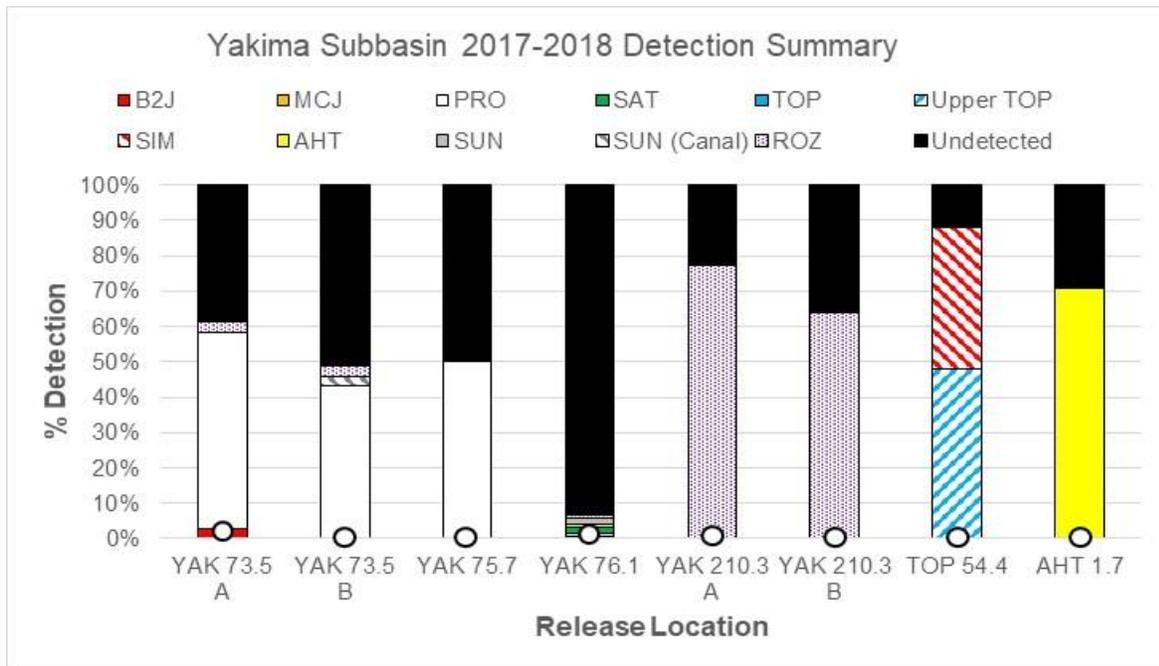
Figure 13. Summary of PIT array detections from each release event (with at least one detection event) in the Yakima Subbasin for the 2017-2018 broodstock Pacific Lamprey translocation. For the release location, “YAK” stands for Yakima, “TOP” stands for Toppenish, “AHT” stands for Ahtanum, and the number next to the stream name is the river km (see Part I for more information). The three letter abbreviation assigned by PTAGIS is used for each of the detection site (see Table 4 for more description of the site). The white circle on the graph indicates the relative location of the release in relation to the respective detection sites (sites above are upstream of the release sites, whereas those below are downstream).

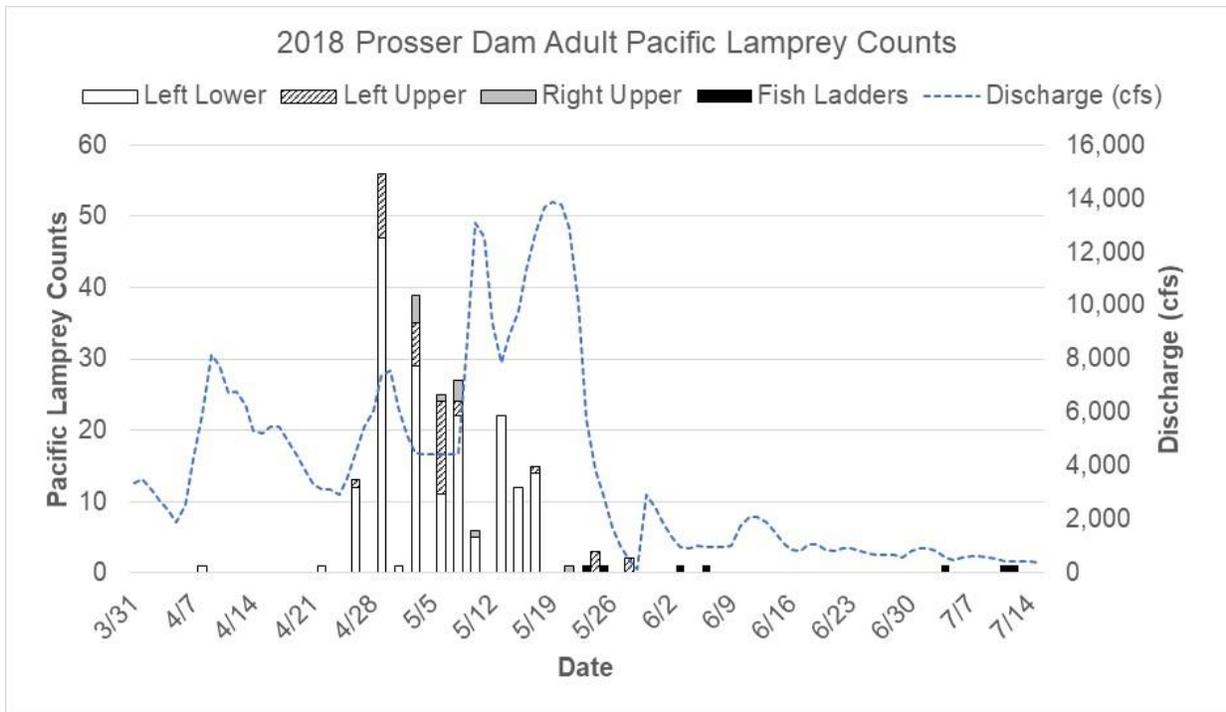
Figure 14. Adult Pacific Lamprey counts during spring/summer 2018 at Prosser Dam by specific migration routes (in relation to discharge conditions).

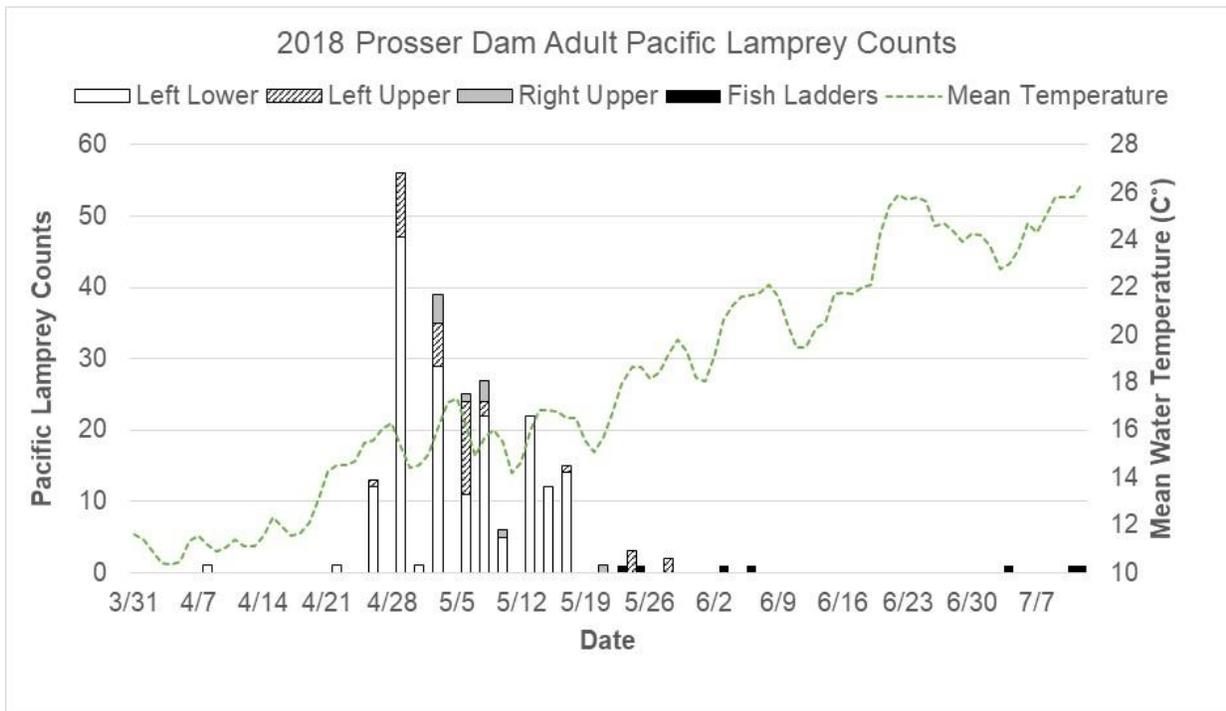
Figure 15. Adult Pacific Lamprey counts during spring/summer 2018 at Prosser Dam by specific migration routes (in relation to mean water temperature conditions).
