Implementation of a Simulated Perennial Side Channel Flow Regime in the Wapatox Diversion (Naches River) to Protect High Densities of Larval/Juvenile Lampreys

Project No. 2008-470-00

Tyler Beals and Ralph Lampman

Report Created: March, 2019

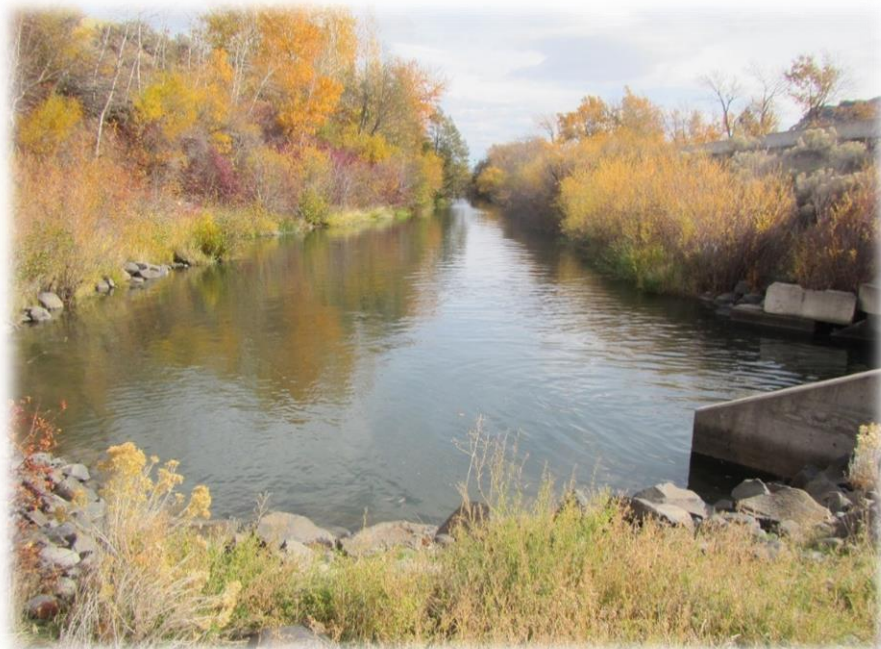
[Cover photo: Downstream view of the Wapatox Diversion irrigation canal (Naches River), immediately downstream of the headgates].

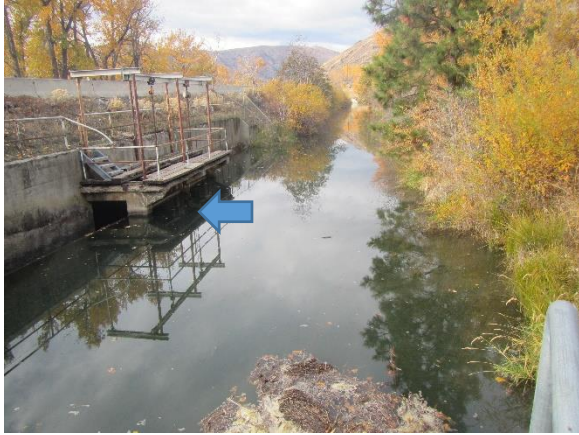
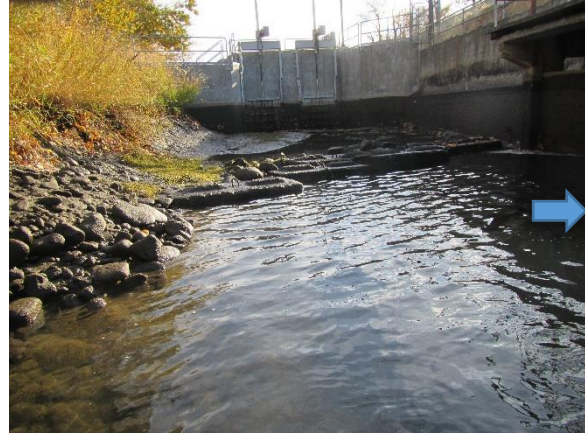
Photo 1. An overview of the canal between the headgates and the regulating gate looking upstream on November 1, 2018 at 12:05 p.m. (left photo). The area upstream of the regulating gates looking downstream (right photo). The blue arrow in both photos show the location of the return flow channel.

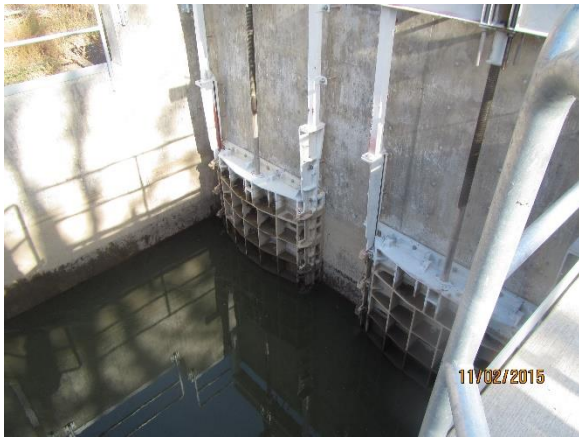
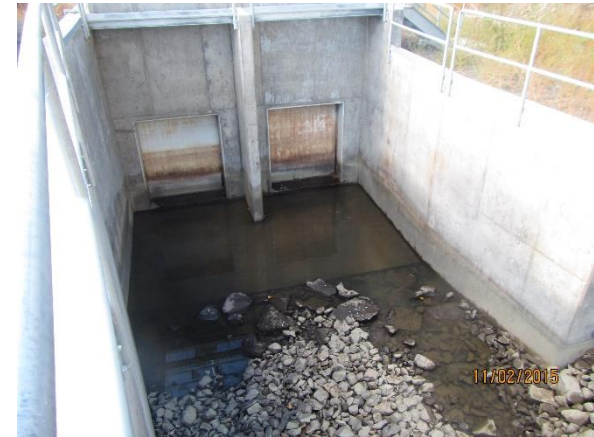
Photo 2. The regulating gates after dewatering looking downstream (left photo). The regulating gates after dewatering looking upstream (right photo). In 2018, the gates were fully shut after the reopening of the headgates for the winter months. Water level is generally low after irrigation shutdown, limiting potential damages caused by freezing water coming into contact with the gates.

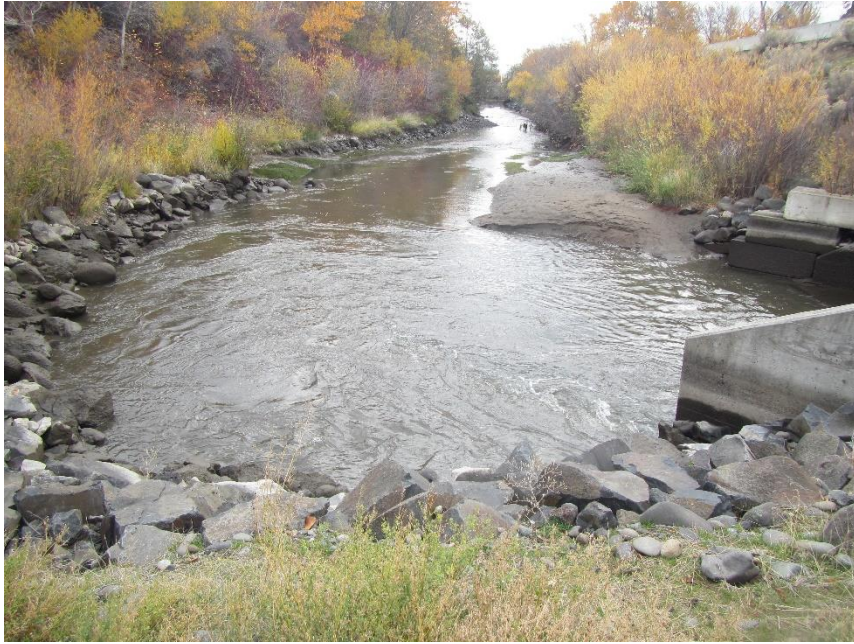
Photo 3. Overview of the canal and dewatered lamprey habitat between the headgates and the regulating gates. The photo is looking downstream from the headgate area. High densities of larval lampreys have been observed annually in this area after fall season dewatering. Many staff hours are required to rescue lampreys from the dry banks (by hand) and from wetted areas (using electrofishing). As much as 550 m² of fine sediment has been exposed and dried after each yearly dewatering event.

Since 2015, larval lamprey surveys have rescued many thousands of larval lampreys from a large area of fine sediment that deposits between the headgates and the regulating gates (Fig. 1 and Photo 3 and 4). Annually after dewatering, a high density of lampreys (up to ~50 lamprey/m²), and a large area of larval lamprey habitat (up to ~550 m² of fine sediment and organic matter) are found between the headgates and regulating gates. Past surveys have shown that the majority of lampreys that enter Wapatox Diversion reside between the headgates and regulating gates with a significantly lesser number found downstream of the regulating gates. When Wapatox Diversion is dewatered in the fall (generally in early November), the headgates and the regulating gates are shut, cutting water supply from the diversion. In November 2018, the BOR and YNF coordinated and managed to maintain sufficient flow year-round in the section upstream of the regulating gates. The availability of regulating gates and the flow return channel at Wapatox Diversion provides the option for water and fishes to return immediately to the river (prior to approaching the fish screens). The canal section downstream of the regulating gates is then left dry, and no water infiltrates the area upstream of the fish screens (preventing damage to the fish screens related to freezing and icing). The results section highlights our observations during this operation in November, 2018.

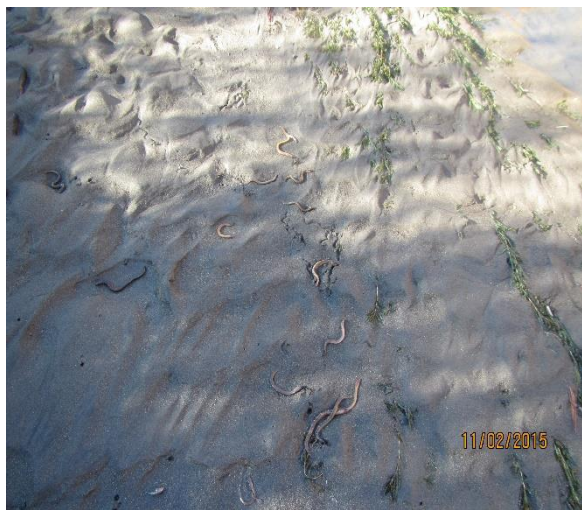
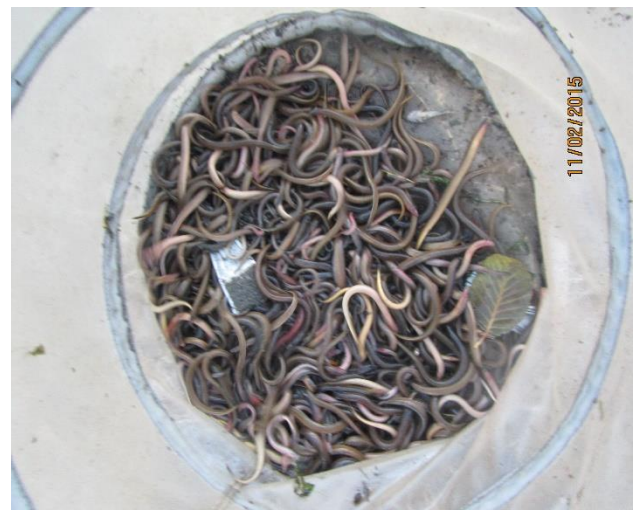
Photo 4. Larval lampreys collected from dewatered banks at Wapato Diversion in 2015; stranded larval lampreys on dry banks shortly after dewatering (left photo) and a collection of many hundreds of larval lampreys from the canal section between the headgates and the regulating gates during electrofishing and bank collection (right photo).

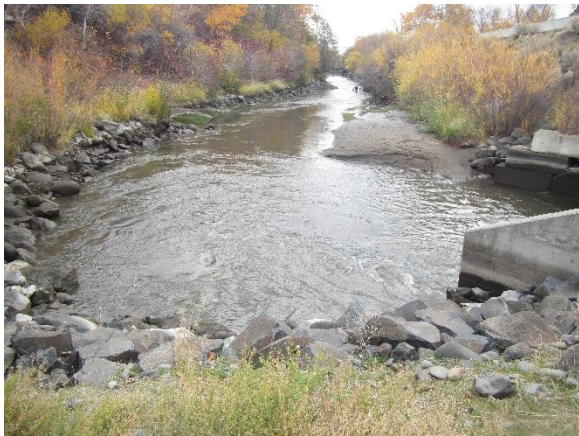
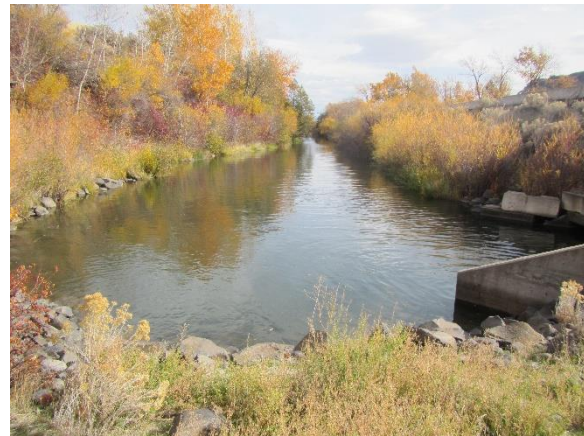
Photo 5. An overview of the canal between the headgates and the regulating gates on November 1, 2018 at 10:40 a.m, approximately five minutes after the headgates were reopened, looking downstream from the headgates (left photo). An overview of the canal at 12:40 p.m., approximately two hours after the headgate was reopened; all exposed larval lamprey habitat was covered again (right photo). Both photos were taken in the same location.

10:35 a.m. – 12:05 p.m. – After safety inspections of the gates, the BOR staff opened one of the three head gates at 10:35 am (gate opened approximately 12” from closed position). The regulating gates were left closed, and dam boards were placed into the flow bypass channel (immediately upstream of the regulating gates) to hold water upstream of the gates. Right around this period, YNF staff observed a large area of exposed fine sediment immediately downstream of the headgates (Photo 5). Larval lampreys were visible on top of the dewatered sediment at 10:40 a.m.; however, YNF staff were not able to enter the area to rescue them. The same area upstream of the regulating gates was observed again at 12:05 pm. By this time (1.5 hours after the headgates were re-opened), all exposed fine sediment was covered by water. Larval lampreys trapped on the dewatered sediment were exposed for up to 3.5 hours, before flow was restored.

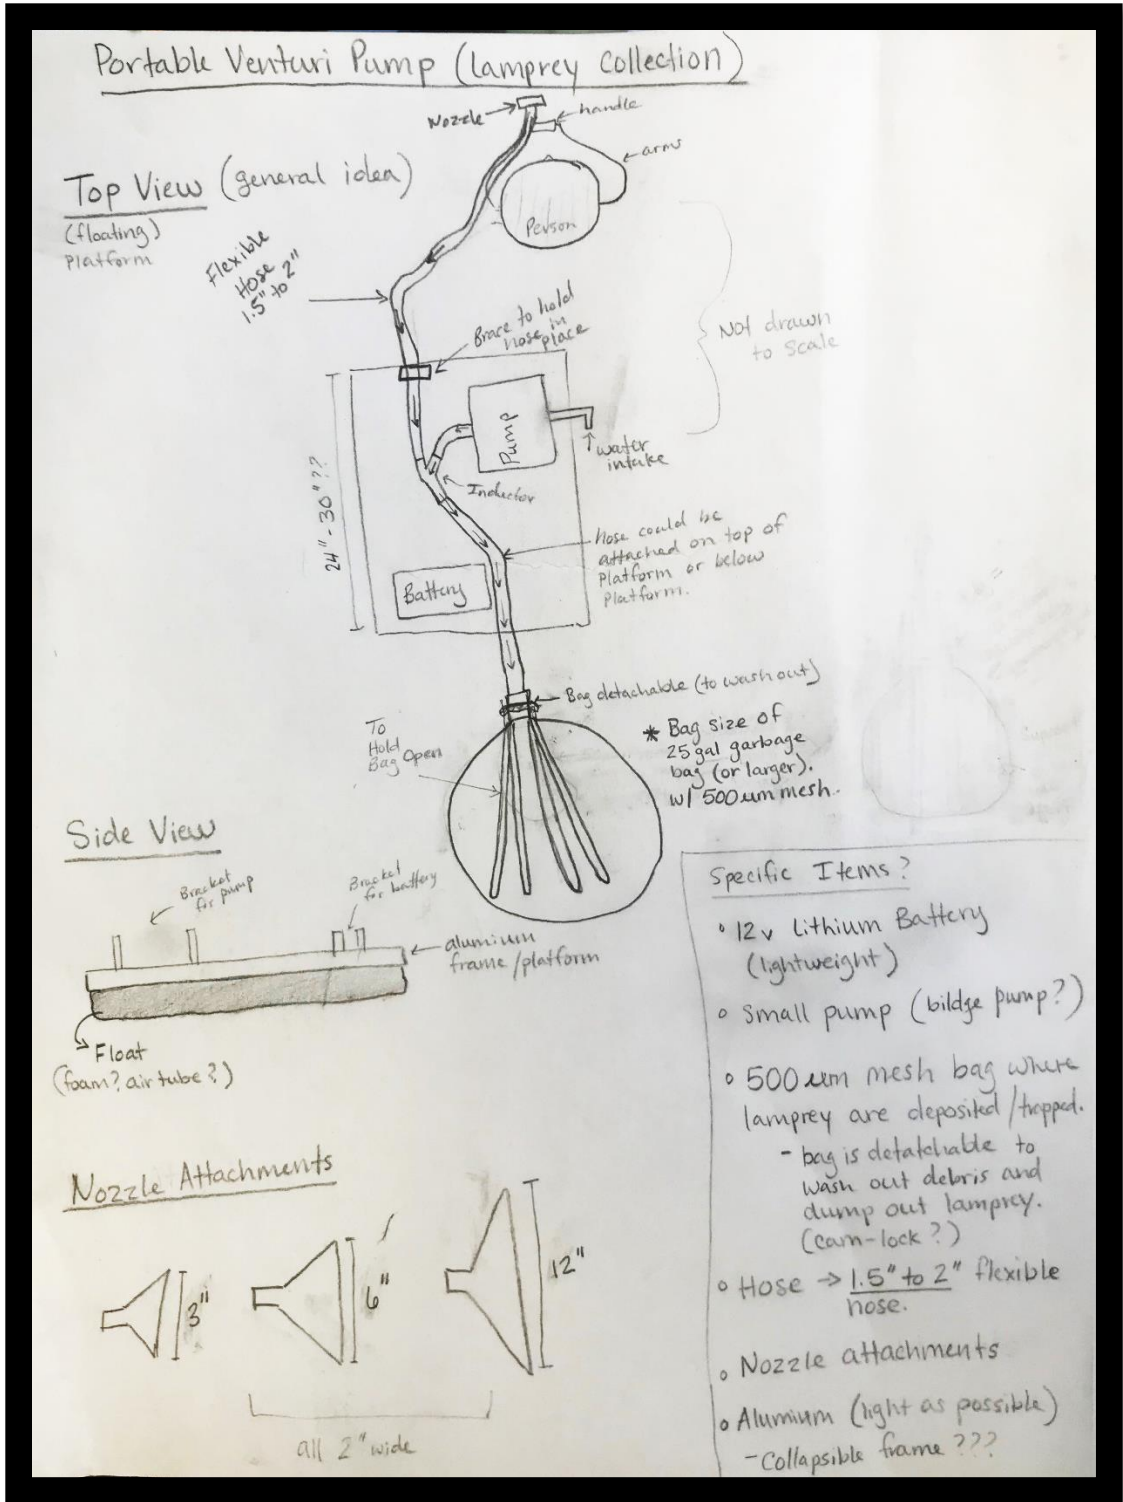
Figure 2. A conceptual design for a portable lamprey sifter that uses a small scale venturi pump in combination with an electrofisher. After the electrofishing forces larval lamprey to emerge, the lamprey sifter will siphon the lamprey into an expandable mesh bag (500-750 micron), which can be sifted in water if any fine sediment is also collected. A few nozzle attachments will be available to allow for the most efficient lamprey collection based on canal water height.

Additionally, accumulated sediment in the canal area downstream of the headgates will need to be dredged using heavy equipment ever few years; this means that during those years, the upper canal area will need to be dewatered for a much longer period. This will require more intensive lamprey rescue efforts during those years. In addition to rescue efforts using electrofishing, the use of a lamprey sifting device (to efficiently remove lampreys from the dredged material) will likely improve the overall lamprey rescue efficiency when the time comes to dredge this high density larval lamprey area. A conceptual drawing is provided below for a portable lamprey sifter that uses a combination of an electrofisher and a small scale venturi pump (Fig. 2), which will aid the rescue of lampreys in very turbid, low-visibility water conditions.
