FY2018 ANNUAL REPORT

YAKAMA RESERVATION WATERSHEDS PROJECT

BPA Project #1996-035-01-Contract #56662 REL 152

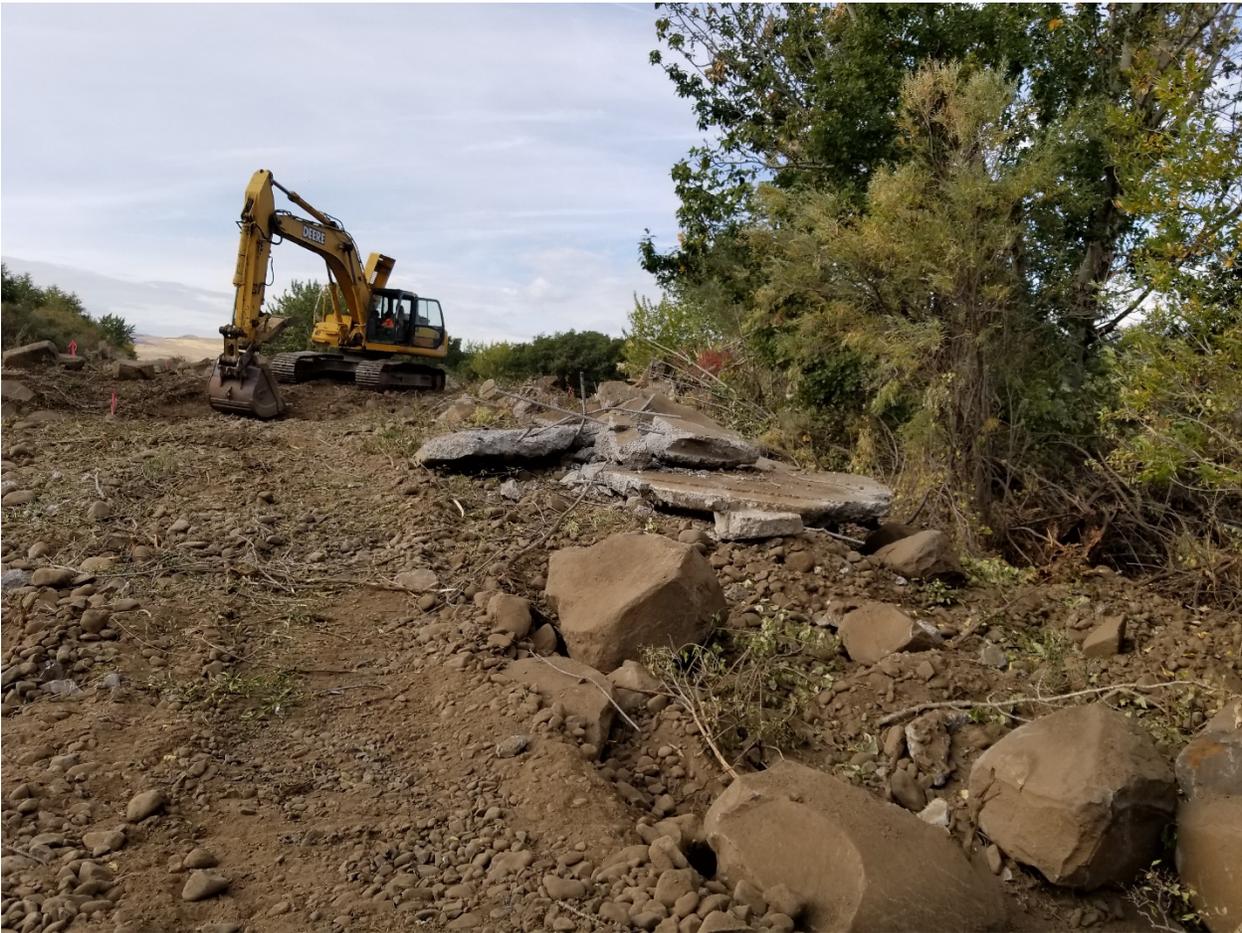
Figure 1. Removal of the 3-way irrigation diversion structure.

The primary objective of this project was to reconnect the flood plain in a section of Toppenish Creek that was straightened by the construction of a levee in the 1970s. We also decommissioned an unused irrigation diversion at this site (Figure 1). To prevent flooding, a smaller set-back levee was constructed connecting high ground and blocking several old distributary channels that could deliver flood water toward the town of White Swan. Four new sections of stream were created to mimic the sinuosity of the stream in un-diked portions of Toppenish Creek upstream from this location (Figure 3). The old sections of stream were blocked at the upper end but left open and connected to the new channel at the lower end to create three small alcoves that provide slow water refuge for migrating steelhead. Parts of these alcoves will likely silt in and create habitat for juvenile lamprey. A fourth large alcove could not be constructed due to cultural resource finds at that location. Engineered Log Jams (ELJ's)(Figure 4) were constructed through-out the project area to provide habitat for rearing steelhead and to aid in the formation of pools. Pile fields were constructed through-out the flood plain to collect wood and other debris transported from upstream during flood events. After the major construction was completed for this project, native trees, shrubs, and grasses were replanted in areas where the existing riparian vegetation could not be saved. We believe the new stream channel will attract more spawning steelhead than the previously diked stream channel and improve the spawning capacity of this reach of Toppenish Creek. It should also improve spring runoff retention and infiltration into the Toppenish Creek alluvial fan.

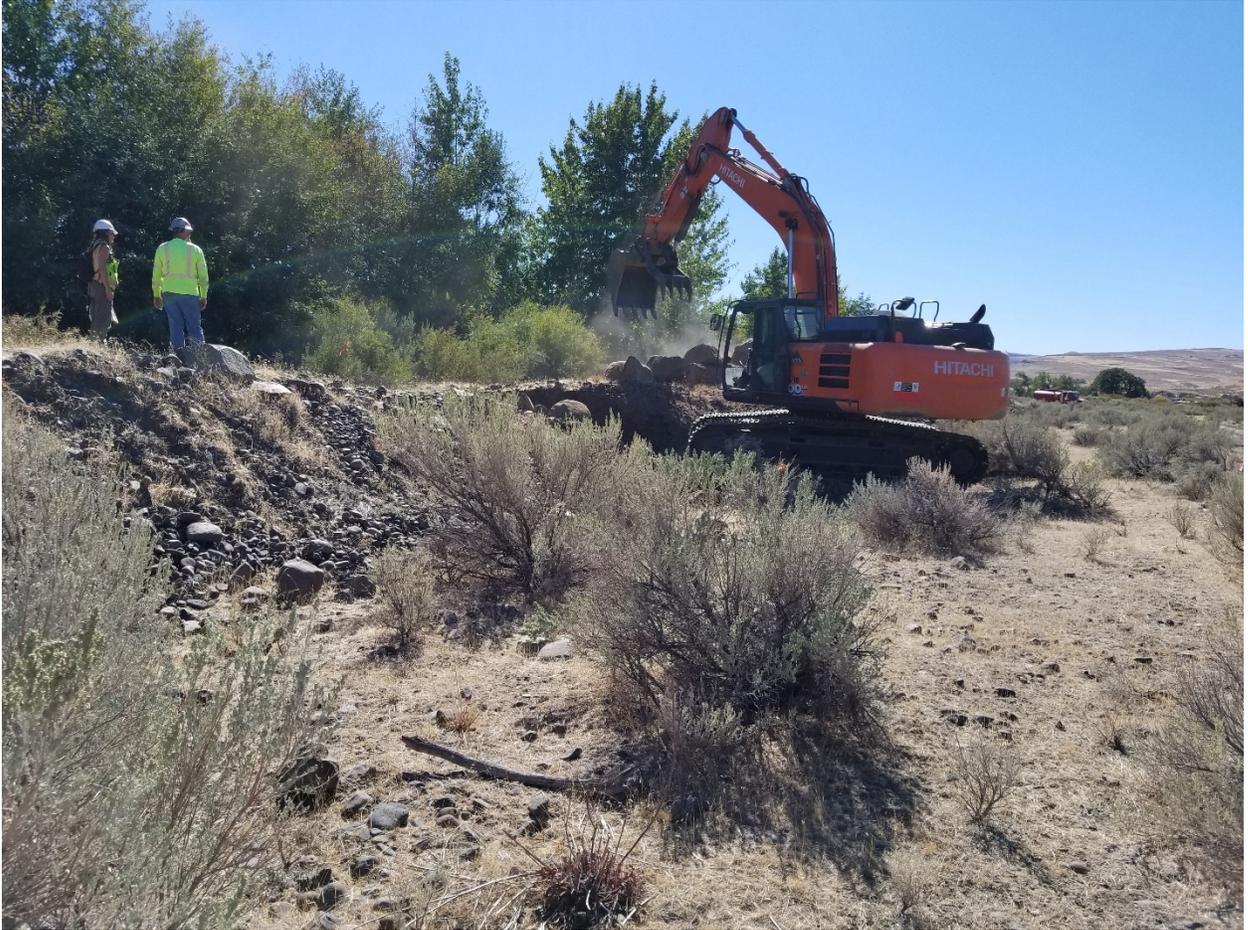
Figure 2. Removal of the 0.3 mile section of levee upstream from the diversion structure.

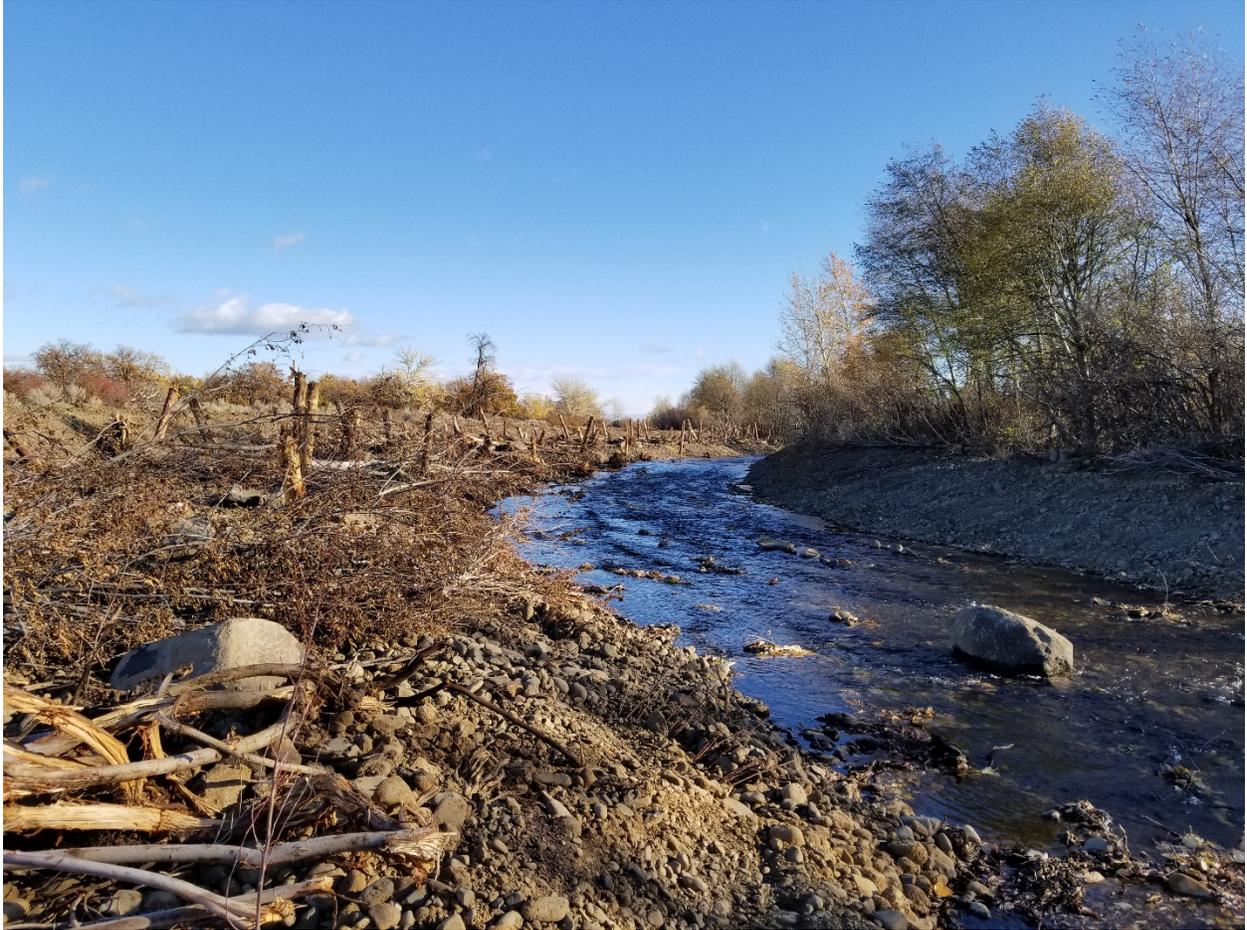
Figure 3. Newly constructed stream channel of Toppenish Creek and inset floodplain in the location where the 3-Way Levee was removed.

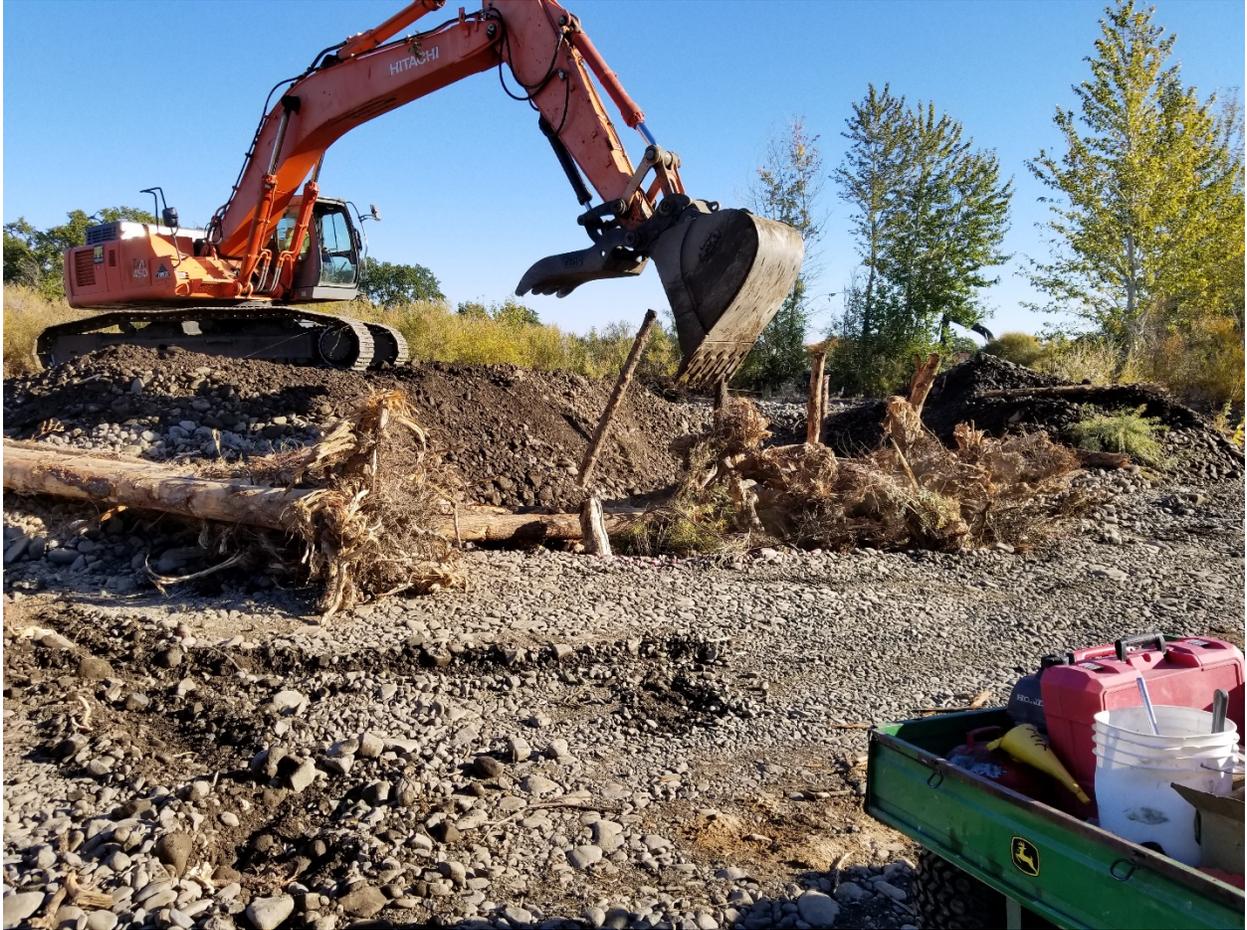
Figure 4. Construction of a large engineered log jam (ELJ) for bank stabilization at the lower end of the 3-Way Levee removal project site.

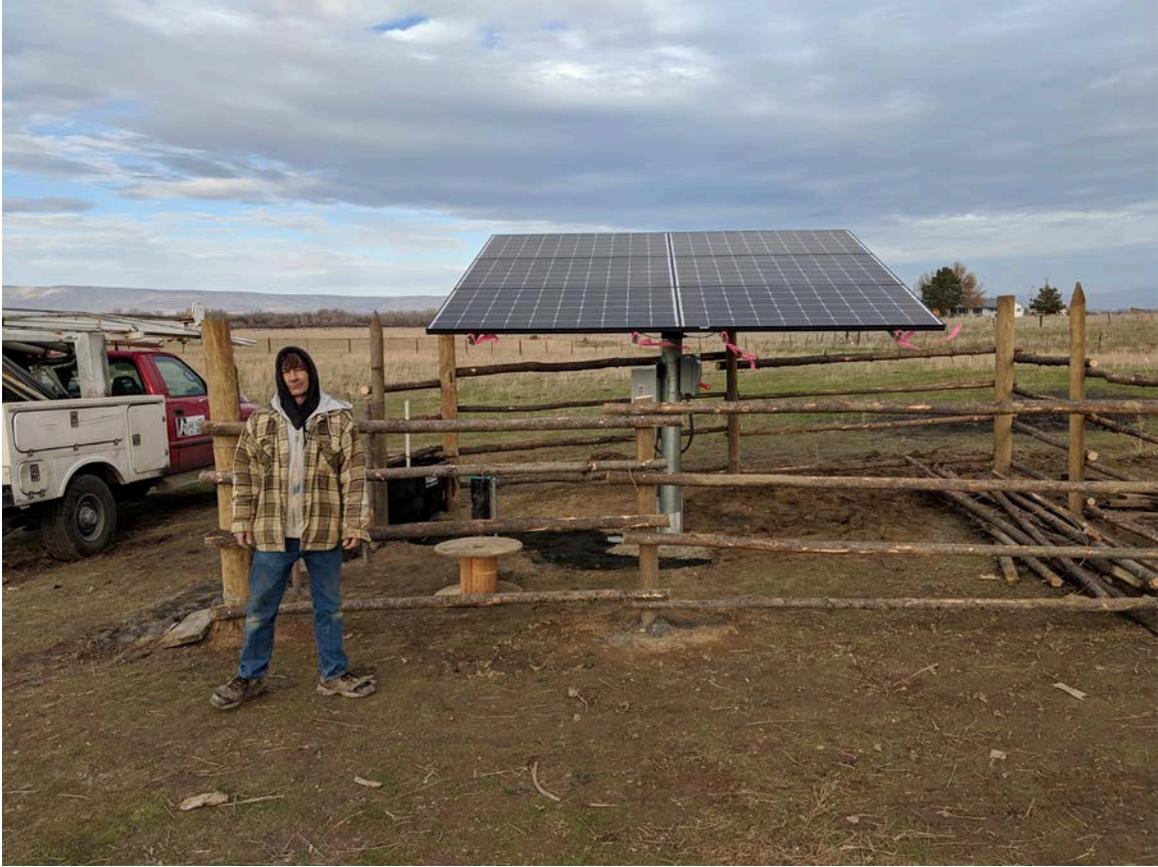
Figure 5. Solar Panels, fence and stock water tank, completed.

To supplement for the lack of water the Yakama Reservation Watershed Project (YRWP) drilled a stock water well and provided a solar powered pump. The pump is activated by a float switch controlled by the level of water within a 300 gallon tank. The well is pit-less which enables it to function in cold weather without freezing by drawing the water back out of the pipe and returning it to a level below the frost line. The project was surrounded by a buck and pole fence to keep livestock from damaging the structure (as shown in figures 5 and 6).

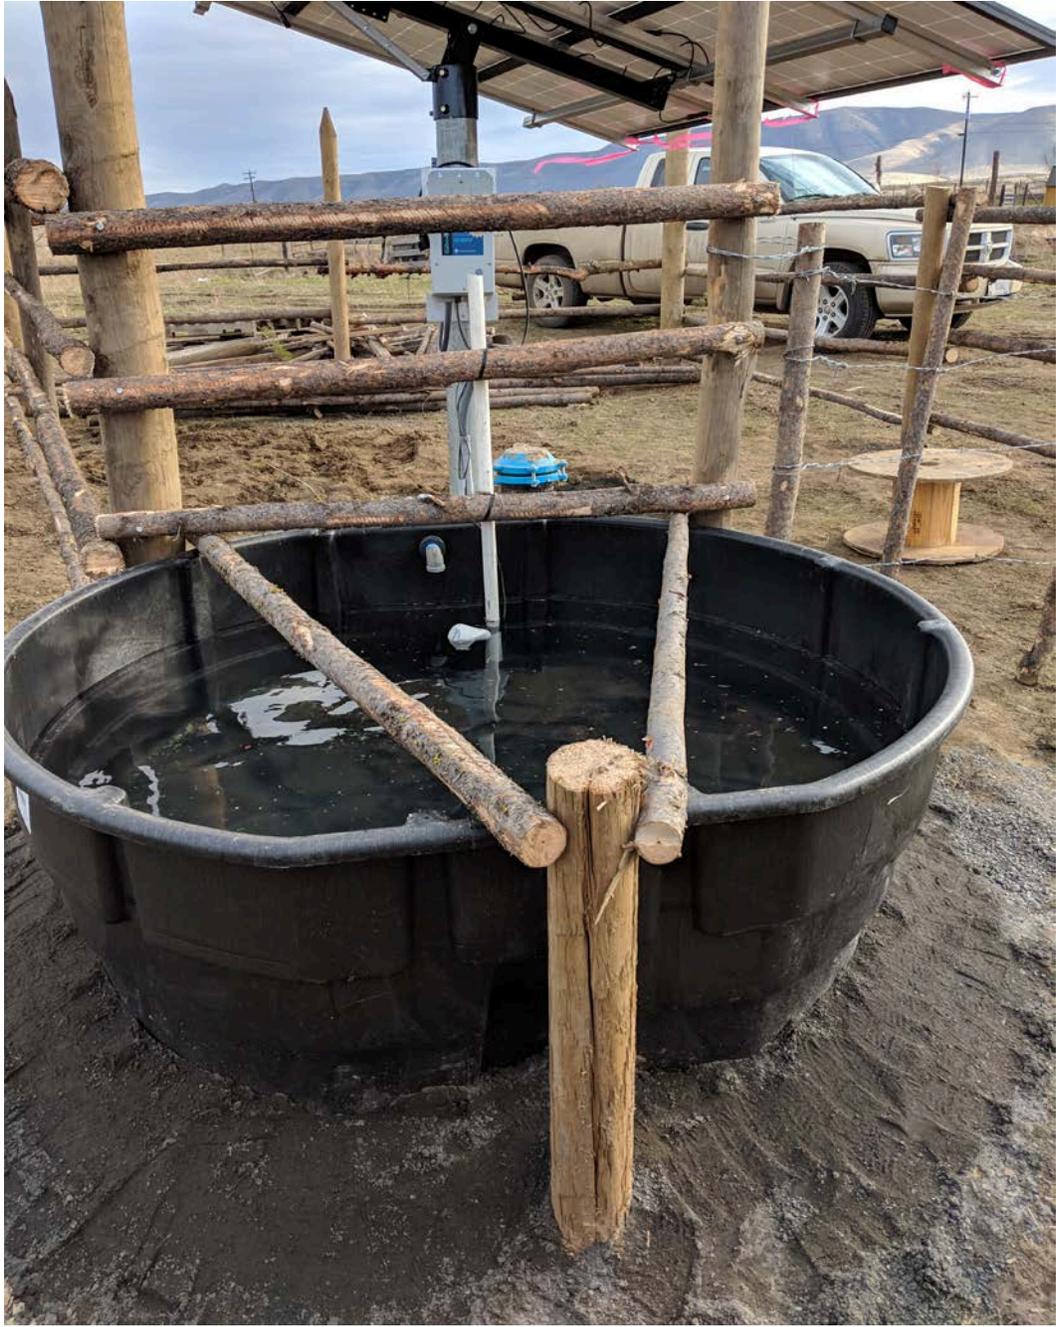
Figure 6. Stock tank and Float Switch.

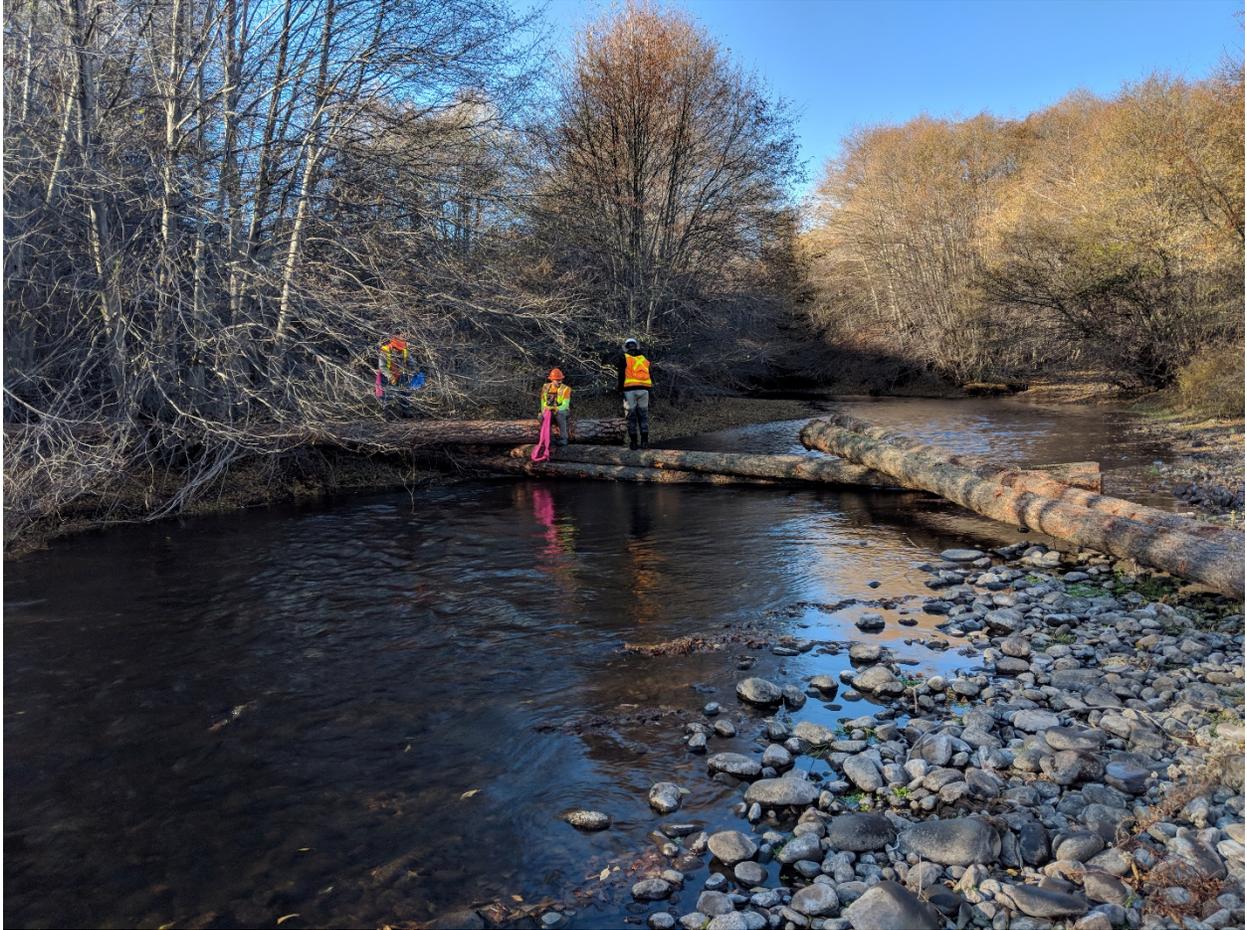
Figure 7. Channel spanning structure designed to forces water out of stream channel and onto floodplain and riparian zone.

Channel Spanning – 8 log structure for forcing water out of the channel and out onto the floodplain and riparian zone (figure 7).

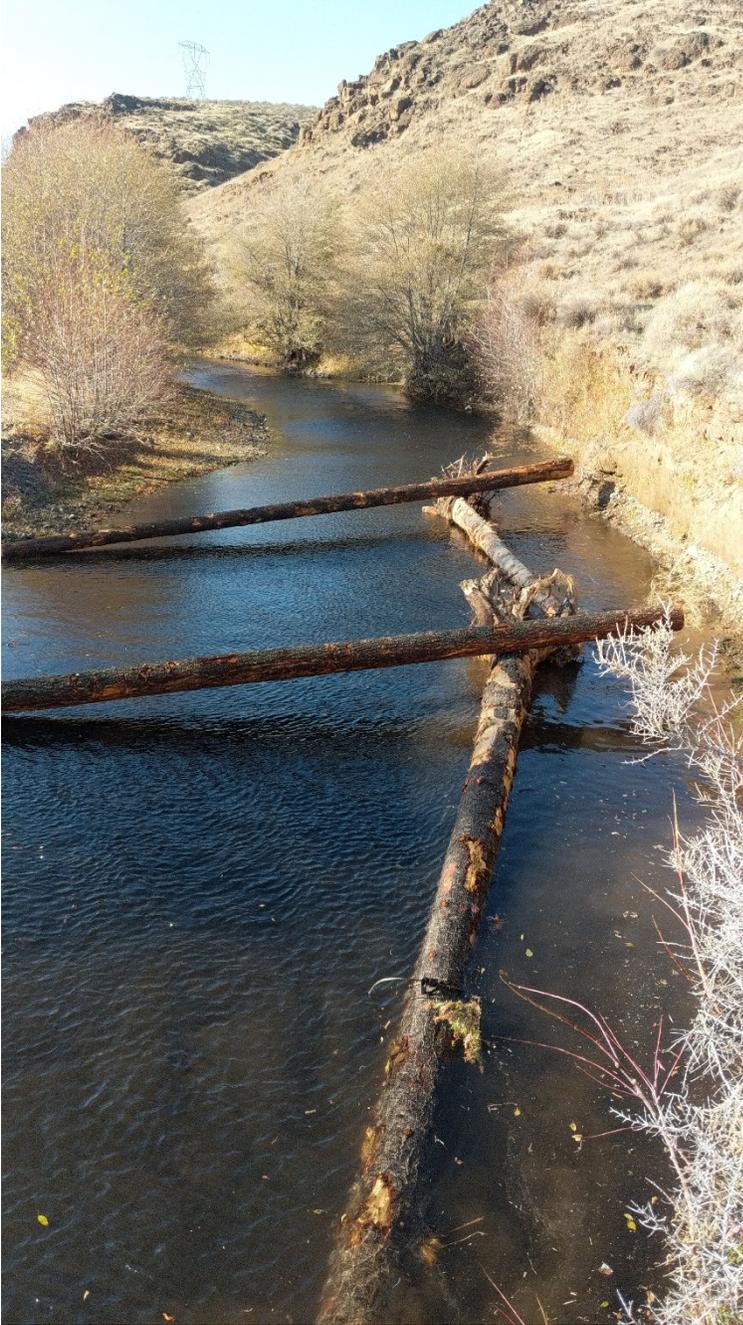
Figure 8. 2x structure designed to limit pressure on the exposed and eroded right bank.

2x – a two log structure for limiting stress on exposed banks (figure 8).

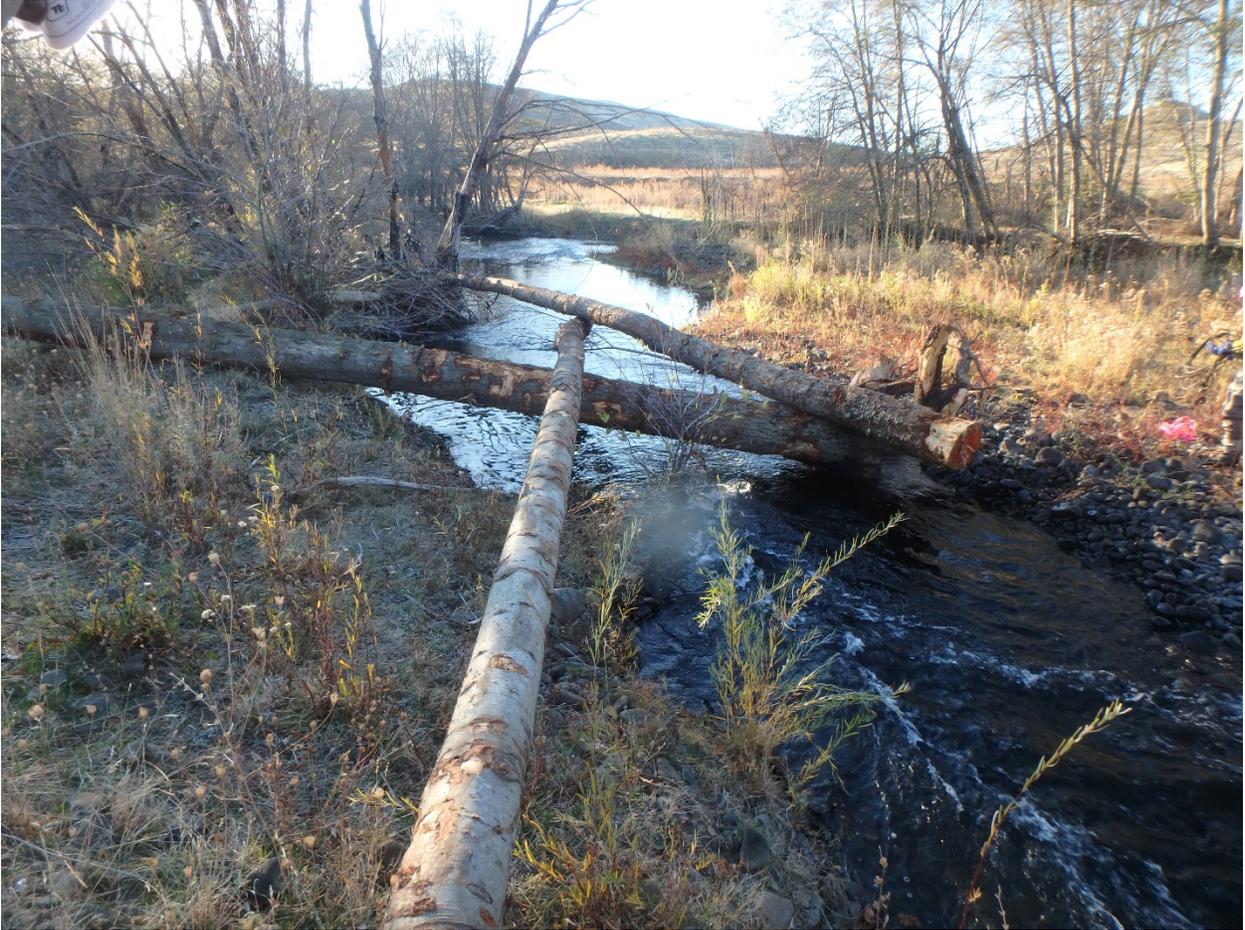
Figure 9. Example of 3x Structure. Includes one (1) root wad and two (2) logs. Designed to relieve banks of high stream energy.

3x – three log structure for limiting stress on exposed banks (Figure 9).

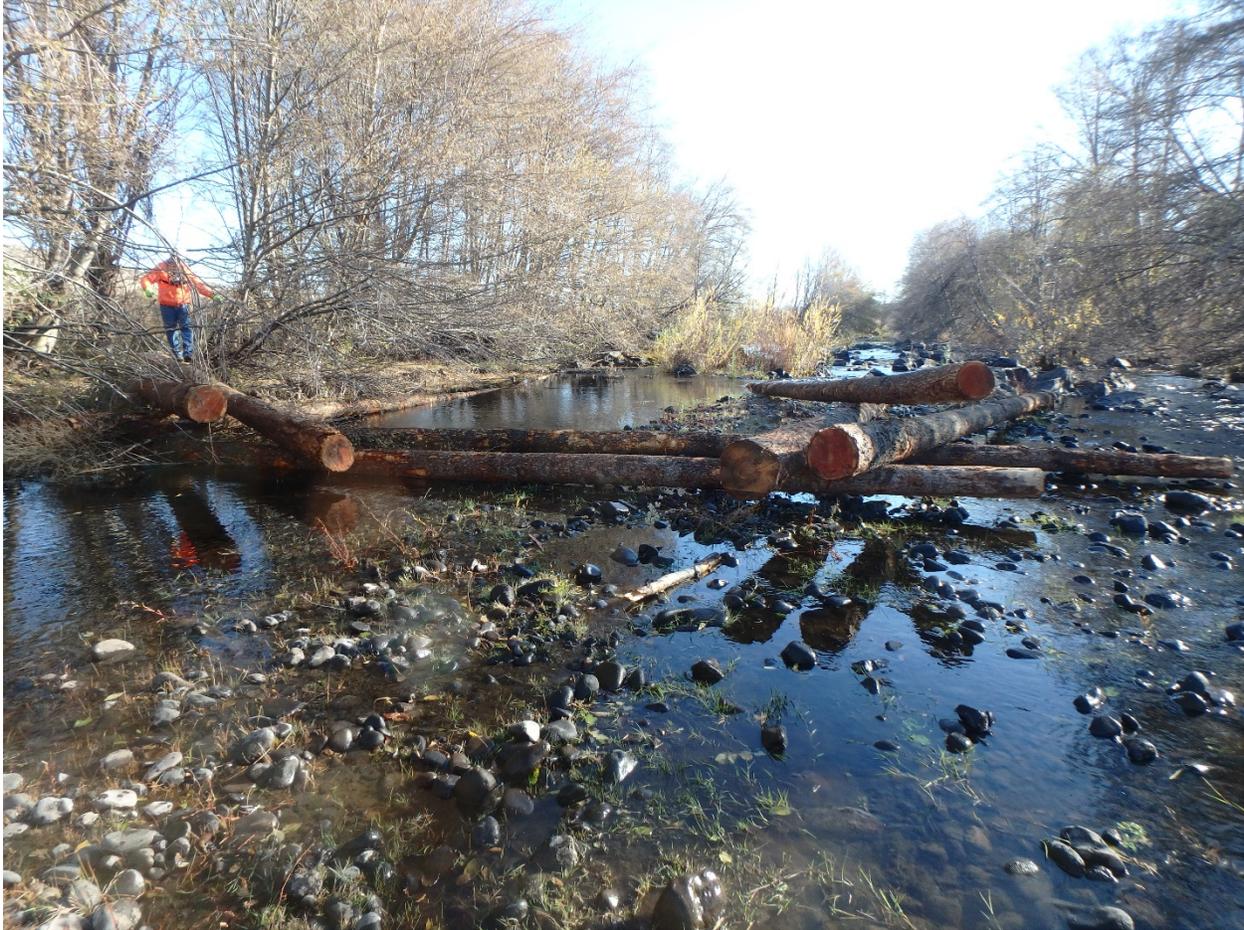
Figure 10. 7 log structure for retaining water in a back-water setting after a high low event.

Alcove – 7 log structure for retaining water in a back-water setting after a high low event (Figure 10).
