# Upper Twisp River and Tributaries

## HABITAT ASSESSMENT

December 2017

TETRA TECH

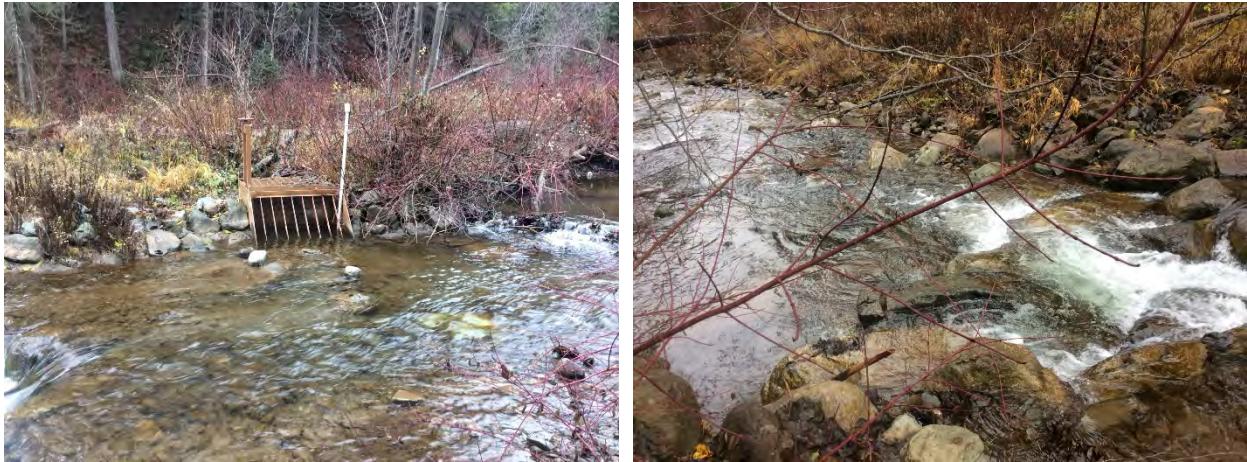
**Figure 2-3. Photographs of Intake (left panel) and Rock Weir (right panel) Diversion in Little Bridge Creek Reach 2 near RM 2.2**

There are currently no known diversions on the UTR mainstem, North Creek, South Creek, Reynolds Creek, War Creek, or Eagle Creek. The irrigation diversion on Eagle Creek was removed and replaced with a well in 2002 (RCO 2017). Canyon Creek and LBC both have existing irrigation diversions. The Aspen Meadows Irrigation Ditch diverts water from Little Bridge Creek for agricultural and domestic use. The ditch was piped in the early 2000s to increase efficiency and reduce water loss. The U.S. Bureau of Reclamation (USBR) replaced a channel-spanning wood weir with a rock weir, shown in Figure 2-3, designed to improve upstream fish passage (USFS 2006a).

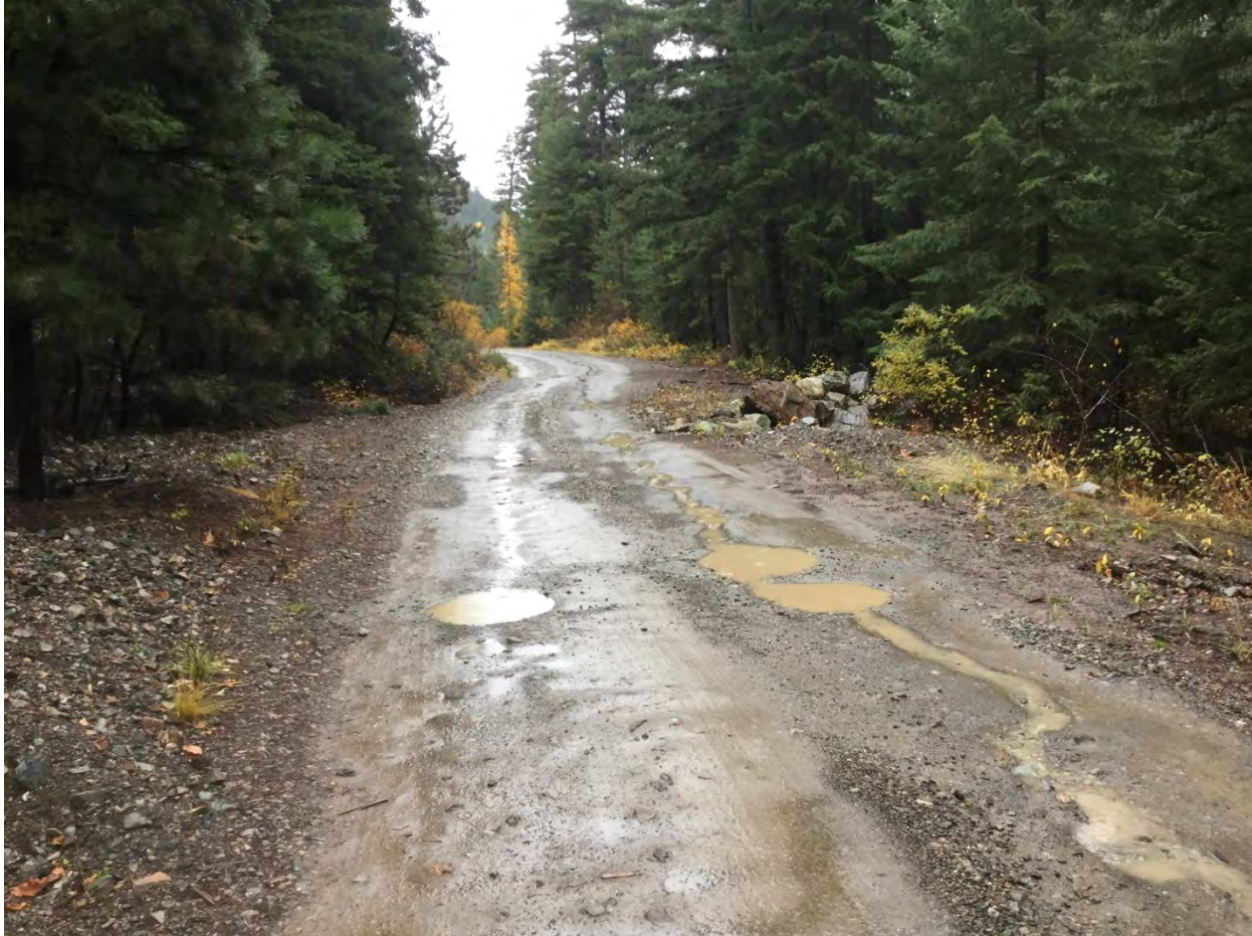
**Figure 2-4. Photograph of Repaired Road Erosion on the NF-4440 Road near RM 23.7**

but past timber harvest and road construction in the Twisp River watershed have apparently accelerated naturally high sediment delivery rates (USFS 2004). Addressing increased sediment from road management in the upper Twisp River was given the sixth highest priority rating in the revised Biological Strategy (UCRTT 2014). The photograph in Figure 2-4 shows an example of recent road erosion that has been repaired on the NF-4440 Road near RM 23.7.

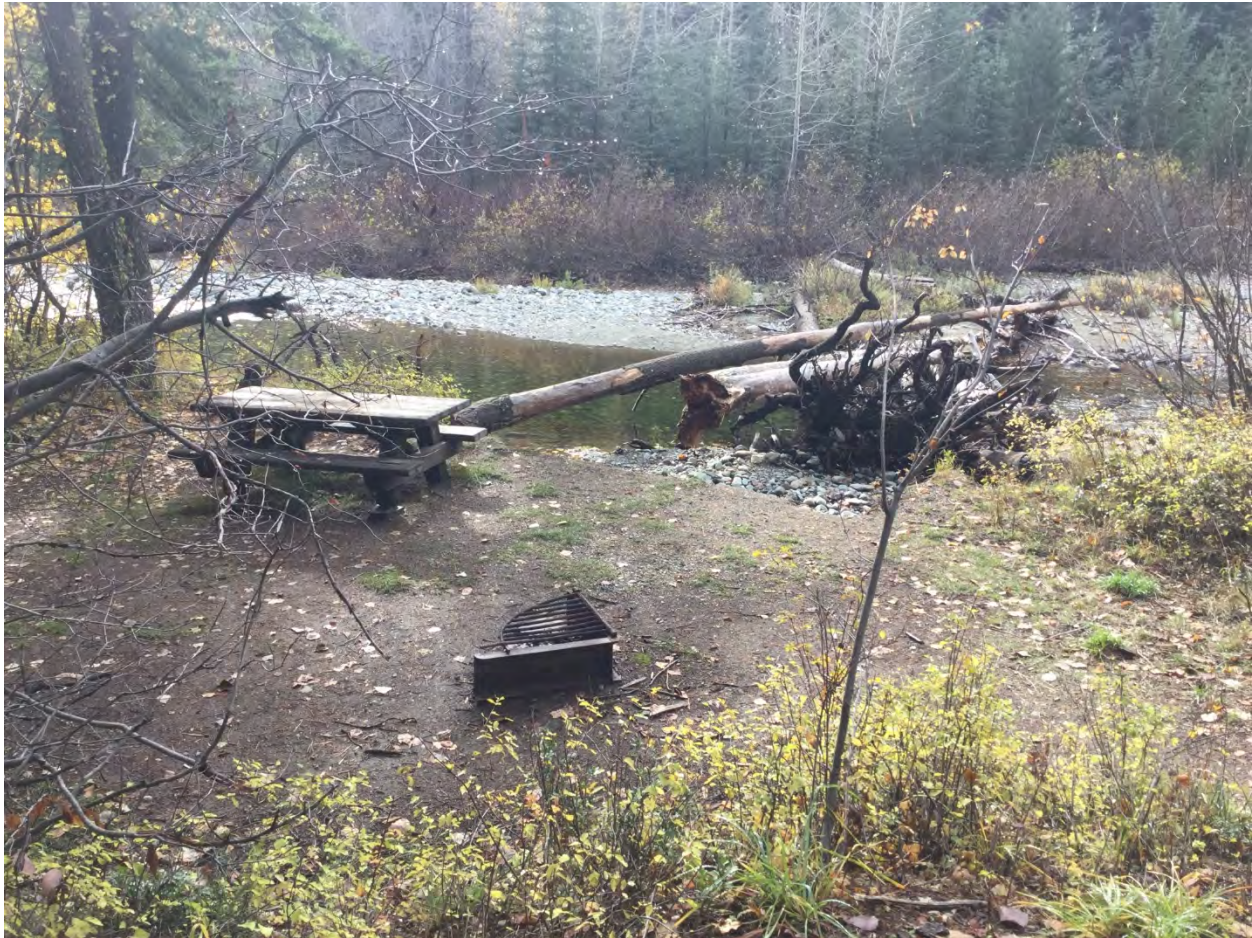
**Figure 2-5. Photograph of Eroding Bank at the Poplar Flats Campground in the Upper Twisp River Reach 3 near RM 24.2**

Recreation use in riparian areas, particularly unsanctioned roads and trails, dispersed camping, firewood cutting, off-road use, and waste dumping has resulted in negative impacts. Figure 2-5 shows an example of an eroding bank encroaching on a camp site at the Poplar Flats Campground in UTR Reach 3 near RM 24.2. Beginning in

1993, the Methow Valley Ranger District has developed a program to manage recreation use impacts, called the Respect the River Program, which combines riparian vegetation treatments with a strong public outreach and education component (USFS 2012). The Twisp River is included in the Respect the River focus area.

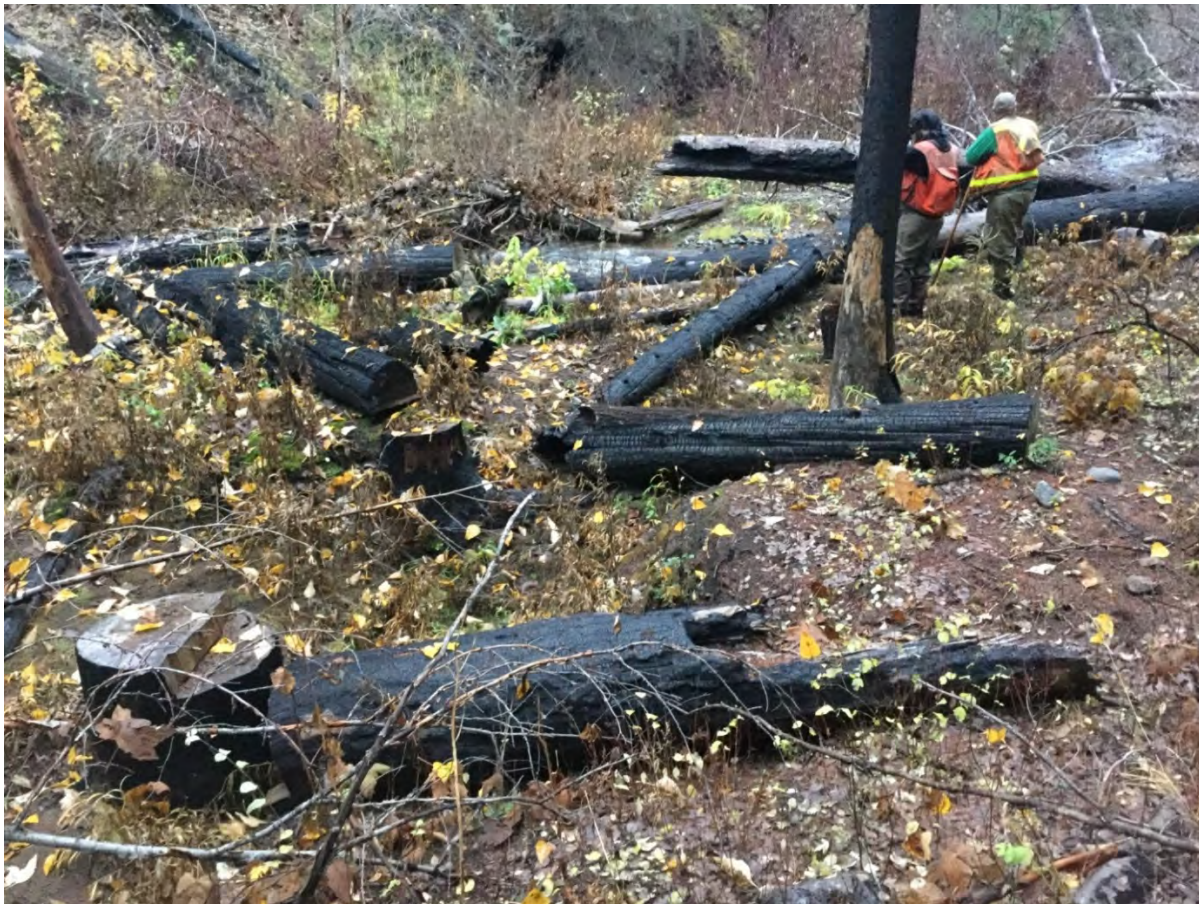
Figure 2-6. Photograph of Burned and Felled Riparian Vegetation in Little Bridge Creek (LBC) Reach 3 near RM 4.3

In 2015, the Okanogan Complex Fires, aided by extremely dry conditions, burned over 520,000 acres, including the Twisp River Fire in the Twisp River watershed (BAER 2015; USFS 2016a). The Twisp River Fire started on August 19, 2015 in a subdivision about 5 miles west of Twisp (USFS 2016a), and burned 11,222 acres (BAER 2015). Tragically, three USFS firefighters were killed during the fire, and a fourth was critically injured (USFS 2016a). The majority of impacts in the Twisp River watershed were downstream of the Survey Area; however, the Twisp River Fire burned the upper portions of the LBC drainage (BAER 2015). Figure 2-6 shows burned riparian vegetation that has been felled for safety in LBC Reach 3 near RM 4.3.

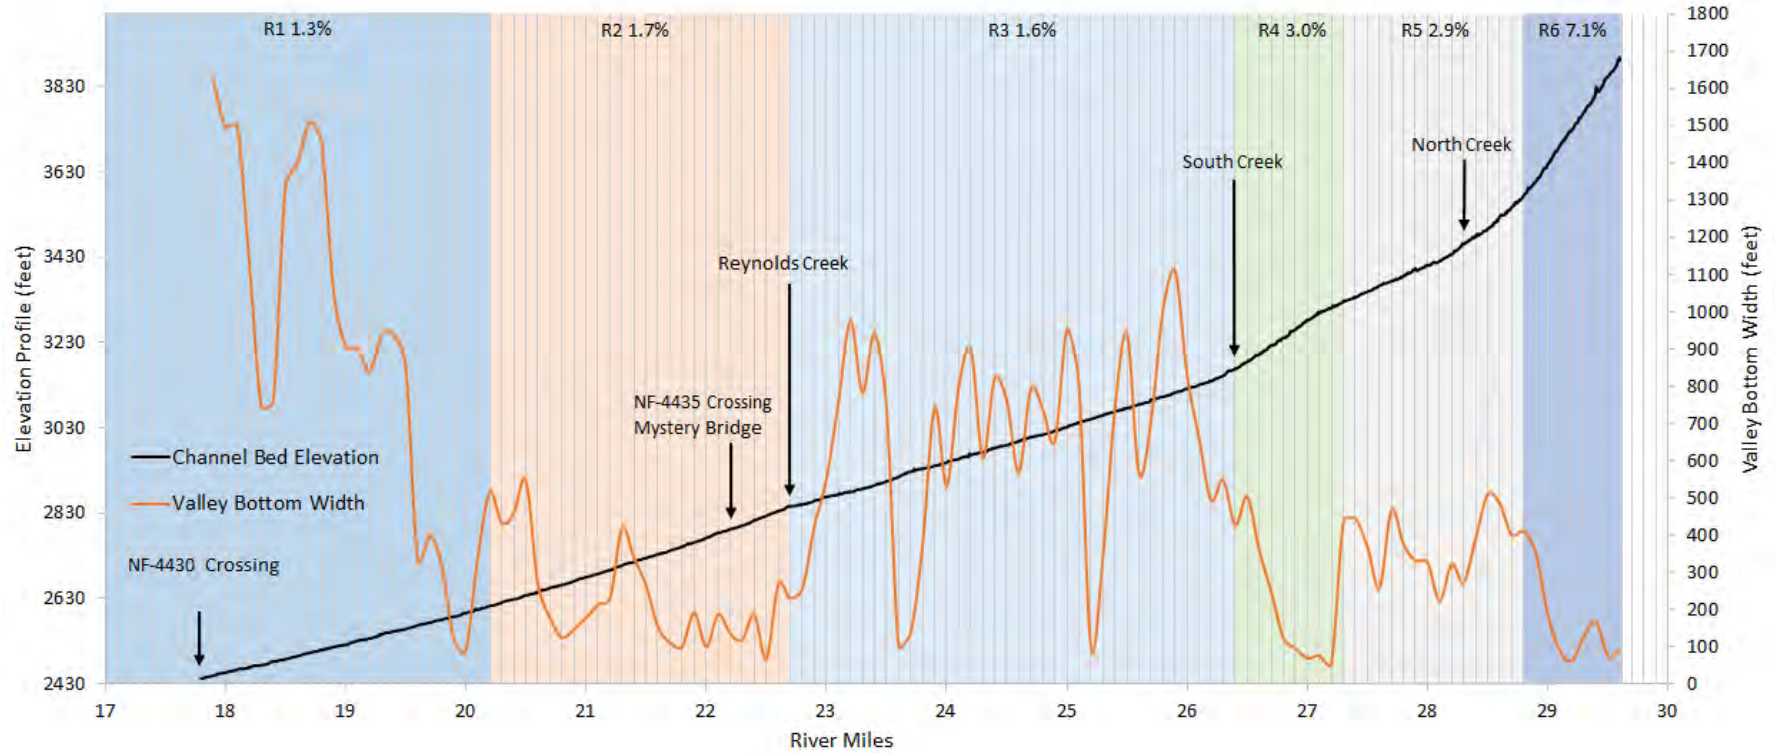
Figure 4-2. Upper Twisp River Longitudinal Profile of Channel Bed Elevation and Valley Width

There is good floodplain connectivity and off-channel habitat in many of the unconfined areas of the UTR. Extensive floodplain wetlands and beaver dam complexes are found in some areas. Unconfined areas also tend to be highly dynamic and prone to migration through channel avulsions. An extensive network of active and relict floodplain channels and channel scars are visible across the floodplain. In contrast, isolated areas throughout the UTR are somewhat incised with limited floodplain connectivity. In these areas, bedforms are mostly featureless, the substrate is relatively coarse, and sediment storage in bars is limited. As previously mentioned in Section 2.3.5, a history of LWD removal from the Twisp River has resulted in reduced LWD quantity and diminished habitat quality.

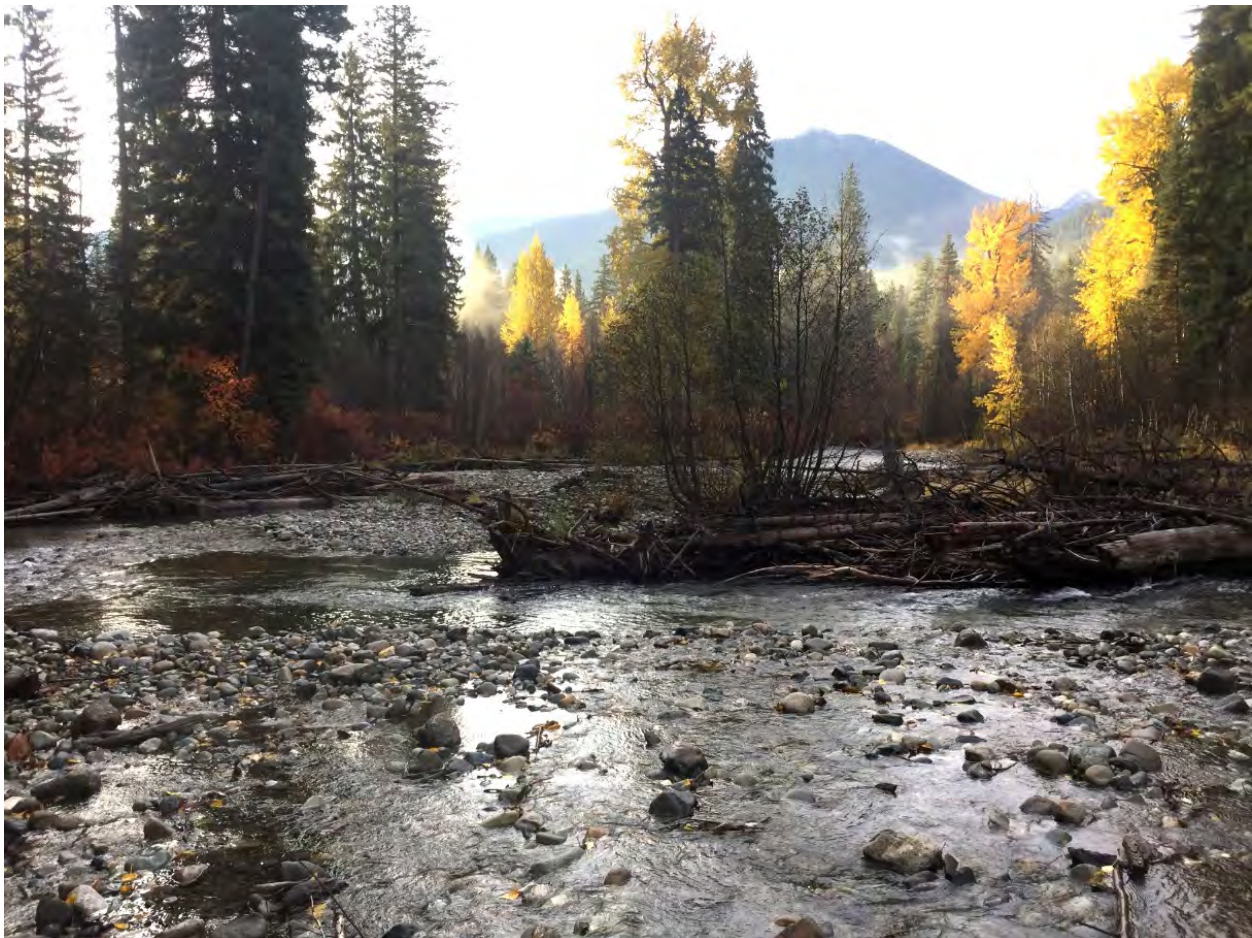
**Figure 4-4. Log Jams and Habitat Complexity in the Upper Twisp River Reach 1 near RM 18.0**

The habitat of UTR Reach 1 exhibits a great deal of complexity and diversity, dominated by riffles and lateral scour pools, as shown in Figure 4-4. Spawning habitat is abundant throughout UTR Reach 1. Evidence of beaver activity is prevalent throughout this reach in the main channel and side channels. Beaver dams are frequent on side channels in this reach and are resulting in large open-water beaver ponds on the floodplain near RM 18.5. Observations of beaver activity in the mainstem Twisp River were limited to individual chewed trees and small, temporary, low-flow main channel dams. Beaver activity was not called out in the earlier surveys, but the 2013 survey did note beaver activity in this reach.

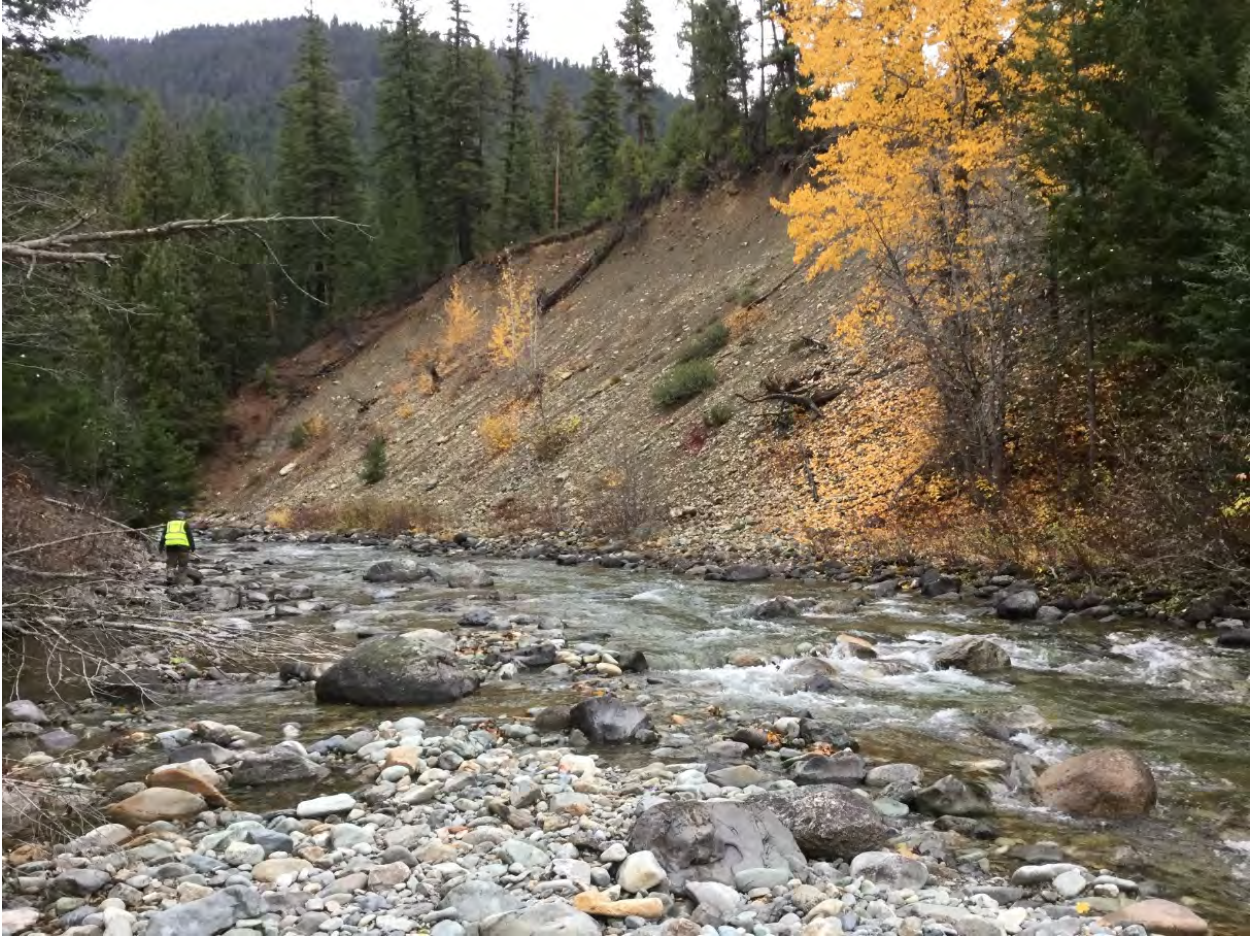
**Figure 4-5. High Eroding Bank on the Upper Twisp River Reach 2 near RM 21.4**

UTR Reach 2 remains relatively low gradient with an average of 1.8 percent. The valley is more confined than in UTR Reach 1, ranging from 175 to 750 feet, and is U-shaped. Large landslide deposits, terraces, bedrock outcrops, and alluvial fans confine the channel to various degrees throughout UTR Reach 2. The substrate in this reach is cobble-dominated, with a higher proportion of boulders than in UTR Reach 1 and less spawning gravels. The channel is single-thread and incised throughout the majority of UTR Reach 2, limiting floodplain connectivity. Bars are less frequent than in UTR Reach 1, particularly upstream of RM 20.8. Frequent bank erosion was observed on the outside bends with point bars and where the channel was interacting with the valley edge, as shown in Figure 4-5. Bank erosion and channel erosion are restricted somewhat in deeply incised areas due to naturally boulder-armored bank materials.

The habitat of UTR Reach 2 is simplified, dominated by riffles, and has fewer pools than in the other upper Twisp River reaches. There is far less available spawning habitat in this reach than in UTR Reach 1. LWD and jams were also less frequent in UTR Reach 2 than in UTR Reach 1. In contrast to both upstream and downstream reaches, there was little evidence of beaver activity in UTR Reach 2.

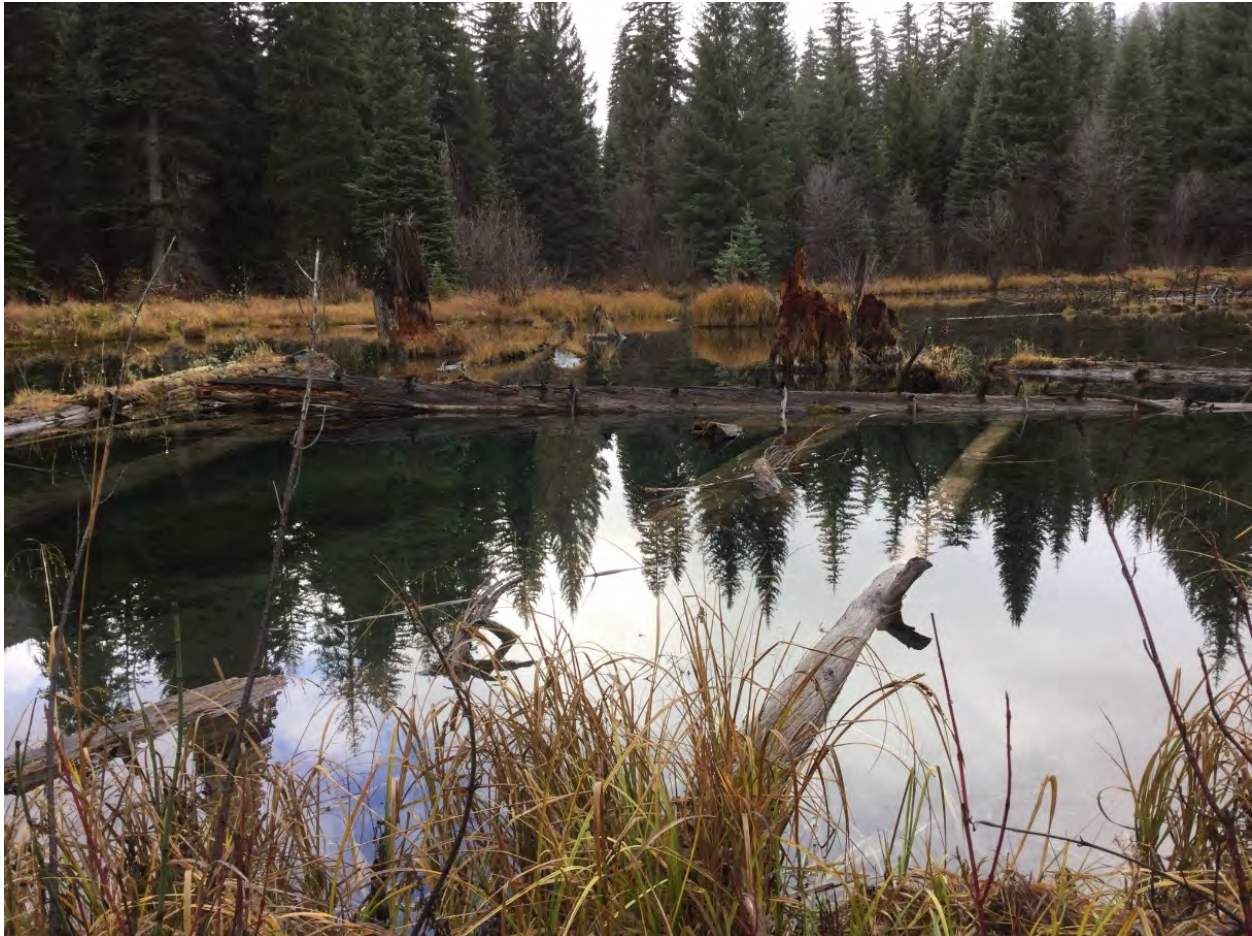
**Figure 4-6. Beaver Dam Pond on the Upper Twisp River Reach 3 near RM 23.1**

floodplains, and off-channel habitat. Spawning gravels were observed in this reach particularly from the downstream end of the reach (22.7) to RM 23.6 and near RM 25.6. Evidence of beaver activity is prevalent throughout this reach in side channels and this activity is resulting in a series of large open-water beaver ponds on the floodplain near RM 23.1, as shown in Figure 4-6. The 2013 survey noted that inactive beaver dams were observed in some of the side channels in the reach while evidence of recent beaver activity was observed in this reach in 2016.

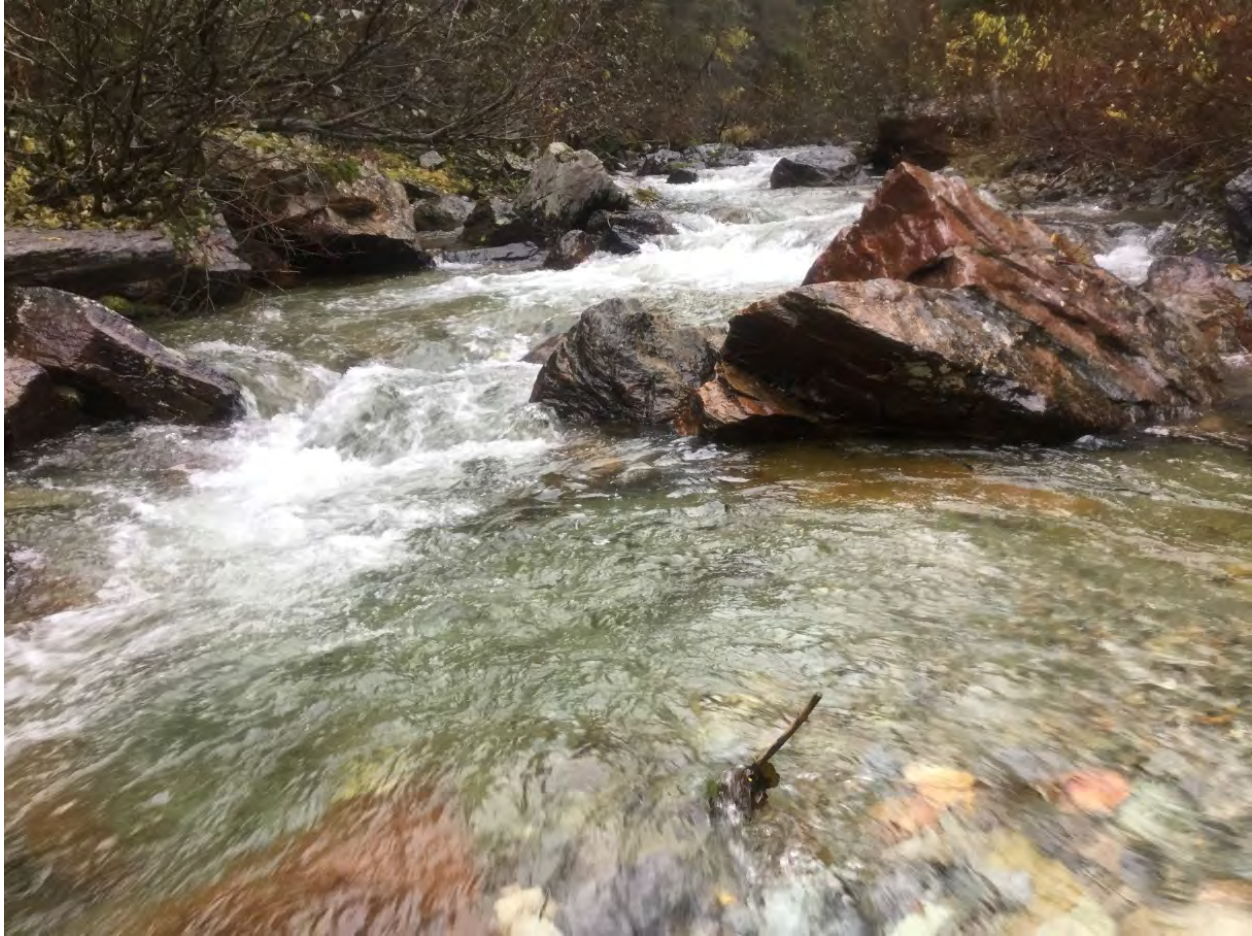
**Figure 4-7. Habitat Conditions in the Upper Twisp River Reach 4 near RM 27.1**

The habitat of UTR Reach 4 is dominated by riffles and short rapids, as shown in Figure 4-7, with relatively frequent scour and plunge pools. The presence of spawning gravels is limited in this reach. No beaver activity was observed in this reach. Beaver activity was not called out in the earlier surveys, but the 2013 survey did note there was no beaver activity in Reaches 6 through 8 in 2013.

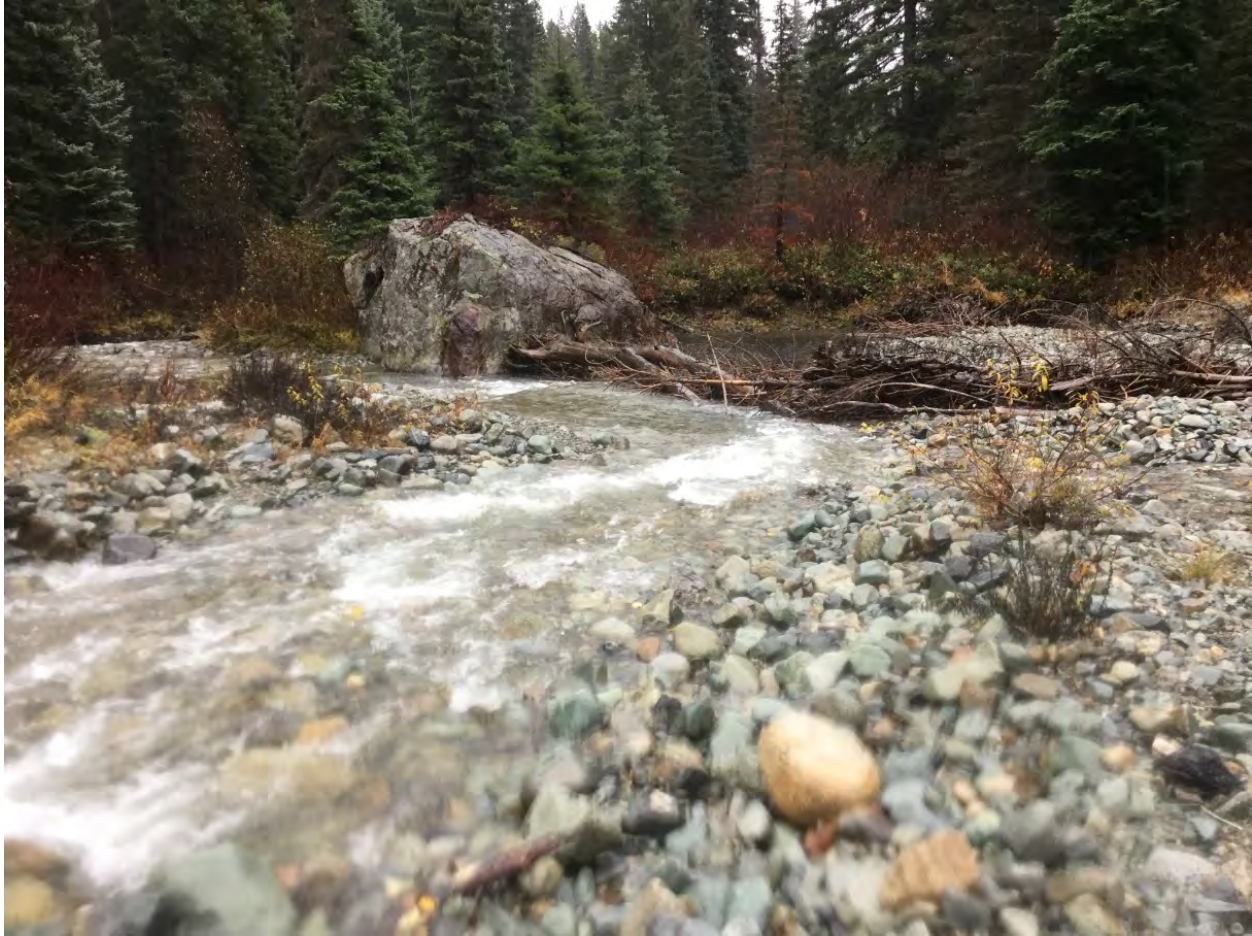
**Figure 4-8. Laterally Active Area of the Upper Twisp River Reach 5 near RM 27.4**

The habitat of UTR Reach 5 varies widely but, in general, is dominated by riffles and rapids, with relatively frequent scour pools and plunge pools associated with log steps and boulders. There are spawning gravels present, more commonly in the relatively unconfined segments. There was also a beaver-dammed side channel in this reach at the North Creek confluence near RM 28.3. No evidence of beaver activity was observed at this location in the 2013 survey.

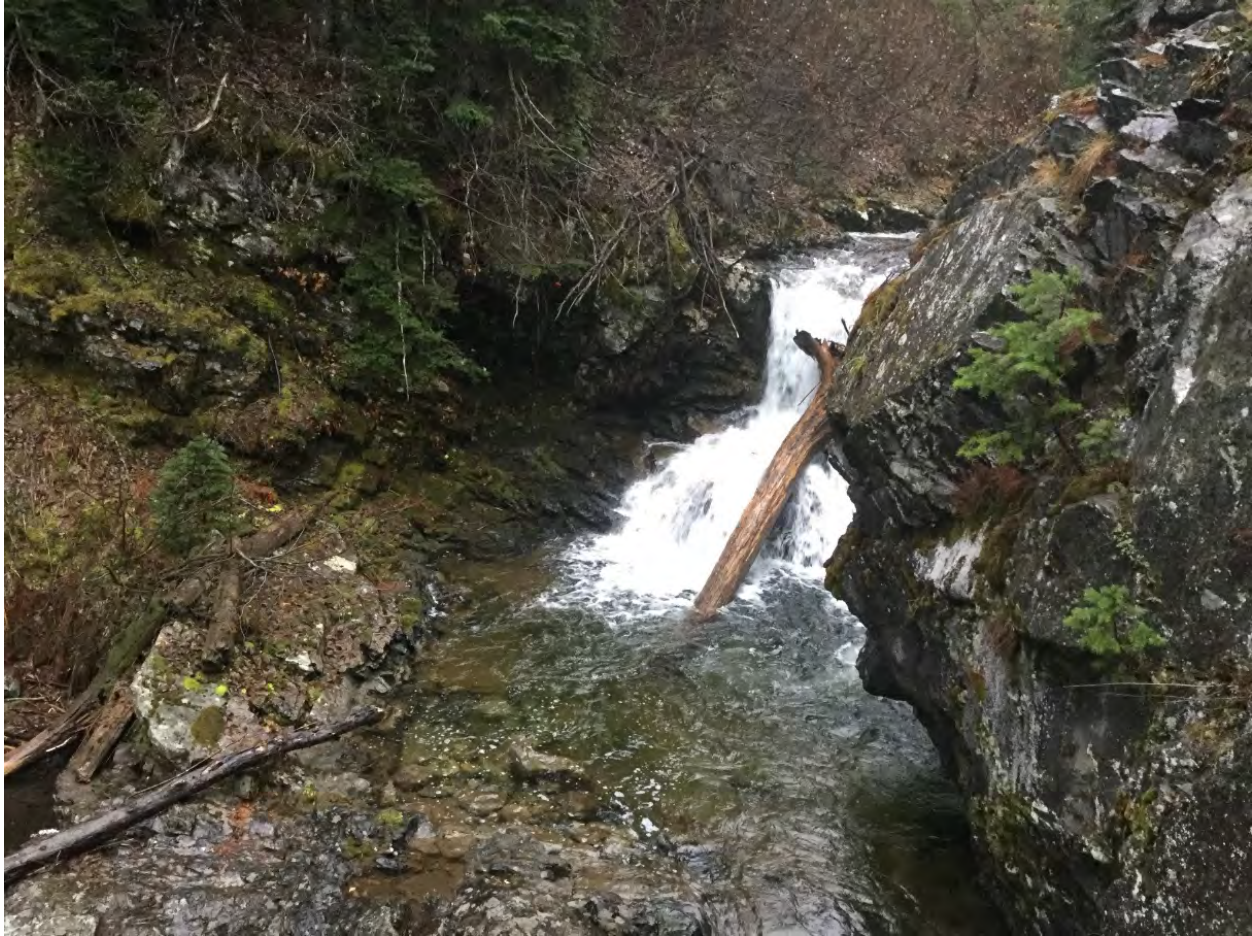
Figure 4-9. Fish Passage Barrier Waterfall (approximately 15 feet high) on the Upper Twisp River Reach 6 near RM 29.6

The habitat of UTR Reach 6 is dominated by rapids, cascades, and short riffles. Plunge pools are frequent and associated with cascades, log steps, and boulders. Bull trout spawning habitat is abundant in UTR Reach 6 with the highest densities of bull trout redds in the Methow River Subbasin (USFS 2014). No evidence of beaver activity was observed in this reach.

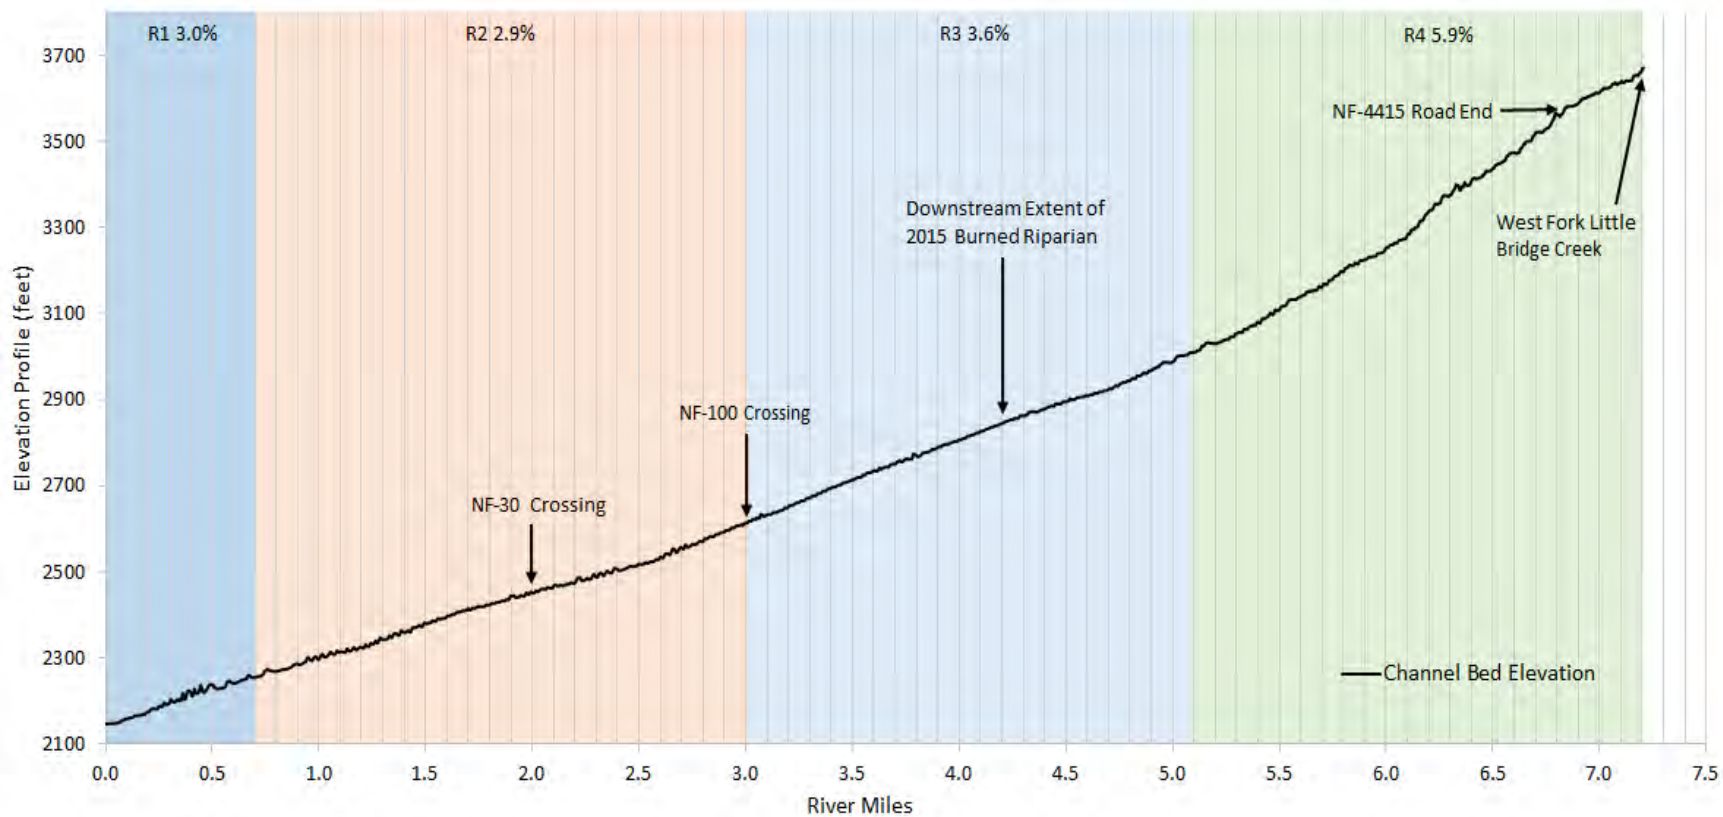
Figure 4-10. Little Bridge Creek Longitudinal Profile and Reach Gradients

There is good floodplain connectivity and off-channel habitat in many of the unconfined areas of the LBC. Extensive beaver dam complexes are found in some areas. Unconfined areas also tend to be highly dynamic and prone to migration through channel avulsions. In contrast, isolated areas throughout the LBC are somewhat incised with limited floodplain connectivity. LWD and logs jams are the primary drivers for instream complexity in these areas.

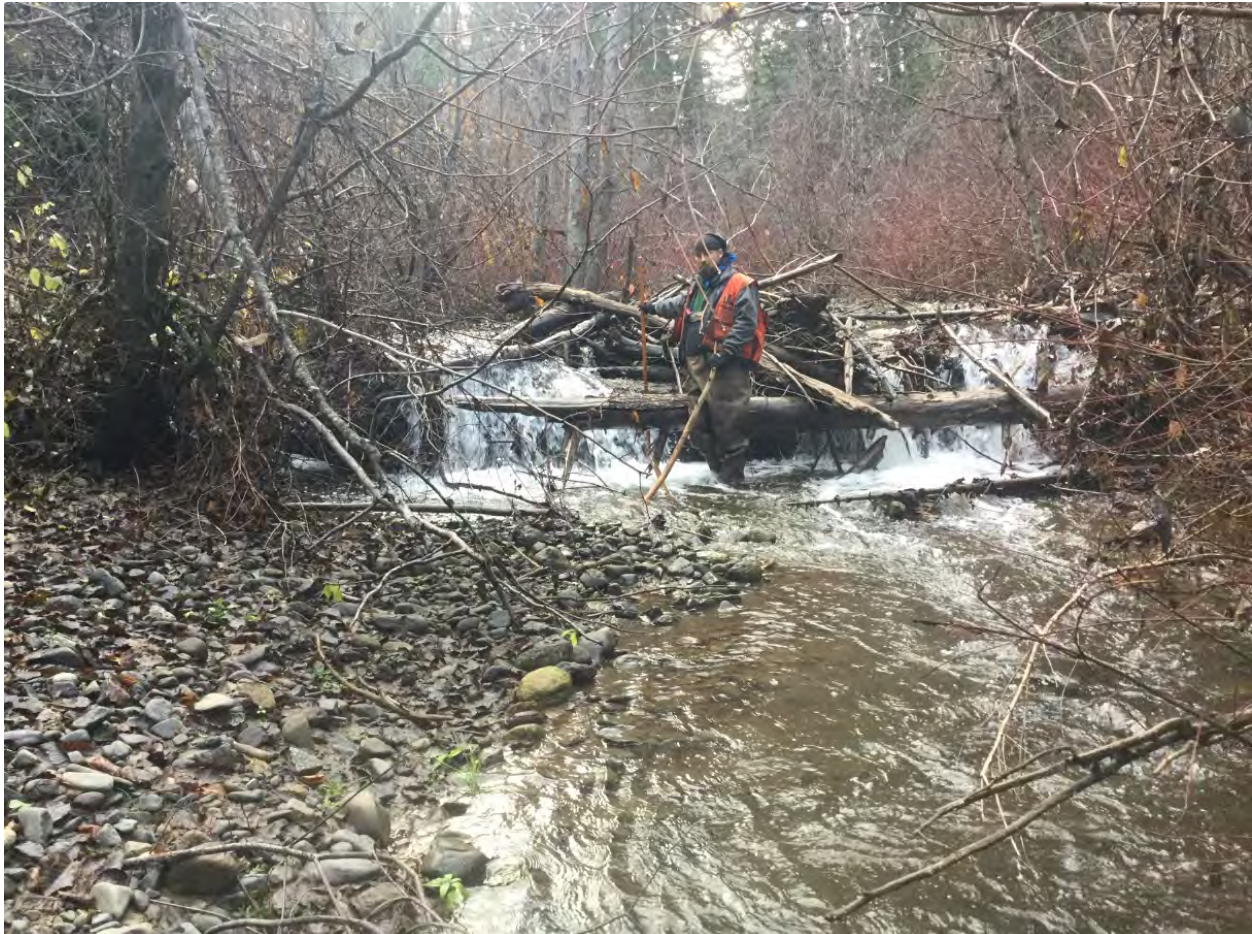
**Figure 4-12. Log Jam Step and Plunge Pool in Little Bridge Creek Reach 1 near RM 0.5**

LBC Reach 1 has an average gradient of 3.0 percent with a somewhat steeper drop near the Twisp River confluence. Most of LBC Reach 1 is incised with little or no floodplain connectivity. The valley narrows from the confluence to RM 0.3 where it becomes narrow and V-shaped. The substrate in this reach is cobble dominated, with higher proportions of gravel observed in infrequent bars. Point bars and active bank erosion were observed in several locations. There was one mid-channel bar in LBC Reach 1 observed upstream of a log jam. The step formed by this jam, shown in Figure 4-12, may be temporarily limiting fish passage due to a 36-inch jump height and a 22-inch plunge pool downstream. Accumulations of fine sediment were observed throughout this reach. Deposits of sand and very fine gravel as deep as 6 inches were observed in areas of lower velocity. The LBC has naturally high quantities of fine sediments that have been exacerbated by past management activities such as timber harvesting, roads, and cattle grazing. Sediment inputs have also increase in the LBC as a result of post-fire erosion following the 2015 Twisp River Fire. Several large boulders with associated scour pools were observed in this reach. The LBC Reach 1 is dominated by riffle habitat with frequent plunge and scour pools, and infrequent, short rapid drops. The pool frequency is 61 pools per mile and the LWD frequency is 56 pieces per mile. There was one short side channel observed in this reach, with inlet flows being controlled by a log jam.

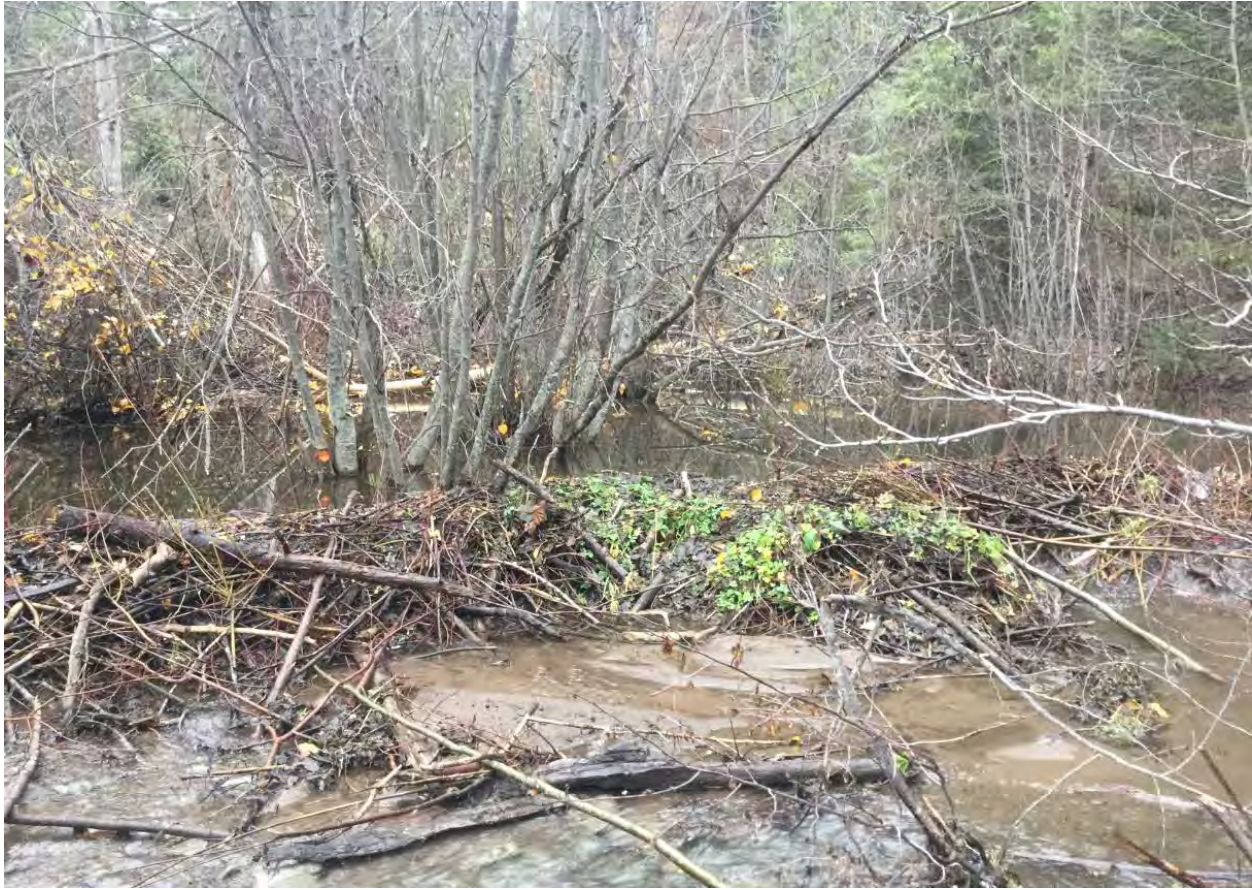
**Figure 4-13. Beaver Dam Complex in Little Bridge Creek Reach 2 near RM 1.7**

The distinguishing habitat feature in LBC Reach 2 is the presence of channel-spanning beaver dams near RM 0.9 and from RM 1.7 to RM 1.8, as shown in Figure 4-13. In both areas, an extensive system of beaver dams has completely dammed the main channel and side channels, inundating nearly the entire floodplain. The habitat between beaver dams is dominated by riffles with frequent plunge and scour pools. Dam pools upstream of channel-spanning LWD were common in this reach. The pool frequency is 72 pools per mile and the LWD frequency is 33 pieces per mile. Off-channel areas and side channels are frequent in this reach, many of which were influenced by beaver activity. No beaver dams were observed in the 1996 or 2006 surveys of the LBC, which indicates a significant change in habitat conditions over that time.

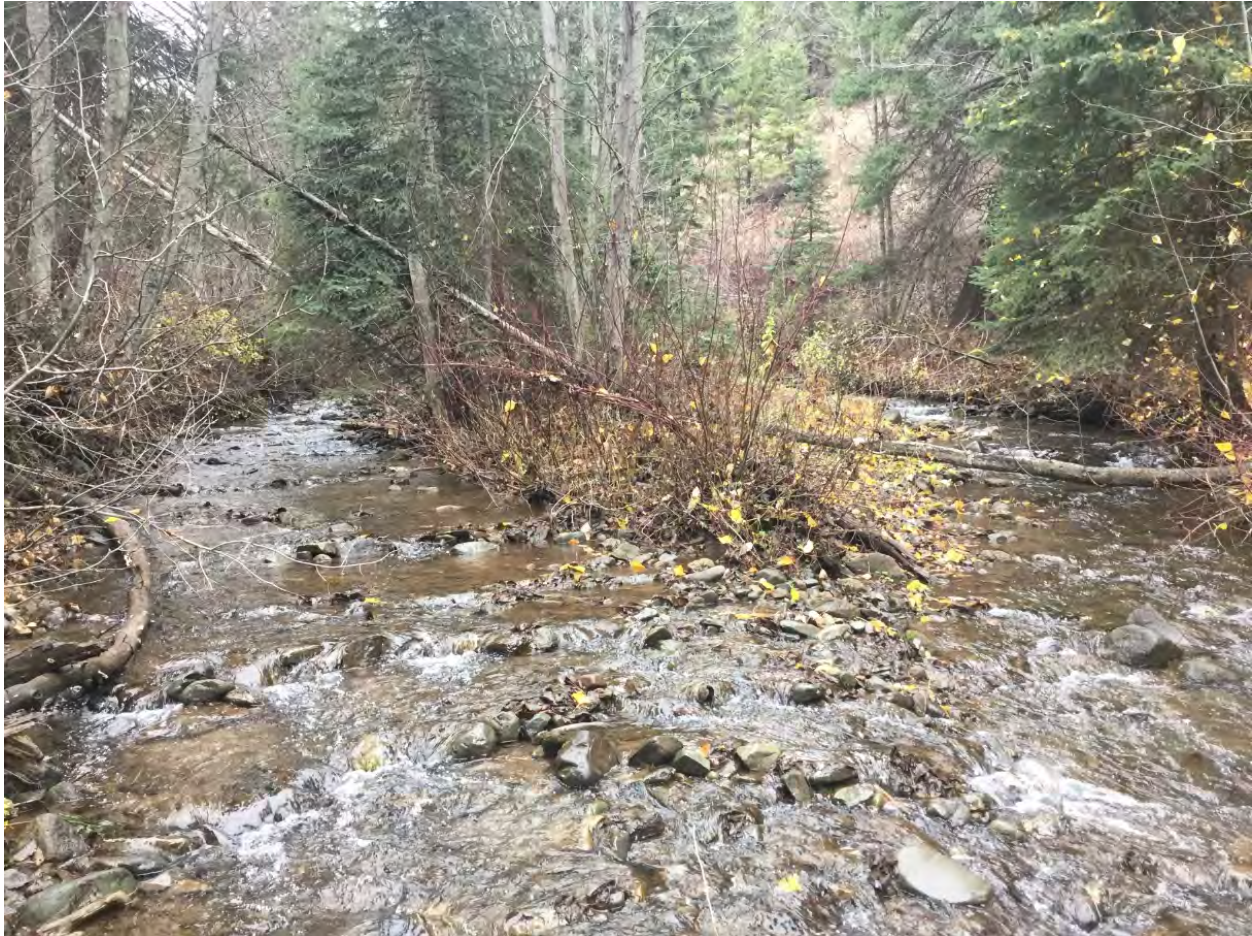
**Figure 4-14. Split Flow around Vegetated Island in Little Bridge Creek Reach 3 near RM 3.0**

shows split flow around a vegetated island near RM 3.0. The habitat in LBC Reach 3 is dominated by riffle with frequent pools. Lateral scour pools and LWD forced pools are more common in this reach than plunge pools or dam pools. The pool frequency is 61 pools per mile and the LWD frequency is 36 pieces per mile. There were multiple side channels in this reach, including both wetted side channels and dry, high-flow channels.

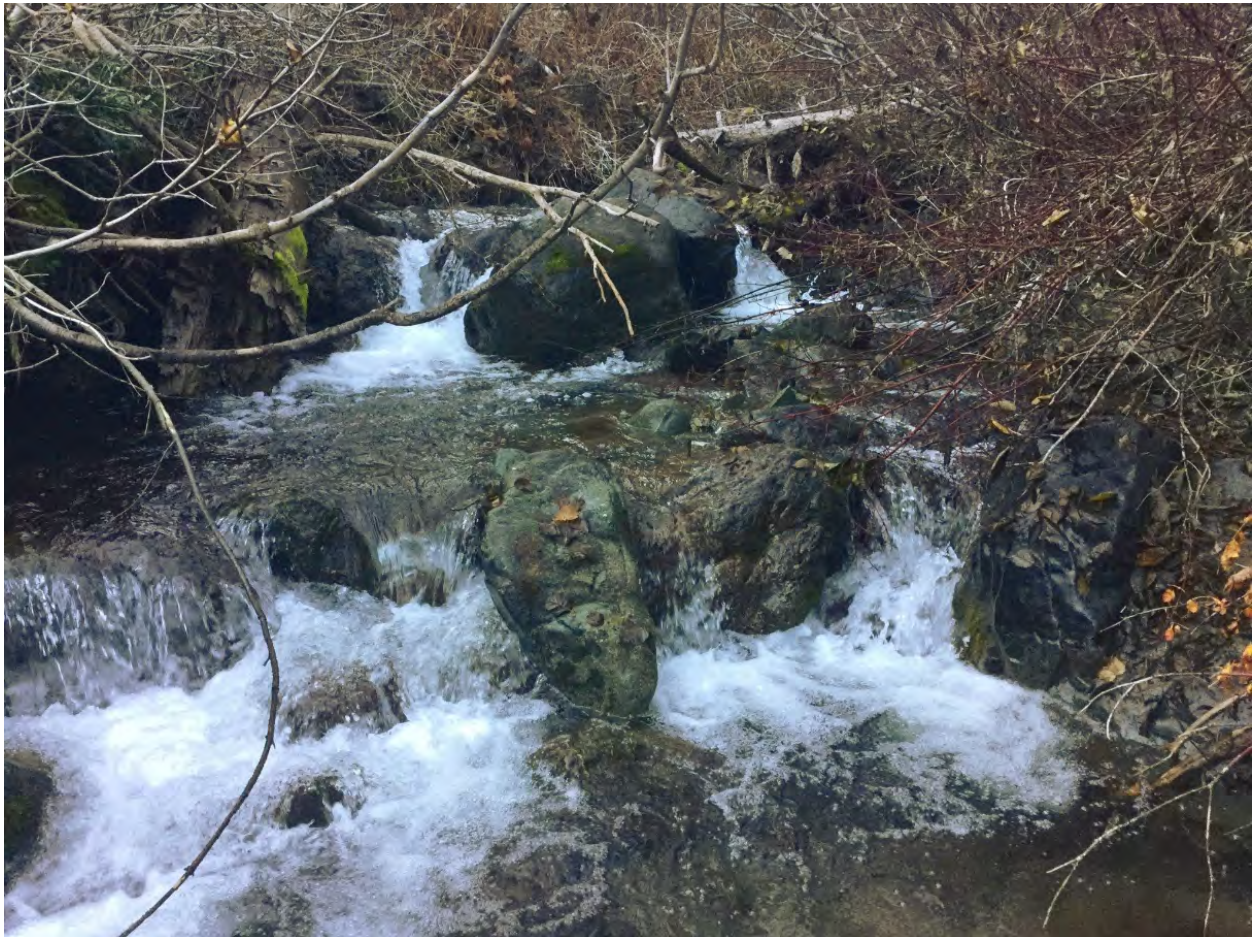
Figure 4-15. Cascade downstream of West Fork Little Bridge Creek Confluence Reach 4 near RM 7.2

The habitat of LBC Reach 4 is dominated by riffles and rapids with short cascades and frequent pools. Figure 4-15 shows a cascade downstream of the West Fork Little Bridge Creek confluence near RM 7.2. LWD and boulder forced plunge pools and dam pools are common in this reach. The pool frequency is 54 pools per mile and the LWD frequency is 34 pieces per mile. Side channels are infrequent in this reach and associated with channel-spanning log jams.
