# Upper Twisp River and Tributaries

## HABITAT ASSESSMENT

December 2017

TETRA TECH

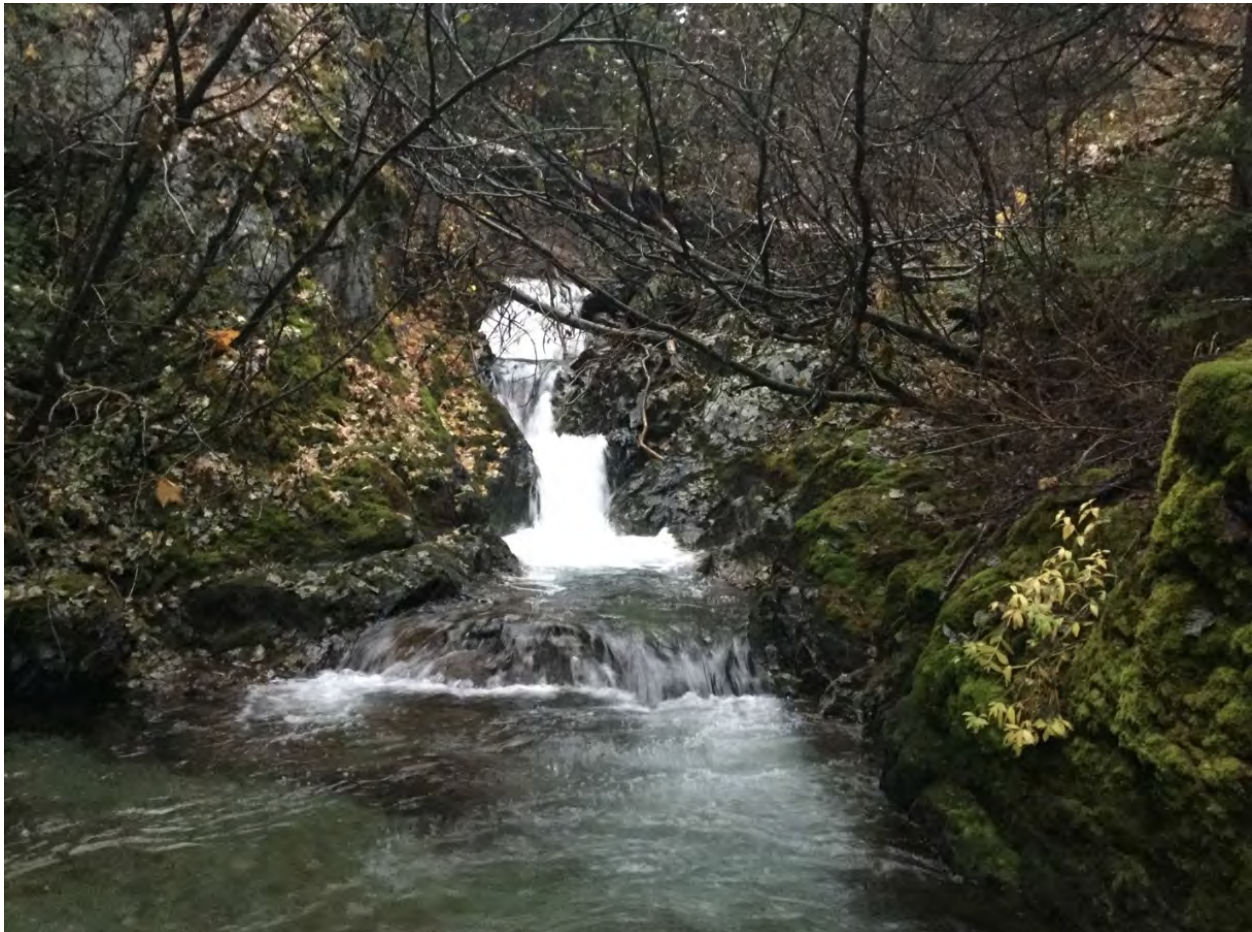
**Figure 4-16.** Fish Passage Barrier Falls at the Upstream Extent of the North Creek Survey Reach near RM 0.6

**North Creek:** North Creek is the uppermost perennial tributary to the Twisp River, entering from the north near RM 28.3. The field survey of North Creek occurred from the confluence with the Twisp River (RM 0.0) to about RM 0.6 where there is a complete fish passage barrier waterfall (Figure 4-16). There is one existing road crossing structure on North Creek on the NF-4440 road near RM 0.5. The crossing is an open bottom arch culvert in good condition, but the culvert width of 17 feet does not span the bankfull width of North Creek, as shown in Figure 4-17. As a result, the North Creek crossing may be susceptible to plugging and possible catastrophic failure, particularly following a large disturbance event such as a flood or landslide. Upstream of the road crossing there is a levee on the right bank and an existing cabin structure. Previous surveys of North Creek noted the presence of a water diversion near RM 0.5 of North Creek for domestic use and an ore mill (USFS 1995a). This diversion structure was not observed in 2016.

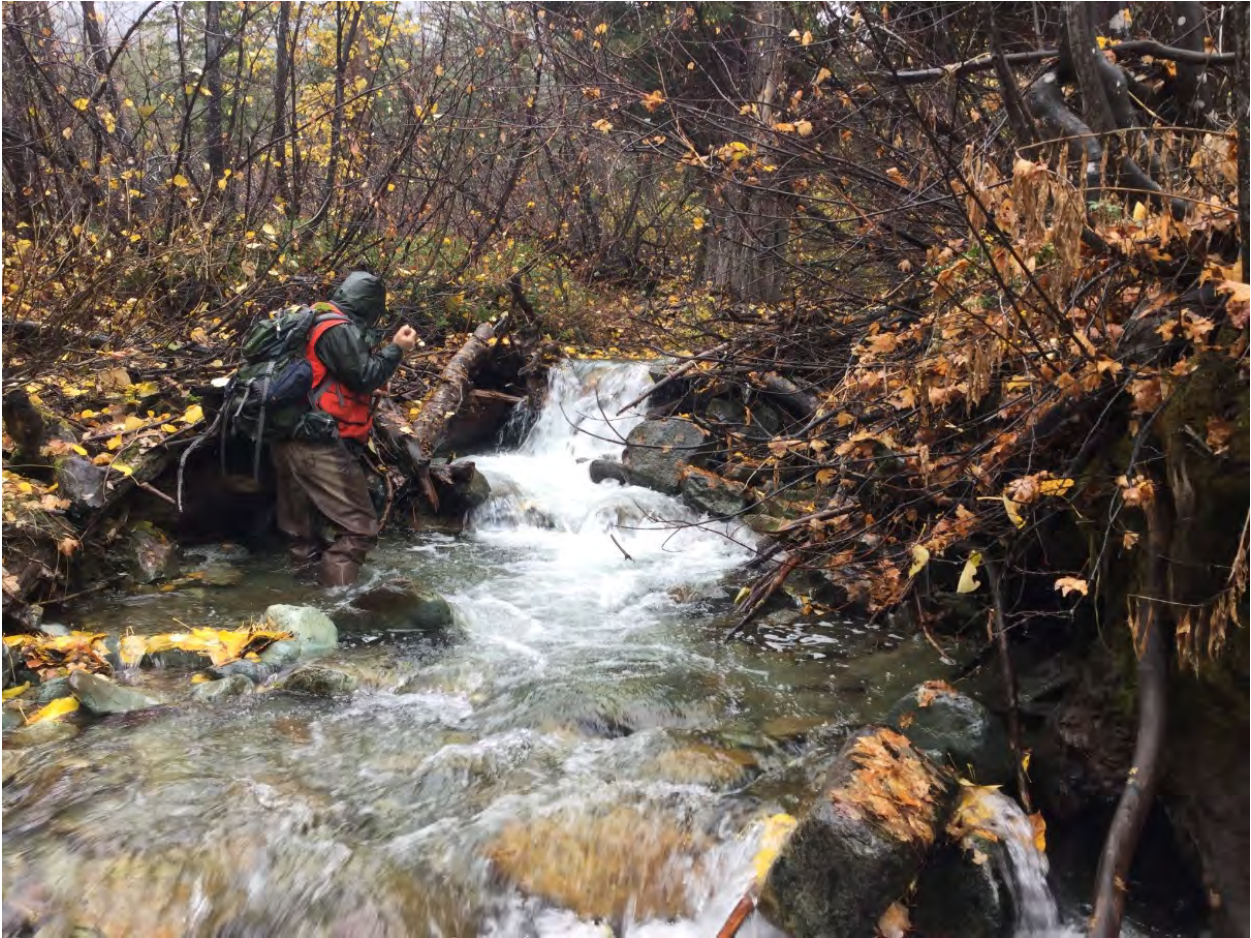
**Figure 4-18. Small Wood and Boulder Drop near RM 0.2 on North Creek**

The average gradient of the North Creek survey reach is 8.4 percent. The average wetted width is 15 feet and an average bankfull width of 30 feet. A total of 6.7 percent of banks were identified as eroding. There are several natural small wood and boulder drops that are potentially limiting fish access to the upper extent of the survey reach. Figure 4-18 shows the most downstream and shortest of those drops near RM 0.2.

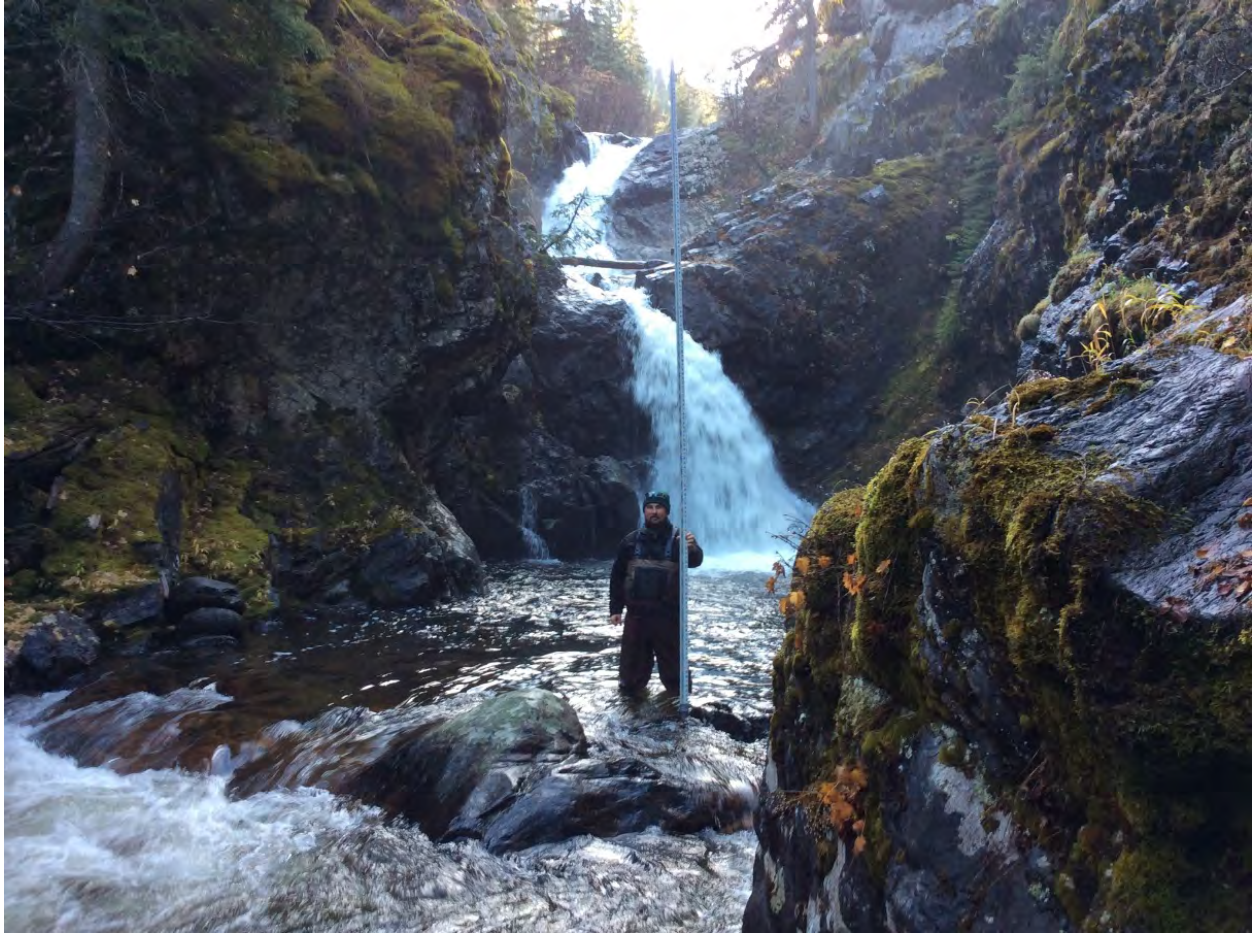
**Figure 4-19. Fish Passage Barrier Falls at the Upstream Extent of the South Creek Survey Reach near RM 0.6**

**South Creek:** South Creek enters the Twisp River from the southwest near RM 26.4, across from the South Creek Campground. The field survey of South Creek included a single reach that extends from the confluence with the Twisp River (RM 0.0) to about RM 0.6, where there is a complete fish passage barrier at a series of waterfalls (Figure 4-19). There are no road crossings of South Creek but there is one pedestrian bridge on the South Creek Trail near RM 0.3, shown in Figure 4-20.

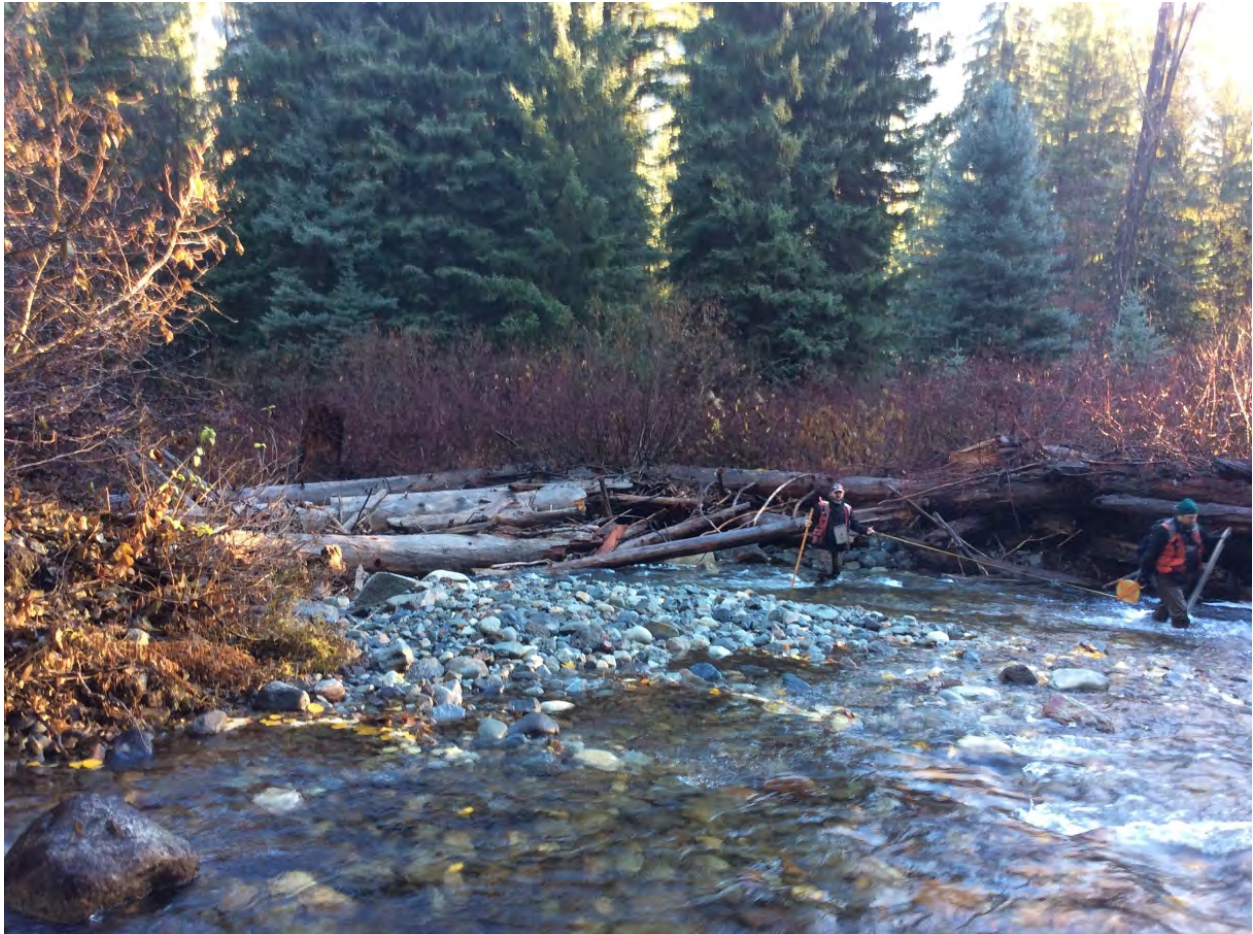
**Figure 4-21. Log Jam on South Creek Downstream of RM 0.3**

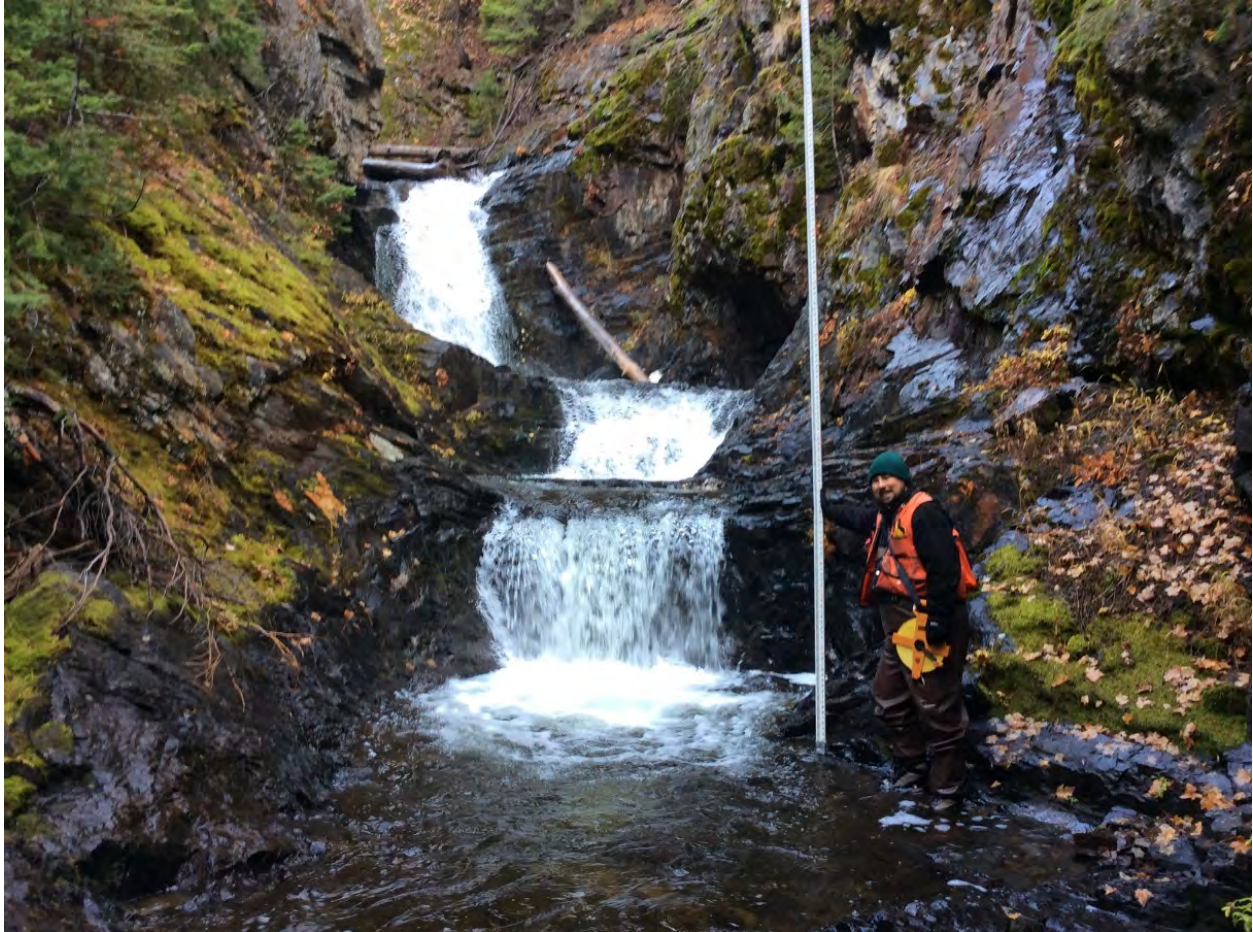
**Figure 4-22. Fish Passage Barrier Falls at the Upstream Extent of the Reynolds Creek Survey Reach near RM 0.6**

**Reynolds Creek:** Reynolds Creek enters the Twisp River from the southwest RM 22.7. The field survey of Reynolds Creek occurred from the confluence with the Twisp River (RM 0.0) to about RM 0.6 where there is a complete fish passage barrier at a series of four waterfalls (Figure 4-22). There is one existing road crossing structure on Reynolds Creek on the NF-4435 road near RM 0.1. The crossing structure, shown in Figure 4-23, is an open bottom arch culvert in good condition with a width of 27 feet. Bank erosion, sediment deposition, and racking wood were all observed at the upstream end of the culvert. The 1993 survey noted a fish passage barrier at this location with a 3-foot jump from the pool to the culvert, so it is assumed that the existing structure was installed after that survey was conducted.

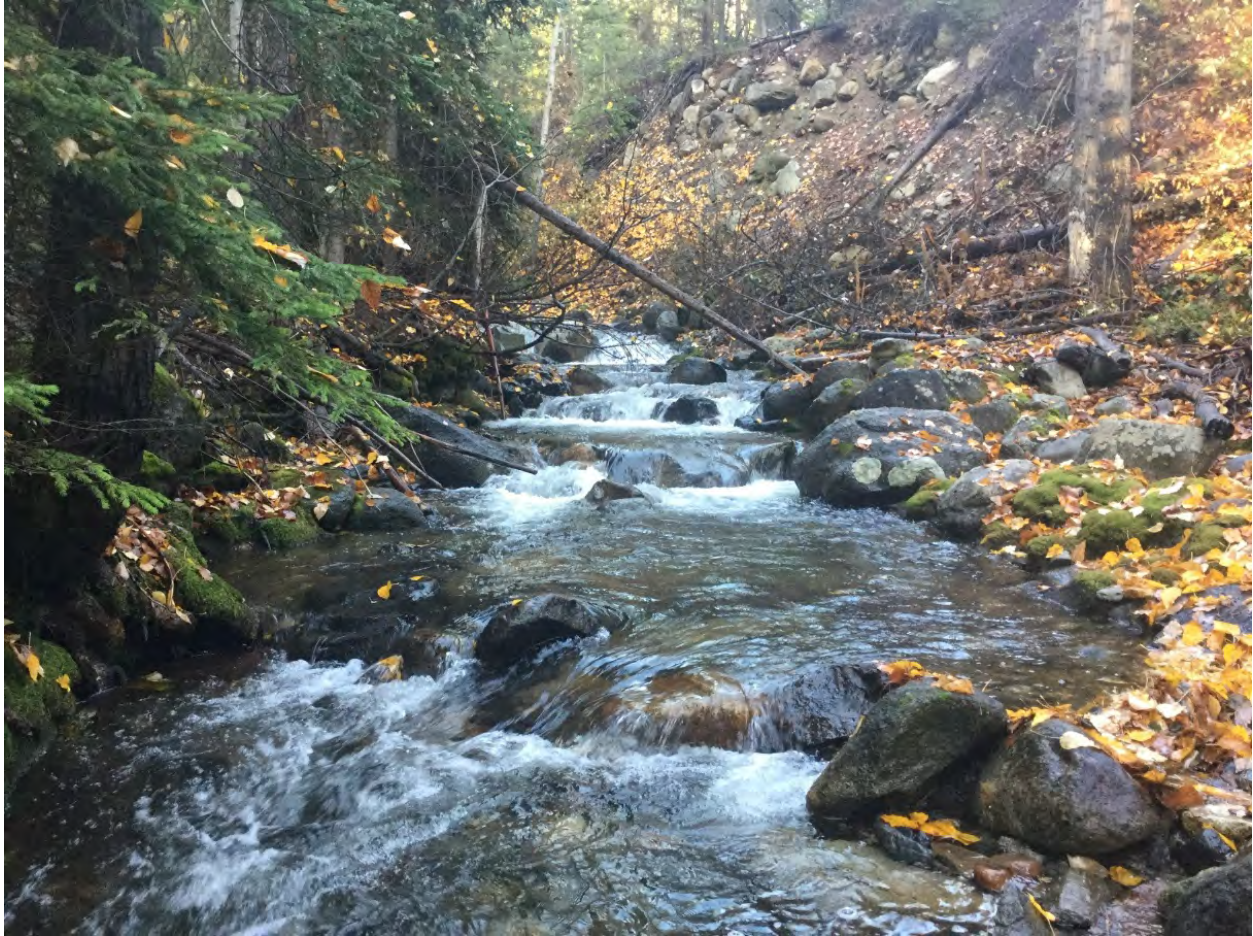
**Figure 4-24.** Cascade Drop to Boulder Plunge Pool on Reynolds Creek near RM 0.4

The habitat of Reynolds Creek is dominated by fast water units for 73 percent of the total length. Reynolds Creek has the highest percentage of pool habitat of all of the tributaries with pools, accounting for 27 percent of the total habitat area. Figure 4-24 shows an example of a cascade dropping into a boulder plunge pool which is common in Reynolds Creek and the other tributaries. The frequency of qualifying LWD in the survey reach was 23 pieces per mile. The overstory along Reynolds Creek is dominated by a mixture of conifers and deciduous trees (ranging from 9 to 21 inches dbh) throughout the drainage, and a mix of shrubby alder and red osier dogwood as the dominant understory.

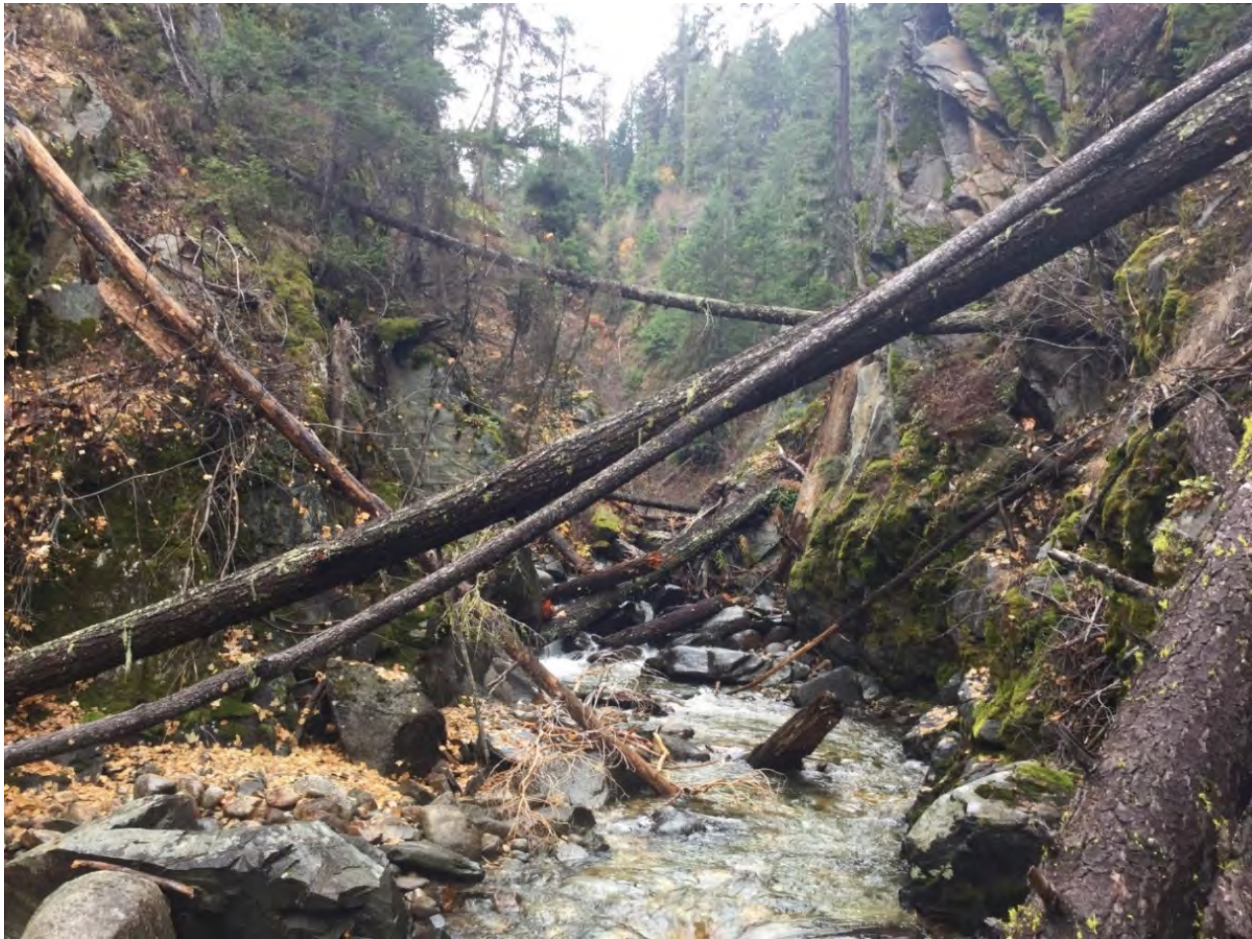
Figure 4-25. The Upper Extent of Surveys on War Creek near RM 1.2

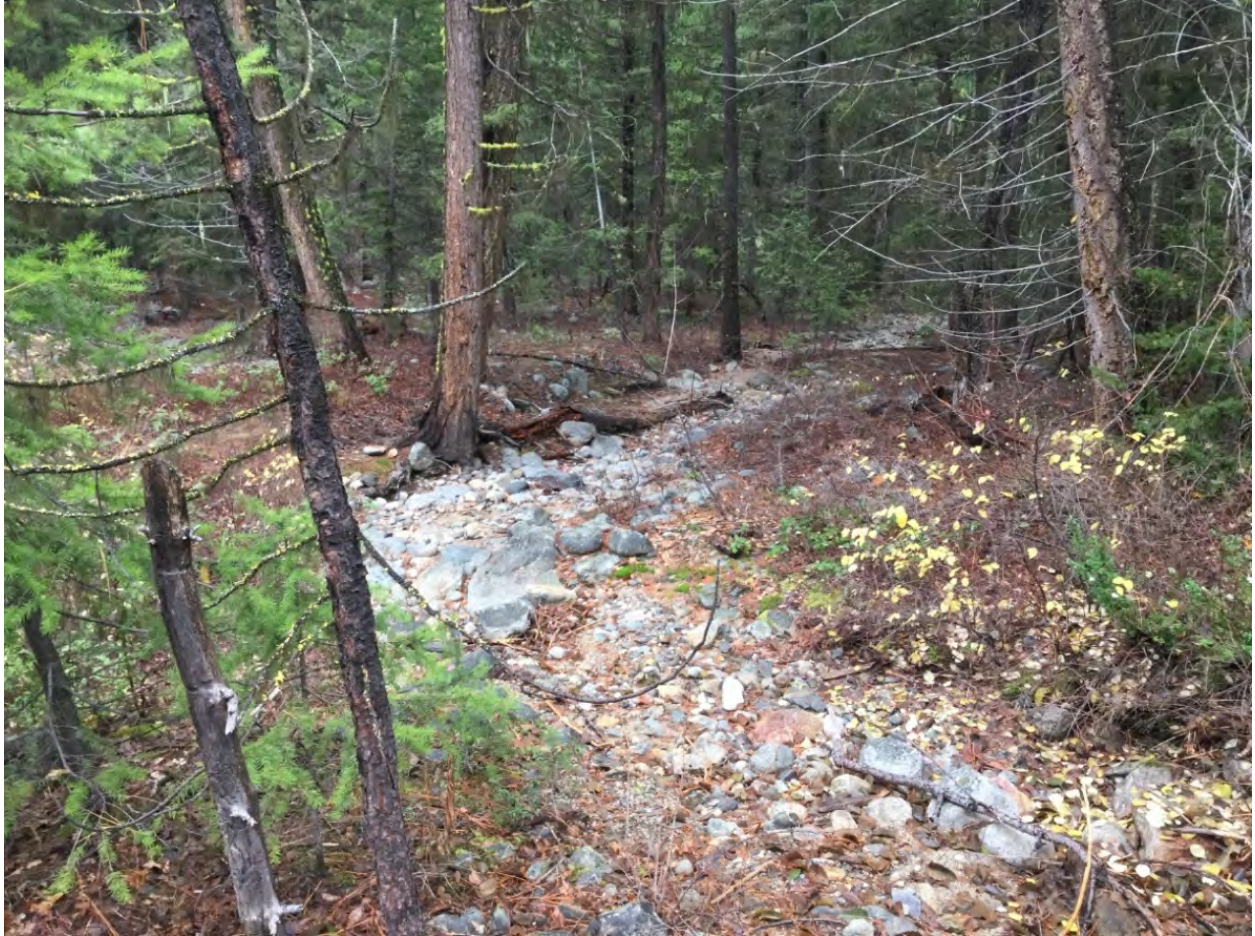
**Figure 4-26. High-Flow Side Channel Adjacent to War Creek near RM 0.6**

The average gradient of the War Creek survey reach is the lowest of all surveyed tributaries at 4.6 percent. War Creek is also the largest tributary in the Project area, with average wetted width of 23 feet and an average bankfull width of 36 feet. A total of 2.2 percent of banks were identified as eroding. There are a number of relict and active high-flow side channels in the survey reach downstream of the FS-4420 road crossing, but no flowing side channels at the time of the survey. An example of a high-flow side channel observed in War Creek is shown in Figure 4-26. The upper half of the survey reach is intermittently confined by bedrock outcrops on both banks.

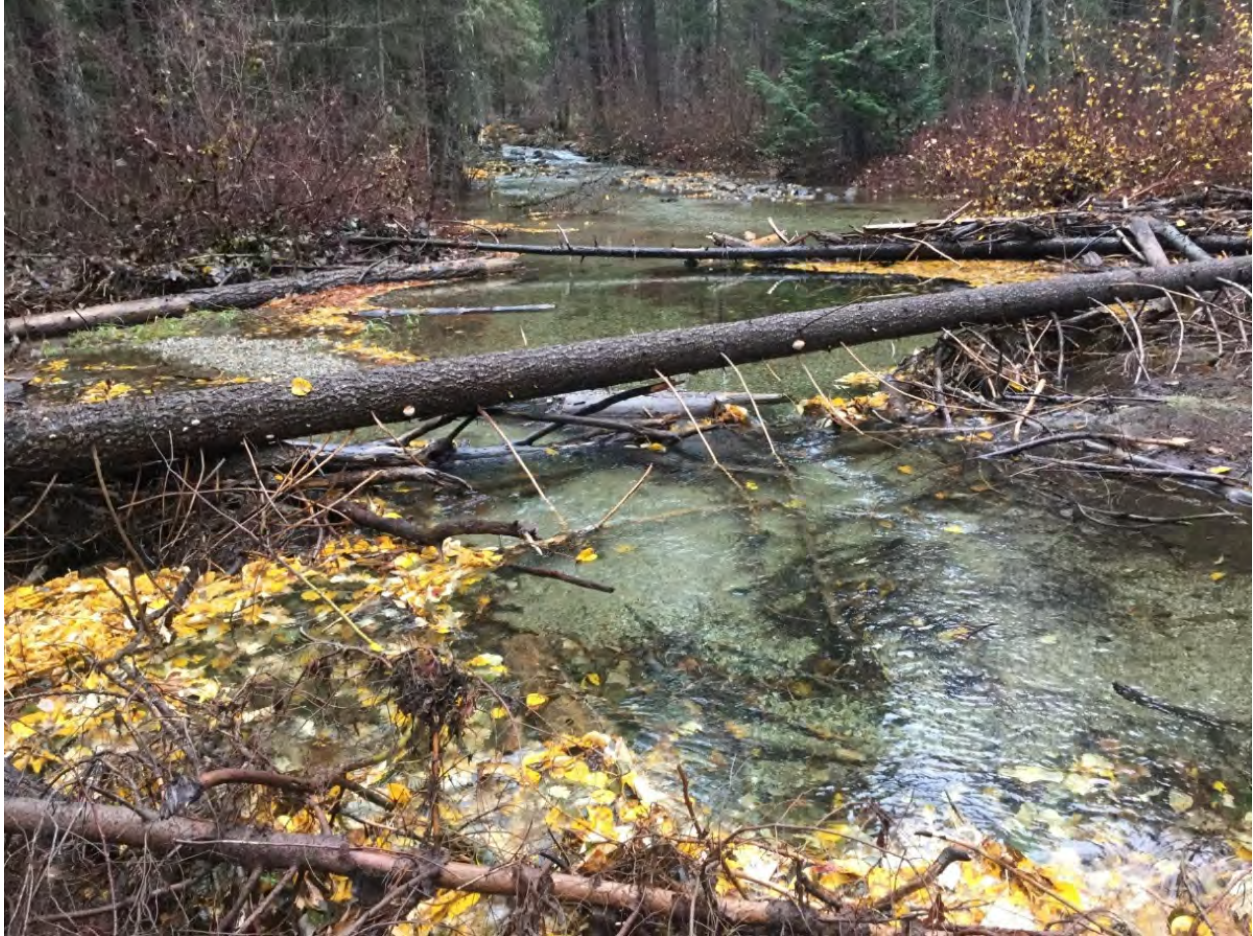
**Figure 4-27. Dam Pool on War Creek Formed by Large Log Jam near RM 0.5**

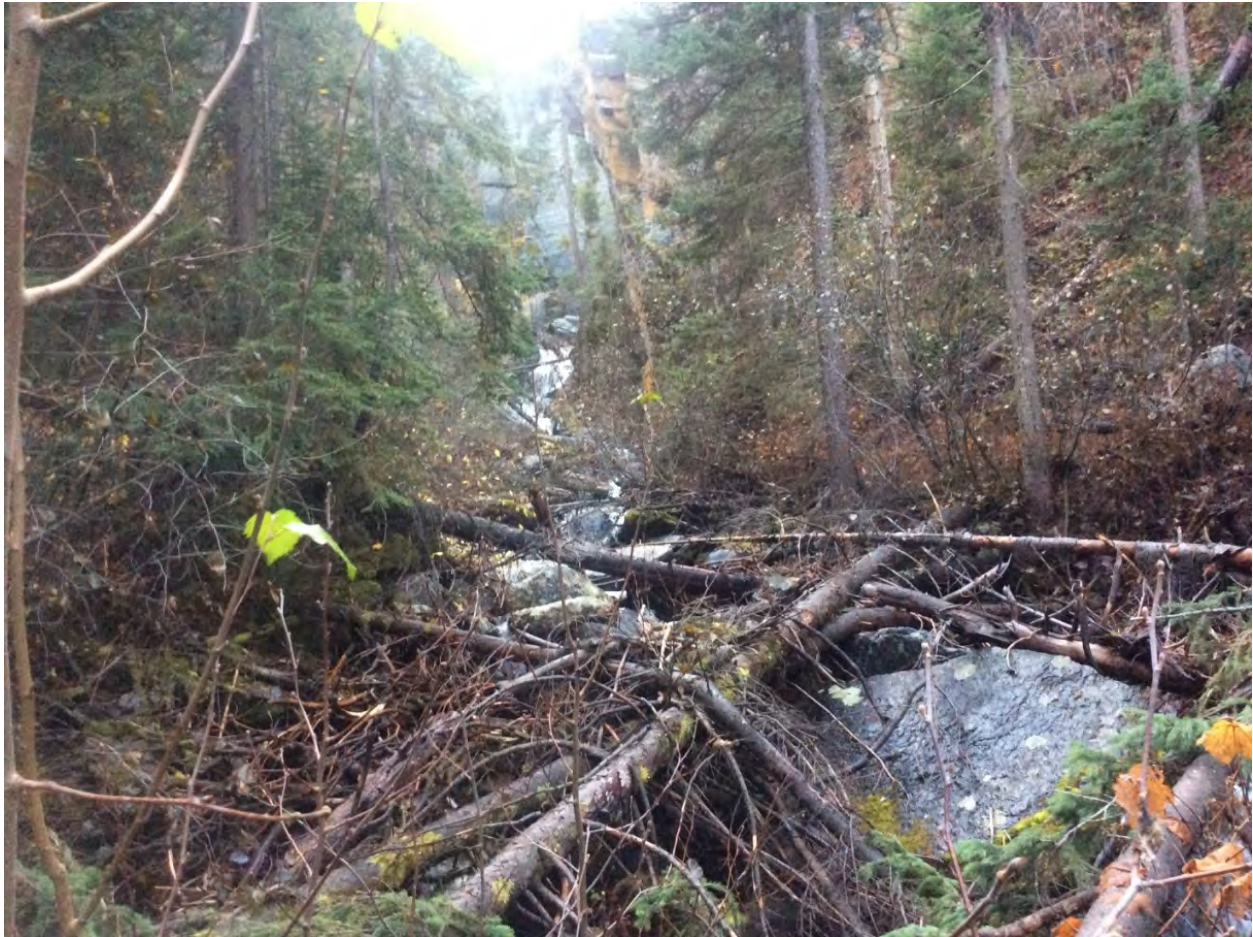
Figure 4-28. Fish Passage Barrier Falls at the Upstream Extent of the Eagle Creek Survey Reach near RM 0.5

**Eagle Creek:** Eagle Creek enters the Twisp River from the west near RM 16.7, less than a mile south of War Creek. The field survey of Eagle Creek was conducted from the confluence with the Twisp River (RM 0.0) to about RM 0.5 where there is a complete fish passage barrier waterfall (Figure 4-28). There is one existing road crossing structure on Eagle Creek on the NF-4420 road near RM 0.2. There is also a pedestrian foot bridge that crosses the creek upstream of the road crossing. The road crossing is an open bottom arch culvert in good condition, but the culvert width of 18.5 feet does not span the bankfull width of Eagle Creek, as shown in Figure 4-29. As a result, the Eagle Creek crossing may be susceptible to plugging and possible catastrophic failure, particularly following a large disturbance event such as a flood or landslide.

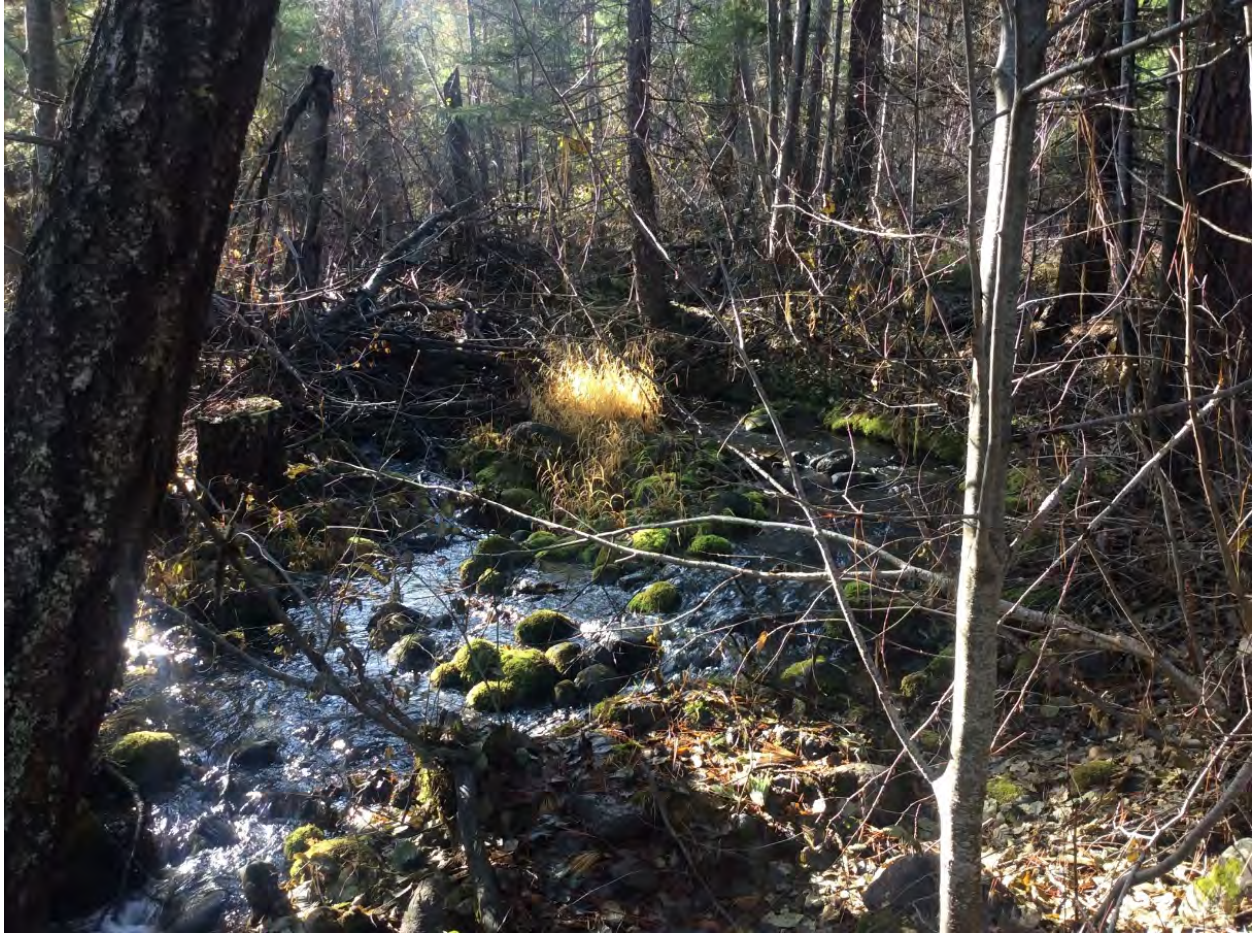
Figure 4-30. Existing Eagle Creek Right Bank Side Channel near RM 0.1

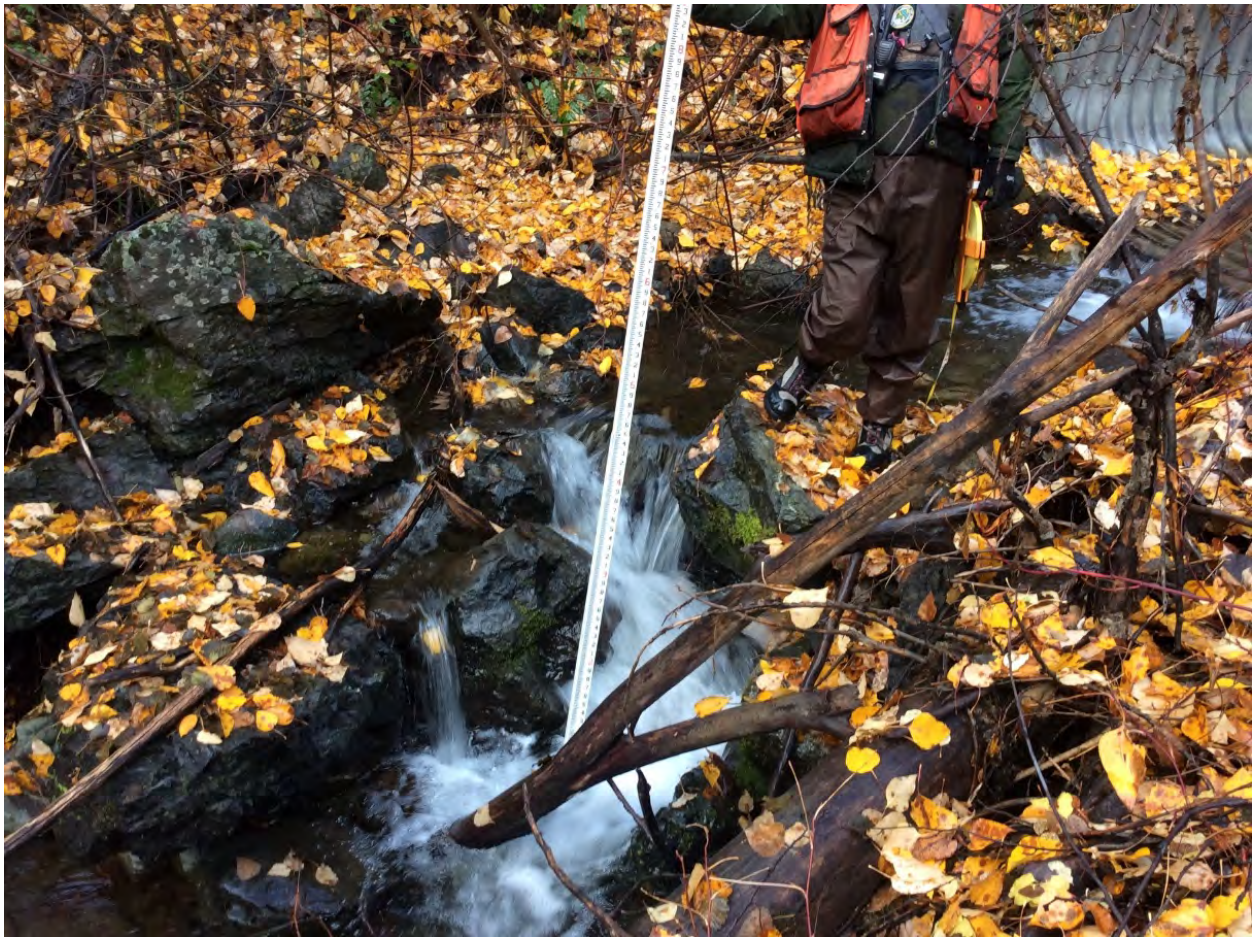
Figure 4-31. Riprap Drop Downstream of Twisp River Road Culvert near RM 0.2

Canyon Creek is more impacted by land use in the last several decades than the other tributaries in this section of the UTR. There were several fish passage barriers identified at the Twisp River Road crossing. The crossing structure is an elliptical culvert with a width of 11 feet. The culvert is a partial barrier with a jump height of 0.8 feet, no sediment in the culvert bed, and a 4.3 percent gradient. The riprap-forced drop immediately downstream of the culvert also appears to be blocking fish passage, as shown in Figure 4-31. There are two diversion structures on Canyon Creek, one near the Twisp River confluence, shown in Figure 4-32, and another near RM 0.2. There are a number of drops functioning as temporary barriers, some of them naturally formed by racking of woody debris and others from diversion piping debris, as shown in Figure 4-33. Roads also parallel the creek on both sides of the creek upstream of the Twisp River Road. Road surface erosion due to improper drainage was noted on the road to the east of Canyon Creek during field surveys. Past logging in the 1980s and 1990s removed riparian vegetation to the channel banks in parts of the survey reach and in upstream reaches (USFS 1994b).

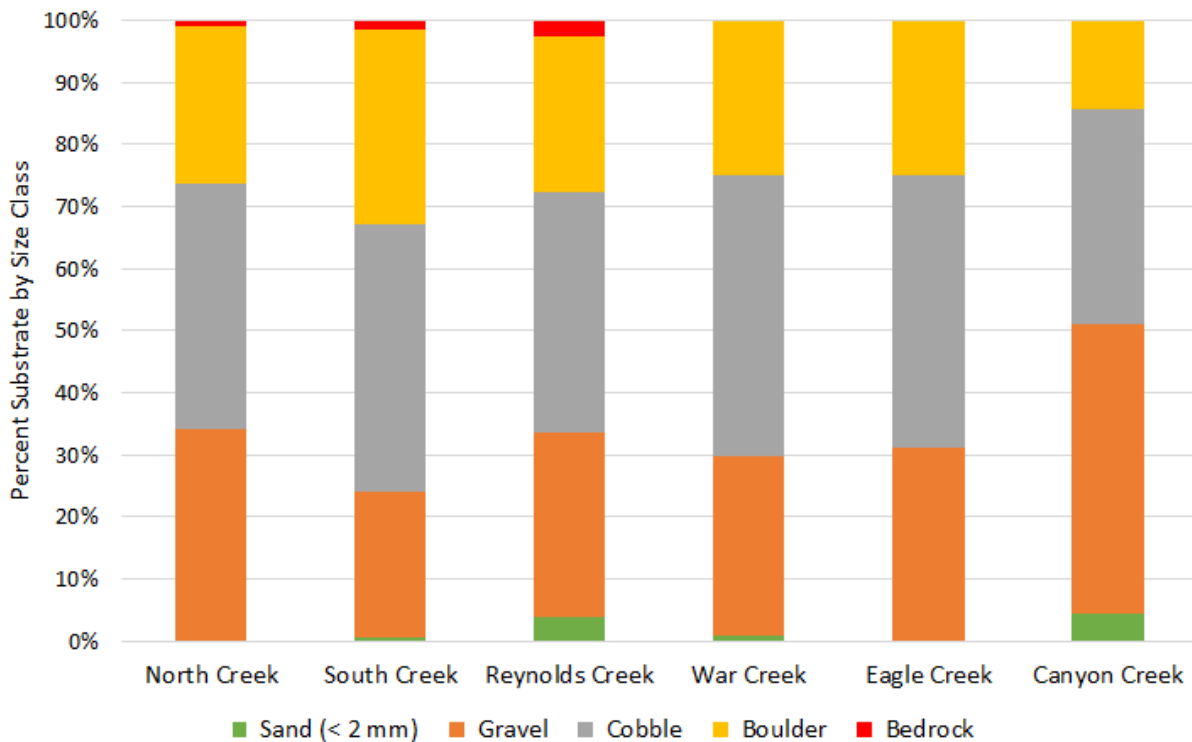
Figure 4-34. Distribution of Substrate Size Classes in Upper Twisp River Tributaries

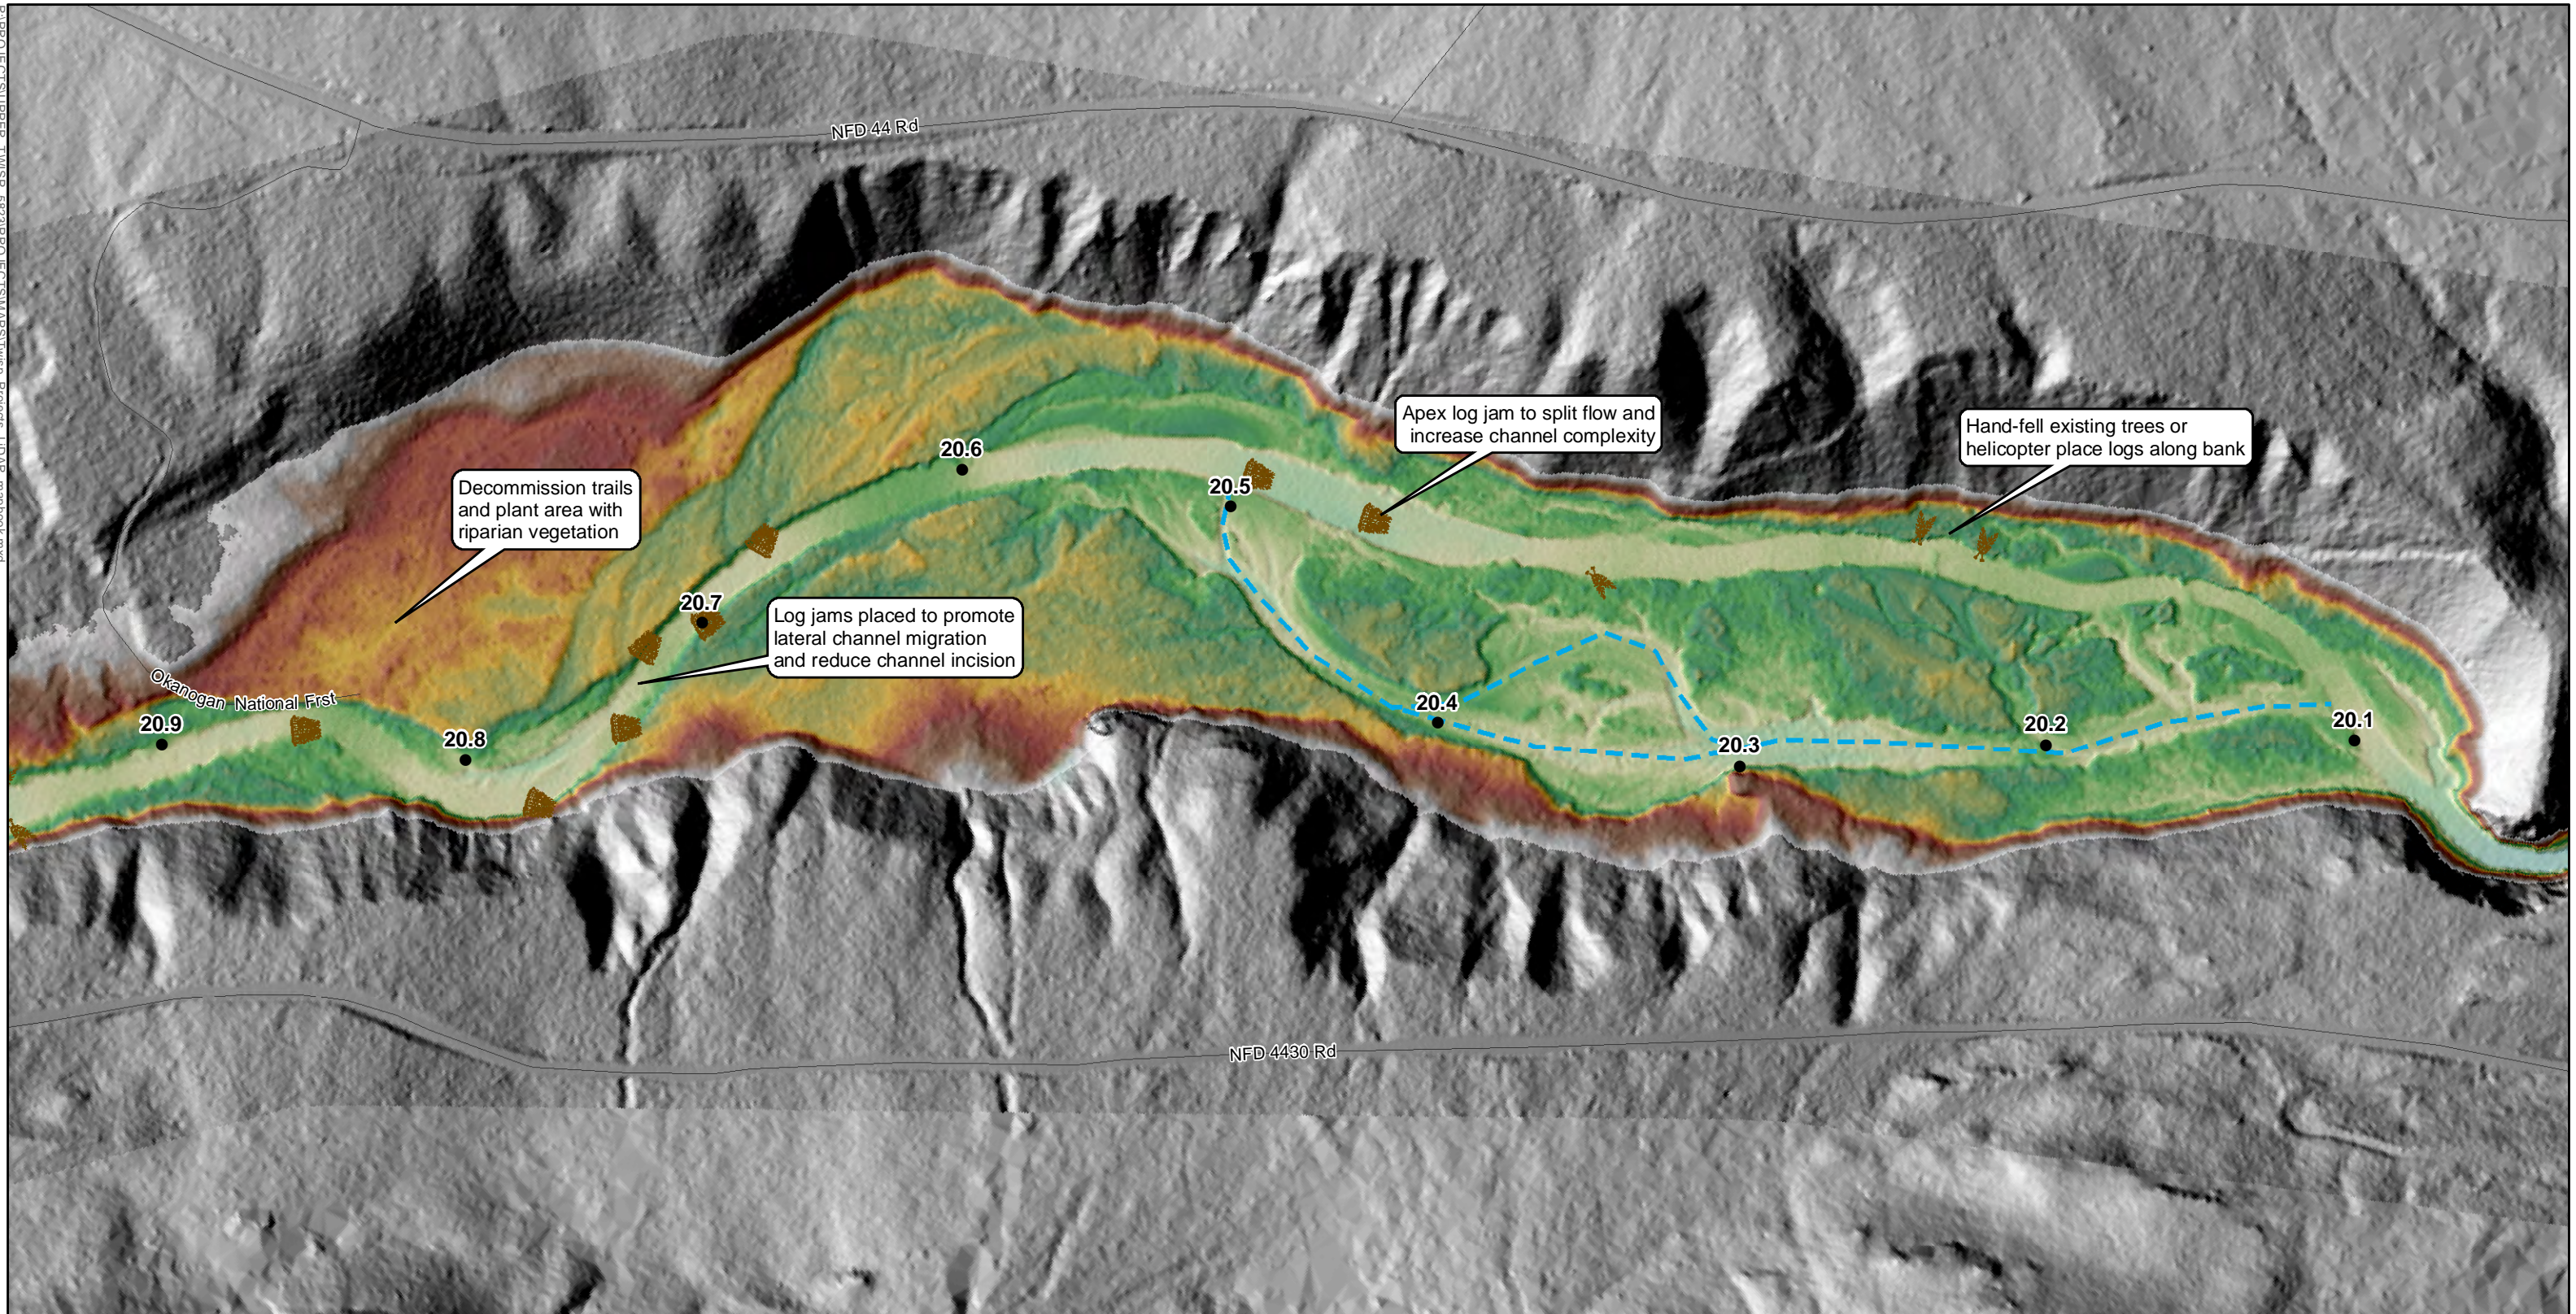
**Figure F-1c. Upper Twisp River Project Area 2: RM 20.1 - RM 20.9**

- River Mile
- LWD Types
  - Bank Jam
  - Mid-Channel Jam
  - Supplement Existing LWD
- Side Channel
- Tributary
- Road Crossing
- Road Fill
- 2006 LiDAR Relative Elevation Model
  - High : 110
  - Low : 95.9
