# Upper Twisp River and Tributaries

## HABITAT ASSESSMENT

December 2017

TETRA TECH

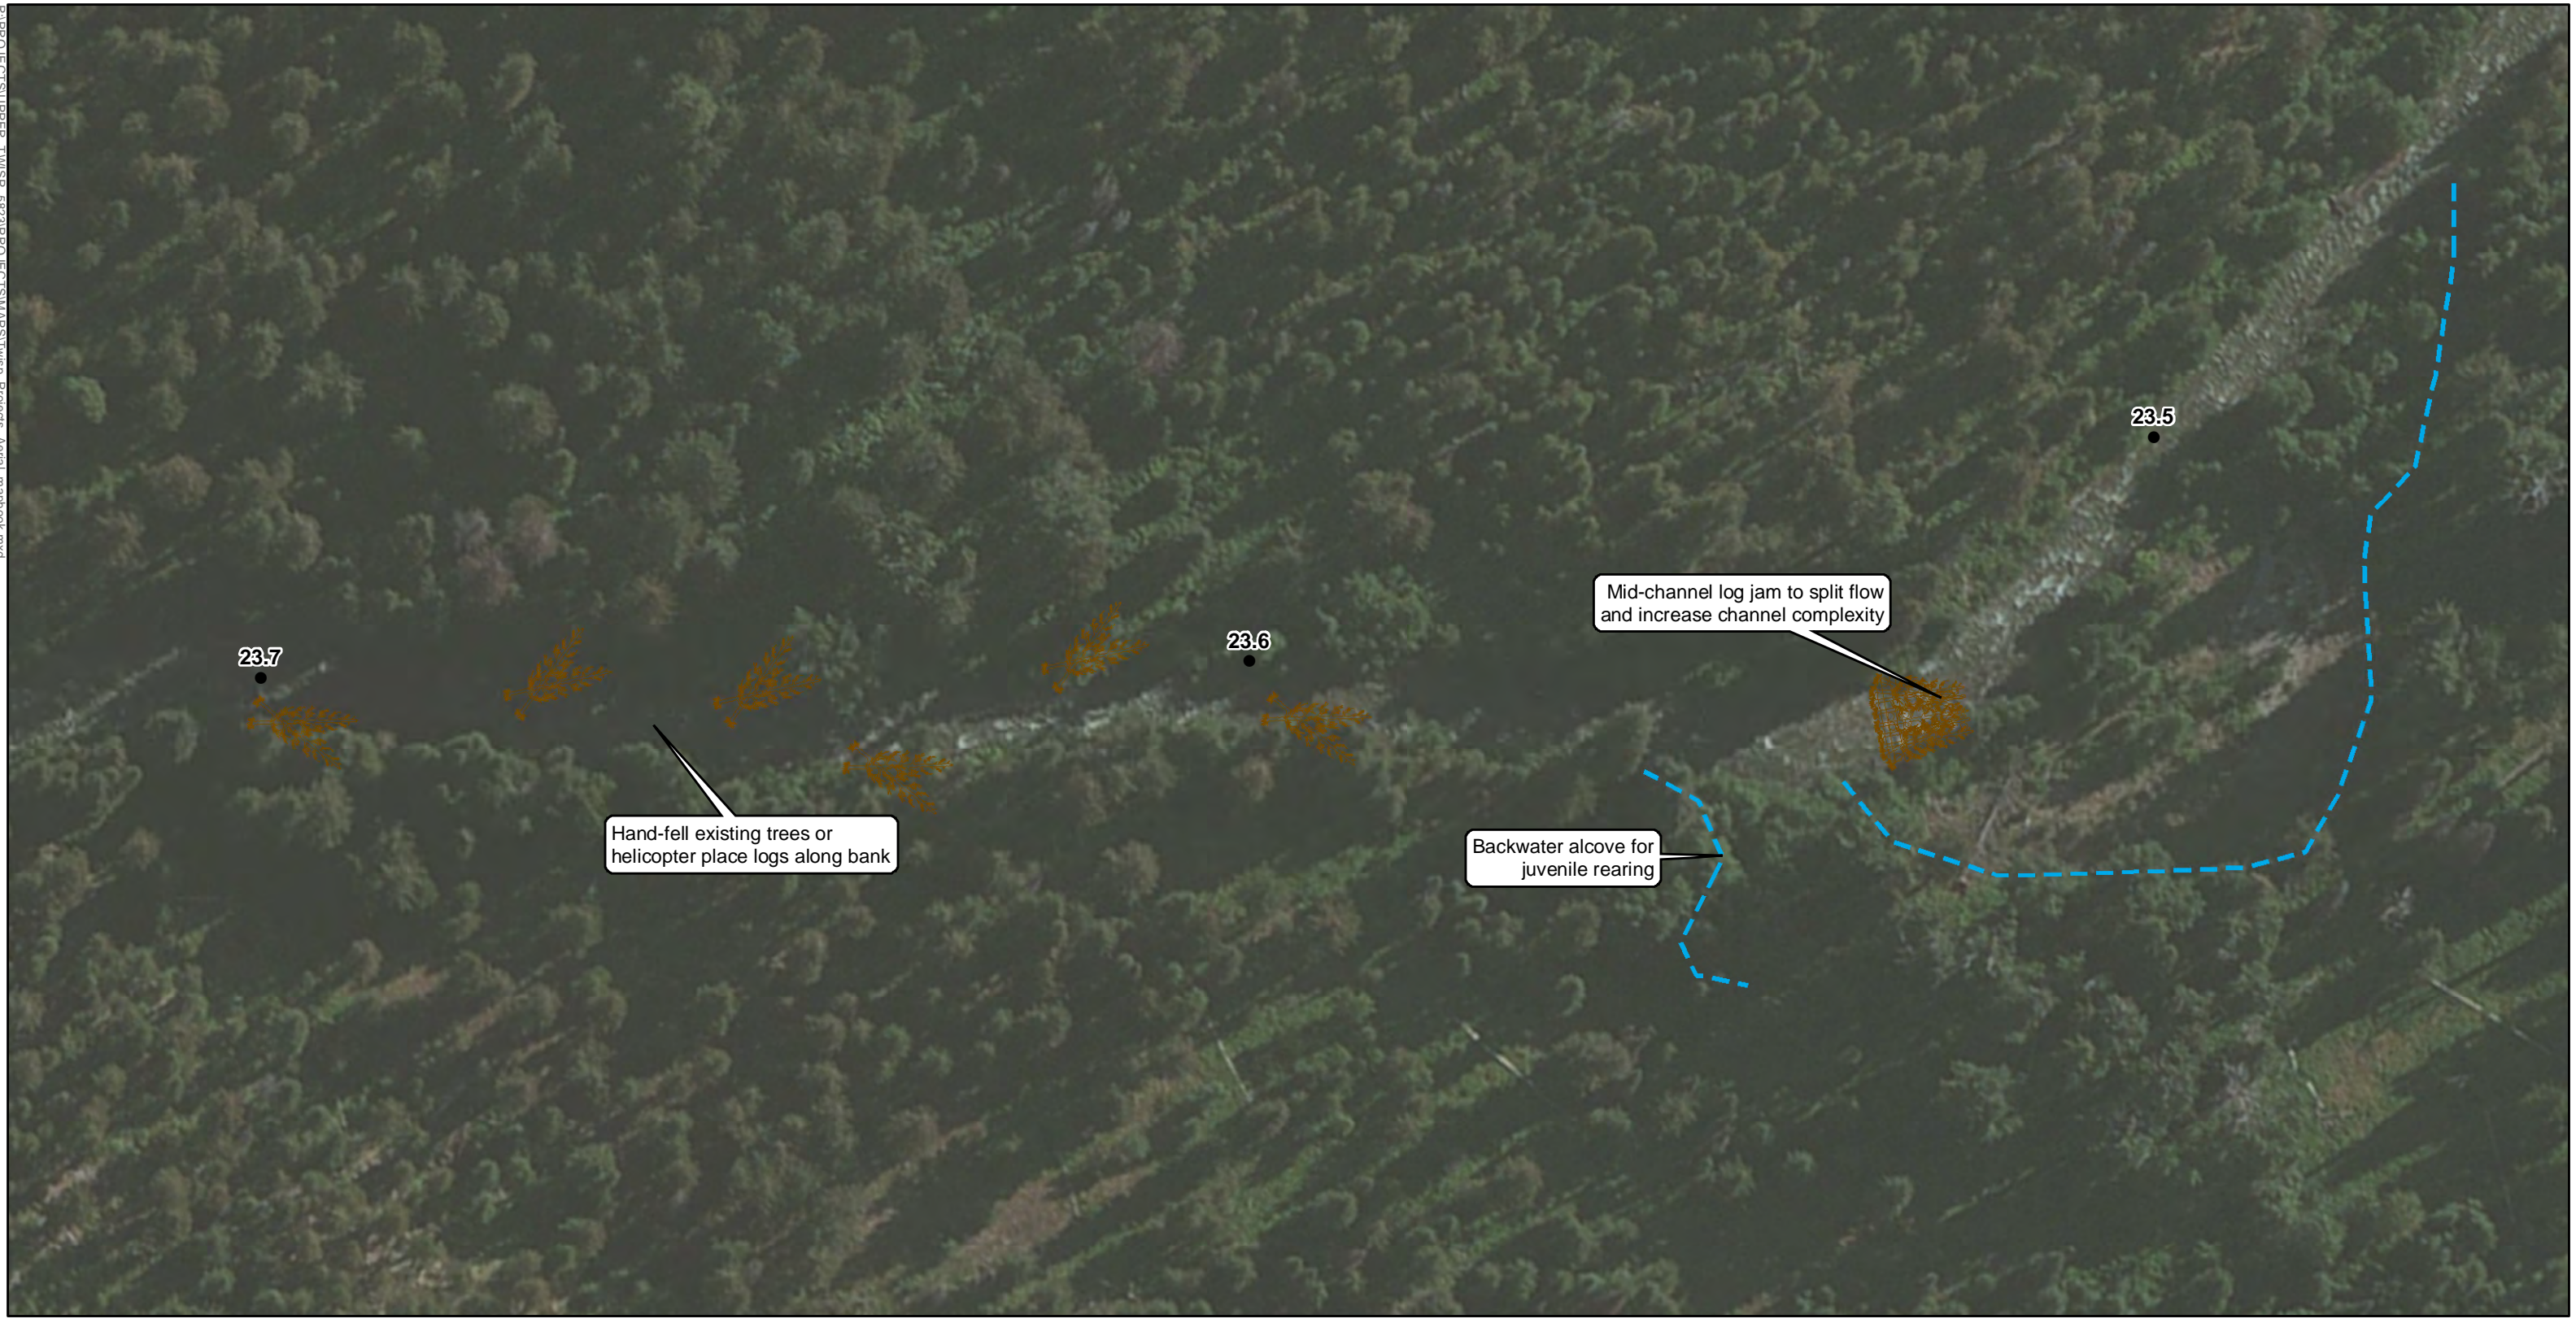
**Figure F-11. Upper Twisp River  
Project Area 6: RM 23.5 - RM 23.7**

- River Mile
- LWD Types
  - Bank Jam
  - Mid-Channel Jam
  - Supplement Existing LWD
- Side Channel
- Tributary
- Road Crossing
- Road Fill

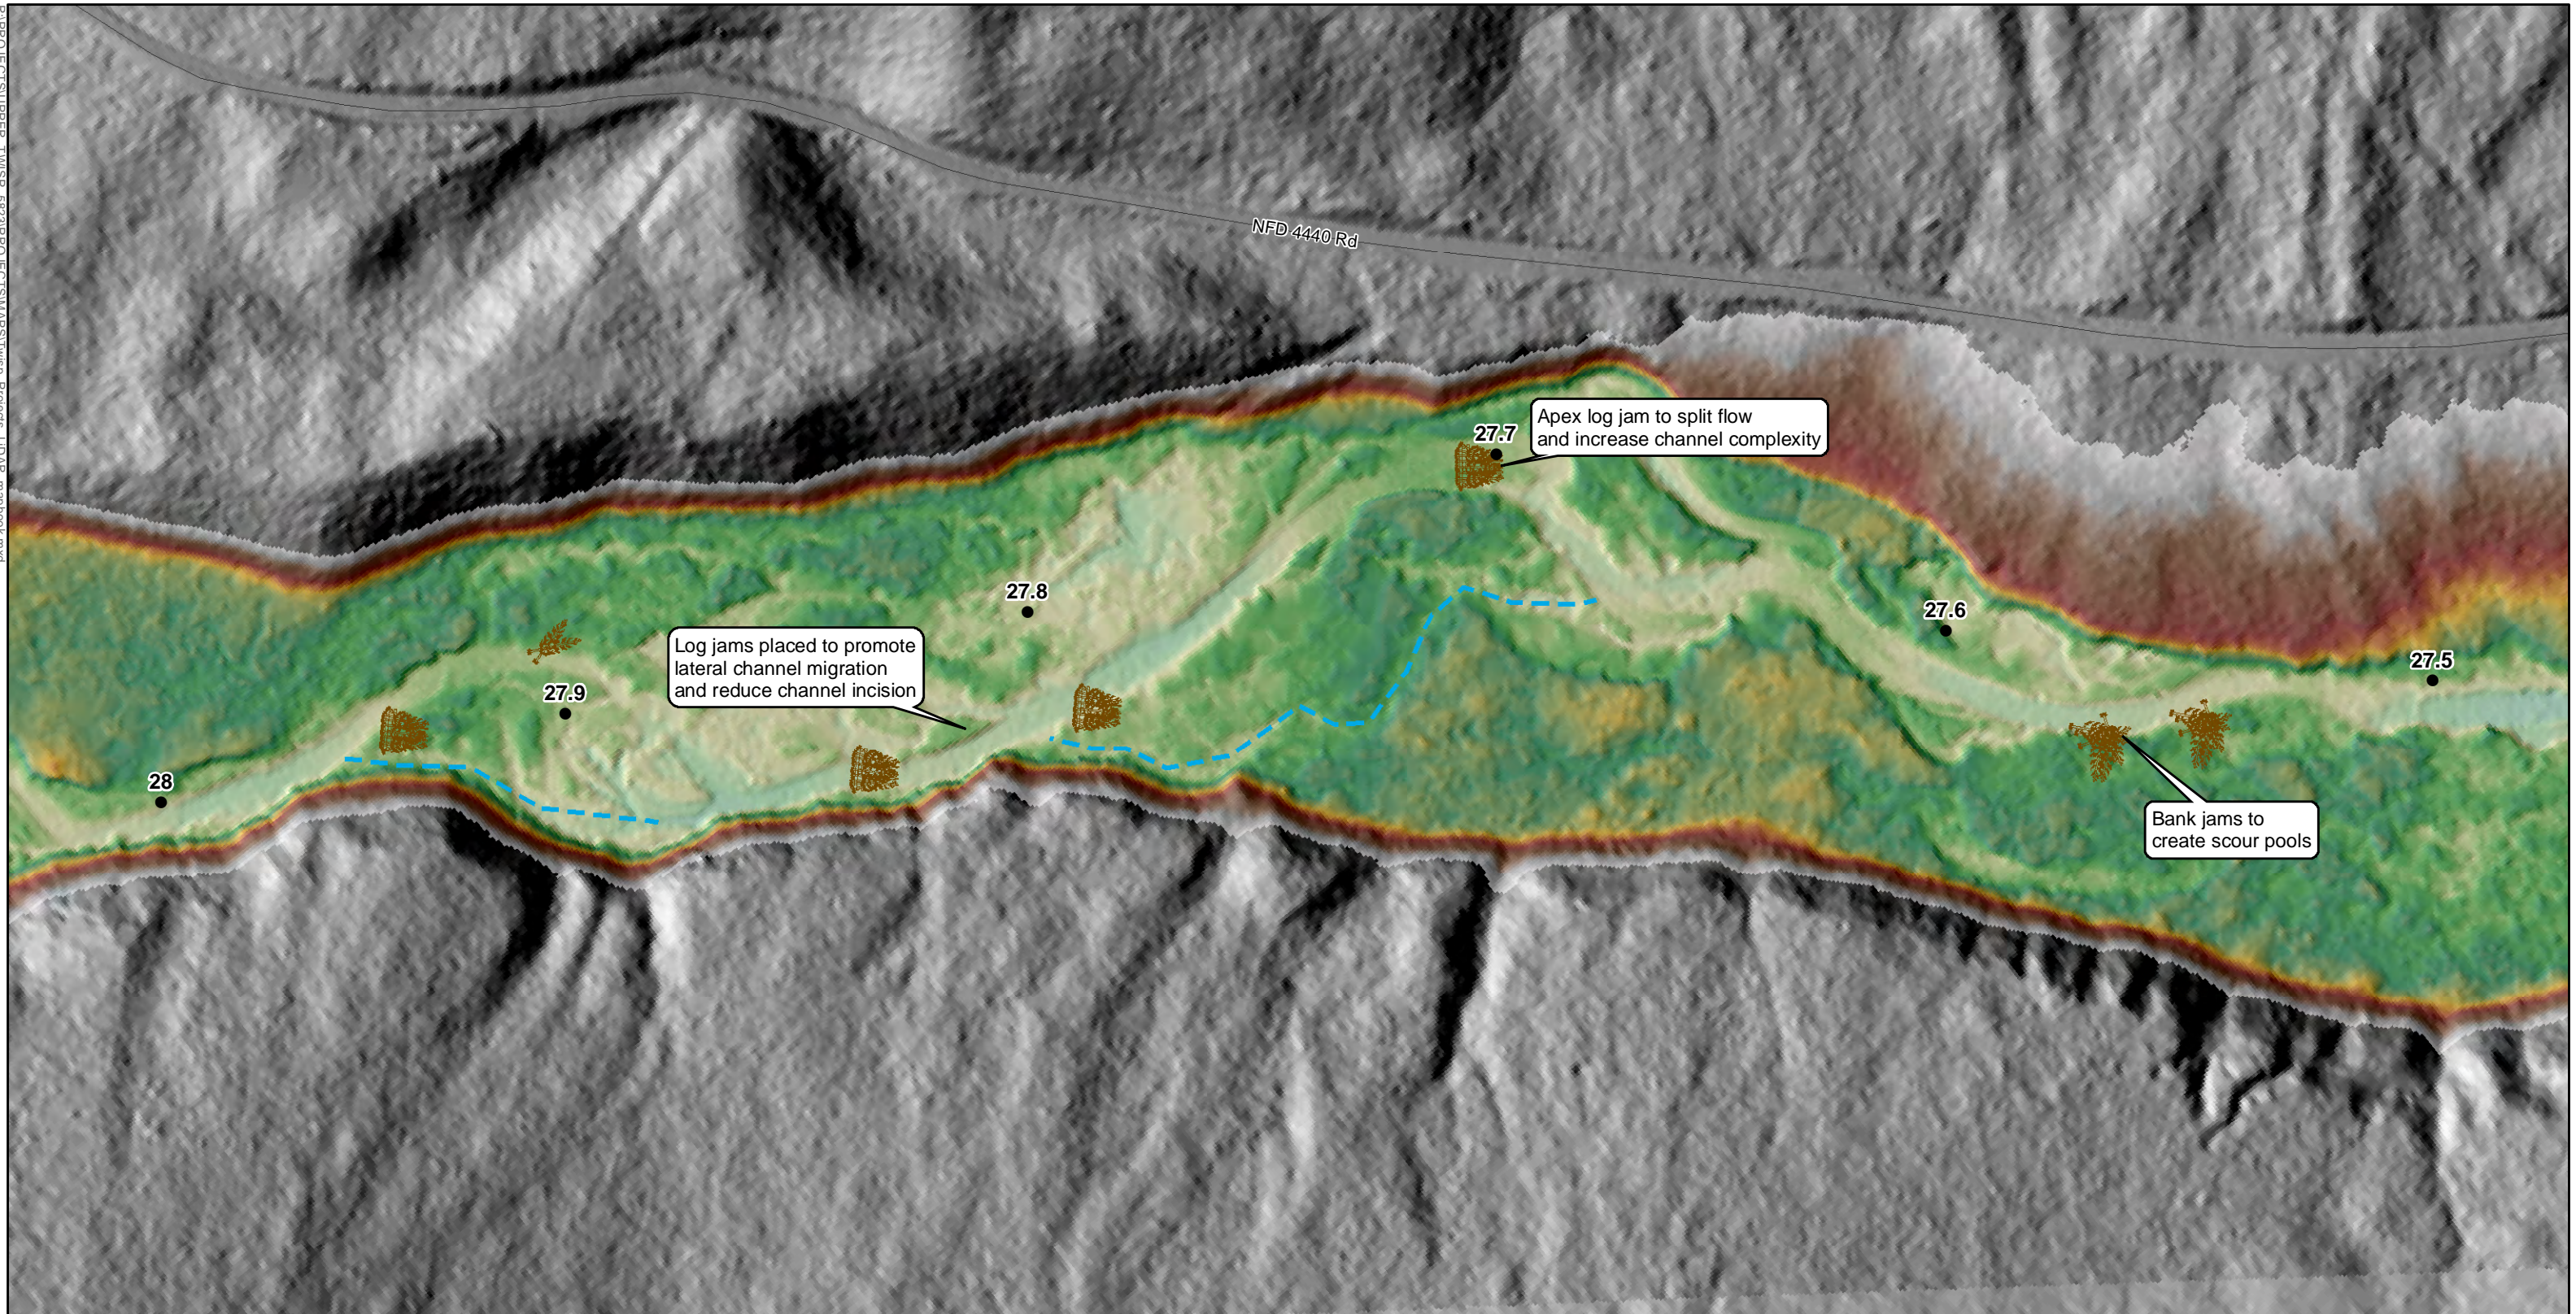
**Figure F-1u. Upper Twisp River Project Area 11: RM 27.5 - RM 28**

- River Mile
- LWD Types**
- Bank Jam
- Mid-Channel Jam
- Supplement Existing LWD
- Side Channel
- Tributary
- Road Crossing
- Road Fill
- 2006 LiDAR Relative Elevation Model**
- High : 110  
Low : 95.9

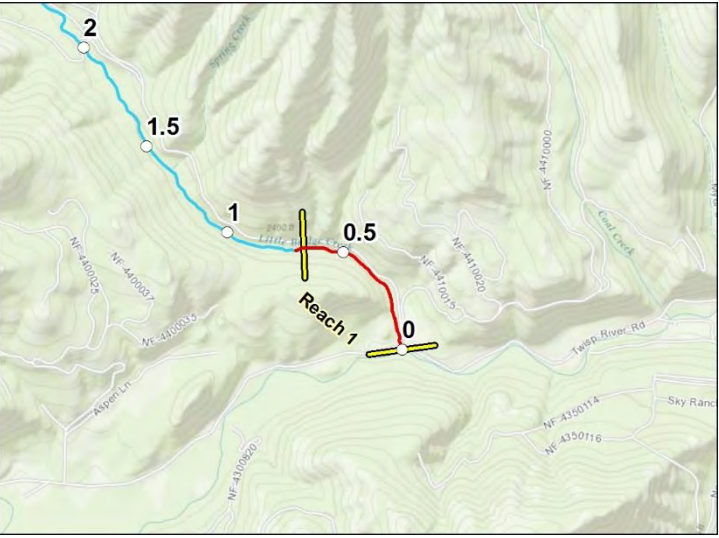
LBC Project Area 1 RM 0.0 to 0.7	<ul style="list-style-type: none"> <li>- Road grading – drainage improvements</li> <li>- Road decommissioning or abandonment</li> <li>- Remove bank armoring</li> <li>- Remove non-native plants</li> <li>- Riparian planting</li> <li>- Install LWD structures (whole trees, jams, etc.)</li> <li>- Remove and/or relocate floodplain infrastructure</li> </ul>	<p>Little Bridge Creek is incised in Reach 1 with little or no floodplain connectivity. The substrate is cobble-dominated, with higher proportions of gravel observed in infrequent bars. Accumulations of fine sediment were observed throughout the reach. It is riffle dominated with frequent plunge and scour pools. Reach 1 flows through narrow, V-shaped valley.</p> <p>Potential restoration actions include: decommission existing ford in lower section of project area; placing large woody debris structures to promote local scour and increase flow diversity and habitat complexity; supplementing existing log jams for increased pool scour and habitat complexity; and removing bank armoring in lower section of project area.</p>	3

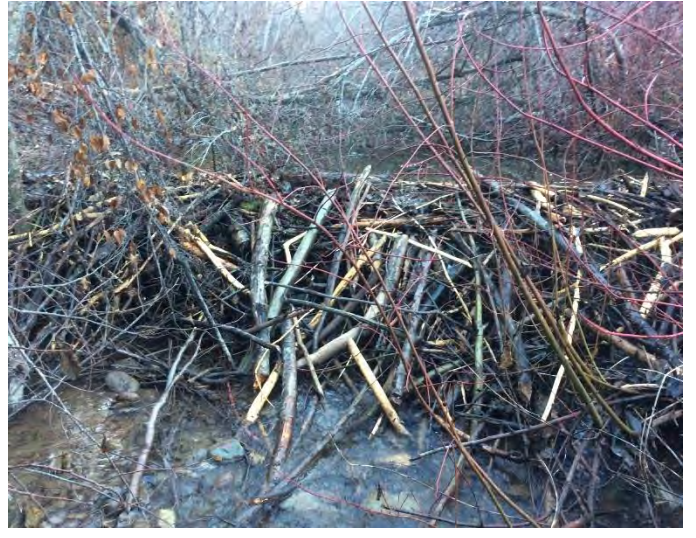
LBC Project Area 2 RM 0.7 to 1.0	<ul style="list-style-type: none"> <li>- Road grading – drainage improvements</li> <li>- Beaver re-introduction or management</li> </ul>	<p>Little Bridge Creek has a well-connected floodplain in this project area. Reach is cobble dominated, with frequent bars containing good quality spawning size material. Active beaver activity at RM 0.9 with channel-spanning beaver dams within the project area. Beaver dam complex has completely blocked main and side channels, inundating a major portion of the floodplain.</p> <p>Potential restoration actions in the project area include installing 'Beaver Deceivers' to increase passage through existing beaver dams and road grading and drainage improvements to reduce sediment inputs.</p>	9

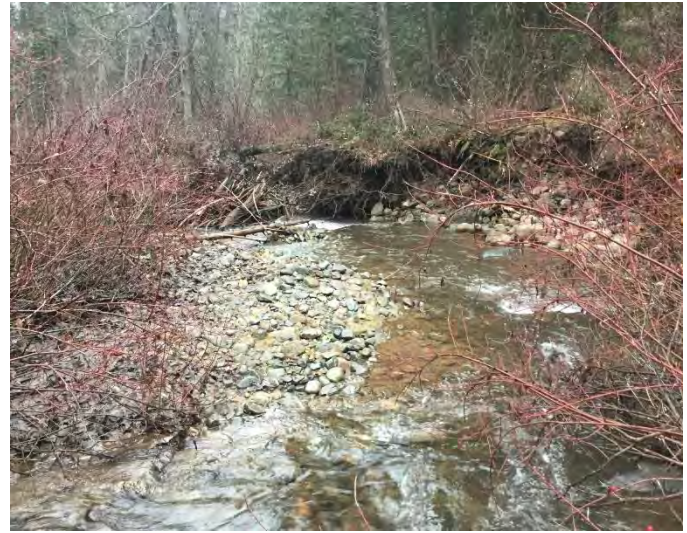
LBC Project Area 3 RM 1.0 to 1.7	<ul style="list-style-type: none"> <li>- Road grading – drainage improvements</li> <li>- Remove non-native plants</li> <li>- Riparian planting</li> <li>- Install LWD structures (whole trees, jams, etc.)</li> <li>- Pool creation/enhancement</li> </ul>	<p>Little Bridge Creek has a well-connected floodplain in this project area, with localized areas of incision and disconnected floodplain at RM 1.6. The valley is wider in Reach 2, but remains relatively narrow (100 – 300 feet). Beaver activity was not present in this project area. Point bars and active bank erosion was observed in several locations.</p> <p>Potential restoration actions in this project area include: improving road drainage to decrease sediment load into creek; installing large wood habitat structures to enhance scour pools and encourage floodplain inundation; and excavating pools in association with large wood habitat structures for increased habitat complexity.</p>	5

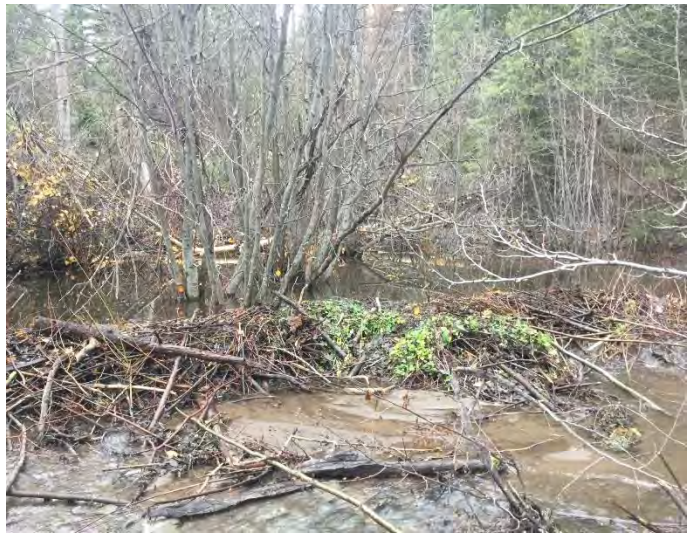
LBC Project Area 4 RM 1.7 to 2.1	<ul style="list-style-type: none"> <li>- Road grading – drainage improvements</li> <li>- Beaver re-introduction or management</li> </ul>	<p>Little Bridge Creek has a well-connected floodplain in this project area. Reach is riffle dominated with frequent plunge and scour pools. Dams pools upstream of channel-spanning LWD common in the reach. Active beaver activity from RM 1.7 to 1.8 with channel-spanning beaver dams within the project area. Beaver dam complex has completely blocked main and side channels, inundating a major portion of the floodplain.</p> <p>Potential restoration actions in the project area include installing 'Beaver Deceivers' to increase passage through existing beaver dams and road grading and drainage improvements to reduce sediment inputs.</p>	10

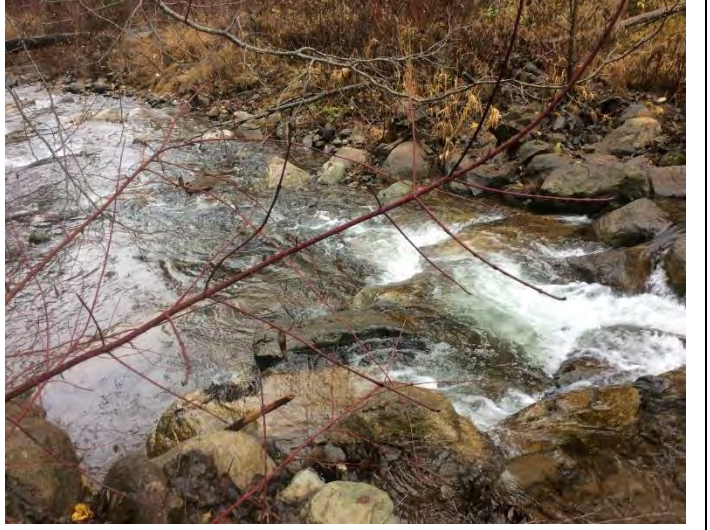
LBC Project Area 5 RM 2.1 to 3.0	<ul style="list-style-type: none"> <li>- Road grading – drainage improvements</li> <li>- Beaver re-introduction or management</li> <li>- Remove non-native plants</li> <li>- Riparian planting</li> <li>- Install LWD structures (whole trees, jams, etc.)</li> <li>- Perennial side channel creation/enhancement</li> <li>- Secondary channel (non-perennial) creation/enhancement</li> <li>- Improve fish passage at existing diversion</li> </ul>	<p>Little Bridge Creek has a well-connected floodplain in this project area. This section is riffle dominated, with multiple side channels, both wetted and dry. The existing irrigation diversion at RM 2.2 may be seasonally affecting juvenile passage. The road crossing at RM 3.0 has scour issues at the upstream end of the culvert.</p> <p>Potential restoration actions in this project area include: install large wood habitat structures to enhance scour pools and encourage floodplain inundation; reconnect relic side channels for increased flow diversity and habitat complexity; and constructing engineered riffle to alleviate passage issues at diversion.</p>	4

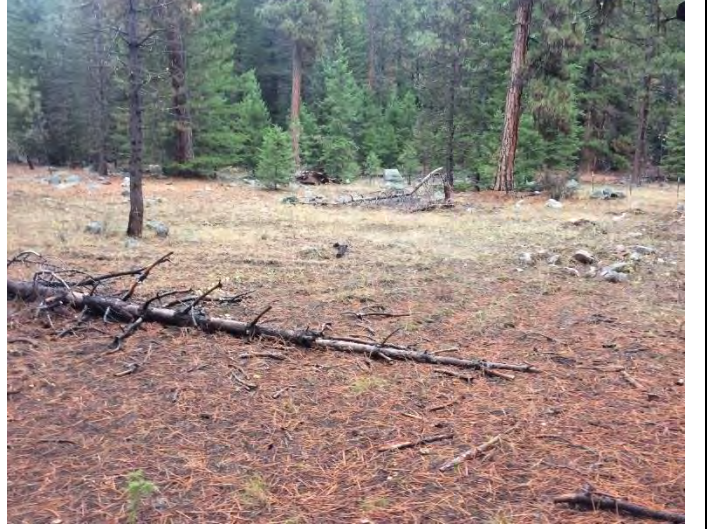
LBC Project Area 6 RM 3.0 to 5.1	<ul style="list-style-type: none"> <li>- Road grading – drainage improvements</li> <li>- Road decommissioning or abandonment</li> <li>- Riparian fencing</li> <li>- Remove non-native plants</li> <li>- Riparian planting</li> <li>- Post-fire floodplain erosion control</li> <li>- Restore streambanks with LWD - bioengineering</li> <li>- Install LWD structures (whole trees, jams, etc.)</li> <li>- Remove and/or relocate floodplain infrastructure</li> <li>- Perennial side channel creation/enhancement</li> <li>- Secondary channel (non-perennial) creation/enhancement</li> <li>- Wetland creation/enhancement</li> <li>- Alcove creation/enhancement</li> <li>- Groundwater fed off-channel habitat enhancement</li> <li>- Pool creation/enhancement</li> </ul>	<p>Little Bridge Creek has increased riparian disturbance from livestock grazing. Riparian was also recently burned, creating areas of erosion. Most of Reach 3 has a well-connected floodplain, with isolated areas of incision. Reach has vegetated islands, braided morphology, and high channel complexity. Reach is riffle dominated with frequent pools.</p> <p>Potential restoration actions in this project area include: installing riparian fencing to restrict livestock access; improve road drainage on main road to decrease sediment inputs; constructing grade control structures upstream and downstream of culvert at RM 3.0 to resolve scour issues; alleviate scour on road fill at RM 3.1 with brush mattress, willow spur, or similar bioengineering techniques; decompact existing access road at RM 3.8 and riparian areas and plant with riparian vegetation; install post-fire erosion control measures to rehabilitate floodplain areas; place logs and install large wood habitat structures with pools to create scour pools and increase channel complexity; reconnect existing relic secondary channels, to increase floodplain connectivity and habitat complexity; and evaluate the potential for groundwater-fed off channel habitat enhancement.</p>	1

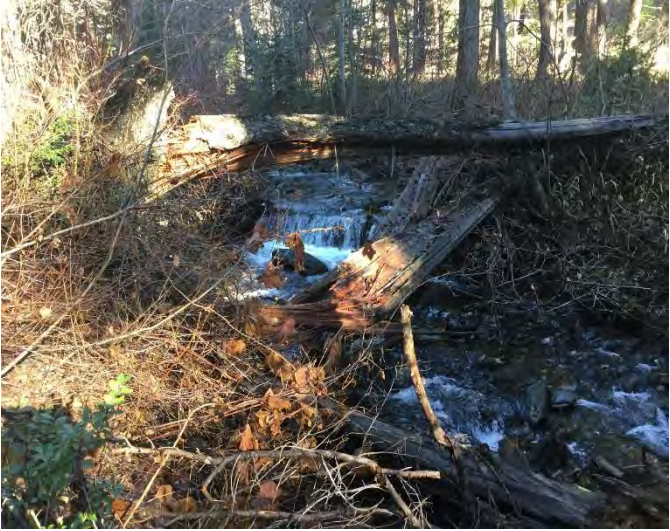
LBC Project Area 7 RM 5.1 to 5.6	<ul style="list-style-type: none"> <li>- Road grading – drainage improvements</li> <li>- Install LWD structures (whole trees, jams, etc.)</li> <li>- Post-fire floodplain erosion control</li> </ul>	<p>Little Bridge Creek flows through relatively narrow valley in this project area. The creek has intermittent segments that are deeply incised followed by segments that are more connected to floodplain. Connected areas are due to large jams, vegetated islands, and high flow side channels. Riffle and rapid dominated, with short cascade sections and frequent pools. Potential restoration actions in this project area include: hand-felling existing trees or helicopter place logs to create scour pools and increase channel complexity; improving road drainage to decrease sediment inputs; and installing post-fire erosion control measures to rehabilitate floodplain areas.</p>	7

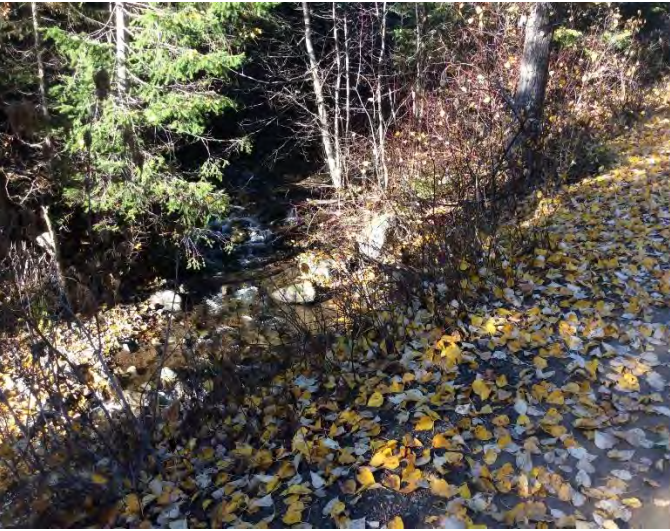
LBC Project Area 8 RM 5.6 to 6.8	<ul style="list-style-type: none"> <li>- Road decommissioning or abandonment</li> <li>- Post-fire floodplain erosion control</li> </ul>	<p>Little Bridge Creek is cobble-dominated in the project area, with increasing proportion boulders. There are a number of wood and boulder steps with jump heights greater than 3 feet that may be temporary fish passage barriers. Wood and boulder forced plunge pools and dam pools are common in the reach. The road starting at RM 5.6 is in close proximity to the creek in inhibits floodplain access. Potential restoration actions in this project area include (No project actions proposed past RM 6.8): considering alternatives for decommissioning road in close proximity to creek and installing post-fire erosion control measures to rehabilitate floodplain areas.</p>	12
