# Lower Toppenish Creek Juvenile Steelhead Survival, Monitoring and Restoration Strategies

**Tim Resseguie,  
Kelsey Martin Harbick,  
and David Lind**

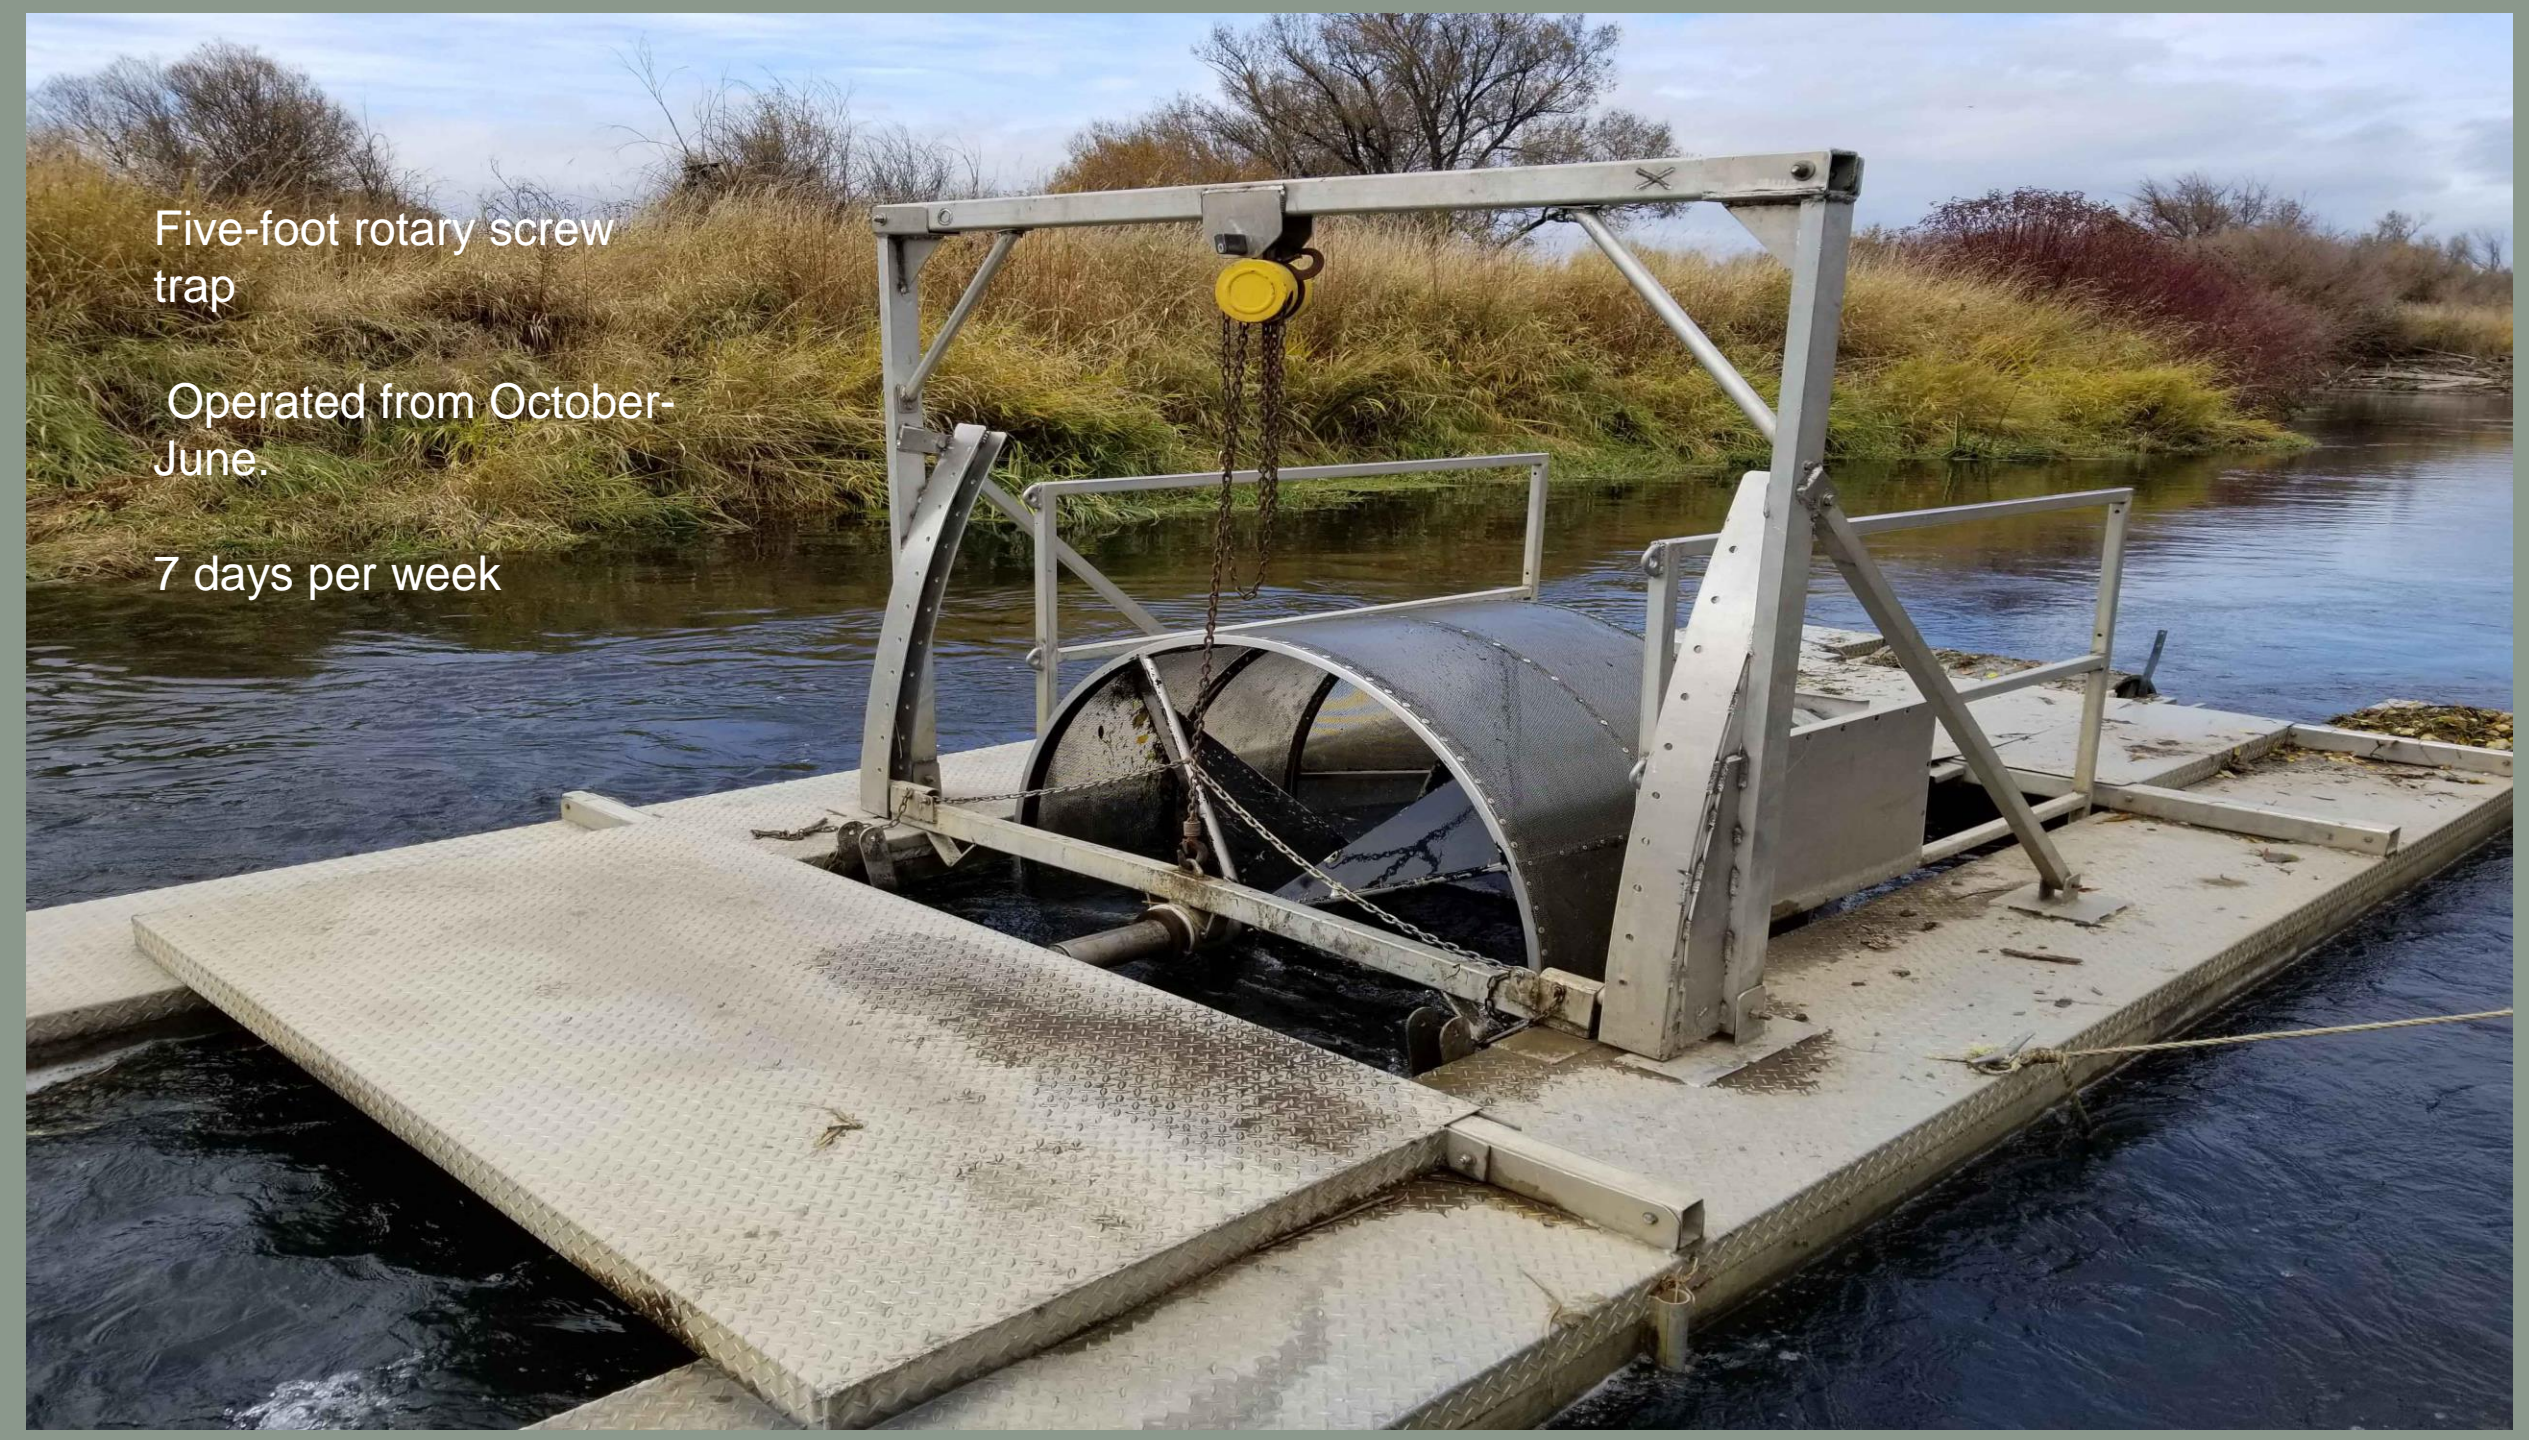
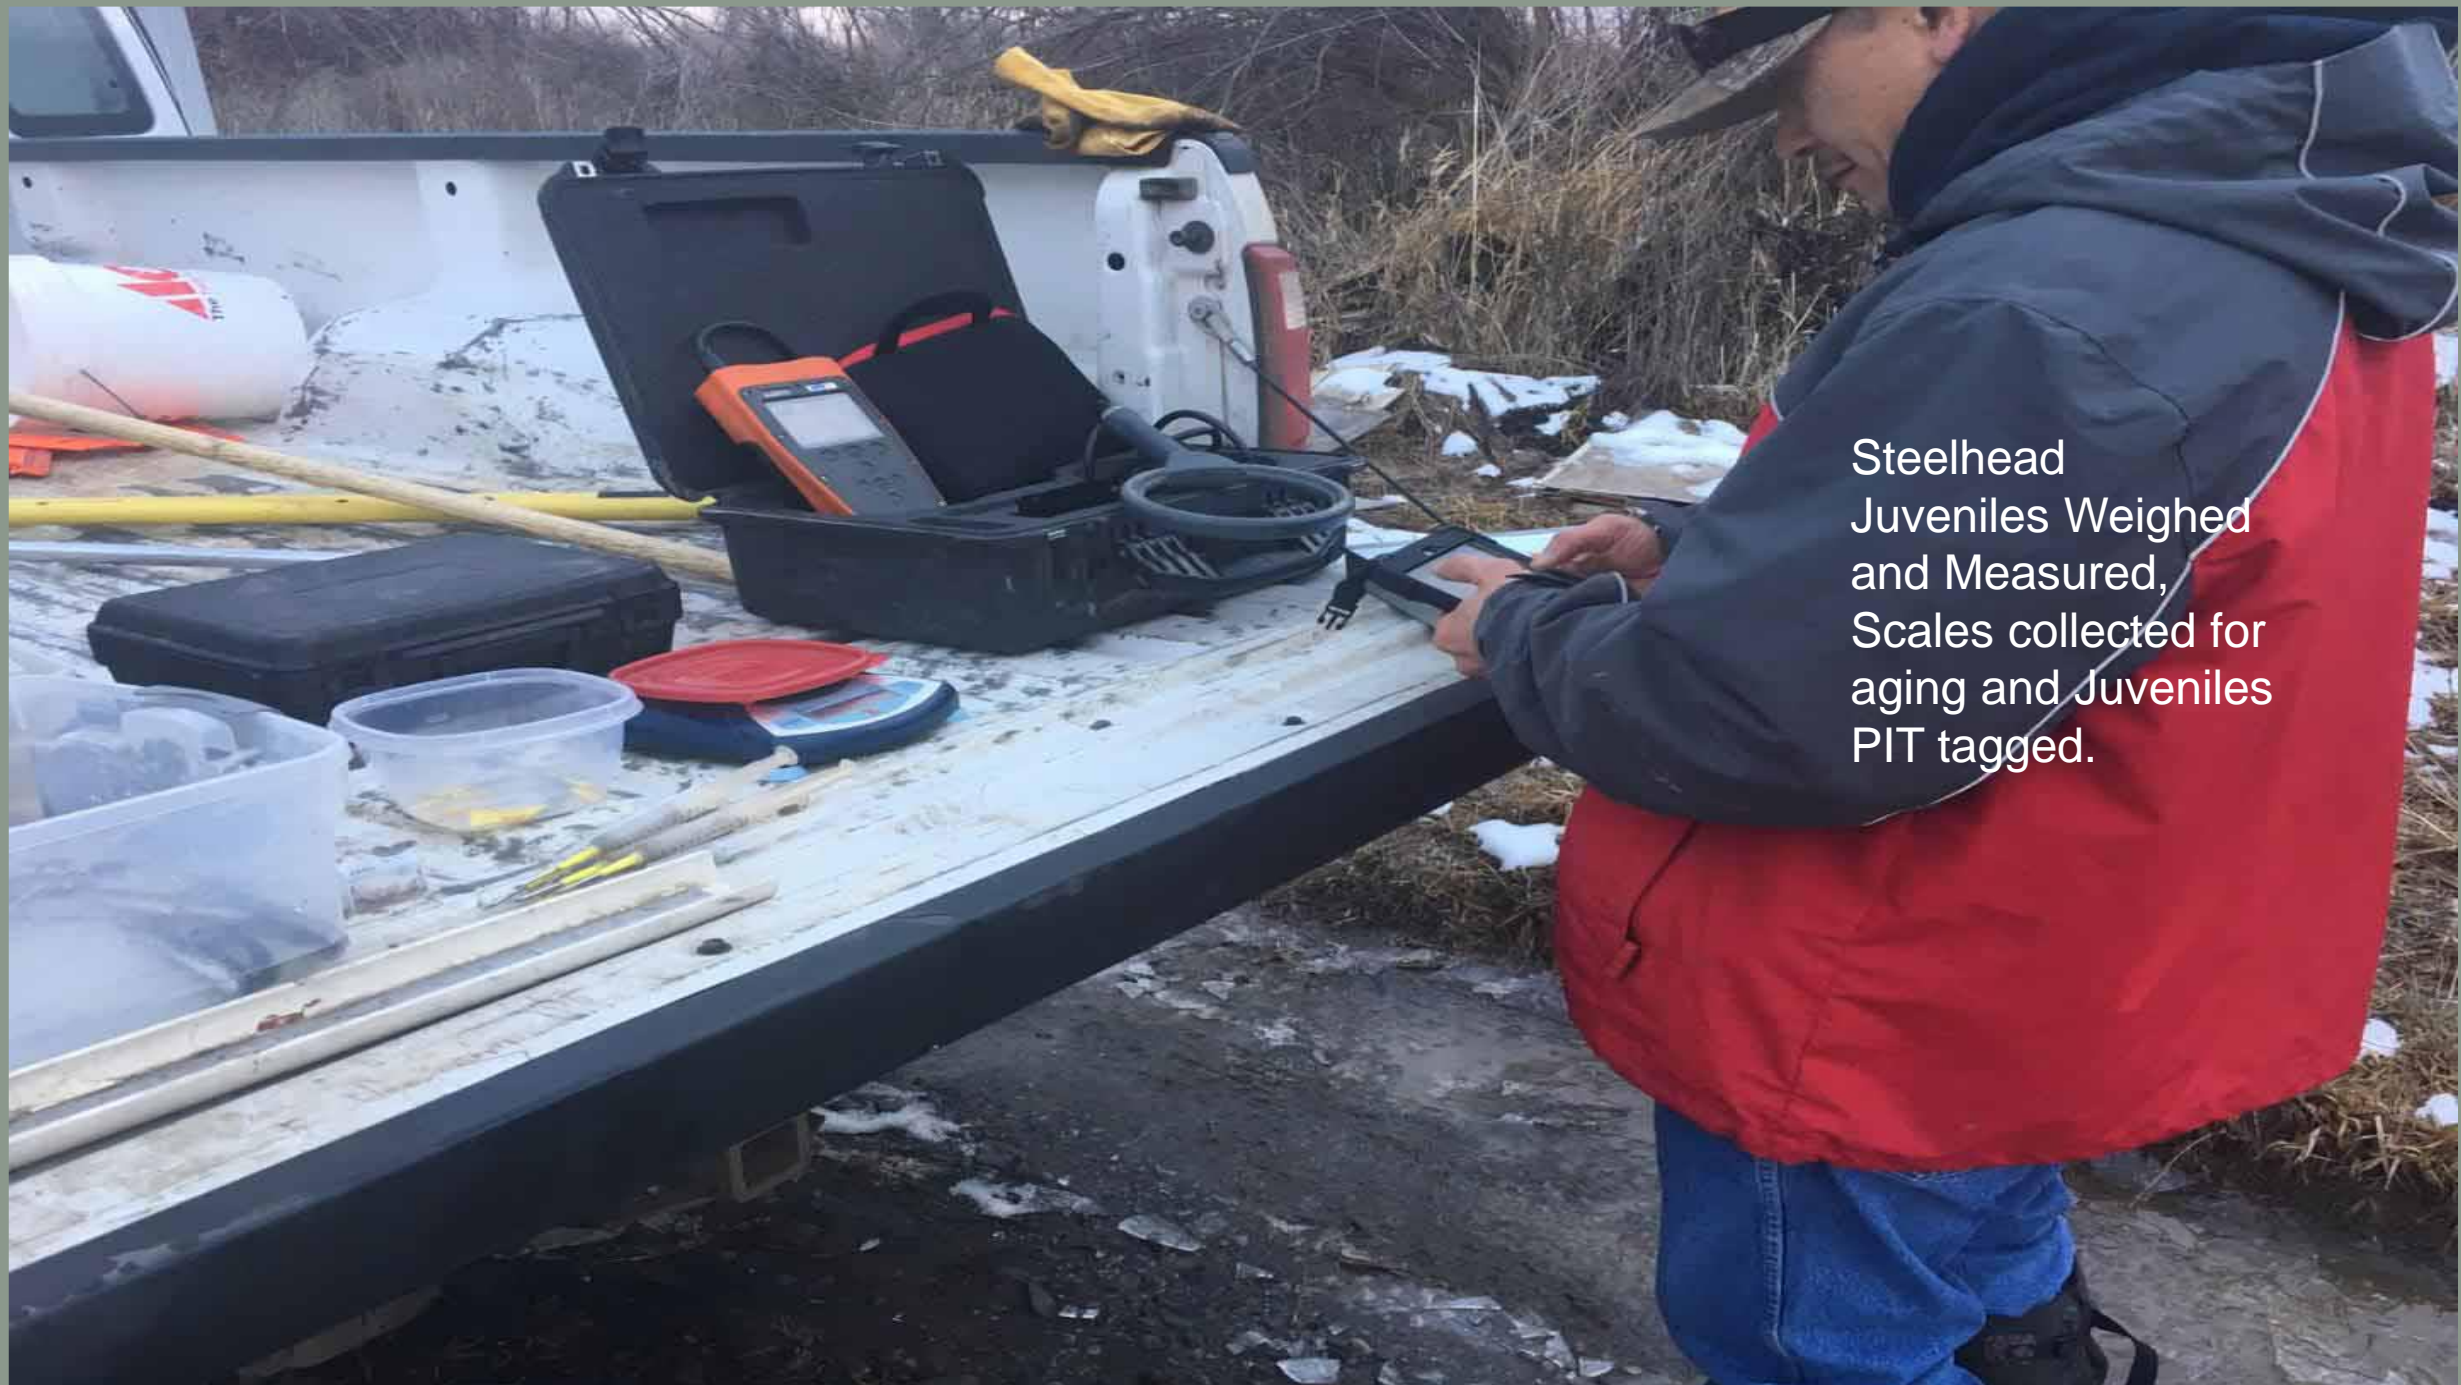
Five-foot rotary screw trap

Operated from October-  
June.

7 days per week

Steelhead  
Juveniles Weighed  
and Measured,  
Scales collected for  
aging and Juveniles  
PIT tagged.

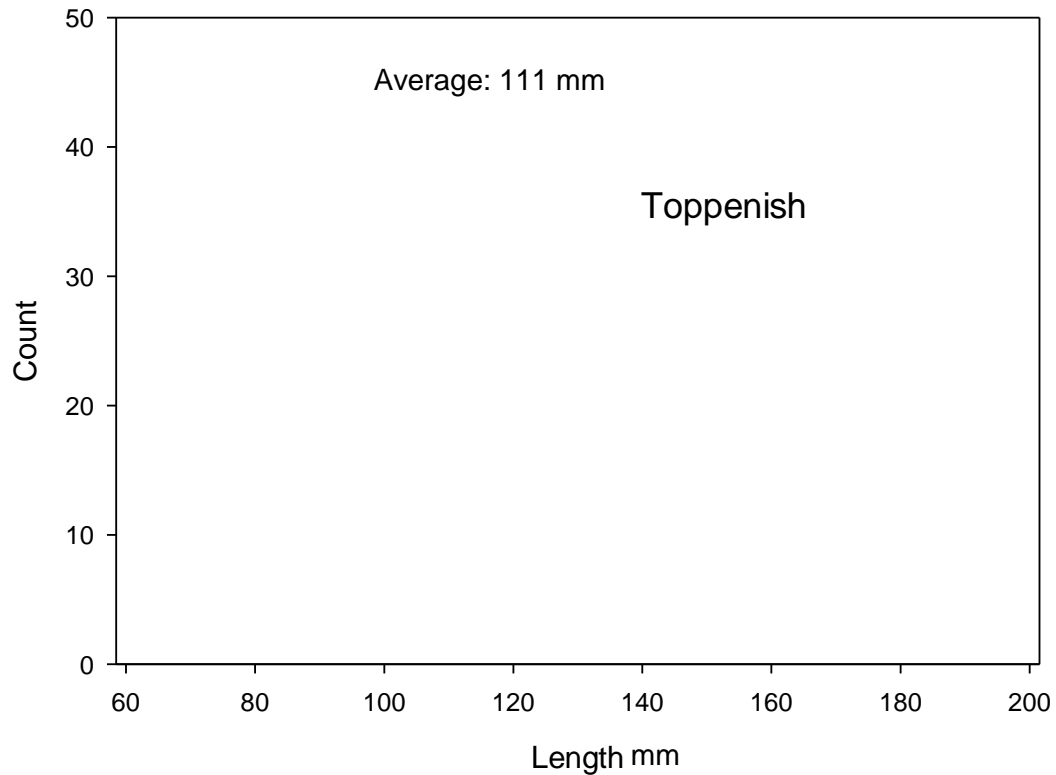
Length-frequency distribution of steelhead captured at the Toppenish Creek River Mile 26 Screw Trap in 2022

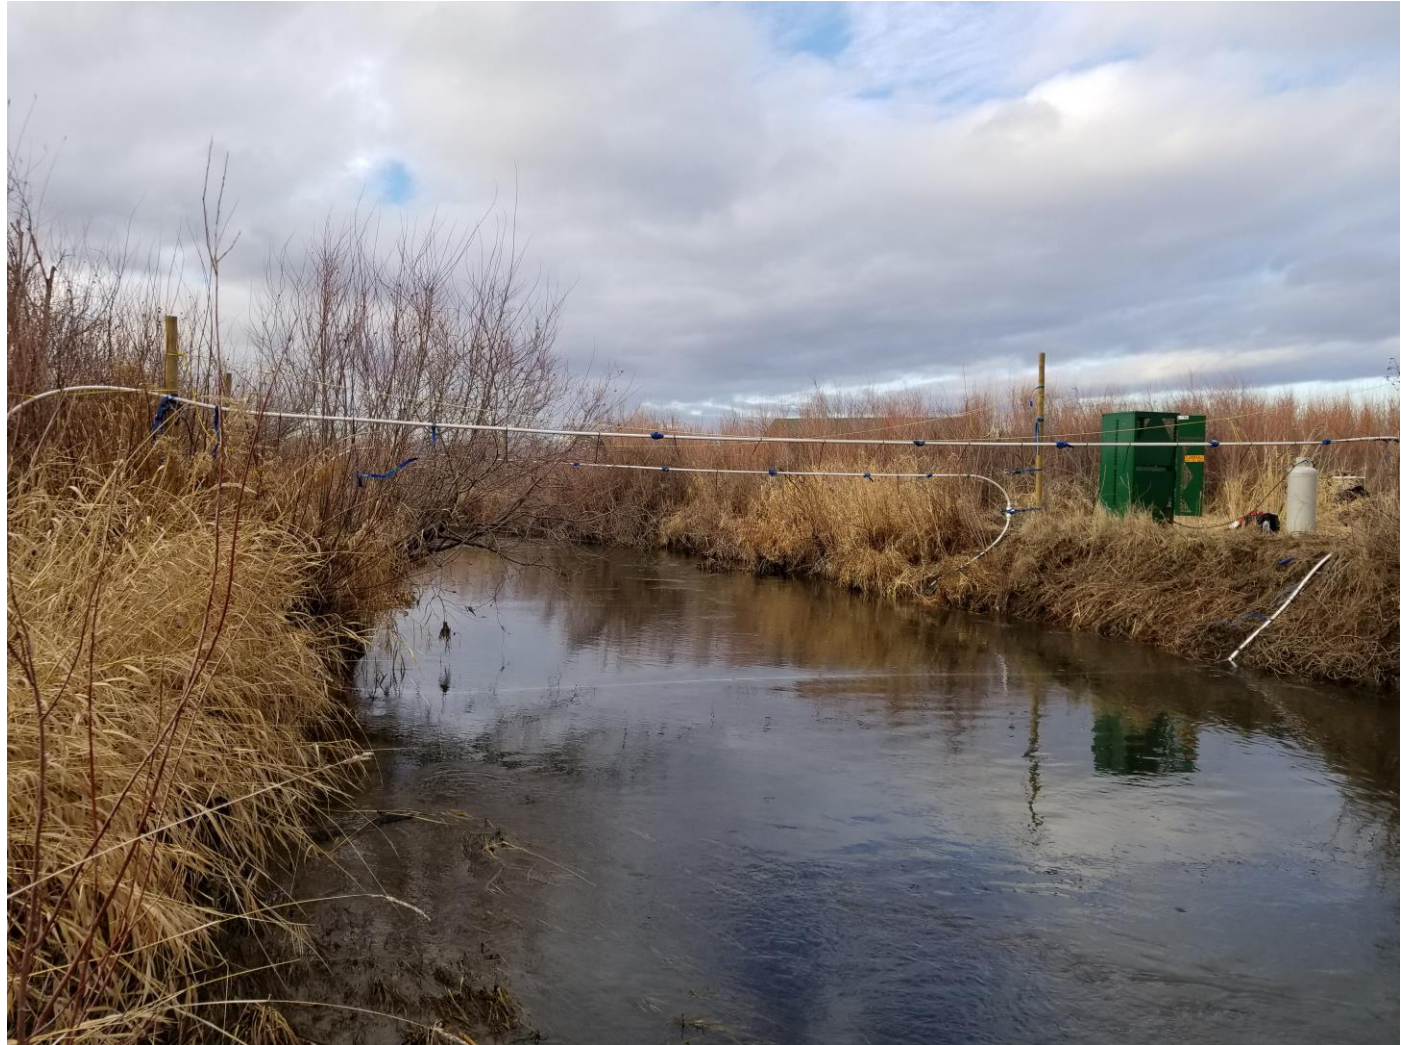
PIT tag antennas located through out the lower Toppenish Creek Watershed to assess reach survival in Toppenish Creek and survival in off-channel habitats.

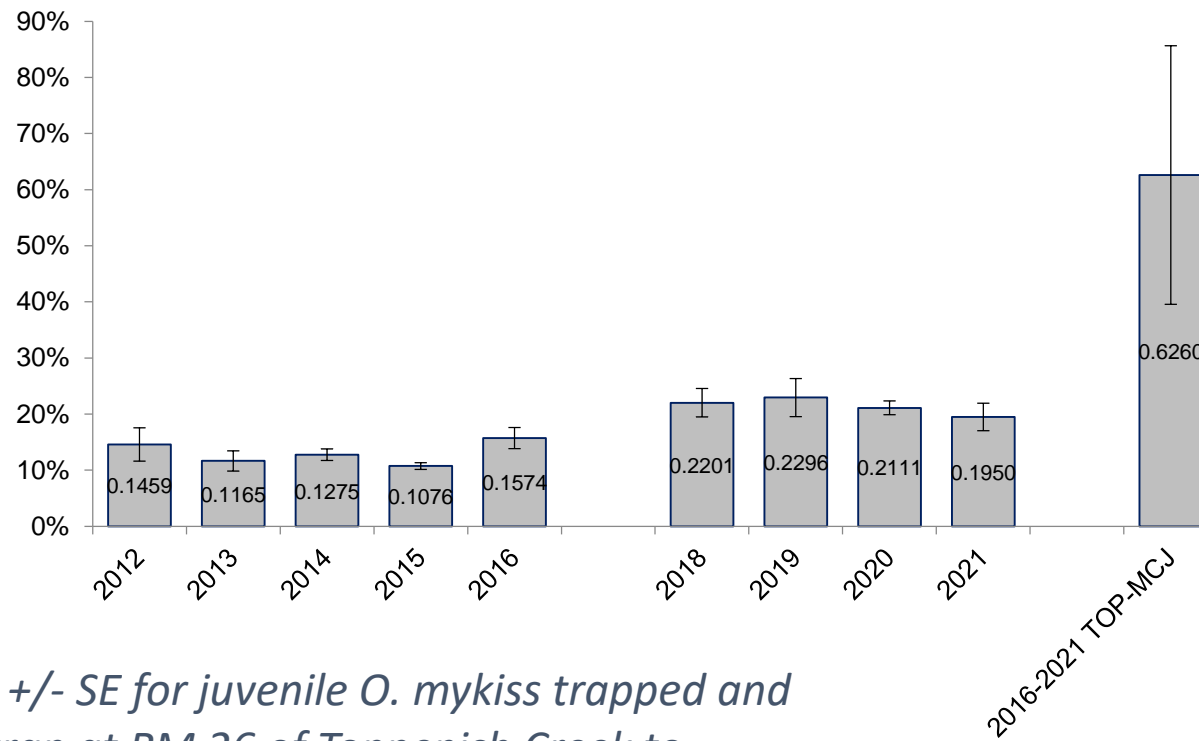
*Survival probabilities +/- SE for juvenile *O. mykiss* trapped and tagged in the screw trap at RM 26 of Toppenish Creek to detection in lower Toppenish Creek (TOP) in the years 2012-2021, and survival probability from TOP to the McNary juvenile bypass (MCJ) pooled over the outmigration years 2016-2021.*

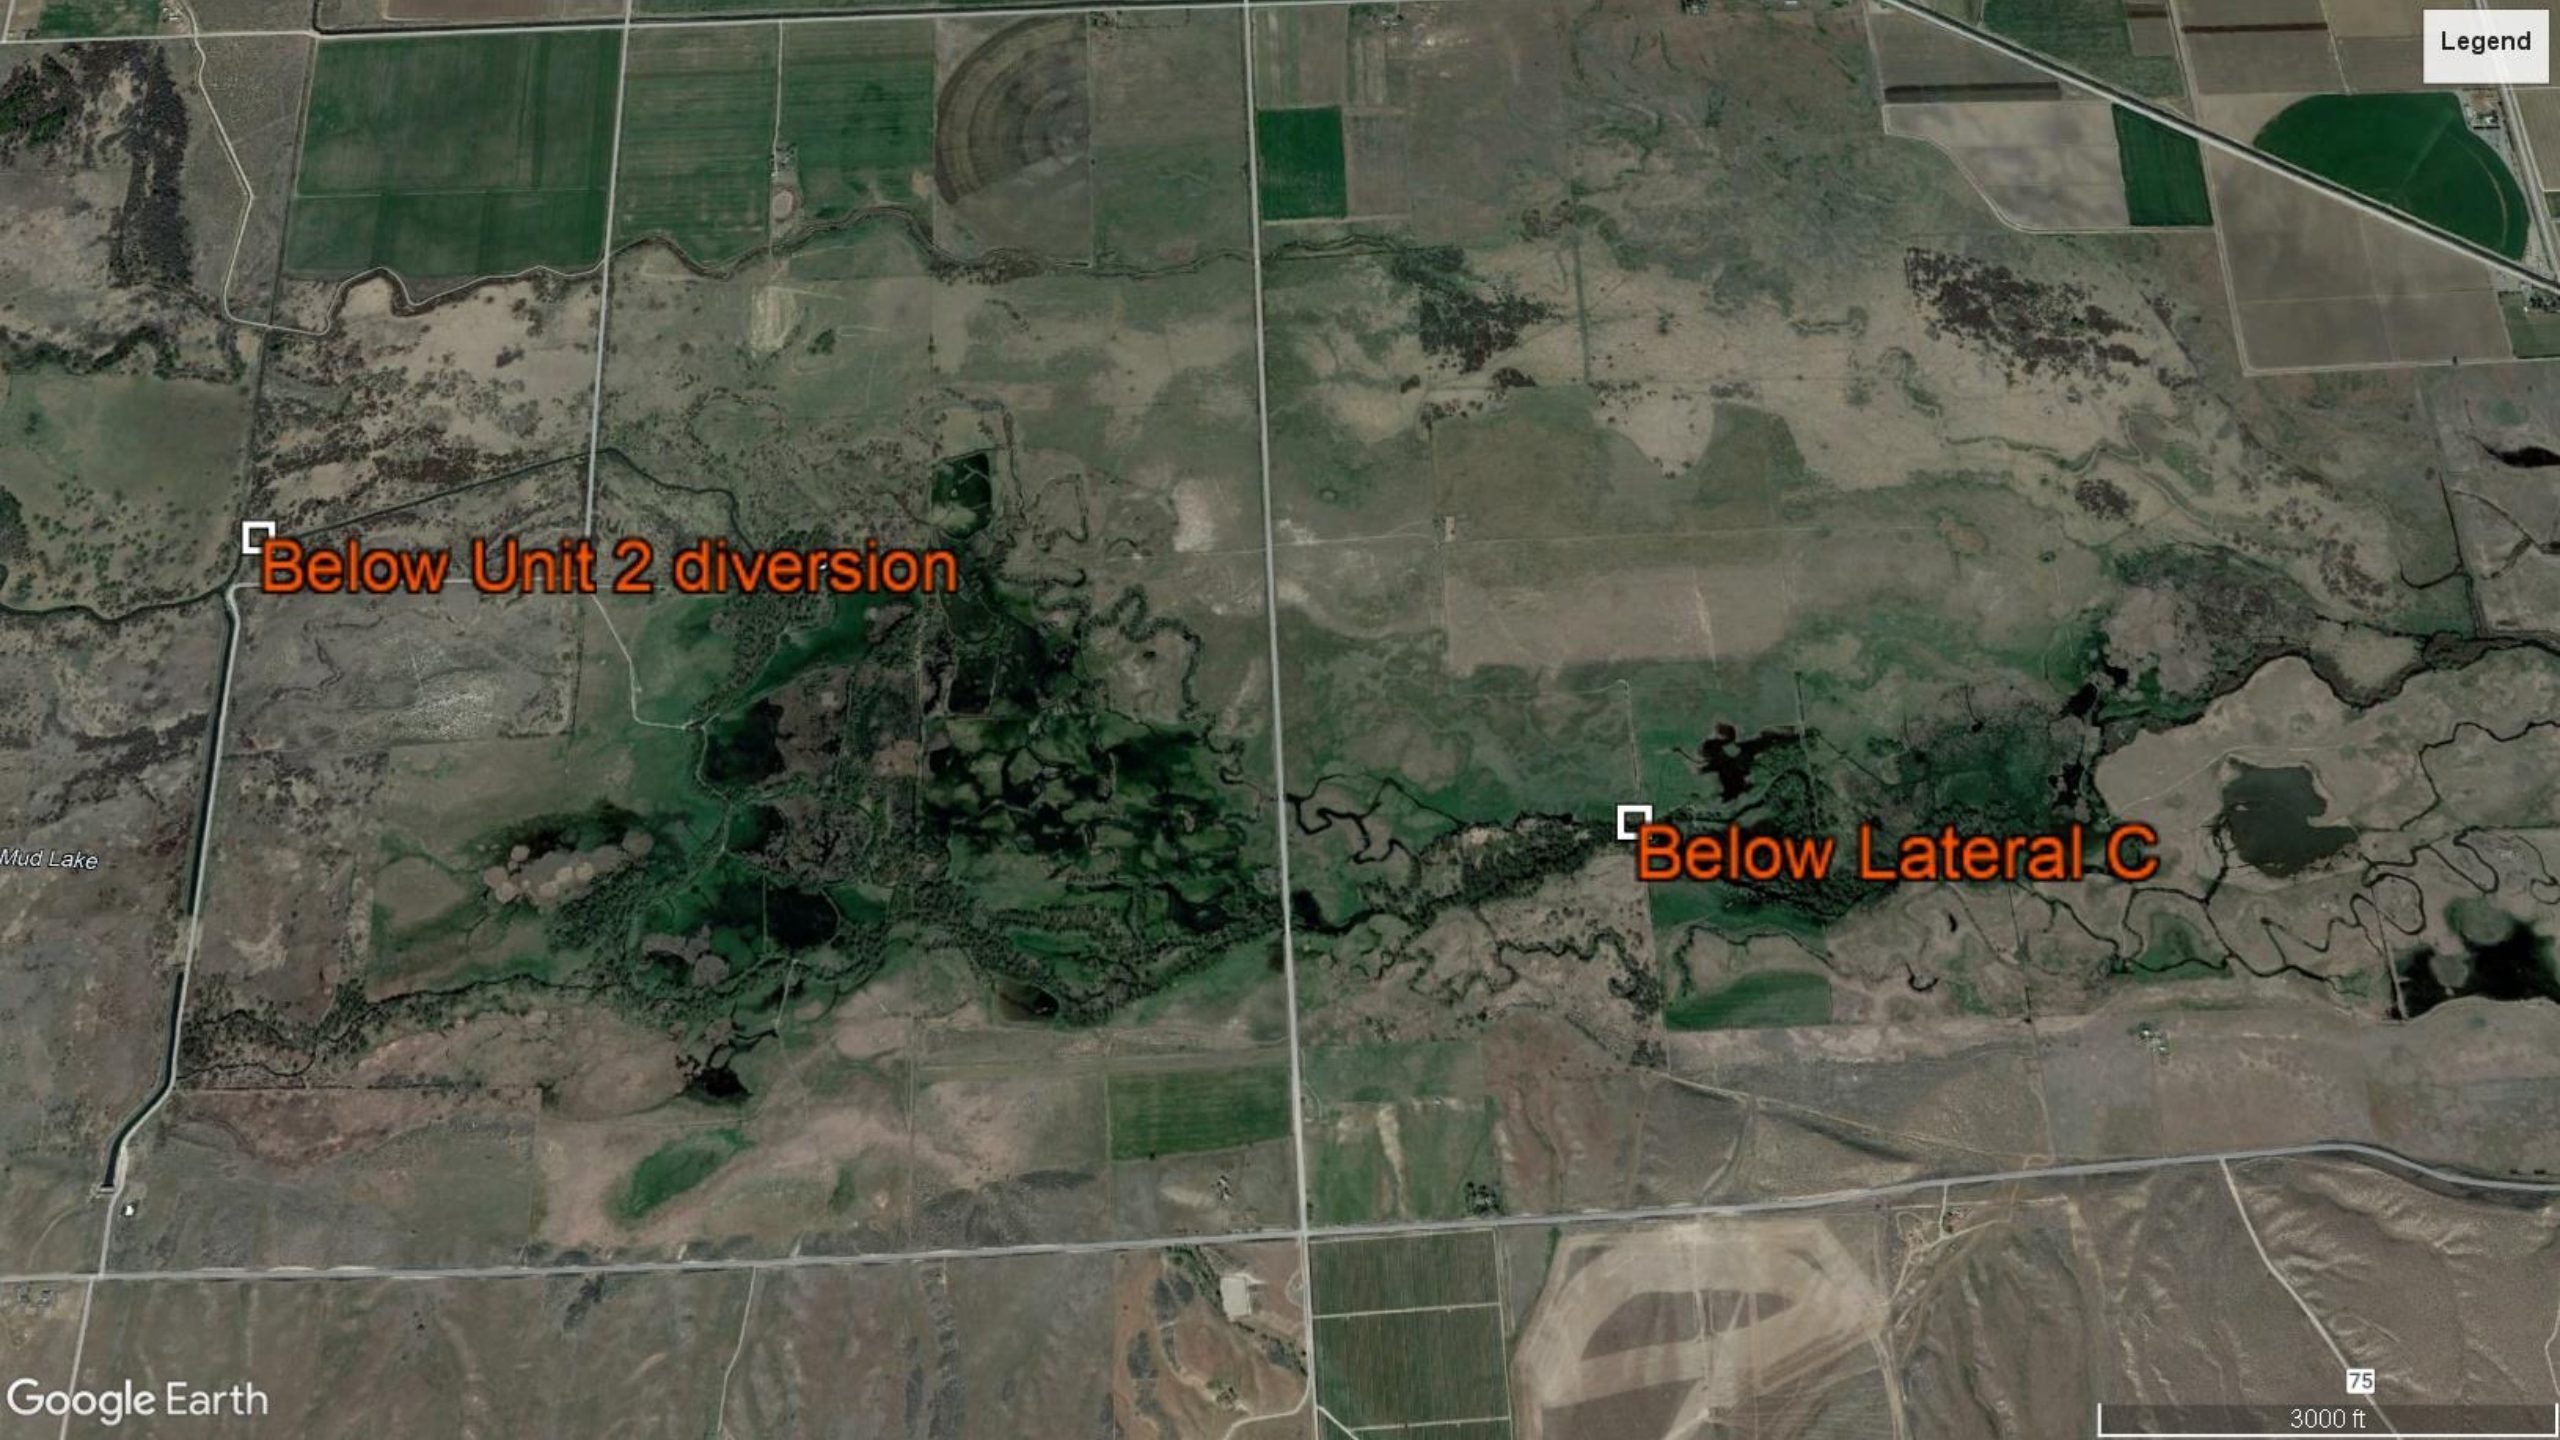
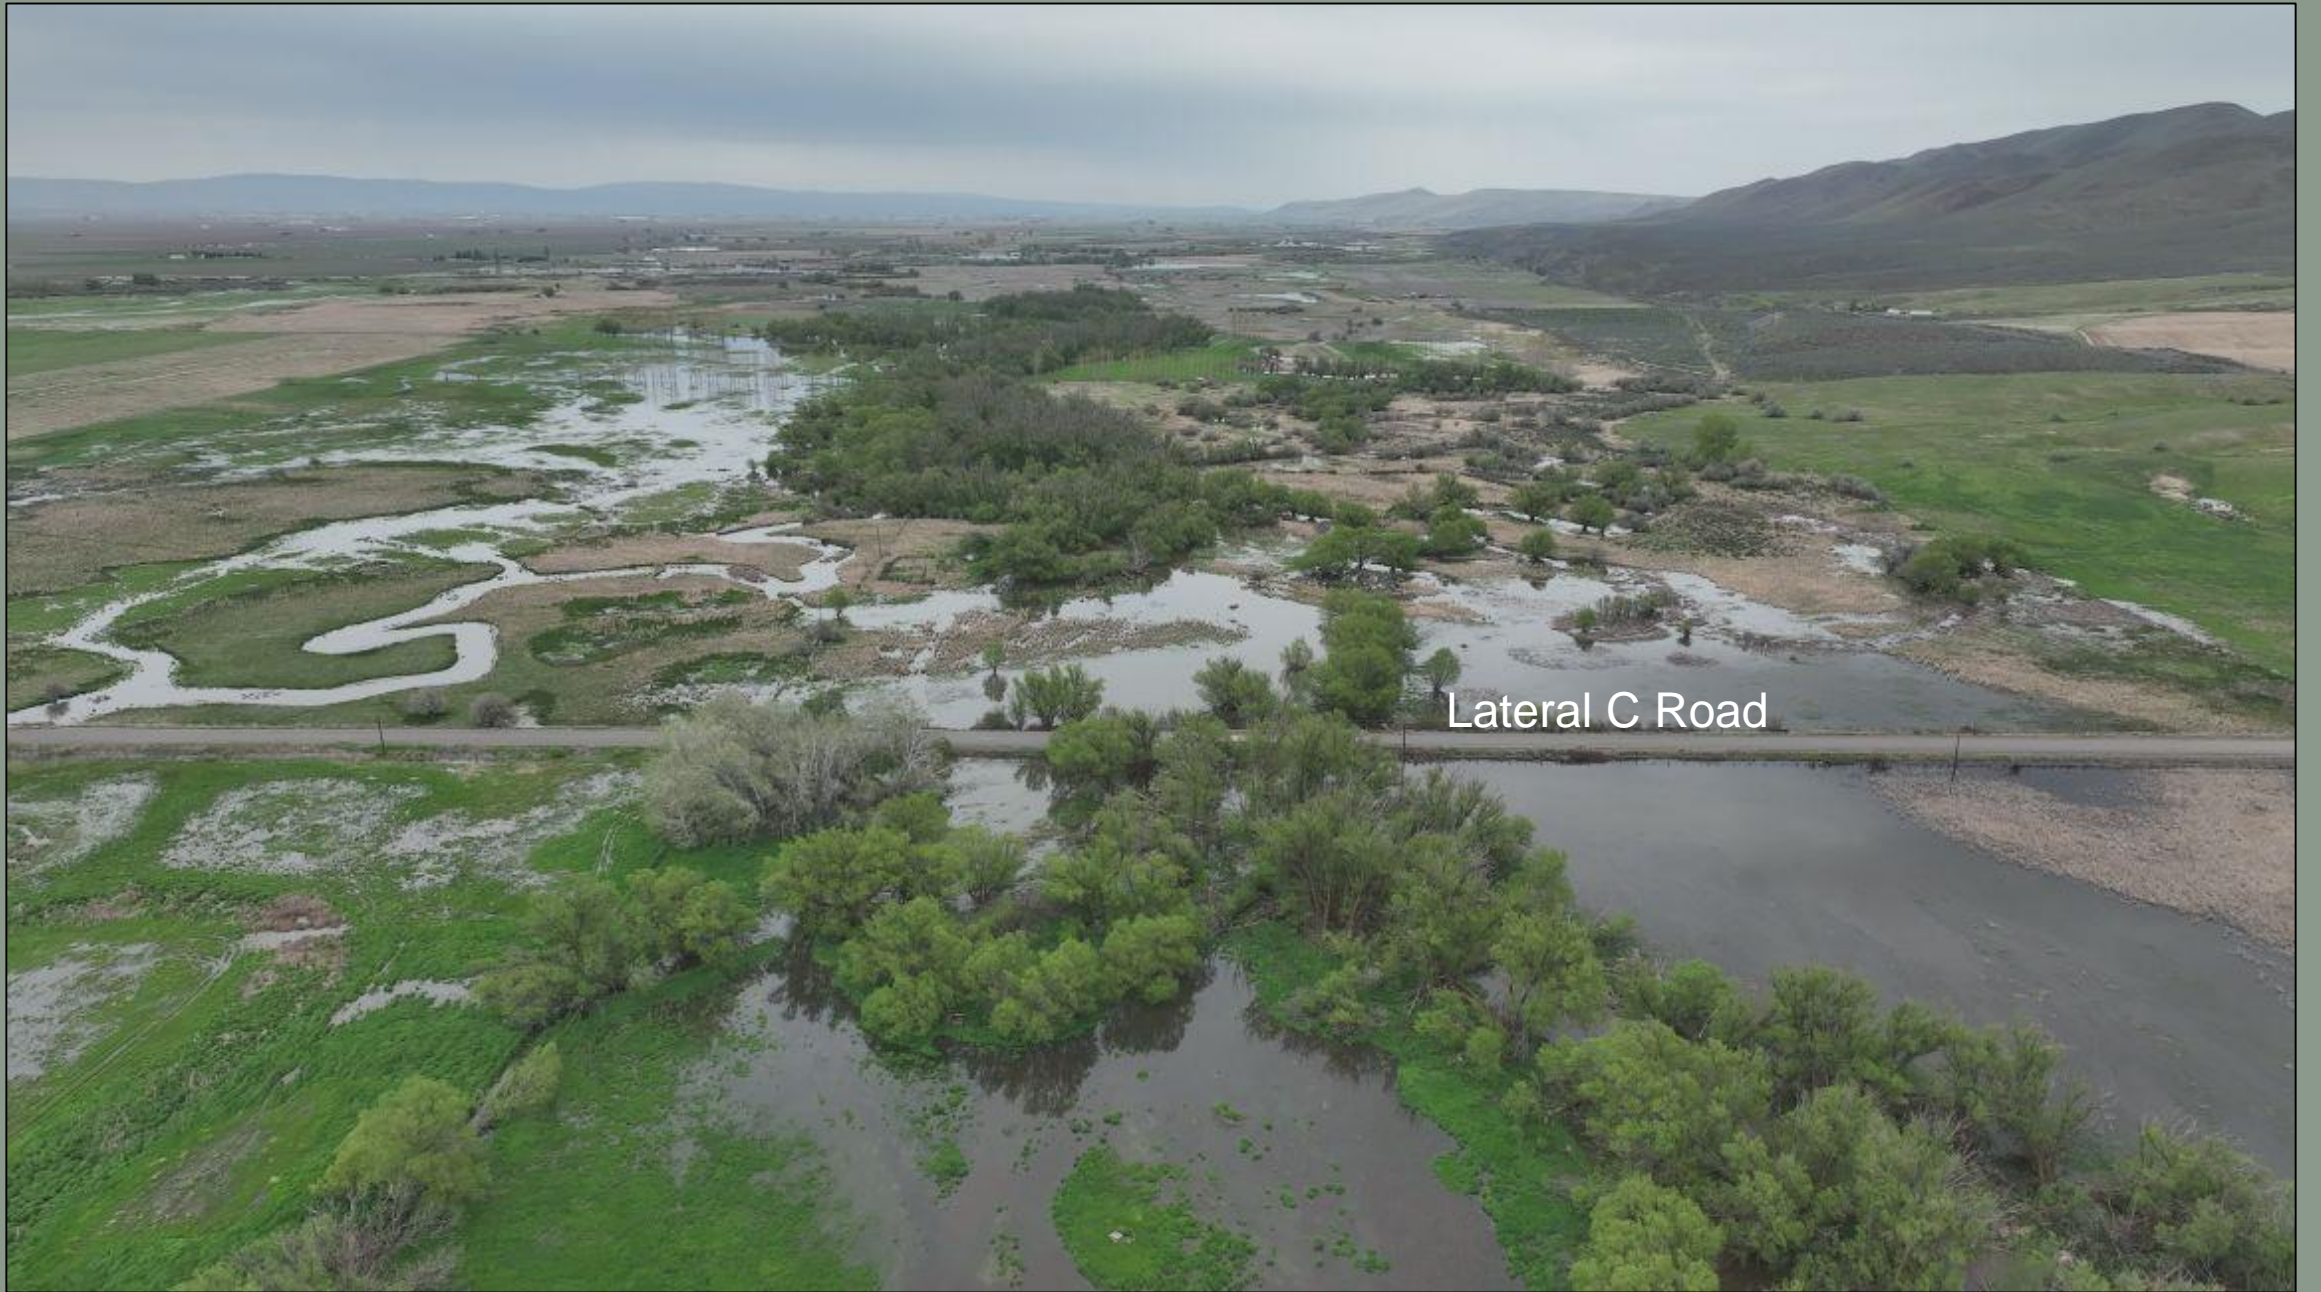
Location of two new antenna on Toppenish Creek planned for installation in 2023.

Below Unit 2 diversion

Below Lateral C

- Installation of two PIT tag antennas
- Scanning flood plain areas for PIT tags to locate areas where stranding may be occurring

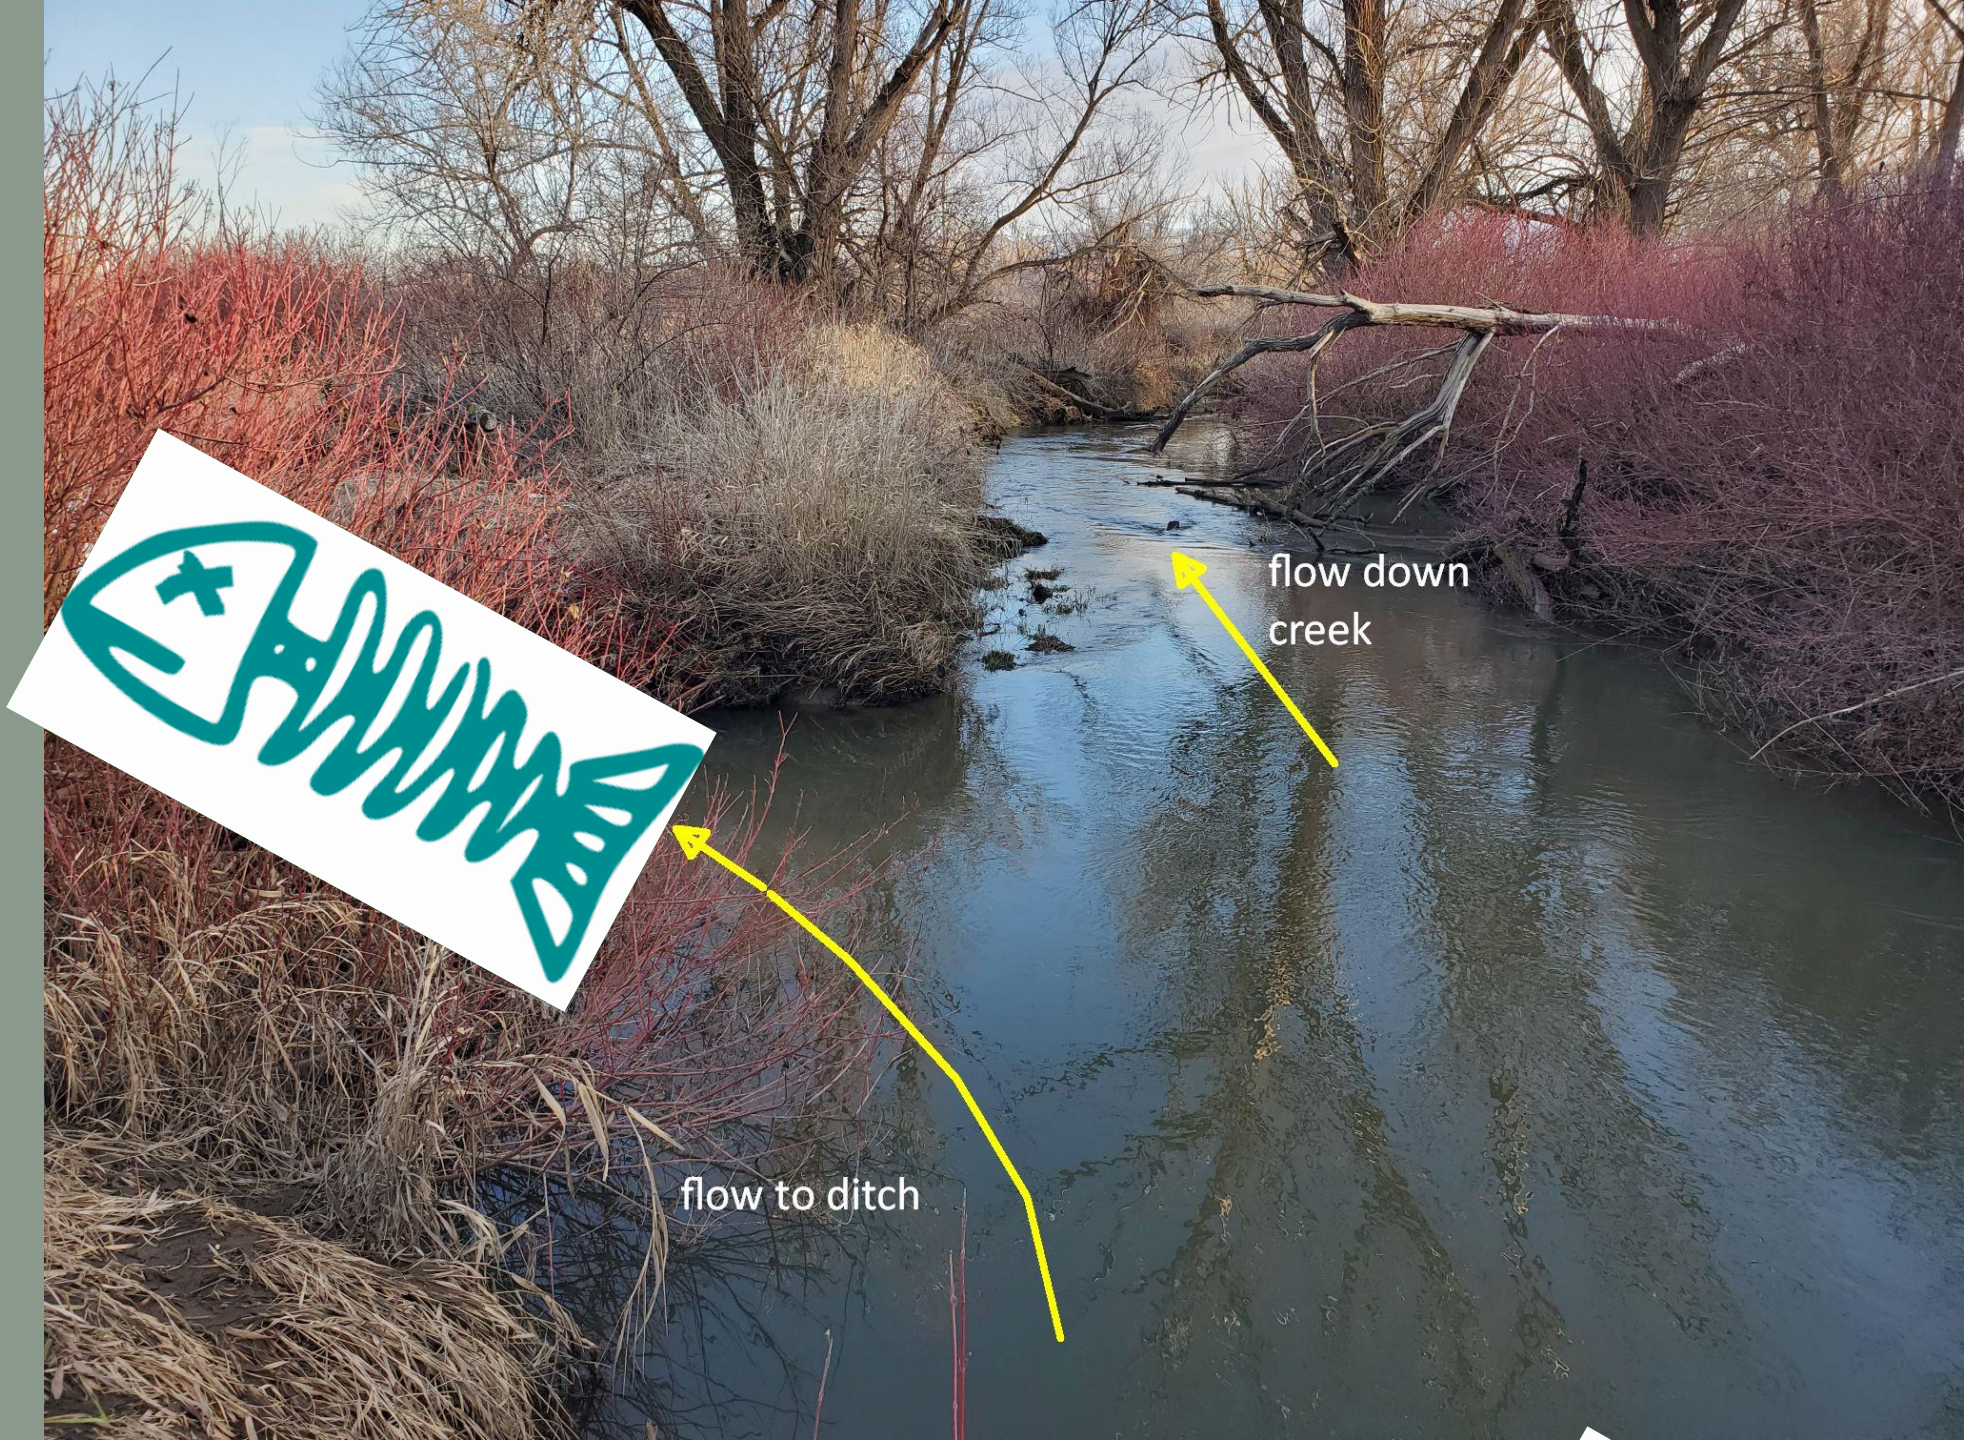
flow to ditch

flow down  
creek

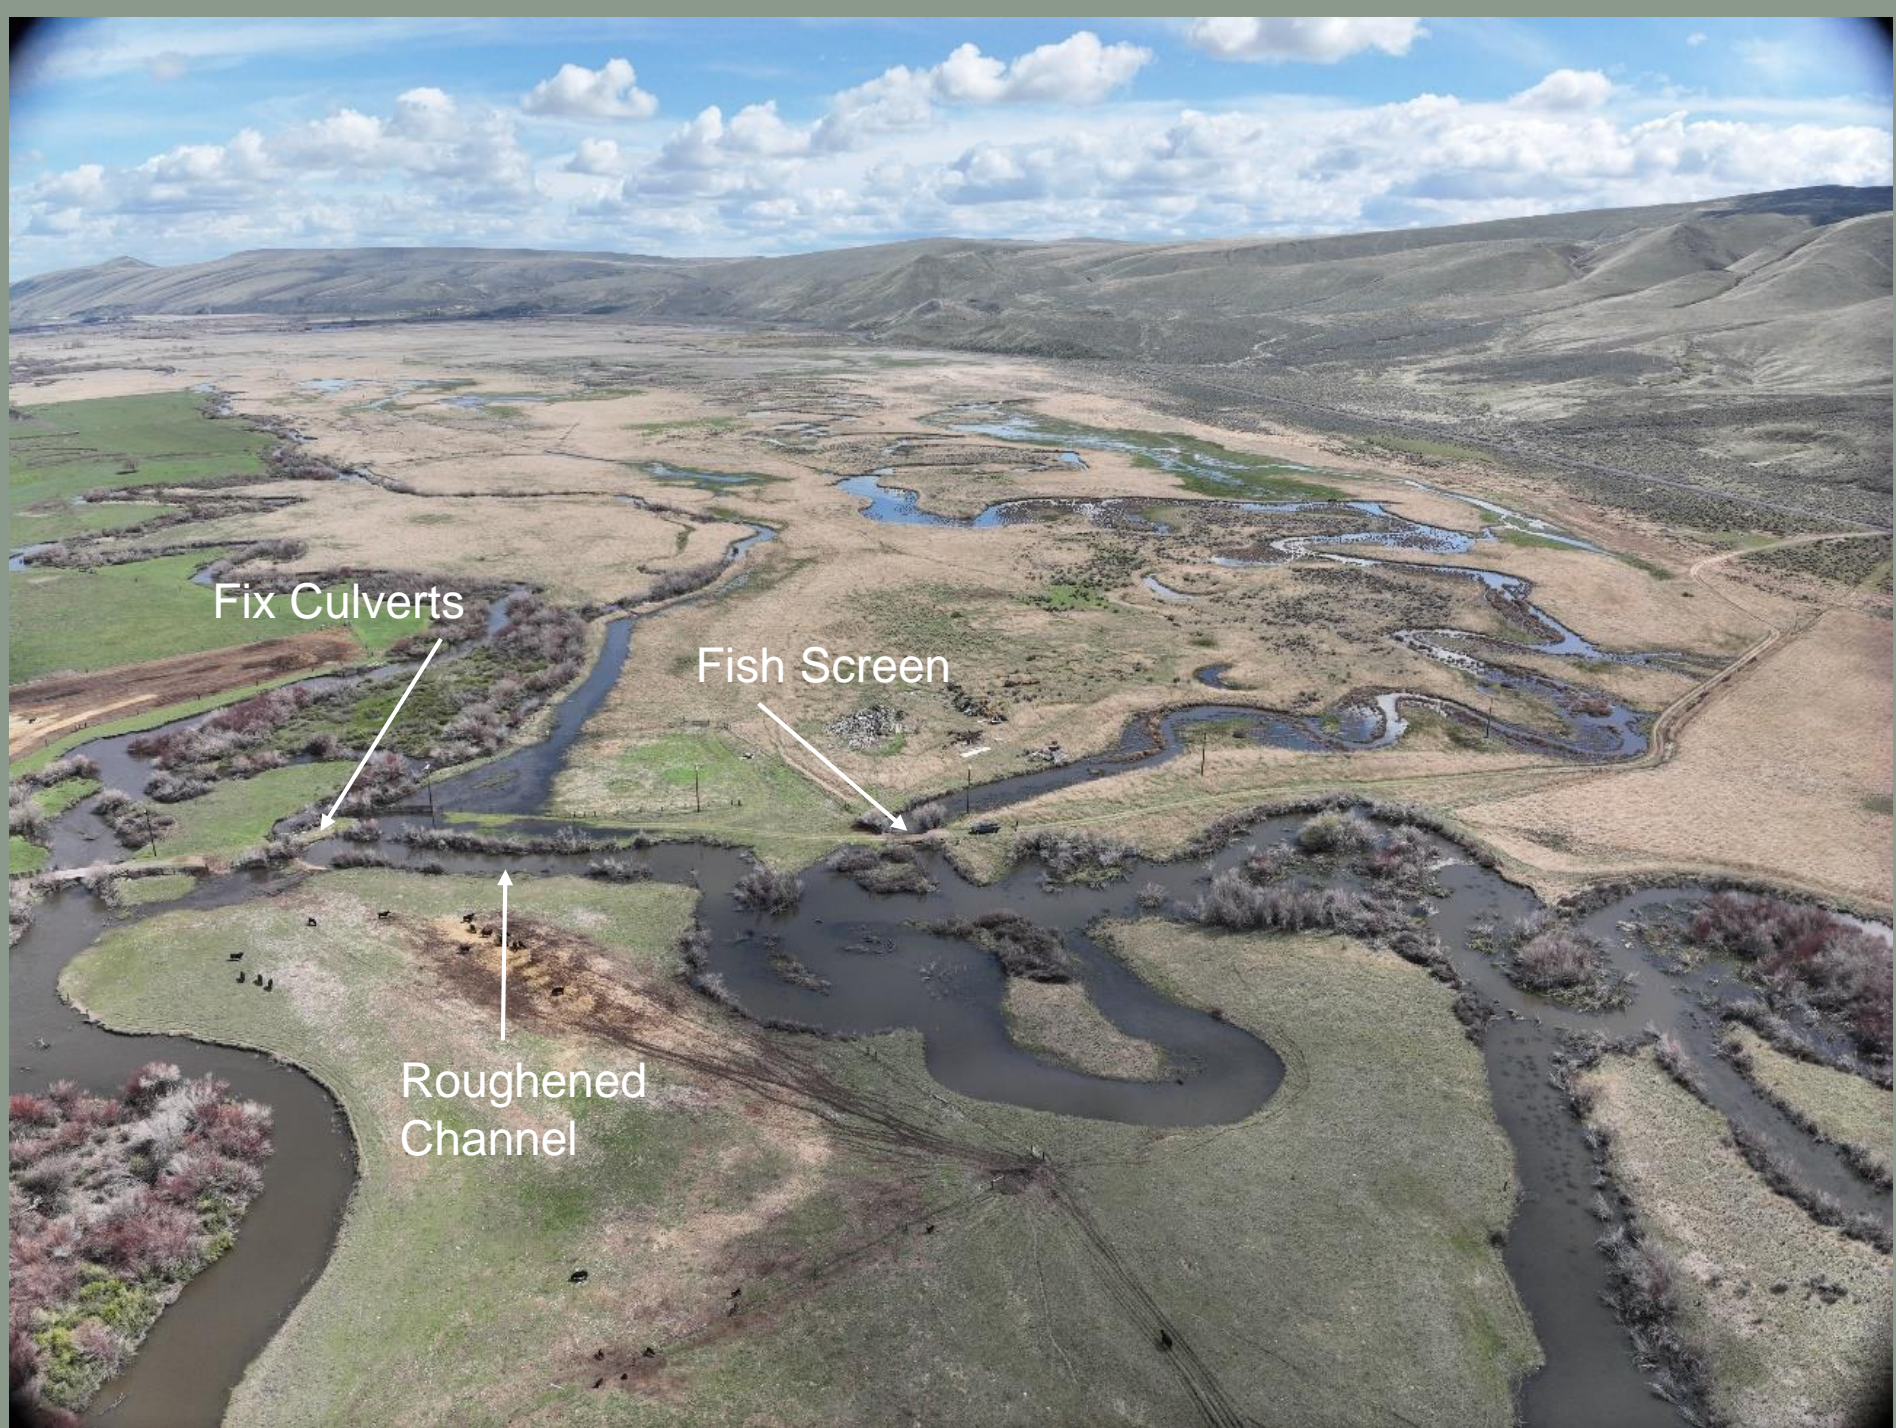
# Snake Creek

Fix Culverts

Fish Screen

Roughened  
Channel
