FLOODPLAIN FOREST REGENERATION AND FLUVIAL PROCESSES:

Status of Cottonwood Forest on the Kittitas Reach and Restoration Implications

Katrina Strathmann
Restoration Ecologist
Mid-Columbia Fisheries Enhancement Group
katrina@midcolumbiafisheries.org

Yakima Basin Science Conference June 14-15, 2023

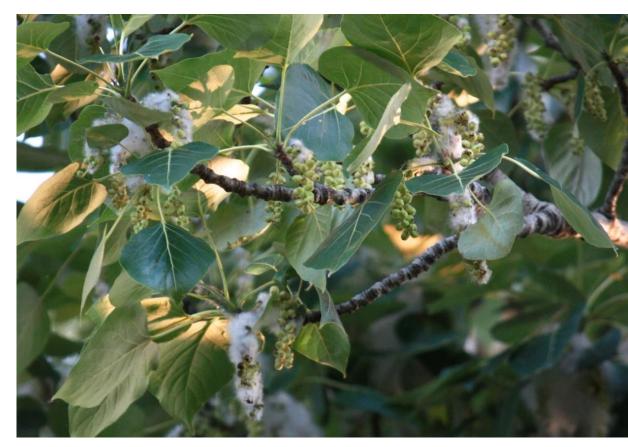
Vegetative reproduction = <u>stand</u> maintenance

Sexual reproduction = <u>stand</u> <u>creation</u>

- Annually, seed released early summer
- Seed is viable for short period

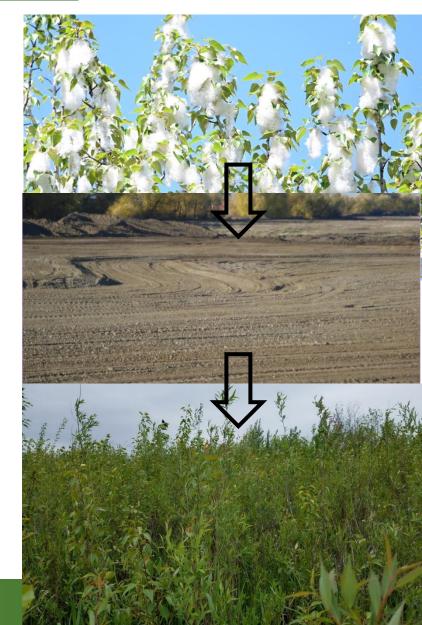
Incorporating Regeneration into Floodplain Restoration

Depth to groundwater < 6 ft during summer high ET

Stand creation using regeneration conditions:

- Created seedbed surfaces → contouring
- Moist soil at seed release

elevations/irrigation
- Propagule source

assisted seeding
- Groundwater available during early root growth → elevations/irrigation
