**FY2013 ANNUAL REPORT**  
MARCH 1, 2013 THROUGH FEBRUARY 28, 2014  
YAKAMA RESERVATION WATERSHEDS PROJECT  
*BPA Project #1996-035-01-Contract #35636*

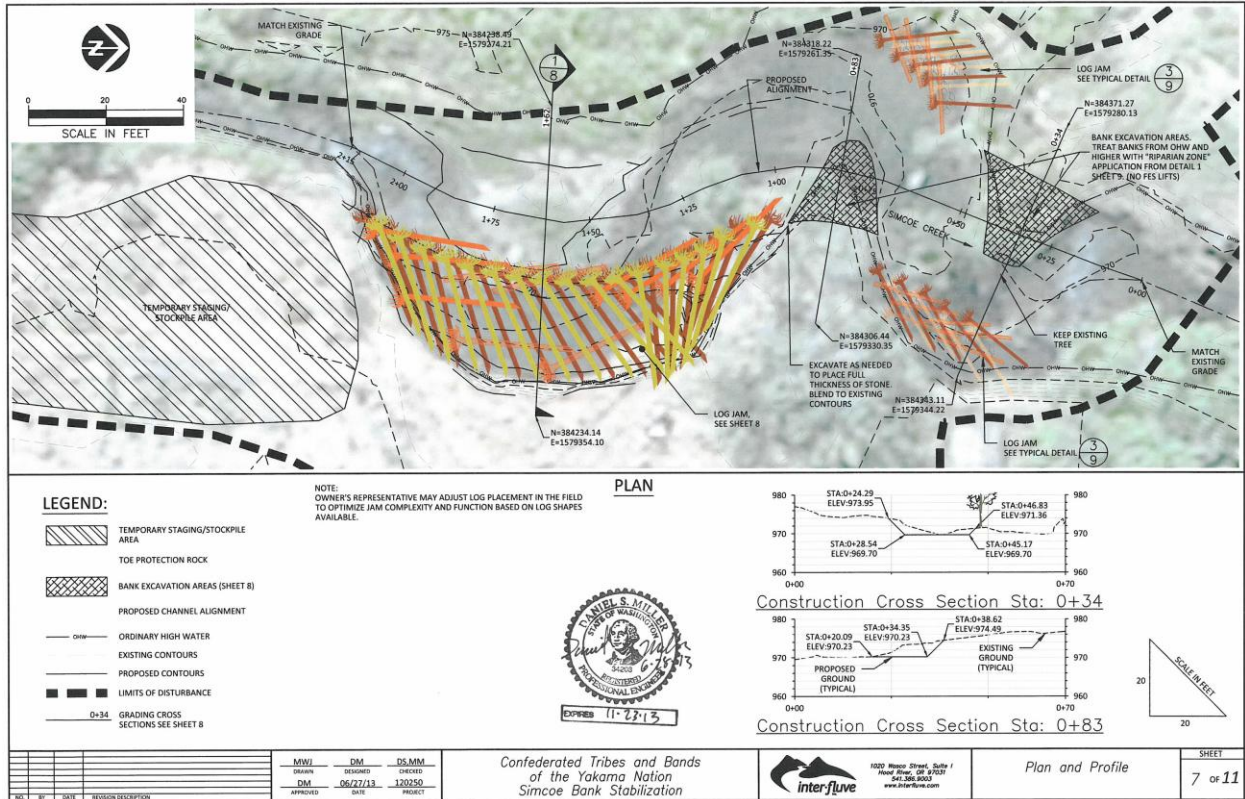
Design conditions included reconstructing the stream bank by adding a rip rap toe, large woody debris, and general fill. However, moving the toe of the existing stream bank does not meet BPA's Habitat Improvement Programmatic (HIP) BiOp with National Fisheries Marine Service (NMFS) criteria to permit this project under the Endangered Species Act (ESA). The project was re-designed so that the toe of the slope does not change, basically eliminating riprap and general fill material. This essentially was not approved for implementation due to liability and safety concerns with the adjacent landowner.

Figure 2. Re-design to meet BPA’s HIP BiOp criteria for ESA consultation

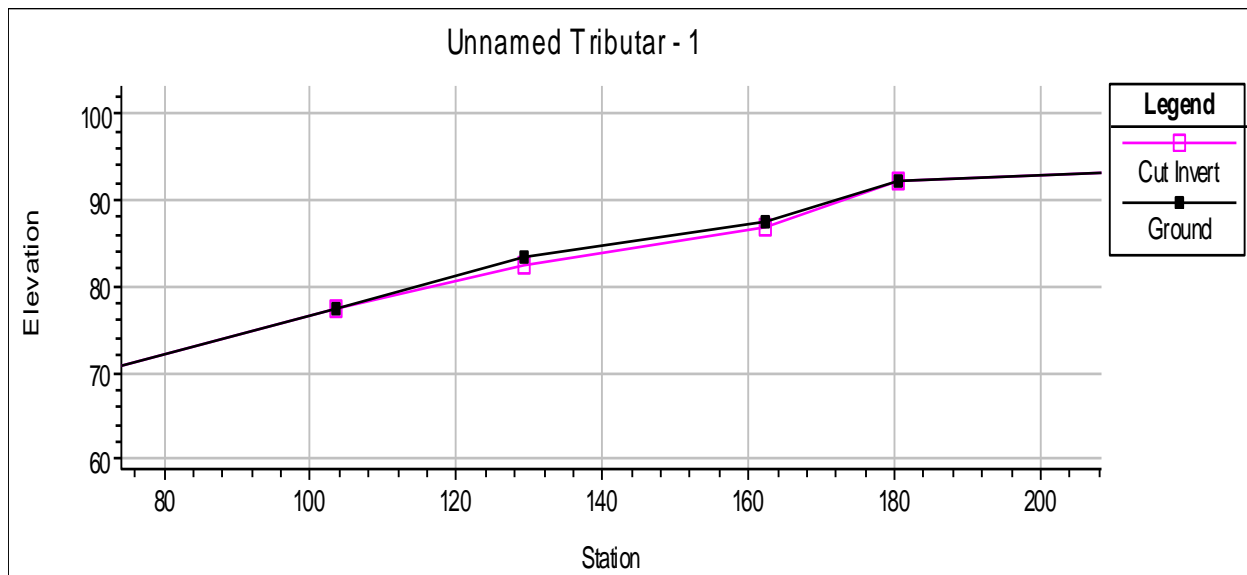
The ford site was excavated ~ 1 foot below the proposed finished grade (pink line in figure 8) then filled with rock with rock sourced from the site. Approximately 83 cubic yards of material was excavated to reach the grade of the finished surface elevation of the ford. 79 additional cubic yards of material was removed to reach the sub grade of the ford. Extra fill material was used for reshaping of the road portion of the project. The slope through the ford area was designed at a 20% slope. The ascent and descent into the stream channel is an approximate 2:1 slope to allow four wheel drive vehicle access. The site was planted with native riparian and upland seed mix and plants immediately following construction.

Figure 8. Longitudinal profile of the stream channel
