**FY2014 ANNUAL REPORT**  
MARCH 1, 2014 THROUGH FEBRUARY 28, 2015  
YAKAMA RESERVATION WATERSHEDS PROJECT  
*BPA Project #1996-035-01-Contract #56662-REL 50*

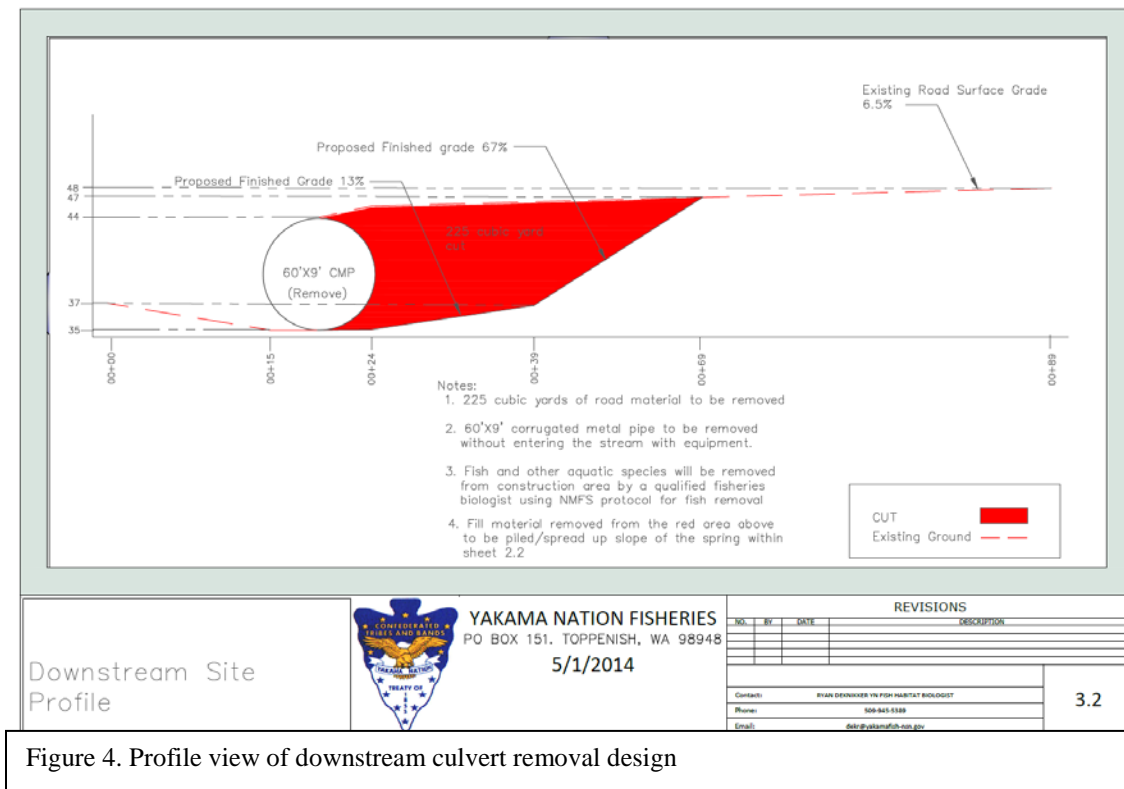
Figure 4. Profile view of downstream culvert removal design

Construction began on the project in September. Due to the remote location of the site and the difficult terrain, heavy equipment was mobilized nearly 17 miles which took nearly a day. Initially, two water bars were constructed on the road leading to the lower culvert to divert surface water into the adjacent riparian area per the project plans. The lower culvert was removed from the creek without entering the water, after fish were excluded (upstream and downstream of the culvert) using block nets. The bank was sloped to the specification of the plans (figure 4), and two additional water bars were constructed on the roadway. Fill derived from the bank excavation was contoured into the hill slope above the most upstream water bar.

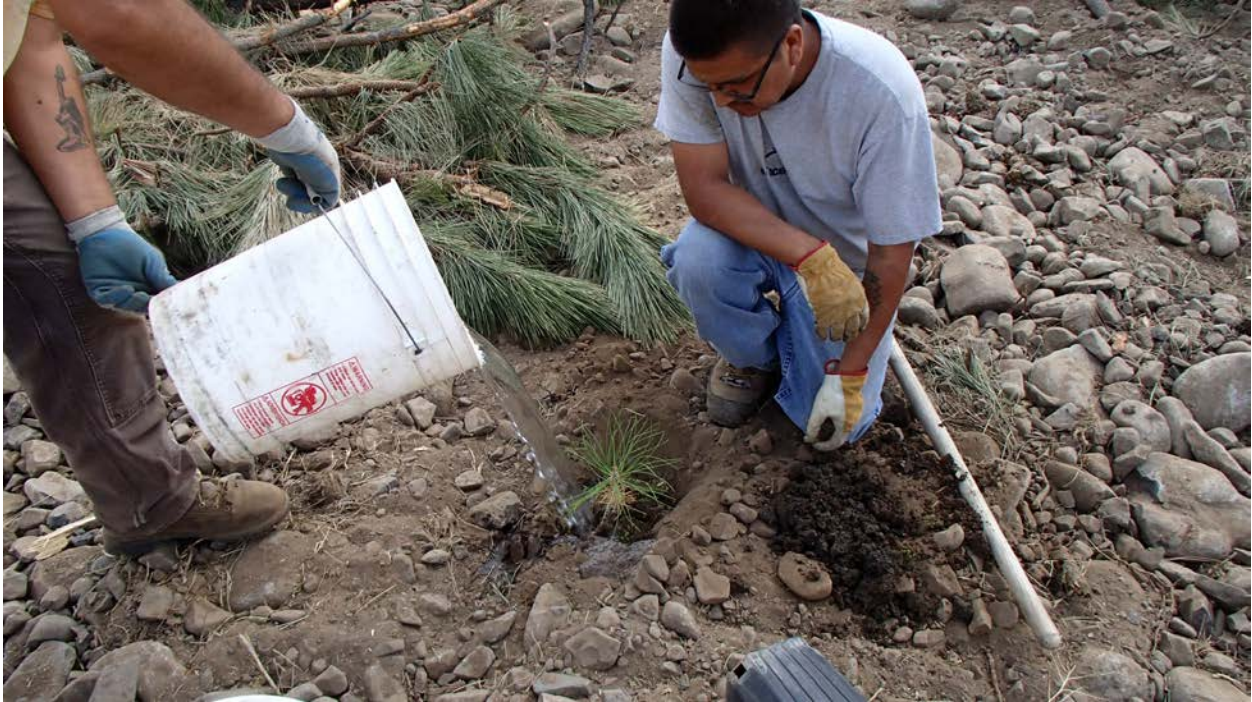
Figure 9. YRWP staff planting container plants at the Willy Dick Creek site, October 2014

YRWP staff planted over 300 container plants sourced from a local native plant nursery, and 50 lbs of riparian and upland seed at the site (figure 9). Plants were flagged to monitor survival overtime and watered until sufficient precipitation provided sufficient water availability.
