NASON CREEK TRIBUTARY ASSESSMENT Chelan County, Washington

BUREAU OF RECLAMATION TECHNICAL SERVICE CENTER, DENVER, CO, AND PACIFIC NORTHWEST REGIONAL OFFICE, BOISE, ID.

JULY 2008

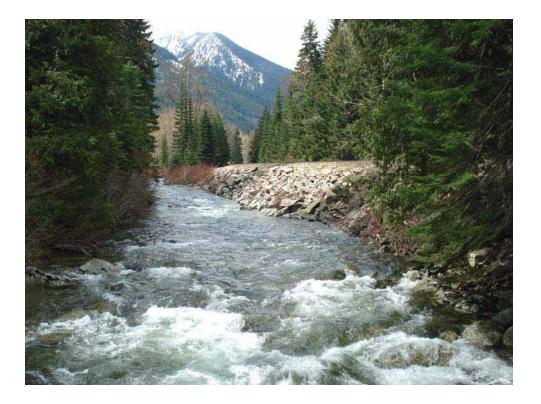
Cover photo: View looking upstream at the railroad grade that defines the left bank. Nason Creek – Wenatchee River subbasin, Washington. (Reclamation photograph by R. McAffee, May 2, 2007).

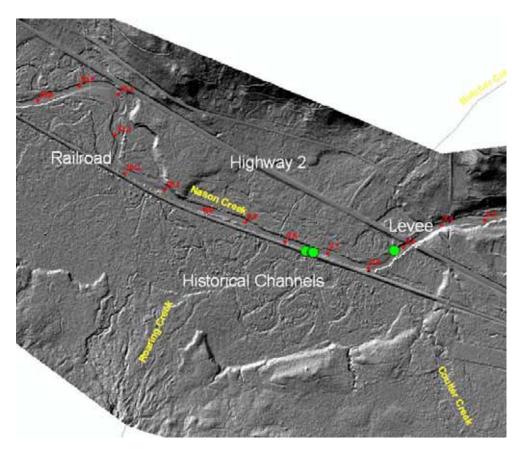
Documentation on the tributary drainage size and impacts to flow connectivity were summarized in Table 6. Within geomorphic Reach 1, there is only one significant tributary (Kahler Creek) and it is presently connected with a side channel of Nason Creek. Geomorphic Reach 2 has no significant historical impacts to flow and there are no tributaries in this reach. The upper surface bounding Reach 2 has large amounts of paved ground. In geomorphic Reach 3, nearly all tributaries and hillslope runoff areas along the right side of the floodplain are partially or fully disconnected due to the railroad embankments, and a large portion of the left side from U.S. Highway 2 (looking downstream) (Figure 5; see maps 25 and 26 in atlas). Even though culverts are present in the railroad and highway embankments, many local biologist believe these are undersized and impact both flow connectivity and fish passage (Figure 7) (Andonaegui 2001). Elevations of ten culvert inverts were surveyed in 2007 and could be further evaluated at project scale evaluations. Most culverts are also thought to impede fish passage where historical fish use occurred (Andonaegui, 2001).

Figure 5. Example of railroad, highway, and levees cutting off flow connectivity between tributaries and present main channel. River miles from 2006 are shown in red text and existing culvert locations are green circles.

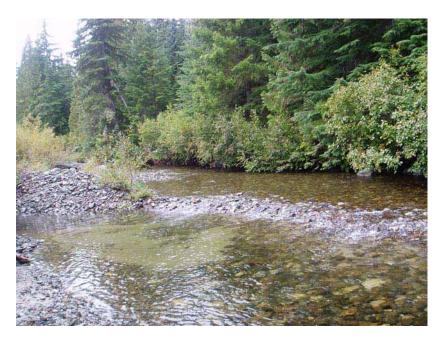
Sediment sizes in the channel above RM 15 were observed in a few locations where accessible by the road, and a helicopter video of the channel from spring of 2006 was also obtained for this effort. In the locations viewed, gravel bars were common and the dominant sediment sizes on the surface of the channel bed and bars ranged from gravel to cobble (2 to 256 mm) (Figure 10 and Figure 11).

Figure 10. Upstream view of confluence of side and main channel in upper subwatershed near split in highway (vicinity of RM 20 to 22). (Reclamation photograph by J. Bountry, October 2007

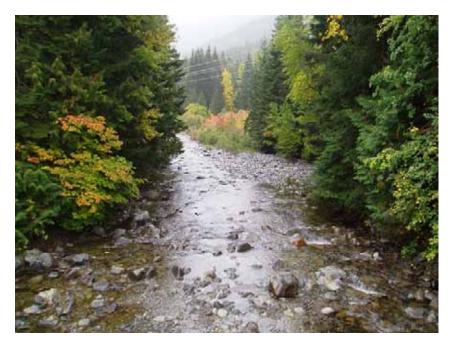
Figure 11. Example of gravel and cobble size sediment near U.S. Highway 2 bridge crossing in upper subwatershed. (Reclamation photograph by P. Makar, October 2007).

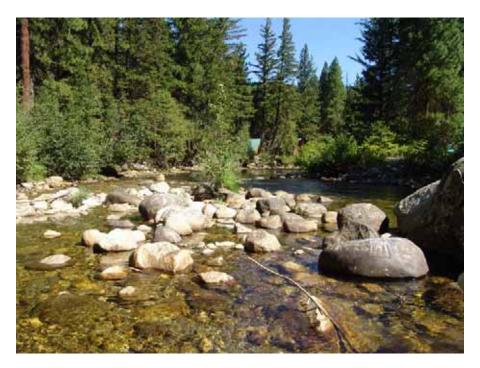
Figure 15. View is to the north looking downstream showing boulder field at downstream end of Reach 2 near RM 9. (Reclamation photograph by D. Bennett, August 9, 2007).

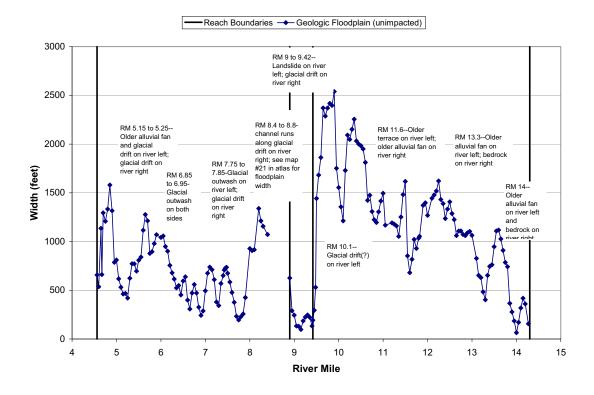
The geologic floodplain is bound by higher elevation geologic features including alluvial fans, glacial drift and outwash, landslides, talus, terraces, and bedrock which in places result in natural confinement of the floodplain width (Figure 22). The most extensive geologic unit along the floodplain boundary is glacial drift and outwash for Reaches 1 and 2, and alluvial fans in Reach 3, both of which can be eroded by the river. Geologic surfaces limit lateral expansion of the floodplain at RM 10.8 to 11.0 from bedrock on the right side and at 14.25 from bedrock on the left side and talus on the right side (see Appendix J for

descriptions of surfaces). Boulders in a historical landslide at RM 8.9 to 9.4 also provide limits on lateral expansion. Glacial banks often have large cobbles that can line the toe of the bank when eroded by the river, thus in some cases limiting the rate of lateral expansion of the floodplain, but not preventing it.

Figure 22. Geologic surfaces that narrow (confine) the historical floodplain width in the assessment area.

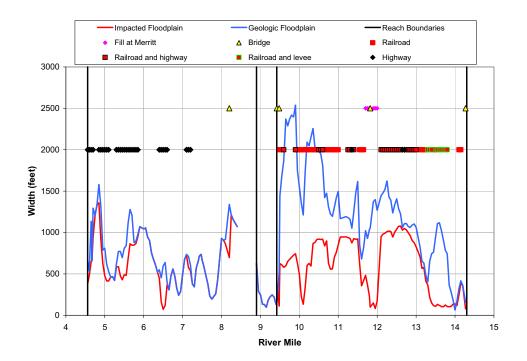
The anthropogenic features also reduce the geological floodplain width in Reaches 1 and 3 as shown in Figure 25. Where there are reductions in the geologic floodplain width, the average reduction in width is 240 feet in Reach 1, and more than twice as much in Reach 3 (660 feet). The reduction in floodplain width in Reach 3 is nearly continuous along the river path, whereas the reduction in floodplain in Reach 1 is more isolated to five smaller areas.

Figure 25. Reduction in floodplain width due to anthropogenic features with locations referenced as symbols that are identified in legend box.

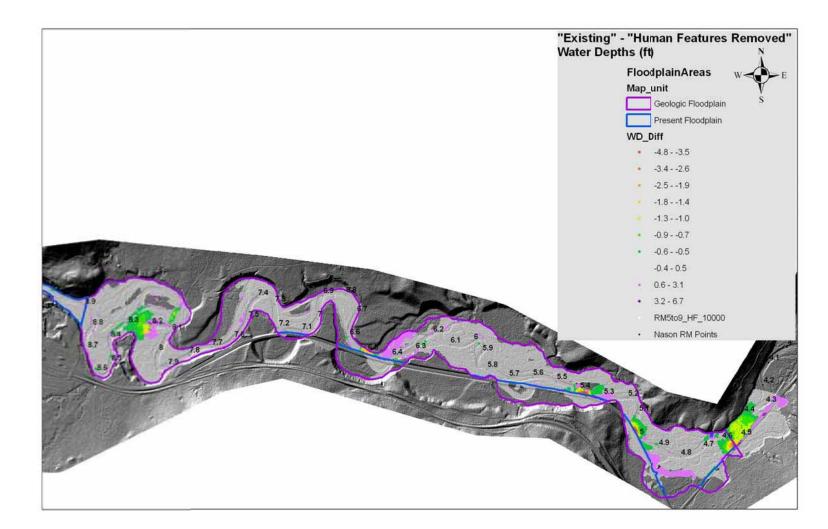
Figure 27. Difference in water depth between impacted present conditions at 10,000 cfs and presumed historical conditions had the highway and bridge embankments not been constructed. The white shading represents the extent of inundation under historical conditions, as compared to impacted conditions which cannot exceed the blue boundary line. The green (smallest reduction), yellow, orange, and red (largest reduction) show areas where water depth would be reduced by at least 0.5 feet if the historical floodplain were accessible. The pink and purple areas show where water depth would increase by at least 0.5 feet within the present floodplain.

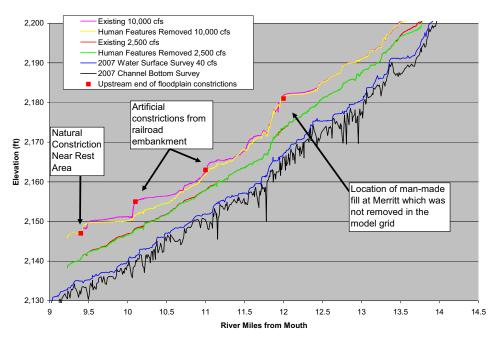
The maximum floodplain width reduction in Reach 3 is 1,800 feet, but the impact to floodplain connectivity is almost continuous along the entire reach (see Figure 25). At the lower river flows such as 2,500 cfs, water begins to inundate side channels in meandering sections. At flows of 5,000 cfs and greater, the flow begins to spills out onto the floodplain. The majority of the floodplain is inundated at 10,000 cfs. Below White Pine and along Merritt in the artificially-confined sections, even 10,000 cfs is mostly contained within the active channel banks. In other artificially-confined channel sections, flooding of overbank surfaces occurs as low as 2,500 cfs. This is a result of backwater caused by rapid widening of the floodplain at the upstream end of constricted channel segments (Figure 28). The water depth is increased in backwater areas in Reach 3 by less than 1 foot at 2,500 cfs and about 3 to 5 feet at 10,000 cfs. When the railroad and highway embankments are conceptually removed to allow access to the historical floodplain for modeling purposes, the backwater is reduced and the slope is more consistent with other areas in the reach not impacted by backwater. The exception is just upstream of RM 9 which is a natural geologic constriction resulting in backwater, and above Merritt at RM 12 where fill was not removed from the model topography (historical floodplain topography could not be estimated for modeling purposes due to the extensive fill at this location). Between RM 13.5 to 14, the slope and water surface elevation reduces because in the modeling scenario, the present engineered channel was filled and the channel allowed to re-access the historical main channel. This changes the alignment, area, and location of flow inundation for this river segment which overall reduces the flood stage.

Figure 28. Backwater impacts from confined floodplain areas in Reach 3.

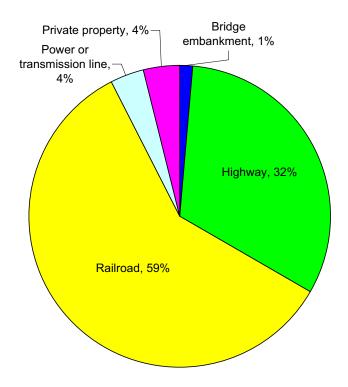
About 50 percent of the main channel in Reach 3 has riprap on at least one side of the main channel (Table 13). Less riprap is present in Reaches 1 and 2. The majority of riprap is associated with protecting the railroad and highway embankments from erosion, but an additional 9 percent is located along bridges, private property, and power and transmission line poles that reduce channel migration in additional areas beyond those confined by the railroad and highway (Figure 29 and Figure 30; also, see maps 23 and 24 for locations of riprap and human-made features that limit migration).

Figure 29. Purpose of bank protection along main channel by type of human feature in assessment area.

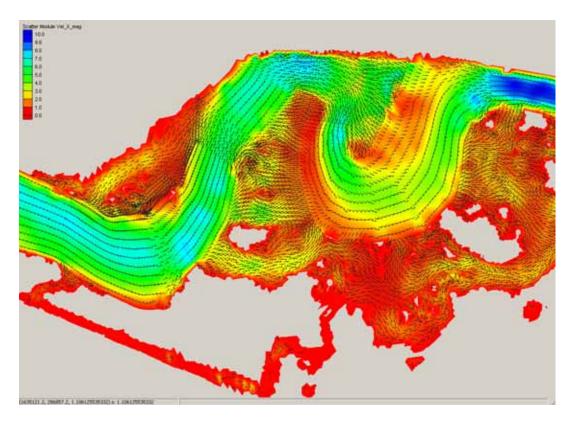
Active migration has occurred since at least 1962 and hydraulic model results indicate this reach has complexity in terms of varying velocity and water depth, which is essential for developing habitat and diversity in the ecosystem (Figure 31). However, barbs and riprap along the outside of the meander bends protect U.S. Highway 2, which impacts the lateral extent of migration (Figure 32). Because the upstream-most meander bend is not locked in with riprap, the channel may eventually cut off the present meander and start a new meander cycle despite the bank protection and in-channel features on river left. The position of the meander bend is impacted at the upstream end because of human-induced channel confinement just upstream.

Figure 31. Example of 2D model velocity vectors (black arrows) and magnitude (color coded legend in feet per second (ft/s)) results around RM 12.7 to 13.3.

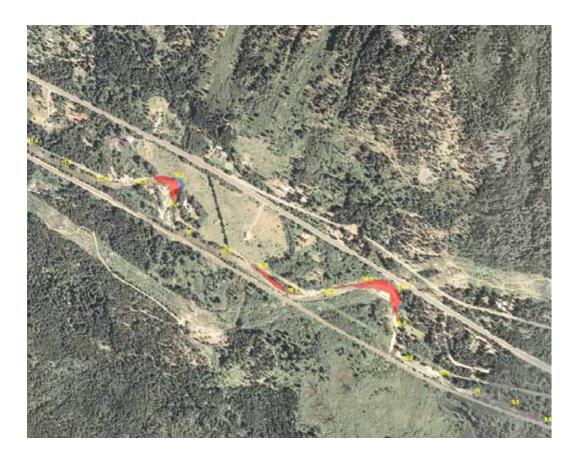
Between 1962 and 2006, the channel has migrated a fair amount in these two sections (Figure 33). The migrating channel areas are pinched between artificially confined sections upstream and downstream, which likely alters the channel position and migration rate. In both locations, the channel is now eroding outward into an unvegetated terrace of the floodplain. If the bank is eroding at an accelerated rate because it is cleared of vegetation, the sediment bar on the inside of the meander bend could be growing at an accelerated rate. This could hypothetically reduce the ability for seedlings to establish on the bar, and also impact channel geometry on the outside of the meander bend if sediment volumes from bank erosion locally overwhelm the river's ability to maintain a scour pool on the outside of the meander bend. Further monitoring and survey data at this site would be useful at a project scale to more clearly understand impacts.

Figure 33. Example of two meandering channel locations (between artificially confined sections) where bank erosion along the outside of a meander bend at RM 10.4 and 11.2 occurred between 1962 and 2006 (colored polygons show erosion areas) (also see maps 29 and 30 in atlas for more locations of channel areas that have been reworked).

Between RM 10.1 and 10.48, the channel meander is progressing toward U.S. Highway 2 and, as of 2007, there was a narrow wedge of floodplain left between the highway and the river bank (see Figure 33). This is also a location where Roaring Creek and Coulter Creek drainages enter, although presently the confluence is blocked off by the railroad embankment with limited flow passage through culverts. This area has the potential to trap sediments that are flowing in from the tributary and hillslopes. The historical main channel downstream of RM 11.1 is believed to have been on the opposite side of the railroad. 2D modeling with the railroad removed shows the difference between the present channel meanders versus the historical channel path which were more sinuous (Figure 34). As discussed for Merritt, part of this change may be due to backwater caused upstream of the confined sections (see floodplain report section), which overlaps with these two meandering sections.

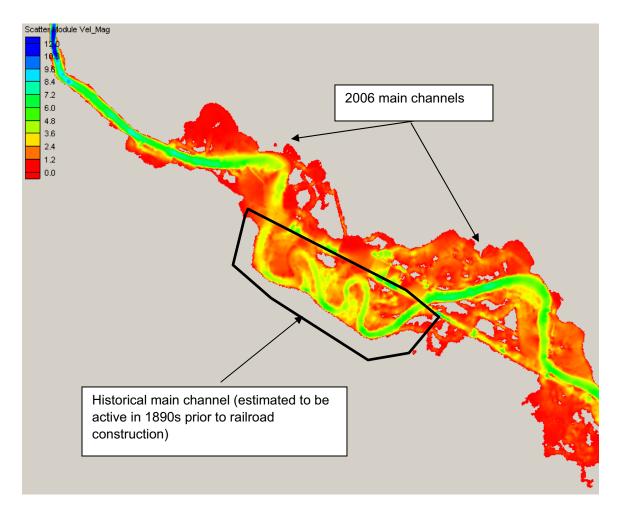
Figure 34. Image showing velocities and channel alignment of existing meanders and historical meander between RM 10.1 and 11.5. Note the tighter meander bends represented with the historical channel as compared to the two present (2006) meanders.

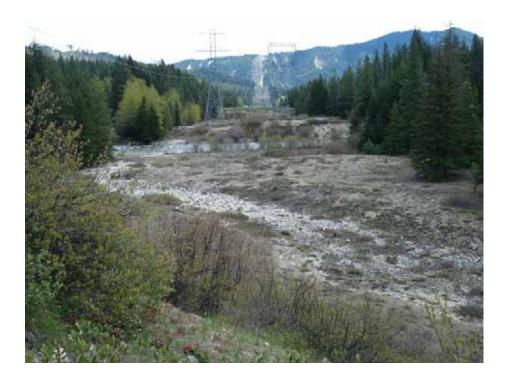
This section has a side channel that has developed through channel migration and reworking since 1962 near the confluence with Kahler Creek (Figure 35). The power line crossing presently runs through this side channel and vegetation has been cleared along its path. There is no bank protection currently, but the power line poles are at risk if further migration occurs. Because the banks have been cleared of vegetation, lateral bank erosion on the left side may be accelerated and altering the rate of migration.

Figure 35. Photograph of split flow at RM 6.

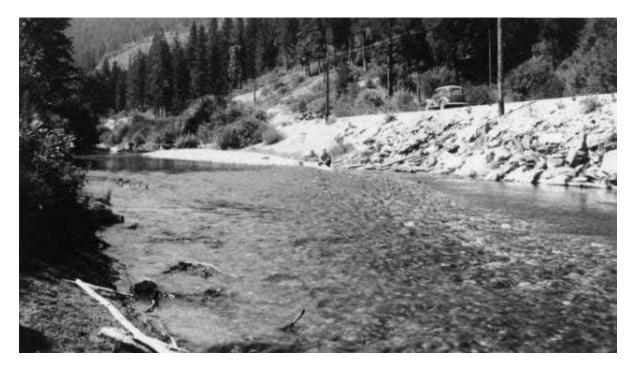
Channel geometry has been impacted in the majority of channel areas along this section of Nason Creek. Some changes are obvious, such as in areas that have been artificially confined, and other impacts are more difficult to discern, such as areas that have been riprapped for many decades along road and railroad embankments (Figure 36).

Figure 36. Historical image labeled as "a spawning riffle on Nason Creek" that also shows the road embankment at an unknown location. Photograph by Alfred S. Witter from 1930s to 1940s timeframe reprinted with permission from Oregon State University Historical Photograph Collection.

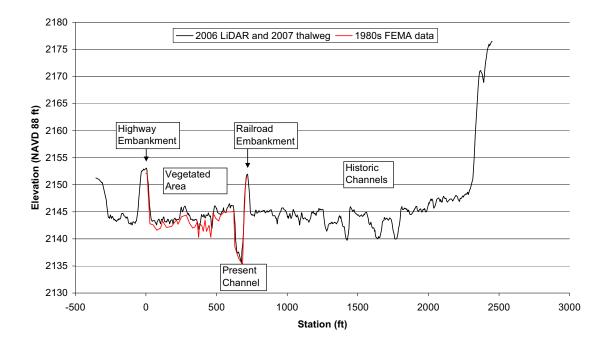
Cross-Section at RM 9.82

FEMA channel survey data from the 1980s was compared to 2006-07 data in confined sections to see if there were any signs of a trend of incision or widening over the last 20 to 30 years (Figure 37; more examples in Appendix G). Where the channel is in the same position as the 1980s data, the bed elevation or channel width has not appreciably changed over the last few decades. The LiDAR data indicates that the present channel is 2 to 3 feet lower than many historical channel elevations that may have been active prior to realignment and straightening. However, 2 to 3 feet of incision may be conservatively high because the historical channels may have filled in with finer sediments from hillslope runoff and tributaries and often have ponding such that the LiDAR would represent the water surface of the pond rather than the actual bottom elevation of the channel. Additional channel incision is not expected to continue based on preliminary investigation of geologic controls, sediment transport capacity, and observations of large cobble sizes present in the bed.

Figure 37. Nason Creek cross section at RM 9.82.

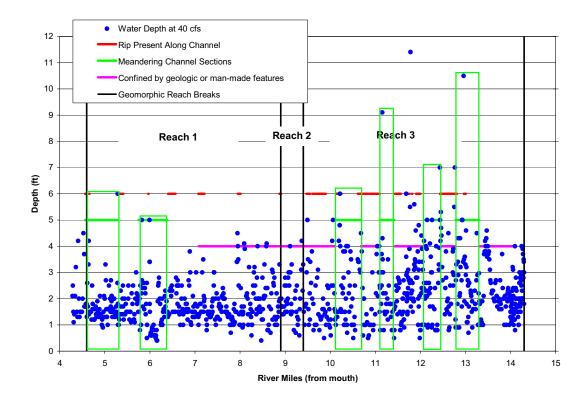
High quality rearing and holding habitat is often associated with areas that have water depths greater than 3 feet. Therefore, the locations of water depths greater than 3 feet from a 2007 survey at 40 cfs (low flow) were overlaid with mapping of areas that are presently meandering and areas that are confined and armored with riprap (Figure 38). Overall the density of 3 feet and greater depths was higher in Reach 3 than Reaches 1 and 2. Meandering sections generally contained a fair amount of the deeper depths, but confined sections also contained several areas of depths greater than 3 feet. It is hypothesized that many of the pools in confined sections are formed as scour pools to release energy so that although they are deep their quality is poor in terms of habitat value. Many of the deepest depths were associated with the presence of LWD (see maps 19 and 20 for LWD locations). The largest depth at RM 11.78 is located in a confined channel that runs along the fill at Merritt.

Figure 38. Plot of water depths greater than 3 feet in assessment area overlaid with meandering and confined sections and riprap.

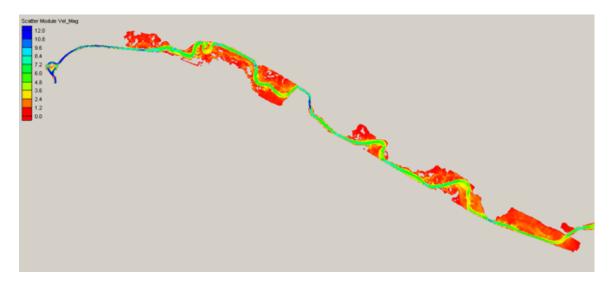
To compare the meandering sections with confined sections, 2D model results for velocity were evaluated (Figure 39). Differences were more apparent in Reach 3 than Reach 1 because the disconnected areas are smaller in Reach 1 and the slope is in most places steeper. Confined sections had consistently higher velocities than meandering sections during a high flow of 10,000 cfs shown in Figure 39, but this was also true for all flows modeled. Areas that had backwater influences from downstream constrictions had lower velocities than confined sections that were not subjected to backwater. A close-up view of velocity vectors shows another impact to channel function. Confined, straight sections have uniform flow paths that contain little diversity in depth, velocity, or shear stress. However, meandering sections are more diverse in terms of channel hydraulics, showing variation in depth and velocity through the meander bend (Figure 40). This diversity in hydraulics is critical to supporting a range of habitat life stages of ESA-listed fish. For example, spawning areas are generally shallow, faster velocity sections compared to deep pools with LWD that offer holding and cover.

Figure 39. Velocity magnitude (ft/s) results from 2D model for RM 9 to 14 at 5,000 cfs.

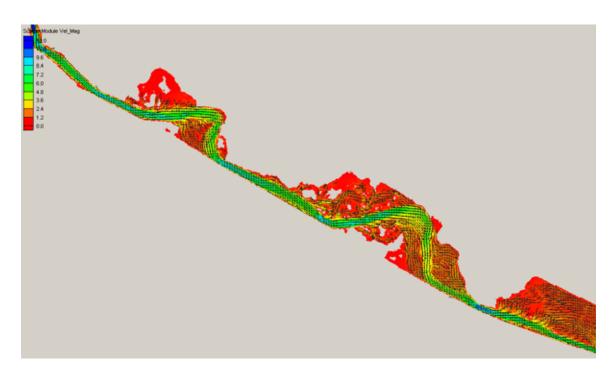
Figure 40. Example model result at 5,000 cfs of velocity magnitude (ft/s) and vectors between RM 9.5 and 11.1 (flow is from left to right in image).

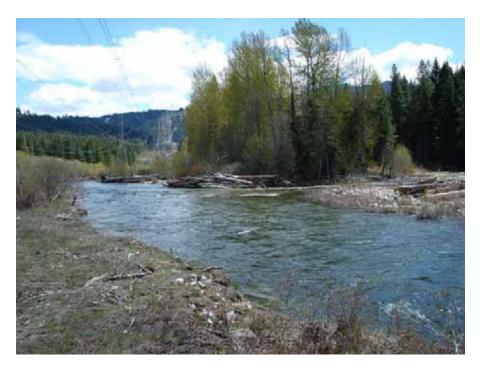
There are a few areas that presently provide opportunities for quality instream and offchannel habitat, but the availability of LWD in the main channel is overall limited and only a few LWD-formed pools exist. The amount of LWD present is likely much lower than it was historically because of timber harvest and log drives that removed all wood from the river in the early 1900s. Recruitment of new wood is limited in the upstream half of the reach because of limited channel migration (both historically and at present), but recruitment increases downstream of RM 6.4 where channel reworking occurs. Overall the vegetation is in good health and recovering from the historical logging, such that shading and future LWD recruitment will be available if channel migration can be restored between RM 7.9 to 8.3 and downstream of RM 6.4. The exception is the power line access corridor that has been cleared of vegetation and often crosses the path of the present channel in this reach (Figure 44). Where power lines cross the main channel, there is limited to no riparian vegetation along the river banks making the bank susceptible to accelerated erosion. These cleared areas offer good opportunities to replant riparian vegetation to help increase shade and LWD recruitment. Protection of both the power line roads and power poles will need to be addressed unless the power line can be set back farther away from the river.

Figure 44. View to the east (downstream) showing large woody debris and split flow located near RM 6.2. (Reclamation photograph by R. McAffee, May 4, 2007).

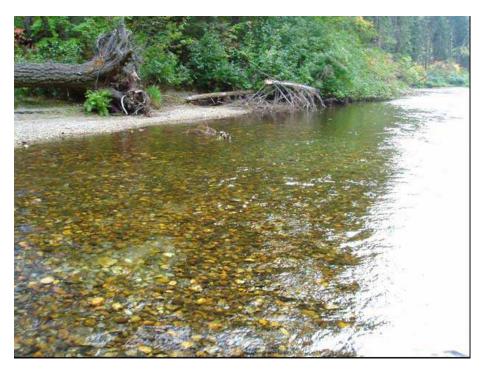
Figure 46. Photograph of spawning habitat present between RM 9.2 to 9.3.

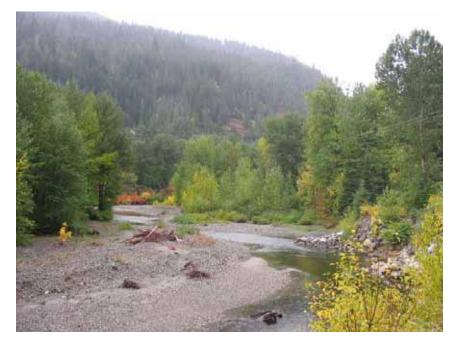
Figure 50. Area near RM 13 that is presently meandering and contains some LWD-formed pools. (Reclamation photograph by D. Callahan, October 9, 2007).
