Chewuch River Reach Assessment

Yakama Nation Fisheries Program

JUNE 2010

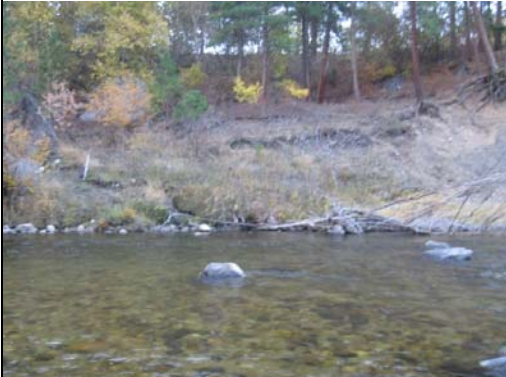
Reach	Project Number	Sub-Unit	Strategy Category	Project Name	Description	Photo
2a	Project RM 2.44L	Inner Zone 2 (IZ-2)	Instream Habitat Enhancement	LWD enhancement	This project is located at a pool tail-out just upstream of a riffle crest. The river left bank is low near 2.44, with low-velocity habitat along the bank. A LWD jam would create and maintain pool scour and enhance existing in-stream habitat.

<p>View to the east at the river left bank near RM 2.44 at a potential LWD location. November 2009.</p>
2a	Project RM 2.68L	Outer Zone 5 (OZ-5)	Off-Channel Habitat Enhancement	Wetland habitat enhancement	At the downstream end of OZ-5, a long, narrow wetland occupies an area that was an active side-channel in 1954. There does not appear to be an upstream surface connection. The wetland appears to be groundwater fed with a downstream surface water connection with the main channel near RM 2.65. The outlet channel has a passable gradient and likely provides access to quality off-channel habitat in its current condition. There is an opportunity to increase habitat cover and complexity in the off-channel complex using LWD. Passage conditions at the outlet should also be further investigated to ensure year-round passage.

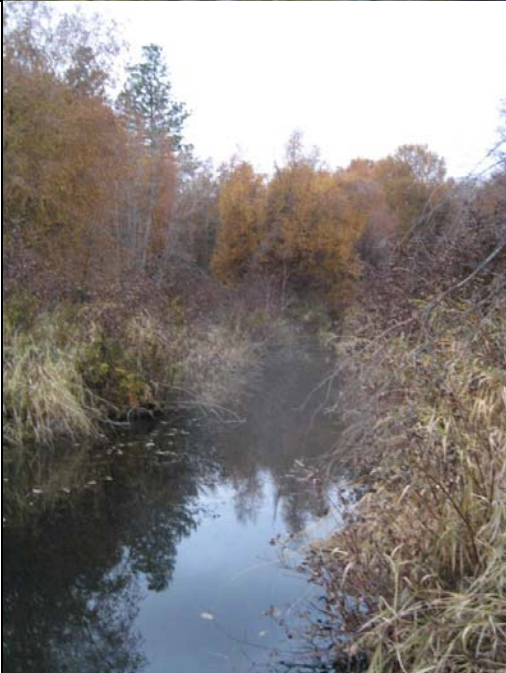
<p>View to the north in the upstream direction at a wetland located at the down-stream end of OZ-5 near RM 2.65. November 2009.</p>

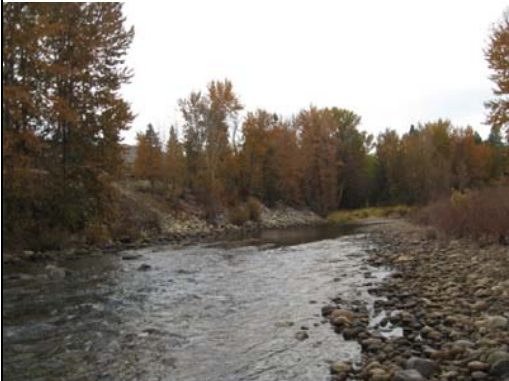
Reach	Project Number	Sub-Unit	Strategy Category	Project Name	Description	Photo
2a	Project RM 5.5R	Inner Zone 1 (IZ-1)	Instream Habitat Enhancement	LWD enhancement	This project involves LWD placement along the river right bank. LWD could enhance scour and pool formation and provide cover to enhance habitat. This project is located immediately upstream of a riffle crest and a narrow low surface that expands along the right side of the channel. The low surface is backed by a terrace with residential development

<p>View to the north in the upstream direction at a potential LWD placement along river right near RM 5.5. November 2009.</p>
2b	Project RM 5.6L	Inner Zone 2 (IZ-2)	Instream Habitat Enhancement	LWD enhancement	A transverse riffle orients flow into the river-left bank. A meander-bend log jam would provide cover, enhance scour for pool formation, and provide bank stability.	
2b	Project RM 5.69R	Inner Zone 2 (IZ-2)	Instream Habitat Enhancement	LWD enhancement	There is an exposed root mass and undercut bank providing limited cover to a shallow pool along the river-right bank near RM 5.69. A LWD meander bend jam would enhance existing habitat through creating and maintaining pool scour and increasing habitat cover and complexity.

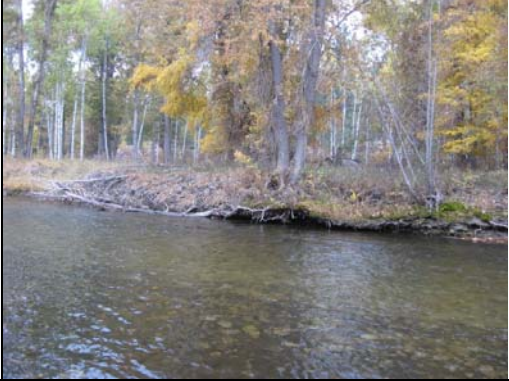
<p>View to the southwest in the downstream direction at the river-right bank near RM 5.76 where LWD could enhance existing habitat. November 2009.</p>

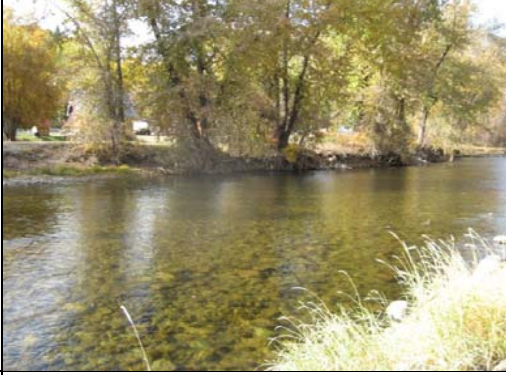
2b	Project RM 7.2R	Inner Zone 1 (IZ-1)	In-Stream Habitat Enhancement	LWD enhancement	This project involves a bank LWD structure along river-right near RM 7.2. There are mature trees along the bank providing shade, and cover in their exposed root masses. The channel flows through a long, shallow pool in this stretch of the river. LWD would enhance scour and pool formation and add to the existing habitat along the bank. There is residential development on the adjacent alluvial terrace.

<p>View to the northwest in the upstream direction at the river-right bank near RM 7.2 where LWD could enhance in-stream habitat. November 2009.</p>
2b	Project CR_Prj-7.2 (USBR 2008b)	Outer Zone 1 (OZ-1)	Off-Channel Habitat Enhancement		The USBR has identified the entirety of OZ-1 as a restoration area with the primary goal of reconnecting primary side and overflow channels. The means to achieve this goal is stated as excavation of channel entrances and improving connectivity.

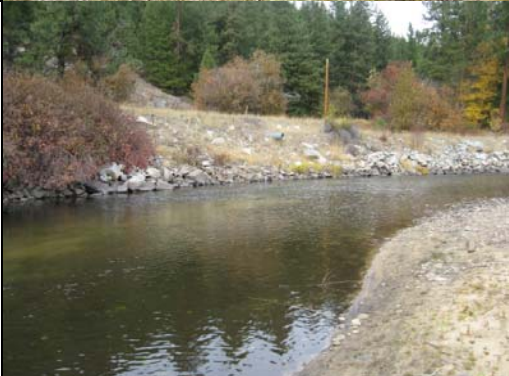
View to the northwest in the upstream direction at riprap along the toe of the road embankment along river-right near RM 9.7 (November 2009).

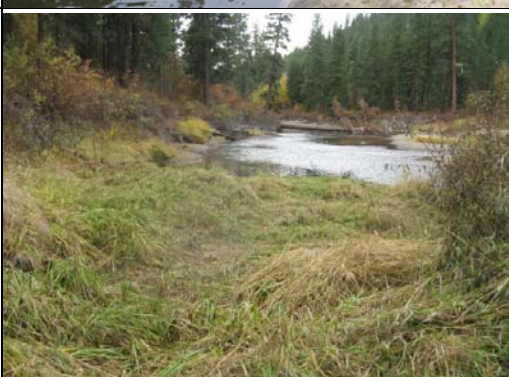
4a	Project RM 9.7L	Outer Zone 1 (OZ-1)	Off-Channel Habitat Enhancement	Side-channel habitat enhancement, alcove habitat enhancement	This project would enhance the connectivity and quality of habitat in an existing high-flow channel. Currently, the channel is overgrown, and does not appear to receive regular scour from high flows. At the time of the survey, there were small wet areas at the downstream end of the feature, but the majority of the channel was dry. Excavation may be necessary along the entire length (approximately 820 ft) to create a well-connected channel. The position of the upstream inlet is controlled by a bedrock outcrop. Other alternatives at this location would be to excavate an off-channel alcove or groundwater-fed channel at the downstream end of the feature.

View to the south in the downstream direction at the outlet of a high-flow channel near RM 9.64 (November 2009).

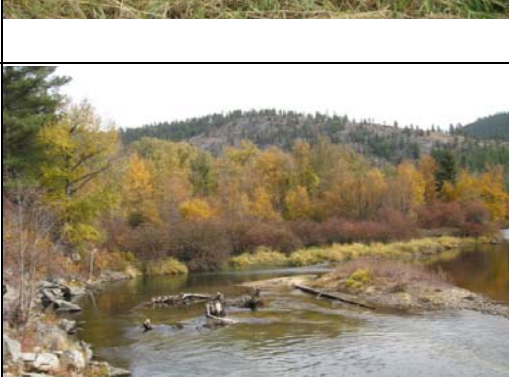
4b	Project RM 9.85R	Inner Zone 1 (IZ-1)	In-Stream Habitat Enhancement	LWD enhancement	Near RM 9.85, the river has scoured a deep pool on the outside of a bend where the river flows against a bedrock outcrop. There are small pieces of wood in the pool now but large pieces would increase cover and habitat quality.

View to the northeast in the upstream direction at a pool on river right near RM 9.85 (November 2009).

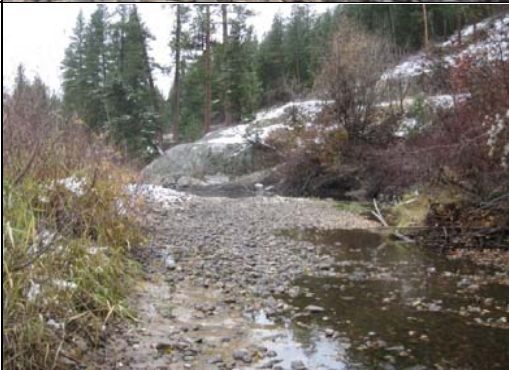
<p>View to the southwest in the downstream direction at a side-channel and bedrock outcrop near RM 11.75 (November 2009).</p>

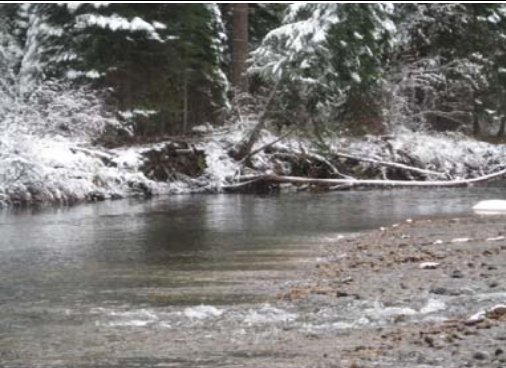
<p>View to the southeast in the downstream direction at a riffle, pool, and LWD on the river left bank near RM 12.12 (November 2009).</p>

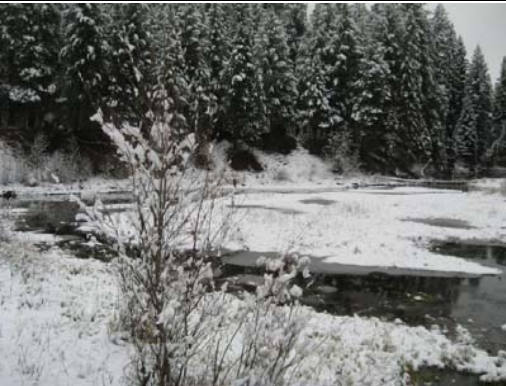
5a	Project RM 12.22L	Inner Zone 2 (IZ-2)	Off-Channel Habitat Enhancement	Alcove and side-channel habitat enhancement	This project involves adding large wood to enhance the cover and habitat quality in an existing backwater that is fed by an upstream side-channel. The upstream side-channel could also be enhanced through excavation to be more active at lower flow periods.

<p>View to the southeast in the downstream direction at a backwater located on river-left near RM 12.22 (November 2009).</p>

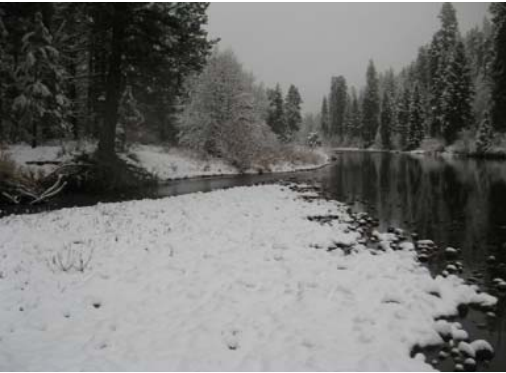
Reach	Project Number	Sub-Unit	Strategy Category	Project Name	Description	Photo
5a	Project RM 12.3C	Inner Zone 2 (IZ-2)	Reconnect Stream Channel Processes	LWD placement to enhance lateral connectivity	Between RM 12.25 and 12.4 there are multiple locations for log jam placements that would re-establish channel geomorphic processes such as lateral migration. In this area, the channel is more complex and wood placements can be used to increase the quality of existing habitat features. A series of bar apex jams near RM 12.4 could be used to enhance split flow conditions, increase scour for pool formation, and enhance habitat cover and complexity. The bank near RM 12.3 is fairly high and slightly undercut with overhanging vegetation. An LWD project here would increase the existing cover, and create scour thereby enhancing pool formation. Near RM 12.25 there are multiple split flows locations and side-channels. This is potentially rich habitat. LWD would be beneficial throughout IZ-2 to maintain channel dynamics and increase habitat complexity. This project is a bar apex jam that would maintain split flow, and increase scour to drive pool formation.

View to the north in the upstream direction at the apex of a gravel bar and split flow location along river-right near RM 12.4 (November 2009).

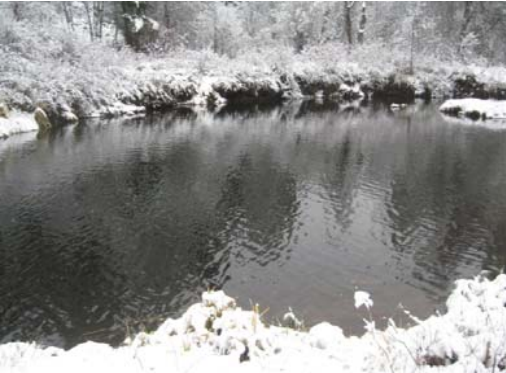
5a	Project RM 12.35L	Inner Zone 2 (IZ-2)	Off-Channel Habitat Enhancement	Alcove habitat enhancement	This project involves enhancement of habitat features in an existing side-channel and backwater. The side-channel, extending from RM 12.35 to 12.4 receives substantial scour during low main channel flows and empties into a large pool off the main channel that provides a backwater area for rearing and migrating fish. LWD would be placed to increase cover and complexity at this site.

View to the southeast in the downstream direction at a large backwater located on river left near RM 12.3 (November 2009).
5a	Project RM 12.45R	Outer Zone 2 (OZ-2)	Reconnect Floodplain Processes	Enhance floodplain connectivity	OZ-2 provides the largest open water wetland in the study area. This feature is an oxbow pond formed by past channel avulsion and maintained through beaver activity. There are multiple high-flow channels originating at the upstream end of the sub-unit that provide high-flow connection to the wetlands. Campsite access roads create barriers in some of these high-flow channels. The USBR (2008b) has identified this as a restoration project area with a focus on removing or installing culverts in these roads to increase connectivity. Other restoration options include enhancing the upstream surface connection to the floodplain by excavating appropriate channel inlets and constructing log jams to increase juvenile rearing fish cover in downstream wetlands.

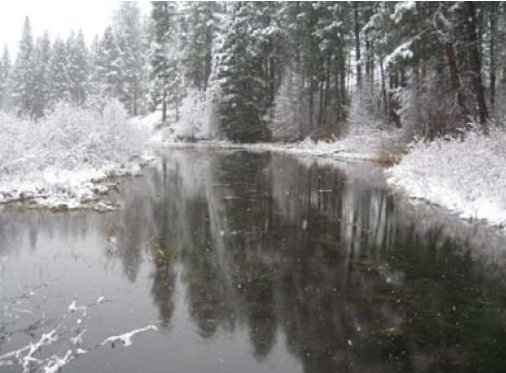
View to the southeast at a large oxbow pond on the west side of the valley near RM 12.3 (November 2009).

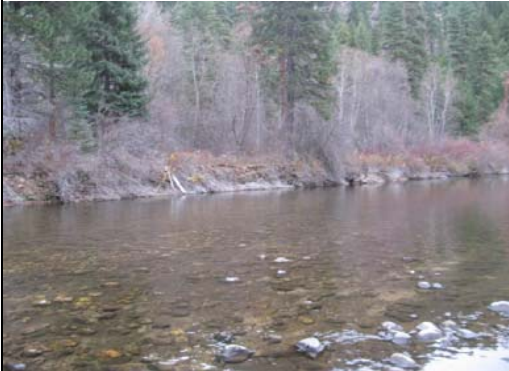
5a	Project RM 12.63L	Inner Zone 1 (IZ-1)	Reconnect Stream Channel Processes	LWD placement to enhance lateral connectivity	Between RM 12.59 and 12.66, there are two opportunities for log jam placements to enhance split-flow processes and bank habitat. Near RM 12.66, there is a potential bank log jam placement with the goal of enhancing in-stream habitat along a high eroding bank that currently provides very little cover. On the opposite side of the valley, there are networks of high-flow channels providing connectivity between inner and outer zone habitats. Log jam placement would be optimized to push water to the west and onto the floodplain. Near RM 12.59 is a bar apex jam at a location where split flow occurs as stage rises annually. The project is intended to enhance split flow over a wide range of discharges and to orient flow towards river right to increase lateral migration and scour of an existing cut-bank and pool.

<p>View to the southeast in the downstream direction at the river left bank near RM 11.66 (November 2009).</p>

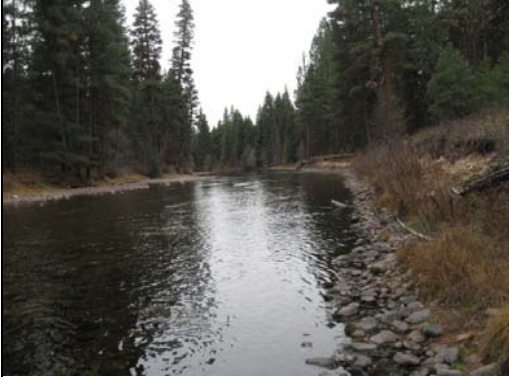
5a	Project RM 12.9C	Inner Zone 1 (IZ-1)	In-Stream Habitat Enhancement	LWD enhancement	There are multiple opportunities for installation of LWD on both sides of the channel between RM 12.82 and 12.95. Near RM 12.95 is a project that focuses on increasing the abundance of LWD in the upstream portion of the reach, which will provide habitat elements that increase local cover and complexity. The upstream end of the reach including this site is a relatively straight, low gradient, and low velocity for several hundred feet. LWD would help to enhance inner-zone geomorphic processes such as lateral migration and scour-and-fill. A log placement at RM 12.82 shares a similar goal and approach to RM 12.95. A lateral bend log jam could increase the dynamics of geomorphic processes such as lateral migration, and provide habitat in a long stretch of low-complexity channel.

<p>View to the southeast in the downstream direction at a hydraulically simple section of river near RM 12.95 (November 2009).</p>

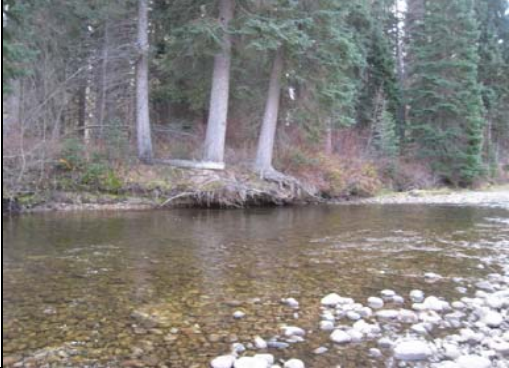
8	Project RM 16.22C	Inner Zone 2 (IZ-2)	In-Stream Habitat Enhancement	LWD enhancement	Log jam placements on both sides of the channel near RM 16.27 could increase the amount of cover and improve the overall quality of in-stream habitat. A site near RM 16.3 has some good existing cover in the form of under-cut root masses. A site near RM 16.22 is without cover, and a bank log jam would greatly increase the quality of habitat in that area. Near RM 16.17, a riffle orients flow into the right bank, creating scour and a pool with good residual depth. LWD could be added to the bank to increase cover and habitat quality in the existing pool.

<p>View to the east at overhanging pool cover along river-left near RM 16.3 (November 2009).</p>
8	Project RM 16.4R	Inner Zone 2 (IZ-2)	Reconnect Stream Channel Processes	LWD placement to enhance lateral connectivity	This log jam project is located at the apex of a large gravel bar that is forming along river-right. The bar apex jam would be placed to take advantage of existing sinuosity and push water to the left to encourage greater lateral migration and sustained habitat formation.

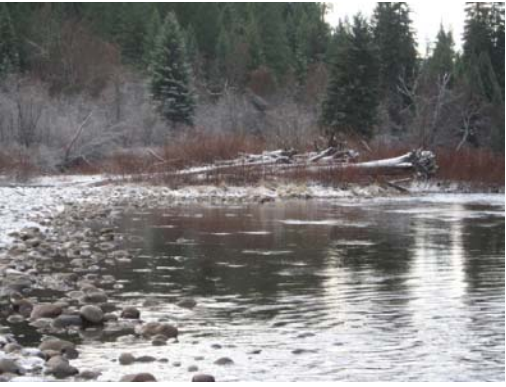
Reach	Project Number	Sub-Unit	Strategy Category	Project Name	Description	Photo
8	Project RM 16.65C	Inner Zone 2 (IZ-2)	Reconnect Stream Channel Processes	LWD placement to enhance lateral connectivity	Between RM 16.5 and 16.8 log jam placements are possible at several bar apexes and in multiple side-channels. A general goal with all the placements is to encourage the processes that are naturally taking place in this area and to enhance the habitat by providing cover and complexity. A bar apex jam has naturally accumulated a relatively significant log jam near RM 16.8 and there is active split flow around the bar at all flow levels. The river-left side-channel has some pool habitat but with little cover. LWD placements would include supplementing the bar apex jam and adding several smaller jams along the left side channel to increase cover and habitat complexity. There are several potential log jam placements around a gravel bar and the multiple active side channels near RM 16.62. A bar apex log jam has formed at the upstream end of the project area. This jam would be enhanced with several large logs to increase scour and enhance flow into the side-channels. Several other large log jams would be placed throughout the river-right and river-left side-channels where there are several small riffle-pool sequences and some undercut banks that would be improved with the addition of wood. Near RM 16.51 there is active gravel bar formation on river-left and active bank erosion on river-right. The bank erosion has resulted in LWD recruitment. This project would entail placing log jams on both sides of the river including a bar apex jam on the left and enhancement of existing bank wood on the right.

<p>View to the south in the downstream direction at a bar apex log jam near RM 16.8 (November 2009).</p>

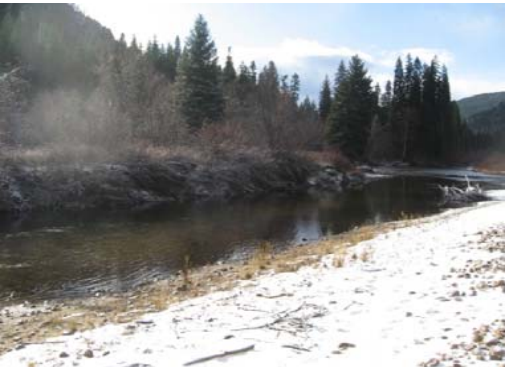
<p>View to the southeast in the downstream direction at a river-left side-channel near RM 16.78 (November 2009).</p>
8	Project RM 16.7R	Inner Zone 2 (IZ-2)	Off-Channel Habitat Enhancement	Side-channel habitat enhancement	There is a long narrow side-channel that runs along the river-right between RM 16.6 to 16.8. This channel is separated from the main channel by a narrow gravel bar. Near RM 16.7 the side-channel turns west and flows away from the main channel providing a greater connection to floodplain habitats. There is outflow at this point that reduces flow in the rest of the side-channel downstream during low flow periods. This project would include several log jams throughout the side-channel including at this outflow location with the intention of enhancing side-channel habitat and floodplain connectivity during high flow events. A wetland at the downstream end near RM 16.6 could be enhanced with wood for cover, and potentially excavated at its outlet to increase its connectivity with the main channel.

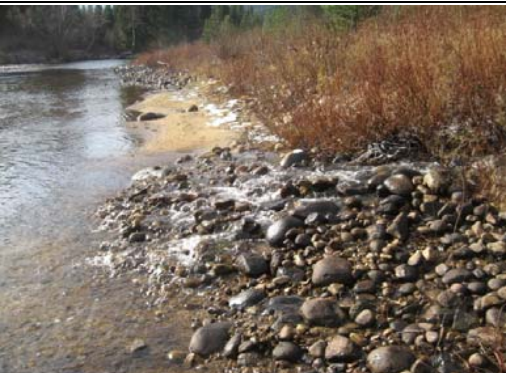
<p>View to the southwest in the downstream direction at a side-channel outflow on river-right near RM 16.7 that dewateres the side-channel for the remainder of its length (November 2009).</p>
