Upper Methow River Reach Assessment

River Miles 61 - 80

SUBMITTED TO
Yakama Nation Fisheries

FINAL - DECEMBER 2015

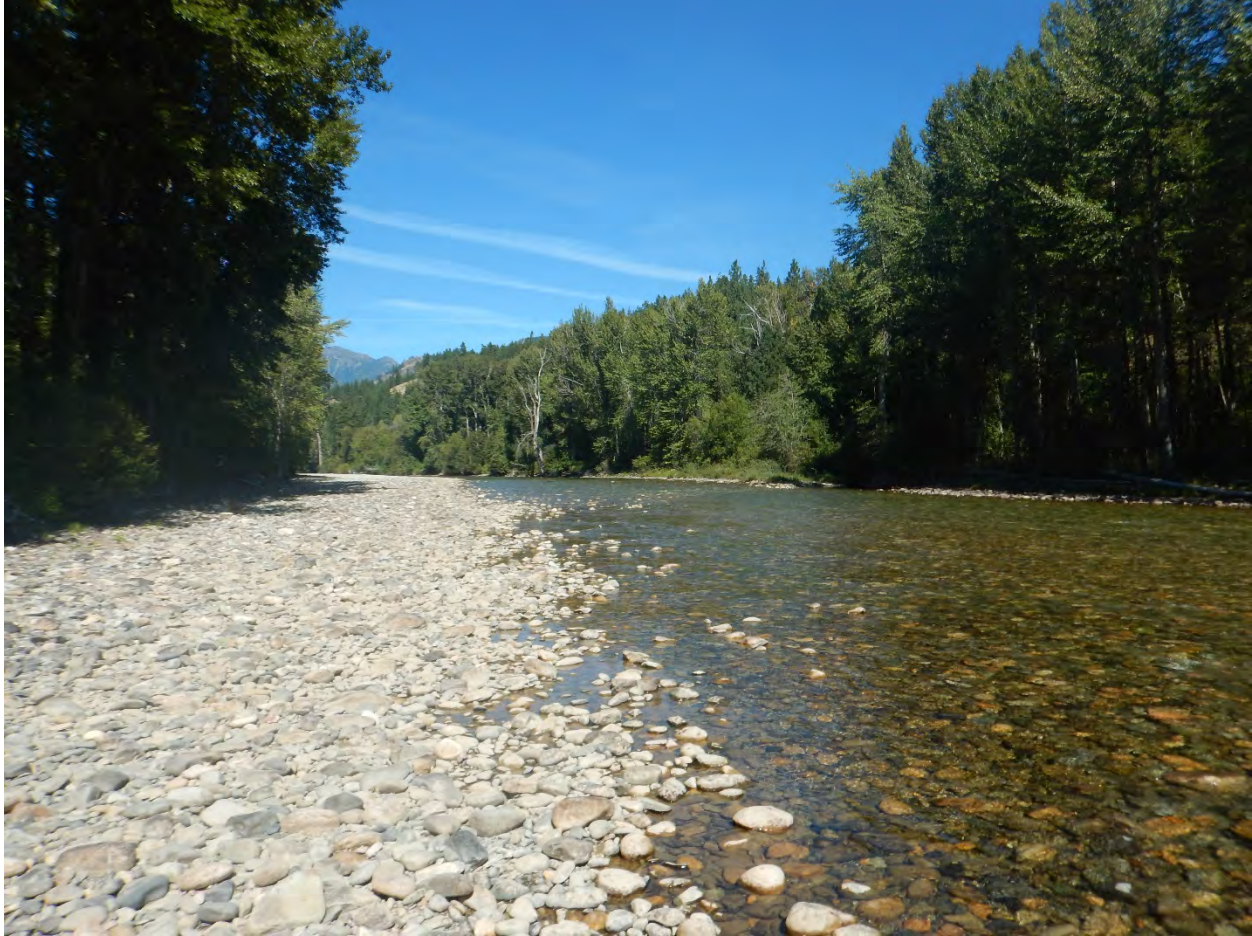
Figure 22. Representative photo of Reach 1; looking upstream at RM 61.3 (9/5/2014).

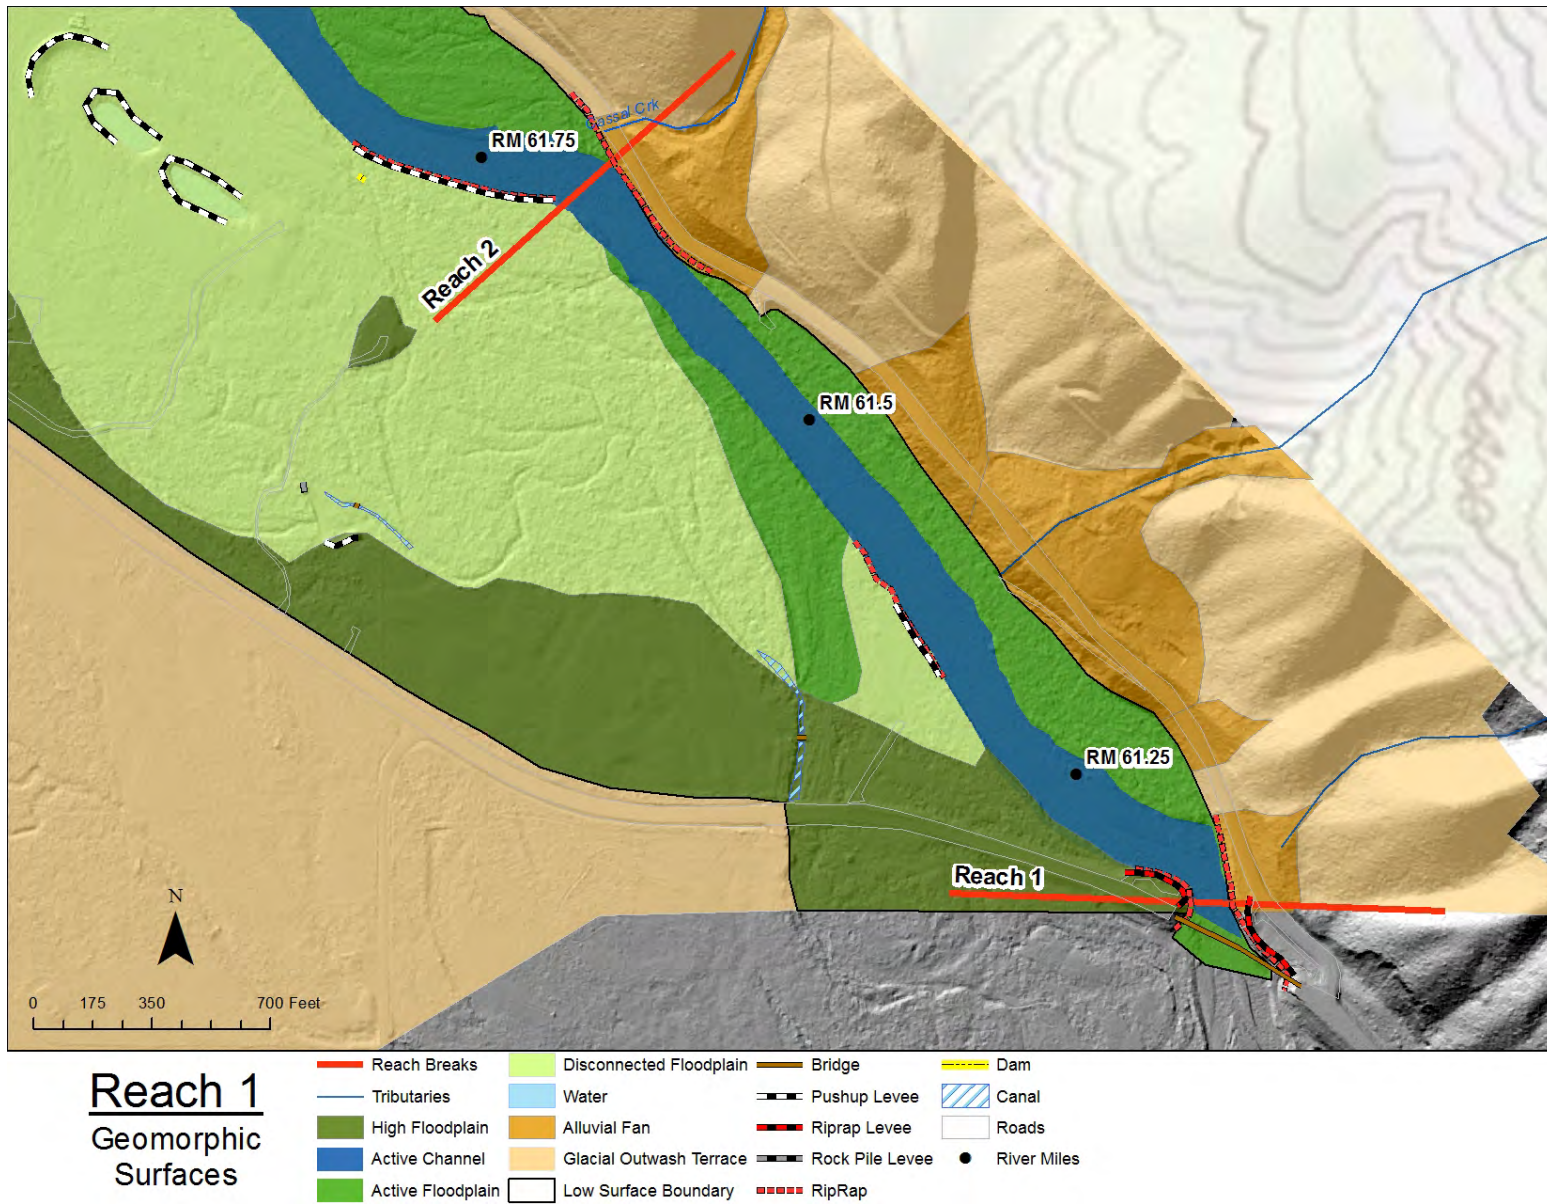
The channel and modern alluvial surfaces in Reach 1 are inset below the glacial outwash terraces. The modern alluvial surfaces of Reach 1 consist of a narrow active floodplain on river-left and a broad active floodplain, disconnected floodplain surfaces, and a high floodplain surface on river-right (Figure 24). All of the floodplain surfaces on river-right are fluvially scarred and the banks are topped with fines from high-flow events. The high floodplain surface at the downstream end of the reach on river-right extends up-valley from the banks of the channel between the active floodplain and the glacial outwash terrace on the western side of the reach. The disconnected floodplains were created by levees and floodplain grading. At the downstream border of the reach are high, riprapped channel banks (approximately 15+ feet) constructed of large, angular boulders (Figure 24).

Figure 24. Geomorphic surfaces of Reach 1 overlain by selected human-built features (levees, riprap, check dams, canals, bridges, and roads).

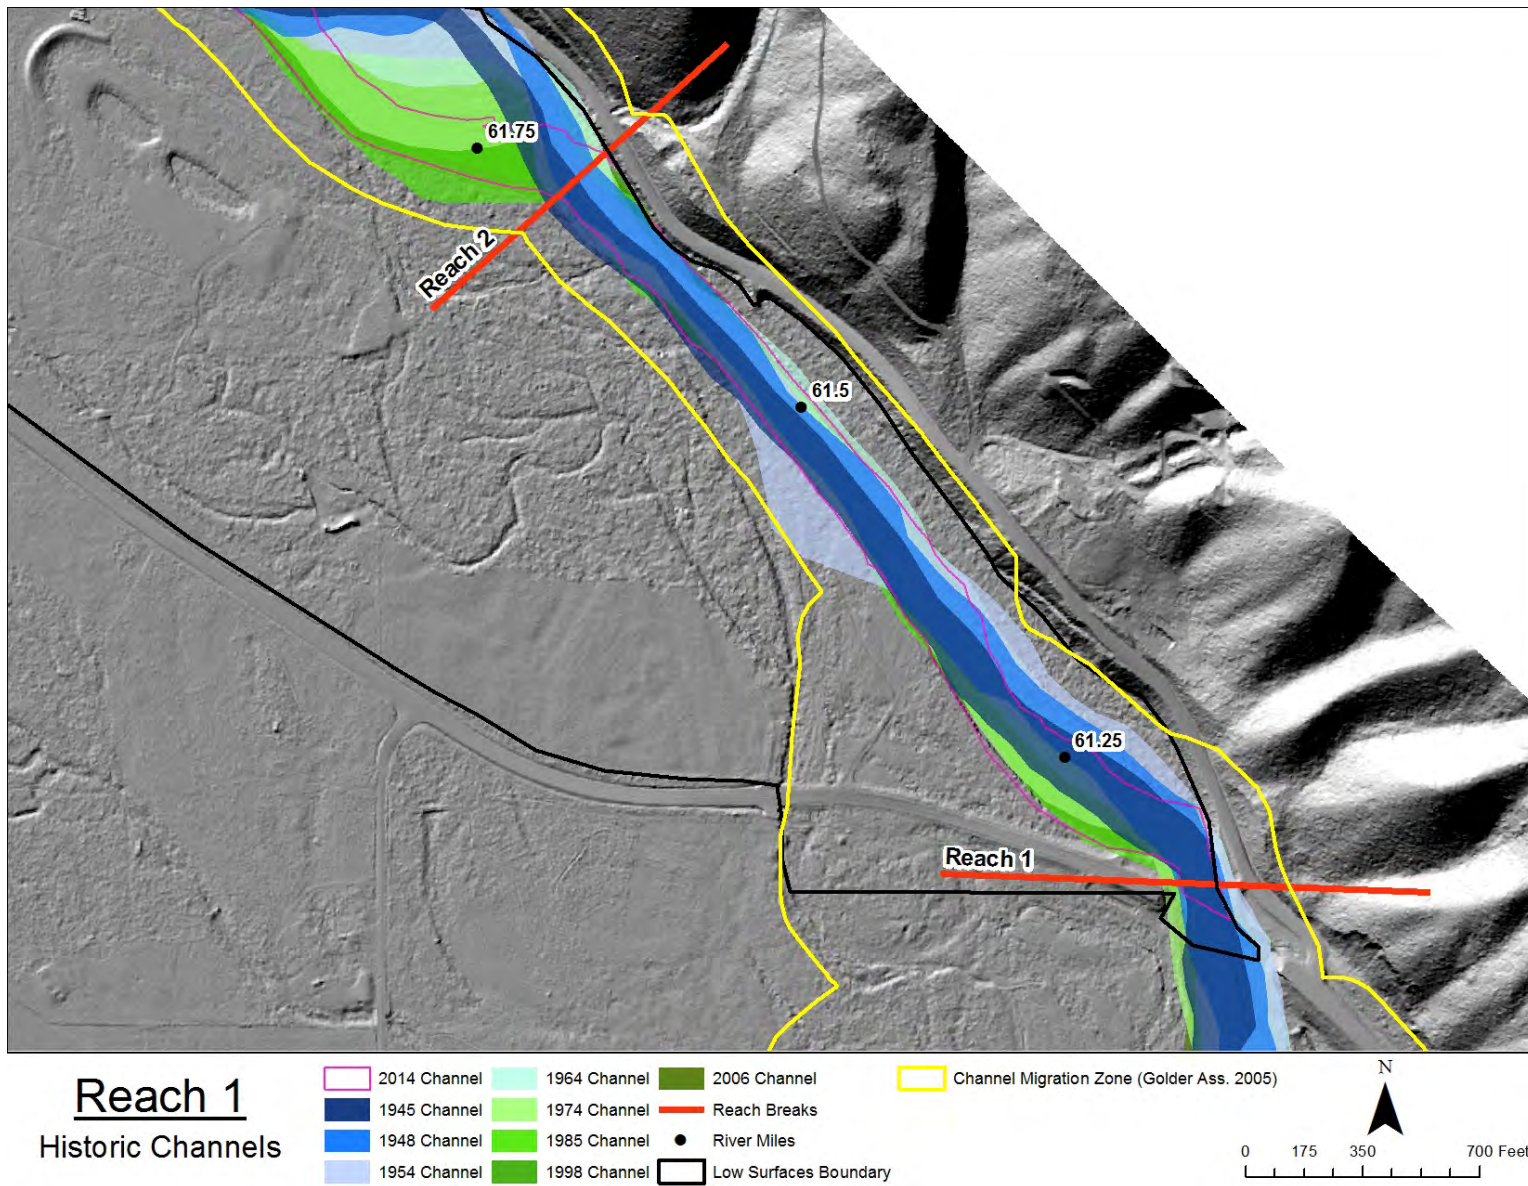
Reach 1 is moderately stable vertically and laterally with a semi-confined channel that is relatively straight. Today the active floodplain available for migration is approximately 1,500 feet wide at the upstream end and diminishes to channel-width (115 feet) at the Weeman Bridge at the downstream end. Based on floodplain scarring, the historical migration zone at the downstream end of the reach was reduced by approximately 1,000 feet when Highway 20 and the Weeman Bridge were constructed. Today the channel remains laterally constricted and locked in place at its most downstream point between bridge abutments and high, riprapped banks. Because of its location – on the east side of the valley against glacial outwash terraces and alluvial debris toes that flank the valley walls – the channel is naturally partially confined on river-left. Bank hardening by the Goat Creek Road embankment increases the stability of the terrace banks which further confines Reach 1 on river-left. On river-right, the upper portion of Reach 1 contains an active floodplain with evidence of surface scarring and modern accumulations of over-bank deposits near the banks from RM 61.35 to 61.7. However, a leveed and riprapped bank in the downstream section of Reach 2 (RM 61.7 to 61.8) diverts much of the effective overbank flow during high waters away from the available floodplain on river-right. The other disconnected floodplain in Reach 1 is demarcated at its upstream end by boulder riprap and a low push-up levee at RM 61.35 to 61.4. However, the channel is creating a narrow, modern active floodplain surface on river-left between the channel and the road embankment from RM 61.2 to 61.65. This floodplain surface is developing as the channel gradually migrates westward into the non-riprapped banks of the floodplain on river-right. Historical imagery indicates that the only lateral migration since 1945 in this reach has occurred here and is minor (Figure 27).

Unnatural confinement and straightening of a river often reduces vertical stability by instigating incision processes. In Reach 1, bed scour during high-energy flow periods has likely decreased the frequency of inundation of the high floodplain surface in the downstream section on river-right. Bed lowering through incision likely migrates gradually upstream in this reach. However, pulses of incoming bedload inputs from upstream (Reach 2) partially off-set bed incision enough to support the development of the floodplain surfaces mentioned above on river-left and elongate channel bars visible during low-flow.

Figure 27. Historical channel locations in Reach 1.

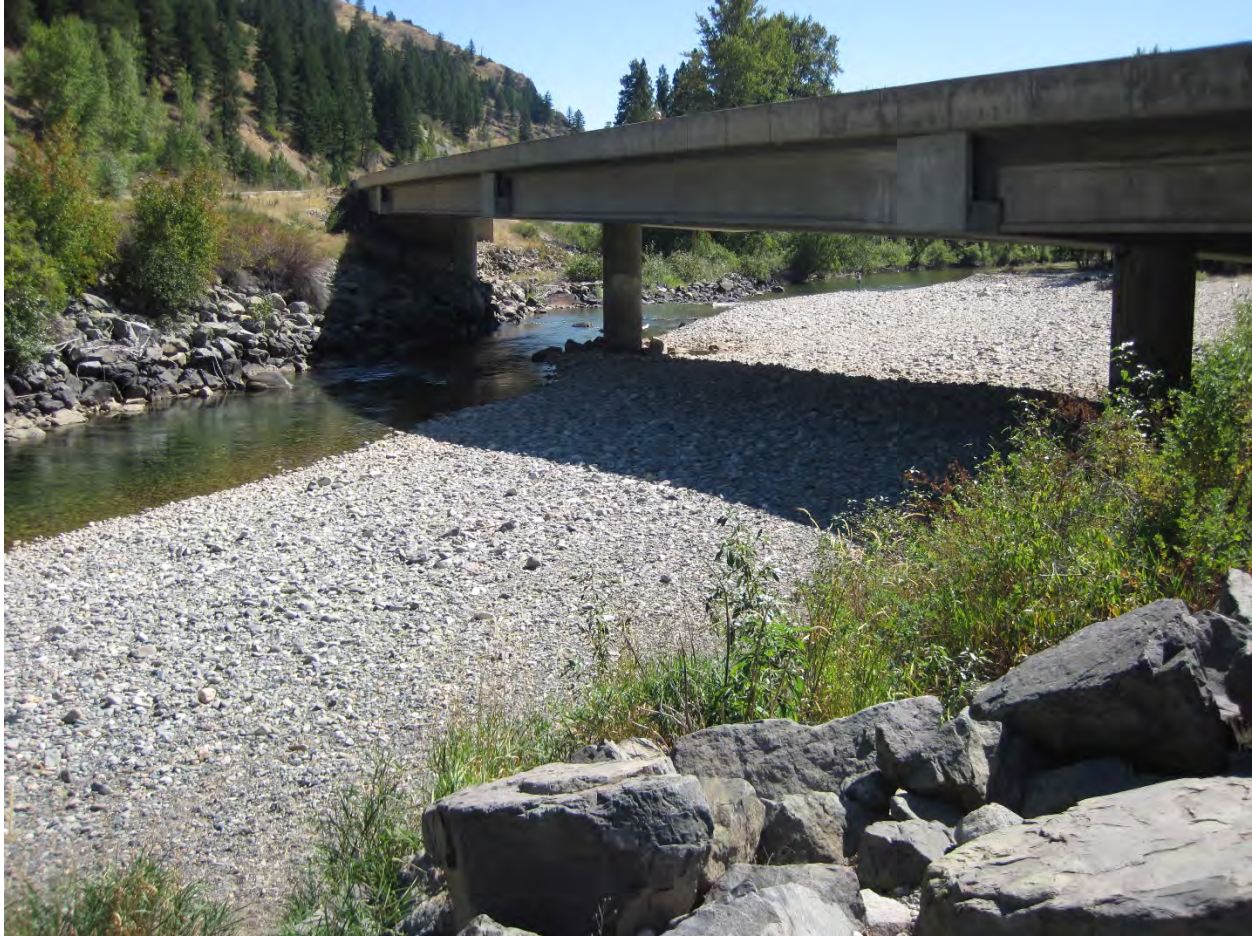
Loss of floodplain function has occurred in the lower portion of Reach 1. The construction of Highway 20 and the Weeman Bridge crossing has resulted in unnatural constriction of the floodplain at the downstream border of the reach. Floodplain scarring and the raised road grade of Highway 20 indicate that approximately 1,000 feet of historical floodplain upstream of the bridge and approximately 2,000 feet of historical floodplain downstream of the bridge has been disconnected. This amounts to approximately 55 acres of disconnected floodplain habitat. These impacts reduce floodplain inundation, induce channel incision, and reduce the formation and long-term availability of off-channel rearing habitats that are created by channel migration processes (e.g. side-channels, alcoves, and oxbow wetlands). The right bank – immediately upstream and at the bridge crossing – has been raised. Large, angular boulder riprap that reinforces both banks was placed to restrict lateral channel migration and to protect the bridge and its abutments (Figure 32). The bridge crossing locks the channel in place along the naturally confining hillslopes on river-left. The bridge's two middle piers interact with channel flow that today results in scour on channel left and bar development on river-right.

Figure 32. Weeman Bridge and the associated riprapped banks at RM 61.15. (9/5/2014)

Recommended actions in Reach 1 are focused primarily on increasing mainstem channel complexity as well as mitigating for the impacts of bank armoring and the effects of the Weeman Bridge and Highway 20 road fill on floodplain connectivity and off-channel habitat. Main channel complexity can be addressed by adding log jams to mid-channel locations at the upstream end of the reach to encourage split flow conditions, and adding large wood to channel margins to enhance complexity along existing bank protection features (i.e. riprap that is currently protecting infrastructure). Channel margin jams are suggested along river-right upstream from the Weeman Bridge to reduce the need for additional bank hardening measures for bridge protection. Restoration objectives also include addressing, or at least mitigating for, the floodplain disconnection associated with the Weeman Bridge and the associated Highway 20 road fill. This may include measures to enhance flood flow through the road prism (e.g. adding culverts or bridges) and/or off-channel habitat enhancement in the river-right floodplain upstream and downstream of the crossing to create floodplain rearing habitat that does not exist due to floodplain disconnection.

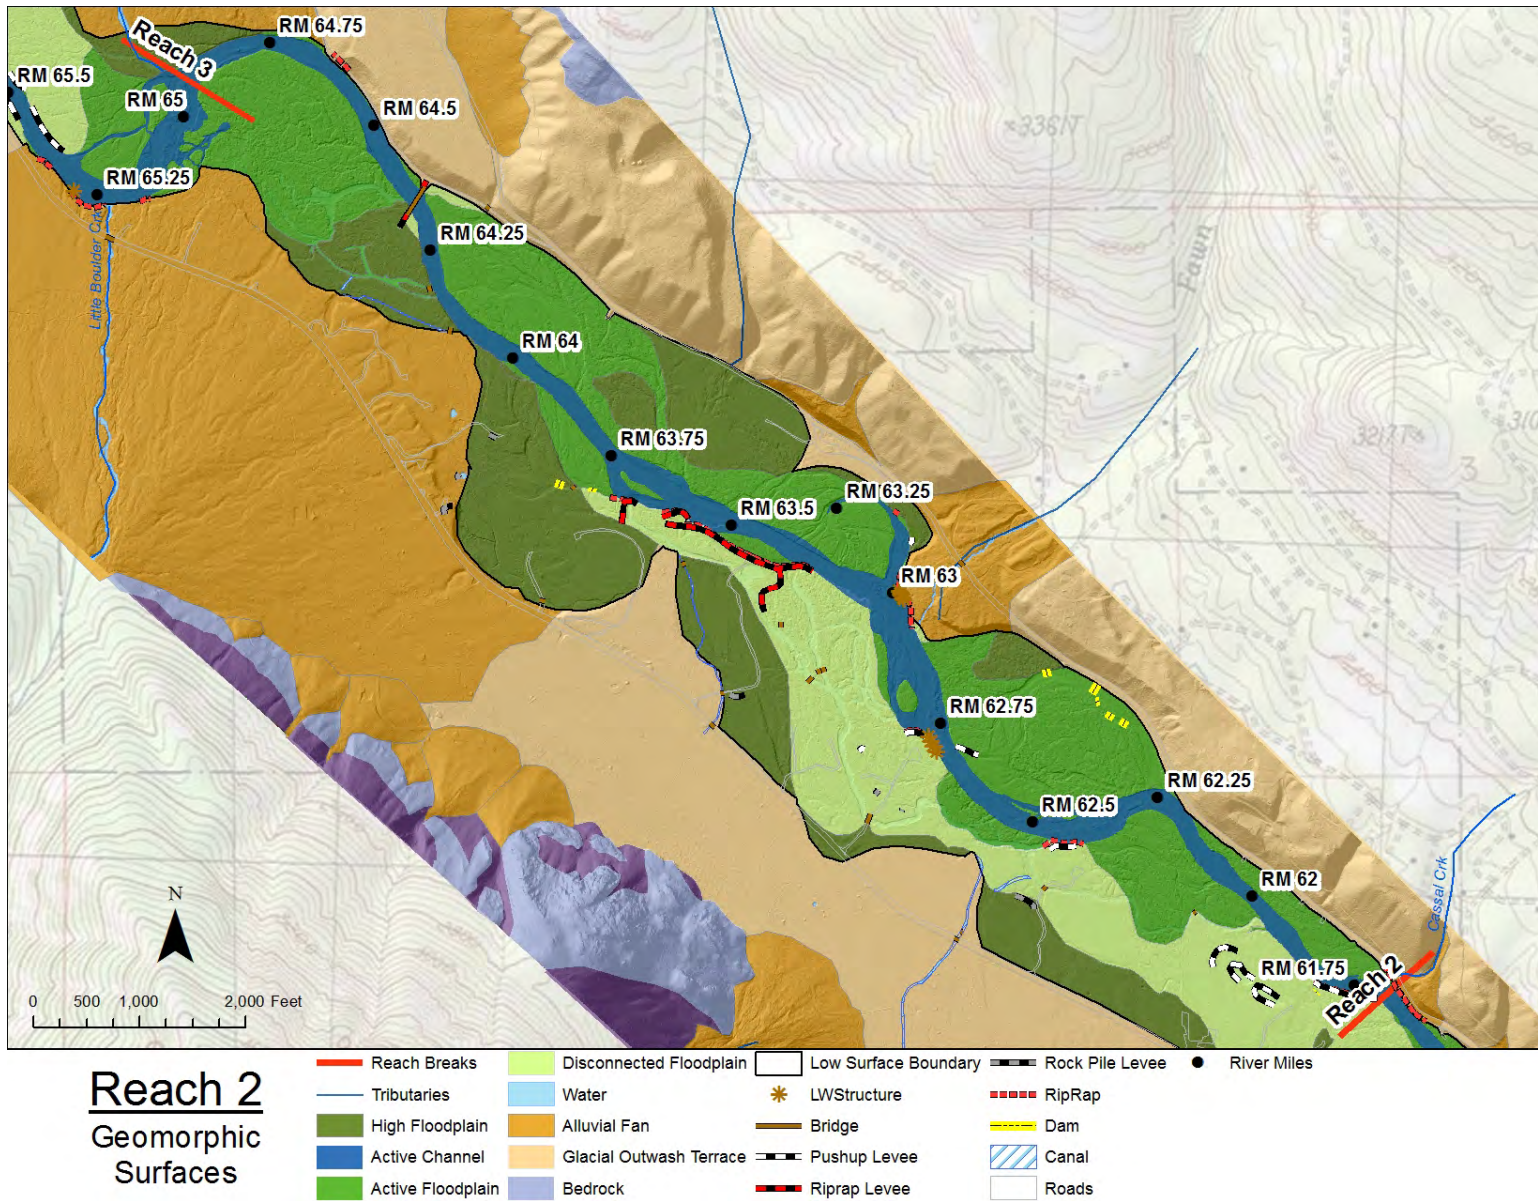
A set of large levees is located in Reach 2 on river-right from RM 63.25 to 63.7. The levees vary in elevation from three to twelve feet high. They are composed of large, angular, boulder riprap and topped with gravels and sand to accommodate a single-track road that is currently designated as a community trail. These levees run parallel to the river for approximately 650 yards. They confine the channel on river-right and disconnect floodplain and side-channels located behind them.

Figure 37. Geomorphic surfaces in Reach 2 with selected human-built features (levees, riprap, check dams, canals, bridges, and roads).

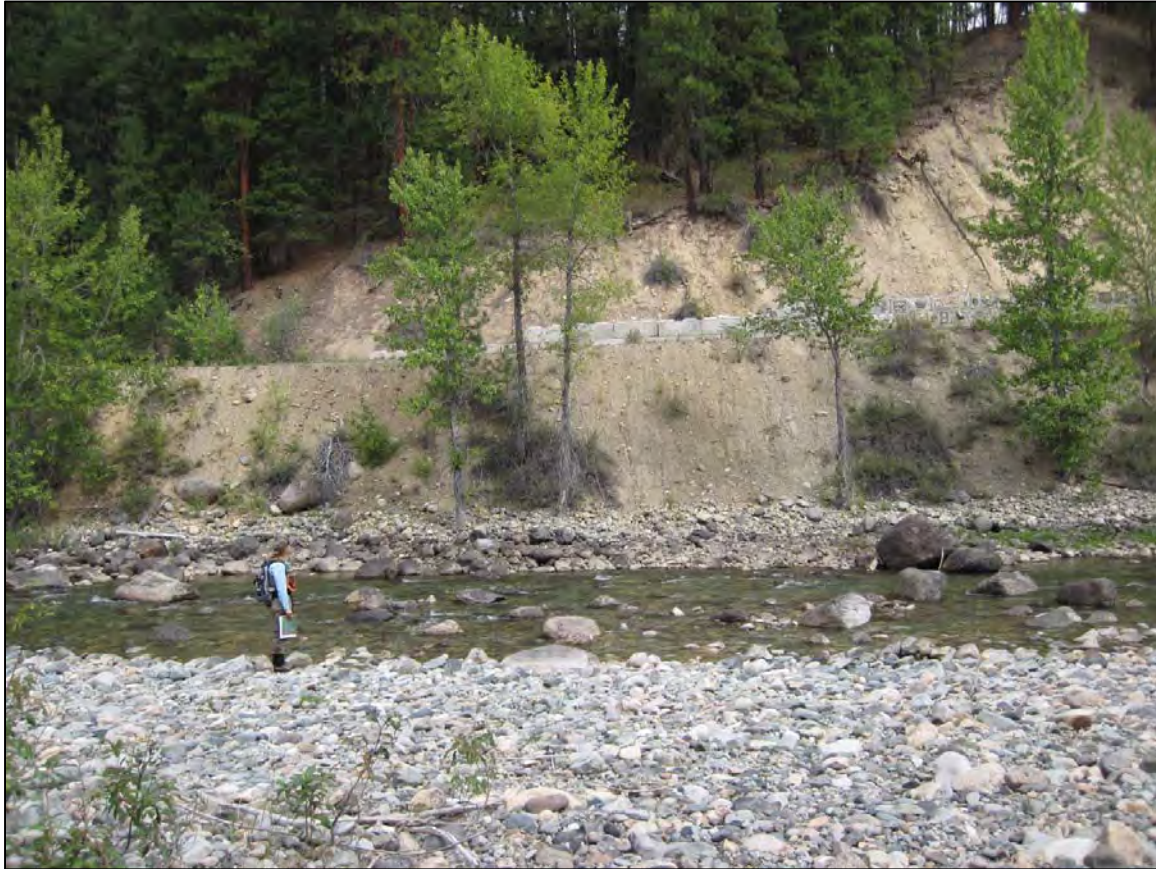
more difficult and slower to erode than the low-lying modern floodplain (Figure 41). Today, the mainstem channel has high cut-banks along glacial terraces on river-left from RM 62.2 to 62.25 and from RM 64.45 to 64.65. Cut-banks composed of alluvial fans contact the channel on river-right at Little Boulder Creek (RM 64.15) and on river-left at Fawn Creek (RM 62.9 to 63.1). The high bank at the Fawn Creek alluvial fan is riprapped with large, angular boulders and large constructed wood vanes; these features armor the bank and now unnaturally confine the channel here. The bank protection constructed along the Fawn Creek alluvial fan at RM 63 was constructed after a high-flow event in 2002 eroded the high bank and a private home was lost (State of Washington 2010).

Figure 41. Cut bank of glacial outwash terrace on river-left at RM 64.55. Old road grade cut into the bank with cement retaining wall for preserving community trail access. (9/3/2014)

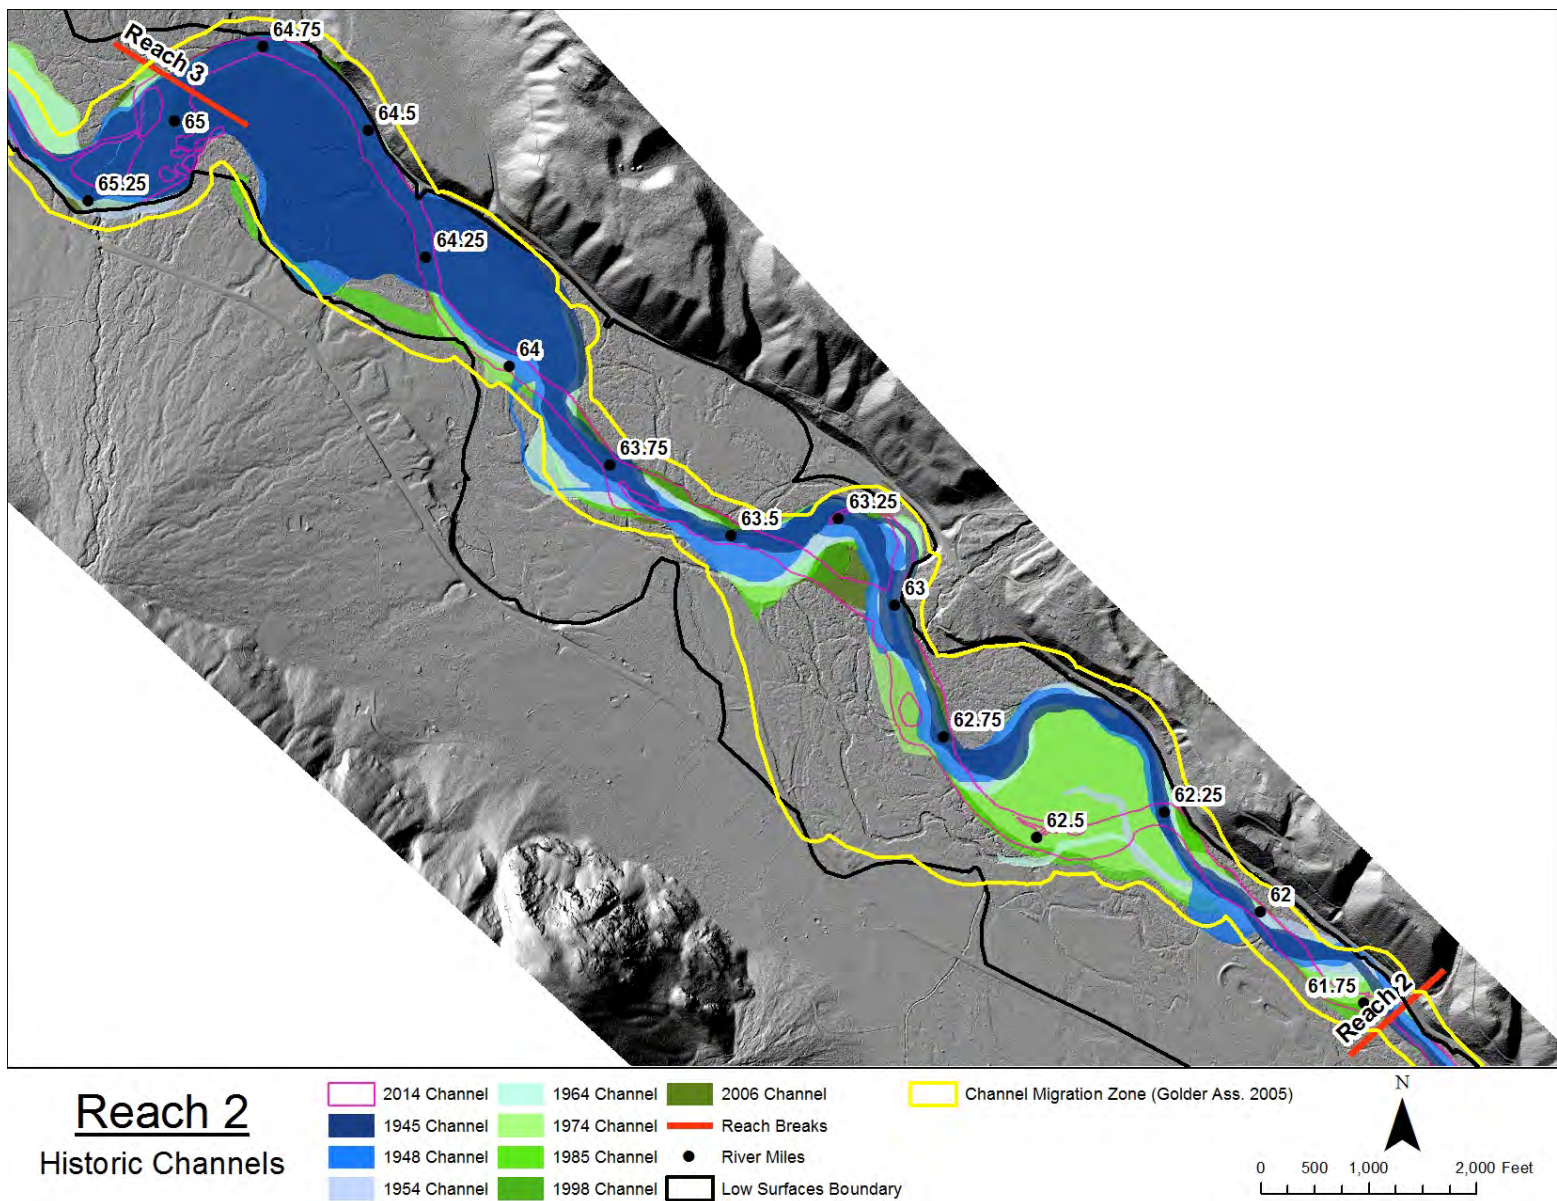
Vertical stability of Reach 2 is considered moderate, but at risk of continued channel incision. The high floodplain surfaces in Reach 2 exist because of both natural- and human-influenced incision processes. Sections of the channel are experiencing bed incision that is likely due to the levees and riprap that constrict lateral migration. Floodplain scarring and historical channel pathways visible in aerial imagery collected between 1945 to 2012 show that three meander bends on river-left – at RM 62.5, RM 63.25, and RM 64 – have been cut off. This resulted in decreased channel length and sinuosity, which leads to an increase in channel gradient caused by bed incision (Figure 42). Additional disconnection of sections of the floodplain has occurred due to surface grading and levees. Combined, these elements will continue to simplify the channel and available habitat in Reach 2.

Figure 42. Historical channel locations in Reach 2.

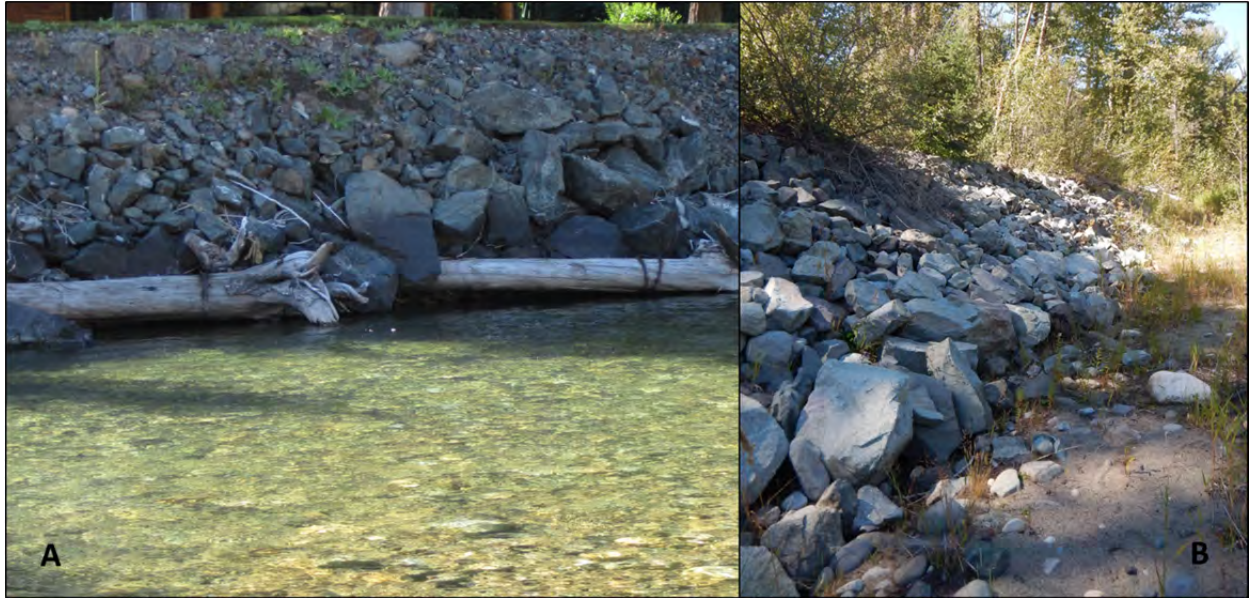
Levees and riprap have reduced the channel migration zone of Reach 2 (Figure 46). The channel width and location in the downstream portion of Reach 2 is largely locked in place. Lateral migration is limited by large-boulder riprapped banks topped with push-up levees on river-right from RM 61.7 to 61.85, RM 62.4 to 62.45, and RM 62.7 to 62.8. Riprap is used for bank protection on river-left from RM 61.7 to 61.75, RM 62.8 to 63.1, RM 63.15, and RM 64.6 to 64.65. Large wood has been attached to the riprapped banks at RM 62.7 (on river-right) and at RM 63 (on river-left).

The most severe alteration to floodplain and habitat function occurs behind the levees on river-right from RM 63.25 to 63.75. The levees are approximately eight to twelve feet high and eight to ten feet wide. The road on the top of the levee is a community trail. The levees completely block channel migration and floodplain inundation. They also block the upstream confluence points of several side-channels. This blockage keeps main channel flow from entering the side-channels, which has resulted in decreased habitat complexity and infilling with fines. The side-channels in this reach would be the longest in the study area had they not been disconnected by the levees. Today, these side-channels are currently wetted by groundwater inputs alone. Reactivation of the side-channel could be achieved by excavating notches into the levee, removing the levee entirely, or installing hydraulically-designed culverts that would allow partial through-flow from the mainstem.

Figure 46. Examples of confining features constructed of large angular riprap in Reach 2, (A) riprapped bank with cabled and anchored logs on river-right at RM 62.7; (B) section of the levee composed of riprap on river-right at RM 63.5. (9/4/2014)

Recommended actions in Reach 2 are focused on increasing channel complexity and lateral channel dynamics as well as improving connectivity to side-channels and floodplains. Complexity and lateral dynamics can be addressed by adding large wood jams to the main channel to enhance and create bar and island development and enhance split flow dynamics. Channel margin jams are suggested to create local pool development and enhance existing features. Side channel and floodplain connectivity can be addressed by removing unnecessary riprap, push-up levees, check dams, and sediment accumulations in off-channel habitat areas. Removal or breaching of levees at RM 63.35-63.7 has the potential to reconnect the largest off-channel impairment in the study area – but further evaluation and planning is needed to address the human-based function that the levees currently serve. Reach 2 also offers good opportunity to take advantage of public-access and recreation that occurs here by adding educational signage at restoration sites. Native riparian vegetation restoration where clearing has occurred is also recommended. Restoration recommendations recognize the importance of maintaining connectivity of the mainstem channel to perennial or groundwater fed tributaries and side-channels. This has been identified as a critical component for fish survival in a system with the potential to seasonally dewater.

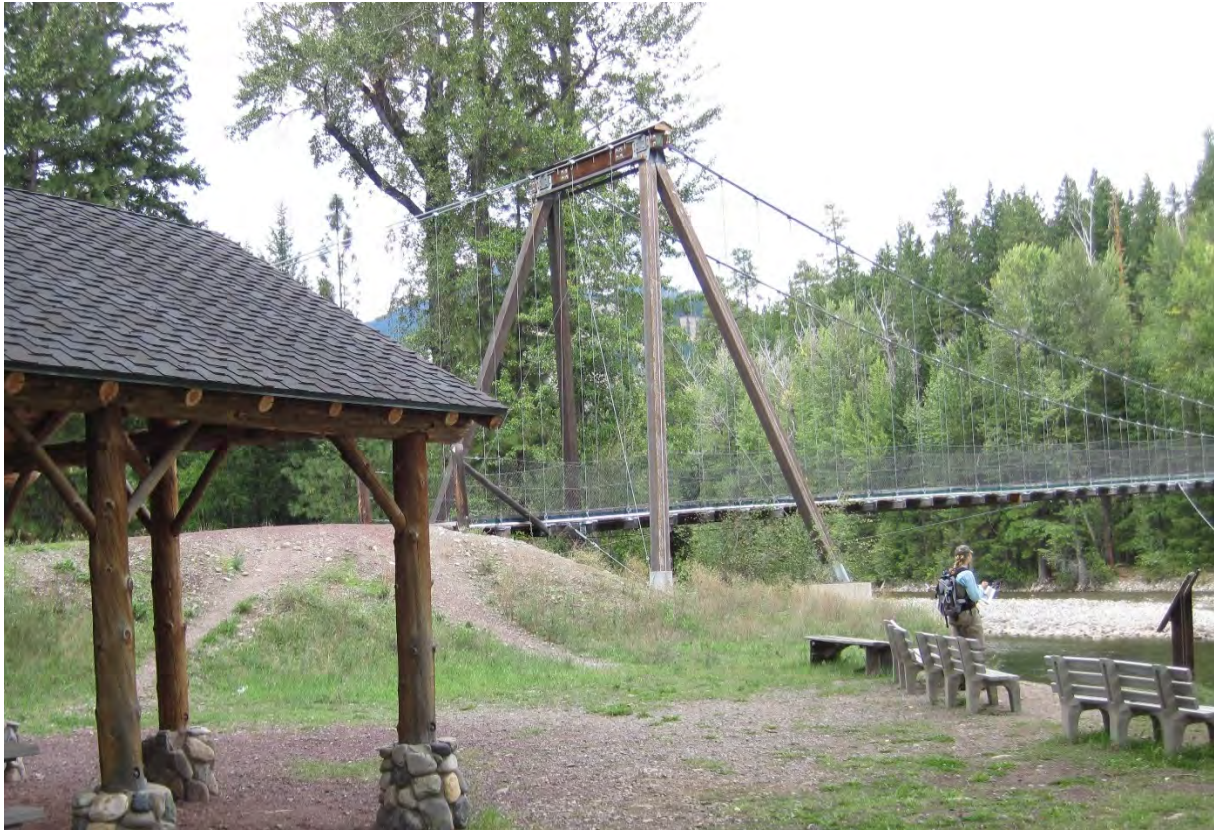
Additional loss of floodplain function occurs at the suspension bridge abutments at RM 64.35 and at an armored bank at the downstream end of the reach on river-right. The suspension bridge abutments are composed of boulders, cobbles and soil (similar to push-up levees). The abutments constrict the channel between them and alter normal floodplain inundation downstream on river-right (Figure 47). At the downstream end of the reach on river-right from RM 61.7 to 61.8, a riprapped bank topped with a push-up levee also confines channel width and location. Floodplain connectivity is reduced behind and downstream from this bank and levee in Reach 2 and Reach 1. Additional floodplain levees in Reach 2 alter localized floodplain inundation processes.

Figure 47. Suspension footbridge abutment and public area on downstream side of bridge on disconnected floodplain at RM 64.35. (9/3/2014)

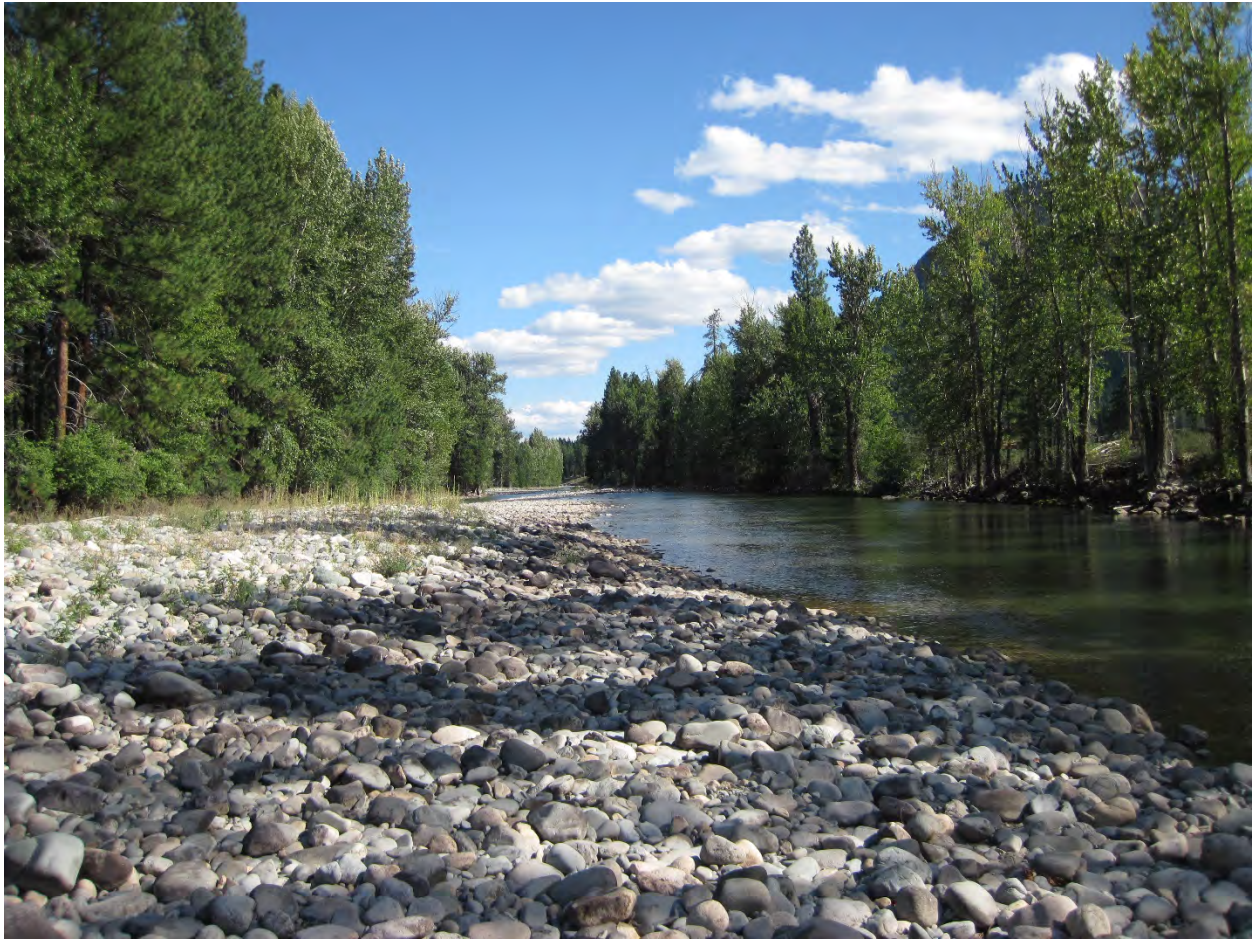
Figure 49. Representative photo of upper section of Reach 3; looking downstream at RM 66.75. (9/3/2014)

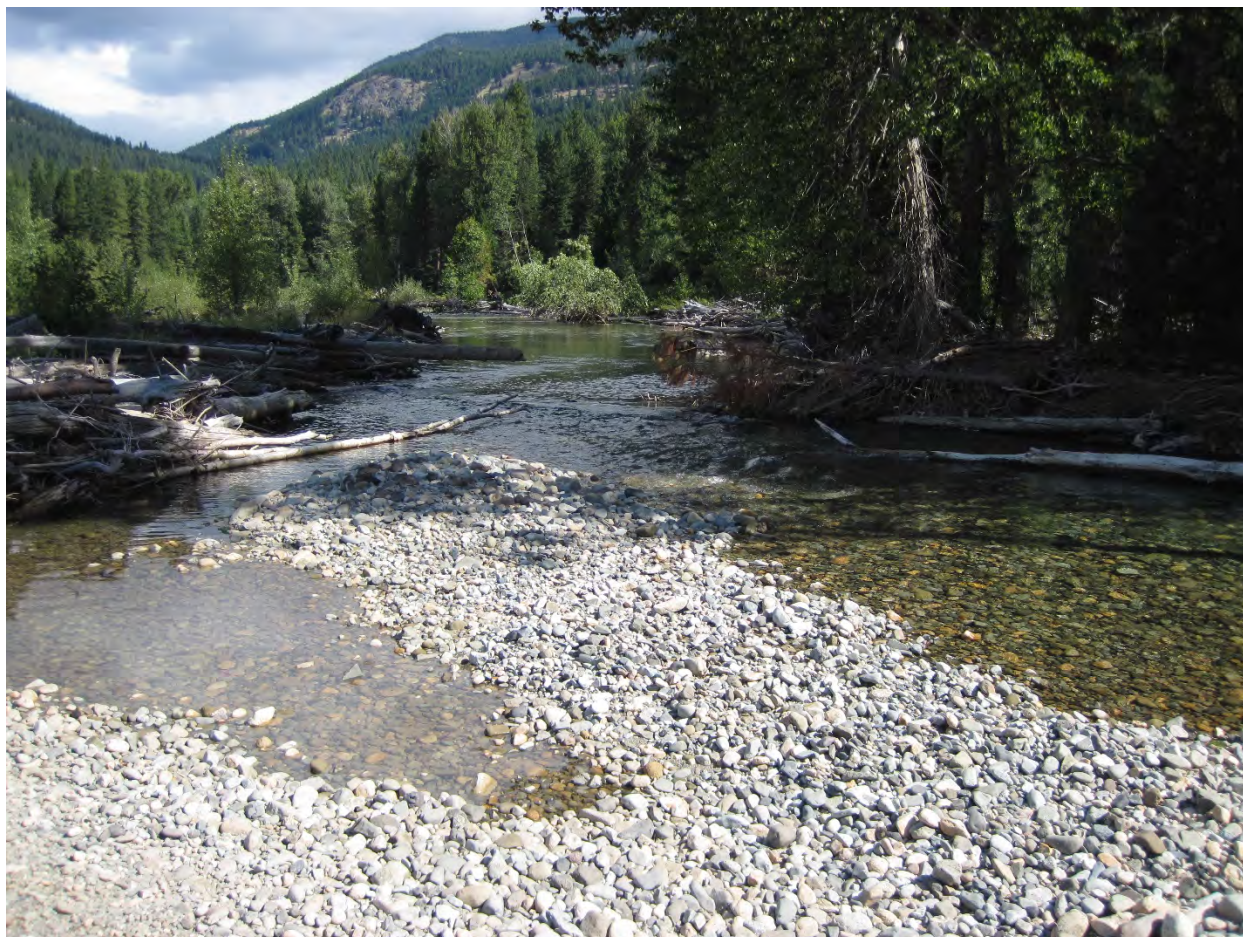
Figure 50. Representative photo of lower section of Reach 3; looking downstream at RM 65.15. (9/3/2014)

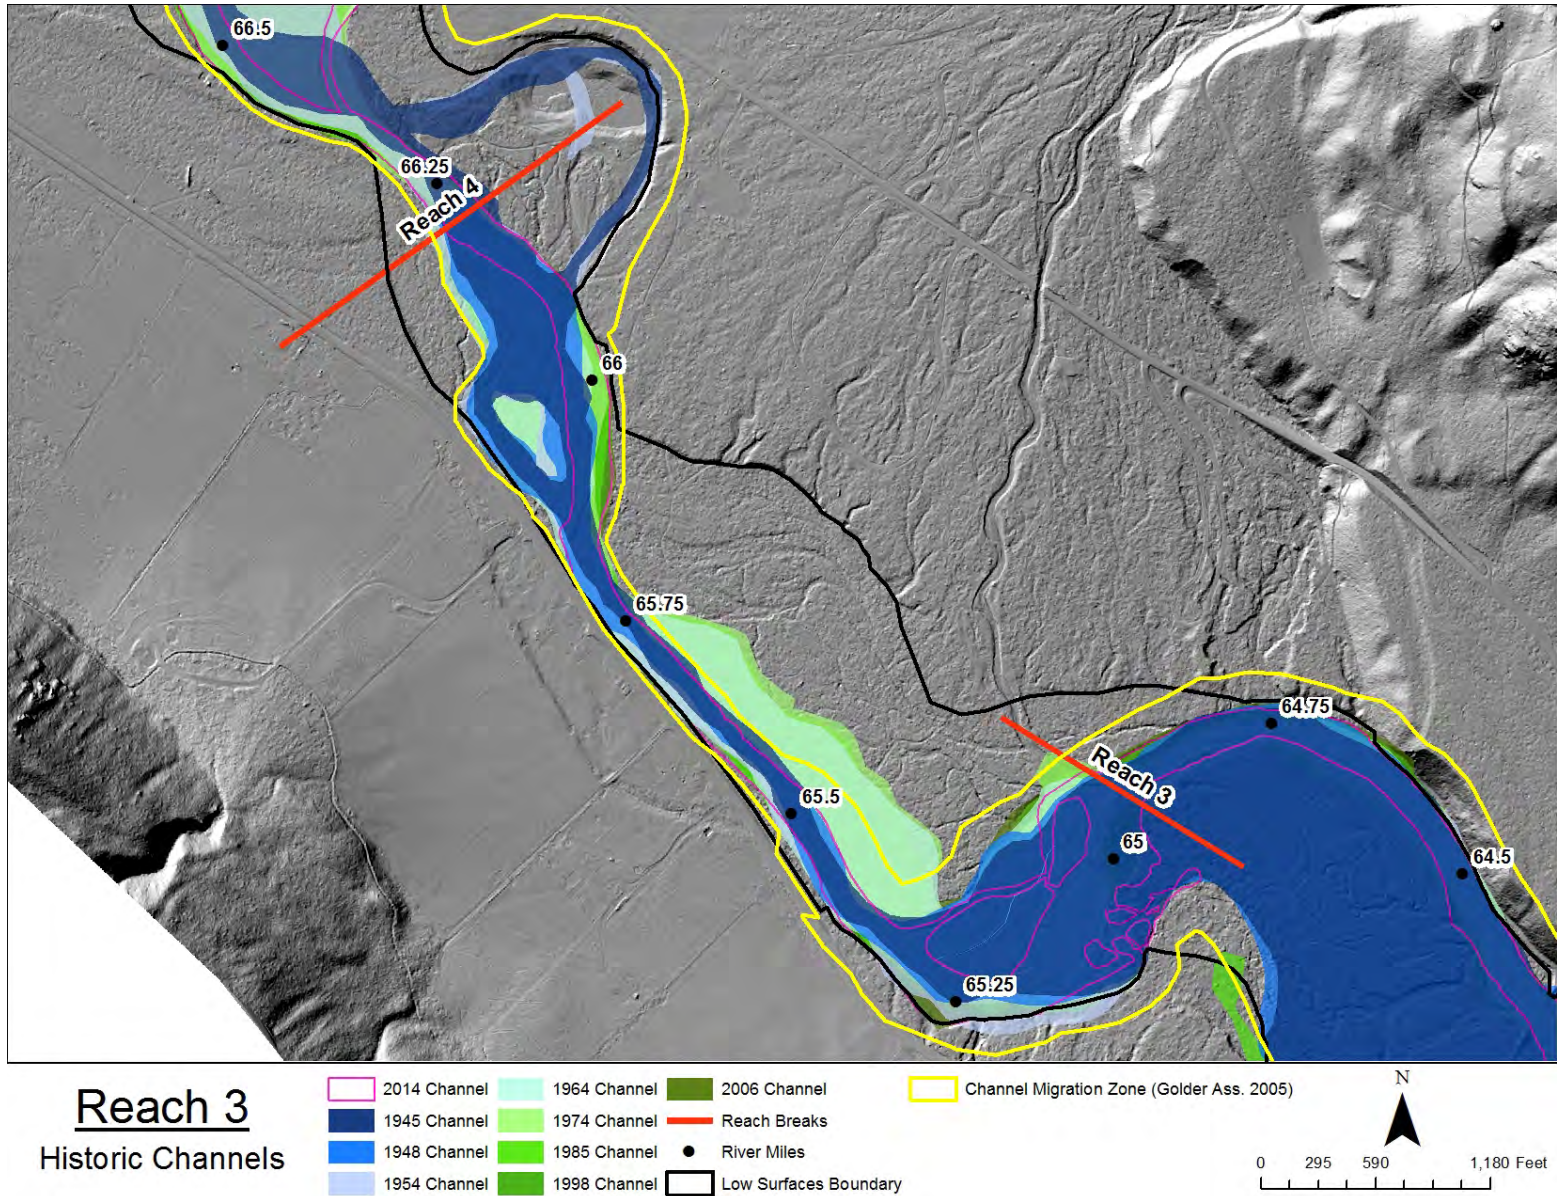
Fluvial scarring indicates that the modern floodplains in Reach 3 are inundated by high-flow events every two to ten years. However, historical aerial imagery and field observation of overbank deposition patterns indicate that the constructed levees and riprap in Reach 3 have reduced active-channel width and normal floodplain inundation. This is most evident from RM 65.35 to 66.75 along river-left, and on river-right from RM 65.4 to 65.6. As a result, the floodplains behind the levees and armored banks have been classified as disconnected. Channel migration has been limited since the construction of the levees and riprap (Figure 55).

Figure 55. Historical channel locations in Reach 3.

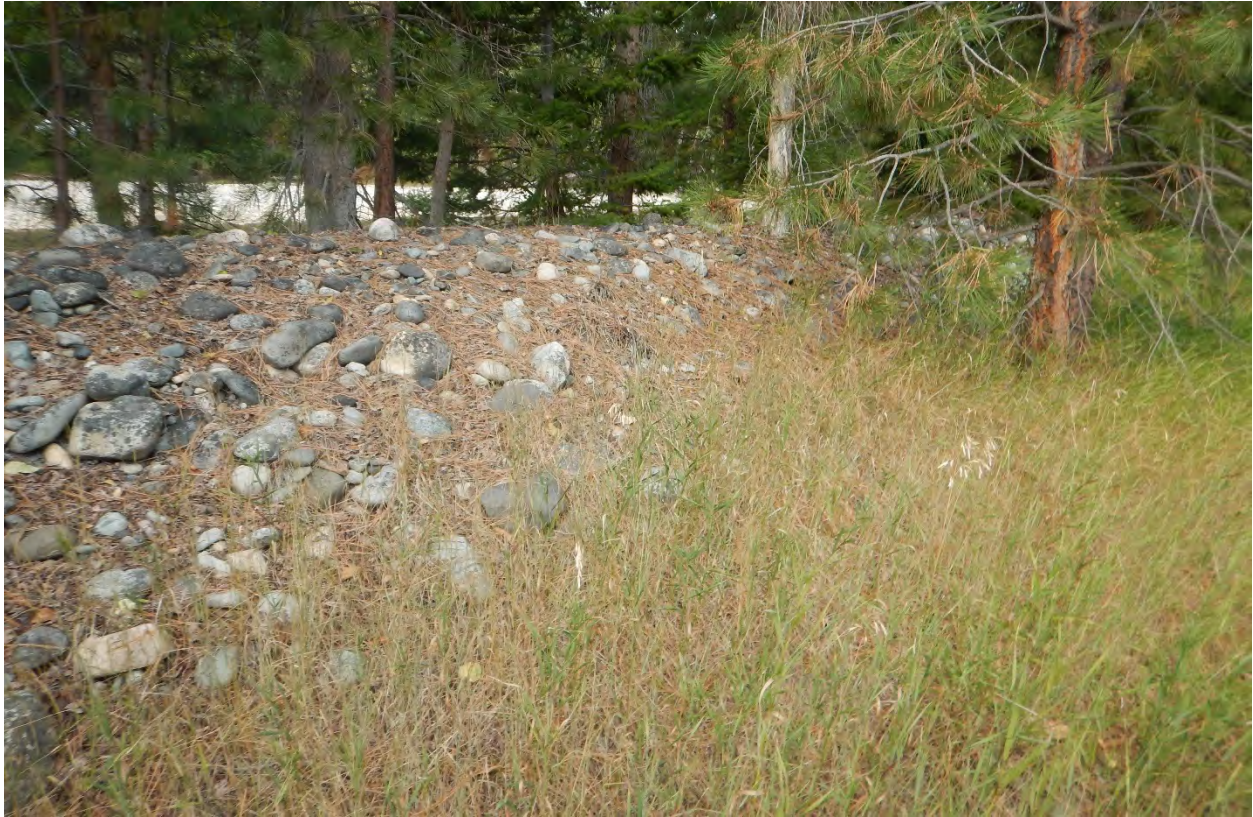
Floodplain function and channel migration have been reduced in Reach 3 as a result of constructed levees and boulder riprap. Approximately one-third of the available floodplain surfaces in Reach 3 have been disconnected from the channel by the construction of push-up levees. The levees have been built on river-right from RM 65.45 to 65.55, and on river-left from RM 65.35 to 65.55, at RM 65.85 (230 feet long), and at RM 65.9 (170 feet long). The most upstream bank protection is a boulder riprap reinforced levee at RM 65.9 on river-left. This levee aids in diverting the channel away from the alluvial fan toe and floodplain surfaces on this side of the reach. In general, the levees range from approximately two to four feet high and are composed of local boulders, cobbles, and soil (Figure 59). From RM 65.35 to 65.55, the channel is straight and basically locked in place due to the levees constructed on both sides of the channel. Here, the channel migration zone has been reduced from approximately 1,000 feet to the width of the channel (approximately 160 feet). Large boulder riprap armors the banks of the channel on river-right at RM 65.15 (100 feet long), at RM 65.35 (175 feet long), from RM 65.25 to 65.3, and from RM 65.75 to 65.8. The riprap between RM 65.15 and 65.35 is installed at the base of a high cut-bank where private homes are located. From RM 65.75 to 65.8, the riprap was installed to reduce bank erosion and protect the infrastructure of Hwy 20 (which lies approximately twenty feet behind the bank). The levees and riprap throughout Reach 3 restrict lateral channel migration and disconnect floodplain surfaces by stabilizing the banks and reducing the frequency and extent of inundation.

Figure 59. Push-up levee from land-ward side in Reach 3 on river-left at RM 65.35. (9/3/2014)
