Upper Methow River Reach Assessment

River Miles 61 - 80

SUBMITTED TO
Yakama Nation Fisheries

FINAL - DECEMBER 2015

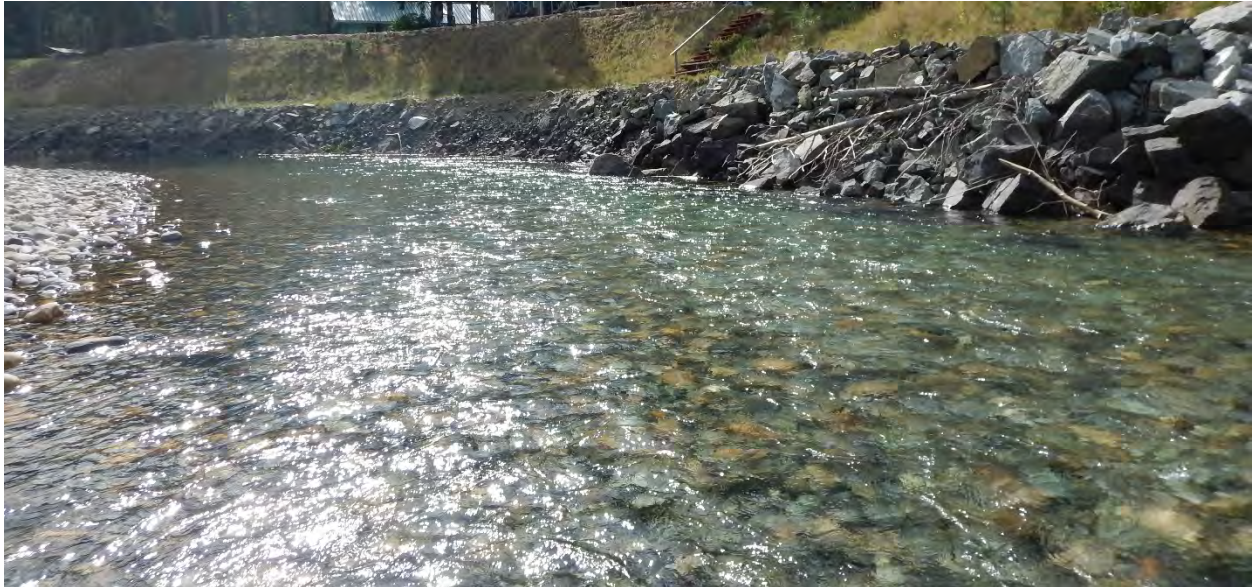
Streambank complexity and riparian vegetation in Reach 3 have been reduced along the riprapped banks. The riprap inhibits bank erosion, and thus alters localized sediment inputs into the system. This is particularly evident along the riprapped cut-bank on river-right from RM 65.25 to 65.3 and from RM 65.75 to 65.8 (Figure 60). The riprap also reduces the complexity of the riparian vegetation community and notably decreases the potential for the establishment of mature stands of trees along these banks. Additionally, this reduces localized shade to the channel and removes the potential for large wood recruitment in these areas. At the private residence on river-right (RM 65.15 to 65.35) and between the channel and Hwy 20 (RM 65.35 to 65.8), vegetation clearing and thinning near the channel bank further reduces the complexity of riparian vegetation and its corresponding benefits to channel function. Historical logging practices at the turn of the century cleared vegetation and utilized the river to transport cut logs to mill sites downstream (Devin 1997). This has likely reduced riparian function and channel complexity over the last century.

Figure 60. Riprap protected cut bank toe in Reach 3 on river-right at RM 65.30. (9/3/2014)

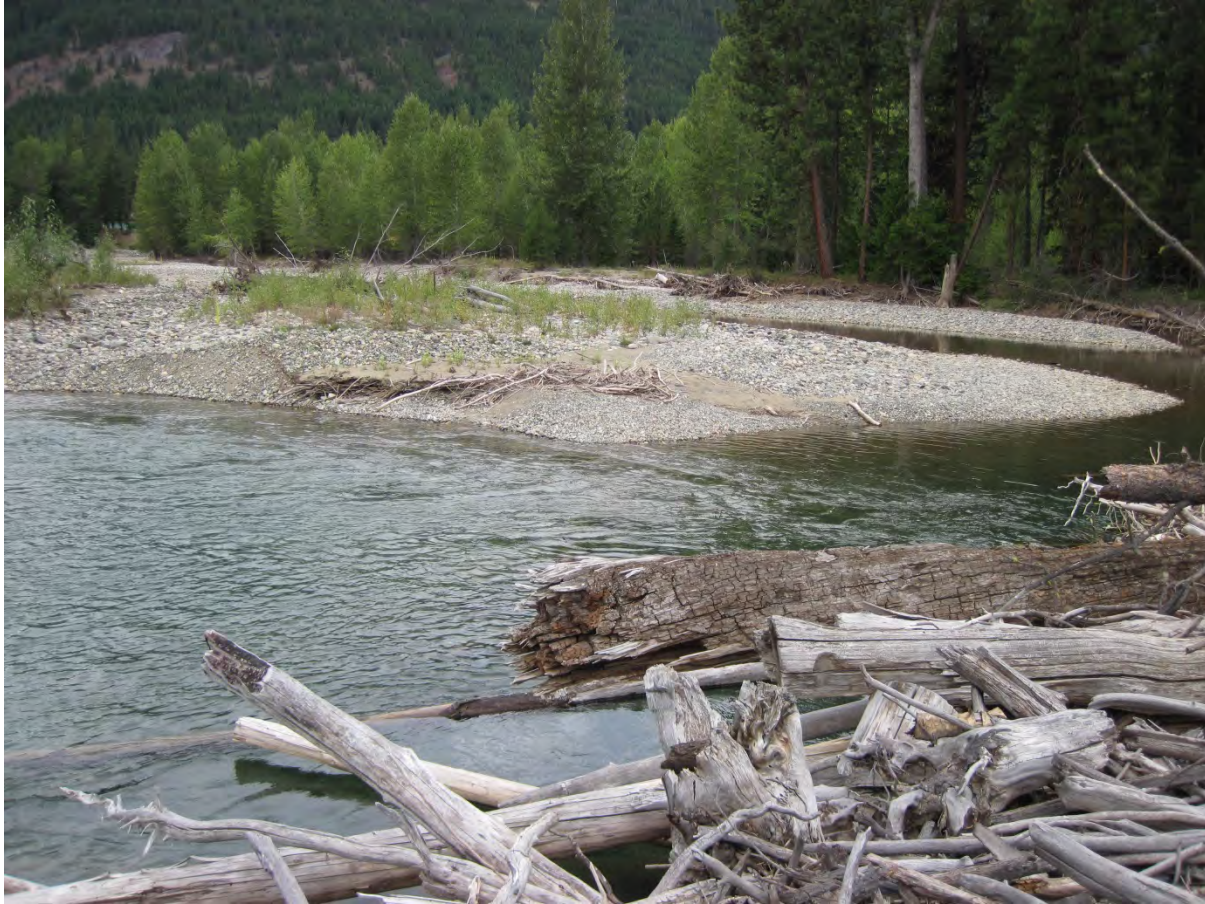
Figure 62. Dynamic, well-functioning downstream portion of Reach 3. (8/29/2014)

Recommended actions in Reach 3 are focused primarily at the upstream section of the reach and include increasing channel complexity and lateral dynamics as well as improving floodplain connectivity. Complexity and lateral dynamics can be addressed by adding large wood jams to the main channel to enhance and create bar and island development. Channel margin jams are suggested for pool development and to enhance existing pool features. Floodplain connectivity can be addressed by removing unnecessary levees and bank armoring. The proximity of Highway 20 will need to be considered with these actions. Native riparian vegetation restoration where clearing has occurred is also recommended. Restoration recommendations recognize the importance of maintaining connectivity of the mainstem channel to perennial or groundwater fed tributaries and side-channels. This has been identified as a critical component for fish survival in a system with the potential to seasonally dewater. The lower portion of Reach 3 is highly complex, full of wood, and very dynamic (Figure 62). No significant work in this lower section is recommended, as it is mainly an area that should be targeted for protection, including a highly-functioning side-channel in the river-right floodplain (RM 64.4 – 65).

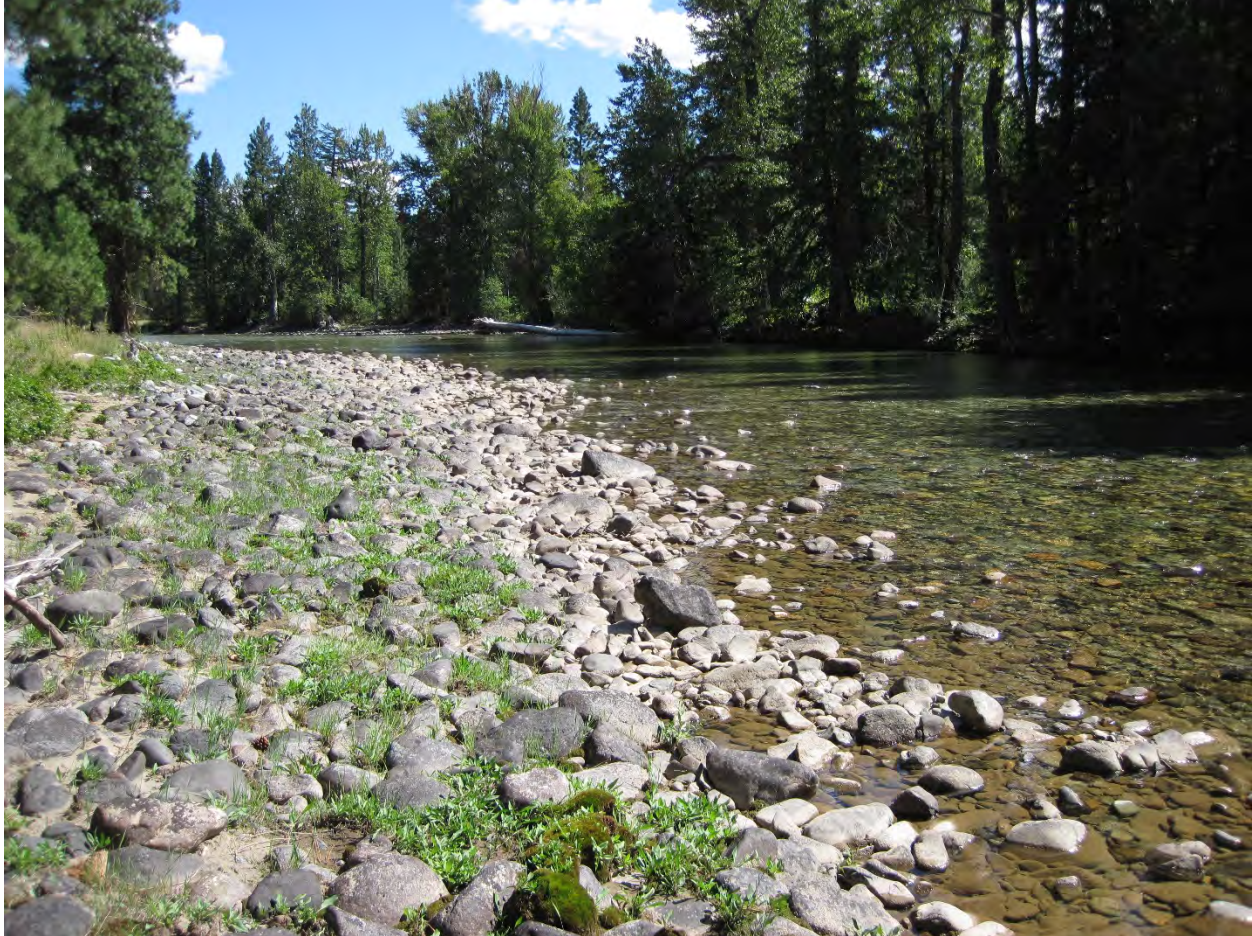
Figure 64. Representative photo of Reach 4; looking downstream at RM 68. (8/27/2014)

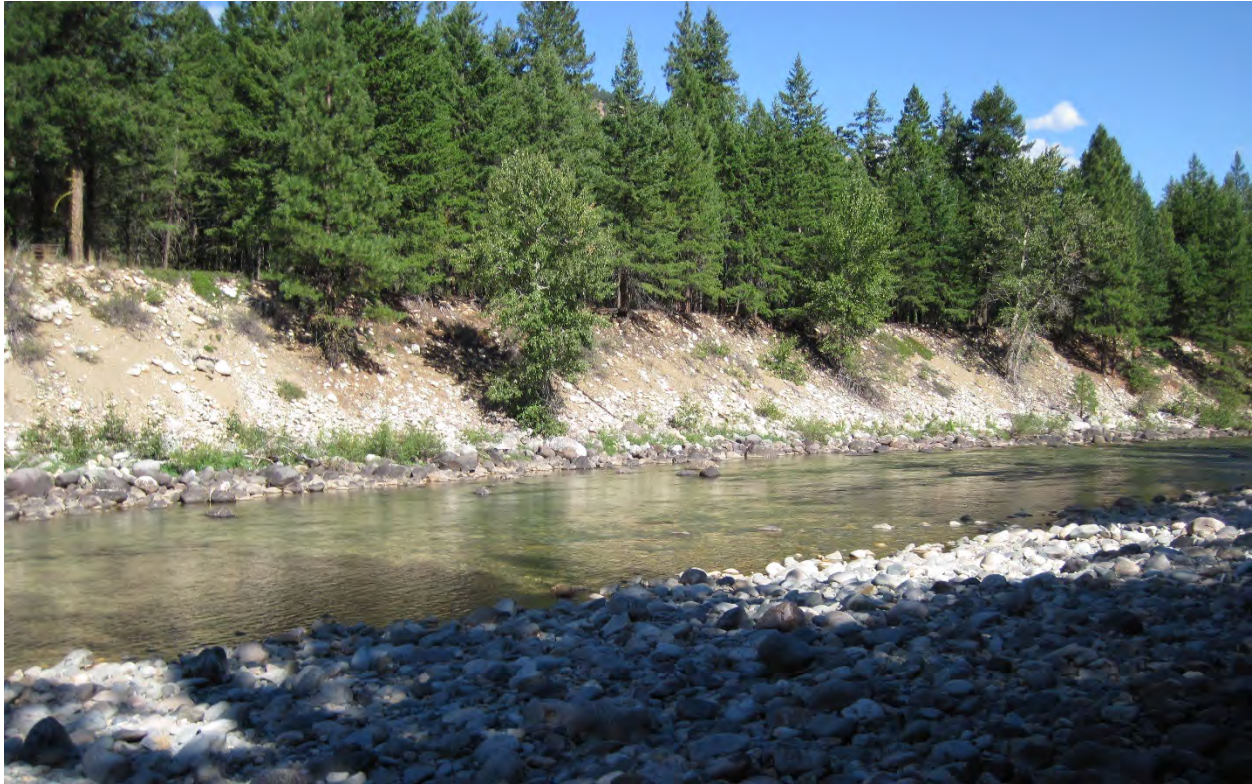
Figure 67. Glacial outwash terrace cut bank on river-left; looking downstream at RM 67.75. (8/27/2014)

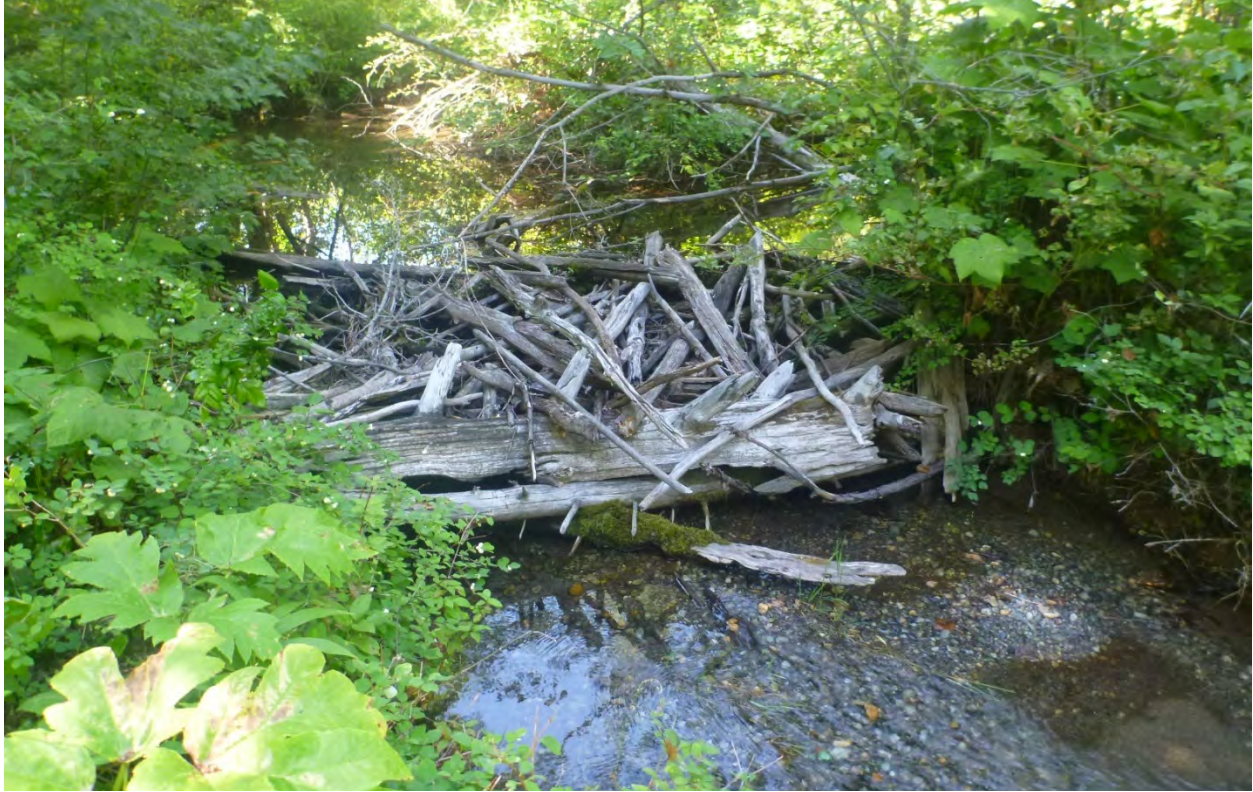
The channel in Reach 4 is single-thread with only two overflow side-channel features and one off-channel, groundwater-fed tributary. The groundwater-fed tributary enters the channel on river-left (east side of the channel) at RM 67.8. This tributary originates from groundwater seepage at the base of the glacial terrace. It is located in an abandoned channel scar that is inset between the outwash terrace and a high floodplain surface. The tributary is a complex off-channel feature with an abandoned beaver dam, racked wood which creates small pools, and substrate of sands to gravel (Figure 68). Tree and shrub vegetation along the banks of the tributary provide shade to this off-channel feature. Decreased water temperatures were observed in the deeper pools of this tributary due to groundwater influx. In August, 2014, fingerlings were seen in the pools of this tributary during field observation. Maintaining the connectivity of this tributary to the mainstem channel is important because it provides approximately 600 yards of cool, shaded, off-channel habitat. Another groundwater-fed feature is offset from the channel by approximately 180 feet on river-left between RM 67.45 and RM 67.65. This feature also occupies an abandoned channel scar, but its surface water has been captured by a dug pond with a levee. The levee ensures that the feature remains disconnected from channel processes.

Figure 68. Ground-water fed tributary with abandoned beaver dam; looking upstream near RM 67.8. (8/27/2014)

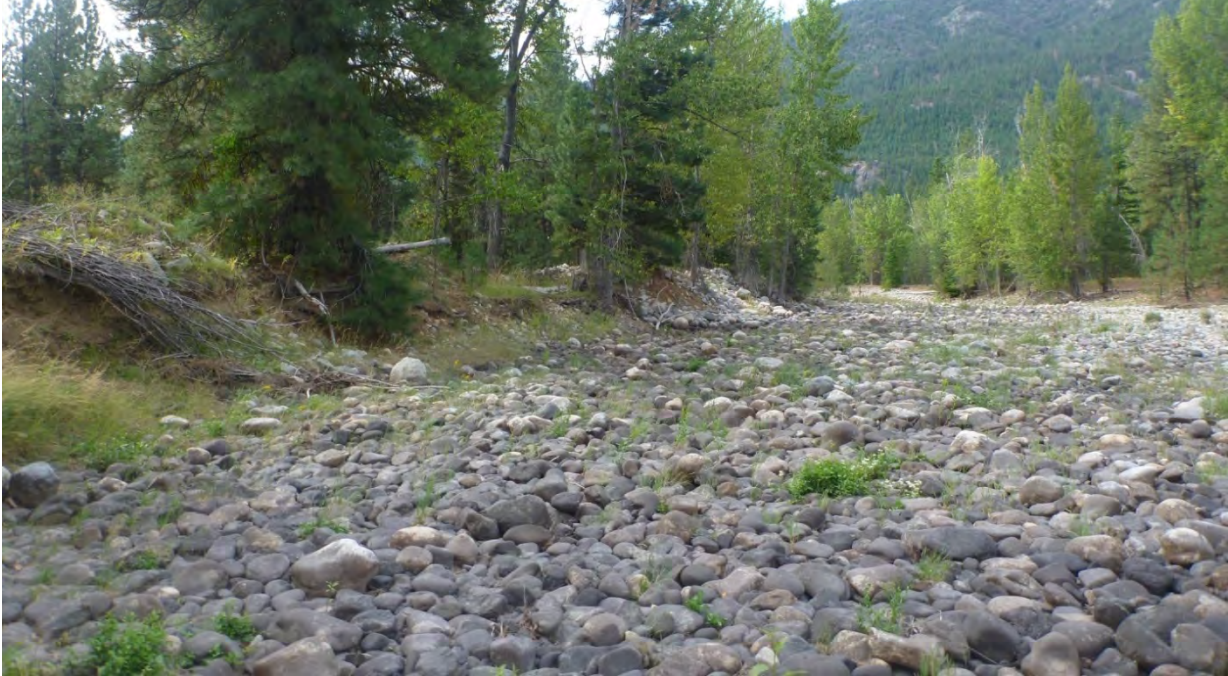
Two side-channels that are activated during high flow locally reduce incision potential by providing additional channel area for flow transmission. A side-channel that runs from RM 66.35 to 66.75 on river-left is over 700 yards long (2,100 feet) (Figure 69). The other side-channel runs from RM 68.25 to 68.35 on river-right (west side of the channel). It is only 225 yards long (675 feet) but it offers a backwater feature during low flows that, if maintained, could provide perennial off-channel habitat. Both side channel features have been scoured and then filled with large cobbles and gravel during high flow events.

Figure 69. High flow side-channel (dry) on river-left near RM 67.75; looking upstream. (8/27/2014).

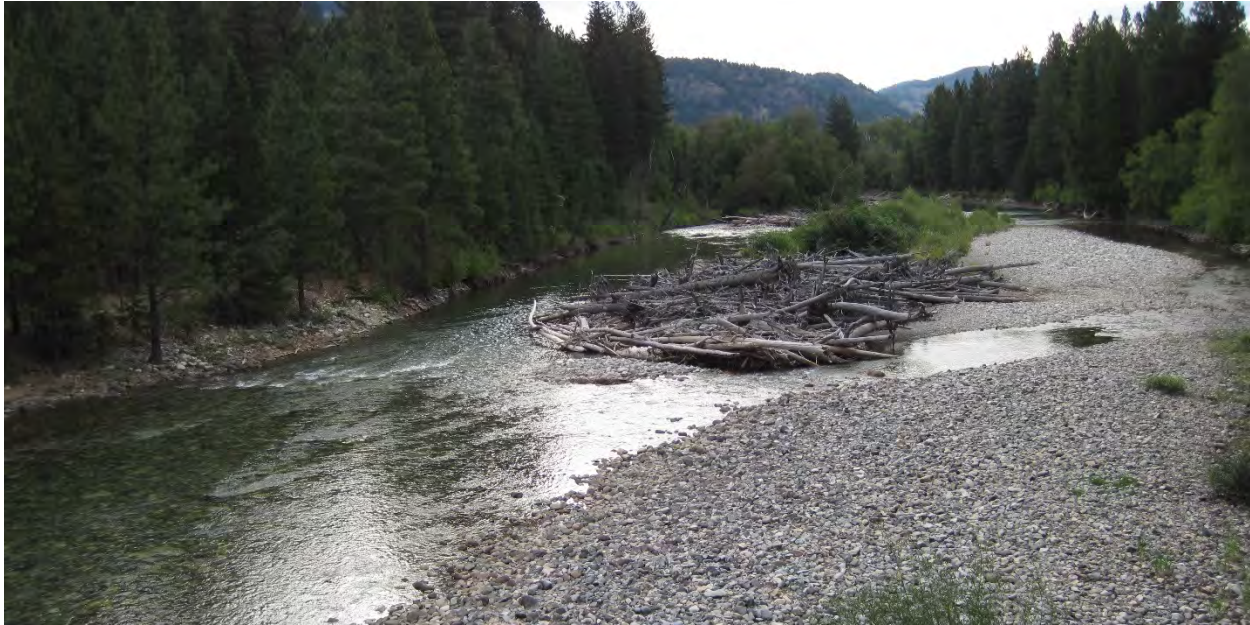
Figure 70. Large wood accumulations on cobble bars; looking downstream from the Mazama Bridge (RM 67.2). (8/28/2014)

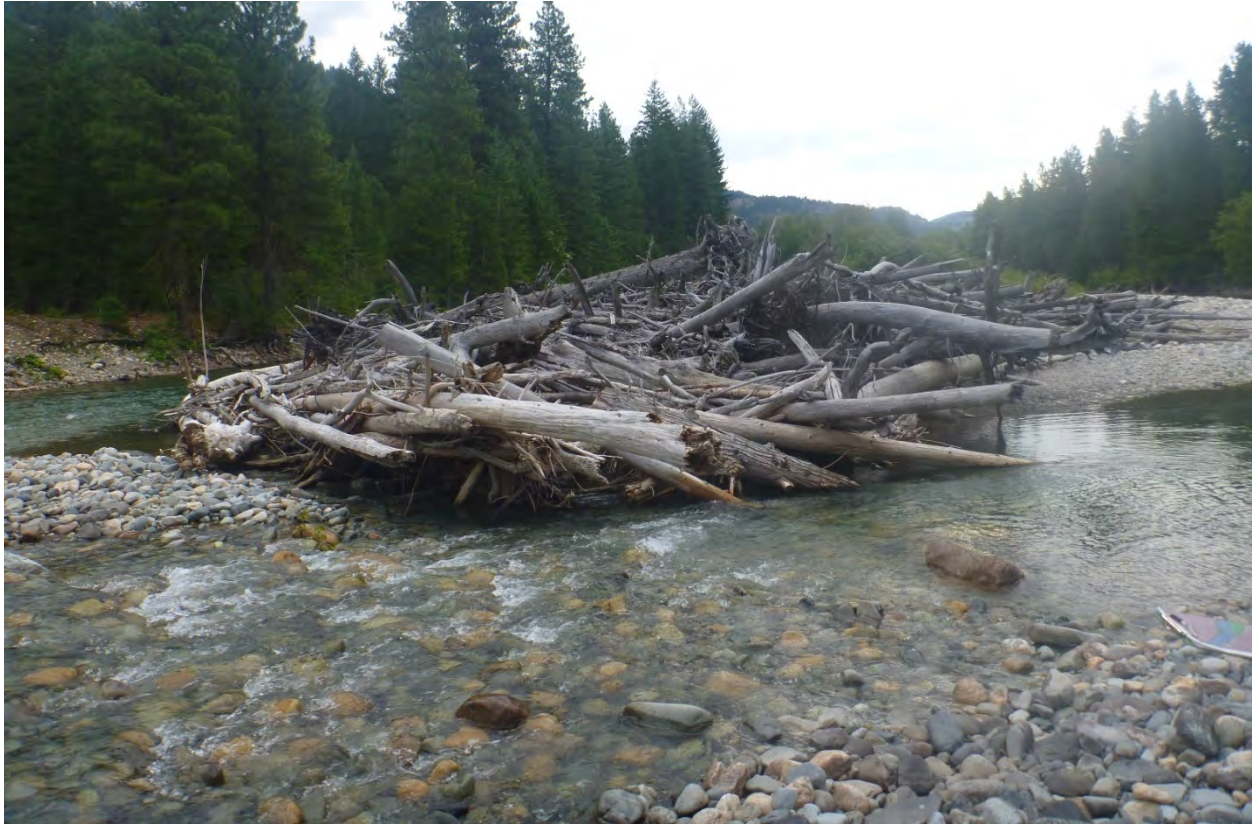
Figure 75. Large wood jam at apex of a cobble bar (RM 67.15). (8/28/2014)

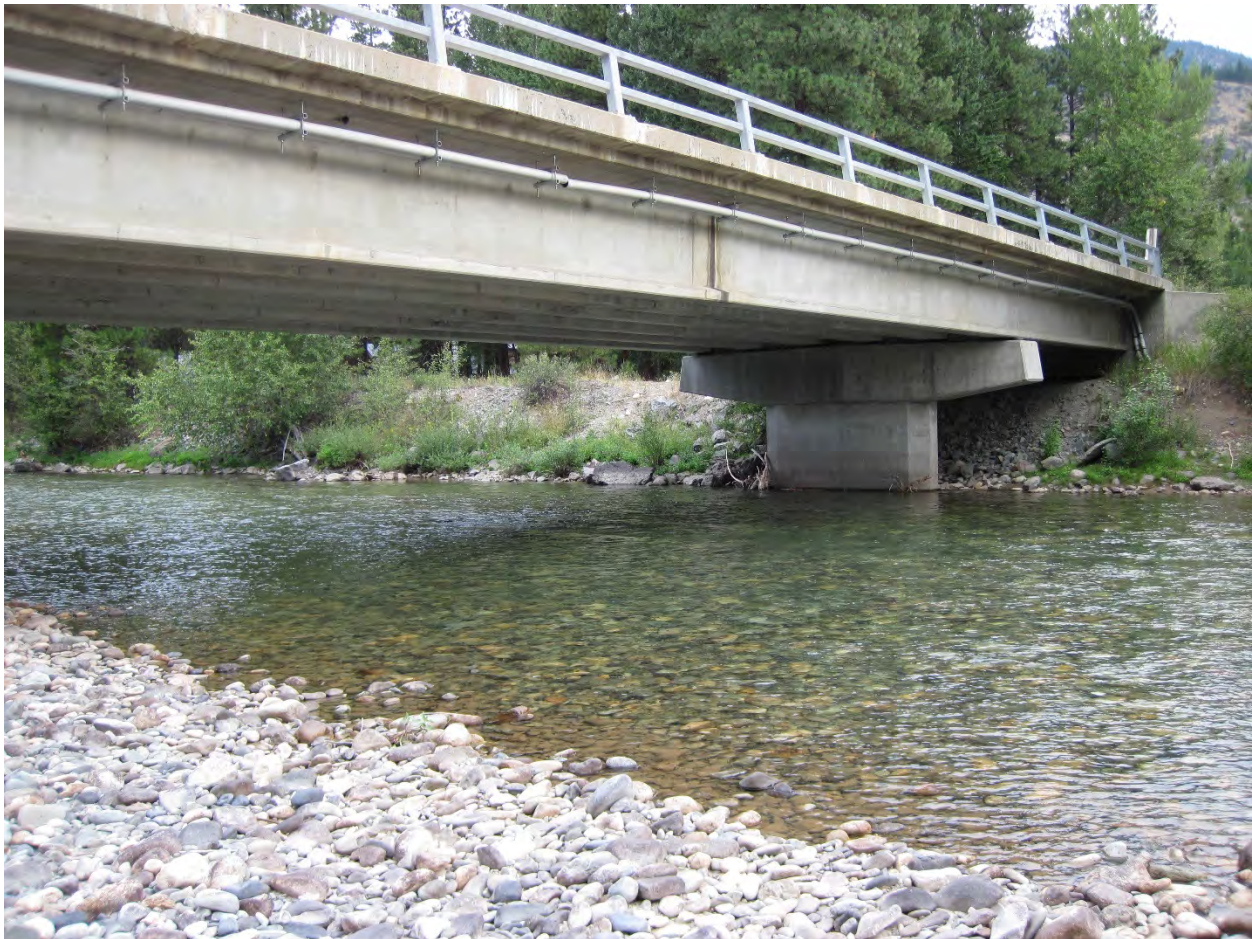
Bridge crossings impact natural geomorphic processes of the Methow River in Reach 4 and its primary tributary, Early Winters Creek. The Mazama Bridge and its associated abutments and riprapped banks constrict the channel's width and limit lateral channel processes by locking the pathway of the channel in place at RM 67.2 (Figure 78). Early Winters Creek has two bridge crossings that influence its lateral processes across the top of its alluvial fan. The Highway 20 Bridge and a Methow Valley Community Trail footbridge cross the creek near each other approximately 550 yards upstream from the confluence. The bridges and their associated abutments and riprapped banks locally lock the pathway of the creek in place. This can promote incision and influence downstream sediment delivery to the Methow River. However, below these bridges, the creek is laterally active, creating a secondary channel that traverses the fan to the mainstem channel. An old river crossing located 280 yards upstream from the confluence was removed over twenty years ago – likely by flood waters. When in use, this crossing likely restricted the pathway of the creek as well as sediment delivery to the mainstem.

Figure 78. Mazama Bridge and riprapped bank on river-left (RM 67.2). (8/28/2014)

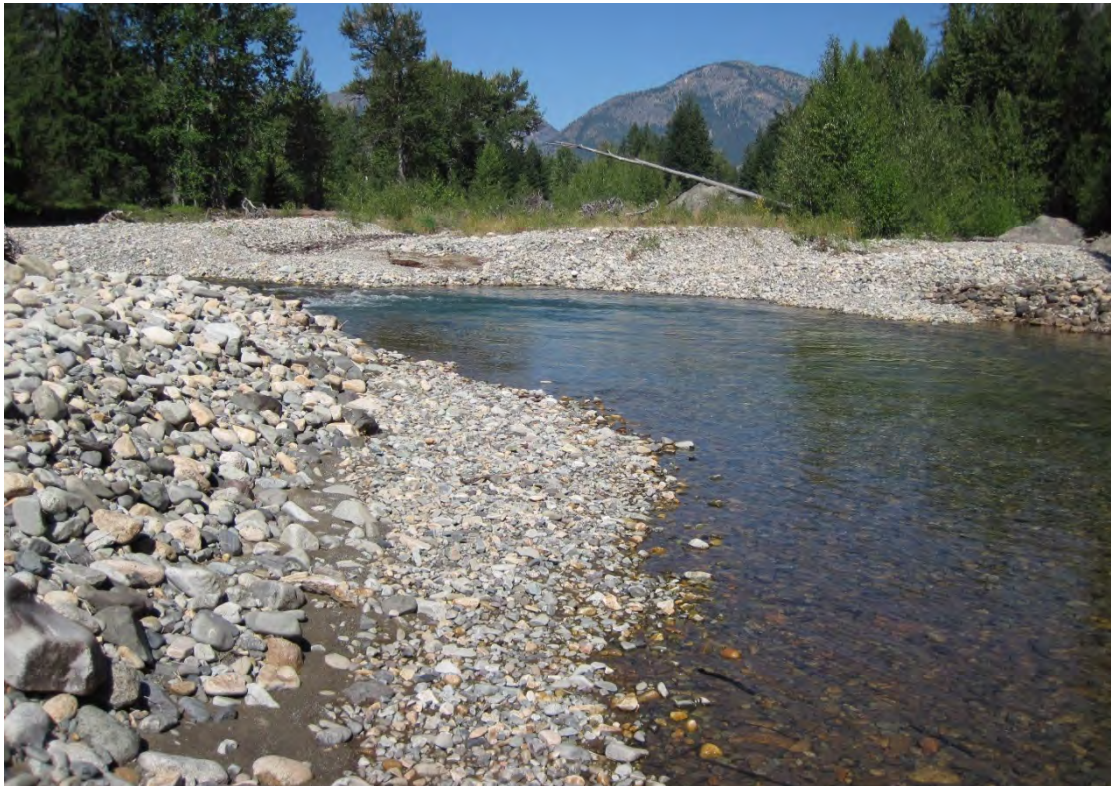
Figure 80. Representative photo of Reach 5; looking upstream at RM 71. (8/26/2014)

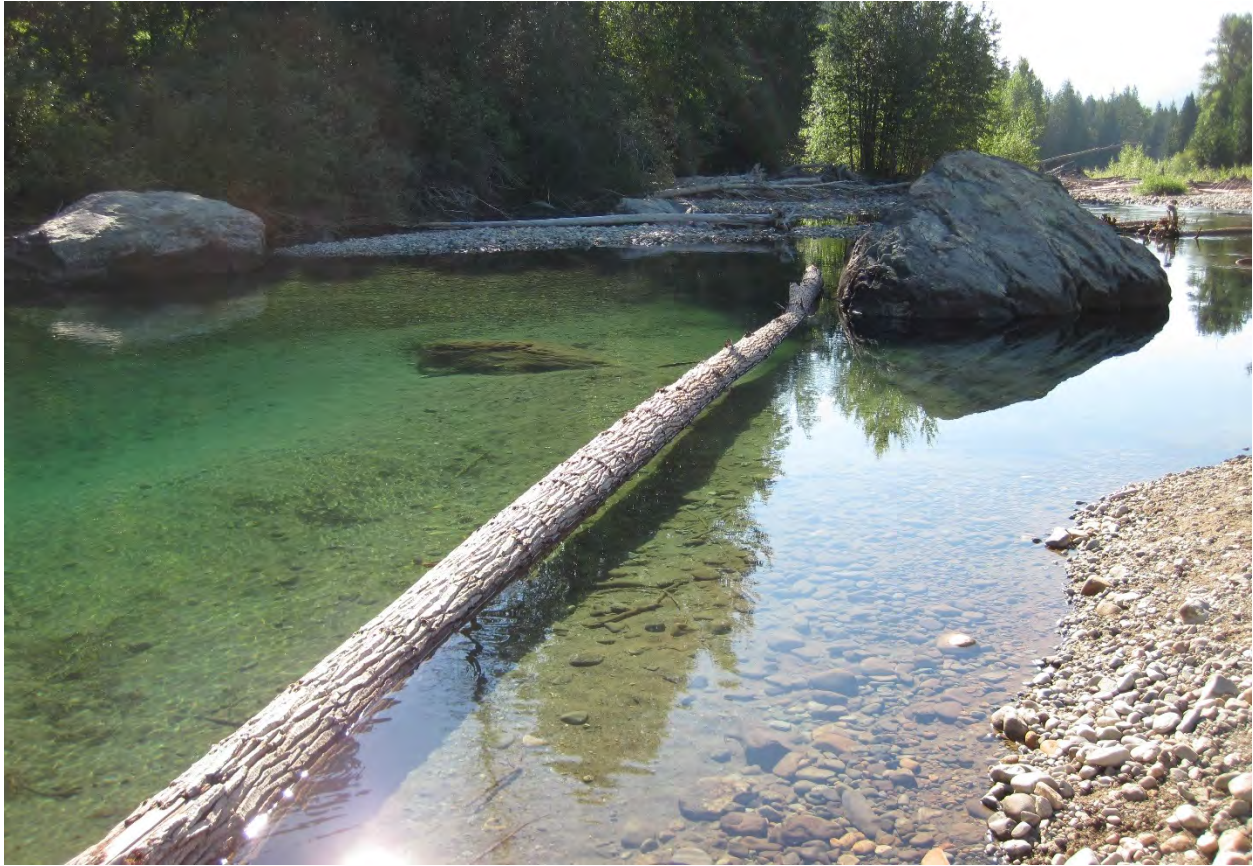
Figure 83. Pool with large boulders at RM 71.2. (8/26/2014)

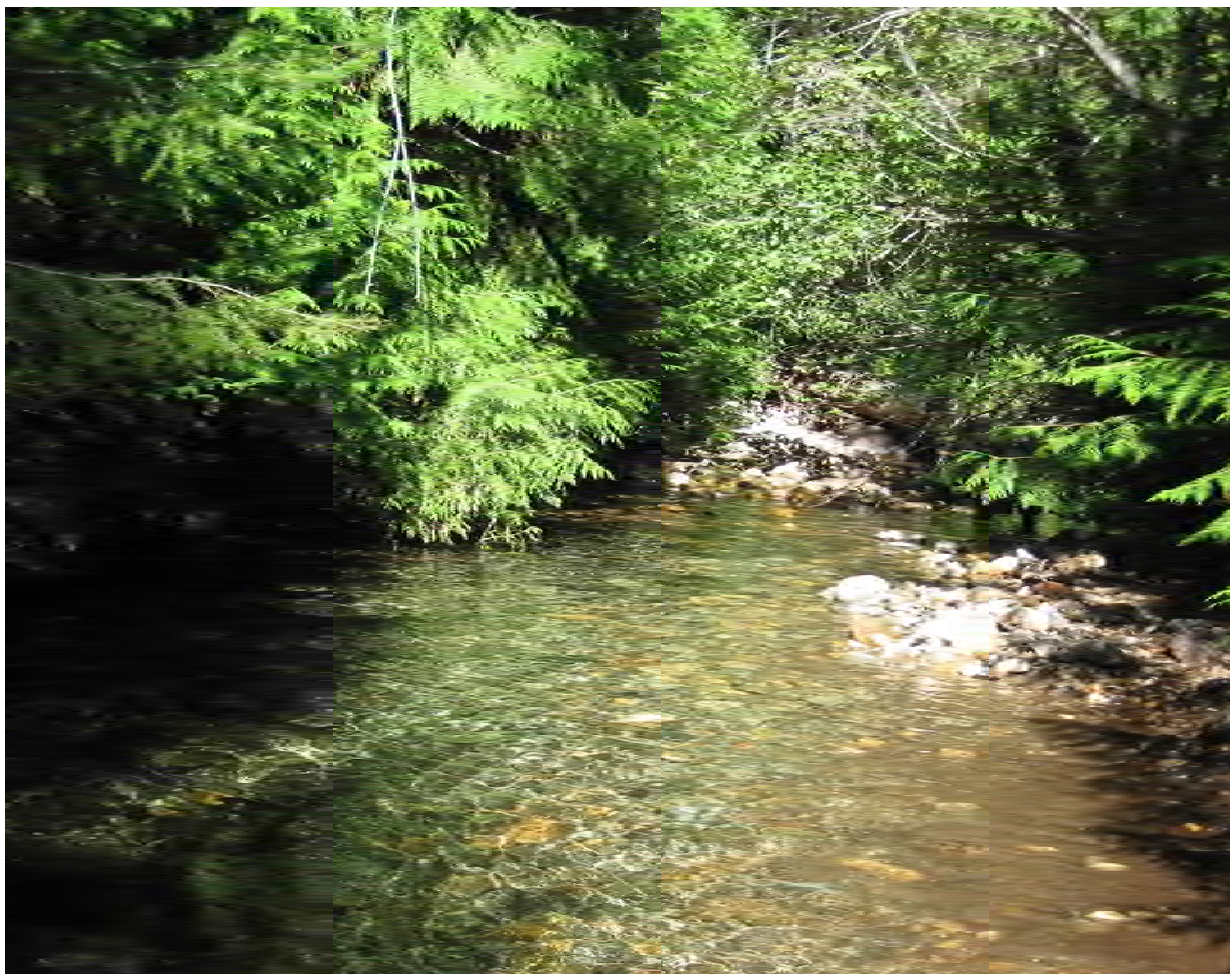
Figure 84. Groundwater-fed tributary near RM 70.4; at downstream end looking upstream. (8/26/2014)

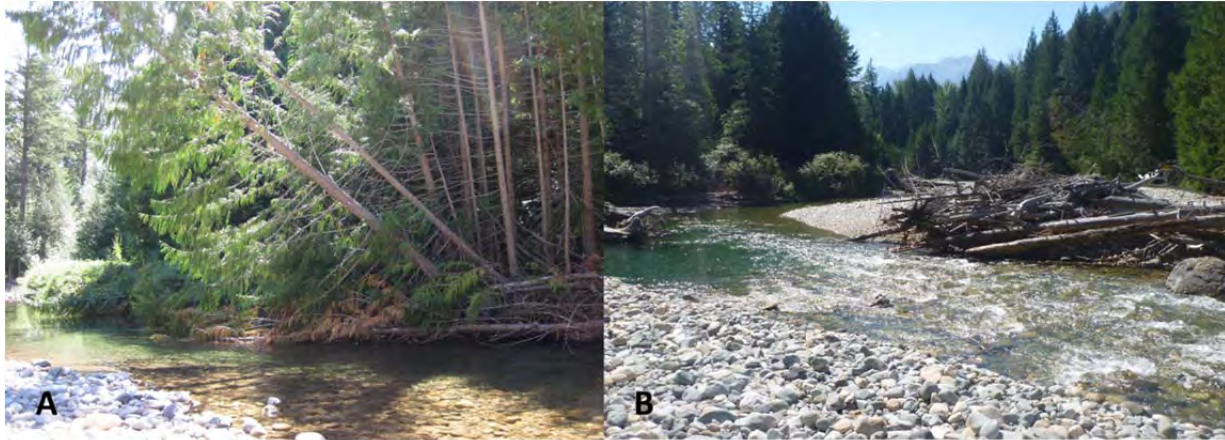
Large wood retention and recruitment is fairly good in Reach 5 with the exception of the riprapped and/or cleared banks. Even in the downstream section of the reach where the channel is confined and less complex, wood retention on the active bar surfaces appears only slightly reduced compared to the more complex middle section of the reach. Retention of wood is high in the upper section of the reach where channel complexity is greatest. Most of the wood in Reach 5 appears to be recruited from local banks or from immediately upstream of the reach boundary. The well-vegetated floodplain and alluvial surfaces adjacent to the channel offer high recruitment potential. Past and current lateral channel migrations resulted in local wood inputs to the channel. In August 2014, fresh wood inputs were observed from eroding banks (Figure 90).

Figure 90. A) Active large wood recruitment through bank erosion (RM 70.7); B) Large wood accumulations on bars. (8/27/2014)

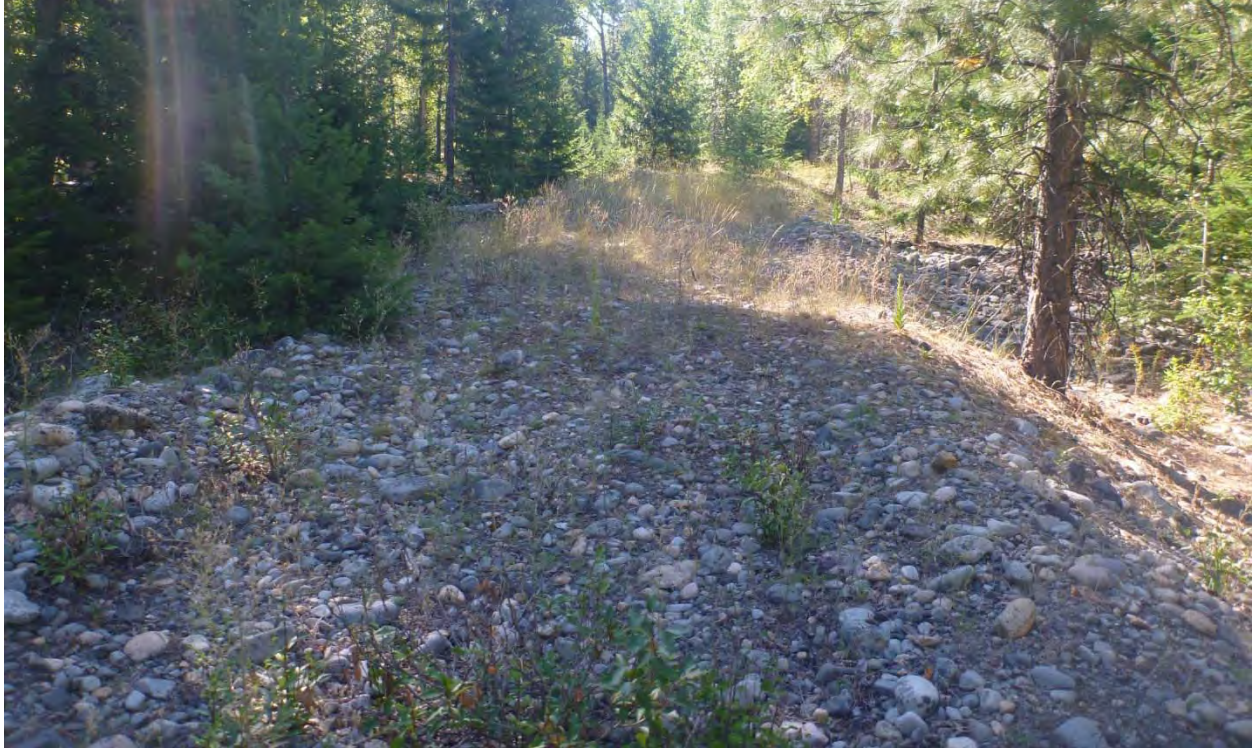
The push-up levee at the edge of the high floodplain surface on river-right at RM 70.75 disconnects floodplain processes. This levee is approximately 400 feet long and diverts channel flow away from the banks of this surface. It is likely that this levee is partially responsible for the disconnection of this surface from the channel. Remnant sections of another push-up levee are located on the floodplain on river-right between RM 71 and 71.25. This levee has been breached by flood waters leaving only an upstream section that is approximately 350 feet long and three feet tall and a downstream section approximately 250 feet long, four feet tall, and 15 feet wide. The downstream section of this levee has a flat road prism on top (Figure 93). It appears this levee was originally built along the 1945 channel boundary, which would have affected floodplain connectivity until the levees were finally breached and eroded. Although the levees have been breached, their presence continues to influence flood inundation patterns and possibly the location of the main channel and side-channels.

Figure 93. Section of the breached push-up levee on the floodplain near RM 71.1. (8/26/2014)

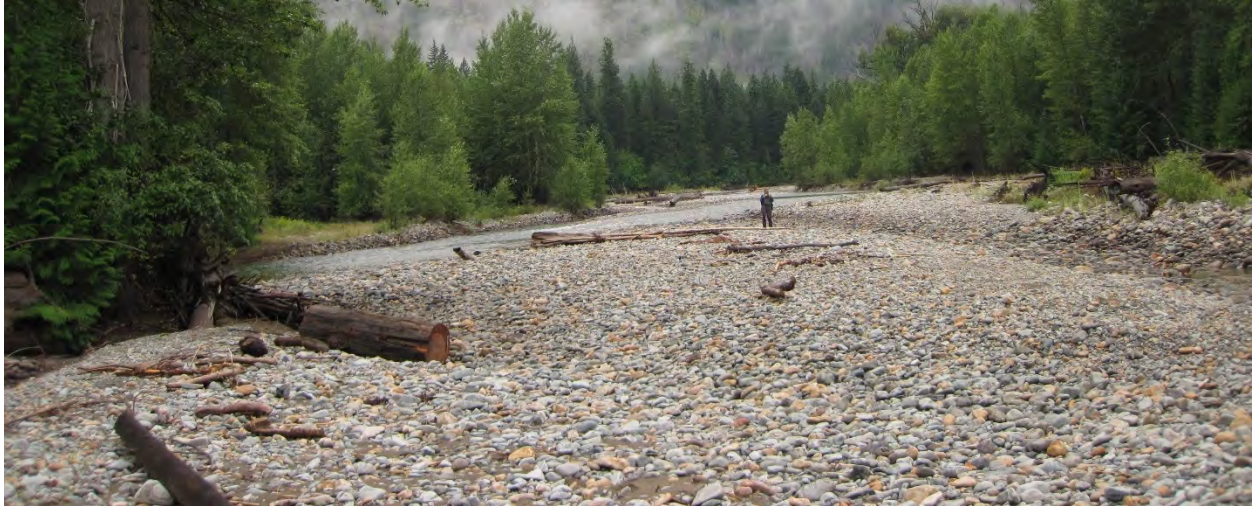
Figure 98. Cobble-gravel filled side-channel near RM 72.5.

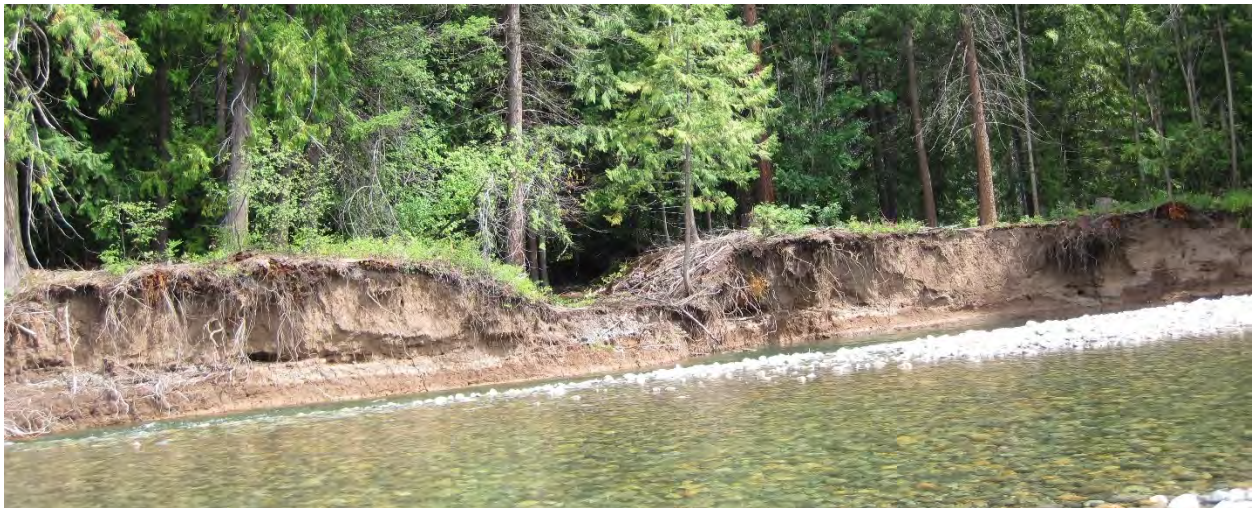
Small high floodplain surfaces in the most downstream portion of the reach on river-right have remnant scroll bar features and developing soil. These alluvial surfaces are the result of channel bed incision, which is likely being amplified by the modern artificial confinement of the channel at RM 71.3 (the downstream border of Reach 6). There is a unique cut-bank feature located at RM 72.2 on river-left where the active channel is eroding into alluvial deposits comprised primarily of fines (silts, sands, and clays). The stratigraphy in the cut-bank reveals a complex layering that includes former locations of a tributary channel, evidenced by gravel lenses and surface depressions (Figure 99).

Figure 99. Cut-bank located at RM 72.2 on river-left -- composed of alluvium (silts, sands, and clays with gravel lenses), with a paleo-channel notch. (8/15/2014)

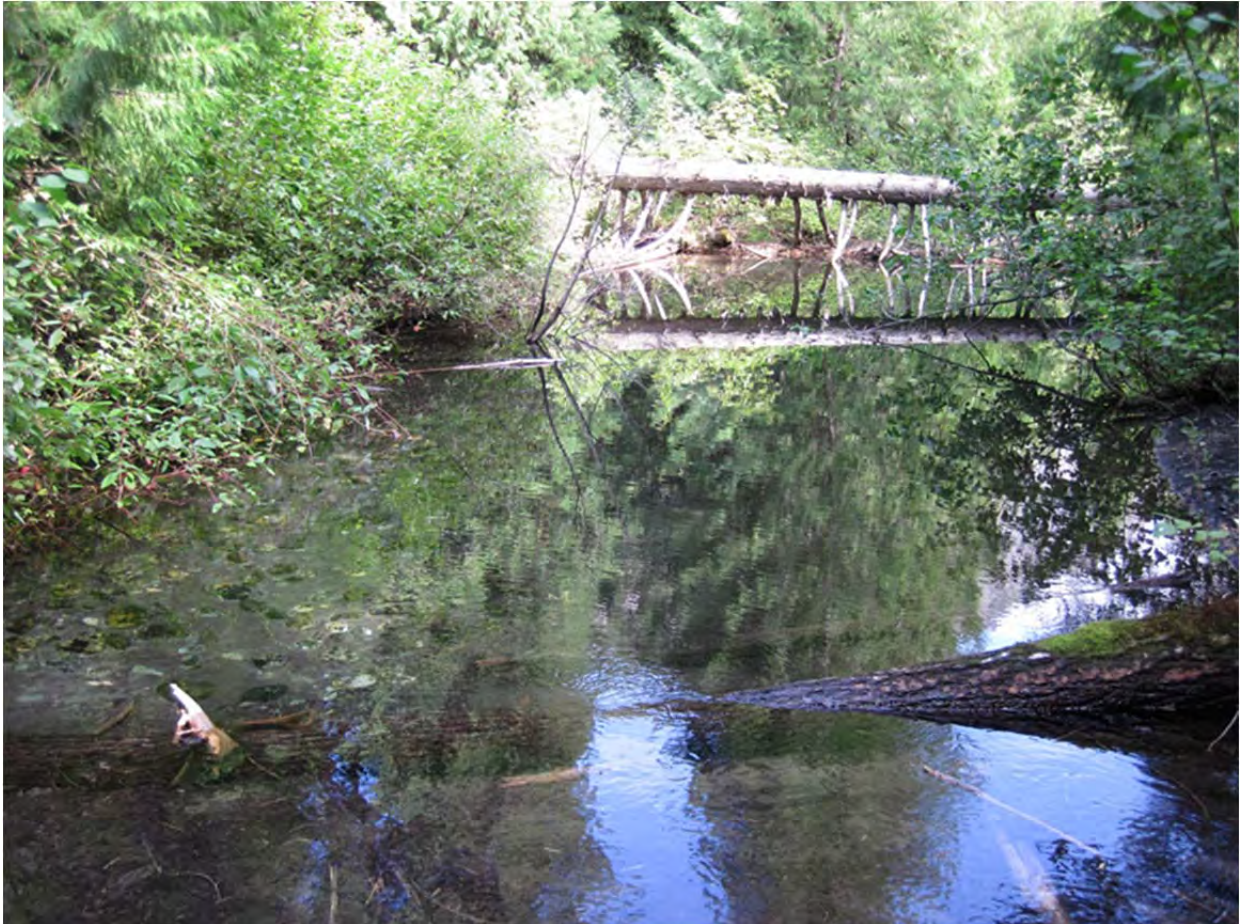
An important hydrologic feature in Reach 6 is the side-channel that traverses the floodplain on river-left from RM 73.8 to 72.3. The feature is now disconnected from the mainstem at the upstream end by a constructed canal that crosses its path. The canal blocks surface flow from entering the side-channel, and instead diverts it off the floodplain. Today, downstream from the canal, this side-channel still has surface flow but it is fed by groundwater inputs alone. The groundwater is generated upstream and from the adjacent terraces and alluvial fans. Where the side-channel borders the toe of a large alluvial fan, notable upslope groundwater inputs lower the temperature of its surface water. This side-channel traverses the edge of the floodplain along the north side of the valley and eventually delivers the collected groundwater to the mainstem as surface flow at RM 72.3. Three large beaver dams and a few log jams create pools that impose natural grade control on the stream and facilitate the local accumulation of fines and nutrients (Figure 102).

Figure 102. Ground-water wetted side-channel, disconnected from mainstem at upstream end by canal. Located on river-left between RM 73.8 and 72.3. (8/24/2014).

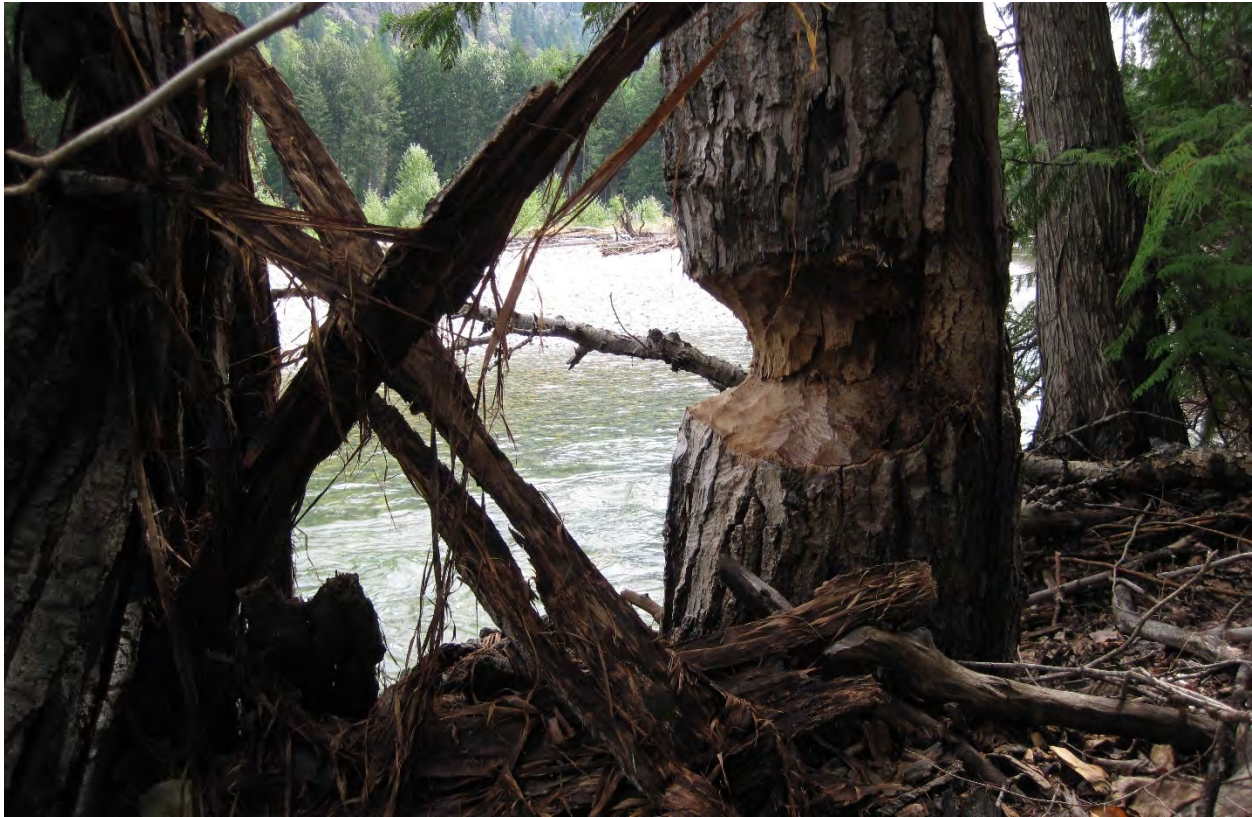
Figure 105. Beaver chew on a large cotton adjacent to the mainstem in Reach 6. (8/15/2014)

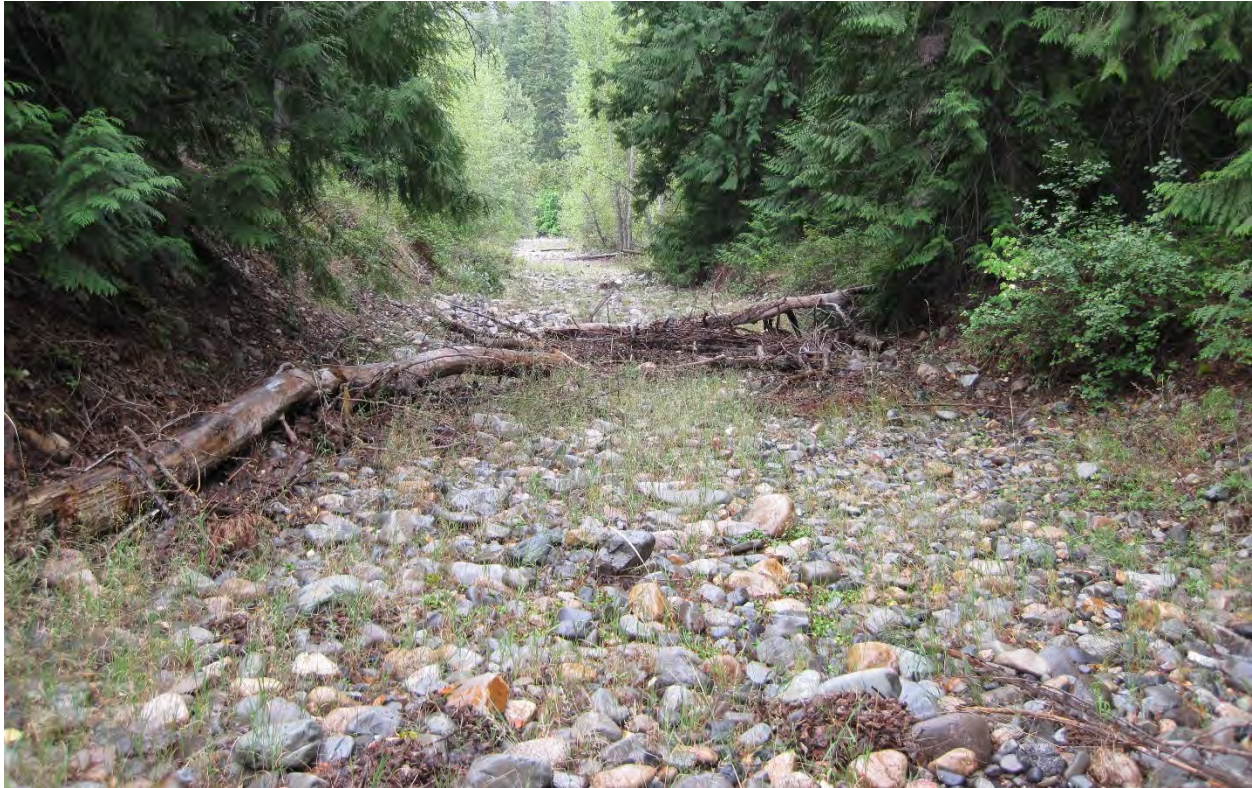
The feature that disconnects the largest amount of floodplain from the channel is a 1,600-foot-long canal constructed across the floodplain on river-left at RM 73.45 (Figure 108). The canal captures surface flow and diverts it off of the floodplain and back to the mainstem channel. It was built to reduce flooding of the private property downstream. This feature also disconnects a prominent side-channel from upstream surface water inputs. The canal was made of material dug from the floodplain; this same material was used to construct a levee along the canal's east side in an effort to further reinforce the canal's purpose.

Figure 108. Constructed canal that drains surface water from the floodplain and disconnects a side-channel. Photo taken at the downstream end looking up-canal near RM 73.45. (8/14/2014)

Recommended actions in Reach 6 are focused on improving floodplain and side-channel function and connectivity as well as increasing channel complexity. Floodplain function and connectivity can be improved by removing/modifying unnecessary riprap and levees, placing meander jams along the bank to improve margin habitat, and removing or selectively breaching the floodplain drainage canal (RM 73.5). Enhanced alcove and side-channel connectivity can be addressed by removing unnecessary riprap and push-up levees, and placing apex jams with select excavation to enhance through-flow. The design and extent of these actions will need to consider the impacts to infrastructure and private property in the Lost River Community. Channel complexity can be increased by placing large wood jams that capture wood, build islands, enhance lateral migration, and deflect flow away from the Lost River Road and Community. Planting native riparian vegetation where clearing has occurred is also recommended.

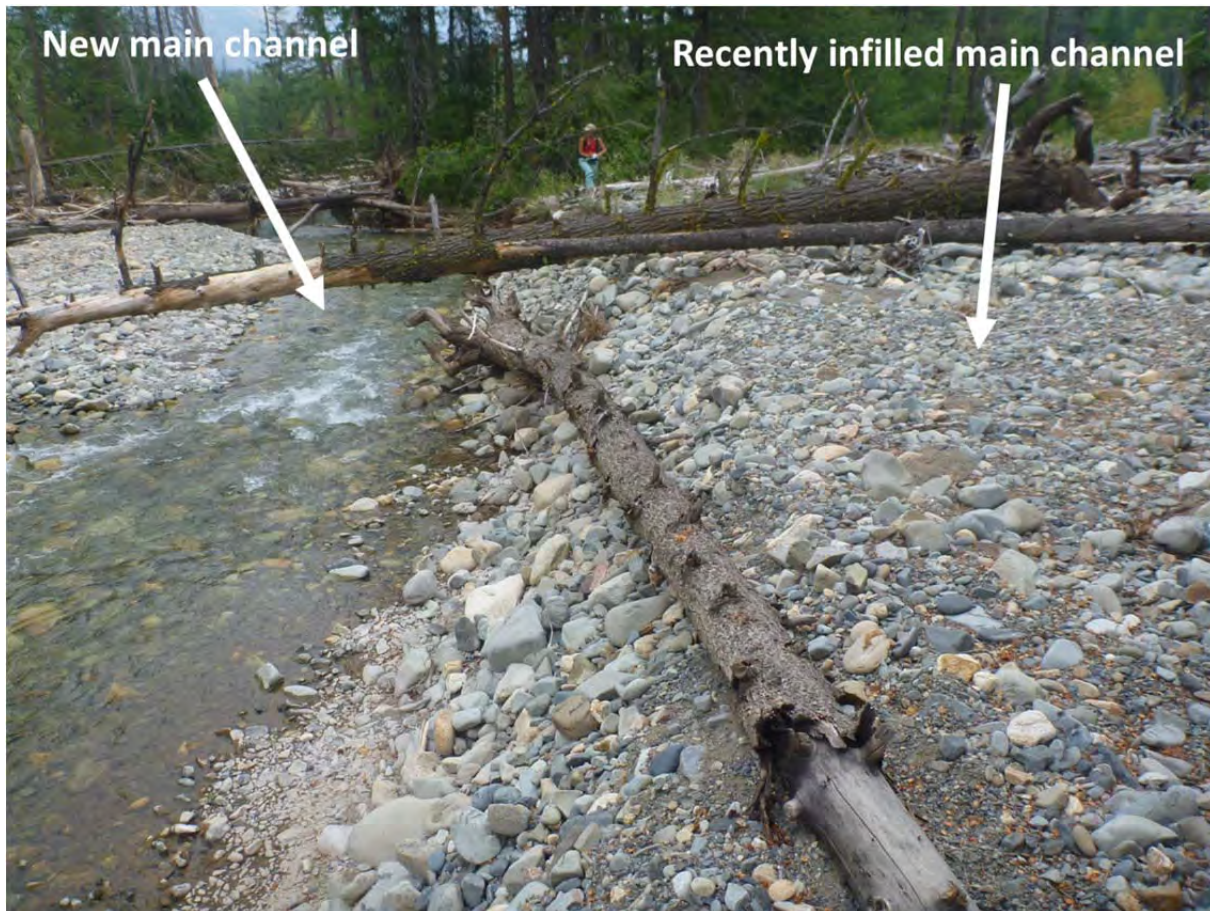
In Reach 7, the floodplain features are inundated at different rates due to the range in surface elevations relative to the channel bed [low (1-2 feet), medium (2-4 feet) and high (4-5 feet)]. Through processes of bed erosion or deposition, the rate of inundation for a particular floodplain surface can change if the channel bed elevation changes. Accumulations of sediment and/or large log jams that force changes in the river's hydraulics at a site can instigate lateral migration, channel avulsions, or the creation of multiple channels. High flow events can result in scour and/or fill of channel beds. A good example of this can be seen at the recently filled and abandoned channel on the south side of the channel at RM 75.75 (Figure 116).

Figure 116. Change in channel location through infilling (instigated by wood accumulations during high flow) and avulsion at RM 75.75.
