Upper Methow River Reach Assessment

River Miles 61 - 80

SUBMITTED TO
Yakama Nation Fisheries

FINAL - DECEMBER 2015

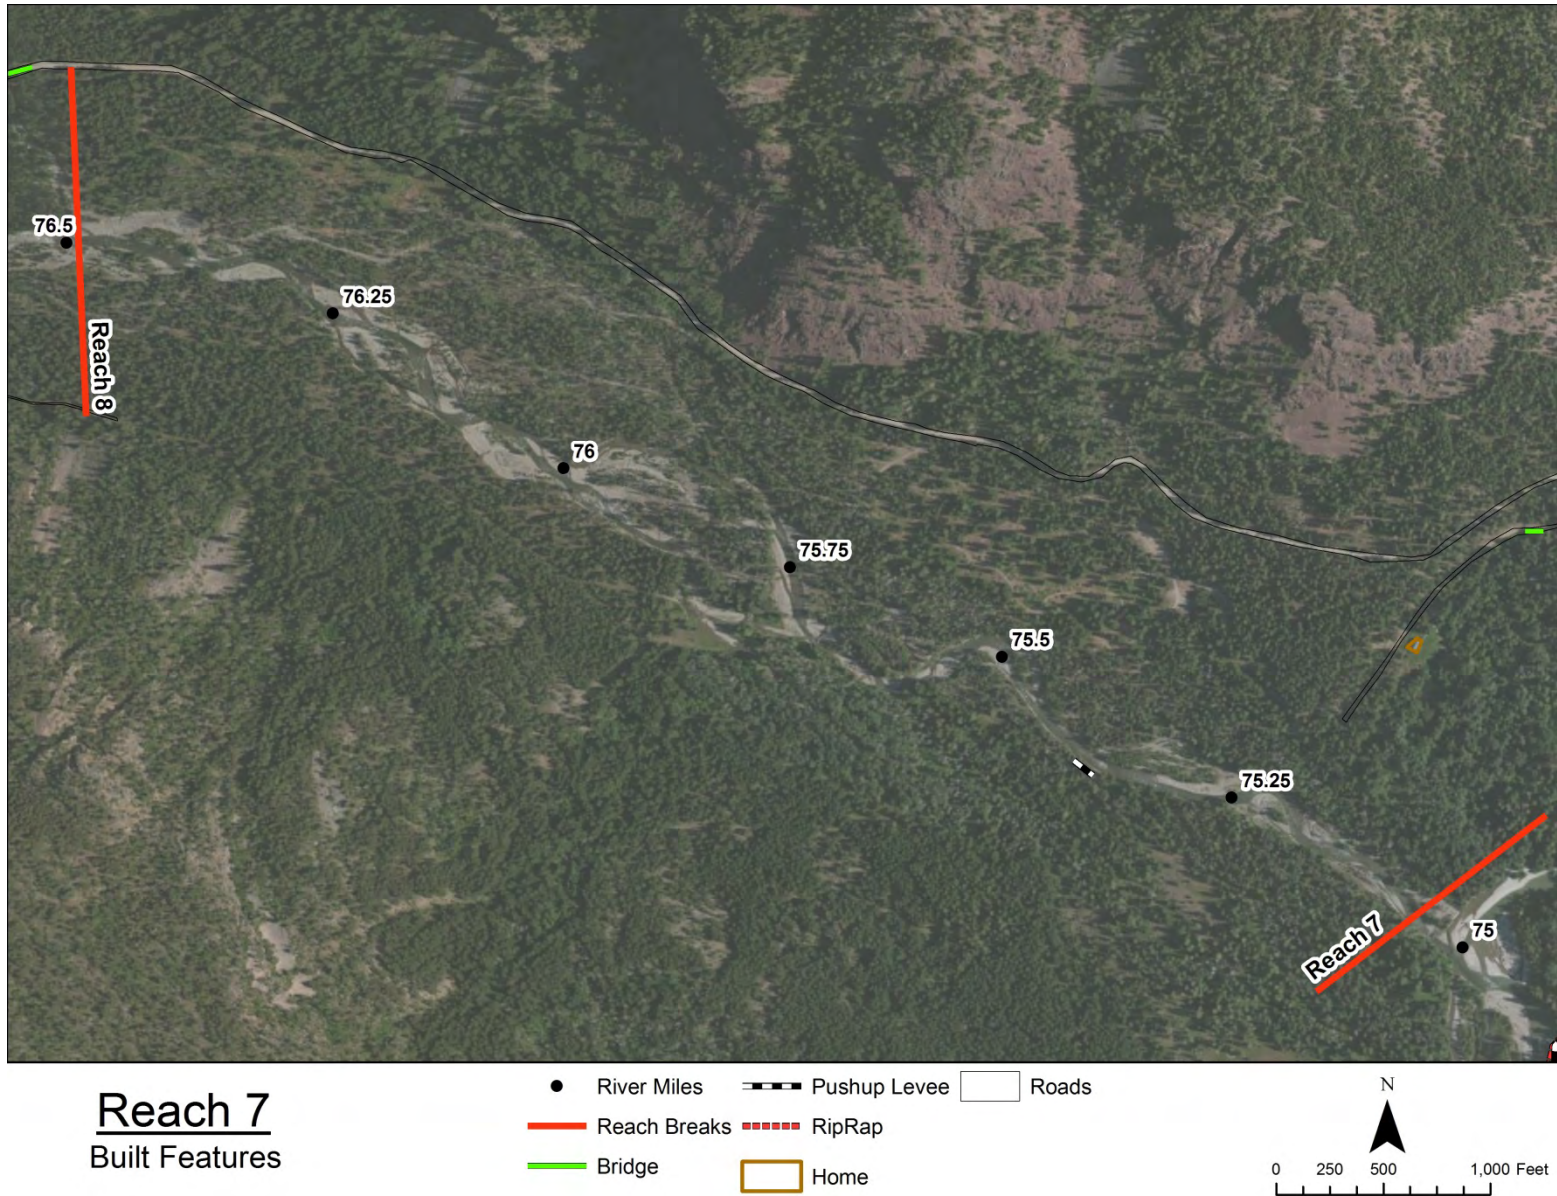
Figure 120. Primary human features in Reach 7.

Human features are mapped in Figure 120. The primary human alteration in the reach includes the following, which is described further in the subsection below.

Recommended actions in Reach 7 are focused on restoring channel complexity and increasing side-channel and floodplain connectivity. Channel complexity is best addressed by placing apex and debris capture log jams to establish more islands and enhance lateral and split flow conditions. Debris capture jams are likely to be effective at capturing much of the smaller wood anticipated to enter the reach from upstream due to recent wildfire, debris flow, and snow avalanche contributions. Side-channel and floodplain connectivity can be addressed by removing the push-up levee, constructing apex jams, and targeted excavation. Channel margin improvements can be made

with large wood complexes along unvegetated banks. Native riparian vegetation planting in the few areas where clearing has occurred is also recommended.

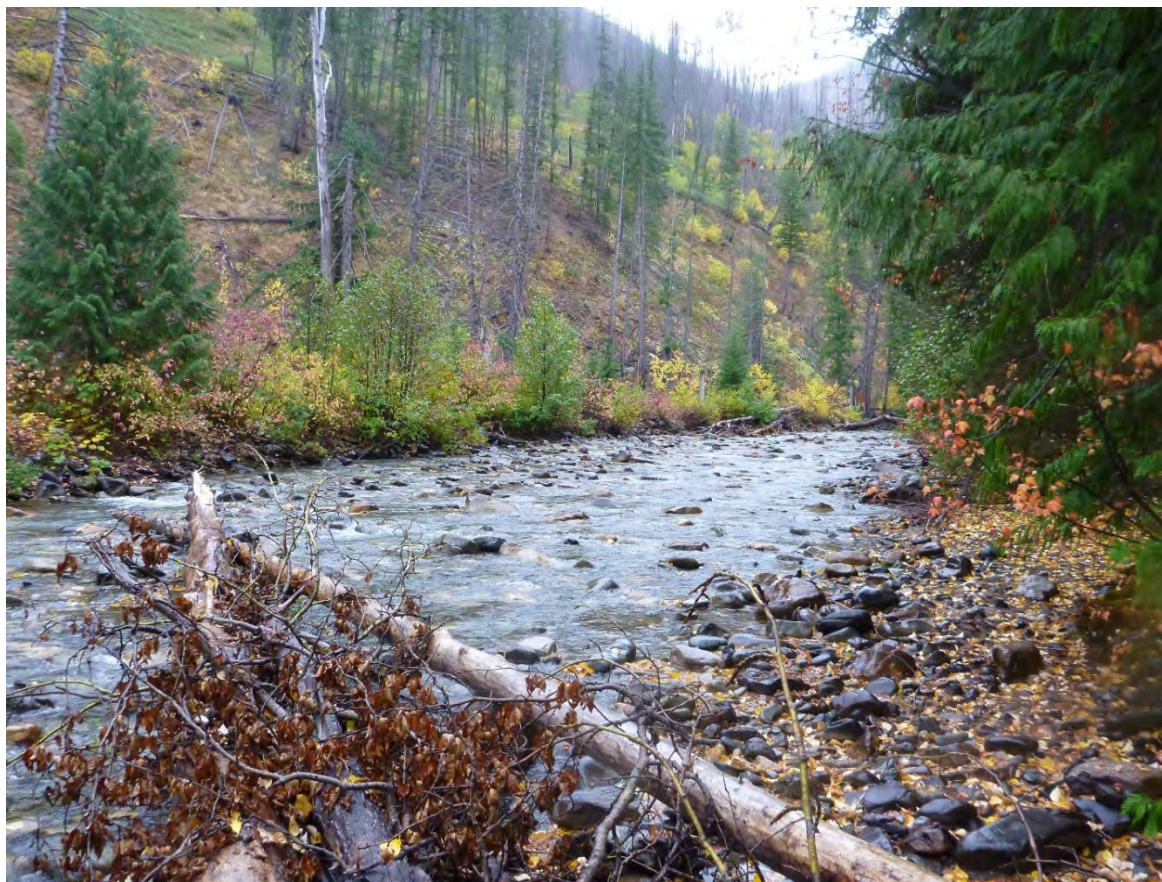
The channel in Reach 8 is a single-thread, riffle-pool stream with extended riffles and short pools (Figure 122). Many of the pools are maintained with boulder steps. There are three side-channels from RM 76.6 to 76.9, where aggradation is occurring due to local sediment inputs and large wood accumulation. The channel bed and active floodplains are composed of materials ranging in size from gravels to boulders, but large cobbles dominate the substrate. Hillslope inputs include weathered bedrock debris, glacial lag, and glacial terraces (rounded sand to boulders). Alluvial fan inputs from river-left (north side of the channel) also contribute sand- to boulder-sized material to the channel. Coarse sand and gravels are efficiently transported through the channel except where they are temporarily stored on floodplains or in localized deposition zones such as bar tops or eddies. The reach is vegetated with maturing forests except where forest fires recently burned most of the vegetation. The forest fire in 2003 left standing snags from RM 77.9 to 78.6; this section now has an establishing understory of shrubs and saplings. The remaining snags are now a plentiful source of large wood to the channel. This wood is influencing and will continue to influence geomorphic processes in Reach 8, and downstream reaches, for a decade or more.

Figure 122. Representative photo of Reach 8; looking downstream at RM 78.25. (10/15/2014)

Recommended actions in Reach 8 are focused on reactivating side-channels and floodplain surfaces. However, existing mostly undisturbed conditions and access challenges limit restoration opportunities in Reach 8. Side-channel and floodplain reactivation can be addressed by removing the push-up levee and bank armoring near Ballard Campground.

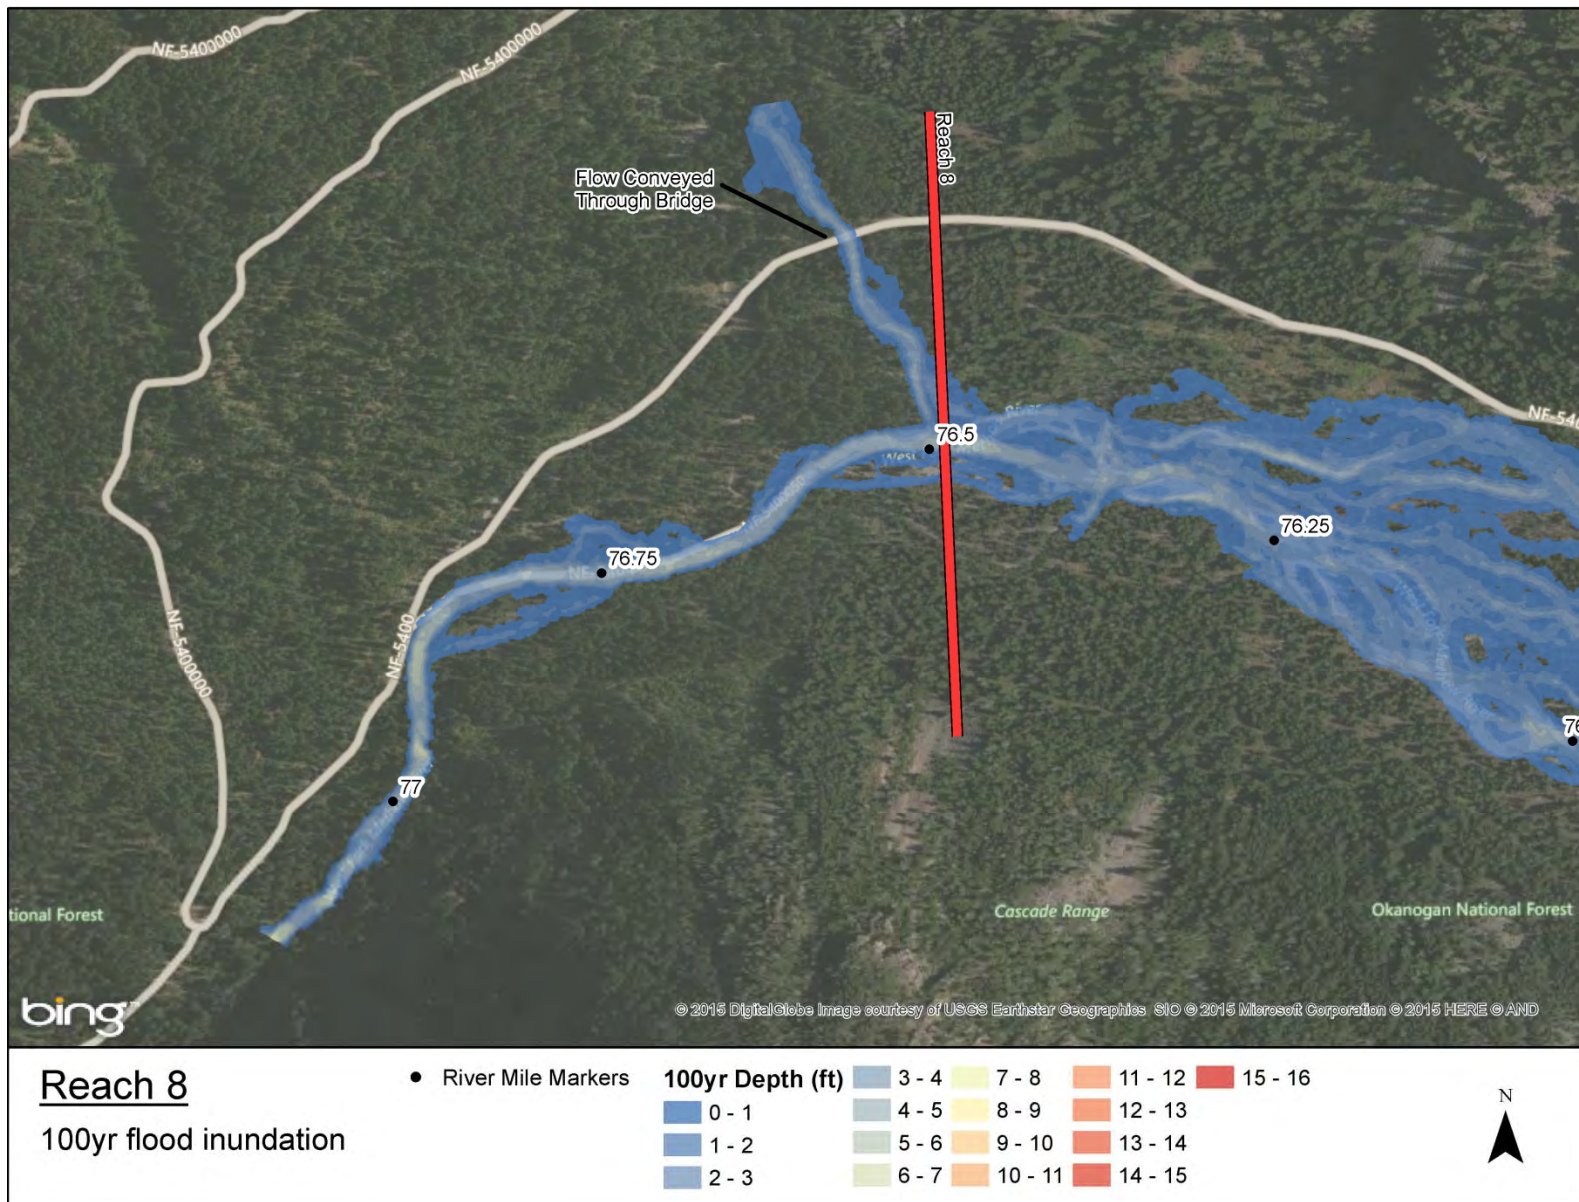
In May 2014, an avalanche deposited hillslope debris and a massive quantity of downed large wood onto the floodplain from RM 79.6 to 79.7. Generated by unstable mountaintop snow accumulation, the avalanche entered the valley, toppling trees and distributing debris onto the valley floor. This event contained enough mass and force to distribute snapped trees on the opposite side of the valley where the avalanche ran up the foot of the slope. Today, large wood debris from this event buries the valley floor and toe slopes for approximately 500 feet (Figure 136). Avalanche-generated fines that had been deposited directly into the channel were subsequently flushed out by late spring high flows of 2014. However, Reach 9 and downstream areas will likely be influenced by this source of large wood and debris for decades.

Figure 136. Downed trees and debris from May 2014 avalanche; looking upstream at RM 79.6. (10/15/2014)

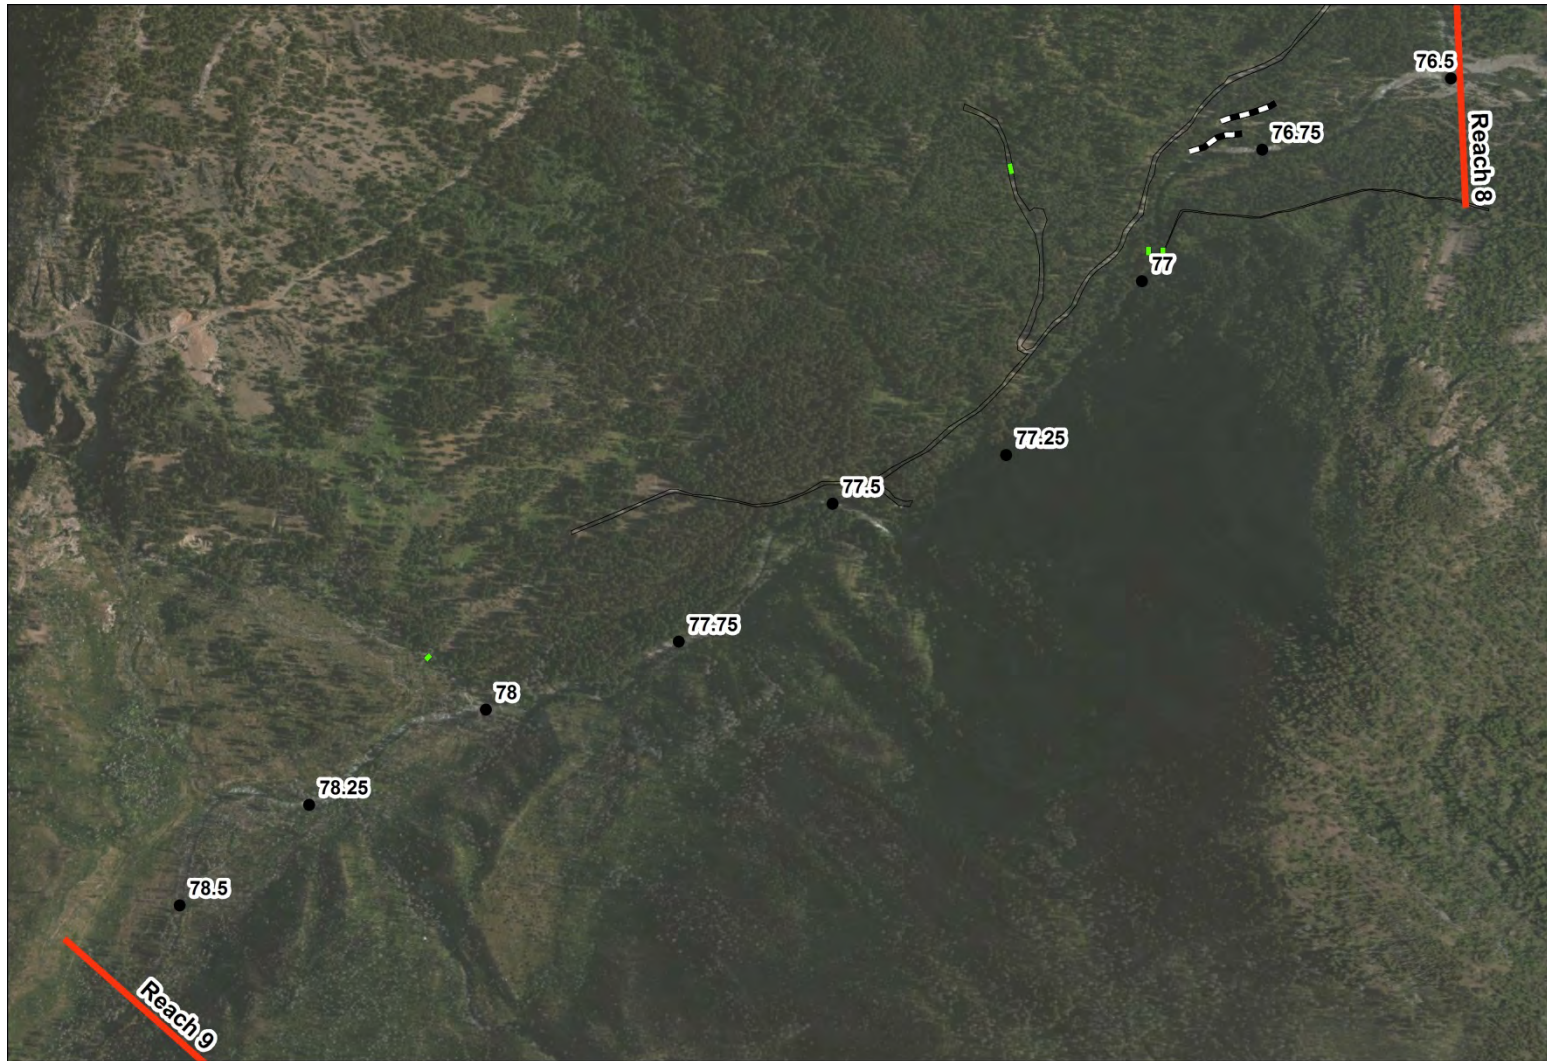
Reach 8
Built Features

The habitat conditions in Reach 8 are discussed in Appendix A. Based on the REI analysis, only 4 of 11 habitat indices are rated as either unacceptable or at risk (see Table 6). Human alterations to Reach 8 are minimal and limited to a dirt road, trails, and three campgrounds that are mostly located above the active floodplain. Construction of push-up levees and the partial clearing of vegetation at Ballard Campground (RM 76.75) have the potential to locally impede natural channel processes. Otherwise, healthy, natural, hydrologic and geomorphic processes are occurring in this reach.

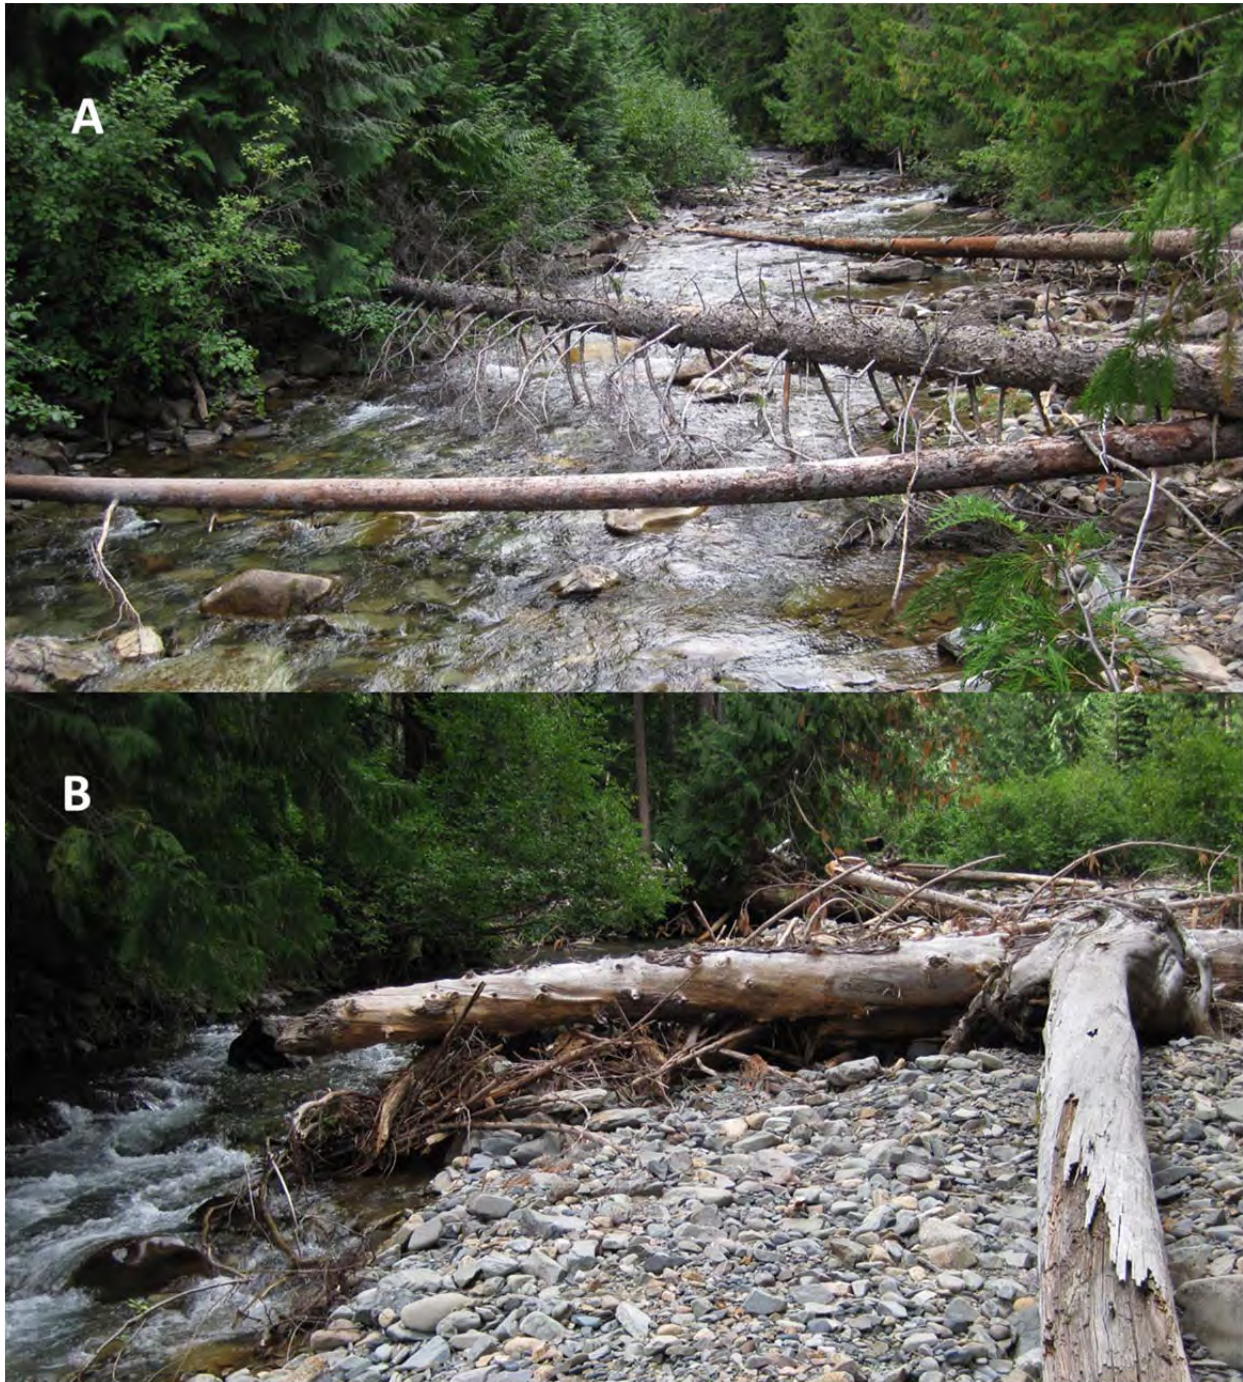
Figure 139. A) Channel-spanning logs and dense floodplain vegetation in Reach 9; looking downstream at RM 79.2, B) Large wood accumulation and cobble accumulations at RM 79.1. (09/02/2014)

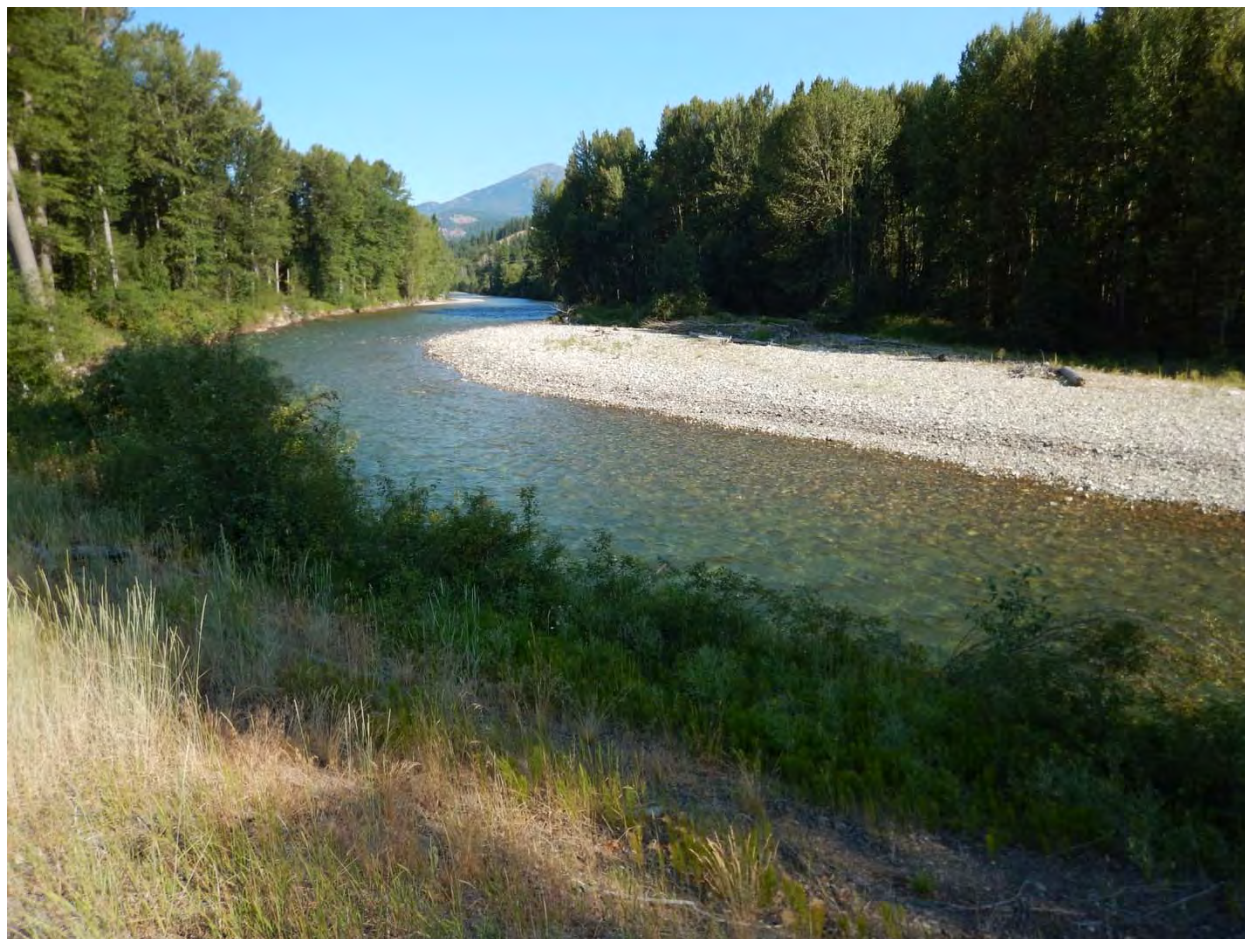
Figure 17. Representative view of Reach 1. Only three channel units were recorded in Reach 1; all were fast water. Observations at the one n^{th} unit in Reach 1 identified both the overstory and understory as dominated by cottonwood, also visible in this photo.

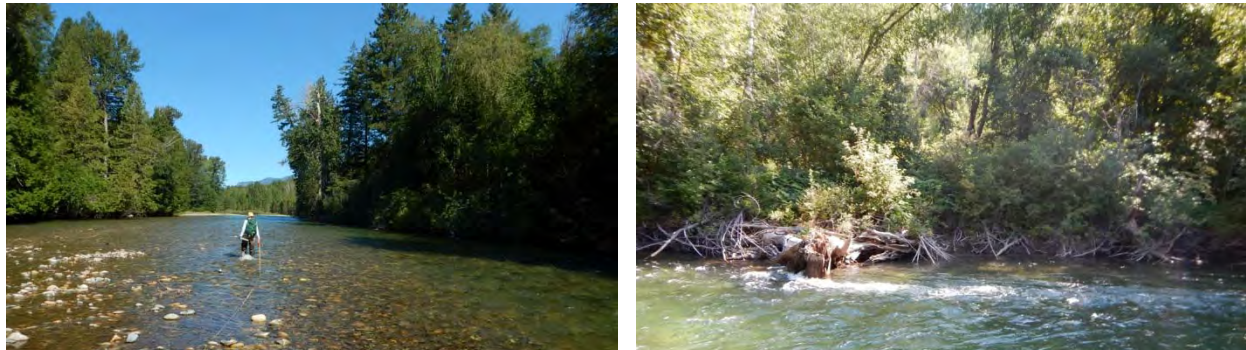
Figure 21. Substrate in Reach 1 is largely composed of gravel and cobble (left). Overall, Reach 1 is relatively deep and fast moving (right).

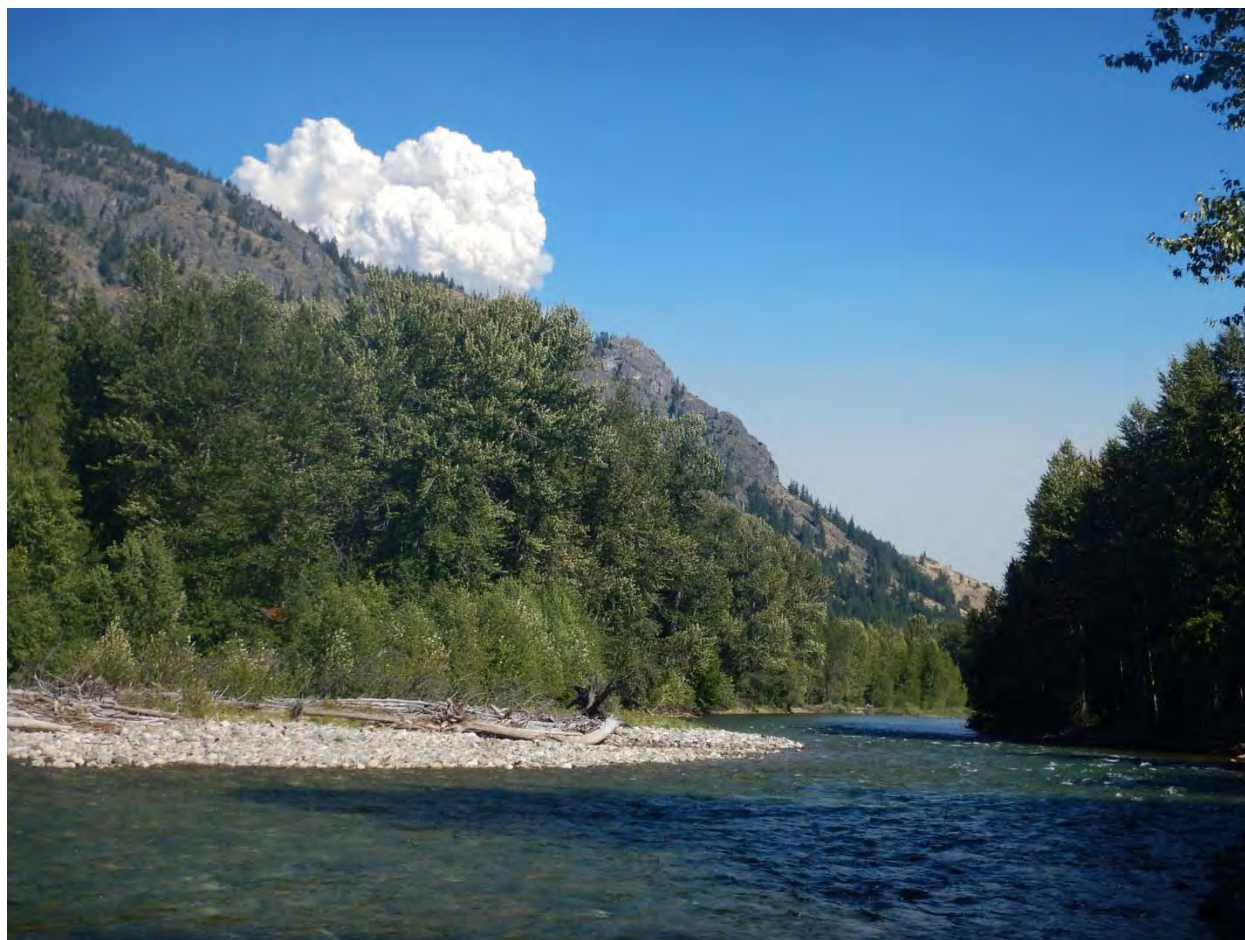
Figure 24. Representative view of Reach 2. In the background smokes rises from the Carlton Complex Fire – creating a pyrocumulus cloud.

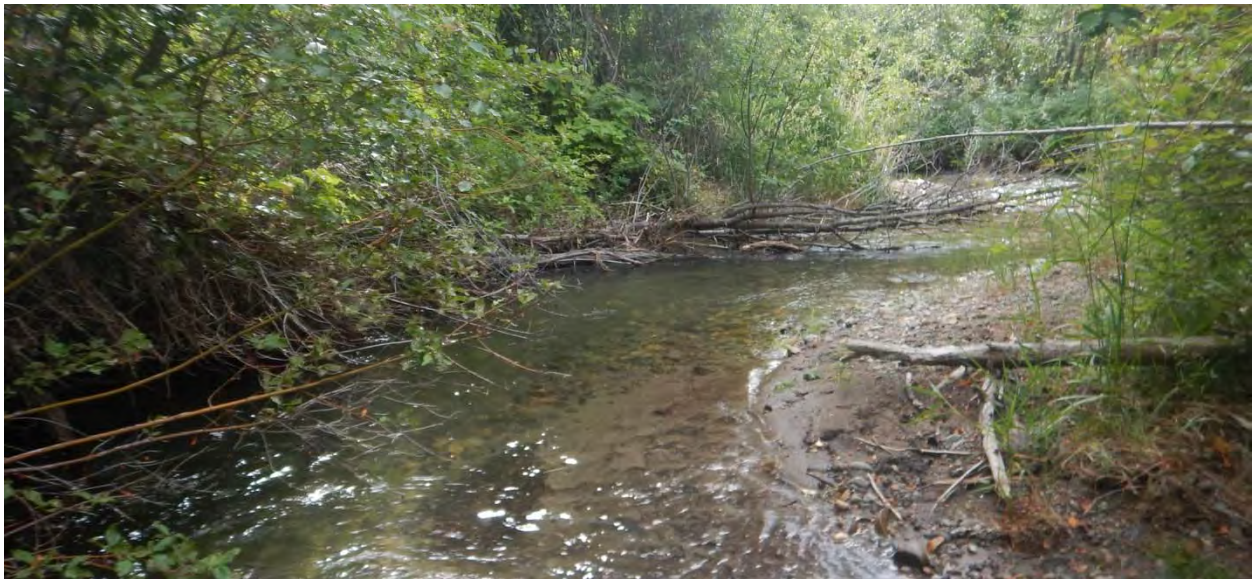
Table 9. Three off-channels entered the Methow River between River Mile 64.3 - 64.5. Photo below is Side 9F.

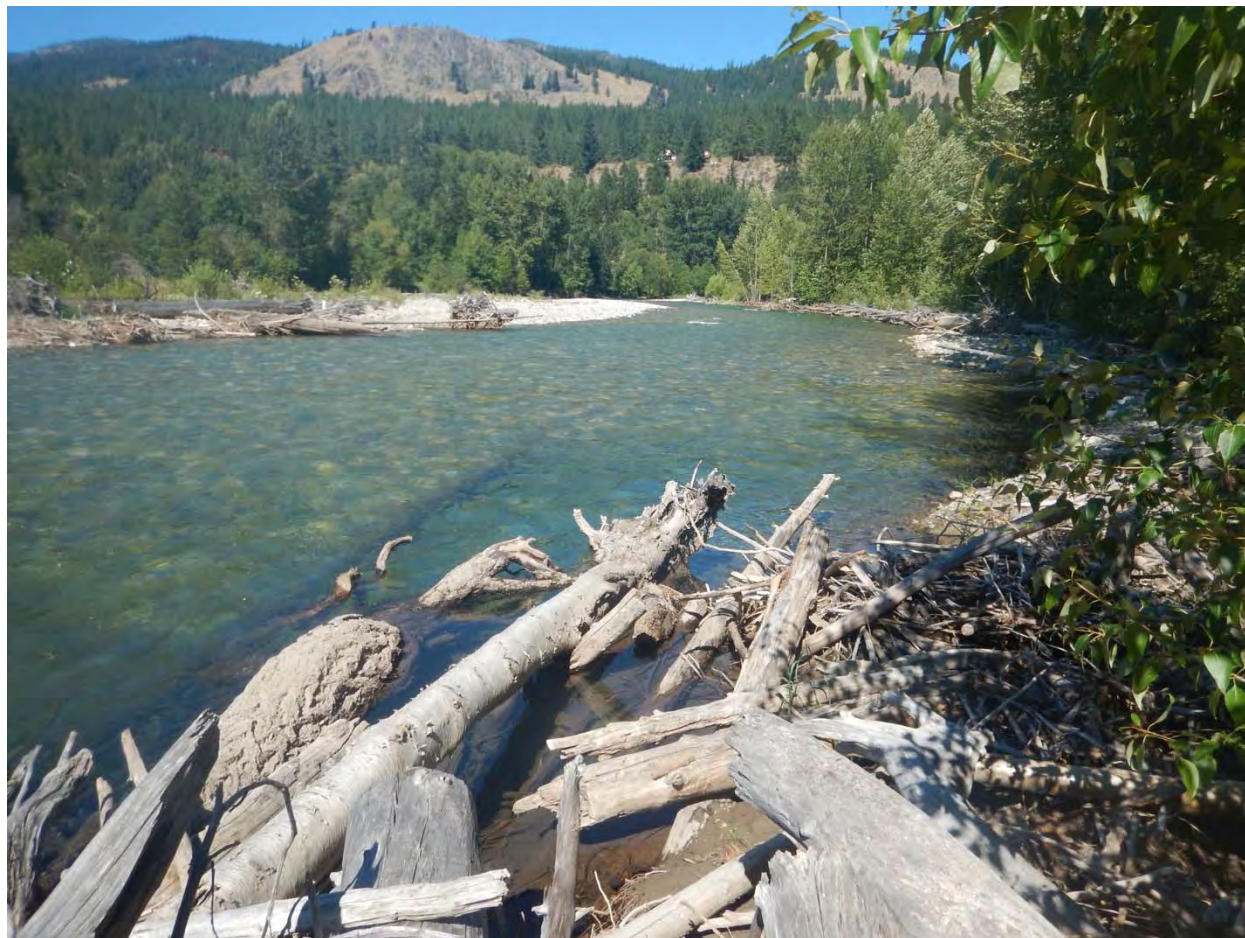
Figure 28. Reach 2 pebble counts indicate a bed substrate of almost equal amount cobble and gravel, as well as a slightly higher than average count of LWD. The image above taken around RM 62.0 reflects these measurements.

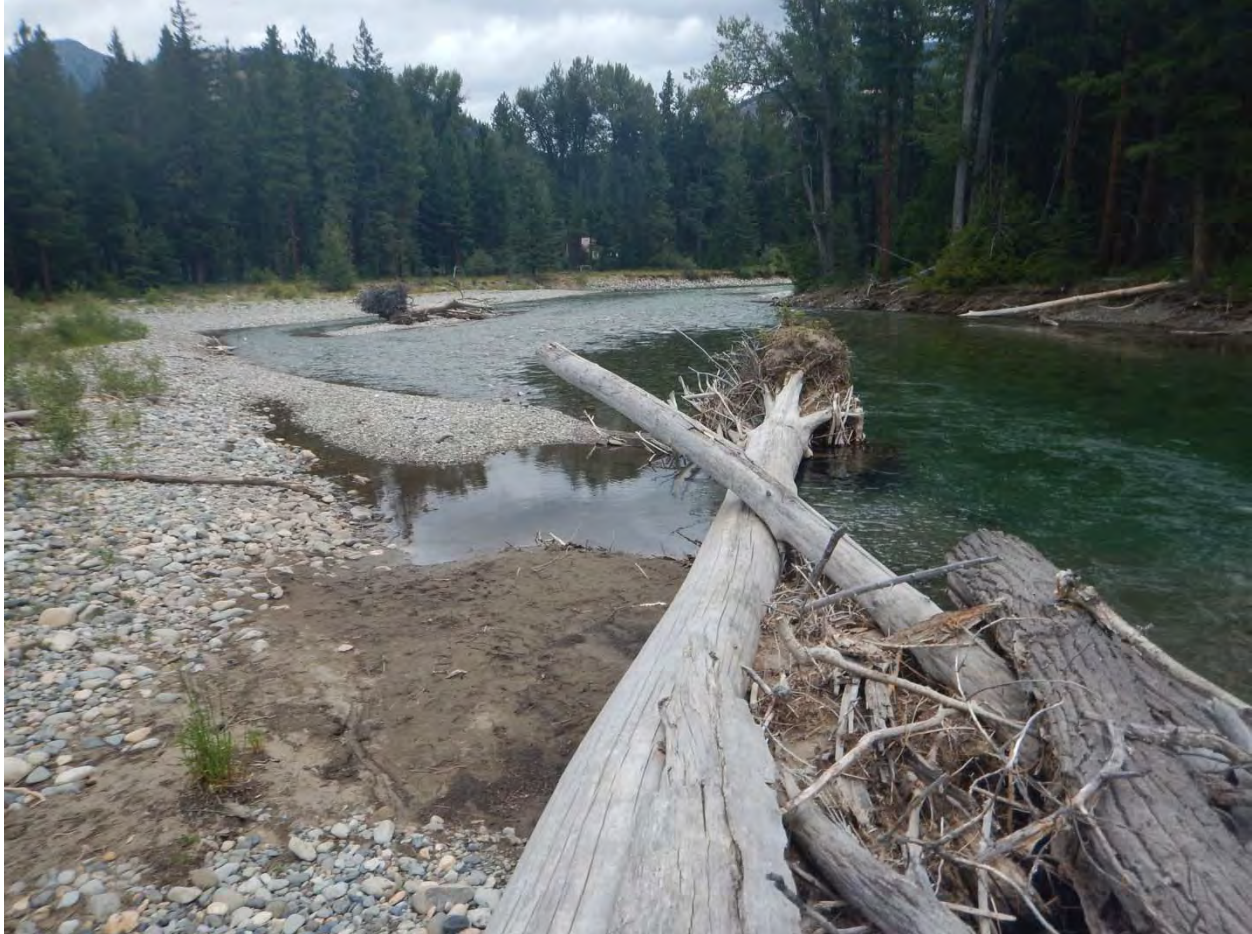
Figure 33. Representative image of Reach 3, which had some of the highest wood counts and a higher than average pools per mile ratio.

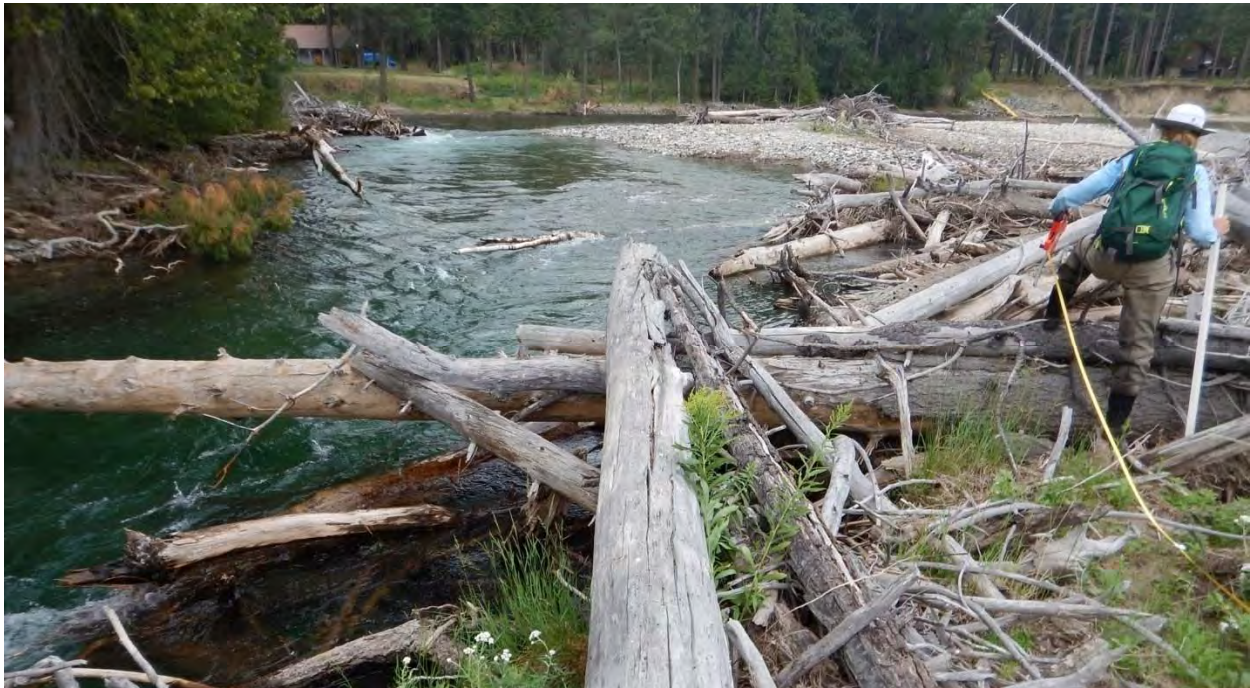
Figure 37. Reach 3 pools are deep, averaging a residual depth of 5.8 feet. Photo above of a pool a RM 65.1 and log jam on river left (right side of photo).

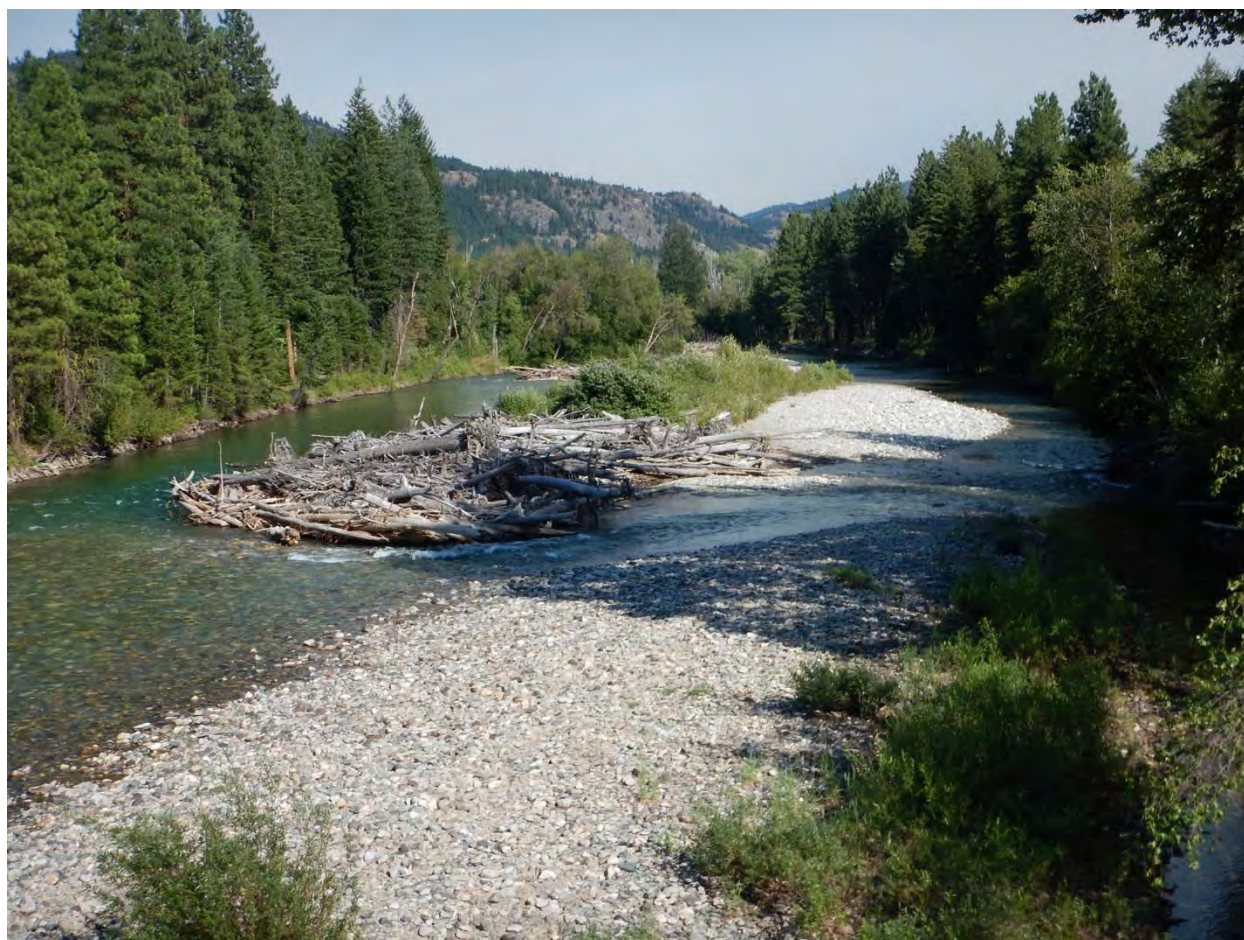
Figure 46. Jam 17 in Reach 4 from the bridge on Lost River Road near the town of Mazama. The jam was estimated to have 100 small, 70 medium, and 30 large pieces of LWD.

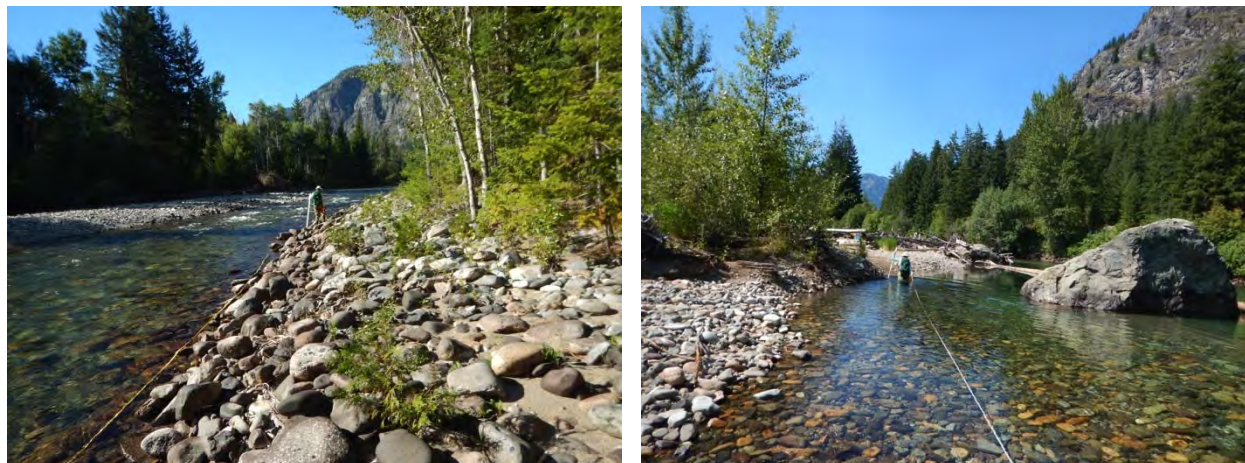
Figure 50. The first half of Reach 5 is mostly fast water with few pools, secondary channels or log jams (above photo left). The second half of Reach 5 contains seven log jams, high quality secondary channel habitat, and a high density of pools, (above photo right).

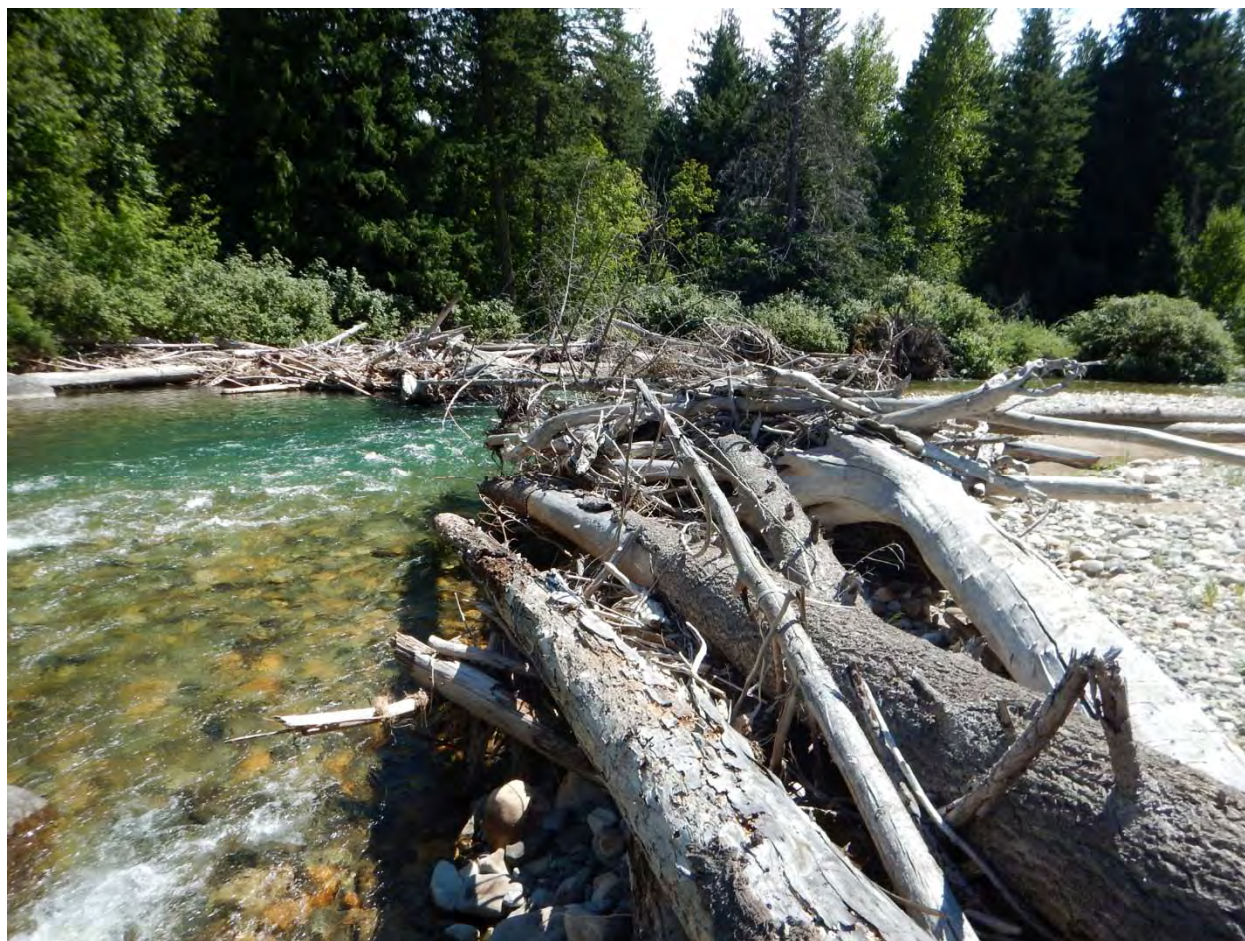
Figure 54.. A 9-foot deep pool and log jams at RM 70.8.

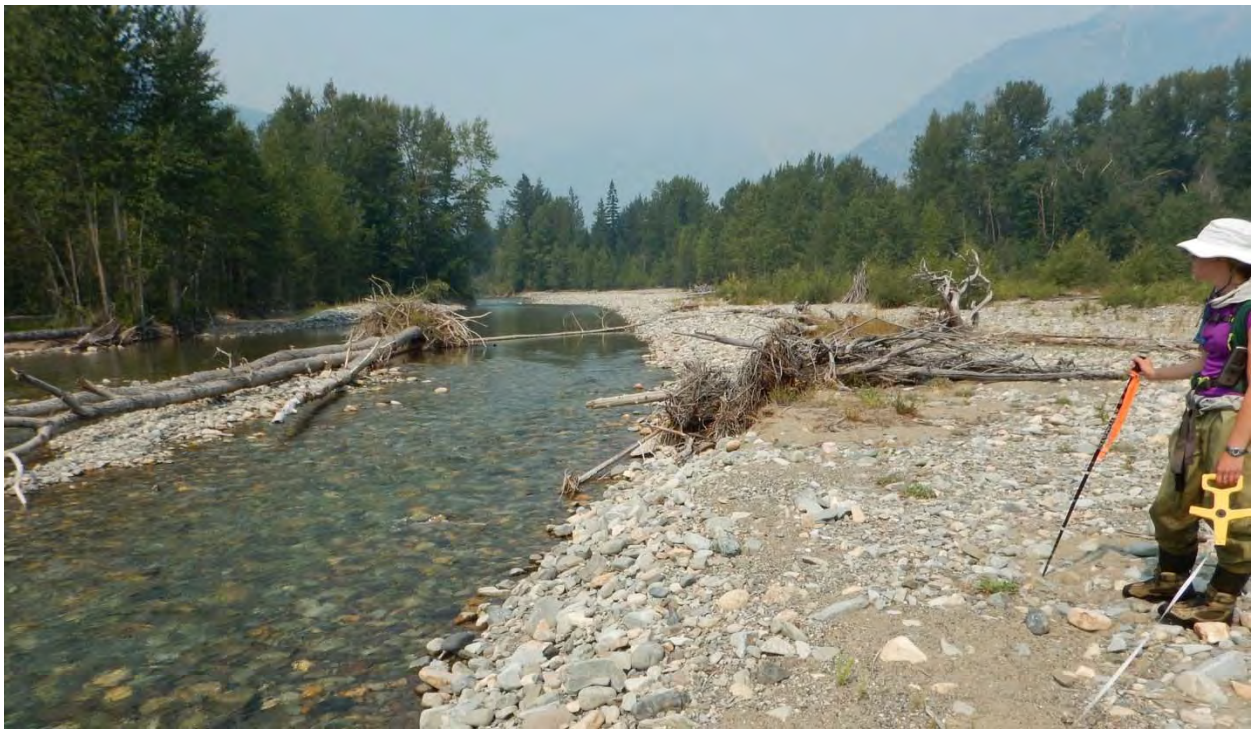
Figure 63. Reach 6 had 23 pools which together composed 27% of the habitat area within the reach. Photo above is a pool at RM 73.9.

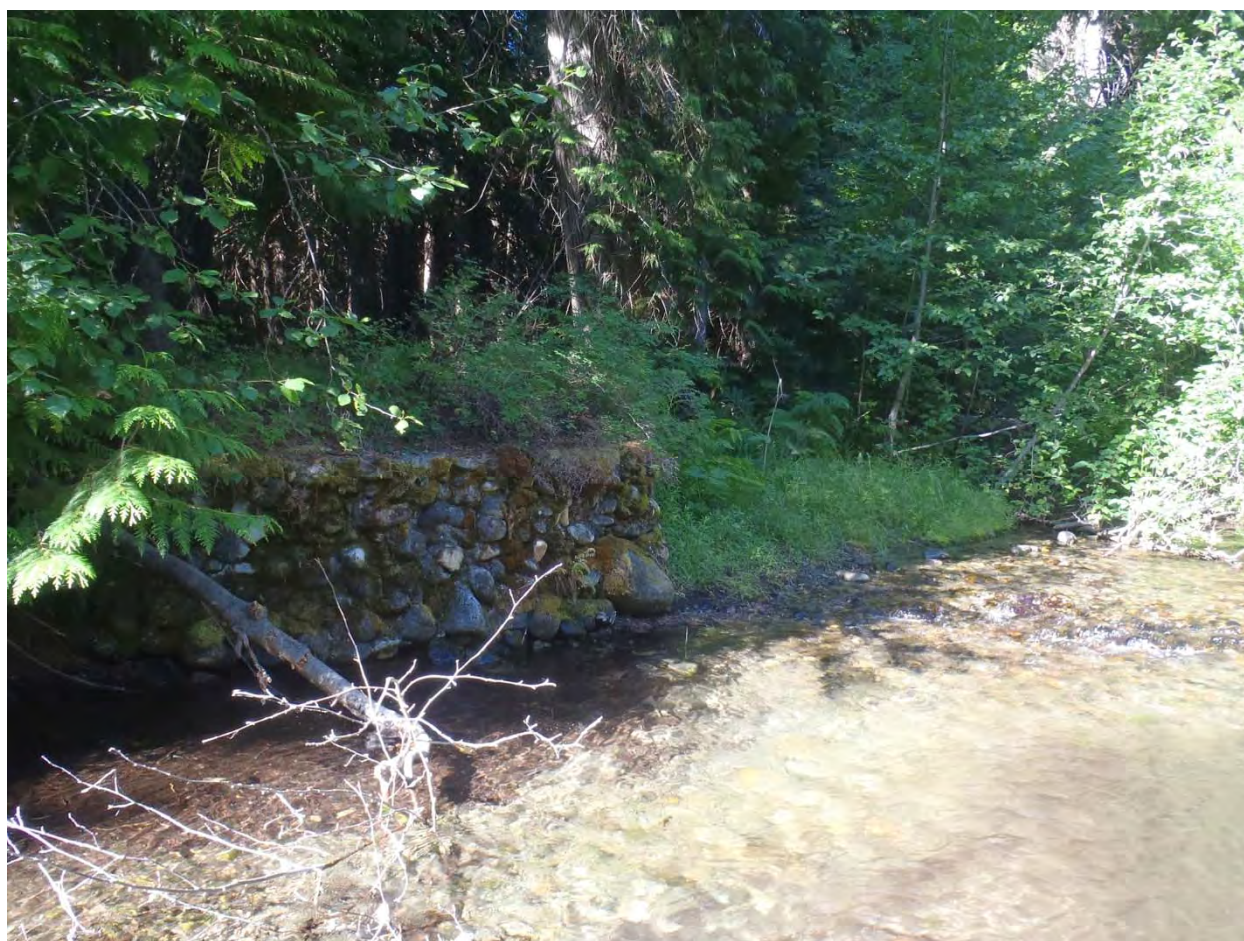
**Figure 64. Remnants of an old bridge along SIDE25S.**

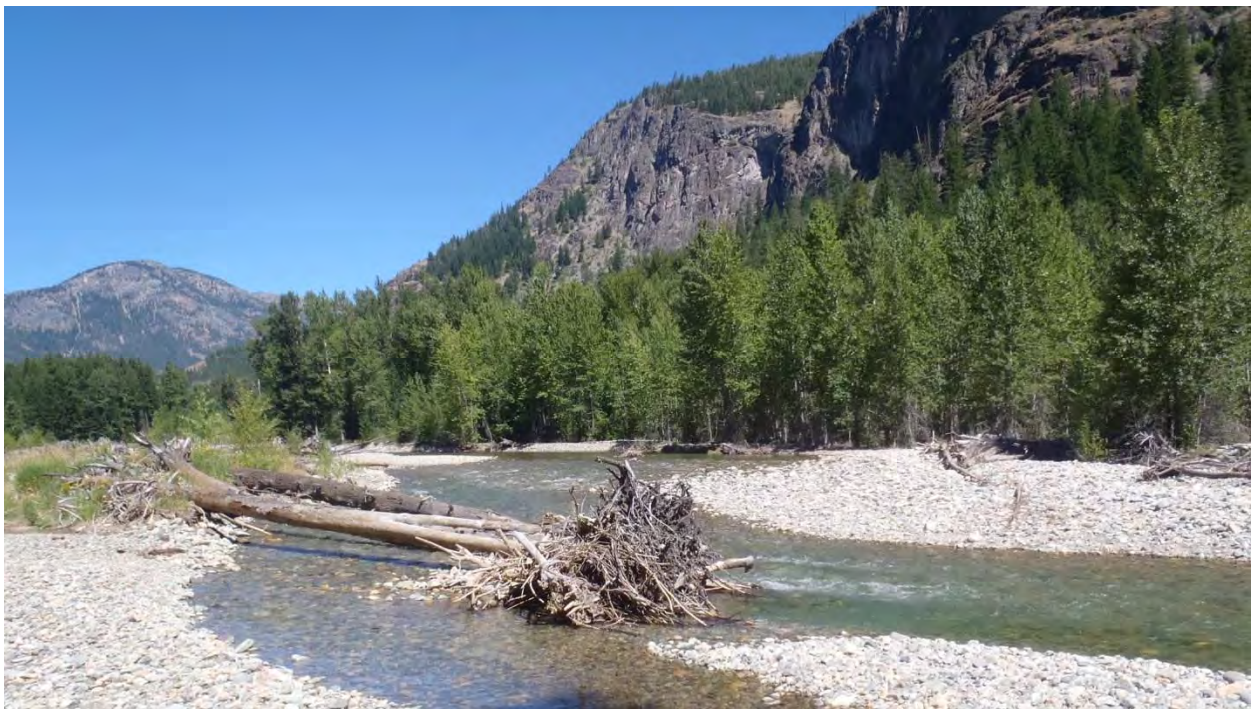
Figure 69. Small trees measuring 9.0 – 20.9 in. diameter were the primary riparian vegetation (78%).
