Upper Methow River Reach Assessment

River Miles 61 - 80

SUBMITTED TO
Yakama Nation Fisheries

FINAL - DECEMBER 2015

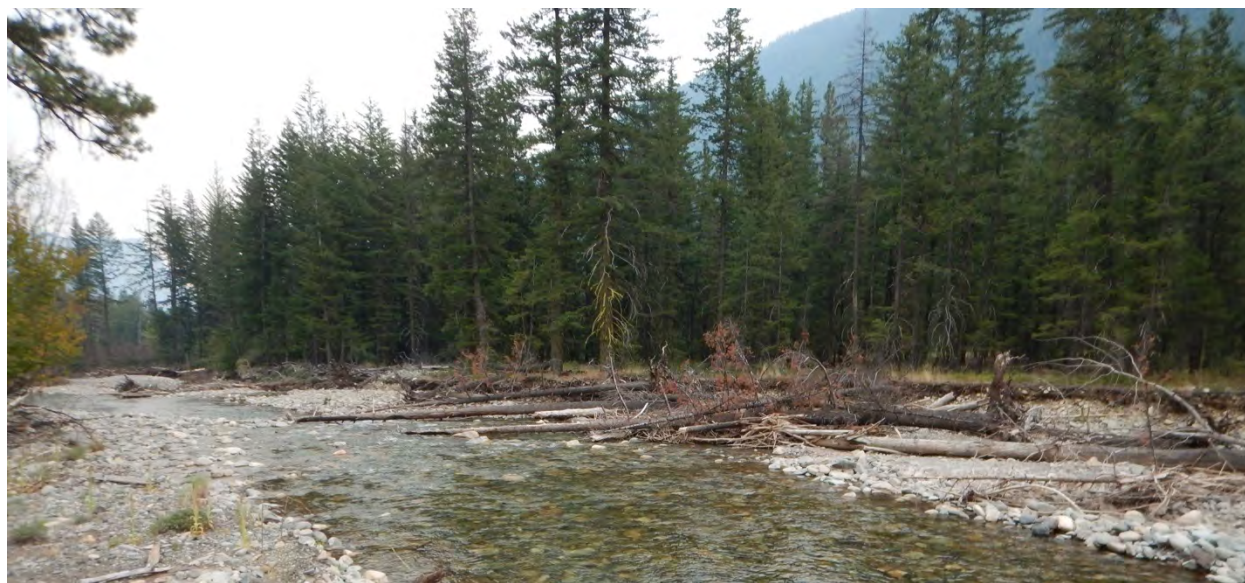
Figure 74. Lateral channel migration resulted in increased LWD at RM 76.0.

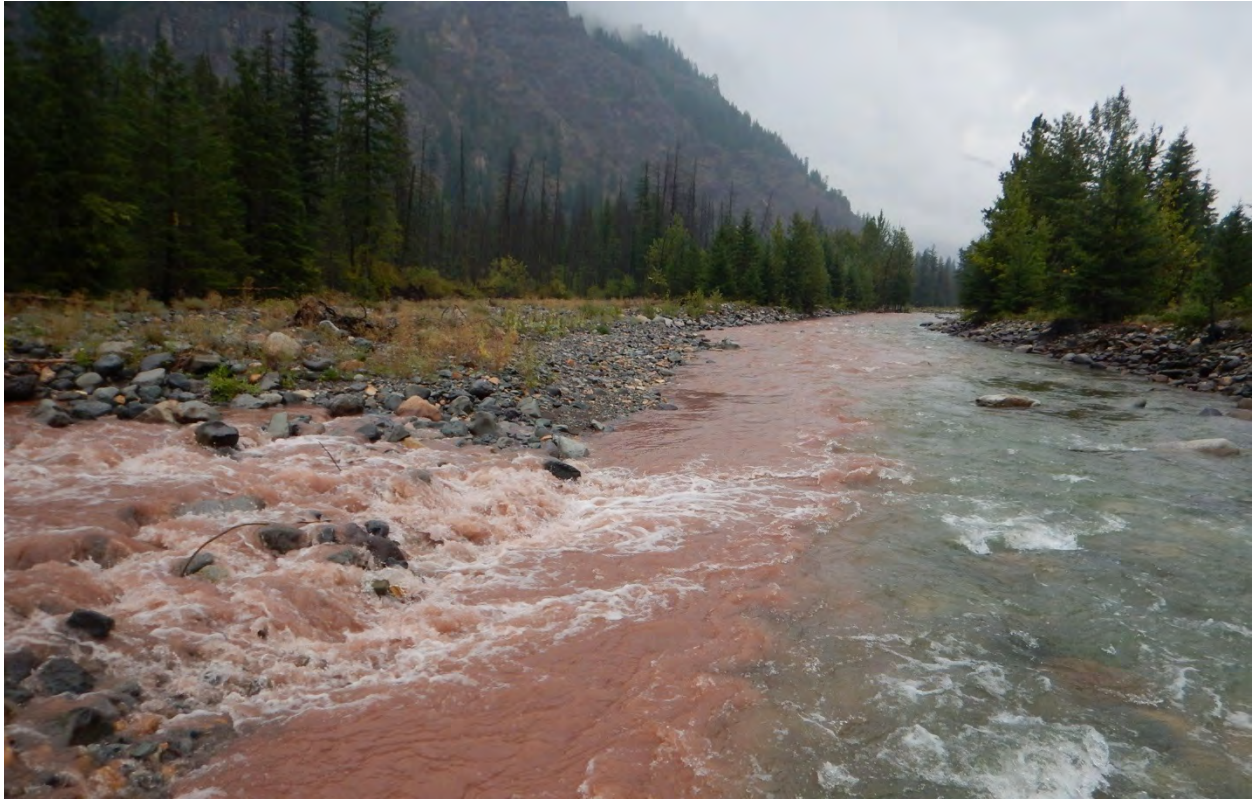
Two pebble counts within Reach 7 identified substrate that was on par with the project area average and included 51% cobble, 42% gravel, 5% boulder and 2% sand (Figure 75). Robinson Creek is a significant contributor of bedload and suspended sediment to the reach (see Figure 76).

Figure 76. Robinson Creek (left) meets the Methow at RM 76.5 following heavy rains

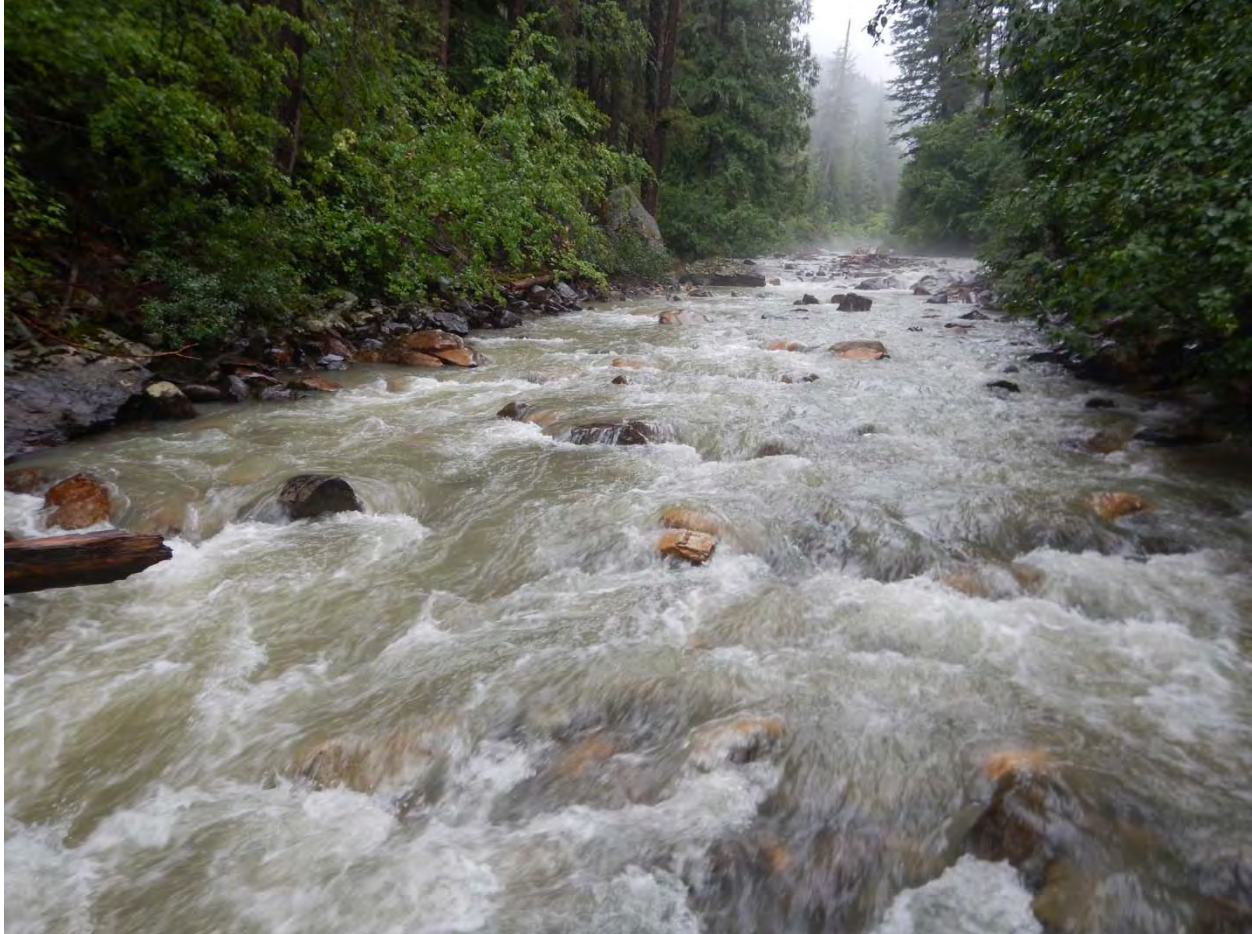
Figure 78. Reach 8 was dominated by relatively high gradient riffles (92%).

Reach 8 is a confined, steep reach composed of 92% riffles, 5% secondary channels, 2% pools, and 1% glides (Figure 80). Water levels were unseasonably high during the survey due to an intense two-day rain event (Figure 78). The higher water levels may have washed out smaller pools that would have been present at normal later summer levels. Reach 8 is a markedly smaller river due to the inflow of Robinson Creek at River Mile 76.5 that was estimated to add 15% of Methow River's flow. While the reach is dominated by riffles, there is high quality salmon habitat in side channels, especially SIDE40F between RM 77.5 – 77.9 which maintained considerable wood and a diversity of pools and riffles.

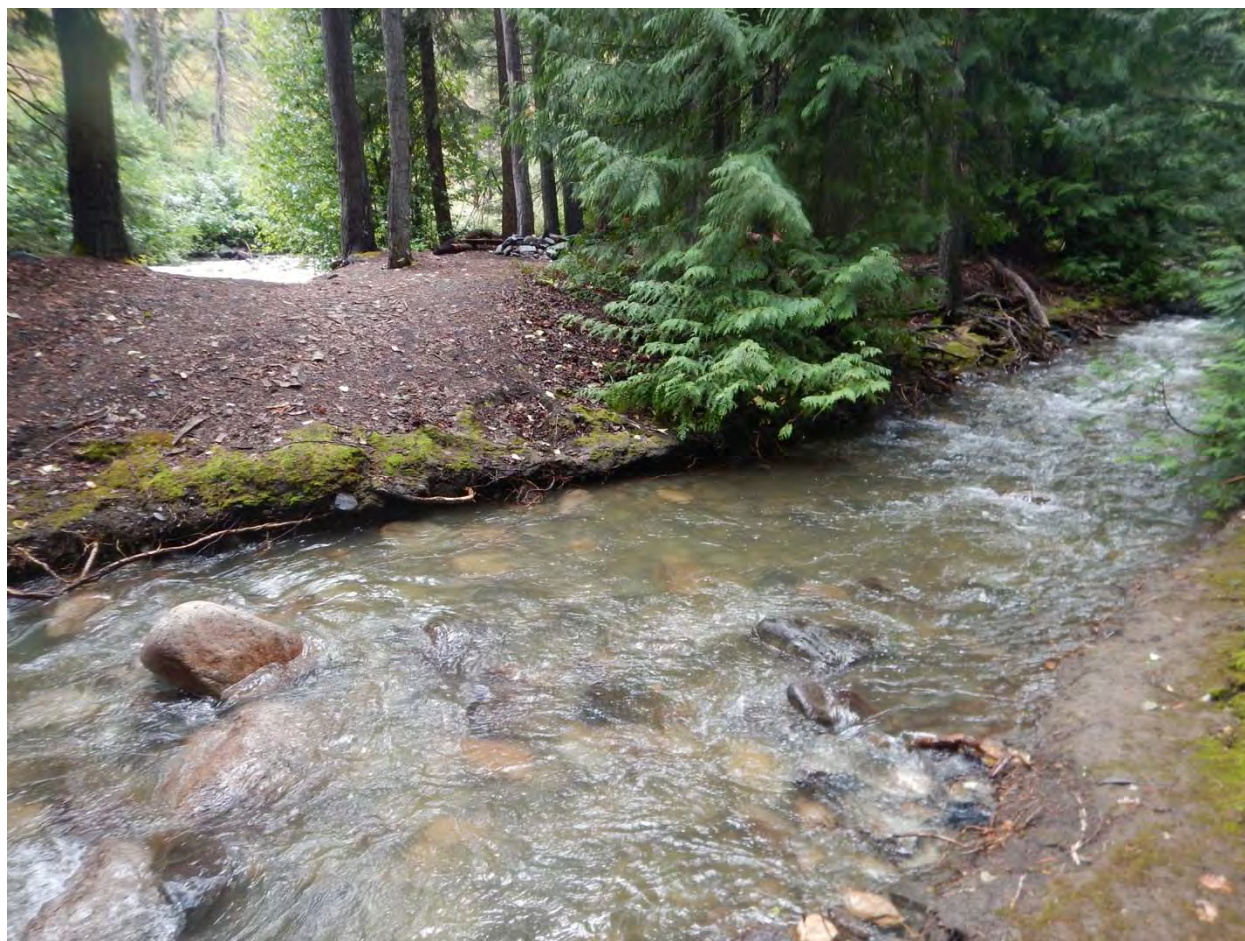
Reach 8 has four side channels comprising approximately 1% of the secondary channel habitat within the project area. The longest side channel is SIDE40F (Figure 82), which maintained a variety of riffles and pools, as well as a large apex log jam at the head of the side channel.

Figure 82. *SIDE40F with the mainstem Methow River in the background.*

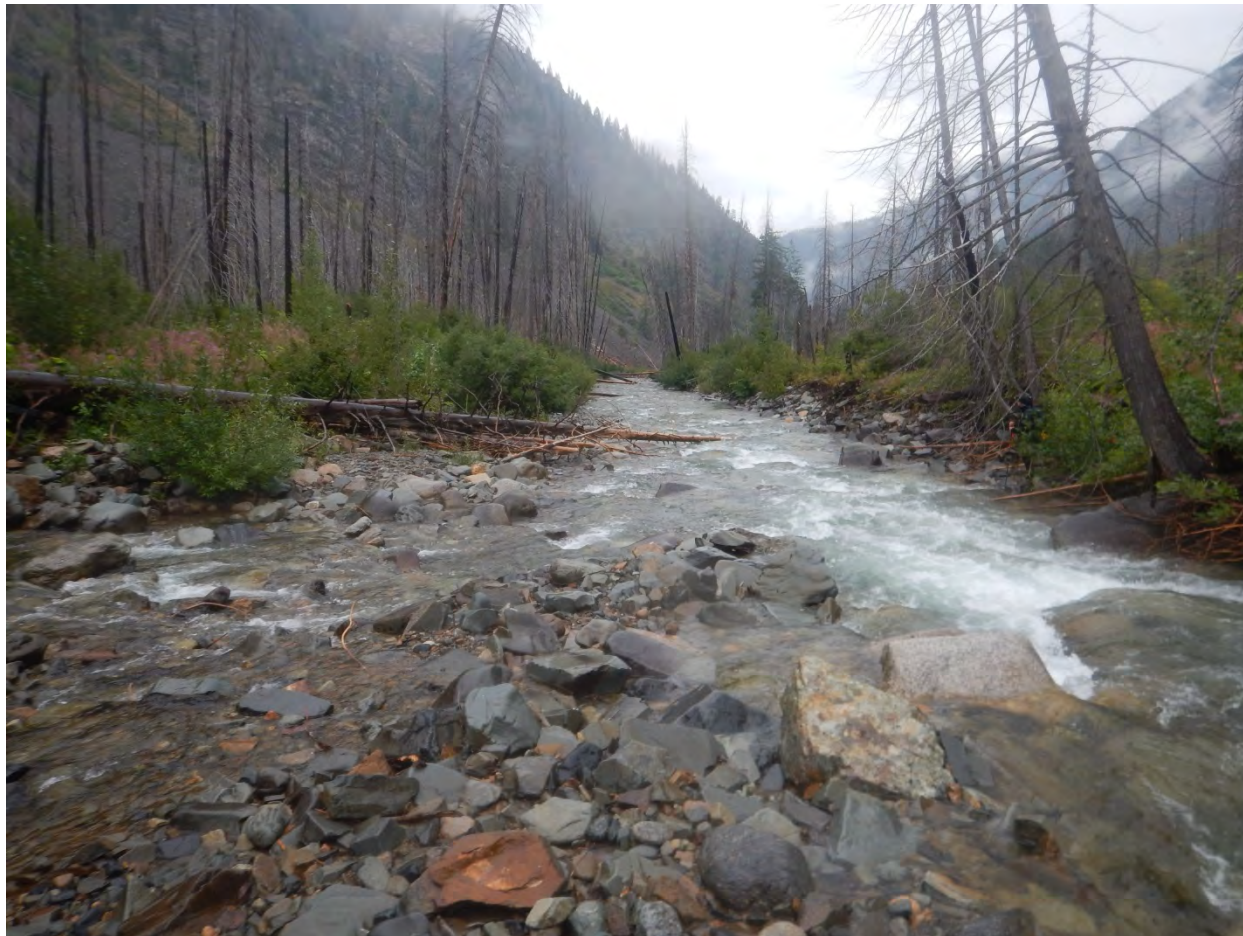
Figure 84. Representative view of Reach 9. Image is taken looking downstream from Trout Creek.

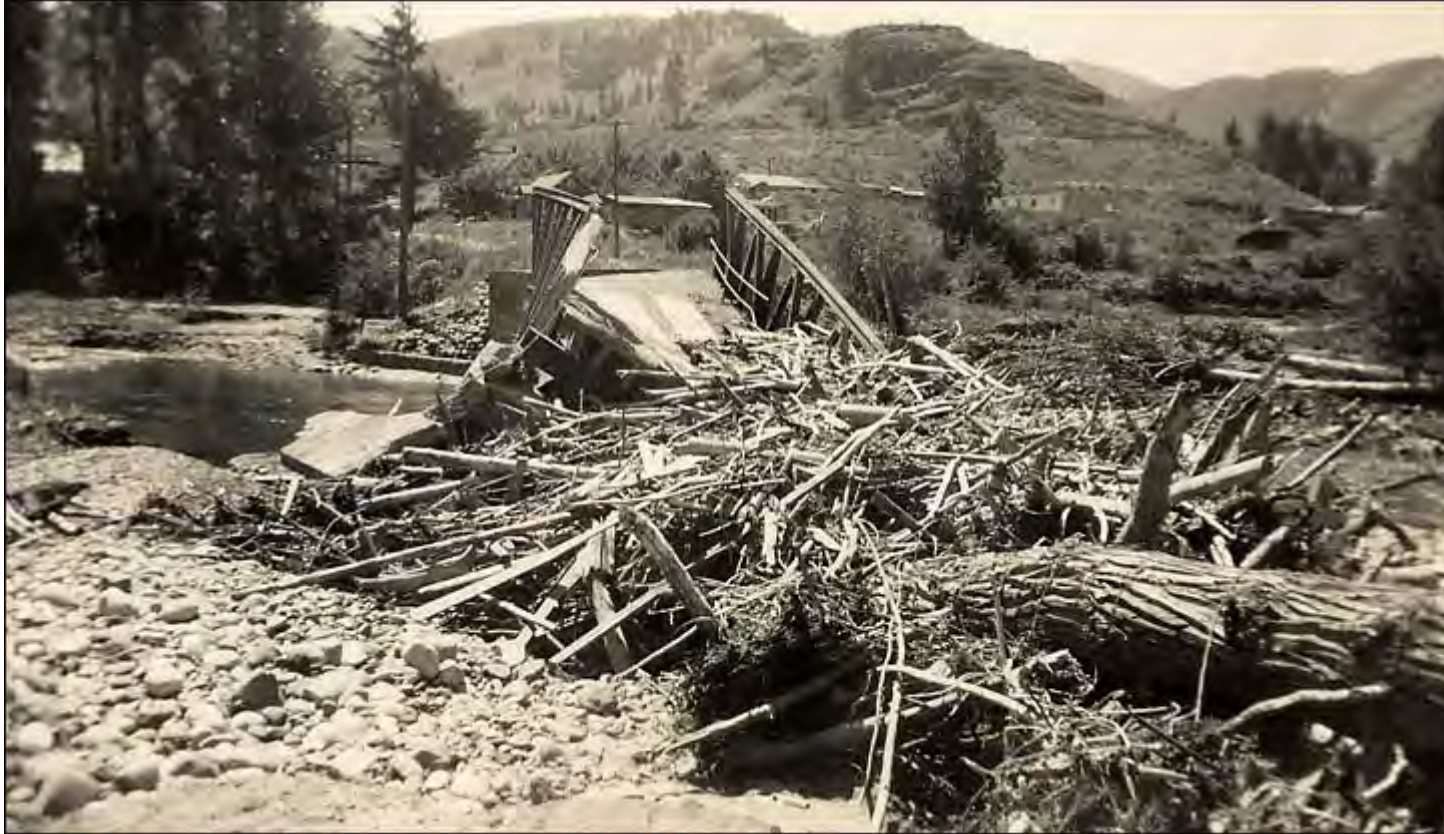
Figure 19. Debris pile and destroyed bridge along the Twisp River by the old creamery after the flood of 1948. Photo from the Wink Byrum Collection, courtesy of the Shafer Museum and the Methow Grist Archive.
