UPPER NASON CREEK REACH ASSESSMENT

Habitat Conditions and Restoration Opportunities from RM 13.7 to RM 16.2

March 2019

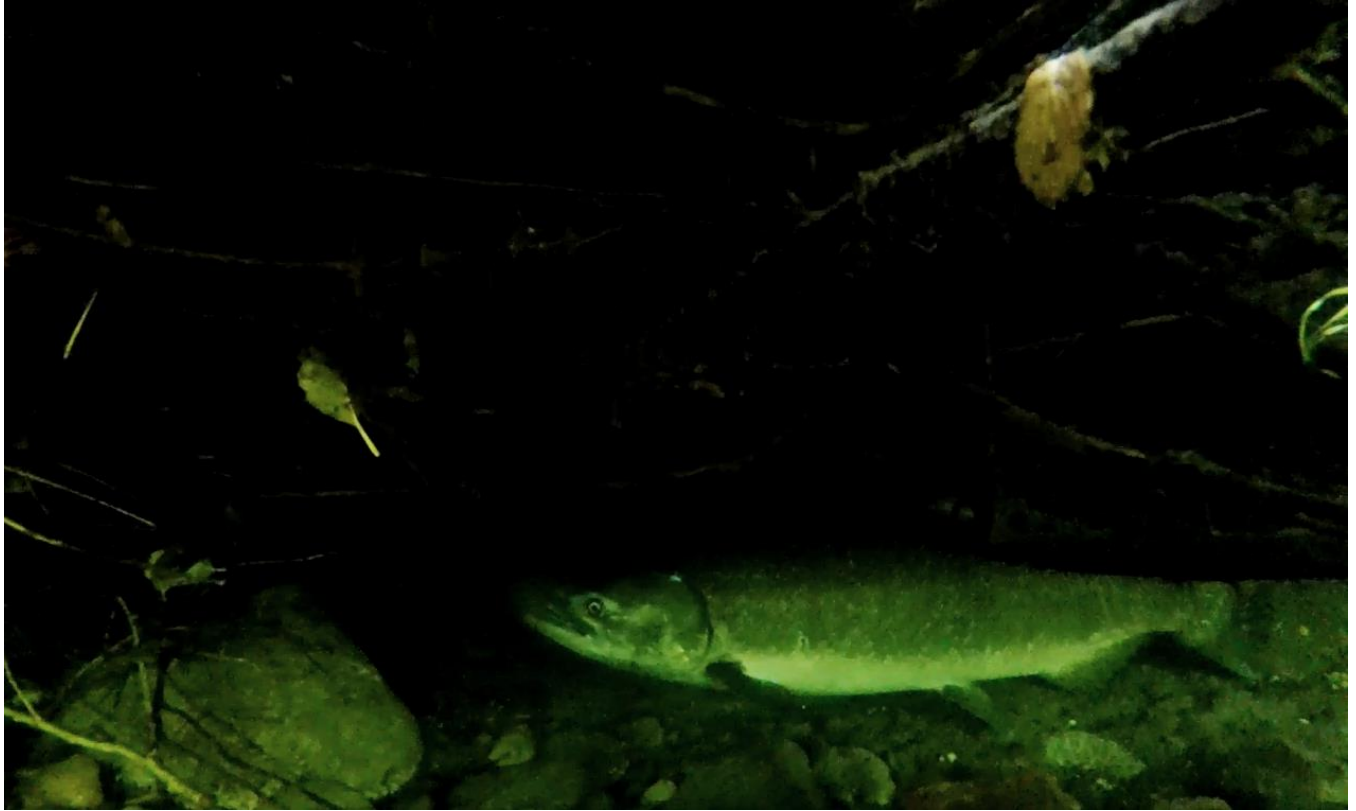
Figure 4. This Adult Chinook Salmon Was Observed Using an Undercut for Cover in Nason Creek (RM 14.9) During Snorkel Surveys in August 2016.

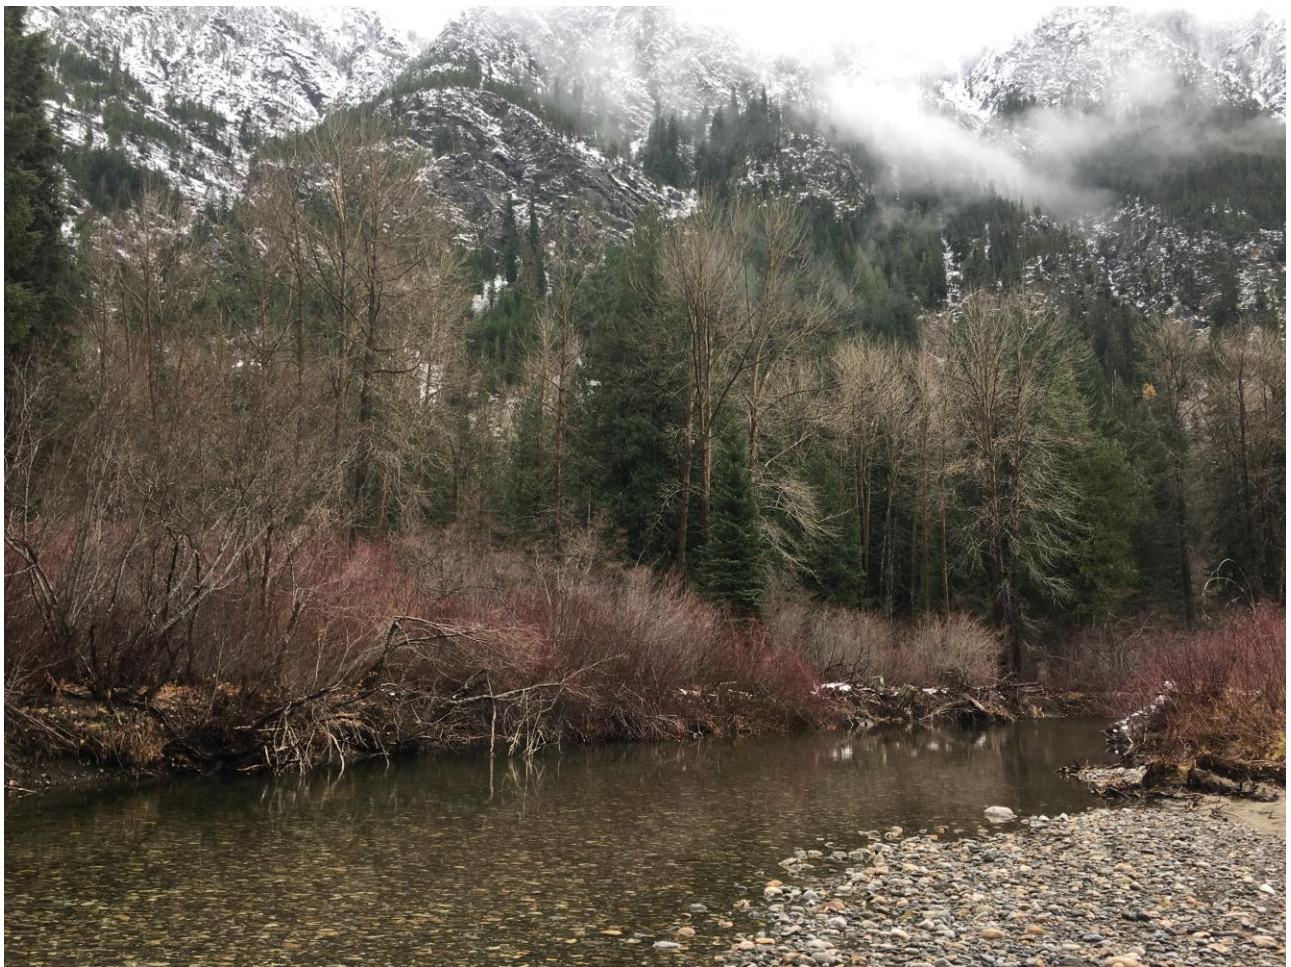
Figure 6. Steep Valley Walls and Flat Valley Bottom of the Upper Nason Reach.

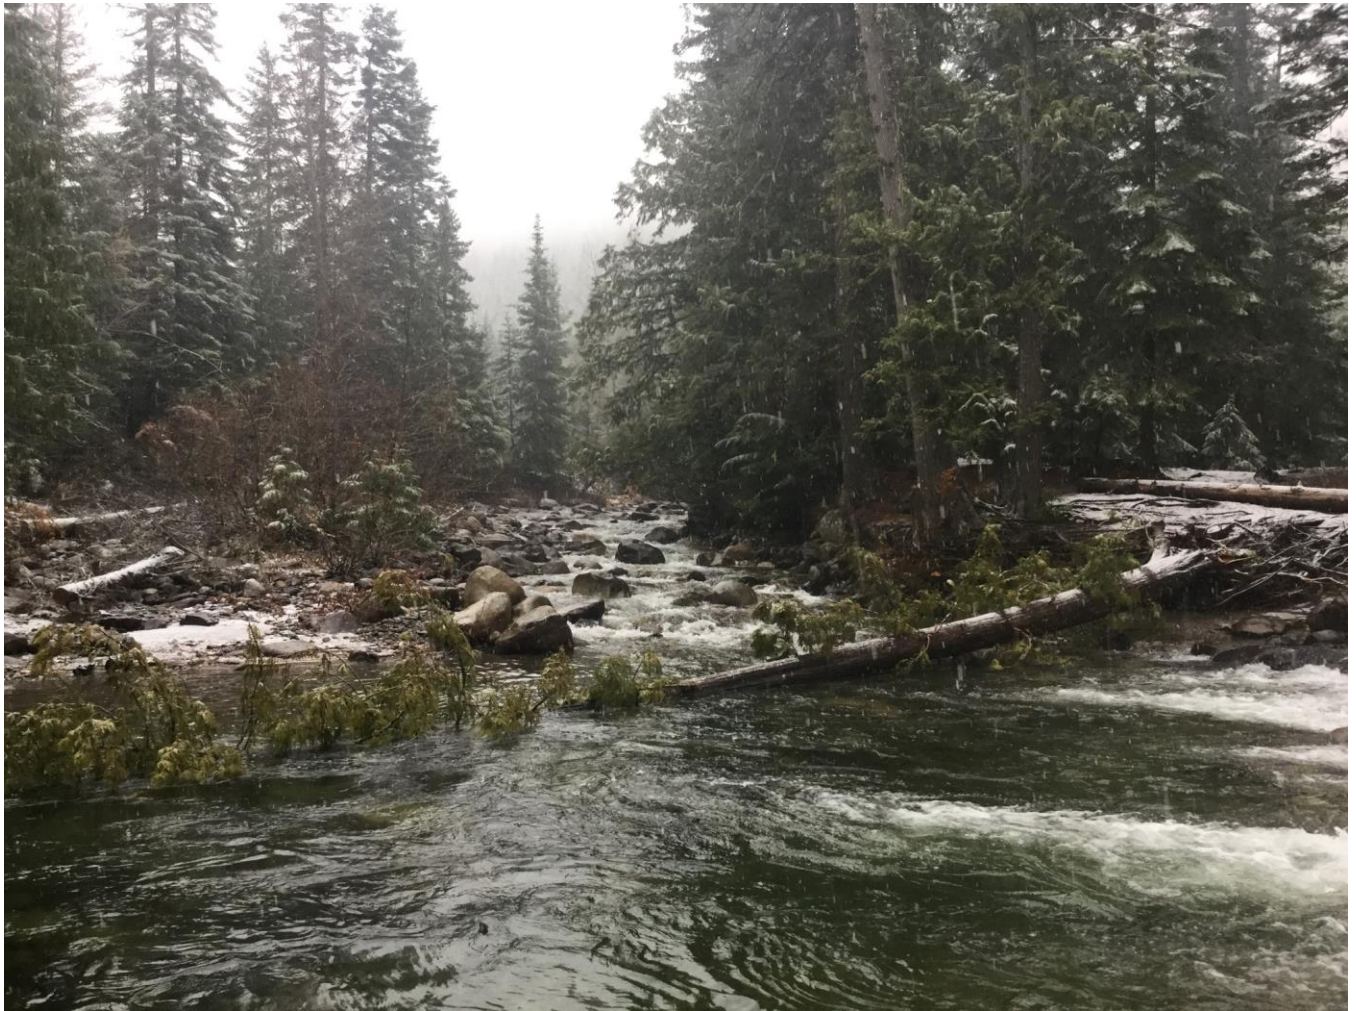
unnamed creek contributes about 1% of total flow and Whitepine Creek contributes about 40% of total flow (Figure 7).

Figure 7. Confluence of Whitepine Creek and Nason Creek.

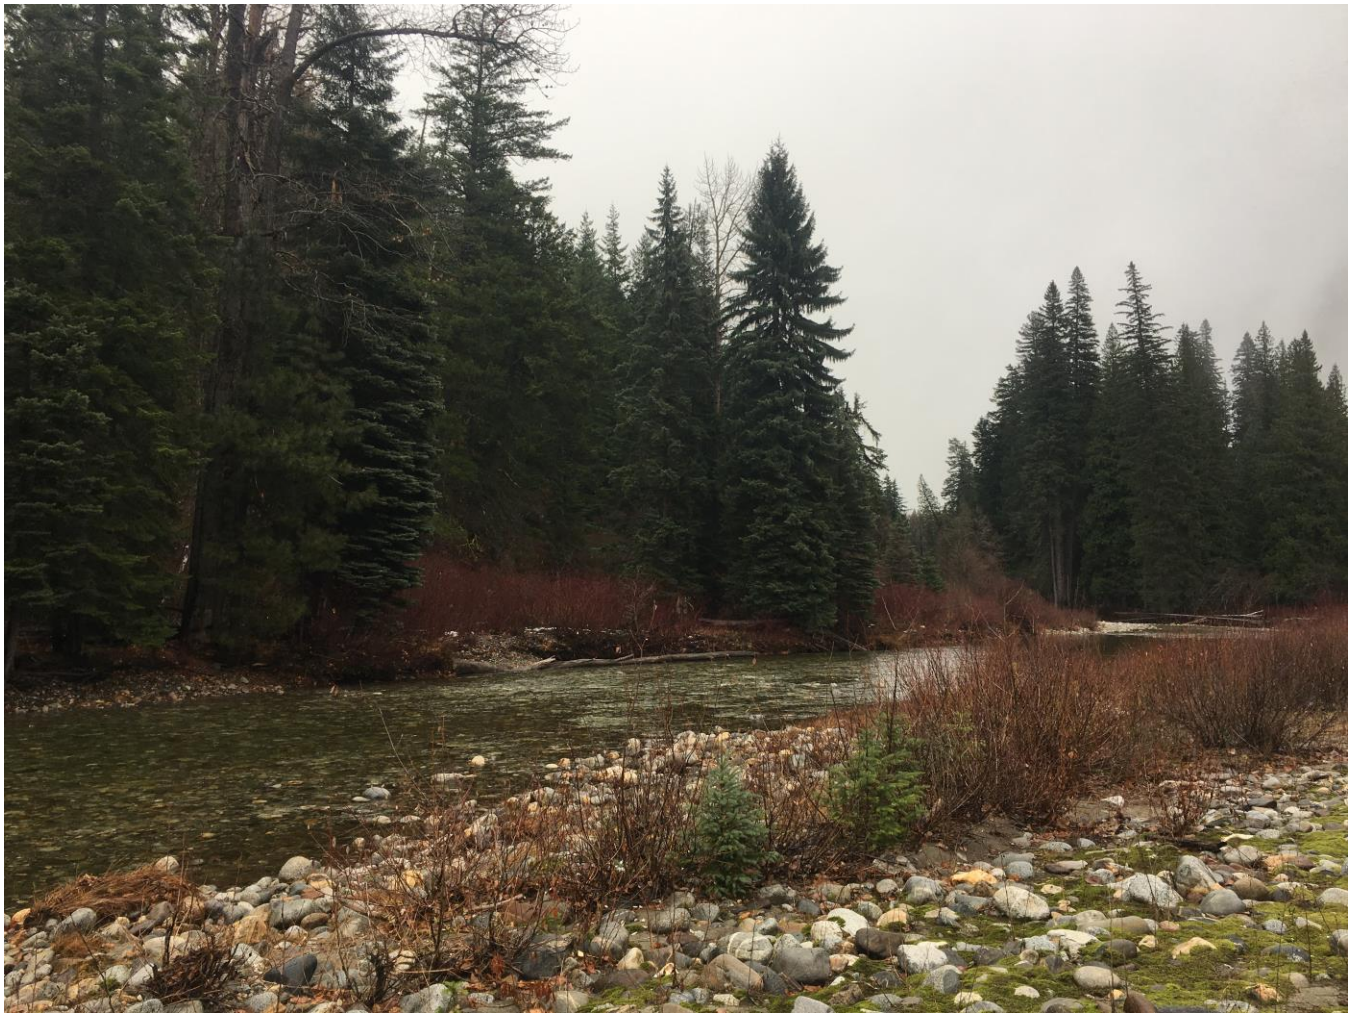
The reach flows through large and mature stands of western red cedar (*Thuja plicata*), black cottonwood (*Populus trichocarpa*), Douglas fir (*Pseudotsuga menziesii*), grand fir (*Abies grandis*), and Engelmann spruce (*Picea engelmannii*) (Figure 9). Most of the banks on either side of the channel are forested upstream of the Cascade Meadows Camp, with trees exceeding the large LWD size threshold (minimum 20 in x 35 ft) (USFS 2012). Downstream of the camp the banks are more commonly lined with small shrubs and trees, including red osier dogwood (*Cornus sericea*), red alder (*Alnus rubra*), willow (*Salix* sp.), and periodic locations where the channel abuts large (21-32 in DBH) to mature trees (> 32 in DBH) (USFS 2012). Riparian wood resources are only entirely absent in limited stretches where the denuded Whitepine Road grade and/or BNSF railway grade run immediately alongside Nason Creek. However, the lack of large wood jams and pieces of sufficient size (60 in DBH and 100 ft long) to remain stable during common flood events diminishes the potential for local bank erosion and LWD recruitment in the reach (Abbe and Montgomery 2003).

Figure 9. Stands of Mature Conifers and Black Cottonwood Along the River Banks that Are Typical Throughout the Reach.

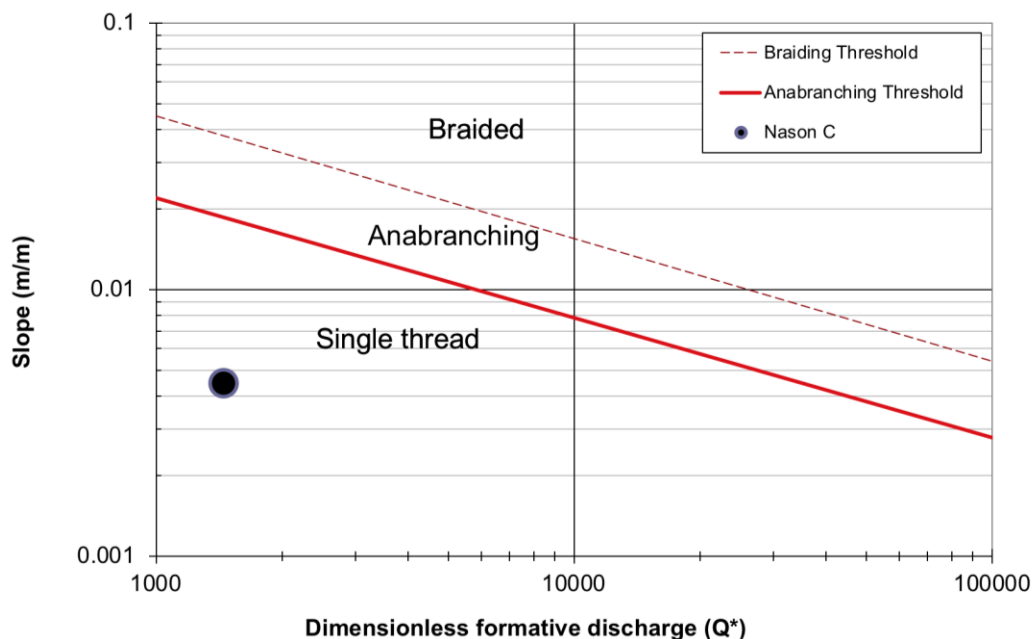
Figure 10. Plot of Predicted Channel Form Based on Eaton et al (2010).

The river through the project reach is primarily a single thread channel, with multiple locations where the channel is laterally confined. Based on the median grain size (D_{50}), formative discharge (Q^* ; $\sim Q_{1.5}$), and channel gradient, Eaton et al (2010) predicts channel form for natural channels. The channel through the project reach in the single thread region of the plot (Figure 10). The channel form predicted by Eaton is a function of the recent geomorphic history at the site, as changes to sediment supply and wood loading can change Q^* . Increasing wood loading can decrease the average grain size on the channel bed through shear stress partitioning, resulting in a higher Q^* . Increases in sediment supply have a similar effect increasing Q^* , pushing the channel toward the anabranching and braided domains. Increasing the shear stress resulting from historic incision can decrease Q^* , trending toward the single thread region of the plot (Figure 10).

The current simplified single thread channel planform, due largely from the lack of stable large wood, suggests that the channel would likely plot toward anabranching under historic conditions (Figure 10). The formation of large logjams would have forced anabranch channel formation by splitting flow, as well as partition shear stress resulting in a finer channel substrate. Based on the reference condition of wood loading and current lack of wood, it is likely that the historic channel was more anabranching throughout the project reach, more so where less confined by alluvial fans.

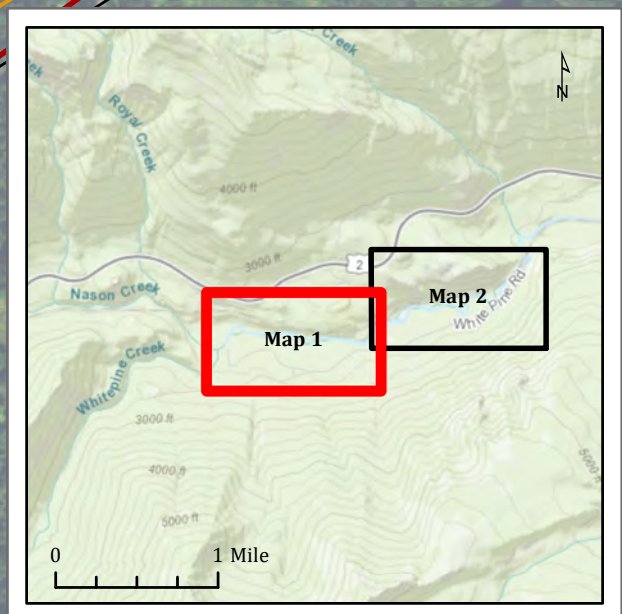
Upper Nason Reach Assessment
Restoration Project Concepts - Map 1

UN7
Condition: Right bank floodplain side channel with multiple beaver ponds. Poned year round. No direct upstream inlet. Potential inlets require 4-6' excavation in forested wetlands. High quality off channel habitat, deep pools with cover.

UN1
Condition: River left high flow channel. River left floodplain is high and above 2-yr flow.
Action: Install LWM on river right downstream of pool (at confluence) to increase inundation of river left side channel.

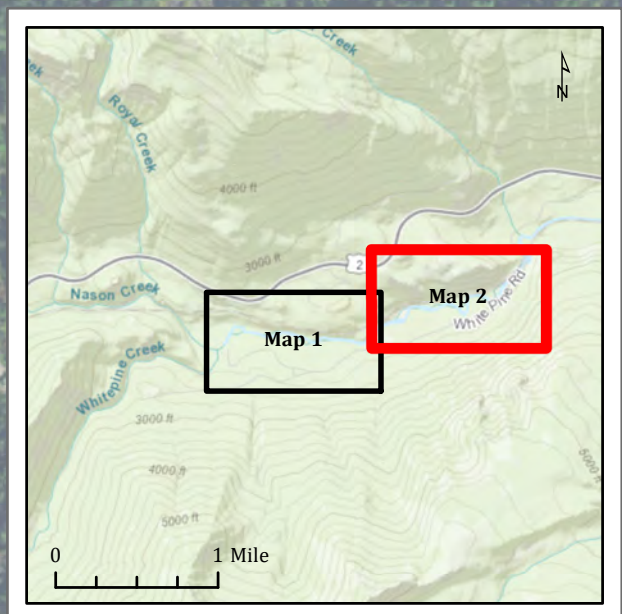
Upper Nason Reach Assessment
Restoration Project Concepts - Map 2

UN8
Condition: High floodplain terrace 5-6', no existing wetted habitat.
Action: Construct large LWM to activate high floodplain side channel.

High Terrace at church camp. Above 100 yr flow.

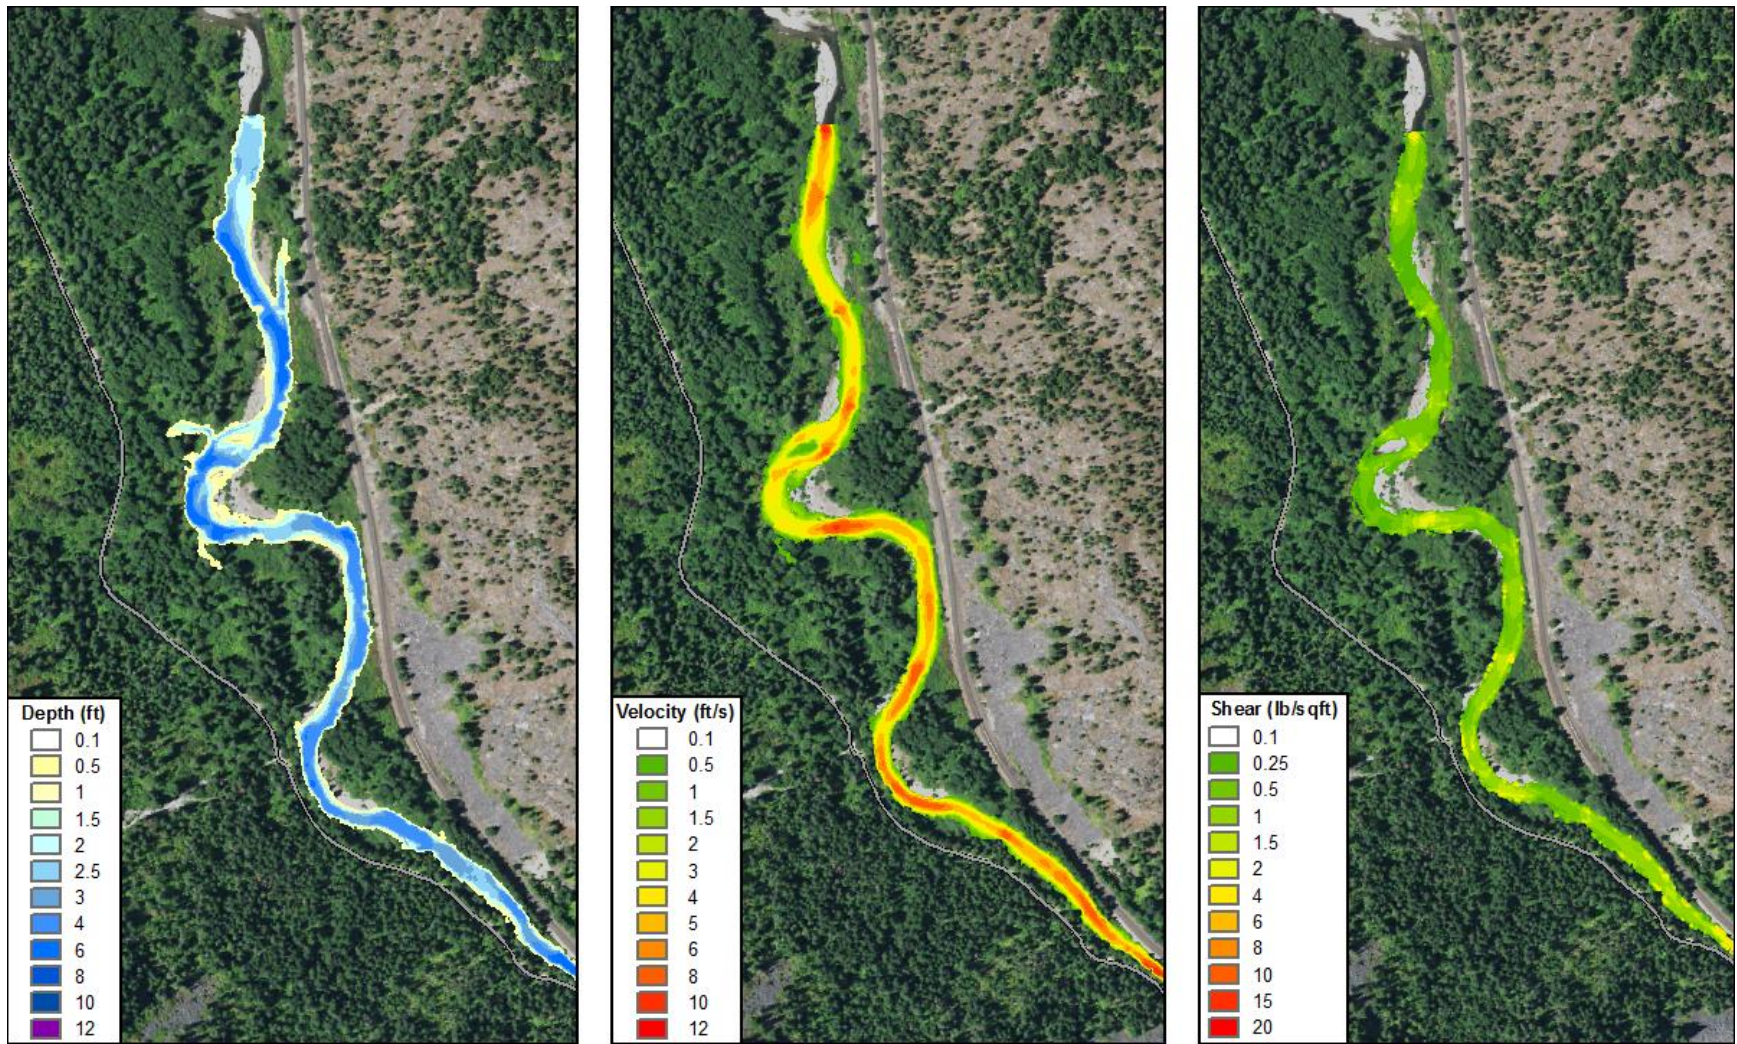
Figure 2. Hydraulic model results map for 1-year recurrence interval.

Depth, velocity, and shear stress at select discharges are presented in Figure 2 through Figure 4. These result maps are representative of the 1-, 2-, and 100-year recurrence interval flows, respectively. Through RM 14, Nason Creek flows meanders through a 600 ft wide forested valley. Average channel width is approximately 75 ft in this reach, with bank heights ranging between 6 to 8 ft. Flow depths for the 1- and 2-year discharges range from 4 to 5 ft and 5 to 6 ft, respectively. Side channels connected with the main channel experience flow just above the 1-year recurrence discharge. The greater floodplain becomes engaged when flows exceed 2500 cfs, or the 5-year recurrence flow.

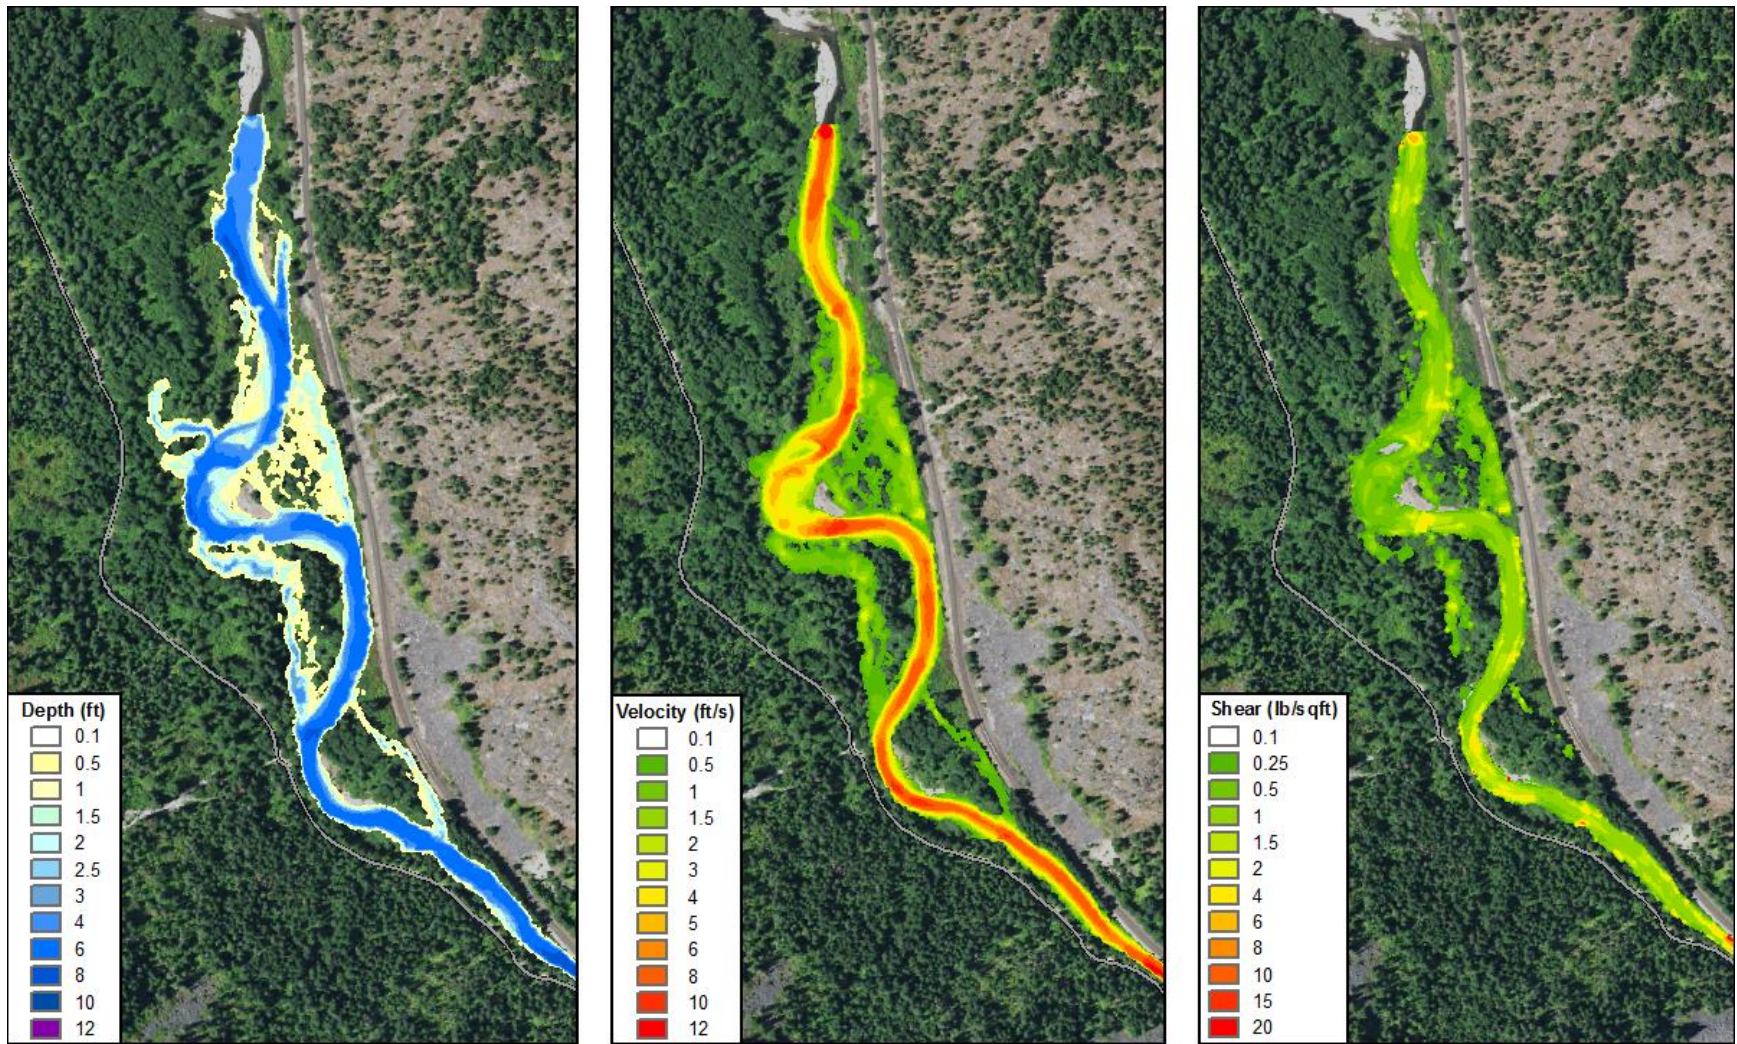
Figure 3. Hydraulic model results map for 2-year recurrence interval.

Beginning at RM 14 the valley constricts to a narrow, highly-confined canyon with a width of nearly 60 ft. At this point, channel gradient increases from 0.003 to 0.009. Channel velocity in the wider valley ranges from 5 to 8 ft/s, and increases to 10 to 15 ft/s in the canyon reach, for the 2-year flow. Significant infrastructure includes the White Pine Rd bridge (RM 13.8) and a railroad bridge (RM 13.7). Water surface elevation for the 100-year flow (2250 ft) is 2 to 3 ft below the abutment approach for the White Pine Rd bridge. The railroad bridge abutment approach is over 20 ft above the modeled 100-year water surface elevation.
