Wolf Creek Reach Assessment & Restoration Strategy *Final Report*

DECEMBER 2020

PREPARED FOR
Yakama Nation – Fisheries
Winthrop, WA

PREPARED BY
Inter-Fluve
Hood River, OR

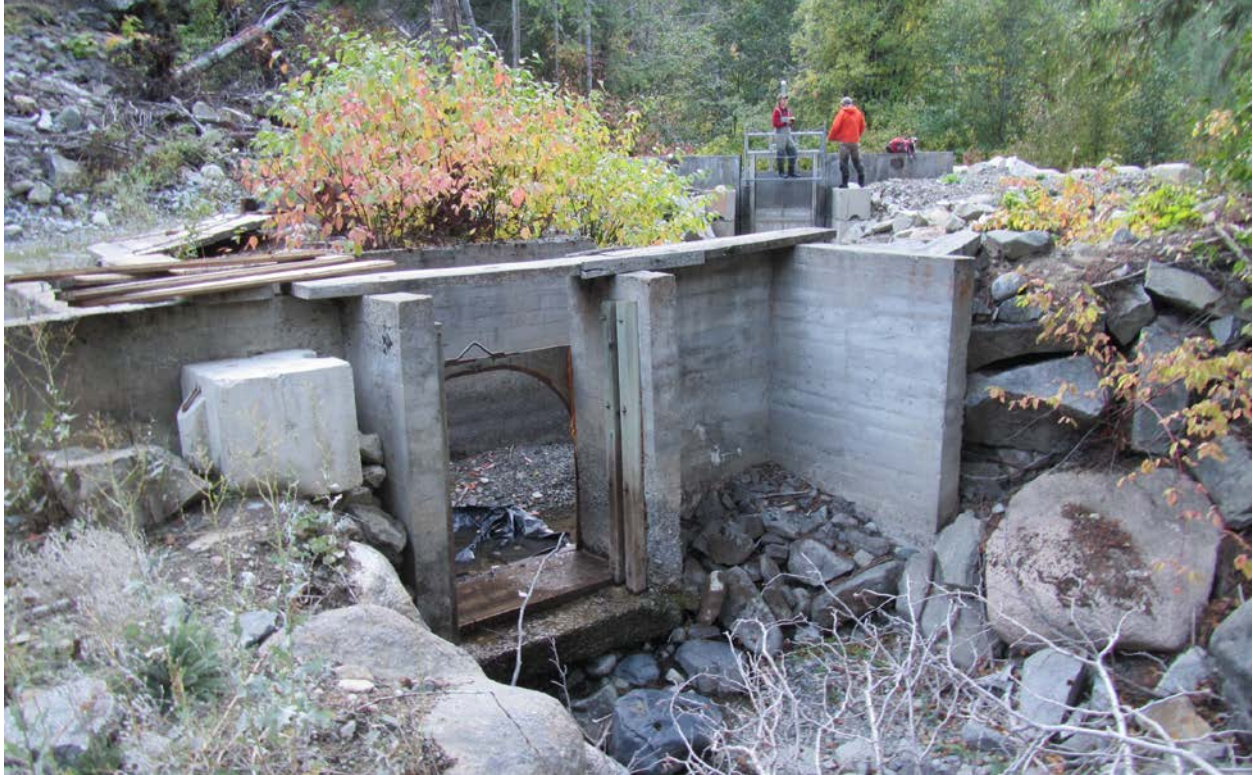
The Wolf Creek Reclamation District operates surface water irrigation diversion facilities on Wolf Creek and Little Wolf Creek. The Wolf Creek diversion, grade control weirs, fish screen, and ditch/aqueduct initiate at the upstream boundary of the assessment area (RM 4.53) – see Figure 11. The existing water right authorizes a maximum instantaneous diversion rate (Q_i) of 30cfs from October 1st to July 1st. Between April 1st and September 30th, the diversion is allowed to divert up to 12.5-13 cfs from Wolf Creek as well as the entire flow of Little Wolf Creek, to ditch capacity. When discharge at the mouth of Wolf Creek lowers to 9cfs or a depth less than 8 inches, diversion at the Wolf Creek ditch/aqueduct is shut off to meet Endangered Species Act requirements (8cfs) and a Trout Unlimited agreement (additional 1cfs) (Haller, 2003; Schull, 2019; USDA Forest Service, 2005). The Wolf Creek diversion and fish screen were improved in 2017 through a joint effort between Cascade Fisheries Enhancement Group, the USFS, and WA Department of Fish and Wildlife to mitigate for loss (take) of juvenile steelhead and bull trout (WA RCO 2011). Little Wolf Creek is the largest contributing drainage within the assessment area. Diverting all of the tributary's surface flow during irrigation season removes its discharge and nutrient contributions to the mainstem channel and removes any seasonal viable habitat it once supported.

Figure 11. Wolf Creek diversion withdrawal gate, ditch, and overflow return gate (foreground). (Photo: 10/5/2019)

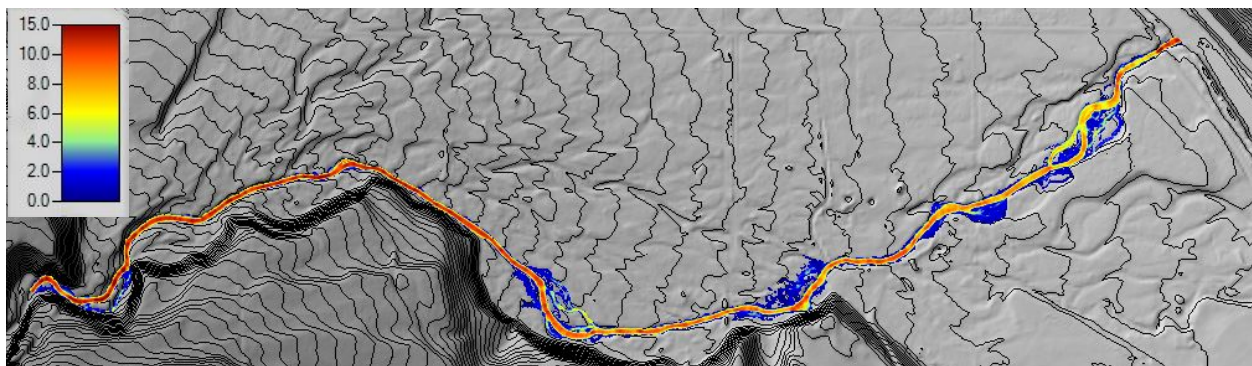
Figure 19. Modeled velocities under existing conditions at the 10-year flow event (637 cfs).

Preliminary model results of flow velocity and inundation confirm field observations that, at existing conditions with anthropogenic confinement and channel entrenchment throughout much of Reach 1, flood flows remain within the entrenched/leveed channel until between the estimated 25- and 50-year flood discharges. This also confirms the degree at which the channel is disconnected from its historical alluvial fan/abandoned floodplain surface. Even at the 100-year estimated discharge, the mouth of the channel is confined and unable to develop river-delta habitat conditions. By the 50-year modeled discharge, surface flows at levee breaches finally begin to wet the alluvial fan. Secondary perpendicular levees and ditches constructed on the alluvial fan for additional property protection are activated at the higher discharges.

Where inset floodplain features exist, high-flow side channels show as activated at the 2-year modeled discharge. Confinement in large sections of Reach 1 produces relatively high flow velocities in the channel, even at the 2-year flood discharge. As expected, velocities are higher in the more confined sections of the reach. This correlates to the increase in bedload grain size from downstream to upstream, as observed during the field survey. The modeled velocities also correlate to the stream power analysis described above.

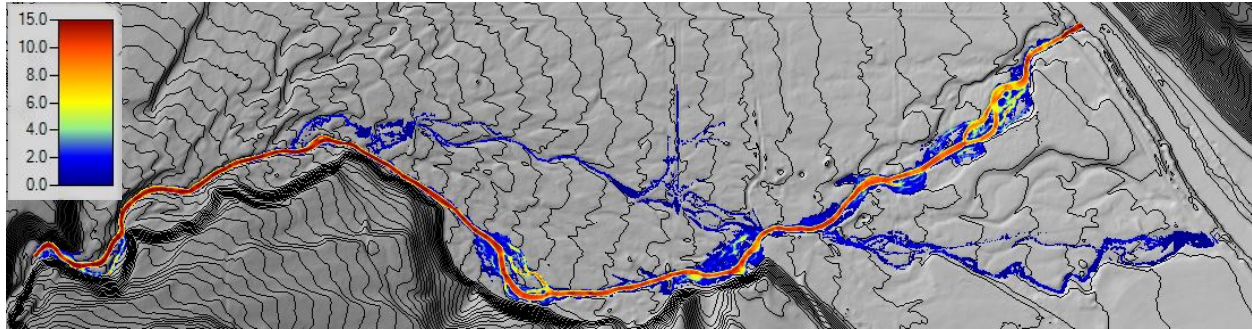
Figure 20. Modeled velocities under existing conditions at the 50-year flow event (1,110 cfs).

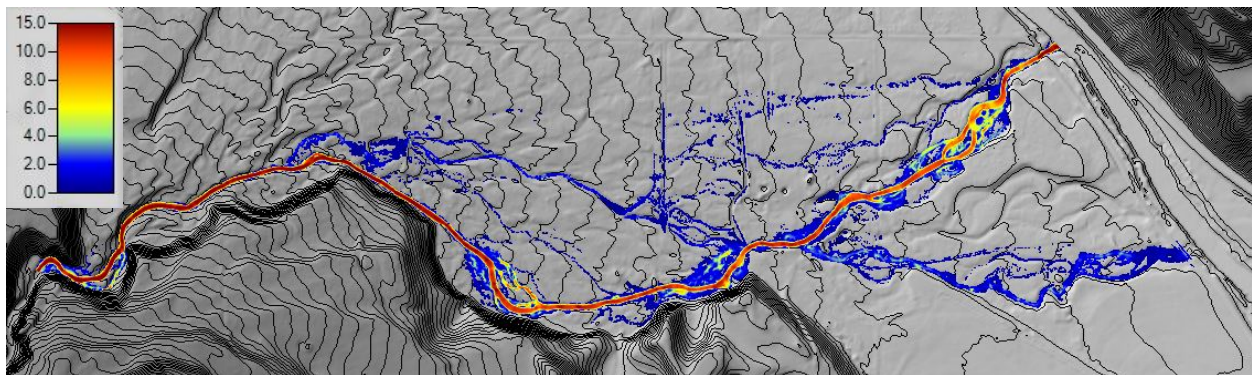
Figure 21. Modeled velocities under existing conditions at the 100-year flow event (1,340 cfs).

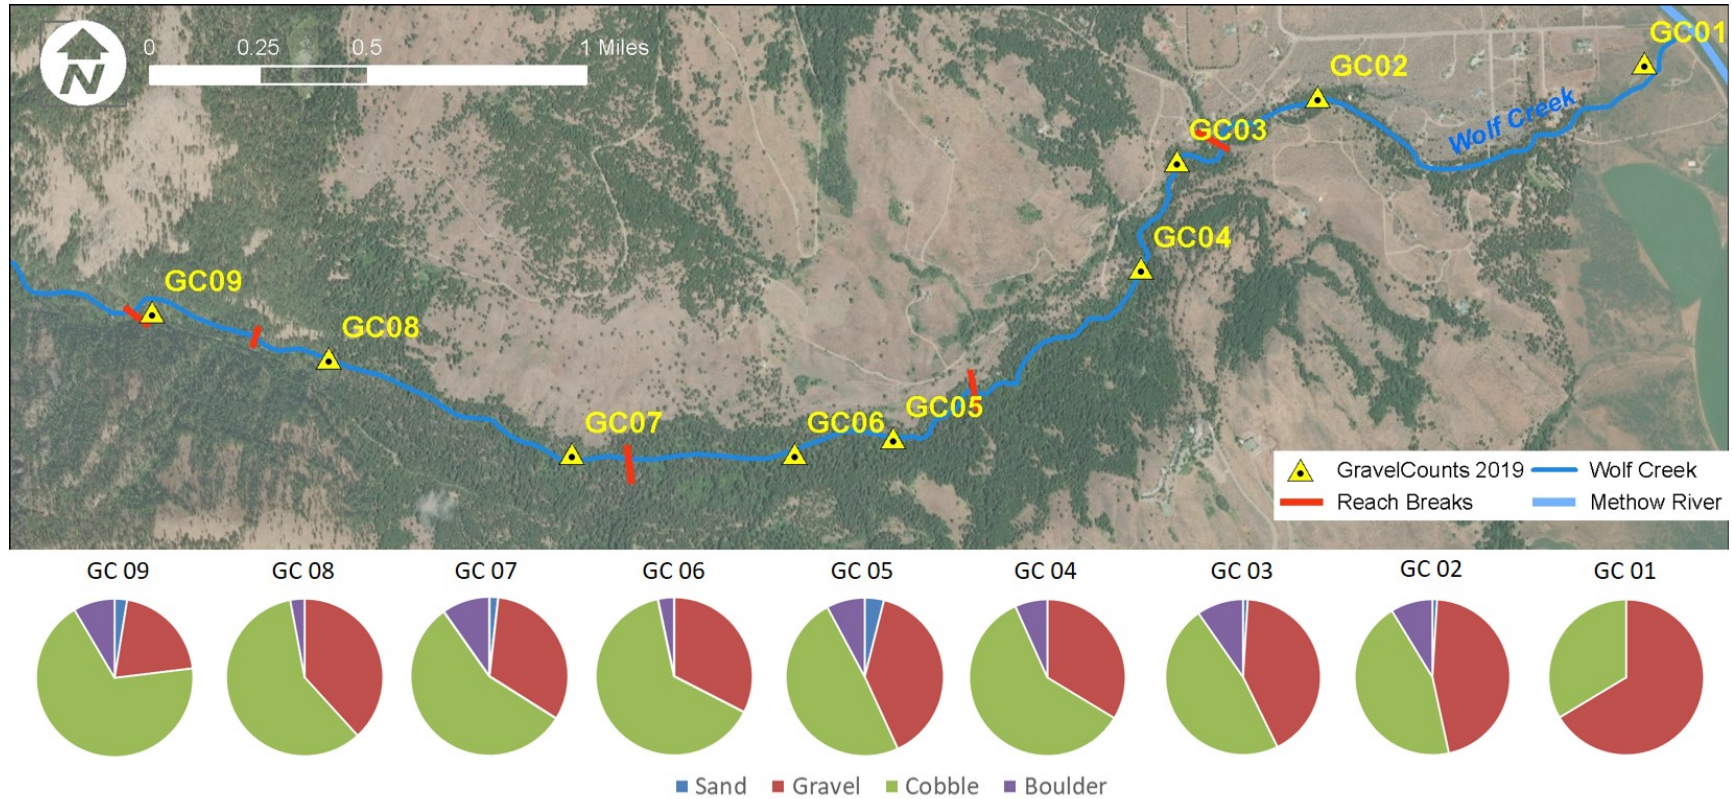
Nine bedload sediment surveys (gravel counts) were performed during the October 2019 field surveys following the Wolman Pebble Count method (1954). This method includes sampling and measuring a minimum of 100 separate pieces of sediment from a representative bed feature. The substrate of Wolf Creek within the assessment area is composed primarily of cobble and gravel with sparse boulders and minimal sands. Figure 25 provides the locations of the gravel count surveys and the distribution of grain sizes at each count.

Figure 25. Gravel Count locations and grain size distribution results (Inter-Fluve: Oct 2019)

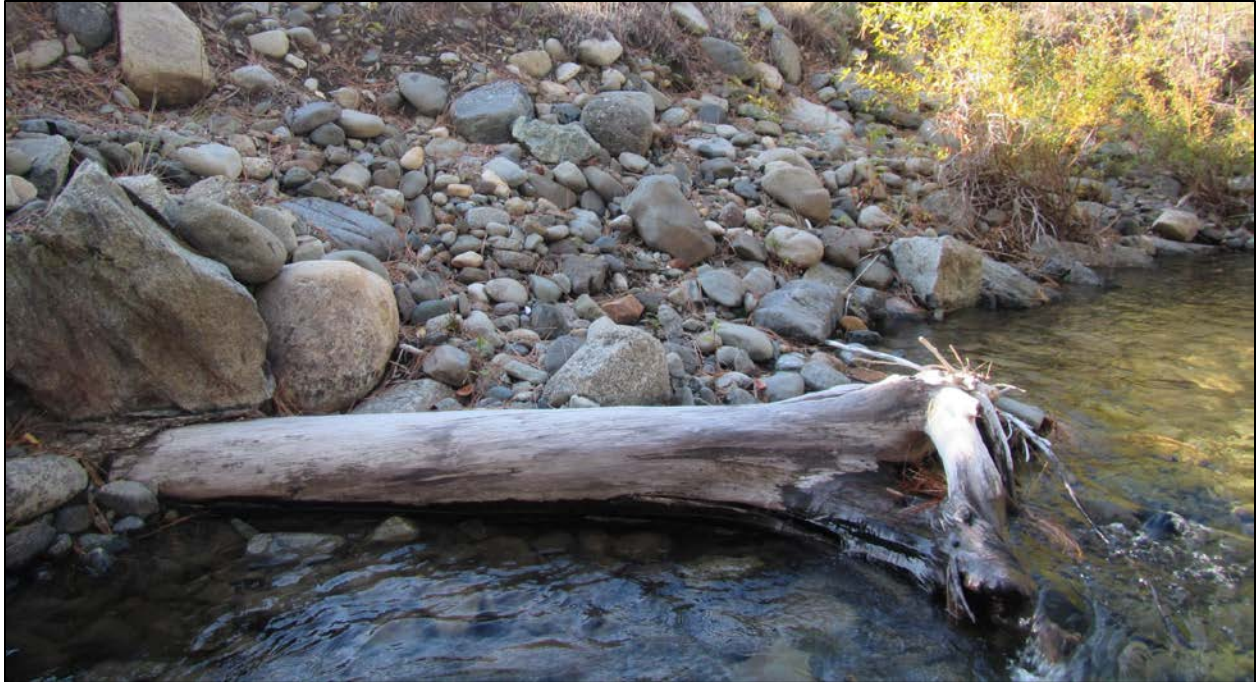
Land use practices on the Wolf Creek alluvial fan (Reach 1) impact both channel and floodplain processes. For example, surface grading and vegetation clearing near homes altered floodplain contributions (large wood and nutrients) and thus further reduced habitat complexity. Levee construction and channel dredging impede potential floodplain connectivity and natural lateral channel processes across the historical alluvial fan. Maintenance and safety requirements associated with human-built infrastructure such as irrigation outtakes, bridges, utility crossings, etc. have likely resulted in periodic “cleaning” of wood from the channel, further reducing natural retention of LWM contributions from the existing riparian area in Reach 1. These activities have simplified aquatic habitat in Reach 1. To partially mitigate for these impacts, seven pieces of partially buried large wood and boulder weirs were installed in the lower section of Reach 1 in 2000 by the Wolf Creek Reclamation District and several private landowners (Figure 26), accounting for most of the pieces of LW counted in the 2019 survey.

Figure 26. Partially buried LW at RM 0.05 on river right in Reach 1. (Photo: 10/1/19)

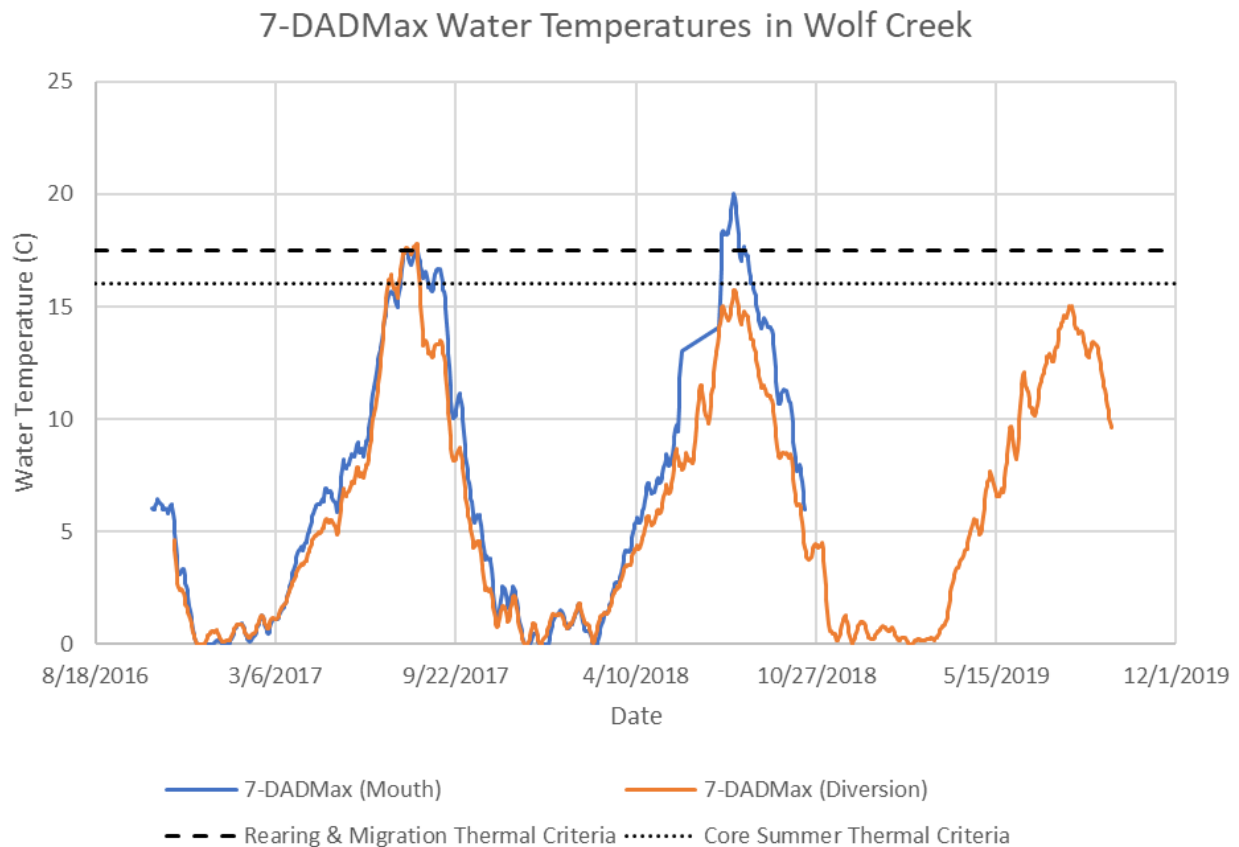
The 7-day average daily maximum water temperatures (7DADMax) were calculated from these data and is shown in Figure 28. The 7DADMax at the mouth of Wolf Creek exceeded the thermal criteria of 17.5°C set by the state of Washington for salmonid spawning, rearing and migration for only three days in 2017 and for a total of 22 days in 2018, between mid-July and mid-August. Water temperatures recorded upstream near the irrigation diversion exceeded the 17.5°C thermal criteria in 2017 for a total of 10 days between late July and mid-August. Temperatures at the diversion did not exceed the criteria in 2018 or 2019.

Thermal criteria for core salmonid summer habitat thermal criteria is 16°C in the State of Washington. Based on the 7DADMax, thermal criteria for salmonid summer habitat was exceeded at the mouth in both 2017 and 2018. In 2017, the 7DADMax exceeded 16°C for a total of 41 days, between July 23 and August 22, 2017, and then again between August 29 and September 7. In 2018, the 7DADMax exceeded 16°C for a total of 36 days between July 14 and August 18. Water temperatures recorded upstream near the irrigation diversion exceeded the 16°C thermal criteria in 2017 for a total of 28 days between July 9 and 13 and then again between July 21 and August 12. Temperatures at the diversion did not exceed the 16°C criteria in 2018 or 2019.

Figure 28. Wolf Creek water temperature monitoring near the mouth (RM 0.1) and upstream of the Wolf Creek irrigation withdrawal at RM 4.53 (which is the upstream extent of the study area) between fall 2016 and 2019. Thermal criteria set by the State of Washington for salmonid spawning, rearing, and migration (17.5°C) is shown with the black dashed line and core summer salmonid habitat (16°C) is shown with the black dotted line. (source: J. Crandall – 2020)

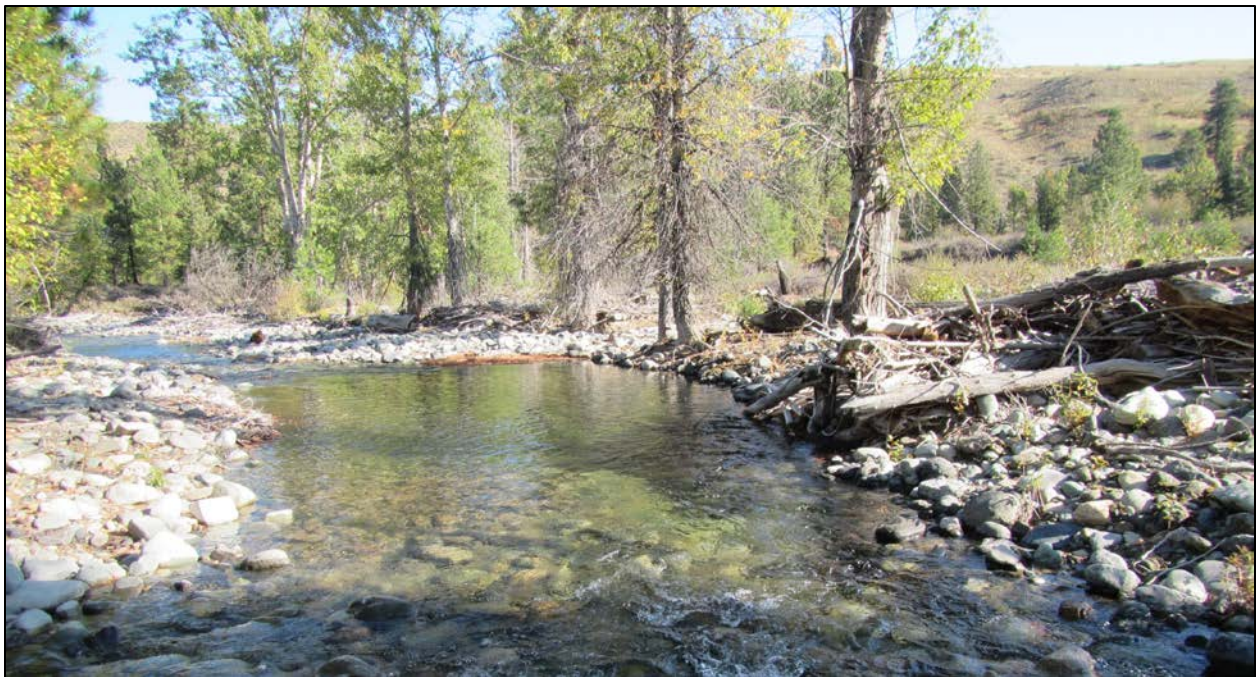
Wolf Creek in Reach 1 has a moderate gradient with a planform that alternates between straight and low sinuosity (Figure 31). The channel is entrenched below its historical floodplain (alluvial fan) throughout the reach. The levees along the channel appear to be constructed of material excavated from the bed of the channel, exaggerating entrenchment and facilitating disconnection of the historical alluvial fan. Channel banks are composed of coarse alluvium (gravel to boulder) that is mixed and topped with gravel and sand. Soils of the modern floodplain and banks along the channel are composed of ashy sandy loam (0-25% gradient) across the lower alluvial fan, very stoney ashy sandy loam (35-65%) in the middle section along the toe of the hillslope, and ashy loam (15-35%) in the upper portion of the reach (USDA & NRCS, 2017). Inset floodplain surfaces in the downstream portion of the reach range from 1-foot to approximately 4-6 feet above the elevation of the channel bed (Figure 32).

Figure 32. Looking upstream at Wolf Creek RM 0.18. The subtle meandering (low sinuosity) channel maintains inset floodplains and sparse vegetation. (Photo: 10/1/2019)

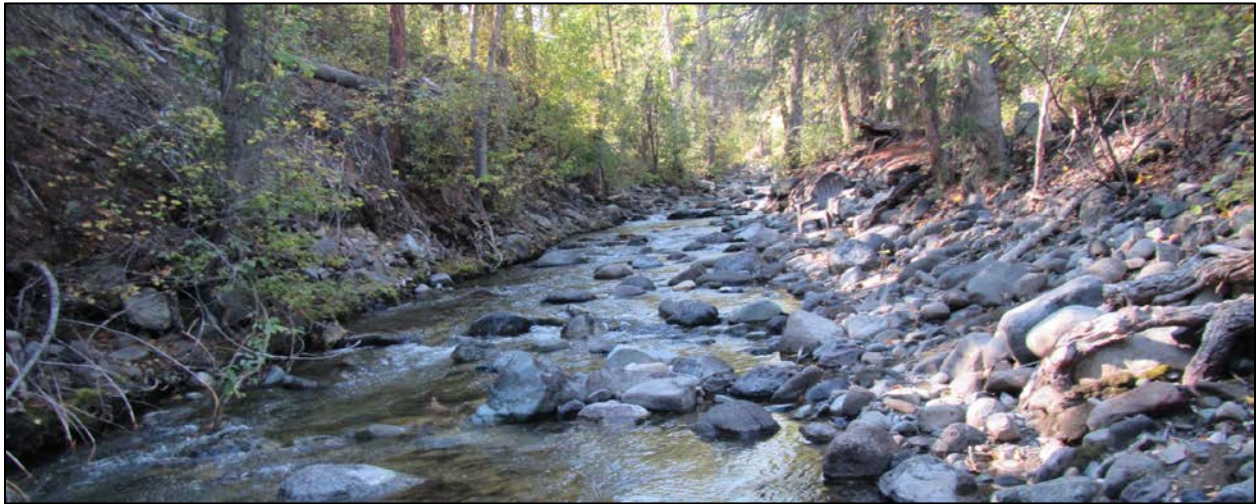
Terrace surfaces and leveed banks range from 6-15 feet above the elevation of the channel bed, increasing in height upstream. Historical aerial photos from 1947 confirm that the mainstem channel has been confined in basically the same location for at least 70 years. A lack of lateral processes in the upstream portion of the reach due to channel leveeing, bridge confinement, and bank hardening (i.e., rip rap, cement walls) has resulted in channel entrenchment and minimal local sediment sourcing for bar or spawning habitat development. Subtle lateral processes occurring in the downstream portion of the reach between confining bridges has developed pockets of inset floodplain surfaces. Where established, tree roots and riparian vegetation contribute additional stability to the banks (Figure 33).

Figure 33. Looking upstream at Wolf Creek RM 0.95. River left (right side of photo) is leveed bank. River right is confining hillslope. Tree roots add additional bank stability. (Photo: 10/1/2019).

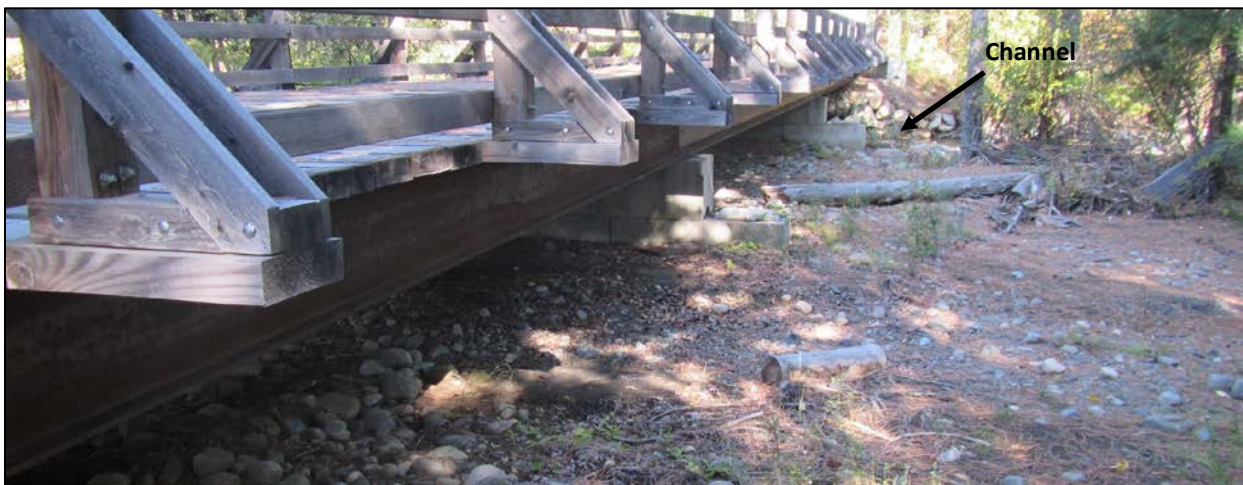
Channel complexity in Reach 1 is impaired by anthropogenic confinements and the continued periodic removal of large wood. The 2020 Habitat Assessment (see Appendix A) measured 79% of the channel as extended riffles, while only 18% is pool habitat, and the remaining 3% is glides. The glides and several of the riffles are plane-bed. The pools occur where large boulders and/or built features, such as constructed bank-attached large wood pieces, or a large boulder weir, foster scour hydraulics. The bed of the channel is dominated by coarse alluvium, gravel-cobble, in the downstream portion of the reach, and cobble-boulder in the upstream. Narrow gravel-cobble bars have formed at the inside bends of the subtle meanders at RM 0.15, 0.35, 0.4, 0.55, 0.79, and 1.09, as well as at the mouth of the channel. Gravel and cobble accumulations were observed at a wide bridge crossing at RM 0.3 (Figure 34) where pilings create downstream hydraulics conducive to deposition.

Figure 34. Private bridge crossing at RM 0.3. Photo at downstream side of bridge on river right looking across active channel where sediment is accumulating. Low-flow channel in background next to boulder gabion and riprap. (Photo: 10/1/2019)

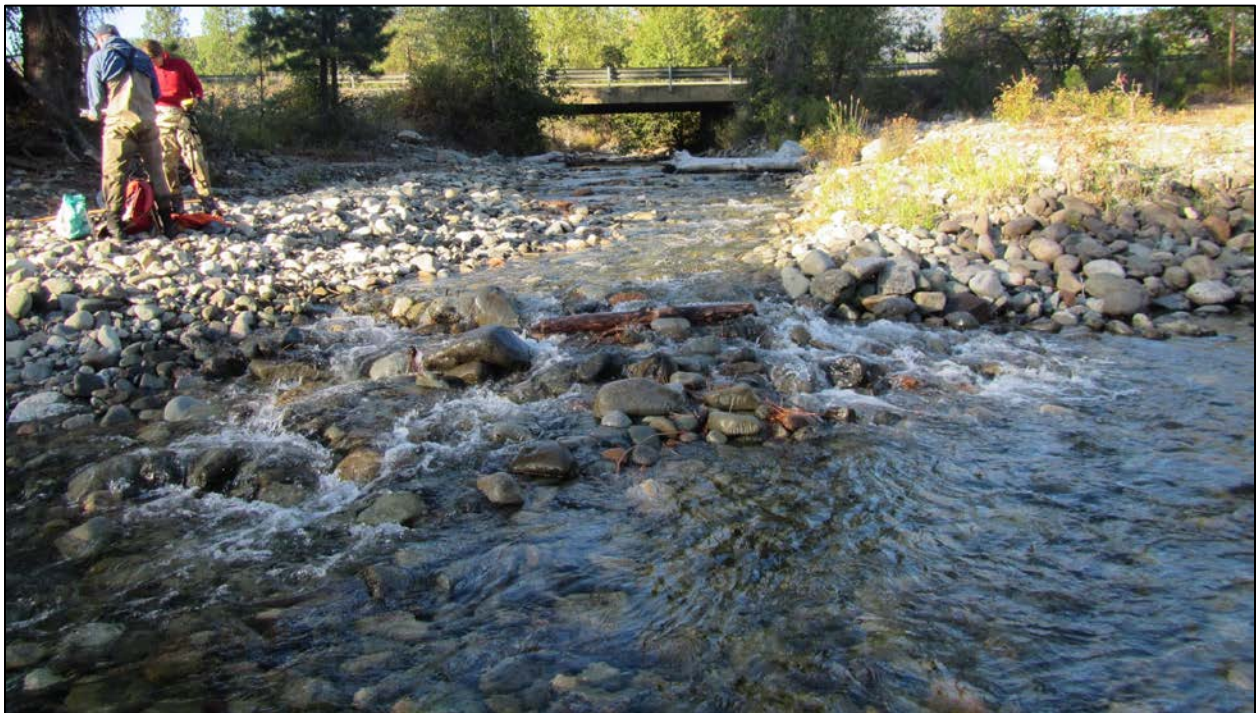
Wolf Creek has only a small cobble delta at its confluence with the Methow River. The stable location of the Methow River at the confluence also produces simplified processes that maintain its own channel entrenchment, which inevitably influences the base elevation of Wolf Creek. The terminus of Wolf Creek at the Methow River is located only 115 feet downstream of the confining Wolf Creek Road bridge crossing (Figure 35). This provides little room for delta or confluence habitat development in a location that should be naturally complex aquatic habitat.

Figure 35. Confluence of Wolf Creek with the Methow River. Wolf Creek Road bridge crossing in the background. (Photo: 10/1/2019)

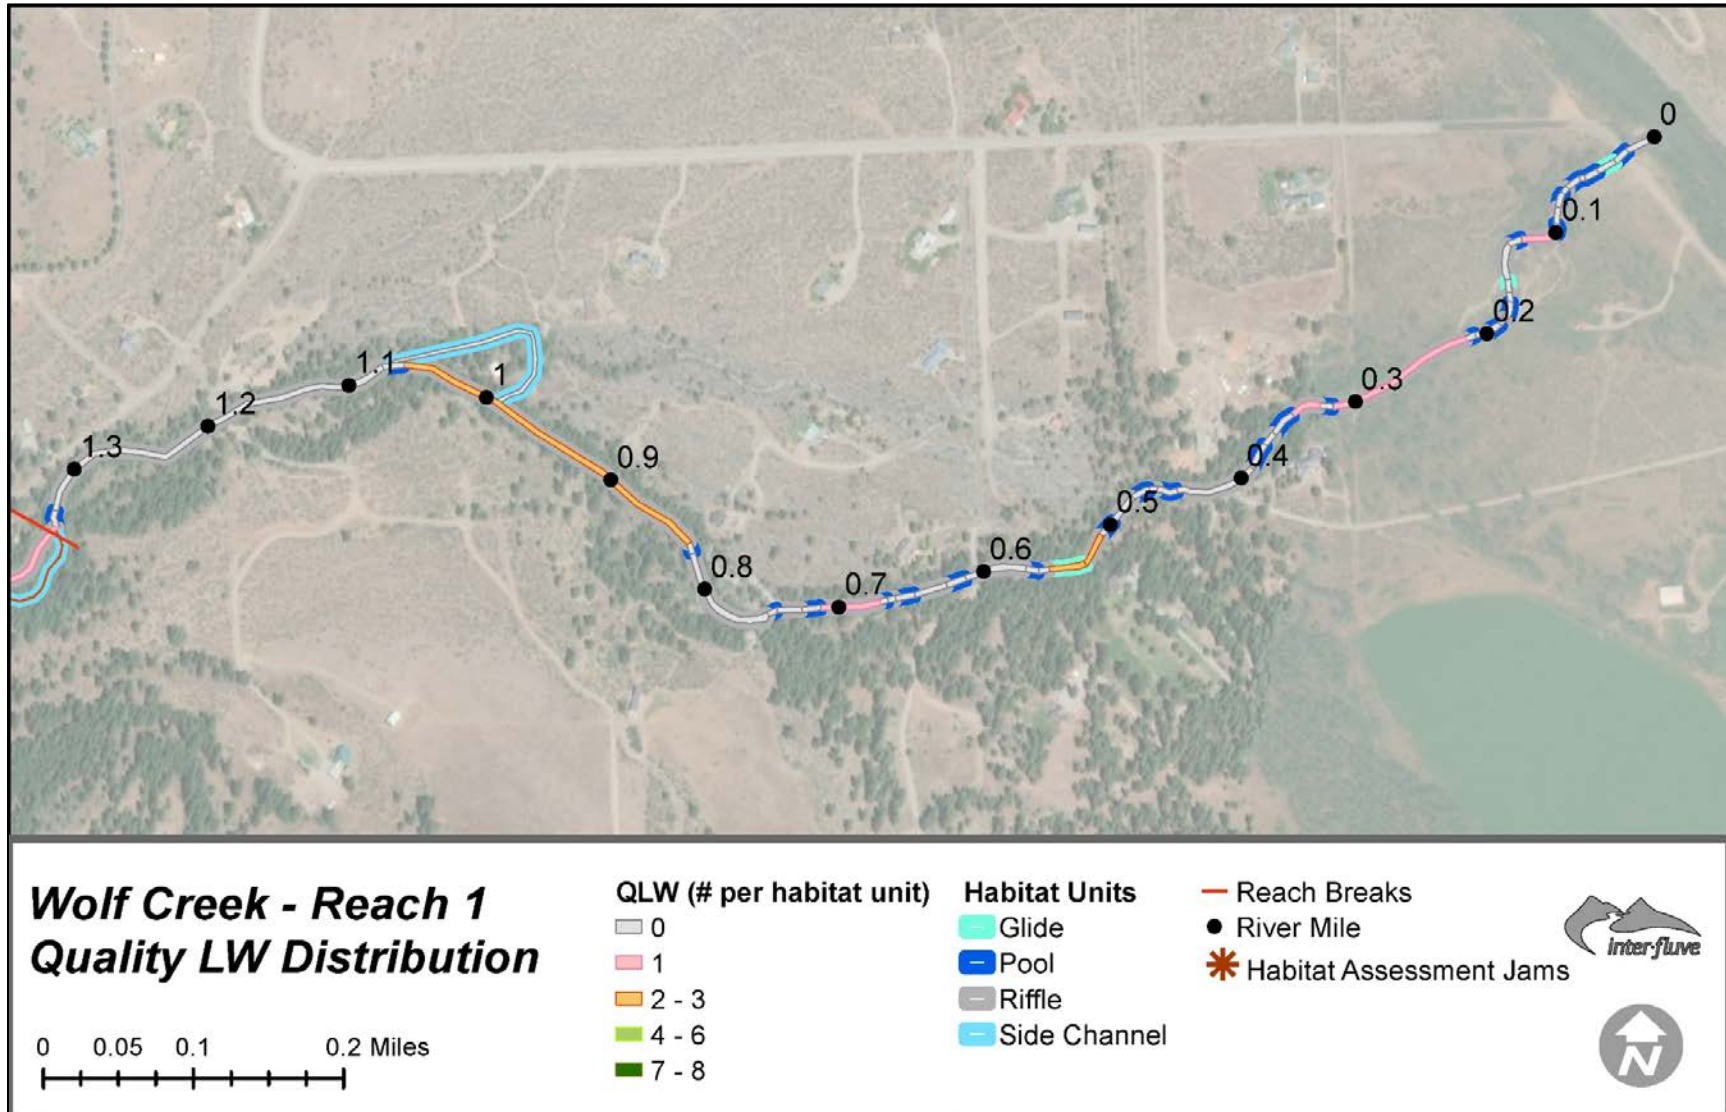
The lack of mature or large trees (21-32-inch dbh), the narrowness of the vegetated riparian zone, and channel confinement limit local source and recruitment potential of large woody materials (LWM) in Reach 1. A total of 52 pieces of LWM and no log jams were observed in the channel during the survey (10/1/2019). Eighty percent of the surveyed pieces are classified as small size class. A total of 10 pieces of quality large wood (QLW: medium or large size class: >12-inch dbh and at least 35-foot long) were recorded. Figure 37 shows the distribution of quality LWM surveyed in Reach 1 in 2019 and its relationship to mapped habitat units. Only two pieces of quality LWM occurred from RM 0.82 to the upstream boundary at RM 1.34 where levees and entrenchment confine the channel and long extended riffles dominate the habitat units. Seven of the LWM pieces are in constructed (partially bank buried or cabled) 1-log features between RM 0-0.07 and at RM 0.14. One piece of quality LW at RM 0.15 had recently been recruited by lateral channel processes and was influencing bed complexity at the time of the survey. Where it occurs, LWM does play a role in providing the minor amount of aquatic habitat and geomorphic complexity that currently exists in Reach 1. The lack of LWM in Reach 1 is the result of past riparian vegetation removal, lack of mature trees in the riparian corridor, lack of channel migration capacity, and probably continued periodic “cleaning” of wood from the channel. Clearing large wood from the channel is a common practice in places where infrastructure such as small bridges, irrigation intakes, and homes exist.

Figure 37. Reach 1 – Quality Large Woody (QLW) Material (>12-inch dbh and at least 35 feet long) distribution by number of pieces per mapped habitat (2019 Habitat Survey) and the location of LW jams (>10 pieces of LWM accumulated).

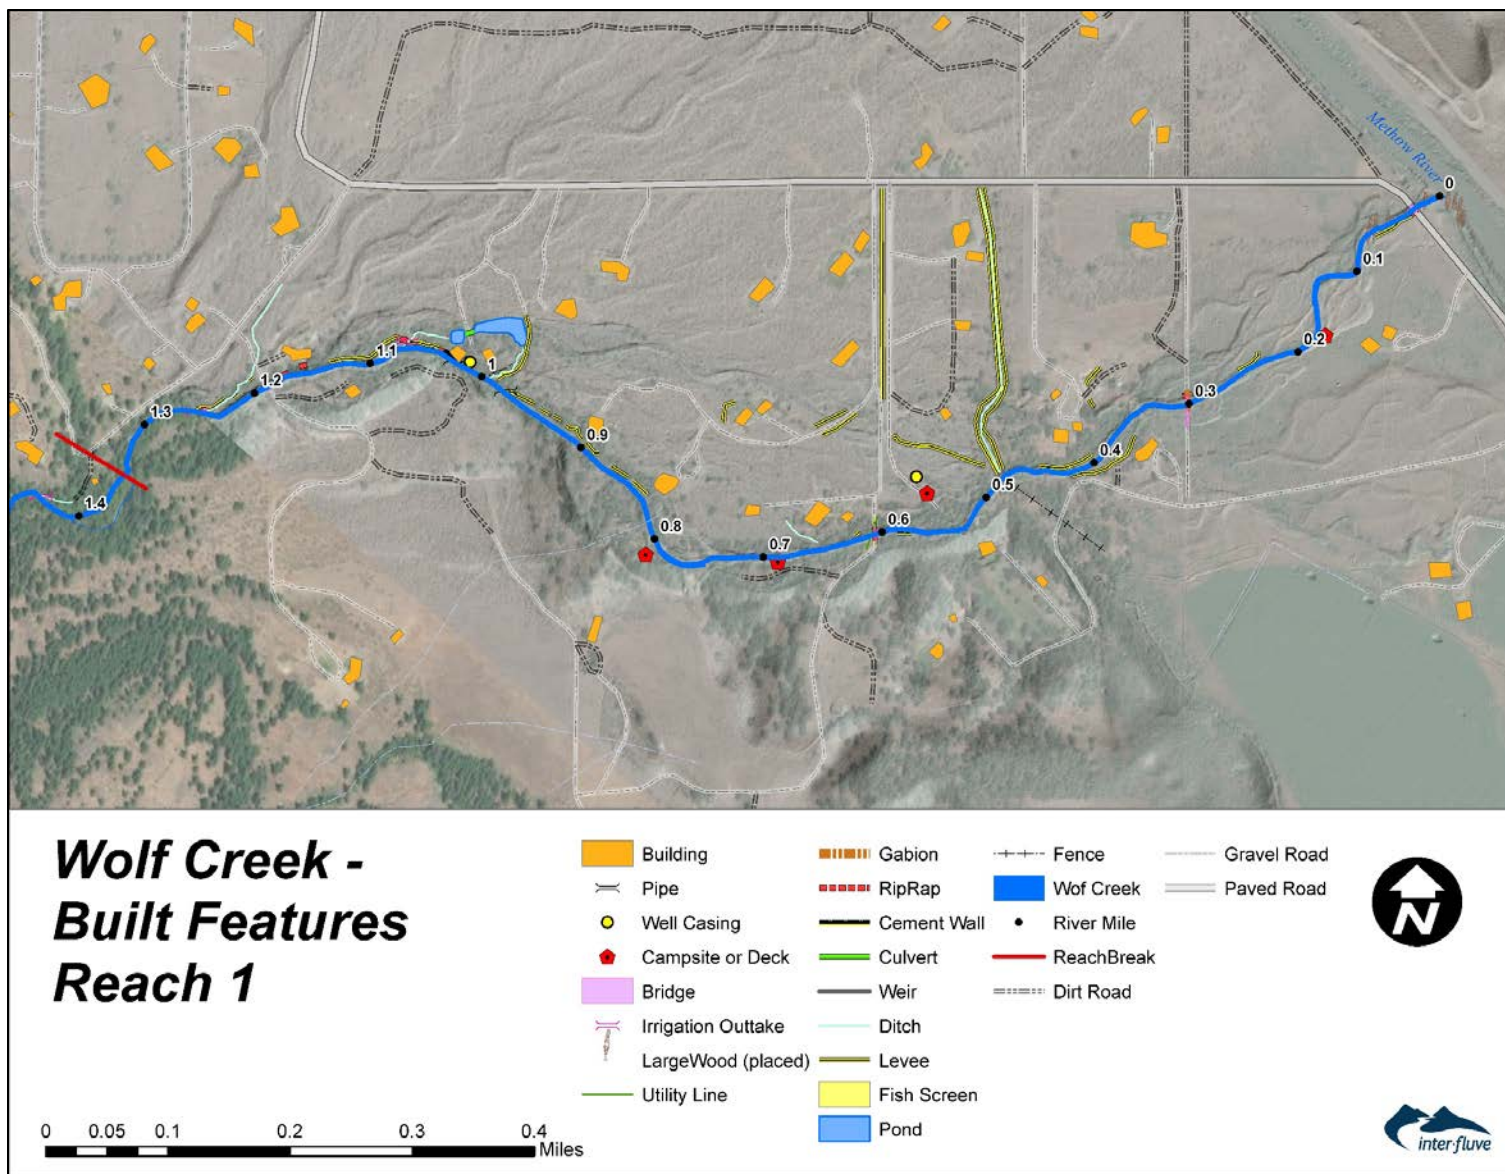
Reach 1 contains the most anthropogenic built-features in the assessment area. In addition to altering flow pathways across the alluvial fan and clearing riparian vegetation, anthropogenic features in Reach 1 include buildings/homes, roads, bridges, levees, riprap, gabions, cement walls, boulder weirs, constructed LW installations, irrigation intakes, ditching, and utility crossings (Figure 39). Levees up to 3 feet higher than the historical floodplain surface and constructed of material excavated locally from the channel or floodplain exist both along the channel and across the historical alluvial fan. An almost continuous levee exists along river left from RM 0.84 to 1.14, including a cement wall (home foundation) and added boulder riprap at RM 1.04. Constructed levees also exist throughout the reach on river left at RM 1.26, 0.4–0.45, and 0.24–0.26 as well as on river right at RM 0.6, 0.37–0.42, and 0.03–0.07. Additional levees of up to 1,275 feet long exist across the historical alluvial fan associated with ponds, ditches (irrigation and drainage), and historical flood pathways to divert flow away from infrastructure and private property. Three bridges cross and confine the channel in Reach 1 at RM 0.03, 0.3, and 0.6. The Wolf Creek Road bridge (RM 0.03) has confining cement wing walls protected with riprap and large boulder weirs at and upstream side (Figure 38A). The two other bridges are private and constructed of railroad cars with cement, boulder riprap, and boulder gabion footings as well as raised access road prisms. The bridge at RM 0.3 is ~145 feet long and thus requires three rail cars and two sets of mid-channel footings (cement and boulder gabions) (see Figure 34).

Cement and riprap bank armoring are present at two irrigation intake points and in a few locations associated with private property protection in Reach 1. The cement wall (home foundation) on river left at RM 1.03 covers approximately 80 feet of bank on river left and protrudes from the bank. The opposite bank is a confining hillslope, making this point the most confined section of the channel (~25 ft wide). The irrigation intake on river left at RM 1.26 is associated with a leveed ditch (Figure 40A).

Figure 39. Reach 1: Anthropogenic built features. Basemap: ESRI World Imagery.

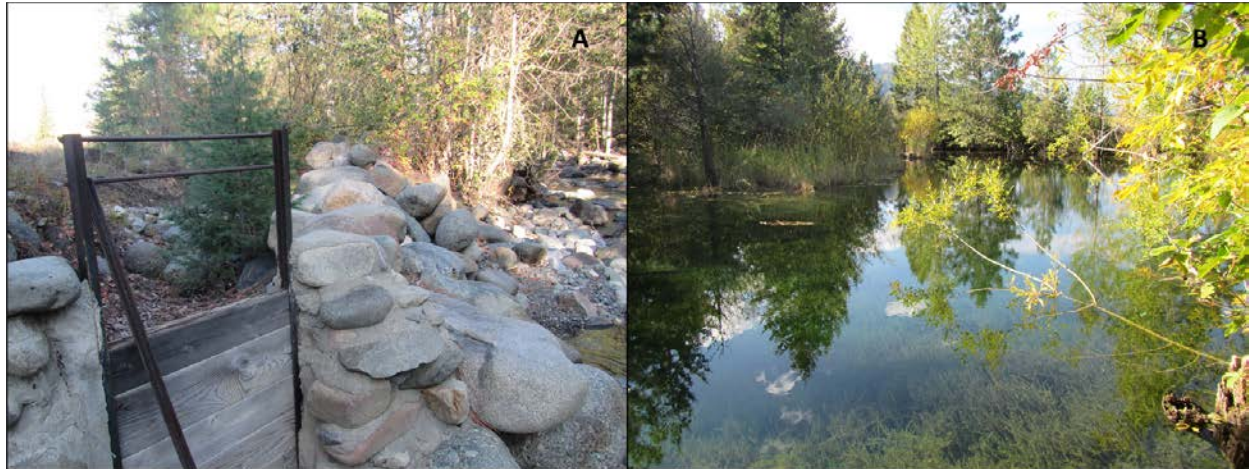
Figure 40. A) Boulder and cement irrigation outtake at RM 1.26 with leveed ditch in the background. B) irrigation-fed set of ponds on historical alluvial fan at RM 1 connected via ditches and culverts to the mainstem channel. (Photos: 10/1/2019)

The irrigation intake at RM 1.07 feeds a set of private ponds with levees that are located on the historical alluvial fan and connected to the mainstem channel via ditches and culverts (Figure 40B). Riprap is also present on river left at RM 1.02, RM 1.04, and RM 1.17-1.19. Other anthropogenic features that interact directly with the channel are large boulder weirs at RM 0.02, 0.03, 0.06, and 1.07. The electric fish-tag counting system with in-channel piping and a data collection box at RM 0.03 imposes minimal impacts to modern channel processes.

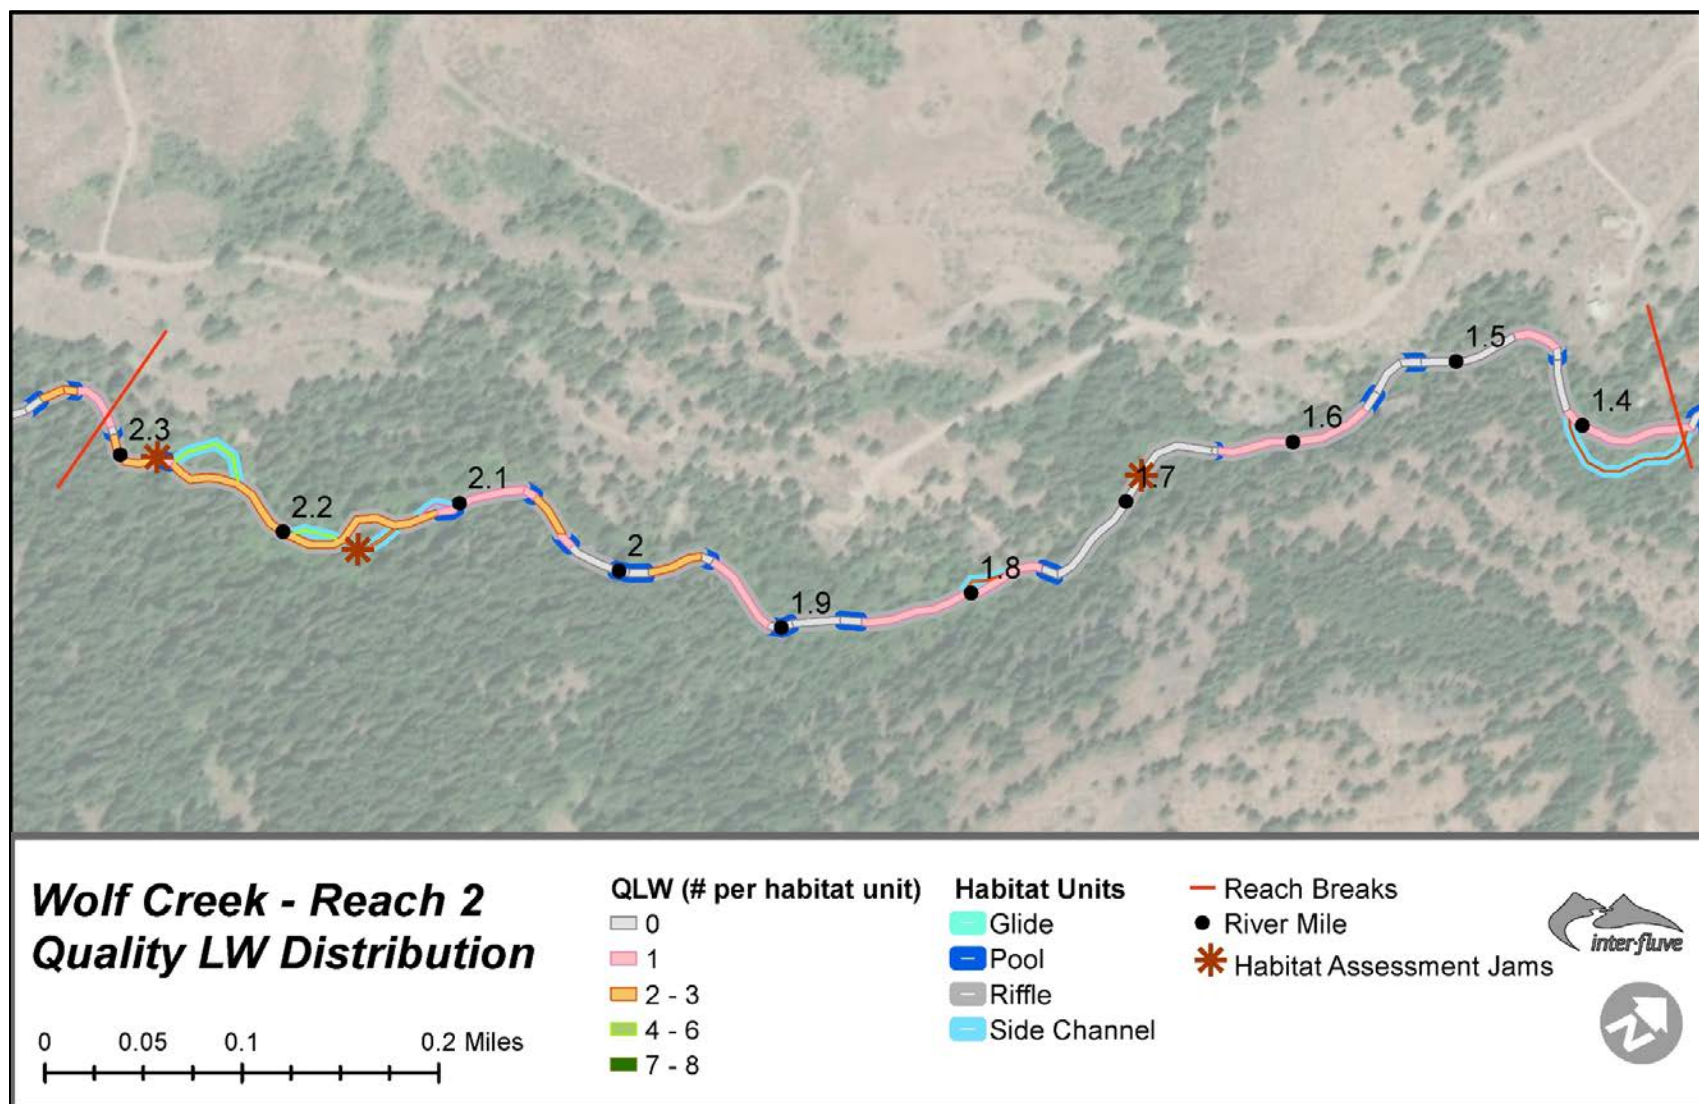
A total of 198 pieces of woody material and three log jams (accumulation of ≥ 10 LWM) were observed in the channel during the survey (10/3/2019). Of the 198 pieces, 65 were classified as quality large wood (QLW); 32 classified as large size class (≥ 20 -inches dbh and >35 -feet long); and 33 as medium size class (12 to 20-inch dbh and at least 35-feet long). The LW jams are located at RM 1.69, 2.17, and 2.28. An additional LW accumulation that does not meet the “jam” classification (> 10 LWM pieces) is located at RM 1.41 at the top of the split-flow side channel. Where they occur, the LW jams and accumulations support geomorphic complexity and habitat function. Figure 46 shows the location of the LW jams and the distribution of the other QLW material (>12 -in dbh and at least 35-feet long) per mapped habitat unit (2019) throughout the reach and the location of the LW jams.

Figure 46. Reach 2 – Quality Large Woody (QLW) Material (>12-inch dbh and at least 35 feet long) distribution by number of pieces per mapped habitat (2019 Habitat Survey) and the location of LW jams (>10 pieces of LWM accumulated).

Reach 2 has less quality LW (QLW) per mile than recommended for quality aquatic habitat conditions. Where LWM and jams occur, they influence geomorphic processes such as channel avulsion, pool scour, sediment accumulations, improved floodplain connectivity, and split flow conditions (Figure 47). The LWM jams are effective at increasing localized geomorphic and aquatic habitat complexity in Reach 2 because it is a relatively high gradient reach with moderate-high specific stream power. Larger masses of QLW are necessary in Reach 2 to effect hydraulics and sustain function. The limited LWM in Reach 2 today is likely the result of past riparian vegetation clearing and logging in the downstream privately owned section that reduced the number of quality (large or medium) sized trees in the riparian area and available floodplain.

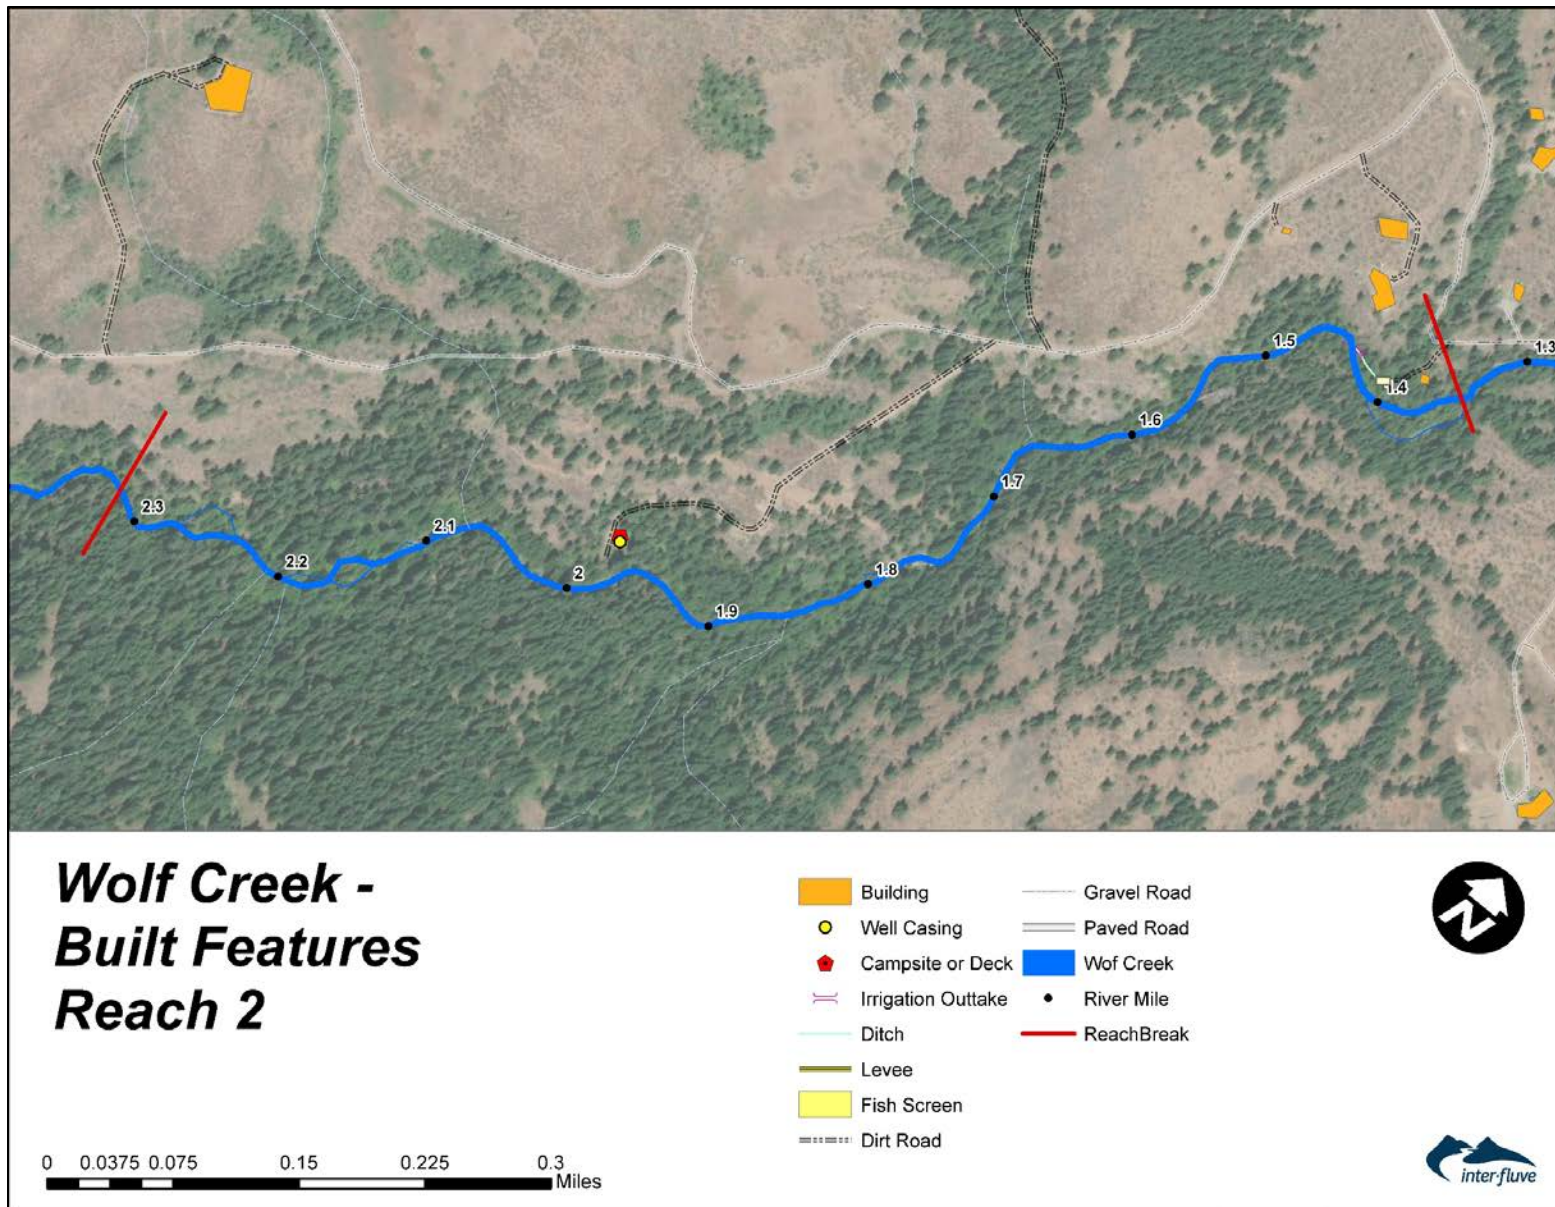
Although the downstream section of the reach is privately owned, anthropogenic features that interact with the channel are relatively minor in Reach 2 (Figure 48). The few home sites located on the hillslopes above the valley floor currently impose no impact to the channel and its floodplain. An access road to the floodplain with a cleared parking area, thinned floodplain vegetation, trail, and a

Figure 48. Reach 2: Anthropogenic built features. Basemap: ESRI World Imagery

well do exist on river left at RM 1.98. The other notable anthropogenic features in Reach 2 include an irrigation intake on river left at RM 1.44 (Figure 49). The intake appears to function seasonally and is constructed of cement, boulders, and steel and is designed to have the quantity of inflow managed by removing or inserting wooden or metal slats. A ditch runs from the intake structure point to a modern fish screen, and then into another ditch to a buried pipe. Evaluation of potential impacts of the intake, ditch, and fish screen and the seasonal management plan of it to fish species of concern are recommended. A pump house and cistern managed and operated by the Wolf Creek Property Owners Association (WCPOA) is located near the fish screen. CWPOA operates the water system for the local community on the Wolf Creek Fan and the community trail at RM 1.35.
