Wolf Creek Reach Assessment & Restoration Strategy *Final Report*

DECEMBER 2020

PREPARED FOR
Yakama Nation – Fisheries
Winthrop, WA

PREPARED BY
Inter-Fluve
Hood River, OR

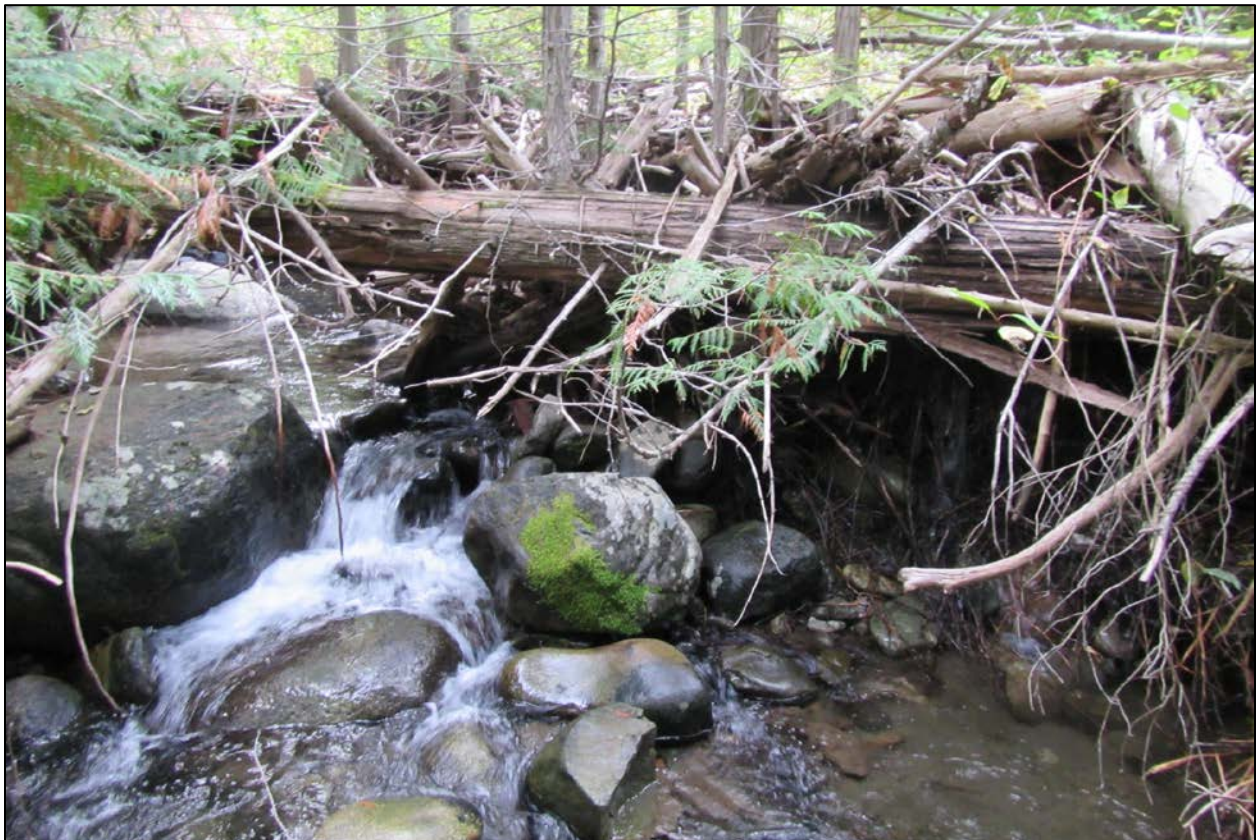
Little Wolf Creek enters the mainstem channel near the upstream boundary of Reach 3 (RM 3.27). However, irrigation withdrawals by the Wolf Creek ditch/aqueduct captures all of Little Wolf Creek's discharge during low-flow months—making it a seasonal or ephemeral supply of surface water to Wolf Creek. Little Wolf Creek has a small cobble delta at its confluence with Wolf Creek. During the October 2019 survey, the Little Wolf Creek delta was wetted (post-irrigation diversion period) and loaded with small debris, see Figure 53. During the July 2020 geomorphology survey, no surface water was observed at the confluence because all of its flow was being diverted by the irrigation ditch. Two other small ephemeral tributaries seasonally contribute minor inputs at RM 2.45 (river right) and RM 2.57 (river left).

Figure 53. Little Wolf Creek confluence. (Photo: Oct 4, 2019)

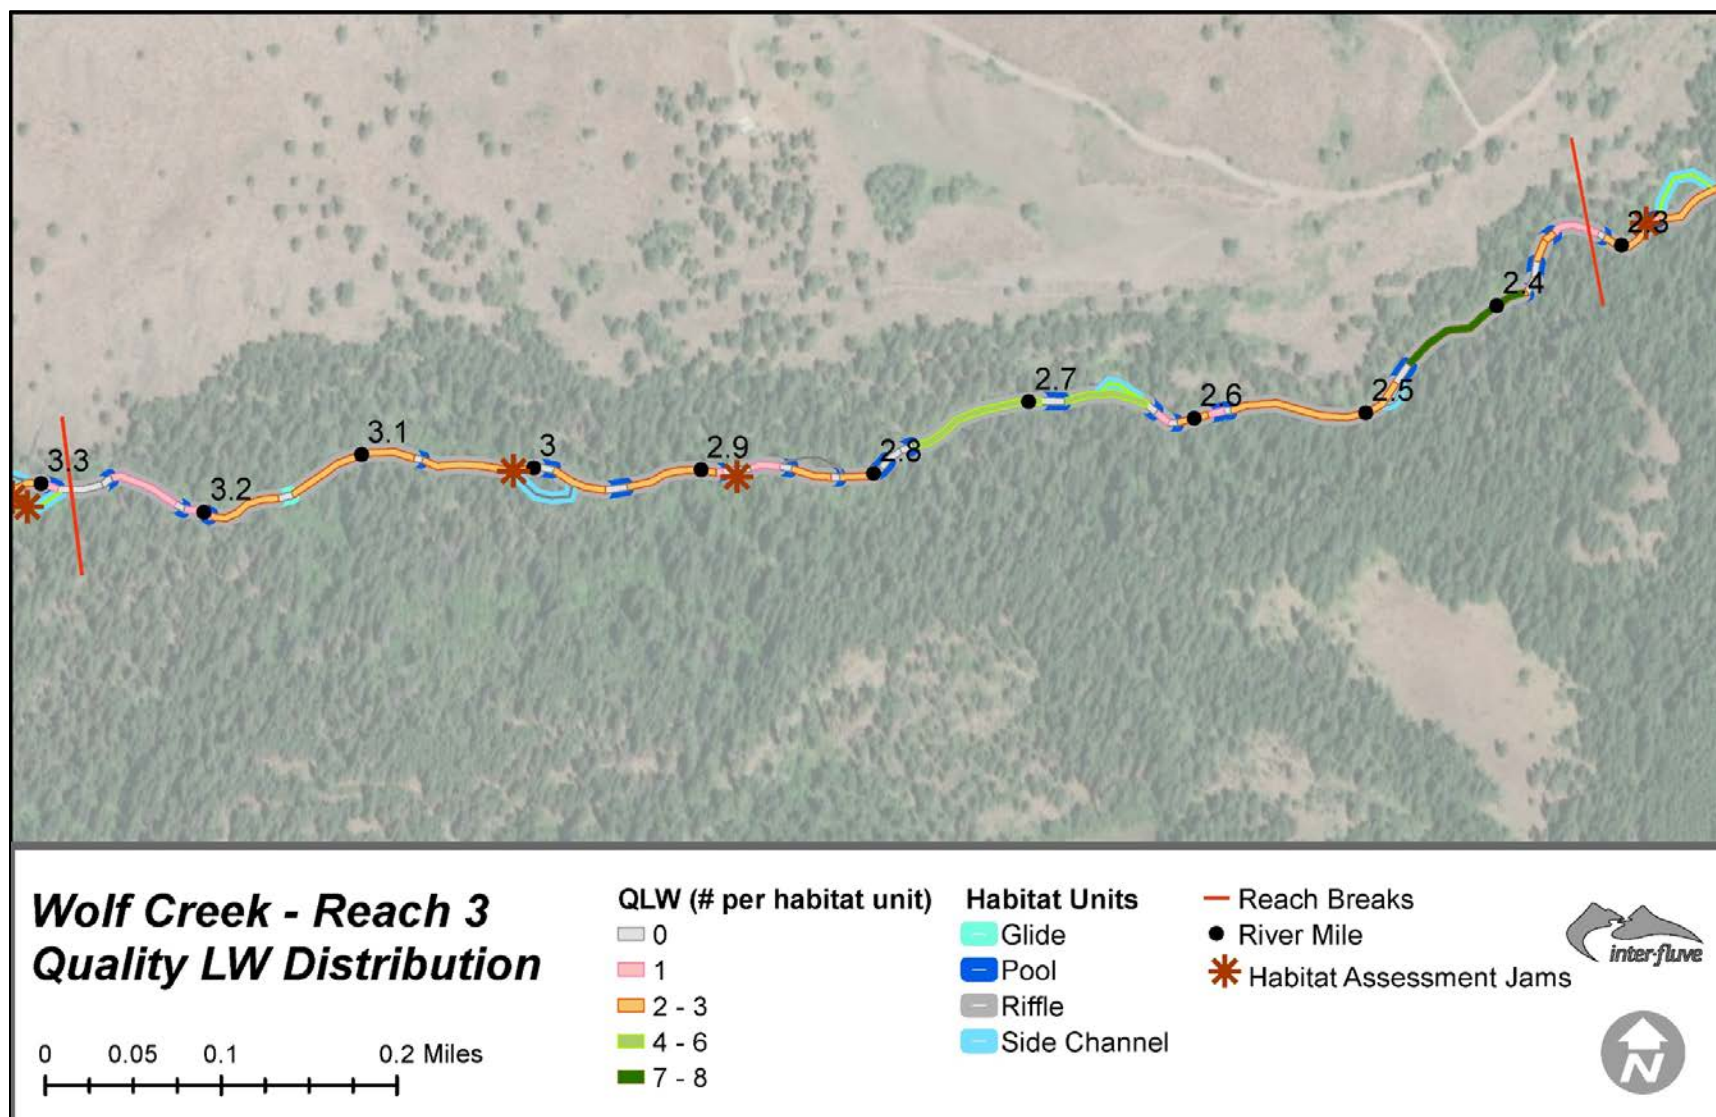
A total of 121 pieces of large woody material (LWM) and two log jams (accumulation of ≥ 10 LWM) were observed in the channel during the survey (10/4/2019). Of the 121 pieces, 48 are considered QLW; 24 classified as large size class (≥ 20 -inches dbh and >35 -feet long); and 24 as medium size class (12 to 20-inch dbh and at least 35-feet long). The LW jams, located at RM 2.88 and 3.02 have multiple pieces of QLW and thus are effective channel influencing and habitat forming structures. See Figure 56 for the LW jam locations and the distribution of the other QLW (>12 -in dbh and at least 35 feet long), per mapped habitat unit in Reach 3. Where LWM exists, it plays an important role in aquatic habitat and geomorphic channel complexity such as pool development/maintenance, gravel accumulations, hydraulic diversity, floodplain activation/development, side channel activation/maintenance, and lateral processes.

Figure 56. Reach 3 - Quality Large Woody (QLW) Material (>12-inch dbh and at least 35 feet long) distribution by number of pieces per mapped habitat (2019 Habitat Survey) and the location of LW jams (>10 pieces of LWM accumulated).

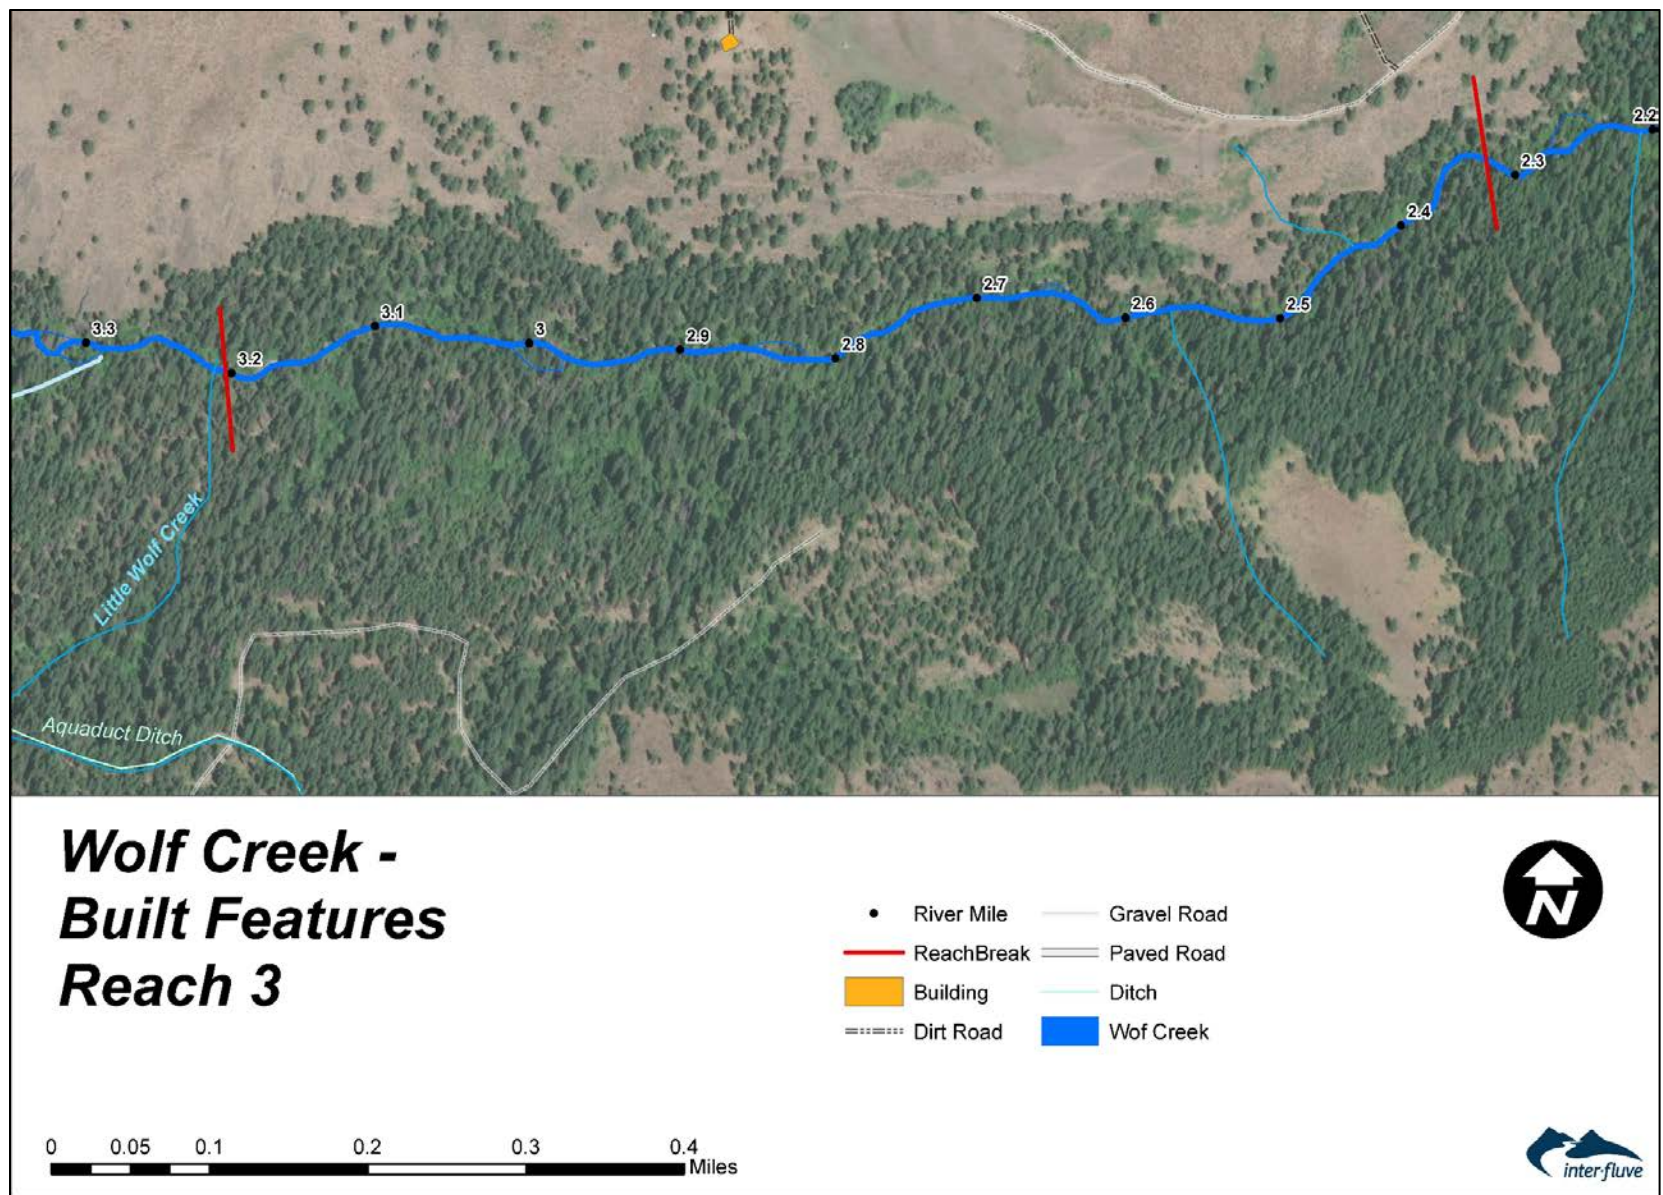
Anthropogenic features that interact with the channel are relatively minor in Reach 3 (Figure 58). A few gravel or dirt roads and homes located on the hillslopes above the valley floor and terrace surfaces do not directly impact the channel or aquatic habitat. The one notable human alteration in Reach 3 is the seasonal irrigation withdrawal by the Wolf Creek ditch/aqueduct that alters the quantity and timing of surface water discharge input from Little Wolf Creek to Wolf Creek at the upstream border of Reach 3. Irrigation withdrawals are reported to capture all of Little Wolf Creek during low-flow summer months when perennial contributions to the mainstem could be beneficial. This also removes lower Little Wolf Creek as potential rearing habitat during these months. Seasonal drying or flow reductions from irrigation withdrawals may also pose stranding issues to fish that choose to utilize it as off channel refugia during high-flow events or for spawning when it is connected. Further investigation is warranted to evaluate the potential impacts of irrigation withdrawal from Little Wolf Creek and the loss of potential habitat it represents to Wolf Creek.

Figure 58. Anthropogenic features in Reach 3. Basemap: ESRI World Imagery

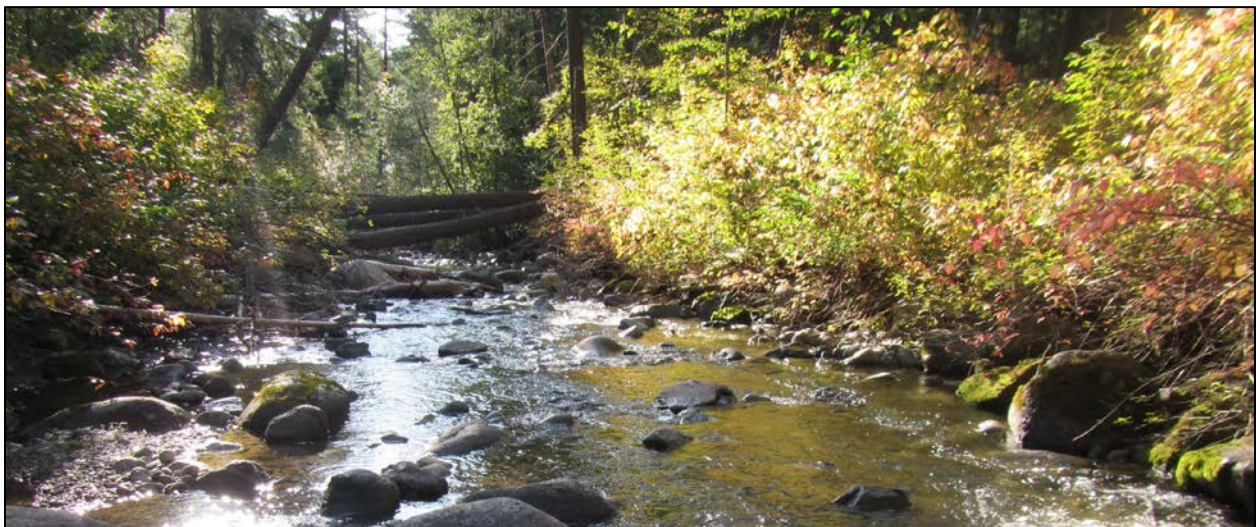
Figure 63. Example of well-established mixed vegetation on floodplain surfaces in Reach 4 – RM 3.82. (Photo: 10/5/2019)

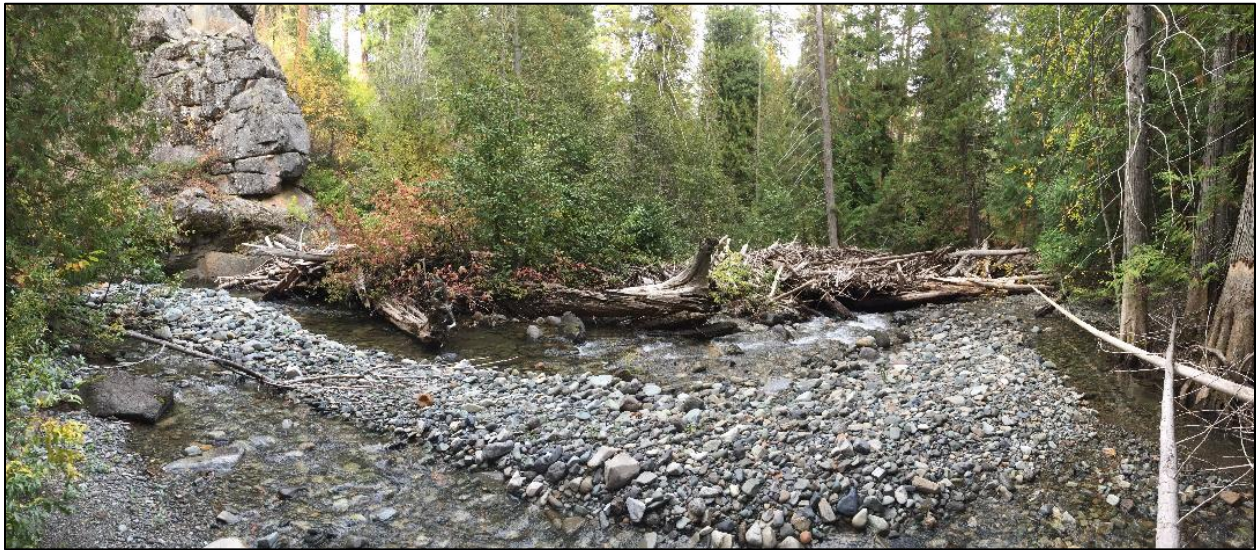
Figure 65. Bedrock wall on river left at RM 3.44 and downstream channel-spanning log jam with bar accumulation upstream. (Photo: 10/4/2019)

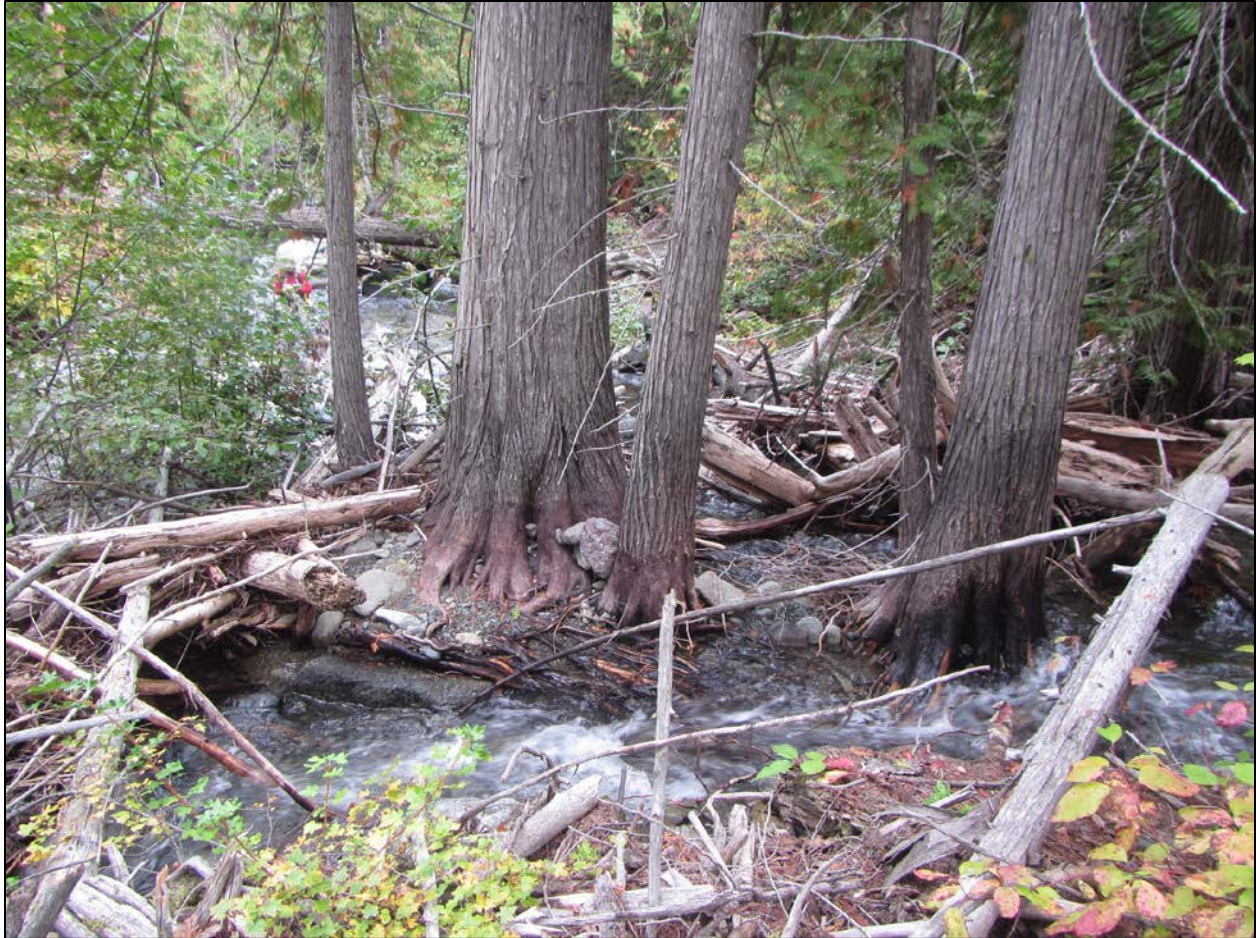
Large Wood jams and geomorphically-effective QLW pieces occur where large boulders or adjacent floodplain trees provide ballasting and where channel planform produces catchment areas (meander bends, side channel apex, etc.). Geomorphic complexity and thus habitat complexity are greatest where QLW interacts with the channel and where available floodplain bordering the channel allows for channel response. The size (quality) of the LW of the mature forests that border Reach 4 are capable of producing geomorphic complexity as single or small accumulations, as well as LW jams where pieces accumulate. Reach 4 has the largest and greatest number of LWM jams in the assessment area. The jams provide good analogues for large wood loading that produces diverse channel complexity (Figure 65). A recently accumulated/ing LWM jam at RM 3.32 has avulsed the mainstem to river left so that the channel is currently multi-threaded with some of the most diverse quality habitat in the assessment area (Figure 66).

Figure 66. LWM jam at RM 3.32 and resultant multi-threaded flow path avulsion across the floodplain. (Photo: 10/4/2019)

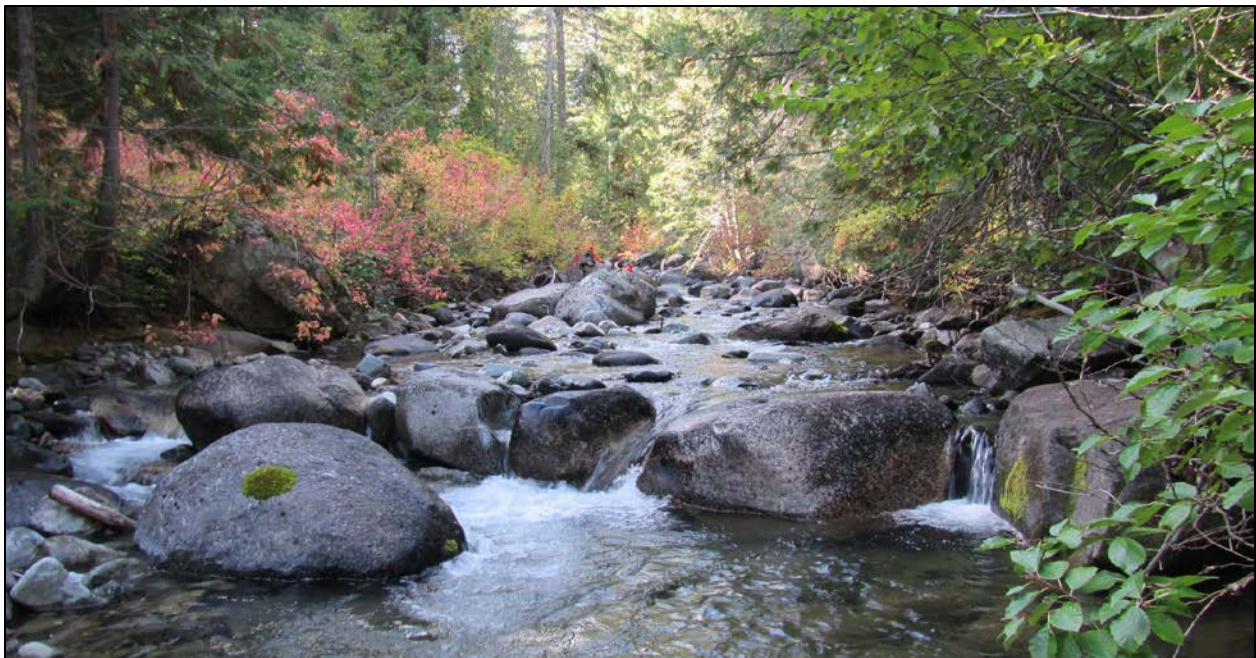
Wolf Creek in this portion of Reach 5 is considered a high gradient channel (reach average gradient is 7.1 %) with a subtle meandering planform. Planform is both a product of the pathway the channel has eroded into the underlying bedrock over time as well as how it has historically and currently situated itself in the valley floor in relationship to paleo and modern alluvial surfaces (terraces and floodplains). The hillslopes, terraces, and the bedrock bank exposures (RM 4.53 and 4.43 on river right) contribute colluvium and debris such as boulders and sediment that add complexity to the channel's geomorphology. The presence of very large boulders in the channel, banks, and across the floodplain influence channel form, localized hydraulics (scour and deposition), LWM retention, and bank and bed roughness and stability. Pool frequency and depth and off channel habitat connectivity to the mainstem are rated as At Risk for quality salmonid habitat conditions in Reach 5 (See REI summary in Section 2.13).

Figure 70. Wolf Creek at RM 4.36, looking upstream. (Photo: 10/5/2019)

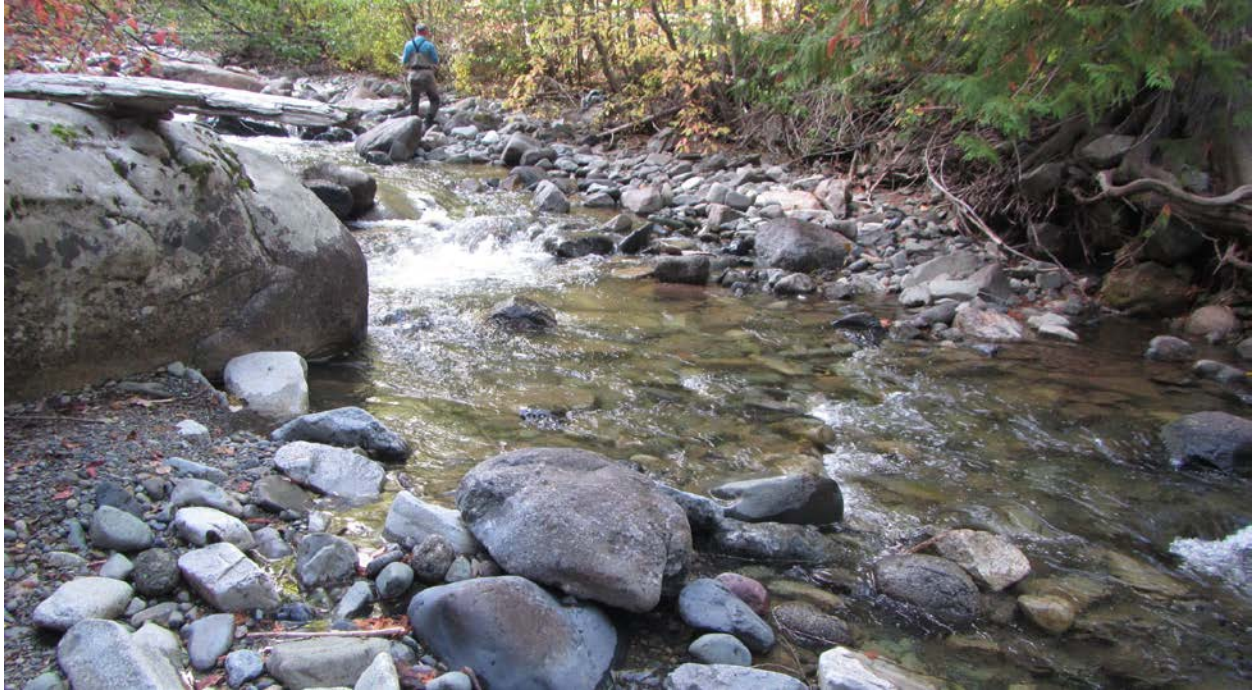
Channel substrate in Reach 5 is composed of boulders and cobble with sparse gravels. Gravels were observed in backwater eddies at boulders and near large wood accumulations. Large boulder colluvium sourced from adjacent hillslopes provide additional complexity to the channel. Based on bed and bank material, hyporheic flow is expected to occur between the channel bed and floodplain surfaces.

Figure 71. Wolf Creek at RM 4.5 (Reach 5). (Photo: 10/45/2019)

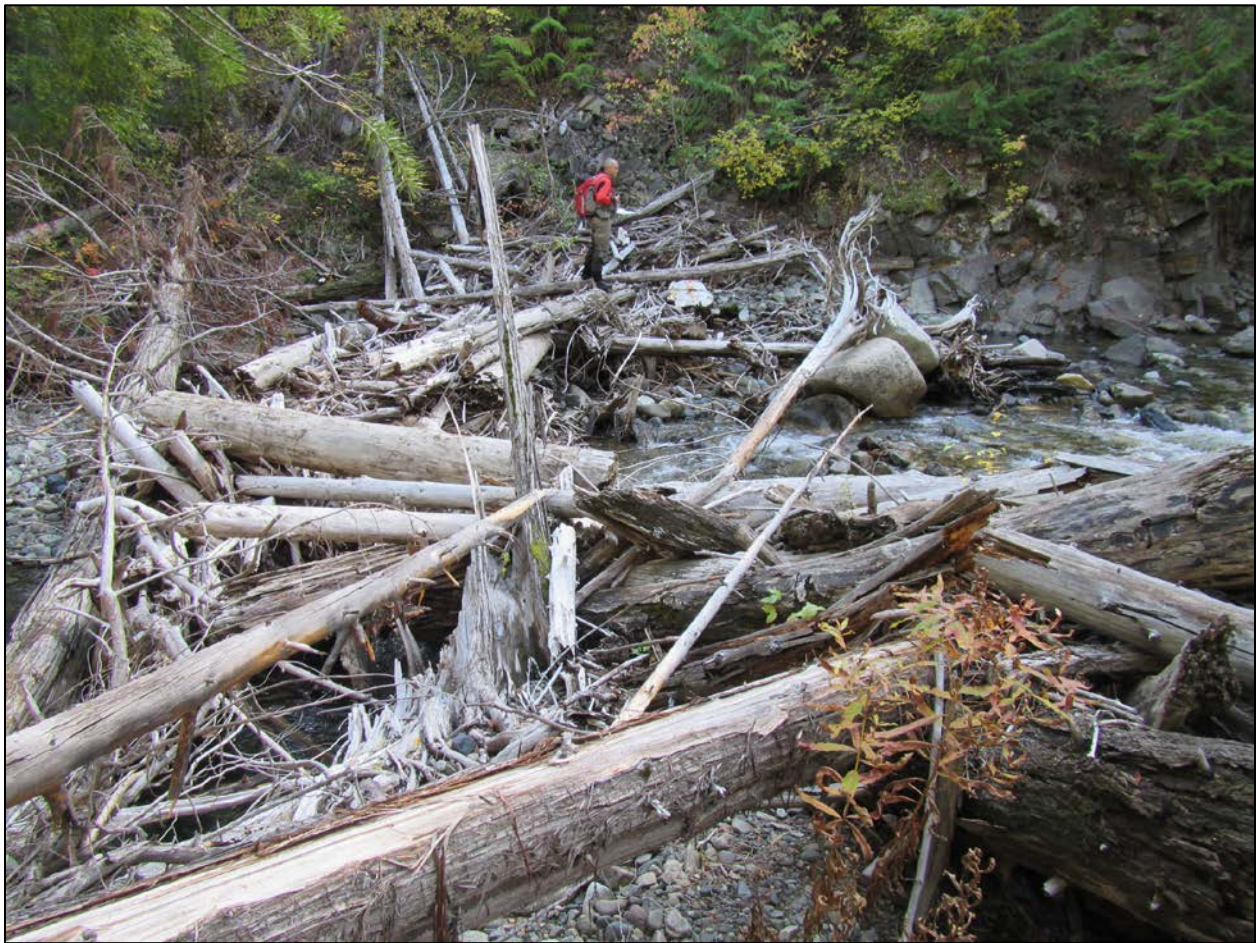
Where LWM exists, it plays an important role in aquatic habitat and geomorphic channel complexity such as pool development/maintenance, gravel accumulations, hydraulic diversity, and floodplain activation/development. There are three likely reasons for a lack of LWM in the upstream portion of Reach 5: the irrigation withdrawal gate and weirs at the upstream end of the reach are maintained and likely regularly cleared of LWM; floodplain vegetation removal and thinning near the infrastructure; . However, LW jams and geomorphically-effective QLW pieces are retained downstream of the structure where large boulders or adjacent floodplain trees provide ballasting and where channel planform produces catchment areas (bedrock meander bend). Geomorphic complexity and thus habitat complexity are greatest where QLW interacts with the channel and available floodplain. The size (quality) of the mature forests that border Reach 5 are capable of producing geomorphic complexity, especially as LW jams. The LW jam at RM 4.42 provides a good analogue example for effective jams for the assessment (Figure 74).

Figure 74. Channel-spanning LWM jam at RM 4.42. (Photo: 10/5/2019)

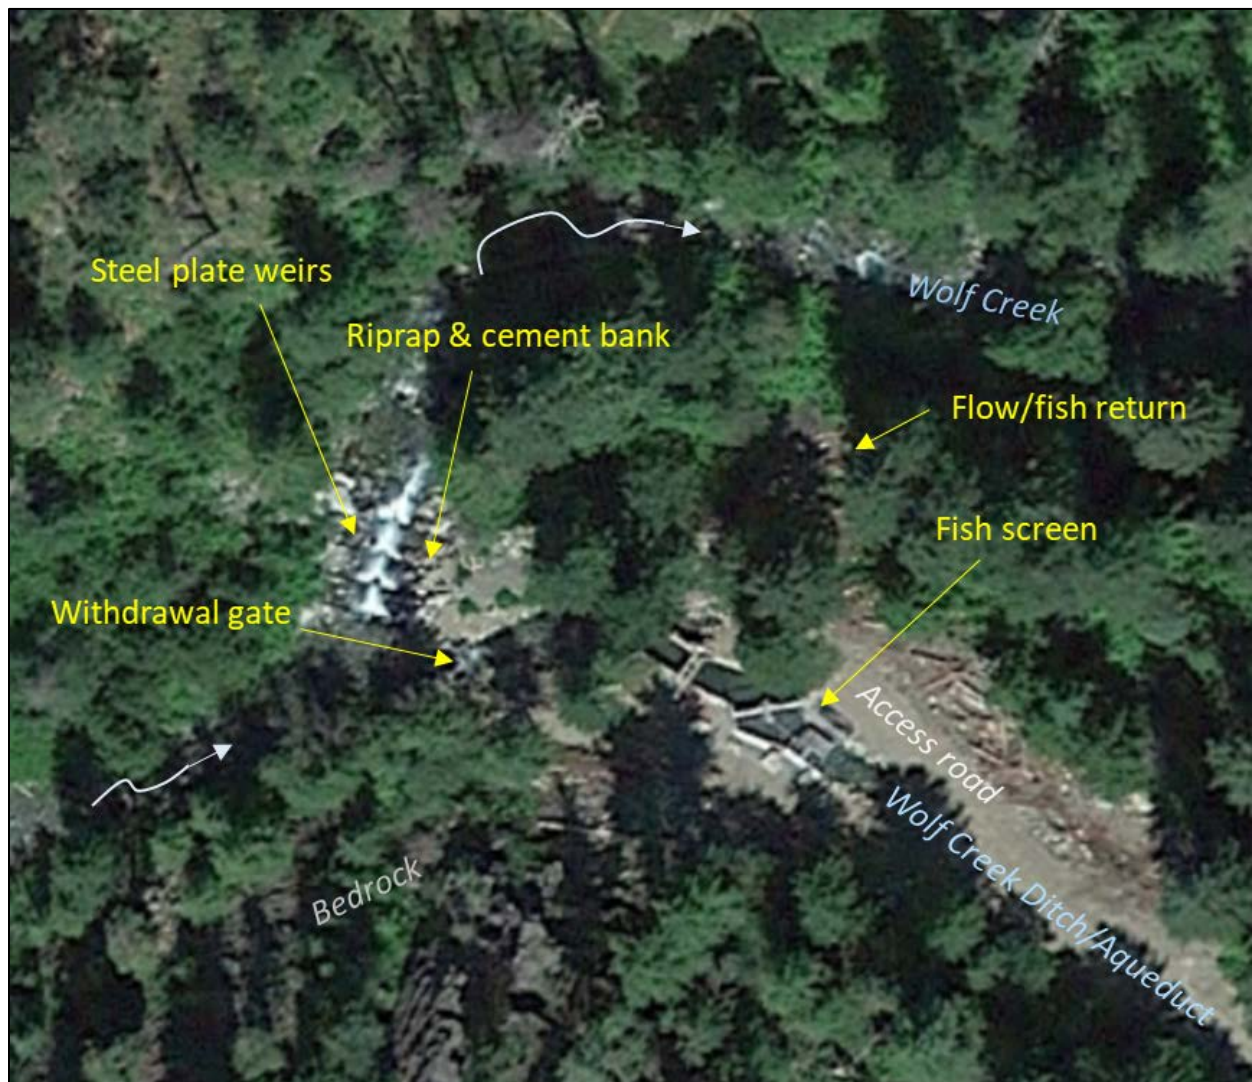
Anthropogenic features that interact with the channel in Reach 5 (Figure 76) are associated with the irrigation withdrawal infrastructure of the Wolf Creek Ditch (Figure 75). The withdrawal outtake gate (RM 4.53) is located on river right downstream from a bedrock bank outcrop and immediately upstream of a set of 5 steel plate weirs constructed to hold bed elevation for the withdrawal (Figure 77). The weirs are reinforced with boulders and notched in the middle to direct flow down the center of the channel (Figure 77). The weirs are currently fish passable for up-migrating adults but may pose a minor passage issue for juveniles at low flows until sufficient bedload accumulates behind the plates. The river right side of the channel is riprapped with large boulders and cement.

Figure 75. Overview of the Wolf Creek irrigation diversion at RM 4.53. (GoogleImage)

Assuming that the Wolf Creek irrigation diversion must remain in place and in functioning order, improvements to the existing grade control weirs would improve fish passage conditions and structure longevity. Constructing a set of boulder steps that have multiple flow pathways at high flow and concentrated but offset flow paths at low flow would provide more natural and easier fish passage instead of a sequence of middle-notched weirs that focus flow energy. Burial of the large boulders could extend into the banks to both maintain flow direction towards the withdrawal gate and provide valley-wide grade control. This design would also minimize ongoing maintenance of the existing weir and outtake point structure.

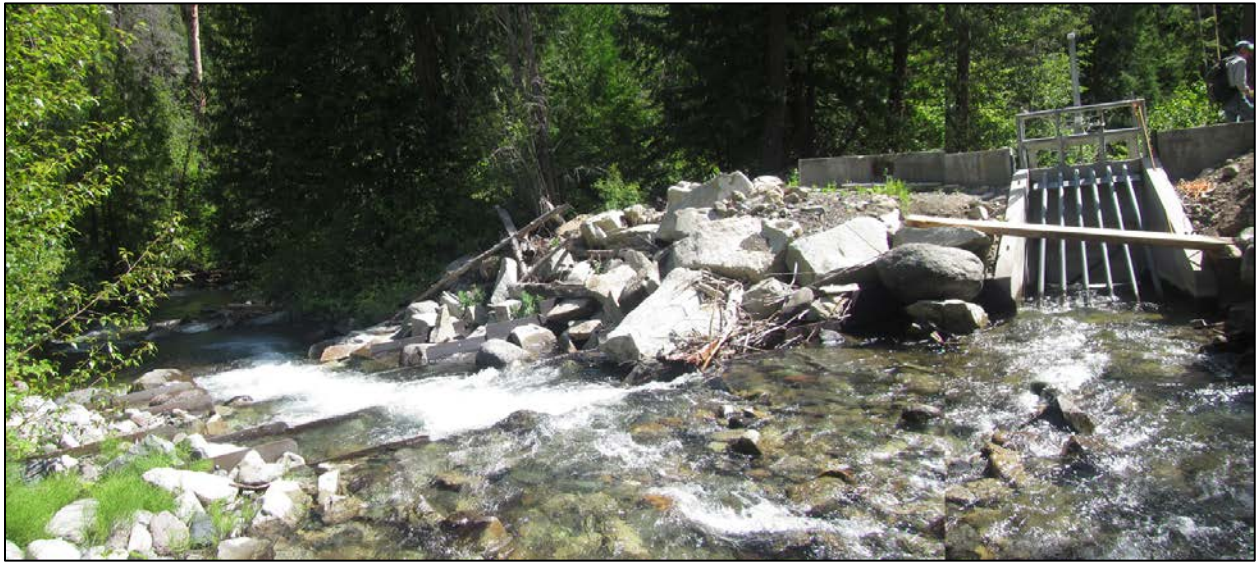
Figure 77. Wolf Creek diversion gate and downstream constructed steel plate weirs at RM 4.53. (Photo: 7/8/2020)

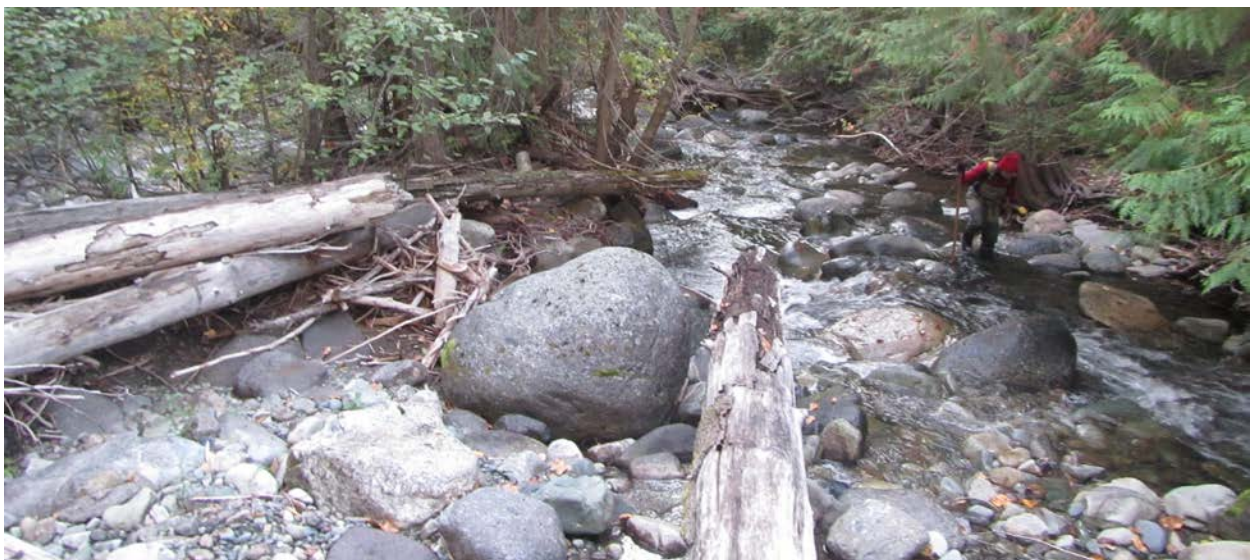
Figure 3. 125-foot long side channel in Reach 3 that had 9 pieces of large wood. (10/4/2019)

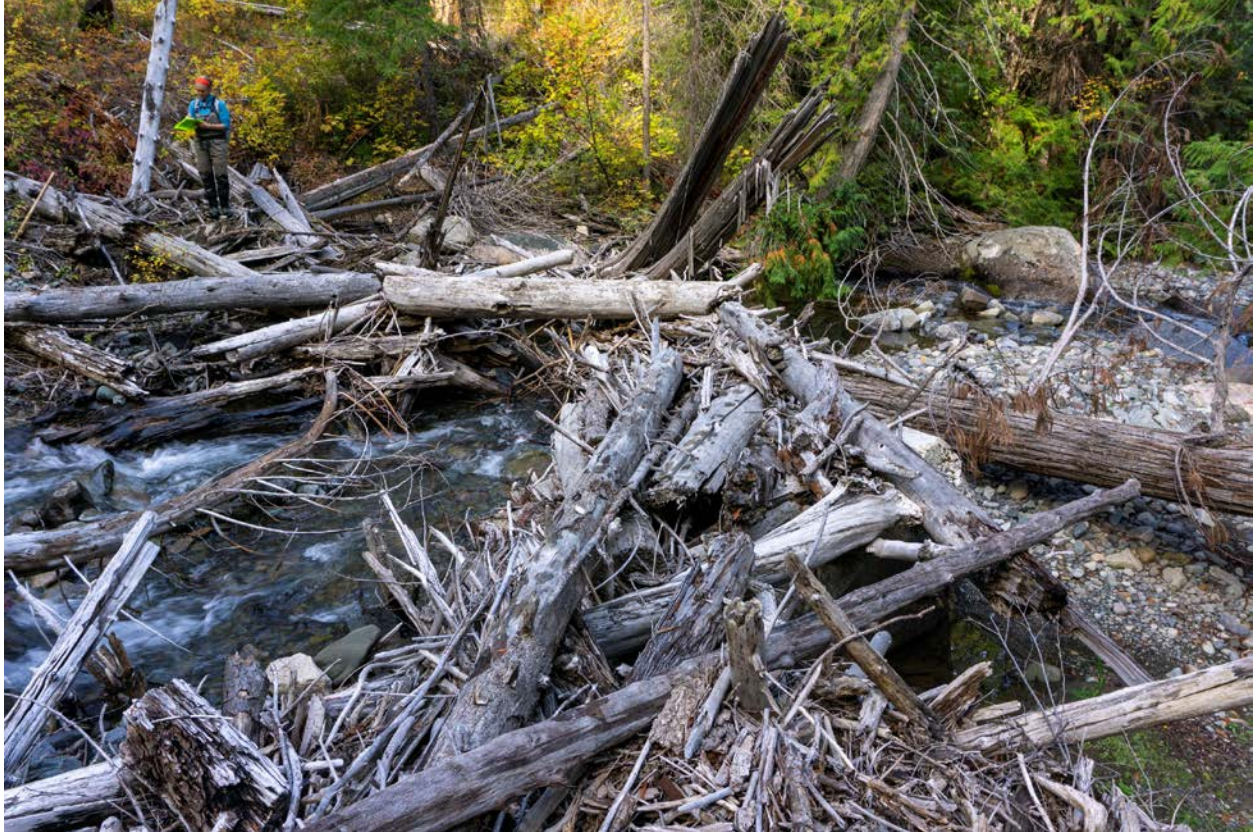
Figure 5. Channel-spanning logjam in Reach 5. (10/5/2019)

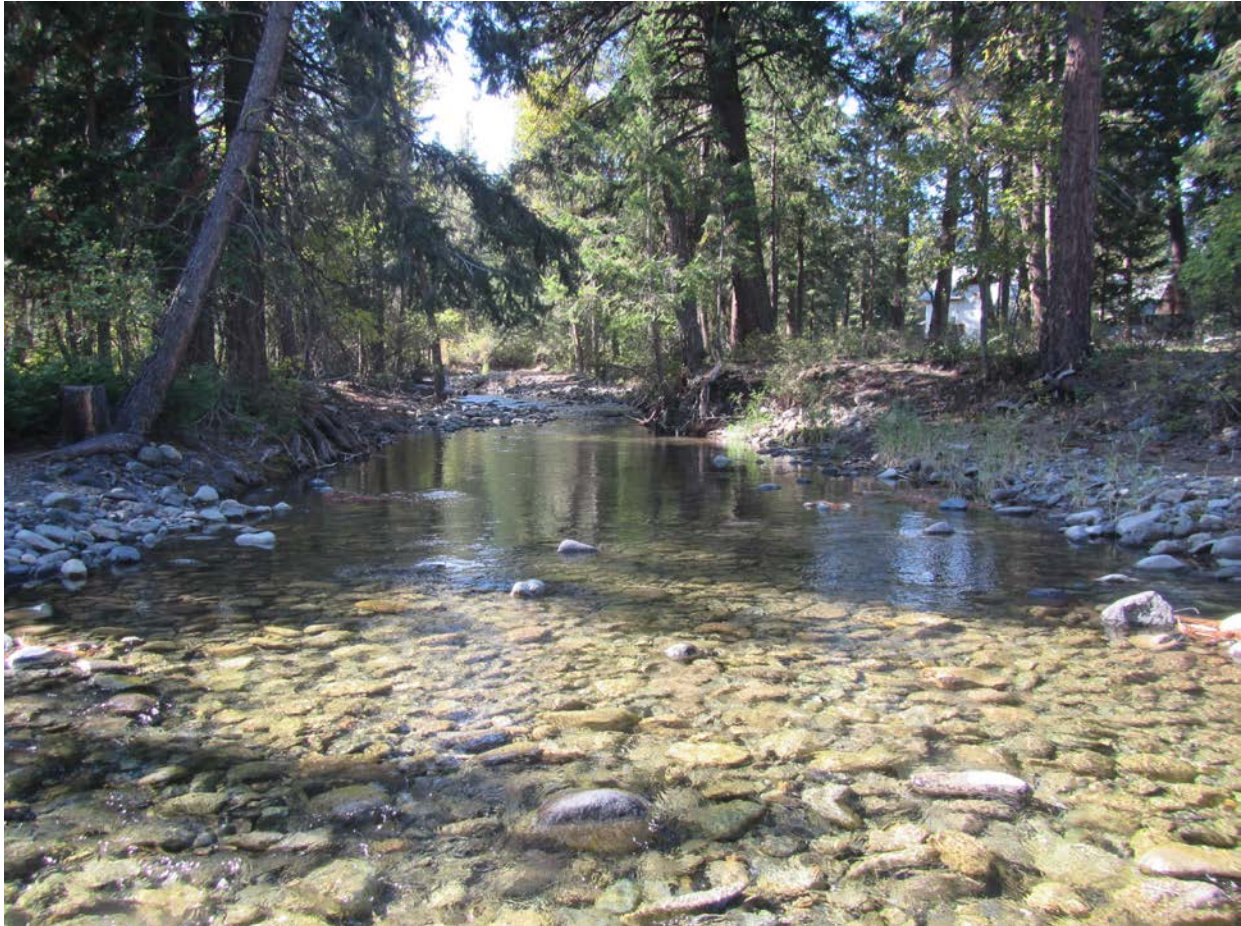
Figure 13. Representative view of Reach 1. Habitat units are dominated by extended riffles. Human-induced channel confinement and riparian impacts are most frequent in this reach. (10/01/2020)

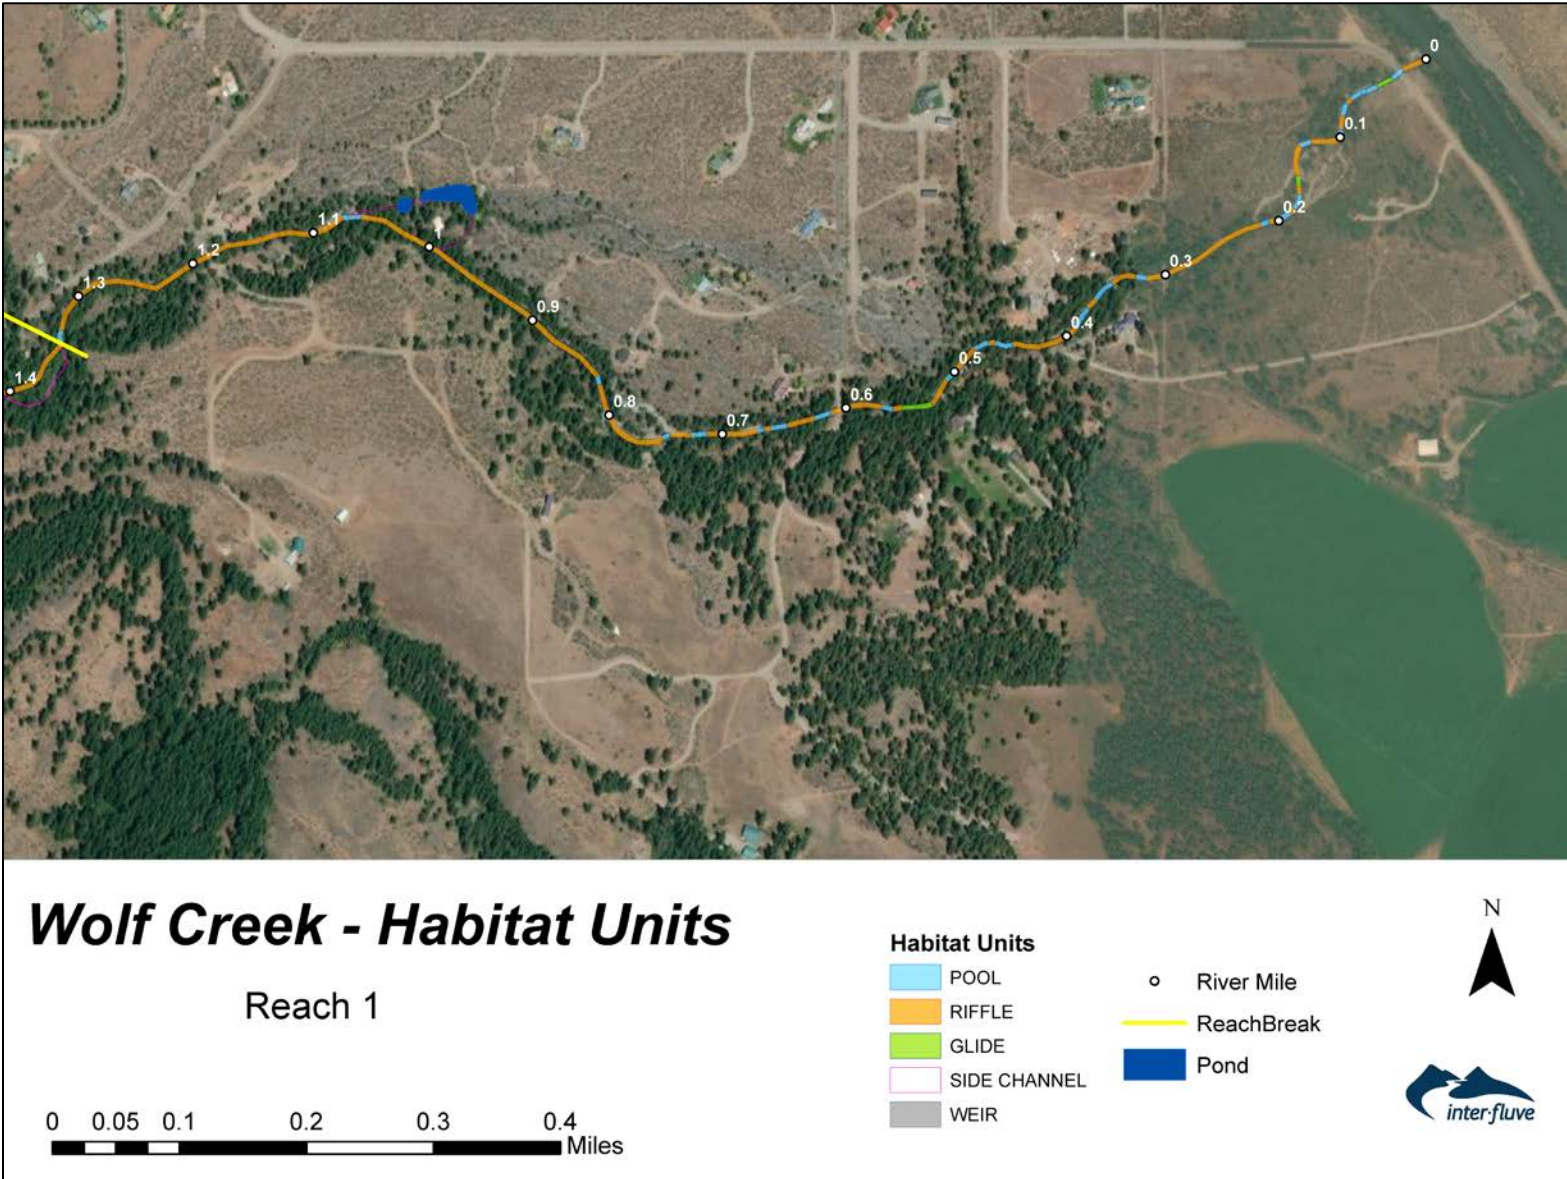
Figure 14. Wolf Creek, Reach 1—channel unit distribution (RM 0-RM 1.34), 2019. Basemap: ESRI Bing imagery

Reach 1 is the longest reach delineated in the study area at 1.34 miles (Figure 14). Similar to all reaches in the project area, a large majority of the habitat area (79%) was riffle; the remaining habitat area was pool (18%); and glide (3%) (Figure 15). No side channels were present in Reach 1. The channel is confined by residential land use, levees, and bridges. Reach 1 maintains the lowest stream gradient of all five reaches at 1.41%.

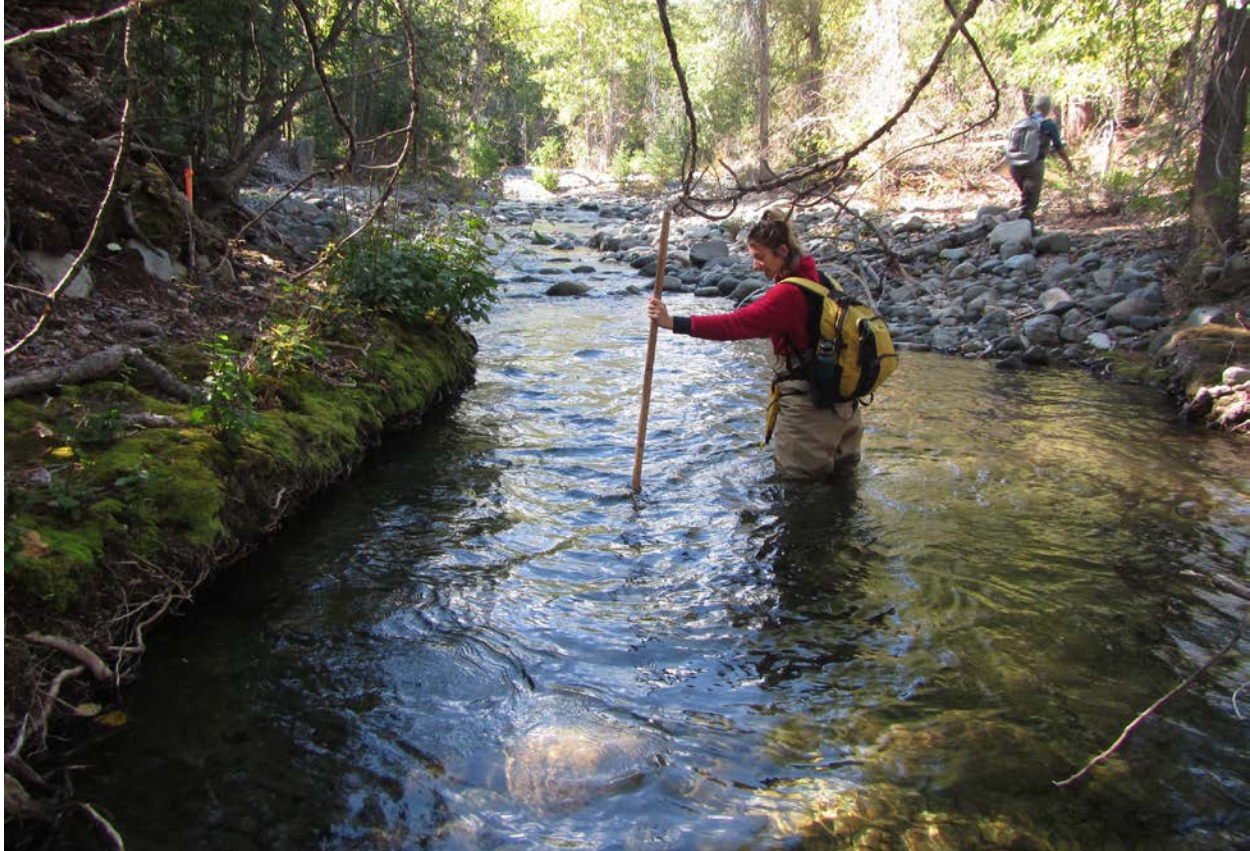
Pool was the second most common habitat type recorded in Reach 1 with 18% of the habitat unit surface area identified as pools (Figure 15). A total of 24 pools were counted—the highest number of pools in the study area. However, the pools were in general short and shallow with 96% of the pools measuring less than 3 feet of residual depth (the entire project area averages 93% less than 3 feet of residual depth). The average residual depth of pools in Reach 1 is 1.6 feet, compared to the study area average of 1.7 feet. Reach 1 averaged 17.9 pools per mile. Mean pool spacing in Reach 1 was 7.7 channel widths per pool, compared to an average of 7.4 channel widths per pool for the surveyed area.

Figure 16. A total of 24 pools were identified in Reach 1. All but one had residual depths of less than 3 feet. (Photo: 10/01/19)

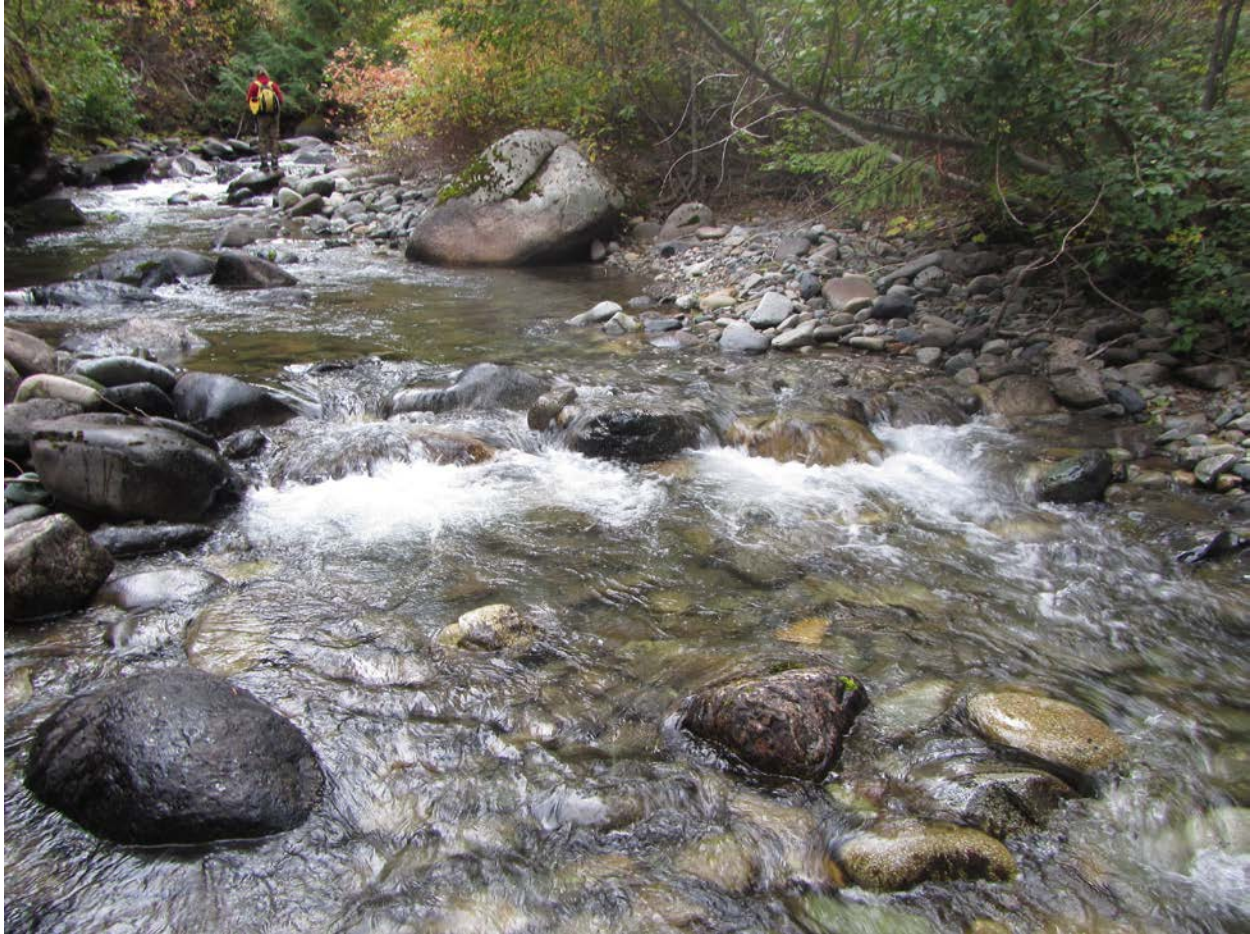
Figure 21. Representative view of Reach 2. Dominant habit unit is extended cascading riffles with large boulders. (Photo: 10/03/2019)
