Wolf Creek Reach Assessment & Restoration Strategy *Final Report*

DECEMBER 2020

PREPARED FOR
Yakama Nation – Fisheries
Winthrop, WA

PREPARED BY
Inter-Fluve
Hood River, OR

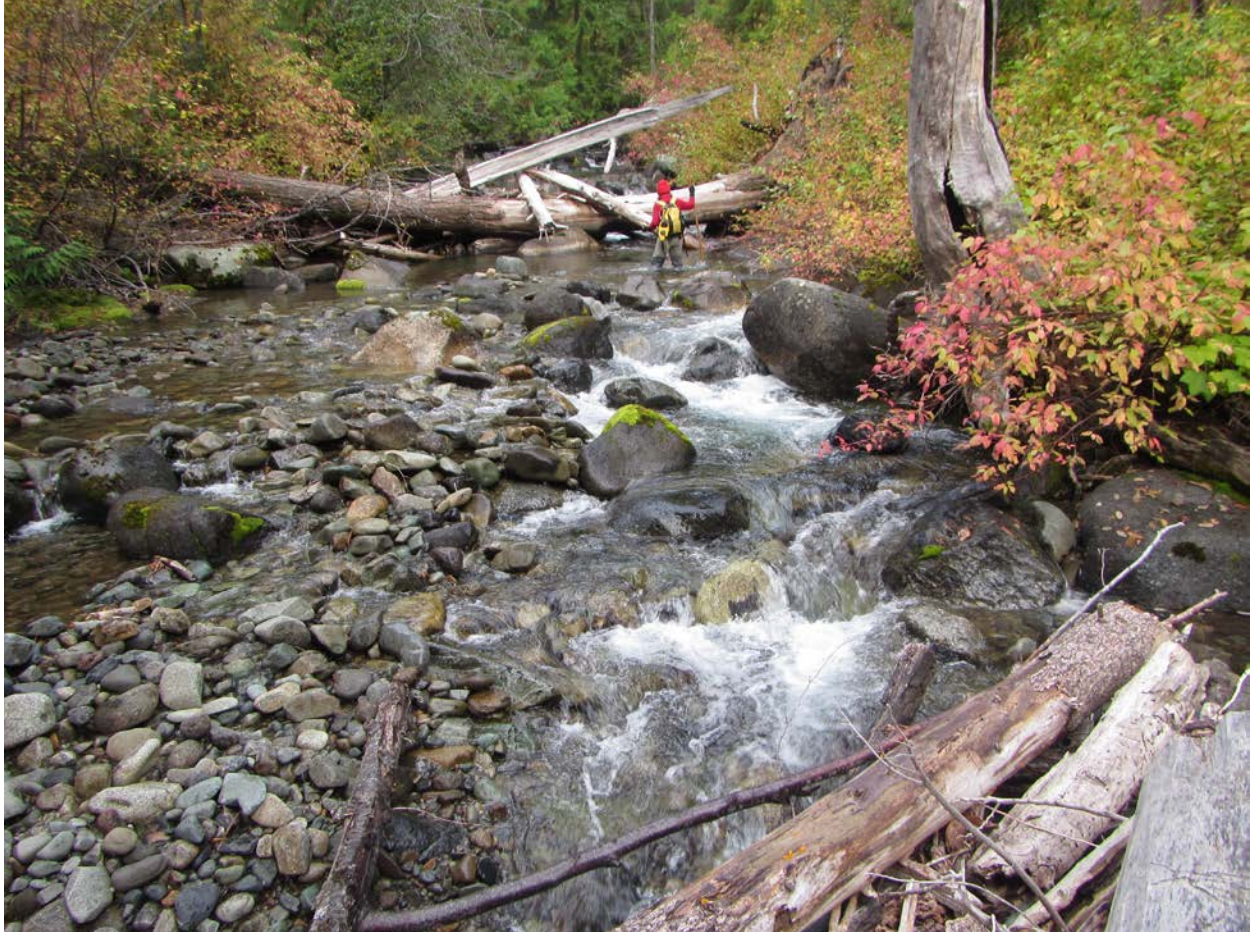
Figure 28. Representative view of Reach 3. Dominant habitat unit is extended riffles with boulders. (Photo: 10/04/19)

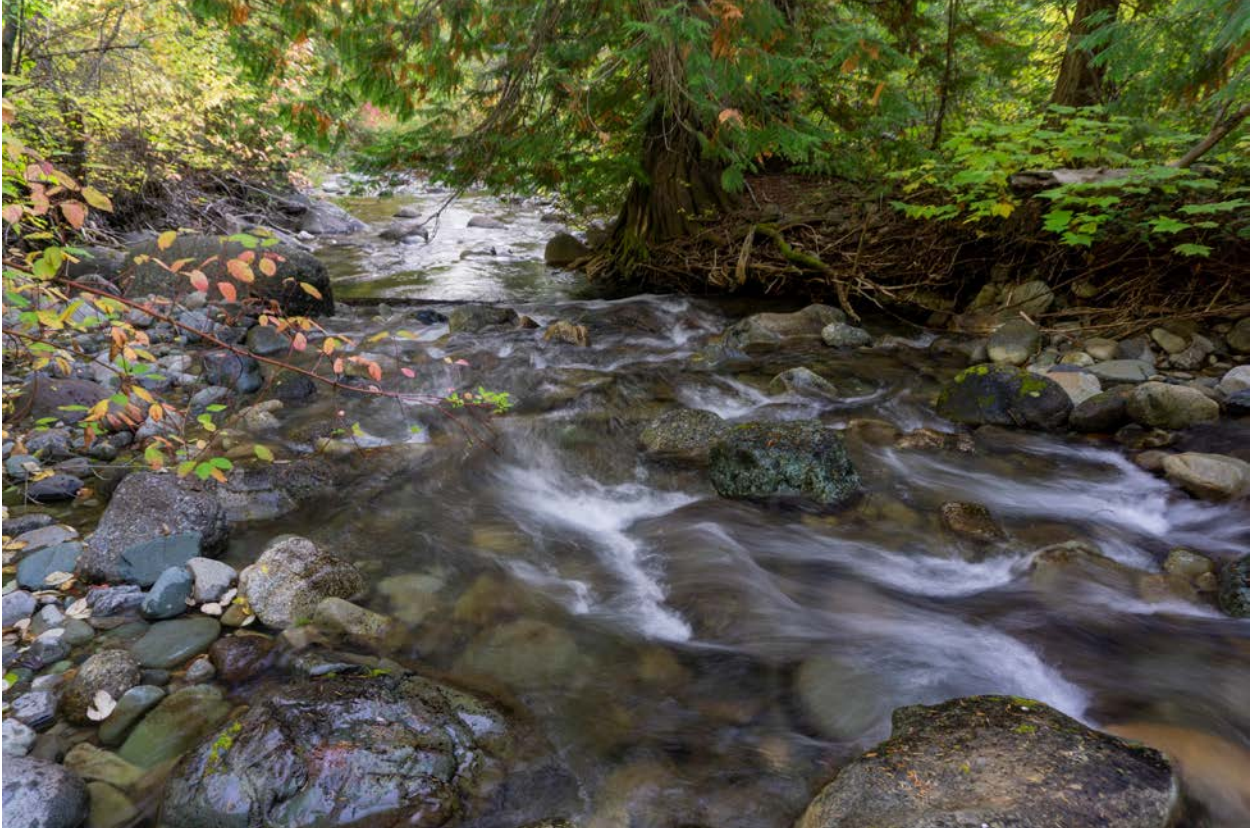
Figure 35. Representative view of Reach 4. Habitat units dominated by extended cascading riffles with boulders. (Photo: 10/04/2019)
