Lower Nason
Assessment of Geomorphic and Ecologic Indicators
Nason Creek, Wenatchee Subbasin

Chelan County, Washington

U.S. Department of the Interior
Bureau of Reclamation
Pacific Northwest Region
Pacific Northwest Regional Office, Boise, Idaho

April 2011

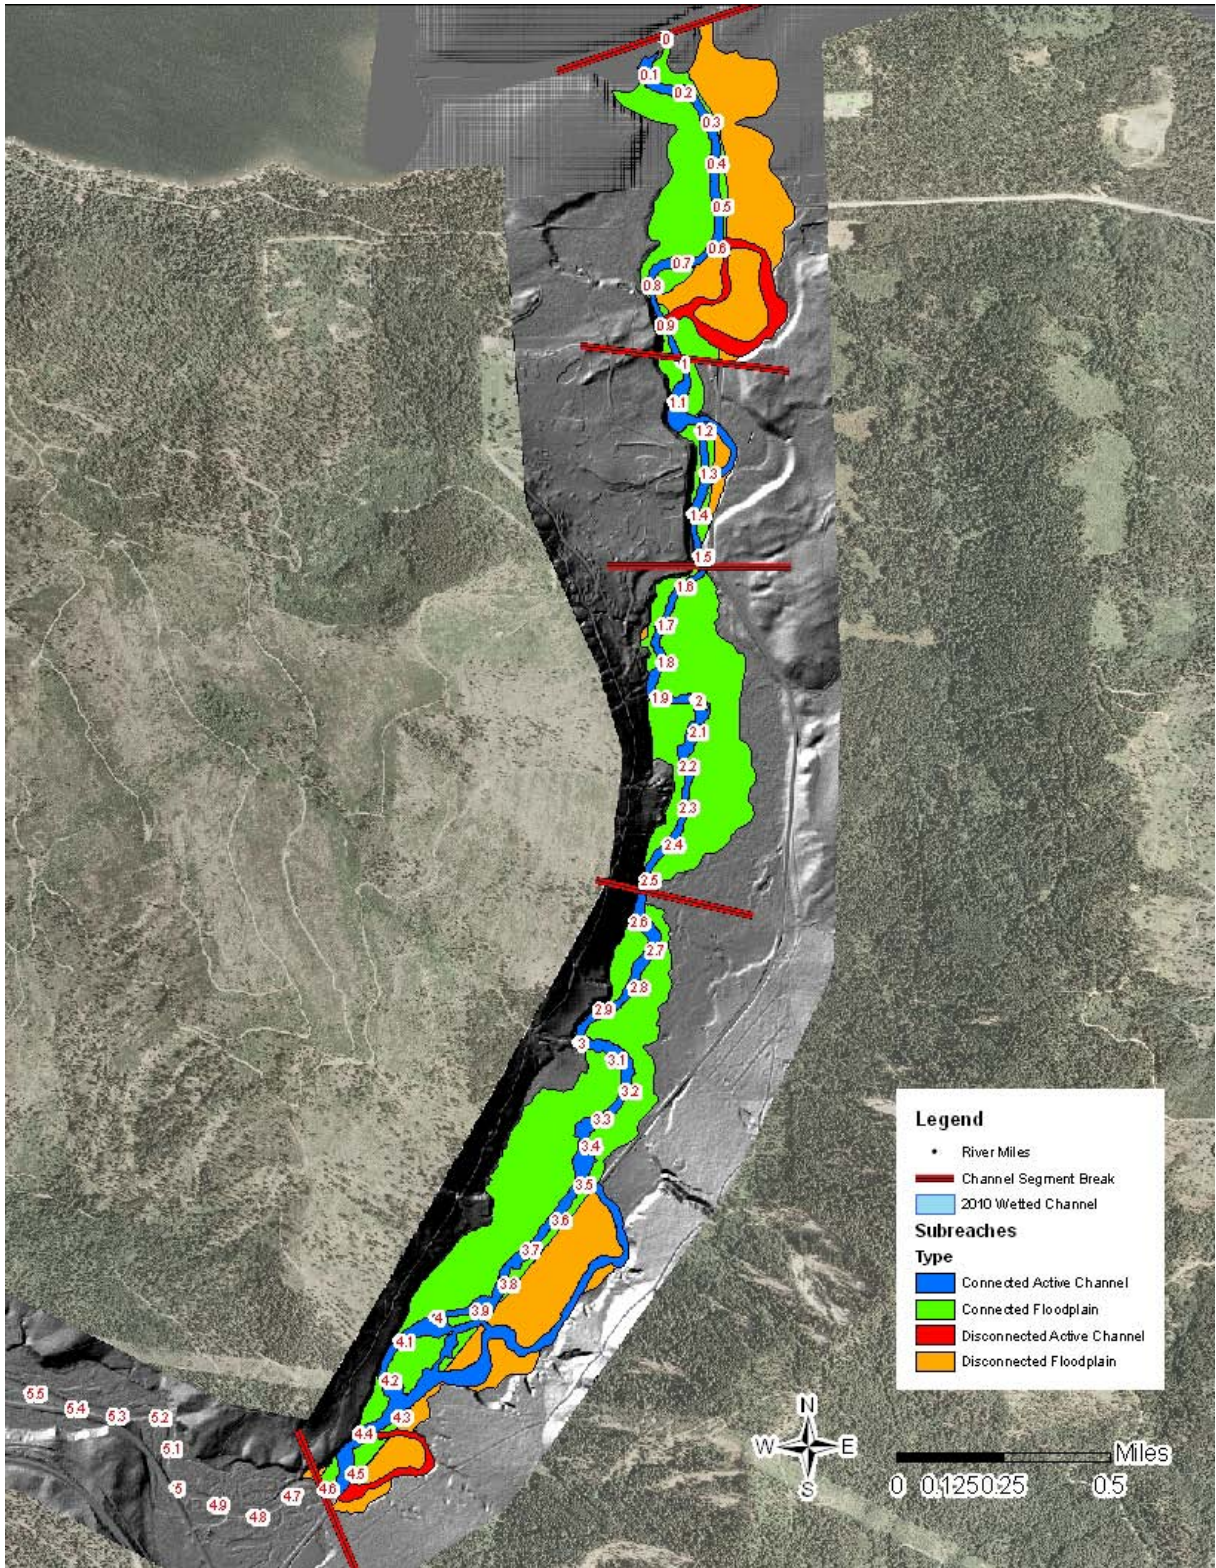
Areas where active channel and floodplain interactions occur unimpeded by topographic features are considered hydraulically “connected”. Conversely, areas where these interactions are impeded are referred to as hydraulically “disconnected”. In general, the disconnected areas are associated with anthropogenic disturbances that have created elevated topographic features (i.e., road grades) that hydraulically disconnect active channel and floodplain interactions. Table 9 summarizes the connectivity by geomorphic channel segment and Figure 6 provides a visual reference of the overall connectivity within the reach.

Figure 6. Hydraulic connectivity between the active channel and floodplain areas

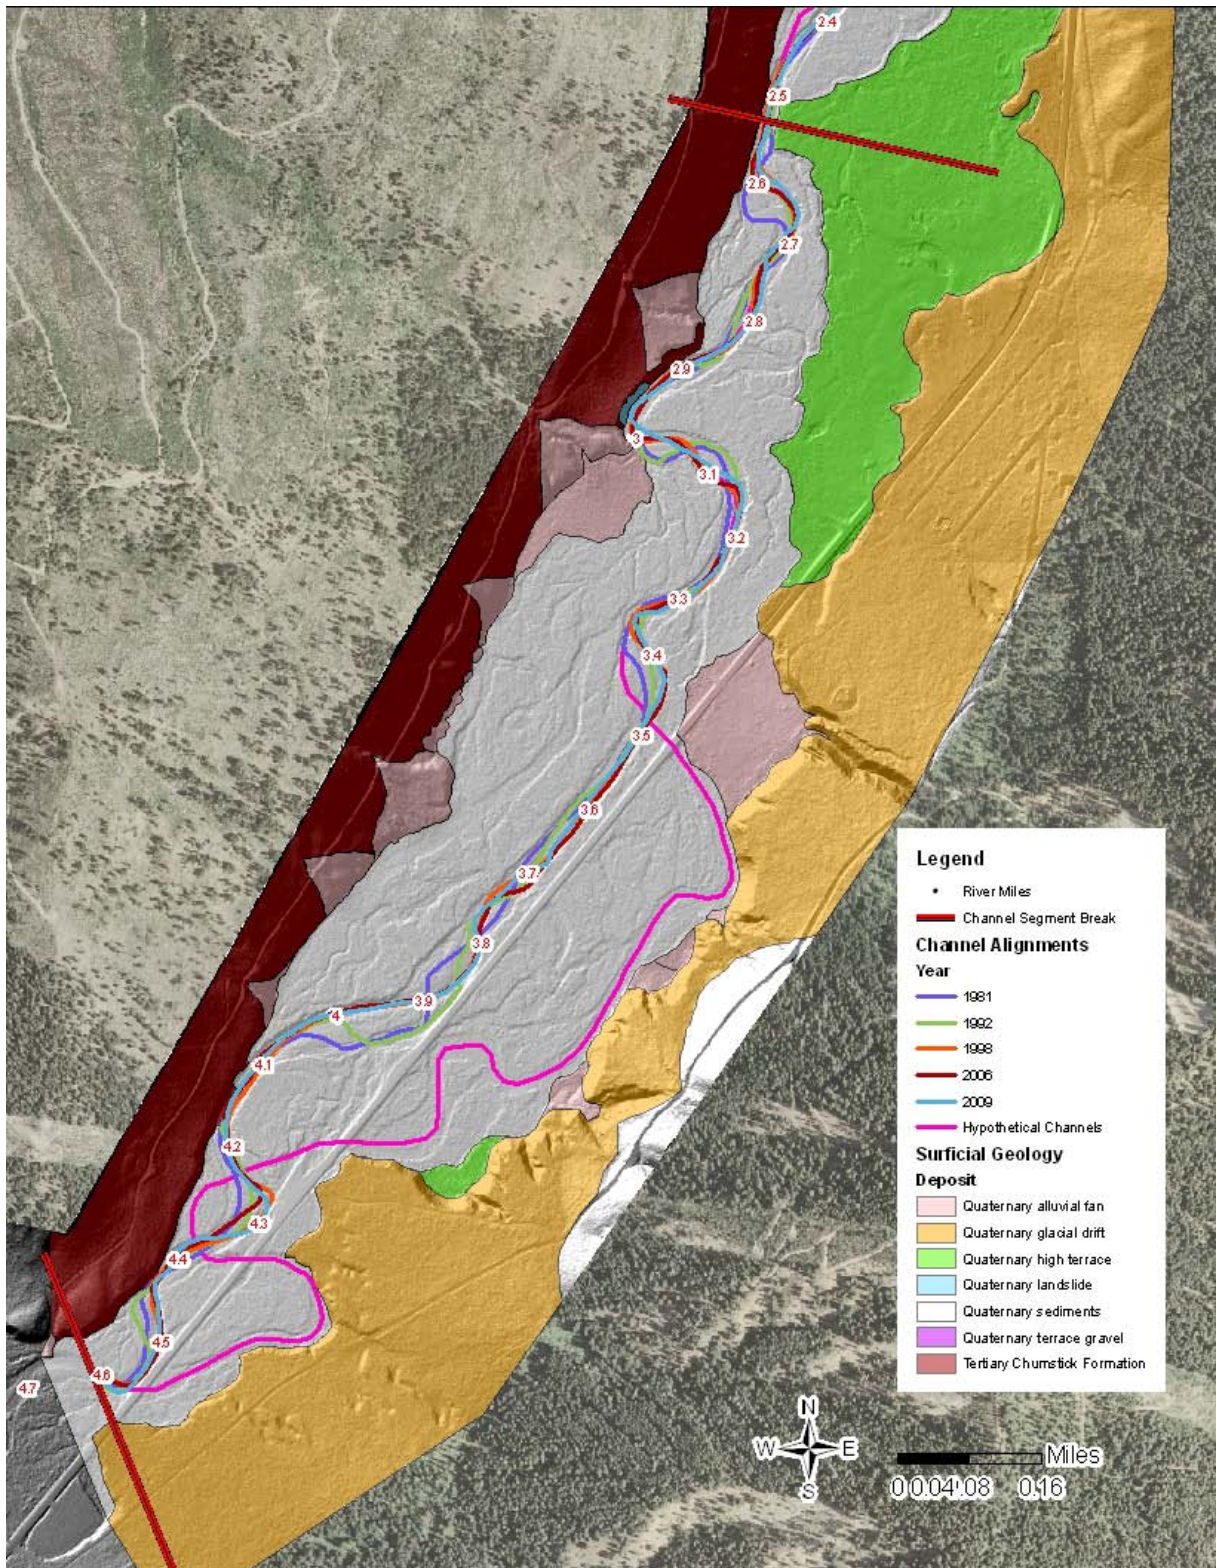
Aerial photographs were used to evaluate channel alignments for a period of about thirty-years. This channel alignment time series was after the re-routing of the channel during the construction of an improved road (State Route 207). To understand historic channel alignments and lateral migration prior to the road construction, a channel alignment was interpreted and traced from the 2006 LiDAR hillshade elevation model (Figure 9). Based on these channel alignments the following geomorphic channel changes are estimated to have

occurred: (1) the channel length has been reduced by about 2,000 feet, (2) the channel gradient has been increased by about 17 percent, and (3) the channel sinuosity has decreased about 17 percent (Table 12).

Channelization and constraints on lateral channel migration have changed the geomorphology of the channel and have resulted in increased streampower and increased sediment transport capacity. These channel changes have reduced channel-floodplain interactions and may have degraded the long-term physical and ecological processes that create and sustain appropriate habitat complexity, connectivity, and variability.

Figure 9. Channel Segment A: Historical channel alignments and hypothetical channel alignment interpreted from 2006 LiDAR hillshade

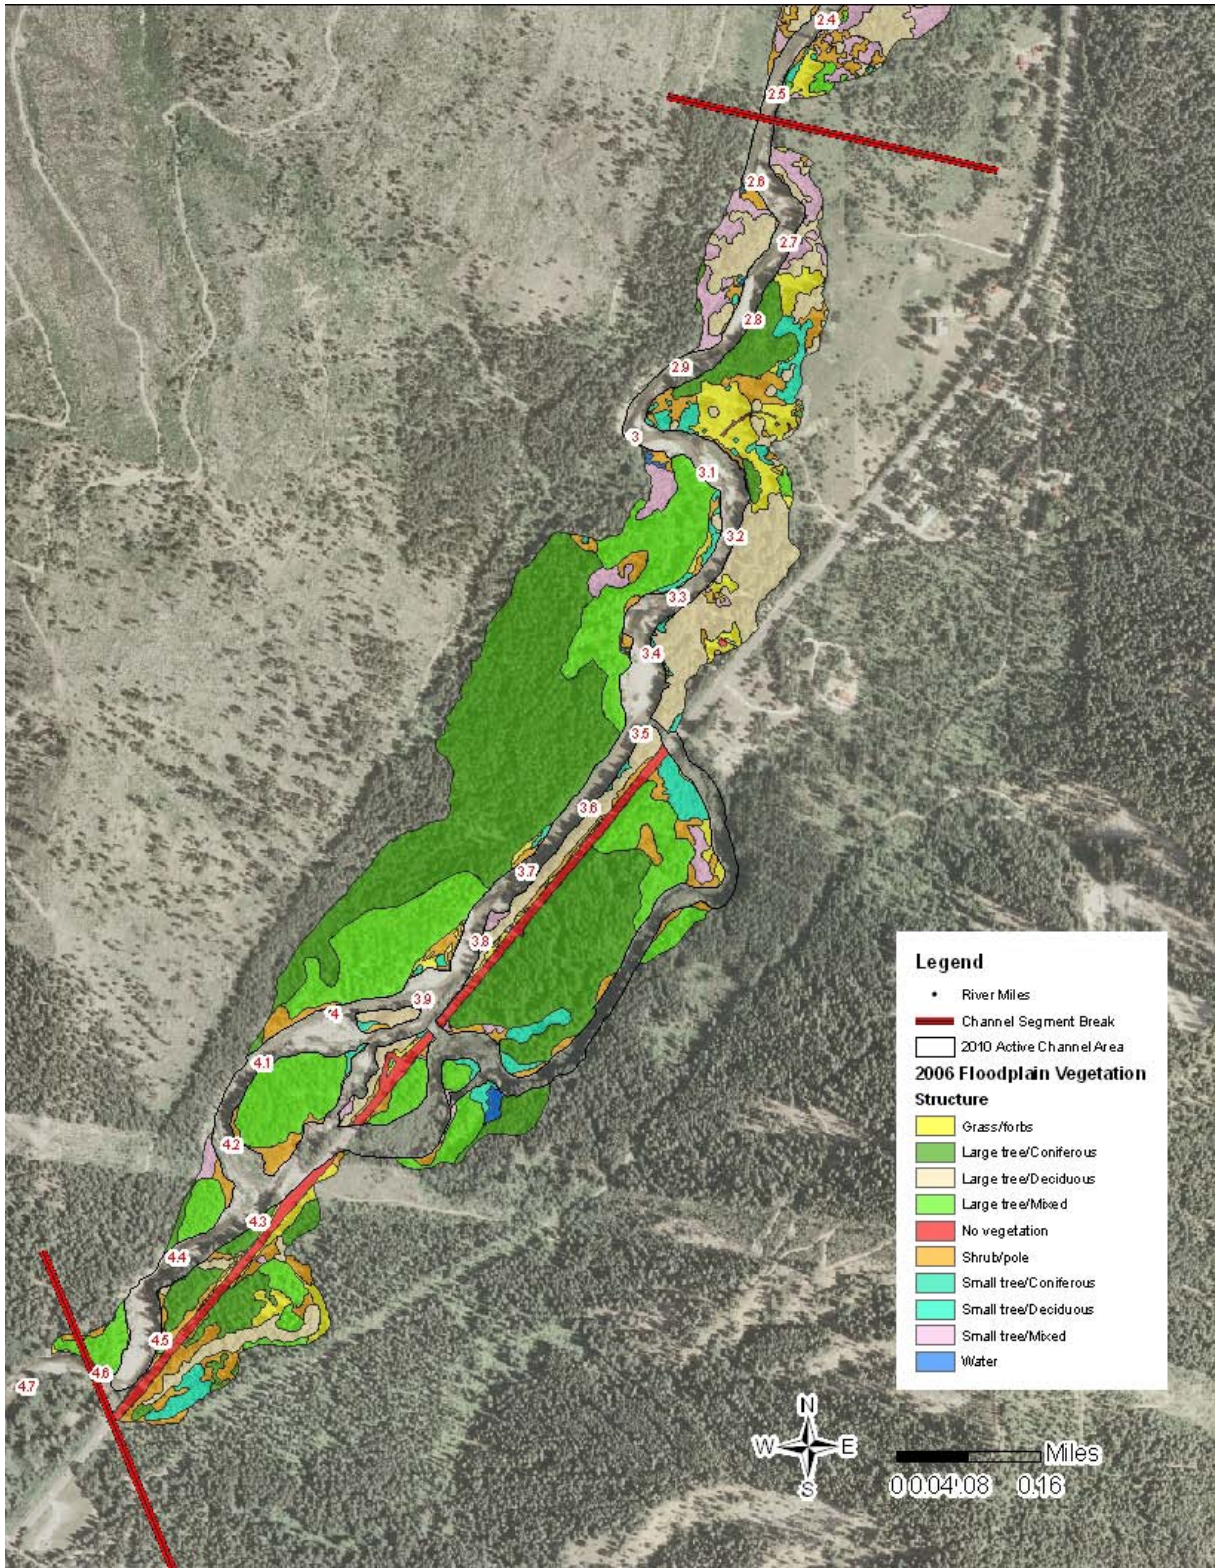
Most of the floodplain within the channel segment is in a Large Trees Condition and compositions of individual stands are coniferous deciduous or mixed, dependent on their location and elevation with respect to the active channel (Figure 11). Areas that are in a Shrub/Pole or Small Trees Condition are typically along the margins of the active channel or along side channels where ground disturbing flows occur. Most of the areas in a Grass/Forb Condition or with no vegetation are associated with anthropogenic disturbances. These disturbances include clearing along the powerline right-of-way, State Route 207, and residential and agriculture development (Figure 12).

Figure 12. Channel Segment A: Vegetation structure adjacent to the active channel and within the floodplain

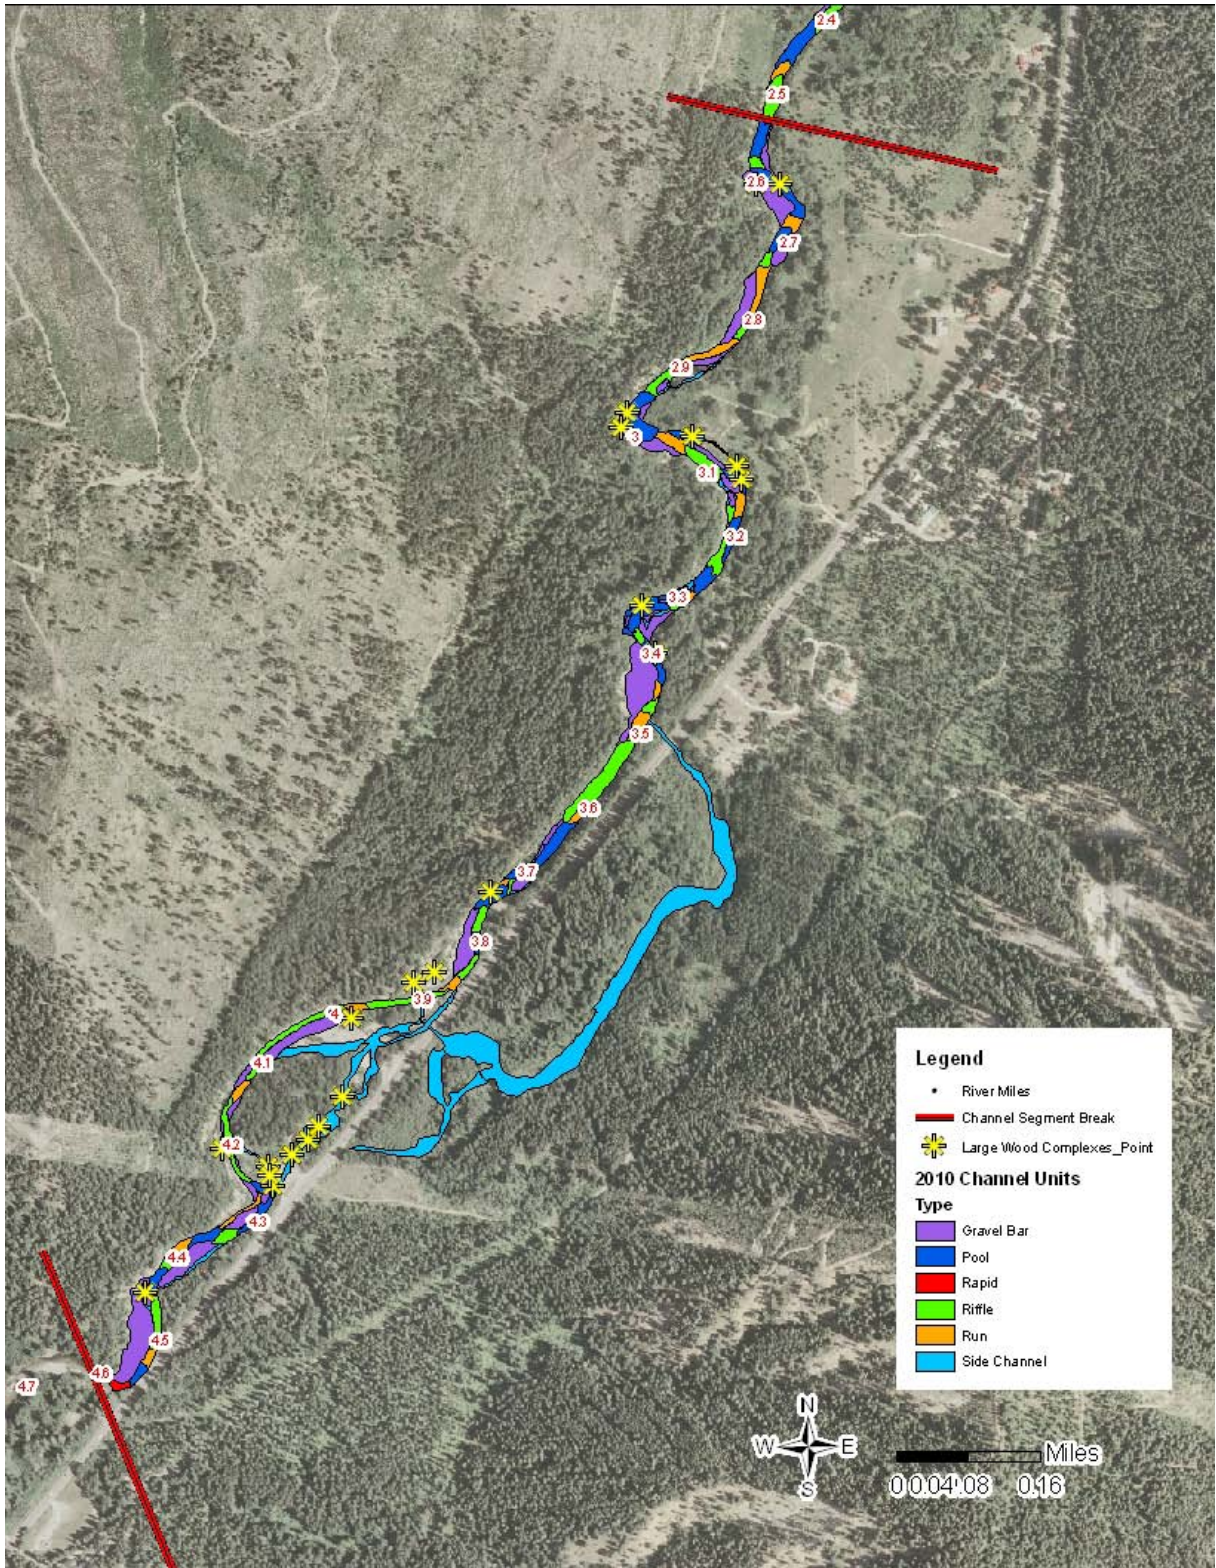
This channel segment has a high percentage of side channels because a historic channel path was reconnected for off-channel habitat in 2007 by the Chelan County Natural Resources Department. The reconnected channel path (SC_3.48_R) provides about 6.61 acres of off-channel habitat and represents about 57 percent of the total side channel units (Figure 14).

Figure 14. Channel Segment A: Visual representation of channel units and their association with large wood complexes

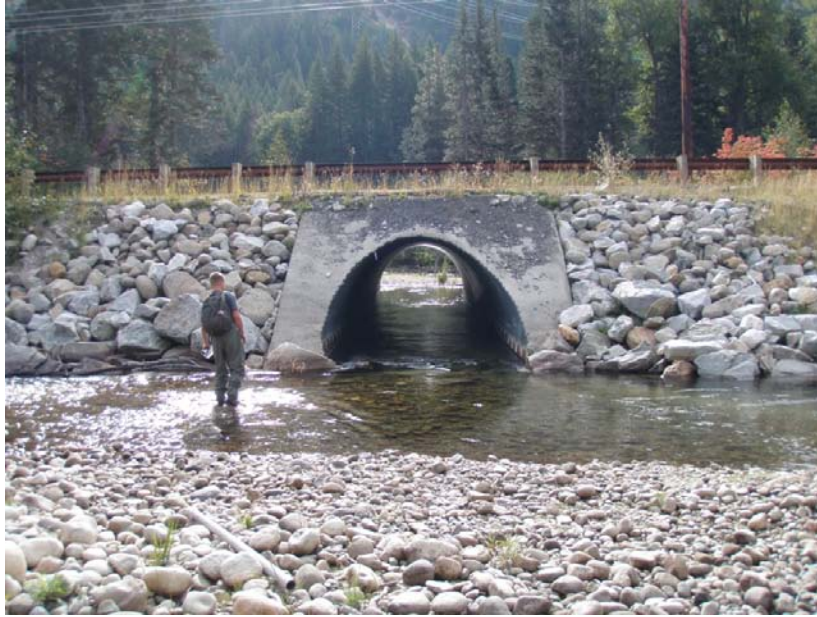
By reconnecting the historic channel path that was isolated by State Route 207 (Figure 16), available off-channel habitat was increased (Figure 17) and sediment transport capacity in the mainstem may have been reduced as flows are distributed over a larger cross sectional area. However, lateral channel migration remains restricted and most of the floodplain remains disconnected due to the road grade.

Figure 16. Channel Segment A: View looking at culvert placed through State Route 207 near RM 3.90 that reconnects historic channel path (side channel SC_3.48_R). Lower Nason Creek, Wenatchee Subbasin, Washington – Bureau of Reclamation Photograph by E. Lyon, September 15, 2010.

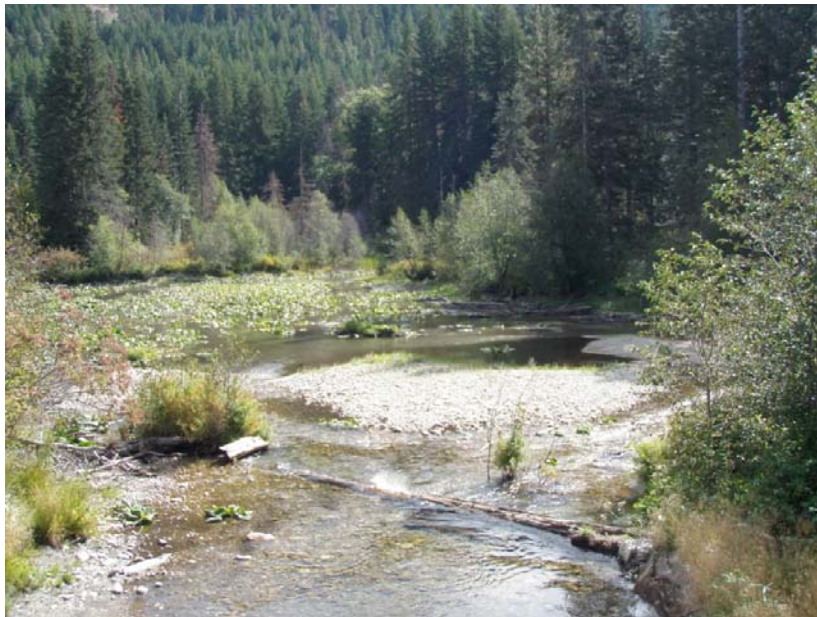
Figure 17. Channel Segment A: View looking downstream at reconnected historic channel path near RM 3.90 (side channel SC_3.48_R). Lower Nason Creek, Wenatchee Subbasin, Washington – Bureau of Reclamation Photograph by E. Lyon, September 16, 2010.

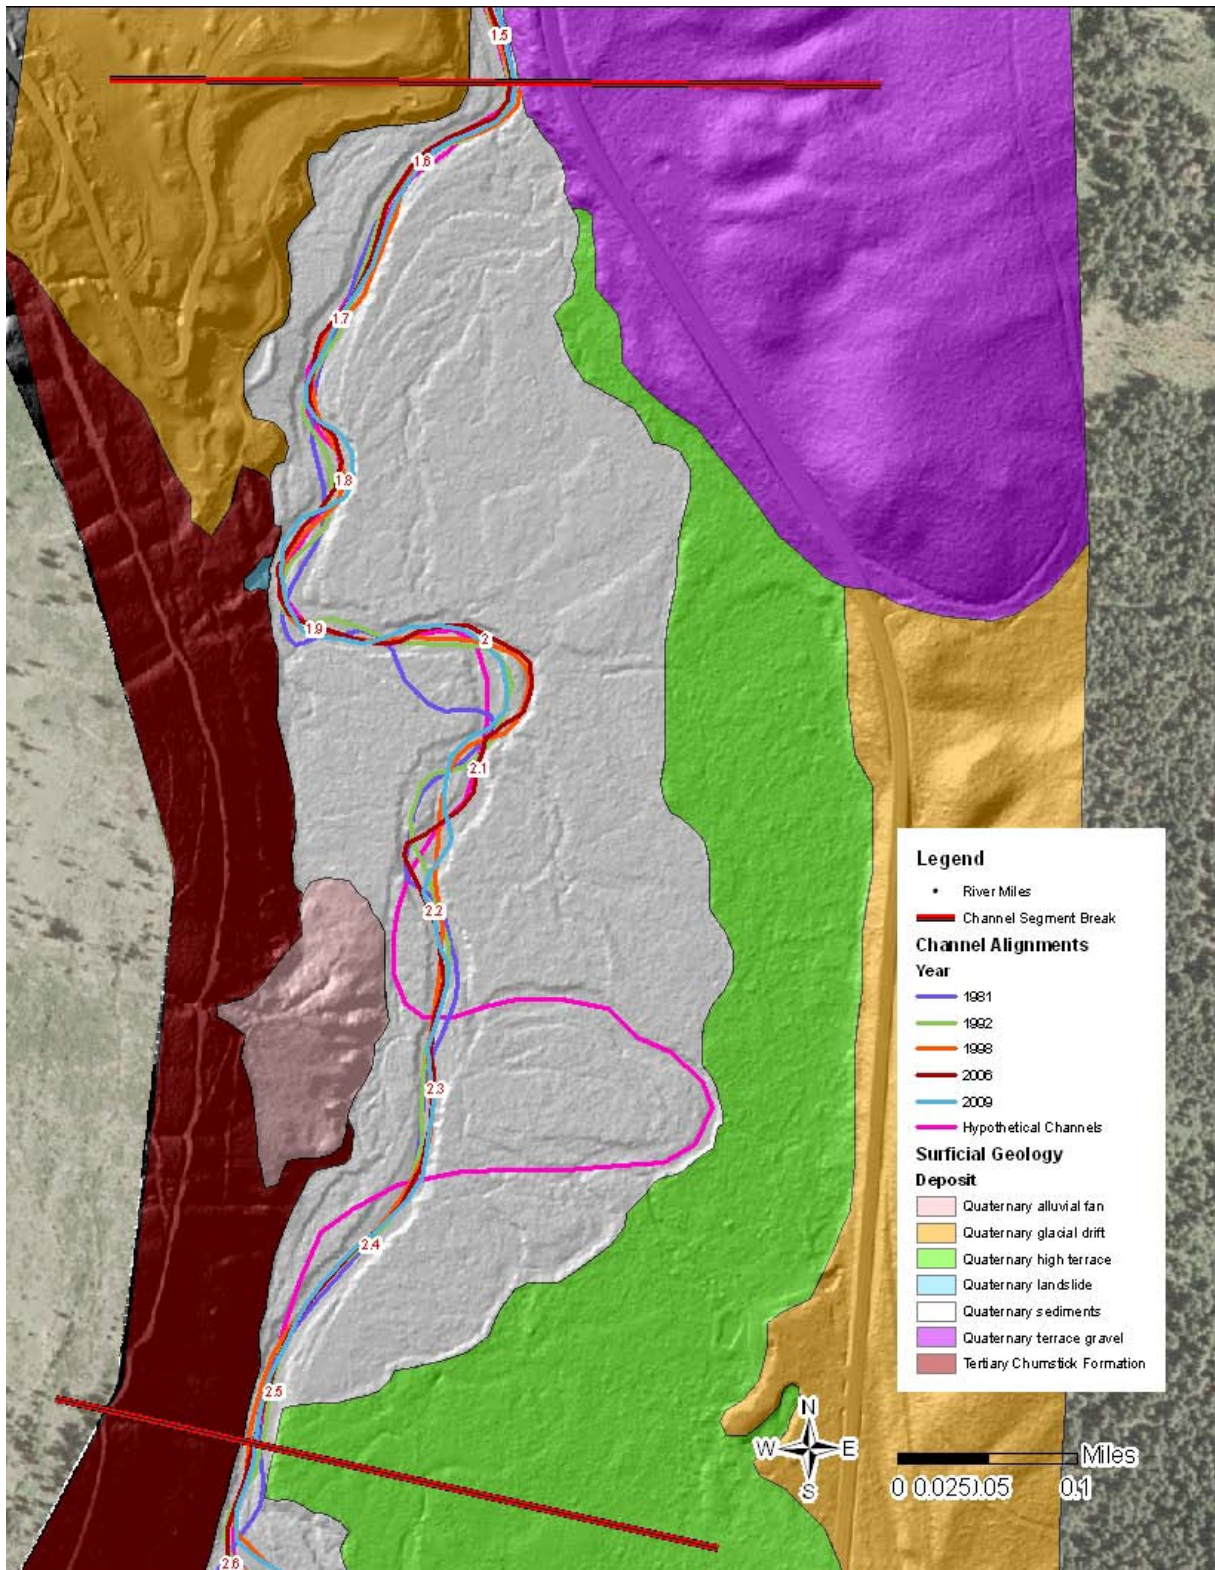
Geomorphic Channel Segment B is located between about RM 2.5 and 1.5 and contains a total area of 85 acres of active channel and floodplain areas. This segment is an unconfined pool-riffle type system. Analysis of historic channel alignments (~30 year period) and a hypothetical channel alignment interpreted from 2006 LiDAR (Figure 18) were evaluated in conjunction with the locations of geologic constraints. No anthropogenic channel constraints were identified in this segment. The channel is able to adjust vertically and laterally to disturbances with a channel gradient range of 0.11 to 0.13 percent and a channel sinuosity range of 1.19 to 1.53 (Table 18).

Figure 18. Channel Segment B: Historical channel alignments and hypothetical channel alignment interpreted from 2006 LiDAR hillshade

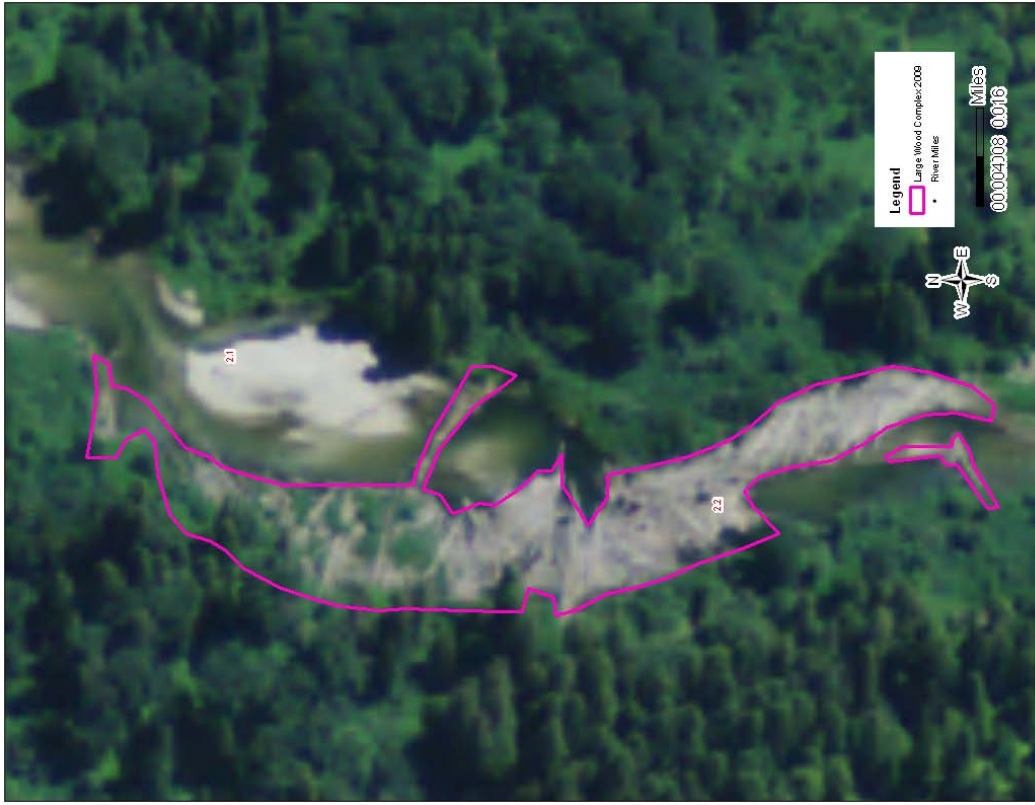
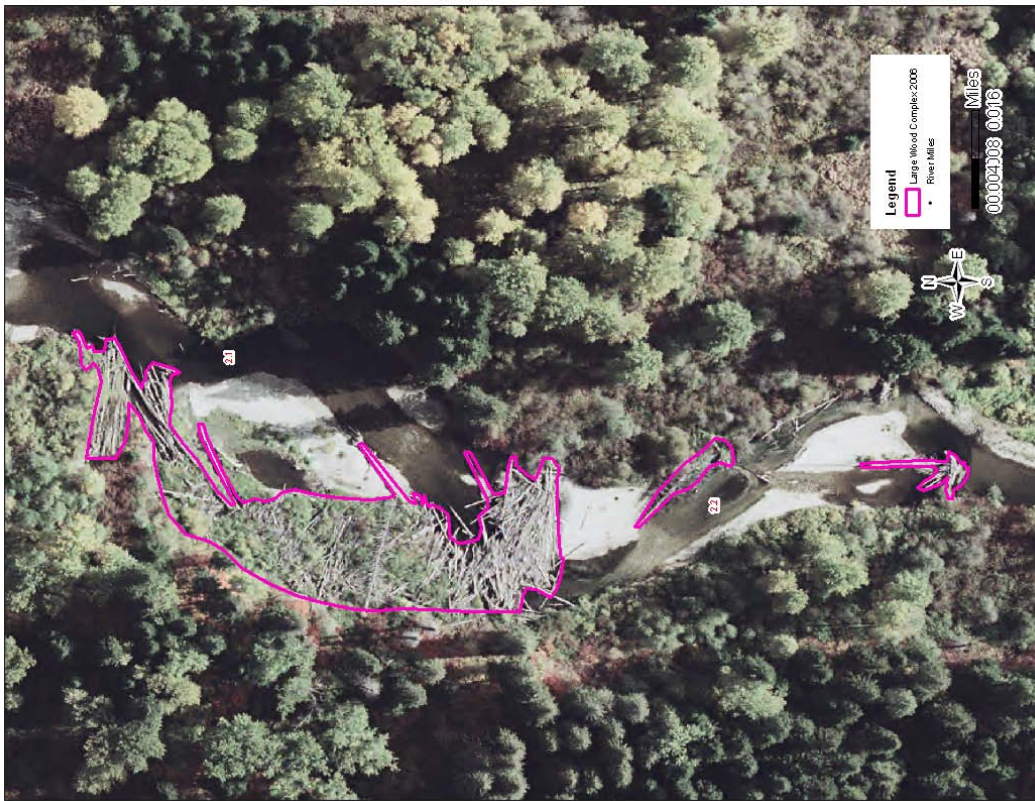
Wood complexes were primarily observed as a channel spanning log jam near RM 2.2 that creates a backwater debris pool and a middle channel scour pool underneath the structure (Figure 24); along meander bend apexes where the wood contributed to the formation of lateral scour pools; and as small log jams that contribute small, pocket pools and riffles.

Figure 25. Channel Segment B: 2009 aerial photograph of large wood complex near RM 2.2

Figure 26. Channel Segment B: 2006 aerial photograph of large wood complex near RM 2.2

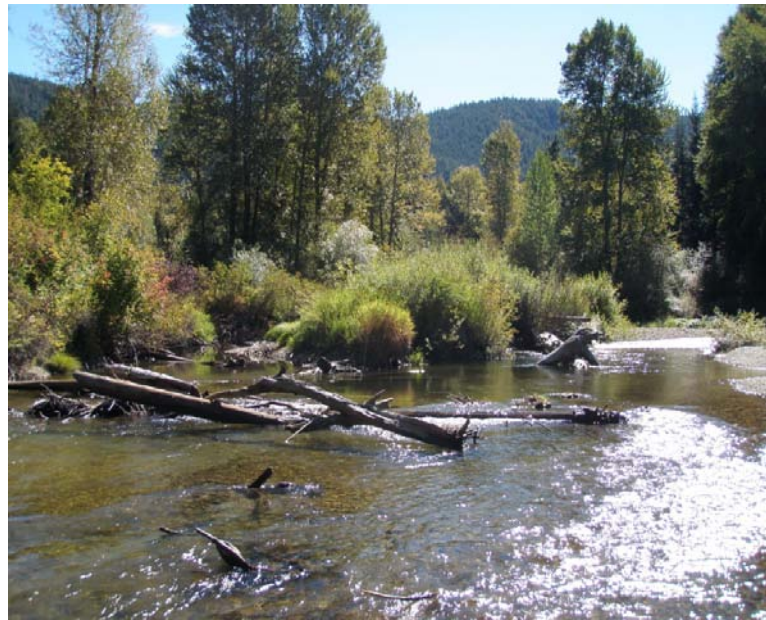
Three side channels were mapped totaling about 0.35 acres (Table 22). About 0.18 acres (51 percent) were classified as gravel bar-type side channels and about 0.17 acres (49 percent) were classified as floodplain-type side channels (Figure 27).

Figure 27. Channel Segment B: View looking upstream at a floodplain type side channel (SC_2.01_R) along river right near RM 2.00. Lower Nason Creek, Wenatchee Subbasin, Washington – Bureau of Reclamation Photograph by E. Lyon, September 14, 2010.

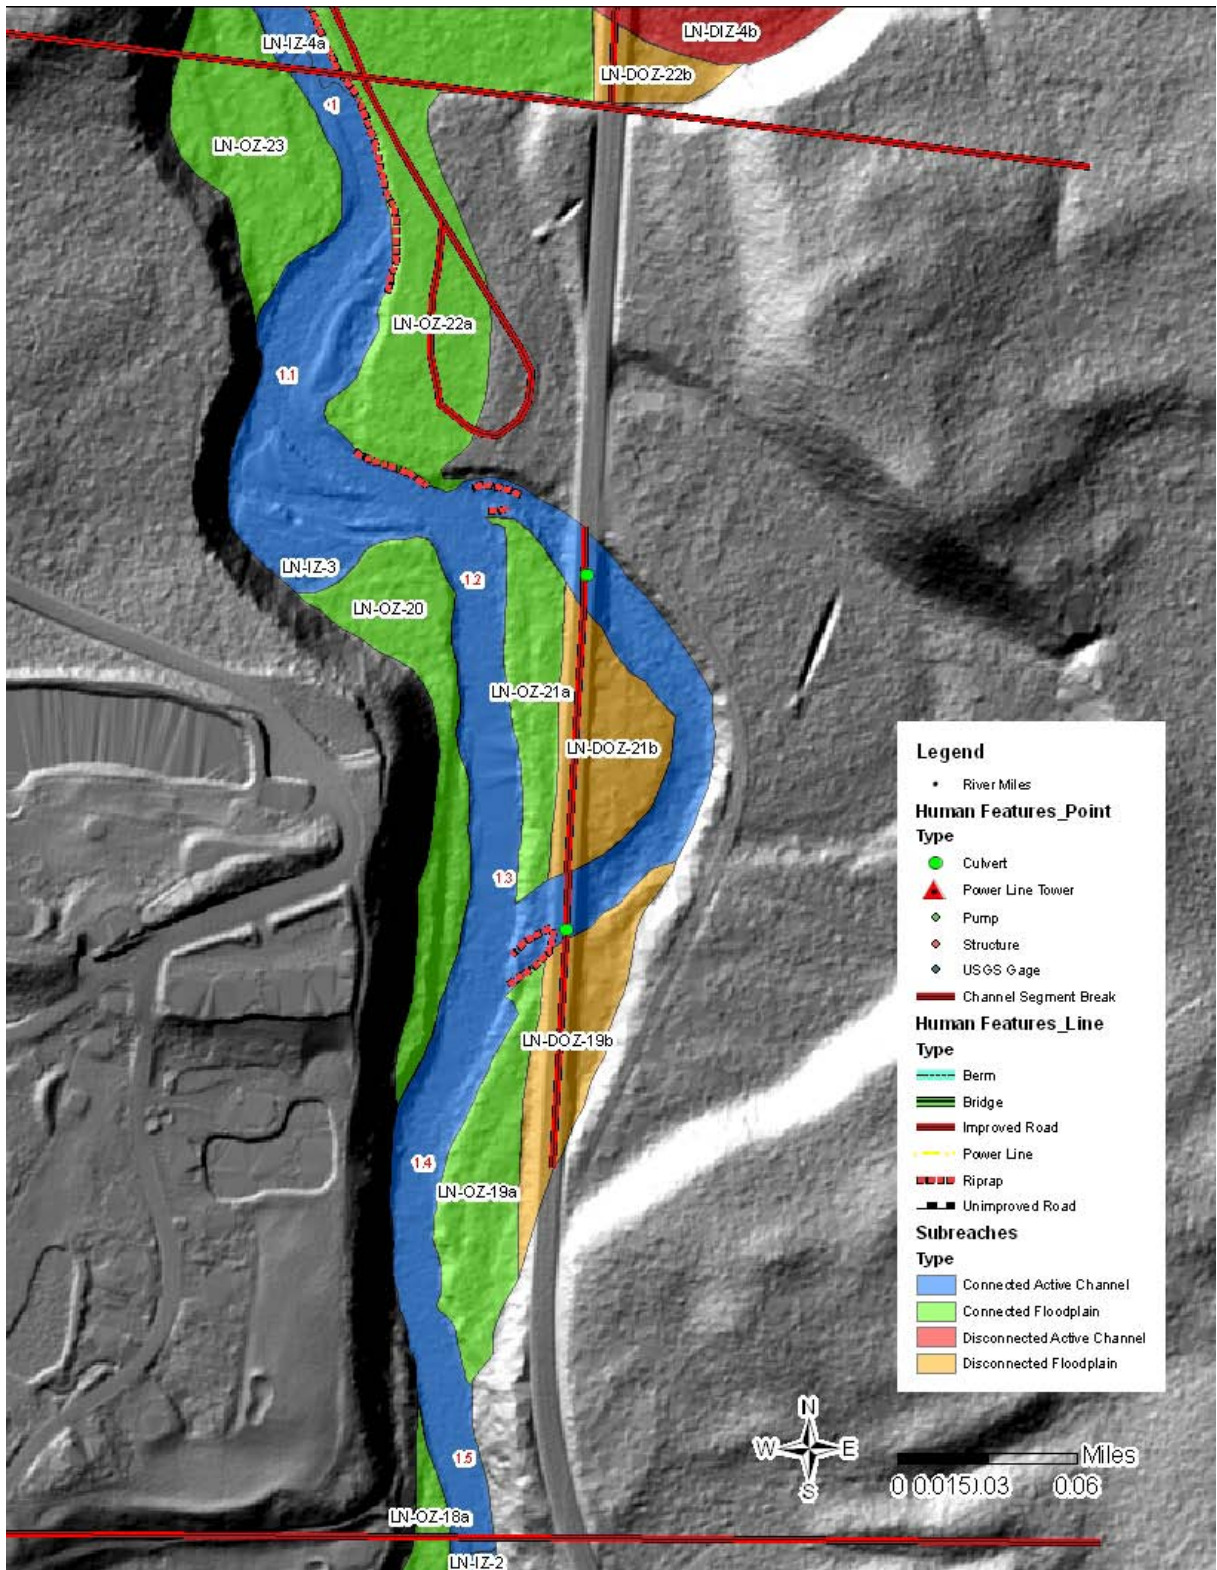
Improved roads in the campground area (LN-OZ-22a) do not have elevated road grades and don't impede floodplain connectivity (Table 26). Riprap placed along the streambank to protect the campground area may be affecting channel hydraulics and geometry, streampower, and lateral channel migration. The riprap decreases channel boundary roughness and maintains or increases streampower that can result in localized scour downstream impacts (Figure 29).

Figure 29. Channel Segment C: Subreaches and subreach complexes

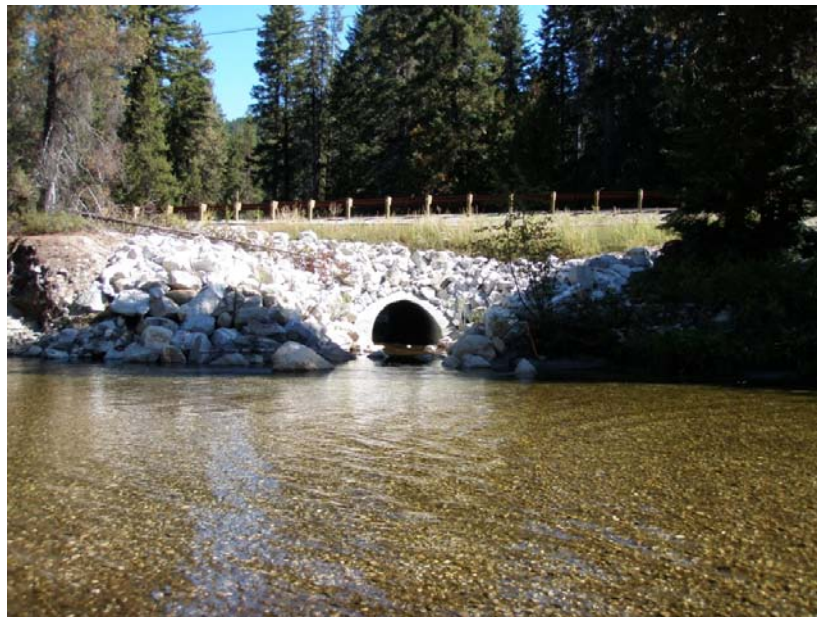
Two side channels were mapped totaling about 1.11 acres. One side channel about 0.85 acres or 77 percent of off-channel habitat was classified as a floodplain-type side channel (Table 28). The stream was re-routed for construction of State Route 207 and disconnected a historic channel path. In 2009, CCNRD reconnected the historic channel path using culverts that created a floodplain-type side channel (SC_1.17_R) to provide additional off-channel habitat and potentially reduce sediment transport capacity during floods (Figure 34). However the road grade still restricts lateral channel migration and floodplain processes. The other side channel was a gravel bar-type side channel that covered about 0.26 acres or 23 percent of available off-channel habitat and provides spawning and rearing habitat.

Figure 34. Channel Segment C: View looking at a culvert placed through the embankment of State Route 207 that reconnects a historic channel path (SC_1.17_R) near RM 1.30. Lower Nason Creek, Wenatchee Subbasin, Washington – Bureau of Reclamation Photograph by E. Lyon, September 14, 2010.

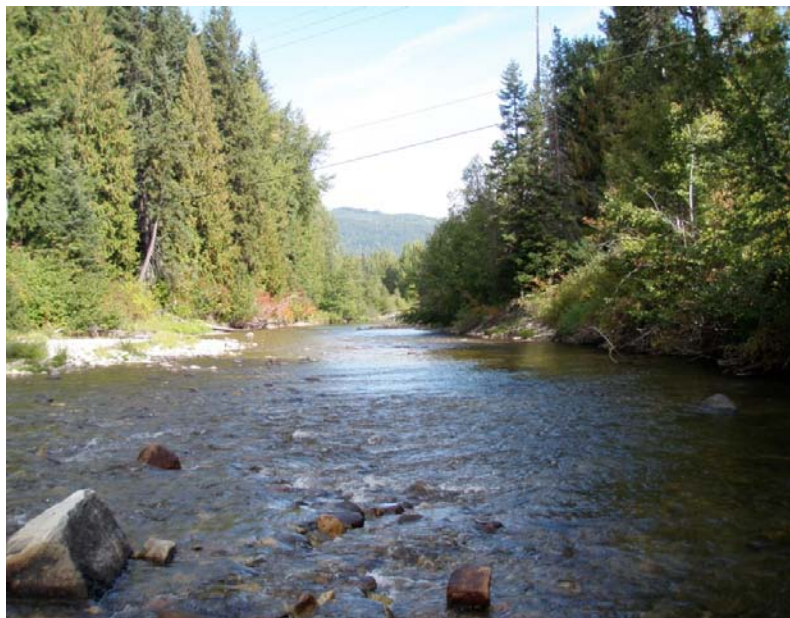
Channelization and constraints on lateral channel migration have changed the geomorphology of the channel and have resulted in increased streampower and increased sediment transport capacity (Figure 36). These channel changes have reduced channel-floodplain interactions and may have degraded the long-term physical and ecological processes that create and sustain appropriate habitat complexity, connectivity, and variability.

Figure 36. Channel Segment D: View looking downstream where the channel has been re-routed and confined by State Route 207 near RM 0.50. Lower Nason Creek, Wenatchee Subbasin, Washington – Bureau of Reclamation Photograph by E. Lyon, September 16, 2010.

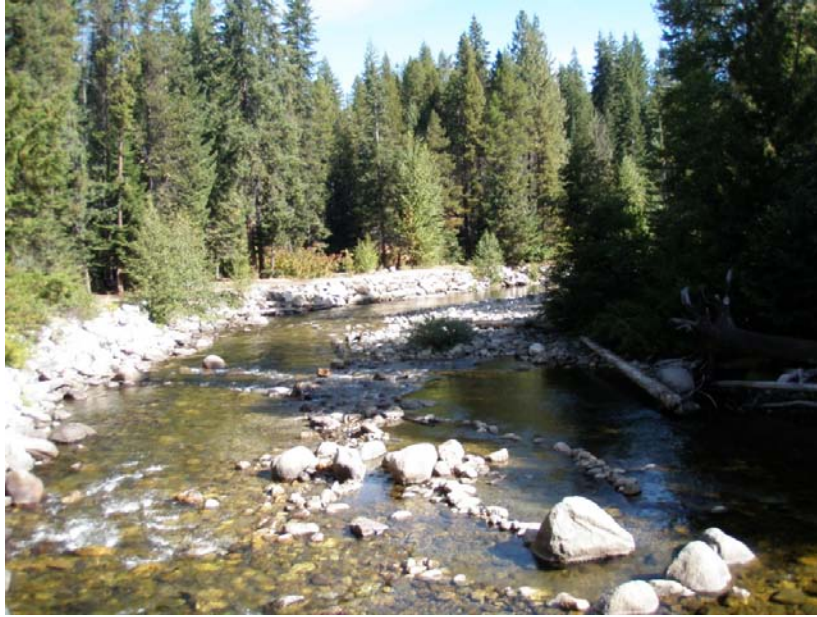
Other anthropogenic features that may affect physical processes include local utility lines, commercial and residential structures, unimproved roads, and riprap (Table 32; Figure 37). The utility lines provide electricity to commercial and residential structures, and may have impacts on floodplain roughness and vegetation structure. For the most part, unimproved roads do not have elevated grades and do not impede floodplain connectivity, but do have impacts on vegetation structure. Riprap placed along the streambank does not impede floodplain connectivity, but does affect lateral channel migration and may affect channel hydraulics and geometry, and streampower. In general, riprap does not provide appropriate channel boundary roughness and maintains or increases streampower than can result in localized scour and downstream effects (Figure 38).

Figure 38. Channel Segment D: View looking from Nason Creek Campground Road bridge at riprap protecting campground along river left near RM 0.80. Lower Nason Creek, Wenatchee Subbasin, Washington – Bureau of Reclamation Photograph by E. Lyon, September 13, 2010.

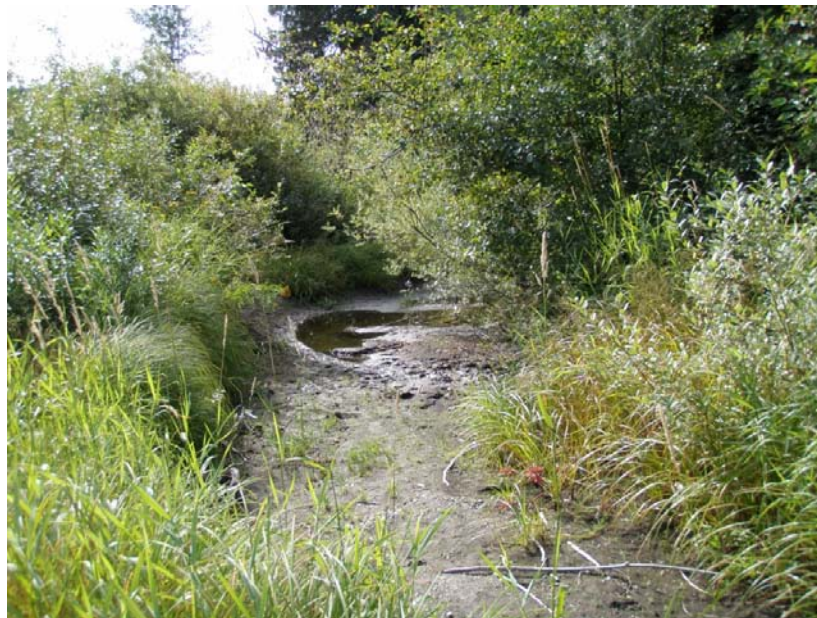
Four side channels were mapped totaling about 0.53 acres. Three of the side channels were gravel bar-type side channels that covered about 0.44 acres or 83 percent of available off-channel habitat (Table 34). The other side channel was classified as a floodplain-type side channel and covered about 0.09 acres or 17 percent of available off-channel habitat. This side channel (SC_0.13_L) was a spring-fed system where signs of beaver activity (i.e., chewed willows) were observed (Figure 42).

Figure 42. Channel Segment D: View looking upstream at spring-fed floodplain type side channel (SC_0.13_L) near RM 0.13. Lower Nason Creek, Wenatchee Subbasin, Washington – Bureau of Reclamation Photograph by E. Lyon, September 16, 2010.

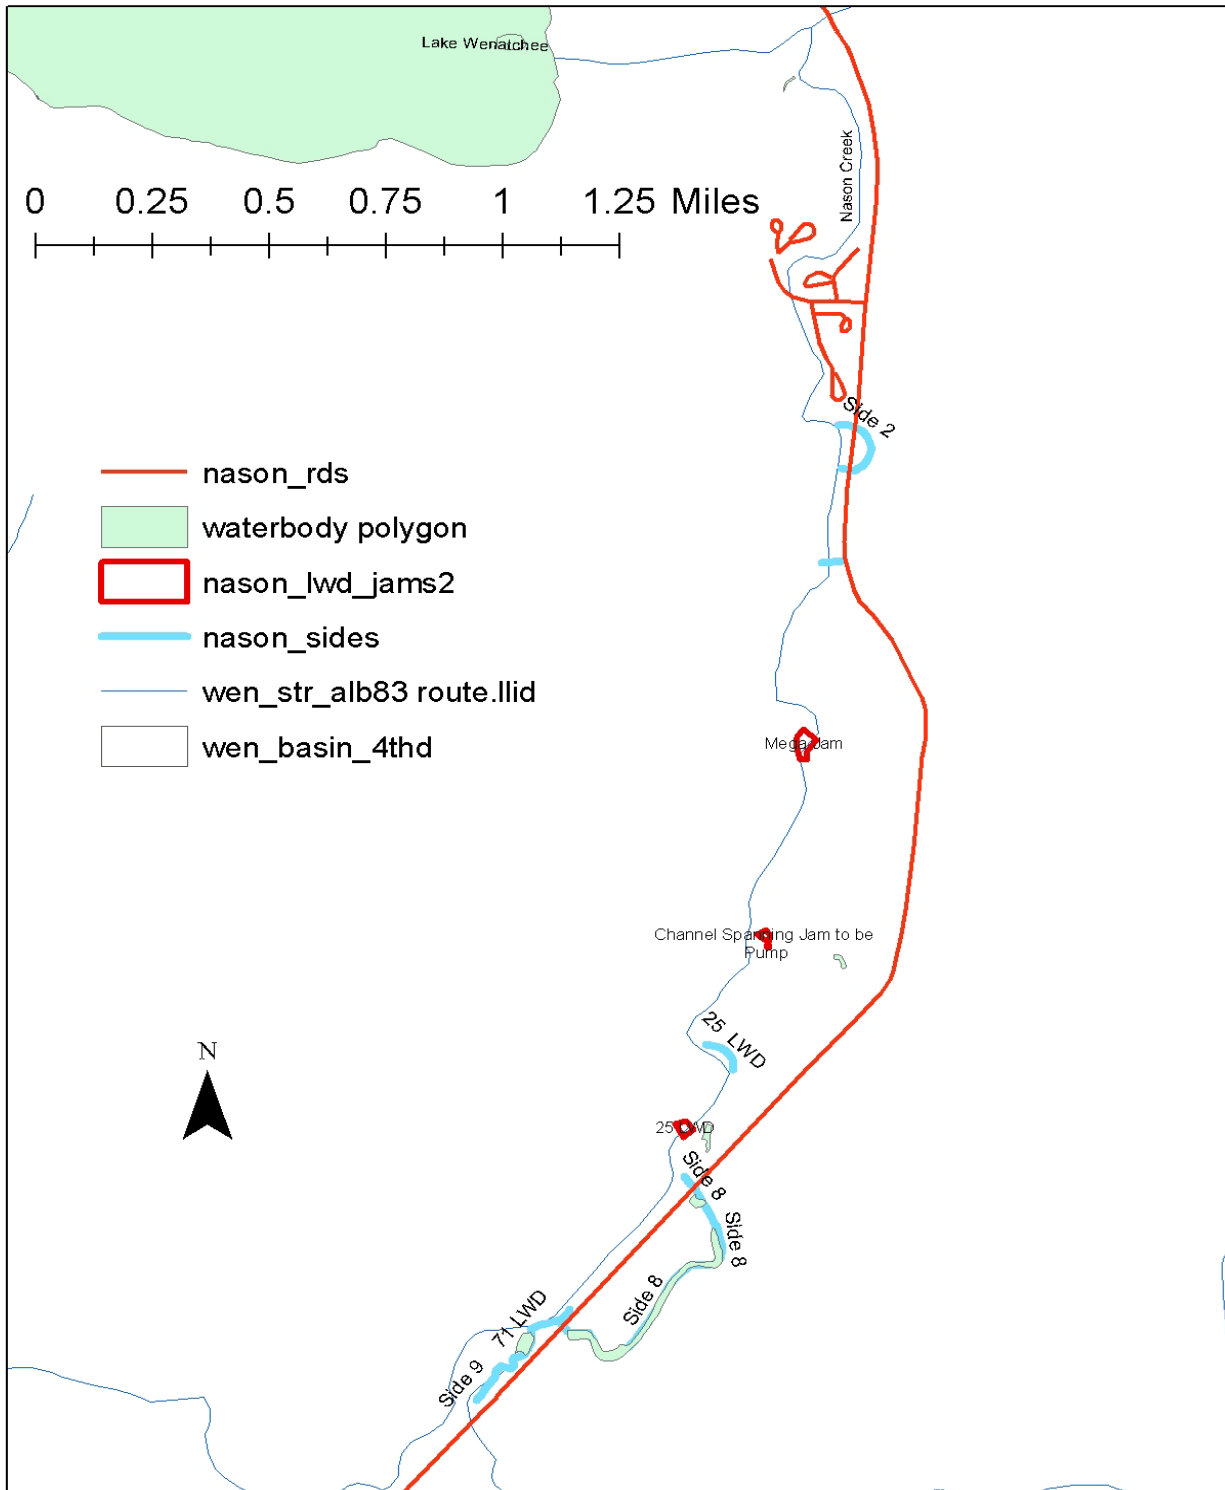
Figure 1. Map of 2010 surveyed portion of Nason Creek showing lwd accumulations, side channels and streamside roads.

Note: The property owner of the land bordering the lwd jam labeled “Channel spanning jam to be” in Figure 1 (also labeled in the Arcmap project) should be contacted. There is an irrigation pump (labeled “Pump” in Figure 1 and Arcmap project) immediately upstream of the tangle of large channel spanning trees and many of the branches of the downed trees have already been trimmed off. We assume the property owner may be trimming branches to prevent pump damage or further property loss. Since the trees span the channel at a stream bend, further lwd accumulation and channel avulsion are likely to occur in the future if the downed trees remain in place. There may be an opportunity for the habitat committee to meet with the landowner and develop solutions that meet the landowner needs and maintain lwd function.

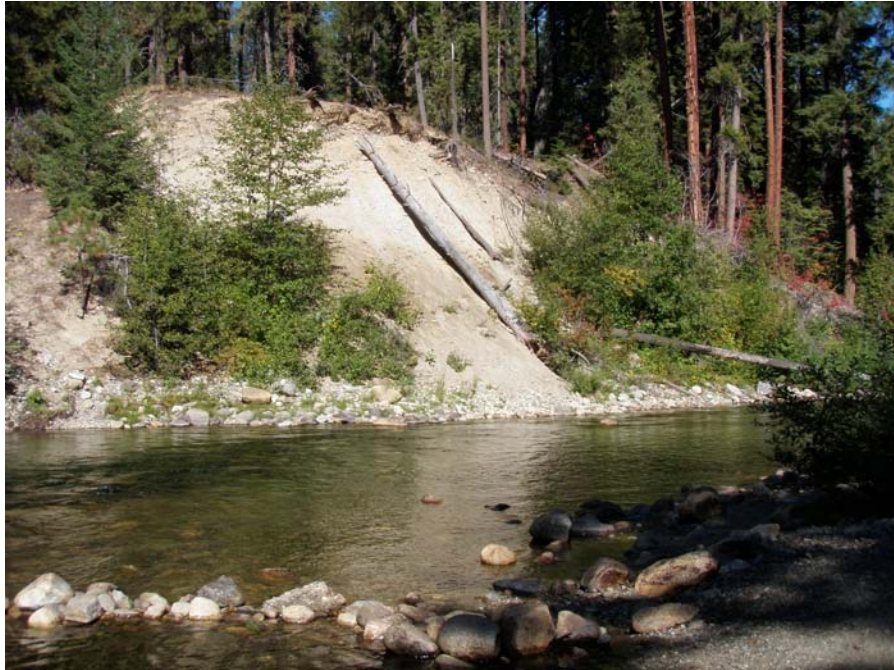
Photograph No. 1. View to the northwest looking downstream at a slide contributing sand and gravel. Lower Nason Creek, Wenatchee Subbasin, Washington – Bureau of Reclamation Photograph by E. Lyon, September 13, 2010.

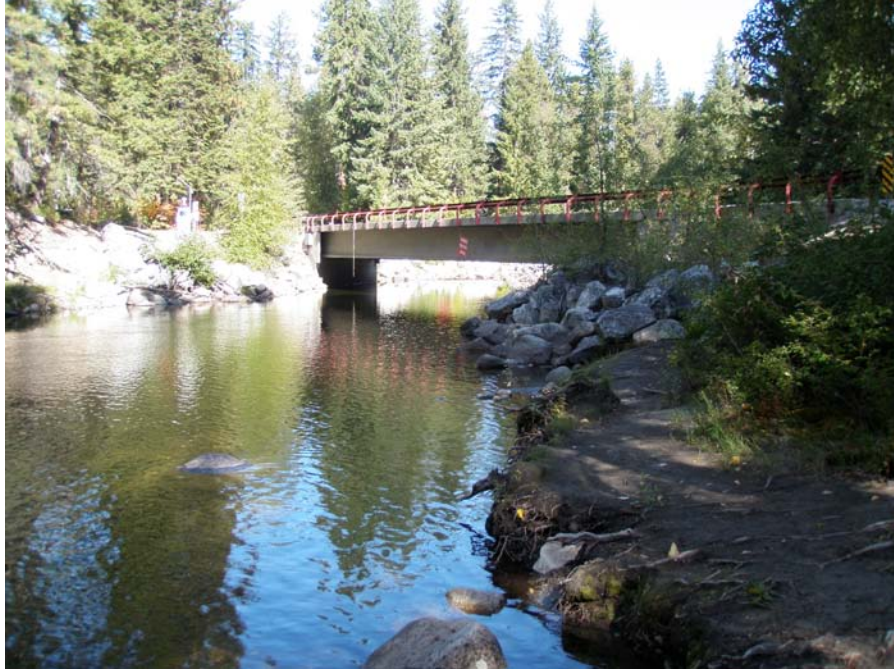
Photograph No. 3. View to the north looking at bridge crossing with riprap protecting abutments and artificially confining the channel. Lower Nason Creek, Wenatchee Subbasin, Washington – Bureau of Reclamation Photograph by E. Lyon, September 13, 2010.
