Lower Nason
Assessment of Geomorphic and Ecologic Indicators
Nason Creek, Wenatchee Subbasin

Chelan County, Washington

U.S. Department of the Interior
Bureau of Reclamation
Pacific Northwest Region
Pacific Northwest Regional Office, Boise, Idaho

April 2011

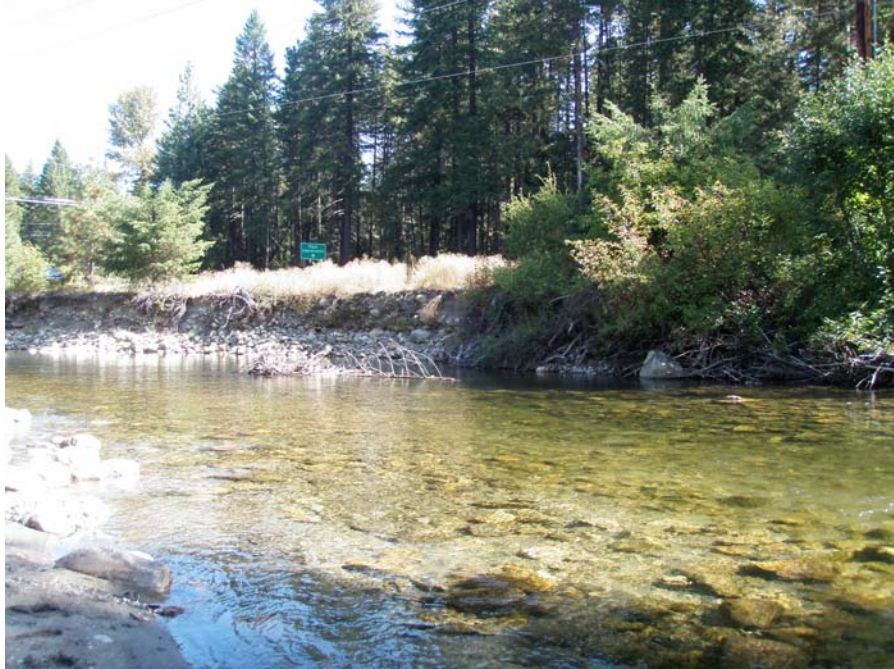
Photograph No. 5. View to the northeast looking at bank erosion along river right that could threaten improved road. Lower Nason Creek, Wenatchee Subbasin, Washington – Bureau of Reclamation Photograph by E. Lyon, September 13, 2010.

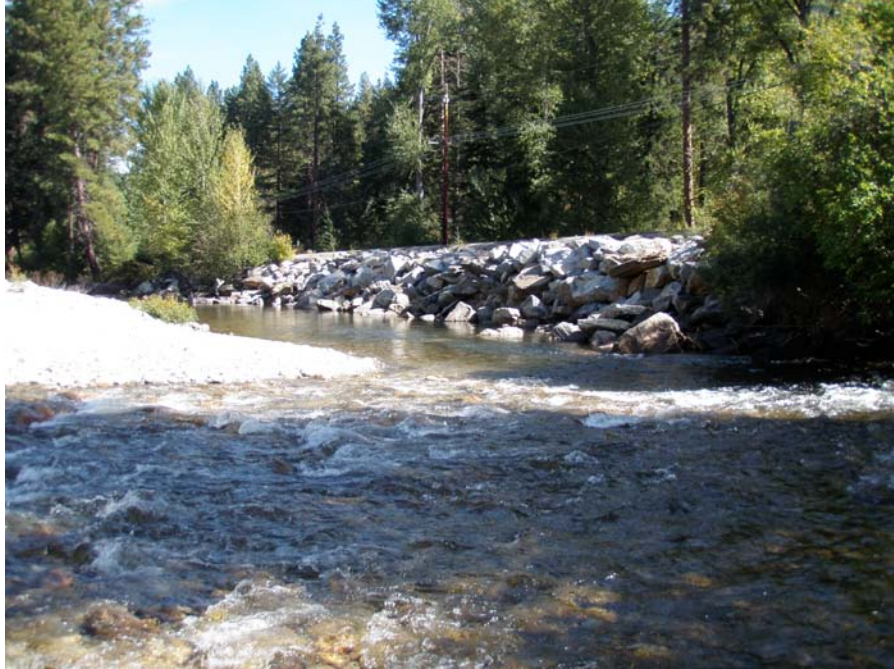
Photograph No. 7. View to the east looking downstream at riprap placed along river right protecting improved road. There is also a disconnected historic channel path behind the embankment. Lower Nason Creek, Wenatchee Subbasin, Washington – Bureau of Reclamation Photograph by E. Lyon, September 13, 2010.

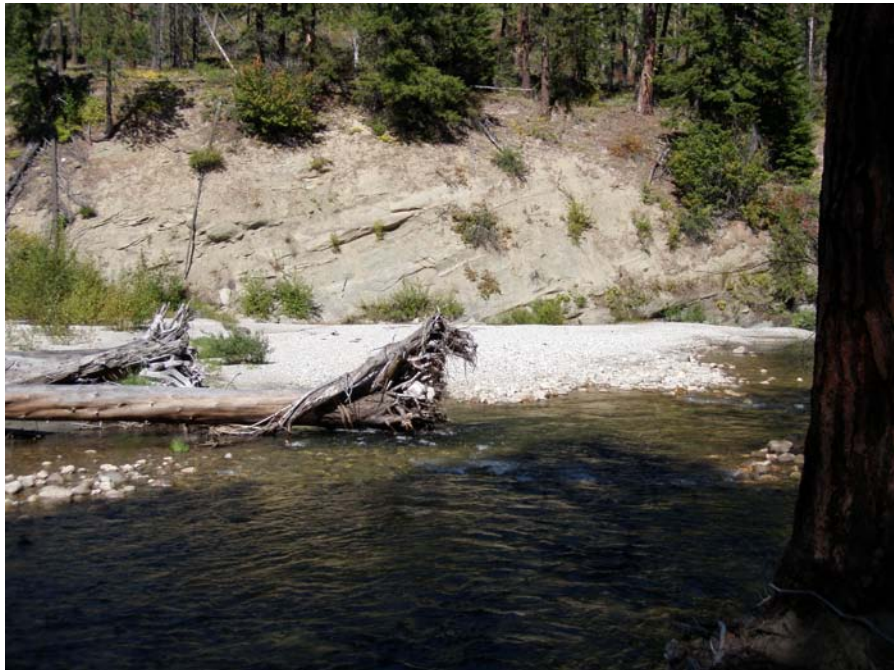
Photograph No. 8. View to the north looking downstream at bedrock (Chumstick Formation) along river left that restricts lateral channel migration. Lower Nason Creek, Wenatchee Subbasin, Washington – Bureau of Reclamation Photograph by E. Lyon, September 13, 2010.

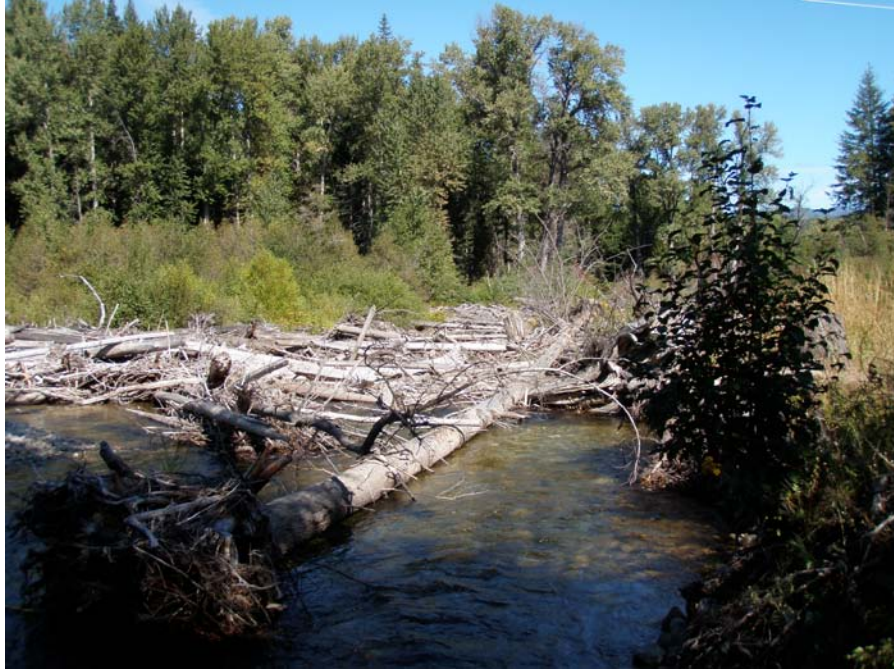
Photograph No. 9. View to the northeast looking downstream at large wood accumulating in side channel along river right. Lower Nason Creek, Wenatchee Subbasin, Washington – Bureau of Reclamation
Photograph by E. Lyon, September 13, 2010.

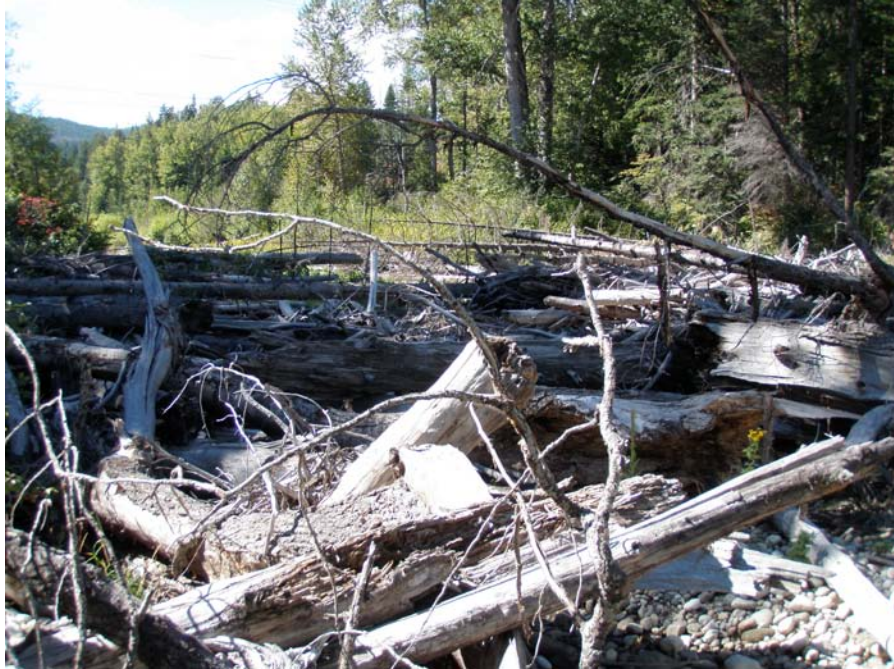
Photograph No. 11. View to the southwest looking upstream at large wood accumulation in a side channel along river right. Lower Nason Creek, Wenatchee Subbasin, Washington – Bureau of Reclamation
Photograph by E. Lyon, September 13, 2010.

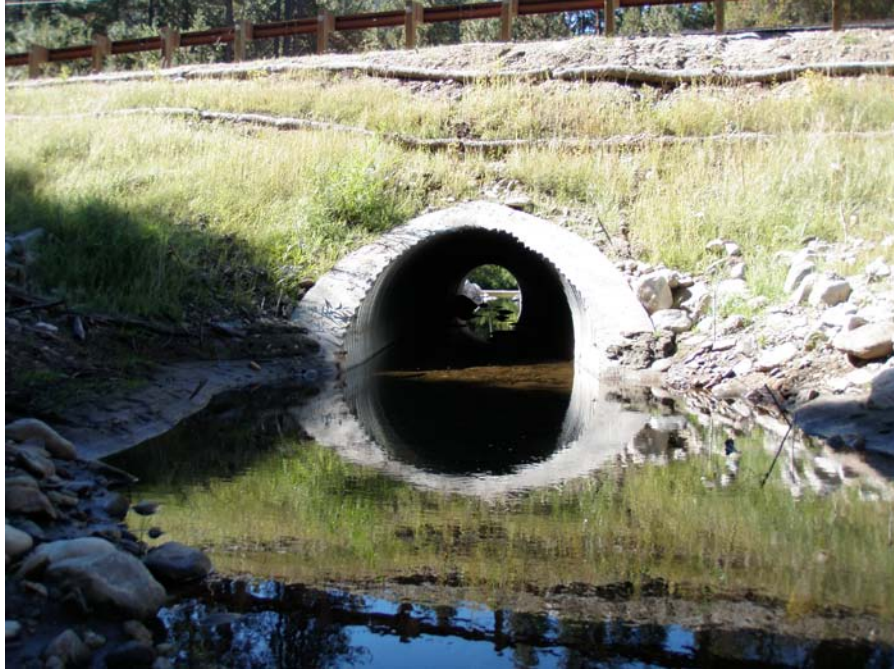
Photograph No. 13. View to the west looking upstream at a culvert placed through improved road embankment to reconnect side channel along river right. Lower Nason Creek, Wenatchee Subbasin, Washington – Bureau of Reclamation Photograph by E. Lyon, September 13, 2010.

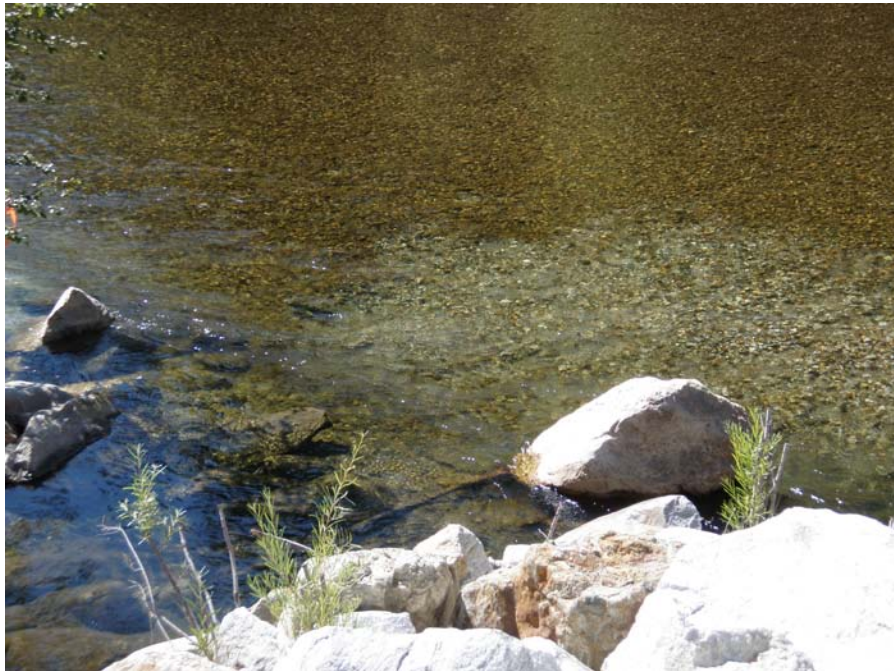
Photograph No. 14. View to the southwest looking at inlet to reconnected side channel through improved road embankment with redd and a spawning summer Chinook salmon. Lower Nason Creek, Wenatchee Subbasin, Washington – Bureau of Reclamation Photograph by E. Lyon, September 13, 2010.

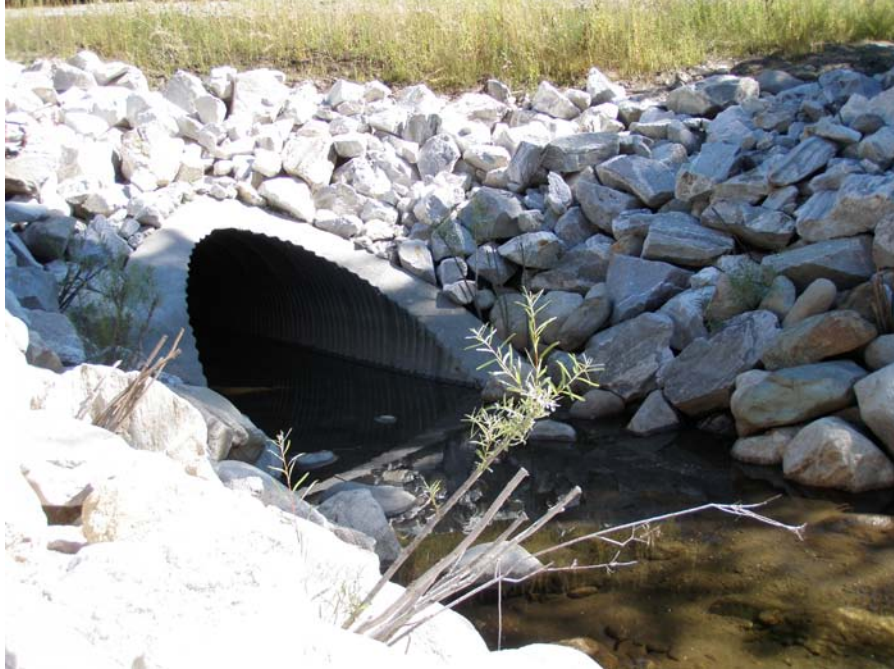
Photograph No. 15. View to the east looking downstream at culvert placed through improved road embankment that reconnects side channel. Lower Nason Creek, Wenatchee Subbasin, Washington – Bureau of Reclamation Photograph by E. Lyon, September 13, 2010.

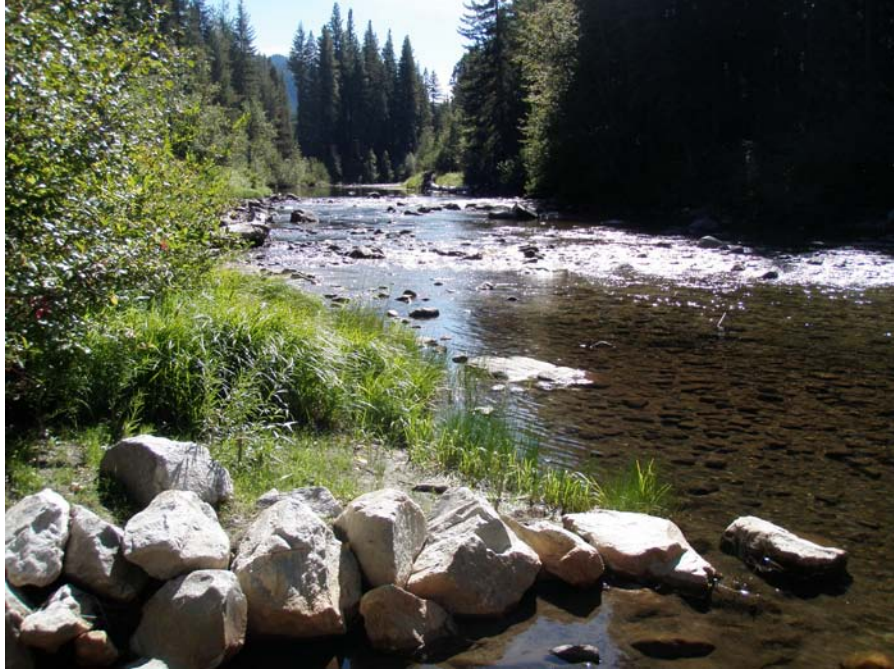
Photograph No. 17. View to the south looking upstream from the outlet of reconnected side channel and pocket pool habitat along the mainstem of Nason Creek. Lower Nason Creek, Wenatchee Subbasin, Washington – Bureau of Reclamation Photograph by E. Lyon, September 13, 2010.

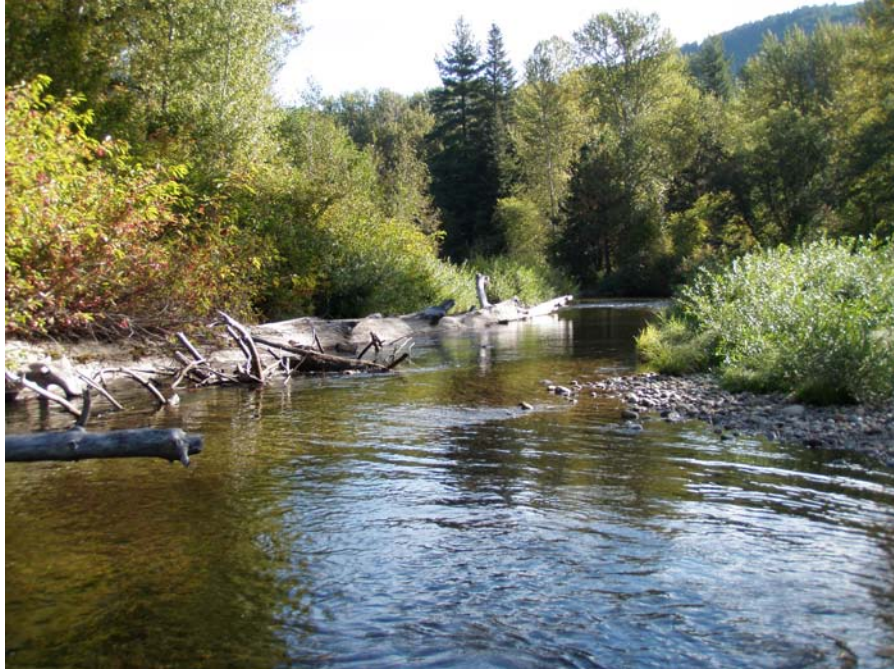
Photograph No. 19. View to the northeast looking downstream at a run and lateral scour pool forced by large wood accumulation along river left. Lower Nason Creek, Wenatchee Subbasin, Washington – Bureau of Reclamation Photograph by E. Lyon, September 14, 2010.

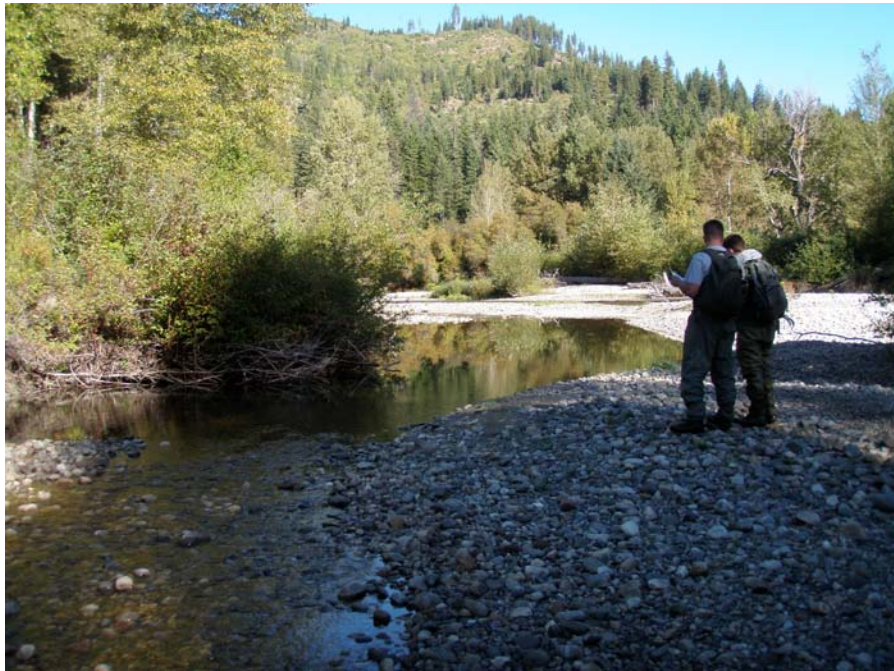
Photograph No. 20. View to the northeast looking downstream at a gravel bar-type side channel along river left. Lower Nason Creek, Wenatchee Subbasin, Washington – Bureau of Reclamation Photograph by E. Lyon, September 14, 2010.

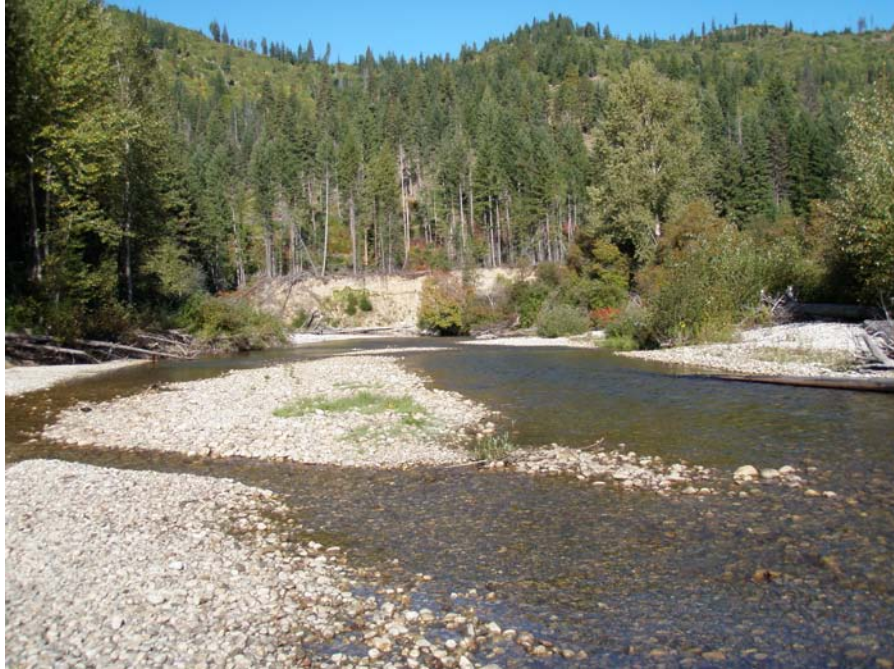
Photograph No. 21. View to the northwest looking downstream at a gravel bar-type side channel along river left and eroding bank in the distance. Lower Nason Creek, Wenatchee Subbasin, Washington – Bureau of Reclamation Photograph by E. Lyon, September 14, 2010.

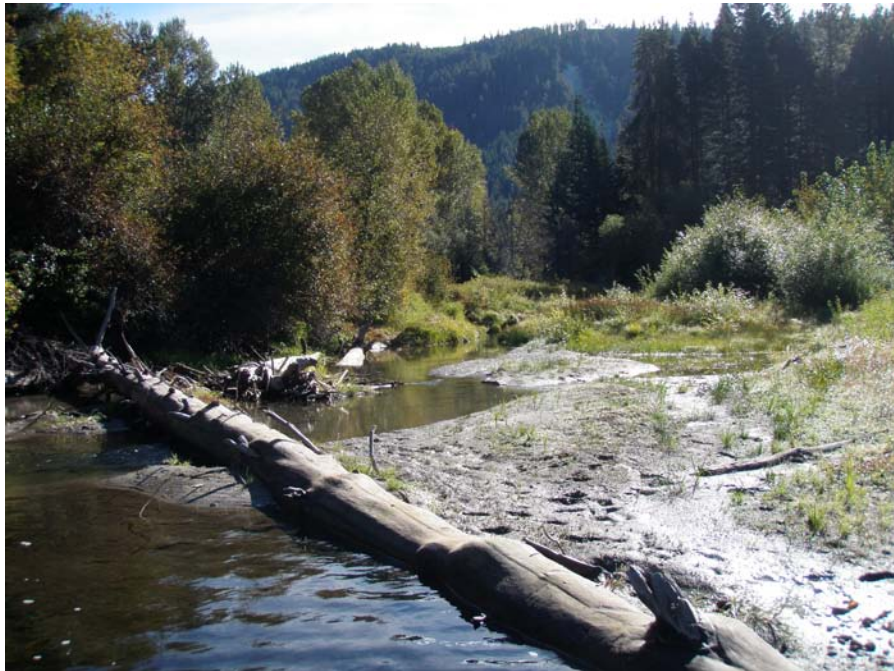
Photograph No. 22. View to the southeast looking upstream at a floodplain-type side channel along river right. Lower Nason Creek, Wenatchee Subbasin, Washington – Bureau of Reclamation Photograph by E. Lyon, September 14, 2010.

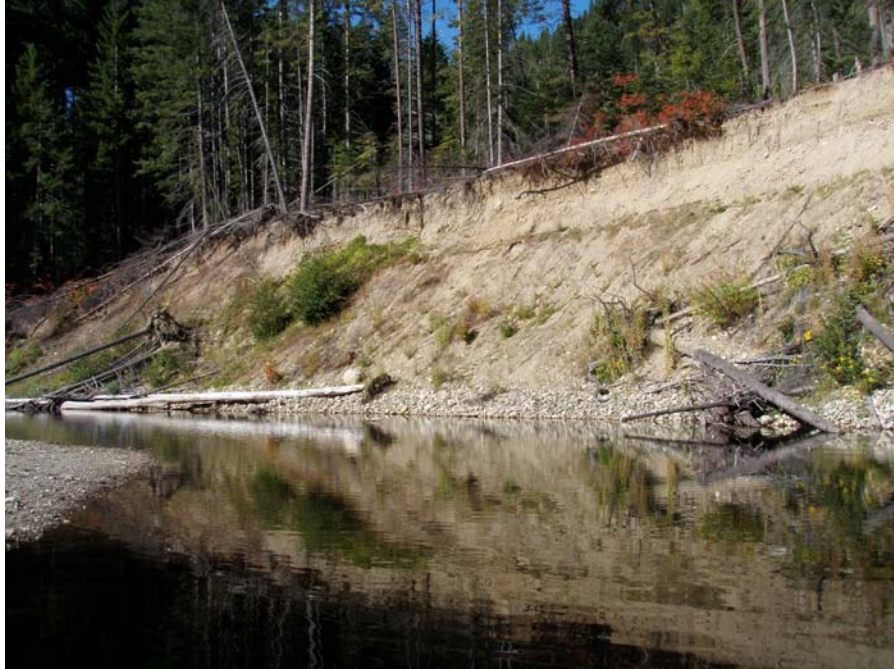
Photograph No. 23. View to the southwest looking upstream at an eroding glacial deposit overlying the Chumstick Formation along river left. Lower Nason Creek, Wenatchee Subbasin, Washington – Bureau of Reclamation Photograph by E. Lyon, September 14, 2010.

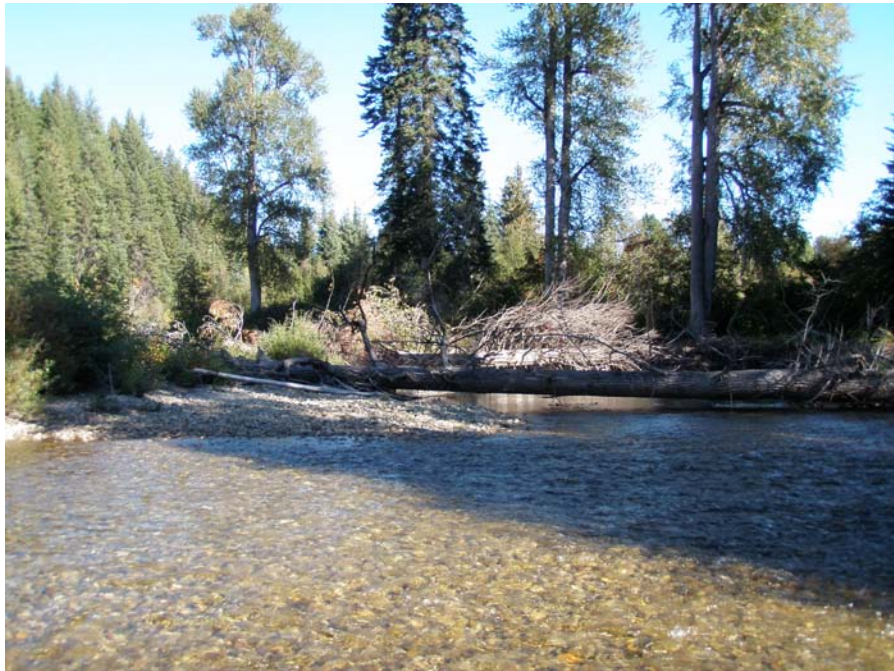
Photograph No. 24. View to the north looking at channel spanning large wood contributing to middle channel scour pool development. Lower Nason Creek, Wenatchee Subbasin, Washington – Bureau of Reclamation Photograph by E. Lyon, September 14, 2010.

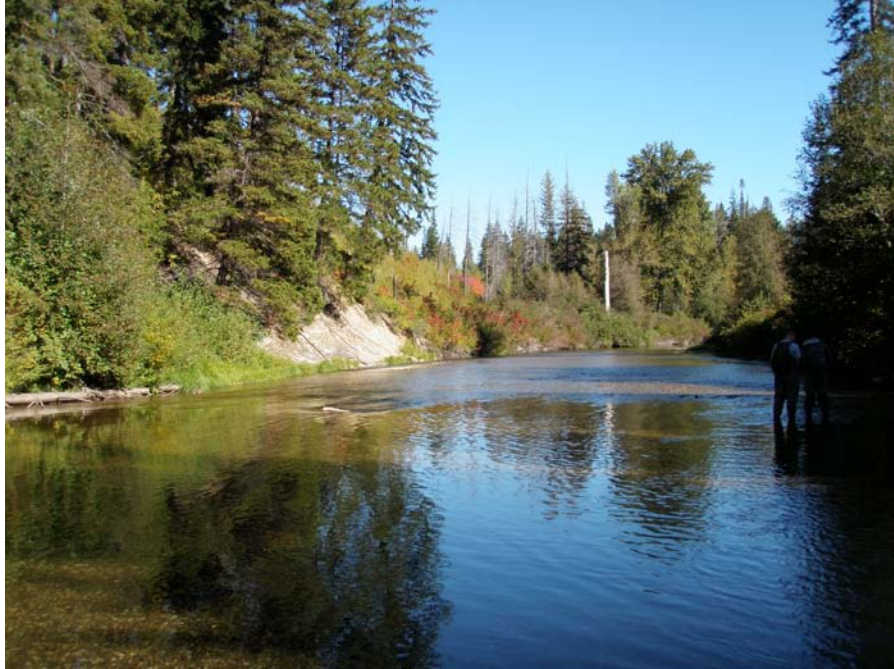
Photograph No. 25. View to the north looking downstream at geologic confinement. Lower Nason Creek, Wenatchee Subbasin, Washington – Bureau of Reclamation Photograph by E. Lyon, September 14, 2010.

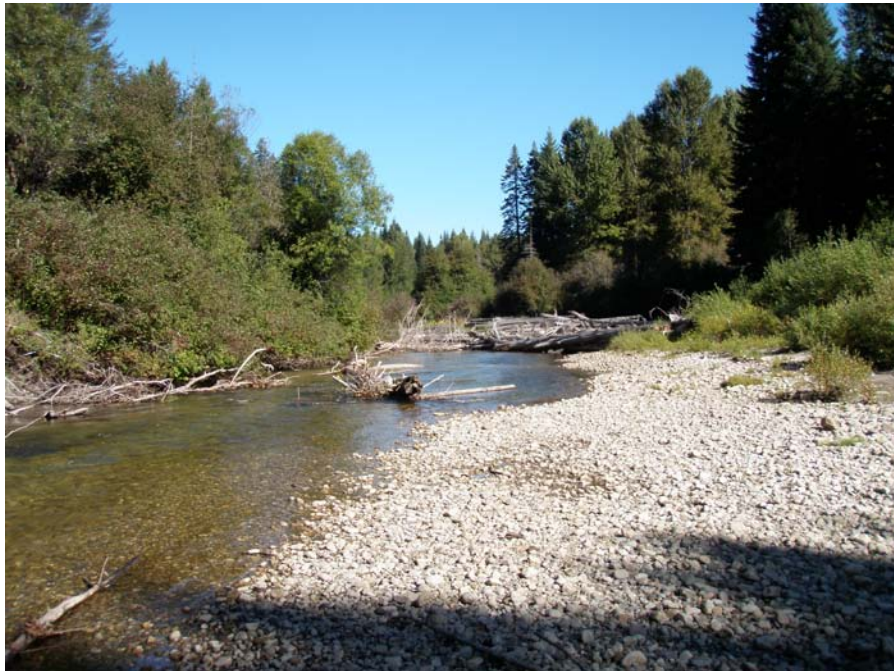
Photograph No. 26. View to the north looking downstream at large wood complex. Lower Nason Creek, Wenatchee Subbasin, Washington – Bureau of Reclamation Photograph by E. Lyon, September 14, 2010.

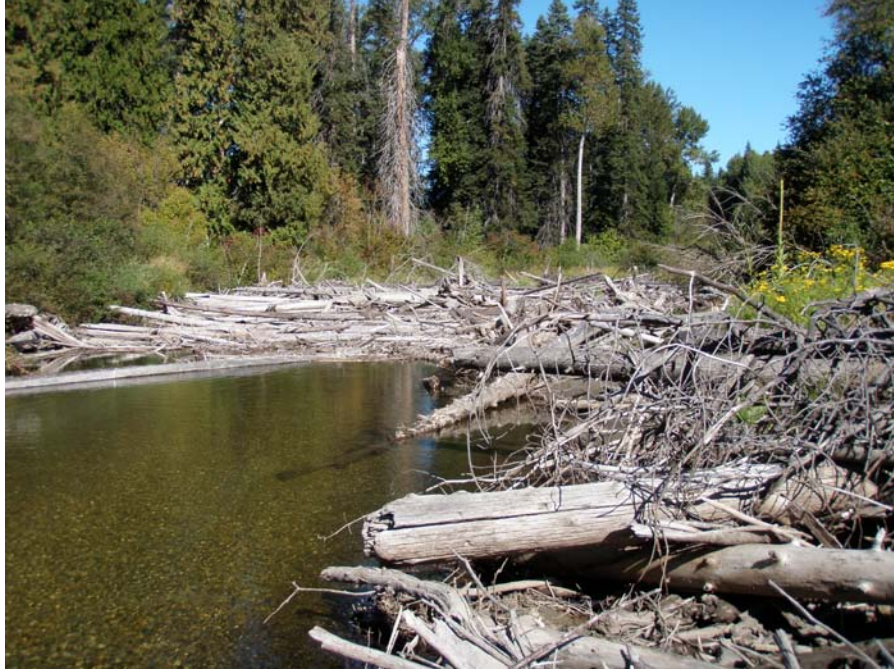
Photograph No. 27. View to the northwest looking downstream at a channel spanning large wood complex. Lower Nason Creek, Wenatchee Subbasin, Washington – Bureau of Reclamation Photograph by E. Lyon, September 14, 2010.

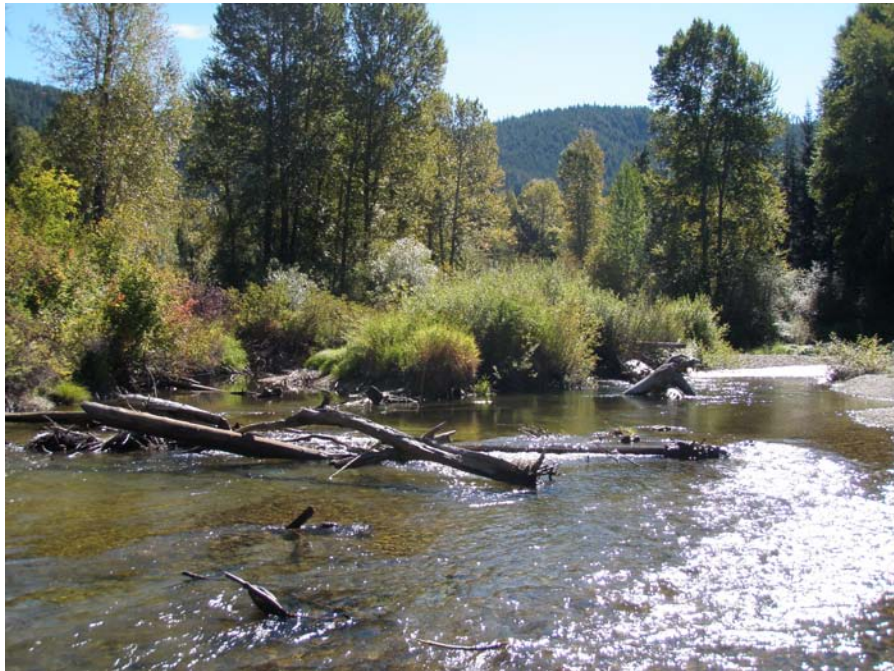
Photograph No. 28. View to the southeast looking upstream at a side channel along river right. Lower Nason Creek, Wenatchee Subbasin, Washington – Bureau of Reclamation Photograph by E. Lyon, September 14, 2010.

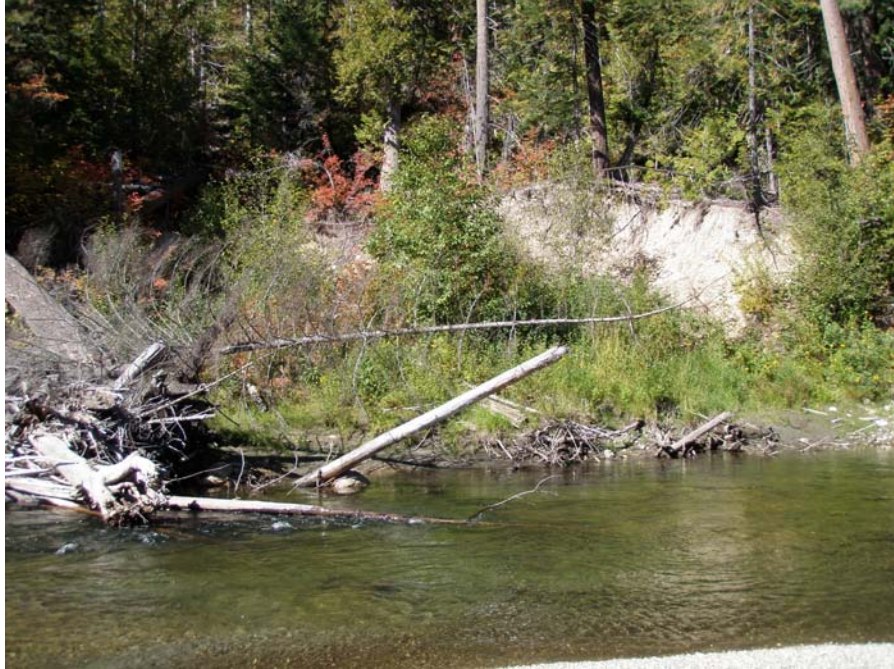
Photograph No. 29. View to the west looking at a landslide in glacial drift along river left. Lower Nason Creek, Wenatchee Subbasin, Washington – Bureau of Reclamation Photograph by E. Lyon, September 14, 2010.

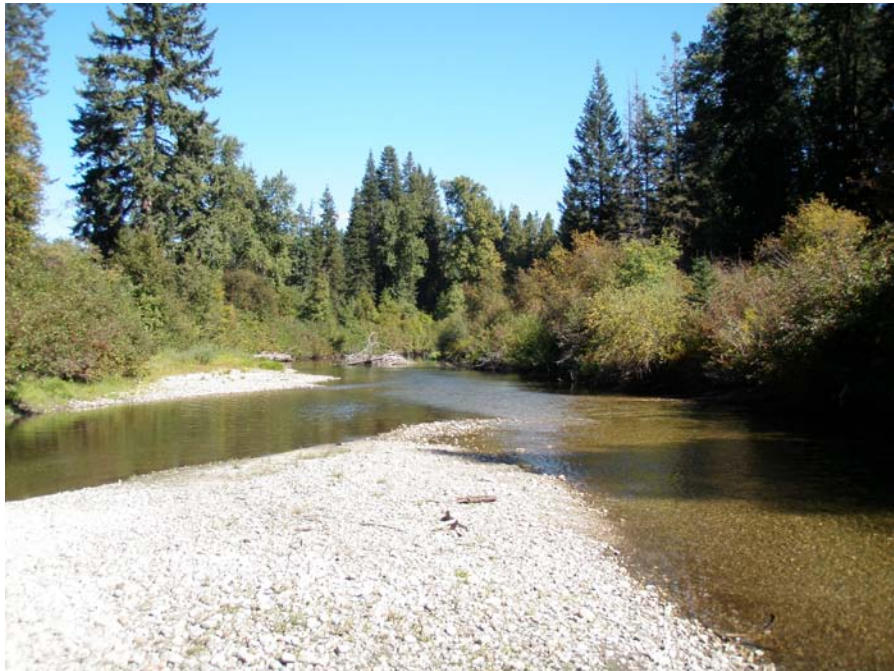
Photograph No. 30. View to the northeast looking downstream at riffle and run channel units. Lower Nason Creek, Wenatchee Subbasin, Washington – Bureau of Reclamation Photograph by E. Lyon, September 14, 2010.

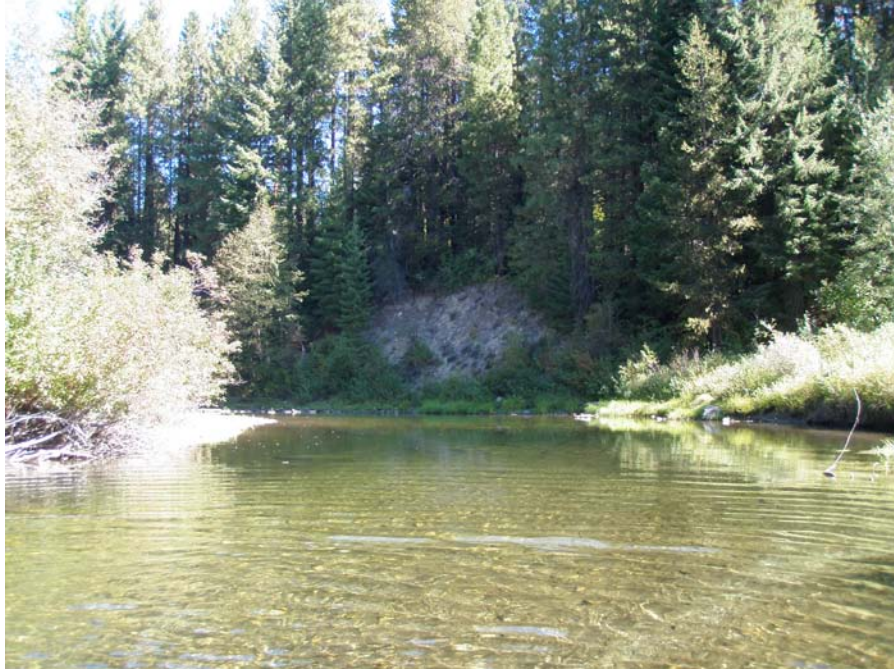
Photograph No. 31. View to the northeast looking downstream at glacial terrace on river right that restricts lateral channel migration. Lower Nason Creek, Wenatchee Subbasin, Washington – Bureau of Reclamation Photograph by E. Lyon, September 14, 2010.

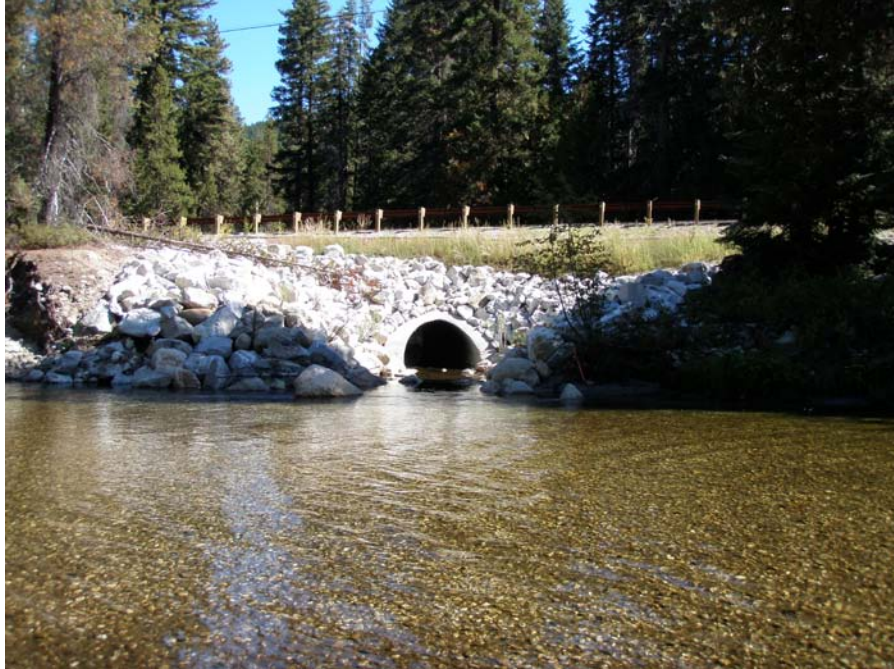
Photograph No. 33. View to the east looking at a culvert that reconnects a historic channel path that was blocked by an improved road. Lower Nason Creek, Wenatchee Subbasin, Washington – Bureau of Reclamation Photograph by E. Lyon, September 14, 2010.

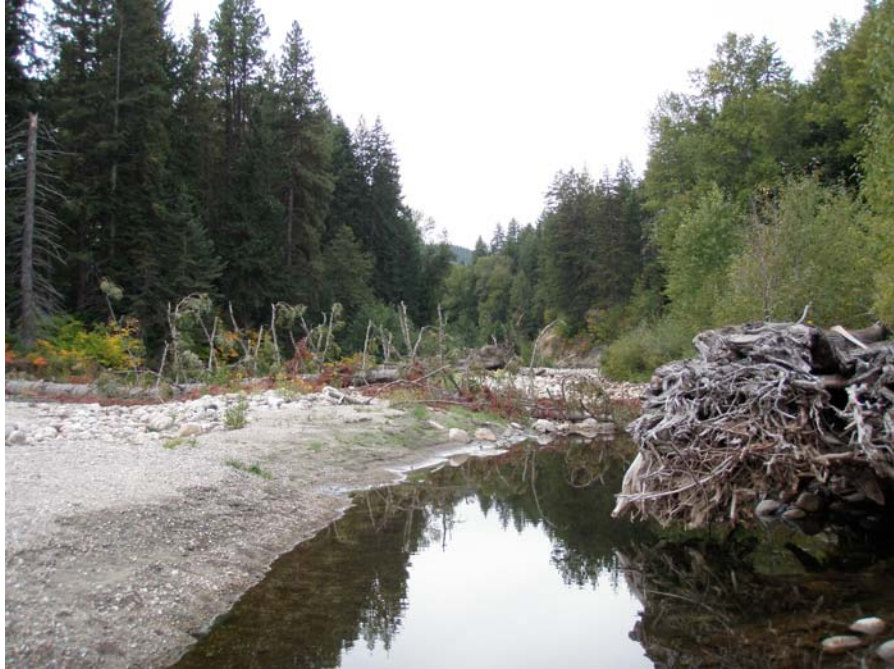
Photograph No. 35. View to the southwest looking upstream at scour pool forced by large wood. Lower Nason Creek, Wenatchee Subbasin, Washington – Bureau of Reclamation Photograph by E. Lyon, September 15, 2010.

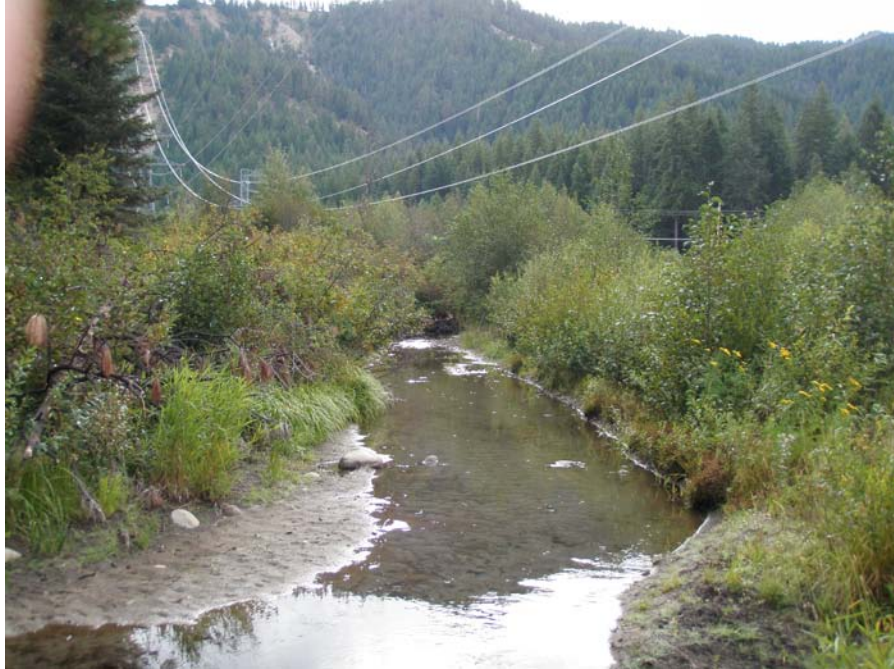
Photograph No. 37. View to the southeast looking upstream at a floodplain-type side channel. Lower Nason Creek, Wenatchee Subbasin, Washington – Bureau of Reclamation Photograph by E. Lyon, September 15, 2010.

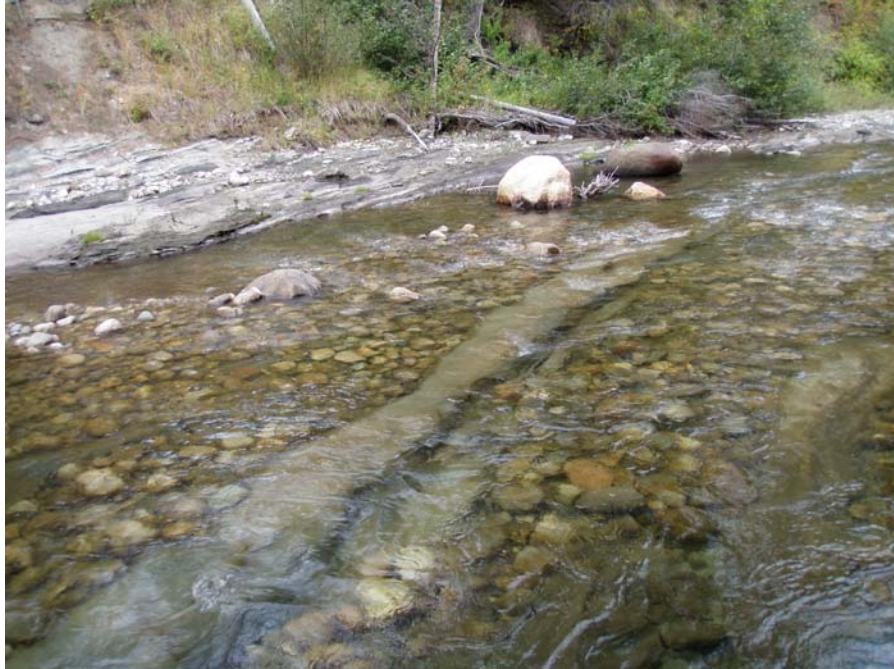
Photograph No. 39. View to the northwest looking at bedrock (Chumstick Formation (Tc)) in the channel that restricts vertical channel migration. Lower Nason Creek, Wenatchee Subbasin, Washington – Bureau of Reclamation Photograph by E. Lyon, September 15, 2010.

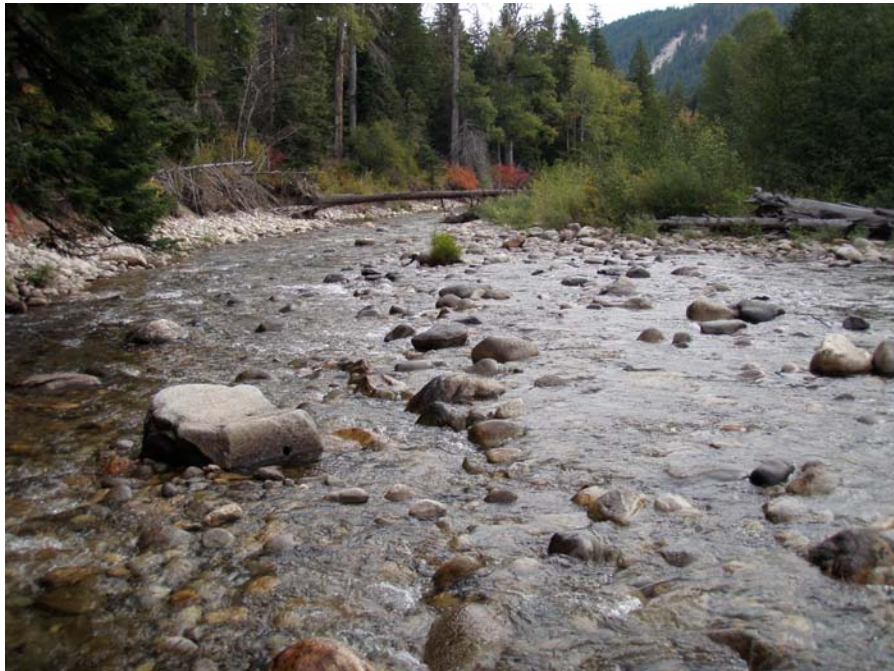
Photograph No. 40. View to the northeast looking downstream at cobble and boulder substrate downstream of bedrock control (refer to photographs 38 and 39). Lower Nason Creek, Wenatchee Subbasin, Washington – Bureau of Reclamation Photograph by E. Lyon, September 15, 2010.

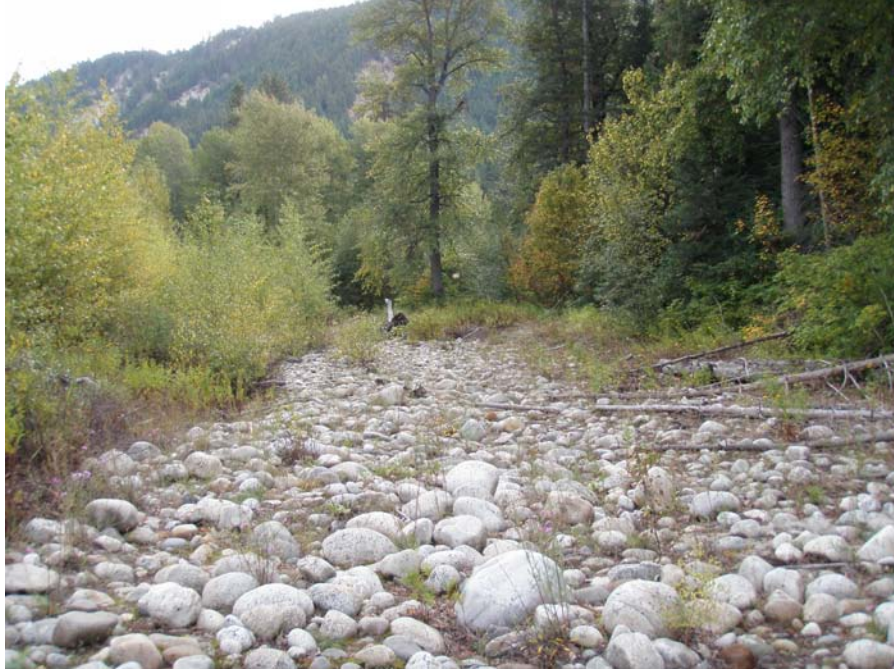
Photograph No. 41. View to the east looking at developing side channel. Lower Nason Creek, Wenatchee Subbasin, Washington – Bureau of Reclamation Photograph by E. Lyon, September 15, 2010.

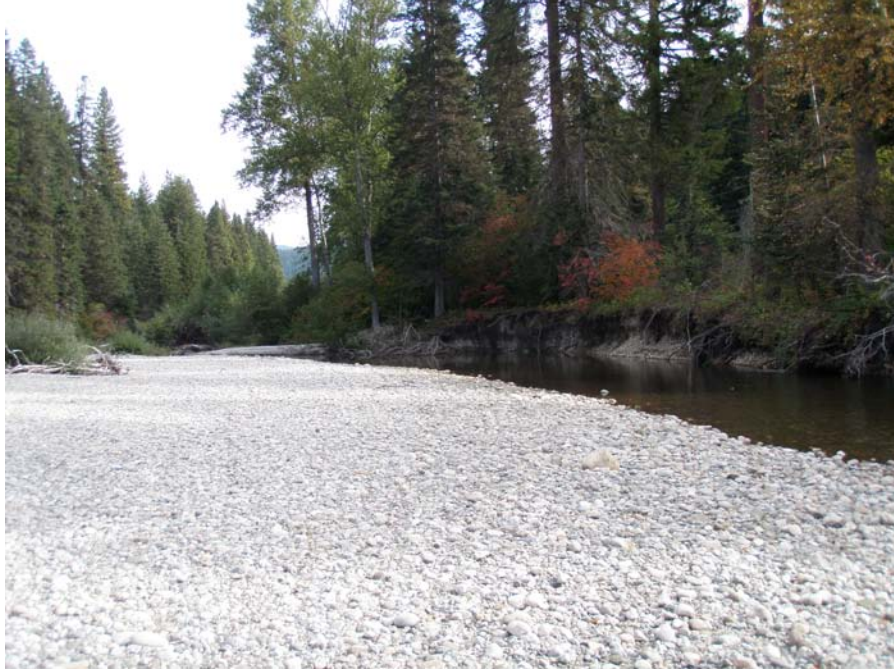
Photograph No. 43. View to the north looking at lateral gravel bar and lateral scour pool along river right. Lower Nason Creek, Wenatchee Subbasin, Washington – Bureau of Reclamation Photograph by E. Lyon, September 15, 2010.

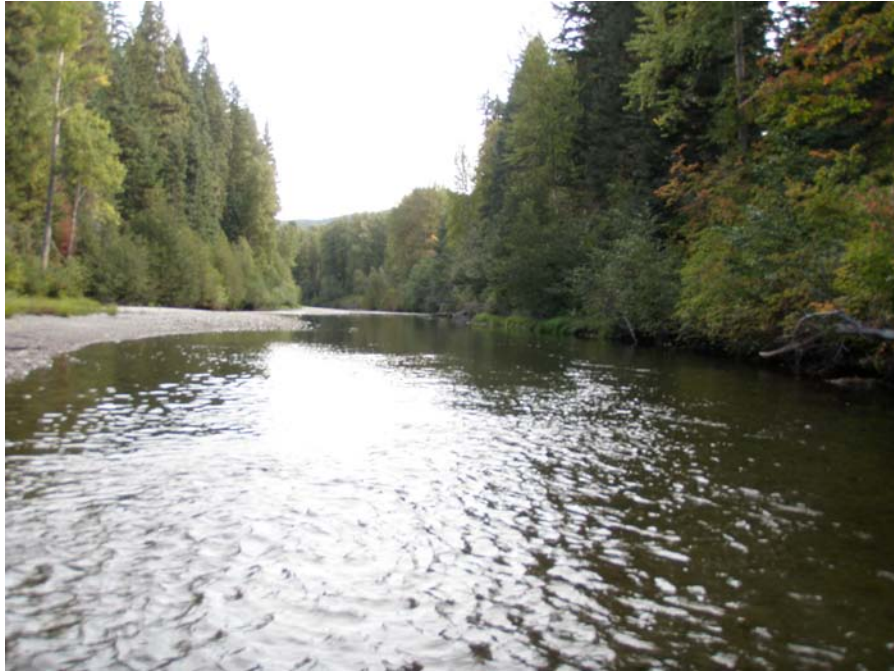
Photograph No. 45. View to the northeast looking at middle channel scour pool. Lower Nason Creek, Wenatchee Subbasin, Washington – Bureau of Reclamation Photograph by E. Lyon, September 15, 2010.

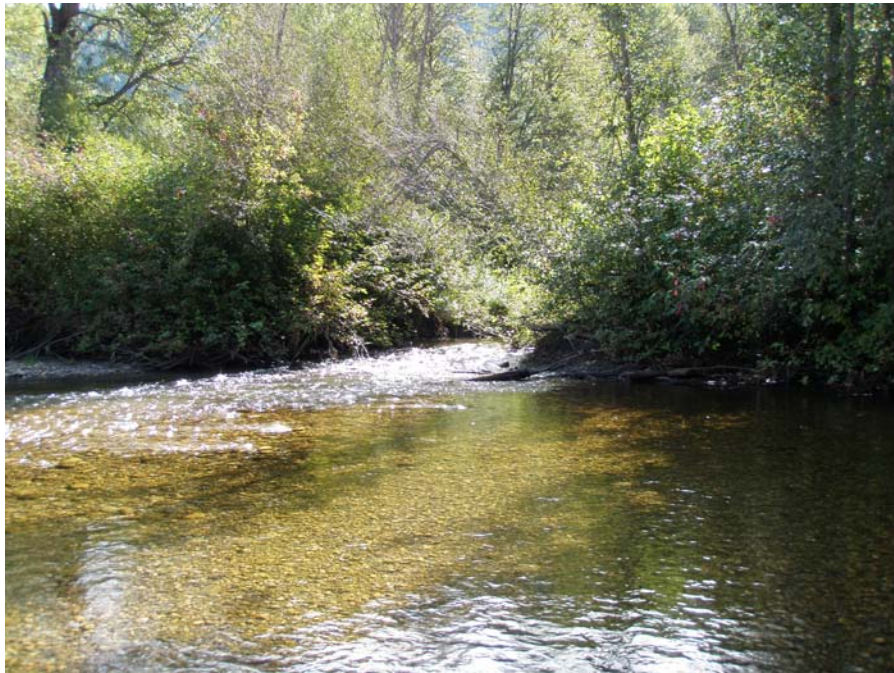
Photograph No. 46. View to the east looking at outlet of reconnected side channel. Lower Nason Creek, Wenatchee Subbasin, Washington – Bureau of Reclamation Photograph by E. Lyon, September 15, 2010.

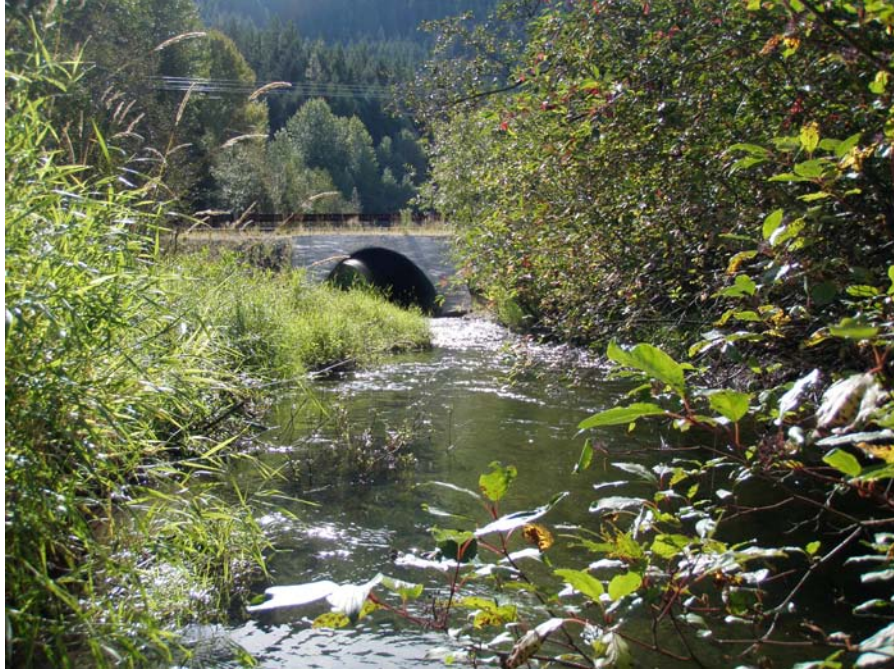
Photograph No. 47. View to the east looking upstream at culvert through improved road embankment that reconnects historic channel path. Lower Nason Creek, Wenatchee Subbasin, Washington – Bureau of Reclamation Photograph by E. Lyon, September 15, 2010.

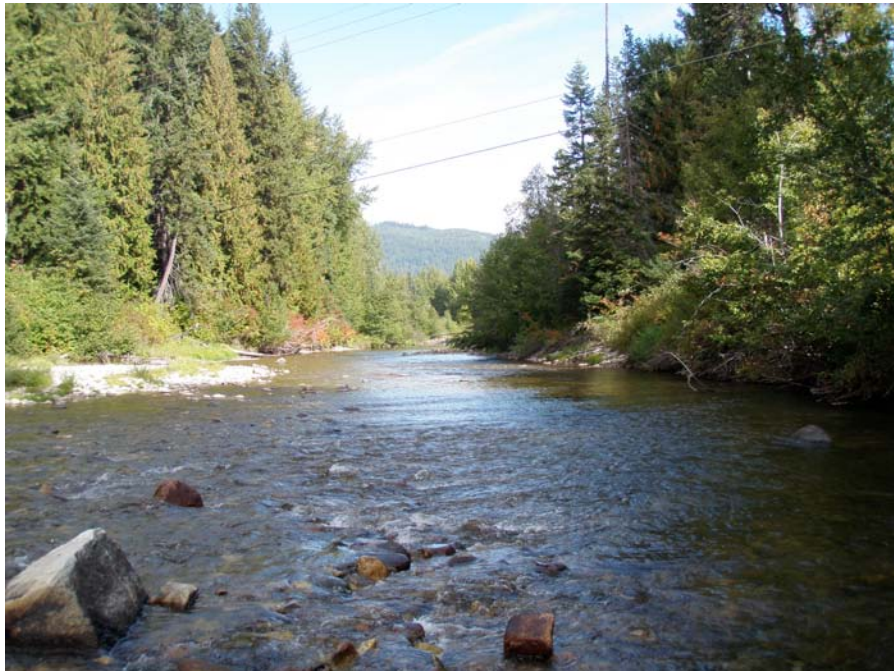
Photograph No. 48. View to the north looking downstream at riffle/pool sequence. Lower Nason Creek, Wenatchee Subbasin, Washington – Bureau of Reclamation Photograph by E. Lyon, September 16, 2010.

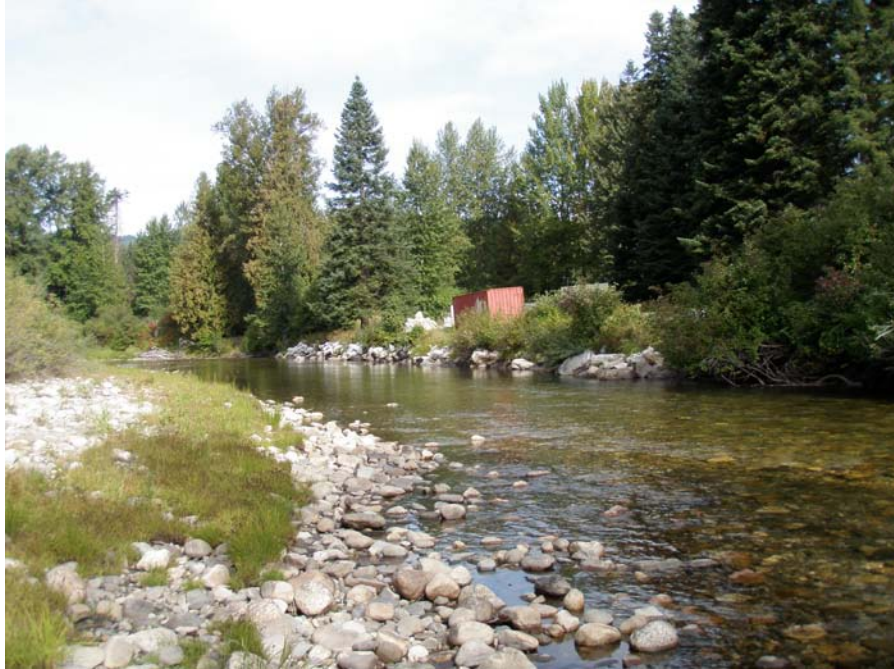
Photograph No. 49. View to the north looking downstream at riprap placed along river right. Lower Nason Creek, Wenatchee Subbasin, Washington – Bureau of Reclamation Photograph by E. Lyon, September 16, 2010.
