Lower Nason
Assessment of Geomorphic and Ecologic Indicators
Nason Creek, Wenatchee Subbasin

Chelan County, Washington

U.S. Department of the Interior
Bureau of Reclamation
Pacific Northwest Region
Pacific Northwest Regional Office, Boise, Idaho

April 2011

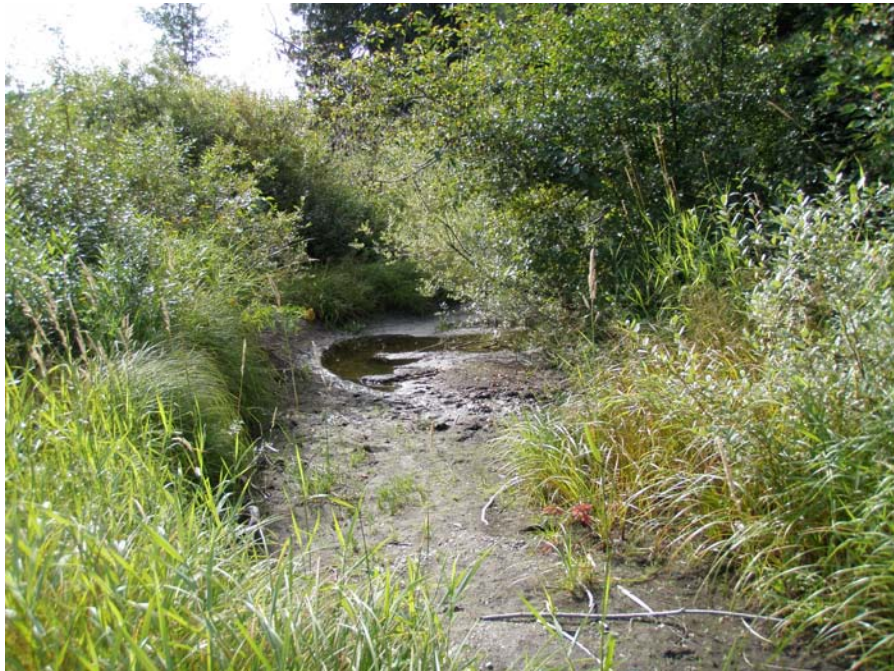
Photograph No. 50. View to the south looking upstream at developing floodplain-type side channel. Lower Nason Creek, Wenatchee Subbasin, Washington – Bureau of Reclamation Photograph by E. Lyon, September 16, 2010.

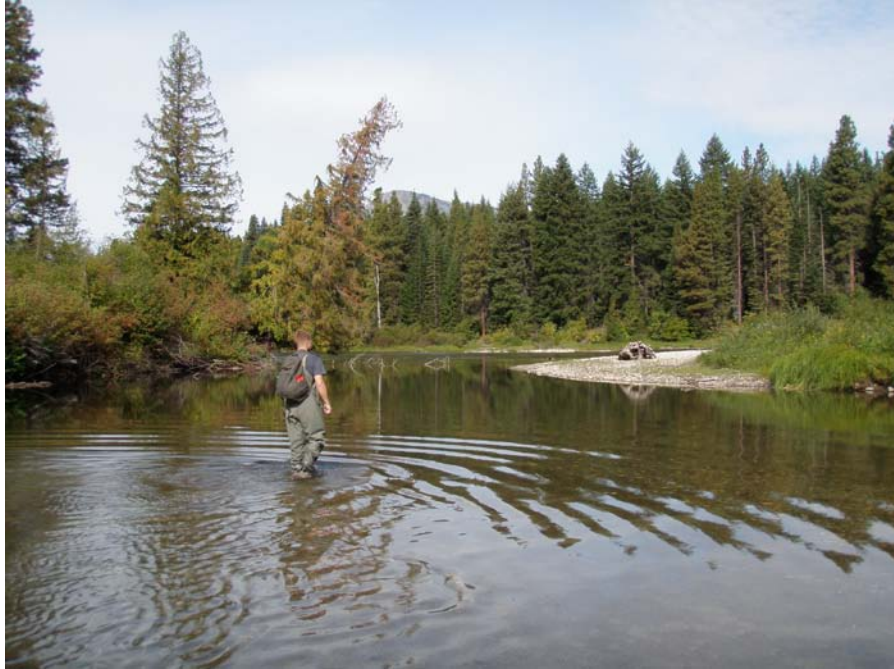
Photograph No. 51. View to the north looking downstream at the confluence with the Wenatchee River. Lower Nason Creek, Wenatchee Subbasin, Washington – Bureau of Reclamation Photograph by E. Lyon, September 16, 2010.

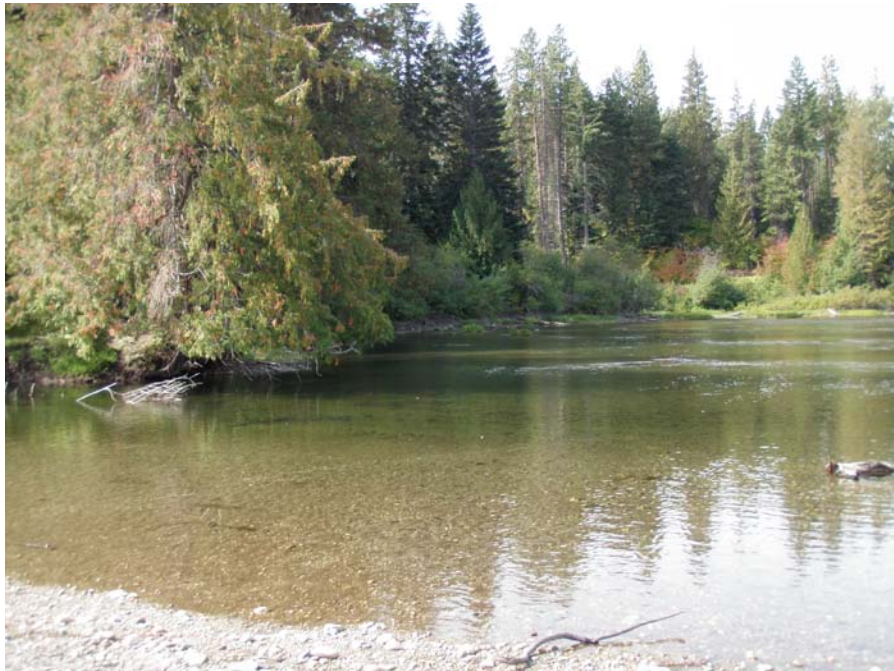
Photograph No. 52. View to the west looking upstream along the Wenatchee River at the confluence with Nason Creek. Lower Nason Creek, Wenatchee Subbasin, Washington – Bureau of Reclamation Photograph by E. Lyon, September 16, 2010.

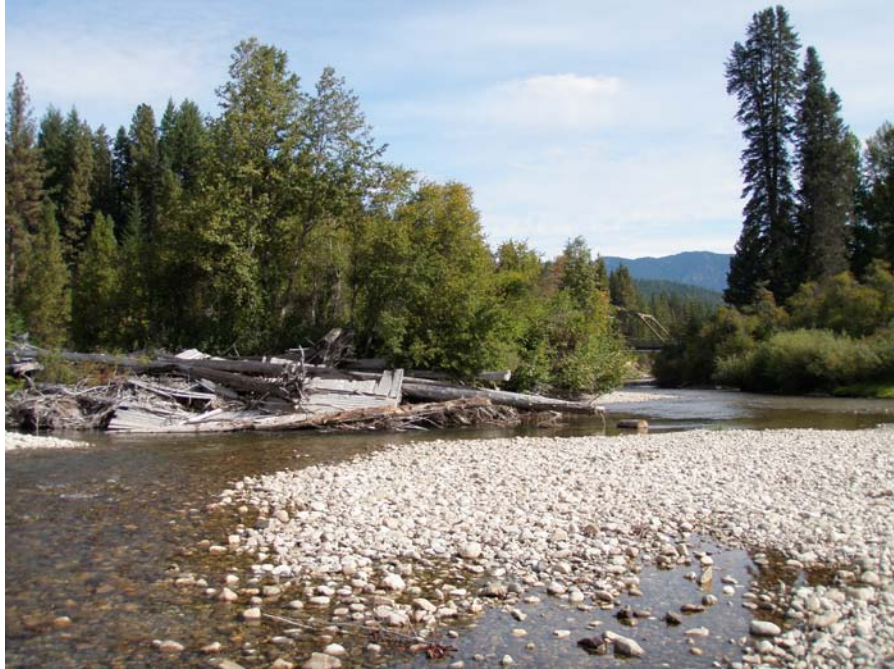
Photograph No. 53. View to the northeast looking at large wood complex along the Wenatchee River near the confluence with Nason Creek. Lower Nason Creek, Wenatchee Subbasin, Washington – Bureau of Reclamation Photograph by E. Lyon, September 16, 2010.

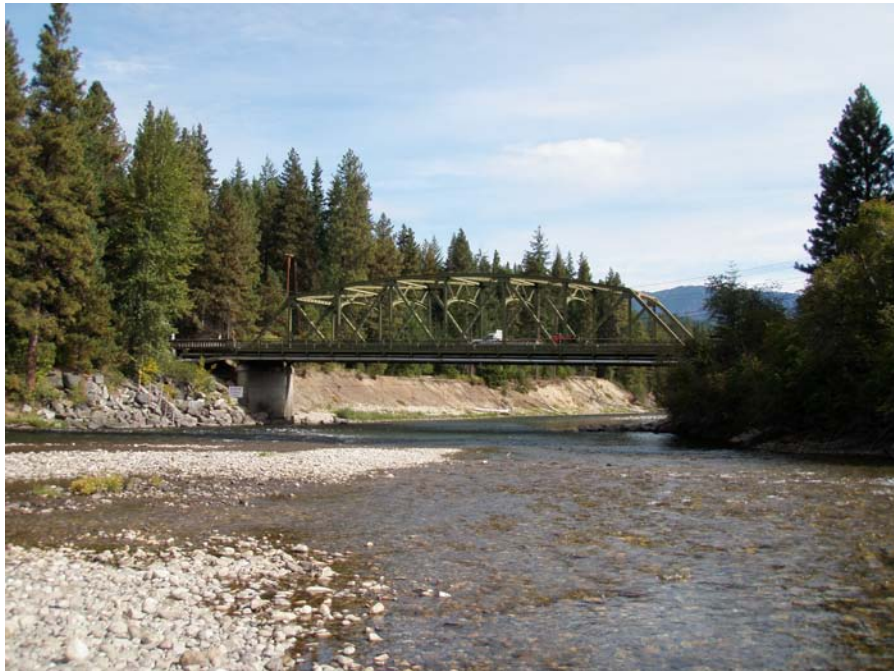
Photograph No. 54. View to the northeast looking at bridge crossing over the Wenatchee River downstream of the confluence with Nason Creek. Lower Nason Creek, Wenatchee Subbasin, Washington – Bureau of Reclamation Photograph by E. Lyon, September 16, 2010.

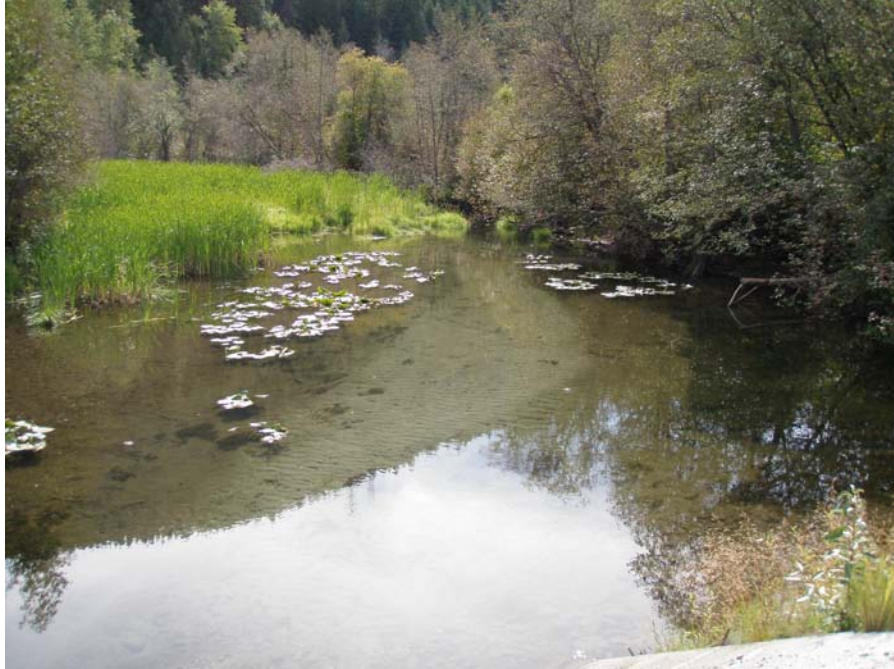
Photograph No. 55. View to the southeast looking upstream at reconnected historic channel path. Lower Nason Creek, Wenatchee Subbasin, Washington – Bureau of Reclamation Photograph by E. Lyon, September 16, 2010.

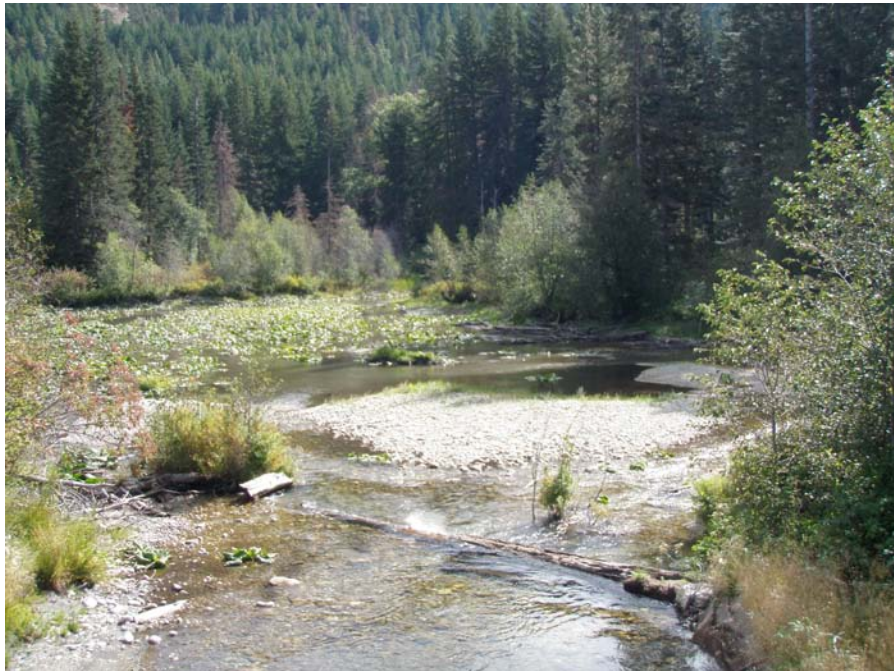
Photograph No. 56. View to the east looking downstream at reconnected historic channel path. Lower Nason Creek, Wenatchee Subbasin, Washington – Bureau of Reclamation Photograph by E. Lyon, September 16, 2010.

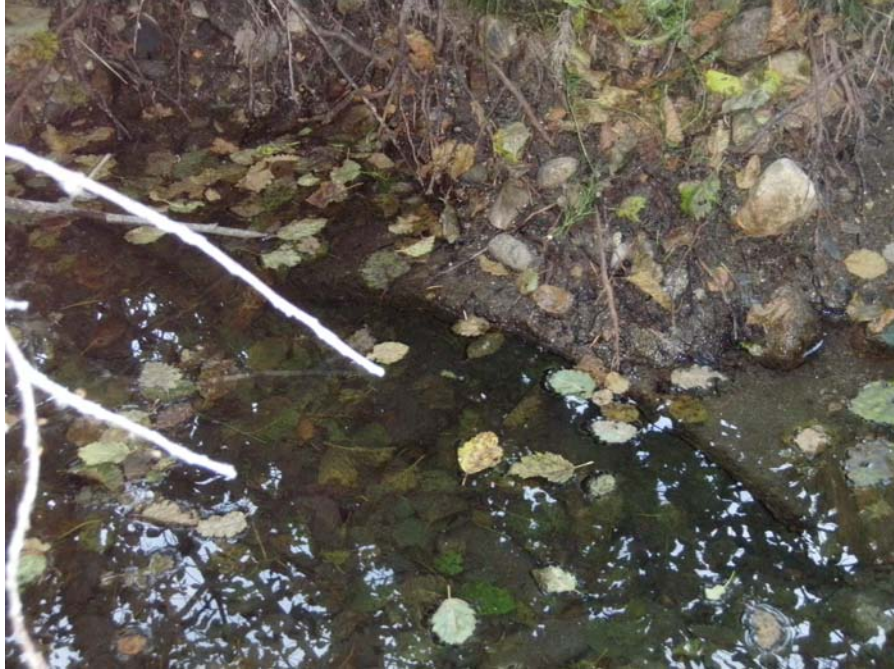
Photograph No. 57. View to the west looking at concrete culvert that poorly connects historic channel path through improved road embankment. Lower Nason Creek, Wenatchee Subbasin, Washington – Bureau of Reclamation Photograph by E. Lyon, September 16, 2010.

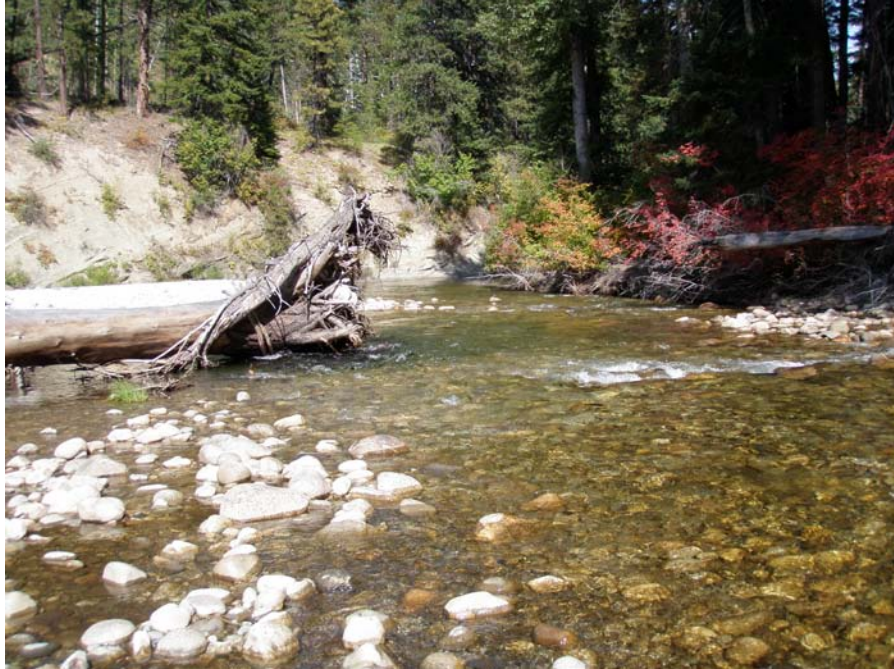
Photograph No. 59. View to the north looking downstream at large wood and riffle. Lower Nason Creek, Wenatchee Subbasin, Washington – Bureau of Reclamation Photograph by E. Lyon, September 16, 2010.

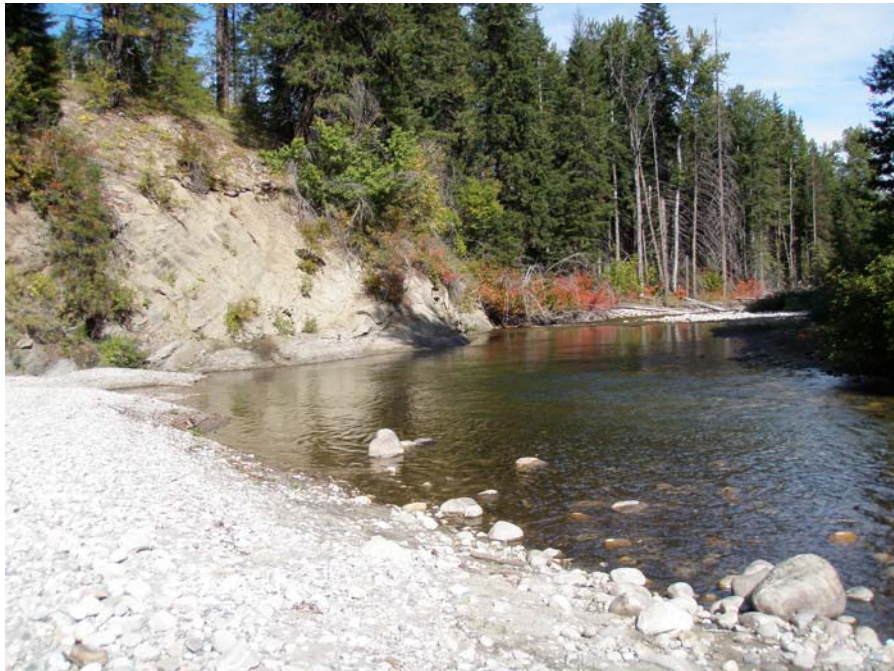
Photograph No. 60. View to the north looking downstream at bedrock (Chumstick Formation (Tc)) that restricts both lateral and vertical channel migration. Lower Nason Creek, Wenatchee Subbasin, Washington – Bureau of Reclamation Photograph by E. Lyon, September 16, 2010.

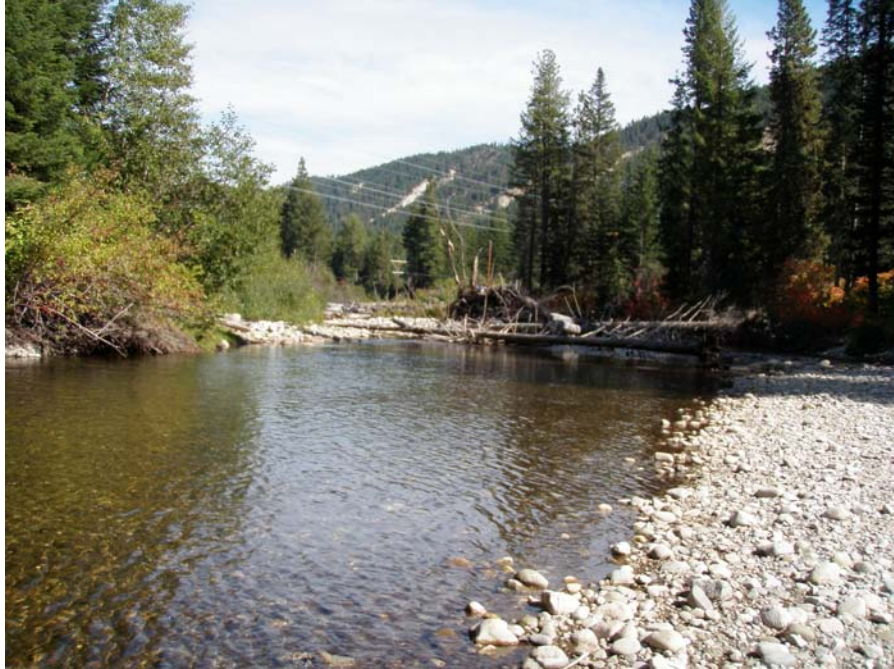
Photograph No. 61. View to the northeast looking downstream at large wood complex in the distance. Lower Nason Creek, Wenatchee Subbasin, Washington – Bureau of Reclamation Photograph by E. Lyon, September 16, 2010.

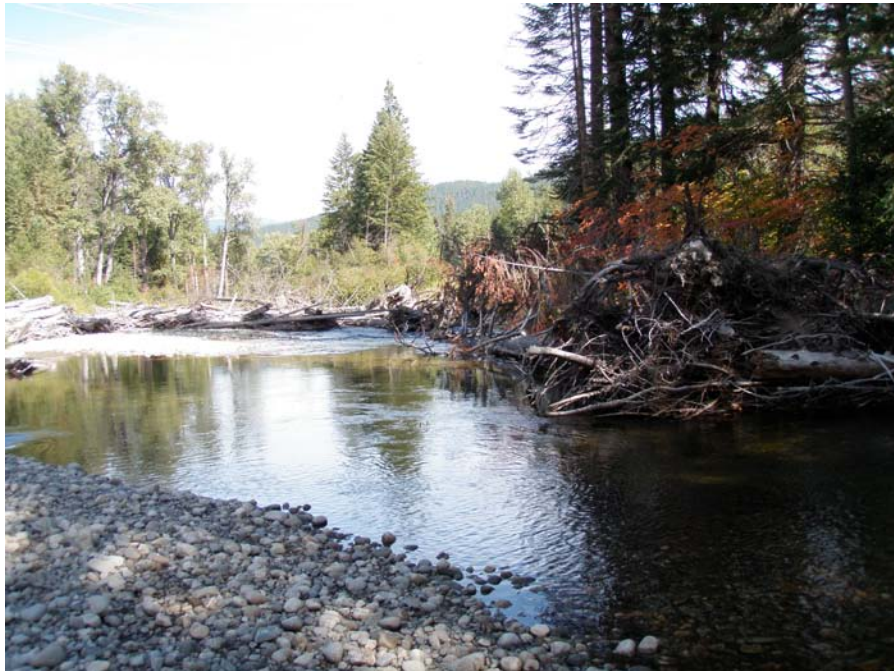
Photograph No. 62. View to the northeast looking downstream at lateral scour pool along river right and large wood complex. Lower Nason Creek, Wenatchee Subbasin, Washington – Bureau of Reclamation Photograph by E. Lyon, September 16, 2010.
