Lower Peshastin Creek

Tributary and Reach Assessment

Wenatchee Subbasin, Chelan County, WA

June 2010

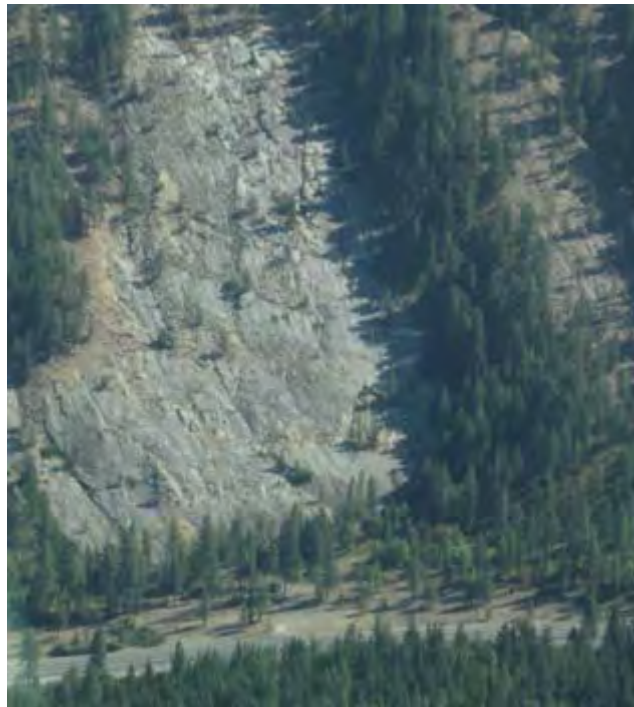
Figure 3. Low elevation aerial photograph of a large Chumstick Formation outcrop on a northwest facing slope of a hogback ridge near river mile 5.9. Sandstone outcrops such as this can contribute fine sediment to the channel over time.

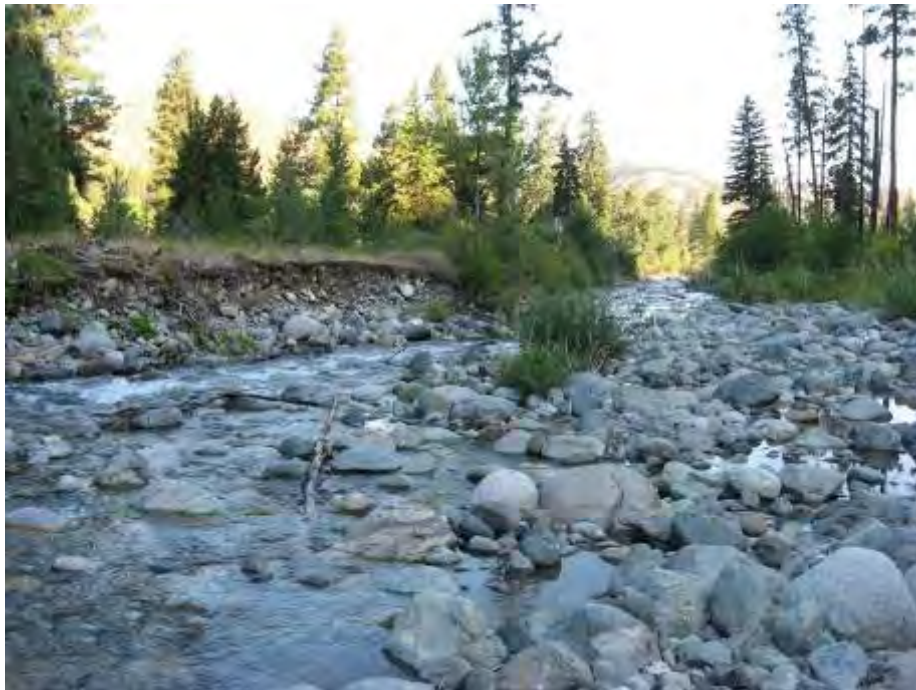
Within the study area, Peshastin Creek is dominated by coarse bank and bed material (Figure 8). Channel bed substrate is largely cobble and small boulder with smaller quantities of bedrock, gravels, and sand. The bed material is primarily derived from incised glacial deposits, hillslope sources, or tributary alluvial fan inputs. Based on pebble counts taken as part of the stream

Figure 8. Illustration of typical coarse bed and bank material along the study reach. River mile 4.5.

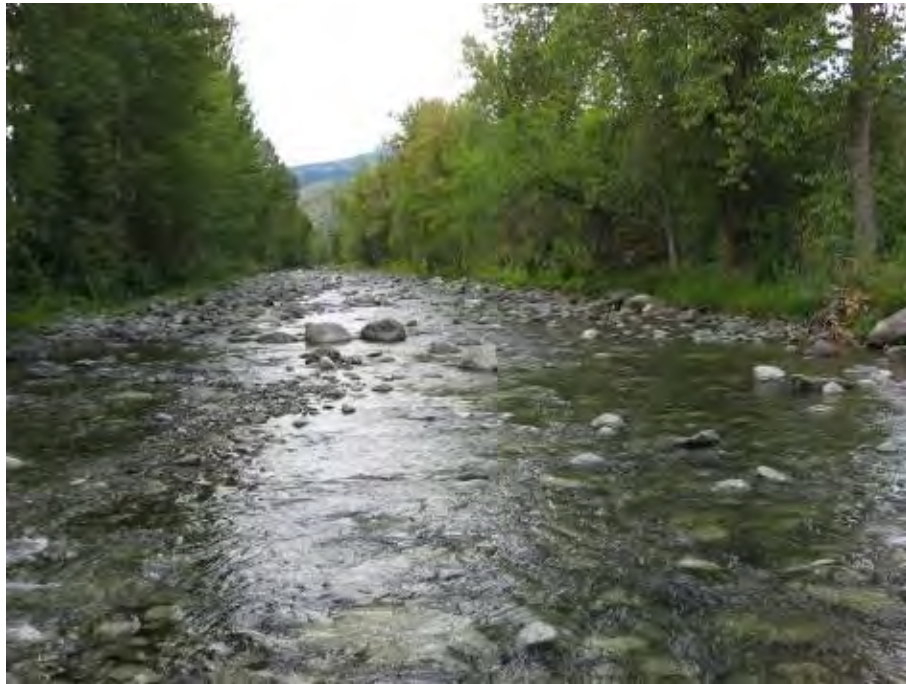
Anthropogenic channel straightening, riparian clearing, and floodplain disconnection have affected natural channel equilibrium processes. Stream segments once characterized by greater sinuosity and pool-riffle sequences have given way to straightened plane-bed segments with uniform bed topography (Figure 10) (USFS 1999). Higher gradient segments with natural confinement have been less impacted by roadway construction. These segments are influenced by large boulders and bedrock outcrops and exhibit step-pool morphology (Figure 11).

Figure 10. Upstream view near river mile 1.6. Long, plane-bed sections such as this are typical in the lower 8.4 miles of Peshastin Creek.

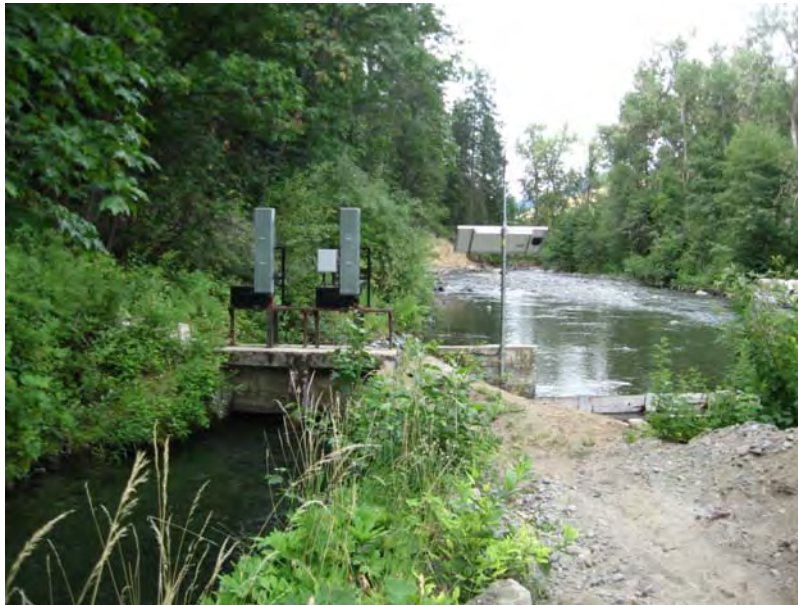
Figure 21. View looking upstream toward the southwest at the Peshastin Canal diversion near river mile 2.5.

irrigation withdrawal rates are maintained, diversion begins to have a proportionally greater impact on instream flows (Figure 24). Portions of the channel downstream of the main diversion at river 2.5 may become de-watered during drought years (Andonaegui 2001). These critically low baseflows create depth and temperature barriers for fish passage. In addition, the diversion canal intercepts flow from several small tributaries that enter lower Peshastin Creek from the east; in some cases eliminating their connection with Peshastin Creek (Andonaegui 2001).

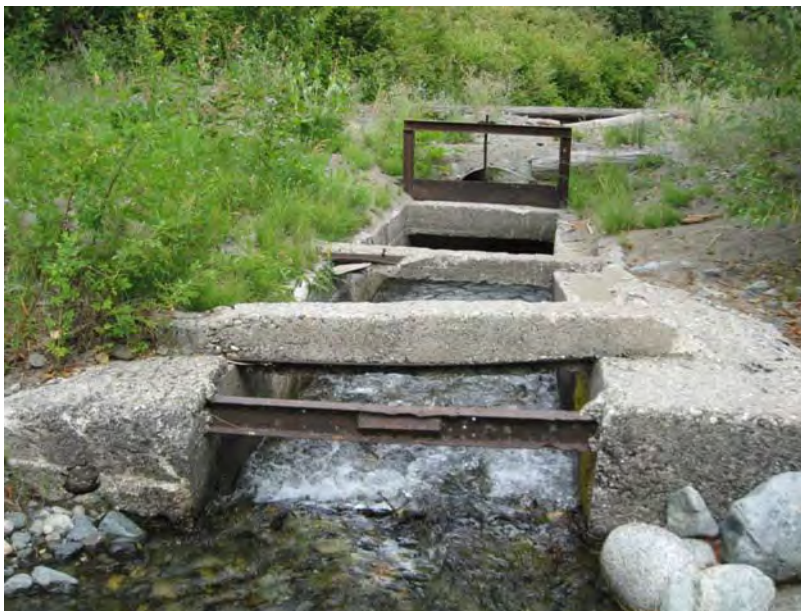
Figure 22. View looking to the north at the Tandy Ditch diversion near river mile 4.9.

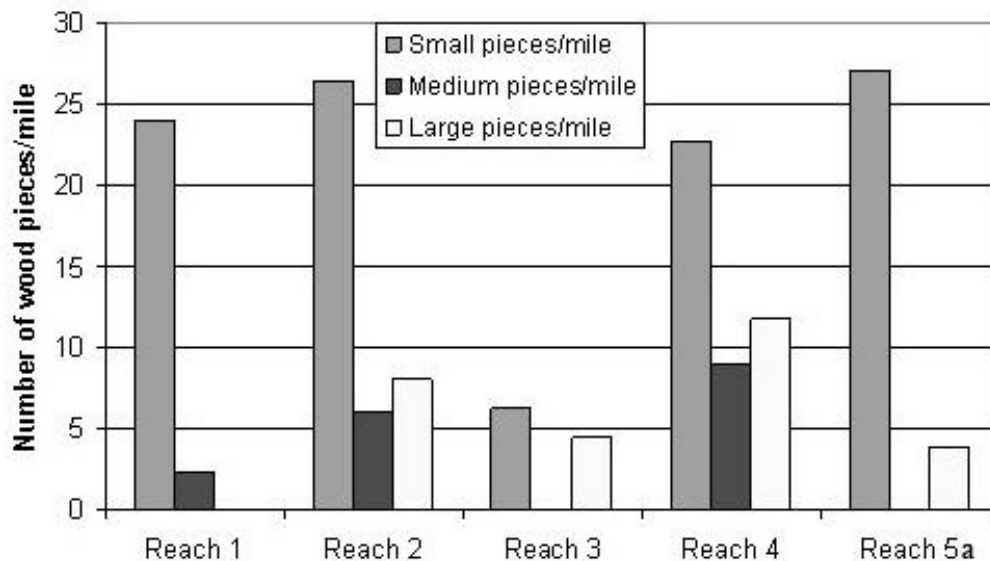
Large wood quantities in lower Peshastin Creek are extremely low. The number of pieces ranges from approximately 10 to 43 pieces/mile (Figure 41 and Table 7) and “small” LWD makes up the majority of pieces (68% for the entire study site and approximately 90% for Reaches 1 and 4) (Figure 41). Median wood loading on “undisturbed” streams of comparable size and type in the region is 274 pieces/mile and the 25th percentile is 80 pieces/mile (Fox and Bolton 2007). The average wood frequency of 35 pieces/mile on lower Peshastin Creek (all reaches combined) is well below these thresholds. According to the REI metrics (see Section 2.9), wood quantities are at the “unacceptable risk” levels in all reaches except reach 4, which is at an “at risk” condition.

Figure 41. Bar graph of small (6 in. by 20 ft.), medium (12 in. by 35 ft.), and large (20 in. by 35 ft.) wood pieces/mile for each reach.

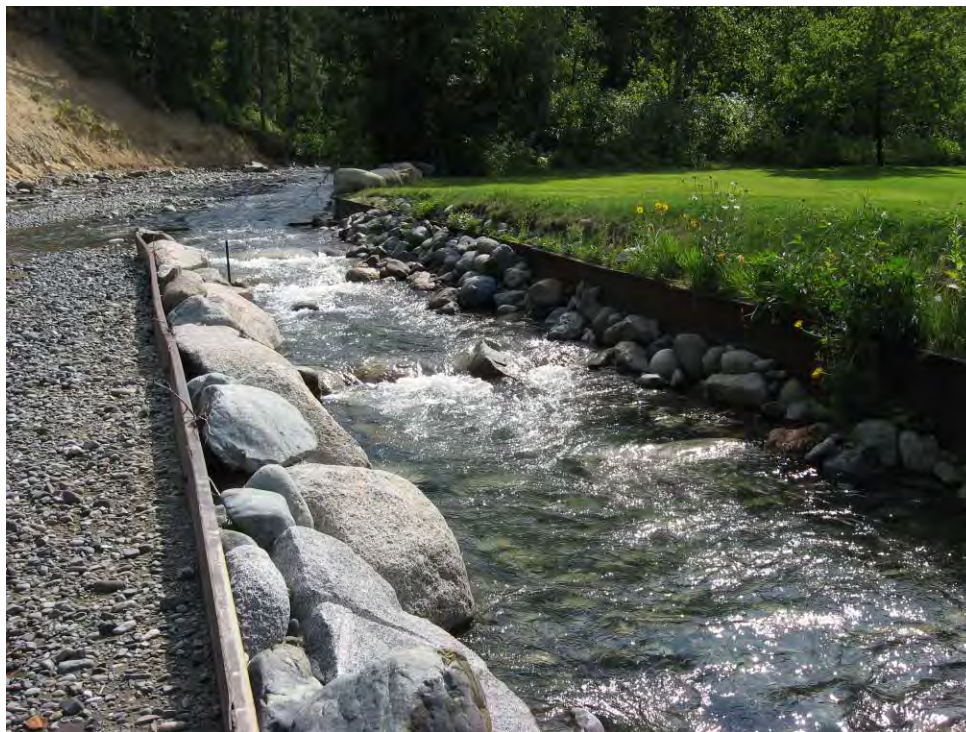
The irrigation diversion dam at RM 2.5 has recently (2005) undergone modification to provide fish passage. This structure now has a fish passage channel on the river left side of the dam (see Figure 46). No other in-channel structural barriers were identified during the 2009 habitat survey.

Based on riffle thalweg depths measured during the habitat survey, the findings from the Needs and Alternatives Study (Anchor Environmental and EES Consulting 2007), and the irrigation diversion structure at river mile 2.5, reaches 1 and 2 are ranked “at risk” for fish passage and reaches 3, 4, and 5a are ranked as “adequate” (see REI Metrics, Section 2.9).

Figure 46. Fish passage channel at diversion dam at river mile 2.5. (August 2009)

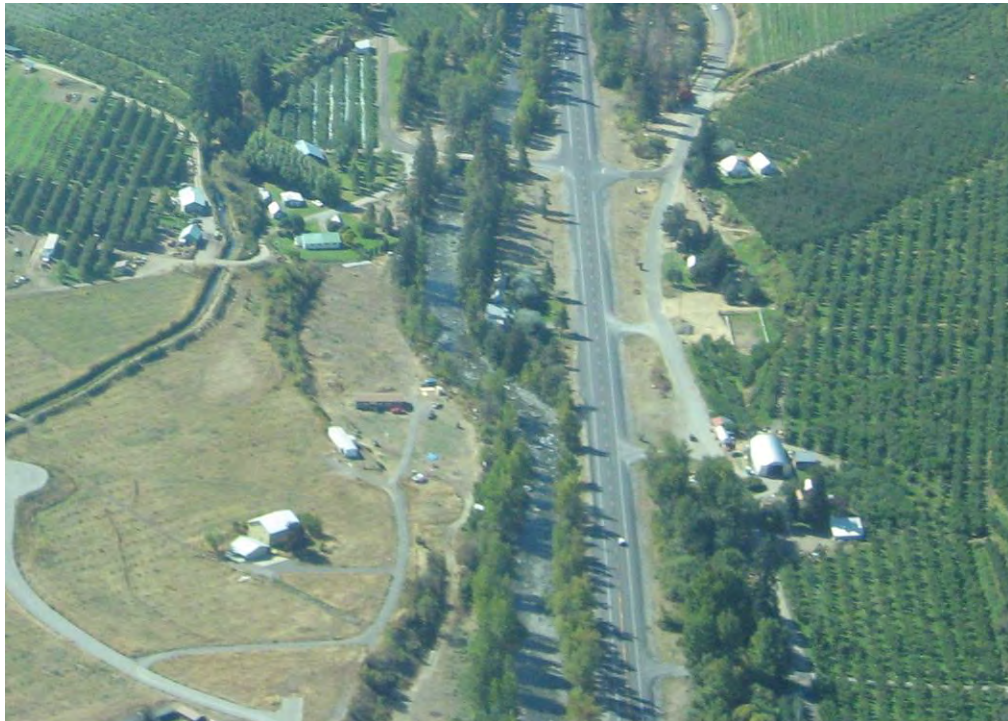
The riparian corridor along the study segment is frequently confined to a narrow corridor that is bounded by agricultural land, residential development, or Highway 97 (Figure 49). The inner zone is dominated by shrub/seedling with some representation of sapling/pole and small tree classes (Figure 47). The outer zone is a combination of grass/forbes and small and large tree classes (Figure 48).

In general, there is a lack of large trees in the riparian zone. Large riparian trees were initially cleared in the late 1800s as part of timber harvest and mining activities. Since the early-to-mid 1900s, riparian trees have been cleared for road building, residential development, and agriculture. The narrow riparian inner zone continues to have a robust shrub component, but in many areas, the outer zone is either non-existent or is confined to a very narrow buffer that lacks large trees that are necessary to provide stream shade, bank stabilization, and a source of LWD recruitment.

Figure 49. Narrow riparian corridor influenced by the Highway 97, agriculture, and residential development near river mile 1.7. (August 2009)

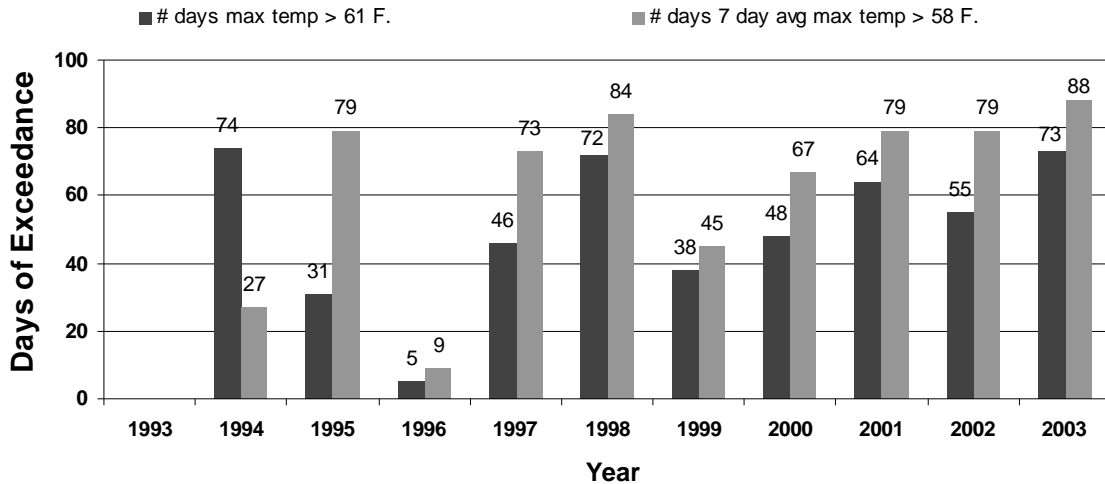
2008). Upstream of the confluence of Negro Creek, Peshastin Creek stream temperature is extremely poor, often exceeding 70°F during the summer (Figure 50). Negro Creek provides a cold water input that improves stream temperature in Peshastin Creek, which fluctuates from the mid to low 60's between Negro Creek and Ingalls Creek (Figure 51). These temperatures still exceed USFS and Washington State water quality standards for temperature. Ingalls Creek provides another cold water input that moderates stream temperature downstream of the confluence, although high temperatures continue to occur in lower Peshastin Creek (Figure 52).

Figure 50. Temperature record for Peshastin Creek above Negro Creek from 1994-2003. Data is from USFS (2008).

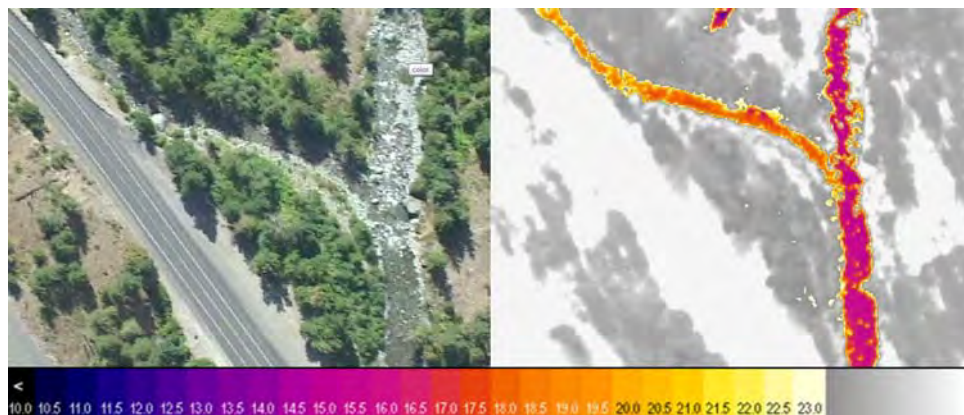
Thermal Infrared Radiation (TIR) imaging was also conducted as part of the TMDL Study in order to provide a spatial representation of surface temperature. Thermal imaging was conducted by helicopter for Peshastin Creek on August 11, 2003. The TIR data revealed areas of cold and warm water inputs; these data can be used to help identify problem areas as well as restoration opportunities. An example thermal image is provided in Figure 53.

Figure 53. Thermal (TIR) image of Peshastin Creek at the Ingalls Creek confluence. The temperature scale at the bottom is in degrees Celsius. Streamflow is from top to bottom of images. Ingalls Creek enters at the top right and upper Peshastin is at left. Ingalls Creek is an important contributor of cool water to Peshastin Creek, and its impact carries downstream for a few miles.

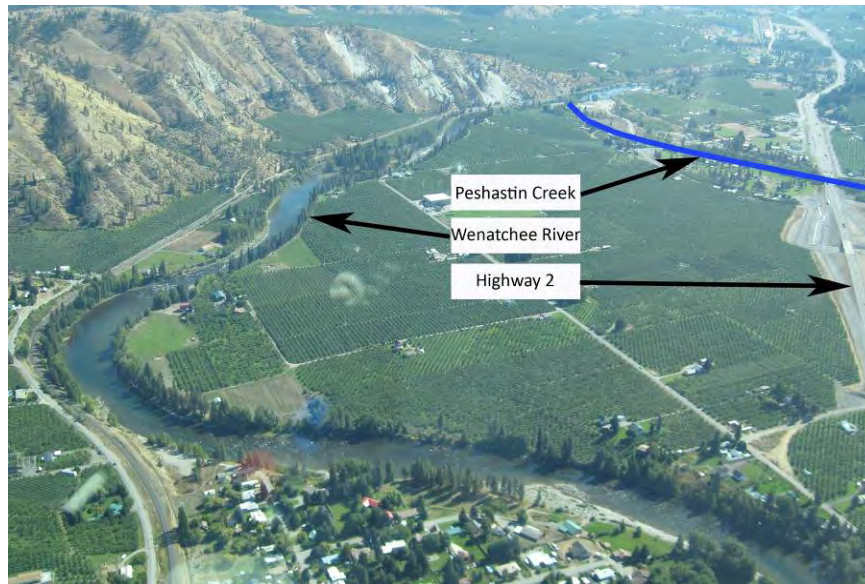
Reach 1 lies within the broad alluvial floodplain valley of the mainstem Wenatchee River. Valley width for Peshastin Creek is unconstrained and a wide alluvial fan has developed over time (Figure 56). The fan deposit is estimated to be about 425 acres, and up to a depth of 100 ft. (MWG 2006). The deposition of this large fan is associated with Pleistocene hydrologic and geomorphic regimes. The modern channel has incised into this material and has established a relatively narrow migration zone and active floodplain restricted to the southern portion of the fan.

Figure 56. Low elevation oblique aerial photo looking downstream to the southeast of the Wenatchee River valley. The blue line in the upper right corner of the photo shows Peshastin Creek's position on the southern portion of the alluvial fan that comprises the entire area between the Wenatchee River and Peshastin Creek. Photo taken September 24, 2009.

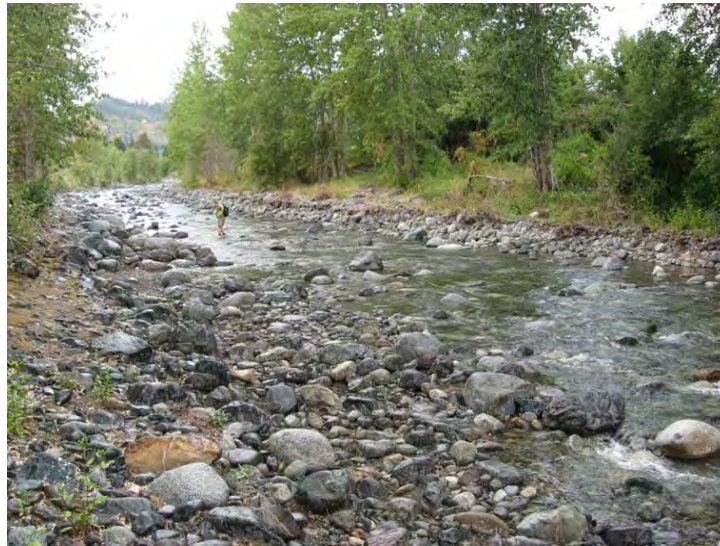
The channel is dominated by plane-bed morphology (Figure 57). Riffles are the dominant habitat unit type, comprising about 86% of the reach (See Section 2.7). Long riffles are separated by short pool sections that do not exceed 2 ft in residual depth. Streambanks through this reach are composed mainly of unconsolidated glacial outwash ranging in size from boulders to sand. This material is easily erodible and provides a sediment source for the channel in this reach. Bed and bank erosion is limited in some areas by bank armoring and hydromodifications. Channel erosion may be further limited due to the presence of large material of glacial origin. Median grain size in the reach is in the small to medium cobble size class (See Section 2.7).

Figure 57. Typical plane-bed riffle morphology, upstream view near river mile 0.1. Photo taken August 13, 2009.

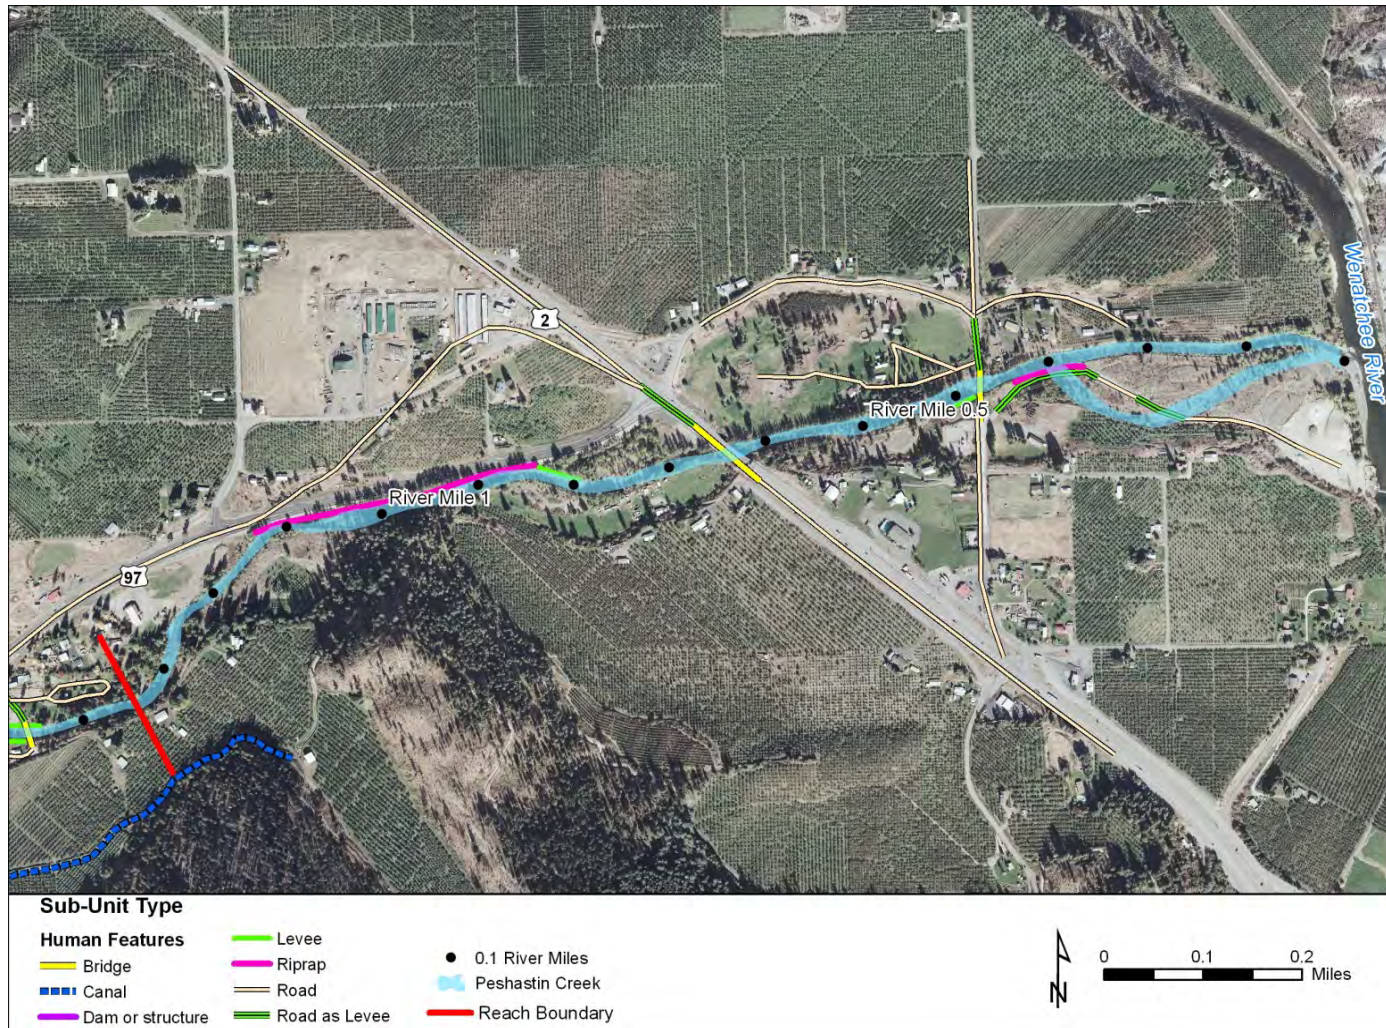
Floodplain development in this reach constrains channel and floodplain processes and affects aquatic habitat. Two bridge crossings (river miles 0.4 and 0.65) and their associated road fills constrain the channel and bisect the floodplain (Figure 58). The bridge crossings limit channel migration and floodplain connections. In all, about 85% of the floodplain is disconnected due to roadways and bridges. In addition, virtually the entire floodplain has been cleared and developed for agriculture, residential, or commercial uses. Disconnection of the historical active channel occurs where the main channel was re-routed downstream of river mile 0.3 following the construction of the Washington Department of Transportation (WDOT) material storage facility. The contemporary channel is now confined to the northern portion of the channel migration zone.

Figure 58. Aerial photo showing human features in Reach 1. Flow is from left to right. Processes are hindered by roadway encroachment, bank hardening, bridge crossings, and floodplain development. The road lines reflect the current alignment of Highway 97, though the photo represents the area before reconfiguration of the highway interchange.

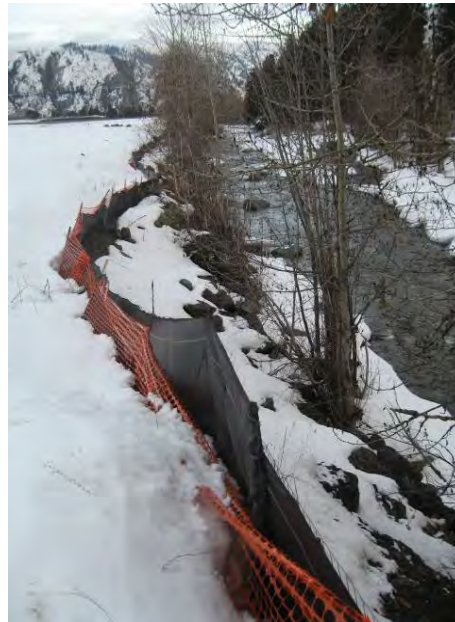
Between river miles 0.65 and 1.1, the interchange between Highways 97 and 2 has been reconfigured, and there is a new alignment for Highway 97 that is not captured by the most recent aerial photos or LiDAR. The new alignment is further from the channel, but a hardened bank remains along the river's edge for about 1,500 feet (Figure 59). Although the new alignment helps to reduce constraints to protection and restoration, the hardened bank remaining along the streamside edge continues to affect channel migration, riparian function, and floodplain processes.

Figure 59. View looking downstream toward the northeast along the former Highway 97 road embankment. Rip-rap was left in place along this channel margin, and enhanced in some locations (January 2010).

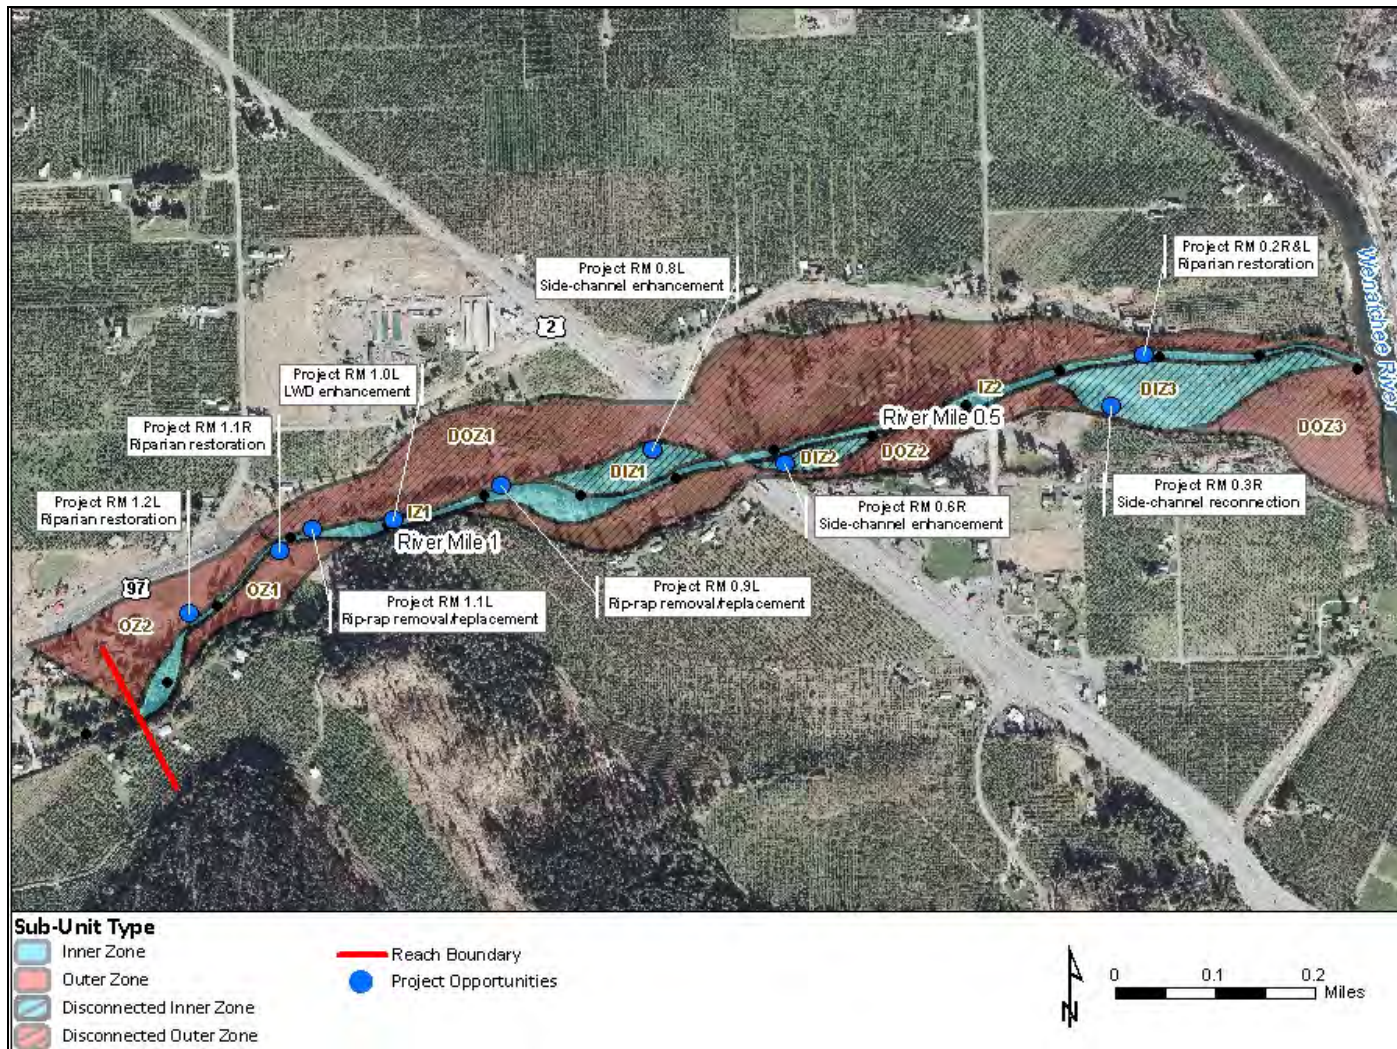
Ten sub-units were identified in Reach 1, including two inner zone units, three disconnected inner zone units, two outer zone units, and three disconnected outer zone units (Table 15, Figure 60, Figure 61). Very little floodplain habitat is left intact due to residential and agricultural development. Channel habitat complexity is low (See Habitat Assessment, Section 2.7). A total of seven specific project opportunities are described in the sub-unit sections below (Table 16). There are significant constraints to restoration work, including the presence of municipal infrastructure, transportation corridors, residential development, and agricultural activity. See Figure 60 for the location of project opportunities.

Figure 60. Sub-units and project opportunities in Reach 1. Flow is from west to east

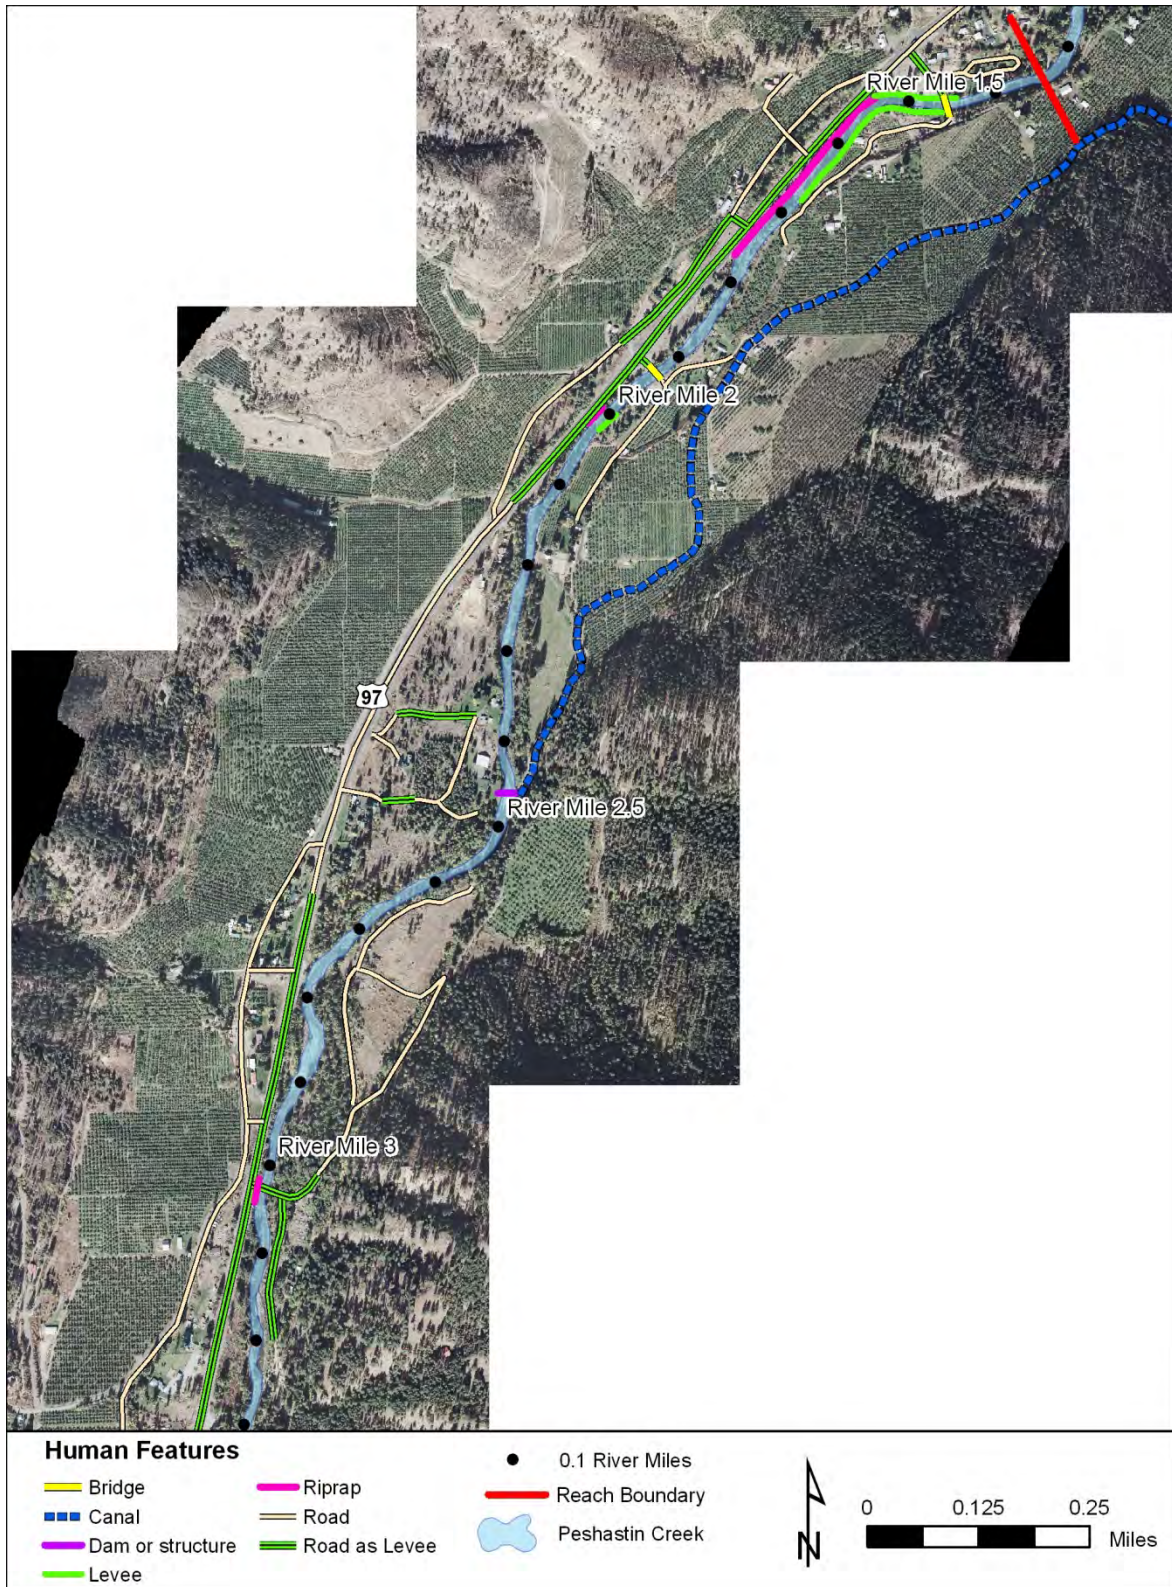
Highway 97 is the dominant barrier to process and habitat connection in this reach. The total length of roadway parallel to the channel in this reach is 3.34 miles. There is over 6,600 feet of road embankment that impinges directly on the north side of the channel (Figure 62). The road, and associated bank hardening, creates a severe limitation to what would otherwise be a laterally extensive floodplain across the valley. Channel straightening associated with the roadway has the potential to steepen the channel, increase sediment transport capacity, and cause incision. Aside from road infrastructure, there are 1,283 feet of other levees in the reach. About 91% of the total area of outer zone sub-units is disconnected from hydrologic and geomorphic processes by the roadway. There are 5 bridge crossings in this reach, located at river miles 5.0, 3.85, 3.05, 1.95, and 1.45. Each of these crossings divides the floodplain and creates a longitudinal barrier to process and habitat connection. The entire valley bottom, including all outer zone sub-units and adjacent terrace surfaces, have been cleared and developed for agriculture and residential uses. Maps of human features are included in Figure 63 and Figure 64.

Figure 63. Human features in Reach 2 (downstream portion). Flow is from south to north.

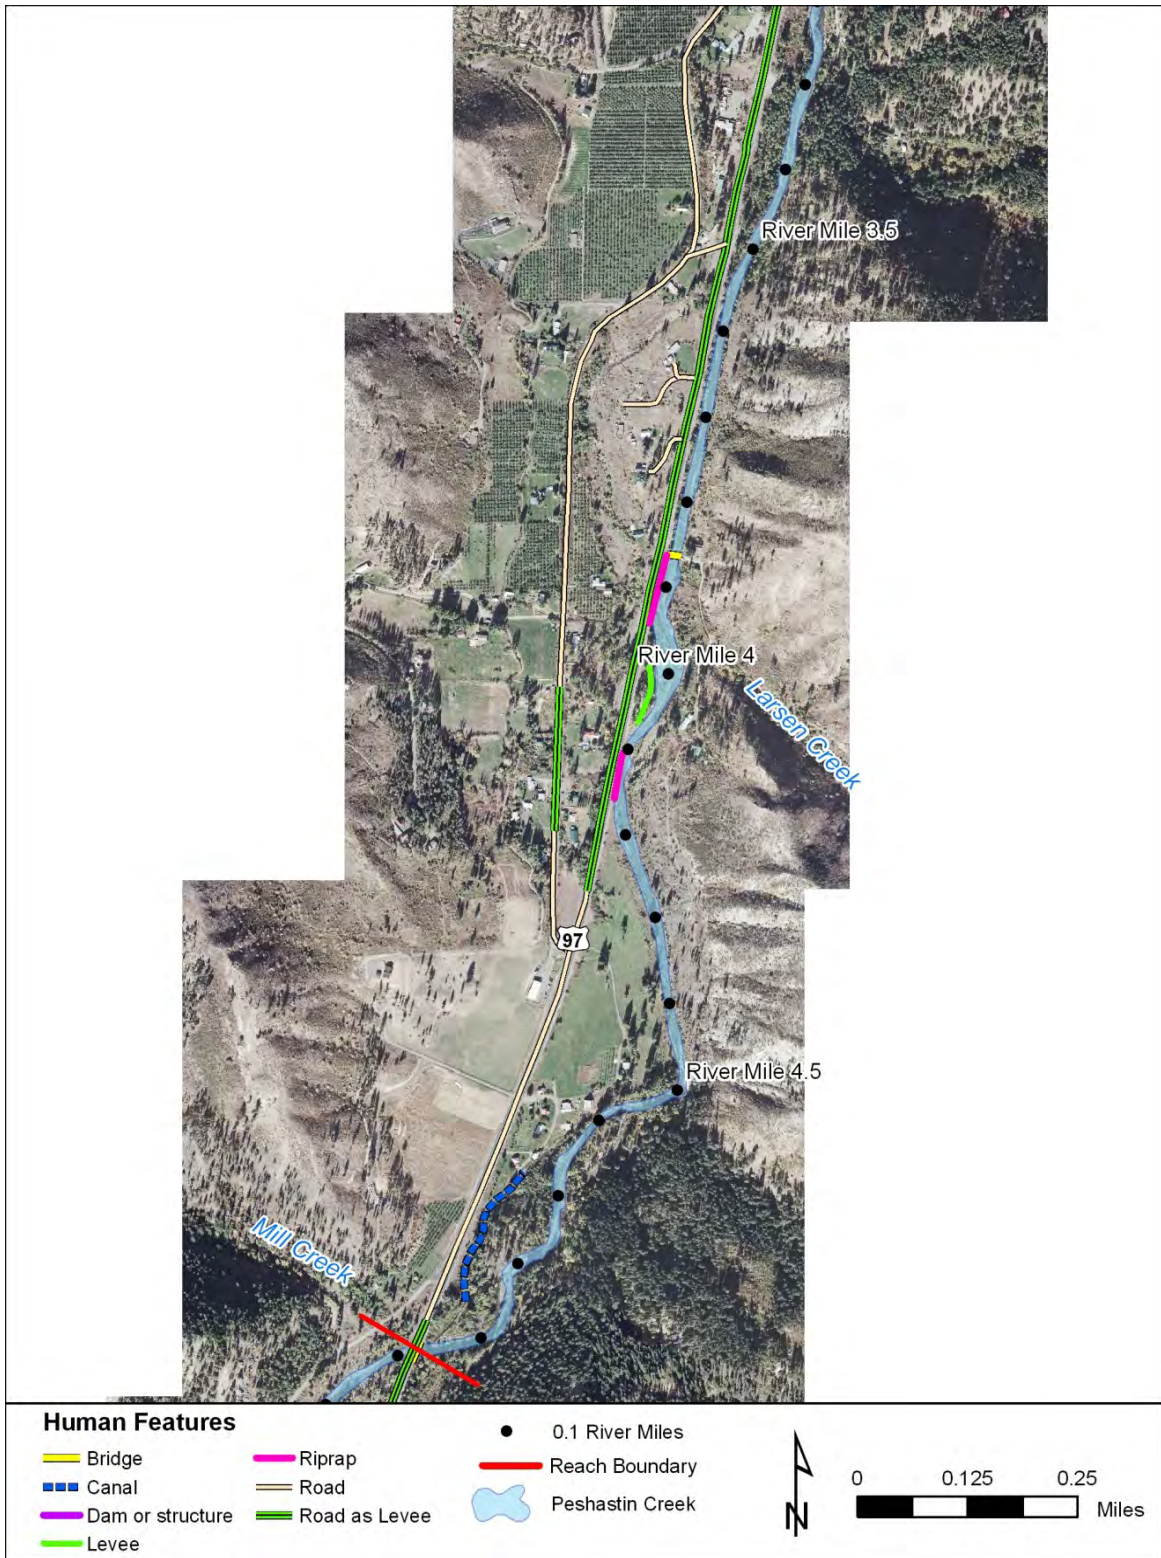
Figure 64. Human features in Reach 2 (upstream portion). Flow is from south to north.

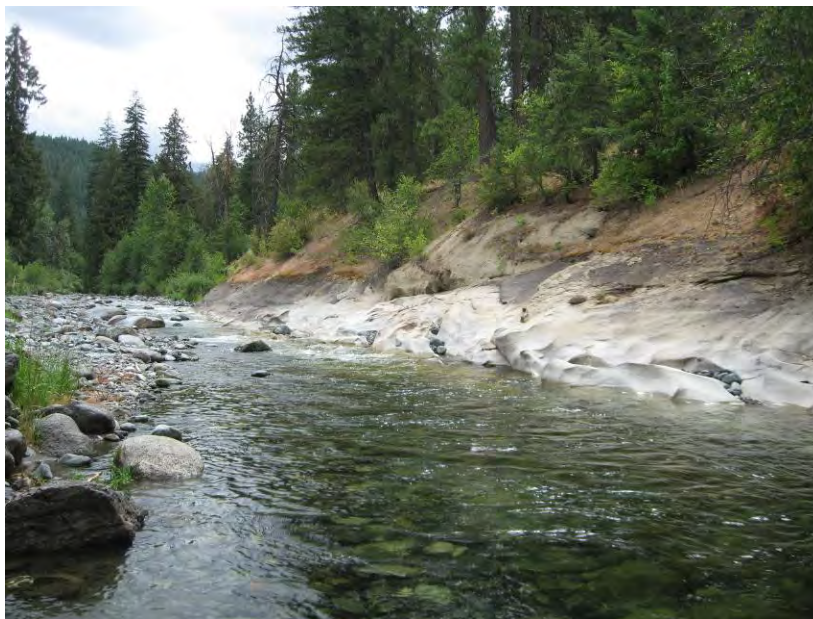
Reach 3 has moderate sinuosity (1.12) and the lowest slope in the study area (0.014). The bed consists primarily of cobble and boulder. Bed morphology consists of long plane-bed boulder-bed segments as well as step-pool segments. Bedrock is present throughout the reach and forms sculpted bedrock pools, especially near the upstream end of the reach (Figure 69).

Figure 69. View looking toward the southeast in the upstream direction near river mile 5.5. At this location, bedrock controls play a role in pool formation. Photo taken in August 2009.

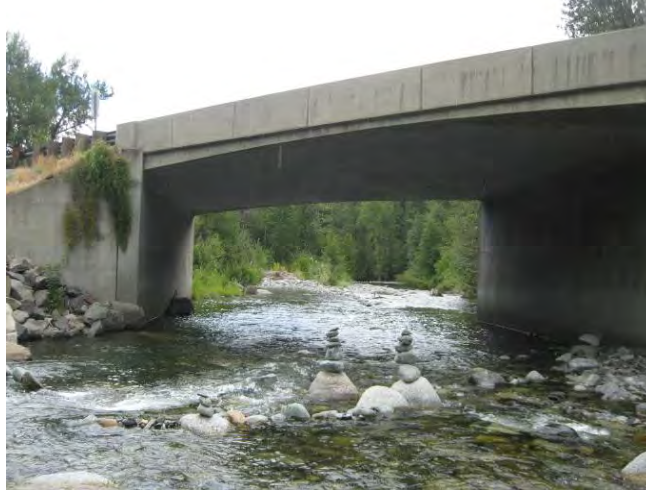
Figure 70. View toward the northeast in the downstream direction near river mile 5.0. The bridge at this location limits local channel dynamics, and floodplain connection downstream. Photo taken in August, 2009.

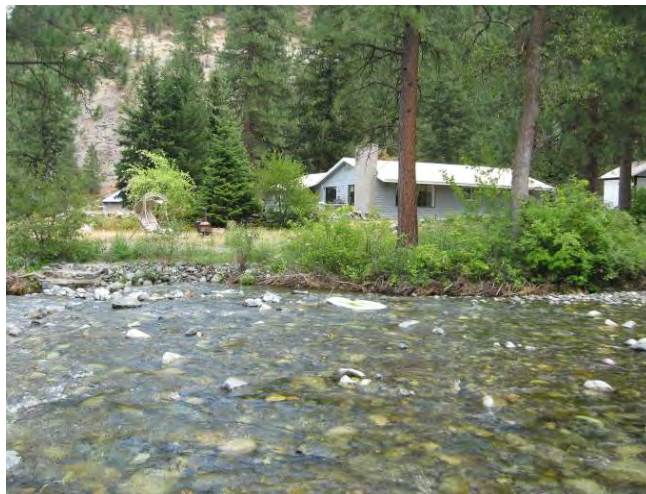
The greatest impact is between river miles 5.2 and 5.7 (Figure 71). In this area, much of the riparian area and floodplain has been cleared. LiDAR data also suggests considerable filling and grading of the floodplain in this area. A map of human features is included in Figure 72.

Figure 71. View to the northeast in the downstream direction at the river right floodplain near river mile 5.6. This floodplain area has been cleared and residentially developed. Photo taken in August 2009.

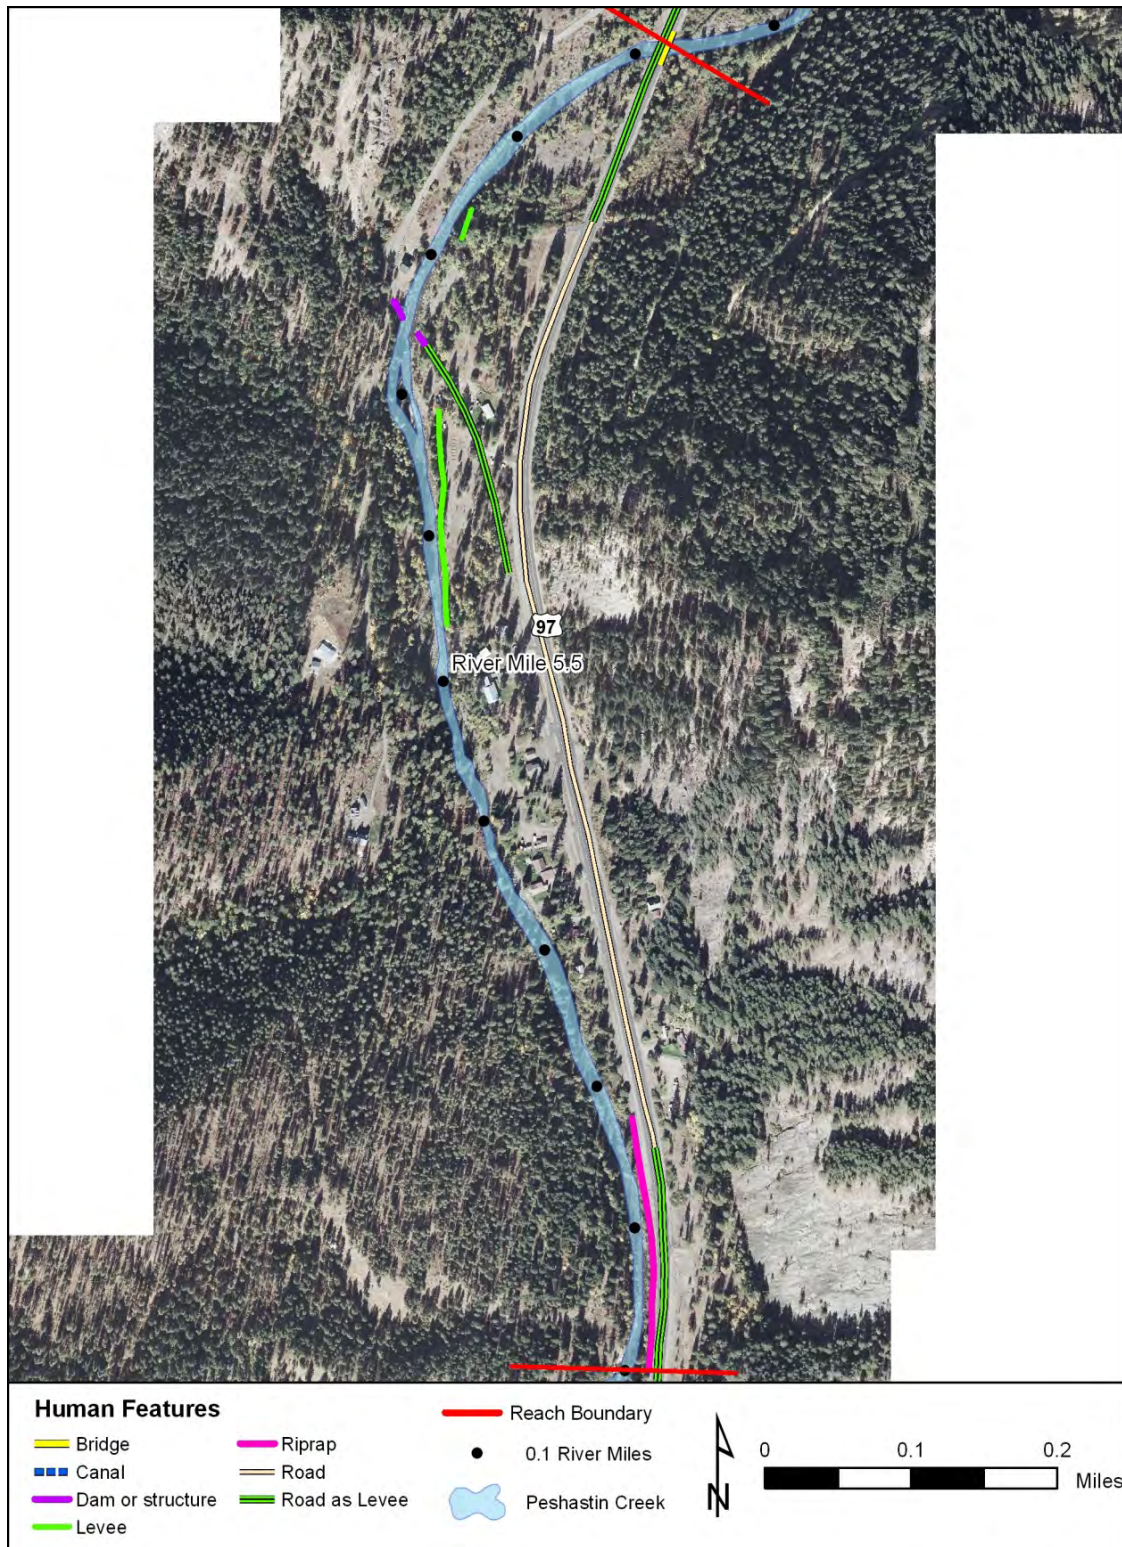
Figure 72. Human features in Reach 3. Flow is from south to north.

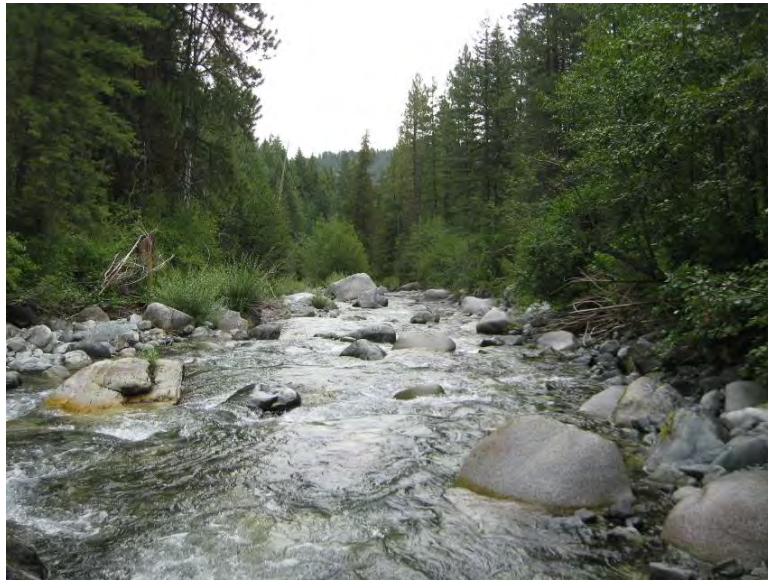
Mapping of historical channels shows very little change in channel pattern between 1962 and 1998. Older channels appear to have been slightly wider, especially at meander apexes. In the upstream portion of the reach between river mile 7.4 and 6.6, the bed is mainly boulder step-pool (Figure 75), with some long plane-bed riffles. In the lower portion of the reach, between river miles 6.6 and 6.0, plane-bed morphology dominates, but it is interrupted by a few long bedrock controlled pools (Figure 76) and short segments of step-pool sequences.

Figure 75. View looking toward the northeast in the downstream direction near river mile 7.0. The photo shows typical bed morphology of the reach. Photo taken in August 2009.

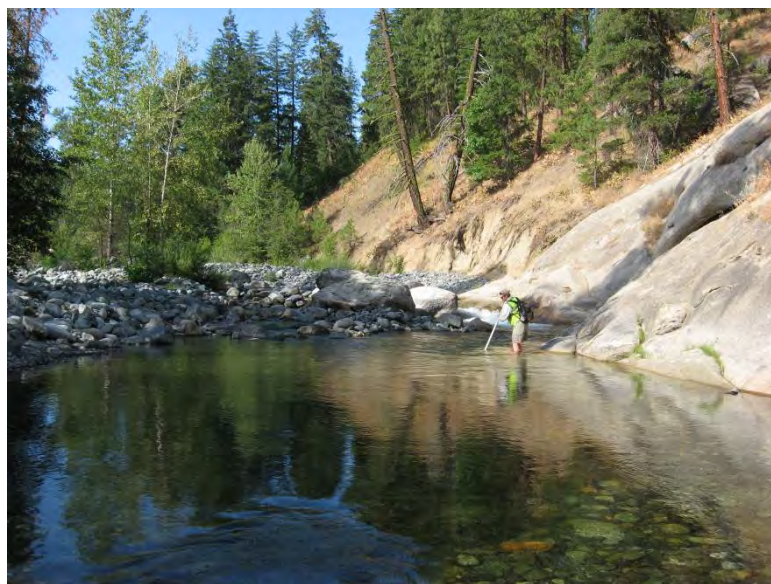
Figure 76. Bedrock pool near river mile 6.2. Photo taken in August 2009.

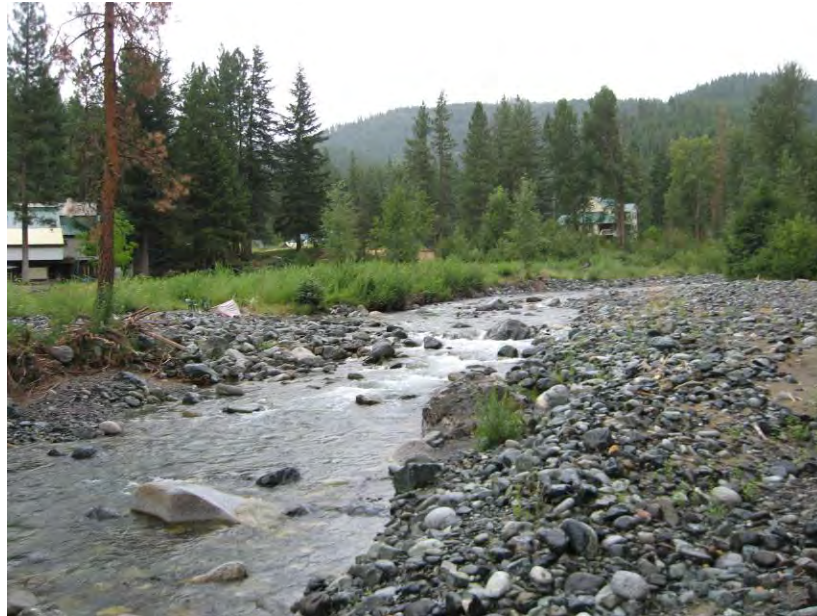
There is scattered residential development primarily along the river-right bank throughout the reach (Figure 77). However, relative to downstream reaches, there is a low degree of human alteration in Reach 4 with about 26% floodplain disconnection. A bridge crossing at river mile 6.45 limits local channel dynamics (Figure 78). Highway 97 cuts off an old glacial channel (possibly an historical, post-glacial mainstem channel location) between river miles 6.5 and 7.3;

Figure 77. View looking toward the southwest in the upstream direction near river mile 6.25. Residential development along the right side of the valley has impacted the riparian area. Photo taken in August 2009.

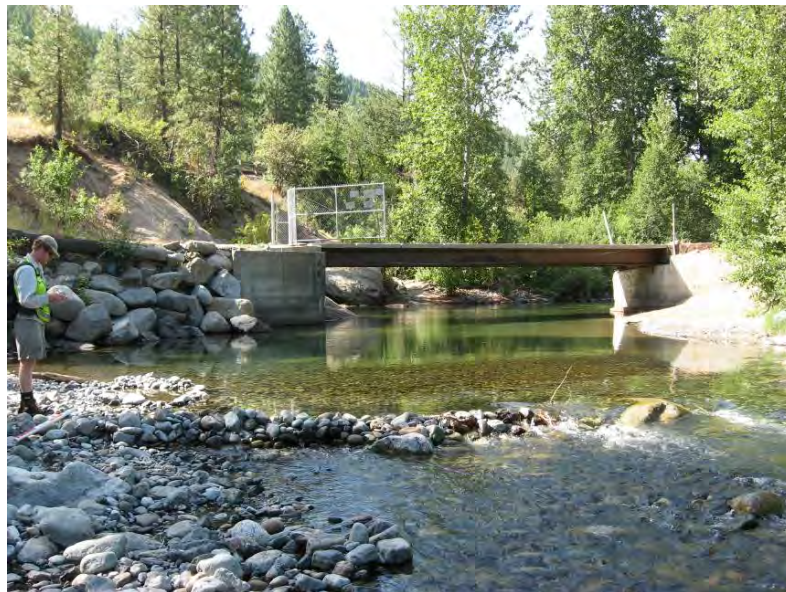
Figure 78. View looking toward the southwest in the upstream direction near river mile 6.45. This narrow private bridge creates hydraulic and geomorphic constraints on the channel and floodplain. Photo taken in August 2009.
