Lower Peshastin Creek

Tributary and Reach Assessment

Wenatchee Subbasin, Chelan County, WA

June 2010

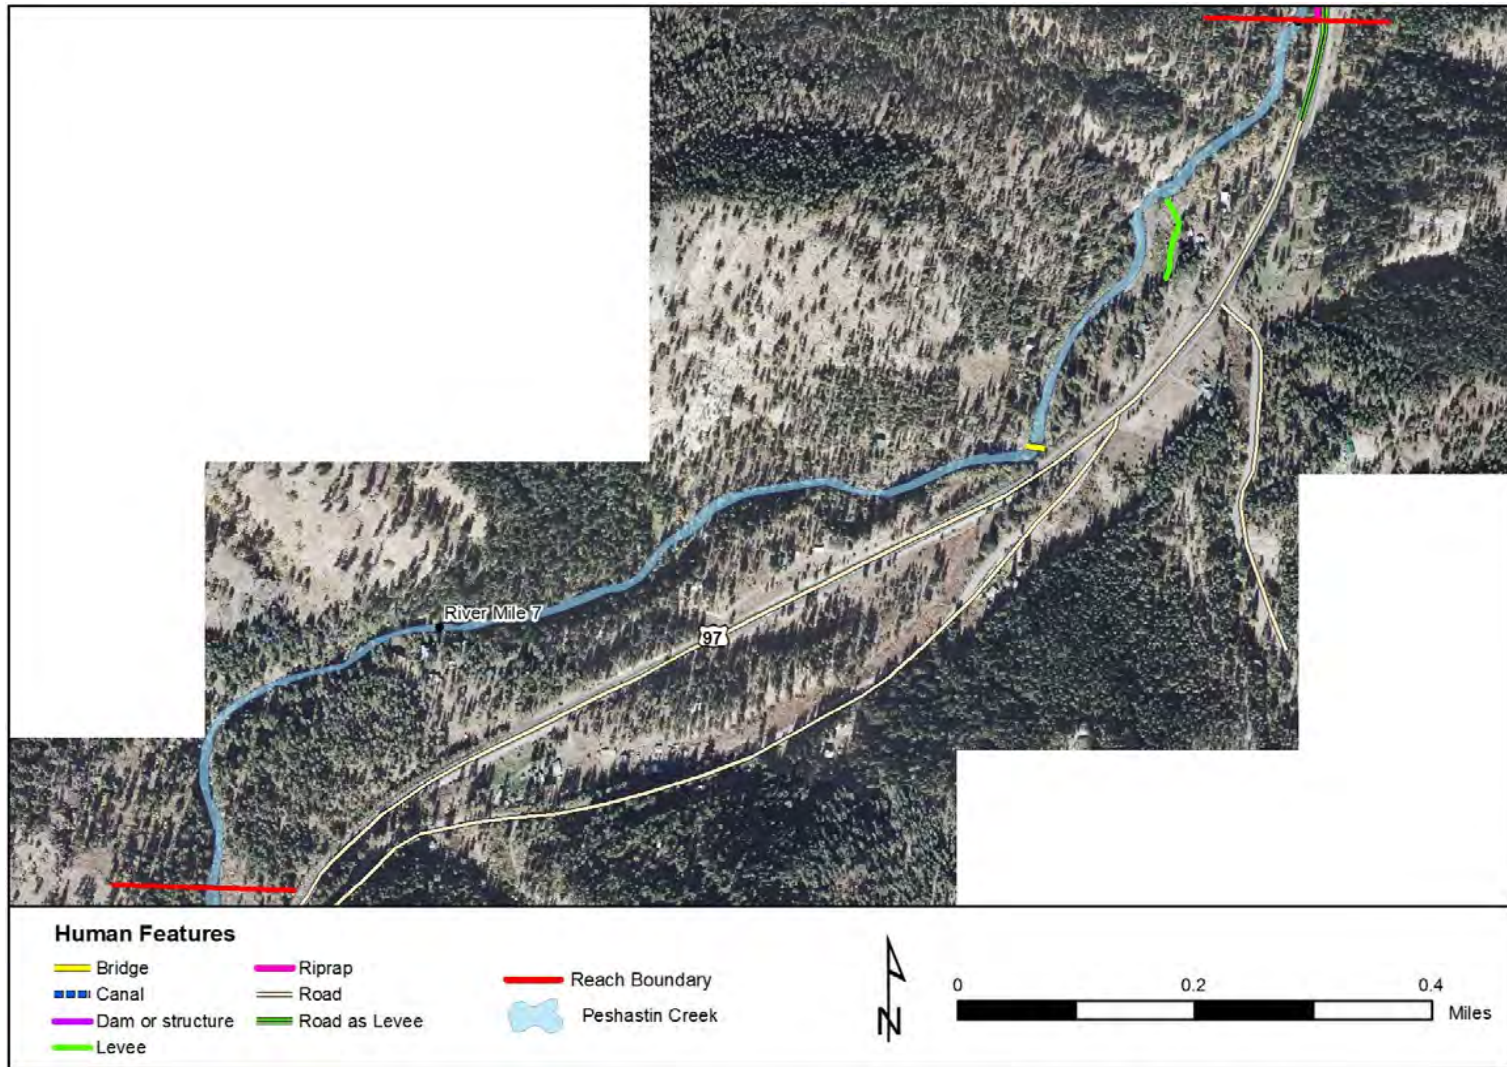
this channel is considered to be outside of the contemporary floodplain for this analysis. The highway is located outside of the active floodplain and riparian zone except for at the downstream end of the reach where the highway abuts the main channel. Figure 79 shows all human features in Reach 4.

Figure 79. Human features in Reach 4. Flow is from west to east.

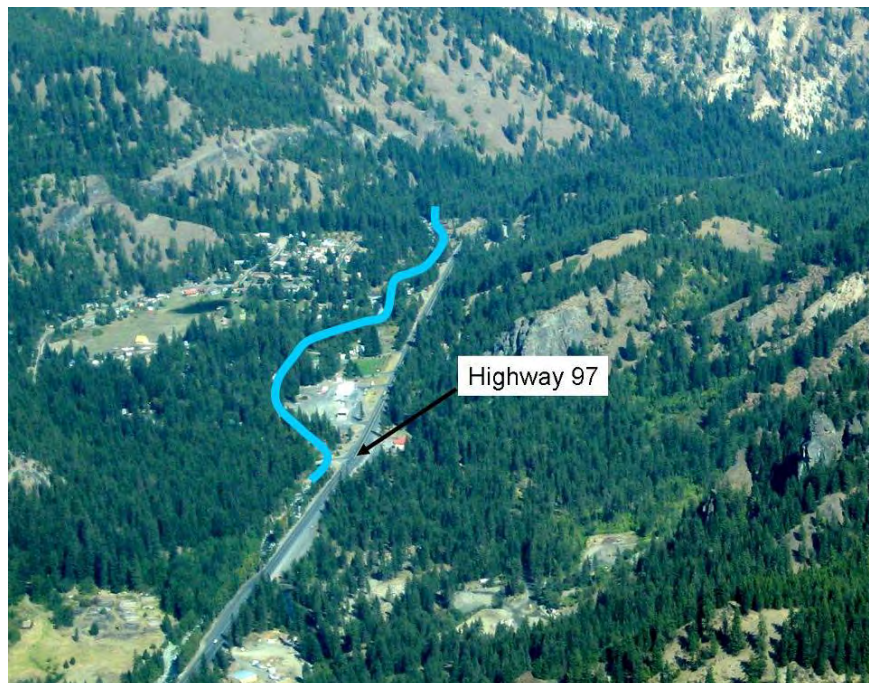
Repeated glaciations during the Pleistocene, with significant ice flow contribution from Ingalls Creek, eroded a wide valley with an average width of 722 feet (Figure 82). The average gradient through the reach is 0.021. The majority of the valley is filled with unconsolidated glacial deposits and more recent alluvial fan deposits and colluvium. The modern channel has incised through these materials and has laterally adjusted to form a floodplain with an average width of 253 feet. Channel pattern has been constant since at least 1962. Older aerial photography was not available this far up the drainage. The channel is the most sinuous in the study area with one long-amplitude meander bend at the upstream end, and a series of more tortuous (bedrock) meanders near the downstream end that locally control upstream grade from river mile 7.7 upstream to river mile 8.0.

Figure 82. View looking downstream at Reach 5a. The channel of Peshastin Creek is highlighted in blue. Ingalls Creek enters just upstream of the bottom left corner of the photo. Photo taken in September 2009.

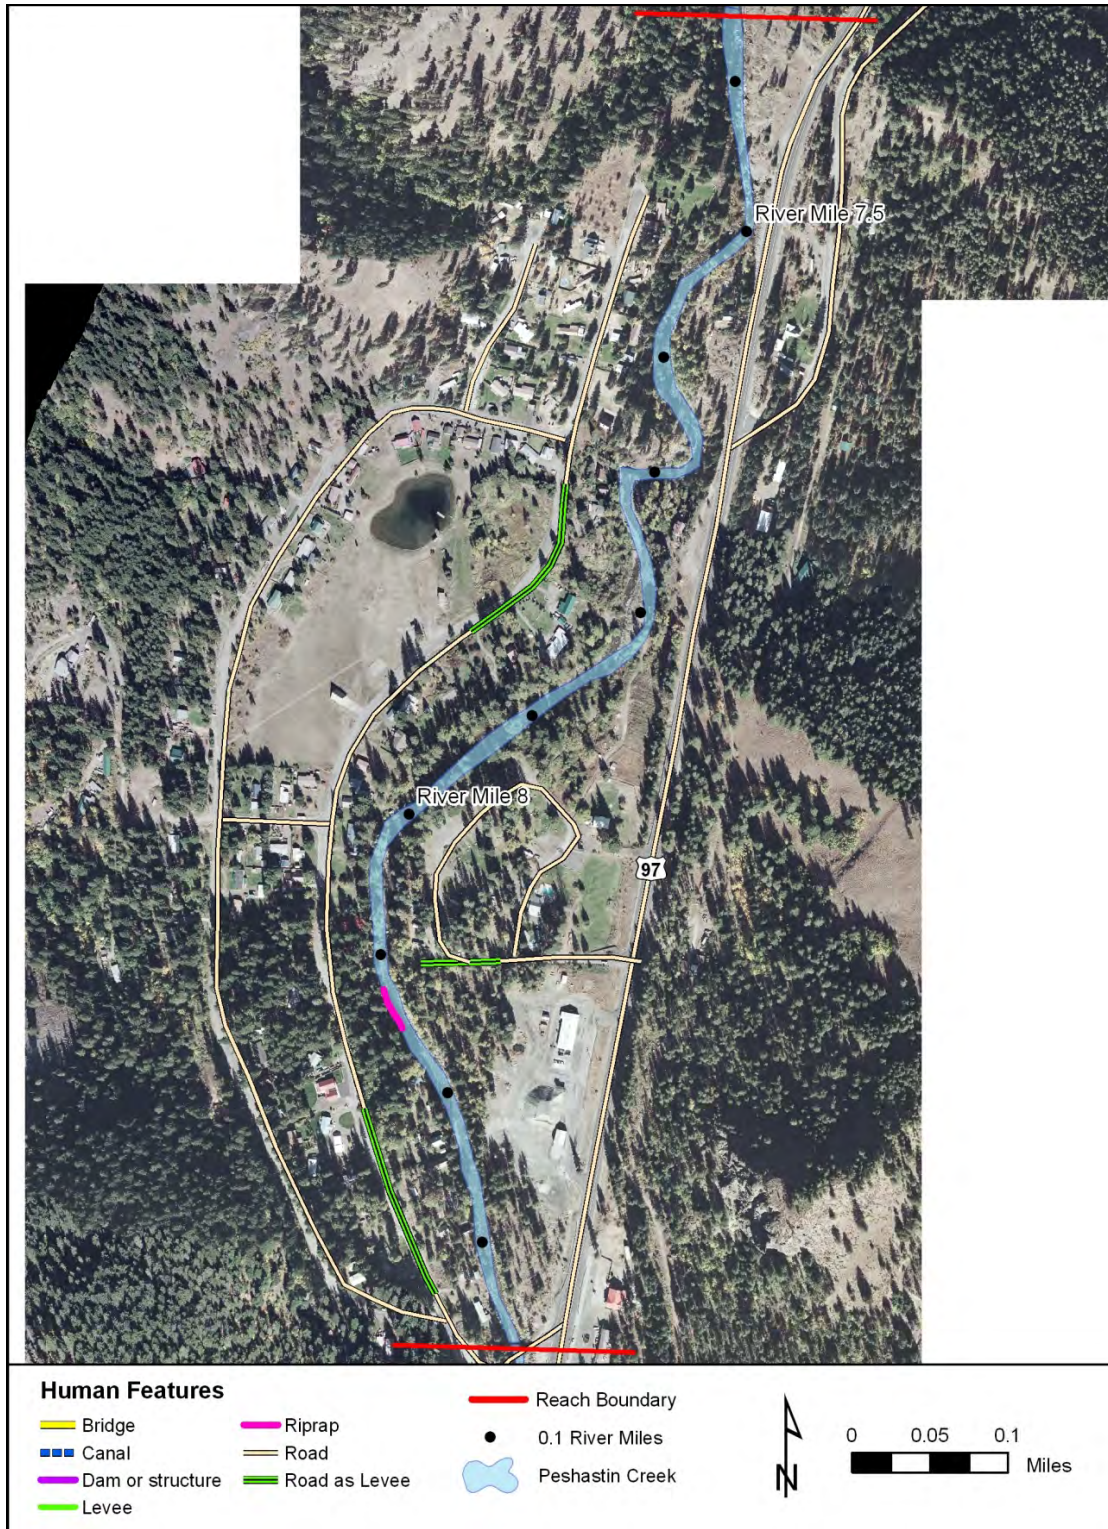
Floodplain development has a significant impact on physical processes and habitat quality in Reach 5a, resulting in 100% disconnection of the historic floodplain in this reach. At the downstream end of the reach, the river has incised into conglomerate bedrock and adjacent development on the rim of the river canyon has little effect on geomorphic processes. At river mile 7.7, the valley widens and there is floodplain development on both sides of the river. A campground and RV park is located along the river-right bank with cleared areas for RV parking and stream access. There are permanent residences in the floodplain on the river-left bank, with intermittent clearing for views, stream access, and recreation. Riparian vegetation is mainly intact as a narrow strip, but significant clearing has occurred farther from the channel associated with roadways and recreational areas. There is a bridge (Ingalls Creek Road) at the upstream end of the reach. The channel is straight and uniform in this area. Upstream of the bridge the stream channel has been straightened alongside Highway 97. See Figure 83 for a map of human features.

Figure 83. Human features in Reach 5a. Flow is from south to north.

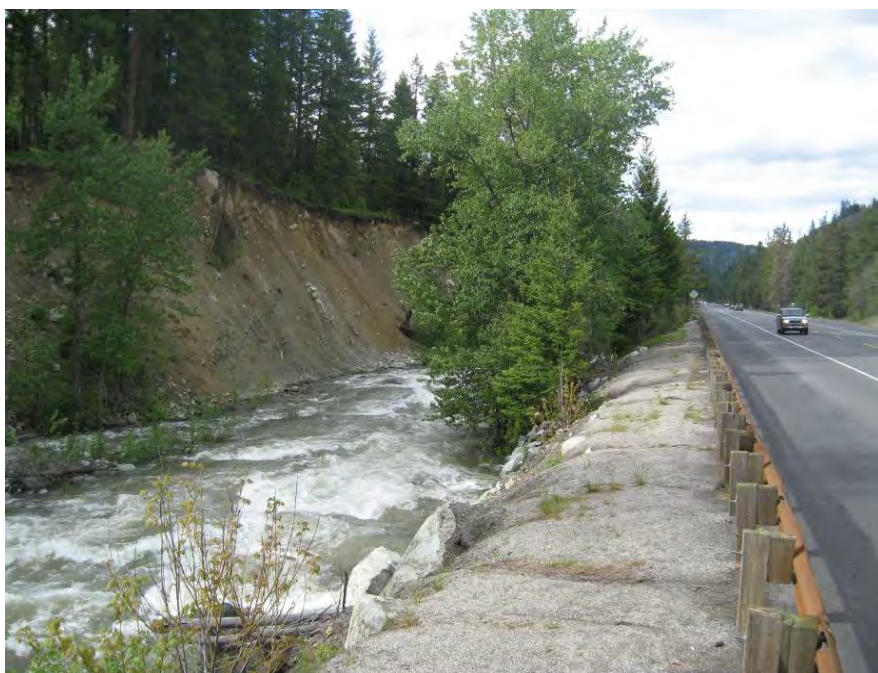
The re-alignment of Highway 97 in the late 1950's resulted in a straight channel and disconnection of nearly all the historical floodplain areas in this reach. The channel is confined by Highway 97 on river-right for its entire length. On the river-left side, levees and spoils piles create barriers to channel/floodplain connection for the majority of the reach. By straightening the reach, its length was reduced and its gradient was increased. A steeper gradient increases sediment transport capacity for a given flow and sediment size, which has likely lead to channel incision and further reduction of channel/floodplain connection. The highway also exacerbates erosion of the glacial terrace at several locations on river-left in the reach (Figure 86). There is a sand and gravel facility in the historical floodplain on the east side of the valley, which consists of roads, extensive re-grading, and vegetation clearing. The floodplain on the west side of the channel has also been developed, though not as intensively. The surface is cleared and there are log stockpiles and several abandoned car bodies. See Figure 87 for a map of human features.

Figure 86. View downstream just downstream of the Ingalls Cr confluence. Hwy 97 directly abuts the channel and contributes to erosion of the high glacial terrace on the opposite bank (May 2010 Photo).

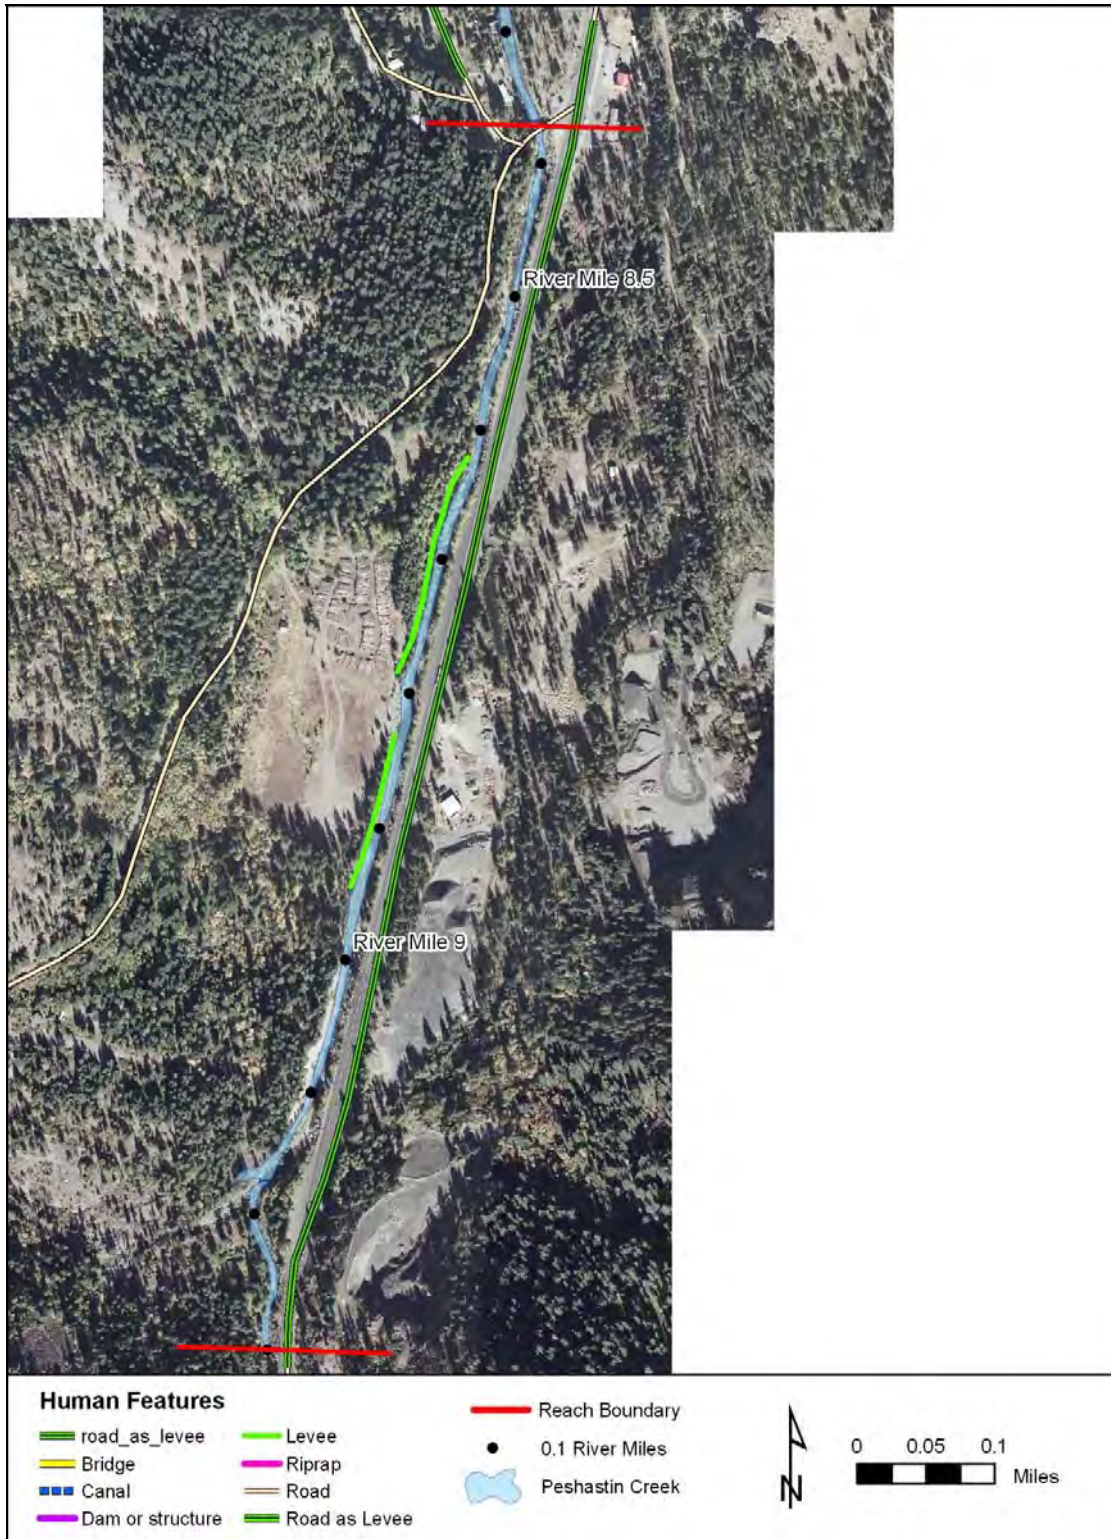
Figure 87. Human features in Reach 5b/6. Flow is from south to north.

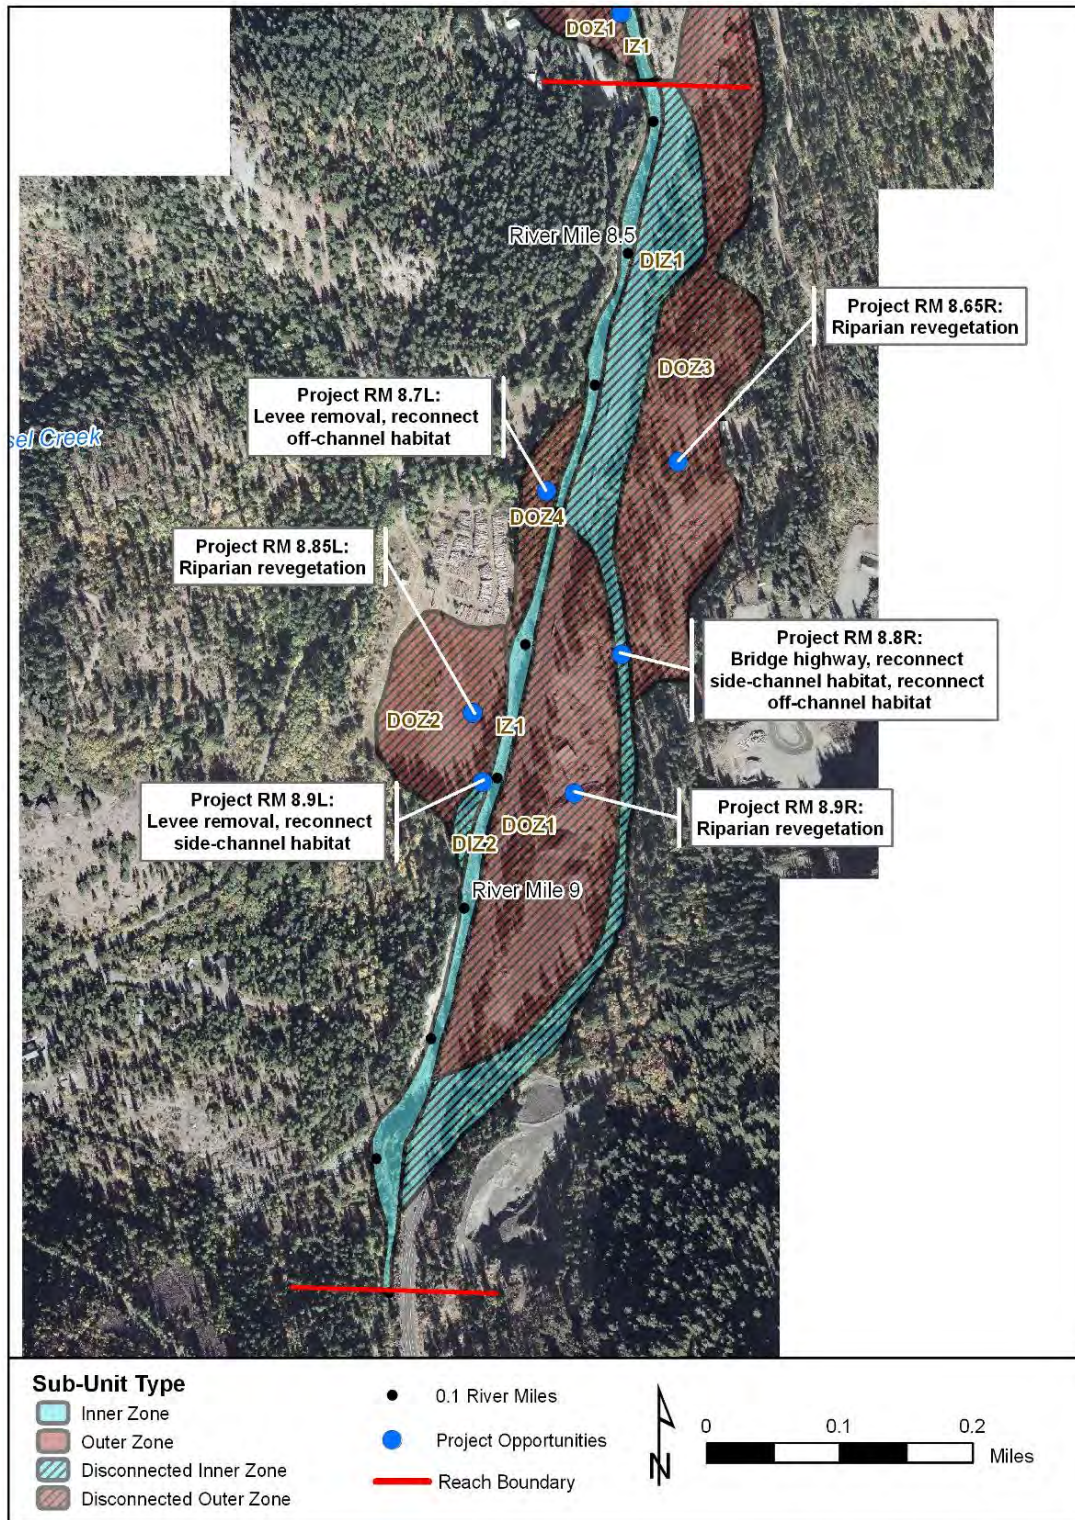
Seven sub-units were identified in this reach including one inner zone sub-unit, two disconnected inner zone sub-units, and three disconnected outer zone sub-units (Table 35, Figure 88, Figure 89). A total of 6 specific projects have been identified in this reach (Table 36).

Figure 88. Sub-units and project opportunities in Reach 5b/6. Flow is from south to north.

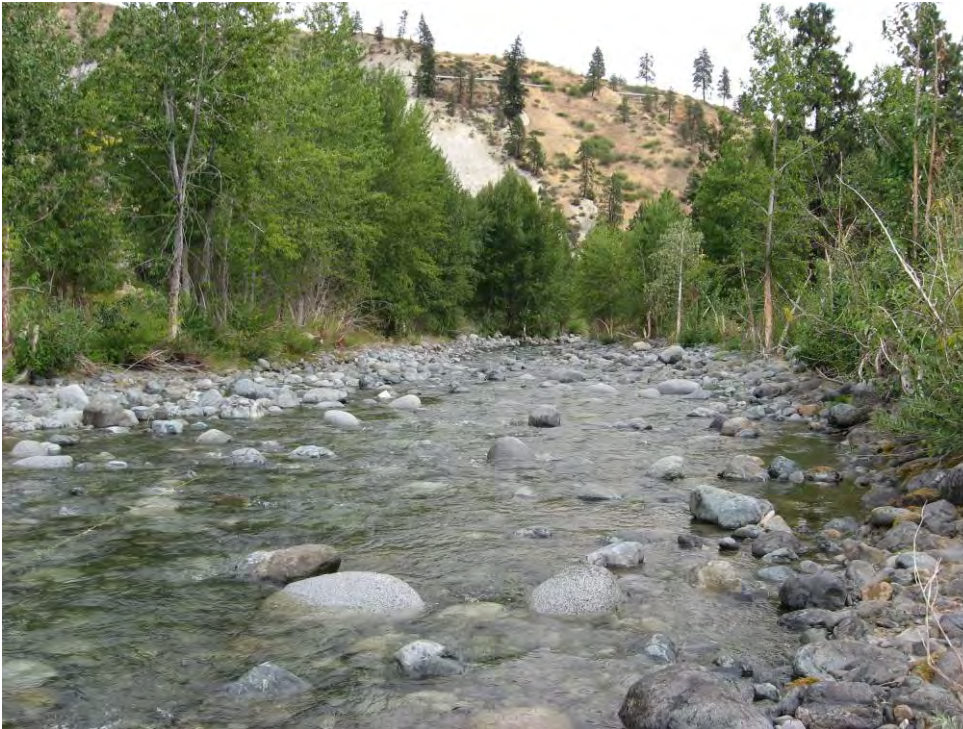
Channel morphology in Reach 1 is dominated by plane-bed segments with infrequent pool-riffle sequences (Figure 3). Although the valley is unconfined, the channel itself is confined due to hydromodifications and incision into glacial outwash material. Bed gradients range from 1% to 2%. In some areas, steep bed slopes may be attributed to historical channel straightening in this reach. Average channel widths are approximately 35 feet (wetted width at time of survey); bankfull widths are more than twice as wide (73.5 ft). The average floodprone width exceeds 400 feet and is the largest relative to the other 4 reaches.

Figure 3. Downstream view in Reach 1 of Peshastin Creek. Approximate river mile 0.2.

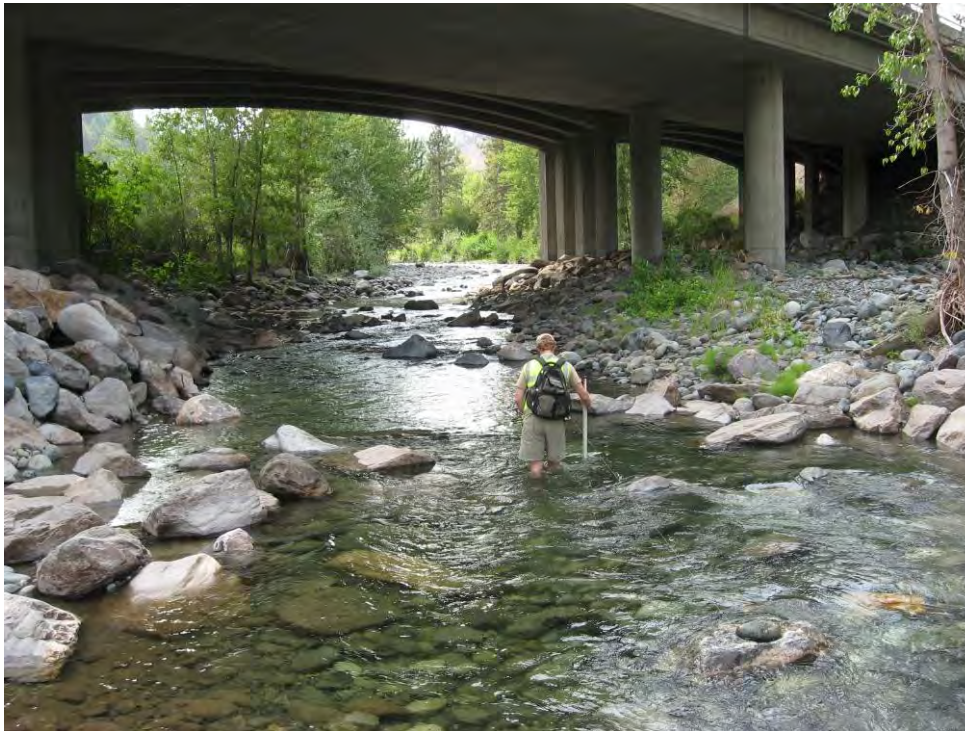
Human activities have modified the channel and associated riparian corridor within this reach. There are levees/road embankments where Highway 97 or other roadways abut the channel. The channel is constricted at two bridge crossings (RM 0.4 and 0.7) (Figure 9); and the lower 0.4 mile has been straightened and is currently incised and disconnected from the floodplain.

Figure 9. Hwy 97 Bridge at river mile 0.65.

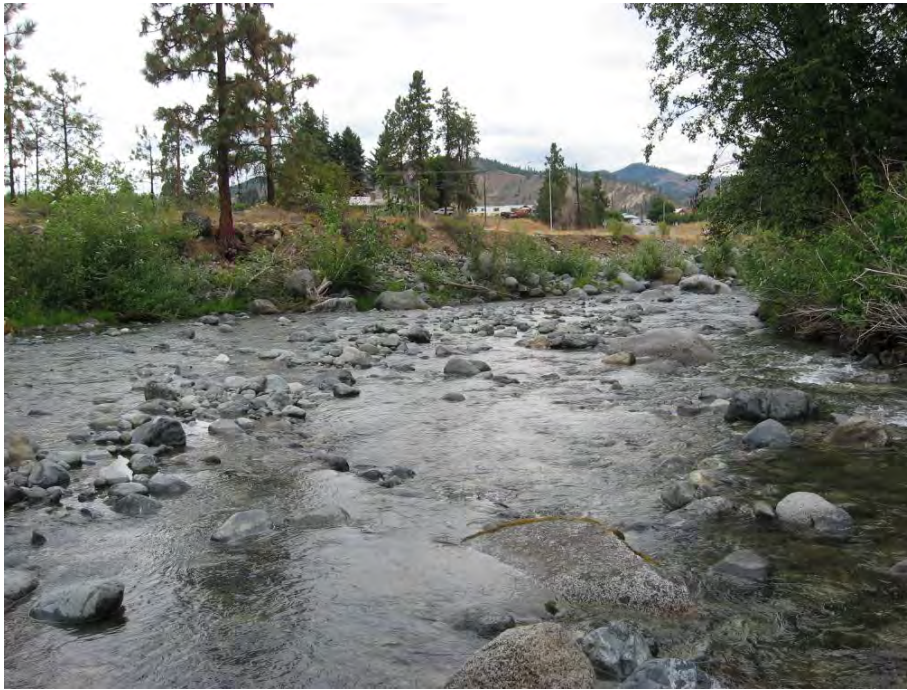
Vegetation in the riparian zone is heavily modified with few large trees in either the inner (near-channel) or outer zones (Figure 10 and Figure 11). The riparian corridor is confined to a narrow buffer through most of the reach. Roadways, residential development, and orchards lie adjacent to the reach and have impacted the width and species composition of the riparian corridor (Figure 12). There is very little shade provided by riparian vegetation and the potential for large woody debris recruitment in this reach is low.

Figure 12. Impacted riparian corridor along the river left bank near river mile 1.2.

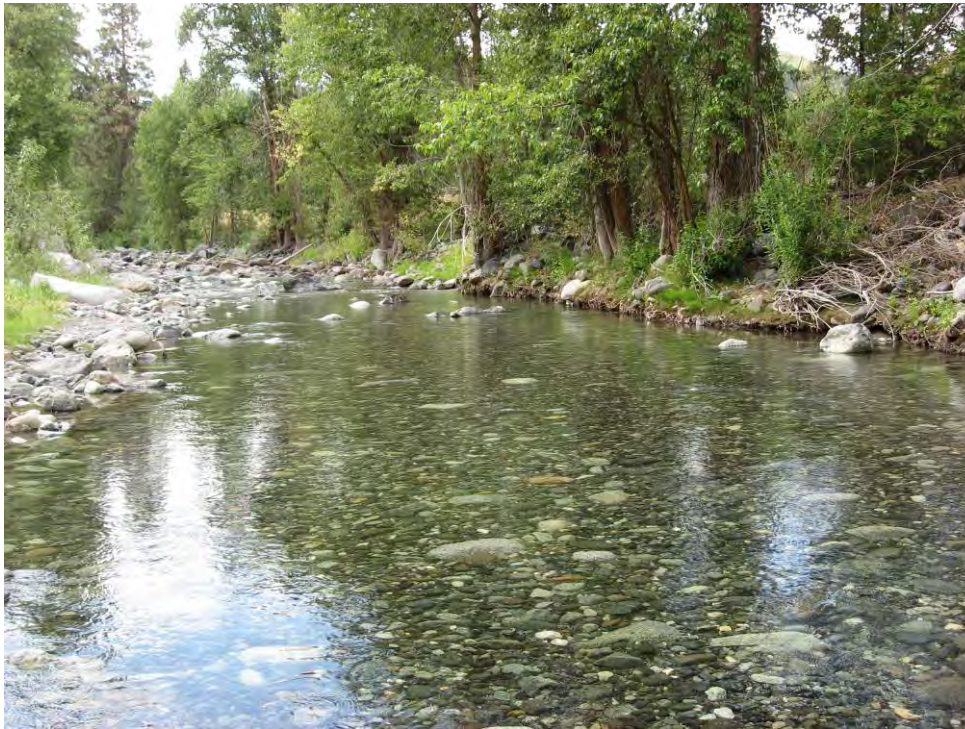
Figure 18. Typical pool in Reach 2 with minimal cover or habitat complexity. River mile 2.0.

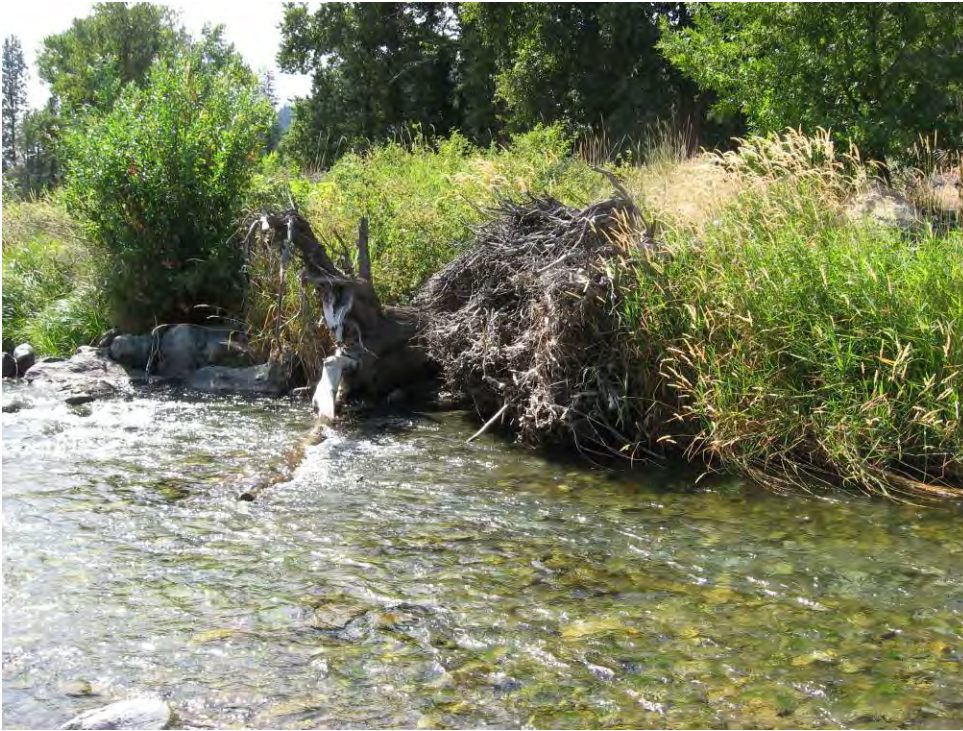
The coarse bed and high frequency of boulders provides areas of localized velocity refuge that may be utilized for rearing by juvenile steelhead and resident trout. Steelhead and Chinook spawning may occur in the handful of suitable pool tail-outs. A few logs with rootwads have been placed near river mile 4.2 on the left bank, presumably to provide habitat-friendly streambank protection (Figure 23).

Figure 23. Logs with rootwads placed for streambank protection and fish habitat near river mile 4.2.

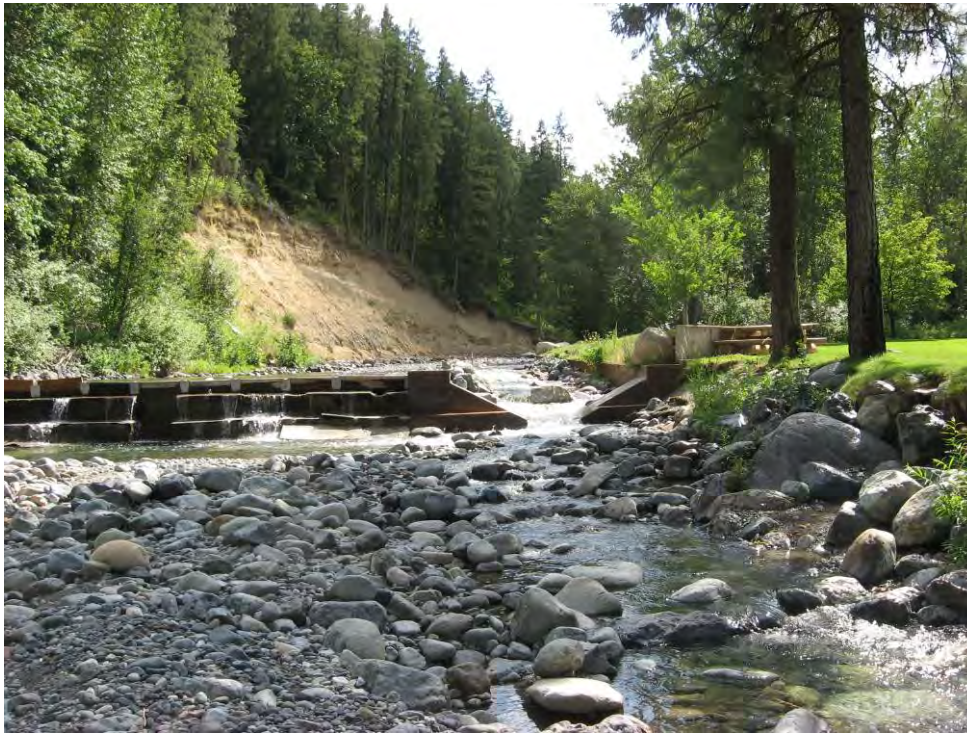
The irrigation diversion dam at RM 2.5 has recently (2005) undergone modification to provide fish passage. This structure now has a fish passage channel on the river left side of the dam (see Figure 24).

Figure 24. Irrigation diversion dam and fish passage channel at river mile 2.5.

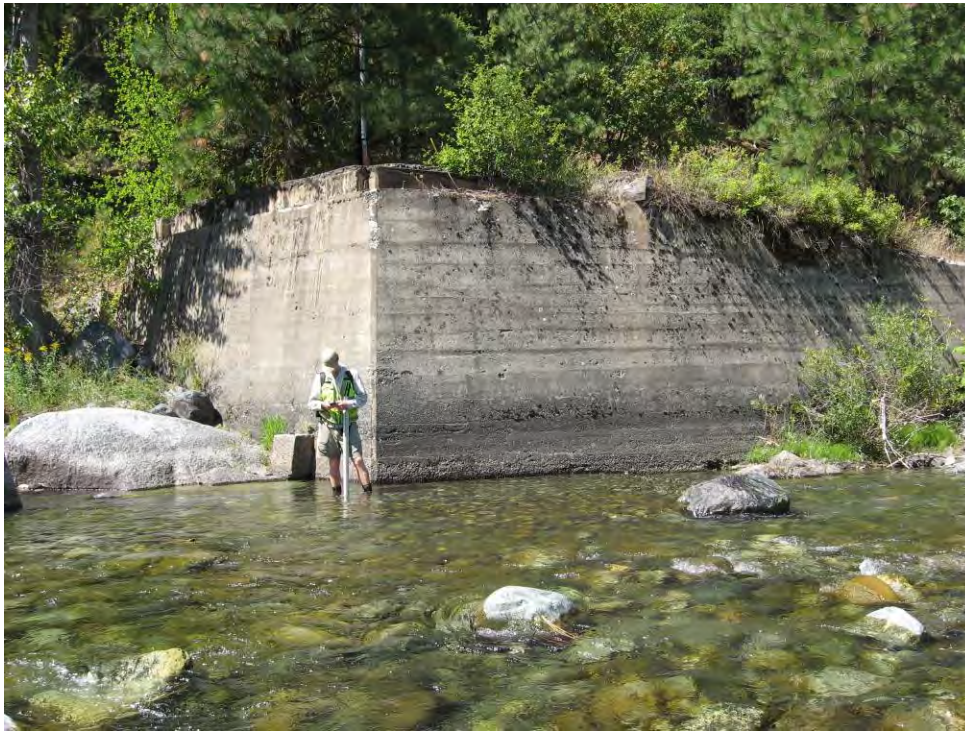
Aside from the presence of Highway 97, general clearing and thinning of vegetation along the riparian corridor is the predominant human disturbance in this reach. There is a concrete bridge abutment at RM 5.25 (Figure 35) that extends for approximately 30 feet on river left.

Figure 35. Concrete bridge abutment (no longer used) at river mile 5.3.

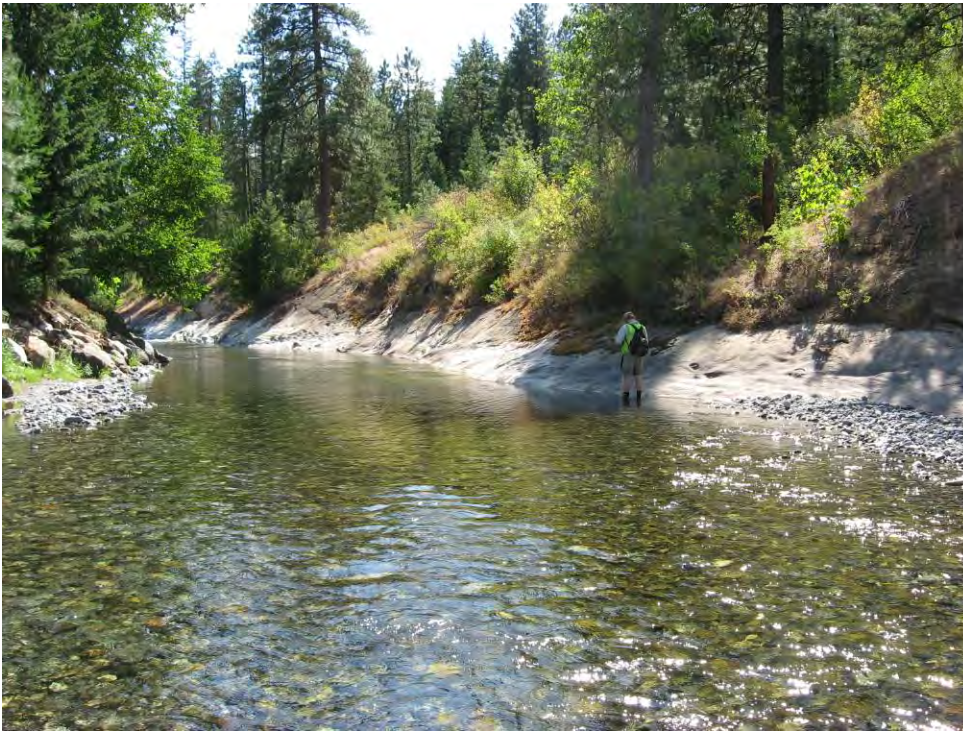
There is limited spawning and rearing habitat in Reach 3. Many of the riffles consist of long, coarse-bedded, plane-bed sections that lack good spawning substrate. Pools are infrequent but several pools are deep and have good tail-out habitat for spawning. In particular, a sequence of pools from river mile 5.4 to 5.6 have long tail-outs with suitable depth and velocity for Chinook and steelhead spawning (Figure 36). These same pools have good depth for juvenile rearing. Most of the other pools have shallow residual depths and all pools have minimal cover and LWD habitat. LWD quantities are very low throughout the reach.

Figure 36. Long pool tail-out near river mile 5.5 with good spawning-sized substrate.

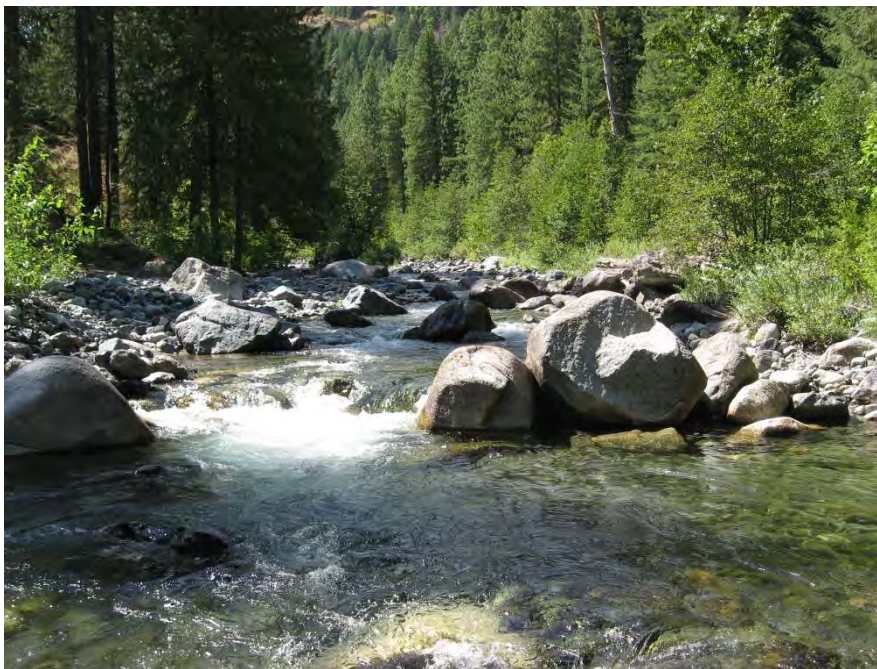
Although the valley is relatively unconfined through this reach, the channel is mostly incised into glacial deposits and bedrock. The reach is primarily a boulder-bed step-pool channel with several coarse (large cobble/small boulder) plane-bed segments and several bedrock dominated segments. There is a ~4,000 ft long cutoff channel on the river right floodplain area that may have been the site of the main channel prior to the construction of the roadway. Bedrock limits the channel adjustment potential of the reach. Average wetted width is 36 ft (wetted width at time of survey) and average bankfull width is 67 ft. Mean channel bed slope is 1.4%.

Figure 39. Step-pool channel segment near RM 7.0.

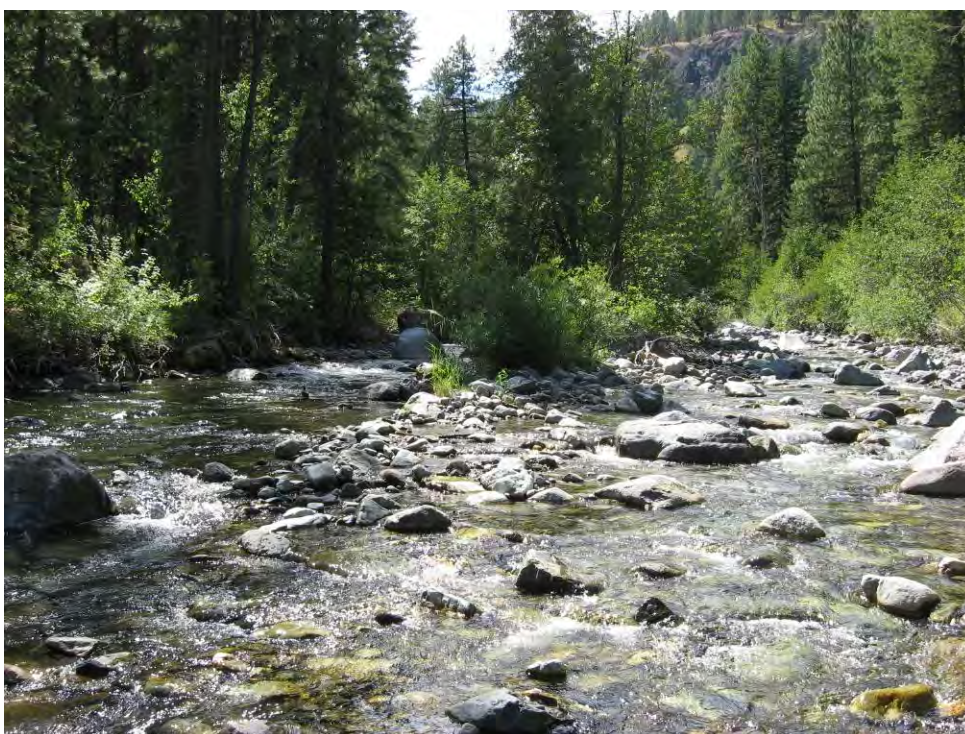
Only one side-channel, 280 ft long, was measured in this reach, accounting for 2% of the total habitat (Figure 43). No other significant off-channel habitat is available at low flow periods.

Figure 43. Side-channel confluence near river mile 7.0.

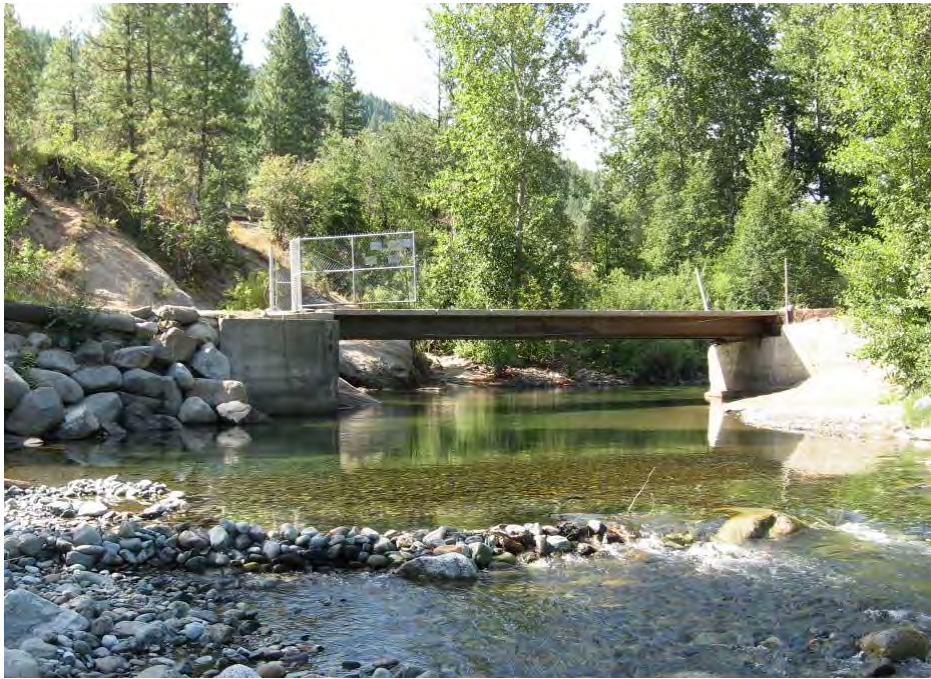
Highway 97 parallels the reach and lies adjacent to the channel in 2 locations. There is a private bridge crossing near river mile 6.5 (Figure 47). There are residences along this reach although much of the reach is undeveloped.

Figure 47. Private bridge crossing near river mile 6.5.

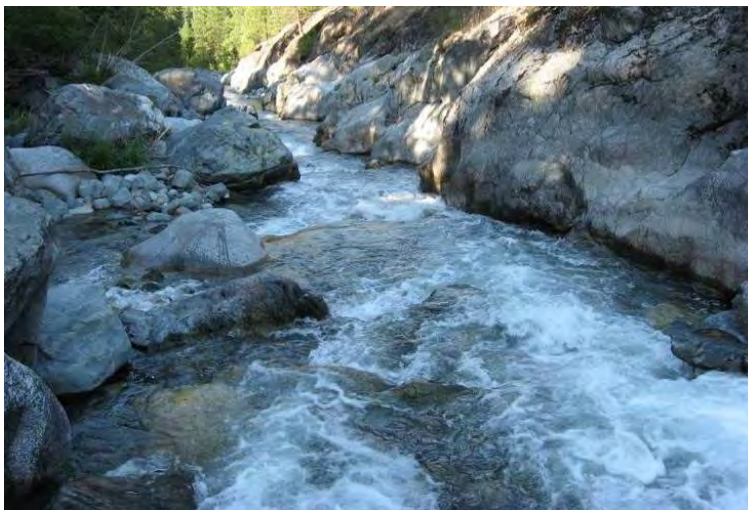
Figure 50. Bedrock canyon at downstream end of Reach 5a. River mile 7.4.

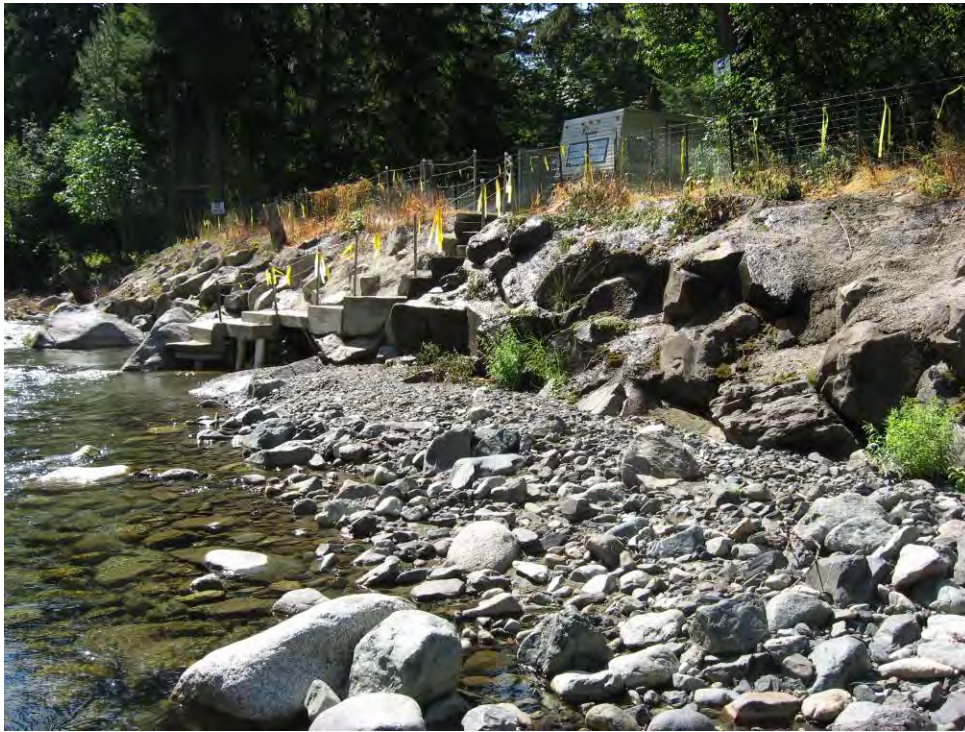
The valley bottom in this reach has been extensively modified by residential development. Houses extend to the channel’s edge in several locations and there are numerous developed and undeveloped access points to the river. Houses, cleared vegetation, and grass lawns are common in the riparian corridor. There is a rip-rap and concrete wall that extends over 100 feet on the river left bank near river mile 8.1 (Figure 57). Ingalls Creek Road crosses Peshastin Creek at RM 8.4.

Figure 57. Bank armoring on river left bank near river mile 8.1.

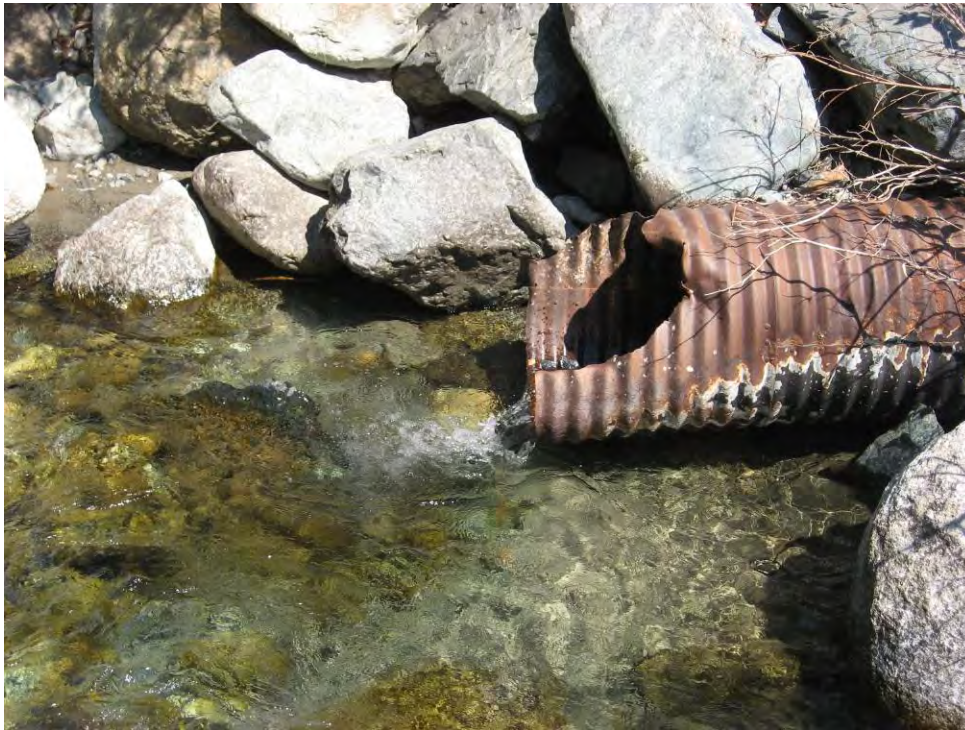
There are no fish passage barriers on mainstem Peshastin Creek in this reach. There is a culvert that enters the mainstem near river mile 8.1 that may be a passage barrier, but the source of the flow and the upstream habitat potential is unknown.

Figure 58. Culvert entering the mainstem on the river right bank near river mile 8.4.

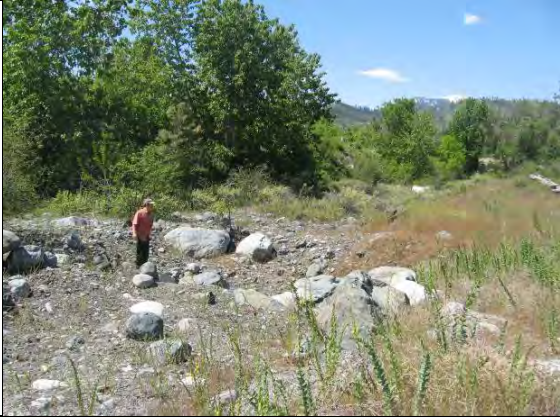
<p>Historical channel in right-bank floodplain near mouth (May 2010).</p>

1	Disconnected Inner Zone 3 (DIZ-3)	Project RM 0.3R (Alt. 2)	Reconnect Stream Channel Processes	Side-channel and off-channel connection enhancement.	In order to maintain the existing roadway location, full side-channel reconnection may not be feasible. This alternative would enhance off-channel and floodplain connection while keeping the roadway in its current location. Culverts would be placed at the two locations where the existing roadway crosses the old channel location. This effort could be combined with excavation of additional side-channel and off-channel/wetland habitat in the delta area that would benefit Peshastin fish populations as well as Wenatchee River fish populations seeking flow and temperature refuge.	
1	Disconnected Inner Zone 2 (DIZ-2)	Project RM 0.6 R	Reconnect Stream Channel Processes	Side-channel reconnection	This site is on river-right downstream of the Highway 2 Bridge. This site is the pre-1962 channel. Excavation of this area and removal of fill material at the upstream end could create a high flow side-channel for velocity refuge and rearing complexity. An alternative to be considered at this site is a re-route of the mainstem channel to increase sinuosity. LWD and boulder structures could be utilized to stabilize the new channel and to provide features to induce scour pool development.

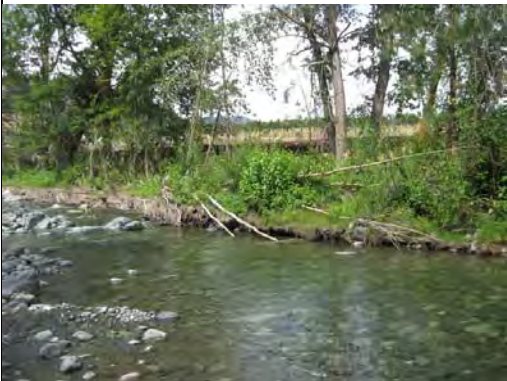
<p>Looking upstream to the northwest at the left river bank near river mile 1.0 (August 2009).</p>

1	Inner Zone 1 (IZ-1)	Project RM 1.0C	Instream Habitat Enhancement	LWD enhancement.	Pool habitat is extremely limited in this reach, and opportunities to increase pool quality should be considered. The project would include a lateral log jam constructed on the river-left bank. Sandstone bed rock in the channel could limit pool depth at this site. However it may be possible to easily excavate the sandstone. If possible, pool depth could be enhanced through excavation and maintained by log jam hydraulics.

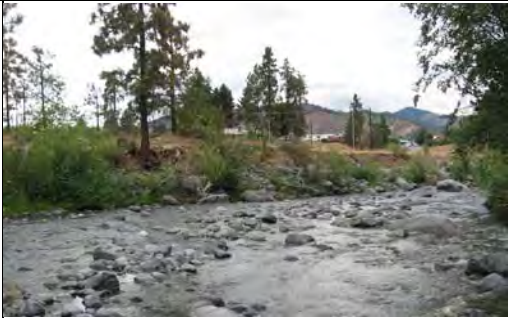
<p>Cleared riparian zone on river left bank near river mile 1.2. (August 2009).</p>
2	Inner Zone 5 (IZ-5)	Project RM 1.65C	Instream Habitat Enhancement	LWD enhancement	This wood placement project includes a river right bank log-jam. The goal of the jam is to add complexity to the otherwise plane bed morphology of the reach, thereby increasing ecological value.

1	Outer Zone 1 (OZ-1)	Project RM 1.1R	Riparian Restoration	Expand riparian buffer (right bank).	A very narrow band of riparian forest extends along the right bank between river mile 1.05 and 1.2 (approx. 900 ft). Plant native riparian forest vegetation within a 100 foot buffer in order to restore riparian functions including stream shade, bank stabilization, and LWD recruitment.	
1	Outer Zone 2 (OZ-2)	Project RM 1.2L	Riparian Restoration	Native plant revegetation (left bank).	There is little to no riparian forest along the left bank between river mile 1.1 and 1.25 (approx. 700 ft). Plant native riparian forest vegetation within a 100 foot buffer in order to restore riparian functions including stream shade, bank stabilization, and LWD recruitment.

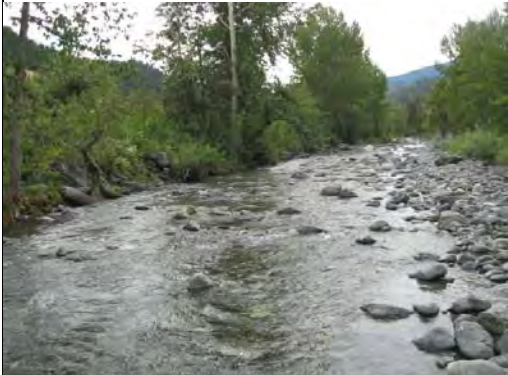
<p>View looking upstream toward the south at a potential log jam location near river mile 1.7 associated with Project RM 1.65C. (August 2009).</p>

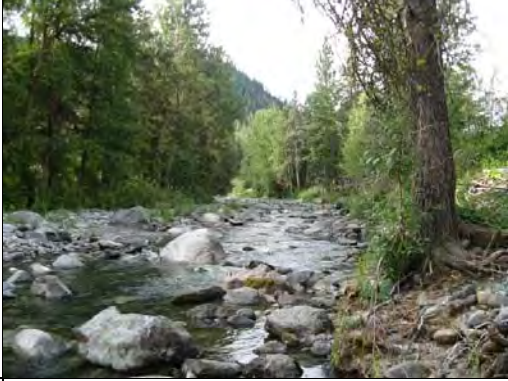
Reach	Sub-Unit	Project Number	Strategy Category	Project Name	Description	Photo
2	Inner Zone 4 (IZ-4)	Project RM 2.25C	Instream Habitat Enhancement	LWD enhancement.	This project includes two potential locations for lateral log-jams between river miles 2.2 and 2.3. These structures would enhance pool habitat and provide instream cover and complexity.

<p>View looking upstream toward the south near river mile 2.2 at a potential log jam location associated with Project RM 2.25C. (August 2009).</p>
2	Disconnected Outer Zone 8 (DOZ-8)	Project RM 2.4R	Off-Channel Habitat Enhancement	Side-channel enhancement	The fish bypass channel at the Peshastin Canal runs along the river-right bank. There is a connection with a floodplain pond that may provide potential stranding risk during certain periods. There may also be off-channel habitat restoration opportunity in this area (this information was provided by Mike Kane, Chelan County Dept of Natural Resources). This site warrants further investigation with respect to stranding risk and restoration potential.

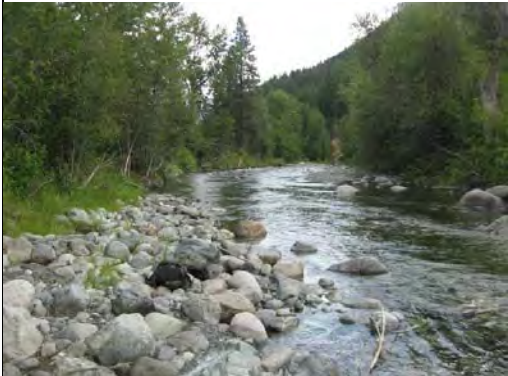
2	Disconnected Outer Zone 7 (DOZ-7)	Project RM 2.7L	Off-Channel Habitat Enhancement	Side-channel enhancement.	This site provides a good opportunity to create off-channel and side-channel habitats by excavating new flood-prone area and side-channels. It might be possible to supplement side-channel work with constructed ground water galleries. The landowner was very receptive to enhancement work on his land.

<p>View looking downstream toward the north near river mile 2.75 at a potential upstream inlet to the Project RM 2.7L side-channel. (August 2009).</p>
