Lower Peshastin Creek

Tributary and Reach Assessment

Wenatchee Subbasin, Chelan County, WA

June 2010

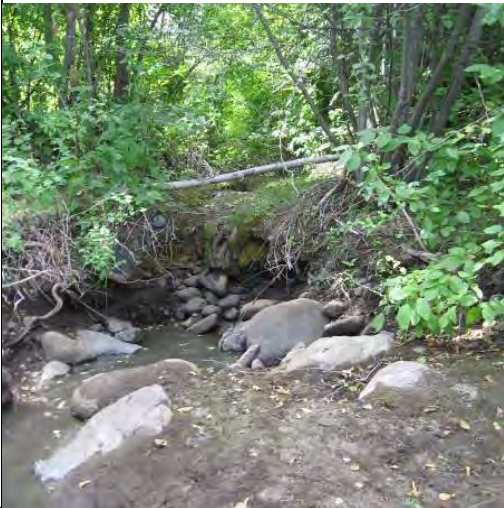
Reach	Sub-Unit	Project Number	Strategy Category	Project Name	Description	Photo
2	Inner Zone 4 (IZ-4)	Project RM 2.9L	Protect and Maintain	Reduction of avulsion risk.	At this site, the existing channel has locally aggraded creating a possibility that the channel will avulse into a side channel adjacent to Highway 97. No rip-rap exists in this area. If the channel avulsed during a flood it is possible the Highway 97 road prism would rapidly erode. Log jams constructed in the lower segments of the valley adjacent to the road would increase local roughness and reduce this avulsion risk. Wood placed on the adjacent gravel bar would further reduce avulsion risk and force floodwater to the right side of the valley where riparian areas and habitats are more intact.

<p>The outflow of the secondary channel on river-left associated with project RM 2.9R. During low flow there is no surface discharge here. (August 2009).</p>

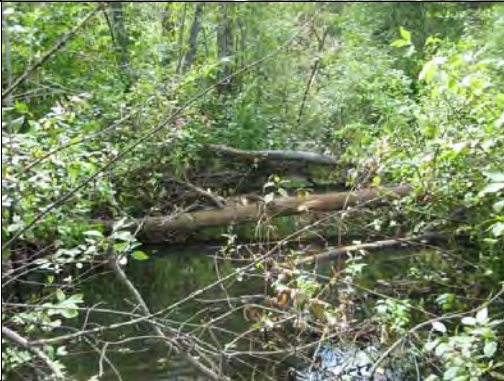
2	Disconnected Outer Zone 5 (DOZ-5)	Project RM 2.9R	Off-Channel Habitat Enhancement	Side-channel enhancement/reconnection.	This project is on the right (east) side of the valley where a high flow side channel runs through an intact valley bottom riparian wetland. The high flow side channel could be re-graded to function as a low flow side channel. There is evidence of beaver activity in the riparian area and the goal of the project would be to enhance the connection of this side-channel to create off-channel habitat and high-flow refuge. Log-jams would be necessary to ensure stability of the main channel and side channel inlet location.

<p>Groundwater pond in a side-channel on river-right near river mile 2.9. (August 2009).</p>
2	Disconnected Outer Zone 5 (DOZ-5)	Project RM 3.0R	Protect and Maintain	Riparian and floodplain protection	The riparian and floodplain area in the downstream portion of the unit (RM 2.8 to 3.0) is undeveloped and retains mature riparian vegetation and floodplain function, especially compared to the upstream portion of the unit where floodplain filling and development have disconnected riparian and floodplain processes.

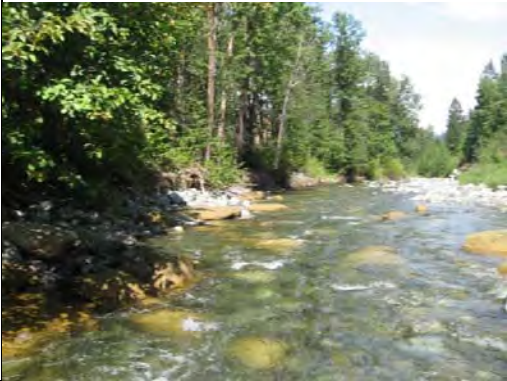
Reach	Sub-Unit	Project Number	Strategy Category	Project Name	Description	Photo
2	Inner Zone 4 (IZ-4)	Project RM 3.35L	Instream Habitat Enhancement	LWD enhancement	This project includes a lateral log-jam along the left bank of the channel. The goal of the wood placement is to provide adult holding and juvenile rearing habitat. This location benefits from having few infrastructure constraints, good existing riparian habitat in the adjacent floodplain, and site access.

<p>View looking downstream at a potential log jam location near river mile 3.35. (August 2009).</p>
2	Inner Zone 4 (IZ-4)	Project RM 3.45L	Instream Habitat Enhancement	LWD enhancement.	This project includes a lateral log-jam along the left bank of the channel. The goal of the wood placement is to provide adult holding and juvenile rearing habitat. This location benefits from having few infrastructure constraints, good existing riparian habitat in the adjacent floodplain, and site access.

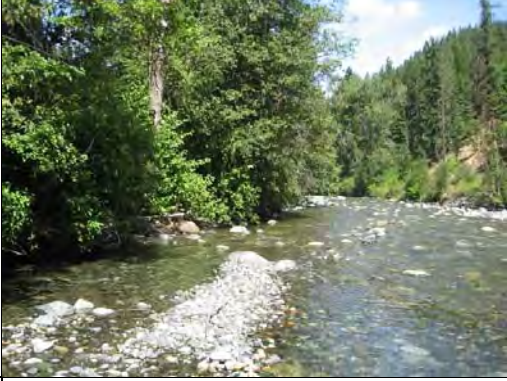
<p>View in the downstream direction toward the northeast at a potential log jam location near river mile 3.45. (August 2009).</p>

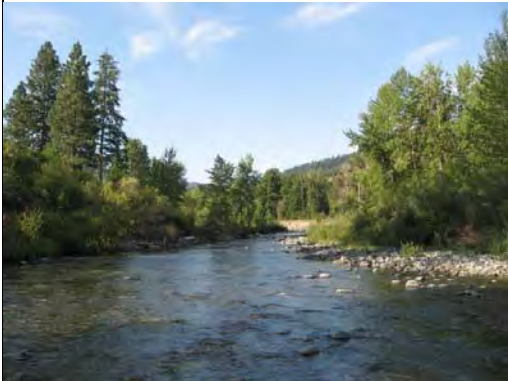
Reach	Sub-Unit	Project Number	Strategy Category	Project Name	Description	Photo
2	Inner Zone 2 (IZ-2)	Project RM 4.0R	Instream Habitat Enhancement	LWD enhancement.	This project is a log jam downstream of Larsen Creek on the right bank. The log jam is a good site to provide habitat and reduce existing bank erosion.

<p>View looking upstream at a potential log jam location on the river-right bank (left side of photo) near river mile 3.95 associated with Project 4.0R. (August 2009).</p>
2	Outer Zone 4 (OZ-4)	Project RM 4.0L	Off-Channel Habitat Enhancement	Side-channel enhancement	This site consists of an existing hyporheic-fed side-channel between RM 3.95 and 4.05 along the river-left side. This project would enhance the cover habitat in the existing side channel. Additional investigation is needed to determine the potential for enhancing flow through excavation and the use of groundwater galleries.

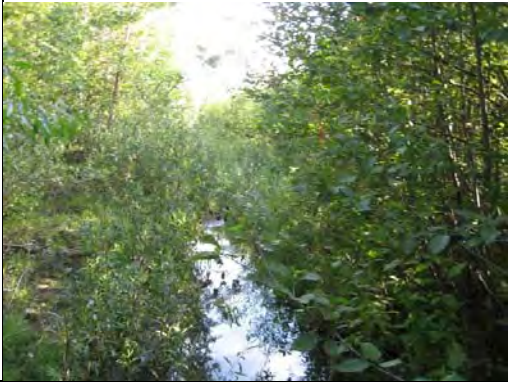
<p>View looking south at the groundwater-fed channel on river left near river mile 4.0. (August 2009).</p>

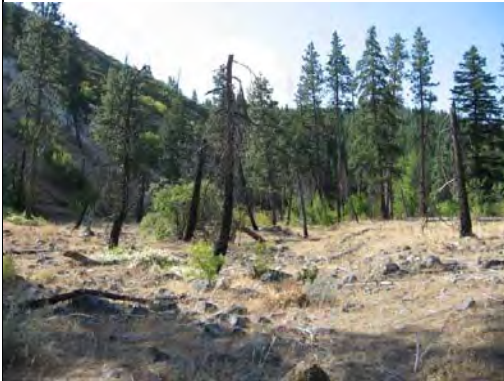
<p>View looking south in the upstream direction at OZ4 near river mile 4.25. This surface is the proposed site for a side-channel project associated with Project 13. (August 2009).</p>

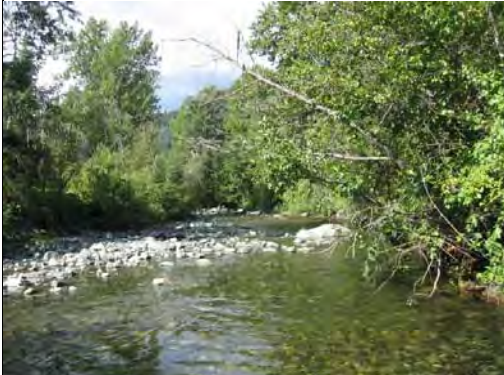
2	Inner Zone 1 (IZ-1)	Project RM 4.6C	Instream Habitat Enhancement	LWD habitat enhancement	This site is on a bend in the Creek near RM 4.65. A log jam here would provide habitat complexity and cover.

<p>View looking downstream toward the northeast at a potential log-jam location near RM 4.65. (August 2009).</p>

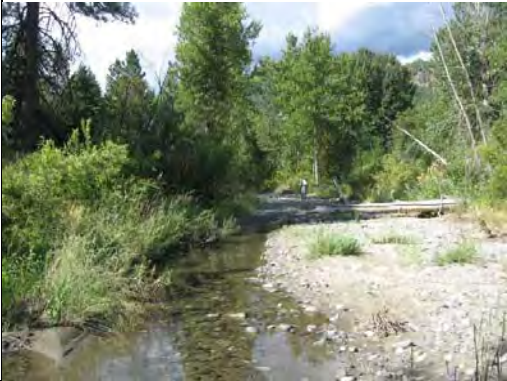
Reach	Sub-Unit	Project Number	Strategy Category	Project Name	Description	Photo
2	Inner Zone 1 (IZ-1)	Project RM 4.6R	Off-Channel Habitat Enhancement	Side-channel habitat enhancement.	There is an existing side- channel (primarily a high-flow channel) within the right side of the valley bottom from approximately RM 4.55 to RM 4.7. This project would enhance the existing side-channel habitat by deepening the lower one third of the channel to increase hyporheic flows. LWD placement within the side-channel would enhance habitat complexity and cover.

<p>Potential side-channel enhancement area near RM 4.6. (August 2009).</p>
2	Inner Zone 1 (IZ-1)	Project RM 4.8C	Instream Habitat Enhancement	LWD habitat enhancement	This site extends approximately 200 feet centered on RM 4.8. A log jam here would provide habitat and could be used to restore natural stability to the rapidly eroding left bank. This effort should be combined with riparian restoration.

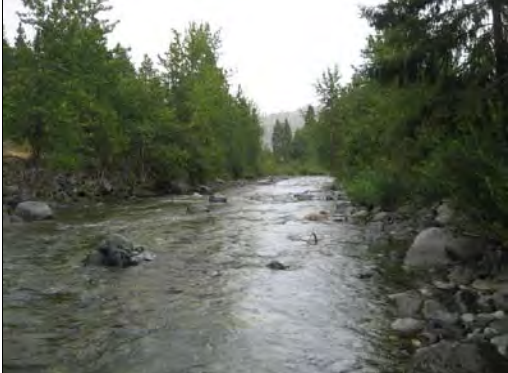
3	Inner Zone 2 (IZ-2)	Project RM 5.1C	Instream Habitat Enhancement	LWD enhancement.	There are two left-bank locations for log jam installations. One near RM 5.1, the other near RM 5.17. This project would place a log-jam into an eroding bank at the upstream end of an existing pool. The log-jam would provide natural rates of stability to the unstable bank, which has a degraded riparian zone. The log jam placements would enhance pool formation and habitat cover and complexity.

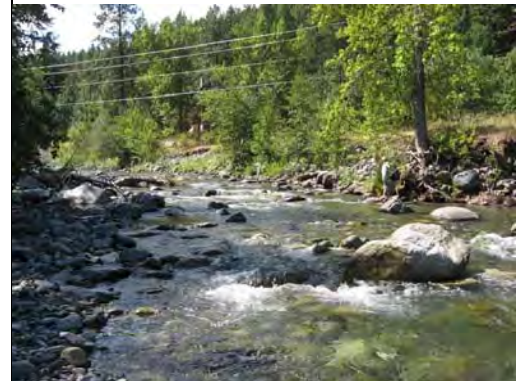
3	Disconnected Outer Zone 2 (DOZ-2)	Project RM 5.2L	Riparian Restoration	Riparian restoration (left bank).	Approximately 1,000 feet of stream in this area, which extends from river mile 5.05 to 5.25, has limited riparian function due to a narrow and intermittent forested riparian buffer. This project would restore a native riparian forest within 100 feet of the stream along this section in order to restore riparian functions including stream shade, bank stabilization, and LWD recruitment.

<p>View looking upstream near river mile 5.2. There are opportunities for riparian restoration along the river-left bank (right side of photo). (August 2009).</p>
3	Inner Zone 2 (IZ-2)	Project RM 5.25C	Reconnect Stream Channel Processes	Bridge abutment removal and LWD enhancement	There is an old road, associated fill, and concrete bridge abutments near river mile 5.25. Although there is no longer a bridge in this location, the concrete abutments continue to constrict the channel and affect channel processes. This project would remove the bridge abutments and the associated fill. Lateral log jams could be constructed to provide stability of the disturbed area and to enhance pool formation and instream habitat complexity.

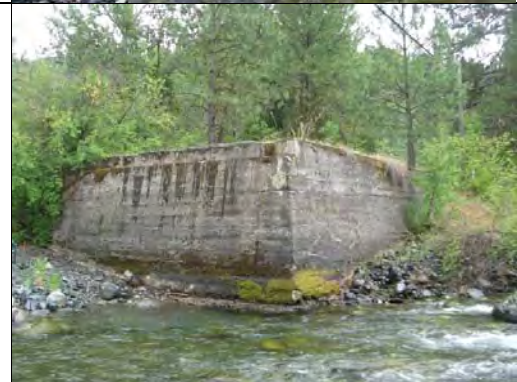
<p>Old bridge abutment at river mile 5.25. (August 2009).</p>

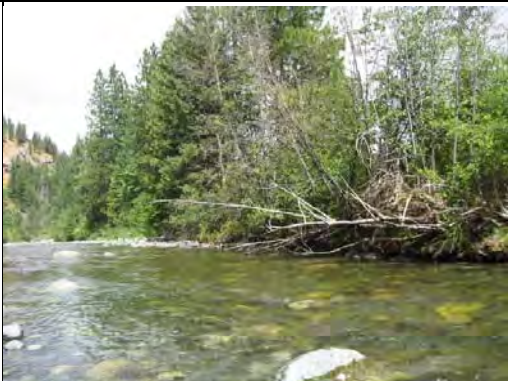
Reach	Sub-Unit	Project Number	Strategy Category	Project Name	Description	Photo
3	Outer Zone 2 (OZ-2)	Project RM 5.4L	Protect and Maintain	Riparian and floodplain habitat protection.	This undeveloped floodplain surface is important for protection due to the limited acreage of undeveloped floodplain in this reach. Protect and allow no further degradation of geomorphic, hydrologic, and vegetative function. Evaluate existing protections and, if necessary, look for opportunities to purchase conservation easements on the property.	
3	Inner Zone 2 (IZ-2)	Project RM 5.4C	Instream Habitat Enhancement	LWD enhancement.	This project is located along the river-right bank and provides an opportunity to place a lateral log-jam in order to increase habitat quality and diversity in the reach. Constraints at this location include houses in the floodplain on river right, and a nearby power line crossing. The log jam site is near RM 5.4.

<p>View looking downstream toward the northeast at a potential log-jam location near river mile 5.41. (August 2009).</p>

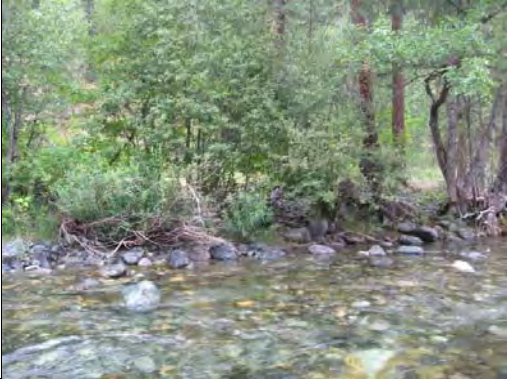
<p>View looking upstream toward the southwest at a potential log jam location along river-left near river mile 6.65. (August 2009).</p>

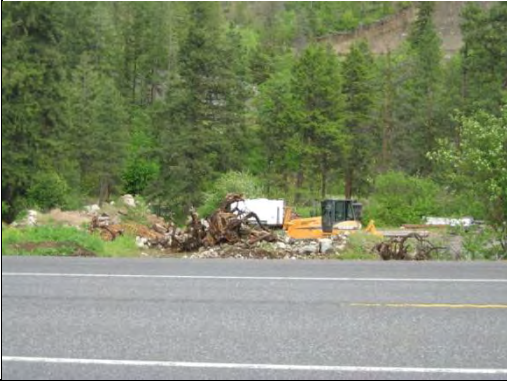
Reach	Sub-Unit	Project Number	Strategy Category	Project Name	Description	Photo
5b/6	Disconnected Outer Zone 1 (DOZ-1)	Project RM 8.9R	Riparian Restoration	Riparian restoration.	This surface has been cleared over large areas. Revegetation efforts in this sub-unit could be scale to achieve a variety of habitat goals. As a minimum effort, riparian vegetation could be planted around the margins of wetlands and wet depressions in the former channel. As a larger scale effort, riparian and upland vegetation, including sage and pine would be planted over larger areas of the sub-unit. This option might include purchase of some developed land. If reconnection of the historical channel was carried forward, this revegetation would be a component of the project.

<p>View to the east across Highway 97 at the cleared surface of the historical floodplain of Peshastin Creek. (May 2010).</p>
5b/6	Disconnected Inner Zone 2 (DIZ-2)	Project RM 8.9L	Reconnect Stream Channel Processes	Levee removal, reconnect side-channel habitat.	This project involves removing 630 ft of levee between RM 8.85 and 8.99. The material forming the levee includes alluvium that was dredged or pushed up from the channel or floodplain nearby, as well as large, angular material that was imported to the site. By removing this levee, habitat and process reconnection could be established for DIZ-2, as well as DOZ-2 downstream. Once the levee has been removed, options for enhancing side-channel or off-channel habitat could be assessed.

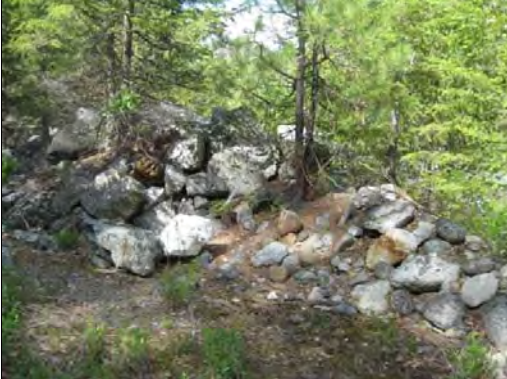
<p>View to the north in the downstream direction at a portion of the levee near RM 8.9 where newer riprap has been placed on top of older alluvial material. (May 2010).</p>
