Lower White Pine Reach Assessment

Nason Creek Chelan County, Washington

U.S. Department of the Interior
Bureau of Reclamation
Pacific Northwest Region
Boise, Idaho

February 2009

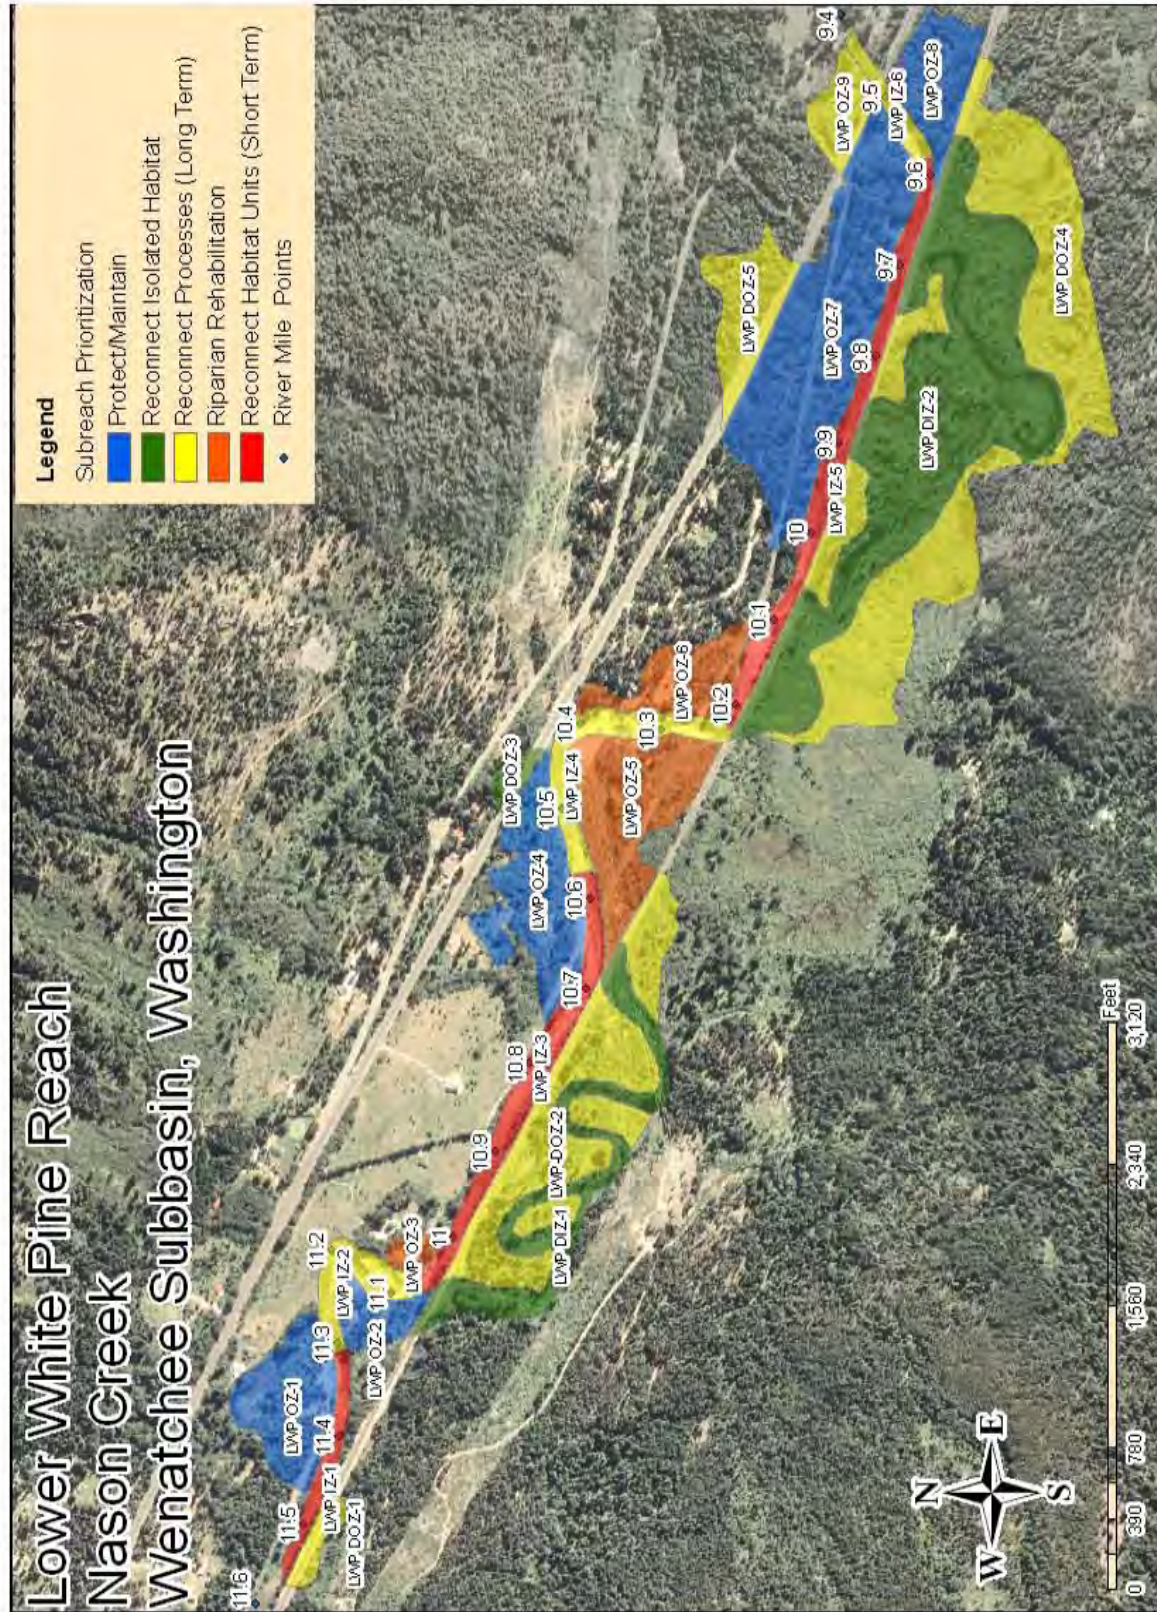
Geomorphic potential is the combined influence of water, sediment, and large woody debris in forming, connecting, and sustaining fish habitat. Over half of the Lower White Pine reach has been disconnected from the active channel and does not contribute to habitat-forming processes. Figure 3 shows a prioritized implementation approach by subreach unit for the Lower White Pine reach. A dual-track rehabilitation approach that would address both long-term and short-term goals with respect to time to implement is necessary to reestablish geomorphic potential and with it healthy stream conditions (Table 2). The long-term track of this approach would involve addressing the disconnected subreaches by a cooperative effort with the two large landowners, the Burlington Northern Railroad and the State of Washington Department of Transportation. The goal of the long-term track is to reconnect disconnected or “relict” subreaches that are currently disconnected by the highway or railroad grade. Subreaches of particular interest include DIZ-1 and DIZ-2, along with adjacent historic outer zone areas of DOZ-2 and DOZ-4, respectively. This cooperative effort can be executed in conjunction with the short-term track that focuses on the rehabilitation of connected subreaches in a series of potential habitat actions that will complement reconnection of the disconnected subreaches. Potential rehabilitation actions necessary in the short term include riparian plantings and noxious weed eradication; unimproved road relocations or removals; and instream large woody debris structures. Subreaches that are candidates for the short-term track of this approach include OZ-1, OZ-2, OZ-3, OZ-4, OZ-5, OZ-6, OZ-7 and OZ-8, all of which already offer form and connectivity, albeit in a diminished condition.

Figure 3 - Subreaches prioritized using the strategy from Roni, 2006.

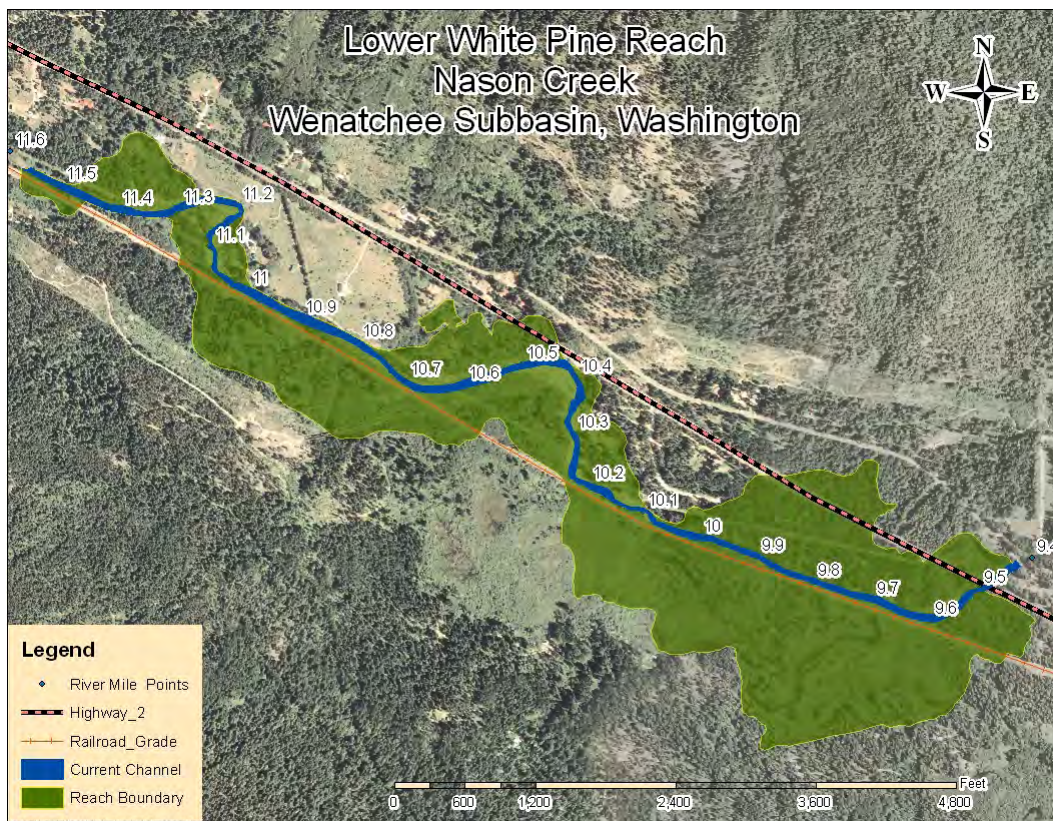
The Lower White Pine reach encompasses about 229 acres of floodplain and active channel of Nason Creek within an alluvial valley from RM 9.45 to 11.55. The current channel and active floodplain are located between Highway 2 to the north and the railroad grade to the south (Figure 7). These two features disconnect sections of multiple inner and outer zones from the active channel and floodplain that total about 55 percent of the total reach area. Table 3 summarizes the acreages of the inner and outer zones.

Figure 7 - Refined reach delineation and boundary conditions of the Lower White Pine Reach.

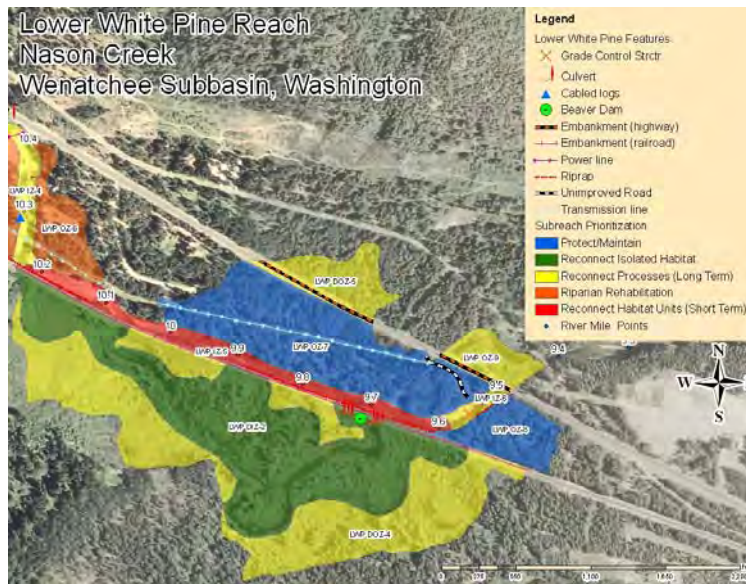
LWP OZ-7 is located in the downstream end of the Lower White Pine reach in the left floodplain along RM 10.0 to 9.5 (Figure 14).

The subreach is about 25 acres in size and contains about 0.2 acres of wetland areas. Natural lateral controls for the subreach are alluvial fan structures. Lengths of anthropogenic features in this subreach include about 2,104 feet of transmission line, 461 feet of undeveloped road, and 102 feet of road embankment (Figure 15). The acres of disturbed vegetation associated with the anthropogenic features listed above plus some clearing for development is 0.5 acre or about 2 percent of the total subreach. The inundation potential is low and when comparing 5,000 cubic feet per second (cfs) (approximate 20-year recurrence interval) stream flow for existing conditions versus potential conditions (i.e., with anthropogenic features removed), the two dimensional-hydraulic model (2D-hydraulic model) results show little change in the area of inundation. Most of the subreach is inundated at both modeled flows.

There are no anthropogenic features that disconnect the subreach from the active channel. The subreach is considered to be functioning at greater than 80 percent; therefore, the subreach is protection-oriented. However, riparian rehabilitation actions can be implemented in tandem with protection strategies to address the low percent of disturbed vegetation. Rehabilitation options are listed in Table 7 and are prioritized to maximize the geomorphic potential of the subreach. Rehabilitation actions in this subreach should be considered collectively with rehabilitation actions recommended in adjacent subreaches to achieve a holistic reconnection and reestablishment of processes at the reach scale.

Figure 14 - A plan view showing the location of LWP OZ-7 in the downstream end of the Lower White Pine reach with, location of anthropogenic features, and the proximity of adjacent subreaches with the corresponding rehabilitation strategies.

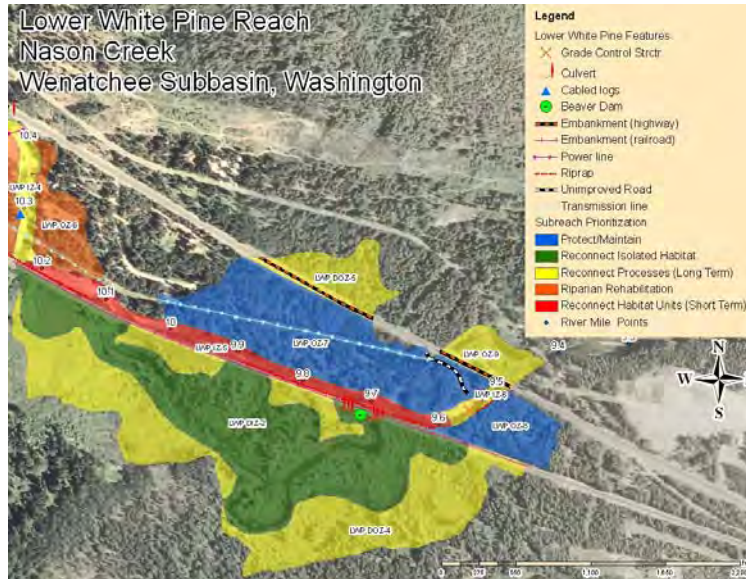
LWP OZ-8 is located in the downstream end of the Lower White Pine reach in the right floodplain along RM 9.6 to 9.5 (Figure 16).

Although no anthropogenic features exist on the interior of the subreach, it is bound on the north side by Highway 2, by the railroad grade on the south side, and a small section of riprap along the right bank. All bounding anthropogenic features are addressed in other subreach descriptions. The inundation potential is low. When comparing approximate 20-year recurrence interval stream flow for existing conditions versus potential conditions (i.e., with anthropogenic features removed), the 2D-hydraulic model results show little change in area of inundation. Most of the subreach is inundated at both modeled flows. Rehabilitation options are listed in Table 8 and are prioritized to protect and maintain the geomorphic potential of the subreach.

The subreach is considered to be functioning at greater than 80 percent; therefore, the subreach is protection-oriented. Rehabilitation options are listed in Table 8 and are prioritized to protect and maintain the geomorphic potential of the subreach. Rehabilitation actions in this subreach should be considered collectively with rehabilitation actions recommended in other adjacent subreaches to achieve a holistic reconnection and reestablishment of processes at the reach scale.

Figure 16 - A plan view showing the location of LWP OZ-8 in the downstream end of the Lower White Pine reach, location of anthropogenic features, and the proximity of adjacent subreaches with the corresponding rehabilitation strategies.

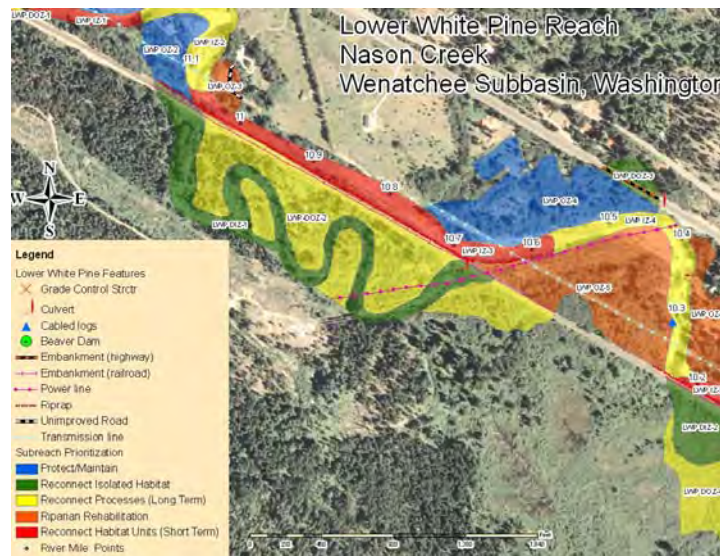
LWP OZ-4 is located in the mid-section of the Lower White Pine reach in the left floodplain along RM 10.75 to 10.45 (Figure 17).

The subreach is about 11 acres in size. Natural lateral controls for the subreach are alluvial fan structures and higher terraces. Lengths of anthropogenic features are limited to about 502 feet of electrical transmission line running through the subreach. The area of vegetation disturbance from the anthropogenic impacts in this subreach totals just less than 3 acres with 0.62 acres from the transmission line and an additional 2 acres that are cleared for development. The percent of the subreach vegetation that is disturbed is 27 percent. The inundation potential is low. When comparing 5,000 cfs (approximate 20-year recurrence interval) stream flow for existing conditions versus potential conditions (i.e., with anthropogenic features removed), the 2D-hydraulic model results show little change in area of inundation. Most of the subreach is inundated at both modeled flows.

There are no anthropogenic features that disconnect the subreach from the active channel. The subreach is considered to be functioning at greater than 80 percent so the subreach is protection-oriented. However, riparian rehabilitation actions can be implemented in tandem with protection strategies to address the low percent of disturbed vegetation. Rehabilitation options are listed in Table 9 and are prioritized to maximize the geomorphic potential of the subreach through the reconnection and reestablishment of both long-term and short-term processes at the subreach scale. Rehabilitation actions in this subreach should be considered collectively with rehabilitation actions recommended in other adjacent subreaches to achieve a holistic reconnection and reestablishment of processes at the reach scale.

Figure 17 - A plan view showing the location of LWP OZ-4 in the mid-section of the Lower White Pine reach, location of anthropogenic features, and the proximity of adjacent subreaches with the corresponding rehabilitation strategies.

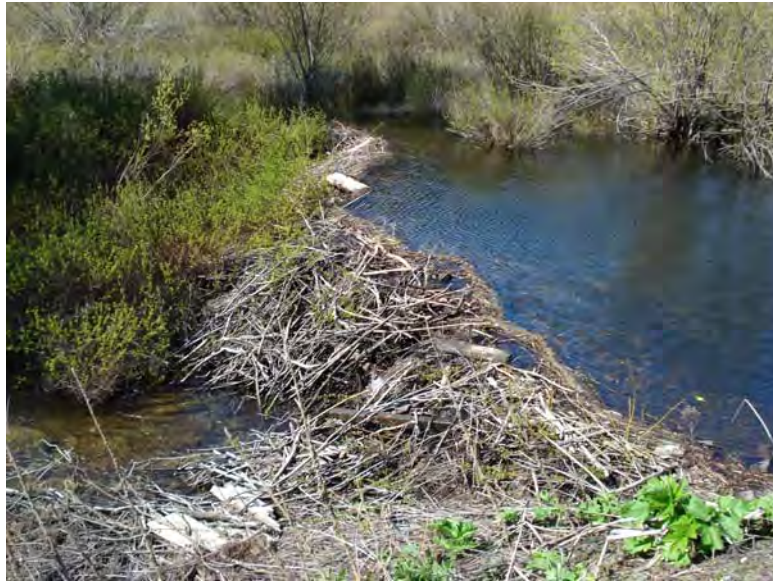
The subreach is about 40 acres in size and represented 5,494 linear feet of historic channel path prior to the construction of the railroad. Natural lateral controls for the subreach are alluvial fan structures. About 36 acres of wetland areas are contained within the subreach (Figure 21 and Figure 22). Anthropogenic features include about 2,333 feet of railroad grade that disconnect the subreach from the current channel at the upstream (RM 10.2), middle (RM 9.9), and downstream ends (RM 9.7). Artificial lateral control from the railroad grade has disconnected this subreach from the active channel at the upstream and downstream ends. At the downstream end of the subreach, there are two sets of triple culverts; however, fish access to existing habitat behind the railroad grade is thought to be limited through these culverts due

Figure 21 - A 4-foot tall beaver dam in the wetlands on the south side of the railroad grade, view to the south. Lower White Pine Reach; Subreach DIZ-2, Nason Creek - Wenatchee Subbasin, Washington. Bureau of Reclamation Photograph by R. McAfee, May 5, 2007.

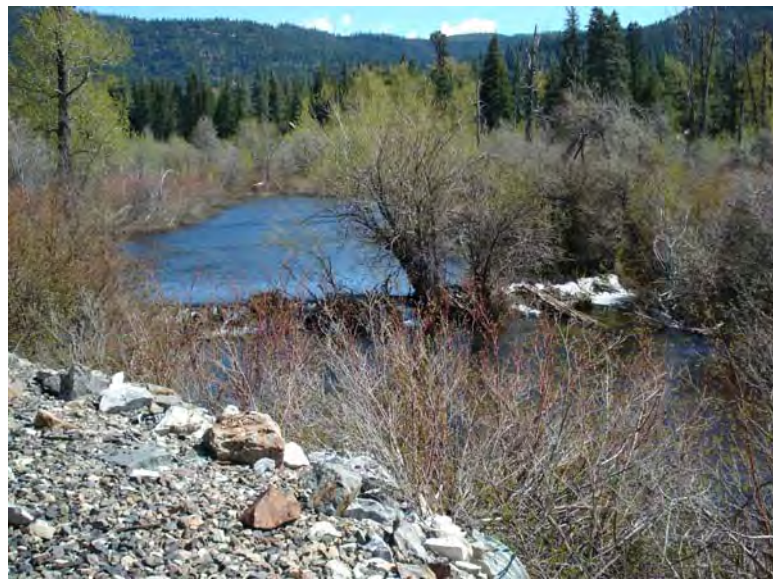
Figure 22 – A larger beaver dam in a wetland complex located on the south side of the railroad grade, view to the southeast. Lower White Pine Reach; Subreach DIZ-2, Nason Creek - Wenatchee Subbasin, Washington. Bureau of Reclamation Photograph by R. McAfee, May 4, 2007.

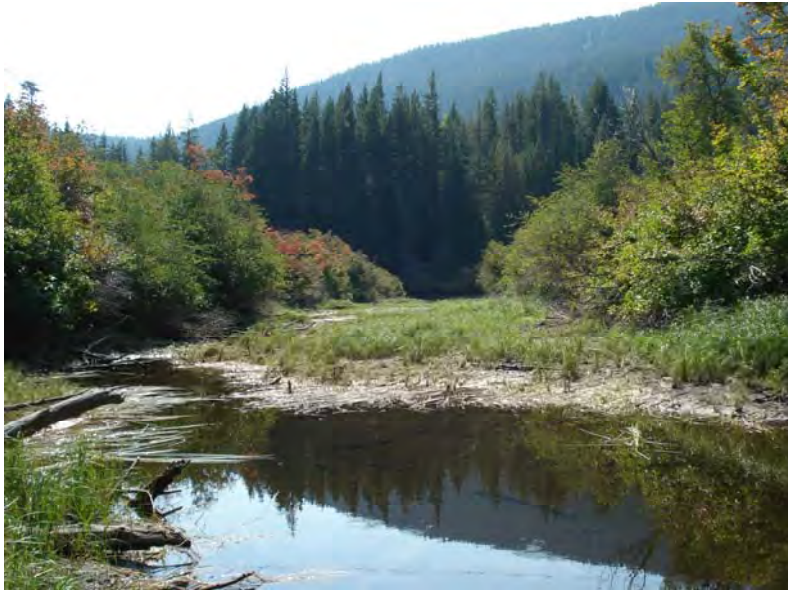
The subreach is about 11 acres in size and represented about 4,755 linear feet of historic channel path prior to the construction of the railroad. About 5 acres of wetland area is contained within the subreach (Figure 24). Natural lateral controls for the subreach are bedrock and alluvial fan structures. Anthropogenic features include about 597 feet of railroad grade and about 492 feet of transmission line that crosses the subreach at two locations. Artificial lateral control from the railroad grade has disconnected this subreach from the

Figure 24 - Wetlands within the historic main channel that is currently disconnected by the railroad grade, view to the south. Lower White Pine Reach; Subreach DIZ-1, Nason Creek - Wenatchee Subbasin, Washington. Bureau of Reclamation Photograph by R. McAfee, September 9, 2008.

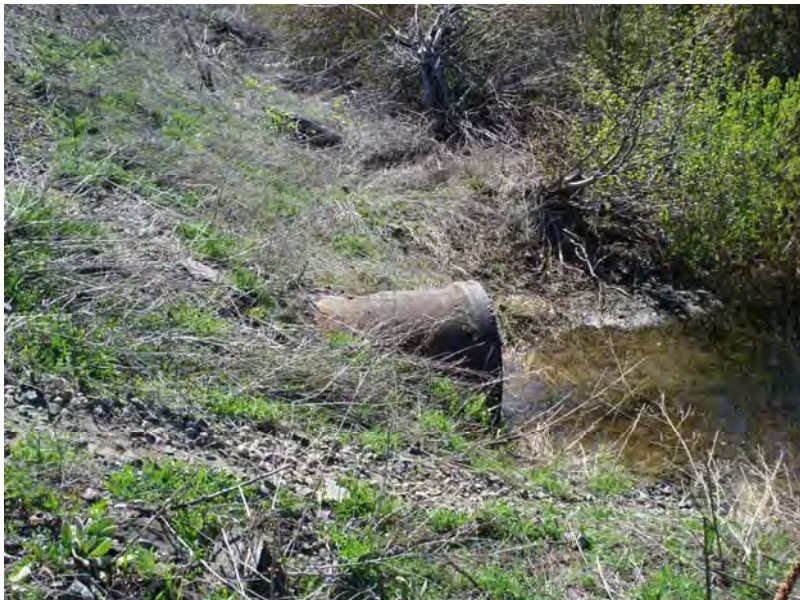
active channel at the upstream and downstream ends. There is a culvert at the downstream end (Figure 25); however, fish access to existing habitat behind the railroad grade is thought to be limited to the observance of the elevation of the culvert on the active channel side at base flow (Figure 52 in the LWP IZ-3 profile). The inundation potential of this subreach is 9 acres or 9 percent of the inundation potential for the entire Lower White Pine reach. Vegetation disturbed by anthropogenic features totals about 3 acres which is about 28 percent of the total subreach area.

Figure 25 - Culvert that drains the wetlands on the south side of the railroad grade at the downstream end of the subreach, view to the southeast. Lower White Pine Reach; Subreach DIZ-1, Nason Creek - Wenatchee Subbasin, Washington. Bureau of Reclamation Photograph by R. McAfee, May 5, 2007.

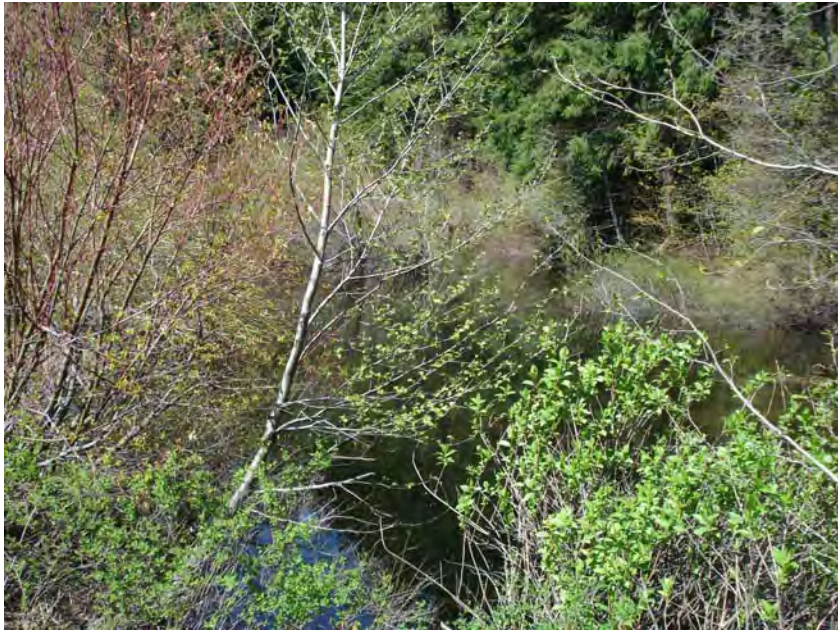
The subreach is about 1.4 acres in size and is disconnected from subreach OZ-4 by about 411 feet of highway embankment. Natural lateral controls for the subreach are alluvial fan structures and higher terraces. Currently about 1 acre of wetland area exists within the subreach (Figure 27). There is one culvert at the downstream end of the disconnected floodplain (Figure 28); however, it may not provide fish access at base flow. The area of disturbed vegetation from the highway embankment in this subreach is 0.6 acres or 43 percent of the subreach. The inundation potential is 1 acre or about 1 percent of the inundation potential for the entire Lower White Pine reach.

Figure 27 - Bottom of the wetlands on the north side of the road, view to the northwest. Lower White Pine Reach; Subreach DOZ-3, Nason Creek - Wenatchee Subbasin, Washington. Bureau of Reclamation Photograph by R. McAfee, May 3, 2007.

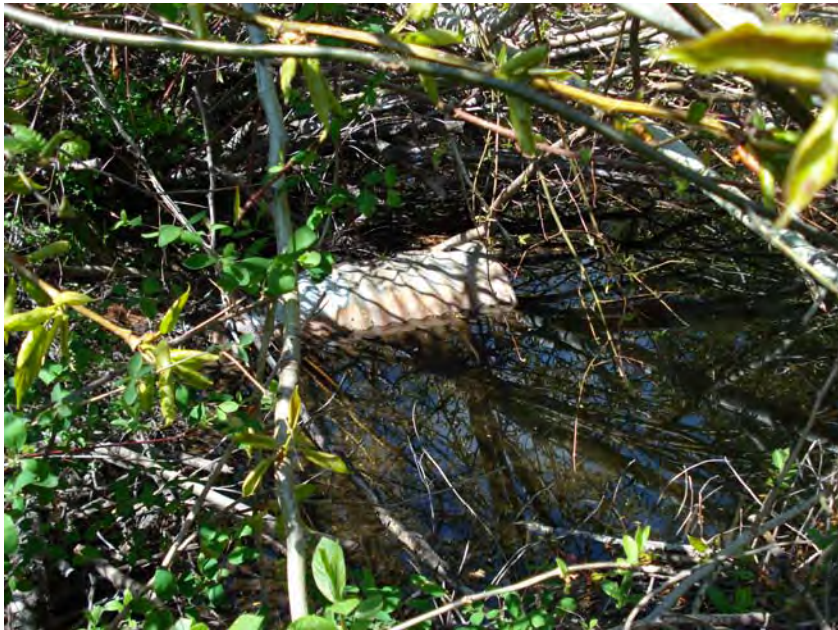
Figure 28 - Culvert that drains the wetlands on the north side of Highway 2. Lower White Pine Reach; Subreach DOZ-3, Nason Creek - Wenatchee Subbasin, Washington. Bureau of Reclamation Photograph by R. McAfee, May 3, 2007.

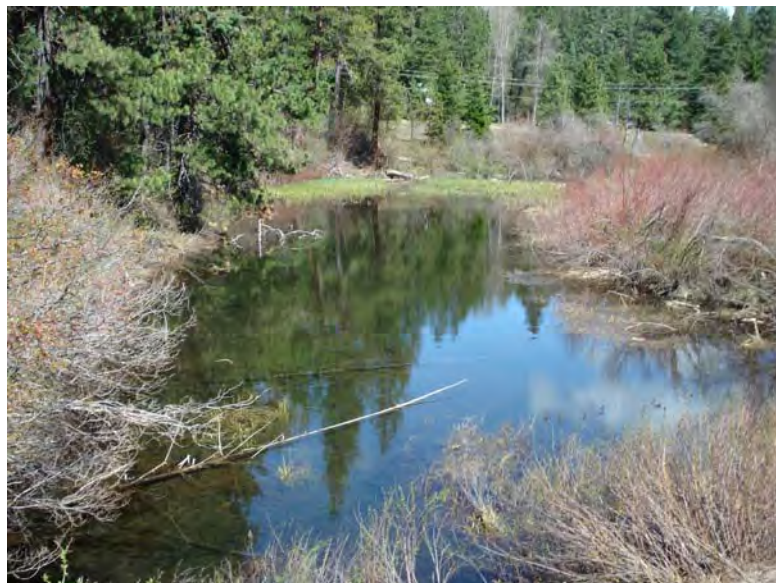
The subreach is about 4 acres in size. The subreach contains about 1 acre of wetland area (Figure 32). Natural lateral controls are alluvial fans structures on the north side. The subreach is disconnected from subreach LWP OZ-7 by 493 feet of highway embankment. There is an additional 173 feet of road embankment in the subreach. The percent of disturbed vegetation in the subreach is 25 percent. The inundation potential is about 1 acre or about 1 percent of the inundation potential for the entire Lower White Pine reach and is essentially the area of the foot-print of Highway 2.

Figure 32 - Top of wetlands in an oxbow on the north side of the road, view to the northeast. Lower White Pine Reach; Subreach OZ-9, Nason Creek - Wenatchee Subbasin, Washington. Bureau of Reclamation Photograph by R. McAfee, May 3, 2007.

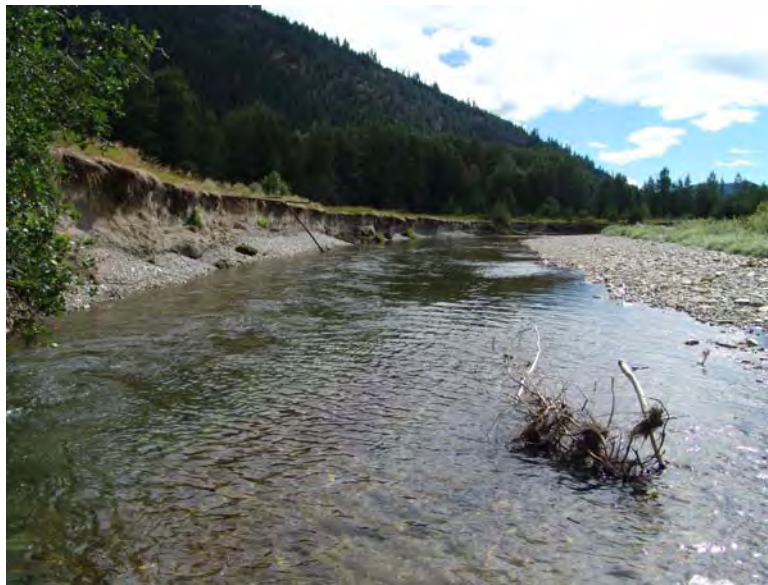
The subreach area is about 3 acres. This subreach contains greater heterogeneity of channel units than adjacent inner zone subreaches with 13 percent pools, 30 percent riffles, and 57 percent runs. There are no in-stream structures within this subreach and anthropogenic features are limited to a transmission line crossing in the downstream end. Natural lateral control for the subreach is an alluvial fan. In this subreach, the channel has limited ability to migrate and it was observed to do so at an accelerated rate as a result of impacts to the riparian vegetation (Figure 36 and Figure 37). Large woody debris is concentrated in complexes at a few locations (Figure 38).

Figure 36 - Accelerated erosion along the cleared left bank, view is to the east looking downstream. Lower White Pine Reach; Subreach IZ-2, Nason Creek - Wenatchee Subbasin, Washington. Bureau of Reclamation Photograph by D. Bennett; August 8, 2007.

Existing conditions in this subreach include an accelerated rate of migration as a result of impacts to the riparian vegetation. The overall lack of large woody debris prevents the creation of complexity at higher flows. It is hypothesized that material is deposited when flows are increasing and eroded when flows are decreasing. The result is incised gravel bars with little change in overall form. Slight to moderate incision and the proximity of protection-oriented outer zones make this subreach rehabilitation-oriented. Rehabilitation options are listed in Table 21. With the effort to reconnect processes, various habitat actions from multiple habitat action classes may be implemented. For example, the habitat actions of reconnecting wetlands and creating diverse channel patterns are listed under the habitat action class floodplain rehabilitation. The habitat action of slowing of water velocities is listed under the habitat action class of in-stream structures. The habitat action of adding large woody debris and engineered log jams is listed under the action class of large woody debris replacement. Floodplain rehabilitation addresses all four viable salmonid populations (VSP) parameters while large woody debris replacement and in-stream structures address two. The number of VSP parameters addressed in respect to reconnecting processes will depend on the action that is implemented. Options are prioritized to maximize geomorphic potential of the subreach through the reconnection and reestablishment of both long-term and short-term processes at the subreach scale. Rehabilitation actions in this subreach should be considered collectively with rehabilitation actions recommended in other adjacent subreaches to achieve a holistic reconnection and reestablishment of processes at the reach scale.

2	Rehabilitation + Protection	Reconnect Processes through the use of various habitat actions from multiple habitat action classes including in-stream structures, floodplain rehabilitation and large woody debris replacement that will result in an increase in the current bed elevation. Combine with Riparian rehabilitation : Apply efforts for a long-term approach that will result in increased large woody debris recruitment potential, increased sinuosity, sorting and retention of spawning gravels, increased number of complex pools, and water quality.	4; Productivity, Abundance, Diversity, and Structure	Medium
3	Rehabilitation + Protection	Reconnect Processes through the use of various habitat actions from multiple habitat action classes including in-stream structures, floodplain rehabilitation and large woody debris replacement that will result in an increase in the current bed elevation. Protect and maintain resulting levels of rehabilitated geomorphic, hydrologic, and riparian function.	4; Productivity, Abundance, Diversity, and Structure	Medium

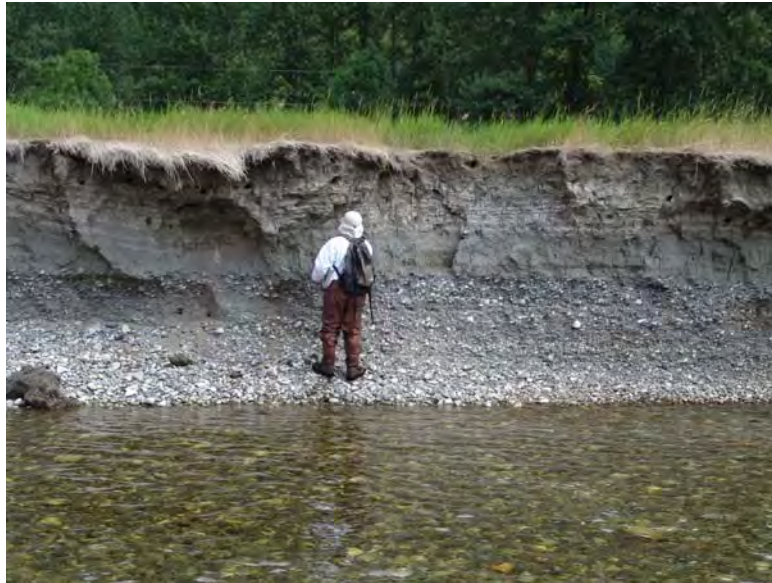
Figure 37 - Stratified material in the left bank at a bank profile site, view is to the north. Lower White Pine Reach; Subreach IZ-2, Nason Creek - Wenatchee Subbasin, Washington. Bureau of Reclamation Photograph by D. Bennett; August 8, 2007.

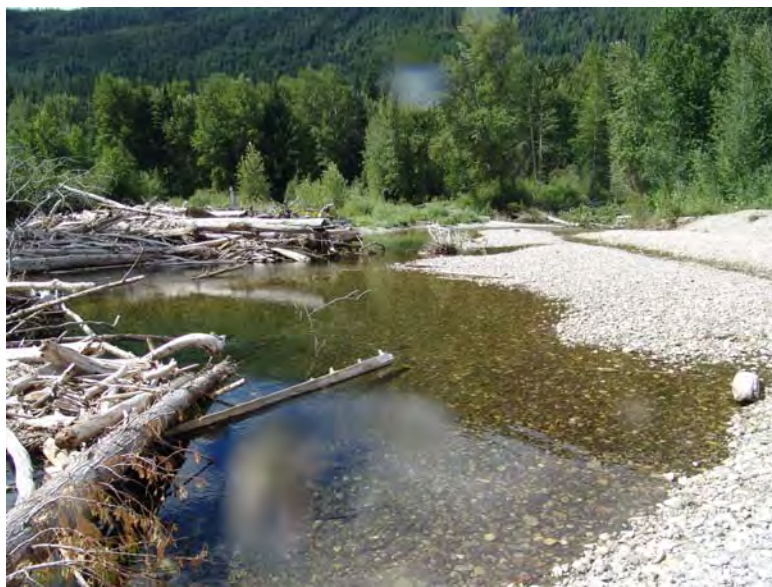
The overall lack of large woody debris prevents the creation of complexity at higher flows. It is hypothesized that material is deposited when flows are increasing and eroded when flows are decreasing. The result is incised gravel bars with little change in overall form. The impacts of anthropogenic features in the form of slight to moderate incision and the proximity of protection-oriented subreaches make this subreach rehabilitation-oriented. Rehabilitation options are listed in Table 20. With the effort to reconnect processes, various habitat actions from multiple habitat action classes may be implemented. For example, the habitat actions of reconnecting wetlands and creating diverse channel patterns are listed under the habitat action class floodplain rehabilitation. The habitat action of slowing of water velocities is listed under the habitat action class of in-stream structures. The habitat action of adding large woody debris and engineered log jams is listed under the action class of large woody debris restoration (UCSRB 2007). Floodplain rehabilitation addresses all four VSP parameters while large woody debris replacement and in-stream structures address two. The number of VSP parameters addressed in respect to reconnecting processes will depend on the action that is implemented. Options are prioritized to maximize geomorphic potential of the subreach through the reconnection and reestablishment of both long-term and short-term processes at the subreach scale. Rehabilitation actions in this subreach should be considered collectively with rehabilitation actions recommended in other adjacent subreaches to achieve a holistic reconnection and reestablishment of processes at the reach scale.

Figure 38 - Large woody debris complexes and pool channel units, view is to the south looking downstream. Lower White Pine Reach; Subreach IZ-2, Nason Creek - Wenatchee Subbasin, Washington. Bureau of Reclamation Photograph by D. Bennett; August 8, 2007.

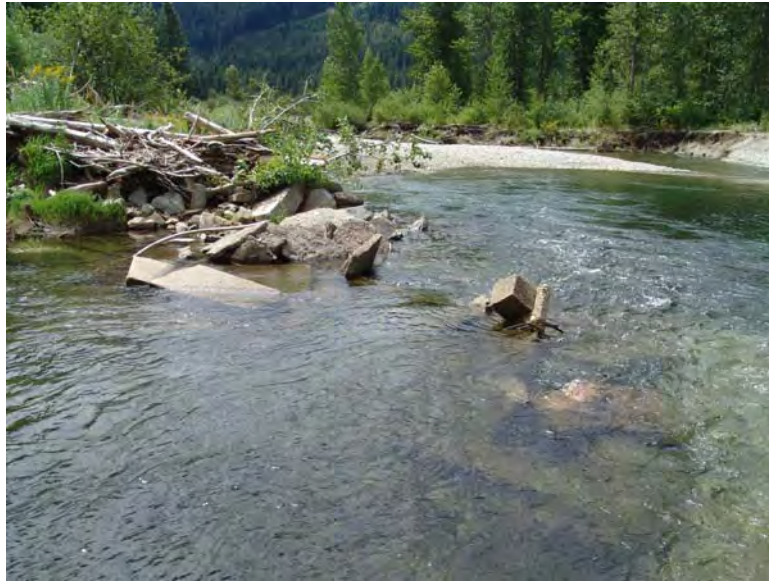
Figure 40 - In-channel structure comprised of concrete ecology blocks, miscellaneous concrete slabs and riprap, view to the south. Lower White Pine Reach; Subreach LWP IZ-4, Nason Creek - Wenatchee Subbasin, Washington. Bureau of Reclamation Photograph by D. Bennett; August 8, 2007.

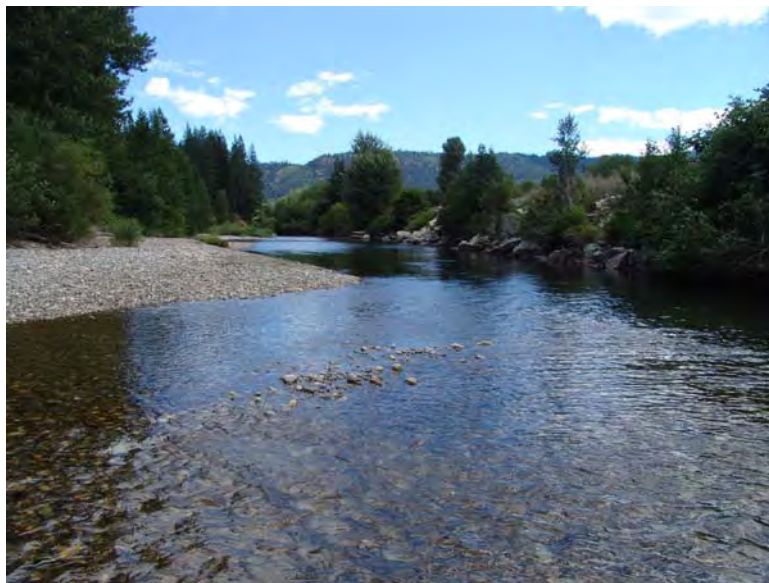
Figure 41 - Channel unit transition from riffle to run and riprap along the right bank, view is to the southeast looking downstream. Lower White Pine Reach; Subreach LWP IZ-4, Nason Creek - Wenatchee Subbasin, Washington. Bureau of Reclamation Photograph by D. Bennett; August 8, 2007.

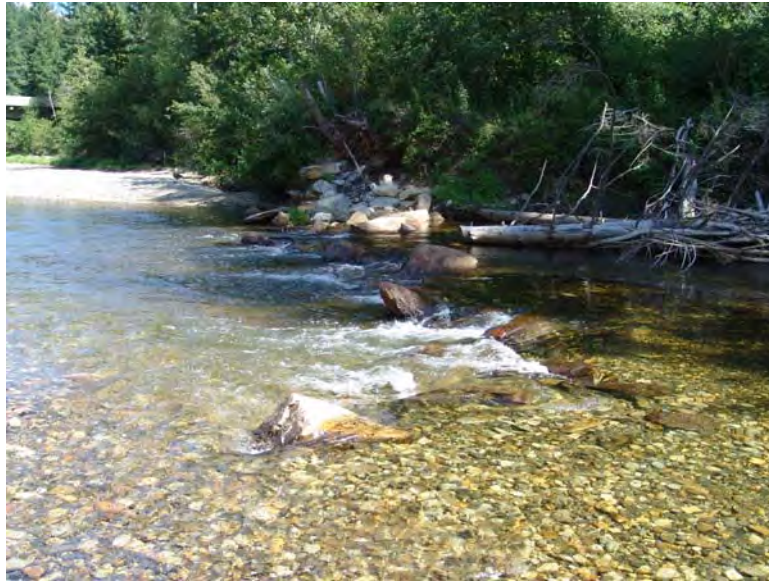
Figure 43 - In-channel rock weir, view is to the east. Lower White Pine Reach; Subreach LWP IZ-6, Nason Creek - Wenatchee Subbasin, Washington. Bureau of Reclamation Photograph by D. Bennett; August 8, 2007.

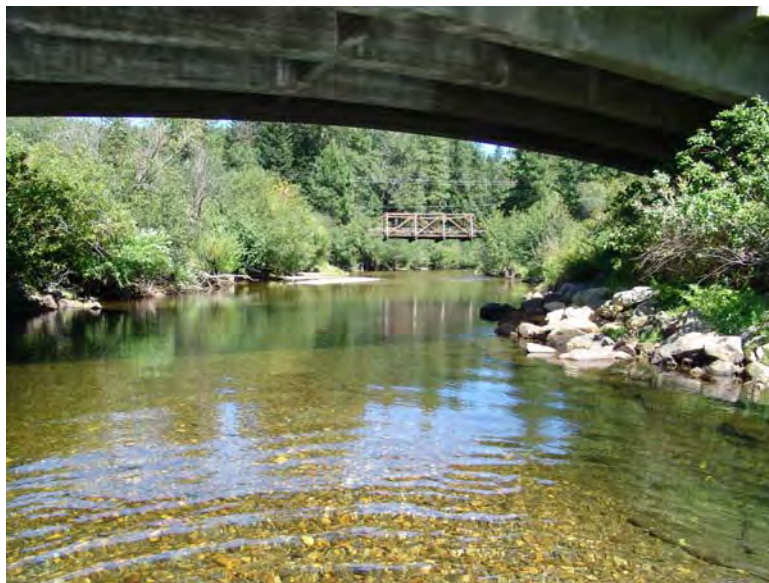
Natural lateral control for the subreach is an alluvial fan; however, artificial lateral control from the bridge abutments imposes some influence on the active channel. Large woody debris is low and the lack of large woody debris prevents the creation of complexity at higher flows.

Figure 44 - Run and pool channel units, brush-vegetated banks and bridge abutments, view is to the northeast looking downstream. Lower White Pine Reach; Subreach LWP IZ-6, Nason Creek - Wenatchee Subbasin, Washington. Bureau of Reclamation Photograph by D. Bennett; August 8, 2007.

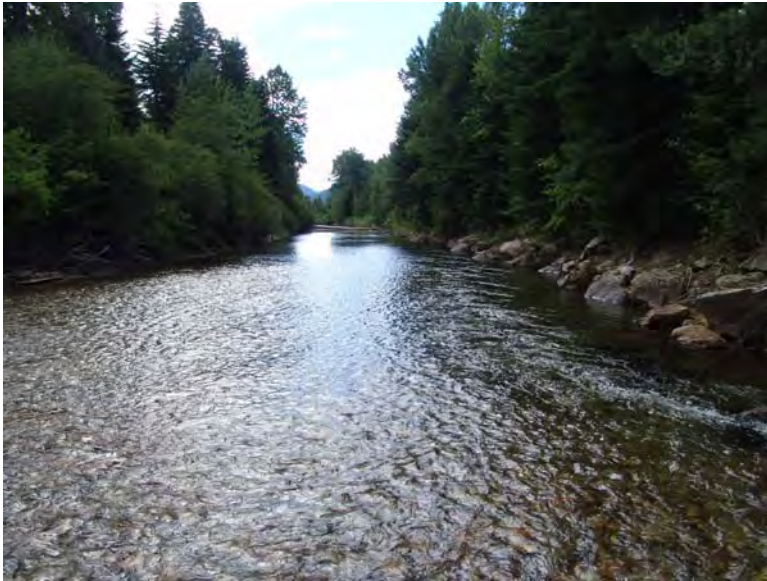
The subreach area is about 3 acres in size and contains much less heterogeneity of channel units than adjacent inner zone subreaches with 10 percent riffles and 90 percent runs. The largest anthropogenic impact comes from riprap. The 550 linear feet of riprap in this subreach protects the railroad grade (Figure 49). Other impacts include a transmission line

crossing at the downstream end of the reach. Natural lateral control for the subreach is an alluvial fan; however, artificial lateral control from the railroad grade imposes greater influence due to the close proximity to the channel. Where the channel was observed to run against riprap, the noted consequences are reduced lateral migration, increased stream power, and thus vertical migration, homogeneity of channel units, and decreased in-stream habitat complexity. Large woody debris is low and pieces that do exist are concentrated in complexes at a few locations. The lack of large woody debris prevents the creation of complexity at higher flows. It is hypothesized that material is eroded when flows are increasing and deposited when flows are decreasing. The result is a plane bed with no real change in form.

Figure 49 - Channel unit transition from riffle to run and the hardened right bank, view is to the southeast looking downstream. Lower White Pine Reach; Subreach LWP IZ-1, Nason Creek - Wenatchee Subbasin, Washington. Bureau of Reclamation Photograph by D. Bennett; August 8, 2007.

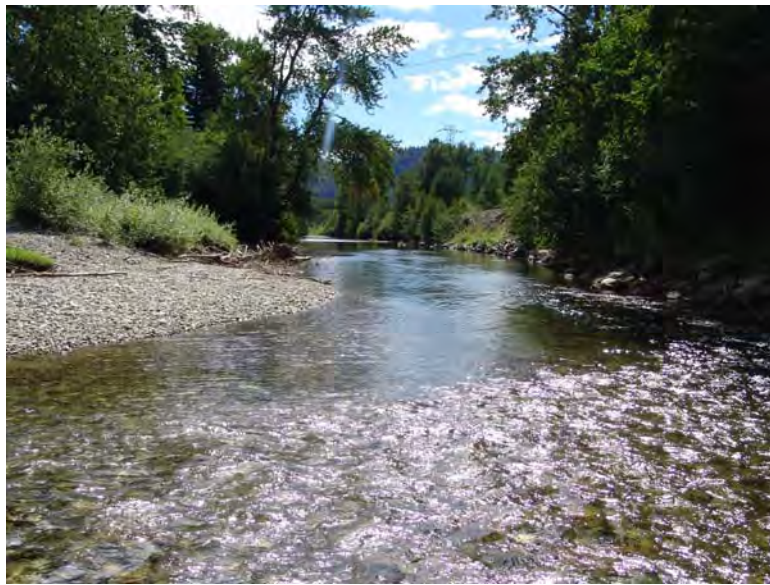
Figure 51 - Transition from riffle to run and the railroad grade acting as the right bank, view is to the southeast looking downstream. The railroad grade disconnects LWP DIZ-1 and LWP DOZ-2 from the active channel. Lower White Pine Reach; Subreach LWP IZ-3, Nason Creek - Wenatchee Subbasin, Washington. Bureau of Reclamation Photograph by D. Bennett; August 8, 2007.

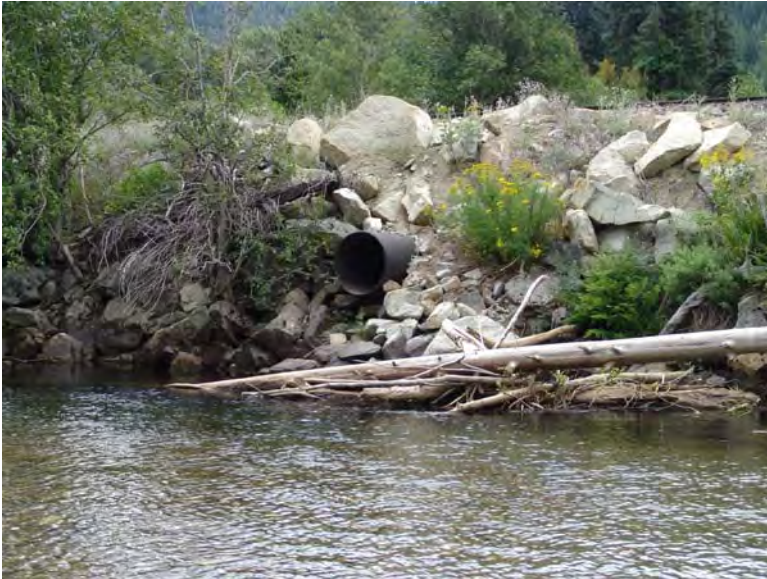
Figure 52 - Elevated culvert through the railroad grade that drains run off water from the area of LWP DIZ-1 and LWP DOZ-2, view is to the south. Lower White Pine Reach; Subreach IZ-3, Nason Creek - Wenatchee Subbasin, Washington. Bureau of Reclamation Photograph by D. Bennett; August 8, 2007.

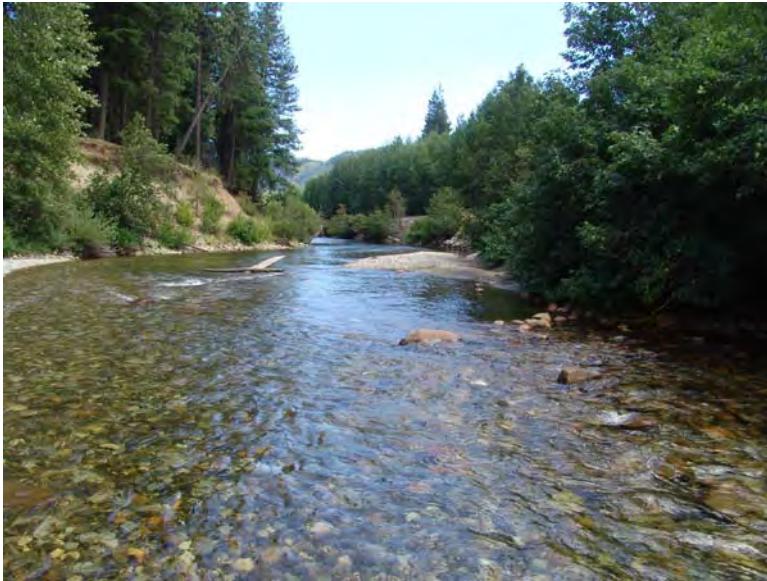
Figure 54 - Channel unit transition from riffle to run; the railroad grade that acts as the right bank and a high left bank, view is to the southeast looking downstream. Lower White Pine Reach; Subreach LWP IZ-5, Nason Creek - Wenatchee Subbasin, Washington. Bureau of Reclamation Photograph by D. Bennett; August 8, 2007.

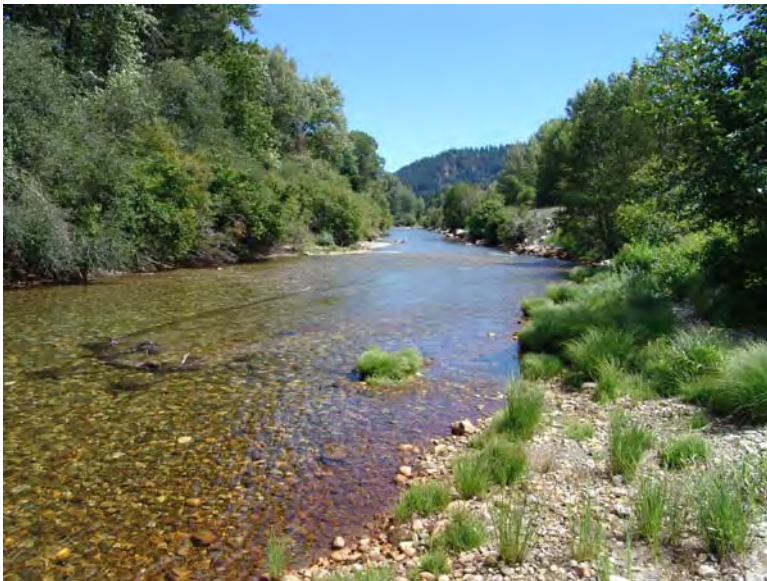
Figure 55 - Riffle in the straightened section of the active channel with the railroad grade acting as the right bank, view looking downstream to the east. Lower White Pine Reach; Subreach LWP IZ-5, Nason Creek - Wenatchee Subbasin, Washington. Bureau of Reclamation Photograph by D. Bennett; August 8, 2007.

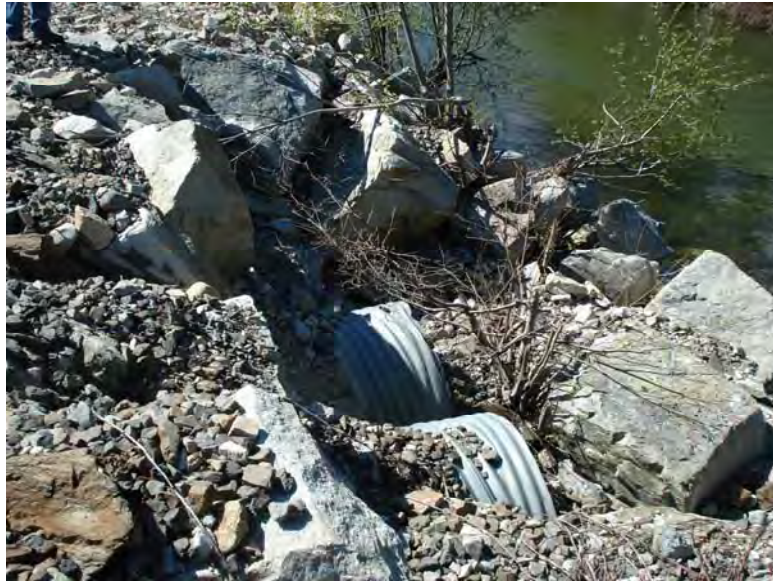
Figure 56 - Three elevated metal culverts that run through the railroad grade and drain the area of LWP DIZ-2 and LWP DOZ-4, view to the northwest. Lower White Pine Reach; Subreach LWP IZ-5, Nason Creek - Wenatchee Subbasin, Washington. Bureau of Reclamation Photograph by R. McAfee; May 4, 2007.

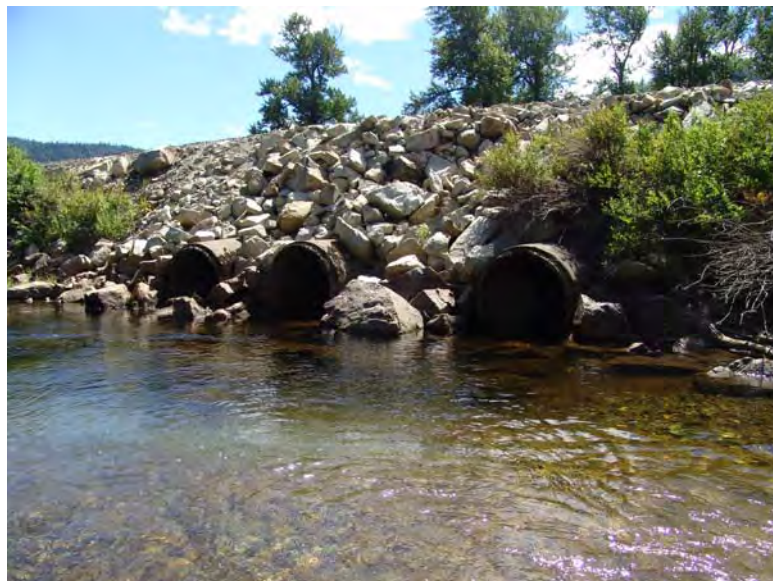
Figure 57 - Three concrete culverts that run through the railroad grade on the right bank, view is to the south. The culverts drain the area of LWP DIZ-2 and LWP DOZ-4. Lower White Pine Reach; Subreach LWP IZ-5, Nason Creek - Wenatchee Subbasin, Washington. Bureau of Reclamation Photograph by D. Bennett; August 8, 2007.

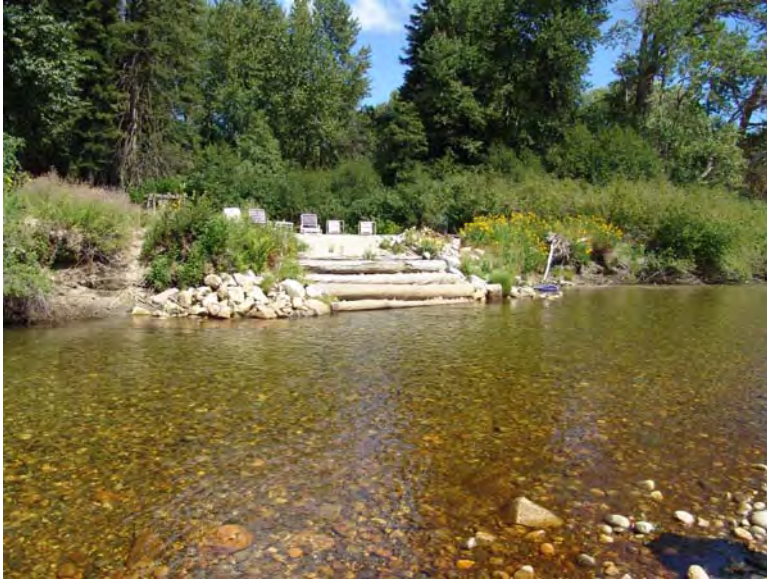
Figure 58 - Small riprap and a constructed boat launch on left bank, view is to the north. Lower White Pine Reach; Subreach LWP IZ-5, Nason Creek - Wenatchee Subbasin, Washington. Bureau of Reclamation Photograph by D. Bennett; August 8, 2007.

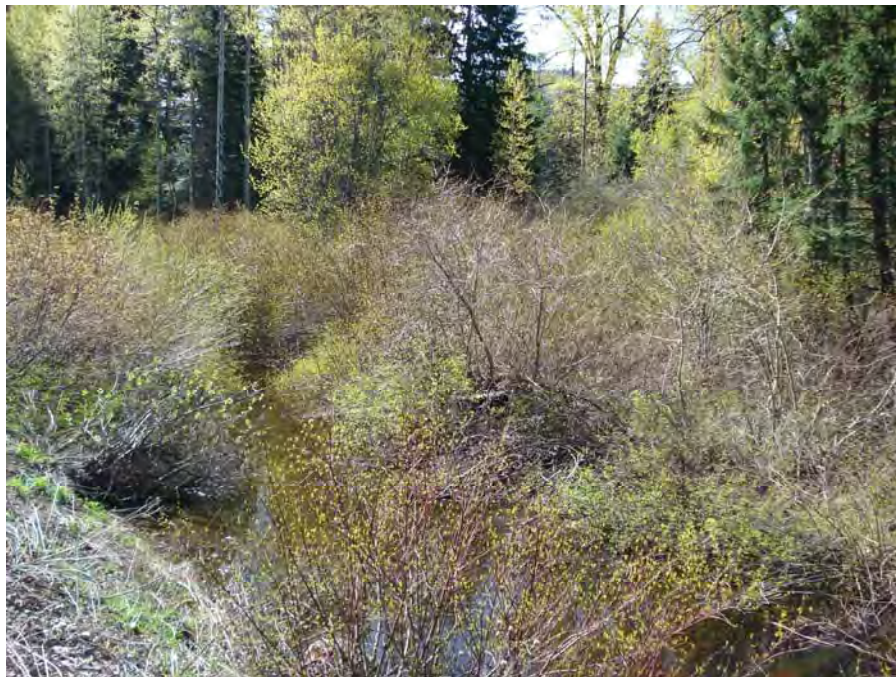
Photograph No. 1. View to the southeast of a historic meander of the main channel cutoff by the railroad grade. Lower White Pine Reach; Subreach DIZ-6, Nason Creek - Wenatchee Subbasin, Washington. Bureau of Reclamation Photograph by R. McAfee, May 5, 2007.

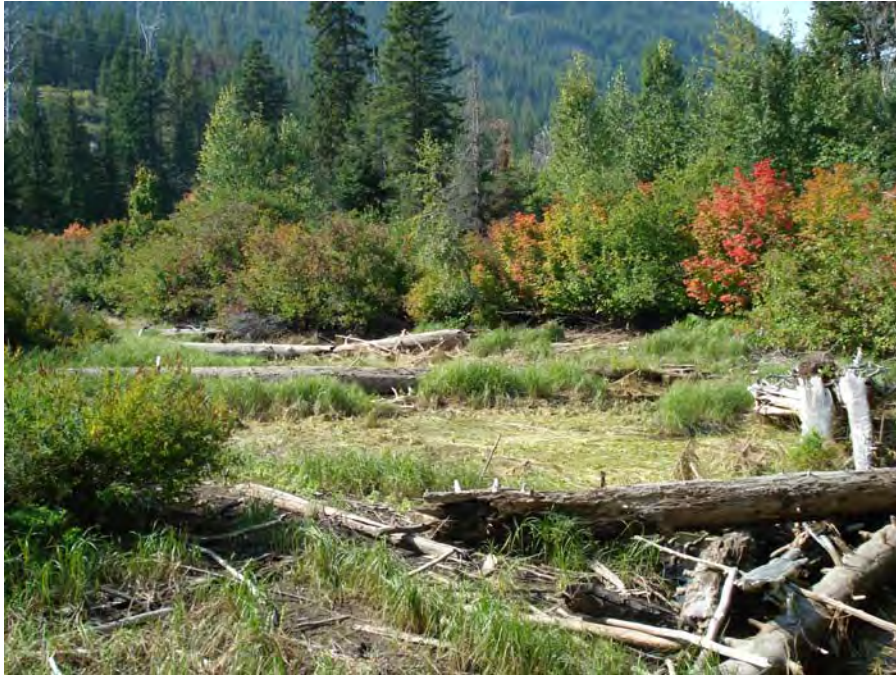
Photograph No. 2. View to the southwest of the historic main channel that is currently disconnected by the railroad grade. Lower White Pine Reach; Subreach DIZ-6, Nason Creek - Wenatchee Subbasin, Washington. Bureau of Reclamation Photograph by R. McAfee, September 9, 2008.
