Lower White Pine Reach Assessment

Nason Creek Chelan County, Washington

U.S. Department of the Interior
Bureau of Reclamation
Pacific Northwest Region
Boise, Idaho

February 2009

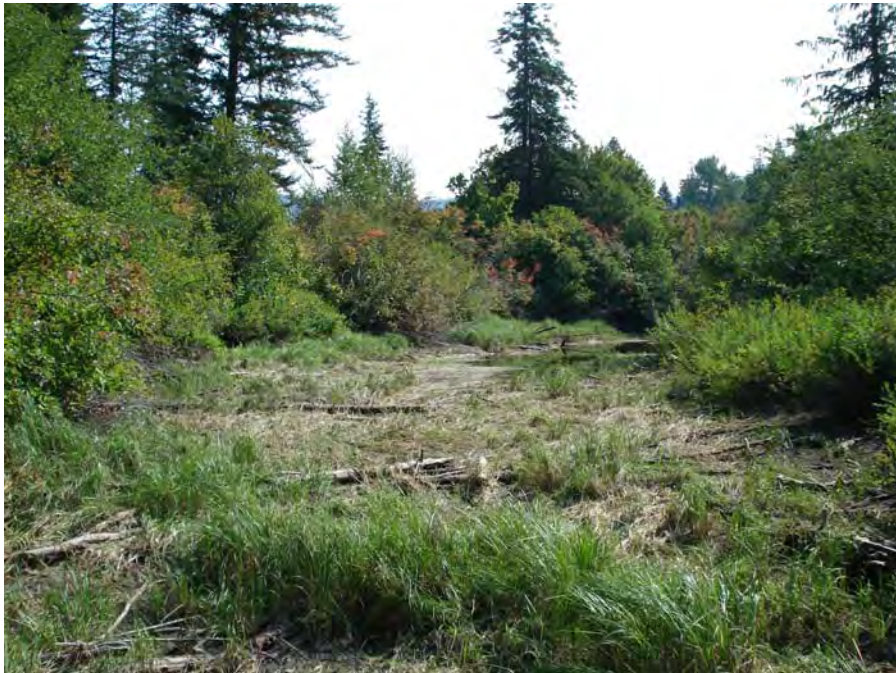
Photograph No. 3. View to the southeast of the historic main channel that is currently disconnected by the railroad grade. Lower White Pine Reach; Subreach DIZ-6, Nason Creek - Wenatchee Subbasin, Washington. Bureau of Reclamation Photograph by R. McAfee, September 9, 2008.

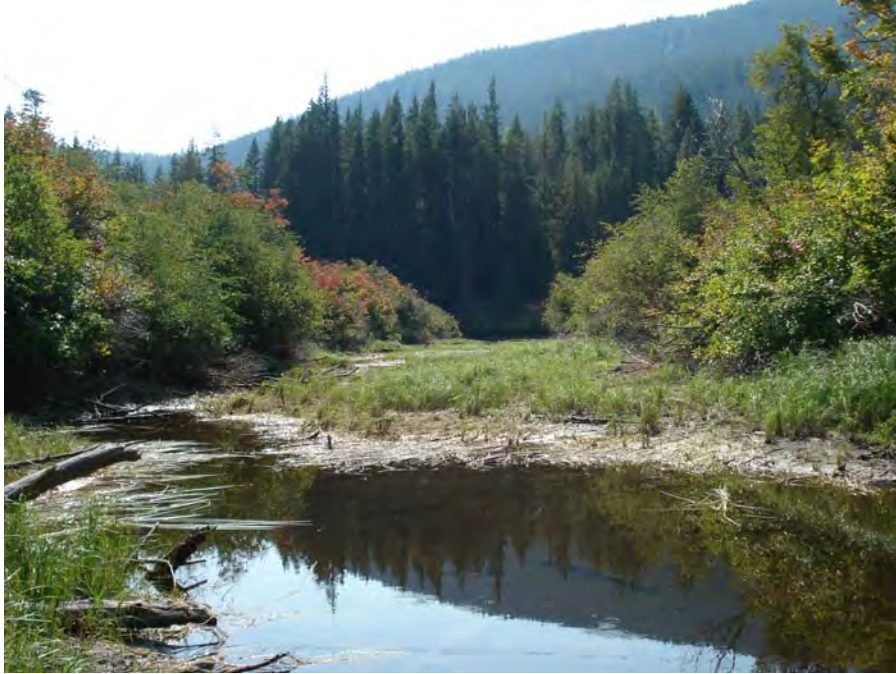
Photograph No. 4. View to the south of wetlands within the historic main channel that is currently disconnected by the railroad grade. Lower White Pine Reach; Subreach DIZ-6, Nason Creek - Wenatchee Subbasin, Washington. Bureau of Reclamation Photograph by R. McAfee, September 9, 2008.

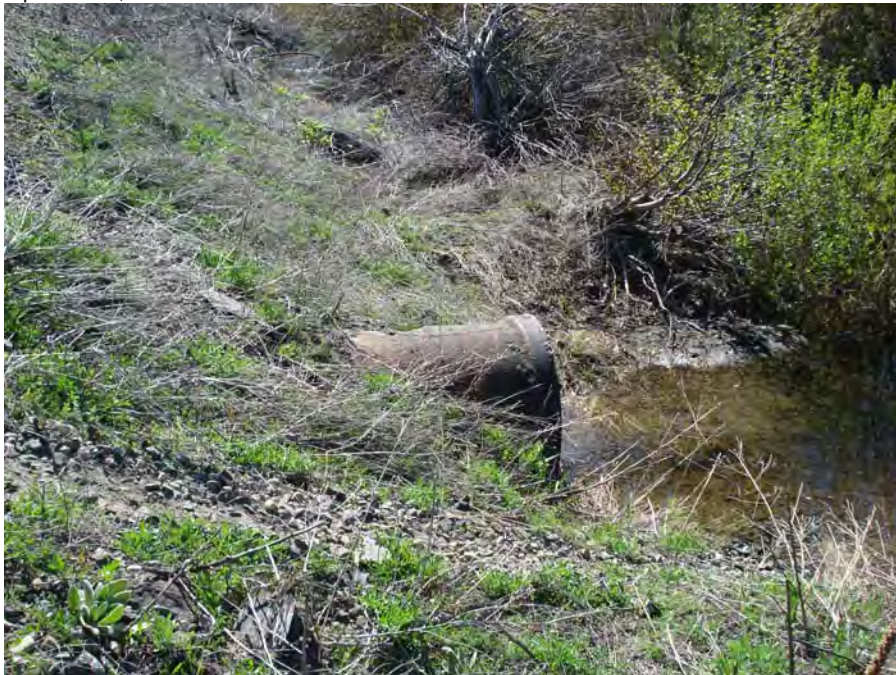
Photograph No. 5. View to the southeast of the culvert that drains the wetlands on the south side of the railroad grade at the downstream of the subreach. Lower White Pine Reach; Subreach DIZ-6, Nason Creek - Wenatchee Subbasin, Washington. Bureau of Reclamation Photograph by R. McAfee, May 5, 2007.

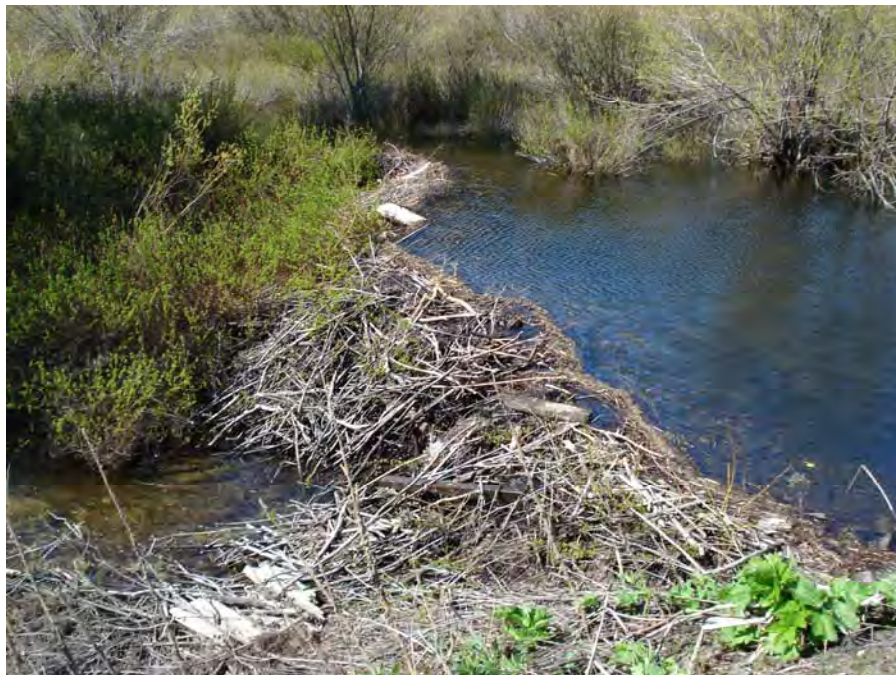
Photograph No. 1. View to the south showing a 4-foot tall beaver dam in the wetlands on the south side of the railroad grade. Lower White Pine Reach; Subreach DIZ-11,

Nason Creek - Wenatchee Subbasin, Washington. Bureau of Reclamation Photograph by R. McAfee, May 5, 2007.

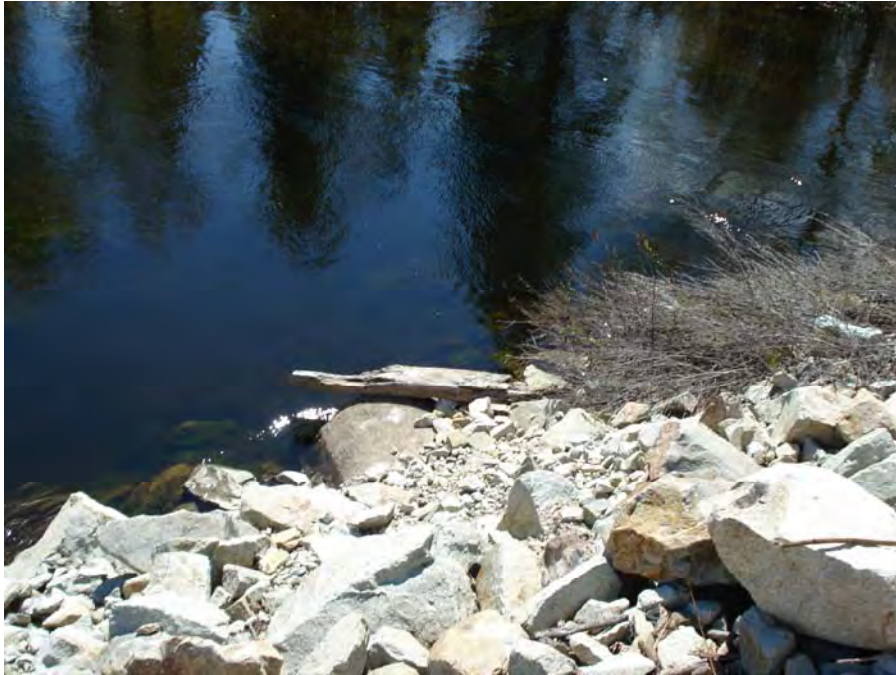
Photograph No. 2. View to the south of three 36-inch concrete culverts that drain the wetland complex to the river. Lower White Pine Reach; Subreach DIZ-11, Nason Creek - Wenatchee Subbasin, Washington. Bureau of Reclamation Photograph by R. McAfee, May 4, 2007.

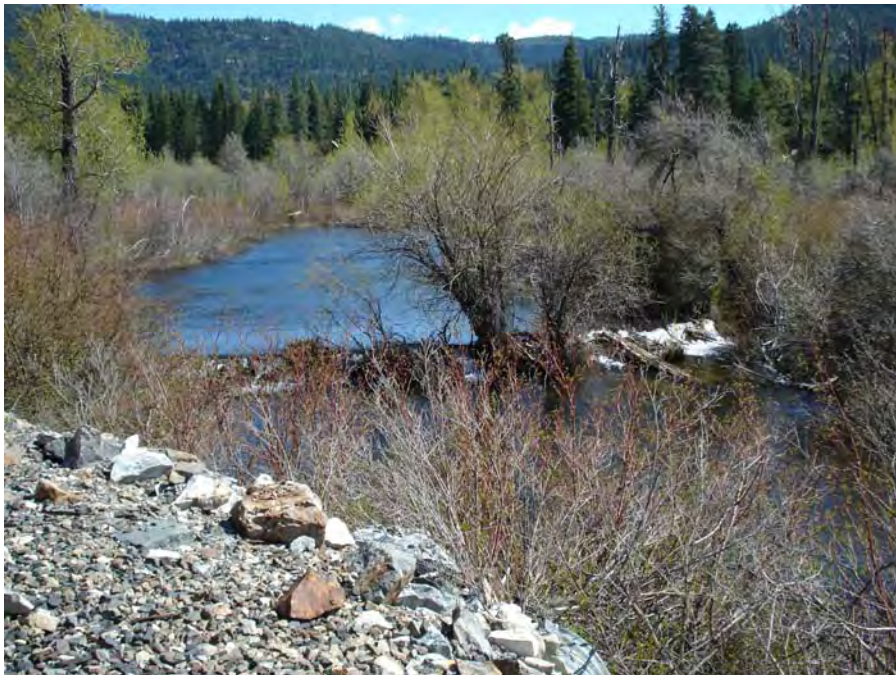
Photograph No. 3. View to the southeast of a larger beaver dam in a wetland complex located on the south side of the railroad grade. Lower White Pine Reach; Subreach DIZ-11, Nason Creek - Wenatchee Subbasin, Washington. Bureau of Reclamation Photograph by R. McAfee, May 4, 2007.

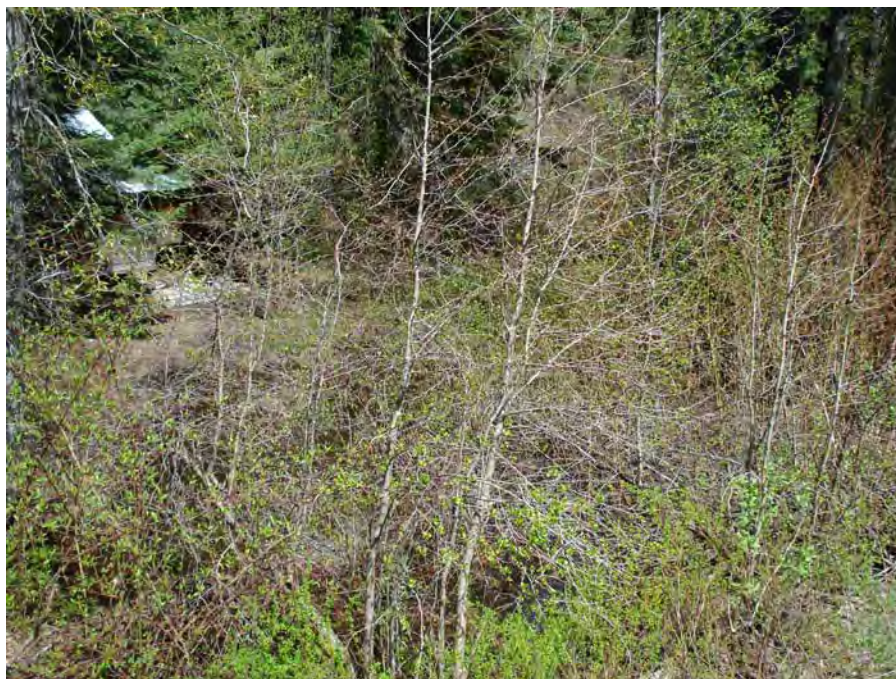
- 411 feet of Highway 2 disconnects this subreach from the adjacent floodplain.
- Just over a half of an acre of wetlands is located in the subreach (photographs 1-3).
- A culvert was noted in the downstream end of the subreach, but is believed to function as run off and ground water control, rather than fish passage (Photograph 4) .

Photograph No. 1. View to the Northwest of the top of an oxbow cut off by Highway 2. Lower White Pine Reach; Subreach DOZ-8a, Nason Creek - Wenatchee Subbasin, Washington. Bureau of Reclamation Photograph by R. McAfee, May 3, 2007.

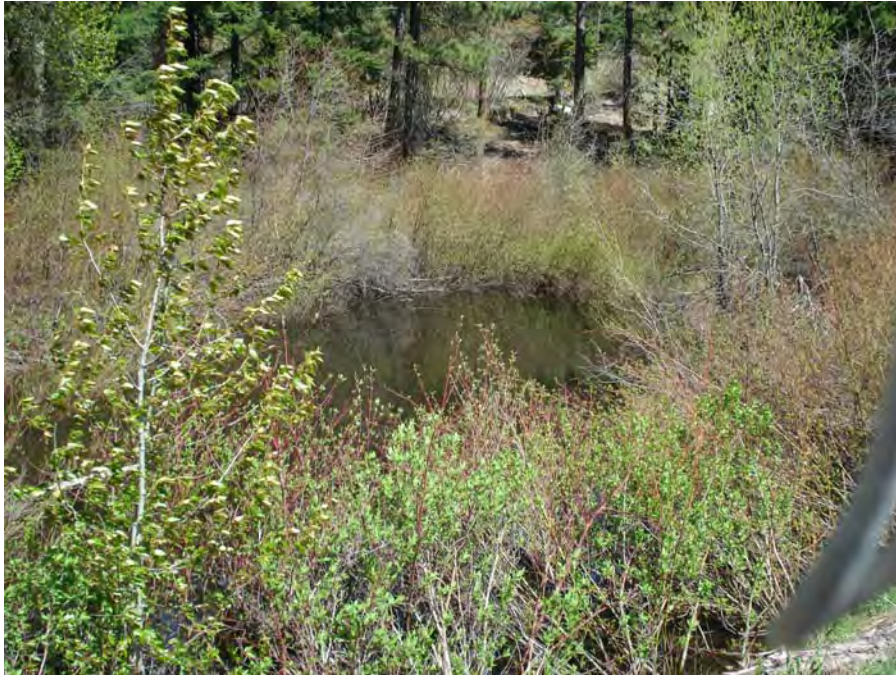
Photograph No. 2. View to the northeast of the top of a wetlands area on the north side of Highway 2. Lower White Pine Reach; Subreach DOZ-8a, Nason Creek - Wenatchee Subbasin, Washington. Bureau of Reclamation Photograph by R. McAfee, May 3, 2007.

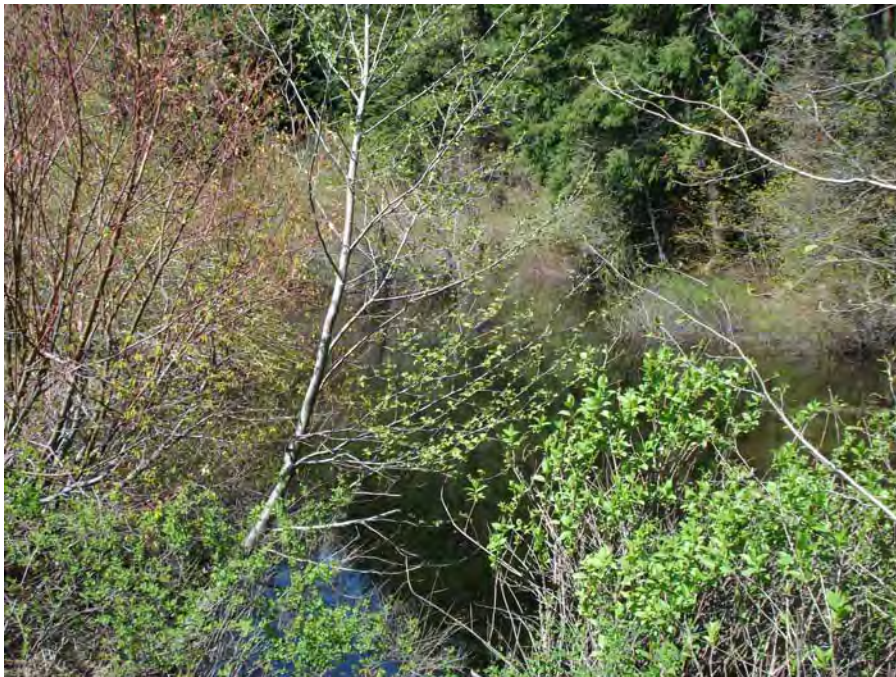
Photograph No. 3. View to the northwest of the bottom of the wetlands on the north side of the road. Lower White Pine Reach; Subreach DOZ-8a, Nason Creek - Wenatchee Subbasin, Washington. Bureau of Reclamation Photograph by R. McAfee, May 3, 2007.

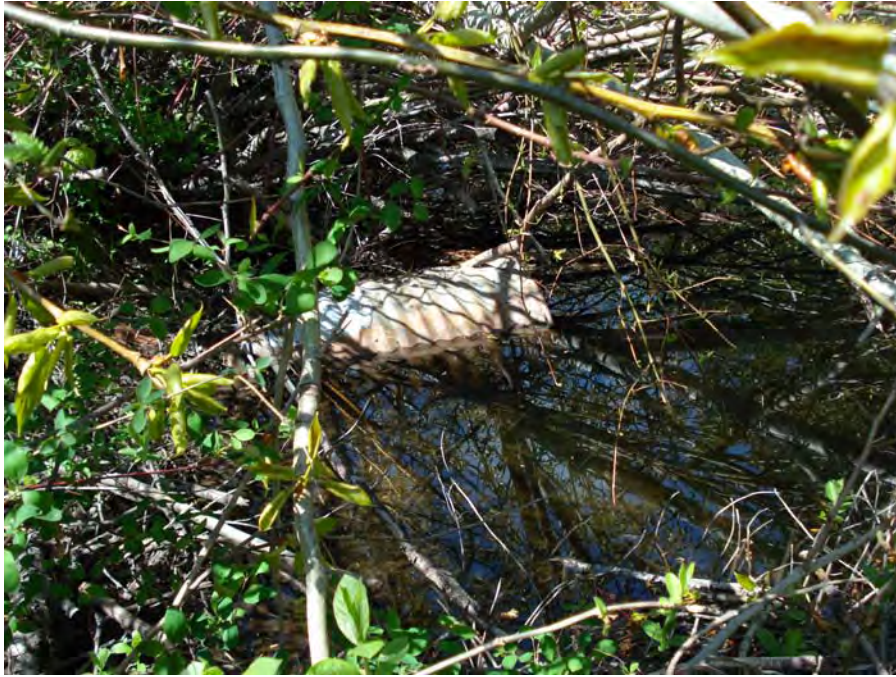
Photograph No. 4. View of the culvert that drains the wetlands on the north side of Highway 2. Lower White Pine Reach; Subreach DOZ-8a, Nason Creek - Wenatchee Subbasin, Washington. Bureau of Reclamation Photograph by R. McAfee, May 3, 2007.

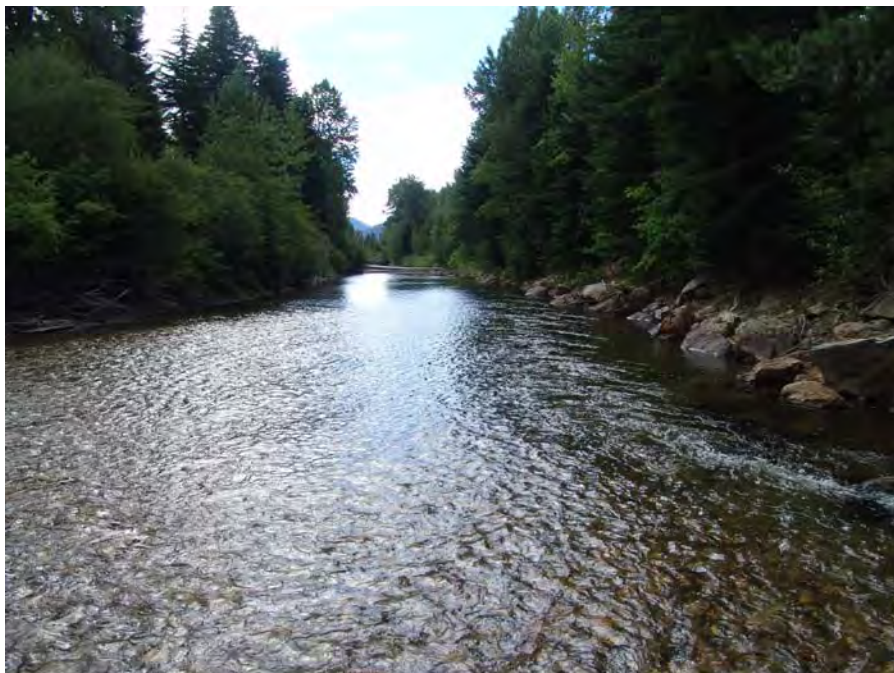
- 550 feet of riprap protects the railroad grade along the right bank (Photograph 1). The current channel is now located on the north side of the railroad grade.
- Local erosion was noted at location along the left bank (Photograph 2).
- Channel units are run and riffle with a plane-bed form (Photographs 3-6).
- 170 feet of transmission line crosses the subreach at the downstream end.
- There are no culverts through the railroad grade.

Photograph No. 1. View is to the southeast looking downstream at a channel unit transition from riffle to run and the hardened right bank. Lower White Pine Reach; Subreach

IZ-1, Nason Creek - Wenatchee Subbasin, Washington. Bureau of Reclamation Photograph by D. Bennett; August 8, 2007.

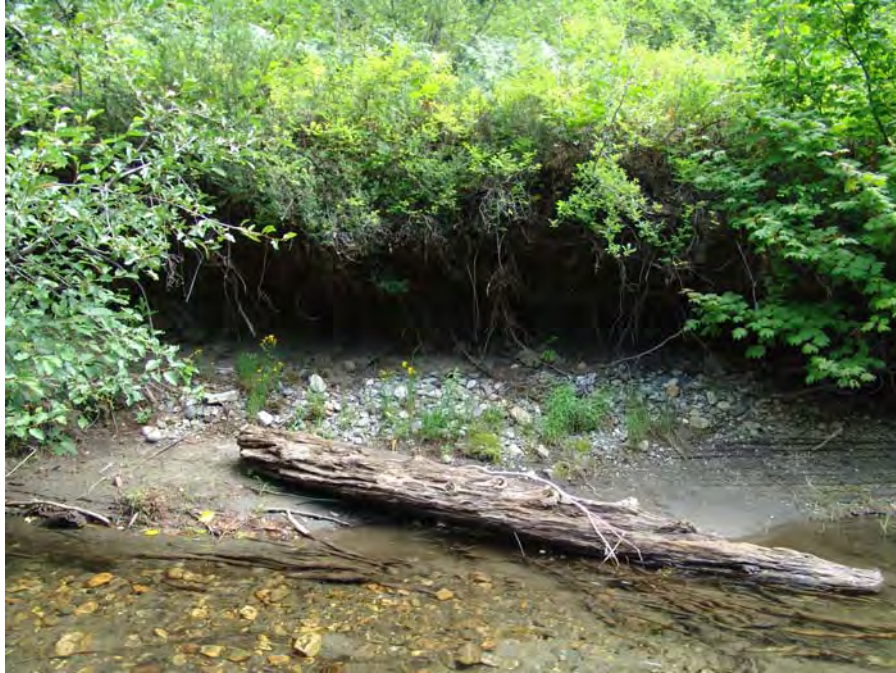
Photograph No. 2. View is to the north showing undercutting erosion and brush vegetation on left the bank. Lower White Pine Reach; Subreach IZ-1, Nason Creek - Wenatchee Subbasin, Washington. Bureau of Reclamation Photograph by D. Bennett; August 8, 2007.

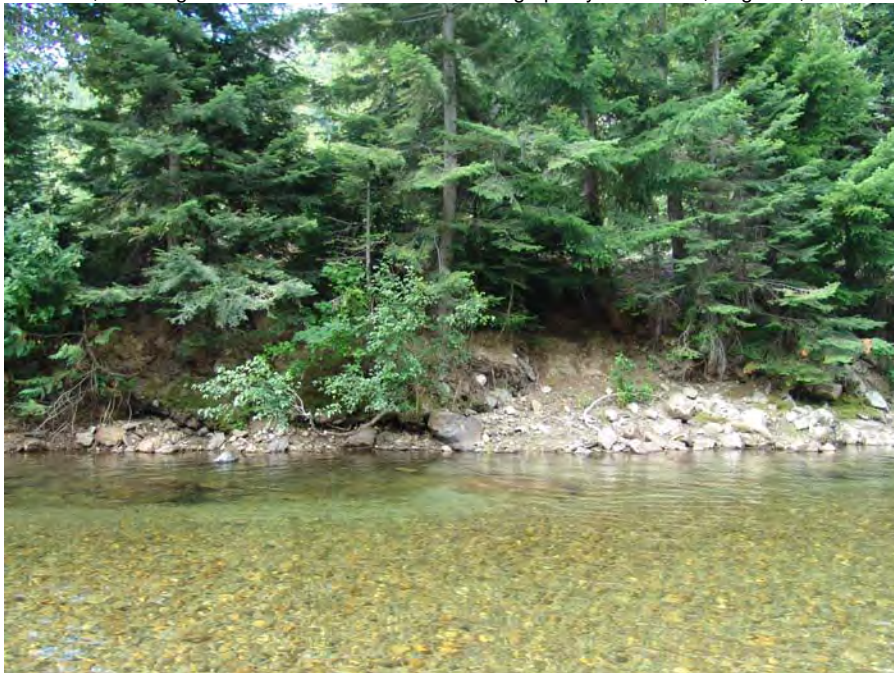
Photograph No. 3. View is to the south looking at the right bank where the railroad grade disconnects LWP DOZ-2 from the active channel. Lower White Pine Reach; Subreach IZ-1, Nason Creek - Wenatchee Subbasin, Washington. Bureau of Reclamation Photograph by D. Bennett; August 8, 2007.

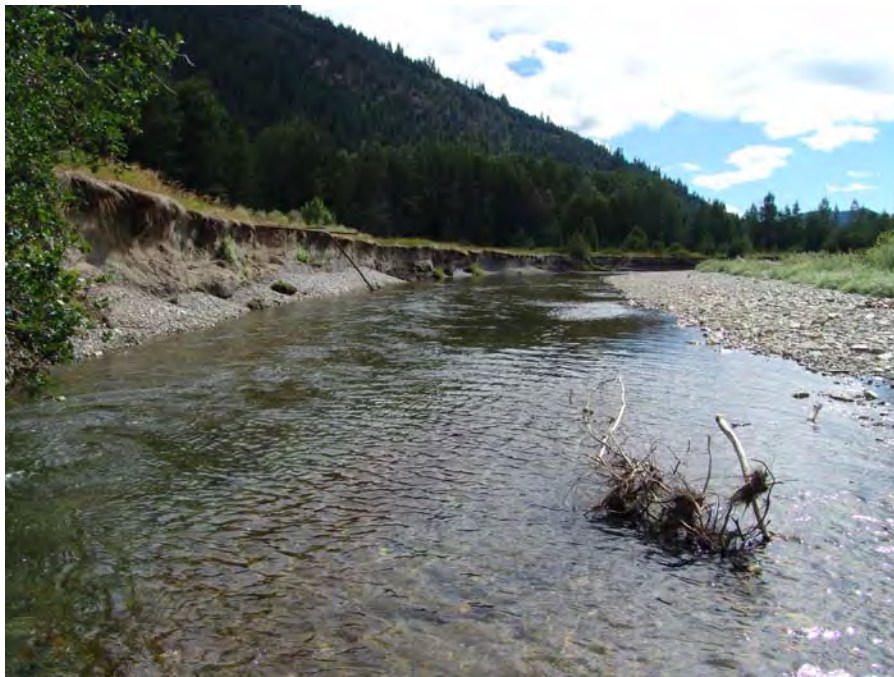
- Vegetation has been cleared from the left bank and the left bank is actively eroding (Photographs 1-3).
- Large wood is concentrated in 1 complex (Photographs 4 & 5).
- Substrate is gravel and cobble (Photograph 6).
- Tall gravel bars and brush vegetation observed along banks (Photograph 7 & 8).

Photograph No. 1. View is to the east looking downstream at the accelerated erosion along the cleared left bank. Lower White Pine Reach; Subreach IZ-2, Nason Creek - Wenatchee Subbasin, Washington. Bureau of Reclamation Photograph by D. Bennett; August 8, 2007.

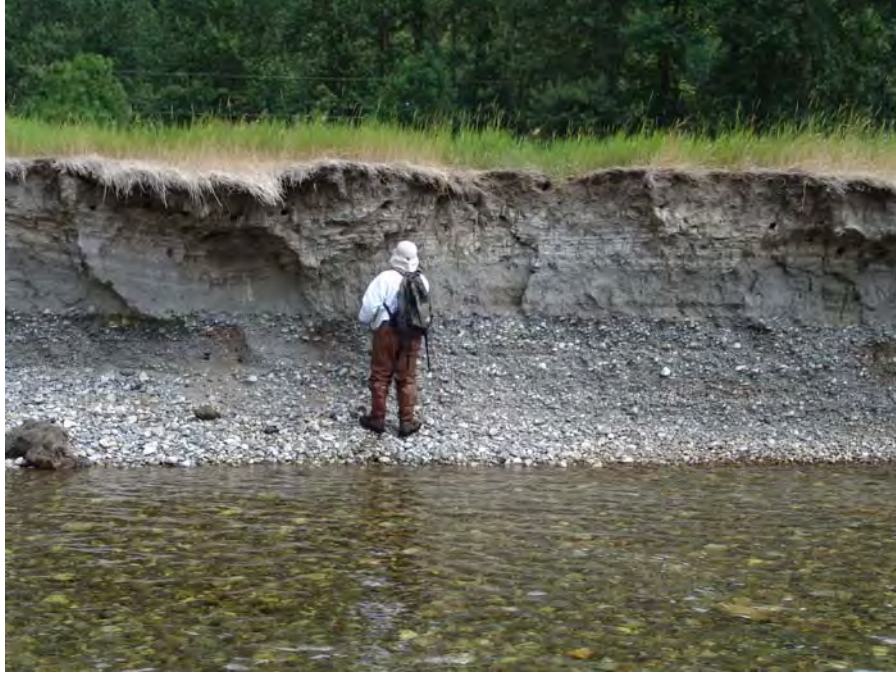
Photograph No. 2. View is to the north showing the stratified material in the left bank at a bank profile site. Lower White Pine Reach; Subreach IZ-2, Nason Creek - Wenatchee Subbasin, Washington. Bureau of Reclamation Photograph by D. Bennett; August 8, 2007.

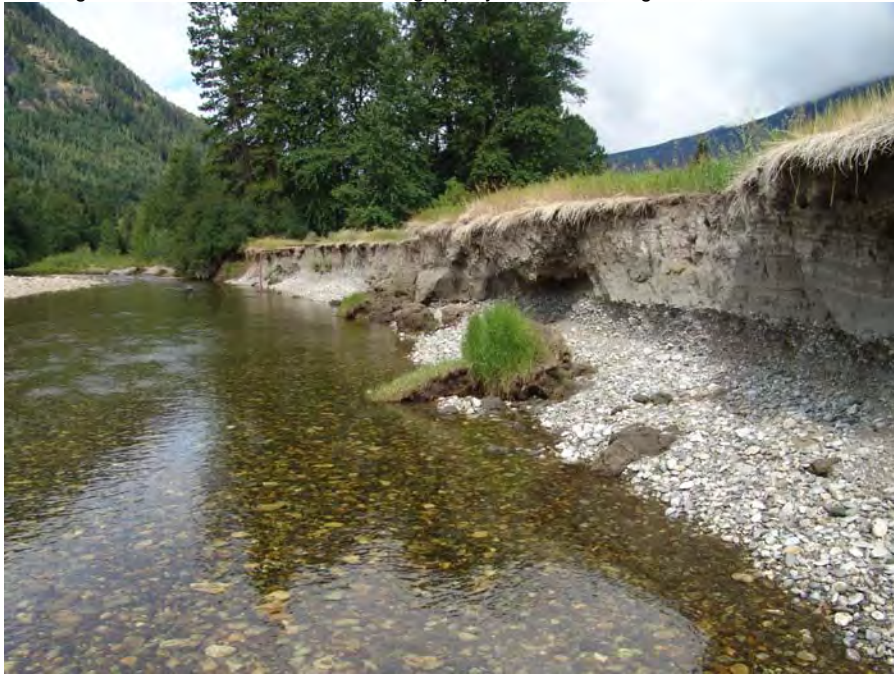
Photograph No. 3. View is to the west looking upstream, showing stratified material and accelerated erosion along the left bank. Lower White Pine Reach; Subreach IZ-2, Nason Creek - Wenatchee Subbasin, Washington. Bureau of Reclamation Photograph by D. Bennett; August 8, 2007.

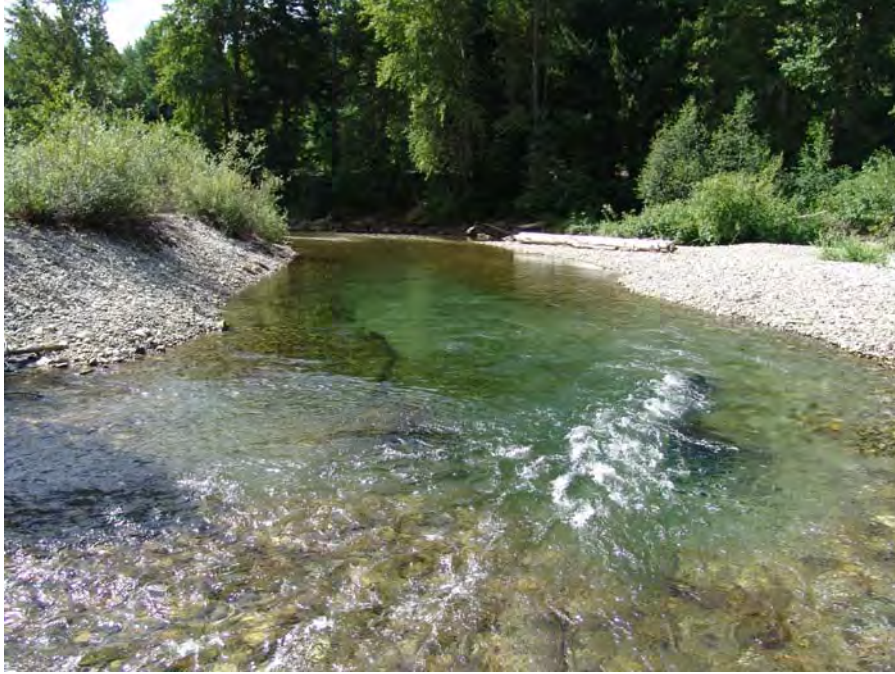
Photograph No. 8. View is to the south looking downstream showing a channel unit transition from riffle to scour pool, and the railroad grade along the right bank where the channel bends to the left. Lower White Pine Reach; Subreach IZ-2, Nason Creek - Wenatchee Subbasin, Washington. Bureau of Reclamation Photograph by D. Bennett; August 8, 2007.

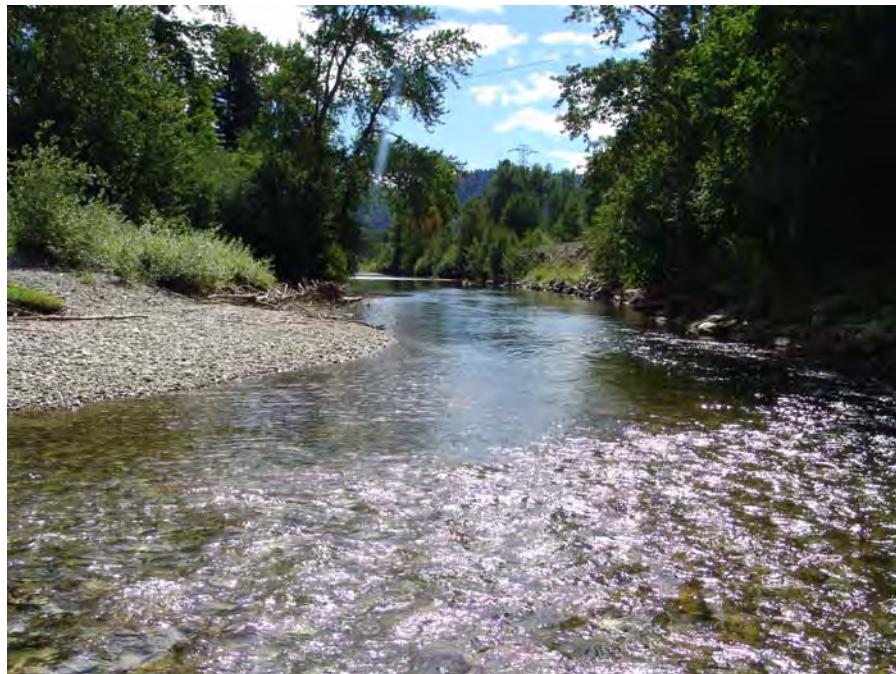
- 2057 feet of riprap protects the railroad grade along the right bank (Photographs 1 & 9). The railroad grade disrupts the historic main channel path. The current channel is now located on the north side of the railroad grade.
- Channel units are mostly riffle and run with a plane-bed form (Photographs 1, 4, 5, 8 & 11).
- Substrate is gravel with cobbles (photographs 2, 6 & 7)
- Erosion was noted along the left bank where vegetation has been altered or removed (Photographs 5 & 8)
- 192 feet of power line crosses the subreach at the downstream end (Photograph 9).
- There is a culvert through the railroad grade at the downstream end; however the culvert does not provide access from the current channel at base flow (Photograph 10).
- An additional 237 feet of riprap protects the powerline along the right bank at the downstream end of the subreach (Photograph 11).

Photograph No. 1. View is to the southeast looking downstream of a transition from riffle to run and the railroad grade acting as the right bank. The railroad grade

disconnects LWP DIZ-2 and LWP 4 from the active channel. Lower White Pine Reach; Subreach IZ-3, Nason Creek - Wenatchee Subbasin, Washington. Bureau of Reclamation Photograph by D. Bennett; August 8, 2007.

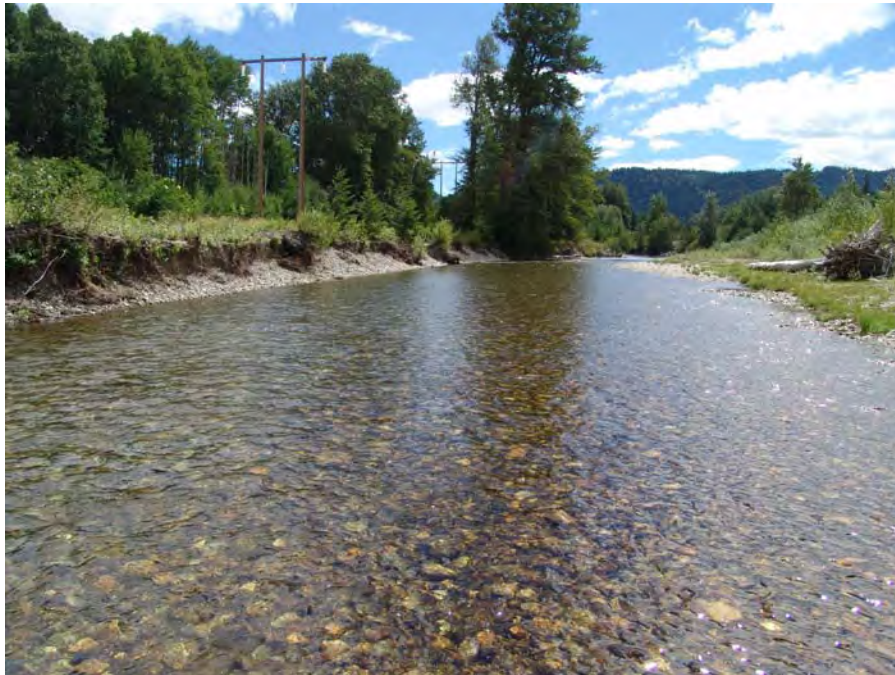
Photograph No. 5. View is to the southeast looking downstream at erosion along the left bank. Note the vegetation removal and a long run for the channel unit. Lower White Pine Reach; Subreach IZ-3, Nason Creek - Wenatchee Subbasin, Washington. Bureau of Reclamation Photograph by D. Bennett; August 8, 2007.

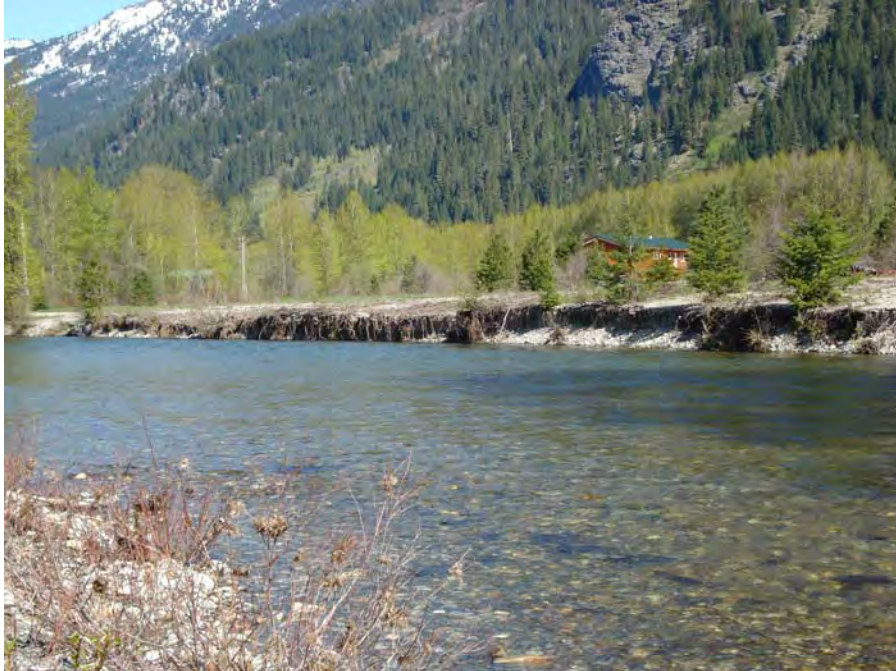
Photograph No. 8. View to the northwest of the eroding left bank with vegetation removed. Lower White Pine Reach; Subreach IZ-3, Nason Creek - Wenatchee Subbasin, Washington. Bureau of Reclamation Photograph by R. McAfee; May 5, 2007.

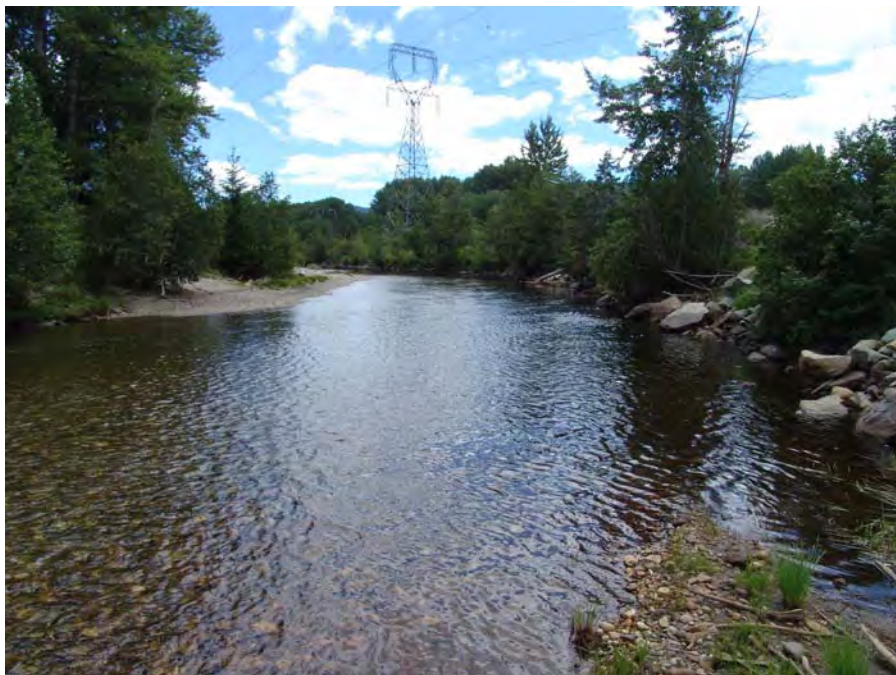
Photograph No. 9. View is to the southeast looking downstream showing a long run for the channel unit and the railroad grade on the right bank that disconnects LWP DIZ-2 and DOZ-4. Lower White Pine Reach; Subreach IZ-3, Nason Creek - Wenatchee Subbasin, Washington. Bureau of Reclamation Photograph by D. Bennett; August 8, 2007.

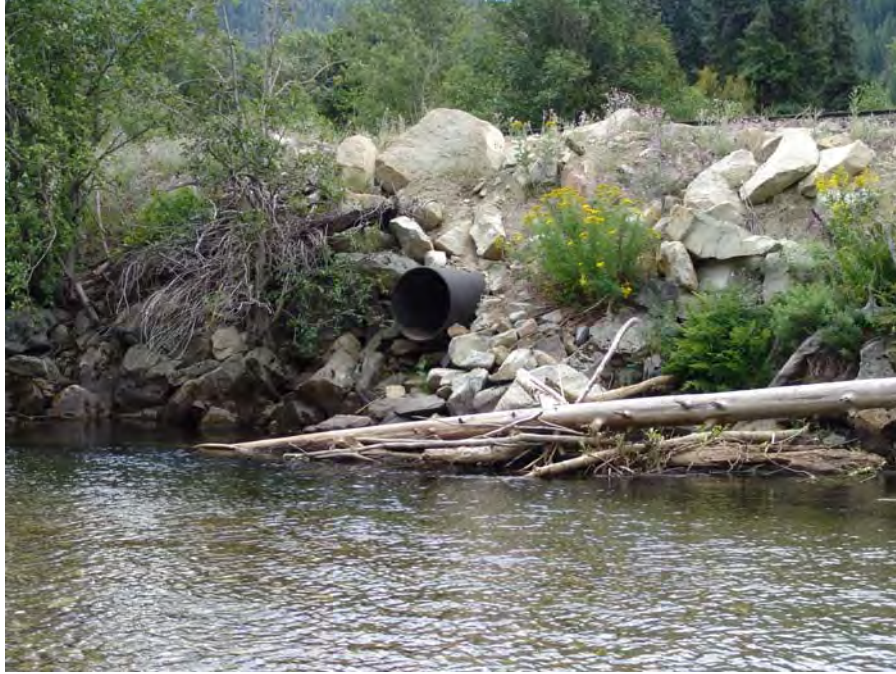
Photograph No. 10. View is to the south looking at an elevated culvert through the railroad grade that drains run off water from the area of LWP DIZ-2 and LWP DOZ-4. Lower White Pine Reach; Subreach IZ-3, Nason Creek - Wenatchee Subbasin, Washington. Bureau of Reclamation Photograph by D. Bennett; August 8, 2007.

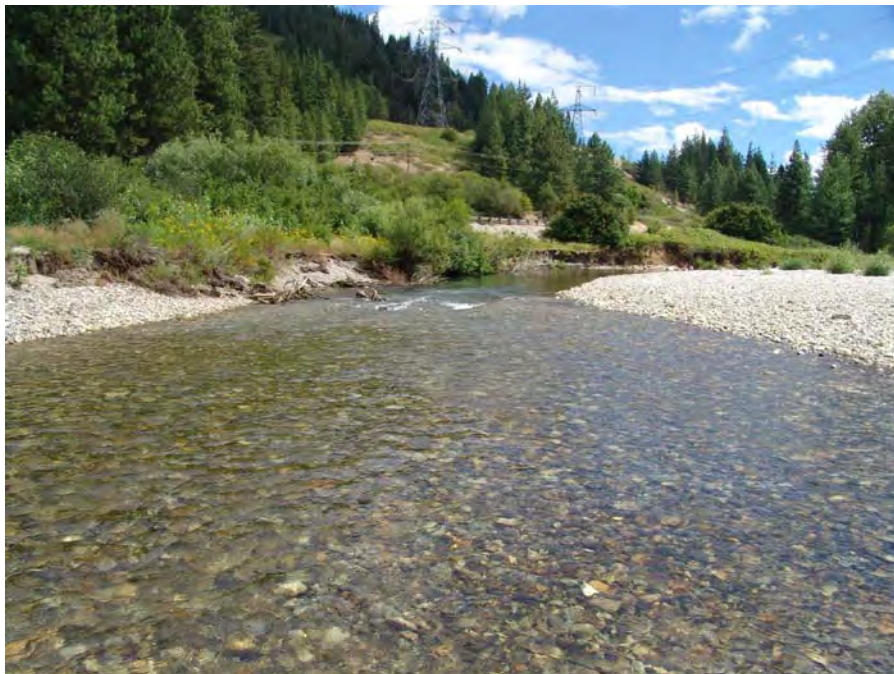
- Erosion was noted along left bank (Photographs 1-6).
- An instream structure is located at RM 10.35 (Photograph 7) and a cabled log at RM 10.29.
- Tall gravel bars with brush vegetation were noted (Photograph 8 & 9)
- Substrate is gravel and cobble (Photographs 10 & 12)
- Slightly more complexity exists in the downstream end of the subreach (Photograph 11).
- About 70 feet of riprap protects the railroad grade along the right bank at the downstream end of the subreach (Photograph 13).
- 122 feet of powerline crosses the subreach in the mid-section.
- 130 feet of transmission line that crosses the subreach at the downstream end.

Photograph No. 1. View is to the northeast looking downstream at a channel unit sequence of run-riffle-pool and erosion along the left bank. Lower White Pine Reach;

Subreach IZ-4, Nason Creek - Wenatchee Subbasin, Washington. Bureau of Reclamation Photograph by D. Bennett; August 8, 2007.

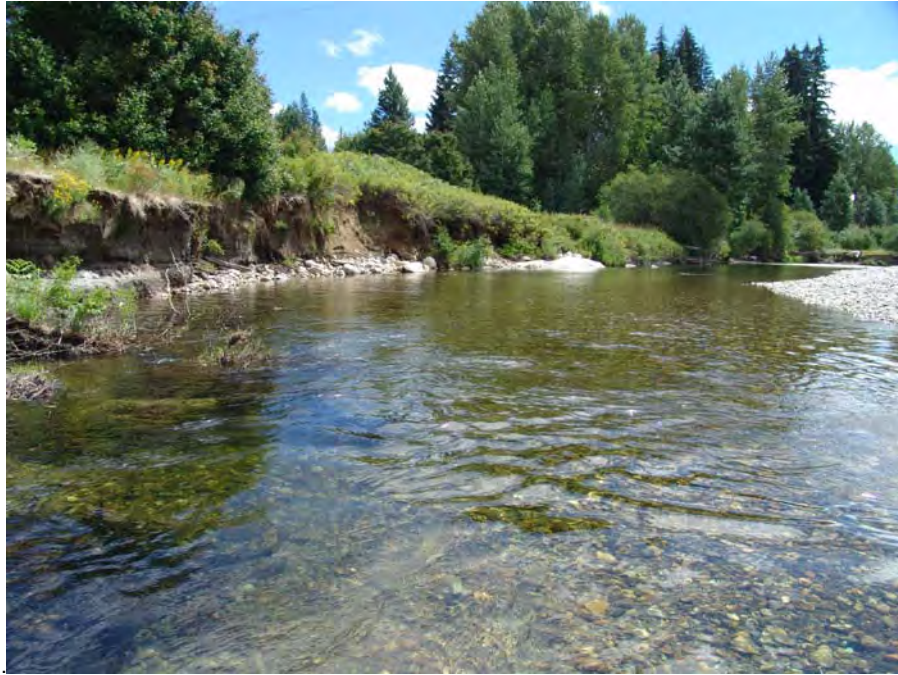
Photograph No. 2. View is to the east looking downstream at pool and glide channel units and erosion along the left bank. Lower White Pine Reach; Subreach IZ-4, Nason Creek - Wenatchee Subbasin, Washington. Bureau of Reclamation Photograph by D. Bennett; August 8, 2007.

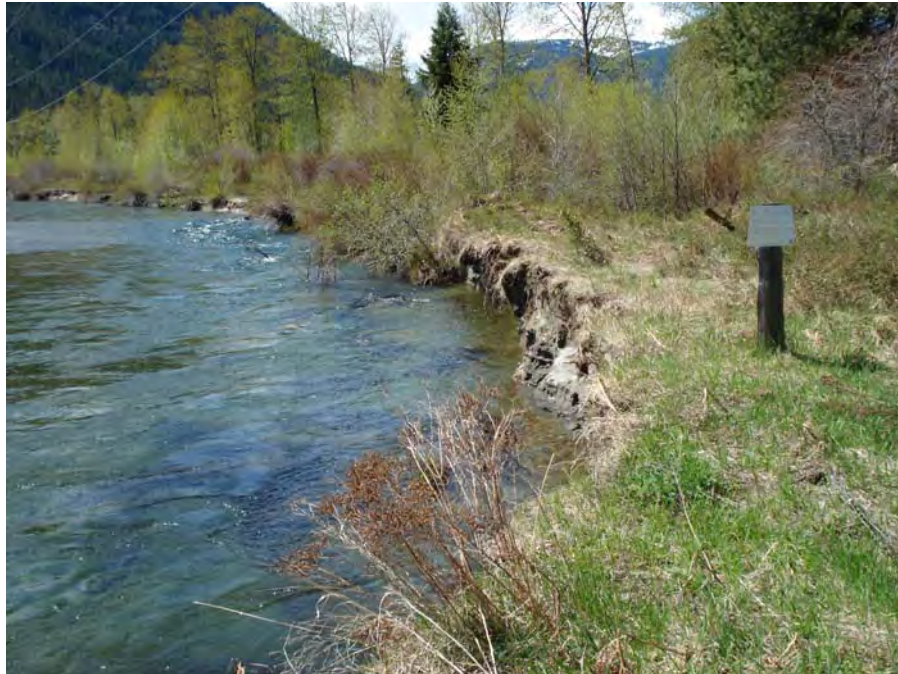
Photograph No. 3. View to the northwest looking upstream at brushy vegetation and the undercut/eroding along the left bank. Lower White Pine Reach; Subreach IZ-4, Nason Creek - Wenatchee Subbasin, Washington. Bureau of Reclamation Photograph by R. McAfee; May 3, 2007.

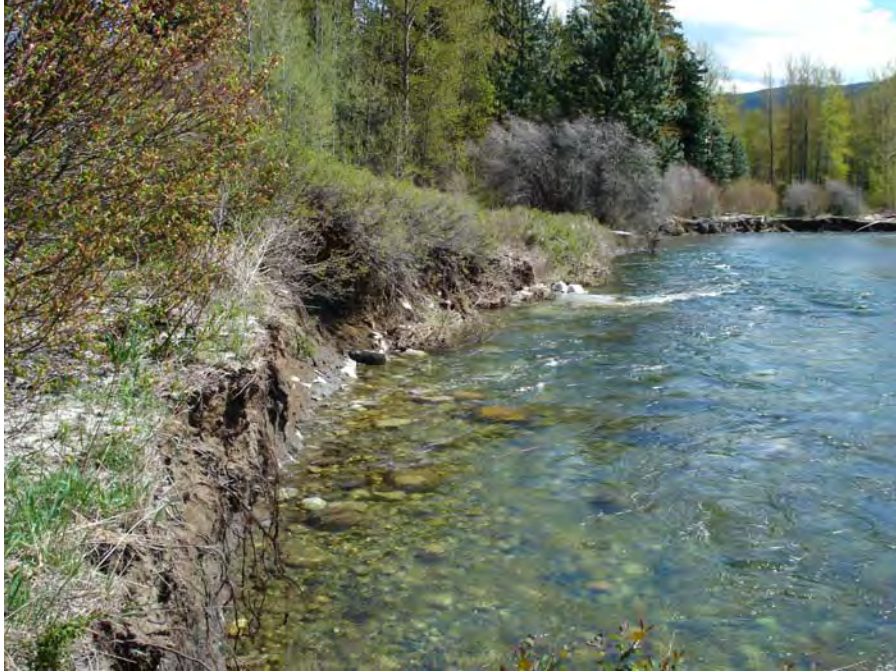
Photograph No. 4. View looking downstream to the southeast of grass and brush vegetation of, and undercut/eroding along the left bank. Lower White Pine Reach; Subreach IZ-4, Nason Creek - Wenatchee Subbasin, Washington. Bureau of Reclamation Photograph by R. McAfee; May 3, 2007.

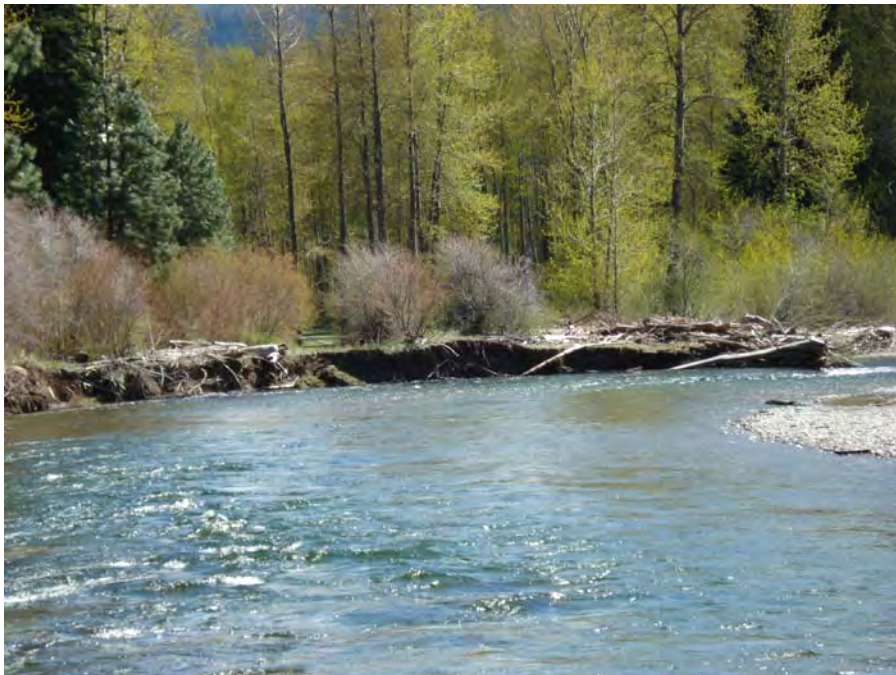
Photograph No. 5. View to the southwest of a channel unit sequence of riffle-run-riffle and undercut/eroding along the left bank. Lower White Pine Reach; Subreach IZ-4, Nason Creek - Wenatchee Subbasin, Washington. Bureau of Reclamation Photograph by R. McAfee; May 3, 2007.

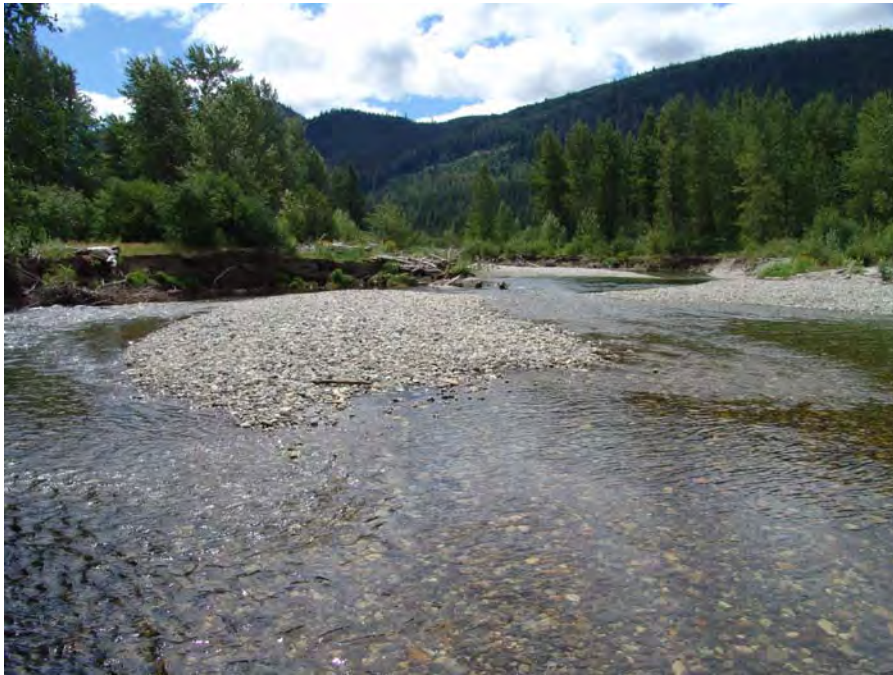
Photograph No. 6. View is to the south looking downstream at a split flow with a channel unit transition of run to riffle/rapid and erosion along the left bank. Lower White Pine Reach; Subreach IZ-4, Nason Creek - Wenatchee Subbasin, Washington. Bureau of Reclamation Photograph by D. Bennett; August 8, 2007.

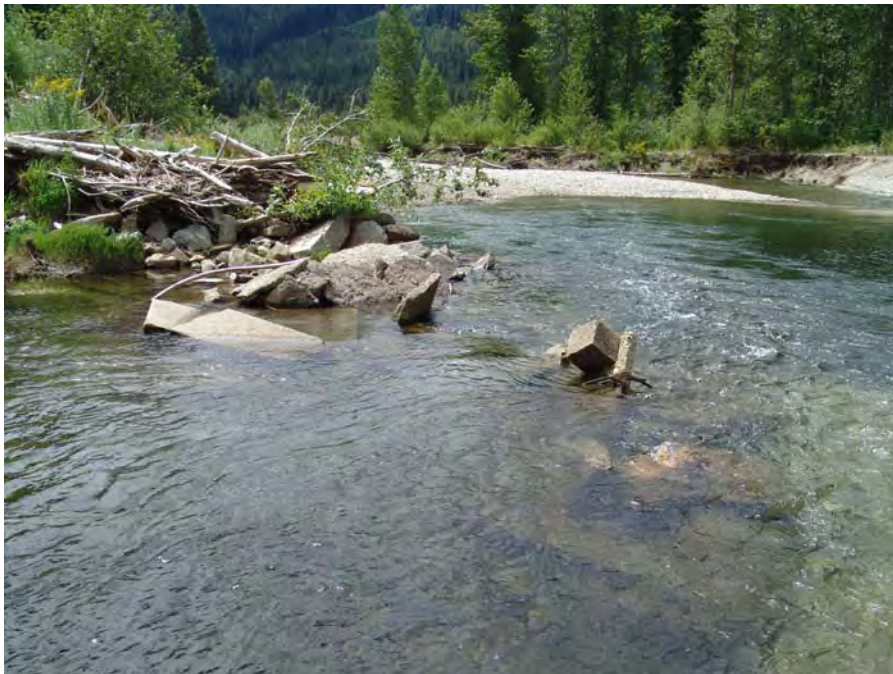
Photograph No. 7. View to the south looking at an in-channel structure comprised of concrete ecology blocks, miscellaneous concrete slabs and riprap. Lower White Pine Reach; Subreach IZ-4, Nason Creek - Wenatchee Subbasin, Washington. Bureau of Reclamation Photograph by D. Bennett; August 8, 2007.

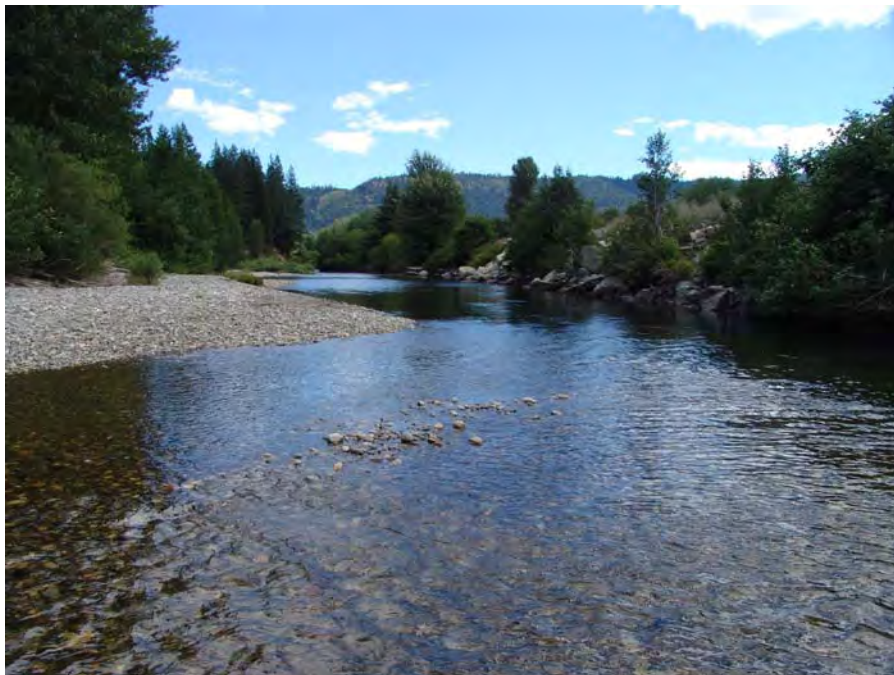
Photograph No. 13. View is to the southeast looking downstream of a channel unit transition from riffle to run and riprap along the right bank. Lower White Pine Reach; Subreach IZ-4, Nason Creek - Wenatchee Subbasin, Washington. Bureau of Reclamation Photograph by D. Bennett; August 8, 2007.

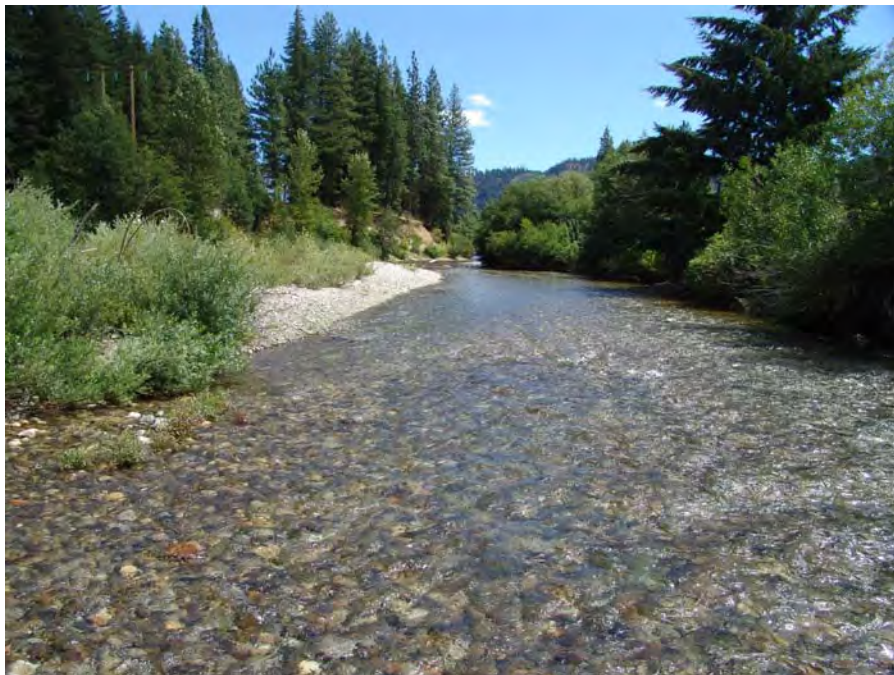
- Two sections of riprap totaling 2,082 feet protect the railroad grade along the right bank (Photographs 1, 2, 4, 9 and 10). The railroad grade disrupts the historic main channel path. The current channel is now located on the north side of the railroad grade.
- Point bars ranging from small to large are noted throughout the subreach (photographs 1, 2, 6, 9, 10, 16, 18 and 19).
- Dominant substrate is gravel and cobble (Photograph 3).
- Channel units are predominantly run and riffle (Photographs 4, 6, 9, 10, 16 and 18).
- Two sets of triple culverts are placed in the railroad grade at the downstream end (Photographs 12-15); however the culverts may not provide access from the current channel at base flow.
- The bank is modified with a small rock spur and log boat ramp near RM 9.67 (Photograph 17).

Photograph No. 1. View is to the southeast looking downstream at a channel unit transition of riffle to run and the railroad grade acting as the right bank. The railroad grade disconnects LWP DIZ-2 and LWP DOZ-4 from the active channel. Lower White

Pine Reach; Subreach IZ-5, Nason Creek - Wenatchee Subbasin, Washington. Bureau of Reclamation Photograph by D. Bennett; August 8, 2007.
