Lower White Pine Reach Assessment

Nason Creek Chelan County, Washington

U.S. Department of the Interior
Bureau of Reclamation
Pacific Northwest Region
Boise, Idaho

February 2009

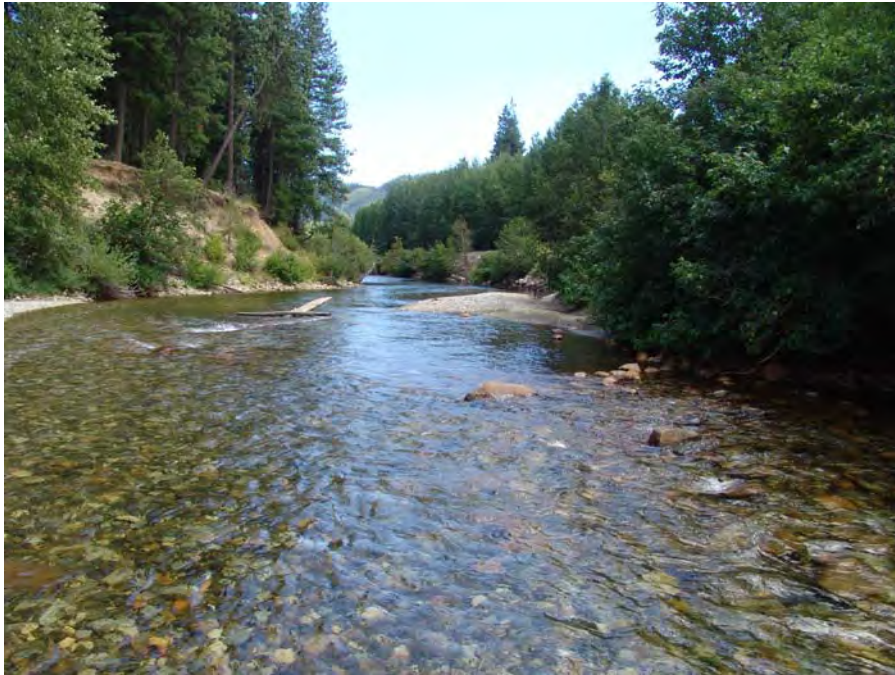
- Two sections of riprap totaling 2,082 feet protect the railroad grade along the right bank (Photographs 1, 2, 4, 9 and 10). The railroad grade disrupts the historic main channel path. The current channel is now located on the north side of the railroad grade.
- Point bars ranging from small to large are noted throughout the subreach (photographs 1, 2, 6, 9, 10, 16, 18 and 19).
- Dominant substrate is gravel and cobble (Photograph 3).
- Channel units are predominantly run and riffle (Photographs 4, 6, 9, 10, 16 and 18).
- Two sets of triple culverts are placed in the railroad grade at the downstream end (Photographs 12-15); however the culverts may not provide access from the current channel at base flow.
- The bank is modified with a small rock spur and log boat ramp near RM 9.67 (Photograph 17).

Photograph No. 2. View is to the southeast looking downstream at a channel unit transition from riffle to run, the railroad grade that acts as the right bank and a high left bank. Lower White Pine Reach; Subreach IZ-5, Nason Creek - Wenatchee Subbasin, Washington. Bureau of Reclamation Photograph by D. Bennett; August 8, 2007.

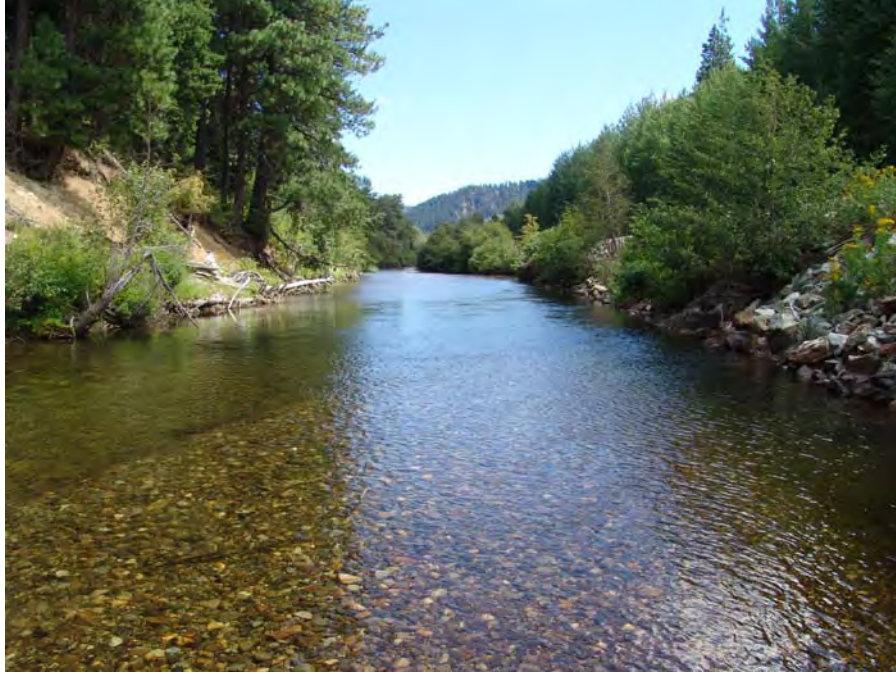
Photograph No. 4. View to the southeast looking downstream showing a long run, the high left bank and the railroad grade that acts as the right bank. Lower White Pine Reach; Subreach IZ-5, Nason Creek - Wenatchee Subbasin, Washington. Bureau of Reclamation Photograph by D. Bennett; August 8, 2007.

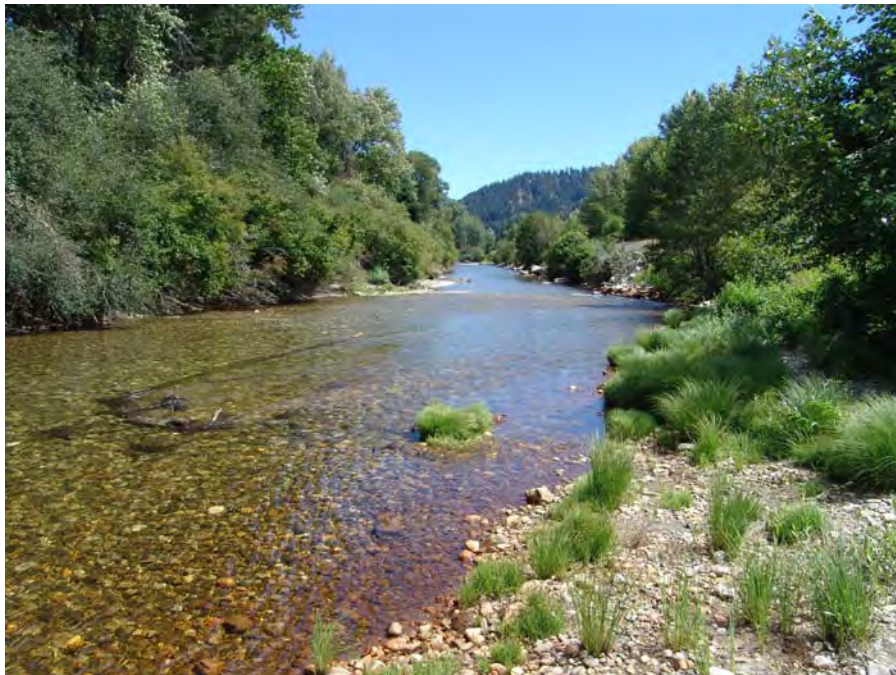
Photograph No. 9. View looking downstream to the east at a riffle in the straightened section of the active channel with the railroad grade acting as the right bank. Lower White Pine Reach; Subreach IZ-5, Nason Creek - Wenatchee Subbasin, Washington. Bureau of Reclamation Photograph by D. Bennett; August 8, 2007.

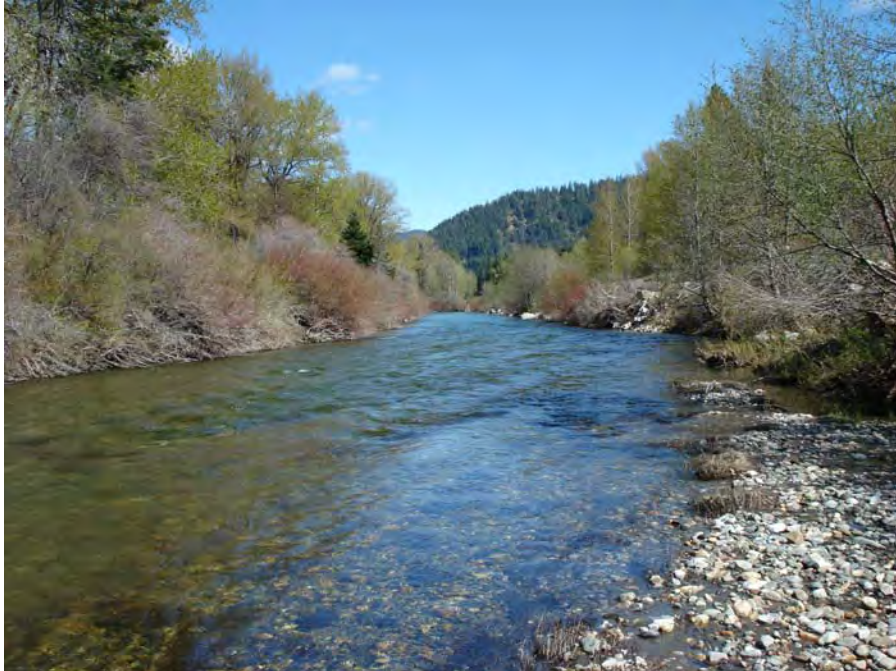
Photograph No. 10. View looking downstream to the east at a riffle in the straightened section of the active channel with the railroad grade acting as the right bank. Lower White Pine Reach; Subreach IZ-5, Nason Creek - Wenatchee Subbasin, Washington. Bureau of Reclamation Photograph by R. McAfee; May 4, 2007.

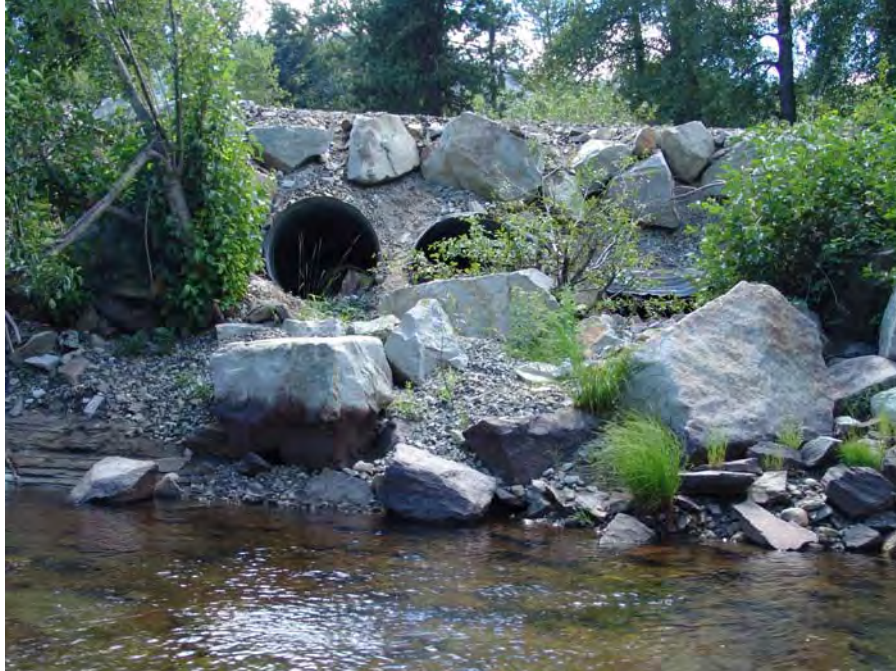
Photograph No. 12. View is to the south of elevated corrugated through the railroad grade that acts as the right bank. The culverts drain the area of LWP DIZ-2 and LWP DOZ-4. Lower White Pine Reach; Subreach IZ-5, Nason Creek - Wenatchee Subbasin, Washington. Bureau of Reclamation Photograph by D. Bennett; August 8, 2007.

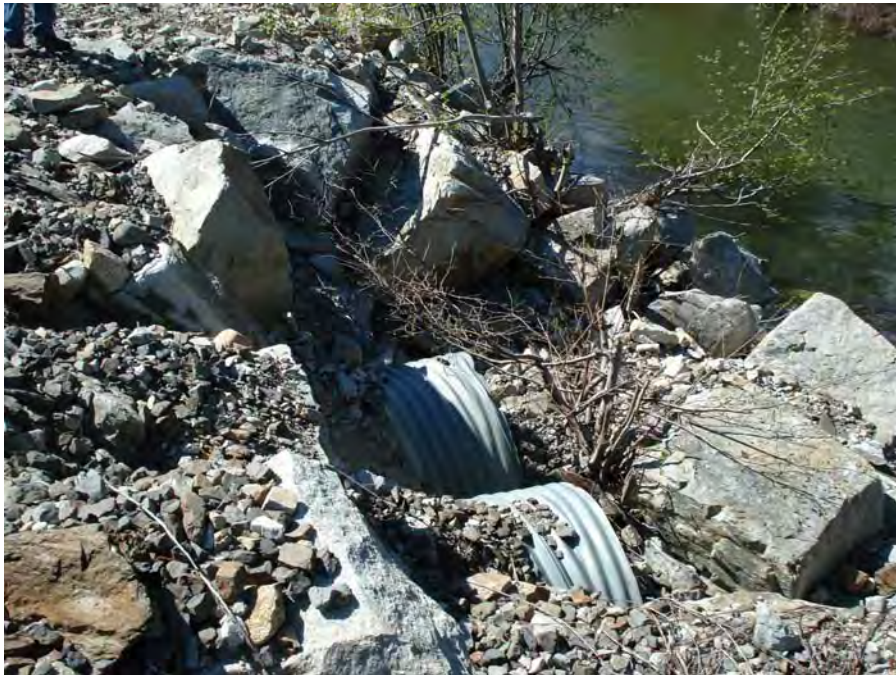
Photograph No. 13. View to the northwest of three elevated metal culverts that run through the railroad grade and drain the area of LWP DIZ-2 and LWP DOZ-4. Lower White Pine Reach; Subreach IZ-5, Nason Creek - Wenatchee Subbasin, Washington. Bureau of Reclamation Photograph by R. McAfee; May 4, 2007.

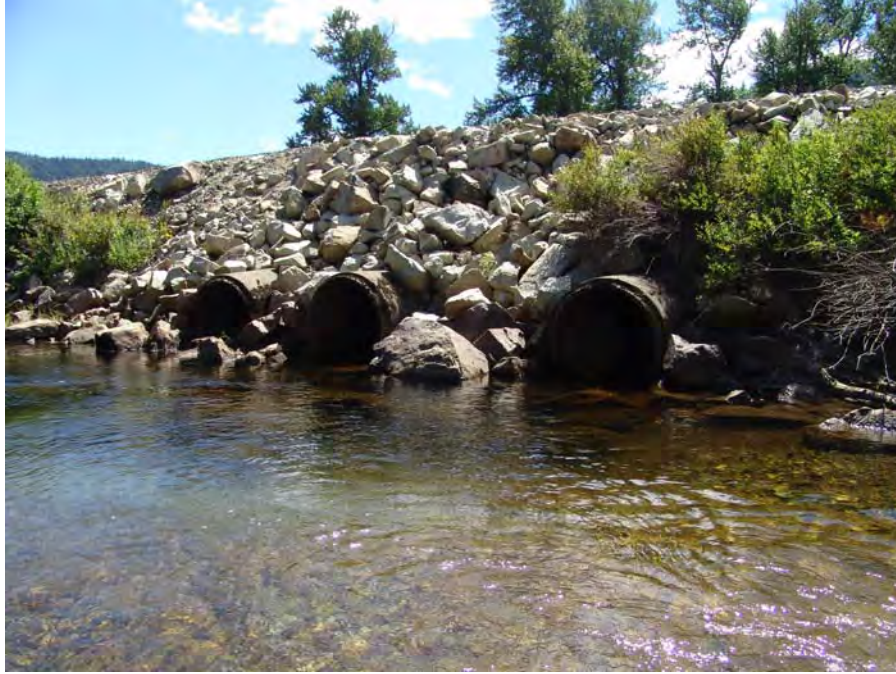
Photograph No. 14. View is to the south looking at three concrete culverts that run through the railroad grade on the right bank. The culverts drain the area of LWP DIZ-2 and LWP DOZ-4. Lower White Pine Reach; Subreach IZ-5, Nason Creek - Wenatchee Subbasin, Washington. Bureau of Reclamation Photograph by D. Bennett; August 8, 2007.

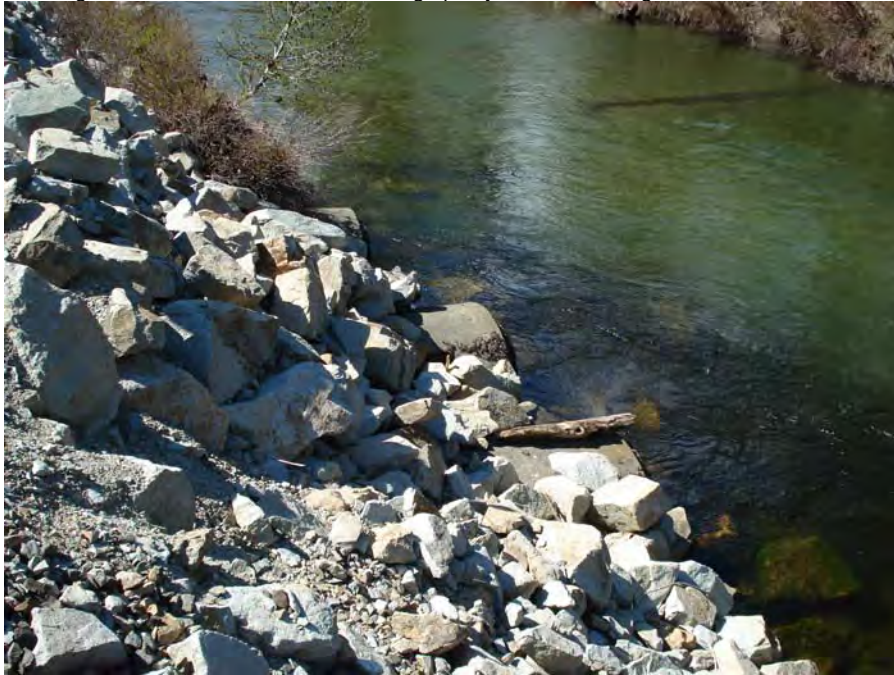
Photograph No. 15. View to the northwest of three concrete culverts that drain the area of LWP DIZ-2 and LWP DOZ-4. Lower White Pine Reach; Subreach IZ-5, Nason Creek - Wenatchee Subbasin, Washington. Bureau of Reclamation Photograph by R. McAfee; May 4, 2007.

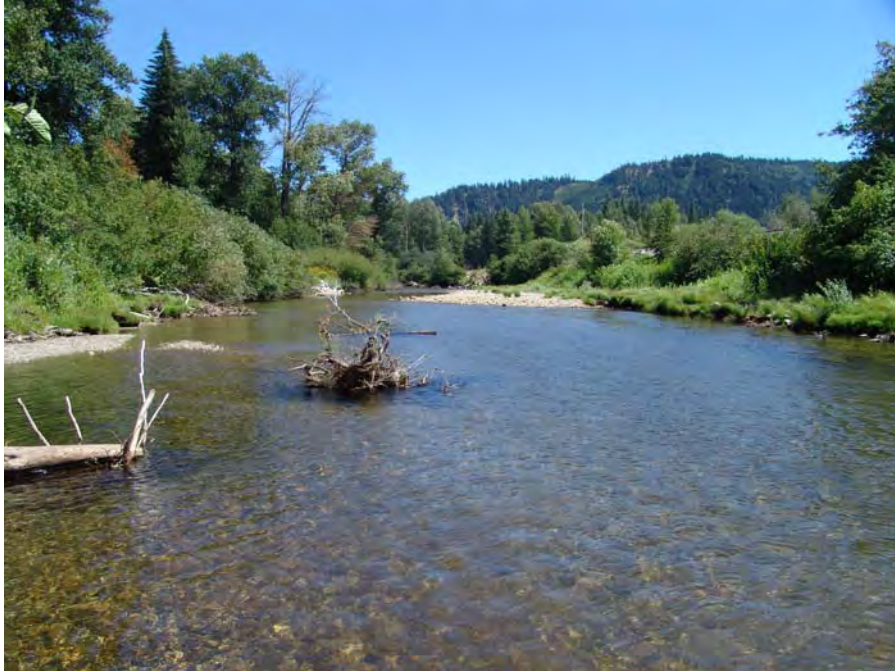
Photograph No. 16. View is to the southeast looking downstream at a run with alternating gravel point bars. Lower White Pine Reach; Subreach IZ-5, Nason Creek - Wenatchee Subbasin, Washington. Bureau of Reclamation Photograph by D. Bennett; August 8, 2007.

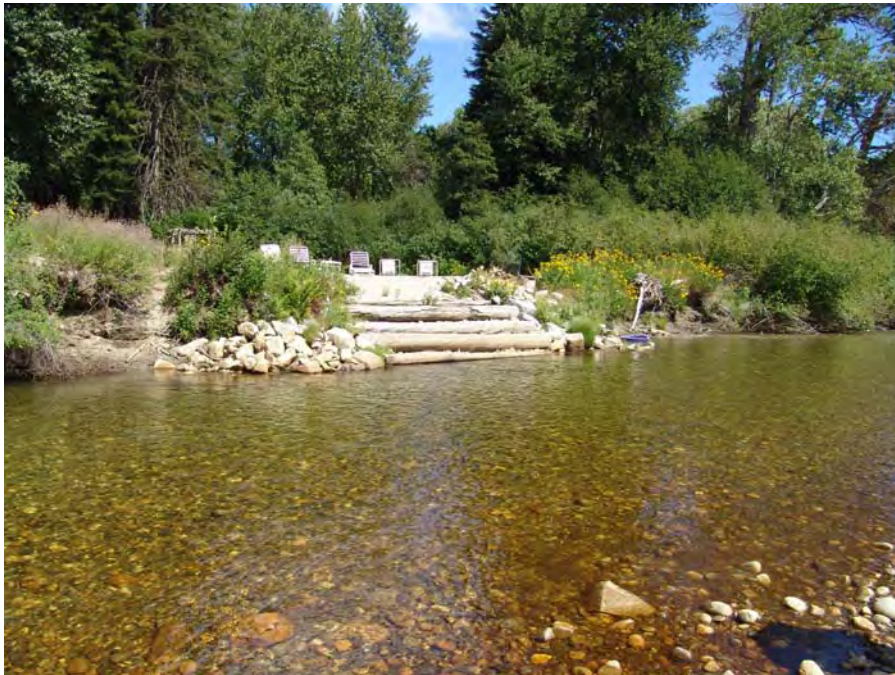
Photograph No. 17. View is to the north looking at small riprap and a constructed boat launch on left bank. Lower White Pine Reach; Subreach IZ-5, Nason Creek - Wenatchee Subbasin, Washington. Bureau of Reclamation Photograph by D. Bennett; August 8, 2007.

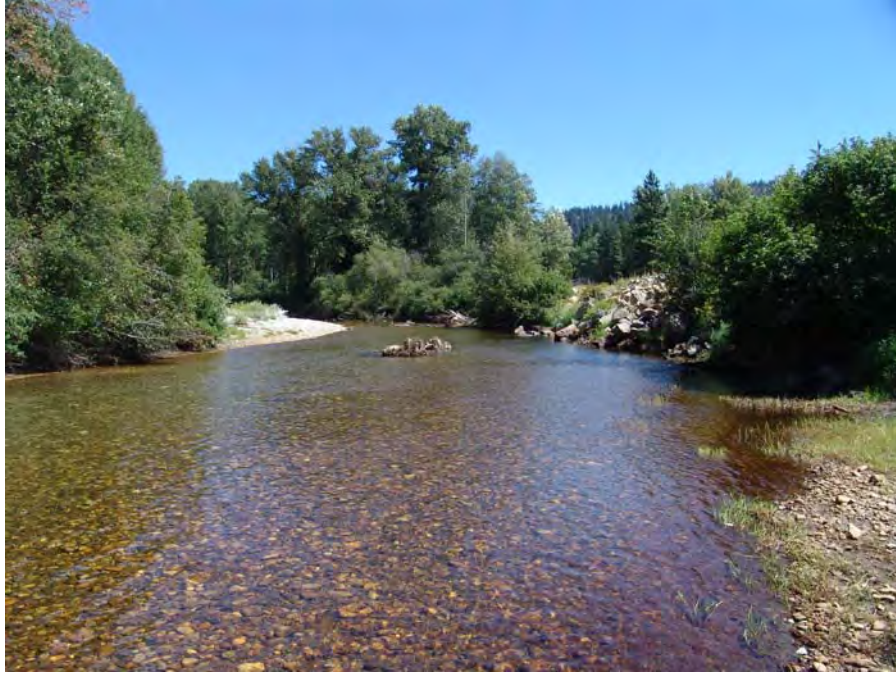
Photograph No. 18. View is to the southeast looking downstream at a long run, a gravel point bar on the left bank and the railroad grade acting as the right bank at both banks. Lower White Pine Reach; Subreach IZ-5, Nason Creek - Wenatchee Subbasin, Washington. Bureau of Reclamation Photograph by D. Bennett; August 8, 2007.

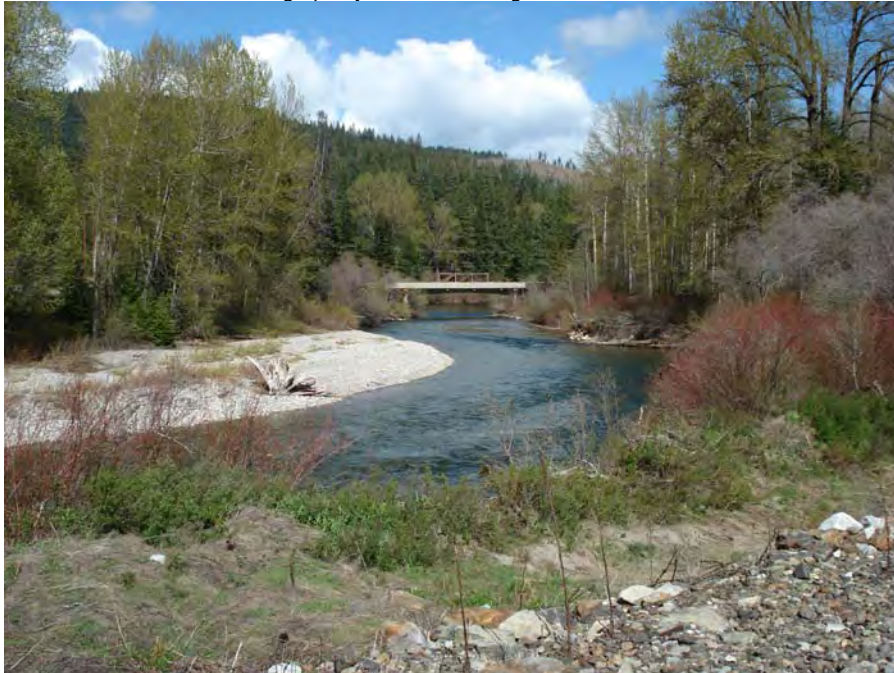
Photograph No. 19. View to the northeast of a channel unit sequence of pool-run-riffle and a gravel point bar on left bank. Two bridges are visible in the back ground. Lower White Pine Reach; Subreach IZ-5, Nason Creek - Wenatchee Subbasin, Washington. Bureau of Reclamation Photograph by R. McAfee; May 4, 2007.

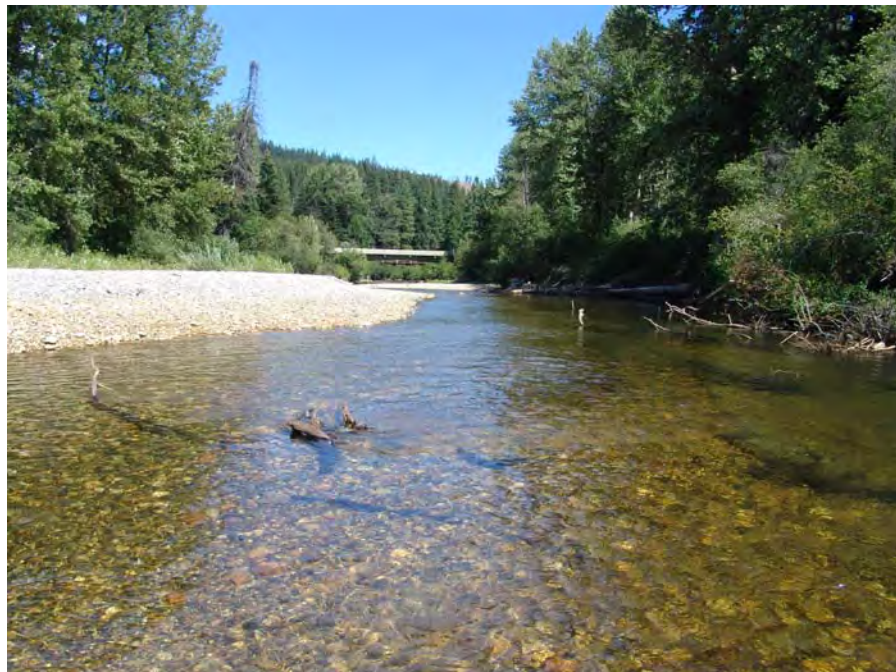
- Local bank erosion noted along right bank (Photograph 1).
- About 255 feet of riprap is located along the right bank that is associated with the Highway 2 Bridge crossing (Photographs 1 & 5).
- Dominant substrate is cobble and gravel (Photographs 2 & 4).
- A v-weir is located near RM 9.56 (Photograph 3).

Photograph No. 1. View is to the northeast looking downstream at a channel unit transition of riffle-pool-run and a gravel point bar on the left bank. Lower White Pine Reach;

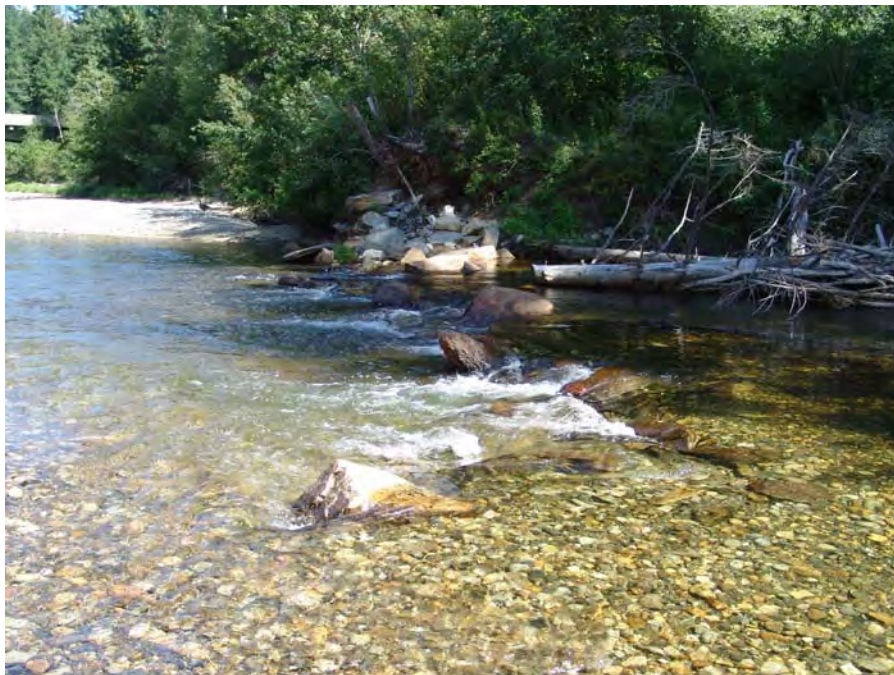
Photograph No. 3. View is to the east looking at an in-channel rock weir. Lower White Pine Reach; Subreach IZ-6, Nason Creek - Wenatchee Subbasin, Washington. Bureau of Reclamation Photograph by D. Bennett; August 8, 2007.

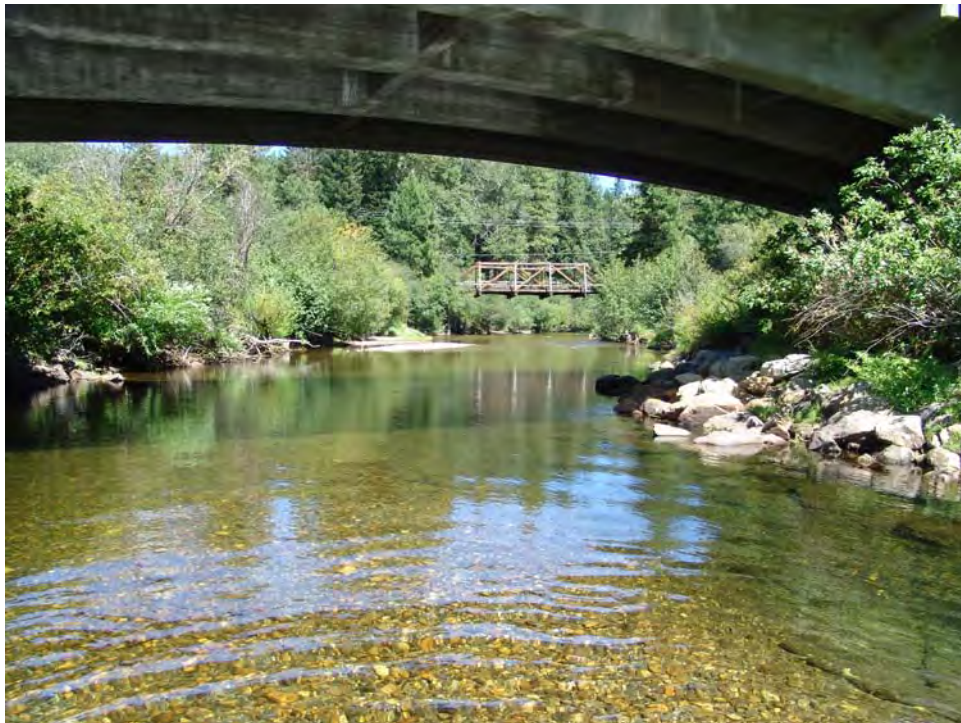
Photograph No. 5. View is to the northeast looking downstream at run and pool channel units, brush-vegetated banks and bridge abutments. Lower White Pine Reach; Subreach IZ-6, Nason Creek - Wenatchee Subbasin, Washington. Bureau of Reclamation Photograph by D. Bennett; August 8, 2007.

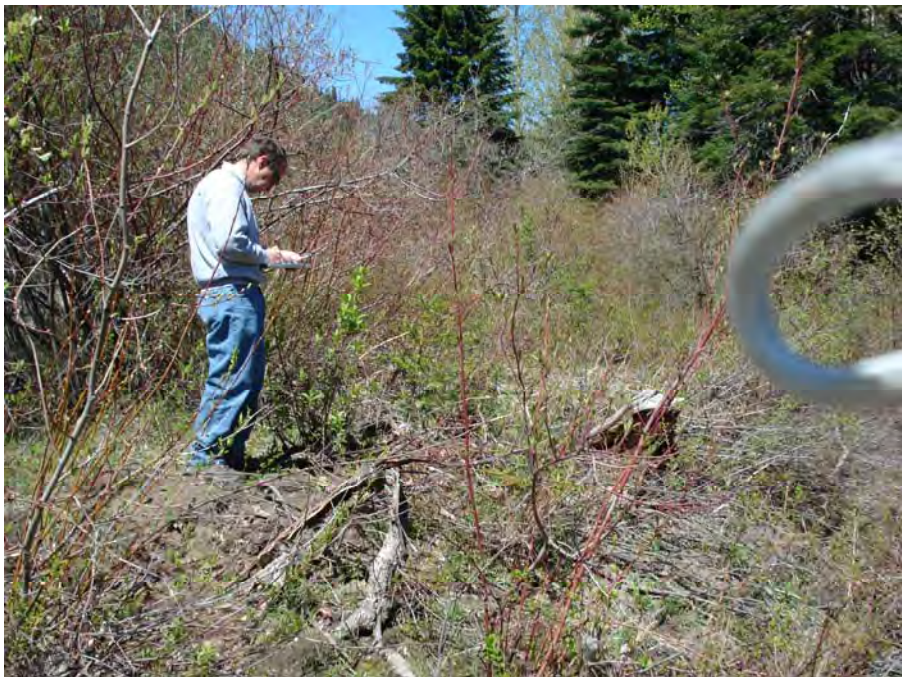
Photograph No. 1. View to the northwest of an embankment on the left bank of the river that cuts off a wetland area on the south side of the road. Lower White Pine Reach; Subreach OZ-12, Nason Creek - Wenatchee Subbasin, Washington. Bureau of Reclamation Photograph by R. McAfee, May 3, 2007.

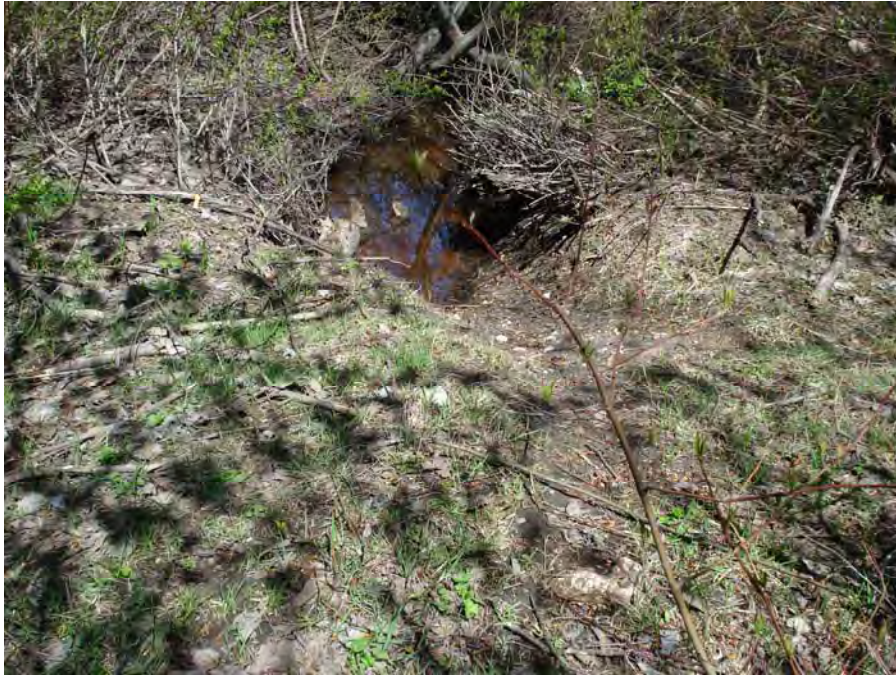
Photograph No. 2. View to the north east of a wetland cutoff by an access road embankment. Lower White Pine Reach; Subreach OZ-12, Nason Creek - Wenatchee Subbasin, Washington. Bureau of Reclamation Photograph by R. McAfee, May 3, 2007.

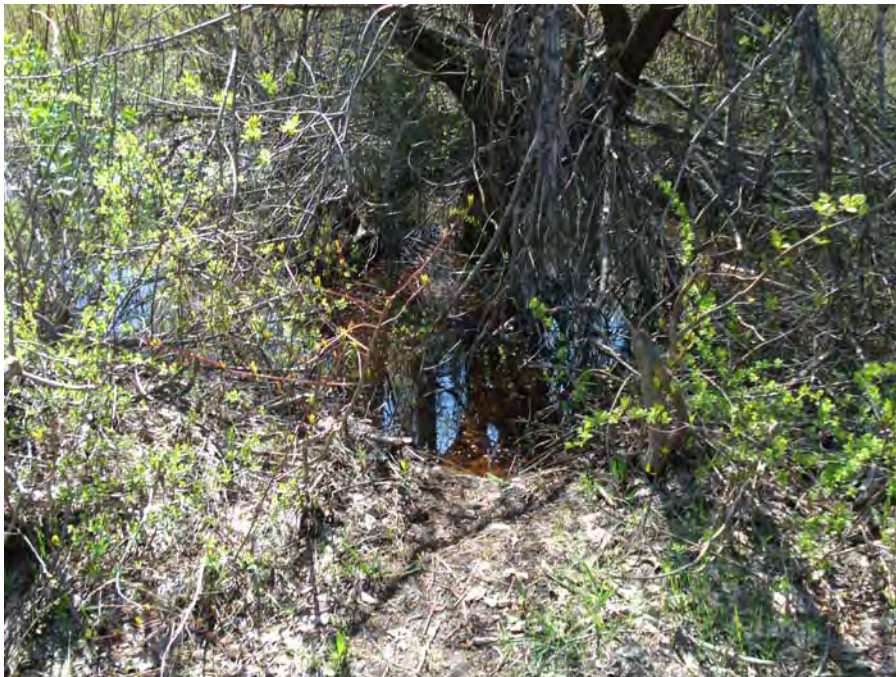
Photograph No. 3. View to the southwest of a wetland cut off by an access road. Lower White Pine Reach; Subreach OZ-12, Nason Creek - Wenatchee Subbasin, Washington. Bureau of Reclamation Photograph by R. McAfee, May 3, 2007.

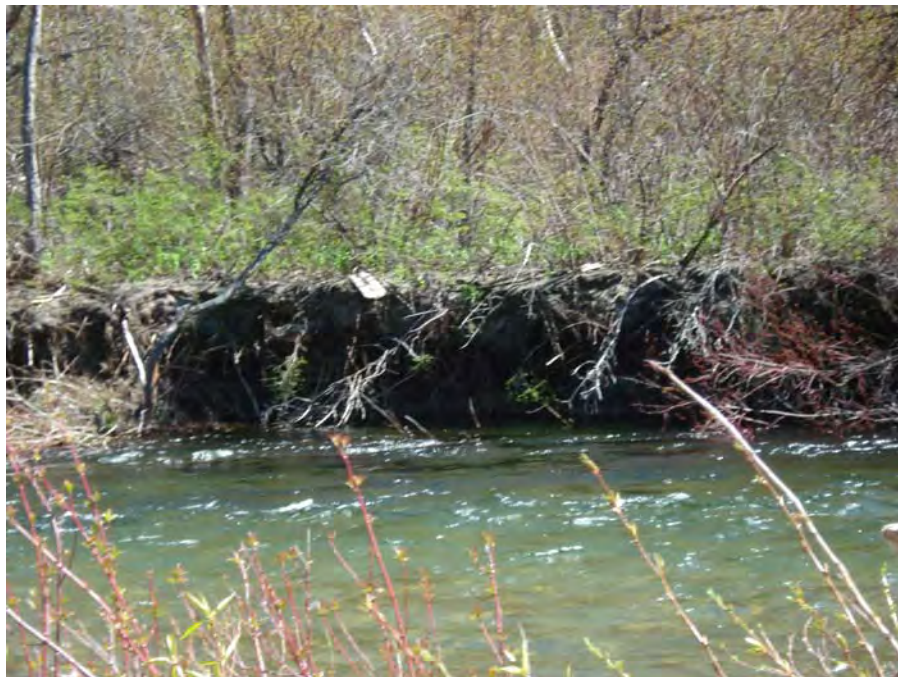
Photograph No. 1. View to the southeast of the eroding right bank. Lower White Pine Reach; Subreach OZ-13, Nason Creek - Wenatchee Subbasin, Washington. Bureau of Reclamation
Photograph by R. McAfee, May 3, 2007.

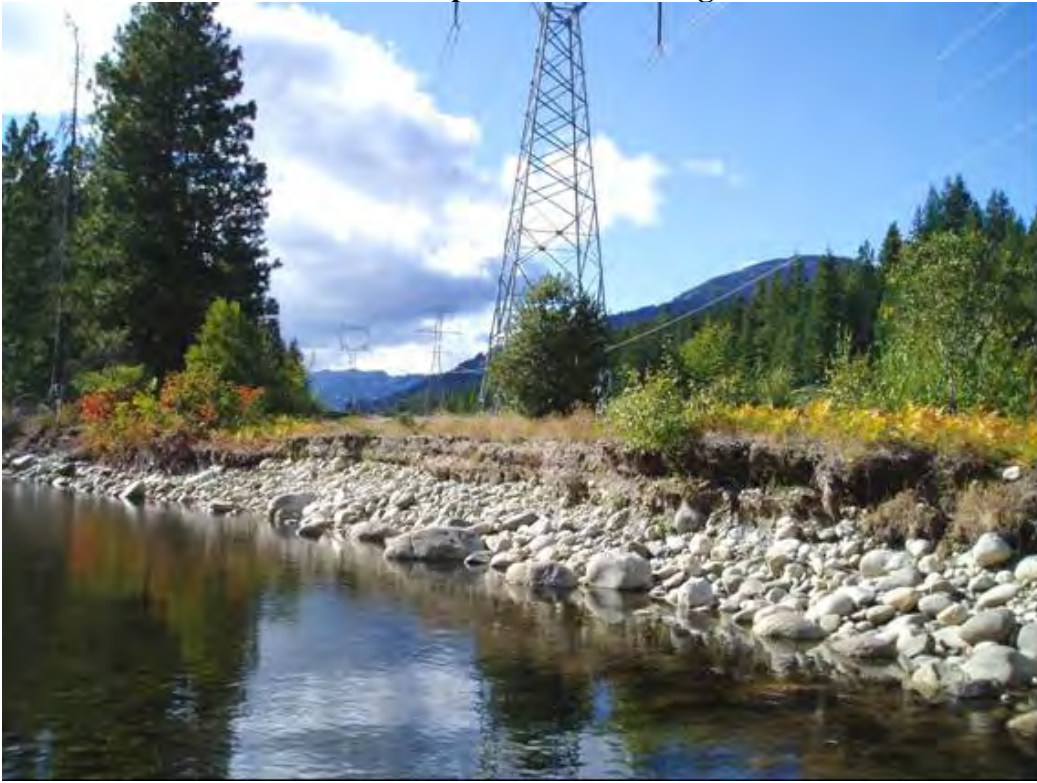
Pool habitat lacking complexity in Reach 1
