# UPPER WENATCHEE RIVER STREAM CORRIDOR ASSESSMENT AND HABITAT RESTORATION STRATEGY

August 2012

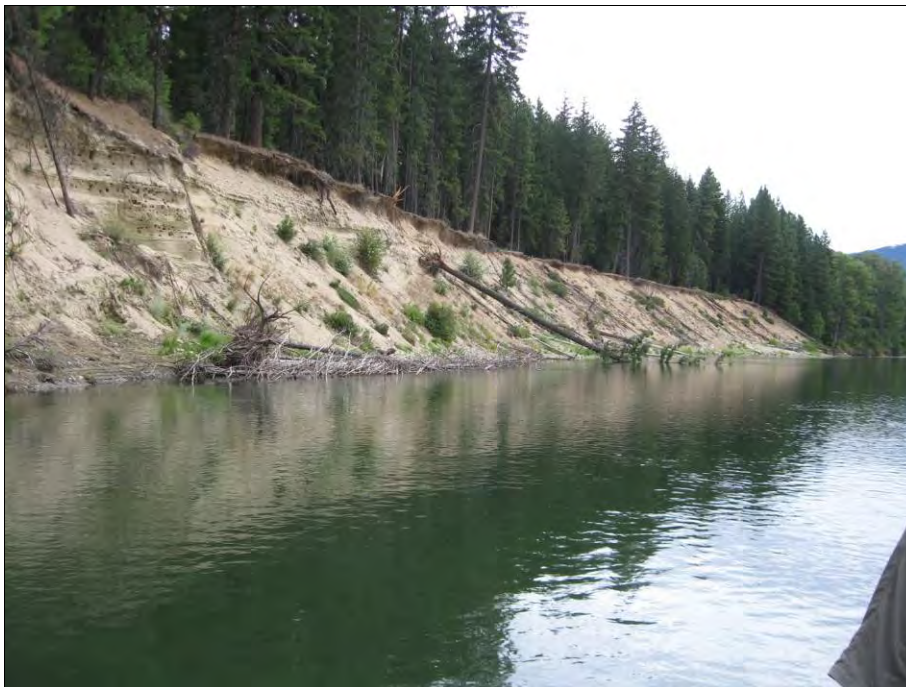
Sediment is contributed to the Upper Wenatchee from tributaries and near-channel banks and hillslopes. These banks and hillslopes provide localized sediment from the easily erodible unconsolidated glacial till, glacial terraces, and alluvial deposits along the channel margins (Figure 26). Glacial deposits provide some erosion resistance because in many locations large material has accumulated at the toe of these slopes. However, high flows are still able to easily erode above this toe support and entrain large amounts of fine grain material from banks. Bedrock outcrops found in the study reach hillslopes is chiefly from the Chumstick Formation, which exhibits downslope trending bed planes that make it more susceptible to mass wasting in weaker units (Figure 27). Sediment contributions from the Chumstick Formation would be expected to provide fine-grain material out of sandstone and shale units, and some gravels out of

**Figure 26.** View of unconsolidated fine grain sediment in terrace slopes along the channel in the study area.

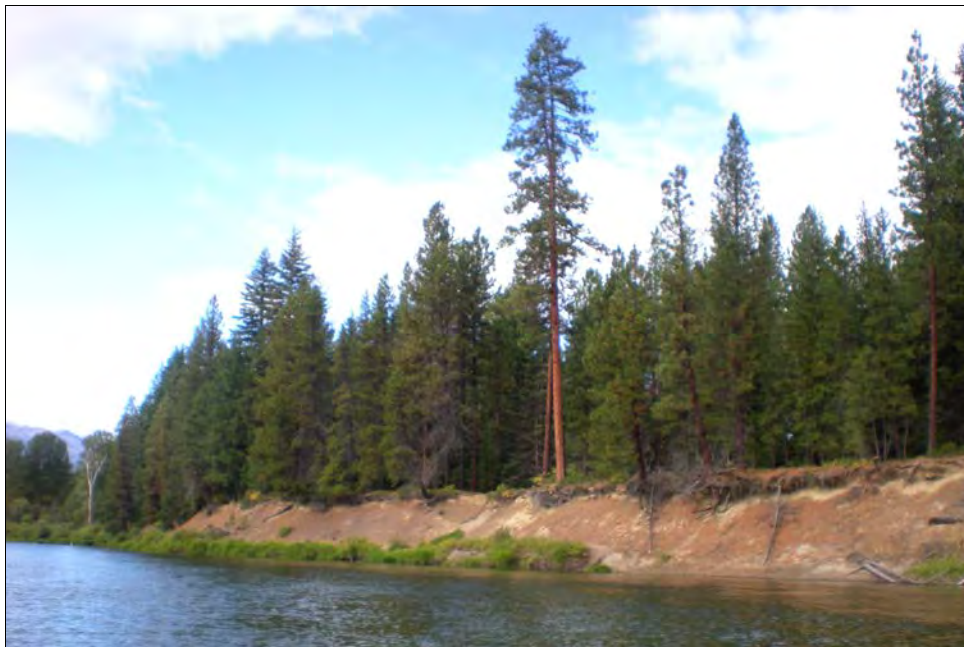
**Figure 29.** Existing riparian area in Reach 9 (taken October 2011). Large ponderosa pine at center represents an older tree that escaped the last harvest and gives some indication of what historical LWD sources may have looked like.

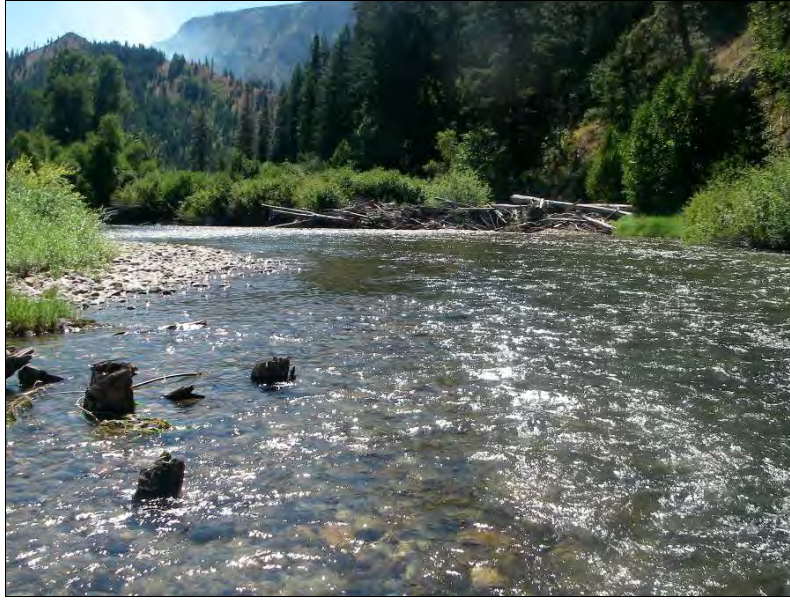
Modern human alterations to this reach are limited, but there is evidence of historical timber harvest and log transport, including a mid-seral stage riparian forest, remnant log pilings (Figure 32), and sunken cut logs (presumably log drive remnants). Potential impacts from these activities are discussed in Section 3.4, but without historical data it is difficult to estimate the specific extent of human alteration. Despite past impacts, it is believed that this reach has been on a trajectory of recovery over at least the past 50 years, which has resulted in the modern habitat complexity observed today.

**Figure 32. Remnant pilings assumed to be from historical logging practices (splash damming).**

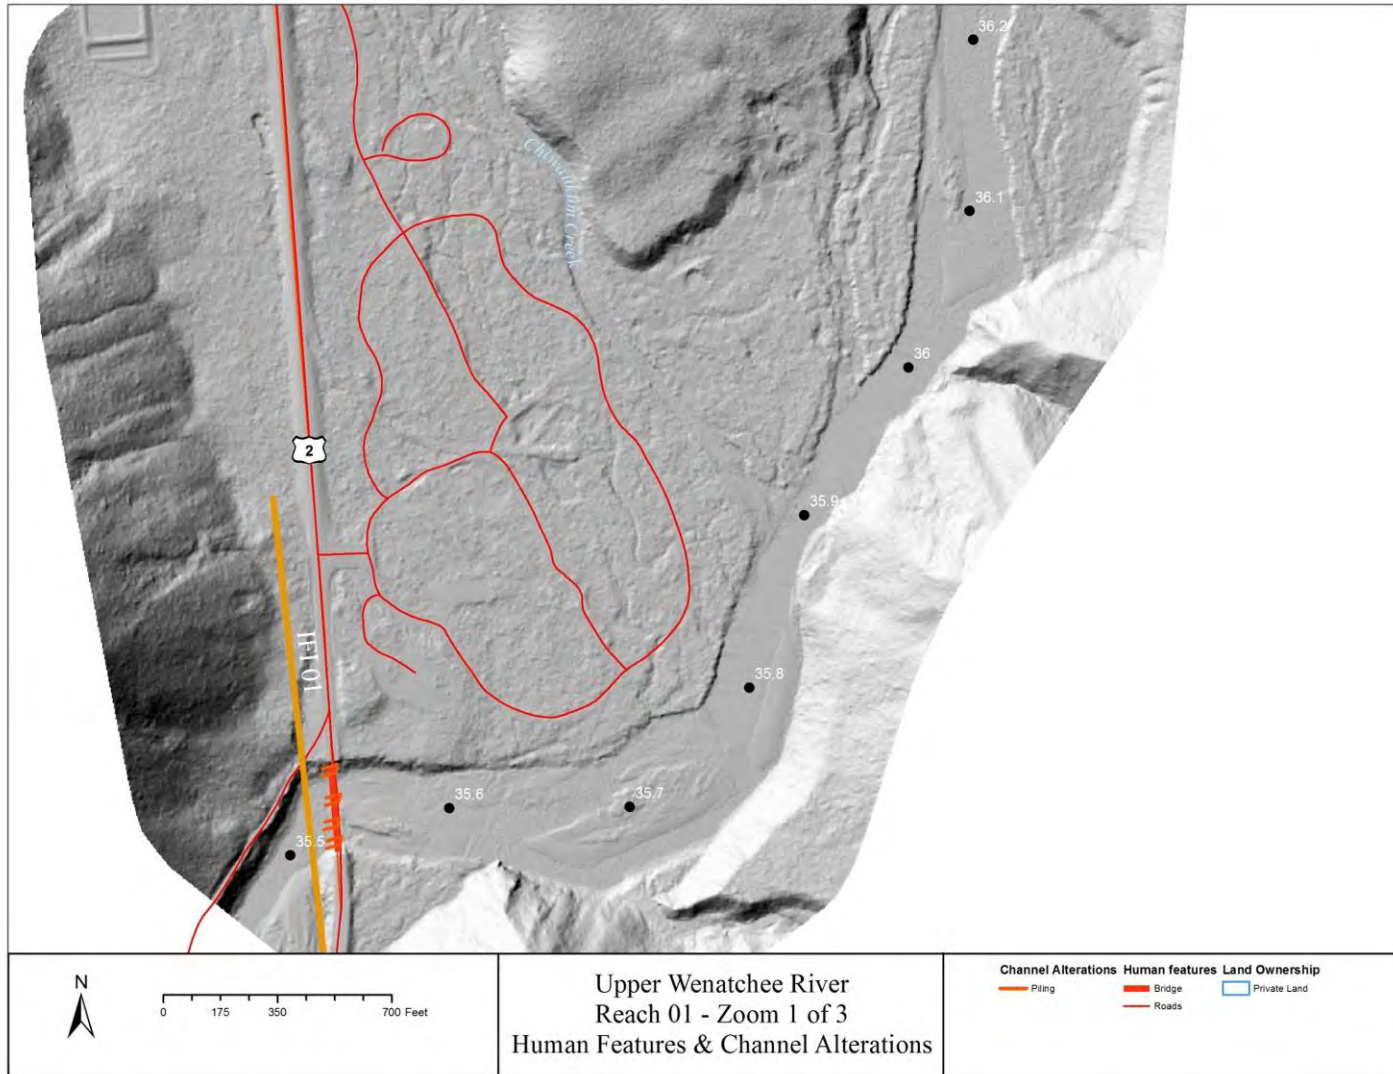
Figure 33. Human alterations in the downstream portion of Reach 1. Flow is from north to south.

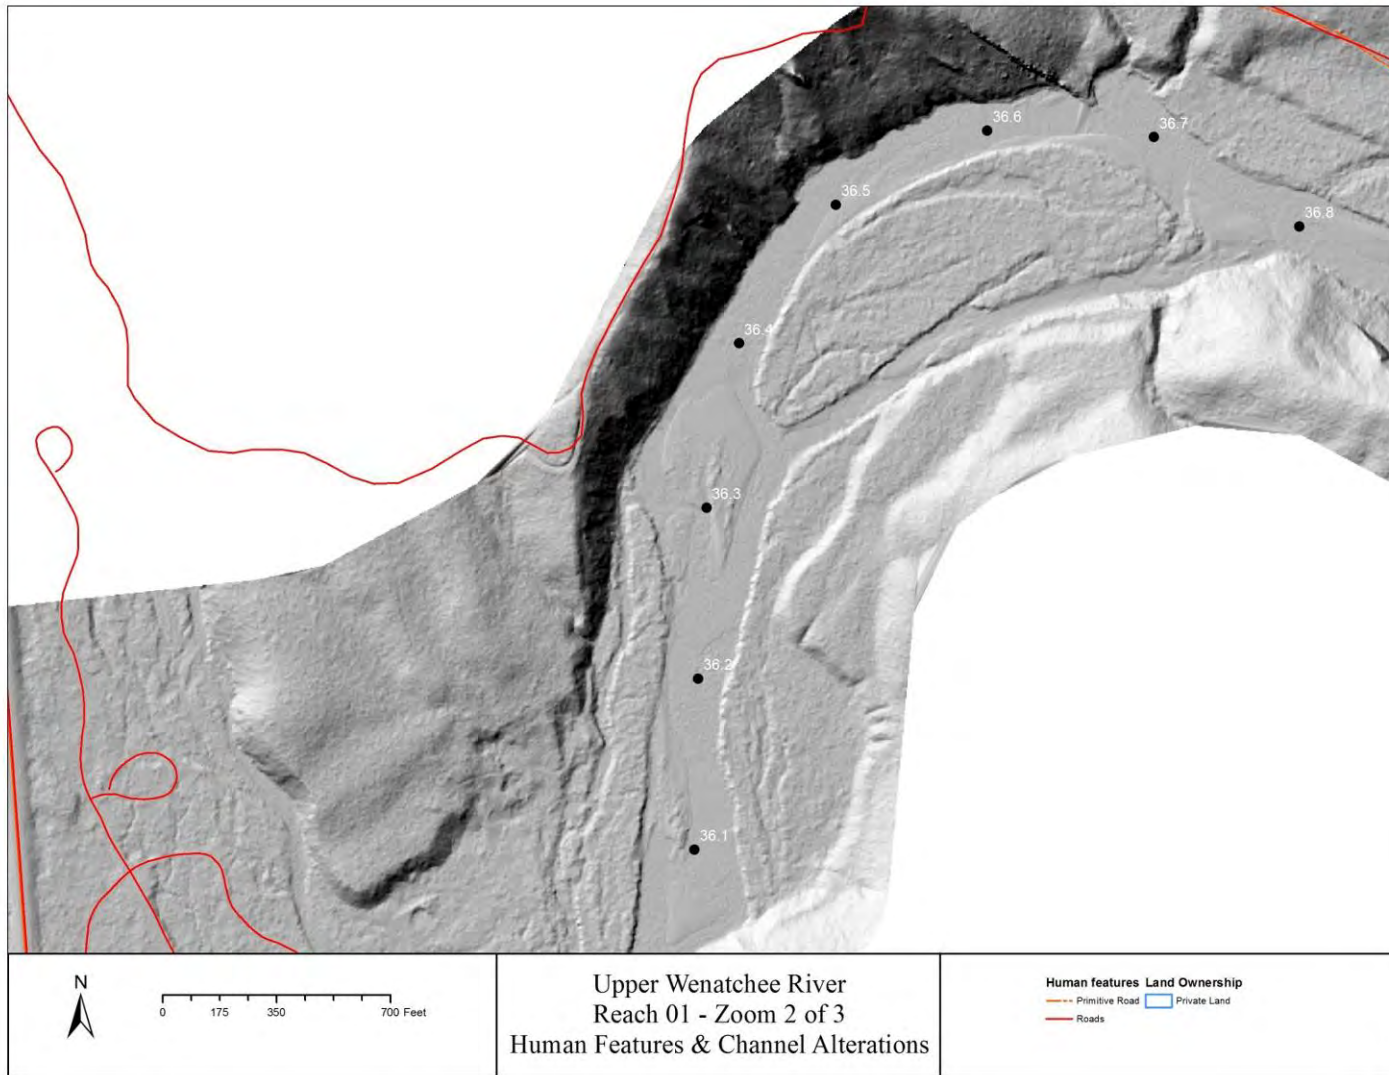
Figure 34. Human alterations in Reach 1. Flow is from north to south.

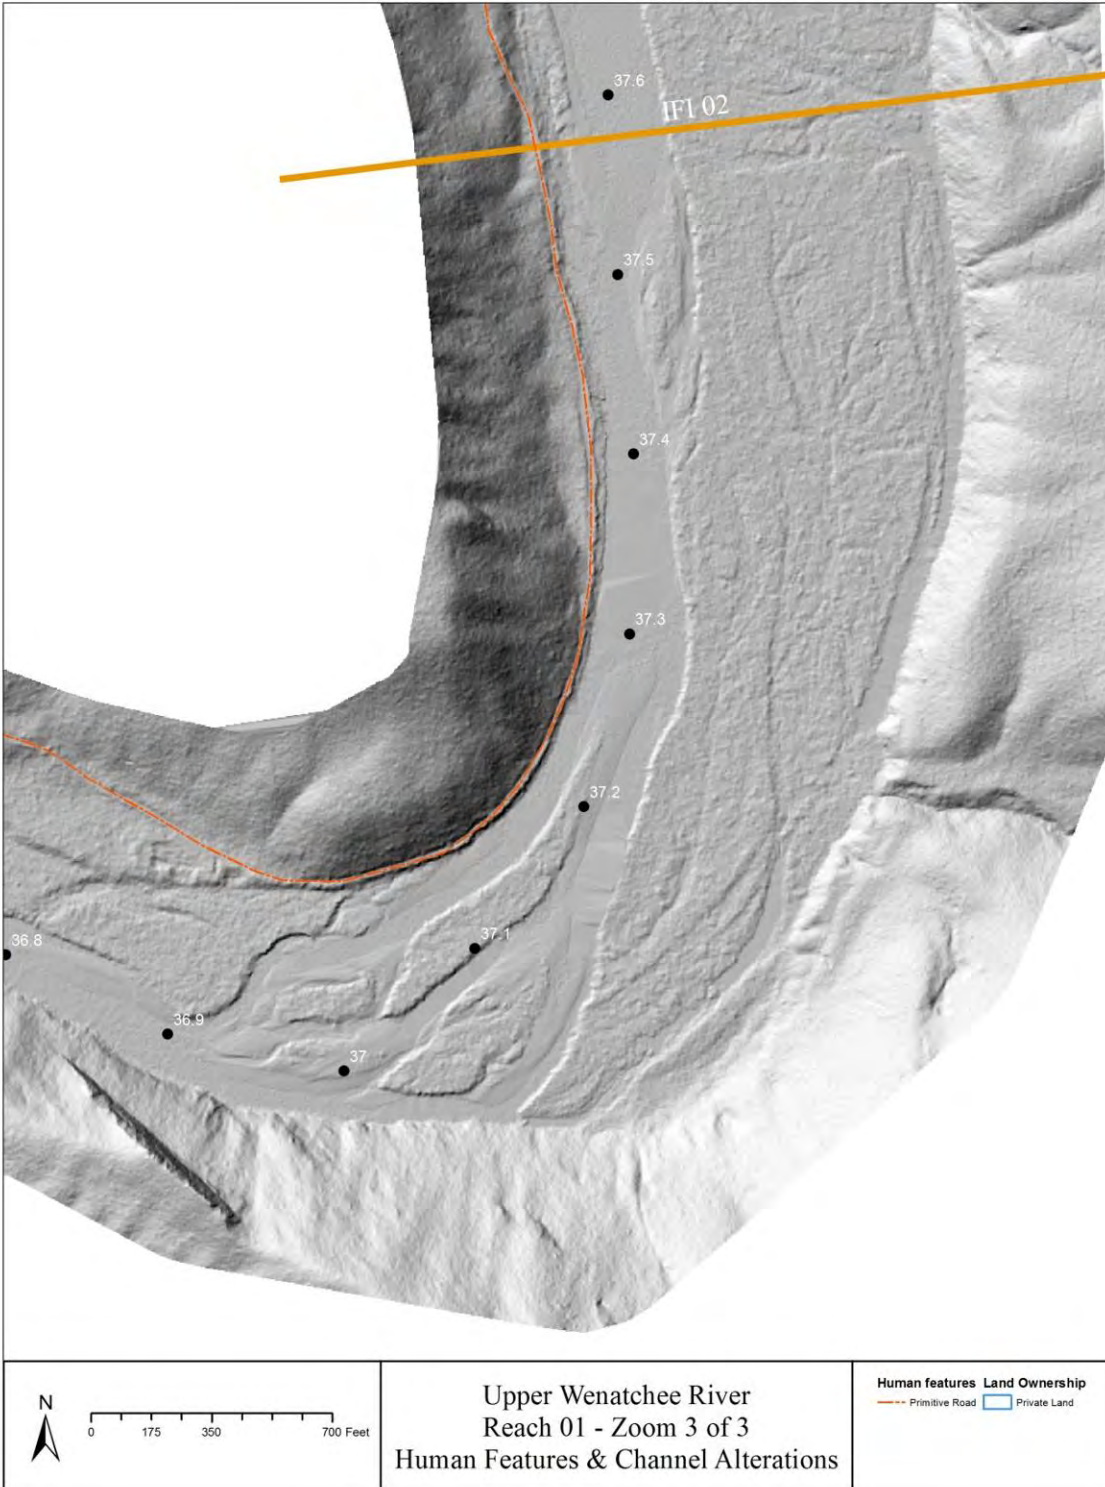
Figure 35. Human alterations in the upstream portion Reach 1. Flow is from north to south.

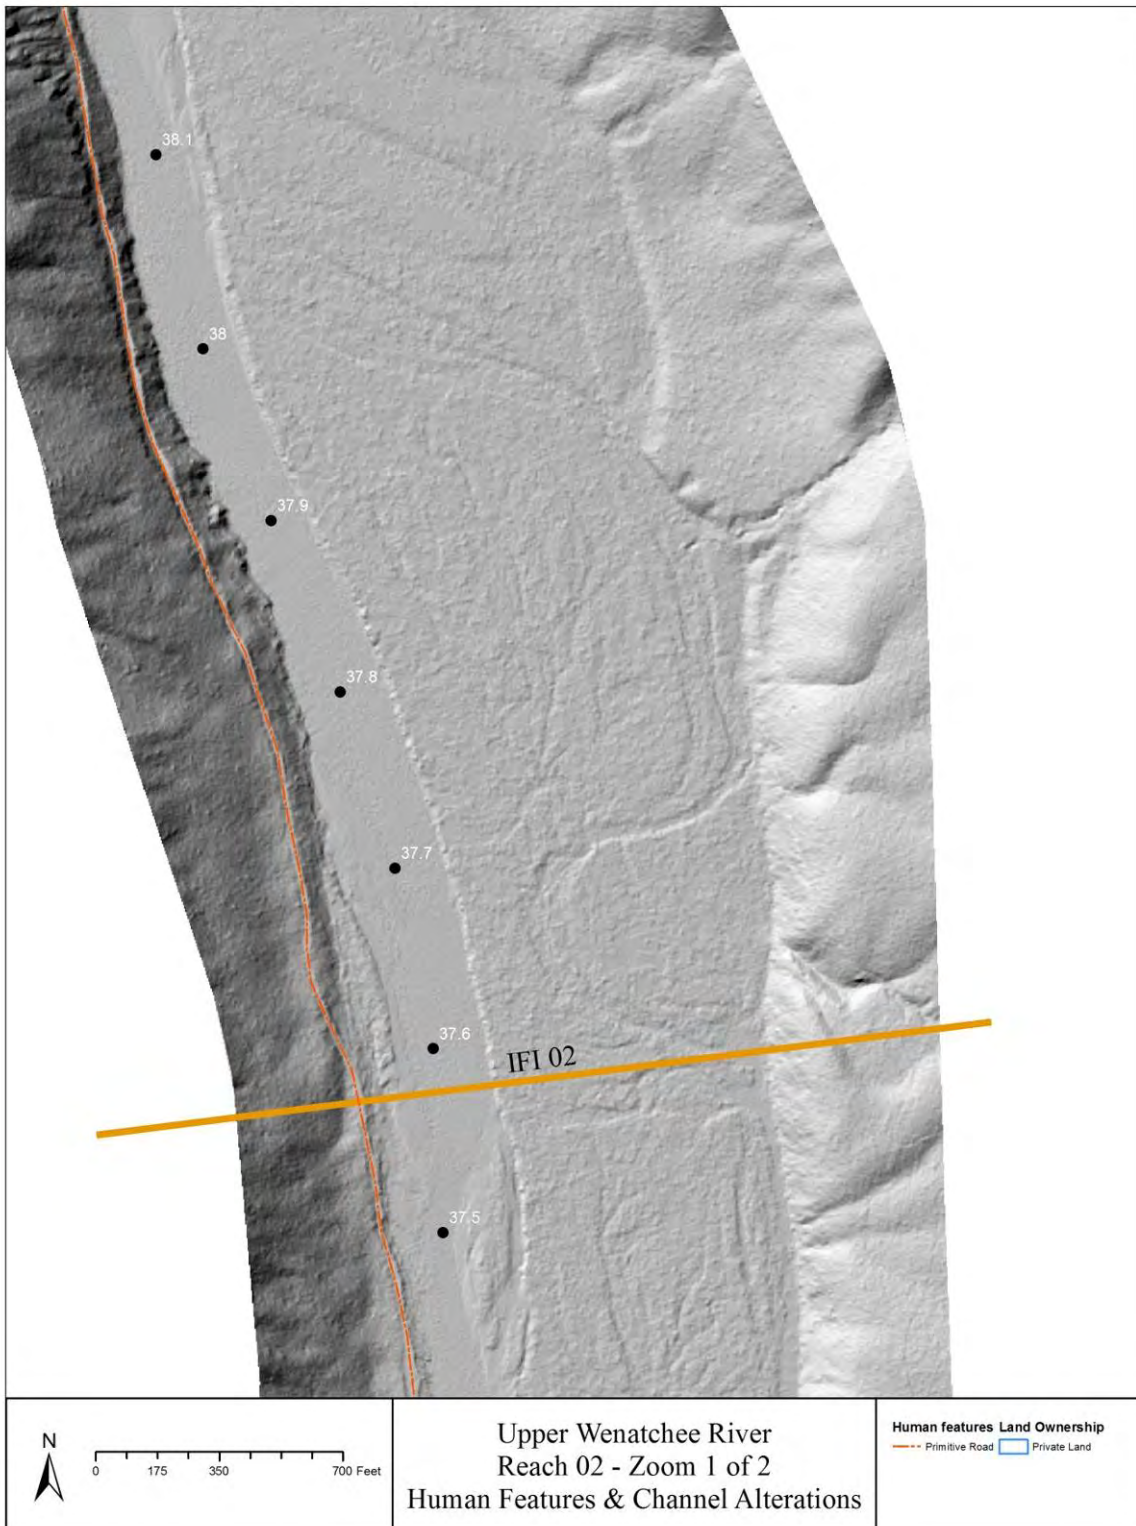
Existing human alterations include a primitive road that abuts the channel on river-right from RM 38.5 to RM 38.6. There is some fill associated with the road but impacts to the channel are minimal as it does not appear to affect channel migration rates or impact floodplain inundation.

Figure 38. Human alterations in the downstream portion of Reach 2. Flow is from north to south.

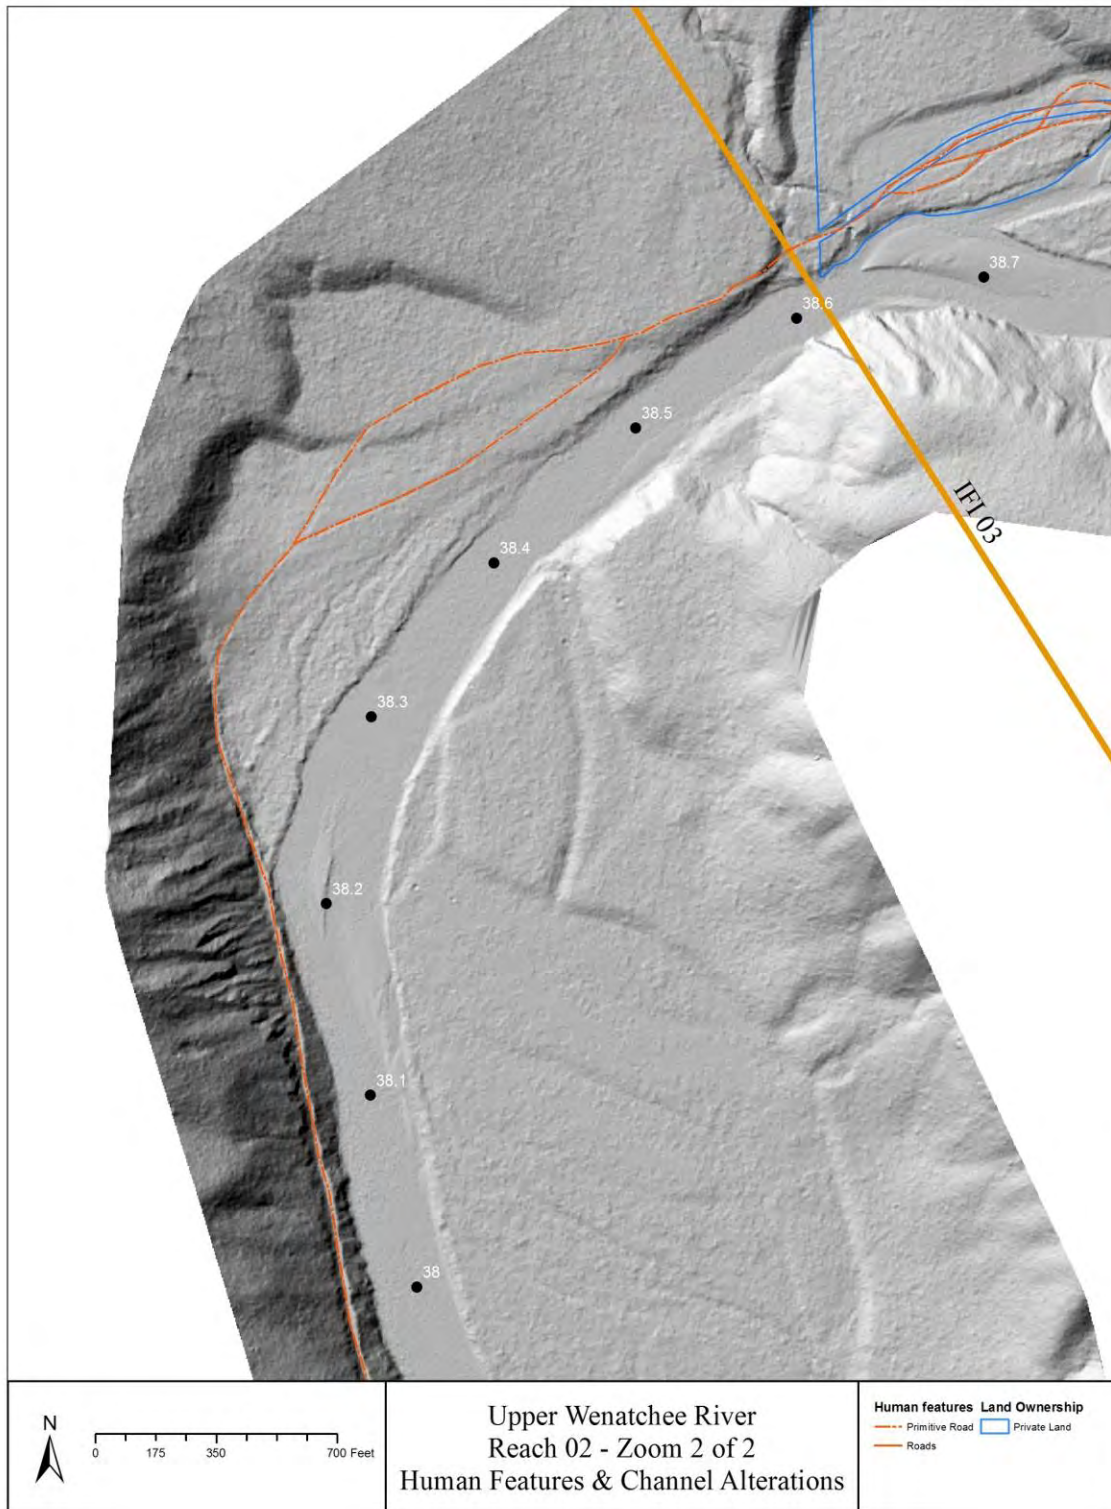
Figure 39. Human alterations in the upstream portion of Reach 2. Flow is from north to south.

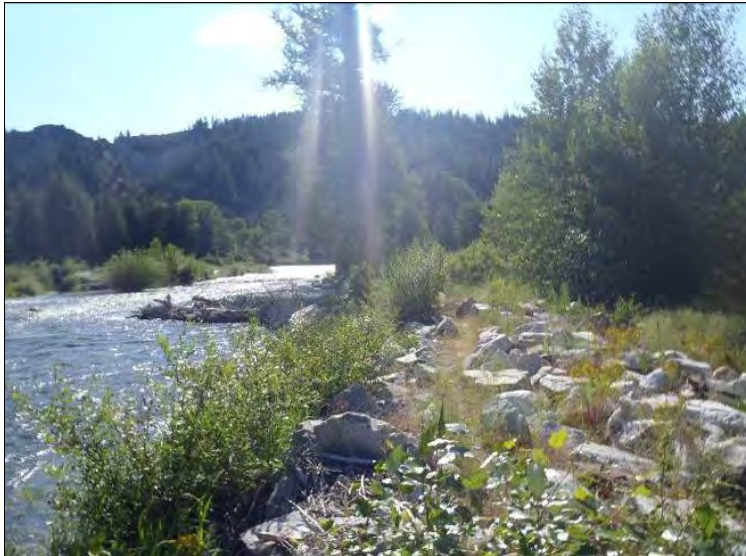
Bank hardening (e.g. riprap, concrete walls) and boulder spurs associated with the development of homesites are present in Reach 3 along the right bank (RM 39.55 to RM 41.81). Extensive riprap (Figure 44) and cement wall construction are located at RM 40.9 to RM 41.8. This bank hardening has disconnected a significant portion of floodplain and restricts channel migration. Site assessment and LiDAR elevation data indicate that this area would be active if bank hardening and walls did not prevent (or limit) floodplain inundation. Despite extensive bank alteration, field observations indicate that flooding continues to be a challenge to homeowners.

**Figure 44. Riprap on river-right (RM 42.8).**

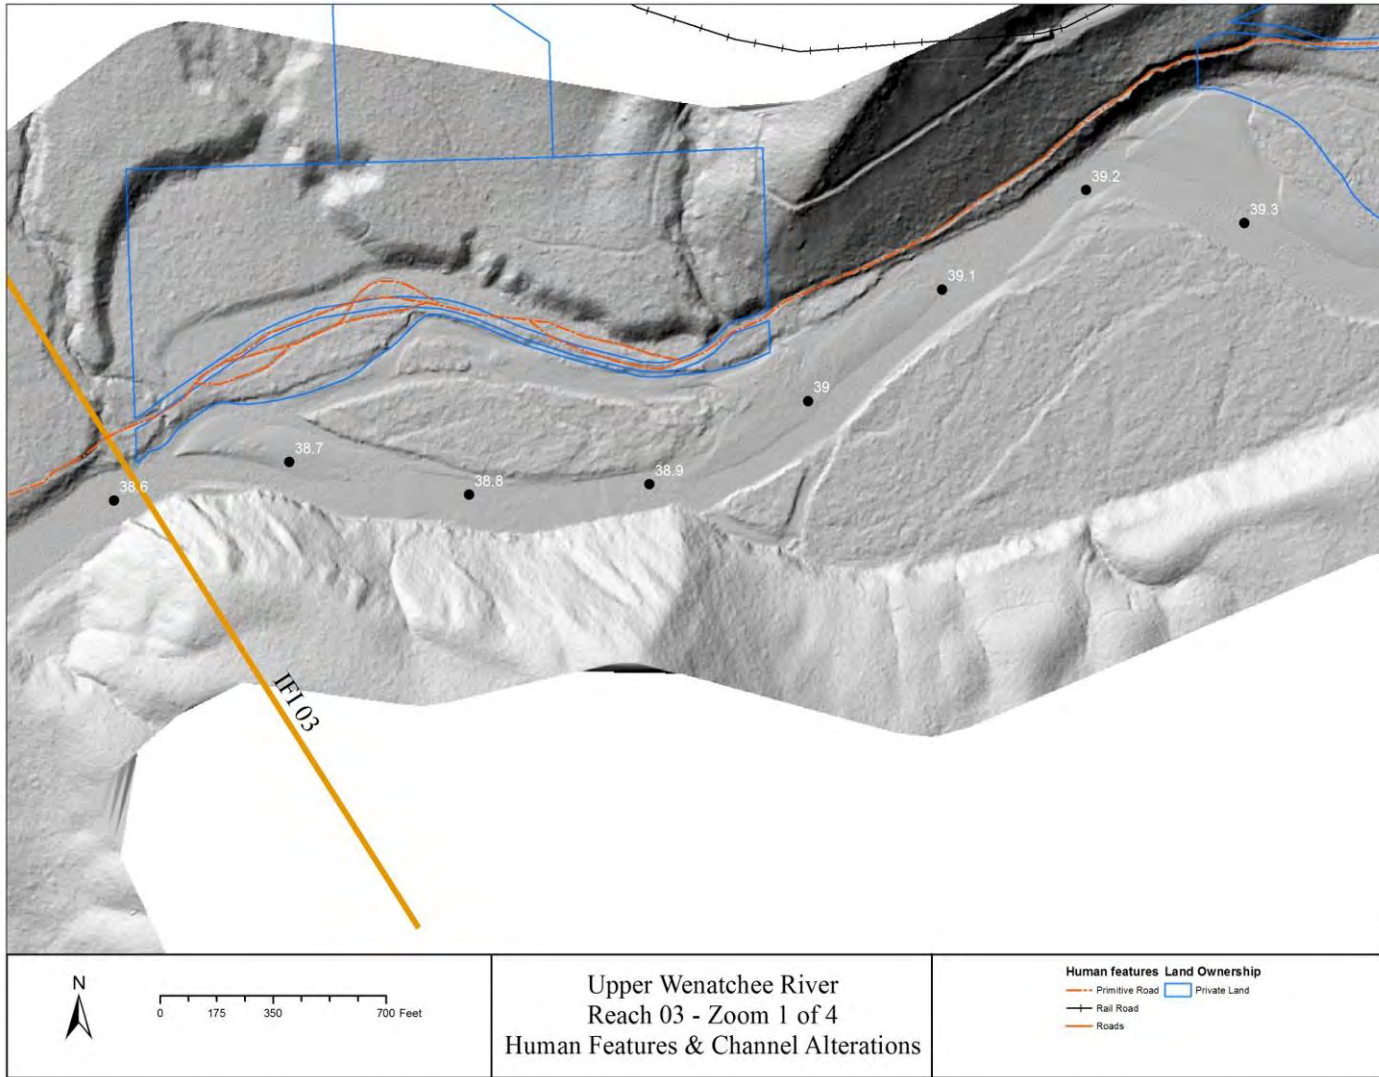
Figure 46. Human alterations in the downstream portion of Reach 3. Flow is from east to west.

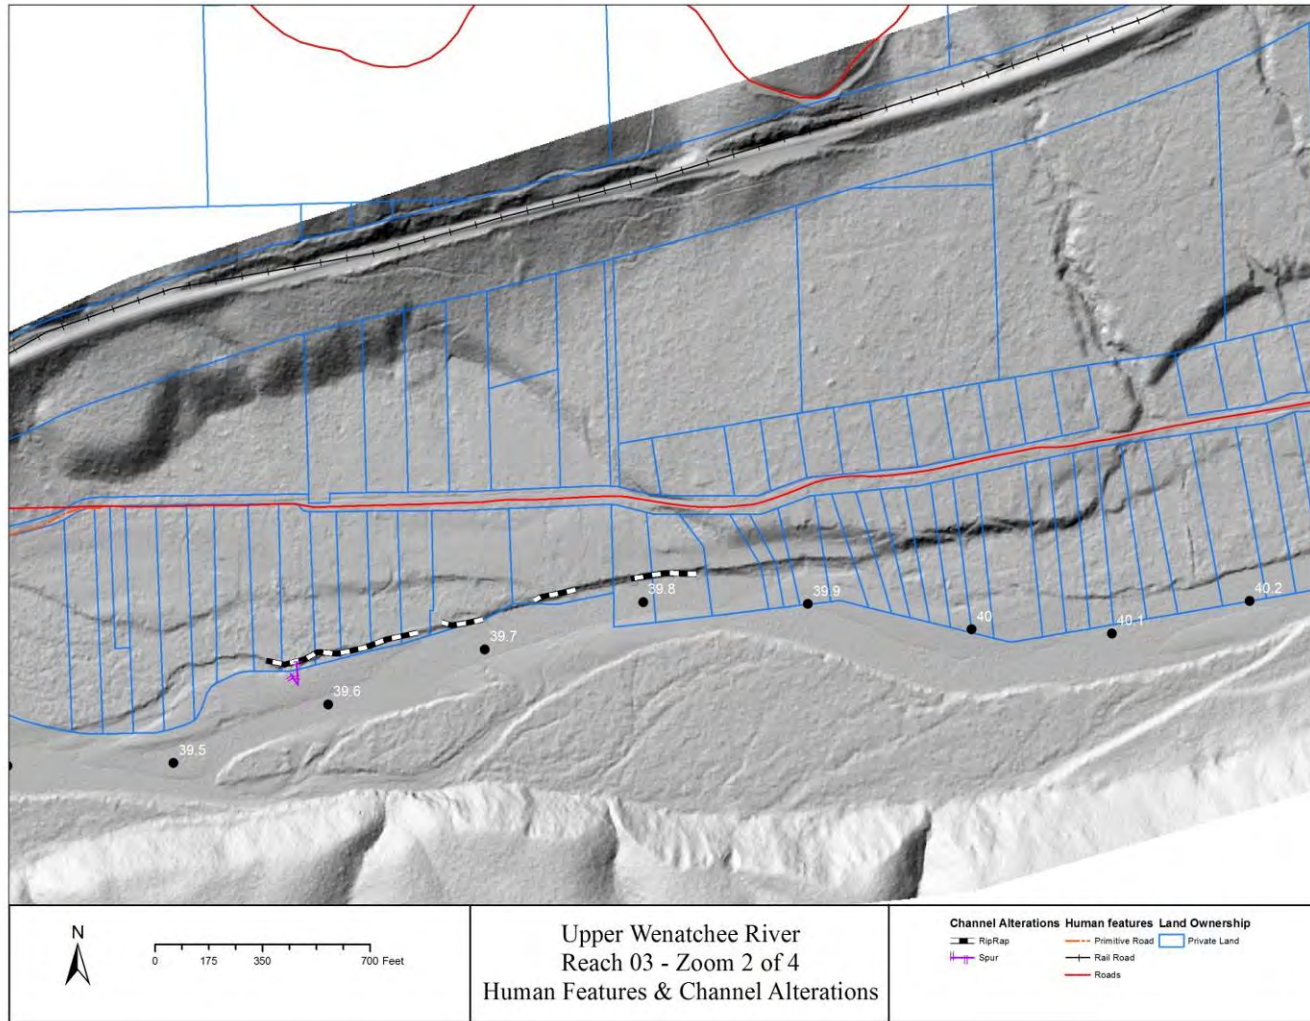
Figure 47. Human alterations in Reach 3. Flow is from east to west.

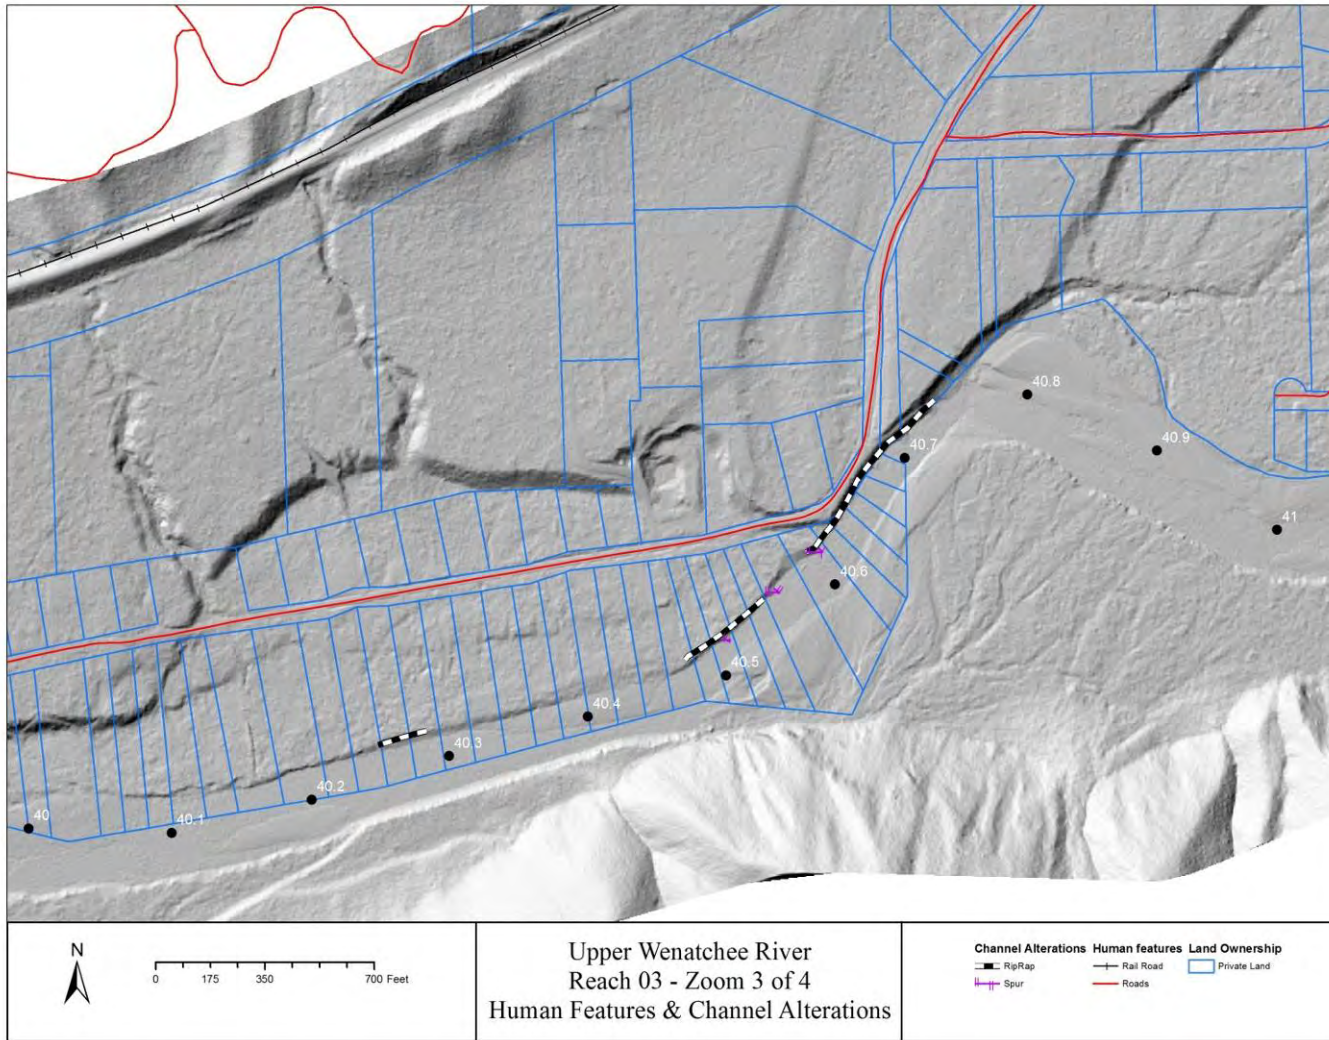
Figure 48. Human alterations Reach 3. Flow is from east to west.

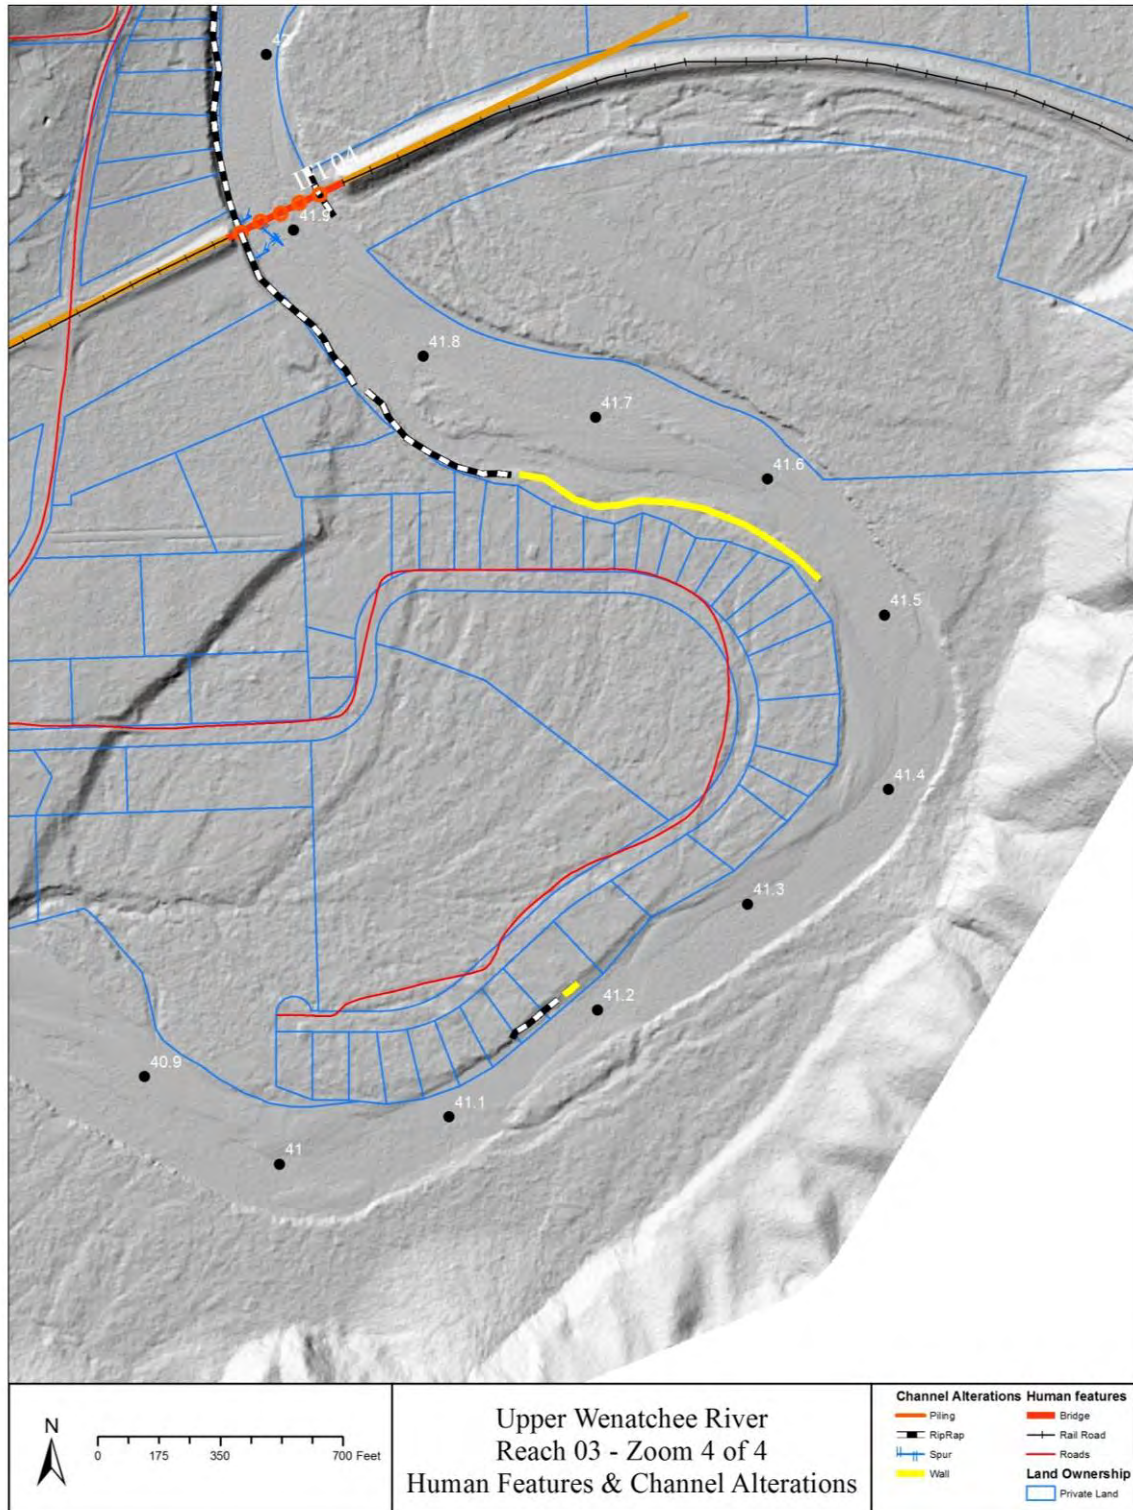
Figure 49. Human alterations in the upstream portion of Reach 3. Flow is from north to south.

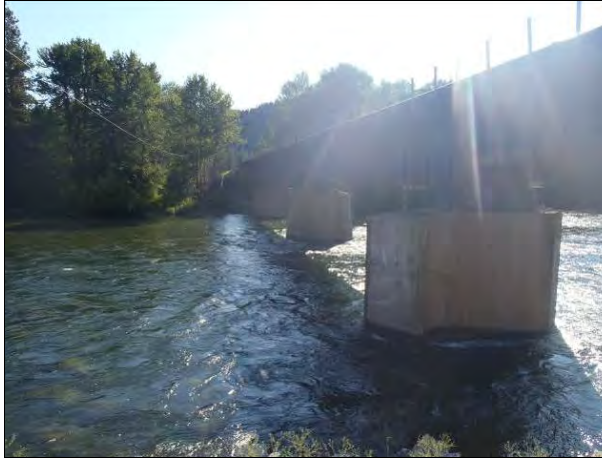
Anthropogenic landscape alterations are prevalent throughout Reach 4. At the downstream-most boundary of the reach the Burlington Northern Railroad laterally confines the channel. Both the left and right bank bridge abutments currently act as hydraulic constrictions during over-bank flows (Figure 52). Riprap has also been installed up and downstream of the railroad bridge further immobilizing the channel and impairing the growth of riparian vegetation (Figure 53).

**Figure 52. Burlington Northern Railroad Bridge Pilings**

Inundation mapping conducted as part of the hydraulics analysis shows that considerable floodplain constriction is created by the Burlington Northern Railroad Bridge crossing at the downstream end of Reach 4, which has likely caused base lowering that has progressed upstream. This is supported by inundation extents within the meander bends in Reach 4 that show limited inundation only at the largest flood events (e.g. 50 to 100-yr events) despite scroll scars evident from LiDAR that indicate these surfaces were laid down in relatively recent history and would therefore be expected to have greater floodplain connectivity.

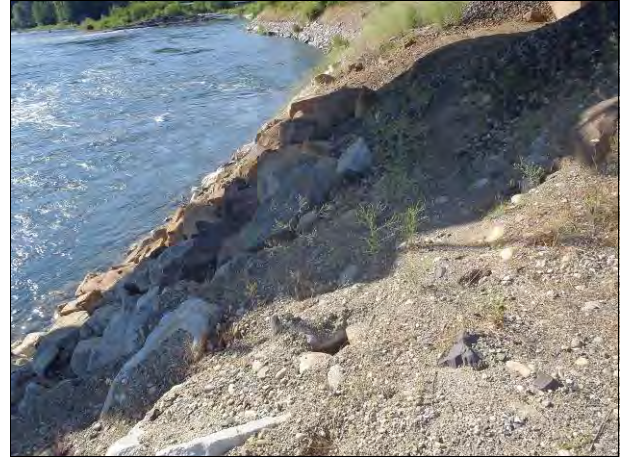
**Figure 53. Right bank armoring**

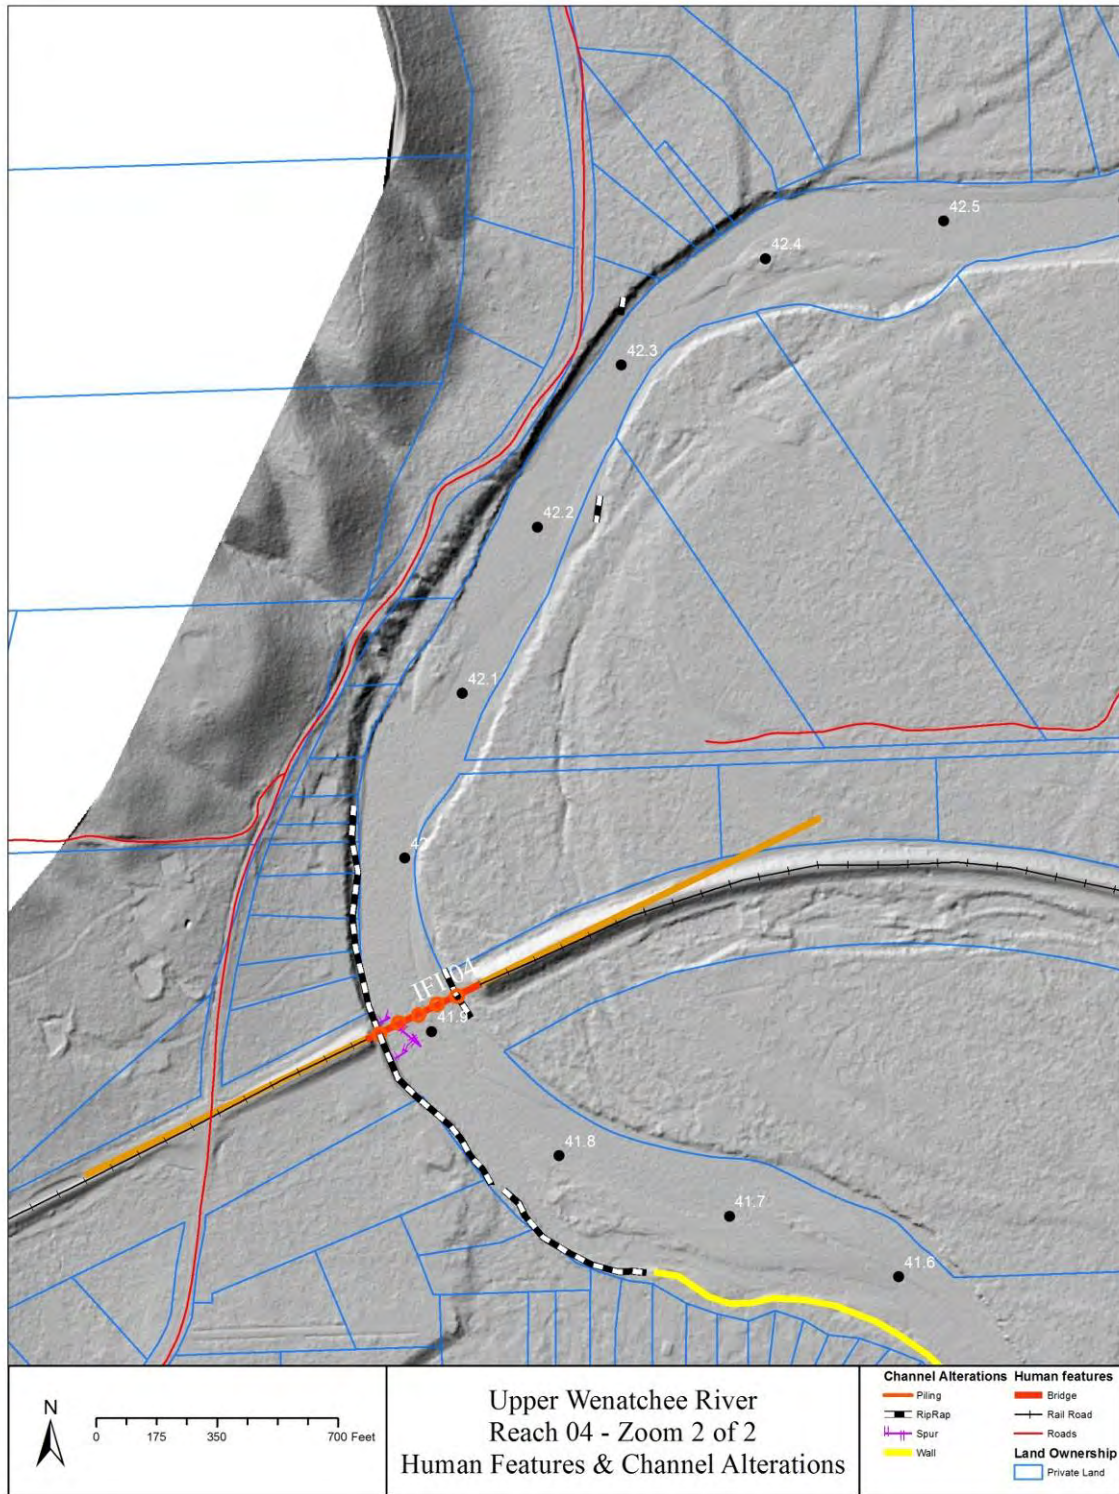
Figure 54. Human alterations in the downstream portion of Reach 4. Flow is from north to south.

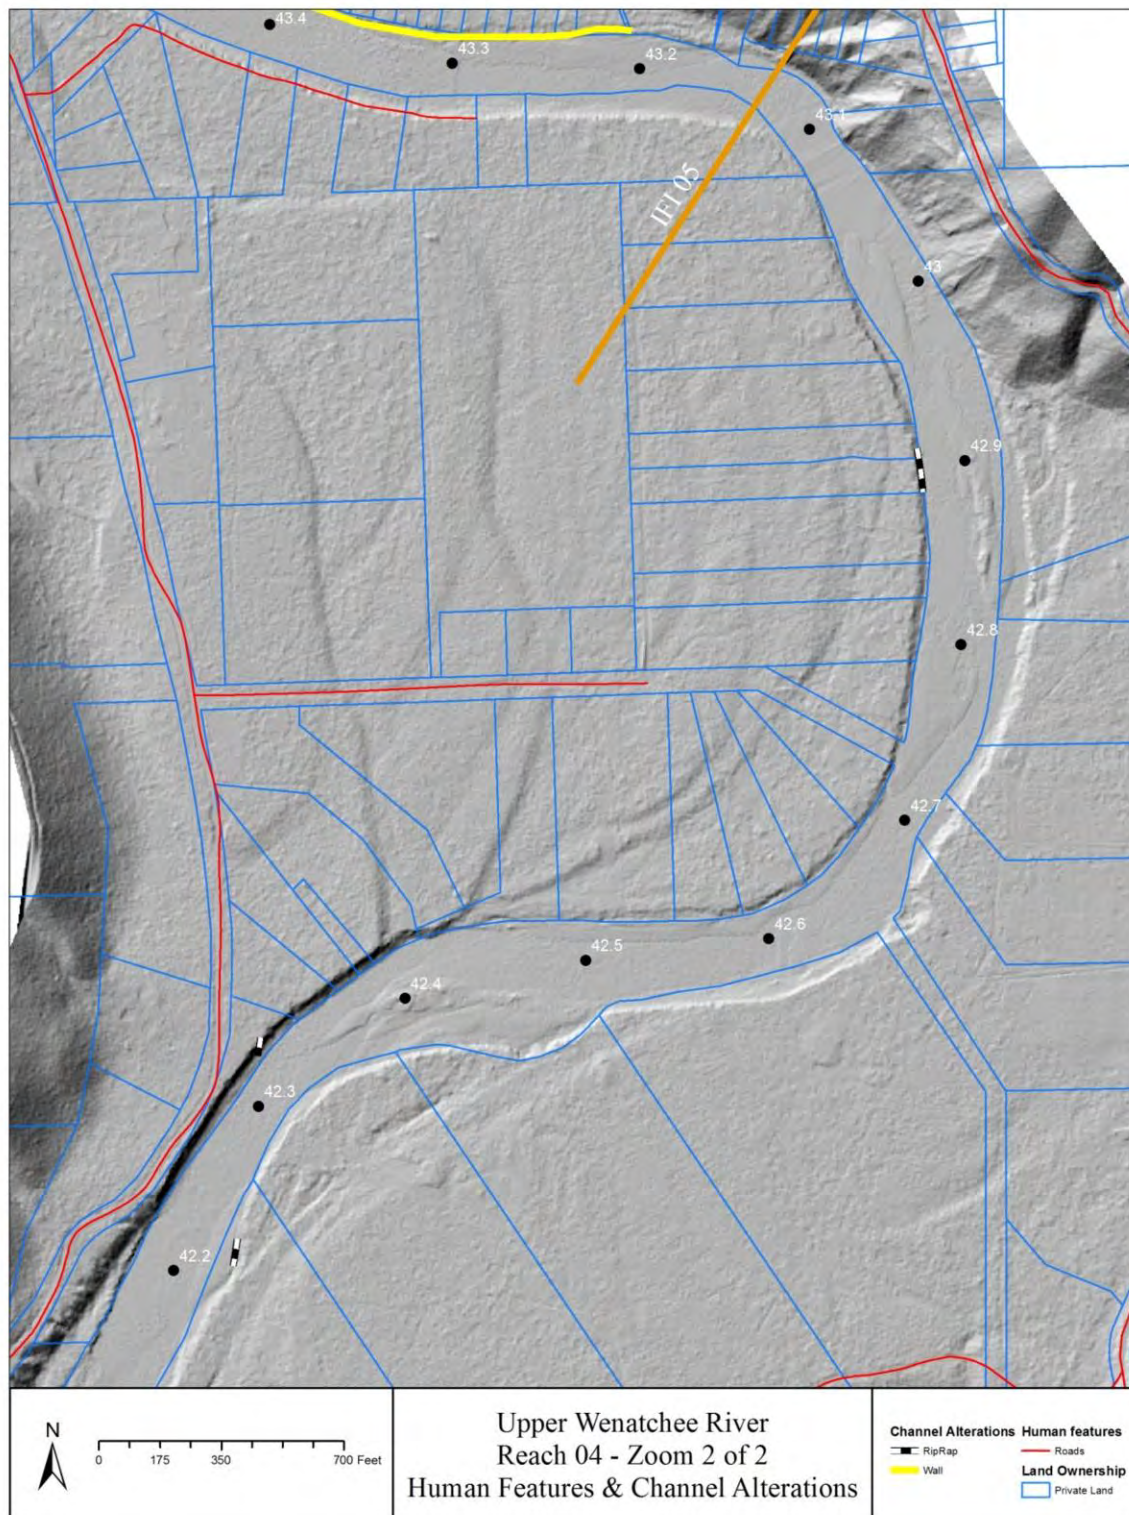
Figure 55. Human alterations in the upstream portion of Reach 4. Flow is from north to south.

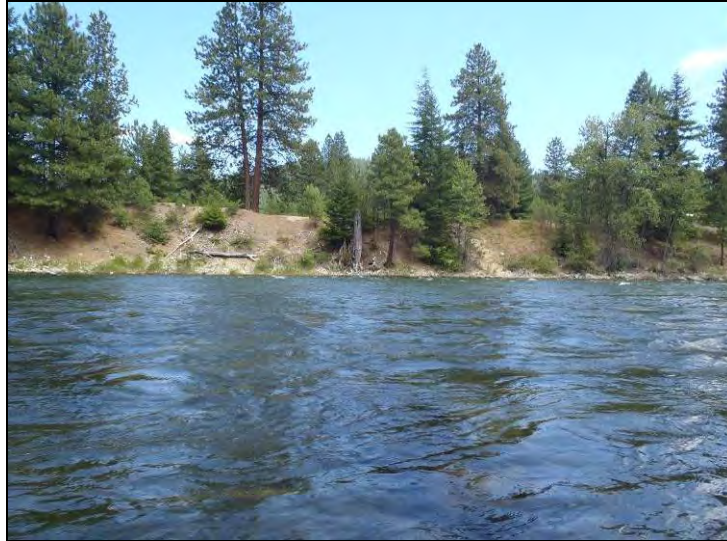
The channel and its modern floodplain are naturally confined within terraces of glacial outwash (Figure 58) and exposures of the Chumstick Formation. The glacial outwash terraces are a result of glacial meltwater mobilizing, transporting, and depositing materials in the Wenatchee valley during and after the last glacial period. Since deposition, the channel has incised into and reworked the glacial outwash deposits (NPCC 2004, Tabor et al. 1987). The channel is further confined by development and bank hardening of the marginal floodplain surfaces. Confinement limits lateral migration and exaggerates changes in flood stage relative to discharge. As a result the river is a transport dominant reach with minimal available off-channel habitat or large wood retention. The gradient of Reach 5 is 0.25%.

**Figure 58. Terraced banks (alluvium terrace deposits). Terrace surface was approximately 8' above water surface elevation (August 2011).**

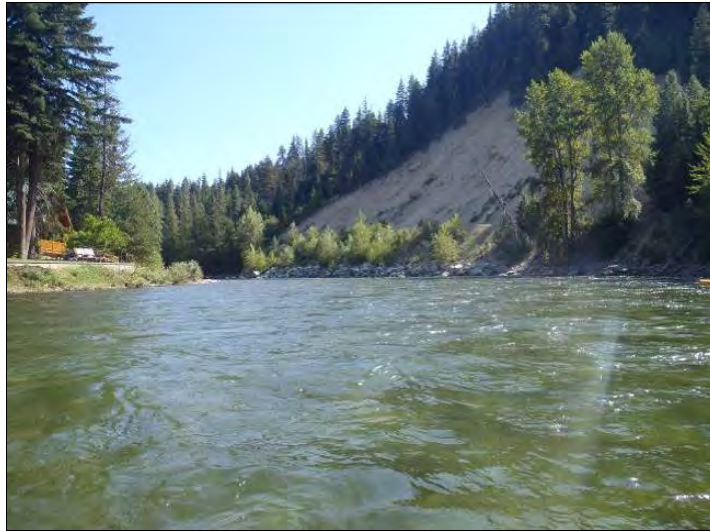
**Figure 66. Homesites along the right bank across from the exposed Chumstick Formation (photo taken at RM 47.1, facing upstream).**

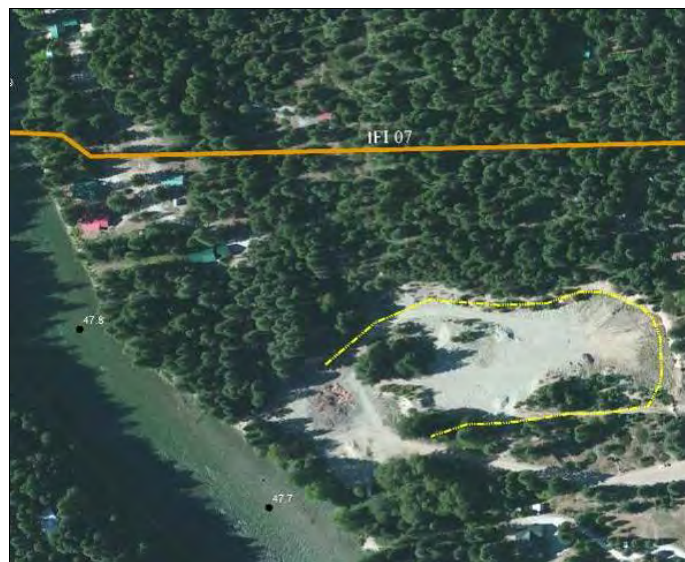
On the river-left floodplain surface at RM 47.7 there is a 3.52 acre gravel excavation pit (Figure 67). Adjacent to the pit a push-up levee has been constructed along river-left to protect the excavation pit. The levee extends up and downstream of the pit in front of residential homes and alters the frequency and extent of floodplain inundation.

**Figure 67. Gravel excavation pit (highlighted in yellow) along left bank in upstream portion of Reach 6.**
