# UPPER WENATCHEE RIVER STREAM CORRIDOR ASSESSMENT AND HABITAT RESTORATION STRATEGY

August 2012

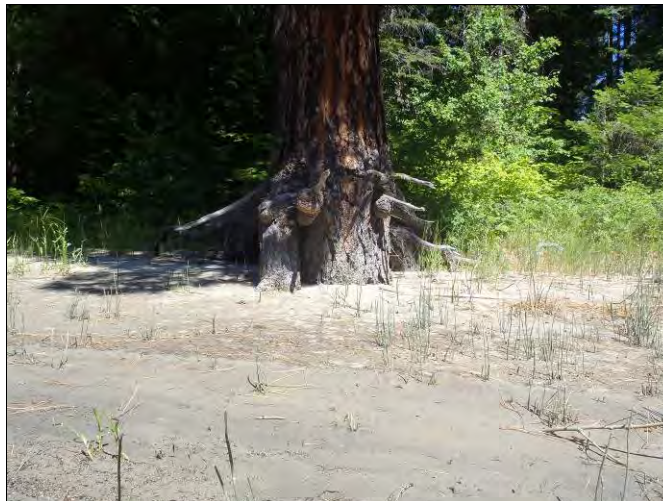
The channel and its modern floodplain are partially confined by terraces of glacial outwash deposits. The channel abuts the high terrace bank on river-right from RM 47.9 to RM 48.14. The modern floodplain surfaces are low with sloping banks and alternate between human-altered and functioning. Hydraulic modeling of floodplain inundation reveals that most of the modern floodplain surfaces in Reach 7 are not inundated with flow events equivalent to or less than the two year flood (Section 3.5.2). This suggests that incision is occurring in this reach even with the additional sediment inputs from the Chiwawa River and its alluvial fan. The relatively short length of the reach and terrace confinement result in a sinuosity of 1.06. The gradient of Reach 7 is 0.25%. Slope is greatest in the downstream portion of the reach where the channel is confined by the terrace. Here transport capacity of wood and sediment also increases, as evidenced by modern scour at the base of riparian vegetation throughout the reach (Figure 74).

**Figure 74. Scour at base of mature ponderosa pine in riparian area.**

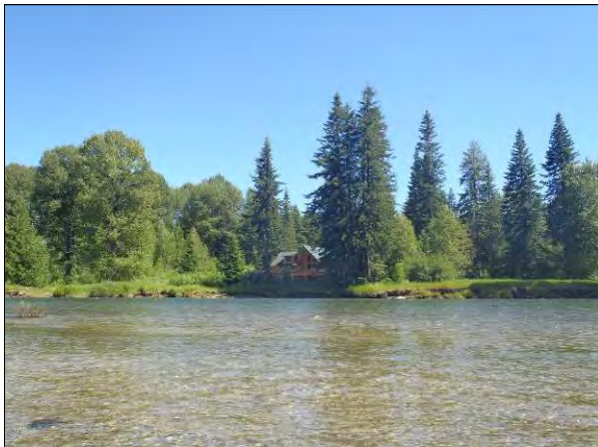
Human alterations affecting the channel are primarily restricted to the left bank. These alterations include home development and riparian vegetation removal and/or alteration. Where homesite development has occurred much of the floodplain has been altered by fill or grading. The riparian canopy has been completely cleared at many homesites, and at other sites, understory shrubs and saplings have been cleared and only select large trees remain. Where canopies have been completely cleared, lateral channel scour is undercutting banks and they are slumping into the channel (Figure 75 and Figure 76).

**Figure 75.** Clearing of riparian vegetation resulting in bank slumping.

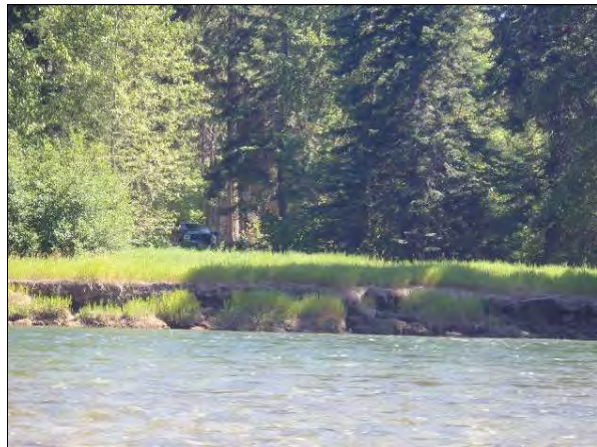
**Figure 76.** Left bank slumping due to lack of riparian vegetation.

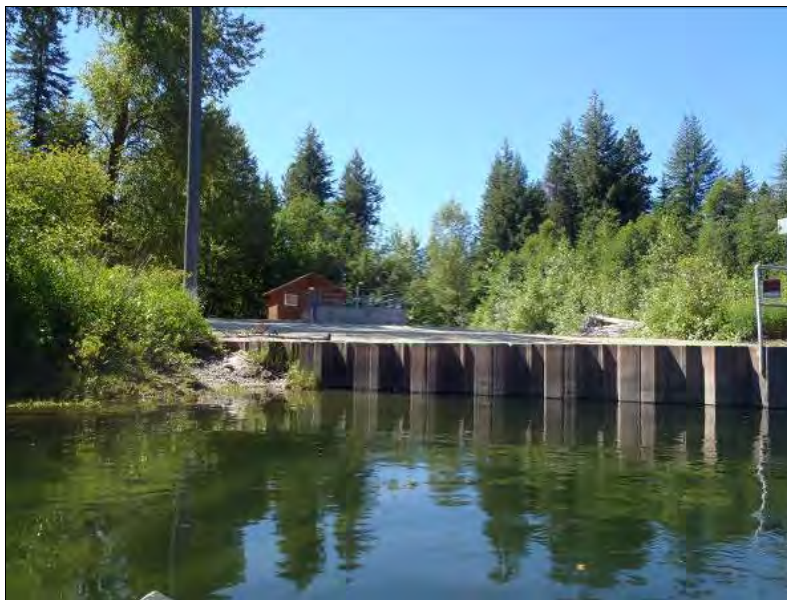
Bank hardening at RM 49.3 further impairs floodplain inundation and lateral migration. A cement and steel retaining wall protrudes slightly into the channel protecting the bank from all channel processes (Figure 82). The wall is part of the Washington Department of Fish and Wildlife's Chiwawa Ponds fish hatchery facility. This facility also includes fill and small buildings. Just upstream from the fish hatchery facility the floodplain surface has been graded and much of the native vegetation has been removed (now dominated with mowed grass) to facilitate community recreational activities. This area contains a disconnected wetland complex. According to the hydraulic modeling, the fish pond facility and its structures directly limit inundation on this low surface. The nearby disconnected wetland complex does get inundation with flows equivalent or less than a two year flood event.

**Figure 82.** WDFW Chiwawa Ponds Fish Hatchery intake structure.

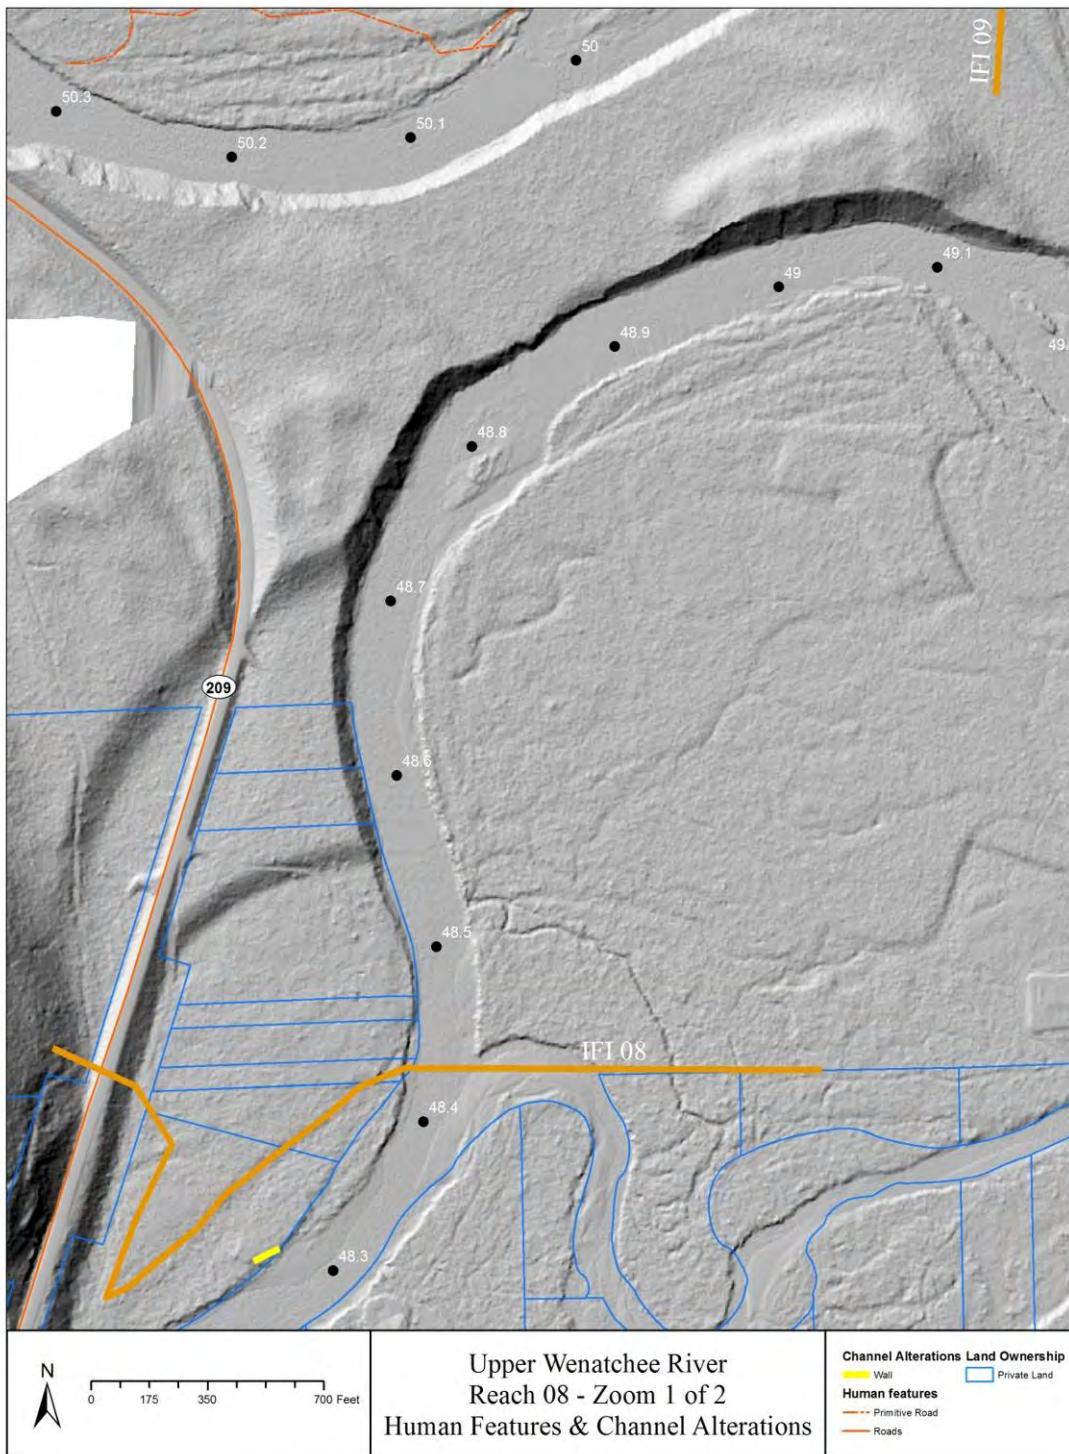
Figure 83. Human alterations in the downstream portion of Reach 8. Flow is from north to south.

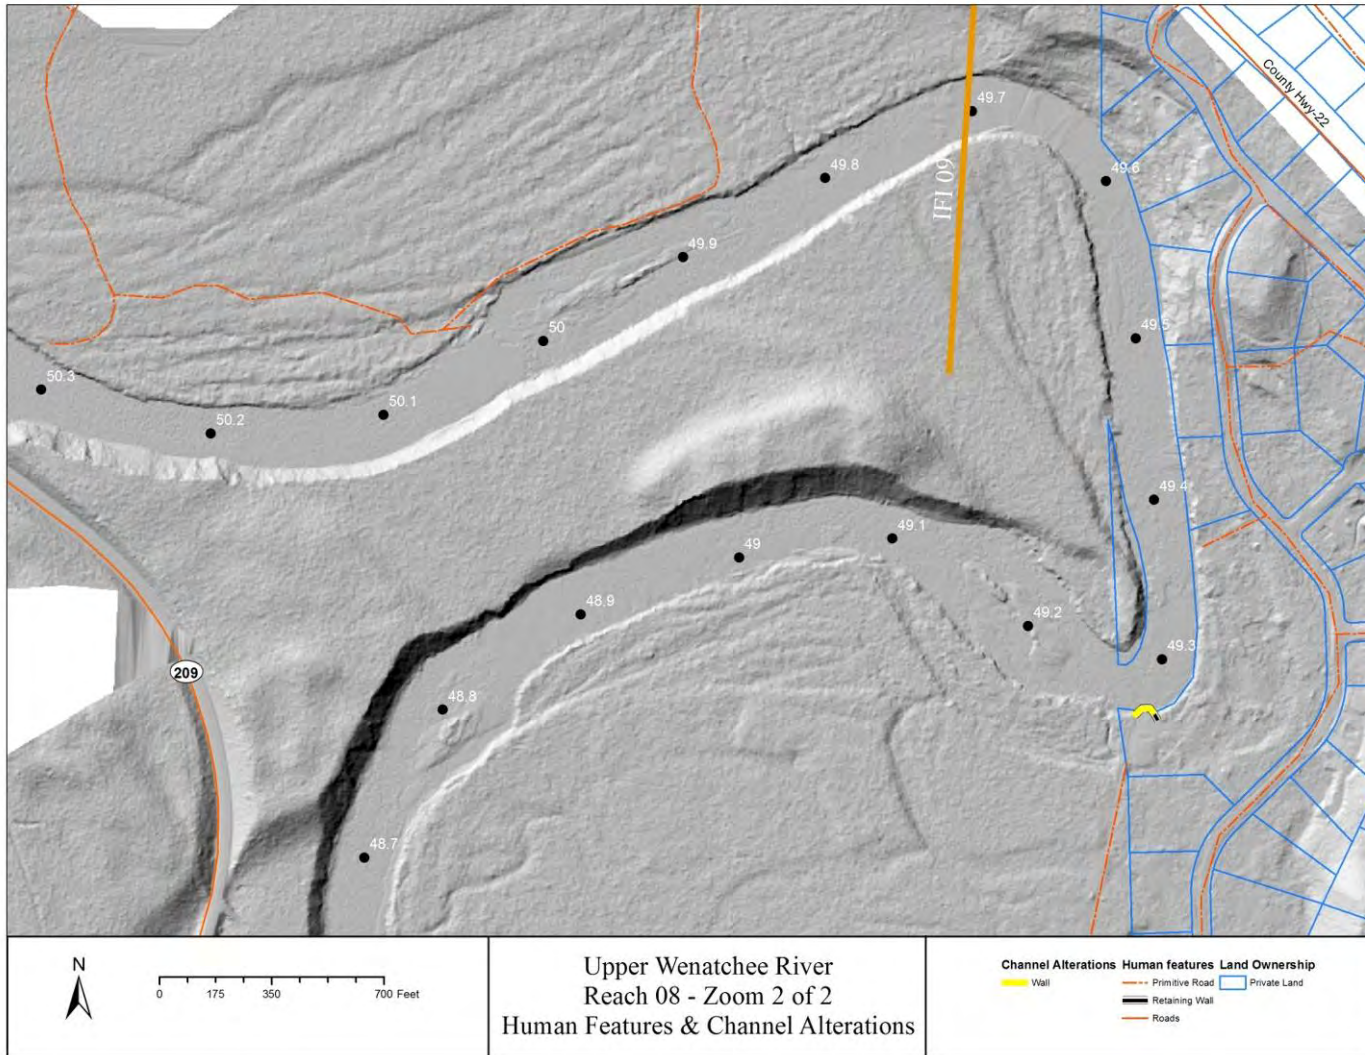
Figure 84. Human alterations in the upstream portion of Reach 8. Flow is from northwest to the south.

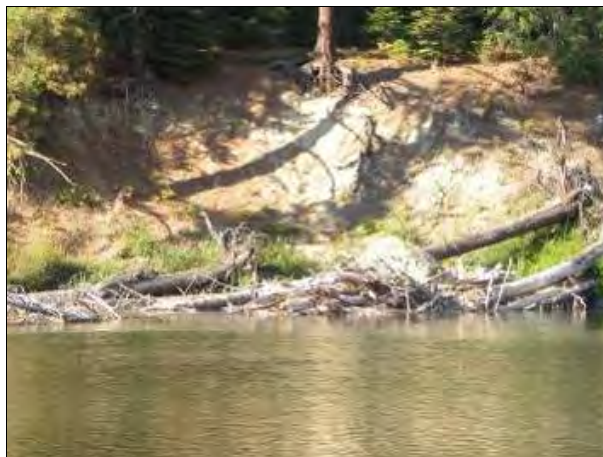
**Figure 86. Example of a channel margin large wood accumulation from steep terrace banks.**

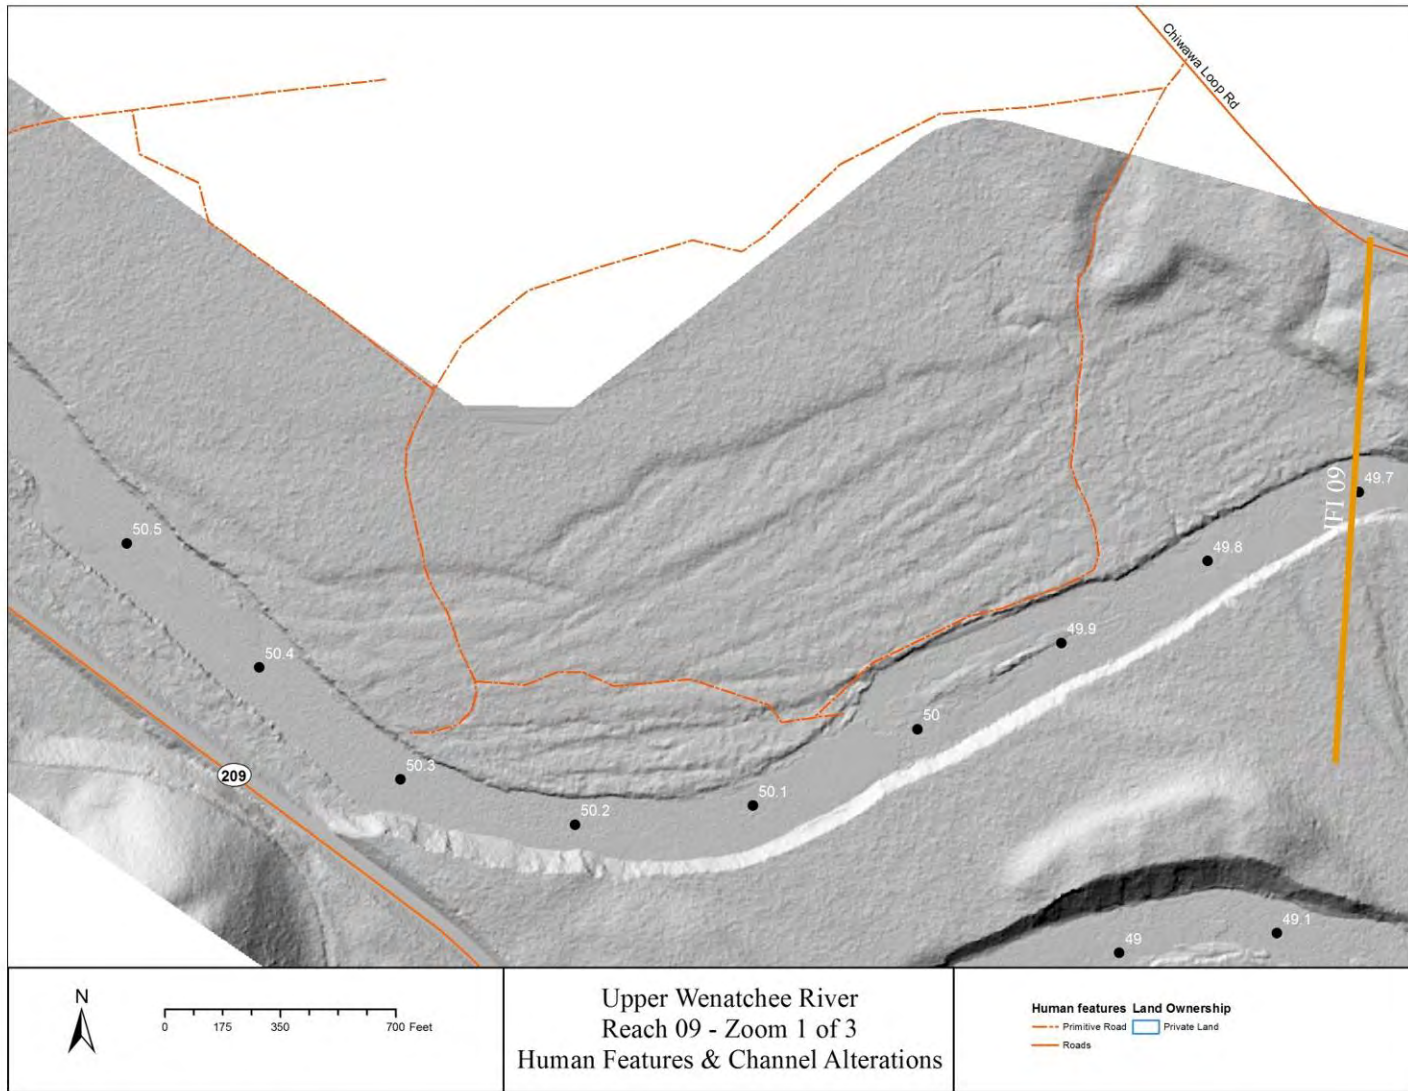
Figure 87. Human alterations in the downstream portion of Reach 9. Flow is from west to east.

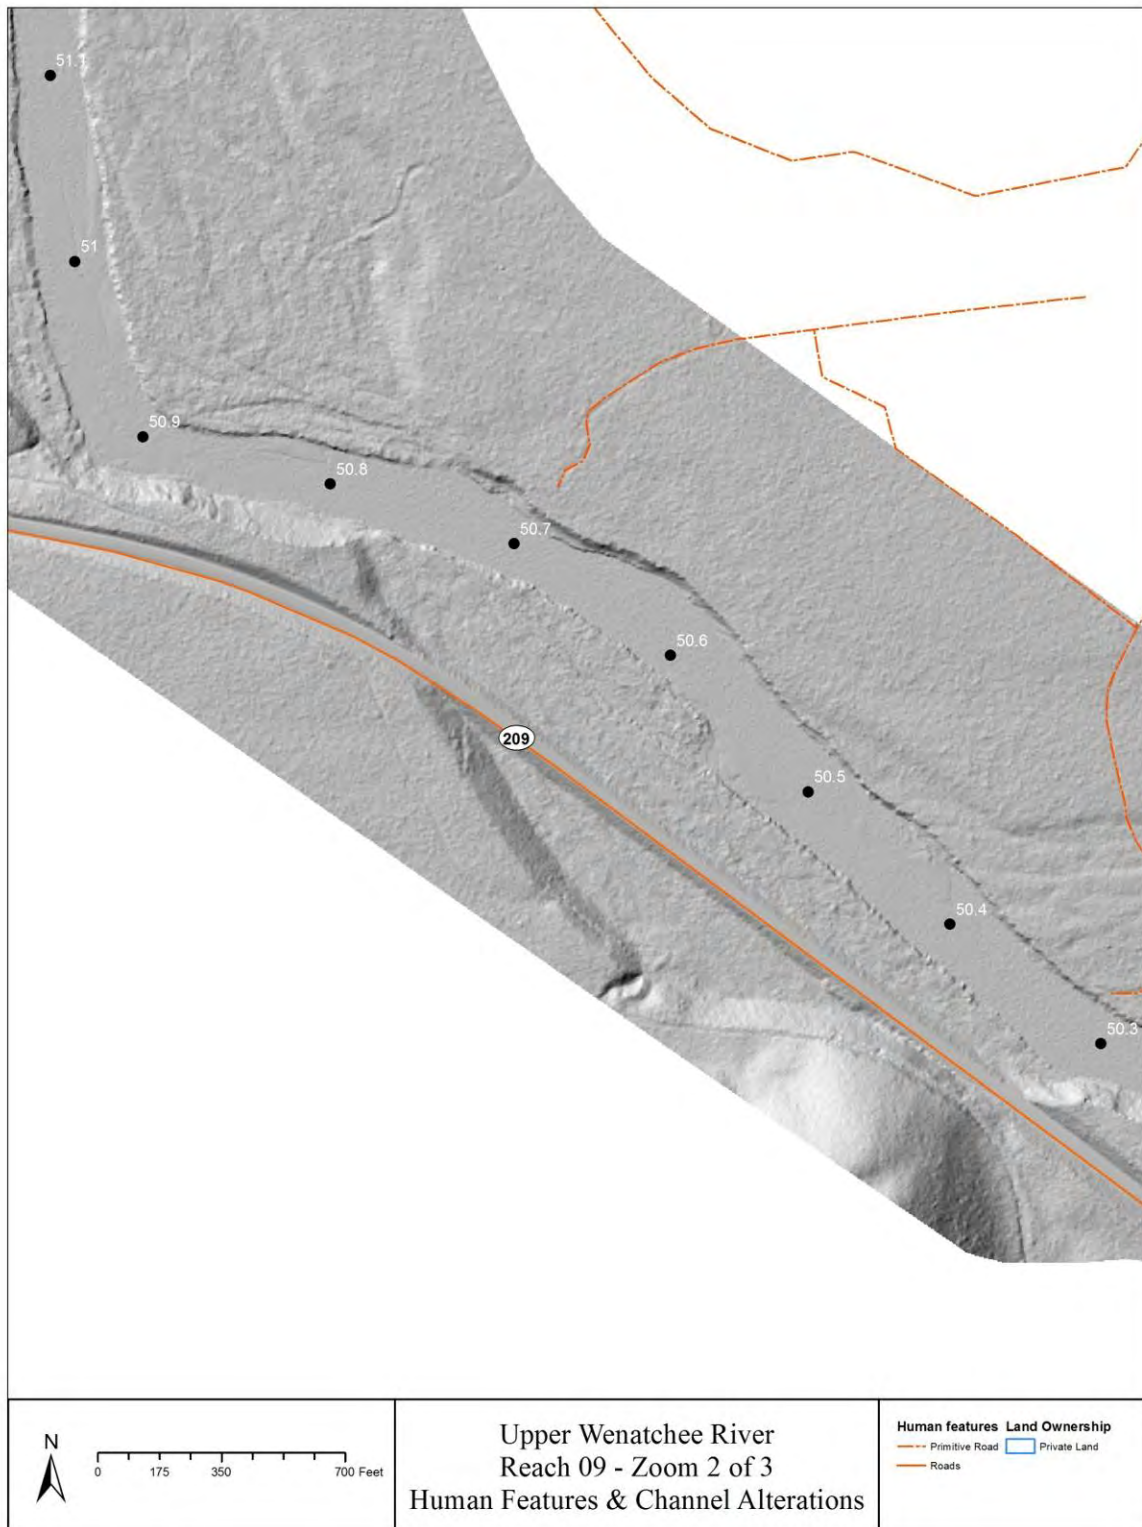
Figure 88. Human alterations in the Reach 9. Flow is from northwest to southeast.

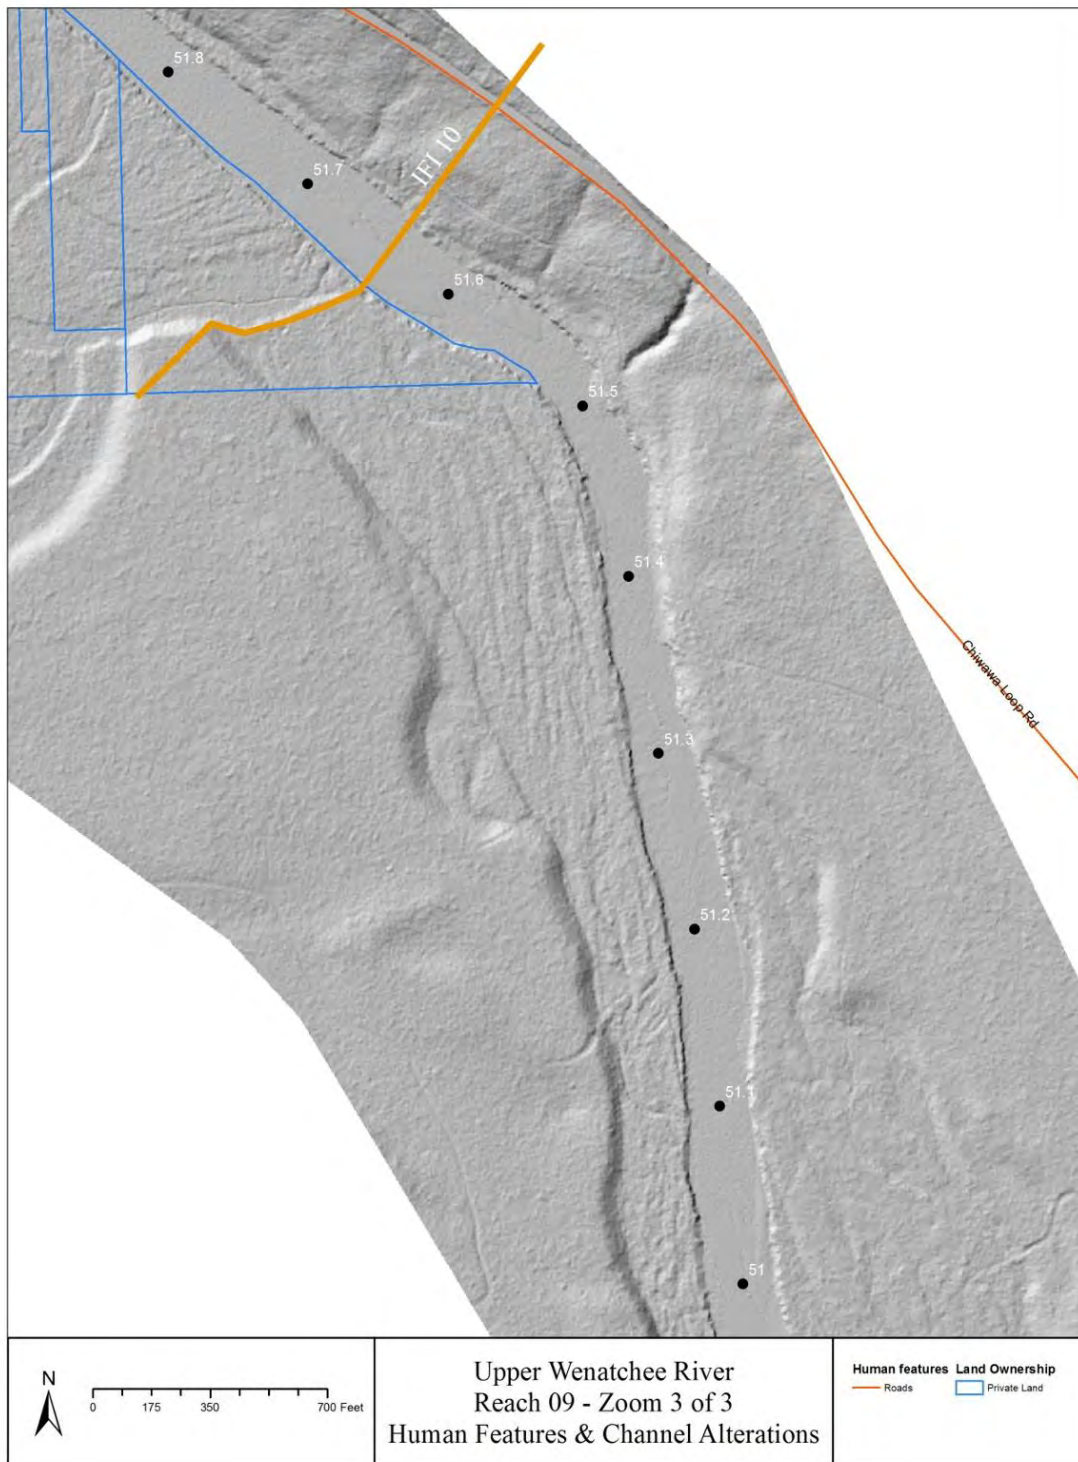
Figure 89. Human alterations in the upstream portion of Reach 9. Flow is from north to south.

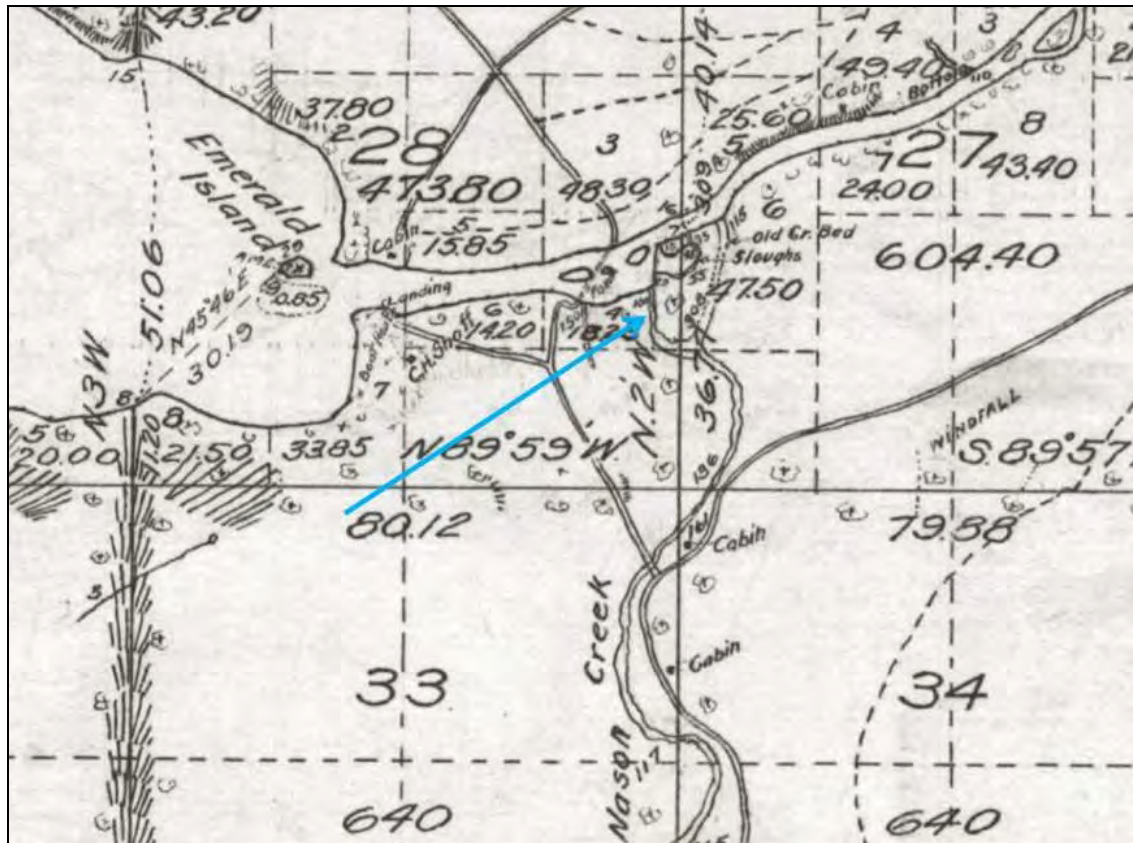
In general, the construction of Hwy 207 impedes the natural migration rates and patterns of what was once a dynamic channel confluence of Nason Creek and the Wenatchee River. This historically active area is evidenced by 1887 survey maps (Figure 94), surface topography, and channel scars visible in LiDAR imagery. Modern flood history (1990) and the hydraulic floodplain inundation model (Section 3.5.2) confirm the potential for dynamic flood hydraulics to occur at the confluence of Nason Creek and the Wenatchee. It appears that the confinement of the channel at the Hwy 207 Bridge further backs up floodwaters at the confluence. As a result, serious flooding of the small community of Lake Wenatchee along Hwy 207 can occur as flood stages breach the road and its fill.

Figure 94. 1887 survey map of confluence of Wenatchee River and Nason Creek. Delineated "Old Cr. Bed" highlights Nason Creek's formerly highly active alluvial fan.

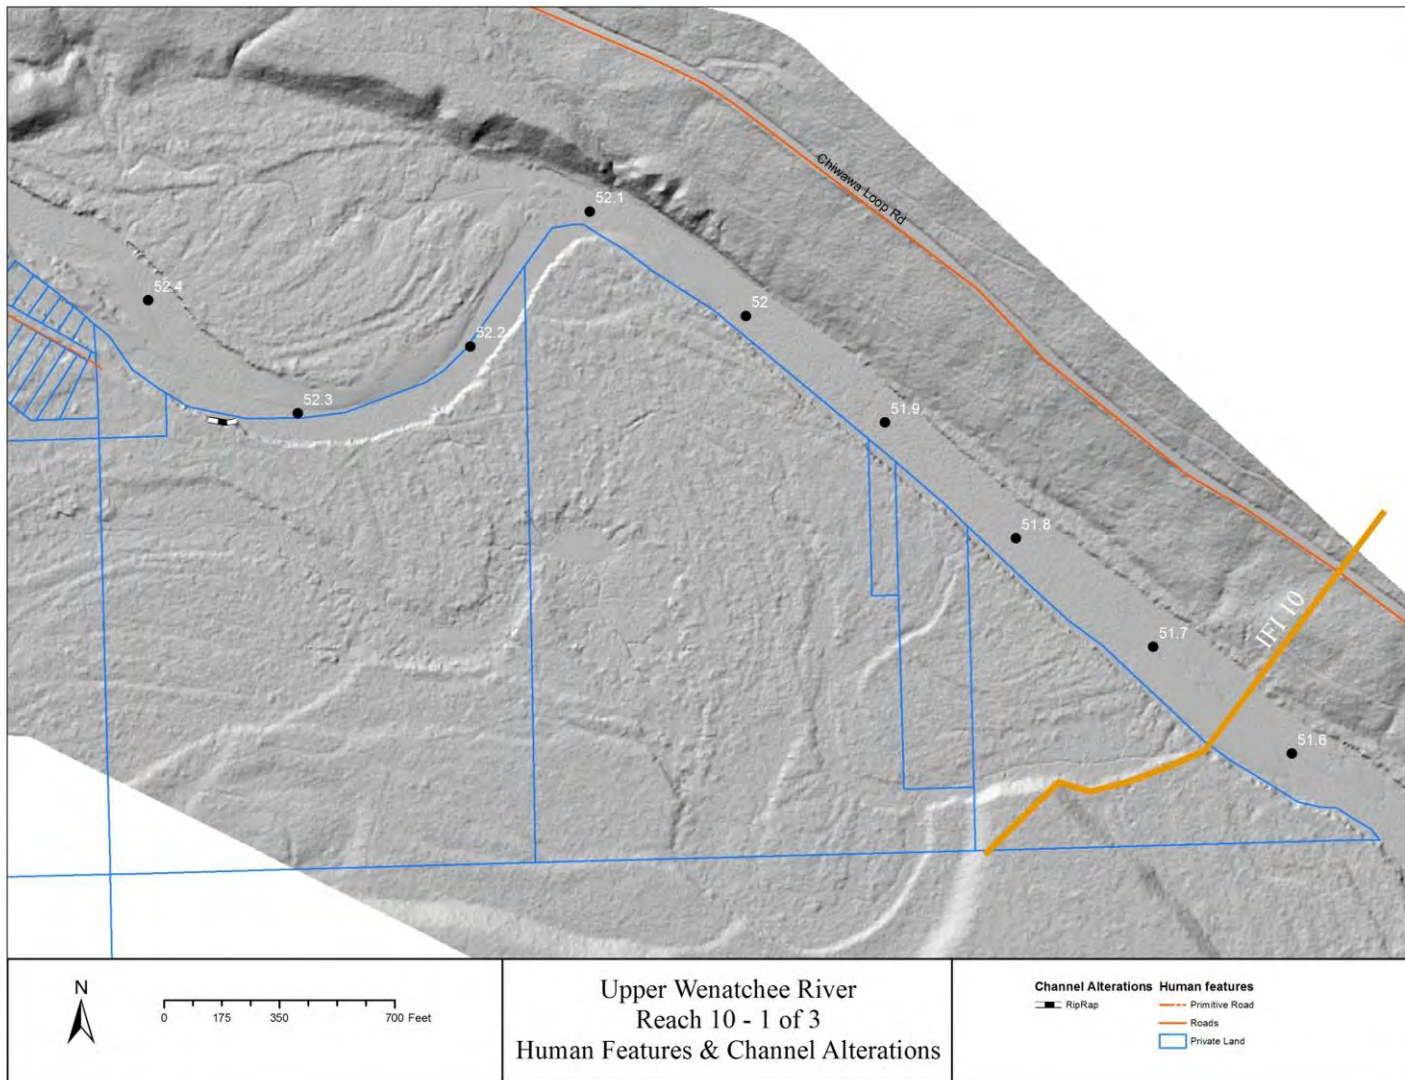
Figure 95. Human alterations in the downstream portion of Reach 10. Flow is from northwest to southeast.

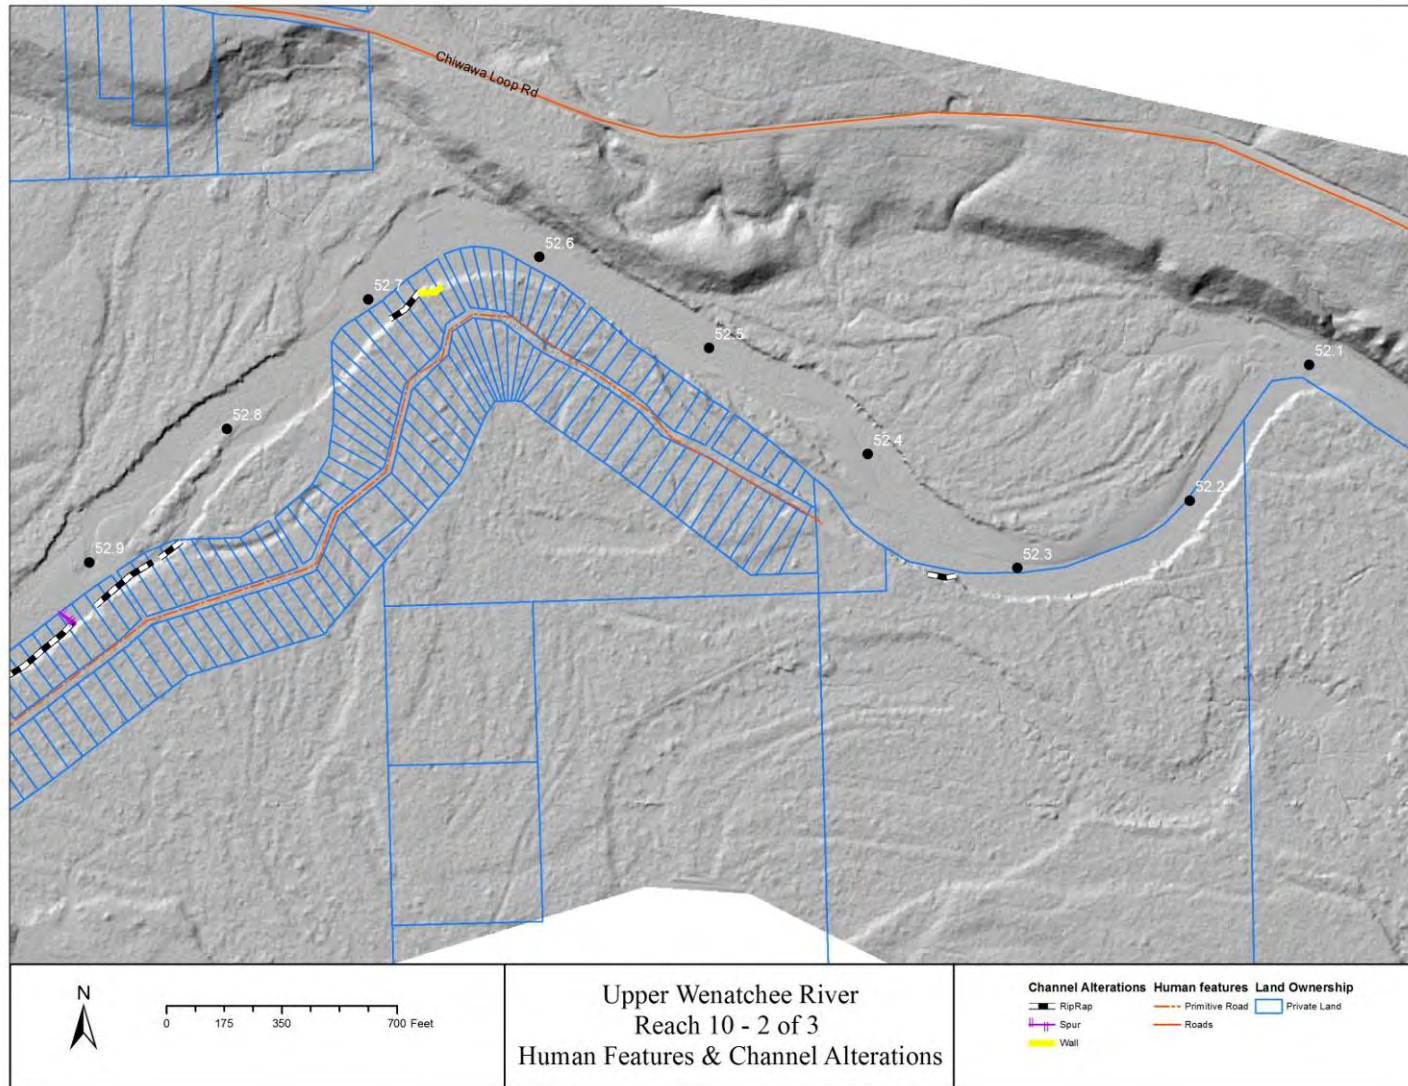
Figure 96. Human alterations in Reach 10. Flow is from west to east.

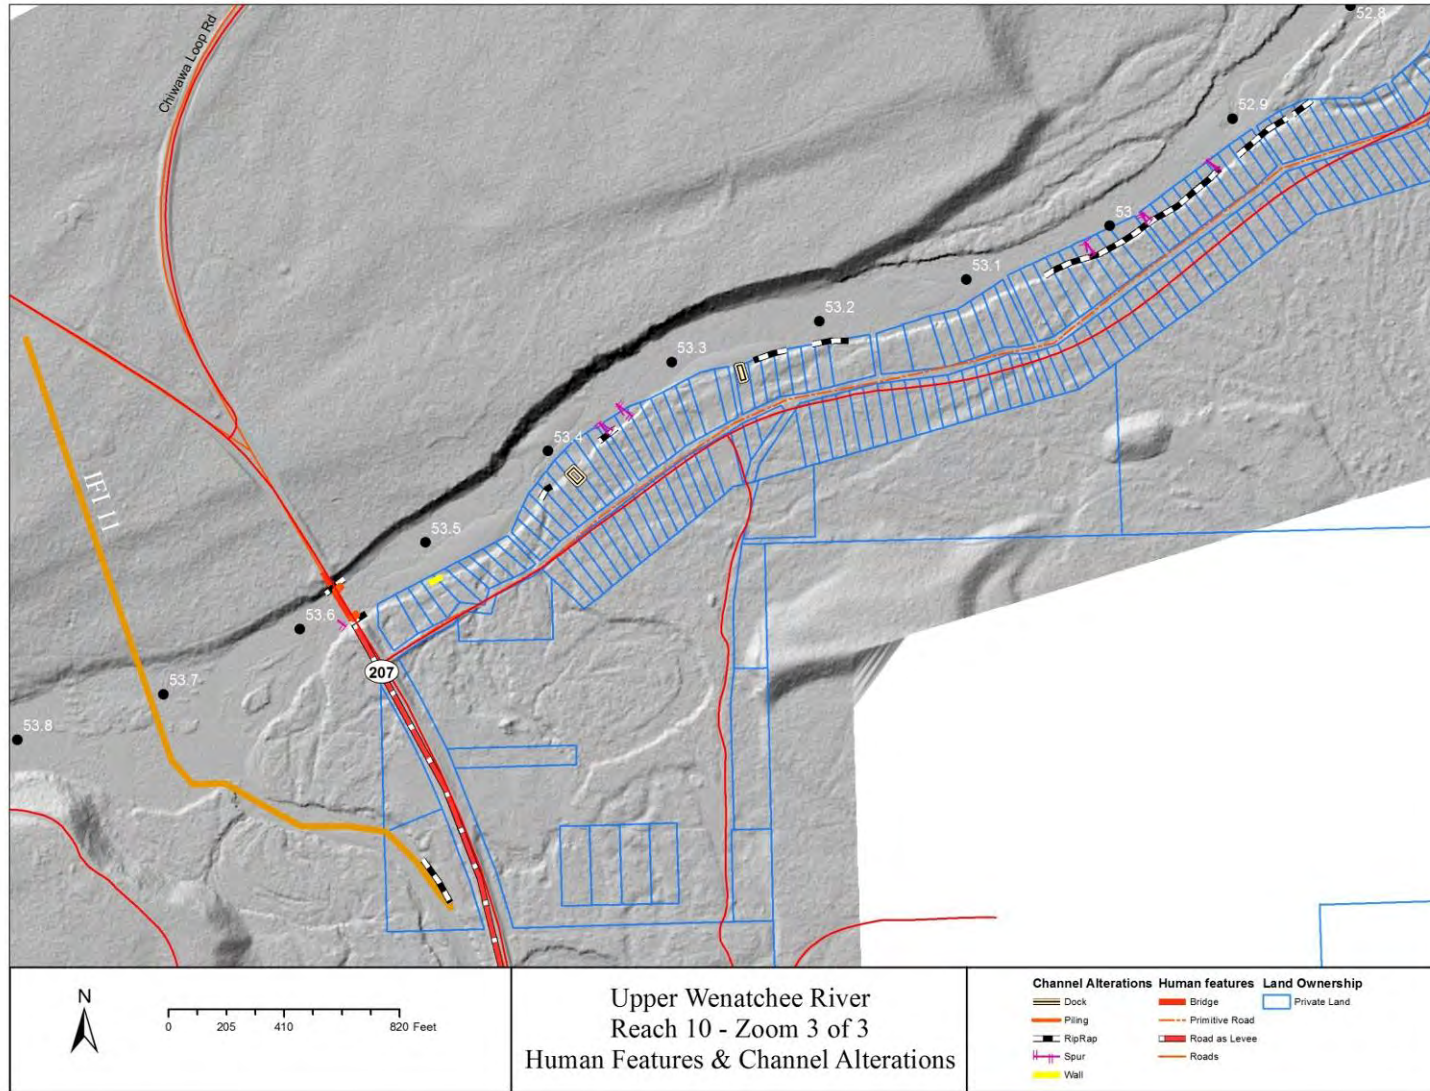
Figure 97. Human alterations in the upstream portion of Reach 10. Flow is from west to east.

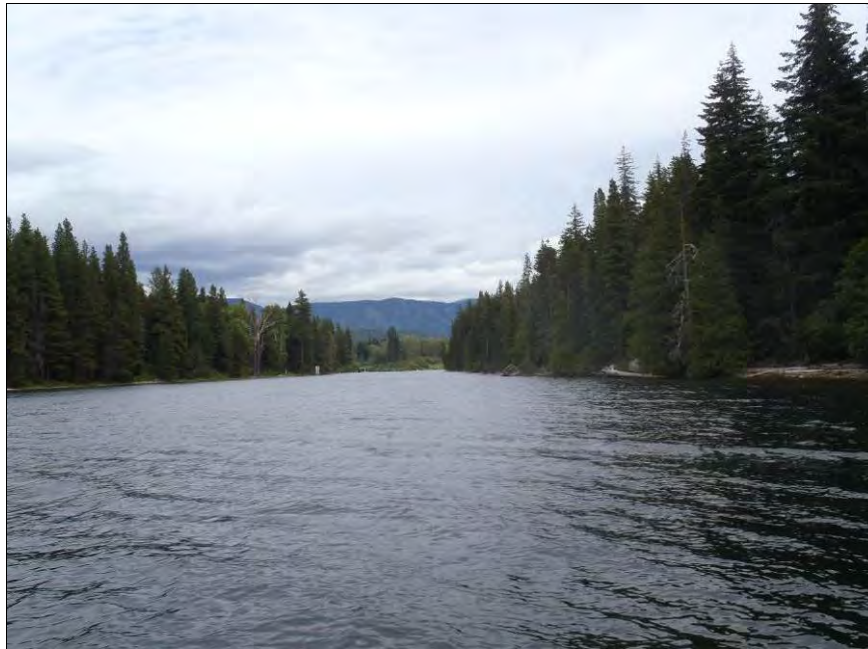
Reach 11 contains an almost perfectly straight channel with a sinuosity of 1.01. The upper 0.5 miles of the reach is entirely confined by glacial terrace deposits that the Wenatchee River has incised through. The channel is planebed with a subtle pool-glide morphology and very limited complexity (Figure 99). At the lower 0.1 miles of the reach channel form and processes are influenced by sediment and discharge inputs from Nason Creek. Here the channel widens and mid-channel island and bar development is occurring behind large glacially deposited boulders and accumulating large wood. Channel substrate throughout the reach ranges from sands to large boulders, with cobbles as the dominant grain size (60%). The overall gradient of the channel in Reach 11 is <0.10%.

**Figure 99. Representative geomorphology of Reach 11, facing downstream (July 20, 2011).**

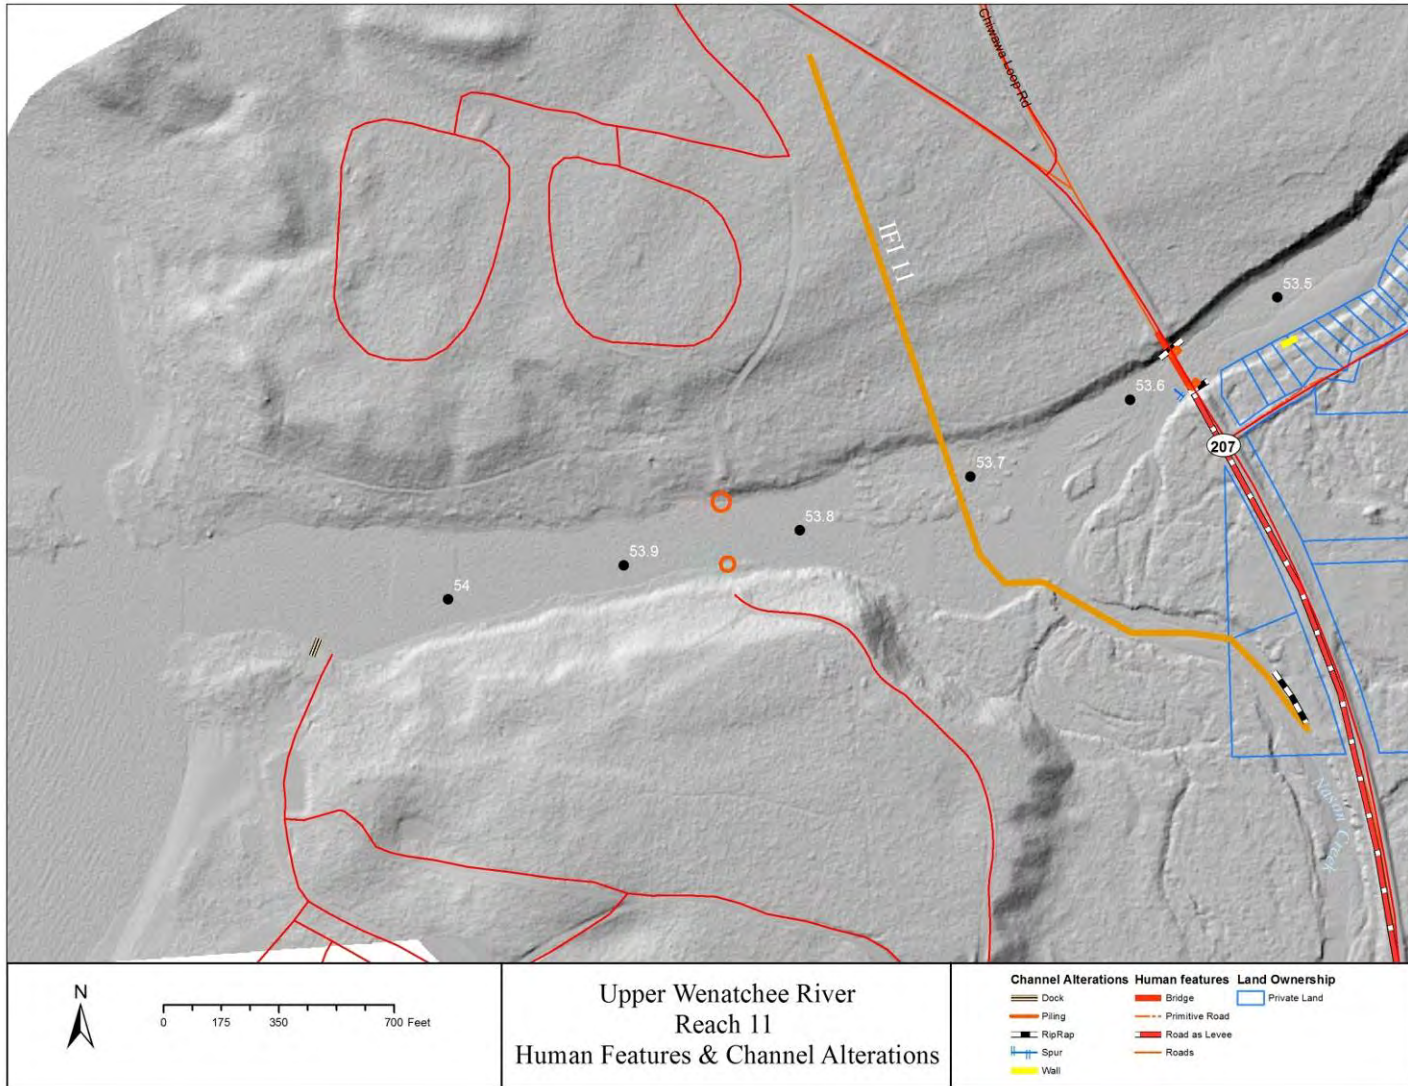
The construction of Hwy 207 and its bridge-crossing only 0.1 miles downstream from the Reach 11 boundary influences channel location and mobility. These structures and their associated fill and bank riprap currently restrict natural channel migration patterns of both Nason Creek and the Wenatchee River.

Figure 100 Human alterations in Reach 11. Flow is from west to east.

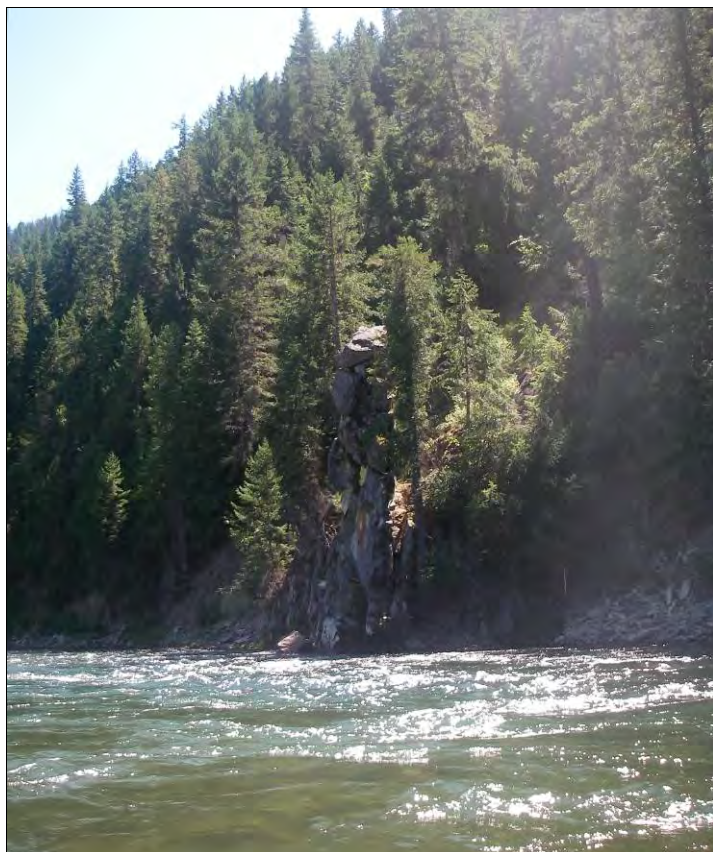
**Figure 14. View looking upstream towards the left bank sedimentary conglomerate hillslope at RM 36.8 (August 2011).**

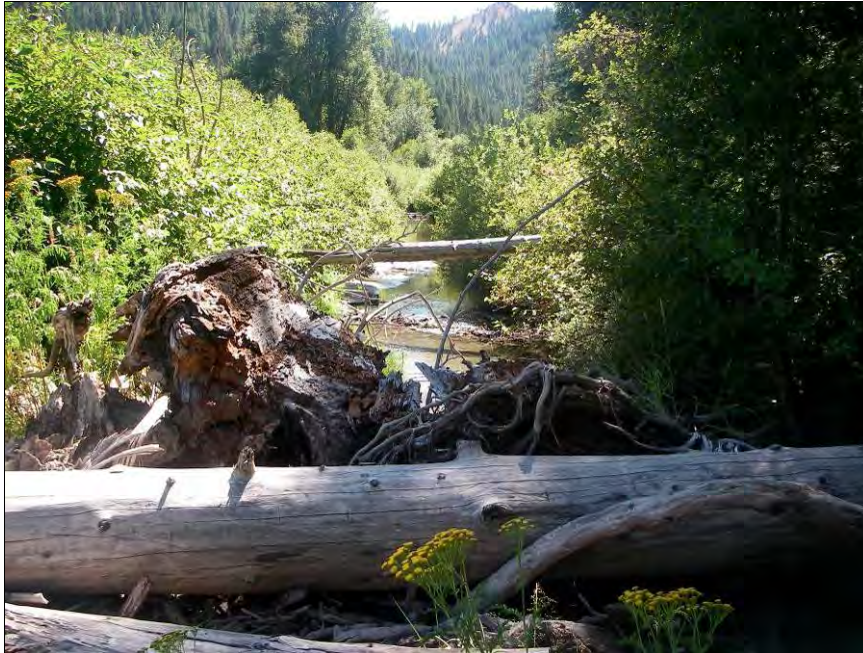
**Figure 17. A backwater marsh (RM 35.95to RM 36.30) has filed in a historical splash dam channel along the right bank floodplain surface in Reach 1 (August 2011).**

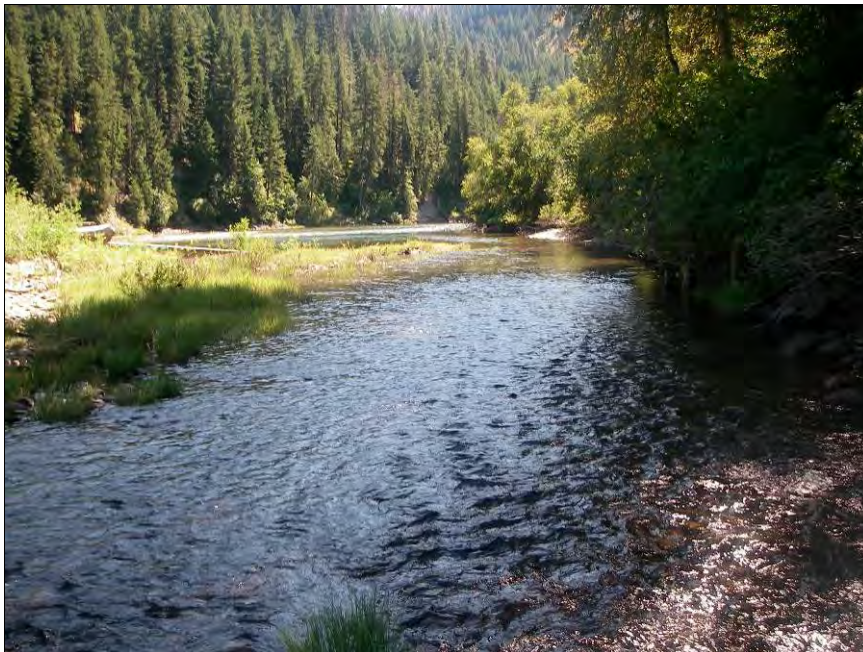
**Figure 18. View looking downstream at a side-channel near RM 36.15 that provides spawning, rearing, and refuge habitat in Reach 1 (August 2011).**

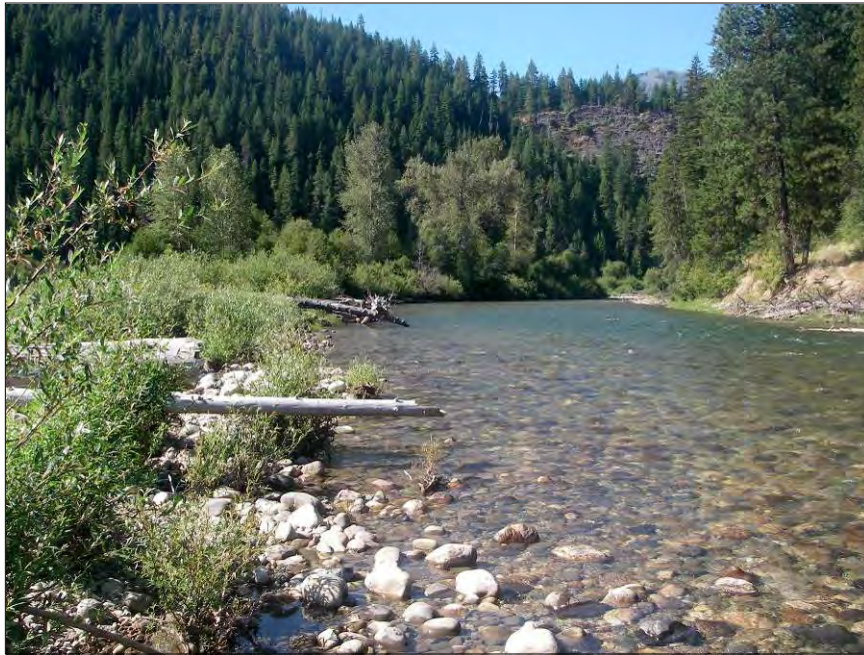
**Figure 19. View looking downstream towards a river-right side-channel at RM 37.25.**

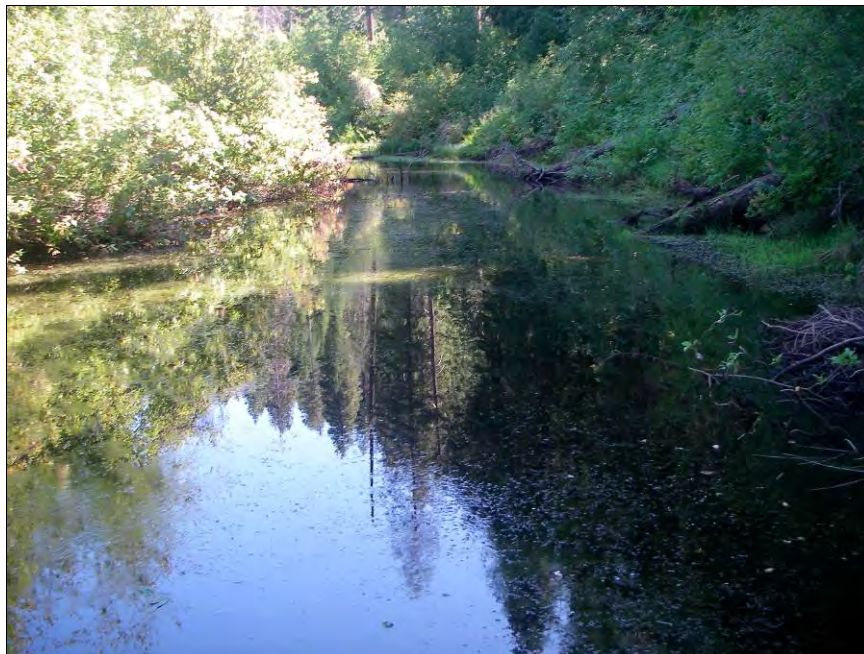
**Figure 20. View looking upstream along a ponded backwater marsh at RM 37.05 (river-left). A left bank steep forested hillslope confines and shades the marsh while providing large and small woody debris (August 2011).**

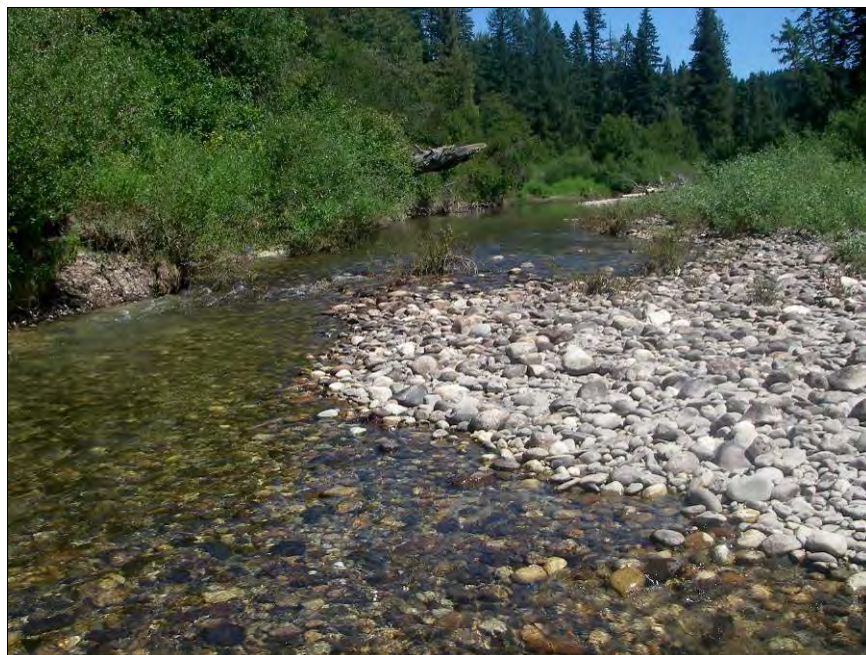
**Figure 21.** View looking upstream at a meander bend side-channel (RM 36.35 to RM 36.80) with sparsely vegetated cobble bars and LWD.

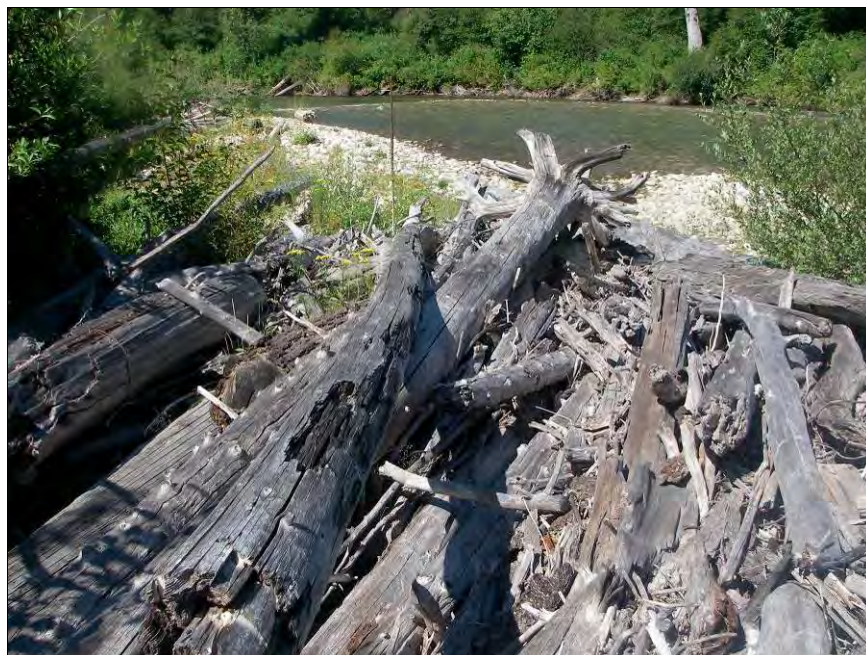
**Figure 22. LWD jams contribute to island formation and bank stabilization, Reach 1 (August 2011).**
