# UPPER WENATCHEE RIVER STREAM CORRIDOR ASSESSMENT AND HABITAT RESTORATION STRATEGY

August 2012

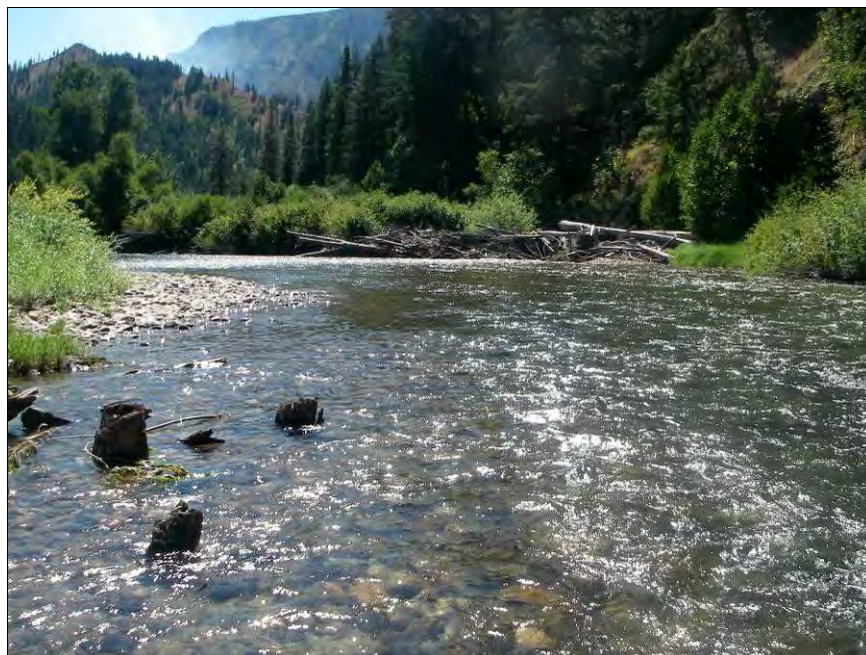
Human activities have impacted the channel, floodplain, and associated riparian corridor within the reach. The primary elements of disturbance were remnants from historical timber harvest and logging operations throughout Reach 1 (Figure 13). Embedded creosote logs and straightened splash dam channels remain at several locations throughout the reach. There is a campground (RM 35.6) and hiking trail along the right bank but their level of disturbance is low. The Hwy 2 Bridge had localized riprap armoring and construction disturbance. It is unlikely that there will be future floodplain development or vegetation clearing within Reach 1 under current US Forest Service management.

**Figure 25. Wood pilings that are presumed to be remnants from historical log drives are found throughout Reach 1.**

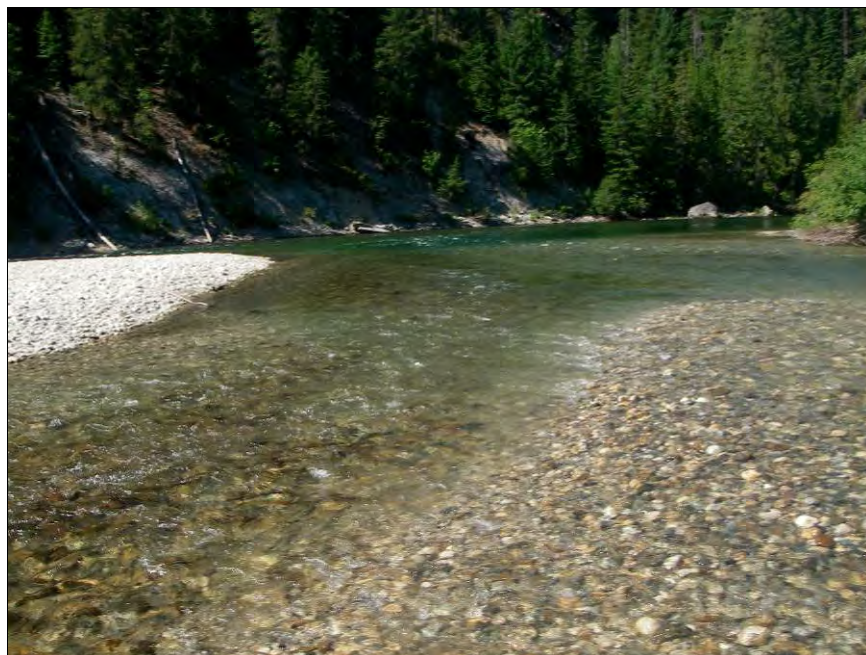
**Figure 26. Spawning gravel and rearing habitat near RM 36.9 where the channel becomes confined at the downstream end of a side-channel complex (August 2011).**

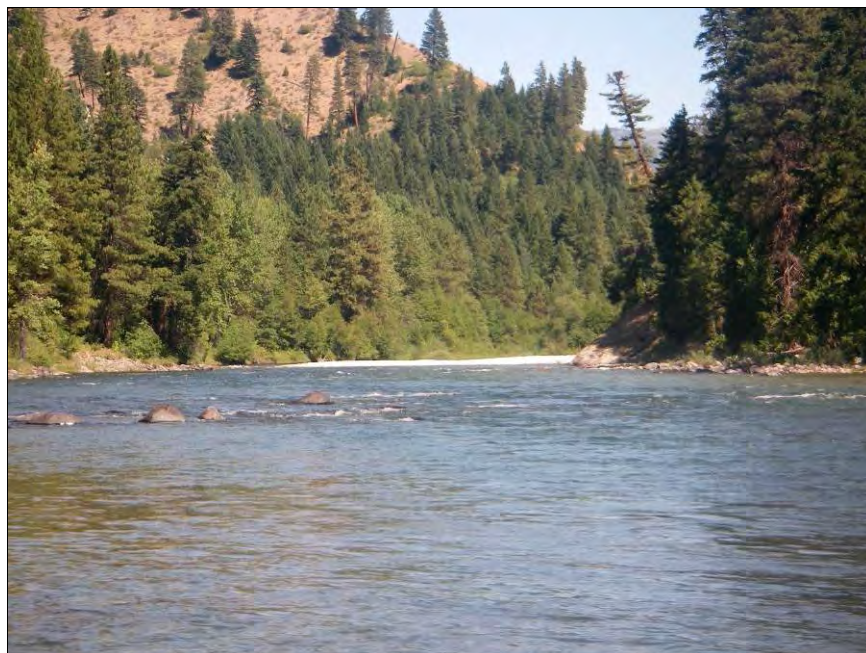
**Figure 28. View looking upstream at the reach boundary near RM 38.5 (August 2011).**

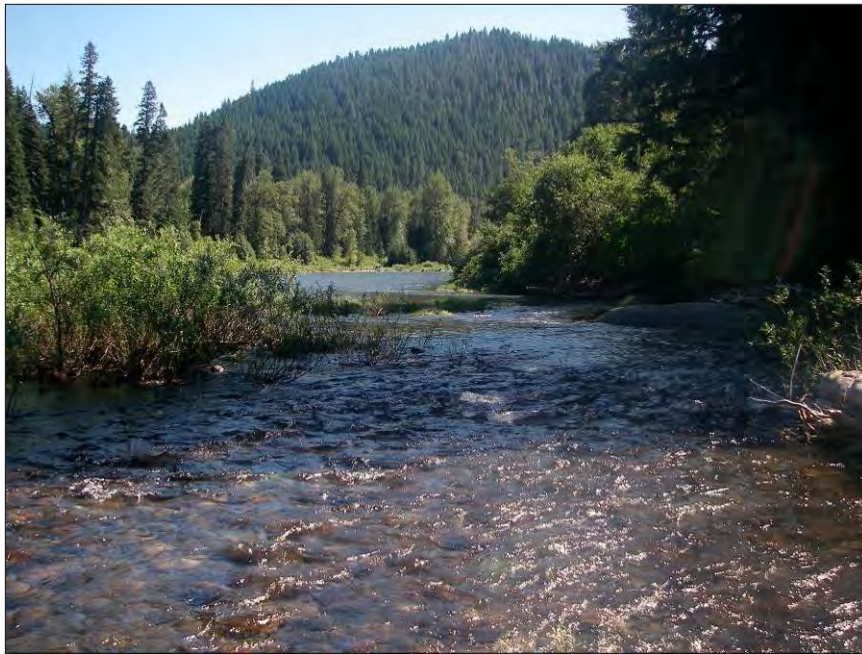
There were two side-channels in Reach 2. A small side-channel, located at RM 37.7, provided some of the only slow water refuge, canopy cover, and LWD observed throughout Reach 2 (Figure 21). It was located near a narrow elongate floodplain surface that abuts the steep hillslope on river-right. A small sparsely vegetated (rushes, grasses, and small willows) sandbar separated this off-channel unit from the mainstem. A second side-channel (RM 38.2) was wide,

**Figure 32. View looking downstream at a river-right side-channel near RM 37.7 that has a frequently inundated sandbar with willow and grasses (August 2011).**

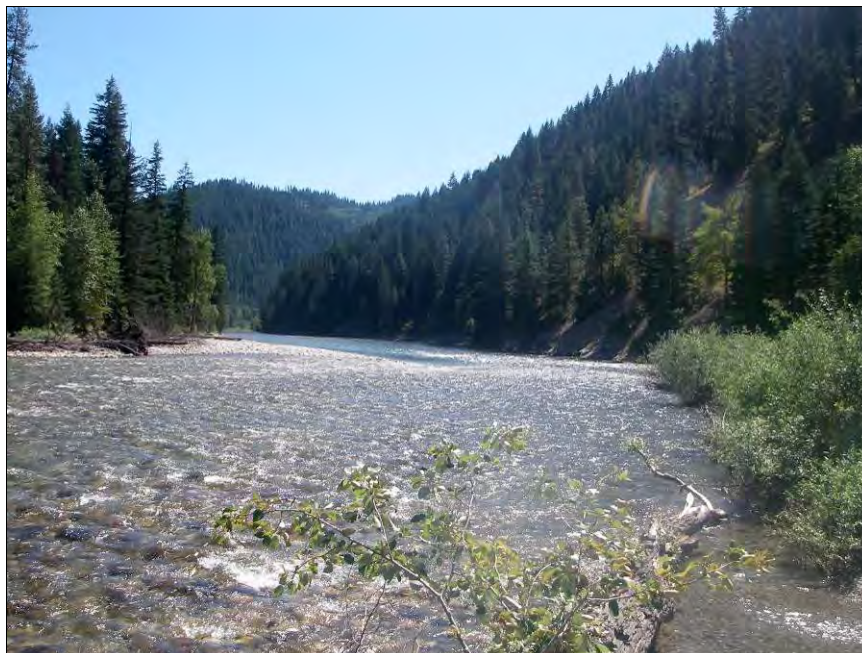
**Figure 33. View looking downstream at a shallow, fast water side-channel near RM 38.2 (August 2011).**

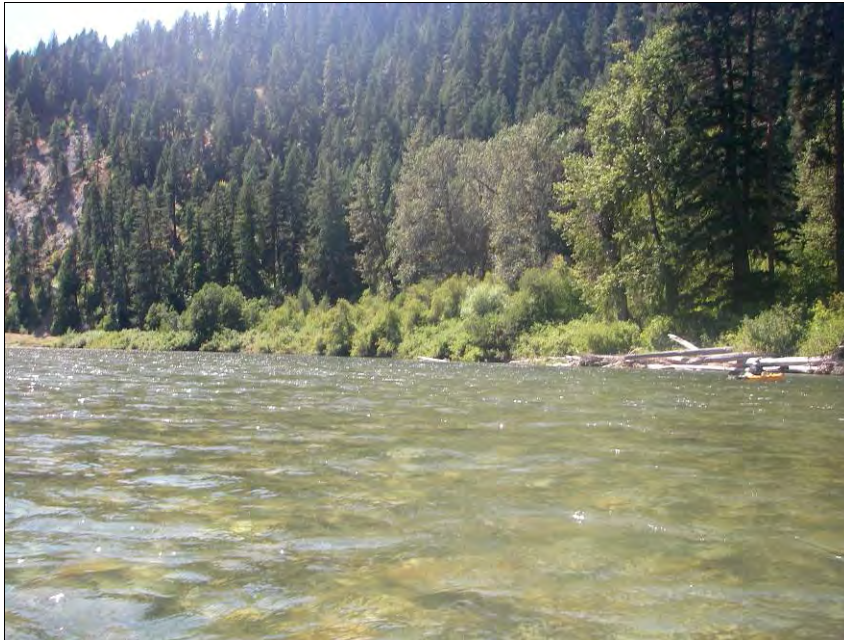
**Figure 37. Small shrubs and saplings have recruited on a low-elevation floodplain along Reach 2 (August 2011).**

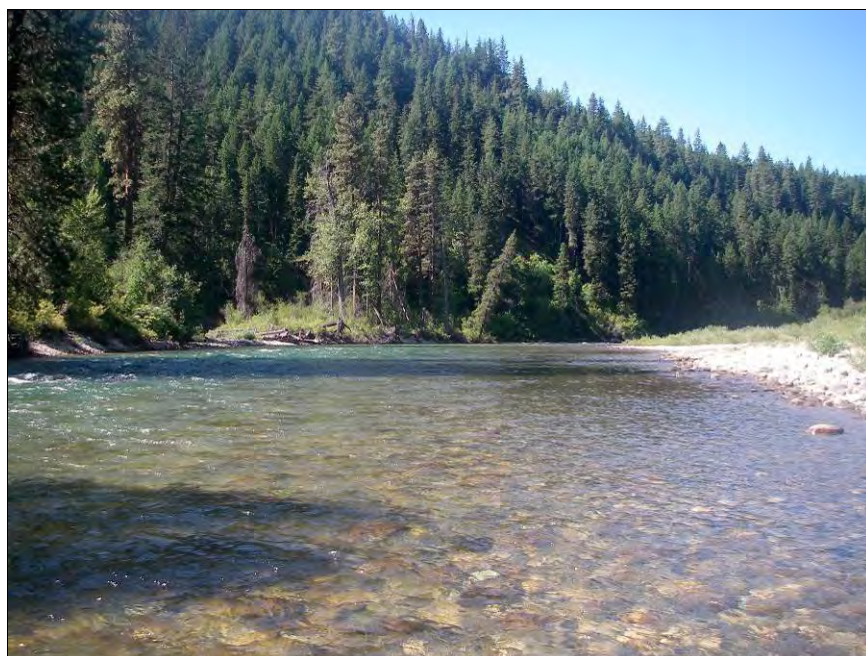
**Figure 38. View looking downstream towards a high-flow side-channel along the left bank at RM 39.0 (August 2011).**

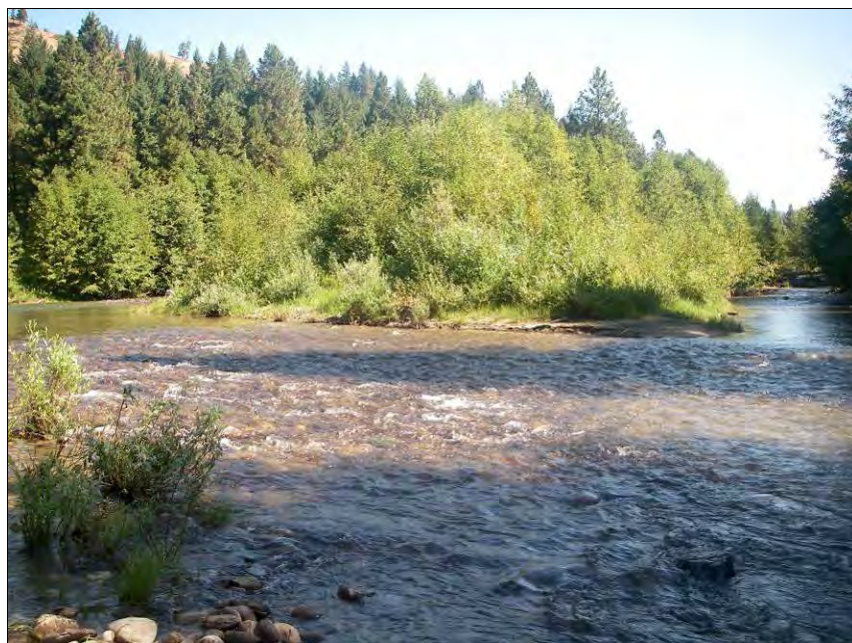
**Figure 42. A right bank braided side-channel provides excellent spawning and rearing habitat near RM 38.75 in the lower portion of Reach 3 (August 2011).**

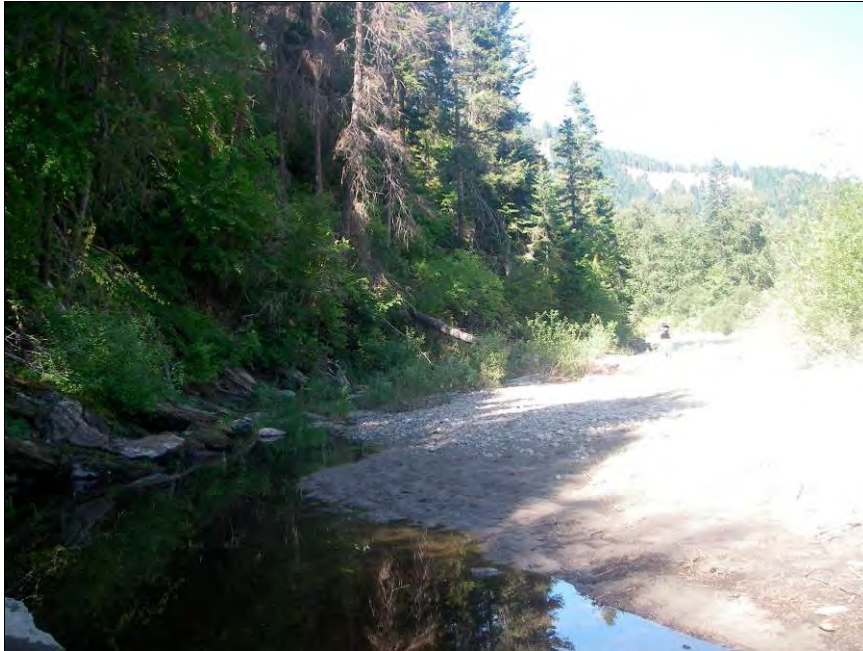
**Figure 43. Left bank floodplain and off-channel habitat at RM 38.9 to RM 39.0 abuts a steep sedimentary hillslope that continues downstream confining the side-channel complex along river-left (August 2011).**

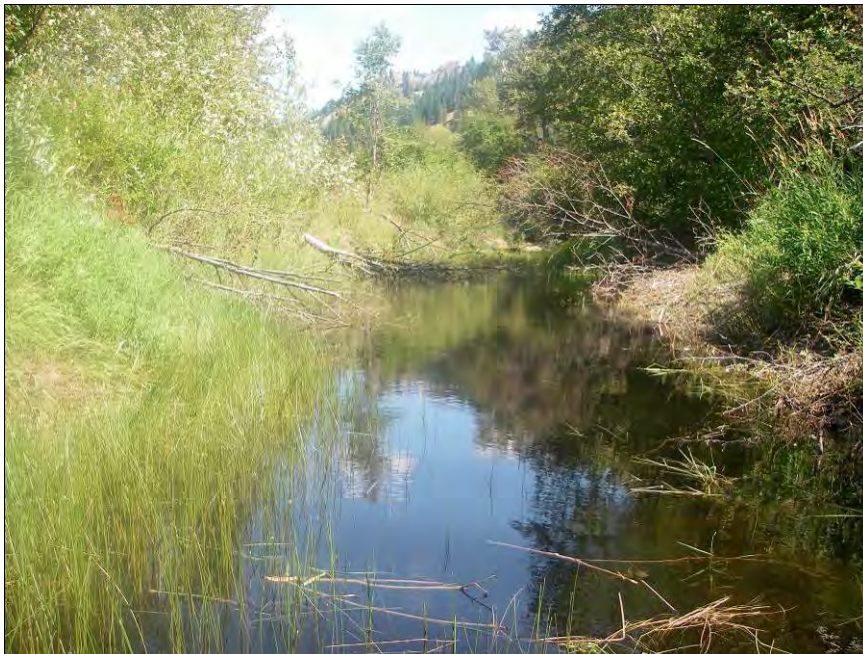
Several narrow disconnected high-flow side-channels were found along the developed floodplain surfaces further upstream in Reach 3. Many of these side-channels flowed around sparsely vegetated, yet highly stable cobble bars that have endured for over 40 years (verified with 1966 WSDOT aerial photos). High water or hyporheic flow maintains these wetted disconnected side-channels (Figure 32). Fry, waterfowl, and wetland vegetation was found in many of the off-channel units in Reach 3. The narrow floodplain surfaces and off-channel habitats throughout Reach 3 are impacted by residential development (Figure 33).

**Figure 44. Representative disconnected (at average flows) side-channel found throughout the upper portion of Reach 3. Many of these side-channels flow around sparsely vegetated, yet highly stable cobble bars. High water or hyporheic flow maintains surface water in these side-channels (August 2011).**

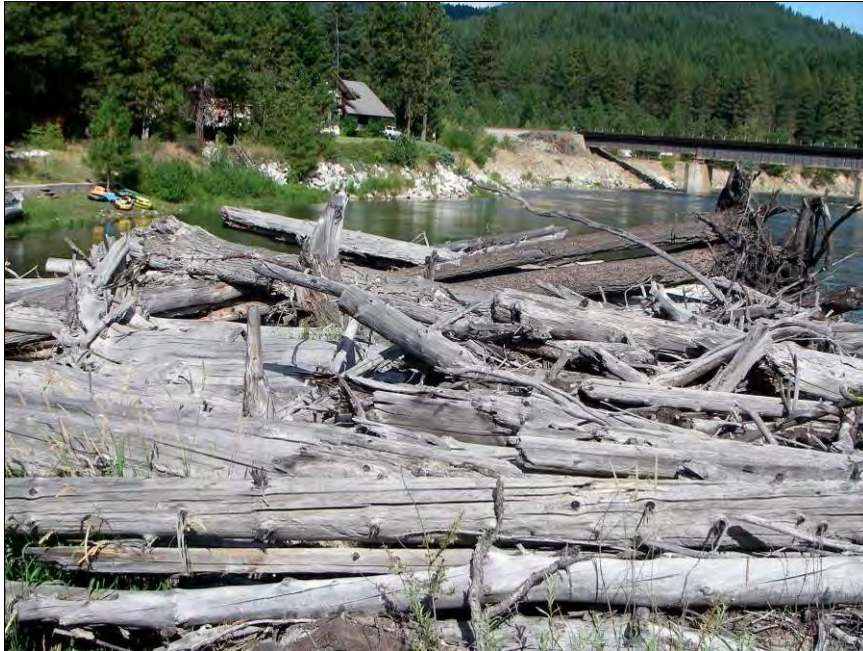
**Figure 46. The largest LWD jam observed throughout the Upper Wenatchee study area was located in Reach 3, just downstream of the Burlington Northern Railroad Bridge at RM 41.8 (August 2011).**

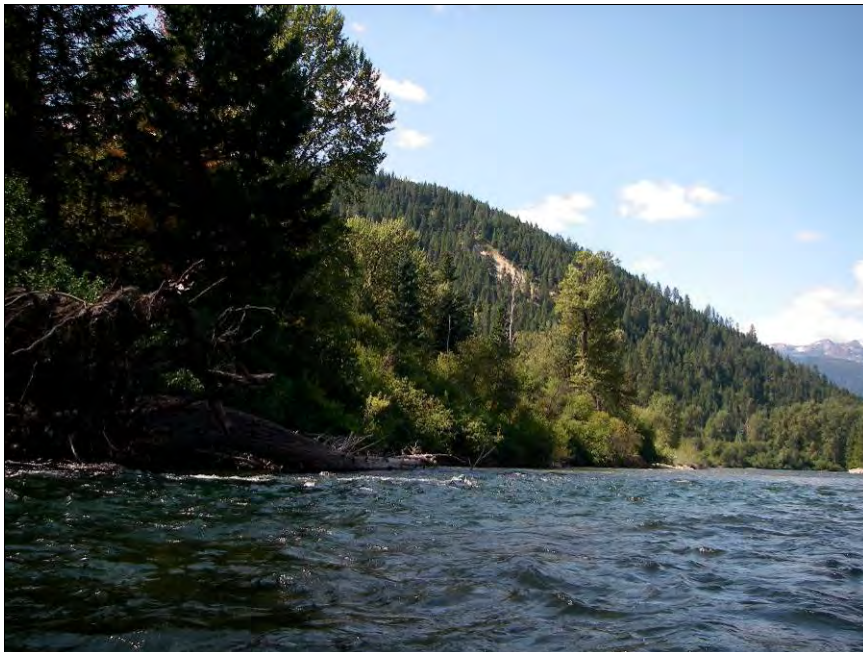
**Figure 47. LWD with attached root wad provides habitat complexity and refuge in Reach 3 (August 2011).**

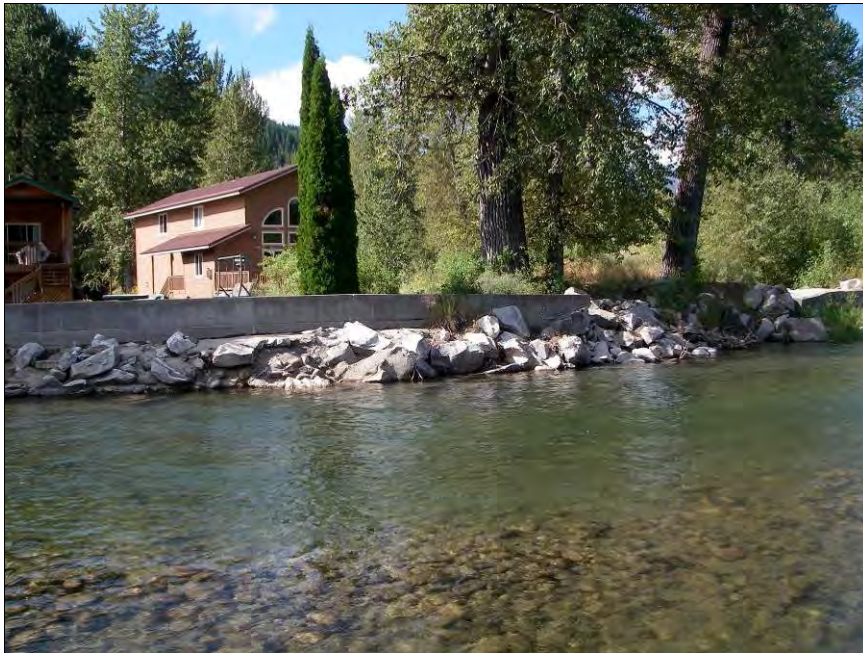
Bank erosion was moderate when compared to other reaches within the study area. Reach 3 had a total of 5,721 feet of actively eroding streambank (measured above bankfull), consisting of 11% of the reach length along both banks. Bank disturbance was often associated with land clearing, roadways, residential uses, river access, and steep banks along terrace surfaces. Erosion was greatest between RM 39.7 to RM 39.9 and from RM 40.3 to RM 40.7 (1,100 and 1,284 feet, respectively). This portion of Reach 3 has been straightened and highly armored with large boulder riprap and spur dikes. Additional bank hardening material was observed near RM 39.55-39.7, RM 41.1-41.2, and RM 41.53-41.81 (Figure 39).

**Figure 51. Concrete bank armor and riprap prevent natural channel process along much of Reach 3’s right bank as seen near RM 41.7 (August 2011).**

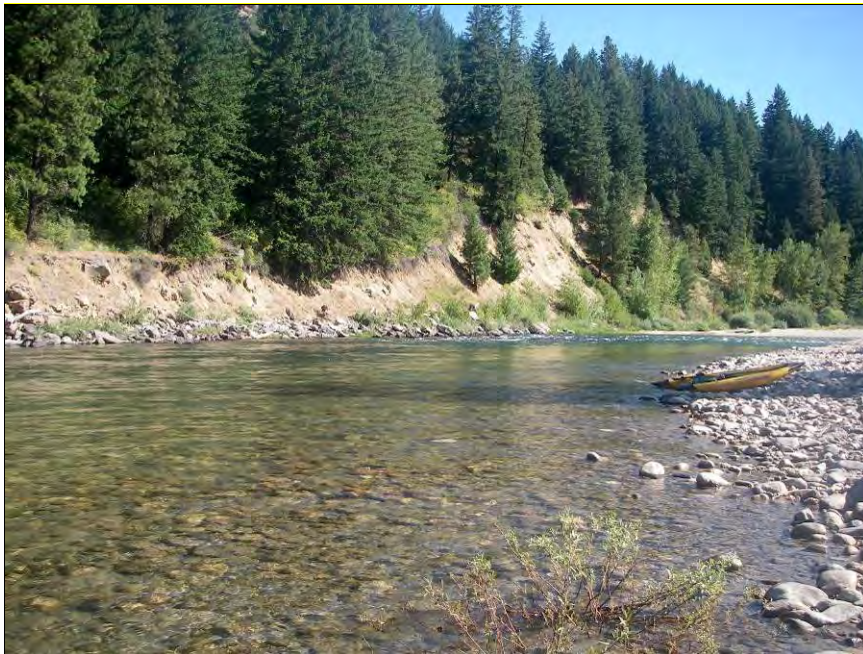
**Figure 52. Erosion along the right bank continues upstream at this meander bend near RM 39.25.**

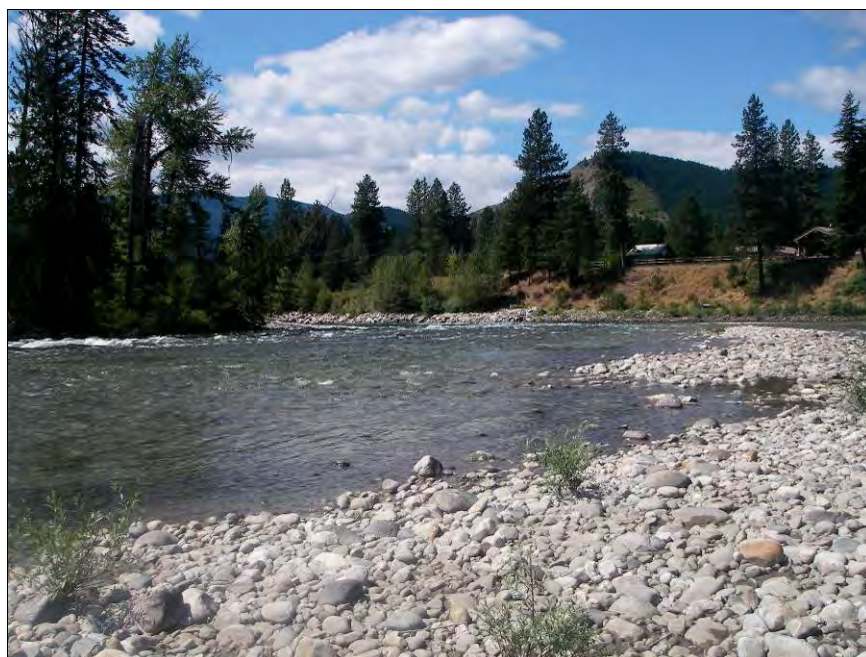
**Figure 53. Large substrate was encountered throughout many mainstem Reach 3 riffles and bars (August 2011).**

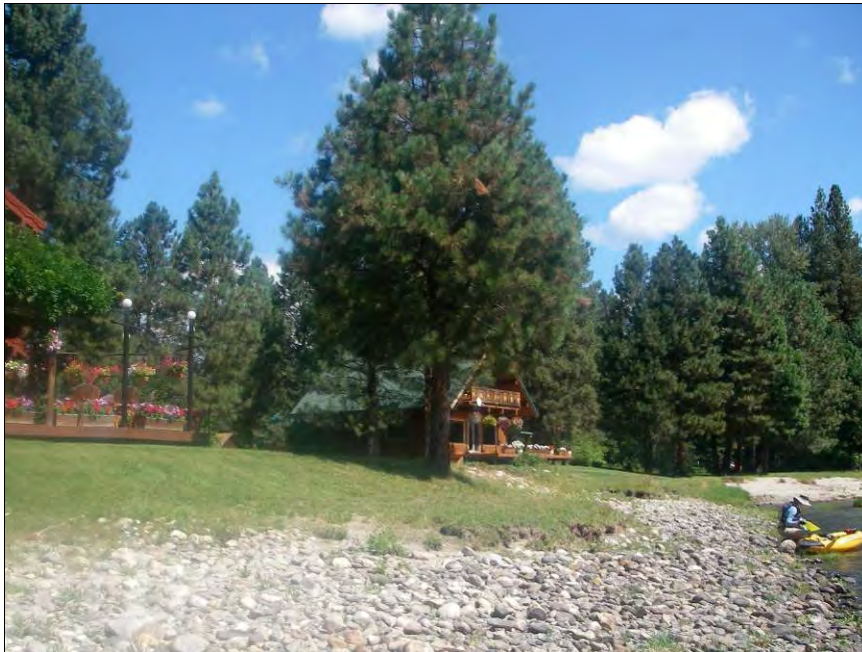
The presence and width of the forested riparian buffer varied within Reach 3. The riparian corridor was disconnected and fragmented by private residential properties, roads, and the railroad along most of the right bank from RM 39.0 to RM 41.9. The presence of a riparian buffer was scarce and fragmented along right bank residential properties, some with lawns extending to the top of bank (Figure 42). Conifer forest dominated the US Forest Service Lands along river-left, while cottonwood and shrubs were dominant along floodplain surfaces along river-right.

**Figure 54. Riparian buffers were scarce and highly fragmented along much of Reach 3’s right bank (August 2011).**

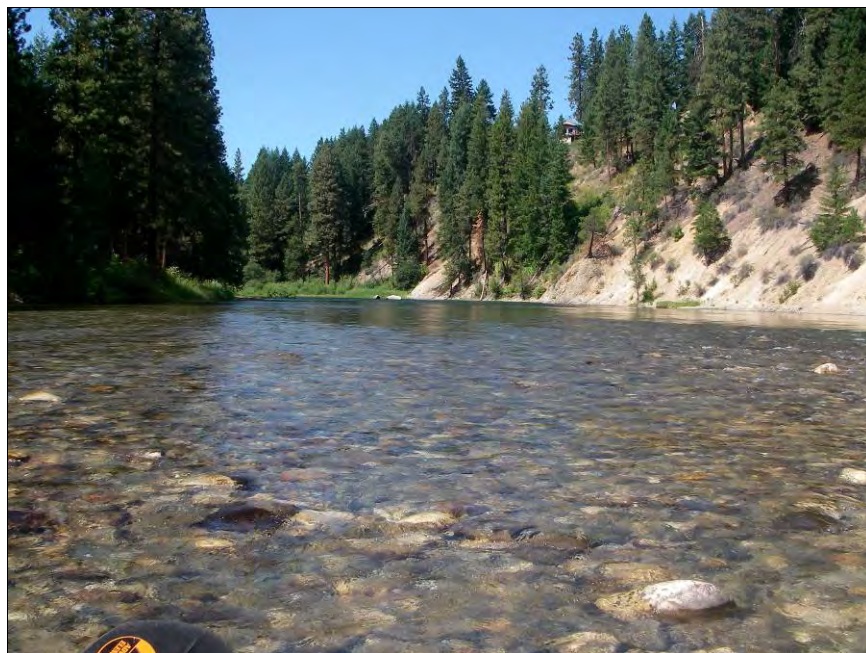
**Figure 56. View looking upstream at the boundary of Reach 4 (RM 43.1). High bank exposure from the Chumstick formation confines the channel along river-left (August 2011).**

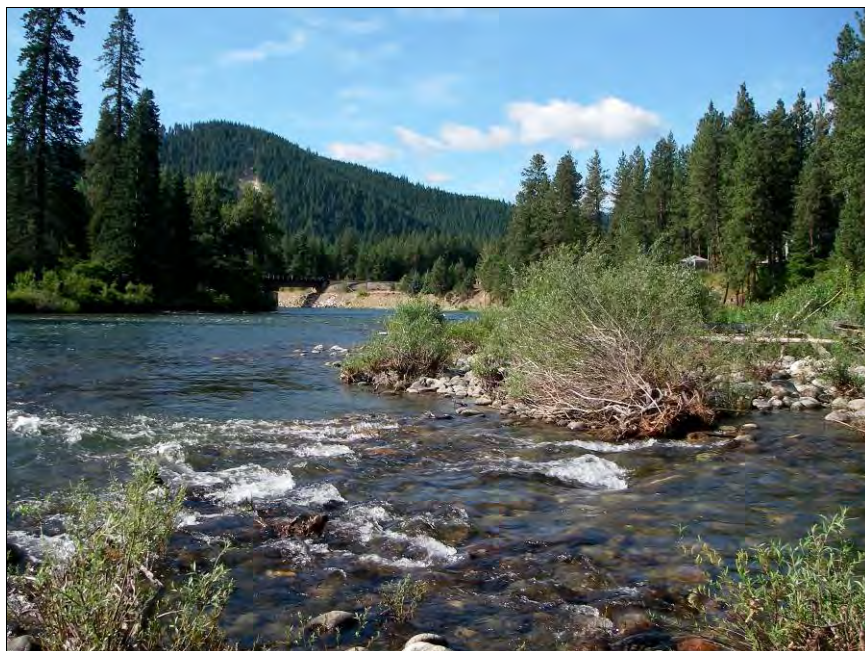
**Figure 60. View looking downstream towards riffle habitat and the right bank terrace towards the downstream end of Reach 4, near RM 42.1 (August 2011).**

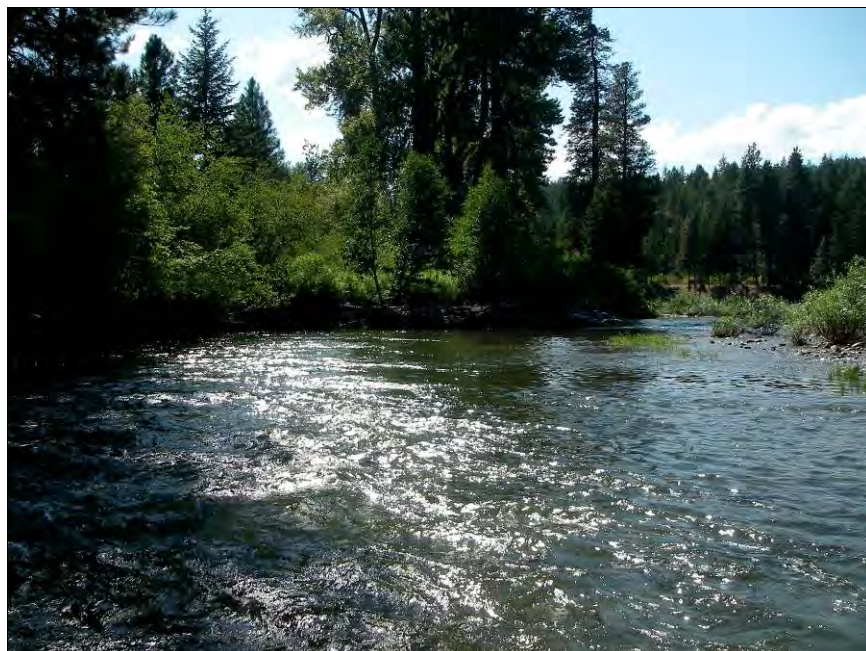
Figure 61. Representative fast water side-channel, Reach 4 (August 2011).

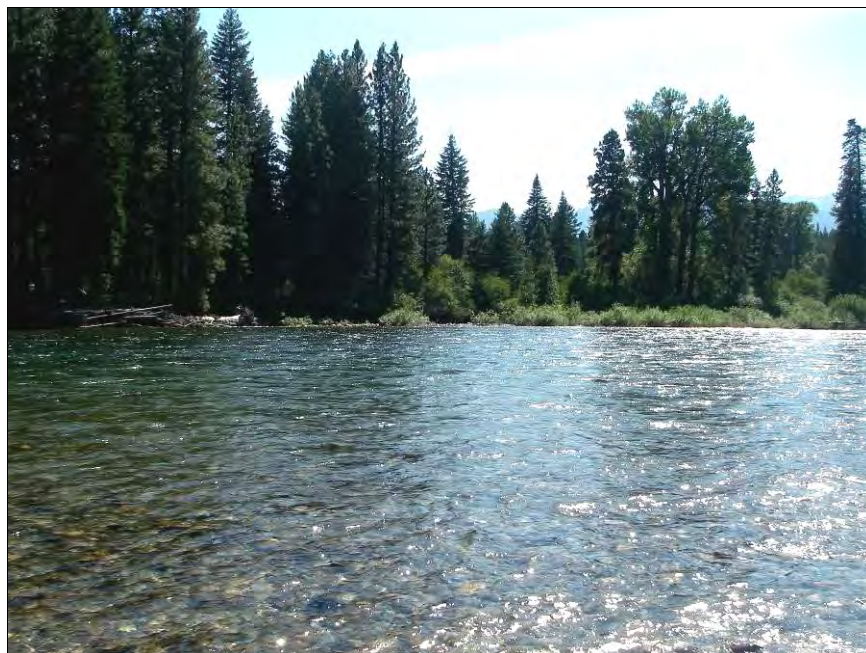
**Figure 62.** Downstream view looking at side-channel habitat and small LWD accumulation along the left bank near RM 42.5 (August 2011).

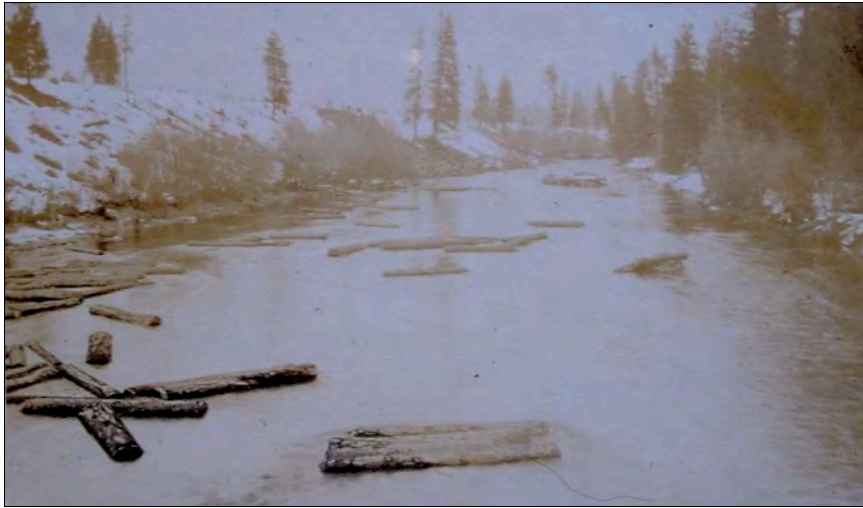
**Figure 67. Historical photo (late 1920s) taken from the Old Plain Bridge looking upstream towards a logged right bank alluvial terrace (left-hand side of photo).**

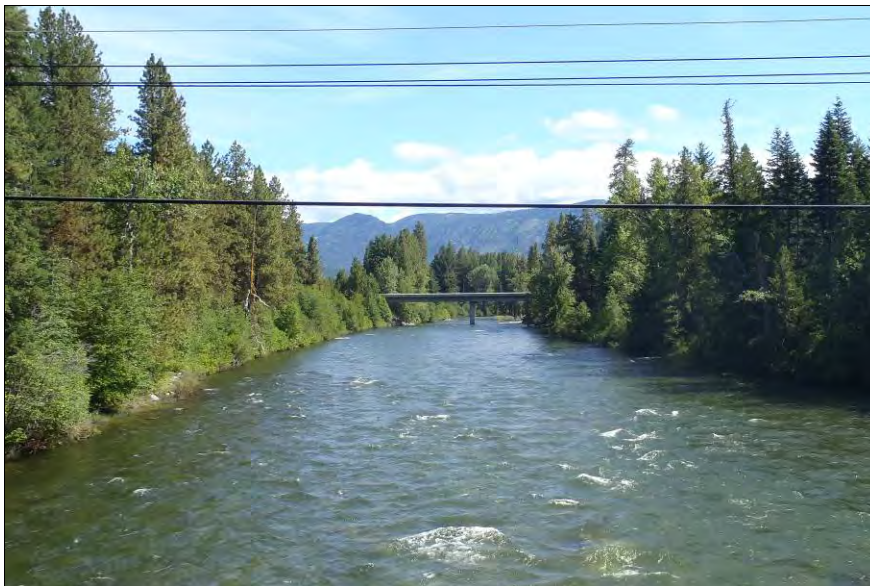
**Figure 68. Recent photo (2011) from the Plain Bridge looking upstream. Historical logged right bank alluvial terrace is revegetated (left-hand side of photo).**

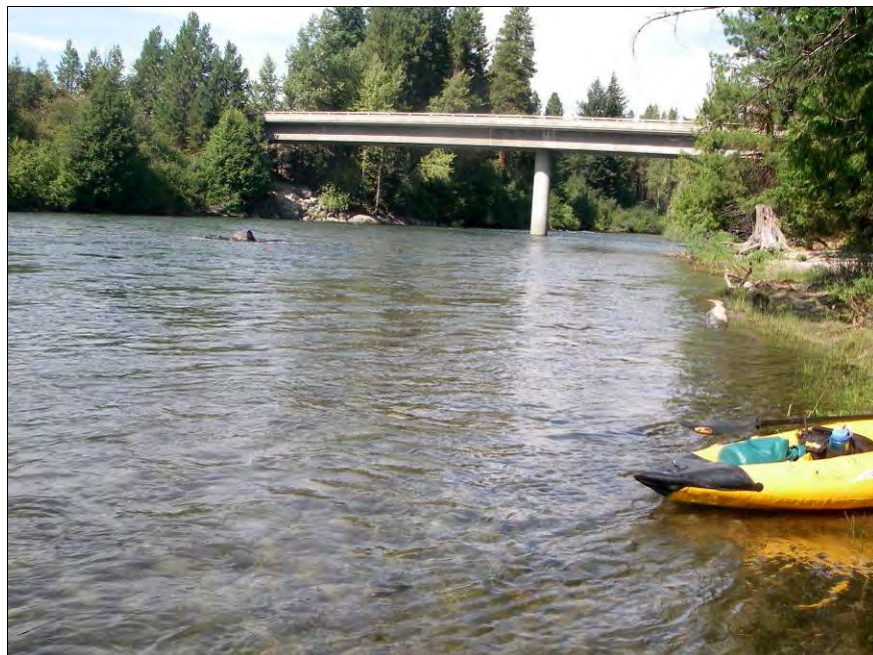
Areas of greatest impact include: the Old Plain Bridge (RM 46.2) crossing; Beaver Valley Rd Bridge (RM 46.4); River Rd where it abuts the channel (RM 43.6 to RM 44.1); and a transmission line (RM 44.45) crossing. These sites were associated with bank armor, land clearing, removal of riparian vegetation, and/or fragmenting the riparian corridor and floodplain. Examples of these impacts are included in Figure 61 and Figure 62.

**Figure 73. Beaver Valley Rd Bridge bisects the upper portion of Reach 5, where the channel is artificially confined by riprap armoring (August 2011).**

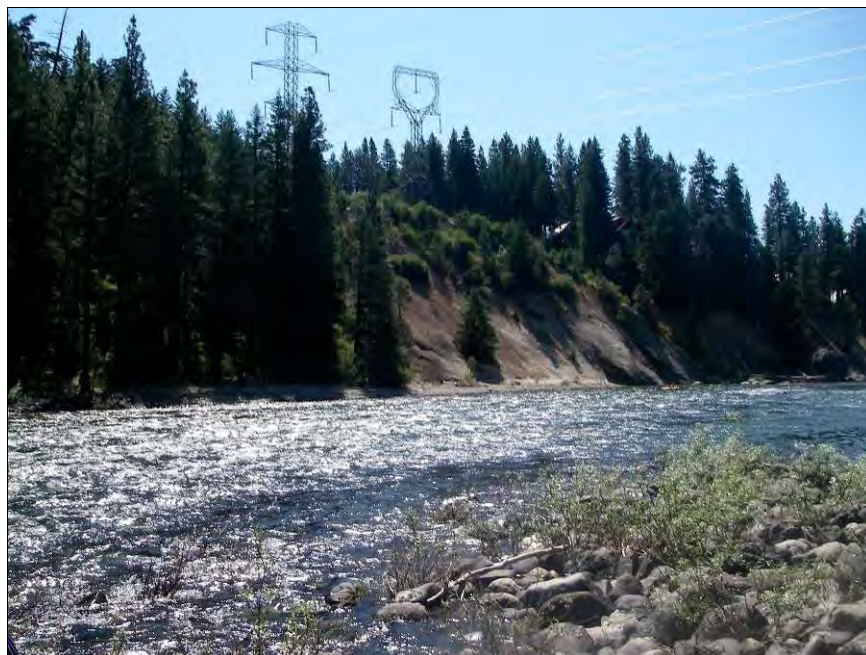
Bank erosion was moderately high when compared to other reaches within the study area. Reach 5 had a total of 5,000 feet of actively eroding streambank (measured above bankfull), consisting of 15% of the reach length along both banks. Bank disturbance was often associated with land clearing, roadways, residential uses, river access, and steep terrace banks.

Figure 74. Transmission line clearing affects the riparian buffer and erosion near RM 44.45 (August 2011).

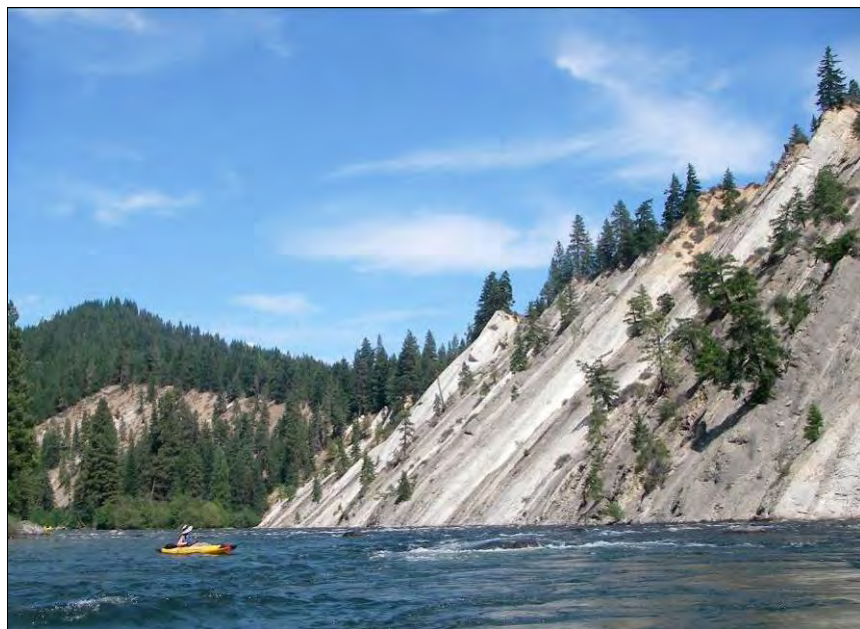
**Figure 76. The Chumstick formation confines much of Reach 6 along river-left. This steep exposed sedimentary rock formation extends from RM 46.7 to RM 46.9 (August 2011).**

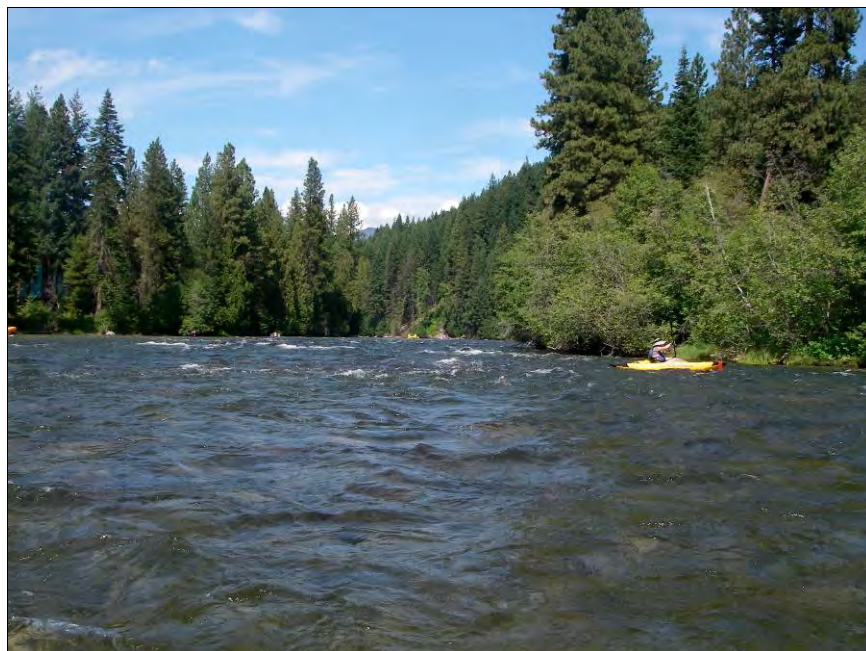
The side-channel at RM 46.9 flowed along river-right (opposite the sedimentary rock formation). It was composed primarily of cobbles (30%) and boulders (50%), providing little spawning habitat and limited velocity refuge. Riparian vegetation along the right bank did provide stream shade despite understory clearing and home building.

**Figure 81. A side-channel (RM 46.9) flows along river-right opposite the steep sedimentary rock formation of Reach 6 (August 2011).**

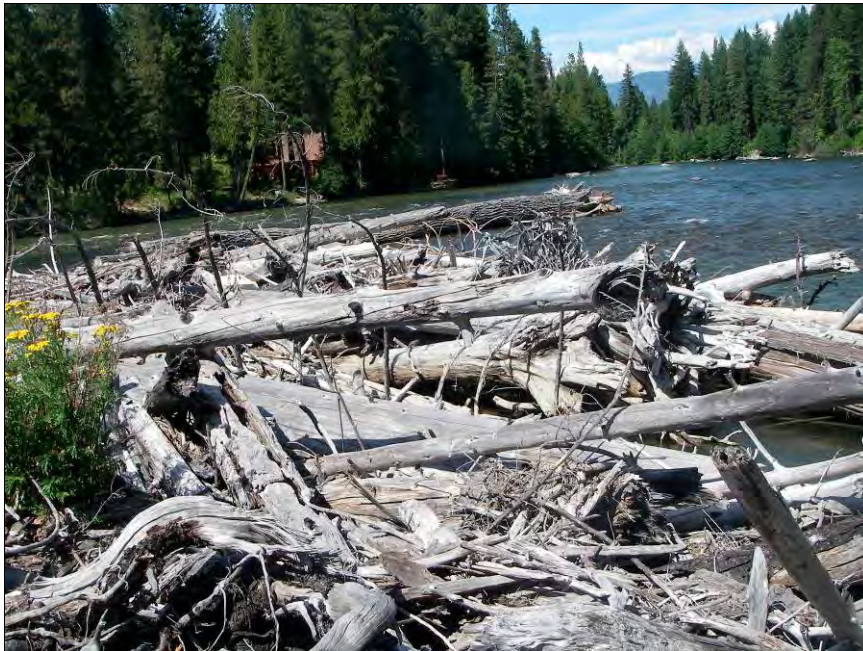
Figure 82. LWD jams have formed along the upstream margins of both mid-channel islands in Reach 6 (August 2011).

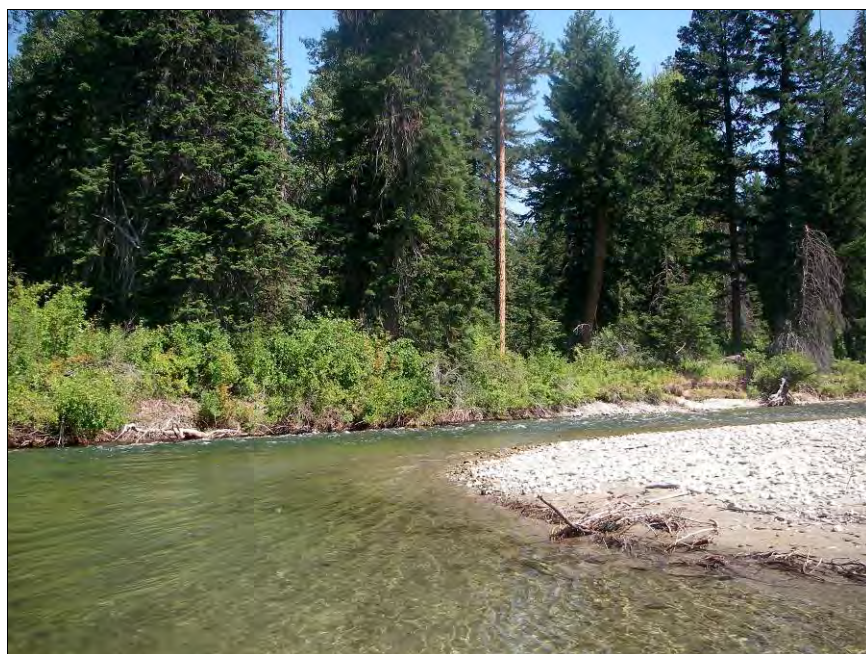
**Figure 86. Sand and gravel alluvial deposits form a bar along the upper portion of Reach 7 on river-left just downstream of the Chiwawa River confluence (August 2011).**

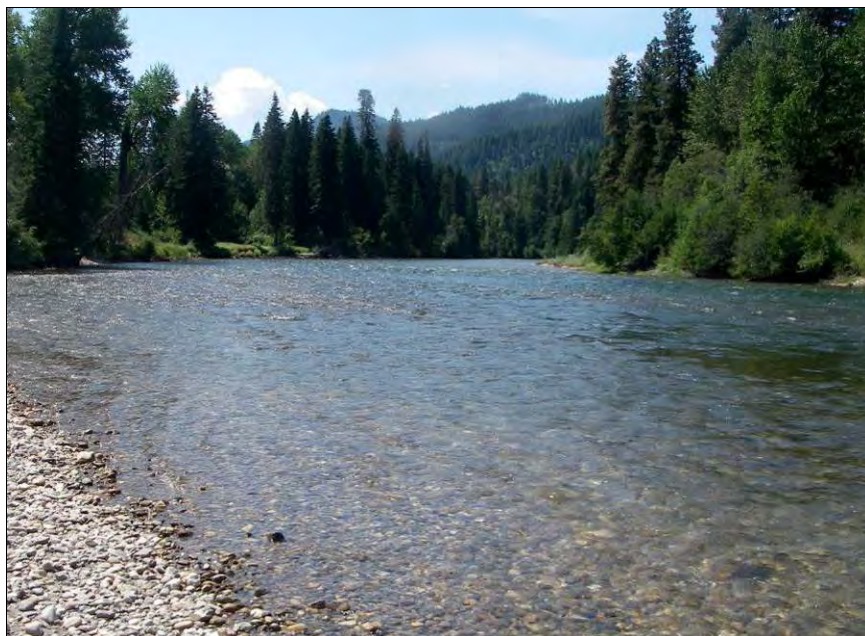
**Figure 90. Alluvial gravel deposits from the Chiwawa River create areas of localized spawning habitat in Reach 7 (August 2011).**

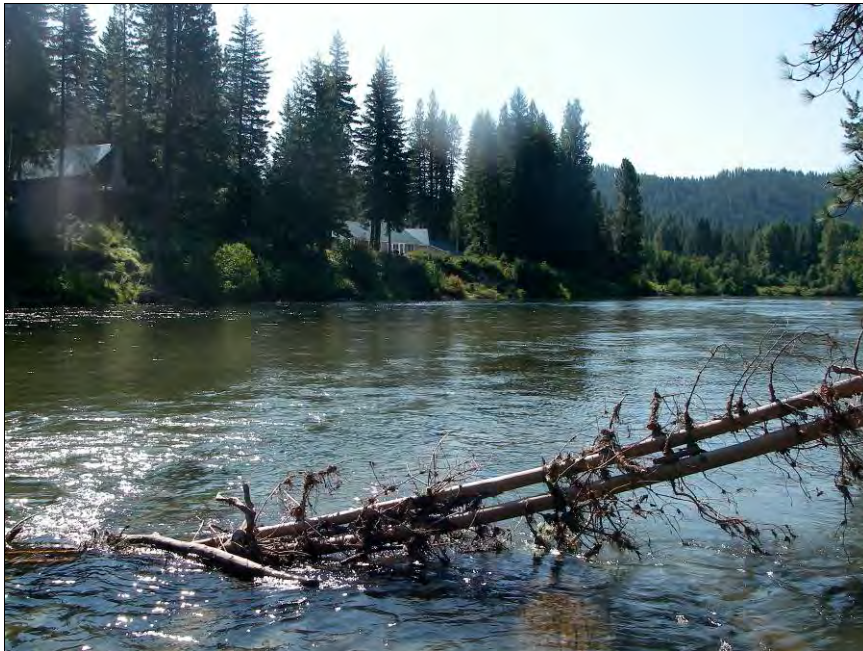
**Figure 92. Glide habitat (RM 49.5) bordered by homesites in the upstream portion of Reach 8 (August 2011).**

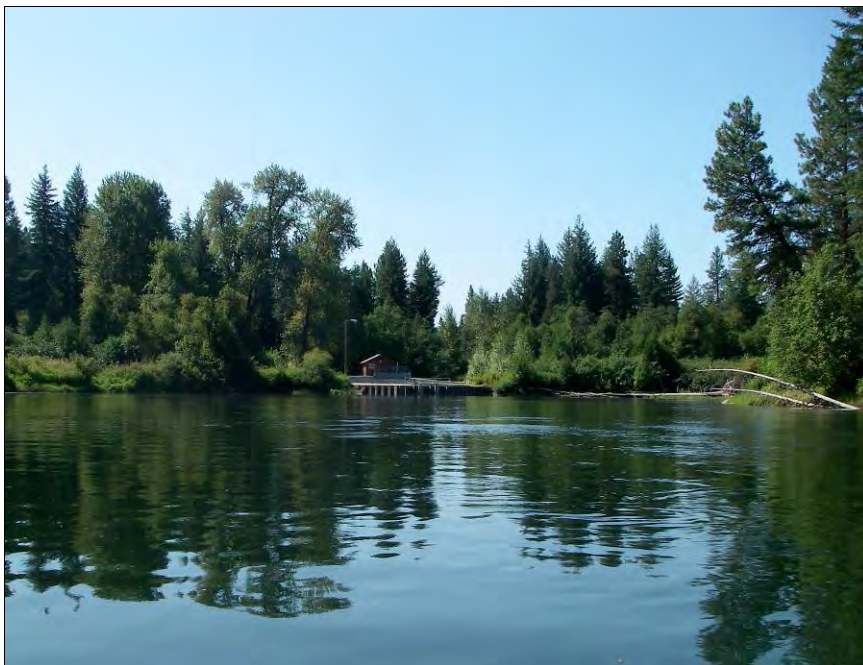
**Figure 93. Small concrete retaining wall at meander bend just upstream from the WDFW hatchery facility (August 2011).**

Bank disturbance primarily occurred along the steep right bank terrace. Erosion was observed along both banks throughout the pool bordering the WDFW facility (RM 49.3) and along the steep terraces from RM 48.8 to RM 49.0. The WDFW hatchery facility was bordered by a concrete retaining wall (Figure 88).

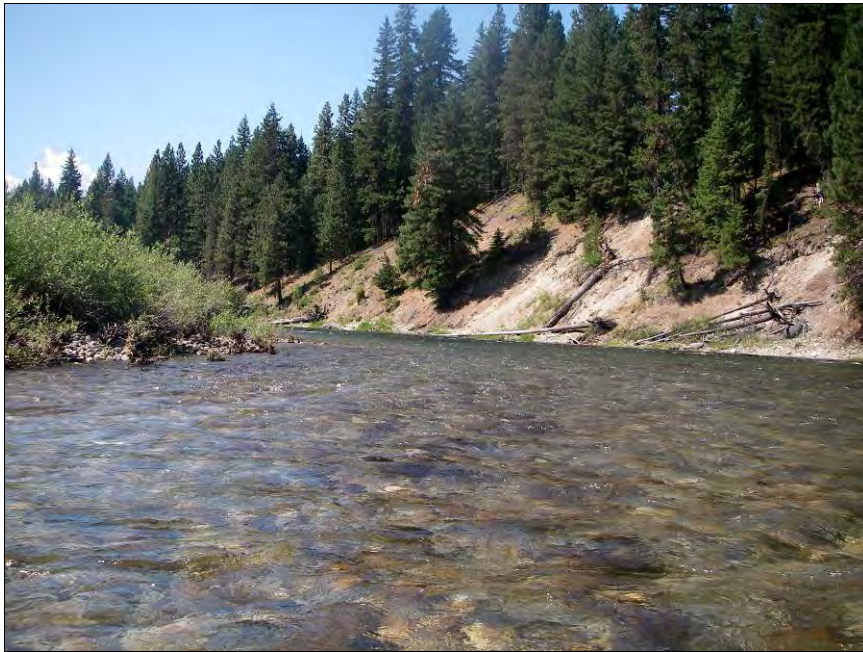
The second side-channel flowed along the river-left bank at RM 48.8. It was a fast water (riffle) unit separated from the main channel by a sparsely vegetated cobble bar (Figure 84). This side-channel appeared to provide both spawning and rearing habitat (gravels and cover).

**Figure 96. View downstream at a sparsely vegetated cobble bar and right bank terrace in the lower portion of Reach 8 near RM 48.8 (August 20011).**

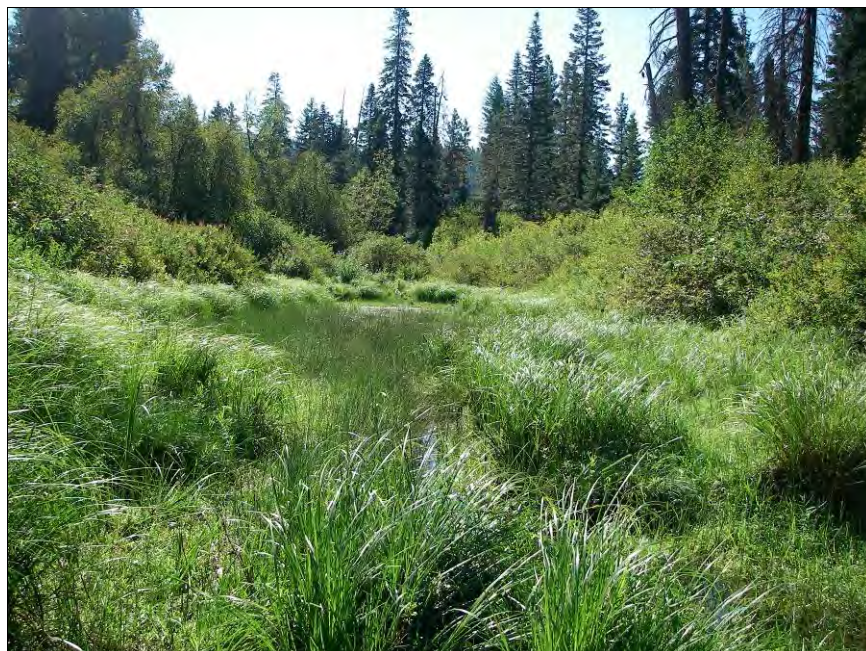
An off-channel marsh (Figure 85) was observed in an abandoned side-channel (meander scar) downstream of the WDFW facility along the river-left bank. Evidence of large wood and scour deposits indicated that this is a high flow channel during floods.

Figure 97. Off-channel marsh along the river-left bank at RM 49.1 (August 2011).

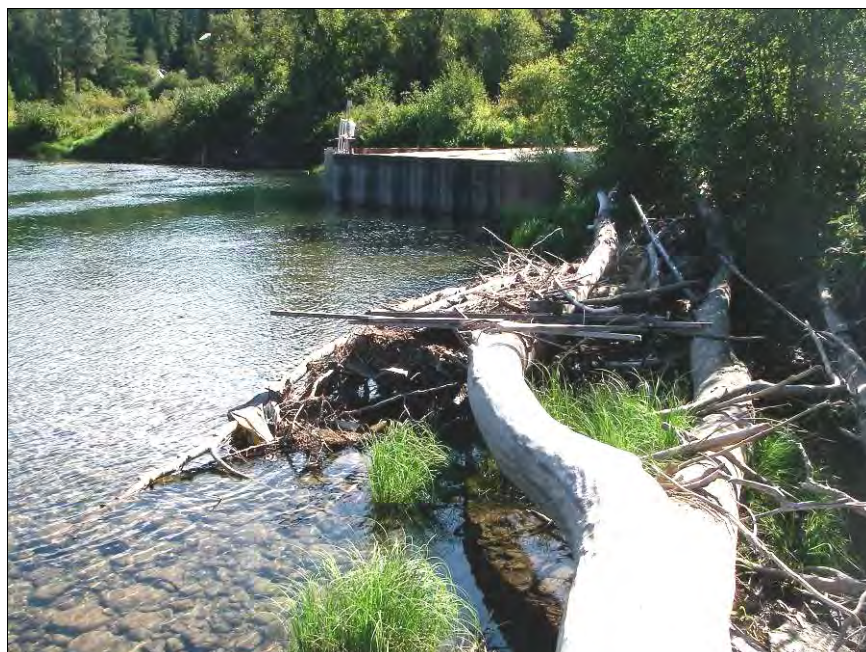
Figure 100. Concrete intake structure at the WDFW hatchery facility (August 2011).

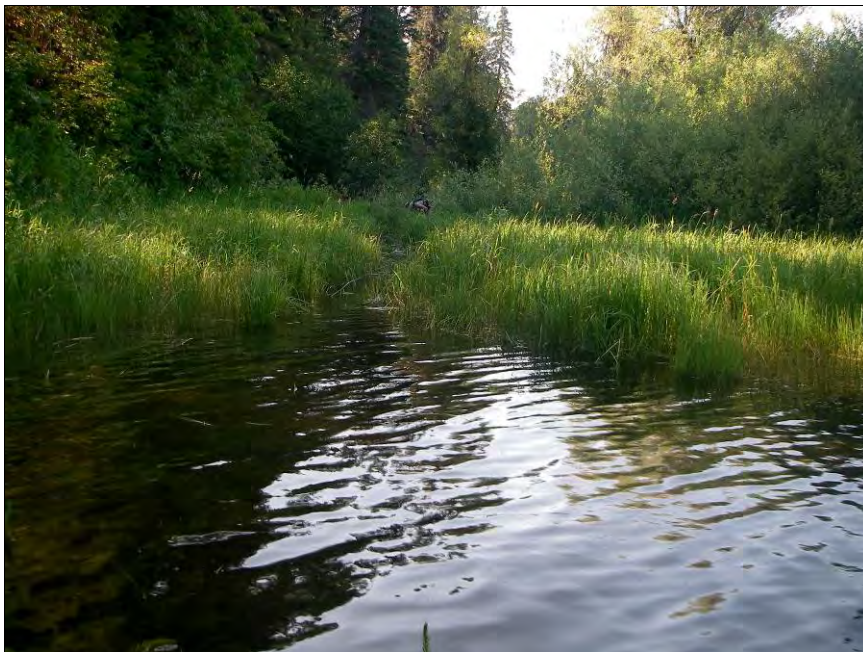
**Figure 107. Beaver activity was observed along a river-right backwater near RM 50.9 (August 2011).**

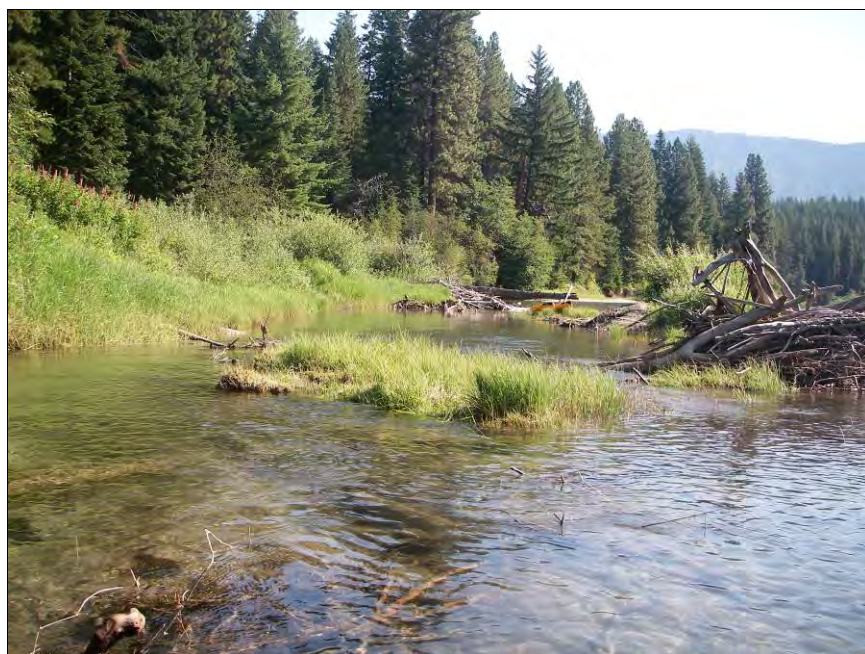
**Figure 108. Woody debris accumulations upstream of the off-channel marsh (RM 50.0) along river-left (August 2011).**
